Panzer-Division 1935-1945

(3) War on Two Fronts 1943-1945

Robert Michulec

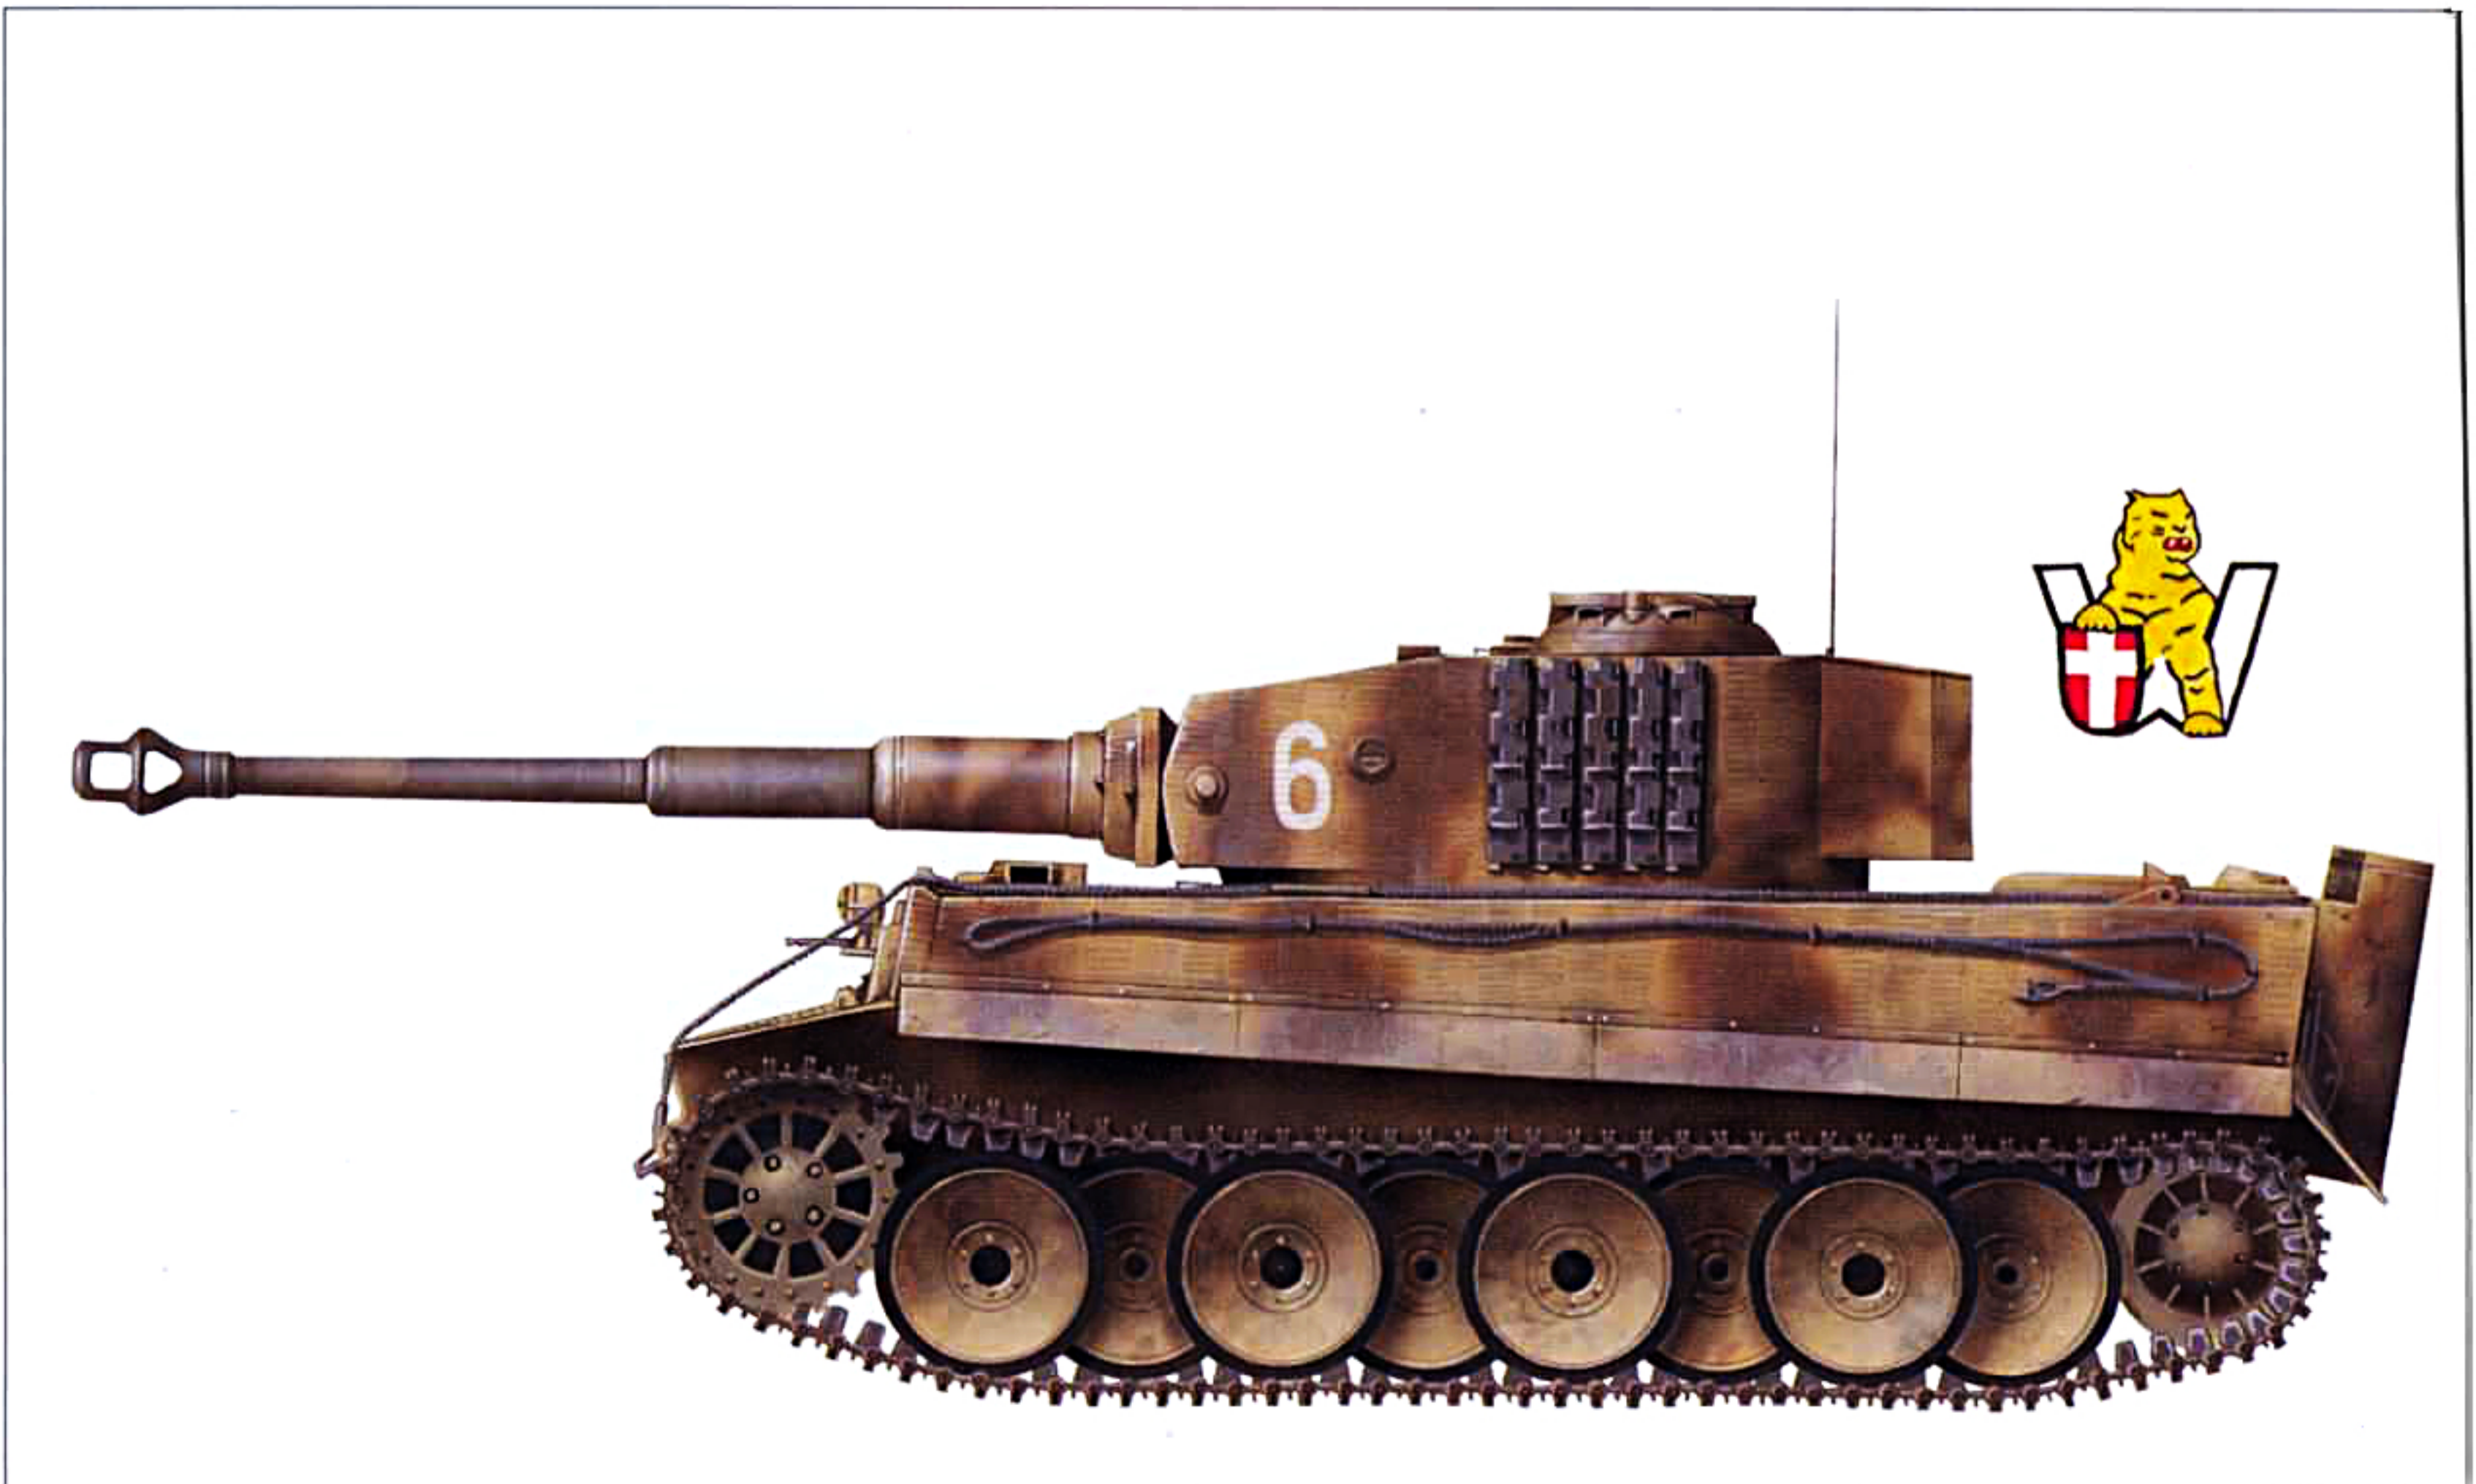
Sd.Kfz.233, unknown Pz.Aufkl.Abt., Poland, summer 1944

This is a later production vehicle that has raised sides on the superstructure around the fighting compartment. The crew have also added an additional spaced armor plate on the front. It is painted in overall dark sand with a random application of green and brown camouflage wavy lines. There are no visible markings.

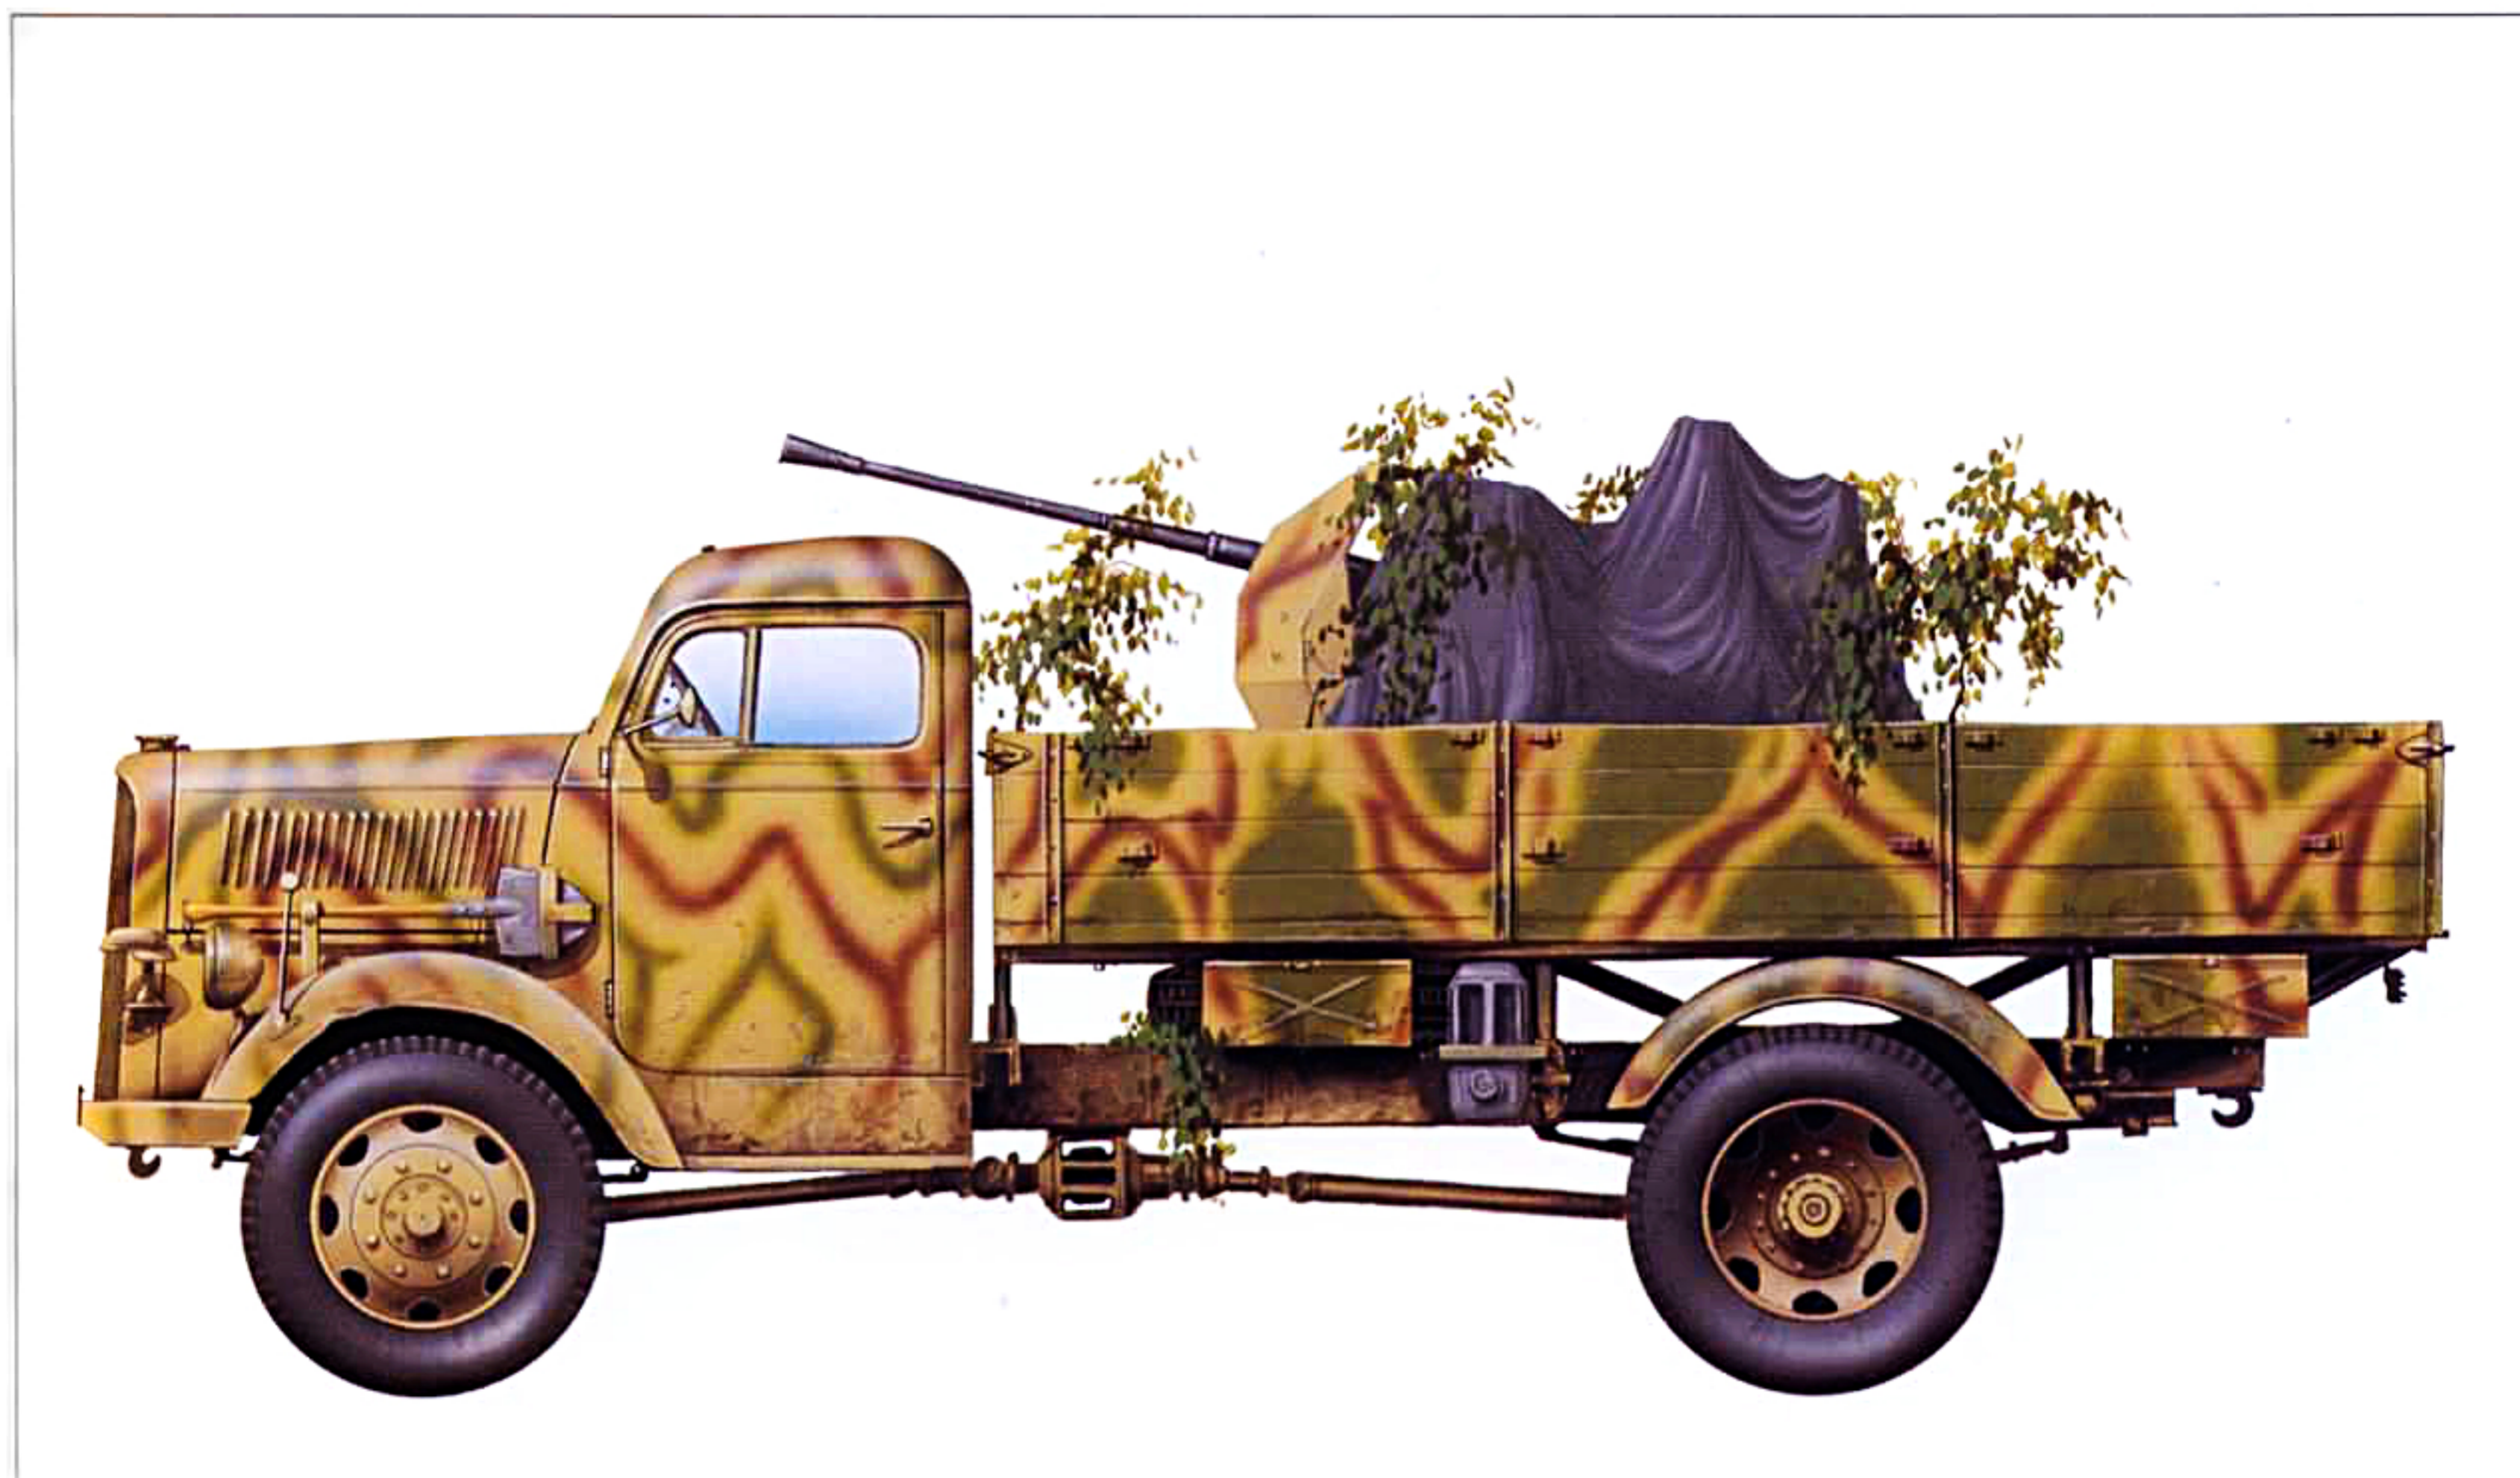
Pz.Kpfw.VI Tiger I Ausf.E., 1./s.Pz.Abt.506, Poland, August 1944

This mid-production Tiger I has a camouflage scheme of brown patches over the dark sand base. The large single digit tactical number, '6', painted in white, indicates this is a 1.Kompanie vehicle. The only other markings on this unit's Tigers, was the colorful emblem painted on the rear of the turret stowage bin, with the color of the 'W' matching the company color. On staff vehicles, the color was green.

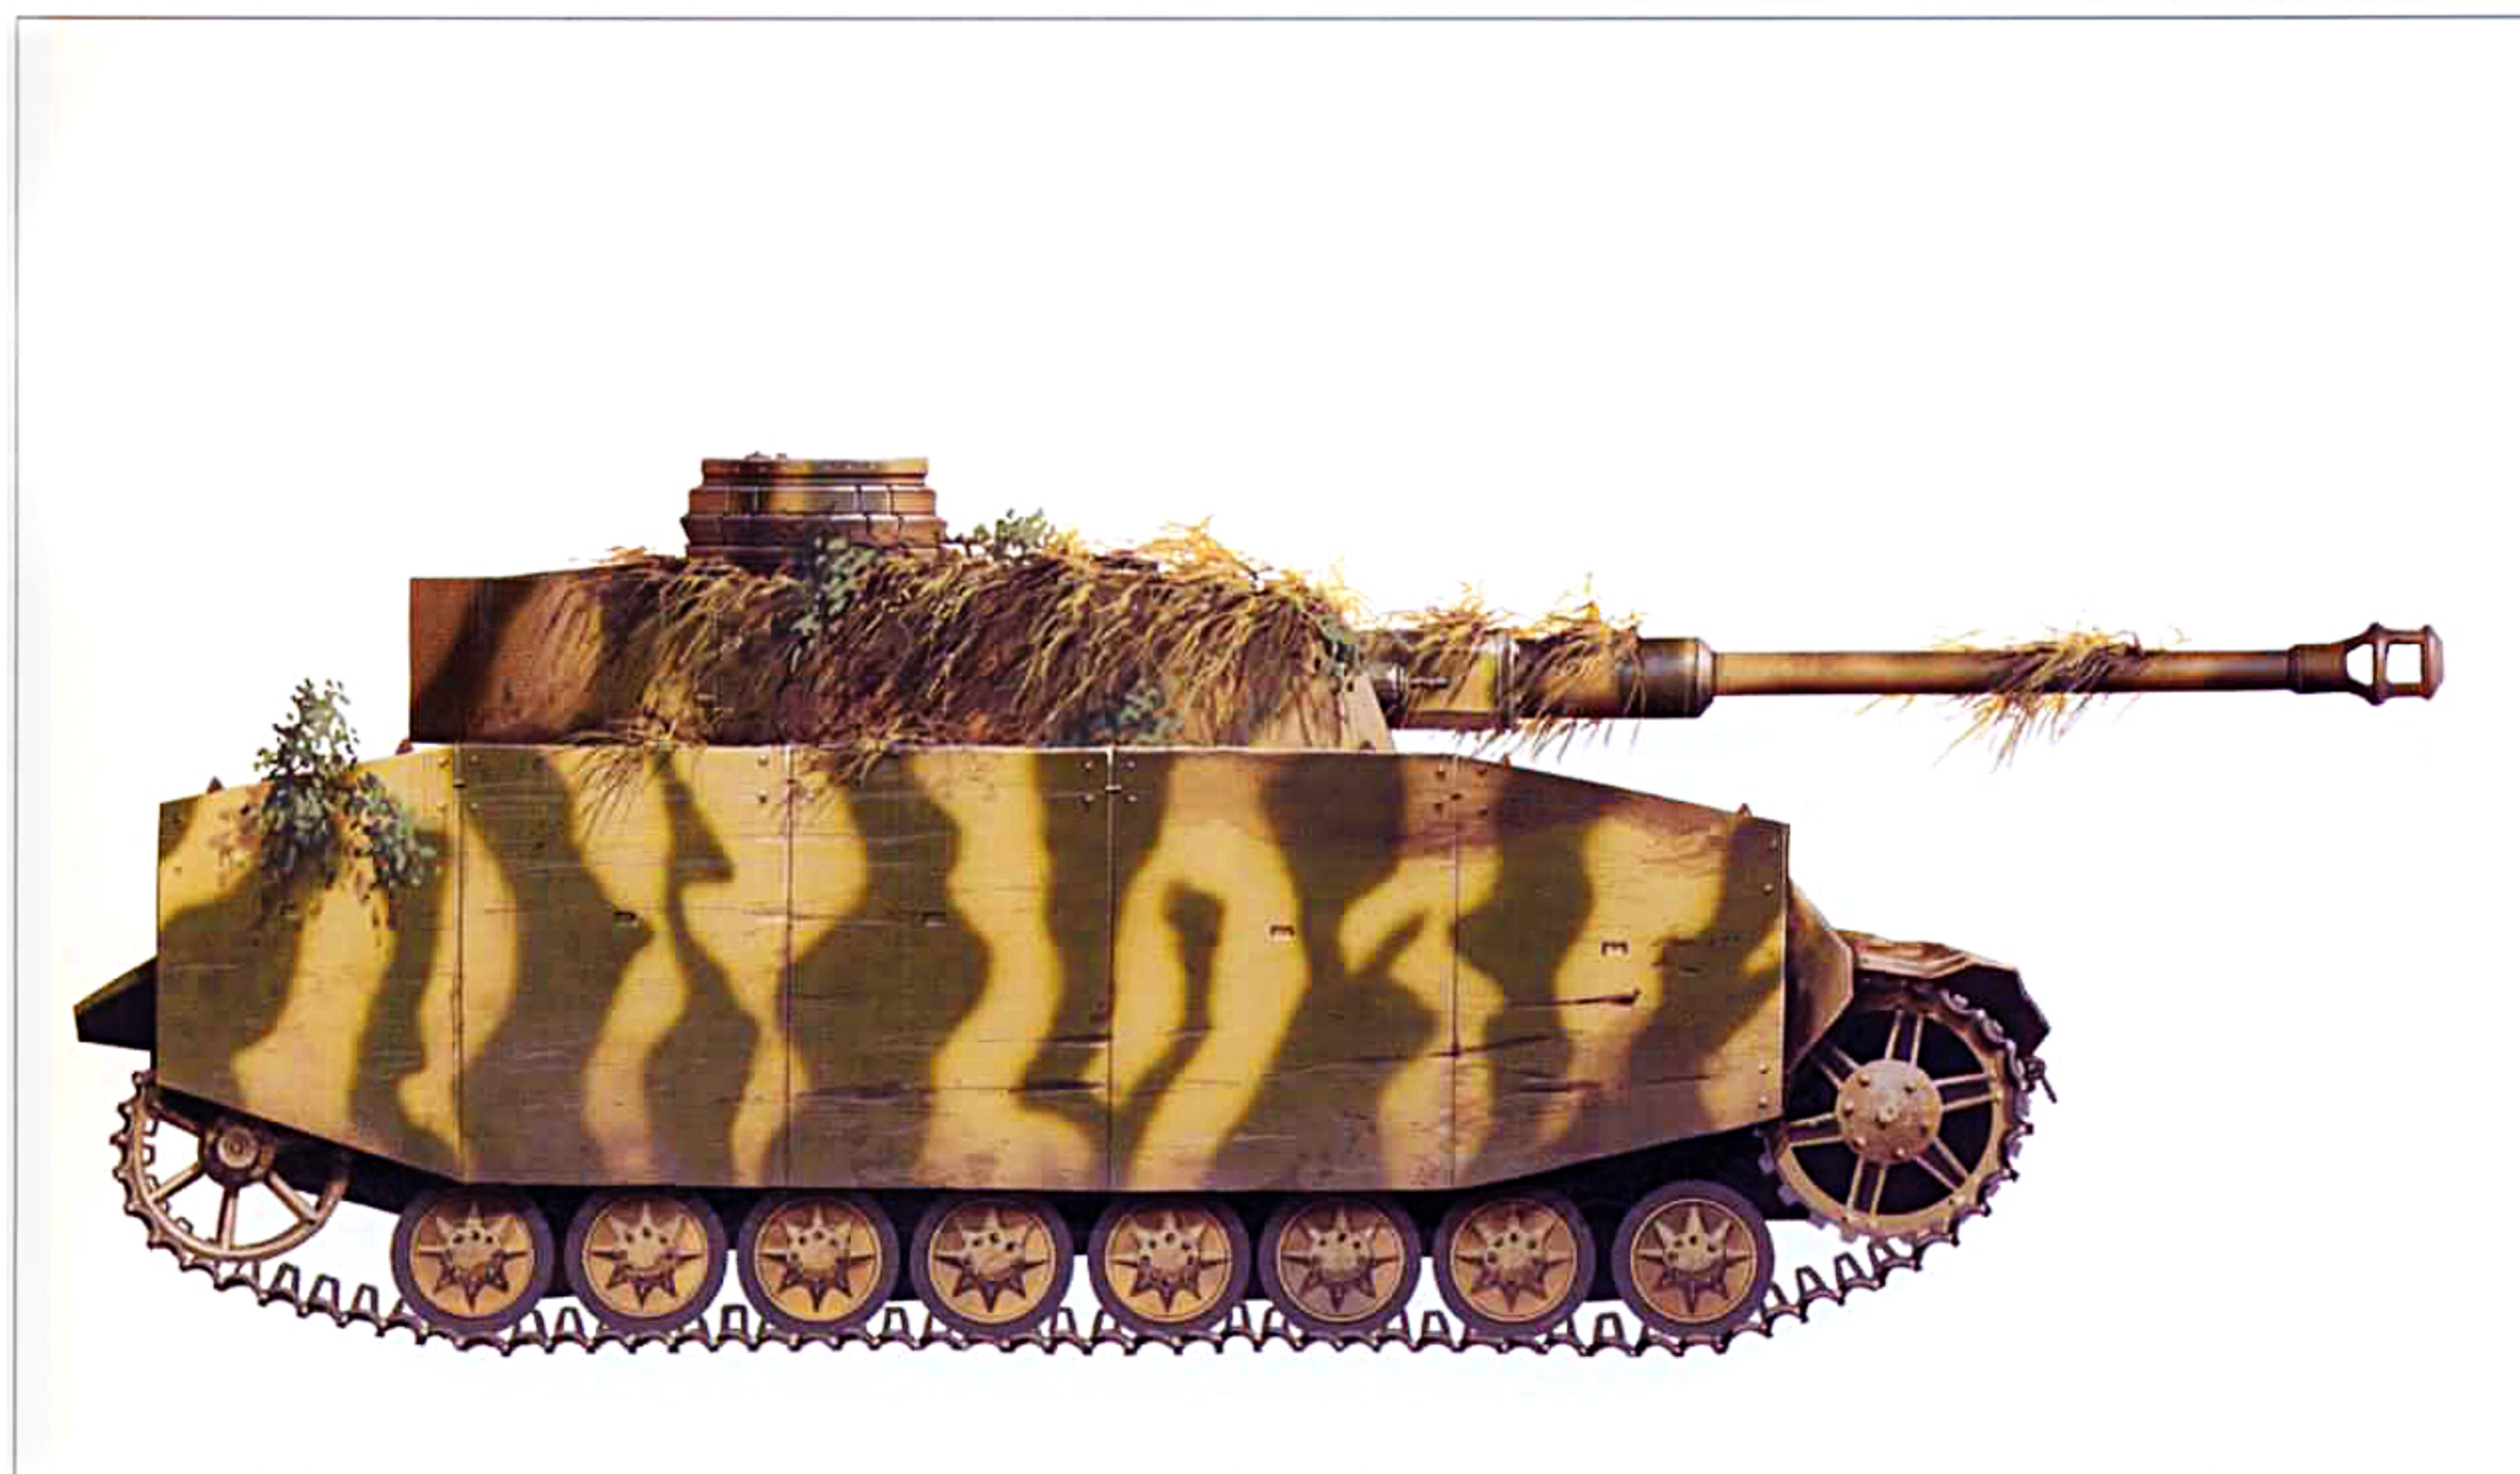
Opel Blitz with 2cm FlaK38, unknown Wehrmacht FlaK unit, Russia, summer 1944

This Opel Blitz 3-ton truck has an elaborate camouflage scheme of green and brown lines and patches applied over the dark sand base. No markings other than the standard vehicle license plates are carried.

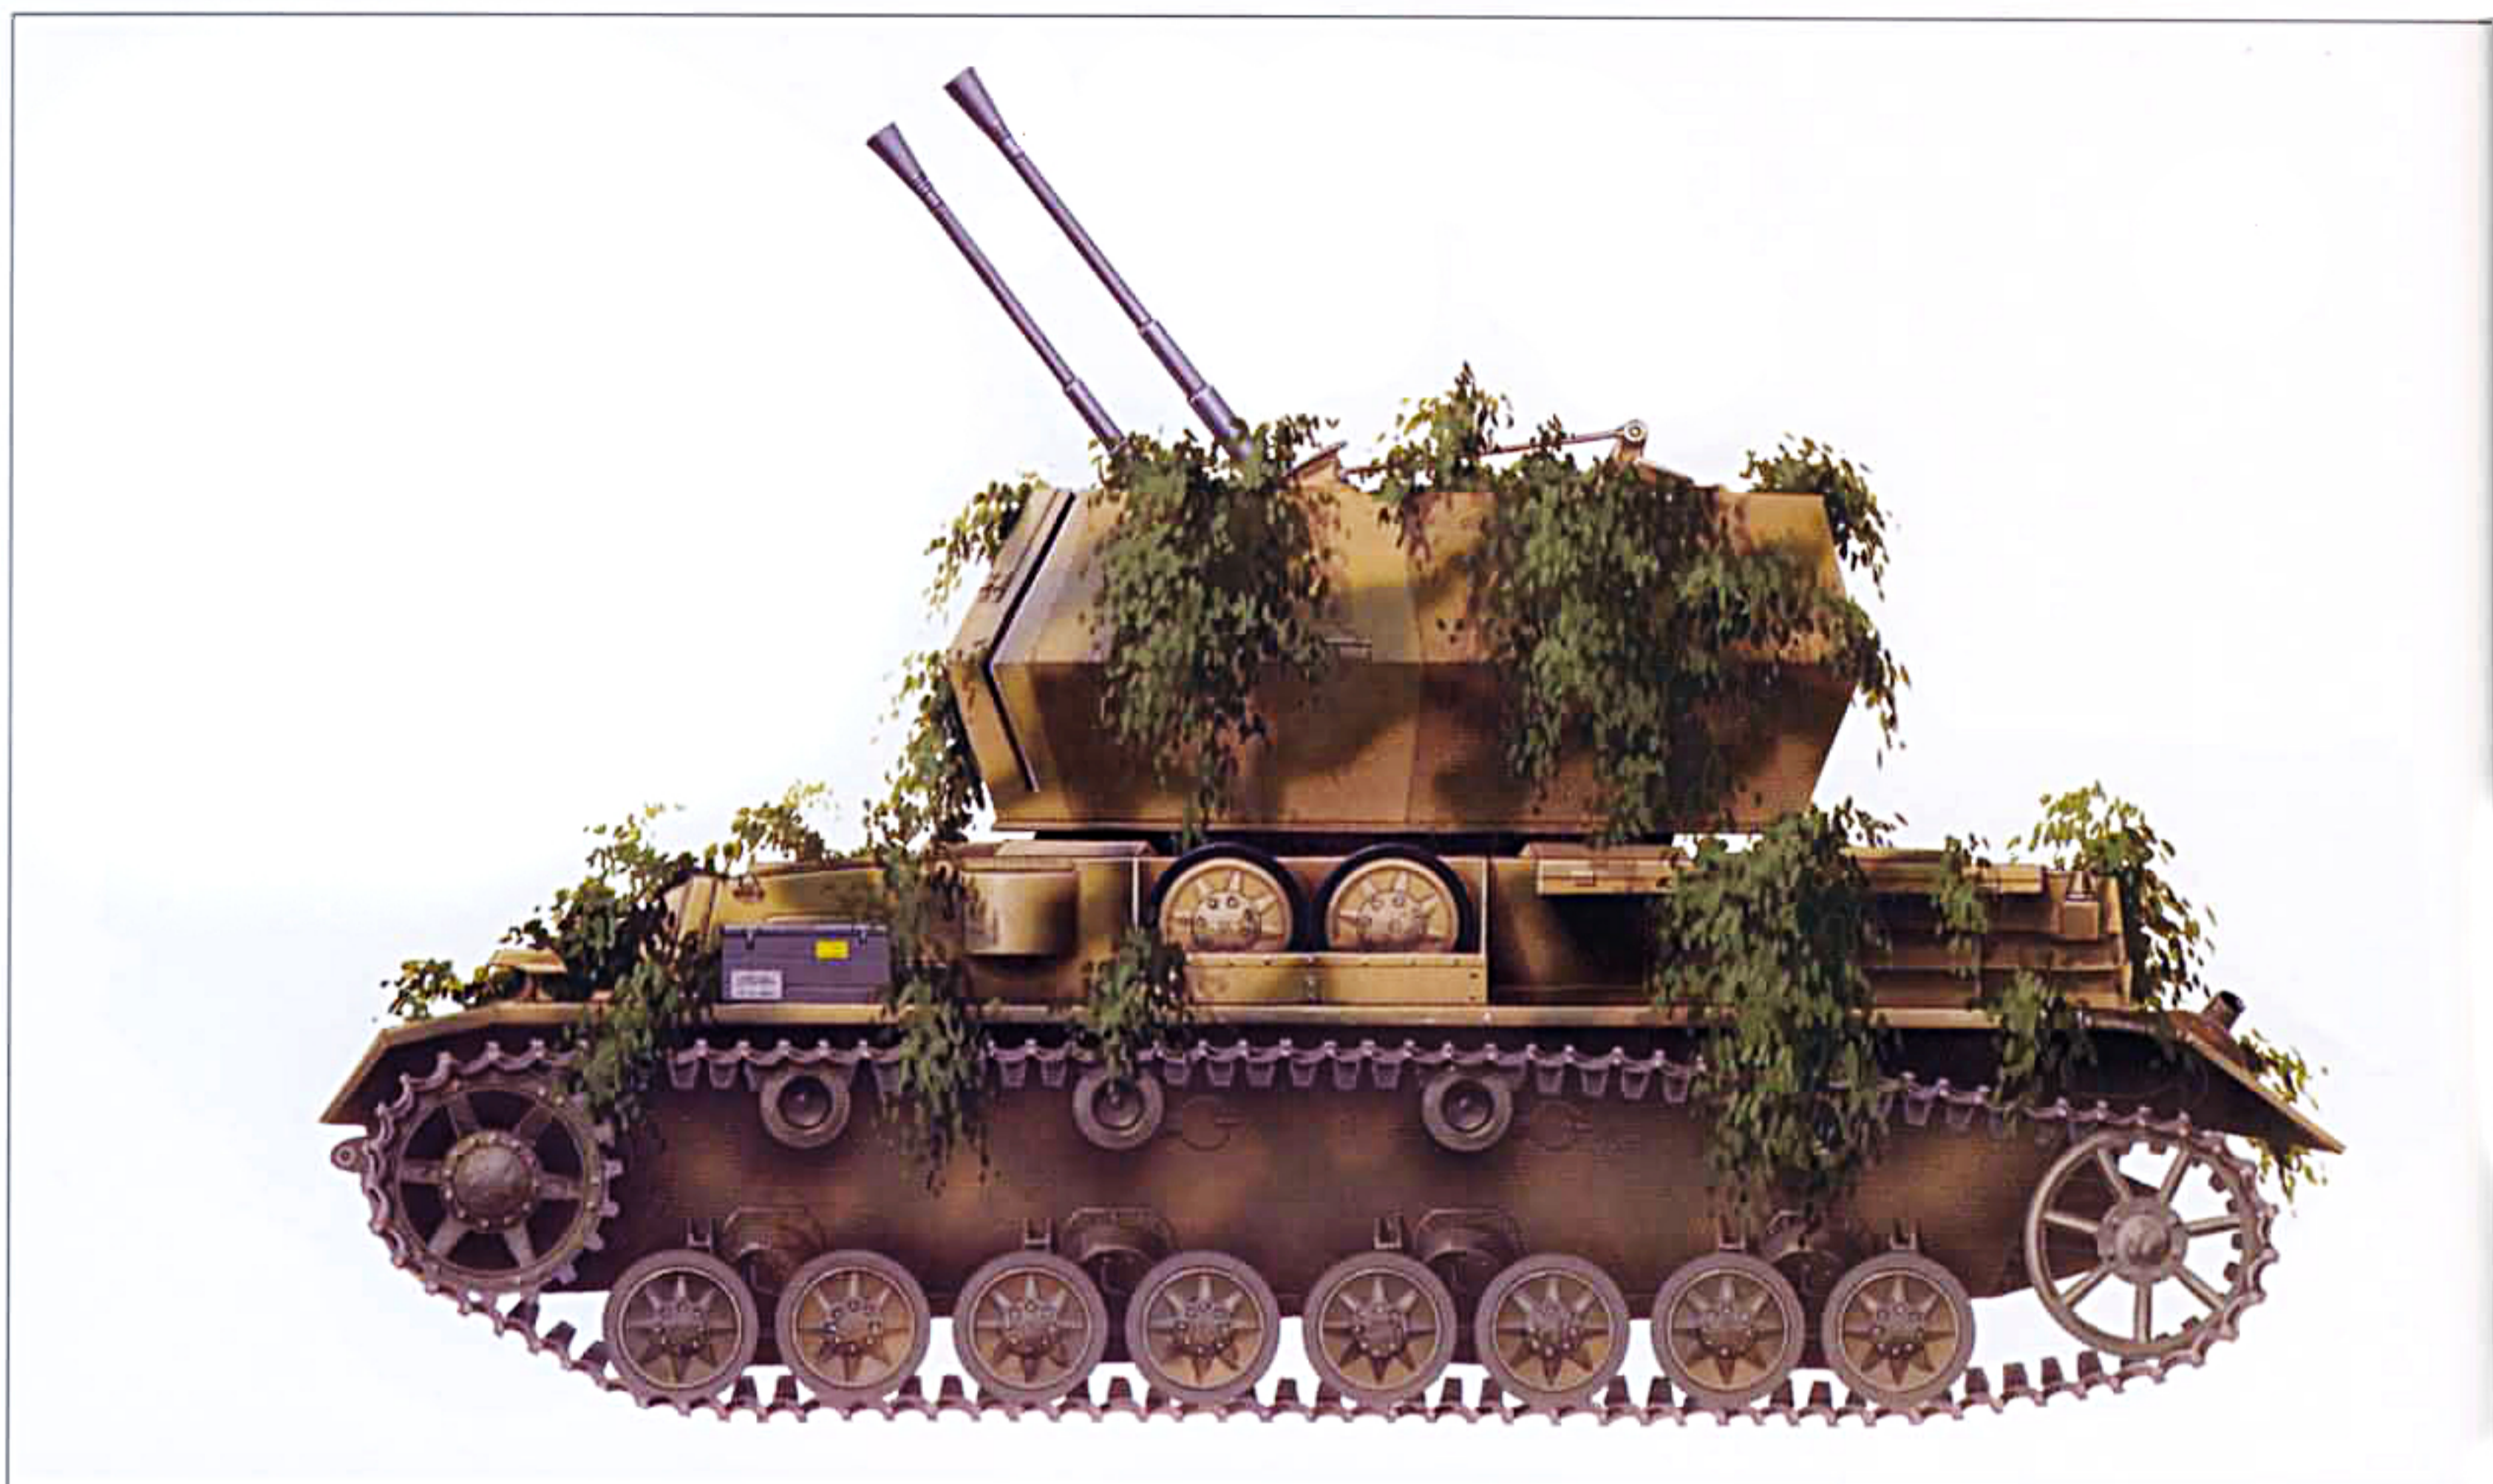
Pz.Kpfw.IV Ausf.J, 2111.Pz.Abt., 111.Pz.Brig., eastern France, September 1944

This Pz.Kpfw.IV Ausf.J is painted with a camouflage scheme of large green vertical stripes applied over the dark sand base. Markings include a three digit tactical number and Balkenkreuz painted on the turret schürzen sides and back, here obscured by the heavy foliage covering the vehicle. Additionally, a small 'vB' is painted in white on the hinged portion of the left front mudguard, probably signifying the name of the unit commander, von Bronsart.

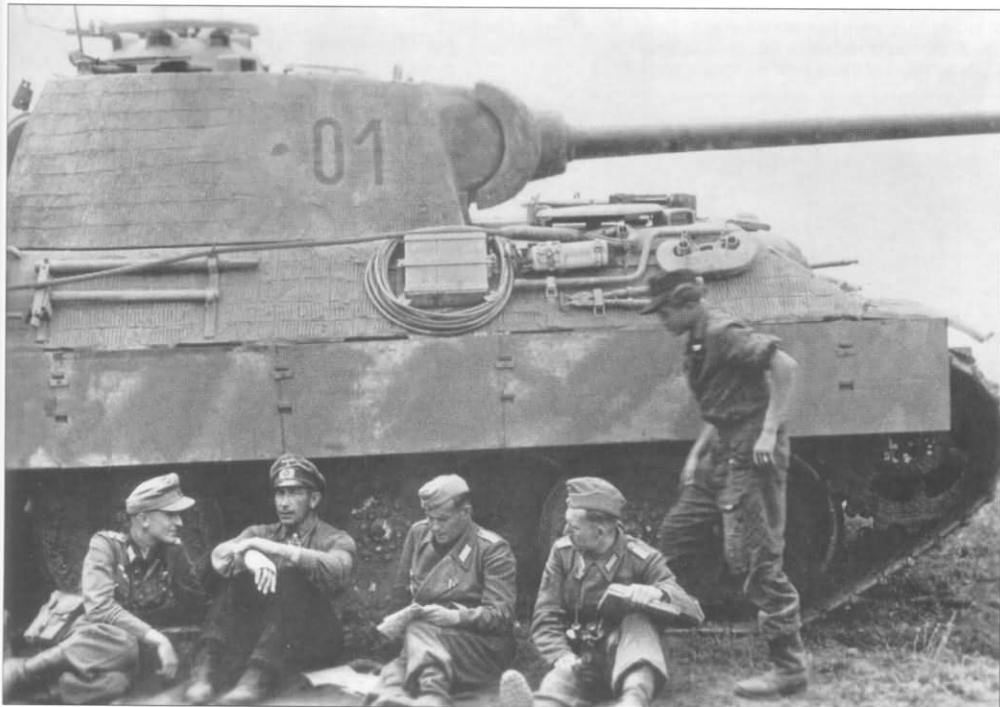
An infantry machine gun squad dismounts from a Pz.Kpfw.V Panther Ausf.G somewhere in Poland during the late summer of 1944. The Panther appears to be fairly new and has zimmerit coating. In early September, zimmerit was dropped along with the requirement to paint the vehicles with dark sand paint. The assembly plants were ordered to apply light patches of camouflage paint directly over the vehicle leaving much of the red oxide primer exposed.

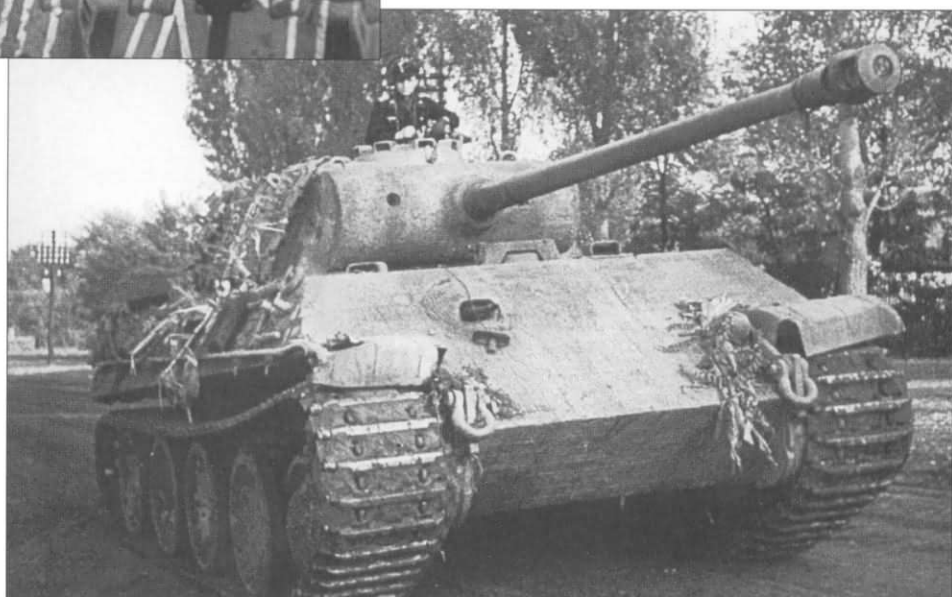
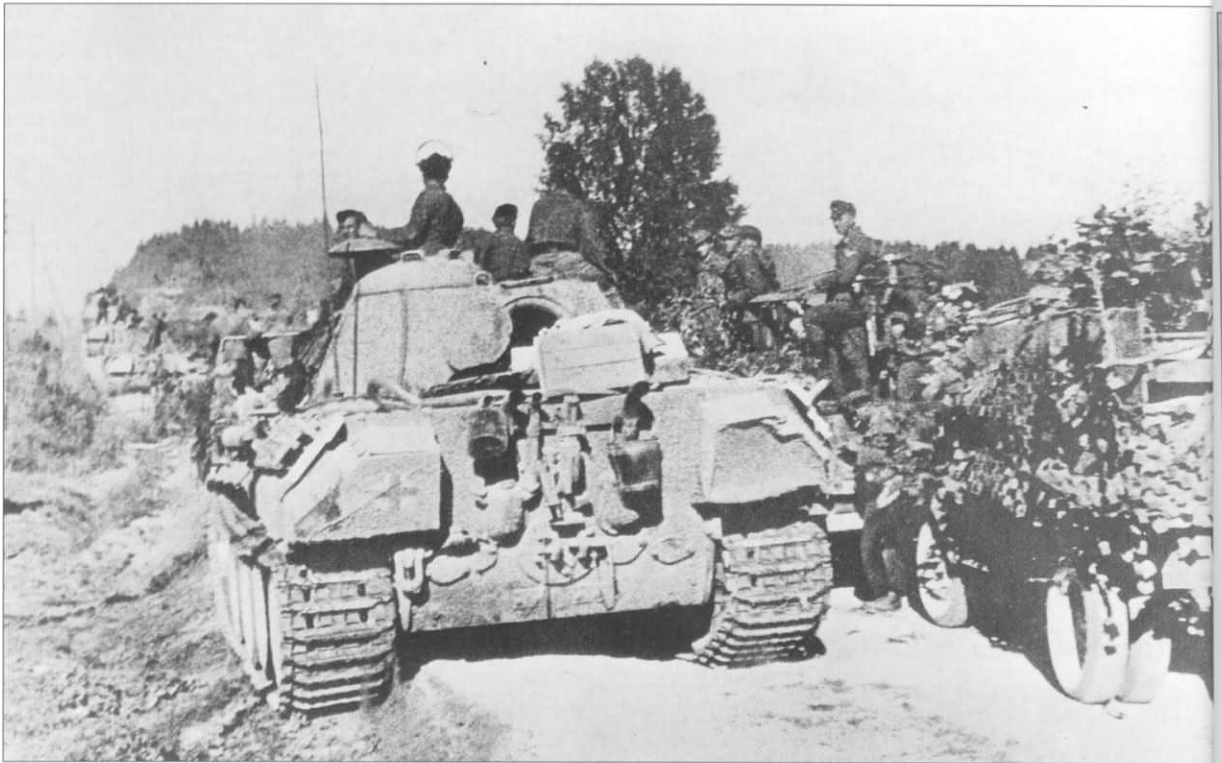
Two photographs of a Pz.Bef.Wg.V Panther Ausf.G from an Army Panzer-Division. It has several rows of spare track links hanging from the side of the turret to bolster its armor protection which was common during the later stages of the war. The white outline tactical number 'IIA1' indicate it is a staff vehicle in second battalion.

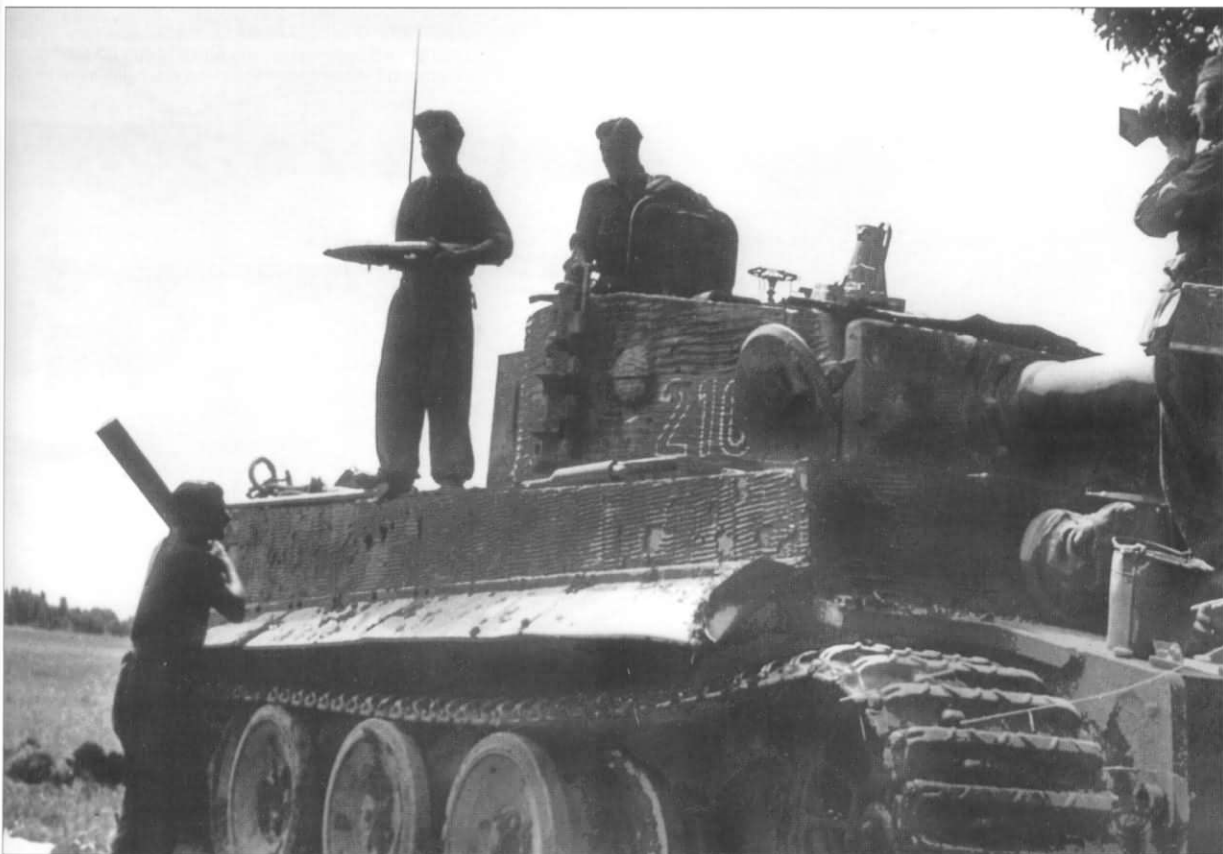
Another Tiger I of s.Pz.Abt.502 having its ammunition replenished while the activity is recorded by a Kriegsbericht who can be seen standing on the front of the vehicle. The tactical number '210' is also painted in red with a white outline. This vehicle is one of those built between October and December 1943 with the gun travel lock mounted on the rear of the hull. It is also missing the front outside roadwheel.

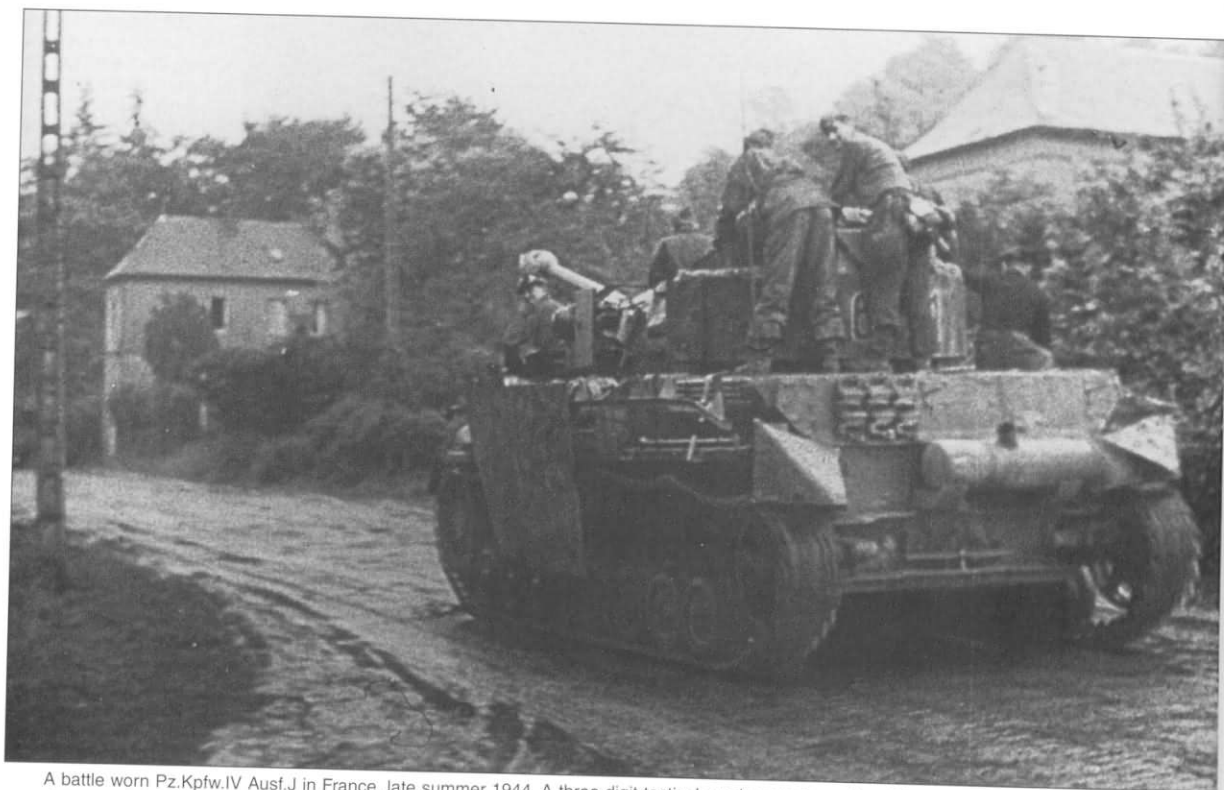
A battle worn Pz.Kpfw.IV Ausf.J in France, late summer 1944. A three digit tactical number starting with a '6' and ending with a '4' can be seen on the rear of the turret schürzen and is probably red with a white outline. The turret traverse motor was dropped in February 1944 and along with it, the small muffler that was mounted to the left of the main exhaust muffler.

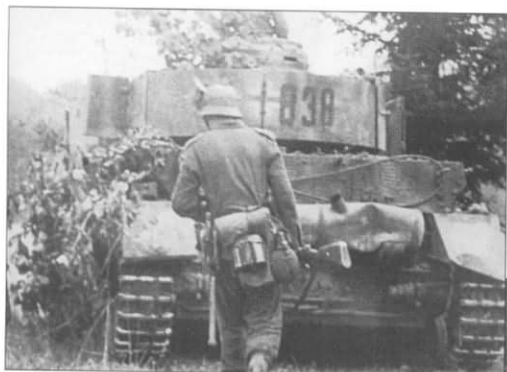
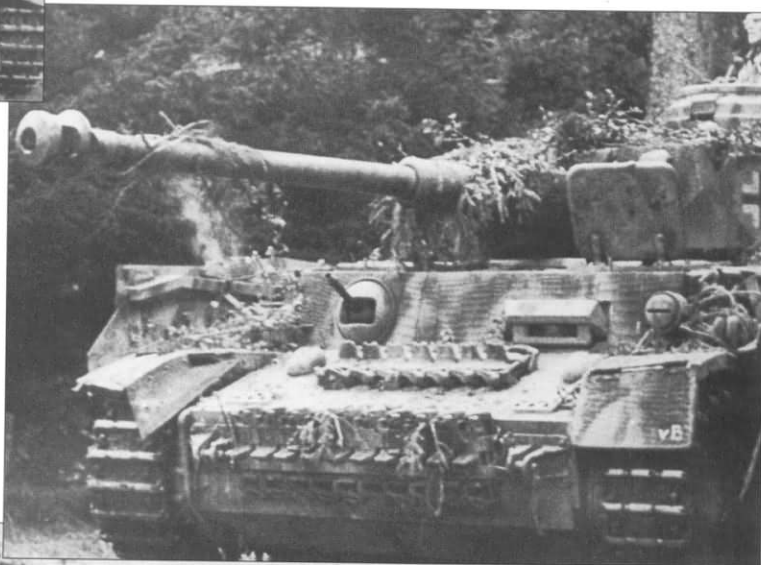
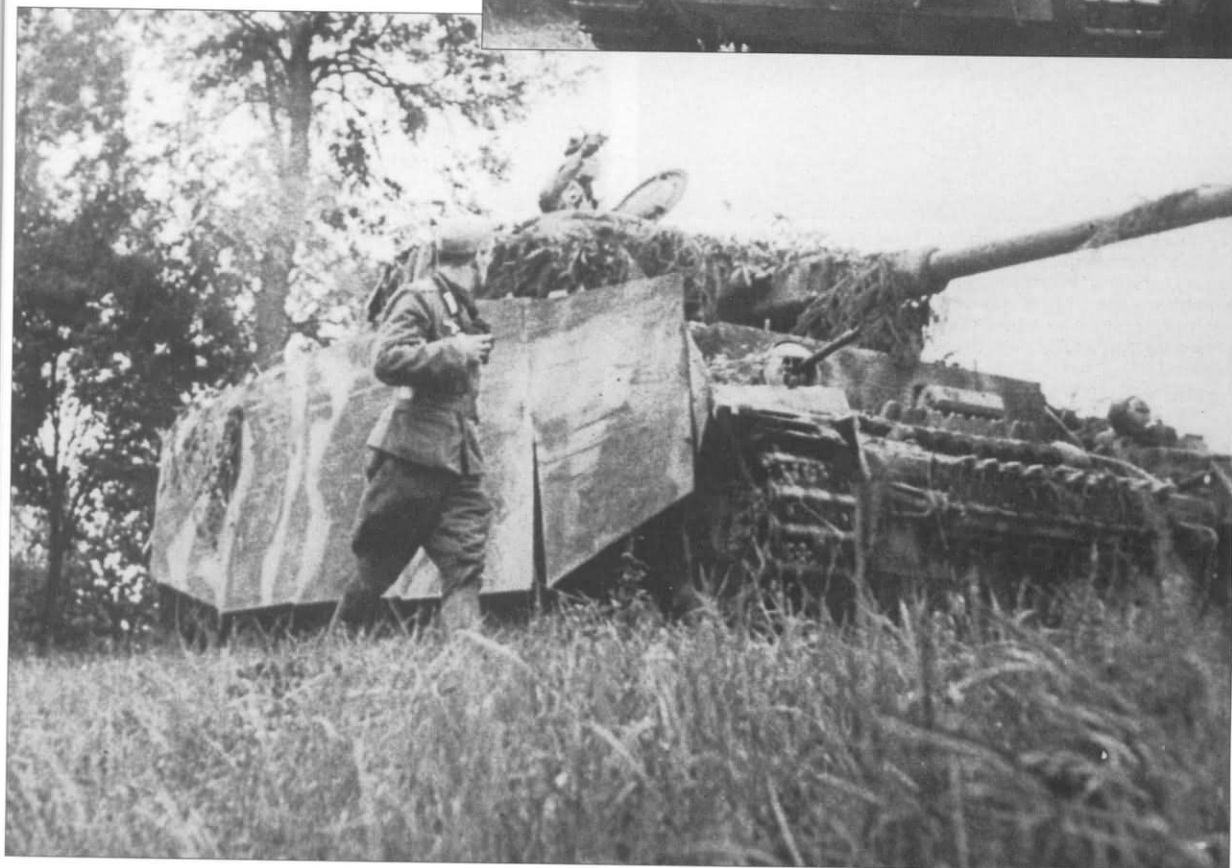
Three photos of a Pz.Kpfw.IV Ausf.J from 2111.Panzer-Abteilung, 111.Panzer-Brigade, in the Lorraine area of France, September 1944. This short-lived brigade, made up of Pz.Abt.2111, equipped with 10 StuG.III, 45 Pz.Kpfw.IV and 8 Flakpanzer IV and I./Pz.Rgt.16 with 45 Pz.Kpfw.V Panther, was formed on September 4, 1944 and disbanded and integrated into 11.Panzer-Division on October 1, 1944. A tactical number, '838', is painted in black beside the Balkenkreuz on one of the vehicles. The inscription, 'vB', on the mudguard of the other, may stand for 'von Bronsart', the unit commander.

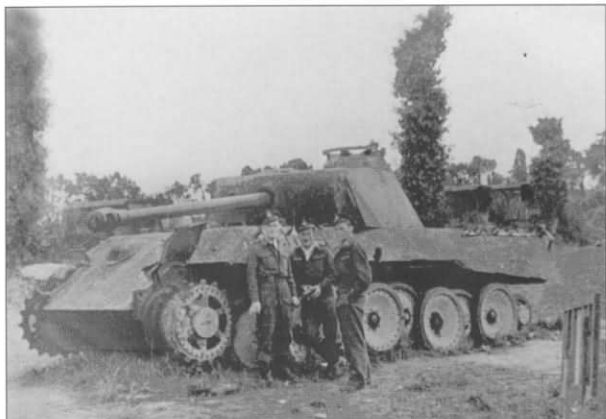
The German Army left the demolished remains of its once vaunted Panzer-Divisions all across the European continent in the summer of 1944. This Pz.Kpfw.V Panther Ausf.A was knocked out by Polish or Canadian forces near Falaise in August 1944. A group of Commonwealth pilots pose with 'their kill' for the benefit of the folks back home. Although fighters took a terrible toll of German armor, it is just as likely that this Panther was destroyed by ground forces.

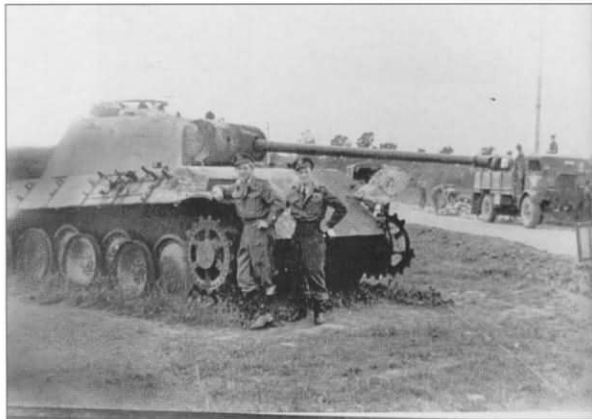
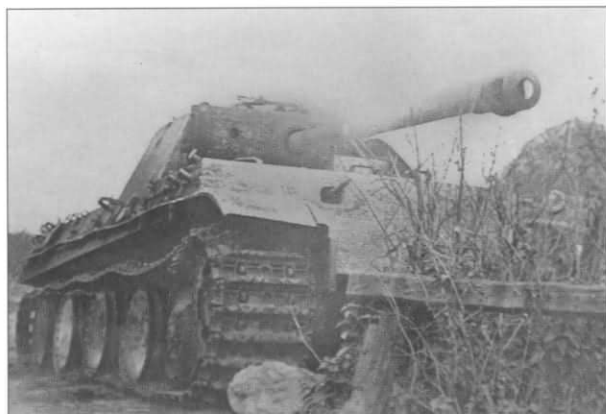
Two Pz.Kpfw.V Panther Ausf.G of 19.Panzer-Division, knocked out by Polish or Soviet forces in the Studzianki area. A fire has ravaged the first vehicle, burning off the rubber tires on the roadwheels. The fire weakened torsion bar suspension has collapsed lowering it noticeably to the ground. The other vehicle also appears to have some fire damage as well. The chassis number, '120734', can still be seen painted in black on the glacis, indicating that it was built in July 1944 at the M.A.N. assembly plant. 19.Panzer-Division was transferred back to Germany from the Eastern Front in May 1944 and was refitted as a 'Panzer-Division 44' in Holland in July/August 1944, with one battalion of Pz.Kpfw.V and one of Pz.Kpfw.IV. They were immediately sent back into action in Poland.
