Panzer-Division 1935-1945

(3) War on Two Fronts 1943-1945

Robert Michulec

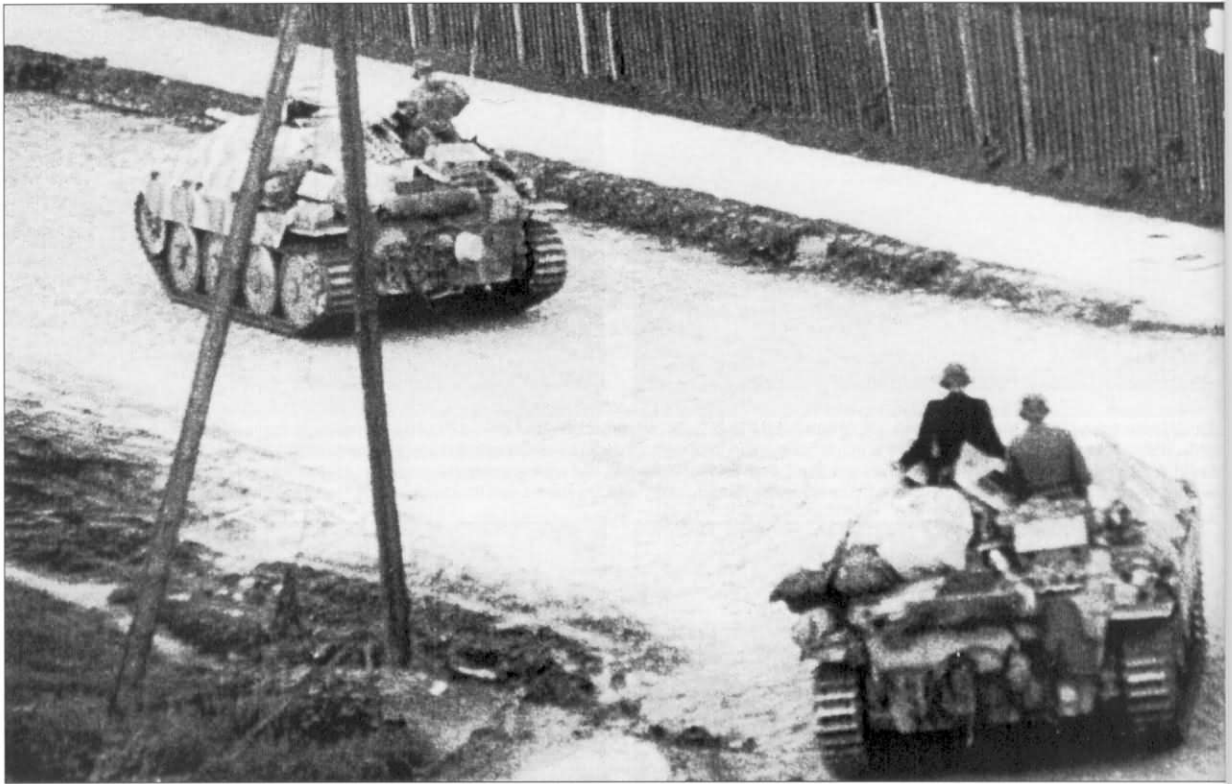
A pair of Jagdpanzer 38(t) 'Hetzer' tank destroyers used by the Germans against the Polish underground army in Warsaw at the beginning of August 1944. Production of these vehicles started in April 1944 and by July 1944, the first combat units began to receive them. They are painted in dark sand with a two color camouflage scheme of green patches with a dark brown outline, best seen on the lead vehicle in the background.

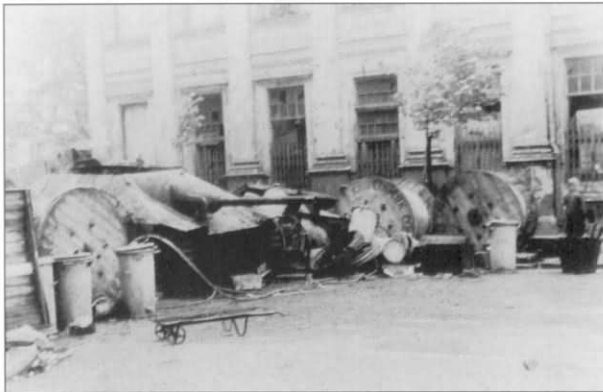
Two photographs of a 'Hetzer' that has been captured by the Poles and is being used in a street barricade in Warsaw, September 1944. The Poles captured three of these vehicles in August and September, one of which was repaired and used against the Germans. This is one of the early models as indicated by the shape of the mantlet. It is also missing the roof and may have suffered an internal explosion. The camouflage scheme is similar to the other two in the photo above.

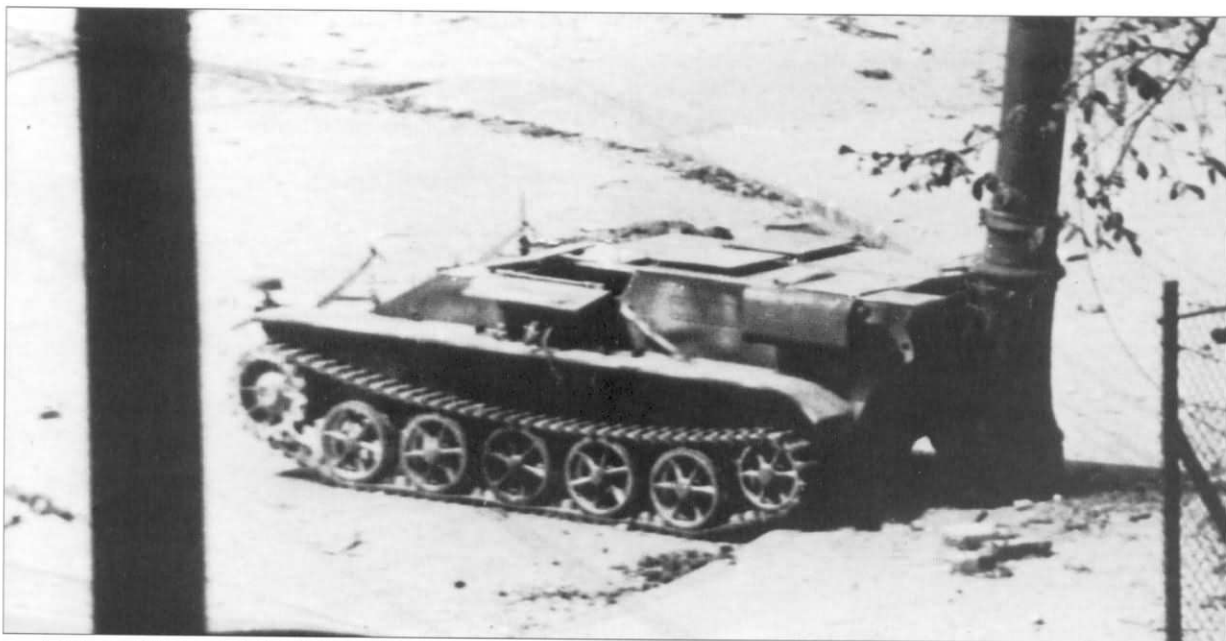
A Borgward B IV Ausf.C (Sd.Kfz.301) demolition vehicle from Pz.Abt. (FKL) 302 sits abandoned on a Warsaw street in August/September 1944, where they were used extensively against Polish partisans hidden in buildings and behind barricades. The Borgwards were radio controlled from a command vehicle, in this case a StuG.III Ausf.G, which guided them to their target where a 500kg explosive charge was dropped. The Borgward was then backed away a safe distance and the charge detonated. On this one, the charge is missing. A camouflage paint scheme can be made out along with the load class shipping stencil on the side.

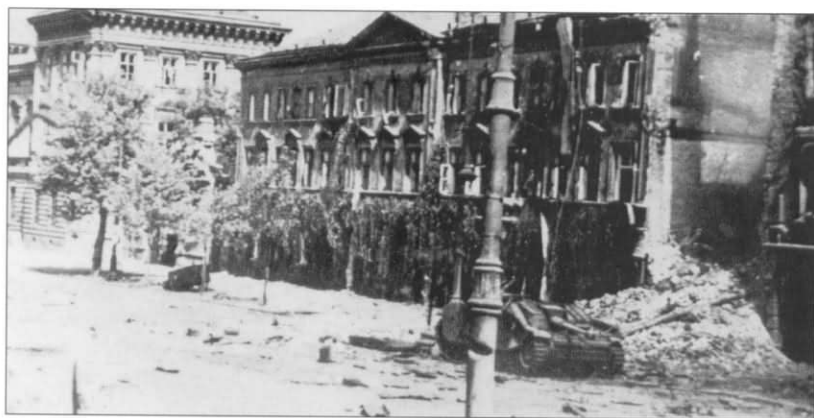
This StuG.III Ausf.G, also abandoned on a Warsaw street, may have been one of the command vehicles from Pz.Abt. (FKL) 302 or Sturmgeschütz-Ersatz-Abteilung 200, the only two Sturmgeschütz units employed in this bloody battle except for a few used by the Kaminski RONA or Dirlewanger Brigades.

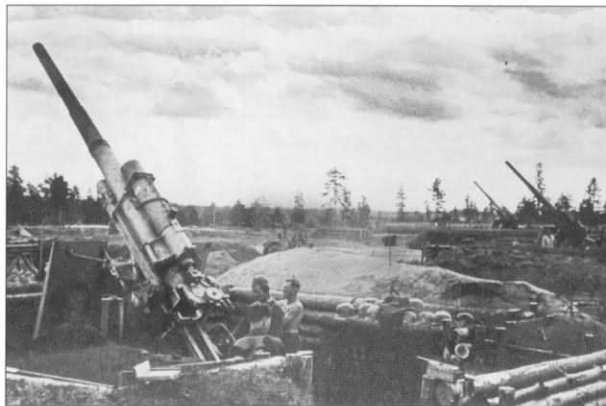
A battery of 8.8cm FlaK18 anti-aircraft guns set up in well emplaced positions in August 1944. As the front approached closer to Germany's borders, anti-aircraft units such as this were forced to evacuate these well prepared positions and become part of a mobile defense against both air and ground targets. These ones are painted dark sand and have white battery markings on the recuperator housing.

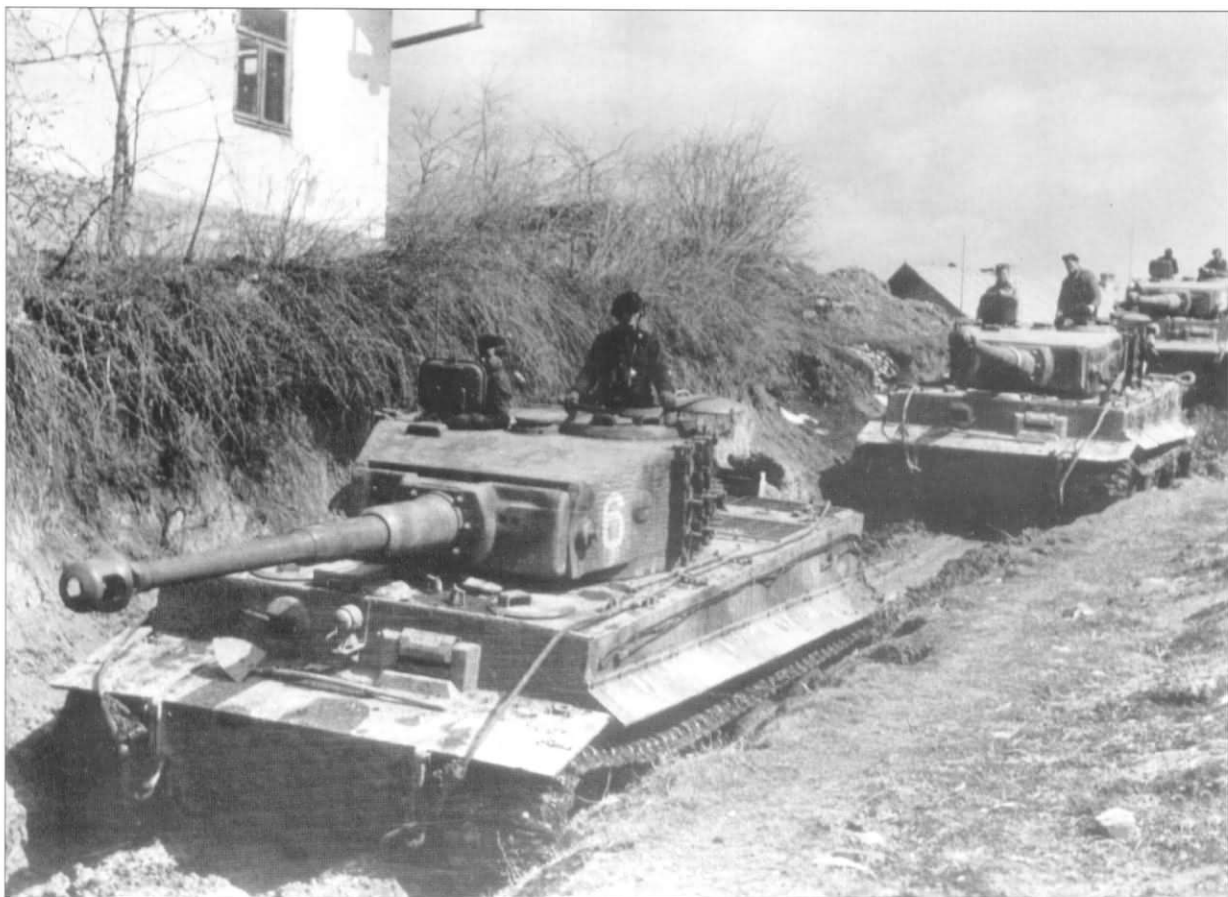
Three Tiger I's from 1./s.Pz.Abt.506 travel down a muddy road in one of the towns in southern Poland in August 1944. They were resupplied with 45 new tanks in March and April 1944 in the Lemberg area. At this time, the battalion's tanks were marked with a large single or double digit tactical number on the forward side of the turret painted in white for 1.Kompanie and red and yellow for 2. and 3.Kompanie. The lead vehicle has the tactical number '6' and the third has the number '5' while the middle vehicle has no visible marking. The battalion lost all its tanks during the Soviet summer offensive against H.Gr.Mitte and was transferred to Germany for rest and refitting with the new Tiger II.

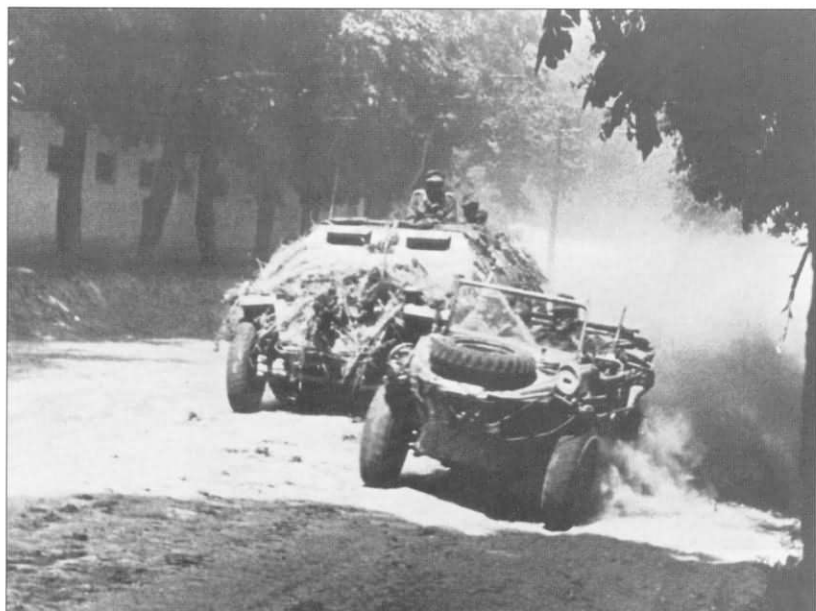
A Kfz.2 Schwimmwagen kicks up a cloud of dust as it races past an Sd.Kfz.251/1 Ausf.D north of Warsaw in September 1944. The half-track has a liberal covering of foliage draped on the front and sides for extra camouflage. Note that it is missing its MG shield.

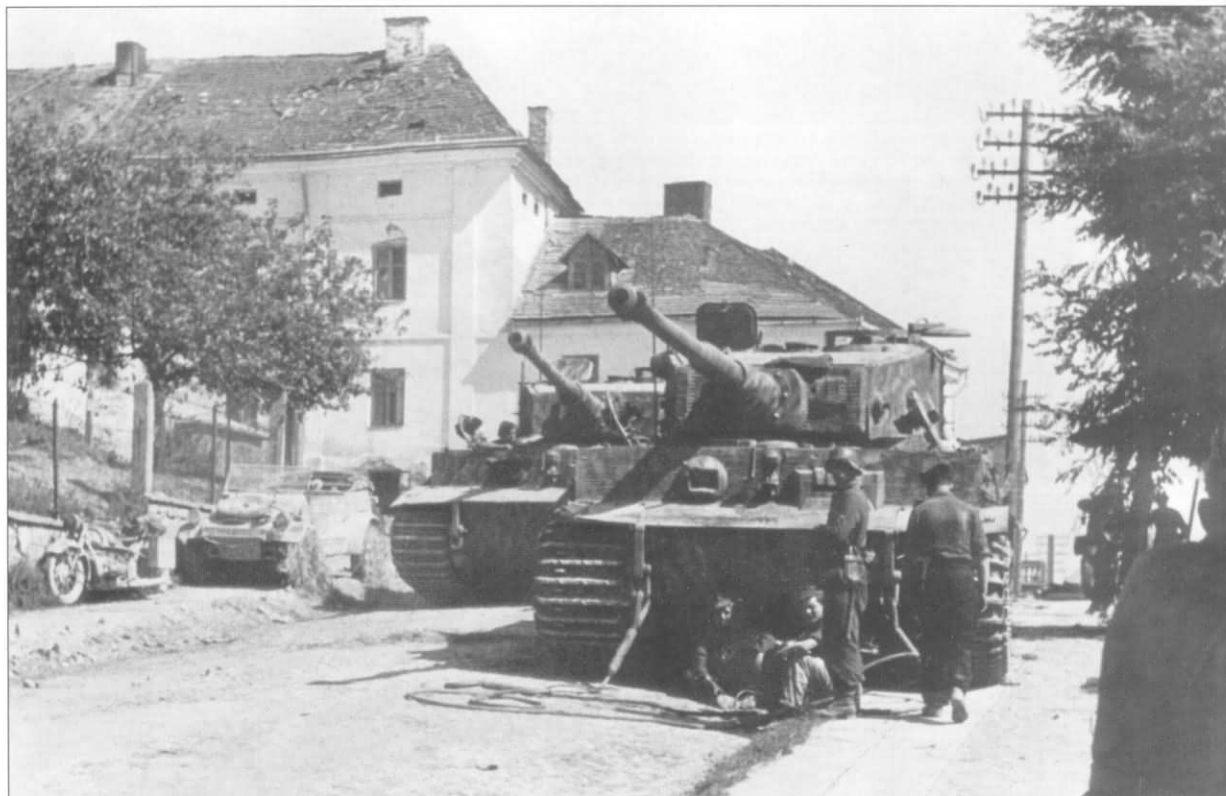
A Tiger I sits broken down beside the road waiting for tow. Part of a small tactical number '2' is barely visible beside the open driver's hatch indicating it may be from s.Pz.Abt.502. The tank has been painted in a very distinctive camouflage pattern of green and brown over the dark sand base and appears to be a new vehicle.

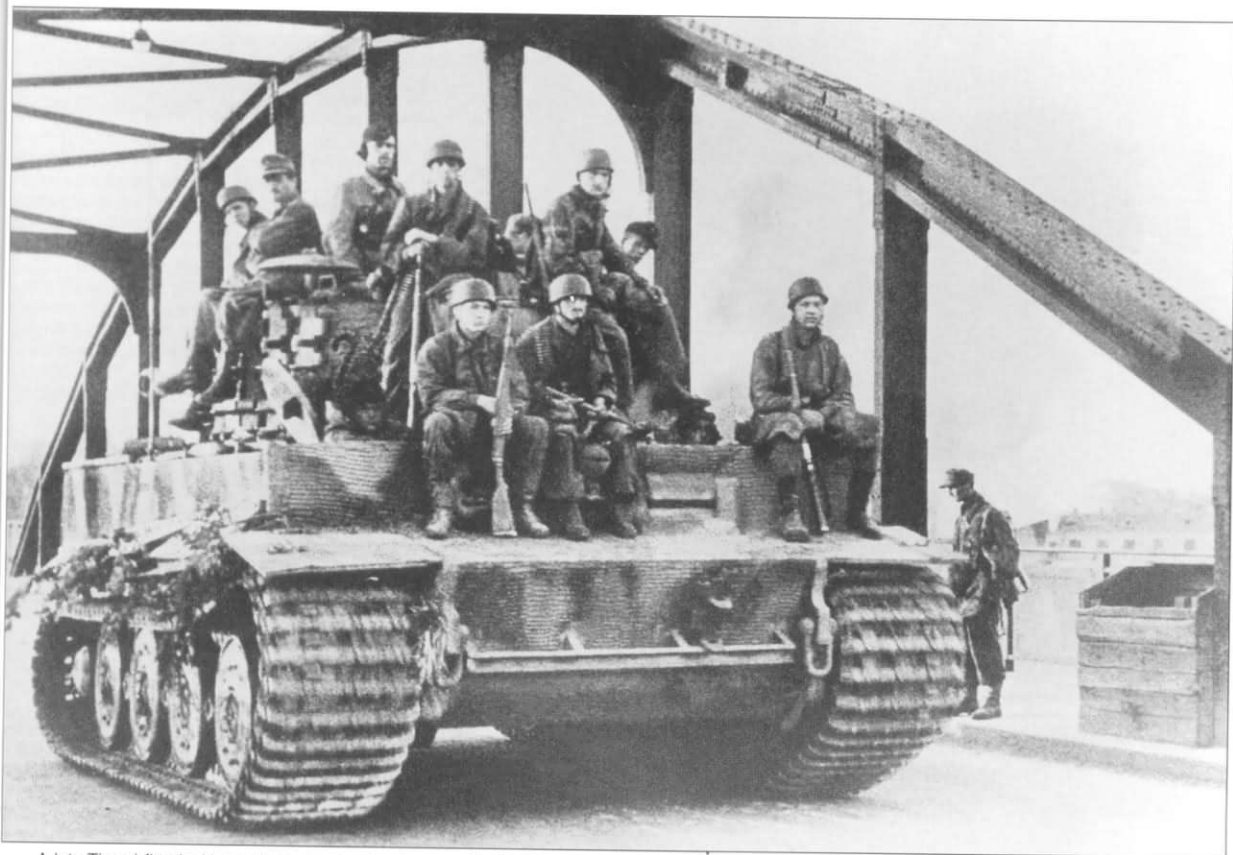
A late Tiger I fitted with steel wheels, ferrying troops of 21.Feld-Division (Luftwaffe) over the Venta River in Lithuania in late August 1944. The turret is turned to the rear revealing the tactical number '237' painted in a location unique to vehicles of s.Pz.Abt.510. Another unique addition to note is the spare track link bar on the front of the hull with three segments. The battalion was formed in June 1944 and saw action mostly in the Baltic States and East Prussia.

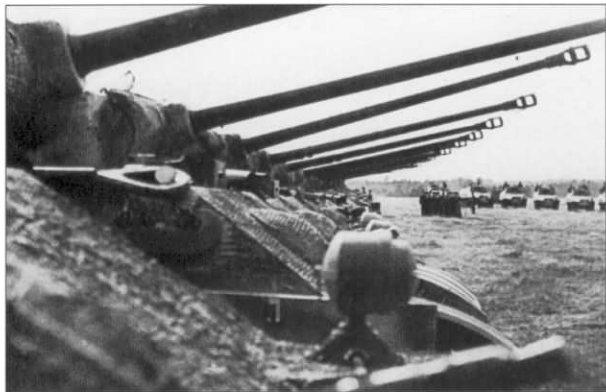
Twenty-two new Pz.Kpfw.V Panther Ausf.G lined up in a field somewhere in Germany, early autumn 1944. These were probably among the last Panthers built with zimmerit coating which was ordered to be dropped on September 9, 1944. In the background can be seen several Sd.Kfz.251/9 Ausf.D half-tracks armed with the 7.5cm KwK37 L/24 gun.

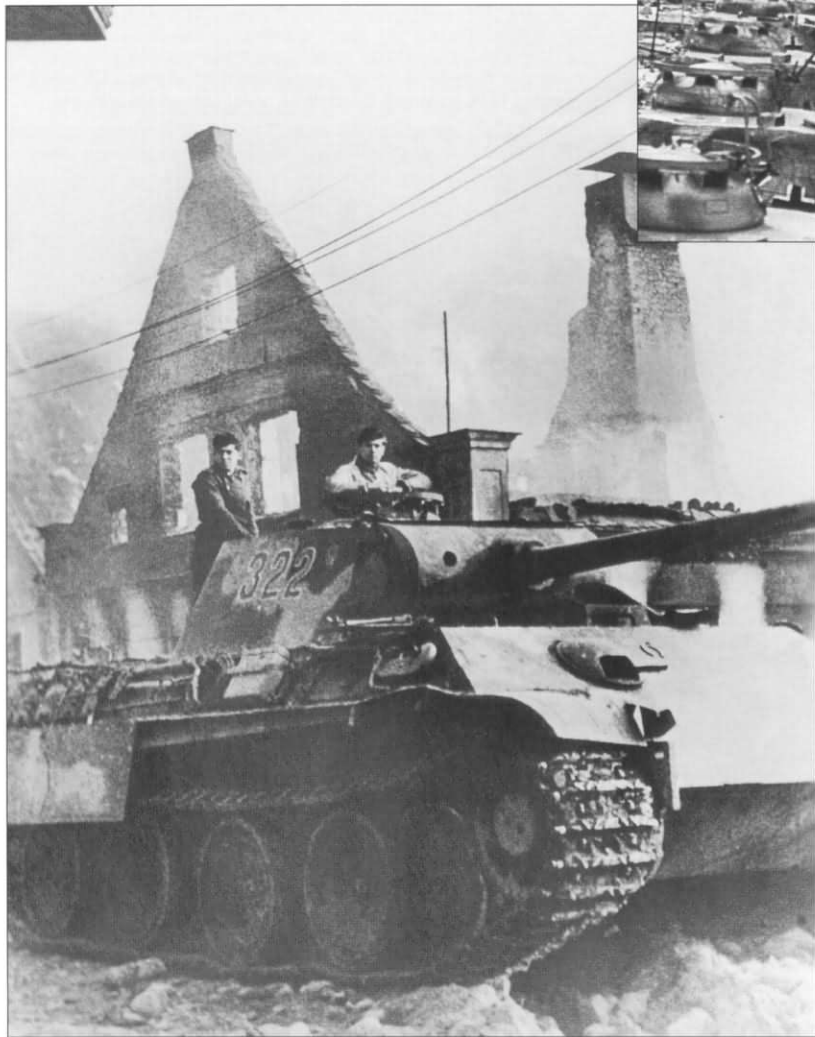
A Pz.Kpfw.V Panther Ausf.G passes through the ruins of an East Prussian city in autumn 1944. There is no zimmerit on this vehicle, indicating it was manufactured after the beginning of September 1944. It is also likely painted in red oxide primer with camouflage patches of green and dark sand that were now ordered to be applied at the assembly plants. The tactical number '322' is red with a white outline.

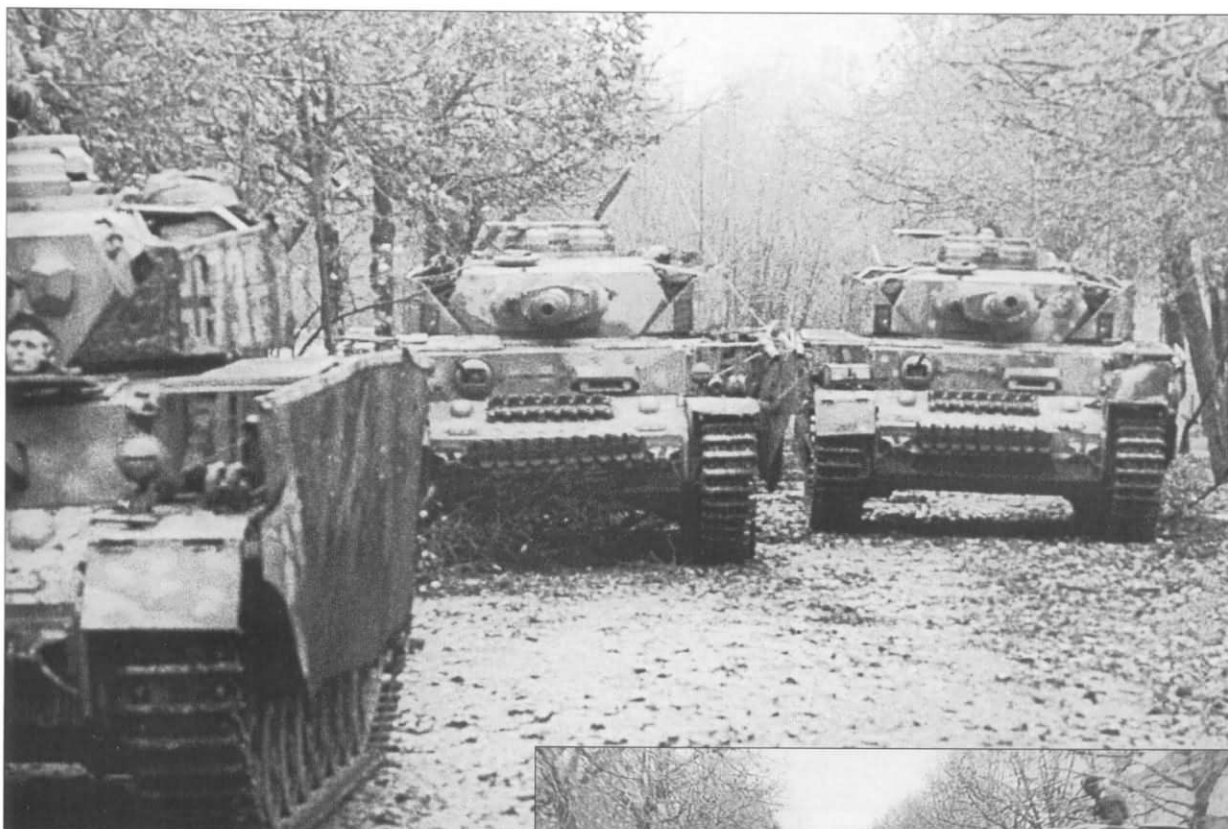
Two photographs of new late production Pz.Kpfw.IV Ausf.J from 5.Panzer-Division, involved in the battle for Goudap in October 1944. Two of the Pz.Kpfw.IV in the first photo, have the red devil's head emblem of Pz.Rgt.31 painted on a black rectangle on the front of the turret schürzen, while the tactical sign of the division, a yellow 'X' on a black square, can be seen painted on the rear of the turret schürzen in the other photo. The Balkenkreuz on it is also painted in an unusual manner with a white stencil outline around the black cross. The Balkenkreuz on the front of the turret schürzen visible in the first photo seems to be more of the conventional type and is followed by a large, white three digit tactical number which in this case, appears to be '733'. They are all painted in a classic ambush camouflage paint scheme.

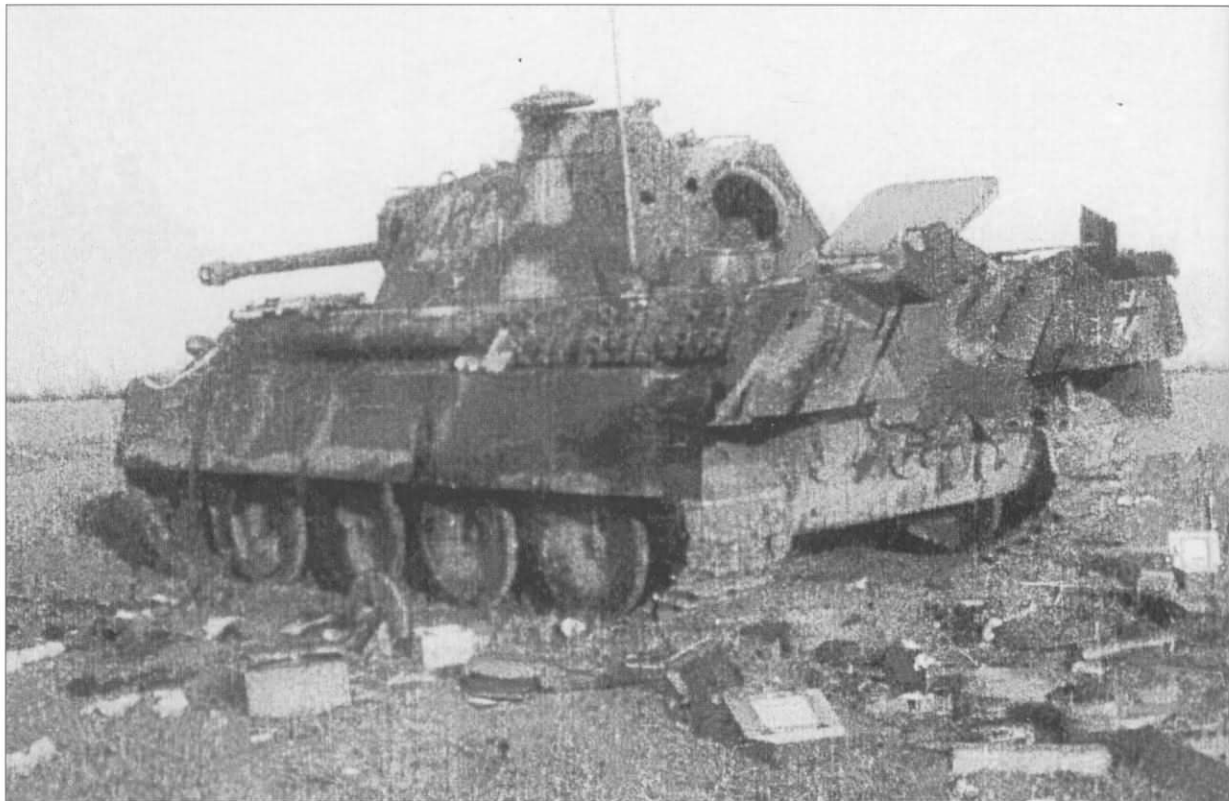
A late Pz.Kpfw.V Panther Ausf.G abandoned on a battlefield on the Eastern Front. The raised fan cover for the crew compartment heater, that was introduced in October 1944, can be seen on the engine deck although the vehicle is still fitted with the shielded exhaust pipes and not the 'flammvernichter' exhaust also introduced around the same time. The tactical number '239' is painted on the side of the turret in large red numbers with a white outline. Note the two penetrations in the 45mm thick rear plate of the turret.

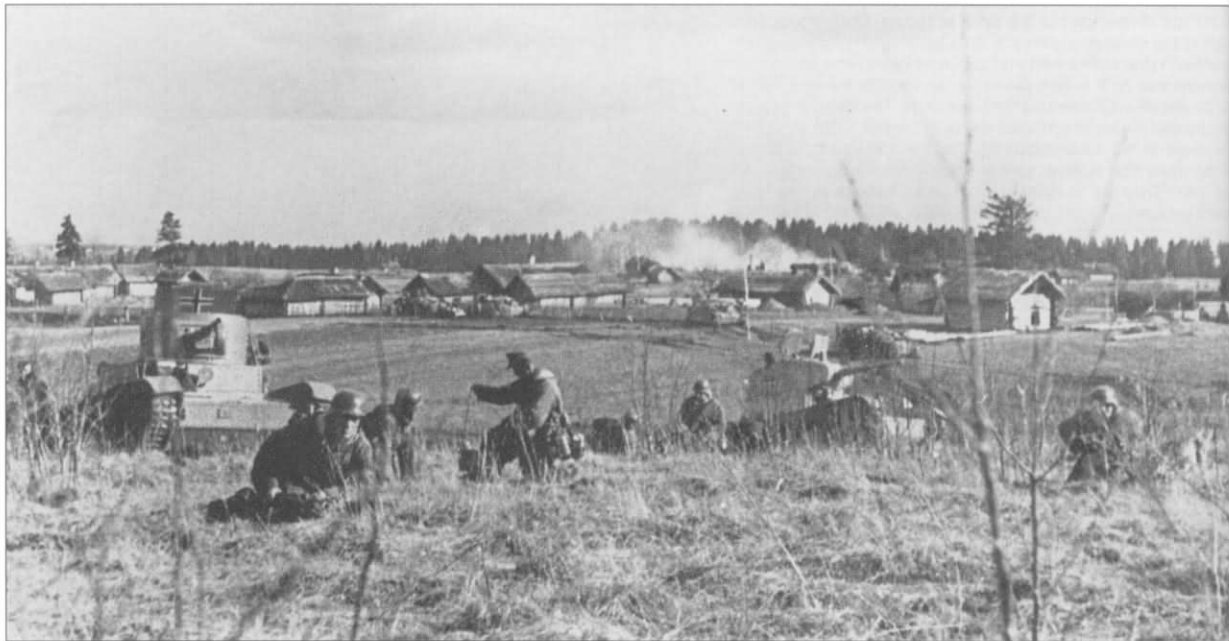
German infantry, clad in winter camouflage uniforms, take up a position on a barren hill in southern Poland or Czechoslovakia in the late fall of 1944. They are supported by two old Russian T-26 tanks captured in 1941 and probably used for anti-partisan duty in the intervening years. The tanks have been repainted in dark sand paint and have large Balken crosses added to ensure they are not mistakenly identified by nervous German gunners. In the background, a pair of StuG.III Ausf.G assault guns can be seen on the road in the village.

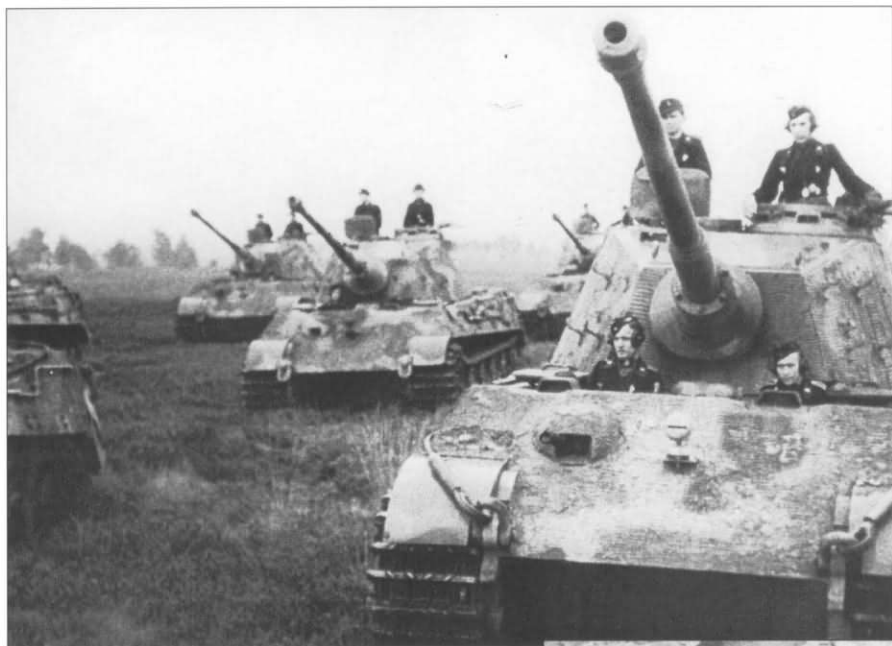
The battalion moves out. Zimmerit was still applied in the factory until September 1944 and all their vehicles were covered with it. In readiness for transport by train, they have all been fitted with the narrow transport tracks. This must have been an awesome spectacle to see.

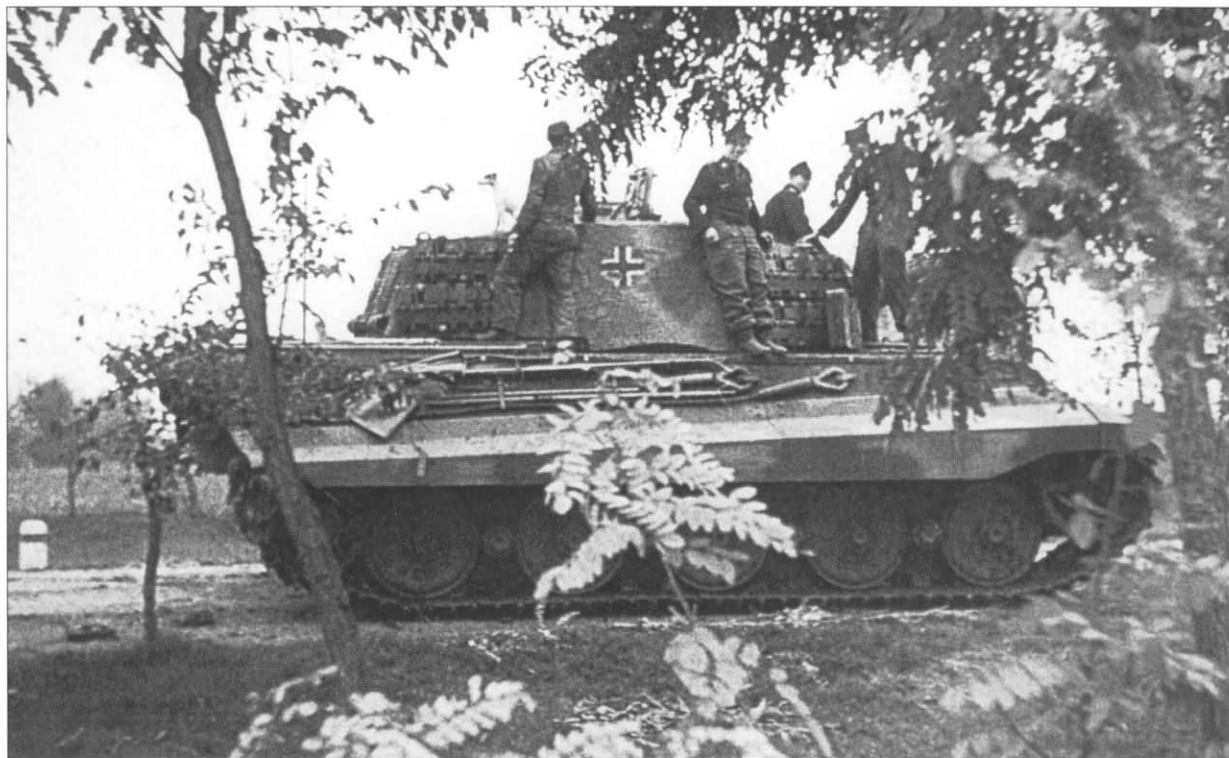
Another Pz.Kpfw. Tiger Ausf.B of s.Pz.Abt.503 in Hungary, October 1944. Just to the left of the crewman leaning back against the turret, can be seen part of the first digit of the tactical number, a '3'. The vehicles would not remain in this pristine condition for long. After occupying the Citadel in Budapest, they were subordinated to 24.Panzer-Division and then 4.SS-Polizei-Panzer-Grenadier-Division for an attack on the Theiss River bridgehead.

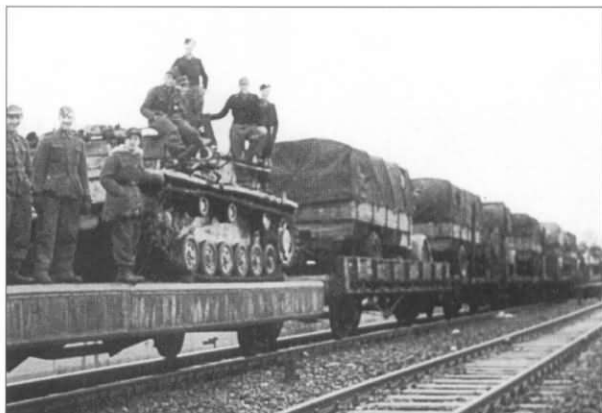
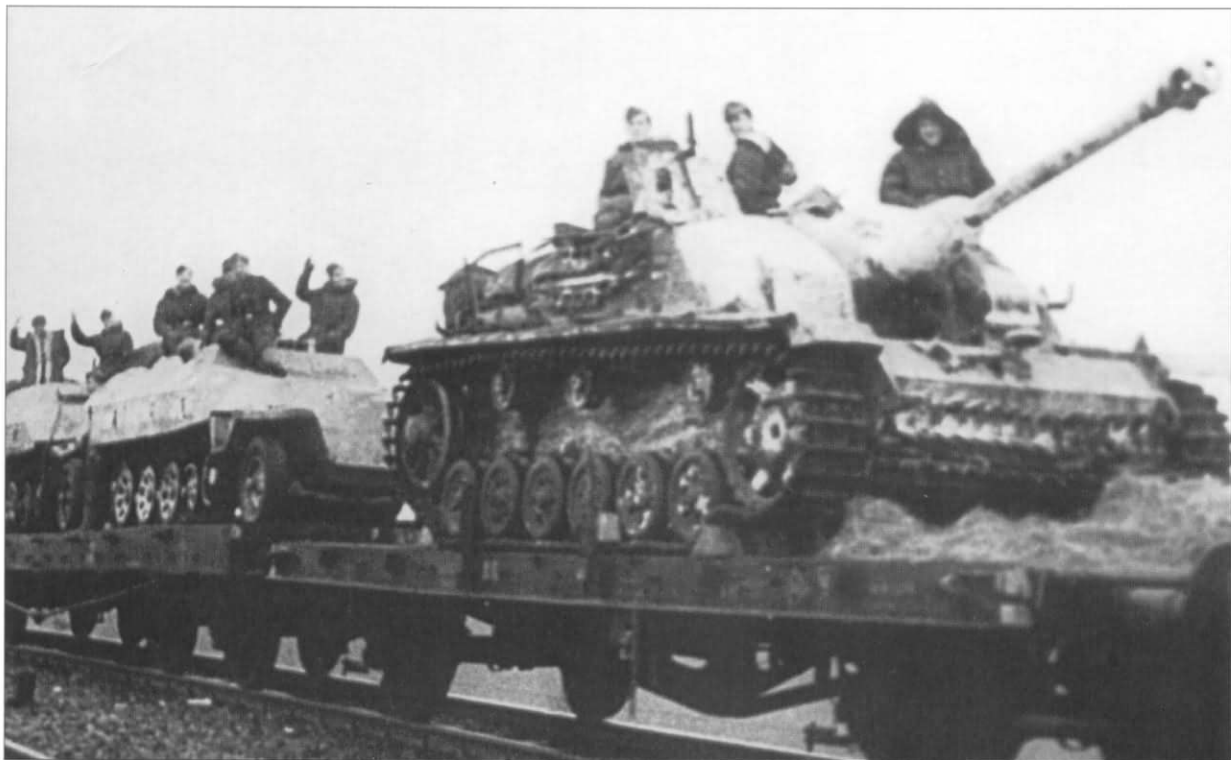
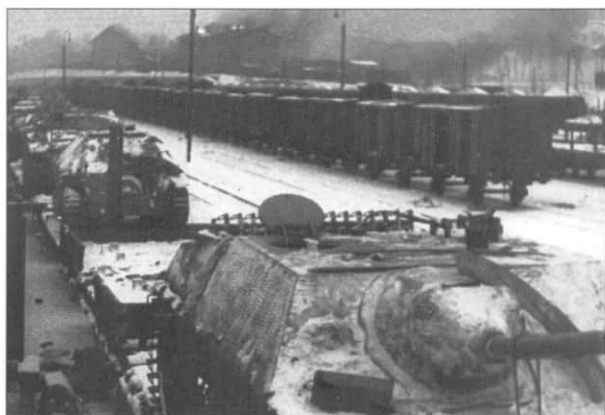
StuG.III Ausf.G assault guns, Sd.Kfz.251/1 Ausf.D half-tracks and transport trucks from one of the SS-Panzer-Divisions, entrained for transportation to Hungary to take part in the Lake Balaton battles in February 1945. The StuG.III in the lower photo has concrete on the forward part of the roof of the fighting compartment for additional protection. A special mount has been attached to the MG shield for using the MG42 in an anti-aircraft role. It appears that the crew have painted eyes and eyebrows on the topflende mantlet which resembled a boars head.

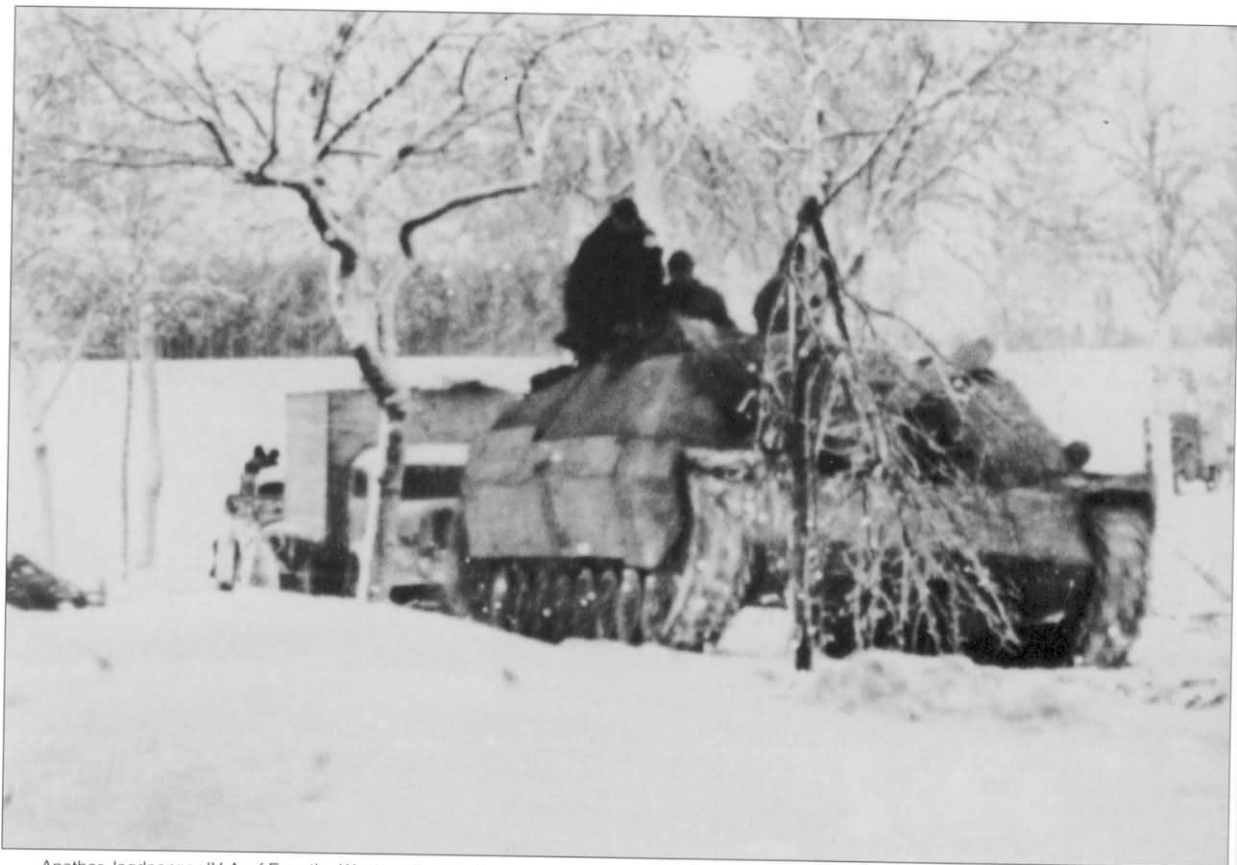
Another Jagdpanzer IV Ausf. F on the Western Front in the winter of 1944-45. The German firm Vomag produced 769 of these vehicles from January to November 1944. In August 1944, they began installing the longer barreled gun, the 7.5cm PaK42 L/70, in some vehicles. The new version was designated Panzer IV/70(V) which had completely replaced the Jagdpanzer IV by December 1944. The schürzen have been modified slightly by the crew of this vehicle. It appears that the brackets have probably been damaged and removed, allowing the schürzen to be bolted directly to the bracket mounting lugs welded to the superstructure. The schürzen were then bent down at that point.

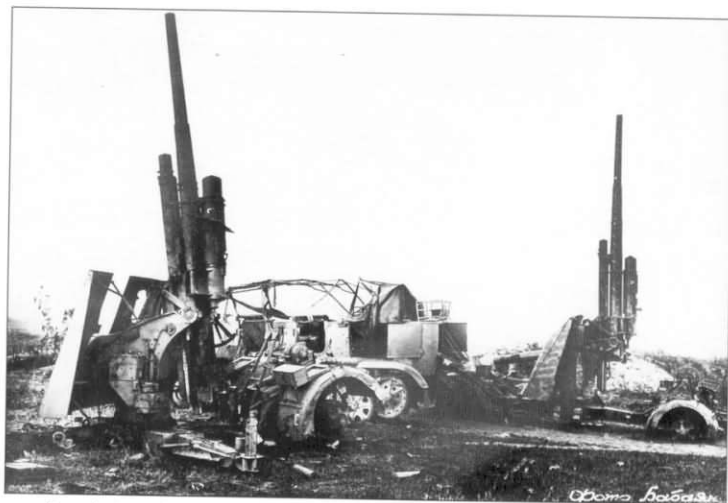
Two photographs showing the wreckage of two Luftwaffe 8.8cm FlaK18 anti-aircraft guns and one of their Sd.Kfz. 7 half-track prime movers, demolished by the Soviet Air Force in February or March 1945 in the Graudenz area of East Prussia. Judging by the elevation on the guns and spent cartridges on the ground, they were able to put up some defensive fire before being destroyed. Both were painted in a camouflage pattern and had their position in the battery, 'A' and 'C', painted in white on the equilibrator housing in the standard fashion. Note the two different styles of gun shield. The half-track has the license number 'WL 477034'.

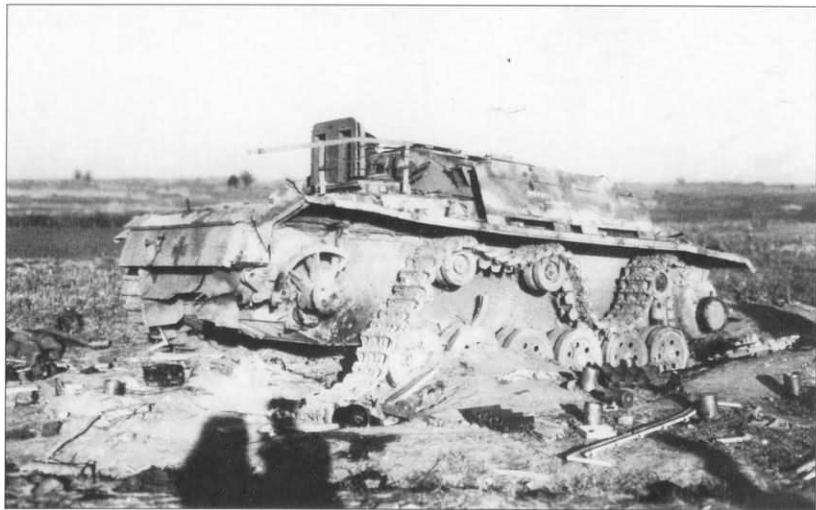
A StuH 42 Ausf.G also destroyed in the same raid. This was a later model vehicle that was prepared for, but not fitted with, the remote control MG mount, but still fitted with side opening loader's hatches. These vehicles may be from a much photographed, but as yet unidentified, Sturmgeschütz-Abteilung that field modified the schürzen plates to hang from short pieces of pipe welded to angles attached to the mudguards. The modified brackets can be clearly seen. Note the 10.5cm casings littering the ground around the vehicle.

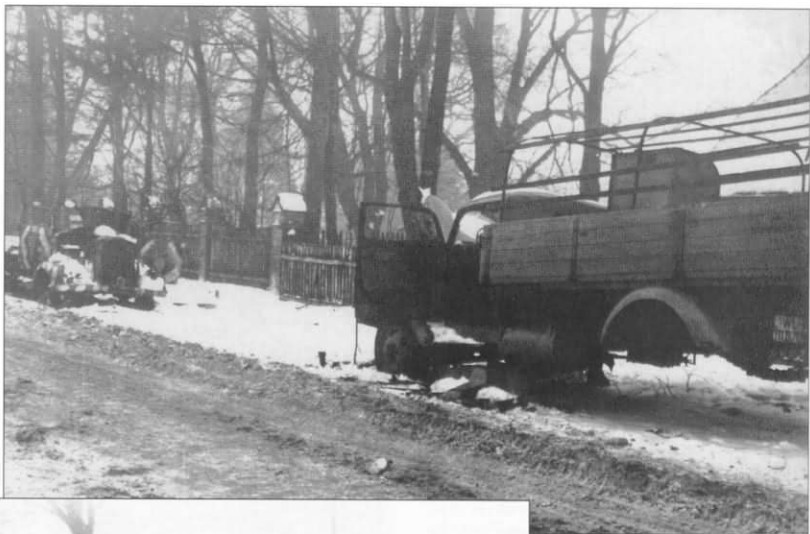
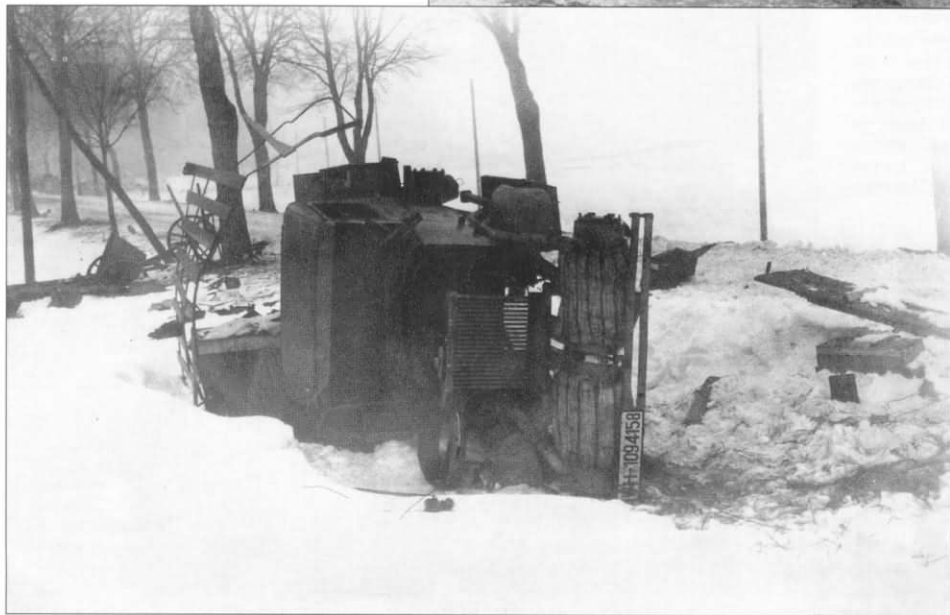
More demolished German soft-skin vehicles destroyed by the Soviet Air Force alongside the road near Torun. The Germans broke through the Soviet lines to escape encirclement and reached the banks of the Vistula River in February 1945, leaving much of their equipment behind. In the first photo, the Opel Blitz in the background had been painted in a winter camouflage scheme of thick, white lines over the old dark gray base. An illegible, shield shaped emblem has been painted on both doors. The closest vehicle has a Luftwaffe license plate number 'WL 111570'. The second photo is of a captured Soviet truck that has been incorporated in the Wehrmacht and has the license number 'WH-1094158'. Two bundles of fascines are still attached to the front bumper.

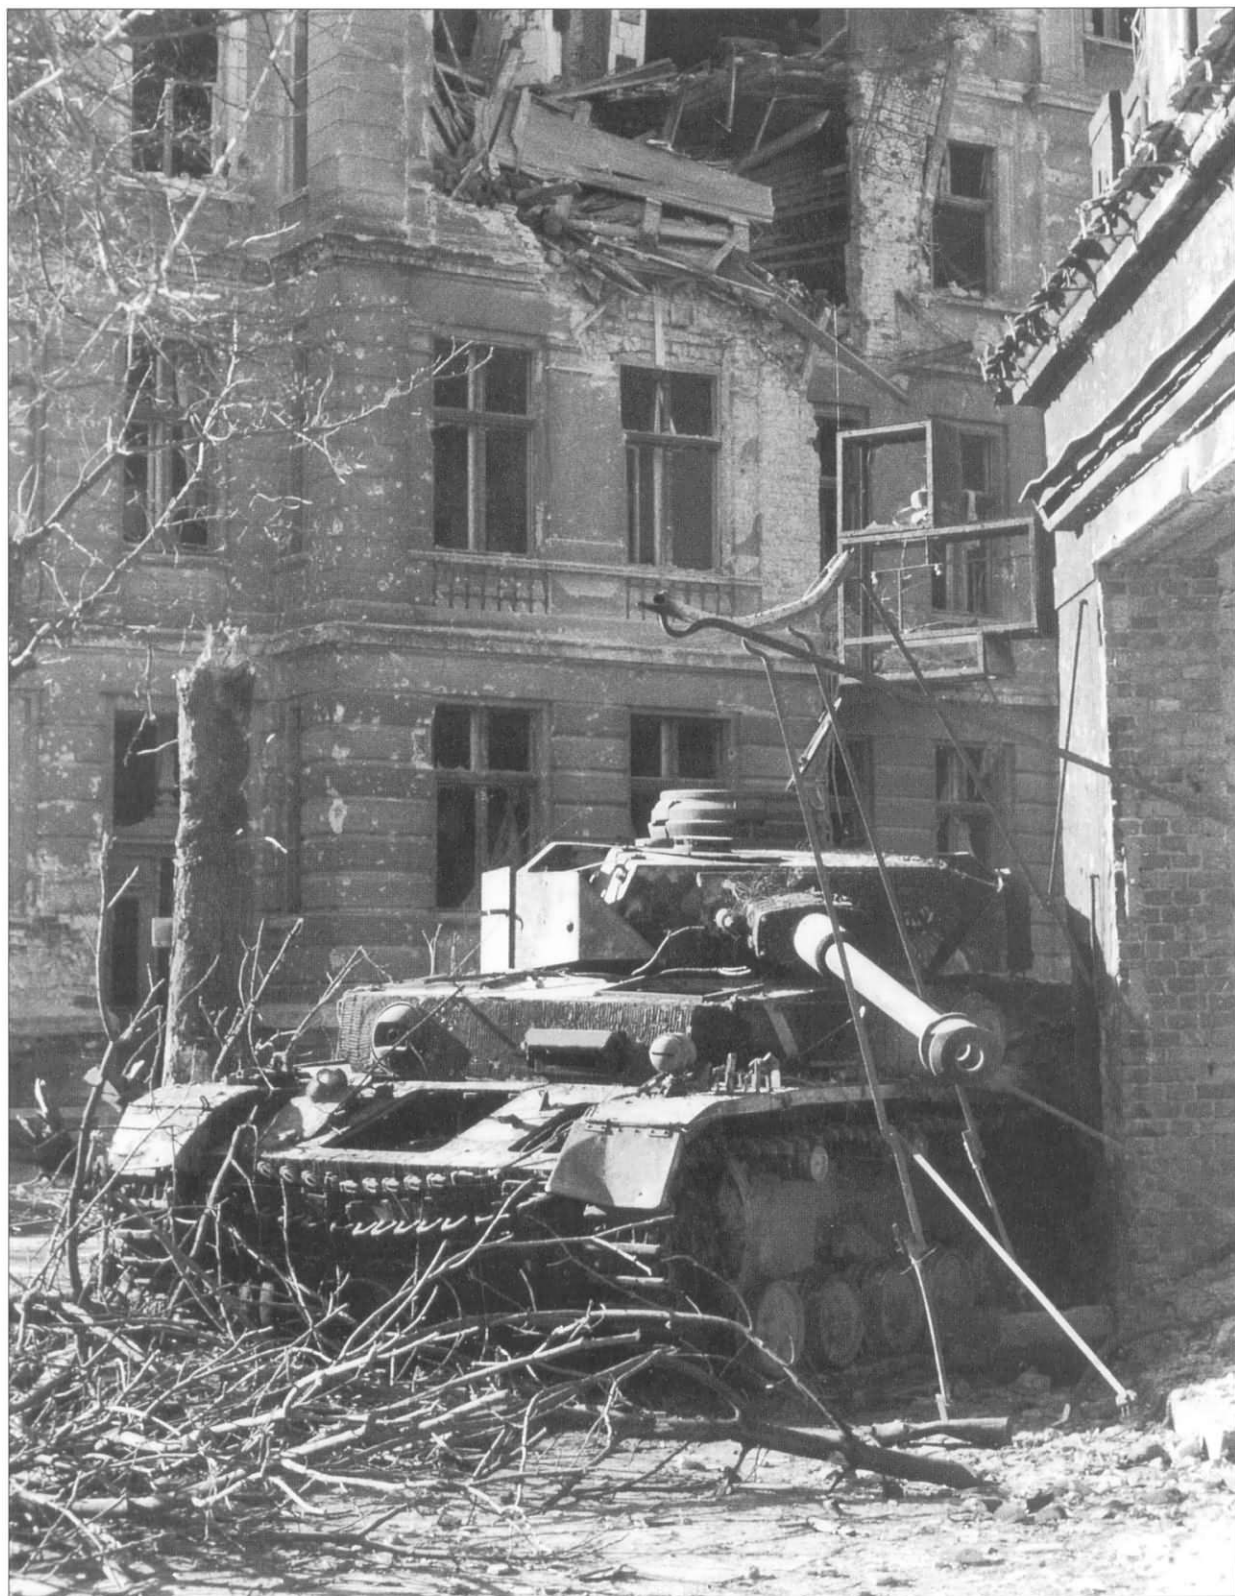
The wreckage of a Pz.Kpfw.IV Ausf.H in Kolberg in the spring of 1945. An internal explosion has blown off the transmission cover plate and driver's hatch and fire consumed the rubber from the roadwheels and return rollers. Note the unusual zimmerit pattern on the front plate of the superstructure.

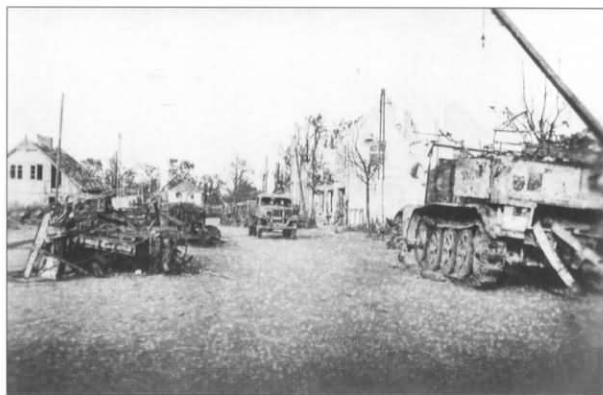
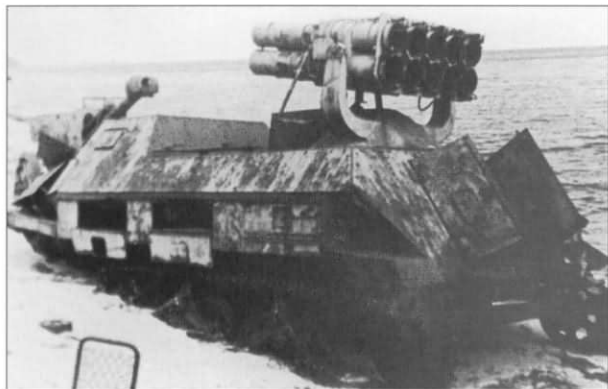
A battery of 15cm Panzerwerfer 42 (Sd.Kfz.4/1) was abandoned on the Baltic coast near Gdynia in April 1945, after firing off all their ammunition. It appears to have been painted in a white winter camouflage which is badly deteriorating from high wave action from the Baltic Sea. A tactical number '3', probably painted in black, can be seen above the open middle bin door. Just over the driver's compartment, a 10.5cm IFH18(M) howitzer can be seen in the background.

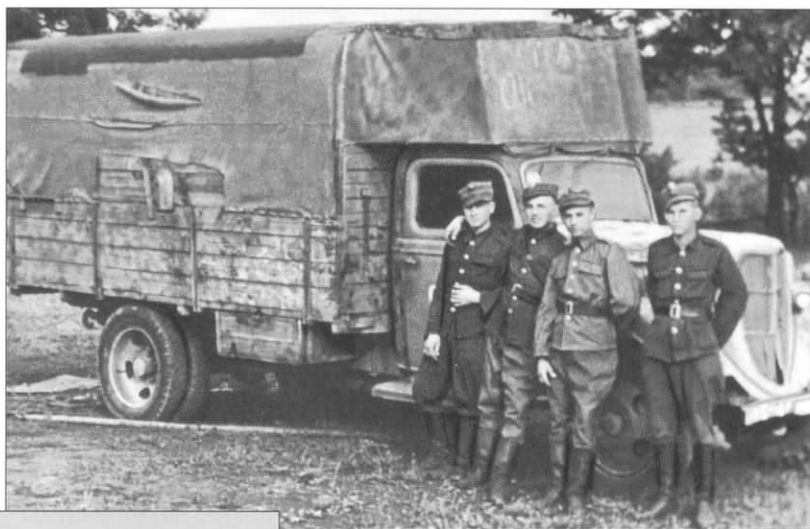
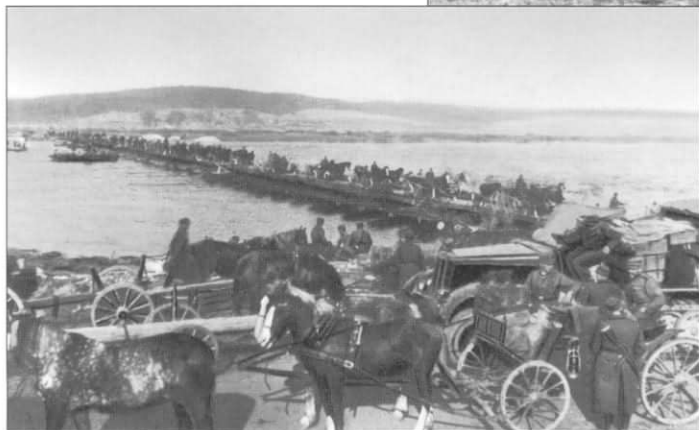
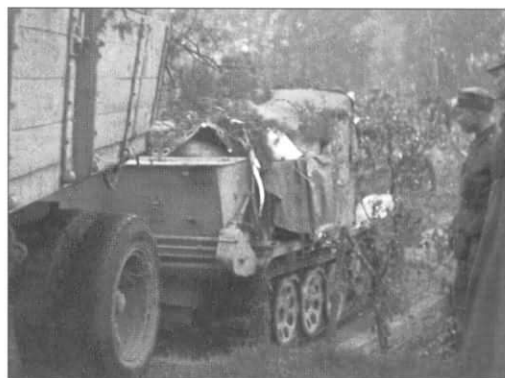
Three photographs of abandoned German transport vehicles that were captured and put to use by the Polish Army during the final days of the war. The first one is a Ford V3000 3-ton truck which has seen long service in the Wehrmacht. It was painted in a dappled camouflage scheme on the wooden box only and appears to have been a civilian conscript as the former owners advertising still can be seen on the front of the canvas top. The next two show Sd.Kfz.7 half-track prime-movers that have been impressed into the Polish Army. Of special interest is the unusual fitting mounted to the back of one, the purpose of which is unknown.

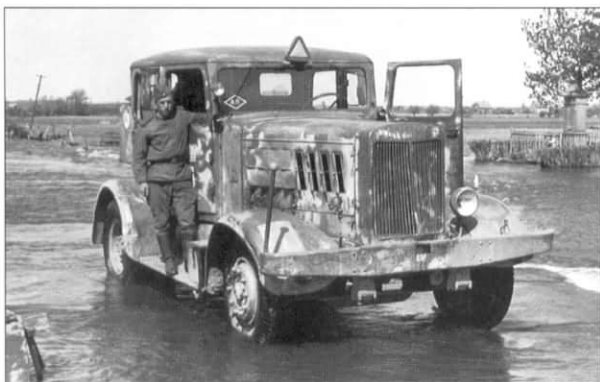
A Soviet soldier poses on this nicely camouflaged Hanomag SS100N German Army tractor which has been abandoned on a flooded road near Berlin in May 1945. Besides the original camouflage, there are a number of markings painted on various parts of the vehicle. One, on the front mudguard, has been painted over and there is one, obscured behind the soldier's leg, painted on the door. A white circle with a number in it, is painted on the rear of the body, visible over the soldier's right shoulder and a white outline diamond with the letters 'An' is painted on the windscreen.
