Panzer-Division 1935-1945

(3) War on Two Fronts 1943-1945

Robert Michulec

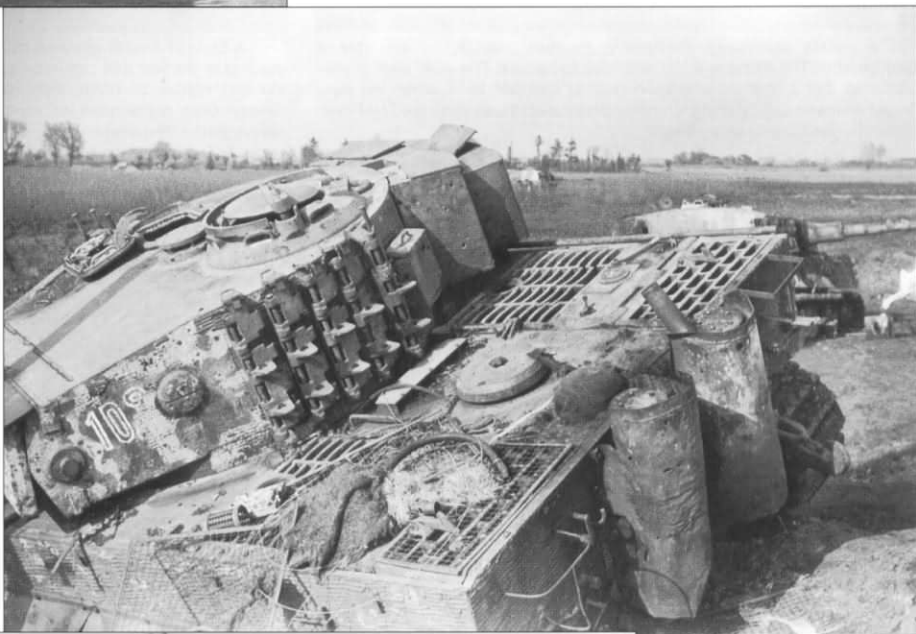
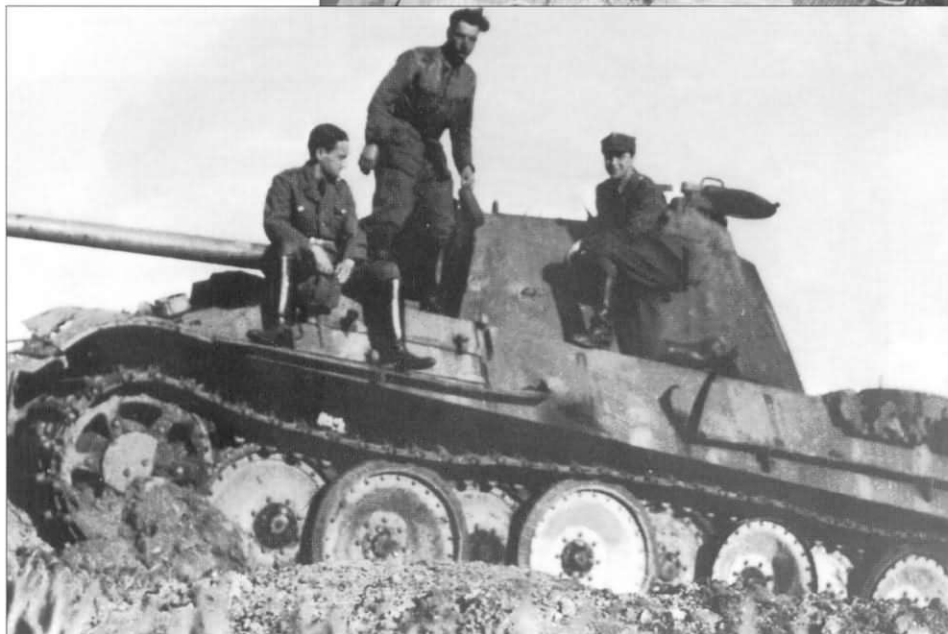
A late Pz.Kpfw.V Panther Ausf.G knocked out by the Polish Army in southern Germany during the last days of the war in May 1945. The anti-tank round penetrated the side of the hull just above the bottom of the sponson, blowing off the gun cleaning rod tube and part of the mudguard. Note that this Panther has foliage loops welded to the turret that were ordered to be installed starting in March 1945. Unusually, it still has the anti-aircraft MG rail welded to the cupola that was ordered dropped in January. The raised fan cover for the crew compartment heater can also be seen.

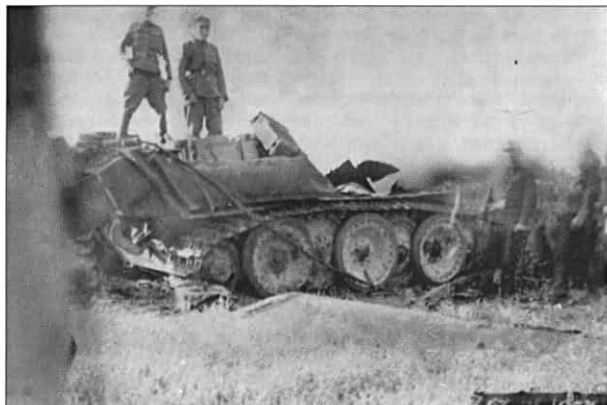
A totally destroyed Pz.Kpfw.V Panther Ausf.G, or possibly a Jagdpanther. The damage is too extensive to be sure. The early style of idler indicates that it was manufactured prior to October 1944, when the new, larger diameter self cleaning idler was introduced. It was destroyed by Polish forces in Germany in May 1945.

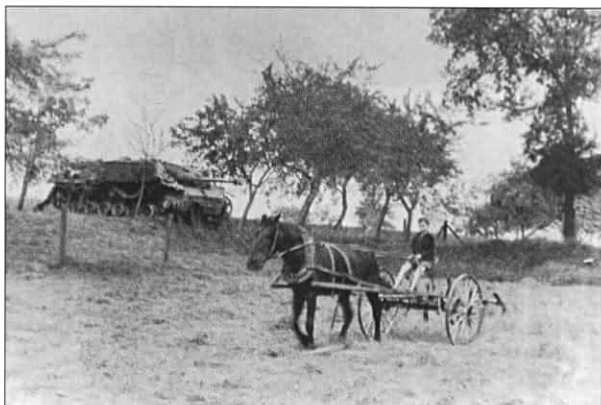
A StuG.III Ausf.G knocked out by the Polish Army near Dresden near the end of the war and pictured here during the summer of 1945. In one of the last battles of WWII, Field Marshall Ferdinand Schörner's Heeres-Gruppe Mitte, surrounded in Czechoslovakia, was ordered to break out and relieve Berlin. The attack was unsuccessful and resulted in the loss of many tanks and self-propelled guns on both sides. The crew of this StuG.III has attempted to improve the armor protection of their vehicle with additional armor plates and spare tracks on the side.

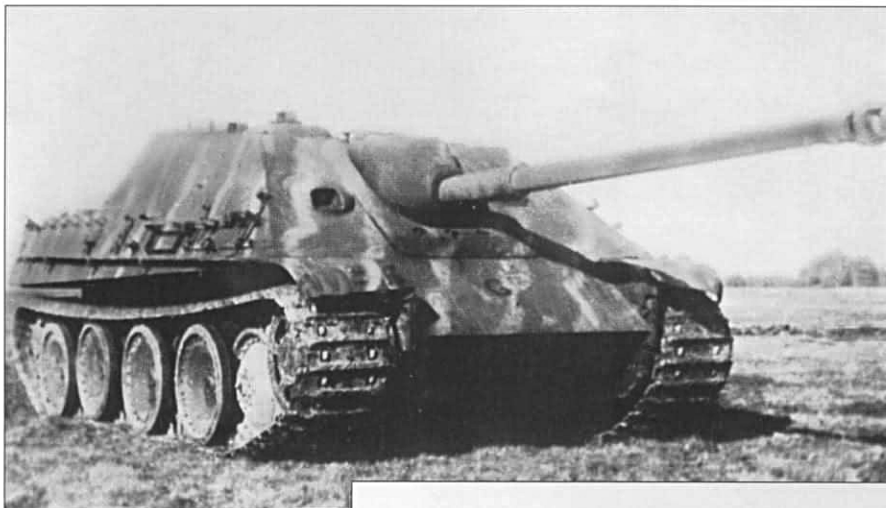
The order for the development of a vehicle mounting the 8.8cm PaK43 L/71 on the Panther chassis was issued on October 2, 1942. A year later, a wooden mock-up was shown to Hitler on December 16, 1943. Production of the Jagdpanther started in January 1944 and continued until March 1945. This late model Jagdpanther was captured by the Soviets and tested at their facility at Kubinka. It is painted in a late war camouflage scheme of brown and dark sand stripes over the dark green base that was authorized on December 20, 1944. The 'G' painted on the glacis may be a post-war Soviet marking.

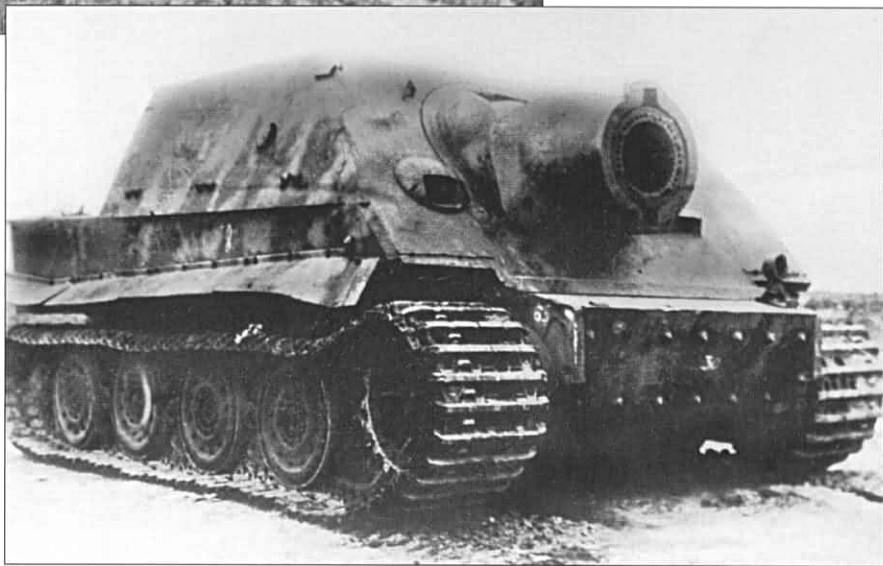
A 38cm RW61 auf Sturm-mörser Tiger, more commonly known as the Sturmtiger. There were 18 of these vehicles built from converted Tiger I hulls from August to December 1944. This vehicle was one of two used by the Germans during the Warsaw uprising and was captured by the Soviets afterwards. The bolted armor plate on the front of the hull and other details indicate that this was the prototype vehicle which was probably rushed to Warsaw for troop trials. It was evaluated by the Soviets after the war and is currently on display at the armor museum at Kubinka near Moscow.
