# PANZERS IN THE EAST

(2) Decline and Defeat 1943-1945

Robert Michulec

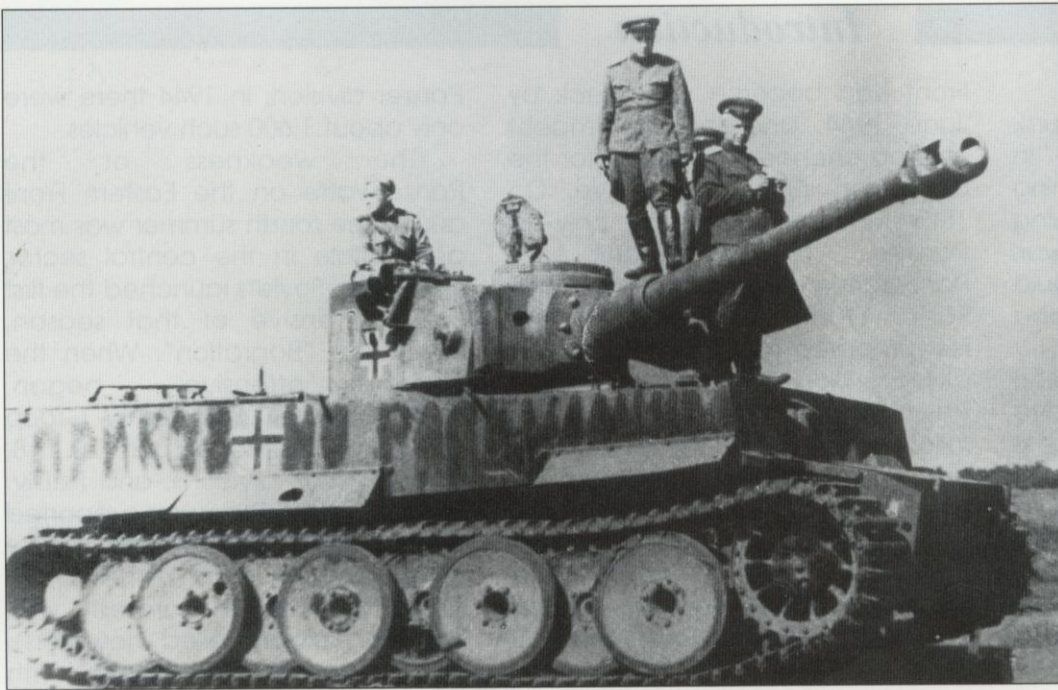
The aftermath of the Battle of Kursk, where heavy losses were inflicted on both the German and Soviet armies. This Pz.Kpfw. VI Tiger I, which was a unit commander's vehicle, was damaged by the Soviets and abandoned by its crew. Note the Cyrillic inscription on the side of the superstructure and the penetration holes. The tank was captured by the Soviets on 10th August 1943 near Grajvoron.

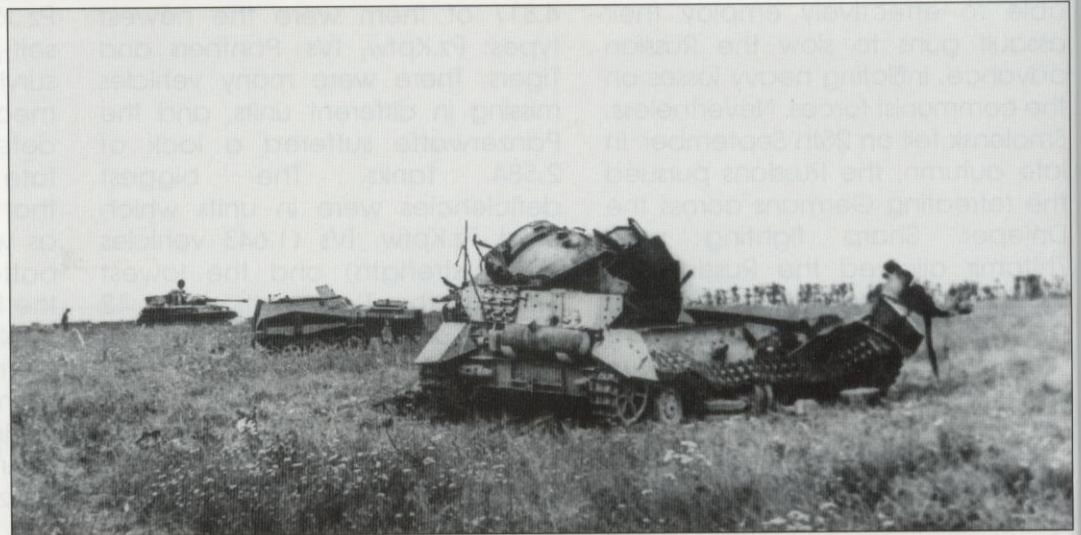
German Pz.Kpfw. IVs and a Sd.Kfz. 250 knocked out by the Soviet defenders near Orel in August 1943. The nearest Pz.Kpfw. IV was completely demolished following an internal explosion of ammunition. It is interesting to note that the turret was blown up along with the main part of the superstructure, which was quite weak, being welded with other parts of the superstructure and the hull.

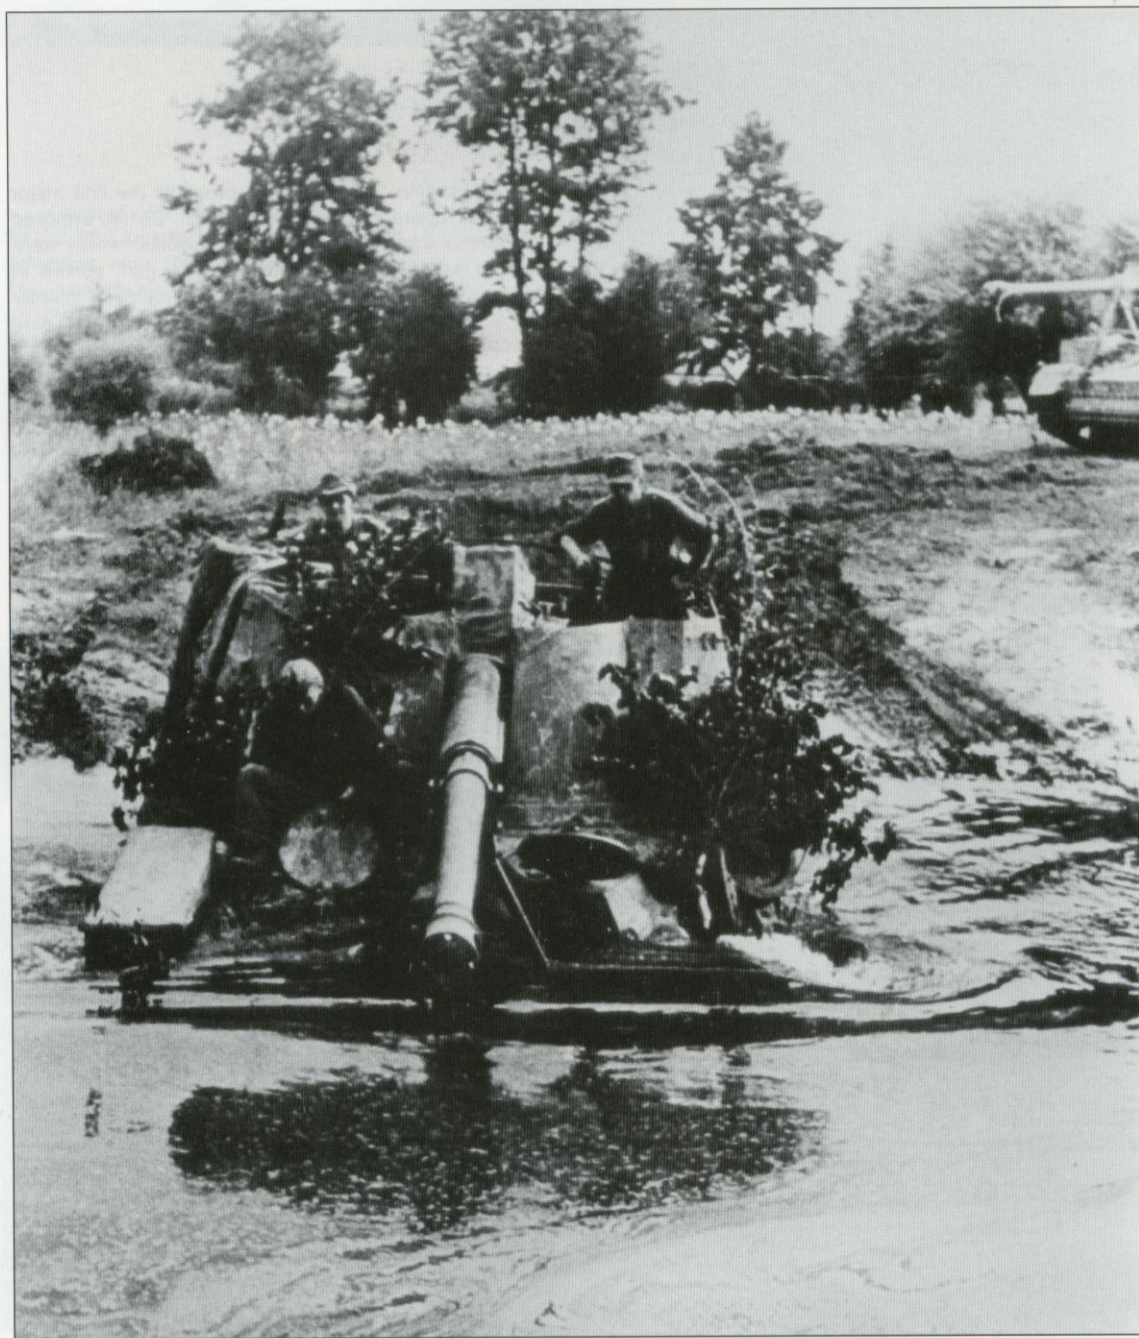
The most feared Panzerjäger (tank hunter) was surely the Nashorn. Armed with the mighty 8.8cm PAK 43/41, these self-propelled guns decimated Soviet tank formations from distances of over 3,000 m (3,028 yards). These vehicles are seen here crossing a narrow ford. Both are finished in plain dark yellow.

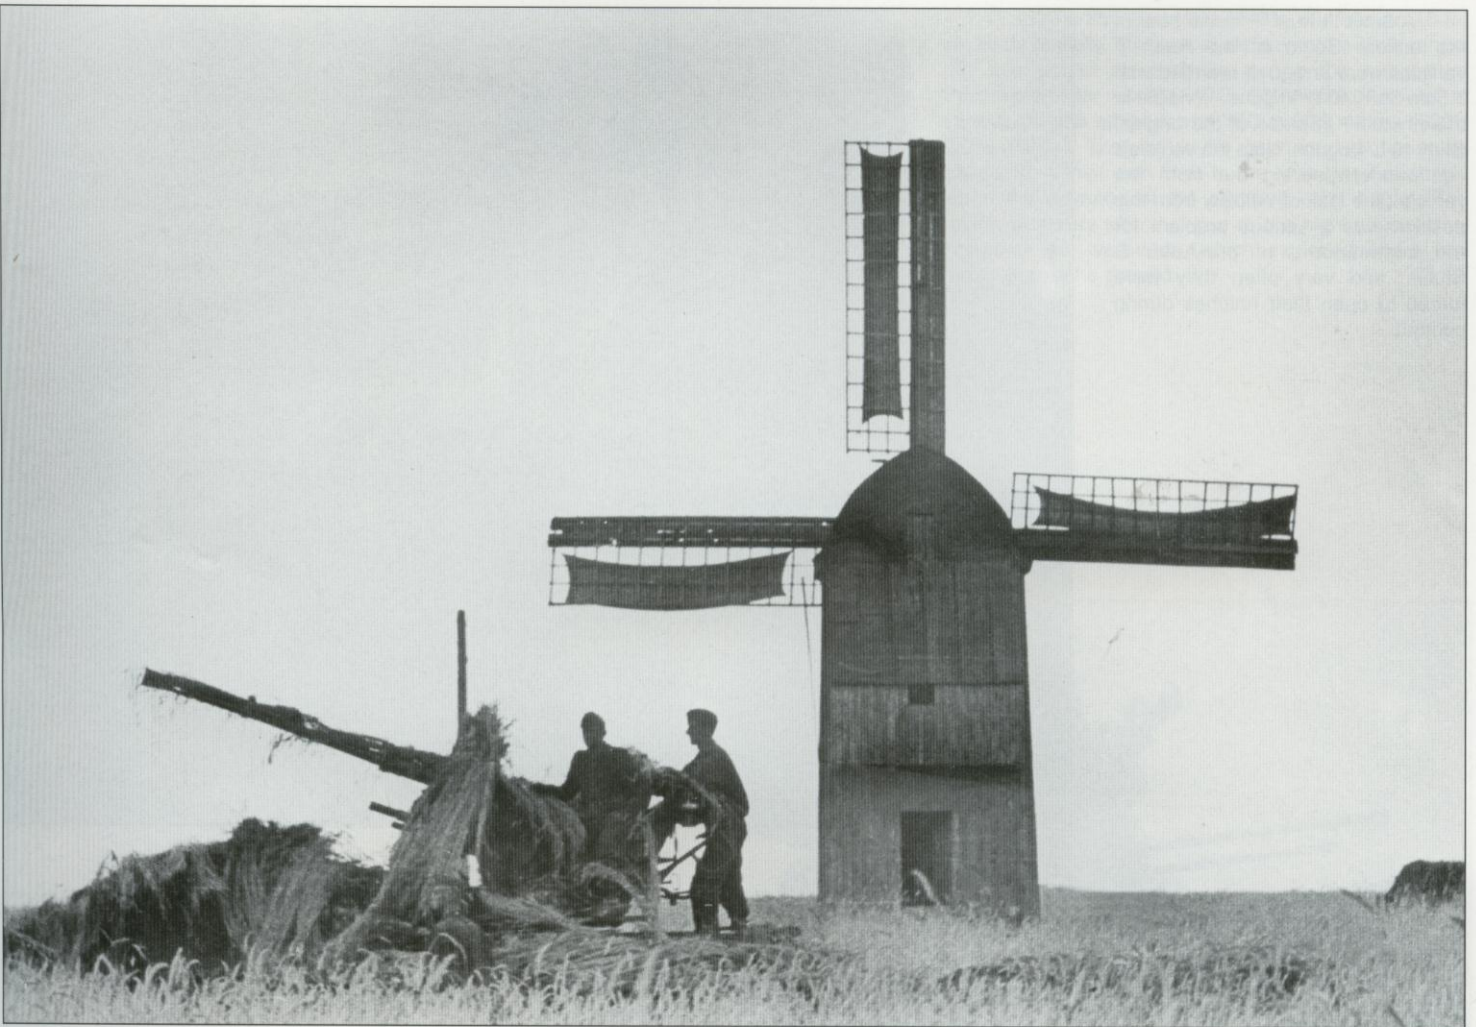
Windmills were a common sight in the Ukraine. The one seen here serves as a backdrop for a heavily camouflaged half-track fitted with a 3.7cm Flak 36 anti-aircraft gun. The main role of Flak units at this stage of the war was not defense against Soviet aircraft, which was the job for the experienced German fighter pilots, but fire support for attacking infantry.

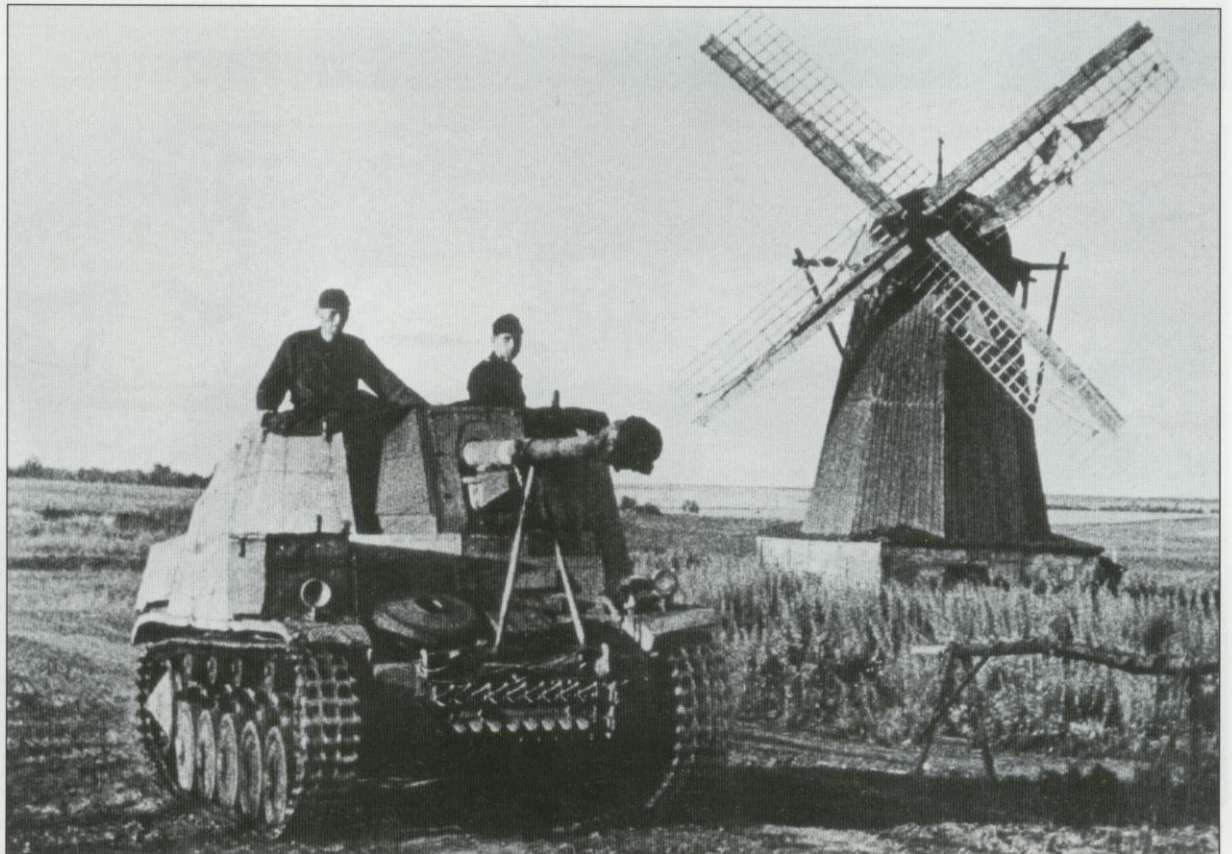
Here another successful tank destroyer, the Marder II, passes by one of the ubiquitous windmills. This vehicle was composed of the Pz.Kpfw. II chassis and the 7.5cm PAK 40/2 gun. The vehicle is not painted in a camouflage pattern. Instead it has wire affixed to it for attaching foliage or tall grass.

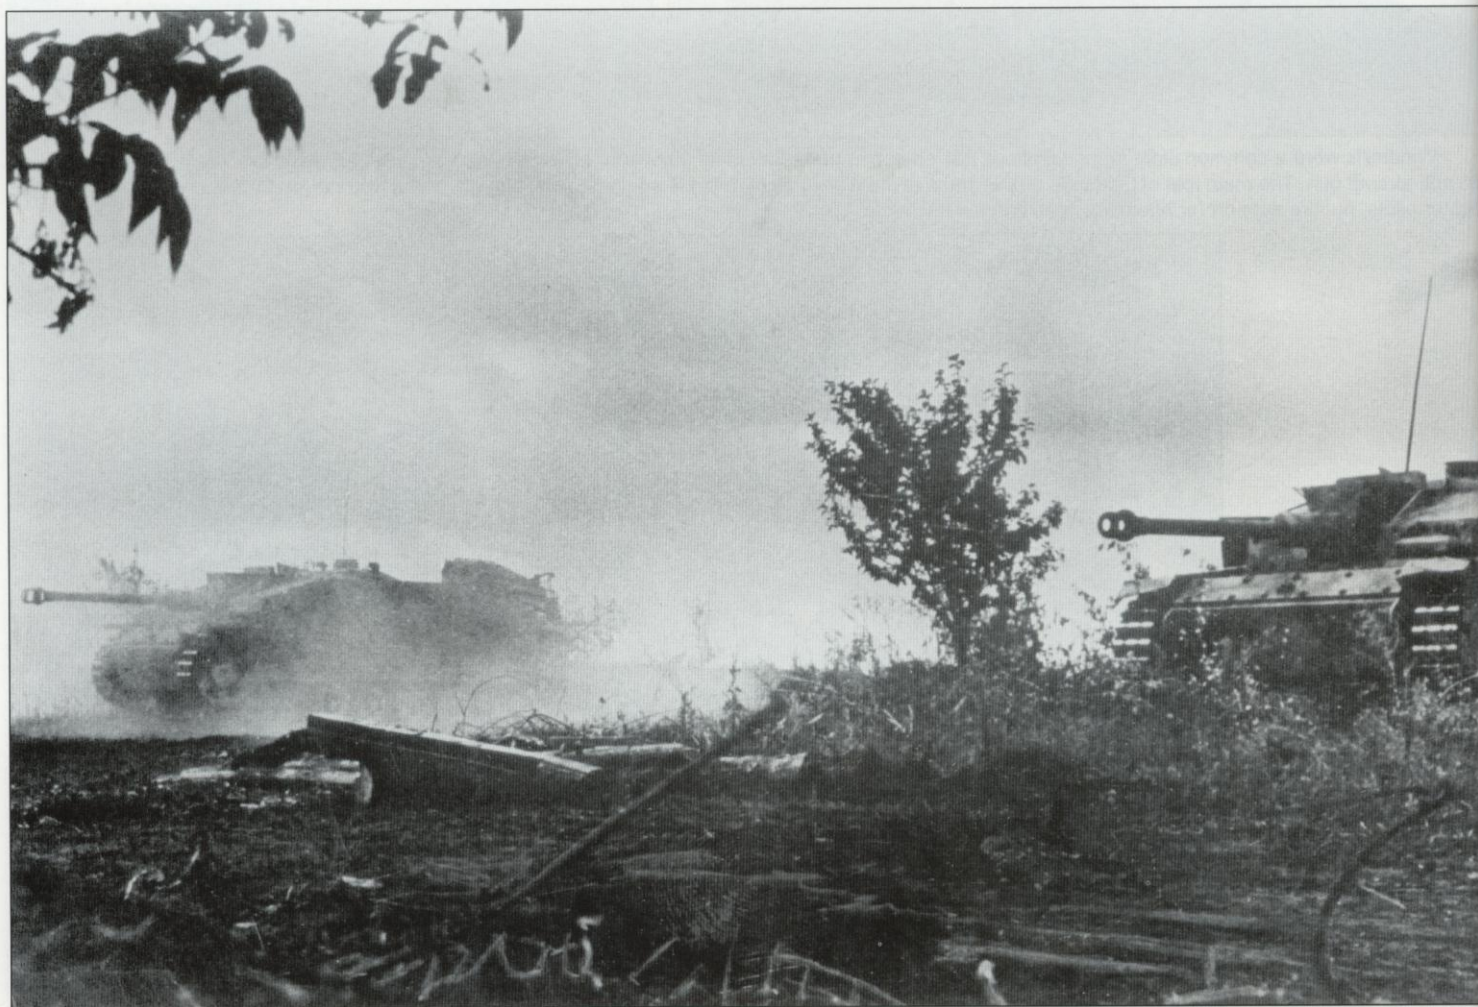
Another shot of Ausf. Fs in a similar situation. Note that both vehicles are equipped with side skirts with additional armor on the frontal plates of the hull and superstructure. Both modifications, which were originally designed for the Ausf. G model, indicate that these vehicles were modernized in the factory during overhauls.

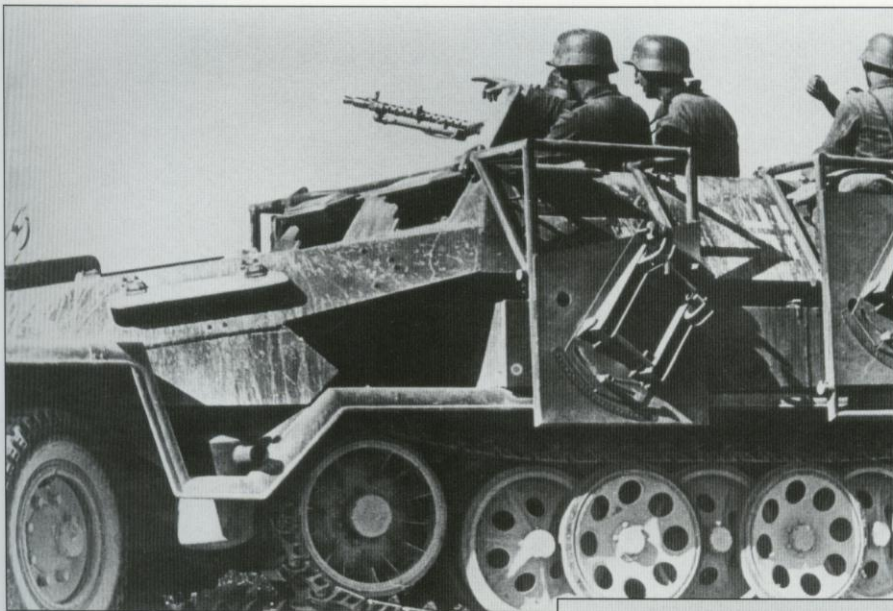
A Sd.Kfz. 251/1 armed with the Wurfrahmen 40 for six 28cm rockets. This sort of artillery had a short range, but this posed no problem during the support of Panzergrenadier attacks. WGr 280s could be fired at various targets at ranges of 750 -1,900 meters (820 - 2,078 yards). They could be used during the entire attack, from their own lines to the final stage of attack, when the advance of the armored units began. The rocket was very effective due to the highly destructive power of the warheads, which exploded about one meter above the ground.

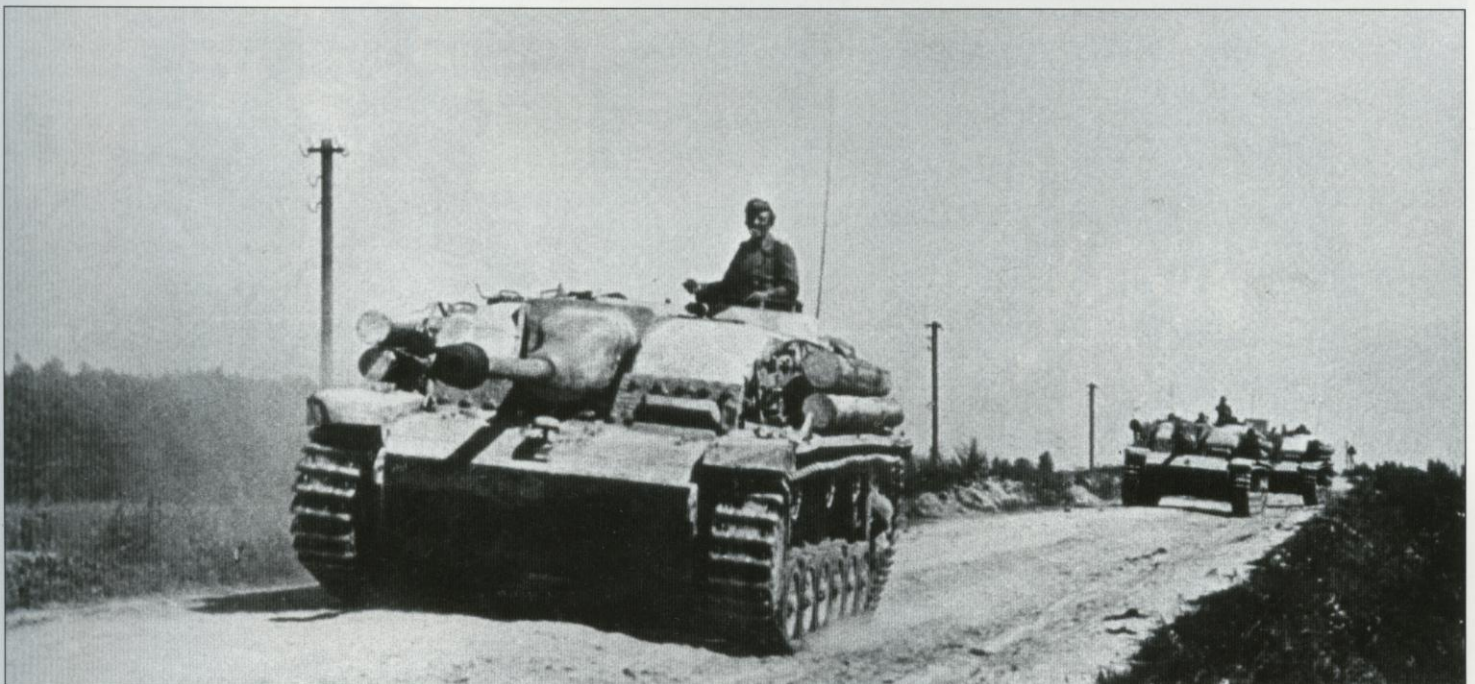
A platoon of late production StuG III Ausf. Gs passes in review for the camera along a dusty road. All the vehicles lack their side skirts, but large wooden logs have been mounted for protection instead. The lead vehicle is fitted with the late-style "Saukopf" mantlet.

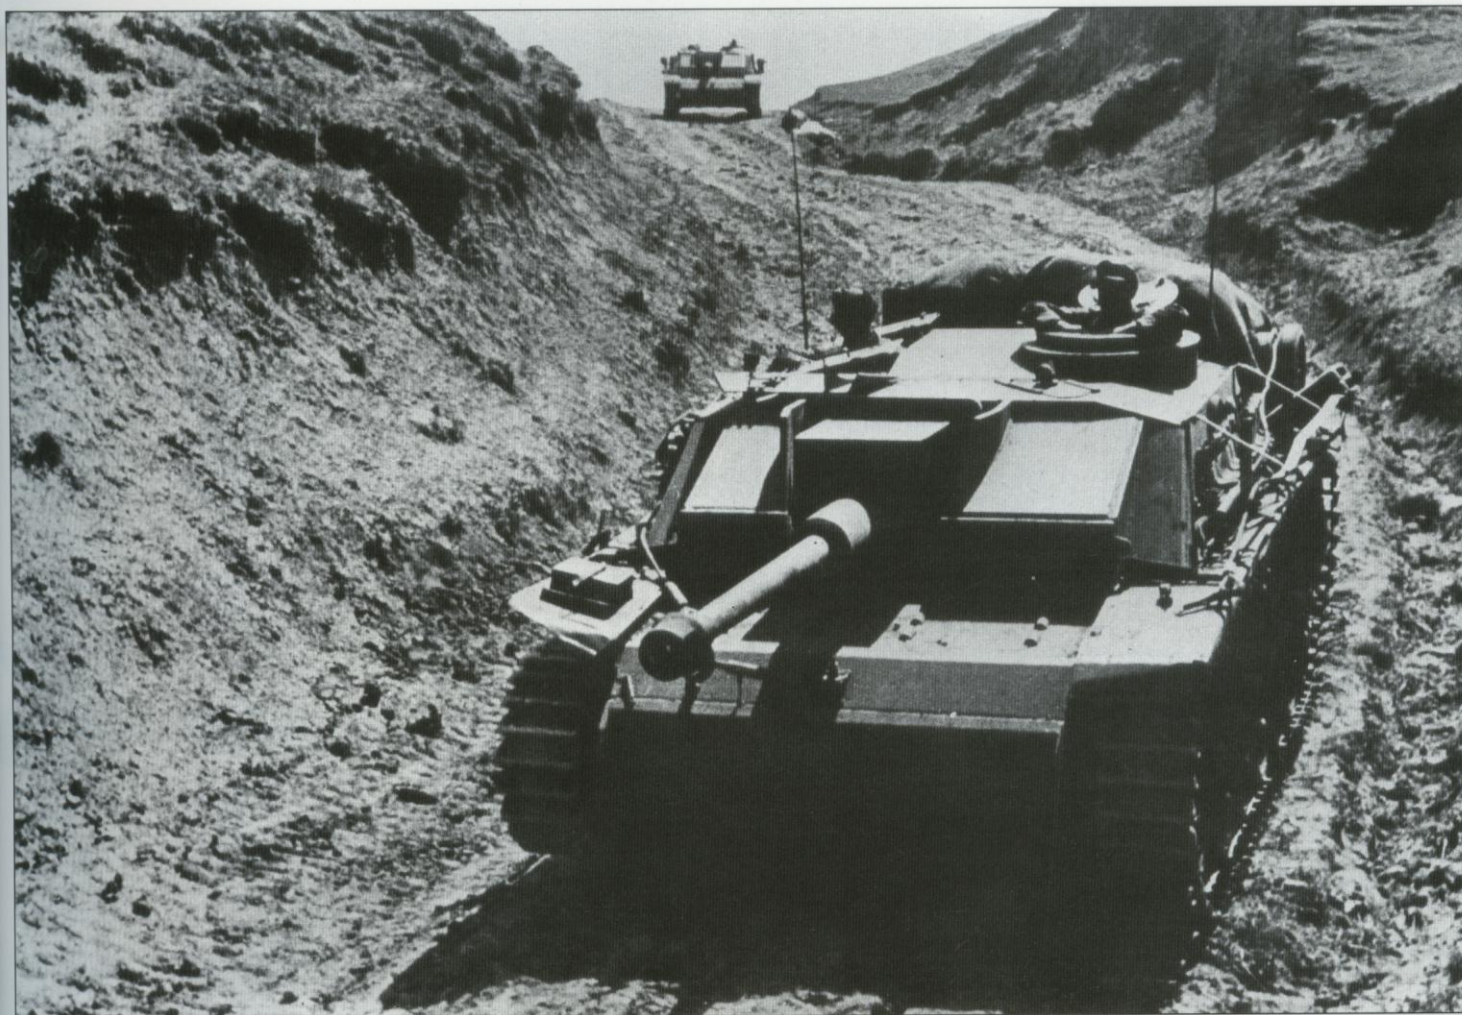
Brand-new (but with one already featuring damage on the front part of the mudguard) StuG III Ausf. Gs are seen on their way to a unit concentration area after arriving from Germany by railway transport.

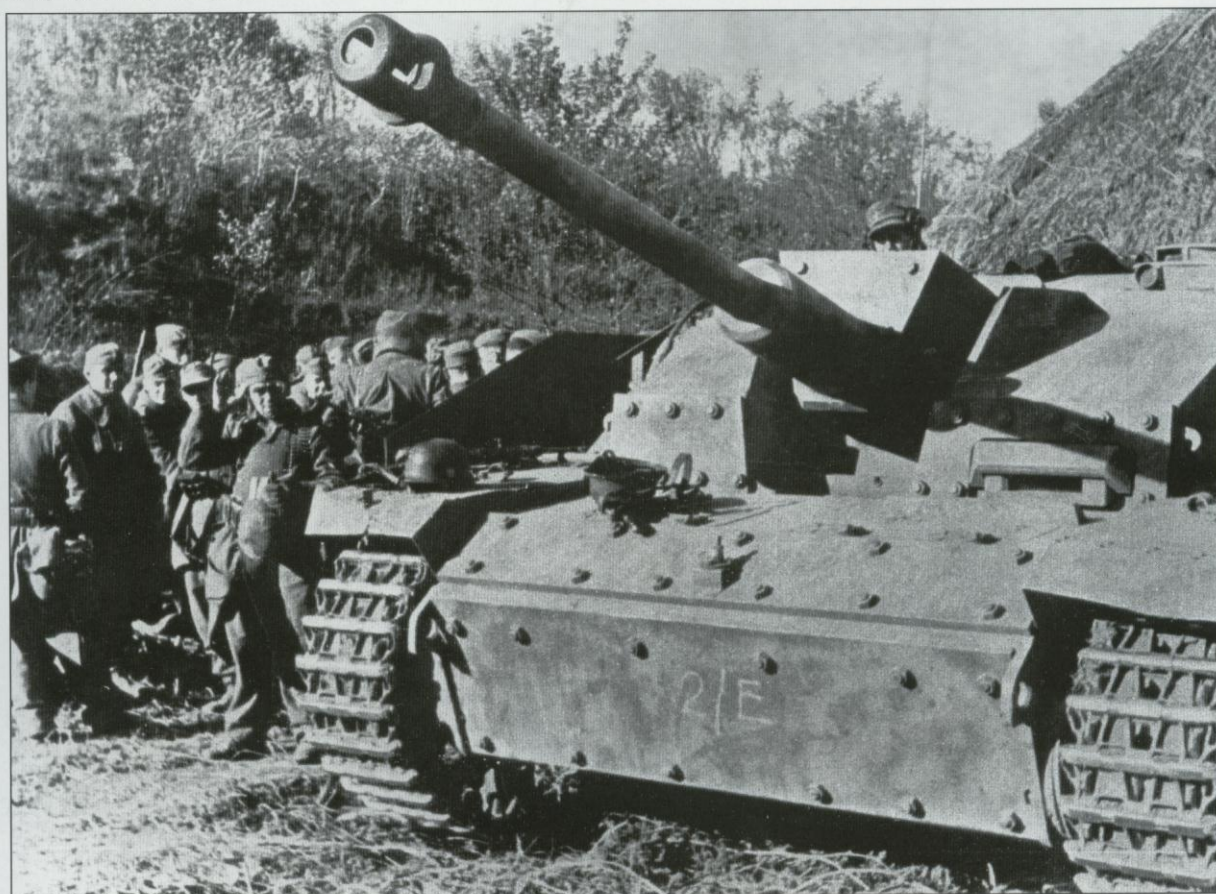
This StuG III Ausf. G waits with support troops for the order to attack. The practice of bolting additional armor to the front of the hull and superstructure is well illustrated in this photo. The meaning of the "2/E" marking is unclear.

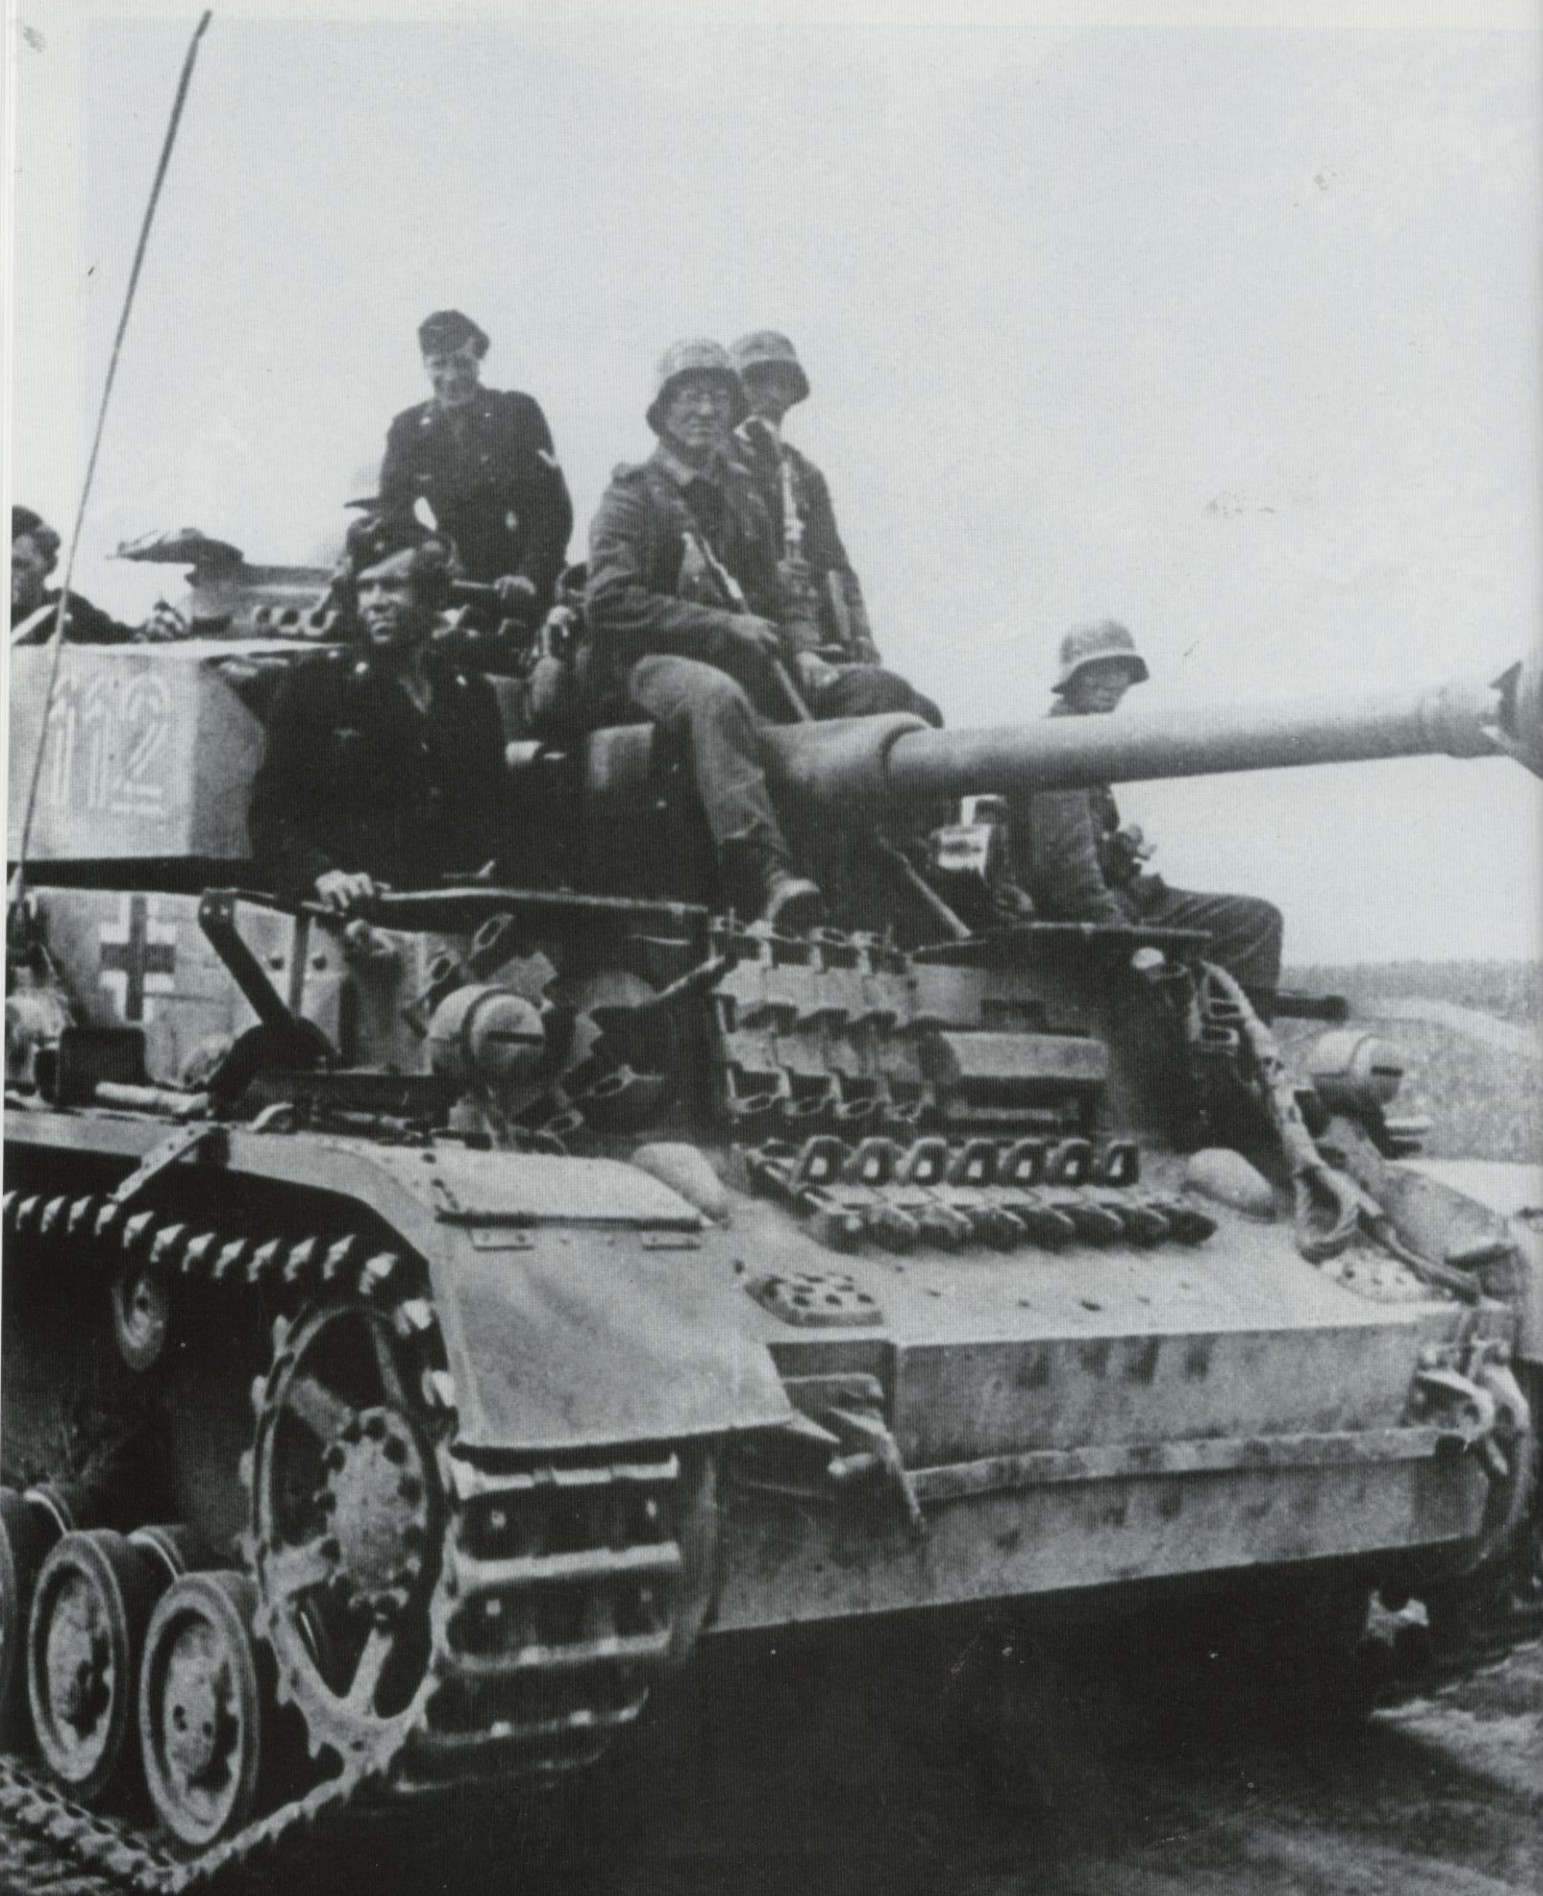
A late production Pz.Kpfw. IV Ausf. G gives a few troopers a lift. Additional armor was welded to the front of the hull. Note the turret spaced armor attachment points for armored skirt on the right side of the tank. Usually only turret skirts were installed; tank crewmen preferred their use over the full set of skirts. Also note that the tactical number is painted only with a white outline in the manner that was typical from the autumn of 1943.

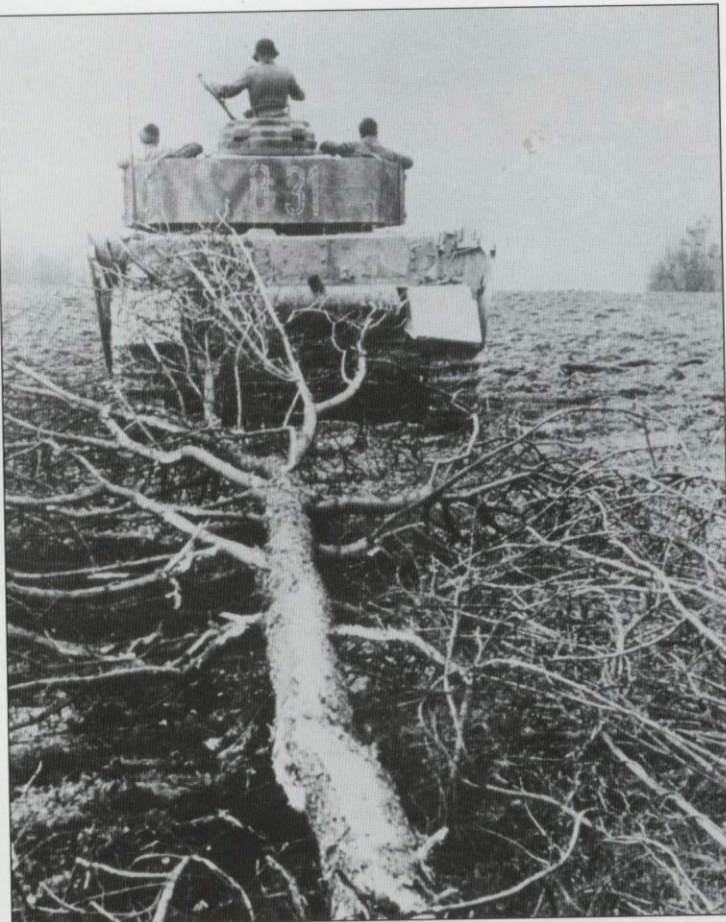
The crew members of a Pz.Kpfw. IV Ausf. H demonstrate that a tree is no obstacle for a German tank. This photo shows to advantage the system of installing side skirts on the superstructure. The tactical number is painted in the standard way — the first figure, which indicates the 8th company, is separated from the two others, which indicate the 1st tank in the 3rd platoon, the vehicle was used by the platoon commander.

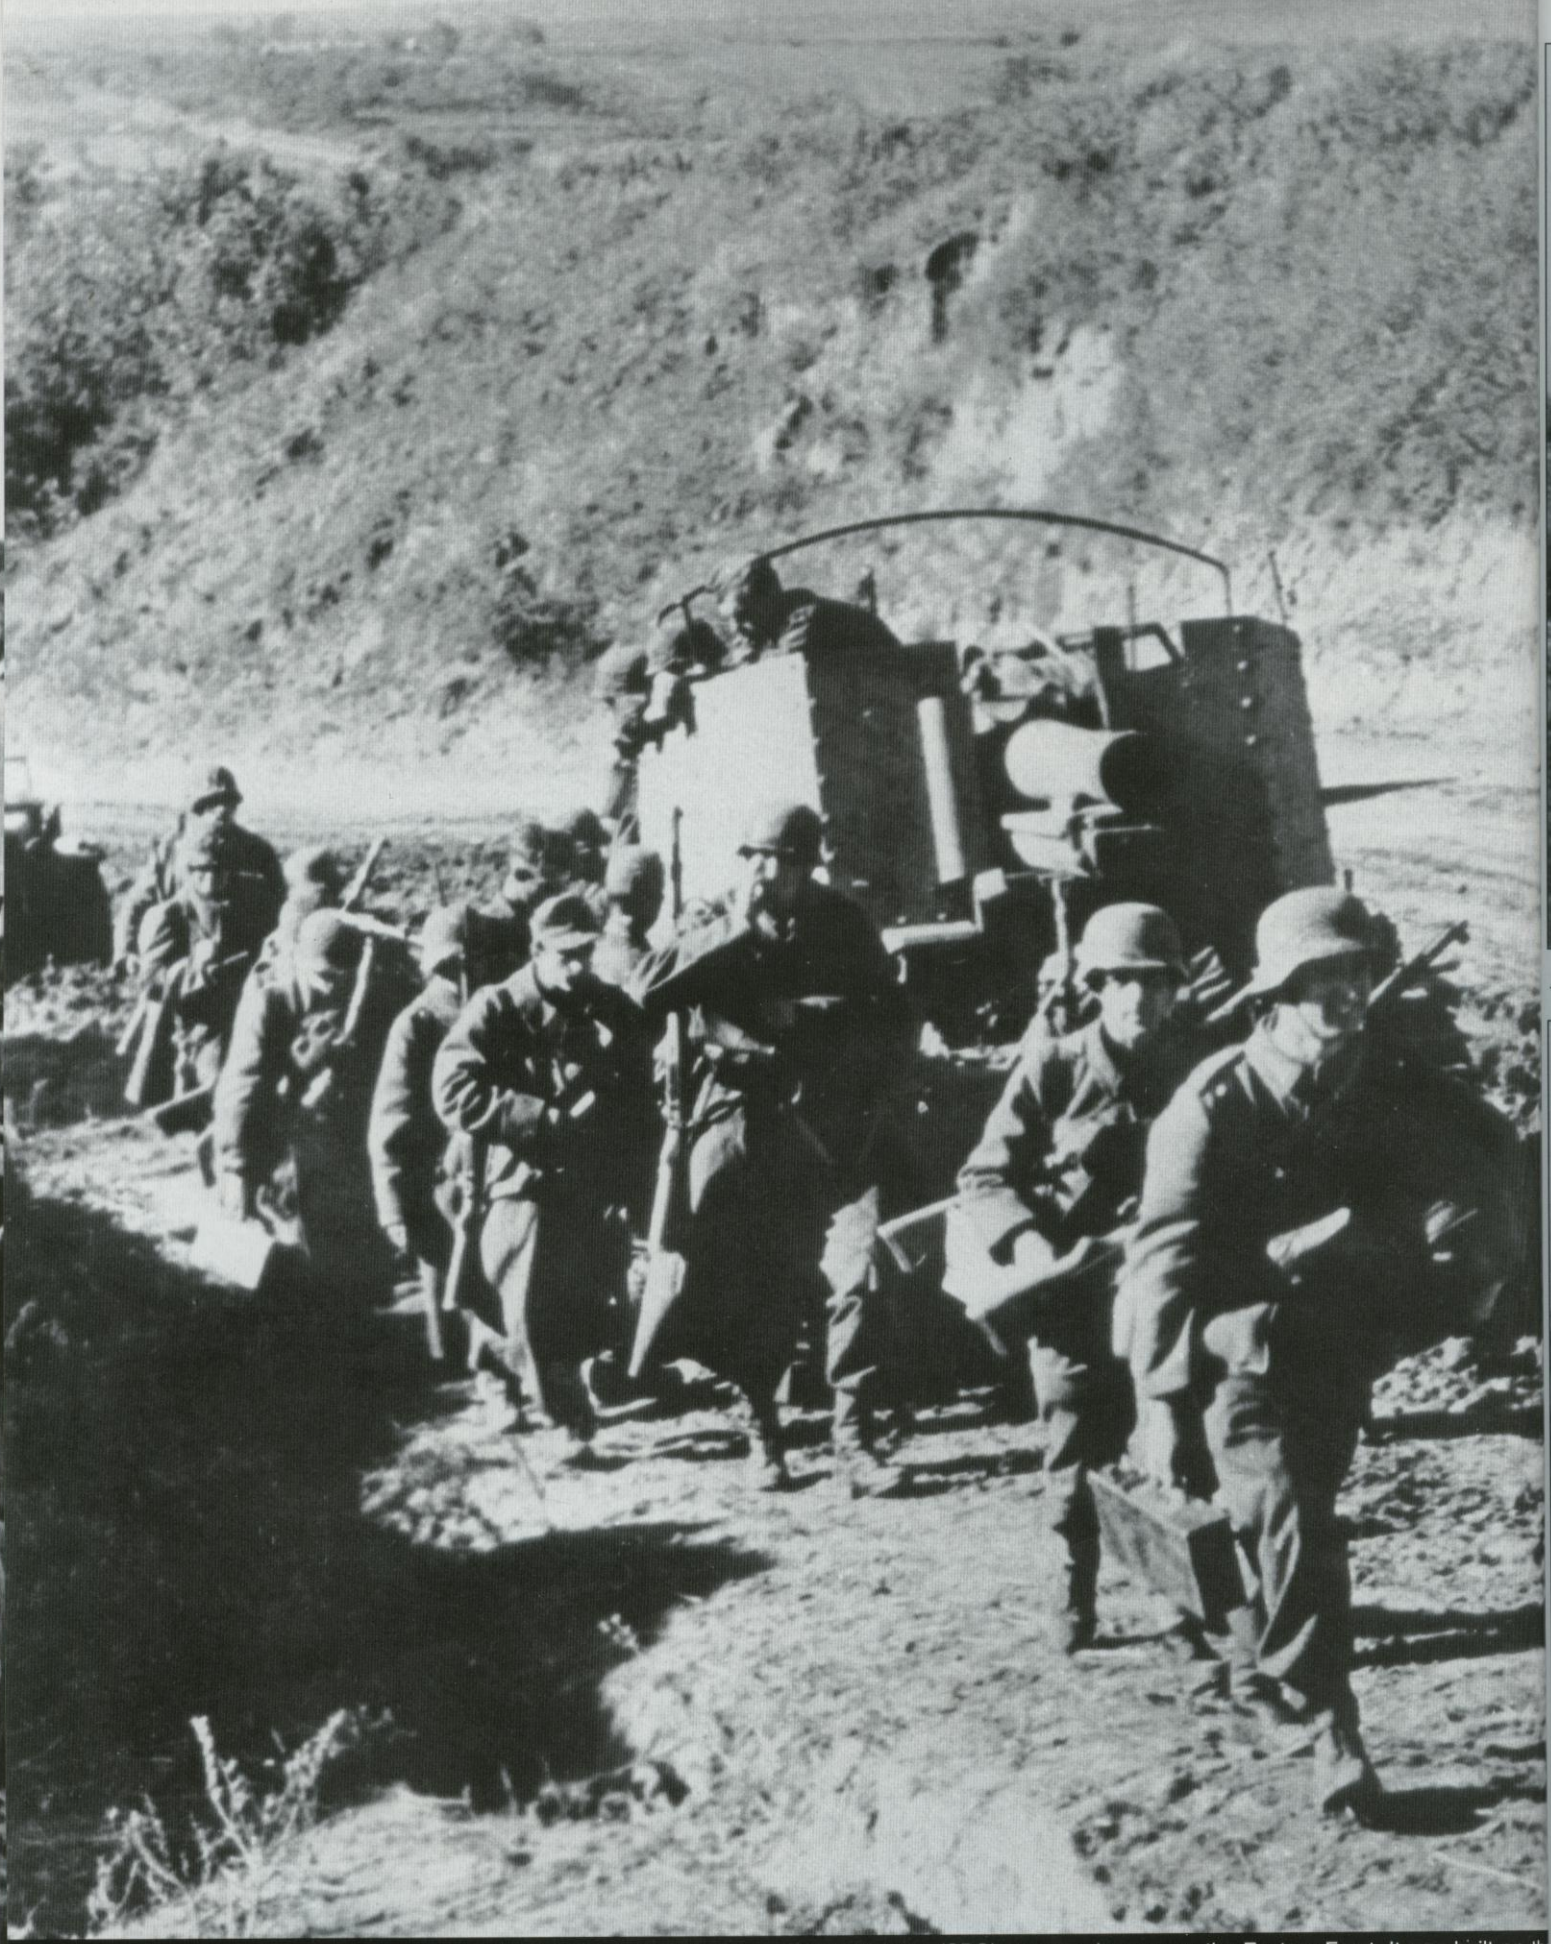
The vehicle shown here, the Sd.Kfz. 138/1 Grille (cricket) heavy self-propelled gun (SPG), was rarely seen on the Eastern Front. It was built on the Pz.Kpfw. 38(t) chassis and was armed with a 15cm sIG 33 gun. About 100 of these vehicles were produced between the beginning and autumn of 1943. They were used in the artillery units of infantry regiments in Panzer divisions.

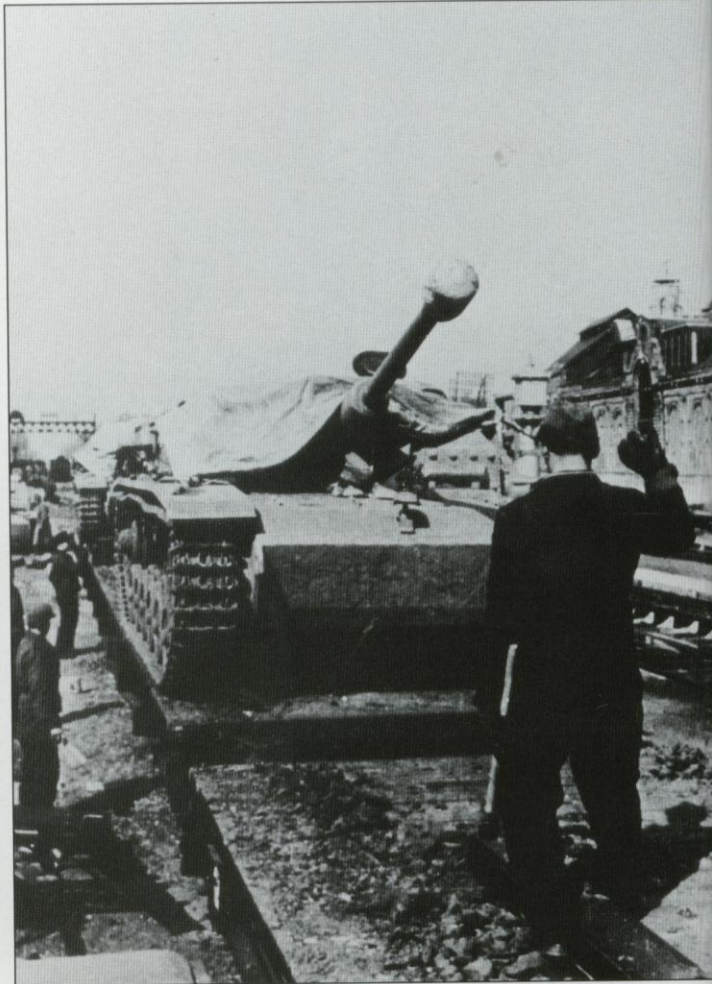
StuGs are loaded onto a flatbed railroad car for shipment to the front lines. The photo shows that the vehicles were transported from the manufacturer without side skirts, which were usually installed in divisional workshops.

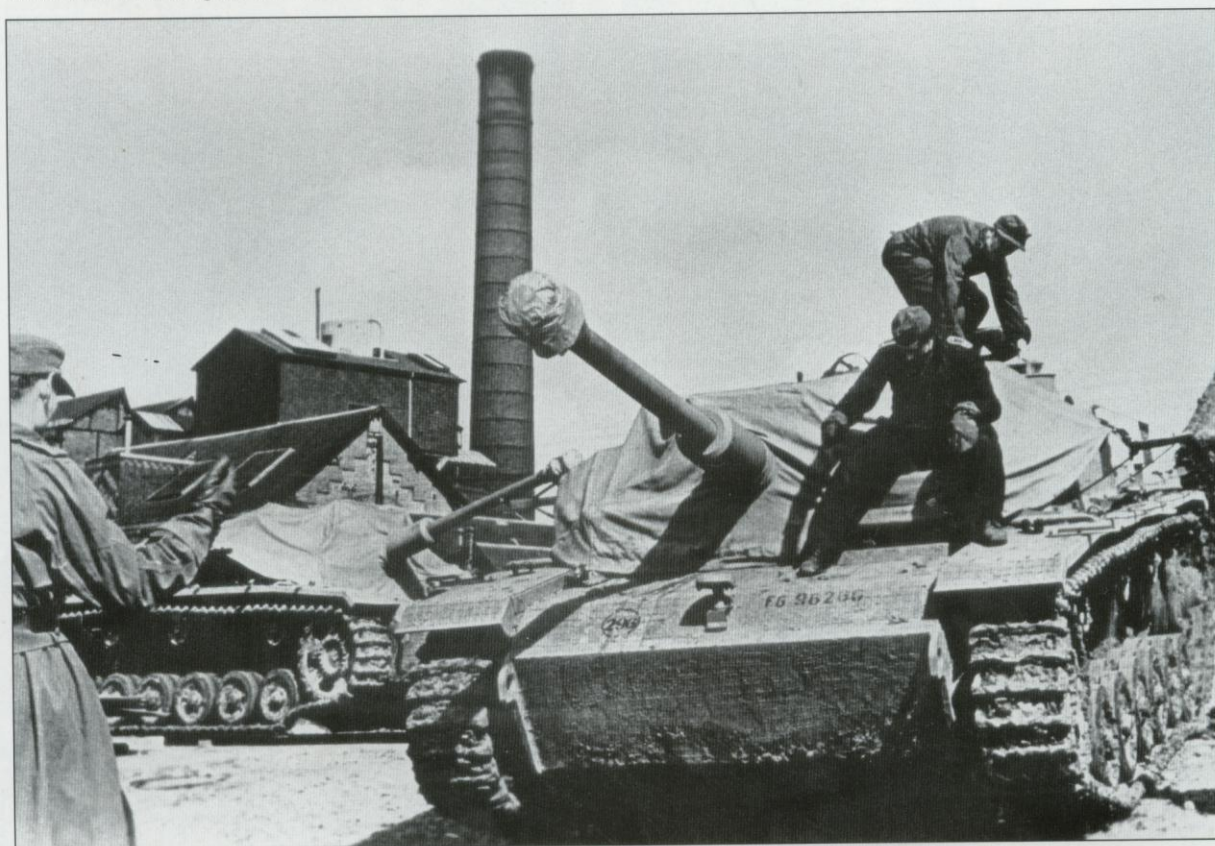
Sturmgeschütz I Ausf. G assault gun are prepared for loading onto railroad cars prior to being transported to the front lines to support the infantry. Note the factory markings. On the front plate of the hull is the serial number of the chassis — FG 96286.

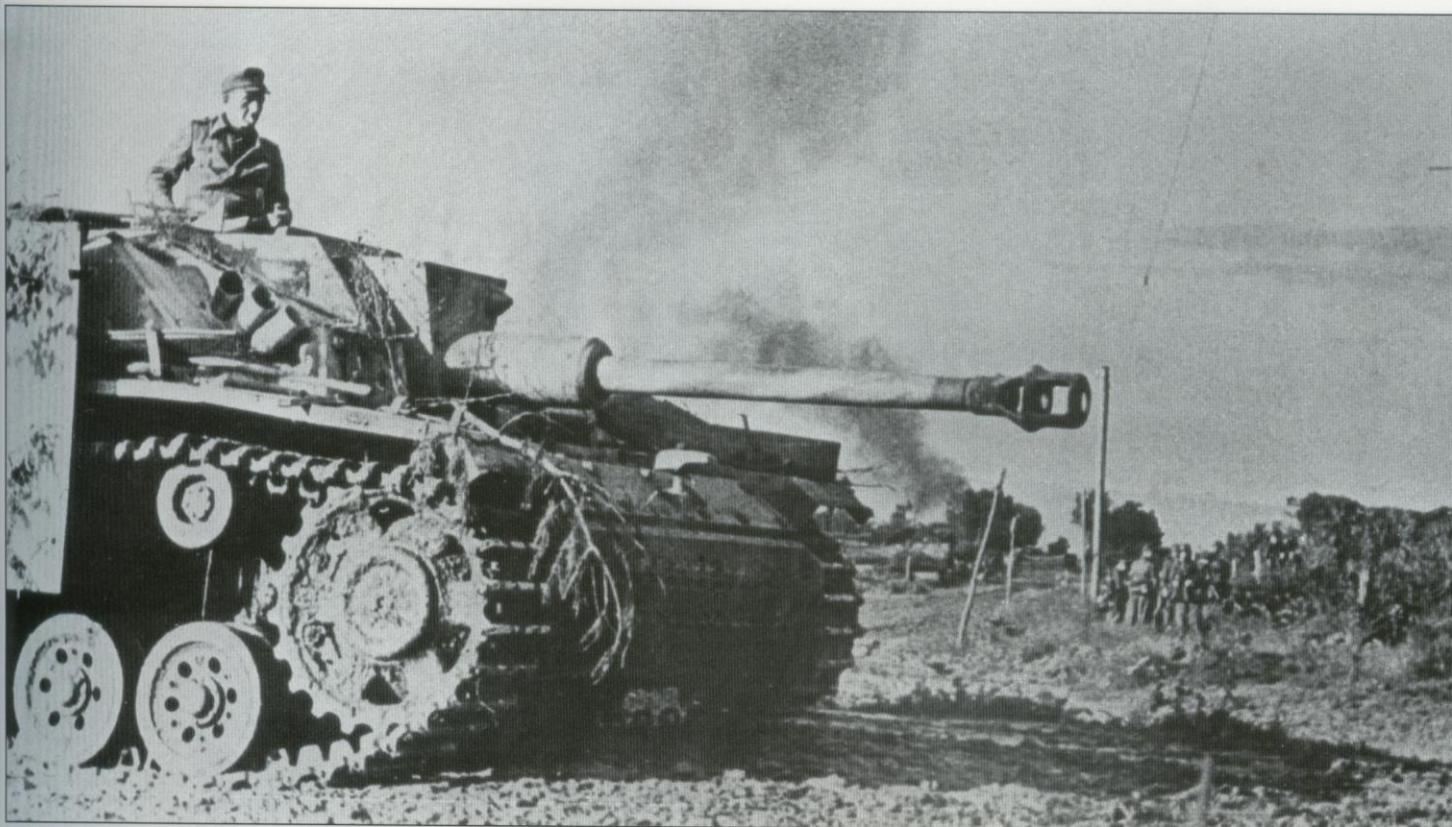
This photo shows a StuG III Ausf. G in action. The front part of the right set of skirts is missing, so the smoke grenade launchers are clearly visible. The muzzle brake illustrates the typical German practice of painting the muzzle brake of tanks and self-propelled guns a very dark color — usually dark gray. During combat in the autumn of 1943, the Panzerwaffe lost the largest number of StuGs since the beginning of war against the Soviets — about 200 vehicles per month. Most of them were lost on the Eastern Front, of course.
