# PANZERS IN THE EAST

(2) Decline and Defeat 1943-1945

Robert Michulec

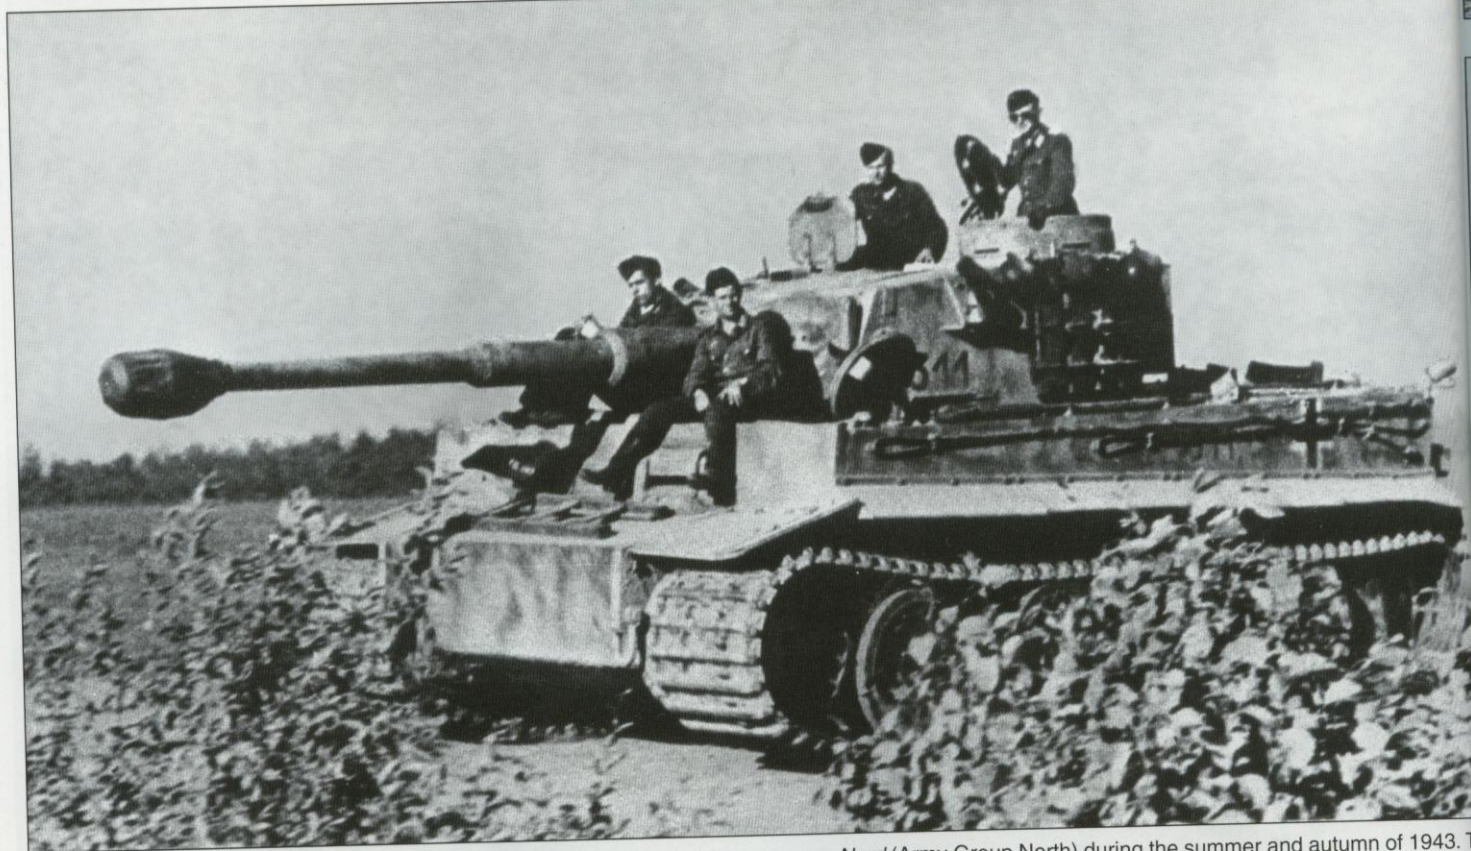
Tiger tank number "311" from s.Pz.Abt.502, which operated under *Heeresgruppe Nord* (Army Group North) during the summer and autumn of 1943. The 1st platoon of s.Pz.Abt.502 was the first Tiger-equipped unit that was rushed to the Leningrad area in August 1942. The tank is from the early series and has smoke candle dischargers installed in the corners of the turret. The tactical number is painted in black on the sides of the turret and hull. The camouflage is composed of an olive green pattern on a dark yellow background.

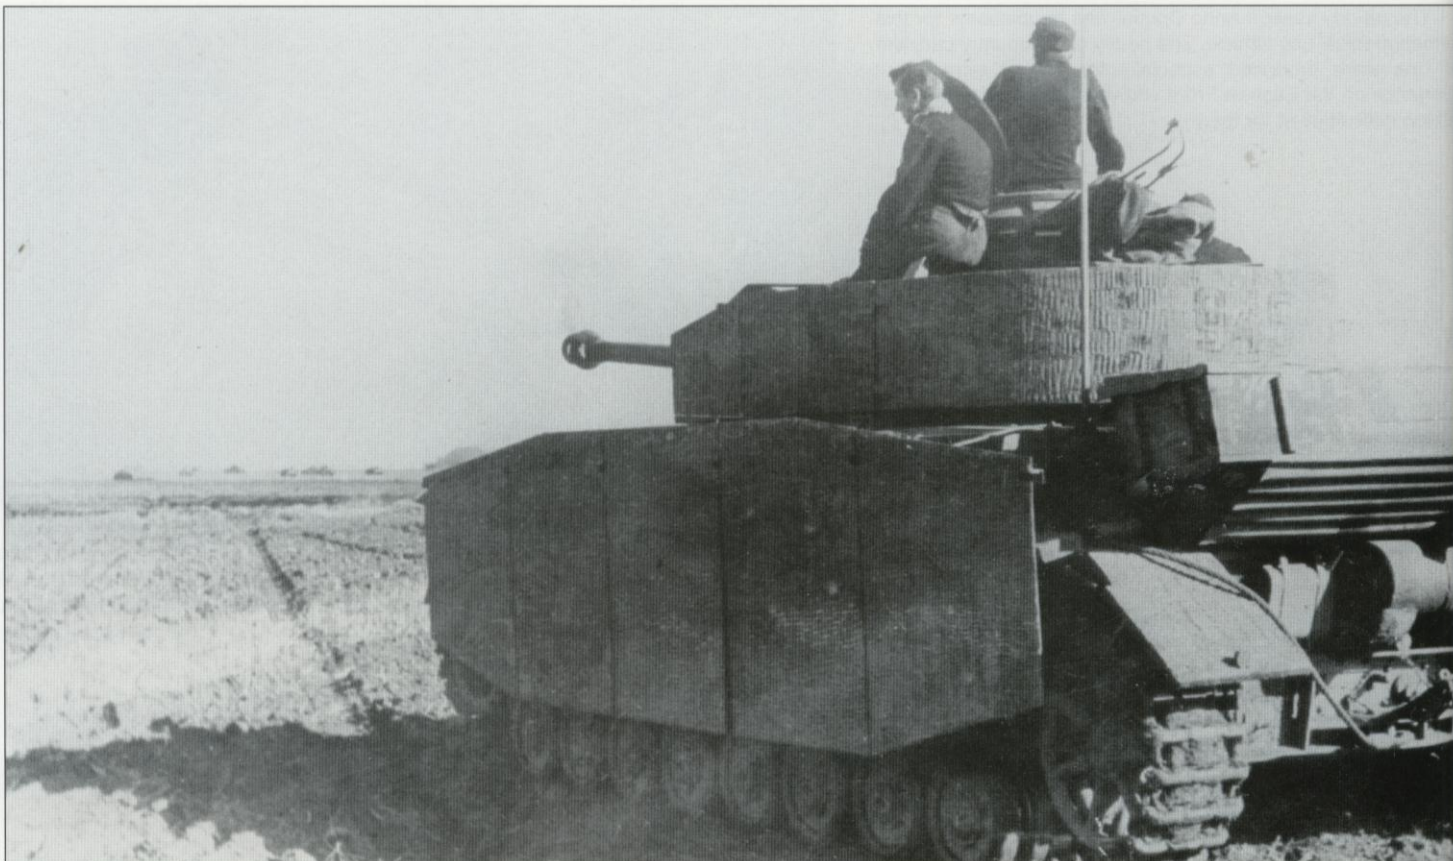
A Pz.Kpfw. IV Ausf. H with a full coat of *Zimmerit* anti-magnetic paste applied to its exterior. Note the non-standard stowage box added to the rear of the vehicle. By the autumn of 1943, the German Army was in full retreat. The Soviet Army fielded 2,600 tanks between Smolensk and Rostov with the intention of pushing the Germans back to the Dnieper River before the year's end.

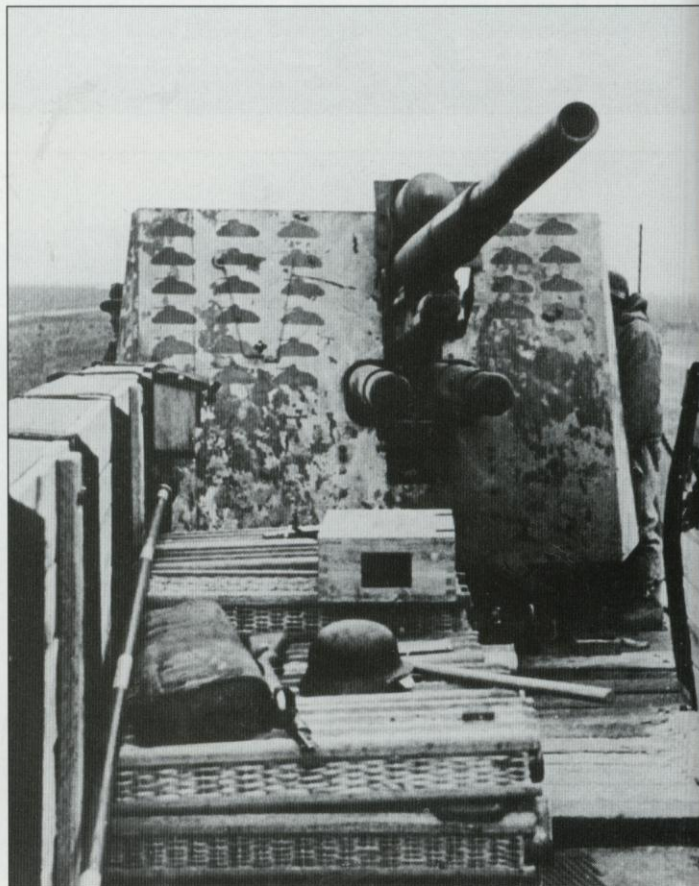
Another "88" gun from the same *Eisenbahnpanzerzüge* displays its successes: 26 tank "kills" on the gun shield and seven or eight air victories on the barrel. Note the damage to the right "armor plate" (composed of sand in a wooden framework), and that the gun has a dark gray barrel and a sand-colored shield.

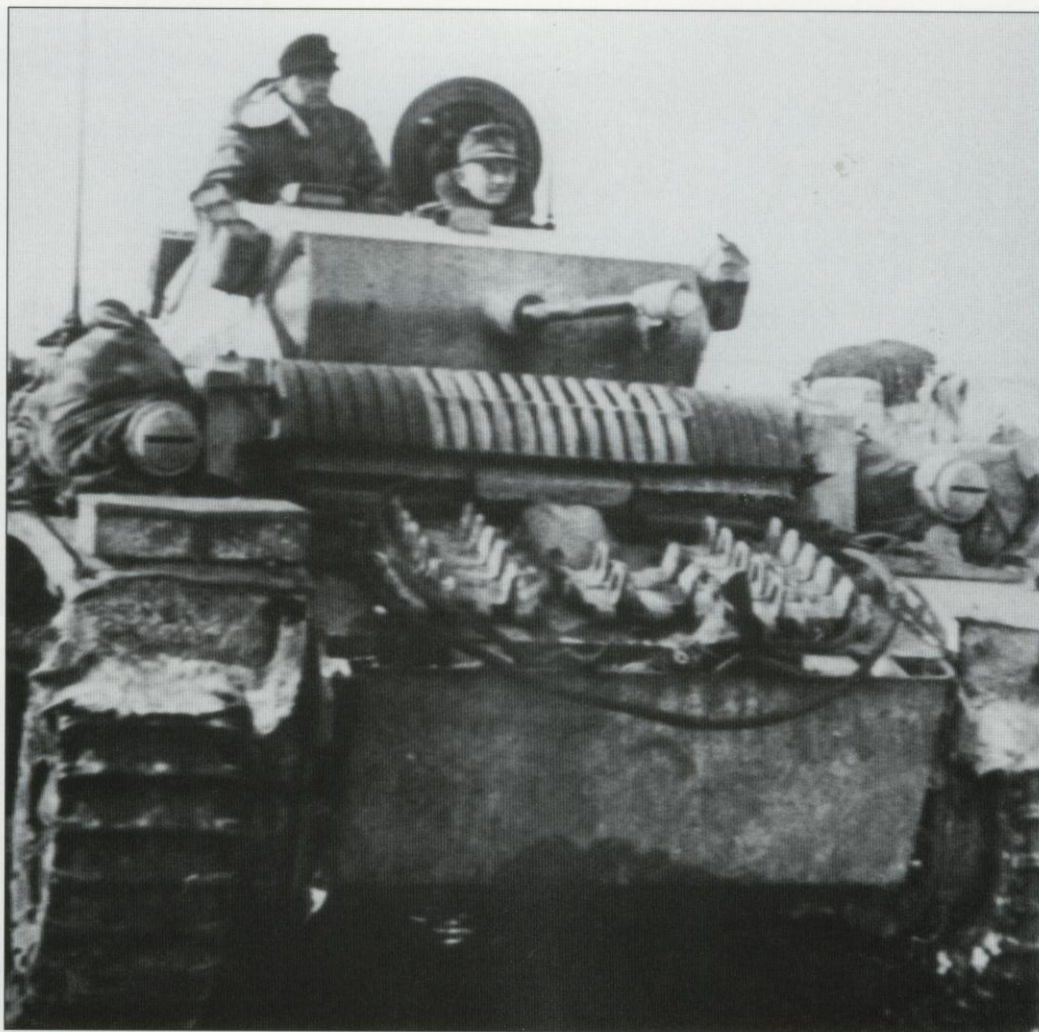
A Luchs of Pz.Aufkl.Abt.19, 10.Panzerdivision preparing to move forward. This reconnaissance vehicle was armed with a 2cm KwK38 L/55 gun and had very good cross country speed. About 100 vehicles were produced from September 1943 on, and issued to the armored reconnaissance detachments of the Panzer divisions. Note the additional armor on the nose plate.

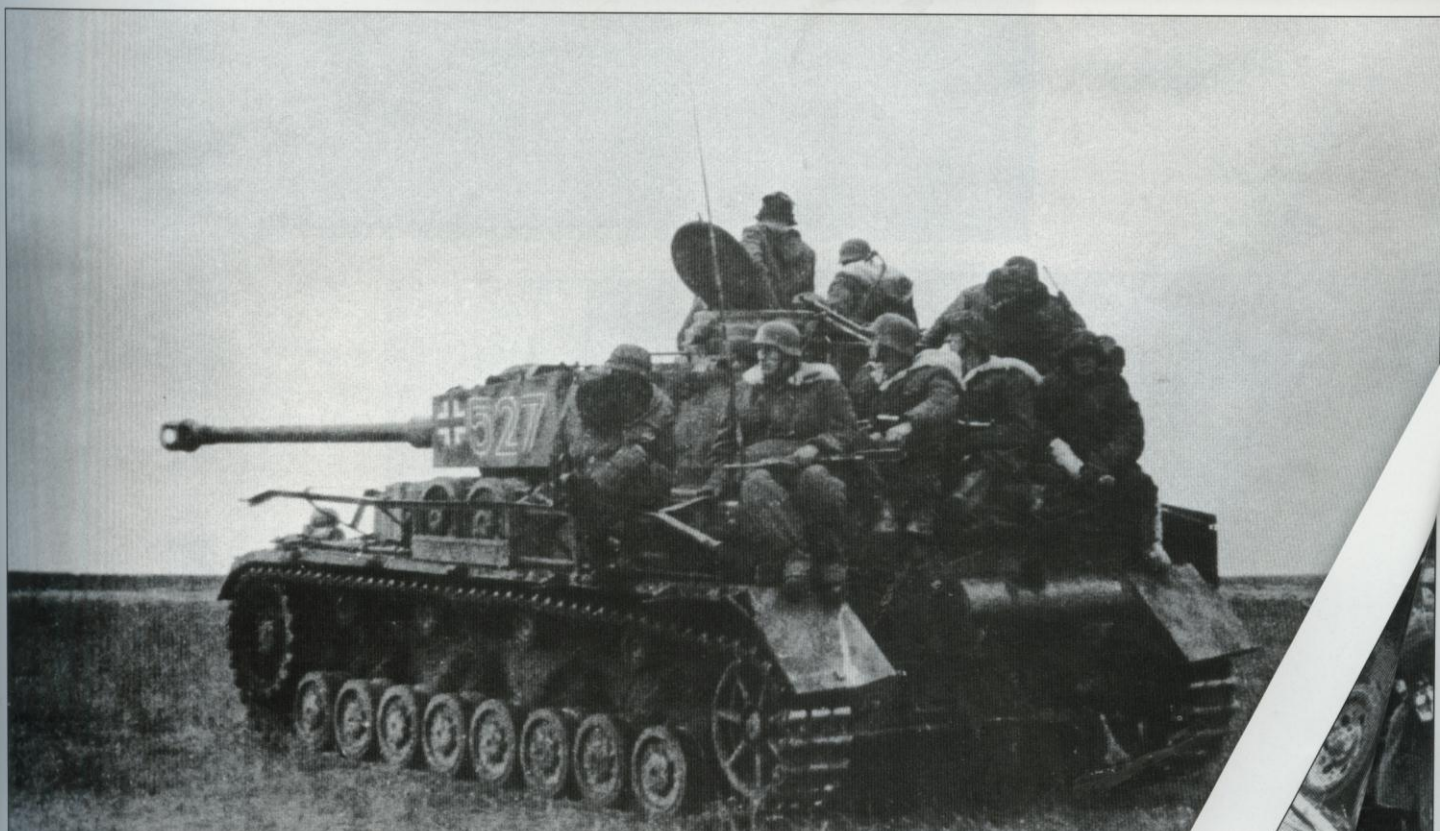
A Pz.Kpfw. IV Ausf. H transports a squad of infantry during the fighting in the autumn of 1943. It is interesting to note that those installed on the left side were lost, probably as a result of combat. The soldiers wear reversible parkas, normally gray and white, but this photo shows that the parkas of two of the soldiers have dark (black?) interiors.

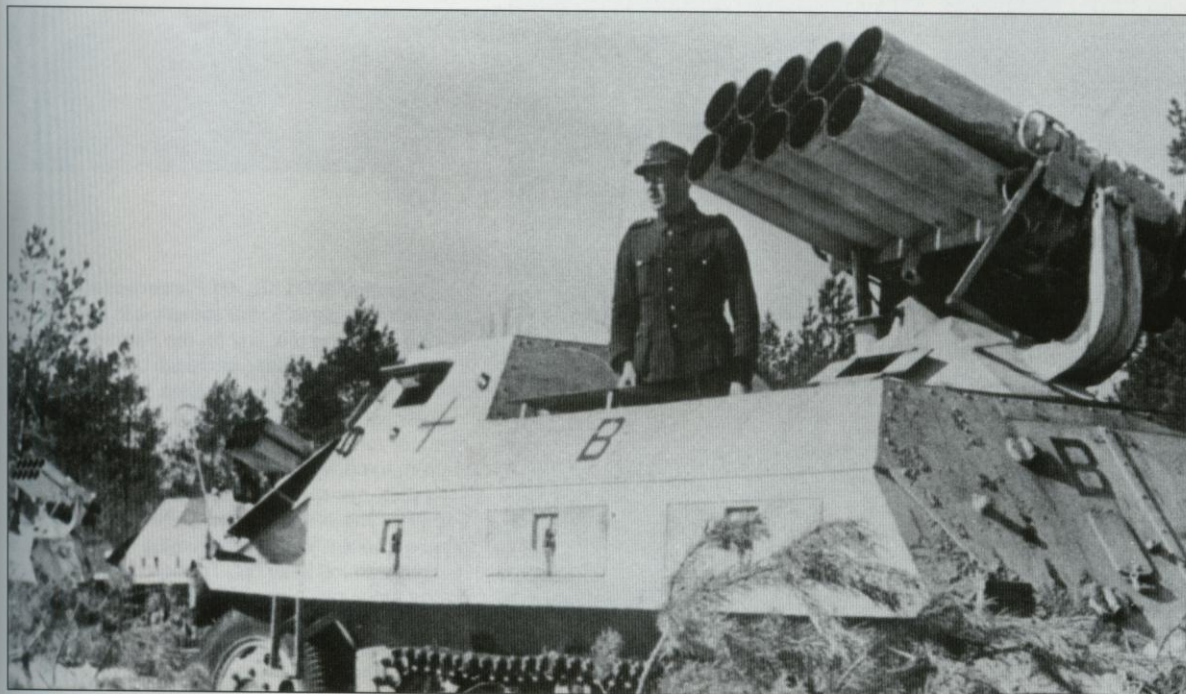
A battery of Sd.Kfz. 4/1 15cm Panzerwerfer 42 self-propelled rocket launchers is seen here during a demonstration. The ten-barreled Nebelwerfer 42 was designed for use on the armored Opel Maultier, which offered mobility and protection to the Nebelwerfer brigades. However, the crew had to load the rockets outside the vehicle.

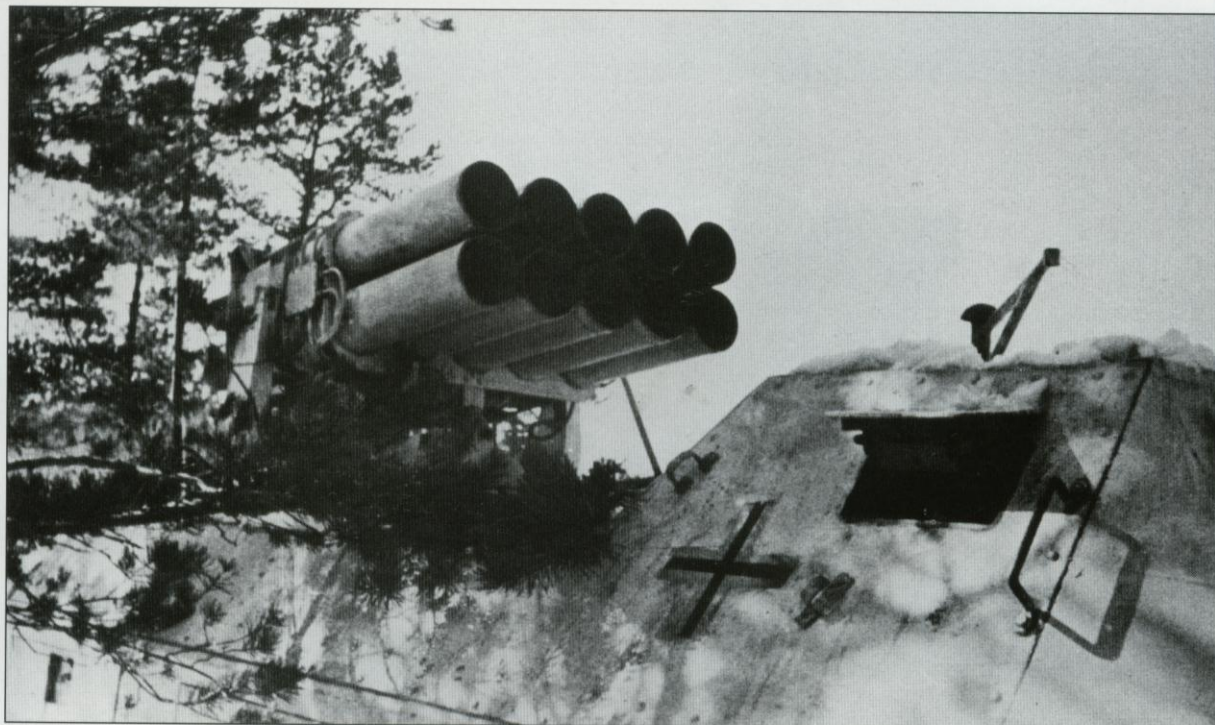
This close-up shot of the 15cm Panzerwerfer 42 shows the details of the rocket launcher and the mount for the 7.92mm MG34 or MG42. The vehicle is painted dark yellow overall. One battery of these vehicles could launch 40 missiles in about four seconds at a range up to 6,500 meters (7,105 yards).

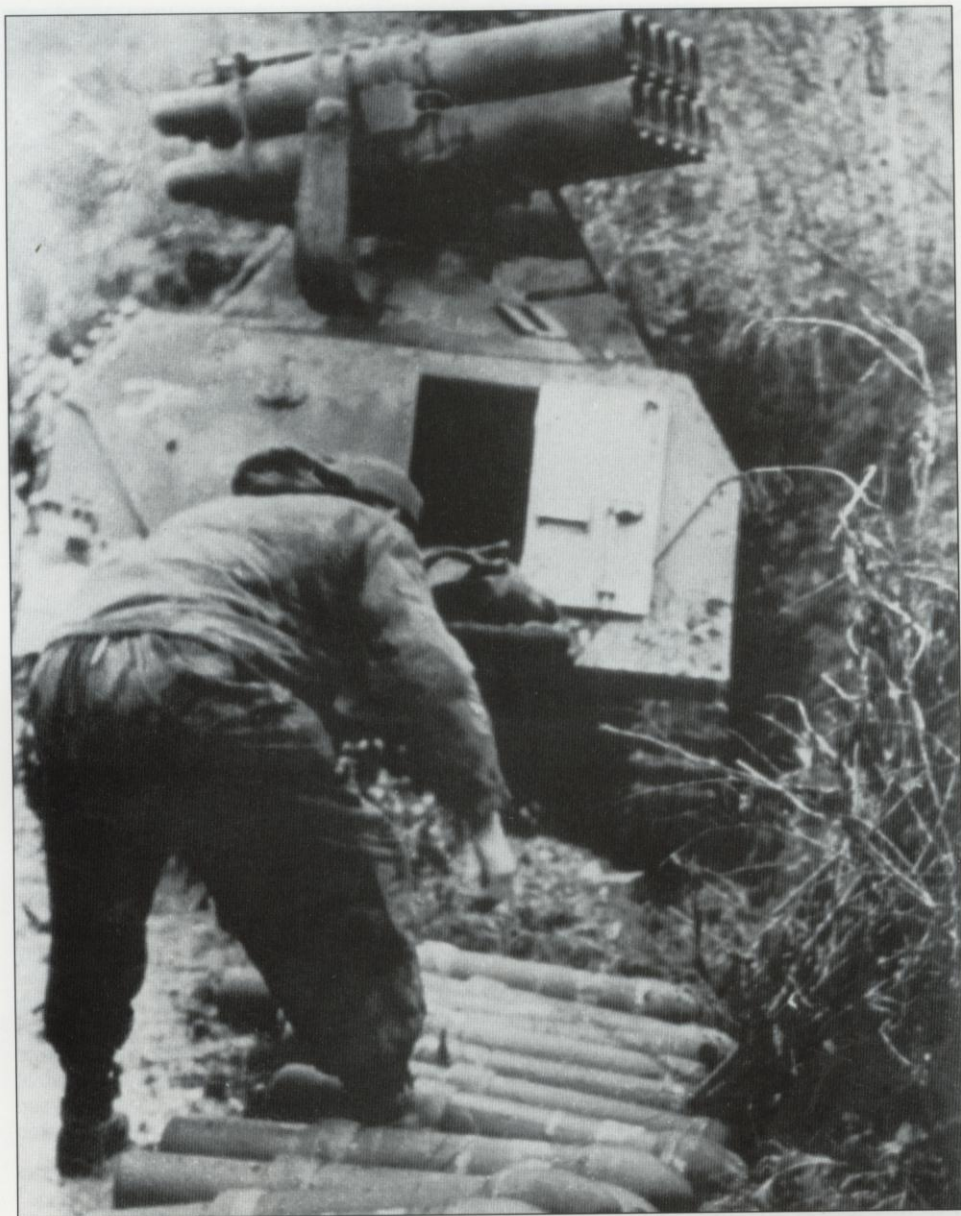
This photo shows over a dozen 15cm rockets ready for loading into the Panzerwerfer 42. The lightweight 10-kg (22-lb) warheads were installed in the rear of the missiles and when they exploded they had a terrible impact on any living target within a 13 x 40-meter (14 x 44-yard) area.

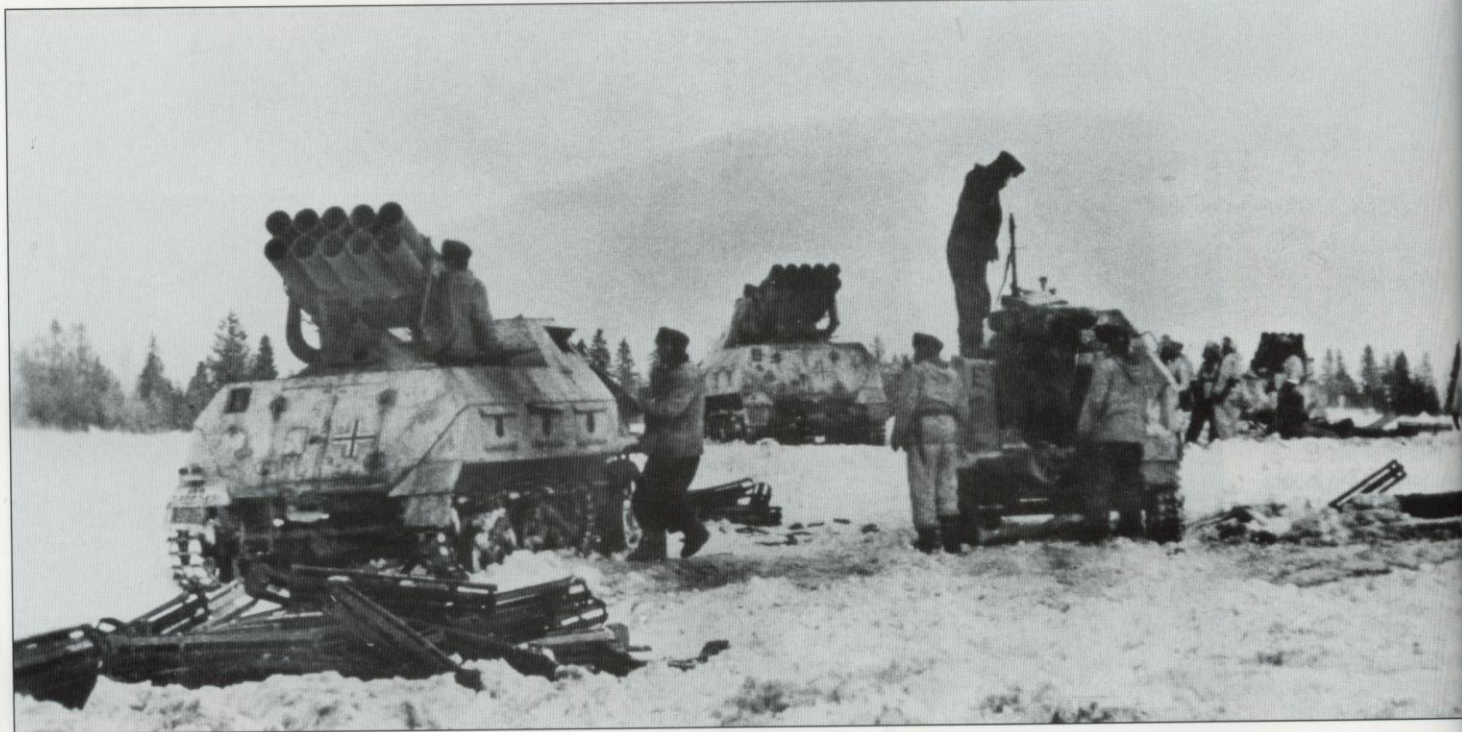
A battery of Sd.Kfz. 4/1 Panzerwerfer 42 rocket launchers prepares to fire sometime in the winter of 1943/44. The normal unit for the Panzerwerfer was the independent battery, and each battery consisted of two platoons of four vehicles. Since they were independent, the Panzerwerfer 42s were used by corps or army commanders. All vehicles in the unit were marked with letters. For example, the Sd.Kfz. 4/1 at left has a black letter "D" painted on left top corner of the rear wall and on the side of combat compartment. The vehicle in the background is marked with the letter "E". The same letter is carried by the ammunition carrier, the *munitionskraftwagen* (Sd.Kfz. 4), visible at right without the Nebelwerfer 42. This half-track is armed with an MG34 for anti-aircraft duties.

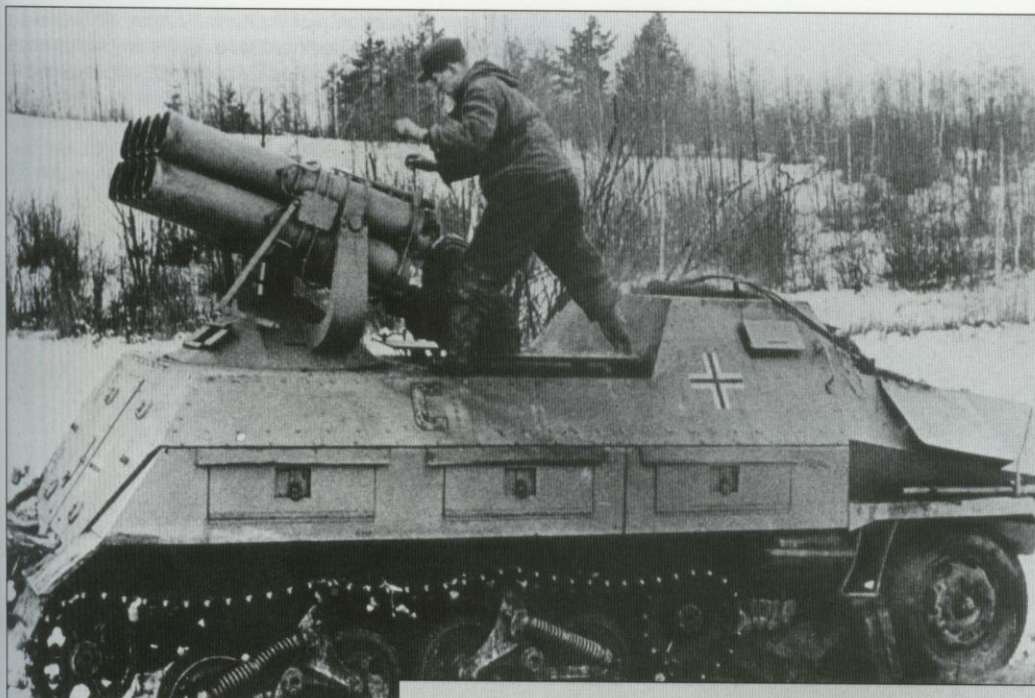
The Sd.Kfz. 4/1 was an effective weapons system even though its rockets had a small range. Its production started in April 1943 in Opel factory, the vehicle being built on the base of the Opel Maultier half-tracked truck. There were 289 *munitionskraftwagen* and 300 Panzerwerfer produced between April 1943 and March 1944. Here we see the first step in loading a rocket into the launcher.

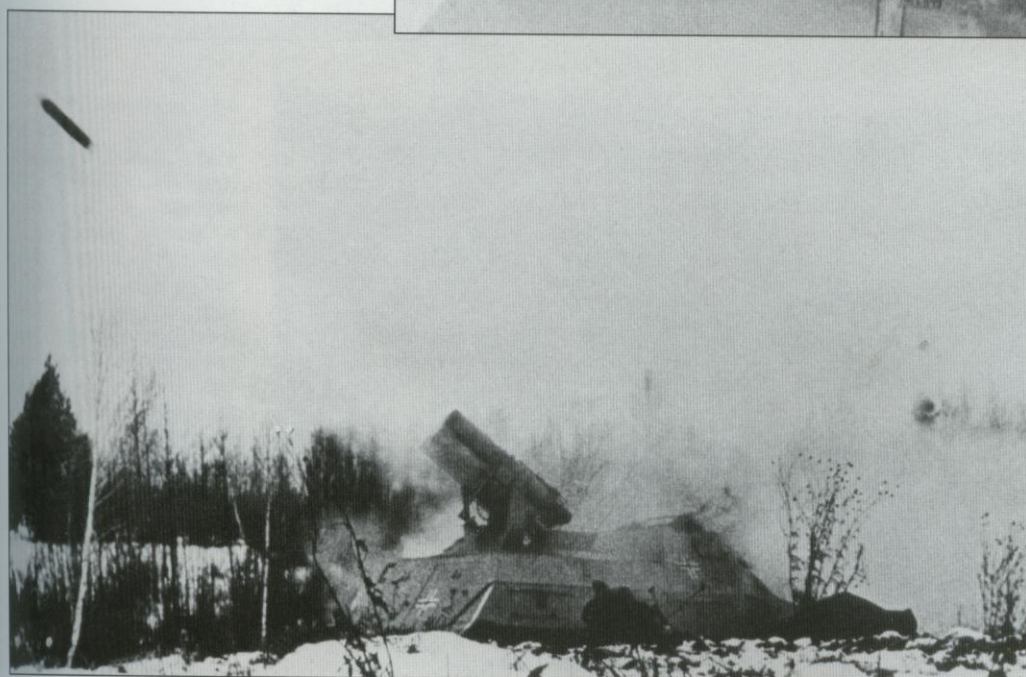
A 15cm Panzerwerfer 42 vehicle fires a salvo at an enemy target. The vehicle is marked with the letter "C" that is partially obscured by the dark yellow base color. During the firing, the crew was hidden within the armored body of the vehicle, so the half-track could move and change its position right after the last missile was fired.

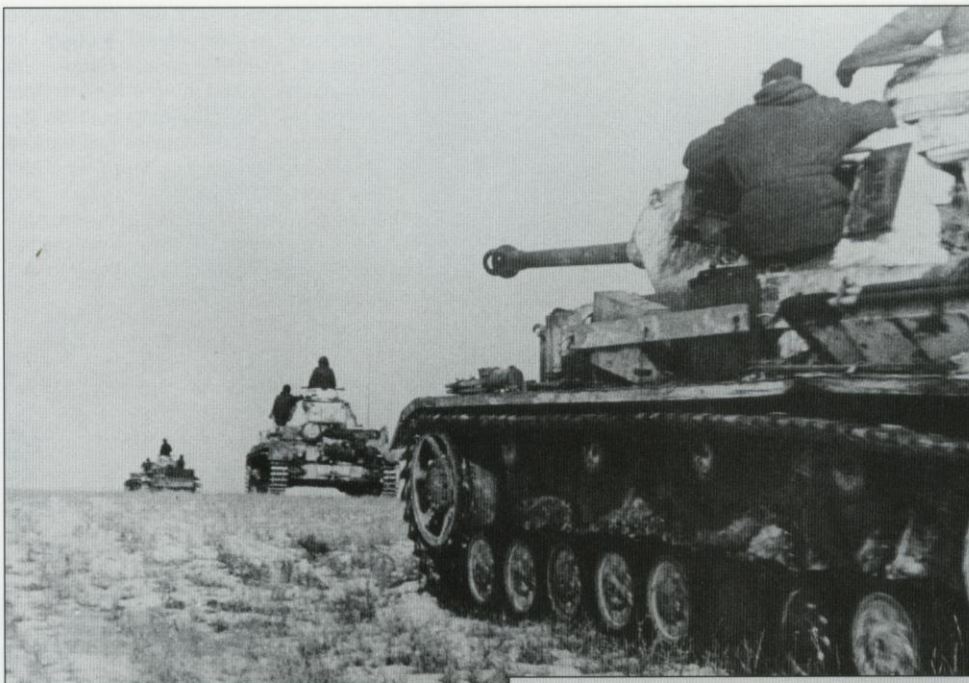
A column of Pz.Kpfw. IV Ausf. Gs (indicated by the split commander's cupola and the antennae affixed to the right side of the hull) move up to the front. This version of the Pz.Kpfw. IV, armed with the 7.5cm KwK L/43 gun, was able to destroy almost any Soviet tank around in 1943. But due to its relatively weak armor it was no match for the T-34's 7.62cm gun.

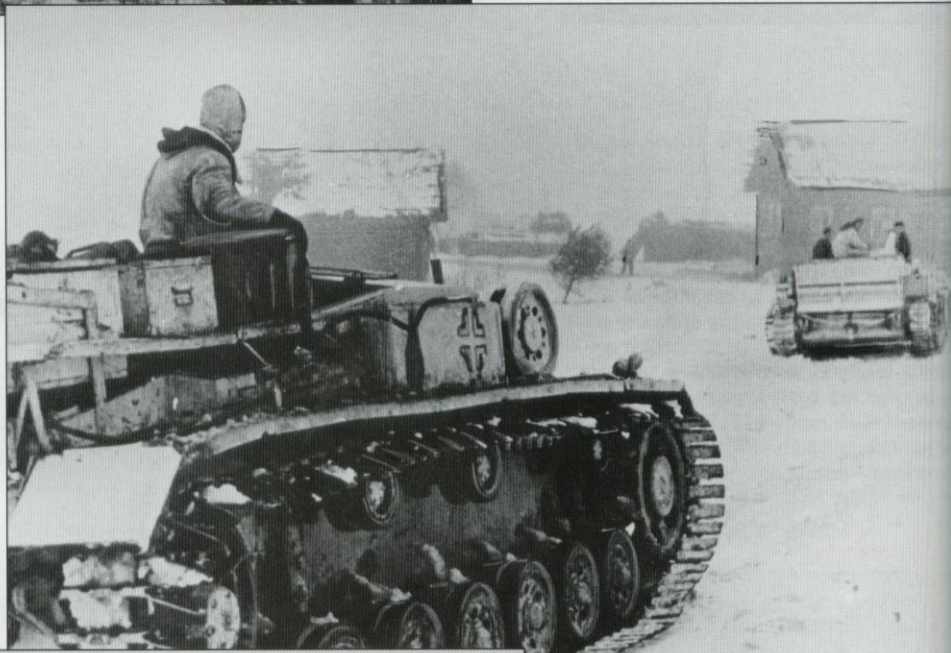
StuG IIIs fitted with widened "Ostketten", or eastern tracks, which were designed for use in the East as one means of preventing the vehicles from sinking into soft ground. Though effective, these tracks were not too popular since they tended to get thrown off during rough turns.

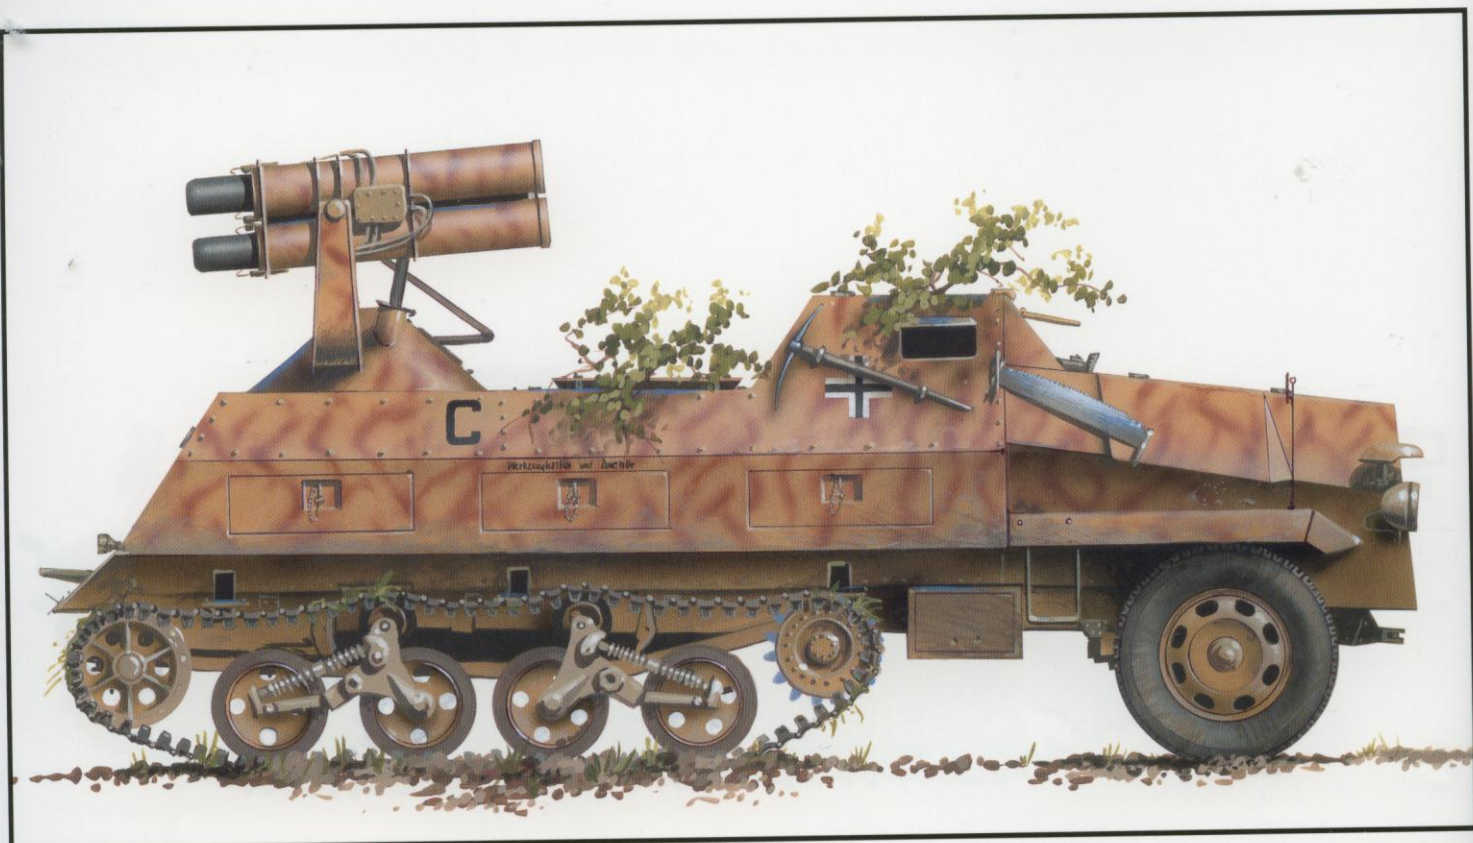
**Sd.Kfz. 4/1 Opel Maultier 15cm Panzerwerfer 42, Independent Artillery Unit, southern sector, Eastern Front, winter 1944/45**

The ten-barreled 15cm Nebelwerfer 42 was designed to use on the armored Maultier. Wearing a typical camouflage scheme for the Sd.Kfz. 4/1, this vehicle has a dark yellow background oversprayed with a red brown pattern for the autumn season. The vehicle carries a non-standard cross in which the center black strokes were the same width as the white borders, and a black "C" as vehicle identification letter in independent artillery units.

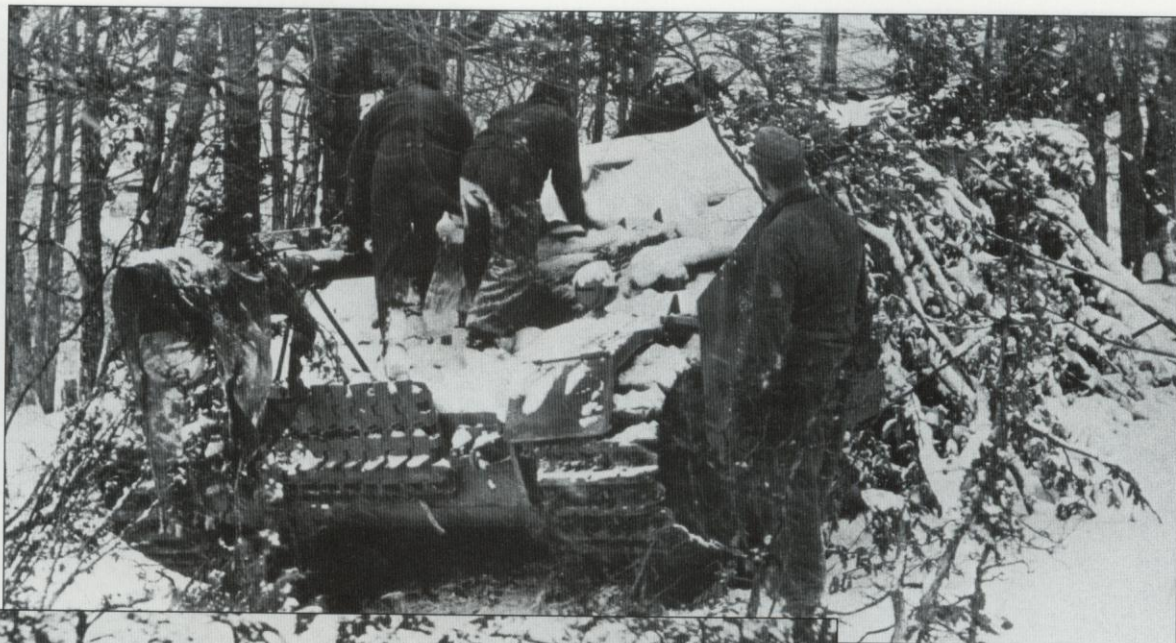
Perfectly camouflaged by snow and foliage, a StuG IV hides in a Russian forest. This vehicle is also equipped with "Ostketten". This photo provides a good view of the construction of these tracks, a section of which is installed on the front plate of the hull. StuGs IVs were first produced in December 1943 as the answer to an emergency situation that occurred in November when production of StuG IIIs dropped by over 50% because of Allied bombing raids. It was improved in a simple way to make it just as combat capable as the StuG III.

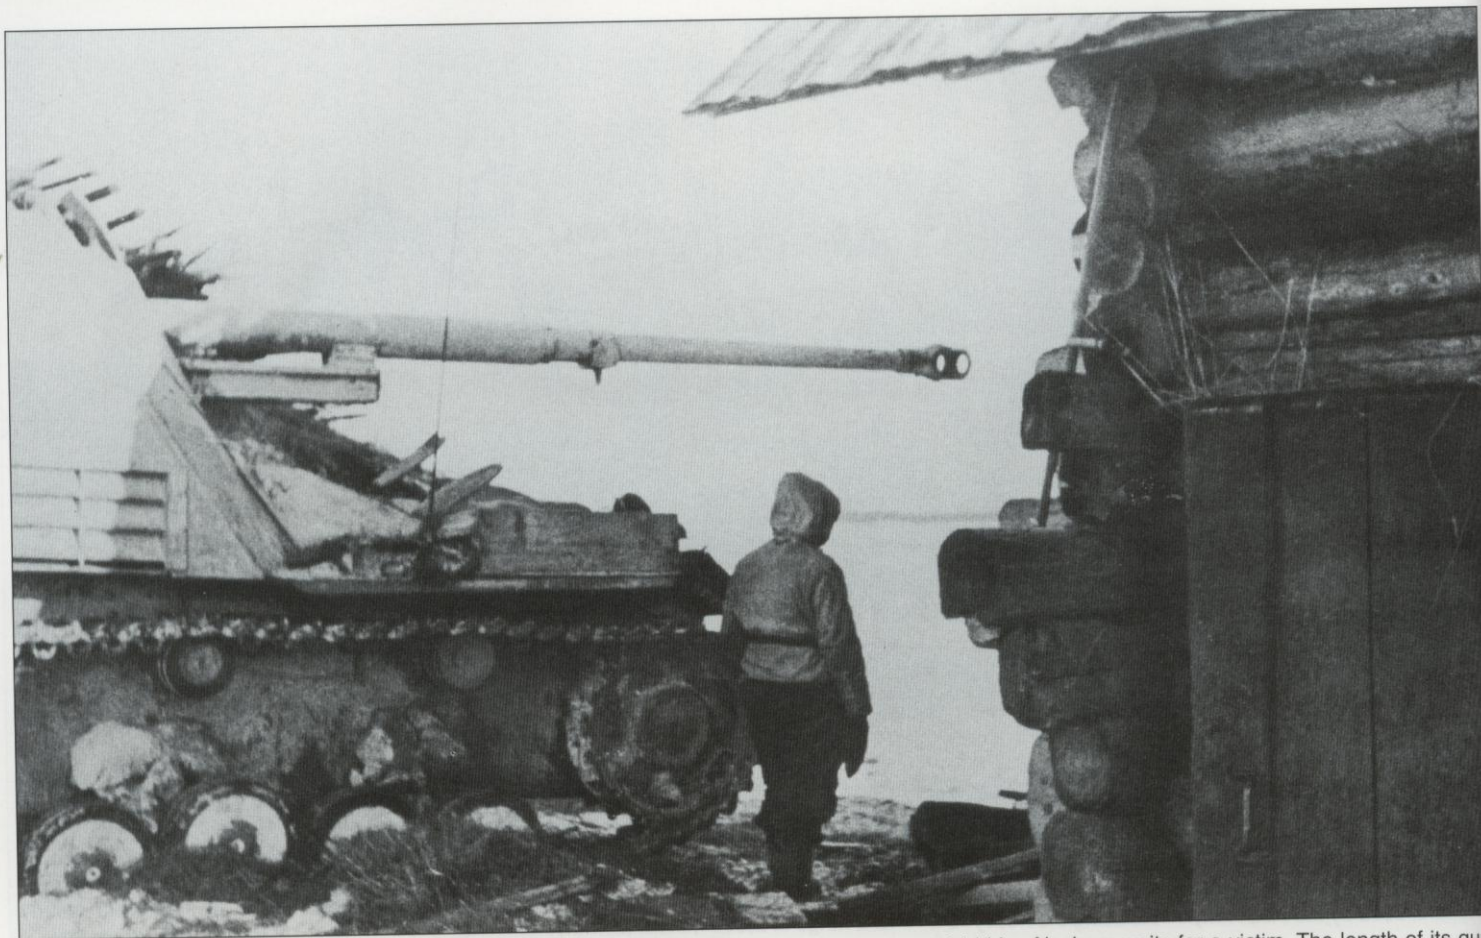
This photo offers a close-up view of the "horn" of the Nashorn (rhinoceros in English) — the PAK 43 gun with a long barrel of almost 5 meters (5.5 yards), which fired anti-tank shells at a muzzle velocity of 1,130 m/s (3,708 ft/sec). The vehicle is camouflaged with whitewash, but the top part of the superstructure is in the basic dark yellow color; no doubt the protective tarpaulin was not removed before the tank was painted. Note the unit insignia painted on the superstructure.

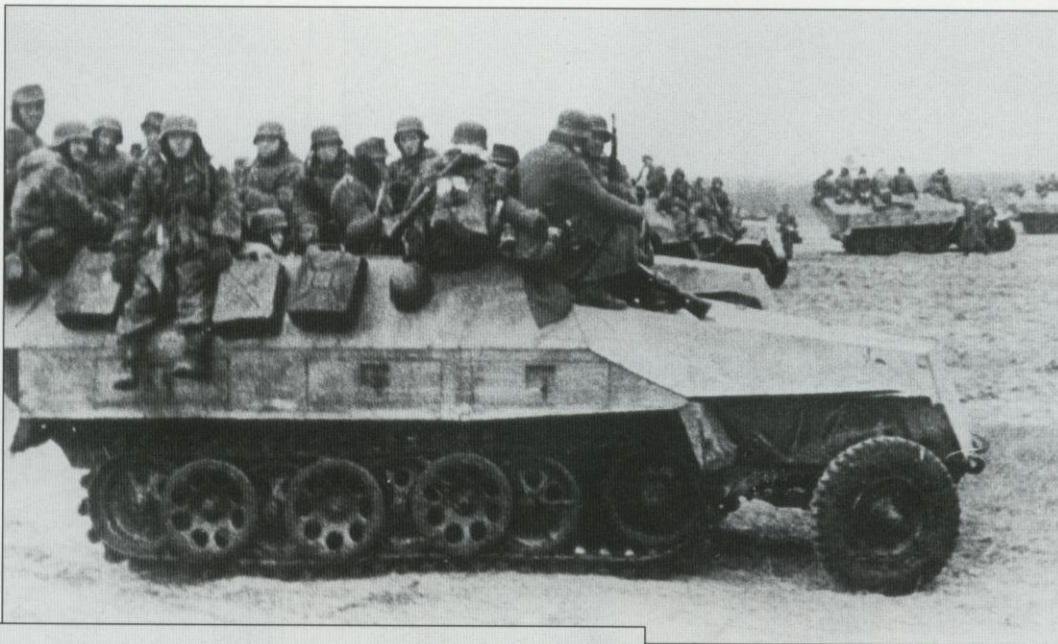
This photo provides a good profile view of a Sd.Kfz. 251/1 Ausf. D. Although in 1944 German industry produced twice as many of these vehicles than in the previous four years together, there was always too small a number of them in the armored divisions. As a result, during military operations the available ones were often used to carry 20-25 troops instead of the usual ten.

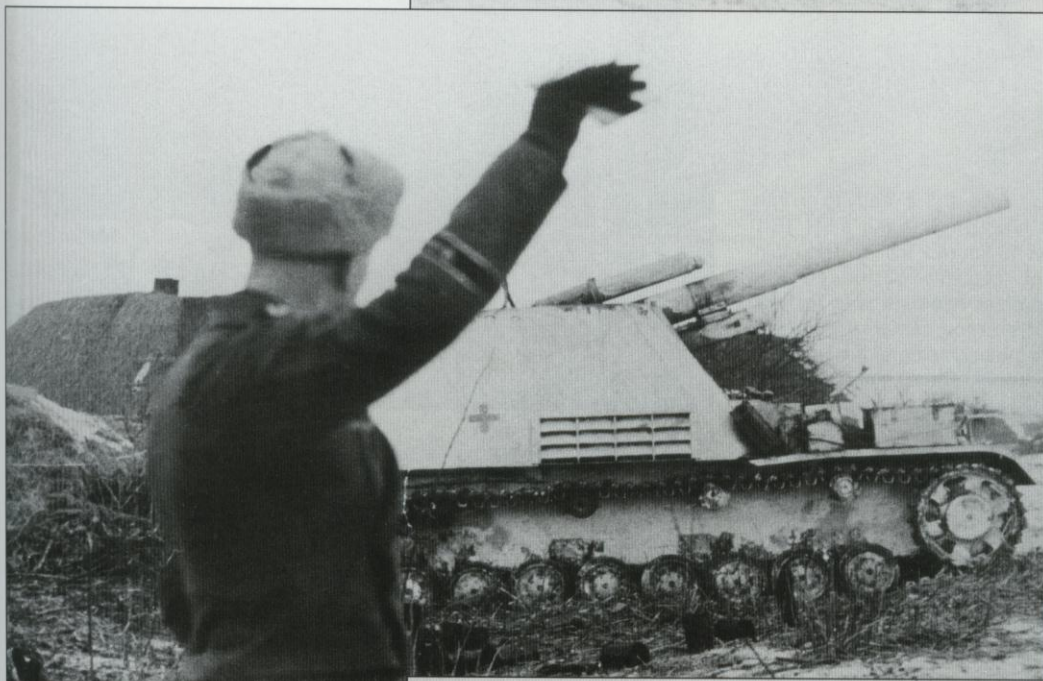
The commander of a Hummel battery prepares to give the order to commence firing. This profile view shows the howitzer's impressive design. Note that only the front part of the gun barrel is painted with white camouflage.

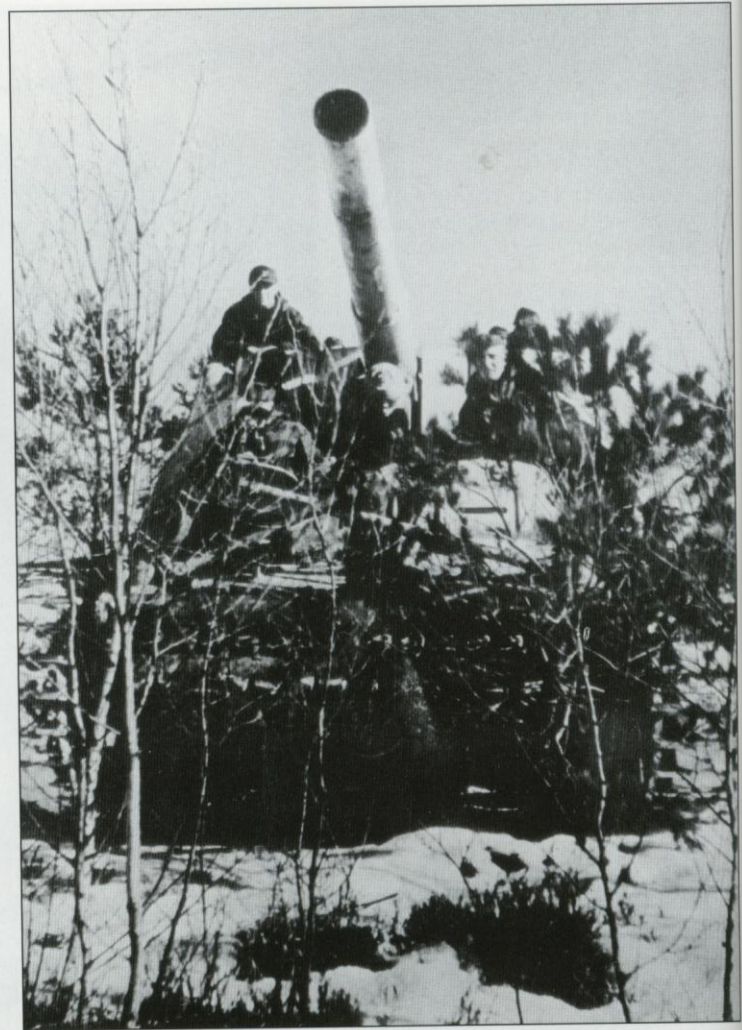
A Hummel has taken up a position in some trees and is ready to go into action. The armament of this self-propelled howitzer was the s.FH 18/1 L/30, which could fire shells at a range of over 10 km (6.2 miles). The main problem with the Hummel was the small capacity of the combat compartment, which could carry only 18 howitzer shells. It was for this reason that the Germans produced many ammunition carriers (*Munitions Fahrzeuge*) based on the same chassis. From the beginning of the Hummel production up to 12th May 1943, 100 self-propelled howitzers and 157 ammunition carriers were produced.

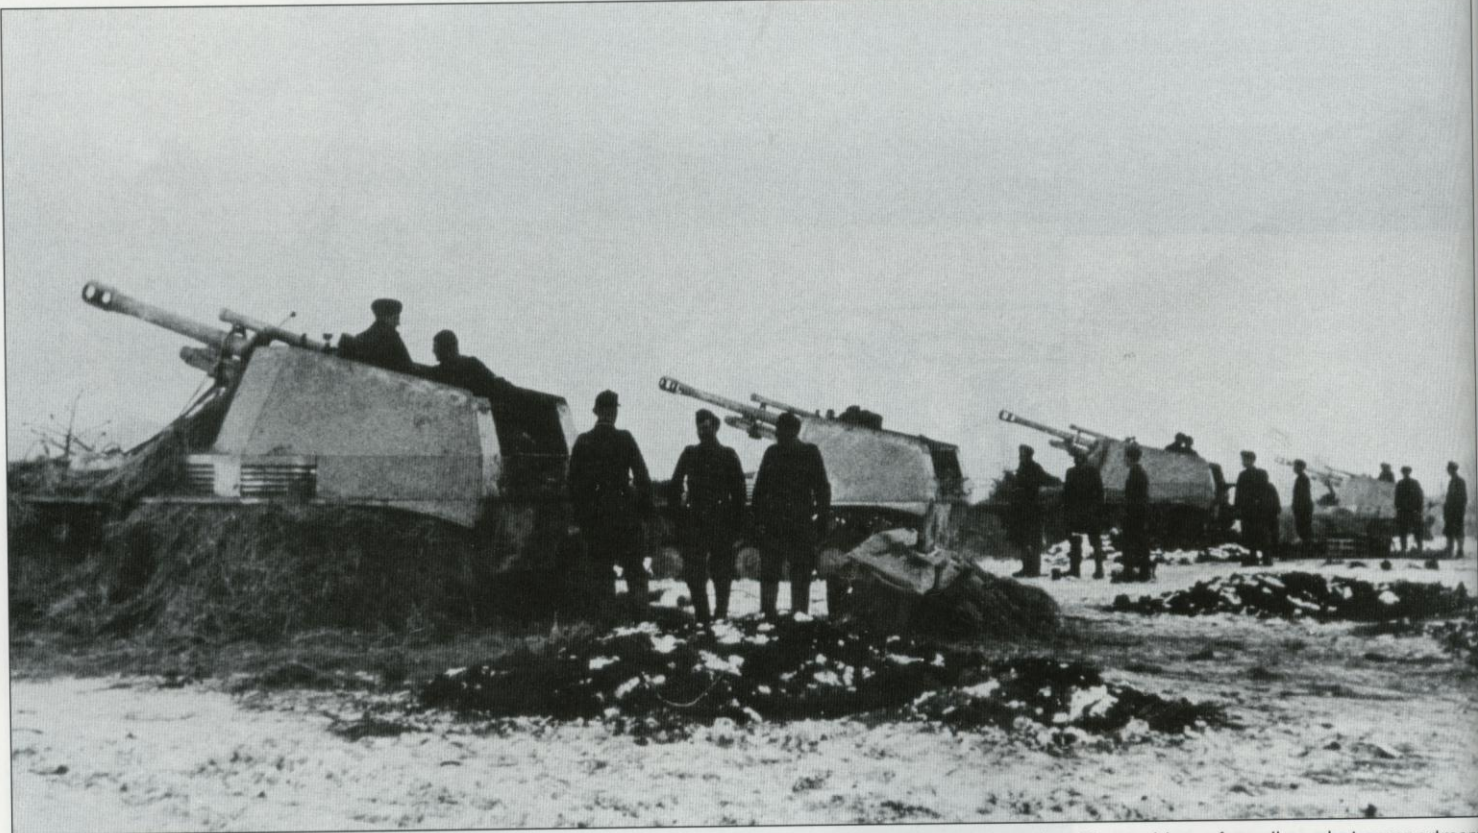
A battery equipped with Wespe (wasp) 10.5cm light self-propelled field howitzers stands ready to open fire. The problem of small combat compartment was even greater with the Wespe than with the Hummel. As we can see in this photo, three out of five crew members must perform their duty outside the vehicle. However, the Wespe could carry twice as many shells as the Hummel.

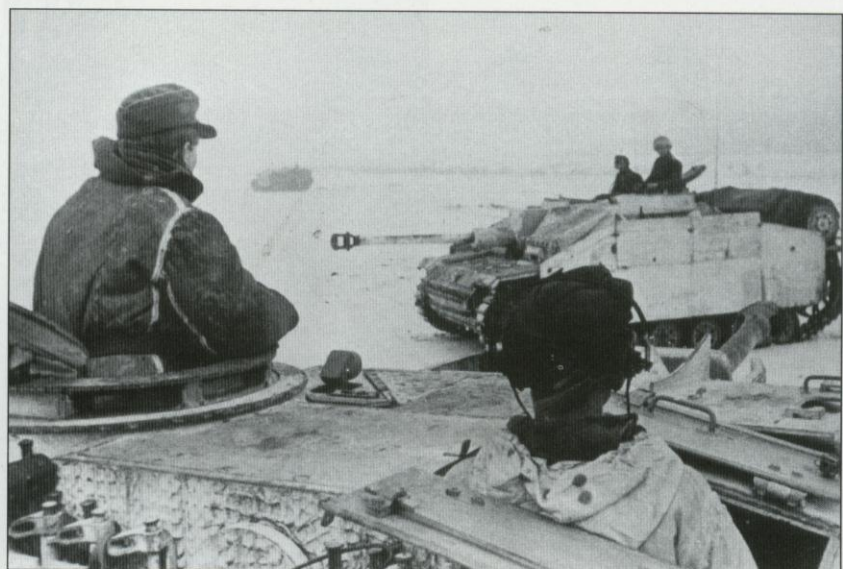
A StuG III Ausf. G viewed from another such vehicle during winter operations in the early 1944 period. This sort of assault gun was the main combat vehicle of the Panzerwaffe in many battles at that time. For example, during the fight for Kirovograd in January 1944, there were 109 StuGs and 56 tanks in three armored divisions and one motorized division. Note the many details of the StuG's upper surfaces.

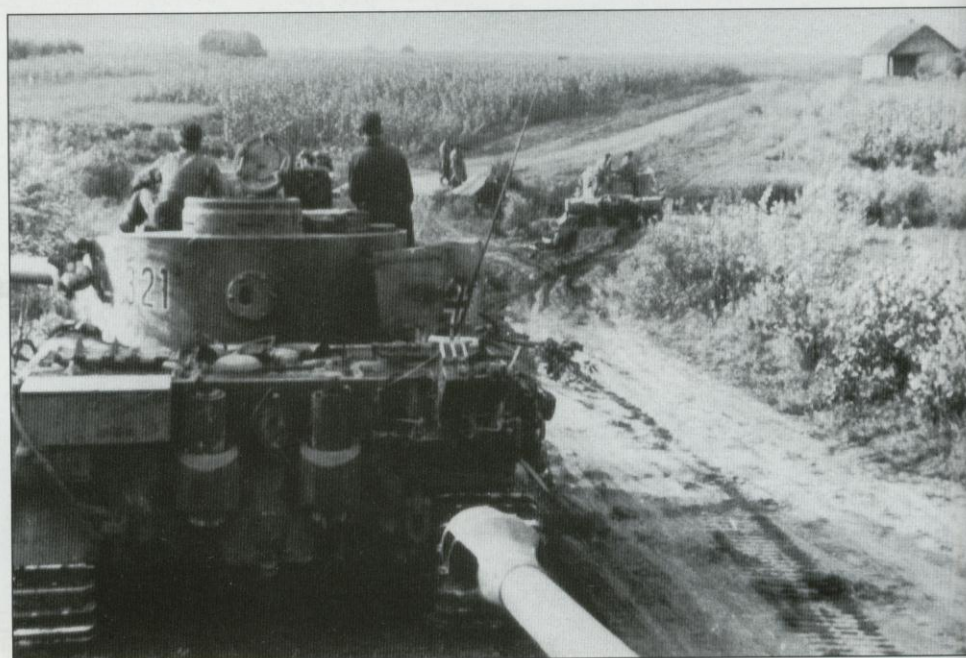
Tigers in retreat. With its powerful 8.8cm KwK L/56 gun and excellent sights, the Tiger was a formidable tank both in the offensive and defensive roles. Tigers seldom operated alone, mutual support was the standard practice. Note the absence of the exhaust cooling shrouds at the rear.

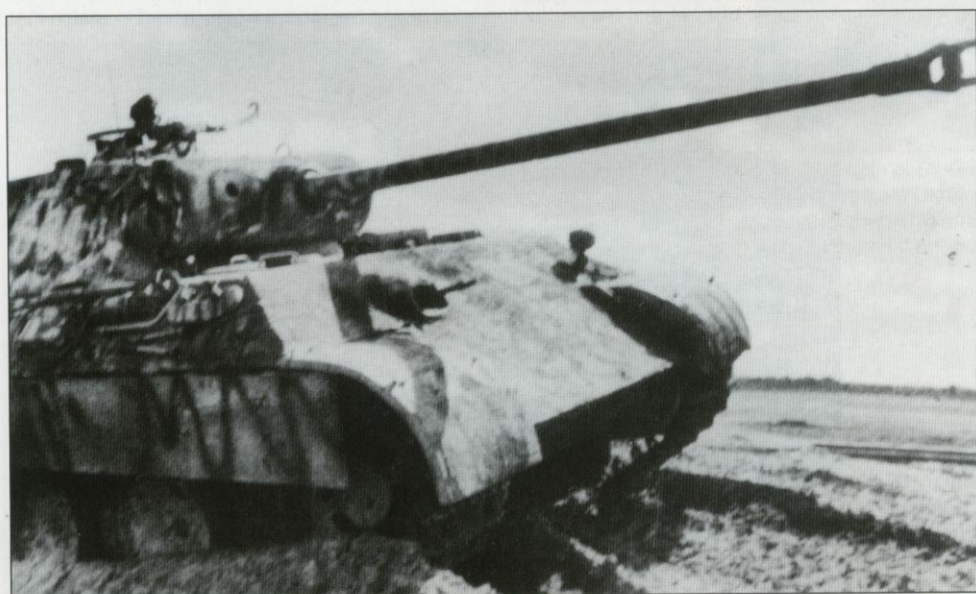
A lone Panther in the open Russian field. This is an Ausf. A with a non-standard camouflage scheme hastily applied. This photo well illustrates the long overhang of the 7.5cm KwK42 L/70 gun.
