# PANZERS IN THE EAST

(2) Decline and Defeat 1943-1945

Robert Michulec

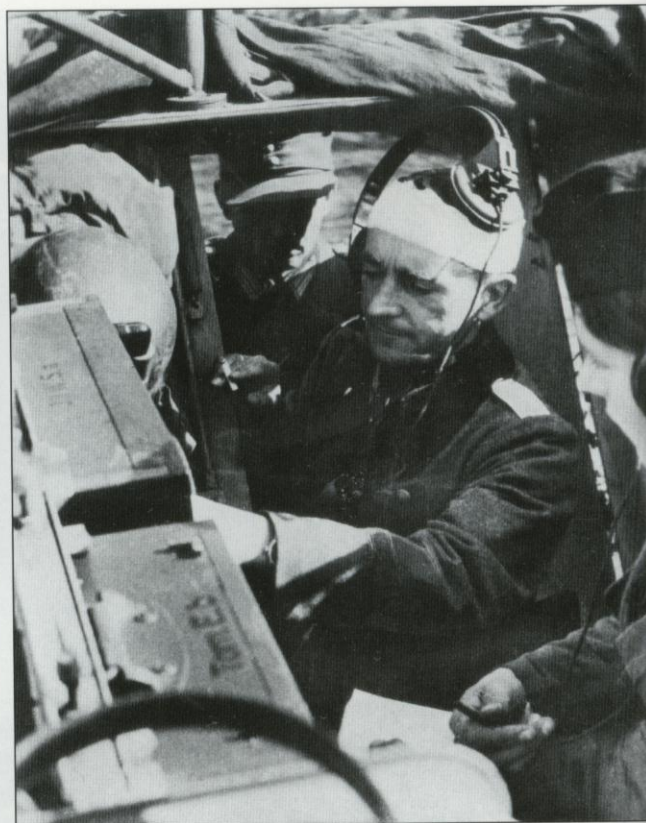
Here we see radio operators at work in the combat compartment of the Sd.Kfz. 250 Neu half-track. Many of these vehicles carried the famous "Enigma" radio sets that assisted the higher level German staffs to control the operation of the war. Note that this ground-to-air communications vehicle has a very cramped interior. The Sd.Kfz. 250/3 Neu carried a rod-and-star aerial instead of the frame aerial.

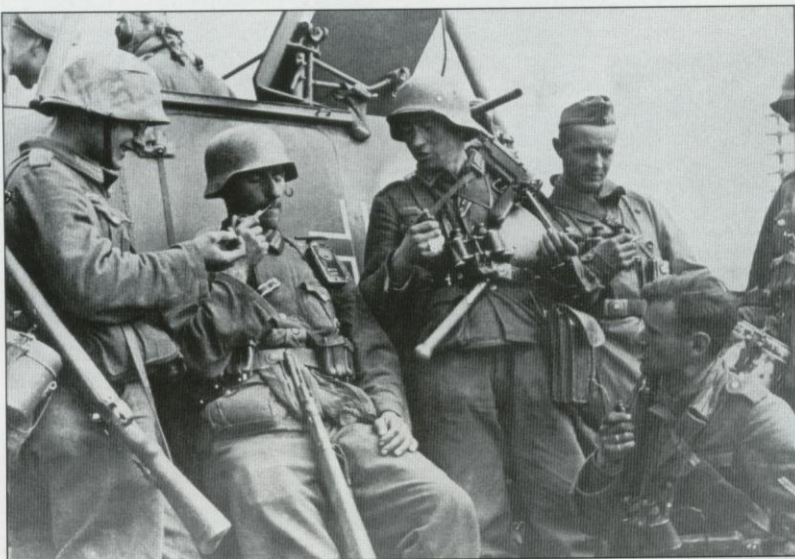
A group of soldiers awaits orders next to a Sd.Kfz. 250/3 *leicht* Funkpanzerwagen ground-to-air communications post, which is equipped with a frame antenna for the FuG8. The armored shield for a machine gun installed in the rear position is quite an unusual modernization.

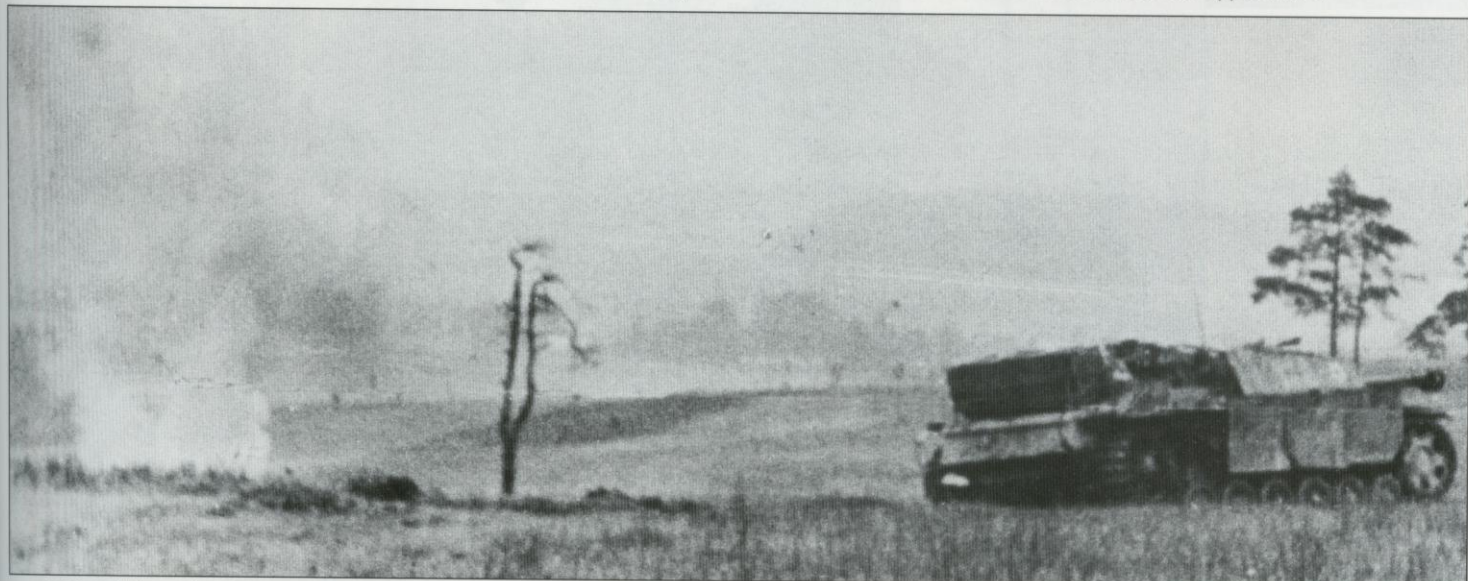
A StuG III in action in some hilly terrain. Despite the poor quality of this photo, it is clearly visible that this vehicle has two separate sets of additional armor plates: one of them bolted to the superstructure and the other attached to the mudguards. This sort of skirting was used in 1944 in a few units in place of the standard large side skirts. It was composed of four short pieces for covering the hull and another two pieces for the side of the combat compartment.

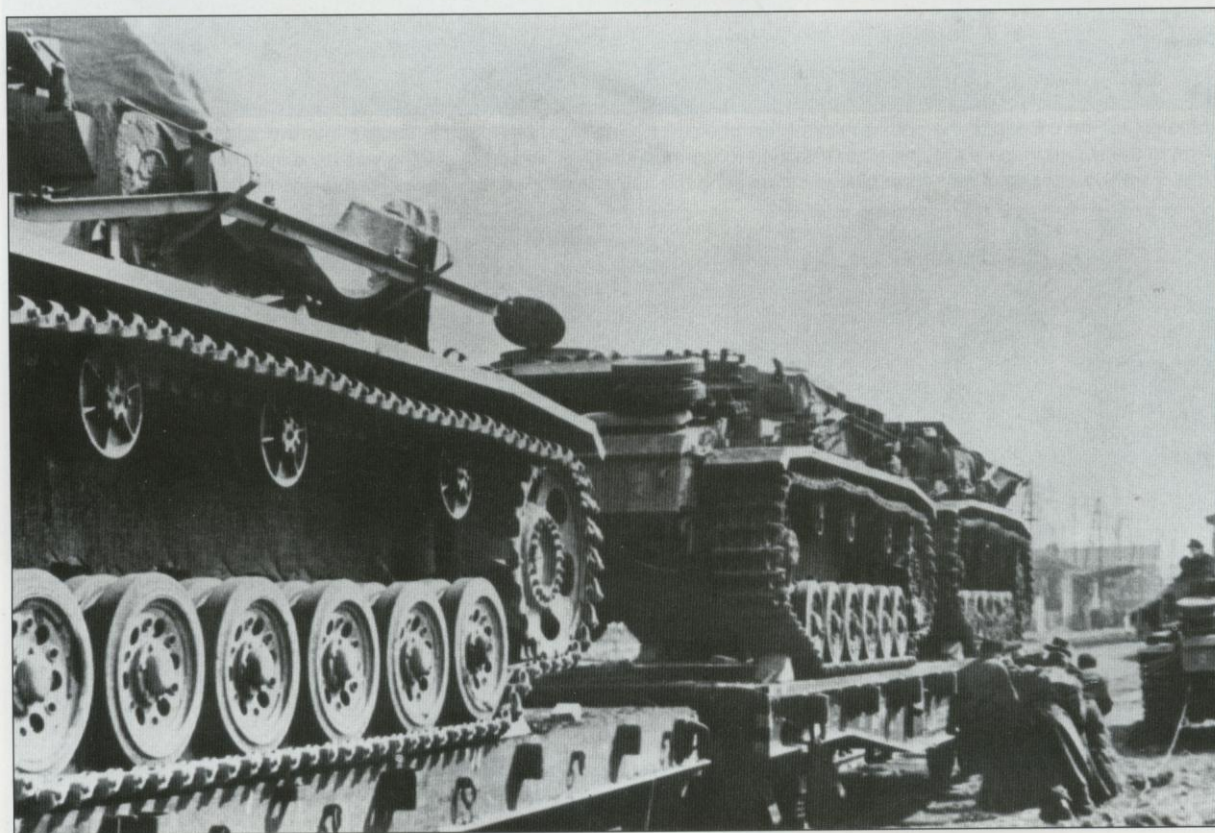
Brand new StuG IIIs on railway flatbed being rushed to the front. These late production vehicles featured the all-metal return rollers. The vehicles are without side-skirts which would be fitted at the workshops upon arrival.

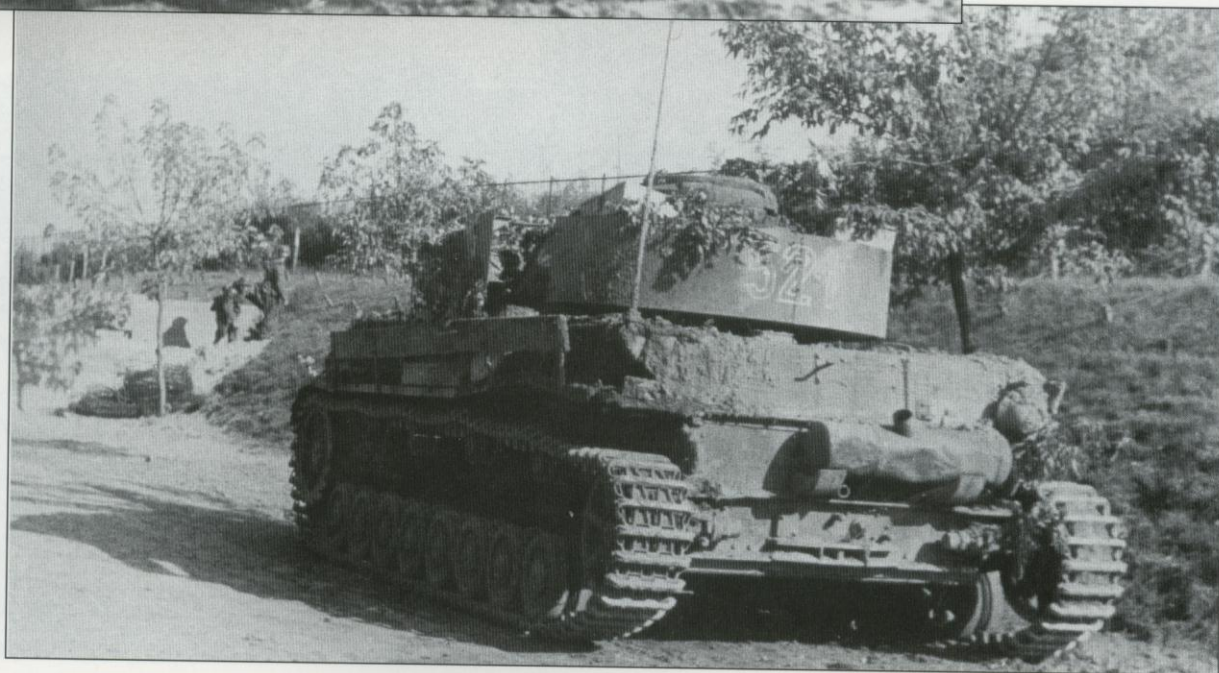
This Pz.Kpfw. IV Ausf. J, which is marked with the stenciled tactical number "521", is fitted with non-standard protection for the crew's belongings attached to mudguard. Oddly enough, it looks like the back portion of a park bench. The tank features standard camouflage pattern, which is clearly visible near the tactical number, but it is also heavily covered with mud.

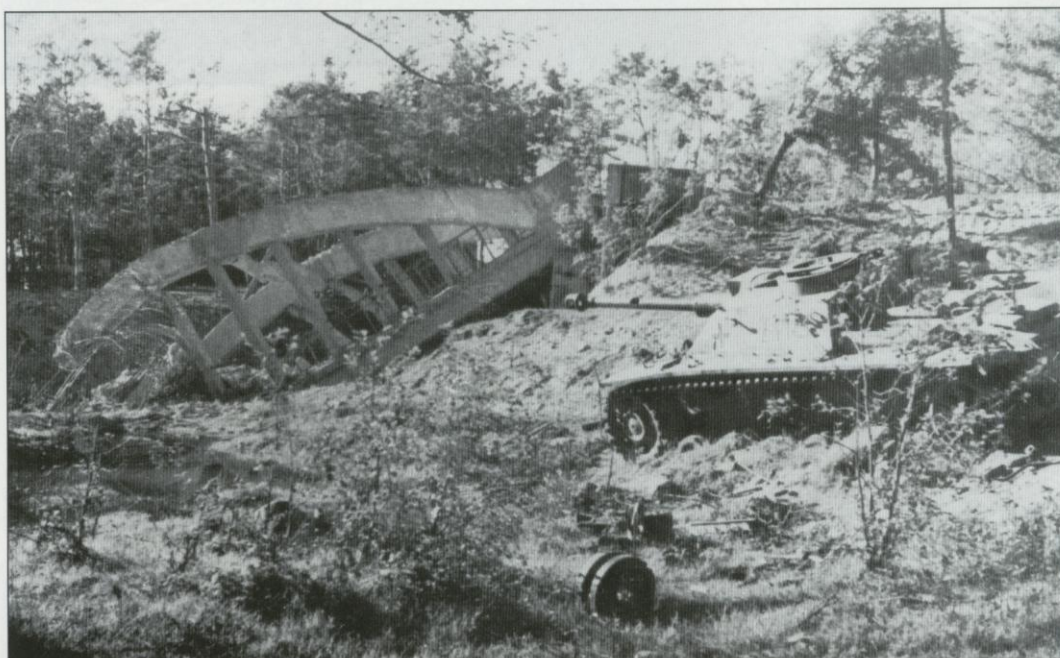
A close-up view of another battlefield, this time somewhere near Warsaw on the eastern bank of the Vistula River during the summer fighting of 1944. The StuG III Ausf. G seen in this photo belonged to 19.Panzerdivision and is marked with the tactical number "211".

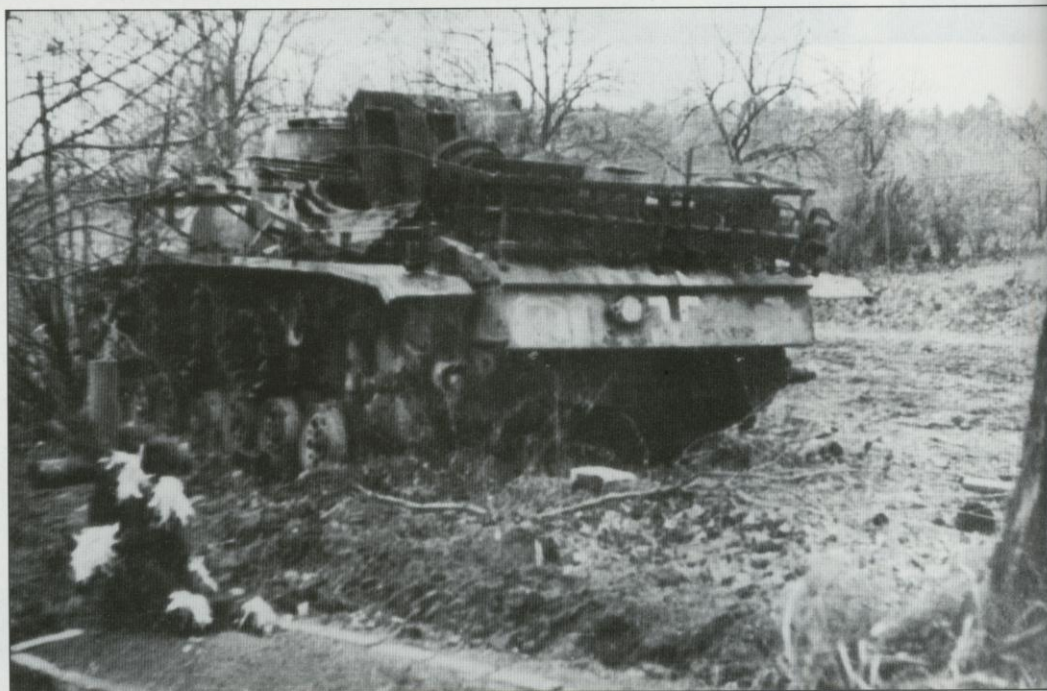
Another StuG III from the same unit destroyed in the same area during the final Soviet assault on the eastern part of Warsaw in September 1944. Its tactical markings are illegible. The StuG III was severely damaged and gutted by fire. One of the crew members who did not survive was buried near his vehicle in a single-man grave marked with a cross and decorated with flowers — a very unusual sight in territory captured by Polish/Soviet troops.

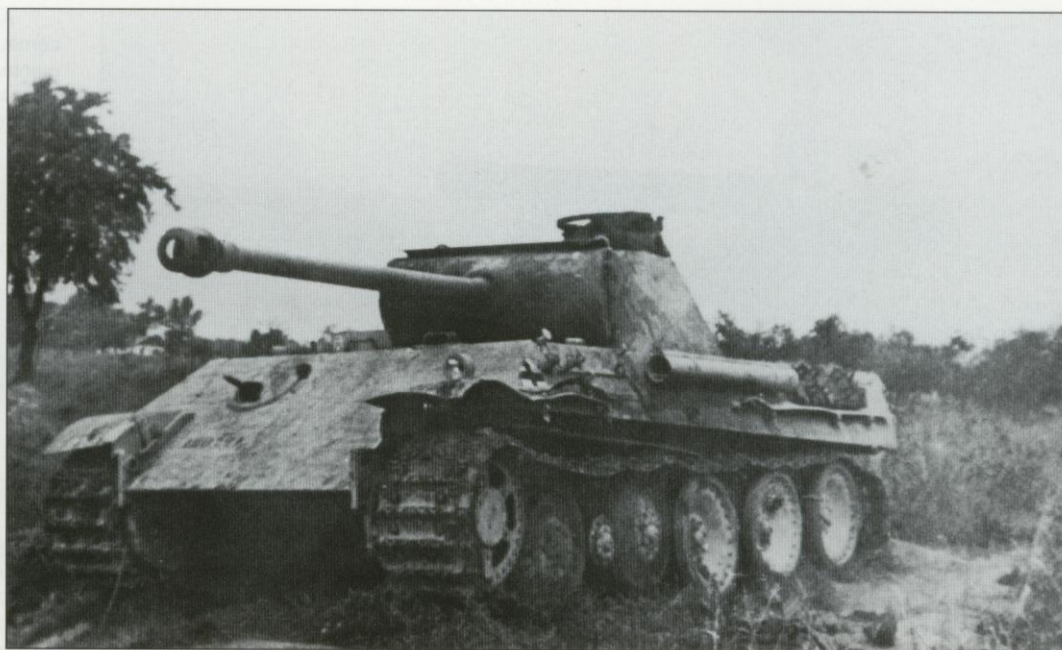
This is an early series Pz.Kpfw. V Ausf. G Panther tank knocked out by Soviet or Polish troops during the battle for the Soviet bridgehead in the Warka area south of Warsaw. Troops from the Fallschirm-Panzerdivision "Hermann Göring" and 19.Panzerdivision were involved in this combat. This Panther belonged to Fallschirm-Panzerregiment "Hermann Göring", which received some of the tanks just before the battle when the division was re-equipped west of Warsaw after arriving from Italy. The tank in the photo is brand-new and wears no camouflage or even a tactical number. Apparently there was no time to apply them. However, the chassis number "120721" is painted in black paint on the glacis.

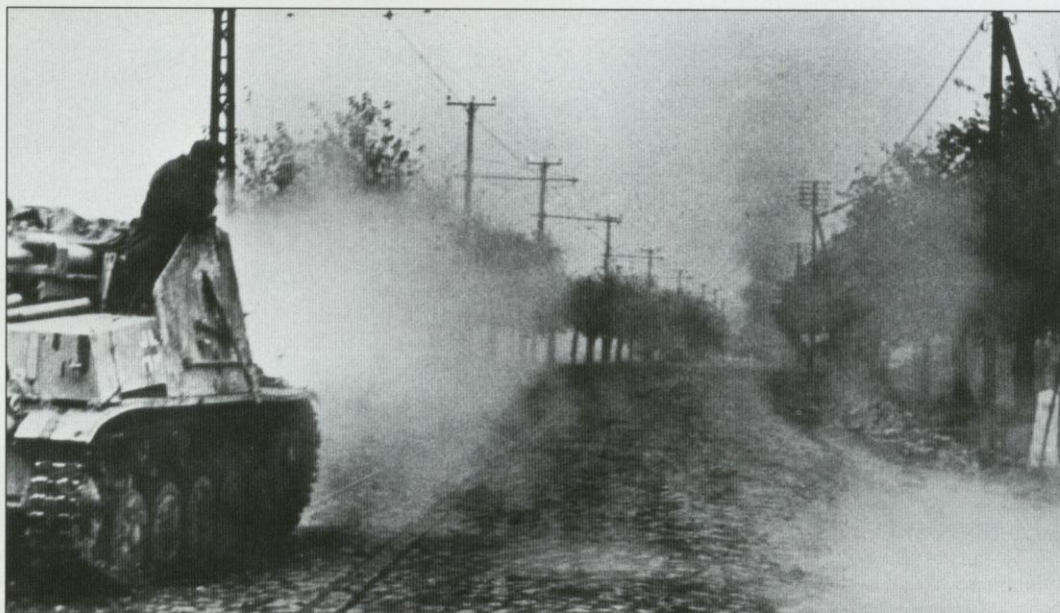
A cleverly camouflaged StuG III Ausf. G in a village somewhere in a German position in the Duena River area near Riga in September 1944. It is equipped with the "Sankopf" gun mantlet, but features only a hand-held infantry MG42 for defense in place of the remote control machine-gun mount fitted to an armored shield.

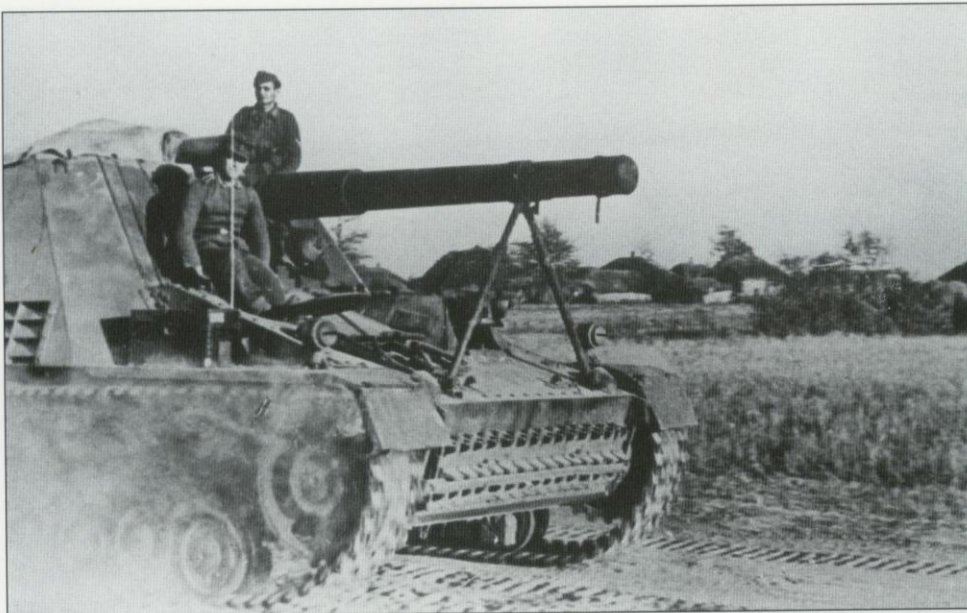
A Hummel on the march. Note how the camouflage of this self-propelled howitzer was painted on the top portions of the superstructure. As usual there is a strip of the base color paint in the area where the tarpaulin was attached on top of the vehicle.

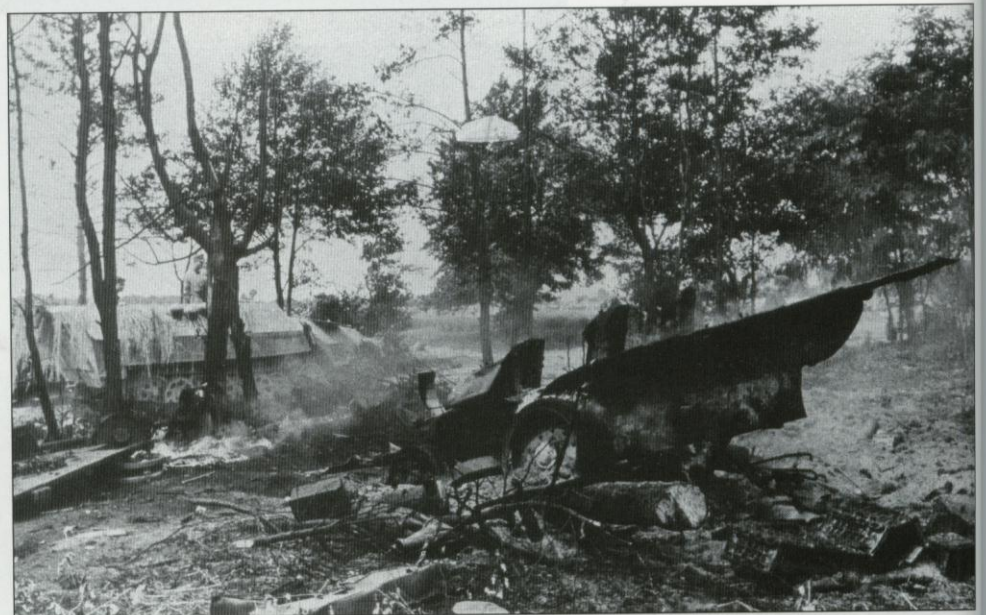
A Sd.Kfz. 251 Ausf. D is just visible in the background as it passes by the remains of a T-34, which illustrate very well the typically poor quality of Soviet production. Note that on the Hanomag the mount for the rear MG42 is used as a hanger for . . . a bucket. The German vehicle is marked with the tactical number "211" (partly covered by helmets) and is camouflaged with straw.

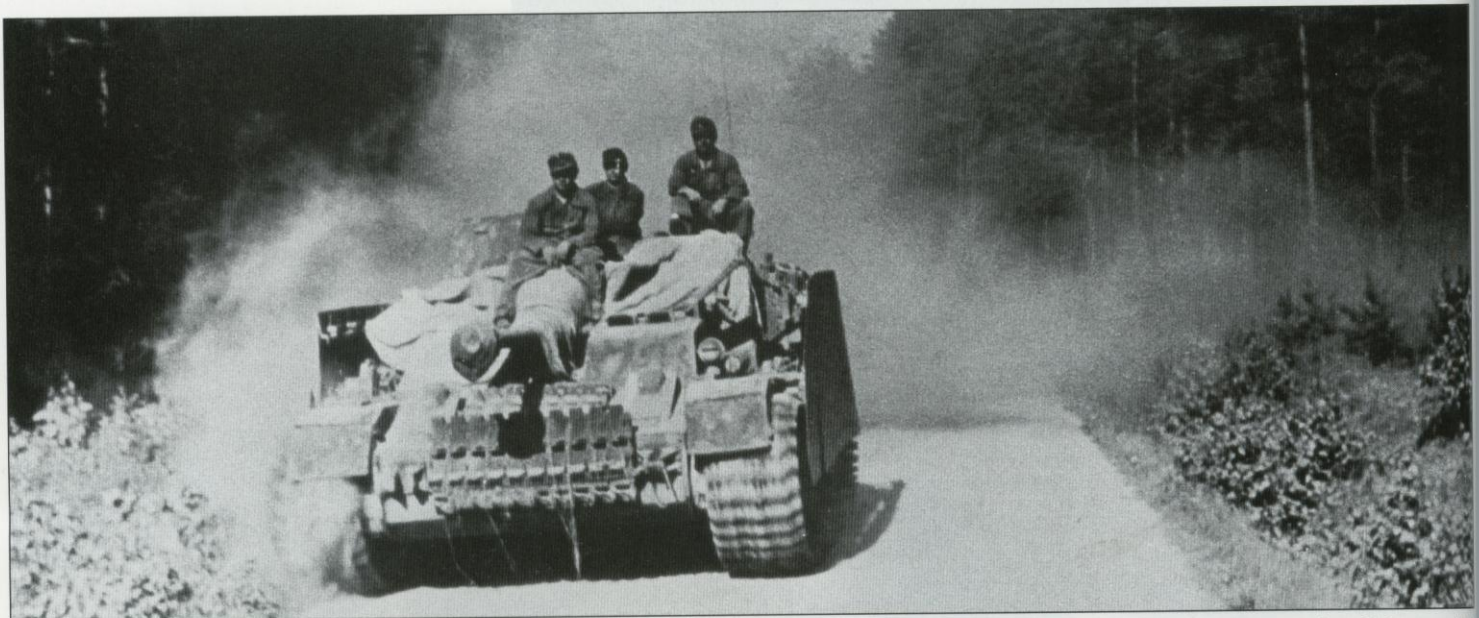
A StuG IV kicks up a cloud of dust as it advances down a forest road. Note the interesting camouflage pattern (most probably green) and the special wider tracks. These tracks were developed in 1944 based on the experience acquired through the use of "Ostketten" in the two previous winters. It is possible that their use was widespread in divisions fighting on the Eastern Front, even though they appear in only a few photos.

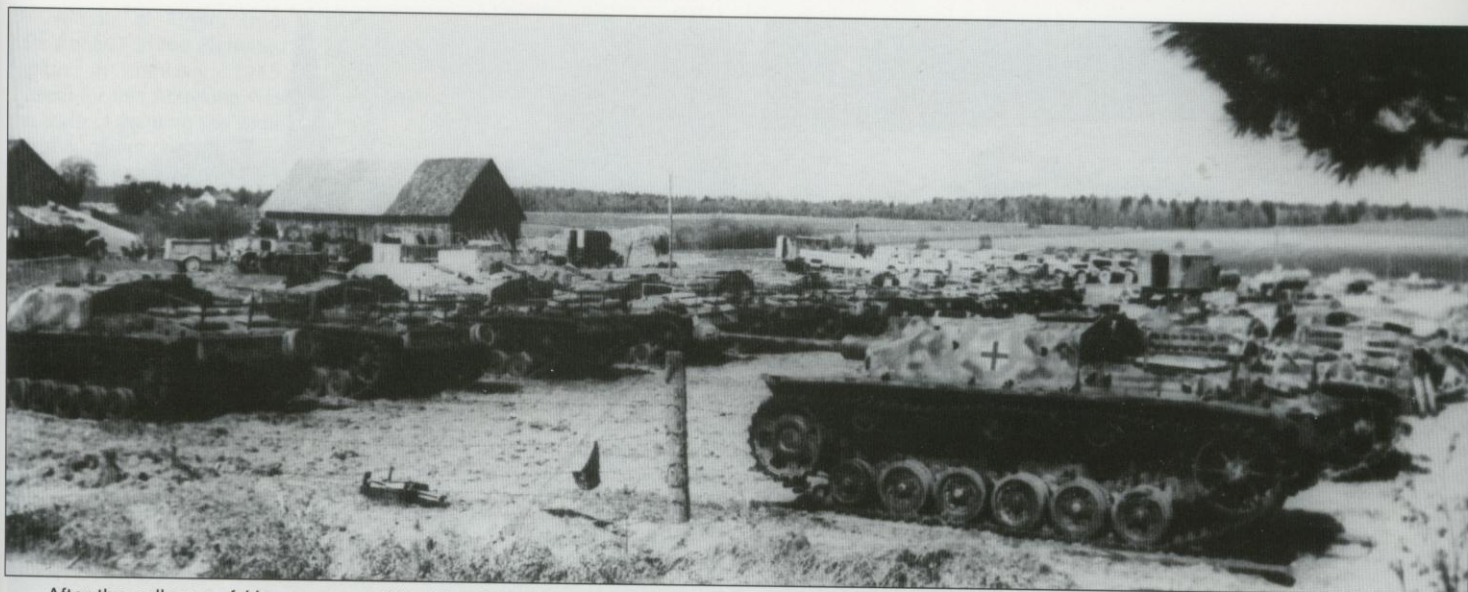
After the collapse of *Heeresgruppe Nord*, the Soviets collected tons of combat equipment from all around the northern areas of Russia, including these StuG III Ausf. F/8s and Ausf. Gs, which originated from the same unit. Almost all of the StuGs seen in this photo are painted in similar camouflage composed of a green and brown pattern over a dark yellow background, which is most clearly seen on the first vehicle of each row.

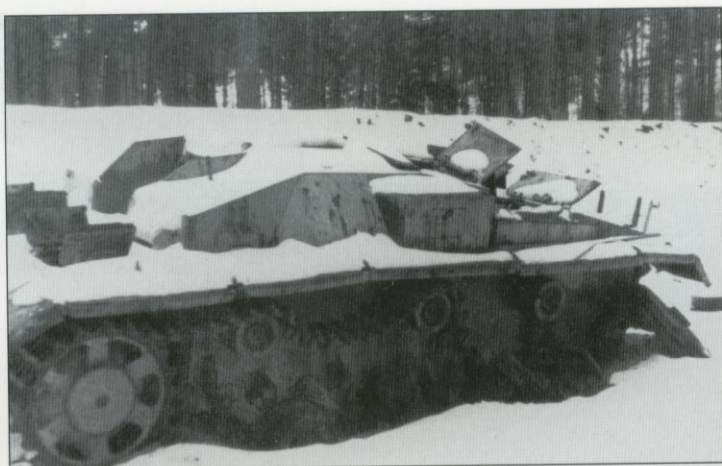
A surprising vehicle belonging to the Panzerwaffe: the old version of the StuG III. After it was renovated and re-armed with a StuK 40 long-barreled gun, it was put into service. During the overhaul the StuG was completely repainted with RAL 7028 dark yellow-colored paint, which is shown to advantage in this photo. At the same time the pre-Ausf. F StuGs were equipped with many interior mechanisms of the Ausf. G. They were often fitted with additional armor, too, including side skirts. Despite a number of major differences from the original Ausf. G, these hybrid models were also called the Ausf. G. Note the load label painted on the side of the combat compartment.

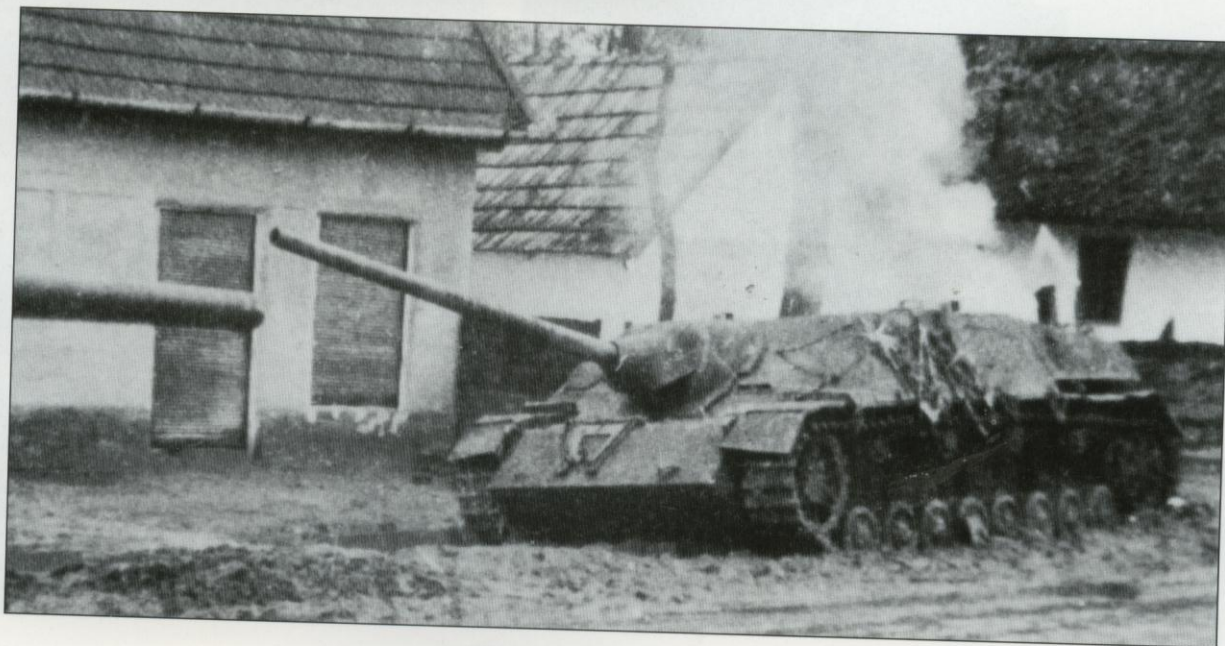
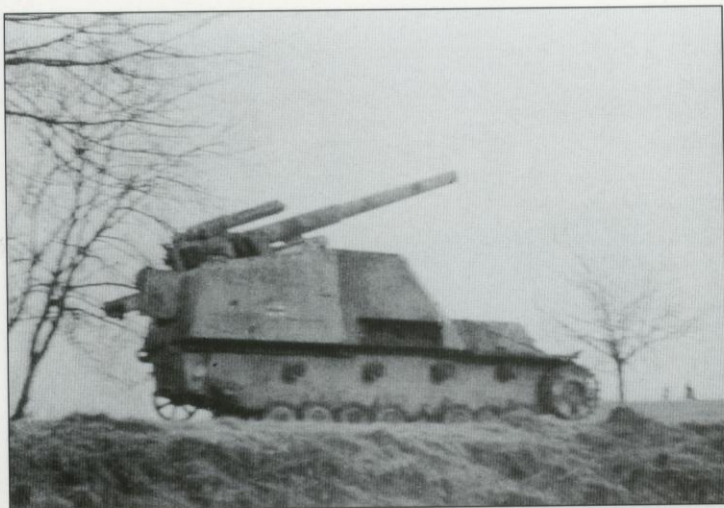
Two views of a Hummel from an SS unit shot to pieces by tankers of the Polish 1st Tank Brigade during battles in the Mirostaniec area in February 1945. It is an early series vehicle with *Zimmerit* applied all over the superstructure surfaces. Most of the German units created in this period had received supply of armor in a short period, so the young crews had little time for training and applying markings.

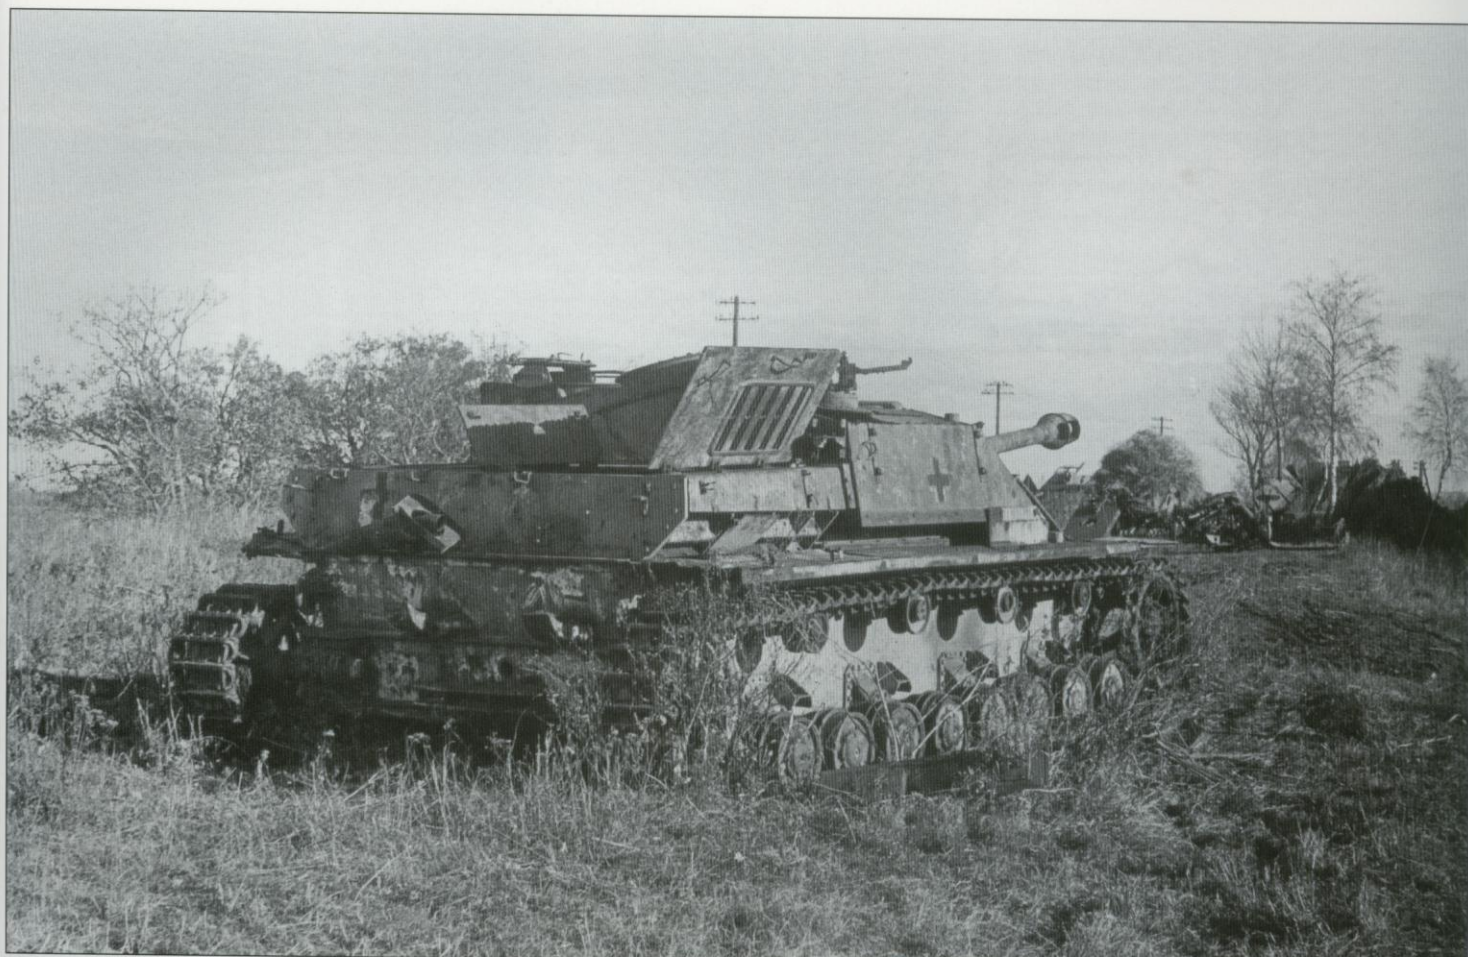
This StuG IV was knocked out during the fight for Pomerania in the spring of 1945. Note that a camouflage pattern was applied to the assault gun's superstructure while the hull was not camouflaged at all. This vehicle has a single armor plate bolted to the side of the superstructure for additional protection.

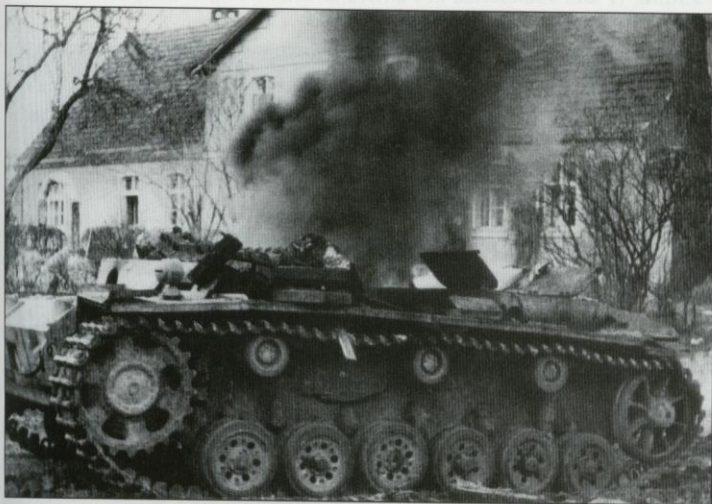
A recovery tank, known as the Bergepanzer III, burns in a German village somewhere in Pomerania in March 1945. This vehicle was converted from a Pz.Kpfw. III that was returned for overhaul in 1944. They were issued to the workshop companies of Panzer units equipped with StuG IIIs and IVs. The tank has additional front armor on the superstructure but is lacking a machine gun.

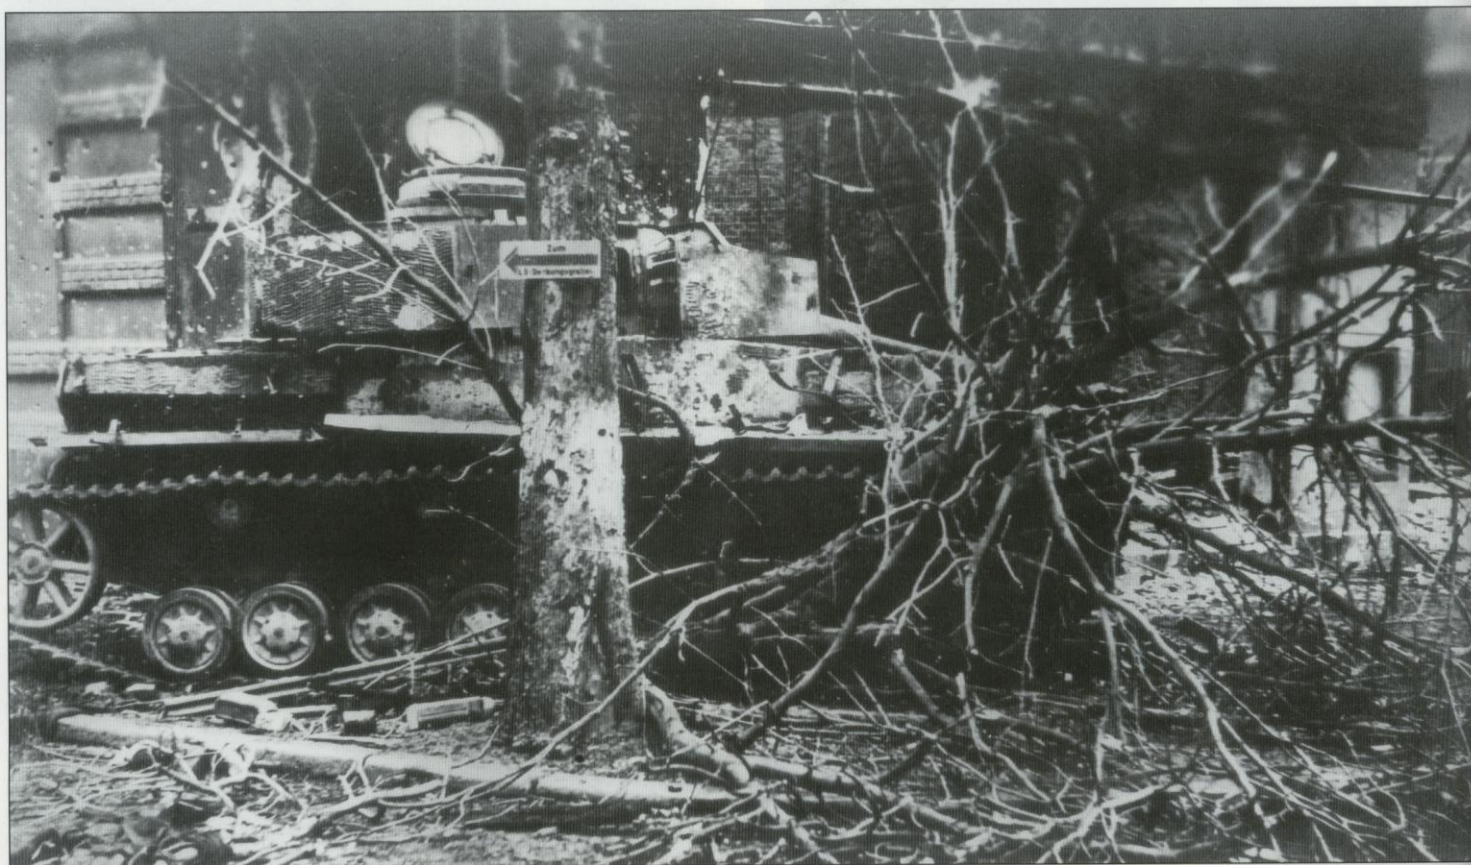
This profile view of the remains of a destroyed Pz.Kpfw. IV photographed in Pomerania in the spring of 1945 shows the resulting fire damage on the exterior of the tank. Note the pattern in which the *Zimmerit* anti-mine paste was applied to the turret skirting.

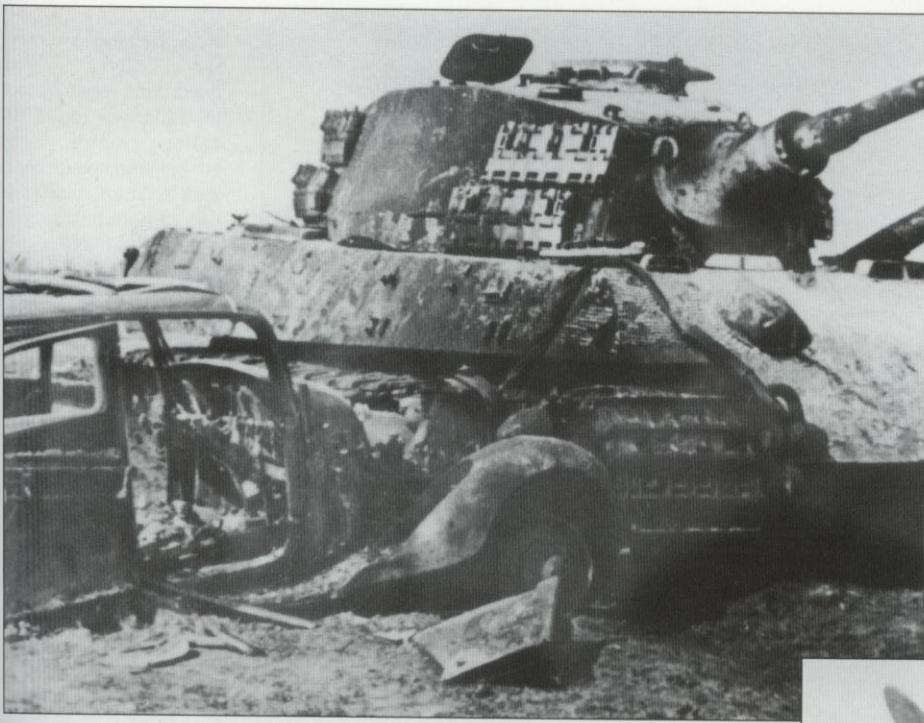
The end of a Tiger. This burned out Tiger II Ausf. B, with Henschel Production Turret, sits on a beach on the Frisches Haff in April 1945. The 8.8cm KwK 43 L/71 gun was probably the best tank weapon in WWII, being able to knock off its opponents with ease. However, the Tiger II entered service too late to change the outcome of the armored war.

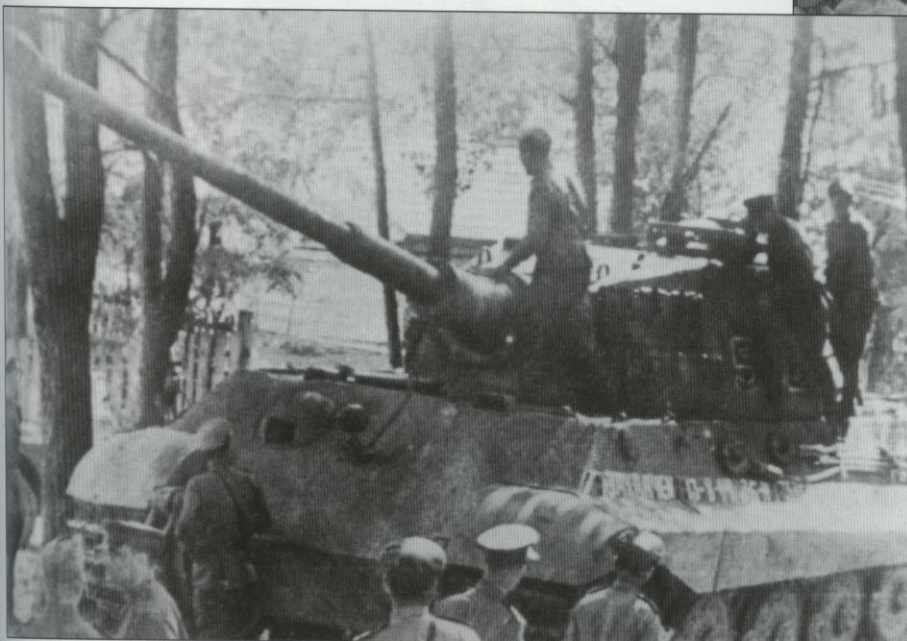
This Tiger II is captured and inspected by Soviet troops, apparently in good shape. It was tank "002" of s.Pz.Abt.501, captured by the Soviets in August 1944. It is likely that this vehicle was abandoned by its crew due to lack of fuel. This vehicle had the side skirts installed, but had the bow machine gun missing. All Tiger IIs were assigned to the independent heavy Panzer detachments of the SS and the Wehrmacht on both Eastern and Western fronts.

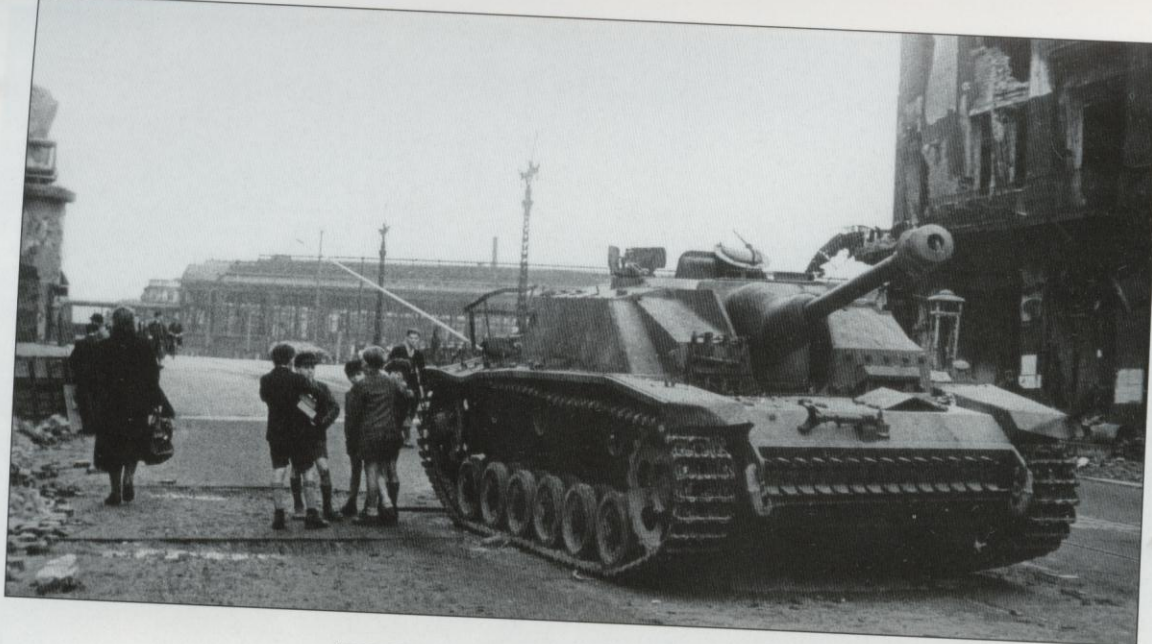
This StuG III Ausf. G was abandoned in the middle of a Berlin street in May 1945. The vehicle is equipped with the "Sankopf" mantlet and the remote-control machine gun with the small armored shield. During the last two weeks of fighting in the Berlin area, the Germans lost about 850 tanks and self-propelled guns, many of them being abandoned due to breakdowns or lack of fuel. The Soviets claimed that they destroyed over 1,700 enemy tanks, however.
