PANZERWAFFE AT WAR

(1) NUREMBERG TO MOSCOW

Robert Michulec & Thomas Anderson

ARMOR AT WAR SERIES

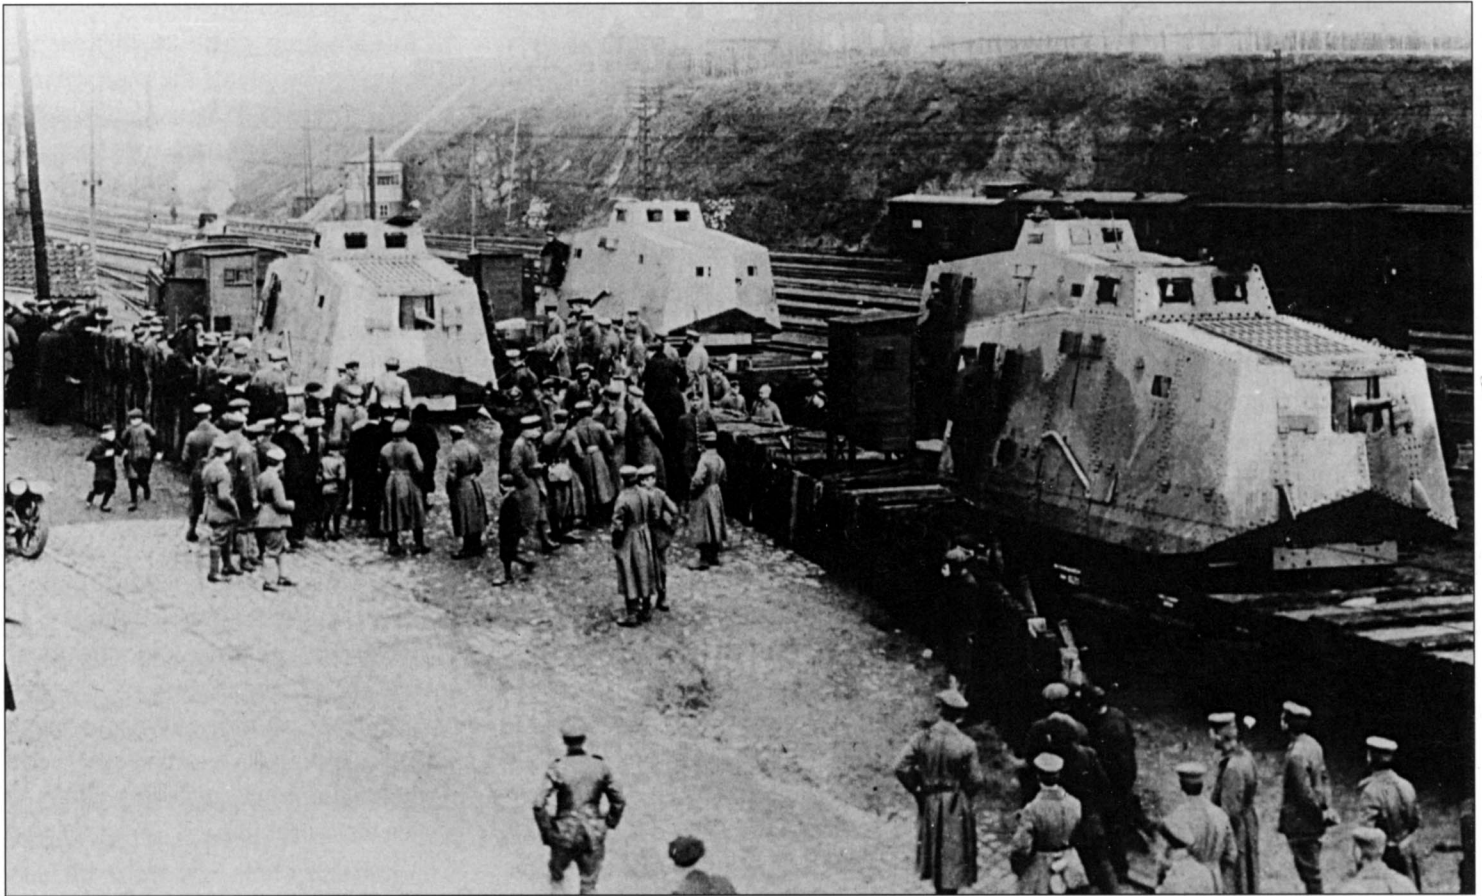
Towards the end of the war, the A7V was redesigned. The result, an example of which is seen here, was called the A7V-U. As is apparent, it showed many similarities to the contemporary British tanks. The rhomboid shape is very evident in this photo. This — unsuccessful — design did not enter into production.

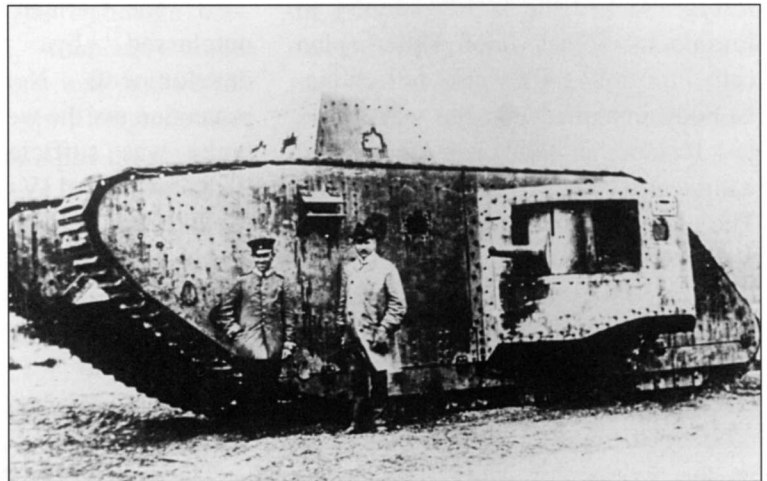
In 1918 a light tank was developed — the LK II. Due to the restrictions imposed on Germany by the Treaty of Versailles, all files and manufacturing machinery were exported to Sweden. There a limited number of “Strijdsvagn M 21” vehicles were produced, which were used well into the 1930s. Note the early camouflage pattern.

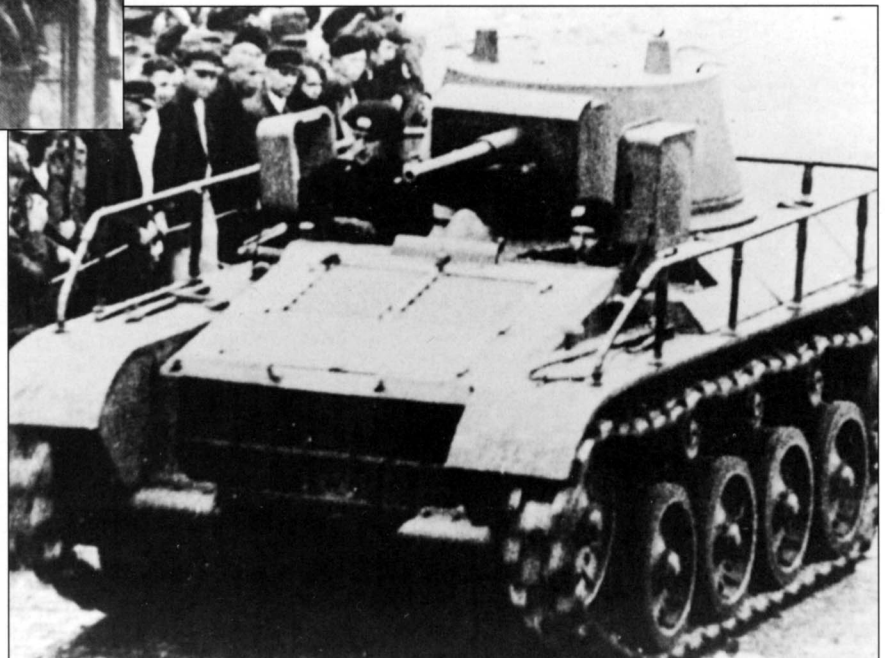
The *Leichtertraktor* was developed during the late 1920s. A small number of these light tanks was produced, which served as experimental vehicles. The armament was a 3.7cm KwK L/45 and a light machine gun. This interesting photo, probably taken during a celebration in 1934/35, shows an improved running gear with greased tracks. Note the black tankers uniform and the *Schutzmütze* (padded beret) that each crew member wears. (F. Schulz)

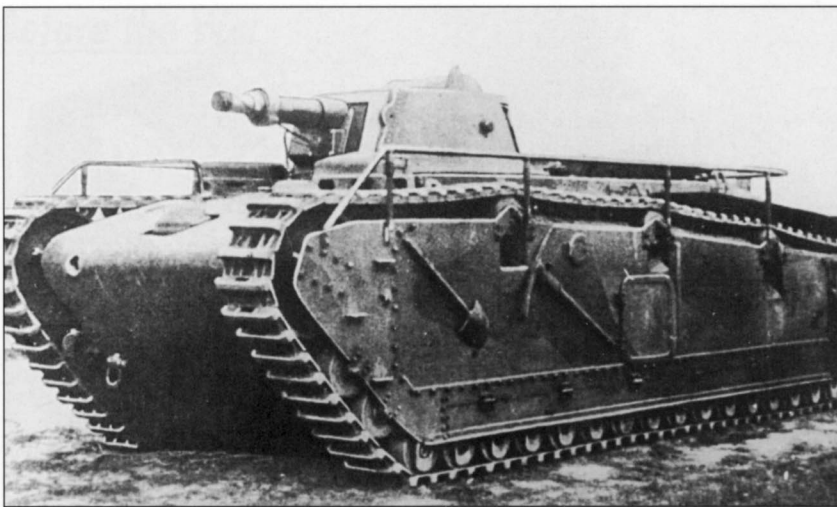
The *Großtraktor* was another step in the advancement of tank technology. This armored vehicle was developed by several firms, but this photo shows the Rheinmetall version. The main armament consisted of a 7.5cm KwK L/24 gun. The careful evaluation of this vehicle at Kazan, where a variety of spring systems, running gears, transmissions and tracks were tested, brought about valuable results.

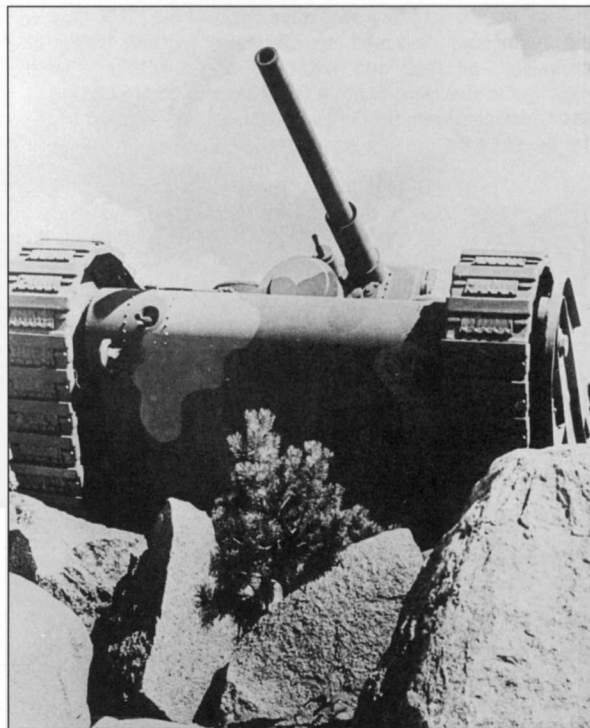
This photo depicts the Daimler-Benz version of the *Großtraktor*. It is interesting that long-barreled guns (here a 7.5cm) were in use as early as 1930. It would take another twelve years before such effective guns were introduced to the German tank force. After being transported back to Germany from Kazan, these vehicles served for a short time in the 1. Panzer-Division. Then, however, they ended their service life as monuments, such as this one that has been placed in front of a Panzer regiment headquarters.

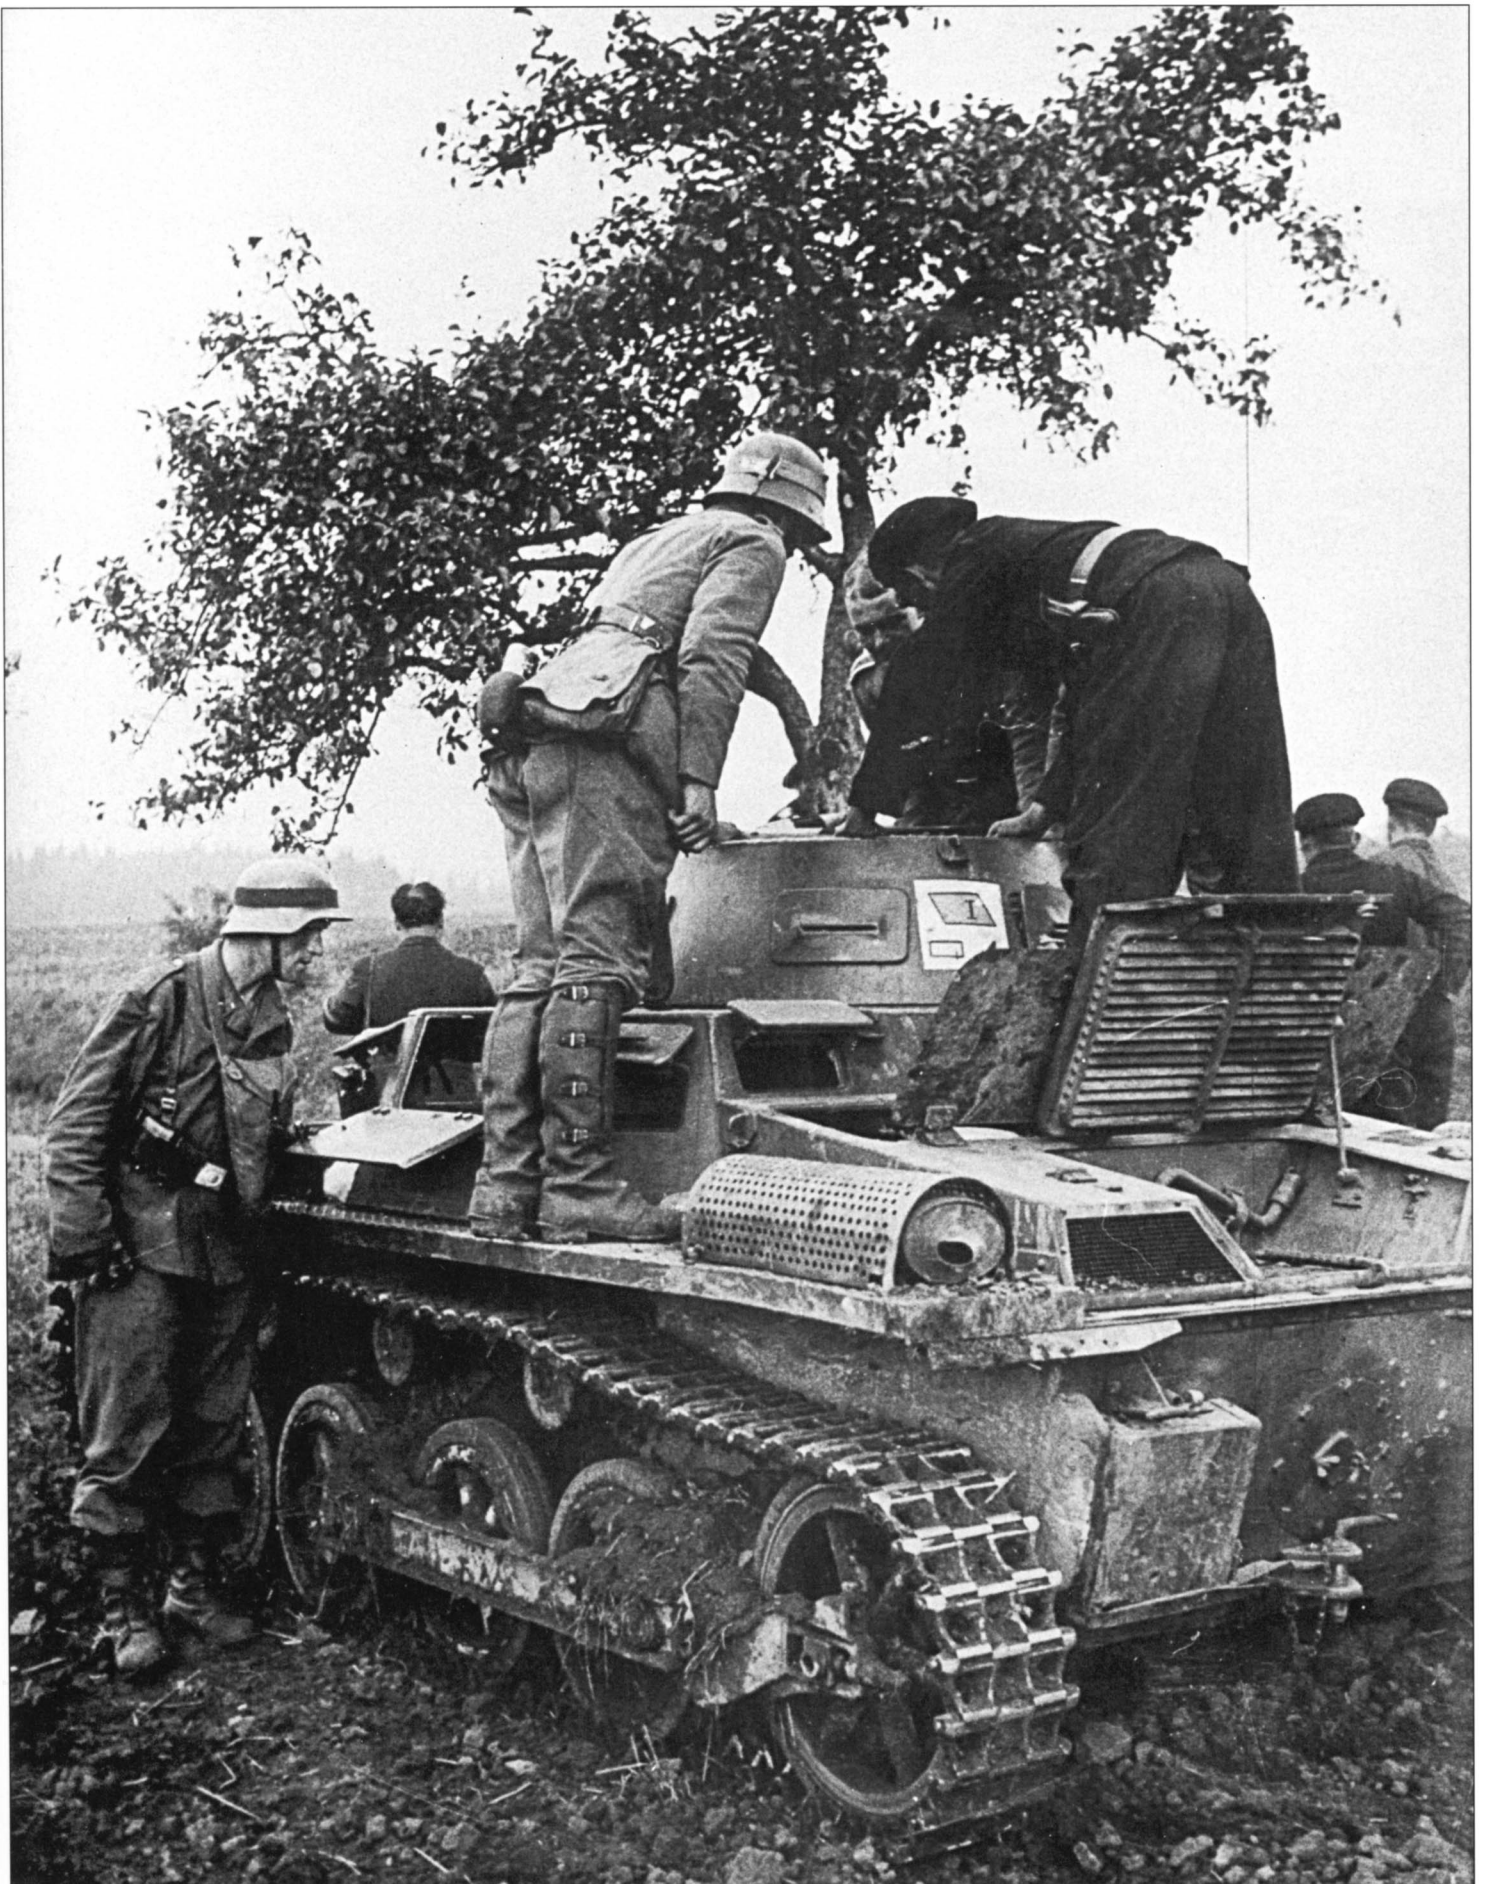
German infantry troopers help us to gauge the size of a Pz.Kpfw. I Ausf. A as they take a close look at the tank during maneuvers. Apart from their practical uses, these light tanks helped to get the army used to modern technology. This Ausf. A shows all hatches open, which offers an interesting view into the engine compartment. The tactical marking on the turret is a non-standard one. Markings like this differed widely in the mid-30s.

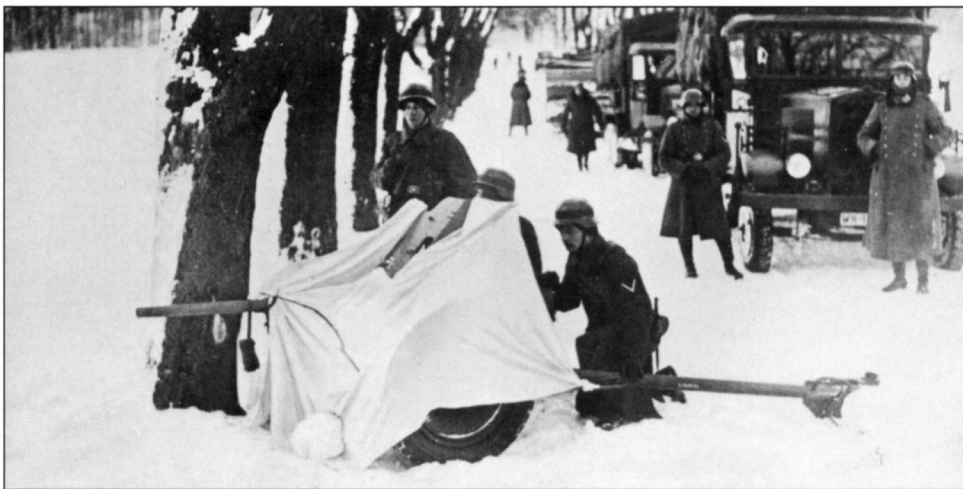
A 3.7cm Pak 36 gun is seen in position during a winter maneuver. The gun crew rather successfully uses a white sheet to conceal the shape of the gun. Apparently the soldiers don't take their job too seriously, as is evident by the bored appearance of the truck drivers. Nevertheless, the antitank gun battalion was yet another important element of a Panzer division.

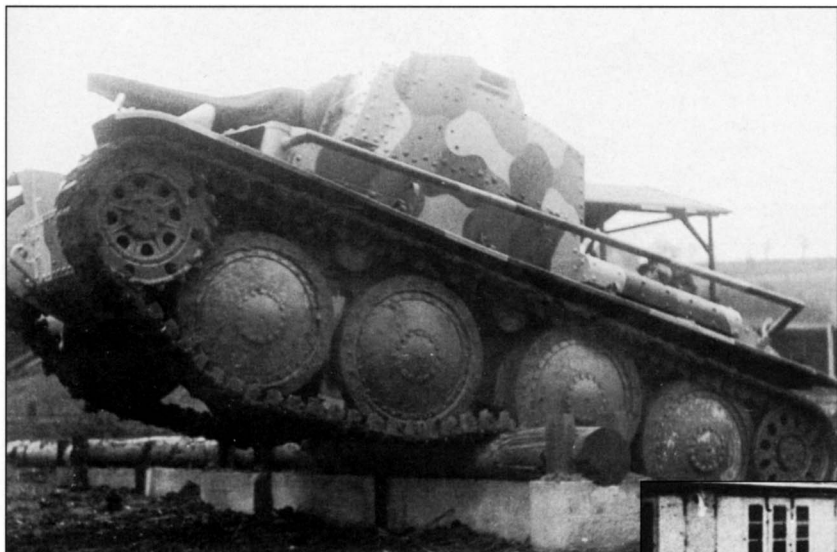
The occupation of Czechoslovakia helped to replenish the German war arsenal significantly. The LT Vz 38, better known under the German designation Pz.Kpfw. 38(t), helped to establish one division. This photo shows the original Czech version of this tank in its three-tone camouflage and fitted with a combat aerial.

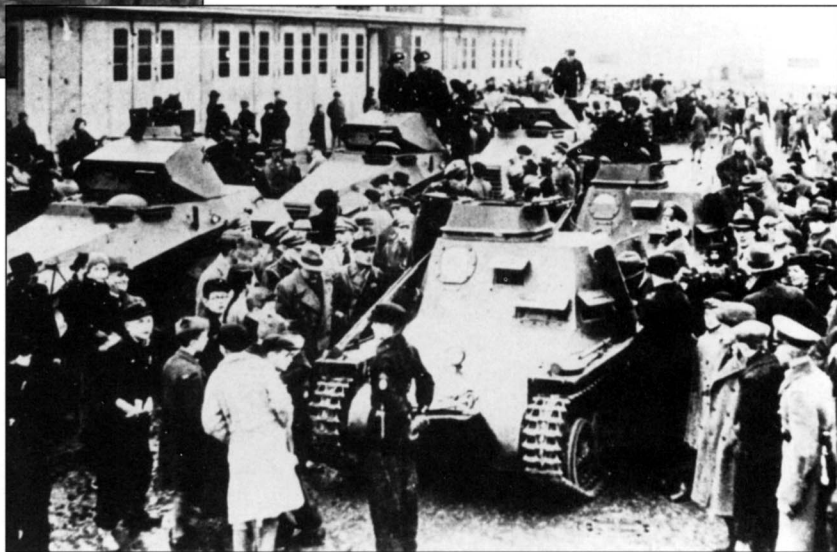
Photographed shortly before the Polish campaign, these early Pz.Kpfw. I Ausf. B *kleine Panzerbefehlswagen* (small armored command vehicles) still lack their machine guns. The aperture for the gun, which is located just below the small cupola, is sealed by a steel plate. Command vehicles were available in large numbers and played an important part during the advance of the German tank force during the Blitzkrieg.

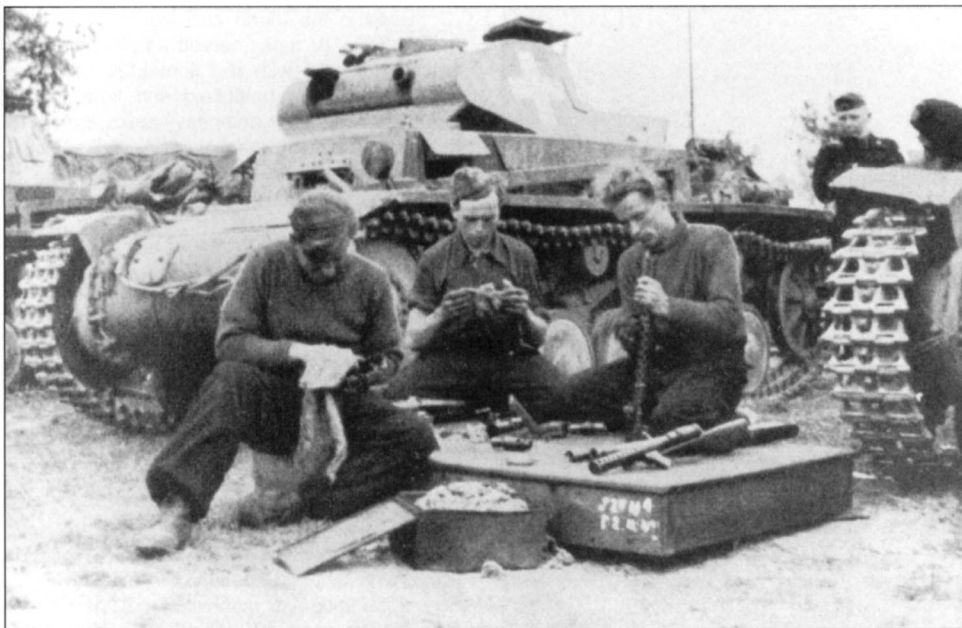
The crew of this Pz.Kpfw. II engage in the necessary chore of cleaning the weaponry of their tank — a 20mm cannon and a co-axial 7.9mm machine gun.. Maintenance work like this had to be done in the field and under all conditions. This early Pz.Kpfw. II, with its distinctive rounded bow, displays a large white cross on its turret. Barely visible under the cross is the rhomboid plate with the vehicle number "612".

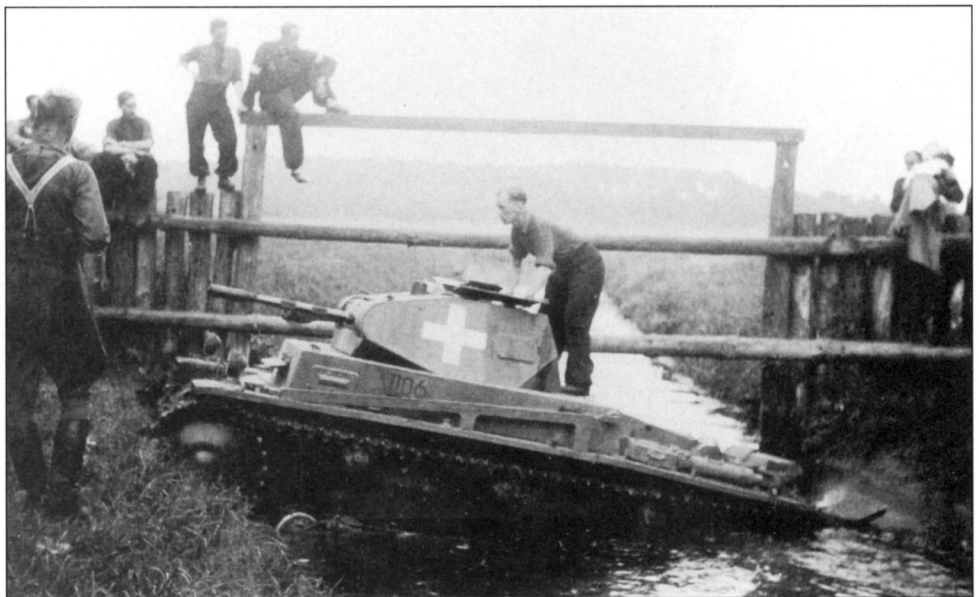
A Pz.Kpfw. IIb fording a waterhole shows the problems the early tanks had to deal with. Insufficient engine power, unserviceable running gear, and lack of deep-wading capability made such fording attempts during combat most dangerous. The number "II 06" painted on the superstructure indicates that this vehicle is from the 2nd battalion's staff section. A solid white cross is clearly visible on the turret.

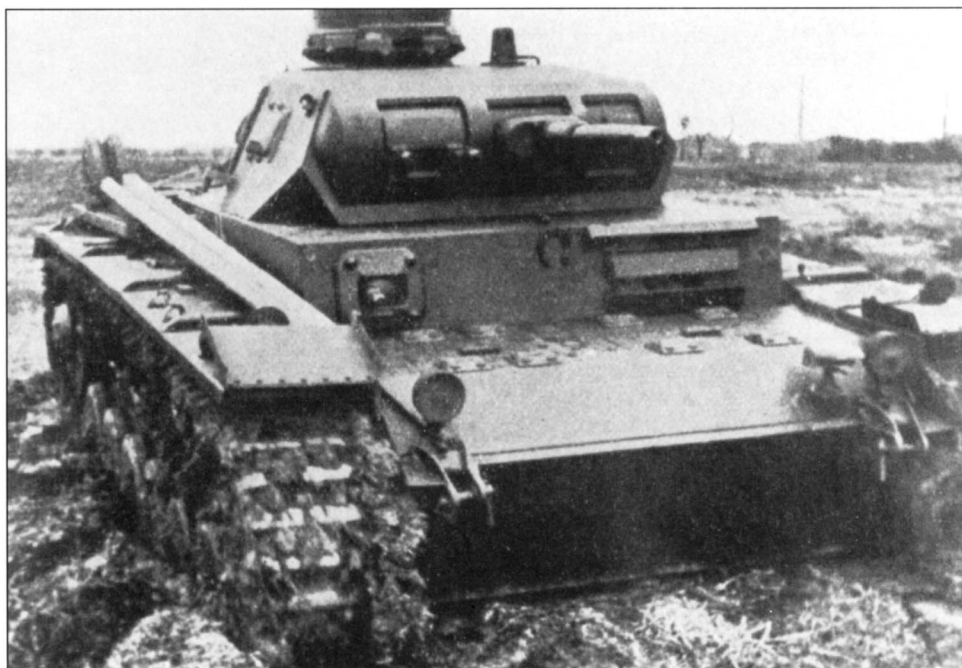
Besides the Pz.Kpfw. 38(t), the only tank suitable for tank vs. tank engagements during the Polish campaign was the Pz.Kpfw. III with its 3.7cm gun. Basically a very good design, the early Pz.Kpfw. III suffered from this ineffective armament and weak 30mm-thick armor. This photo was taken after the Western campaign, as evident by the divisional marking of 6.Panzer-Division. Note that the position of the Notek light has been changed.

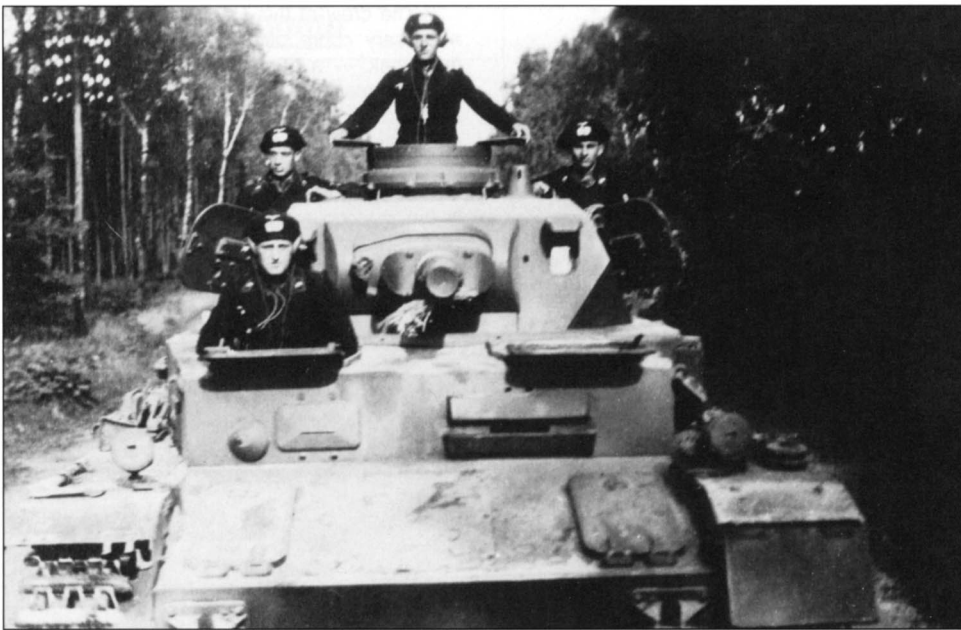
Used in the fourth and eighth companies, the Pz.Kpfw. IV tanks served as attack support vehicles. Armed with a 7.5cm L/24 gun, they would survey the battlefield and fight against enemy gun positions and heavy tanks. Except for the driver, the entire crew of this Ausf. B is visible at their hatches.

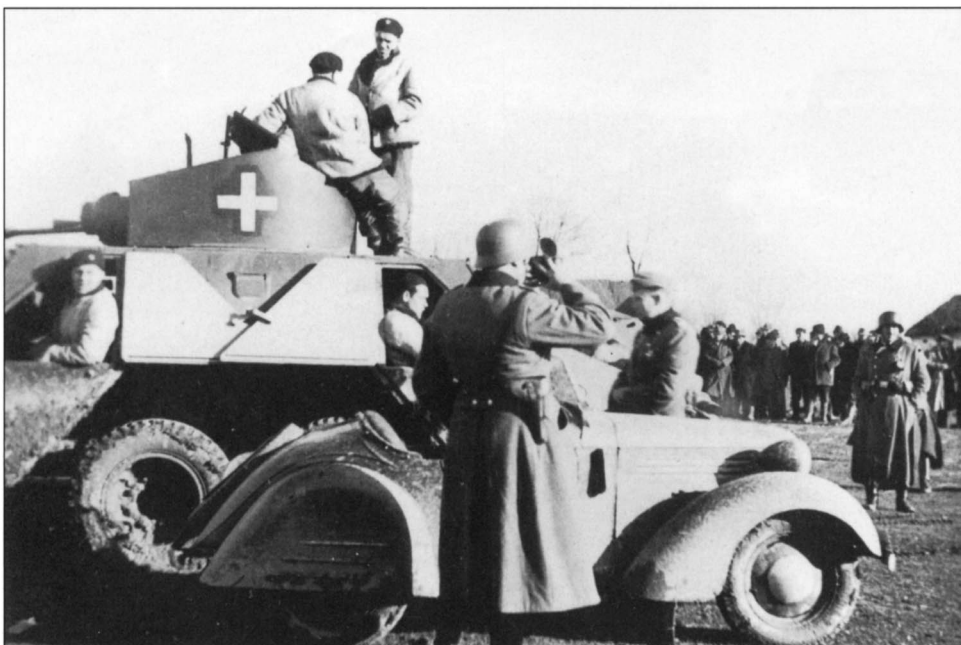
The profile of the ADGZ armored car is shown in this photo. The side hatches are open, illustrating that armor protection was on the lower part of the vehicle. These vehicles were never popular with the German troops. After the first combat in Poland, they were used in an antipartisan role in the Balkans.

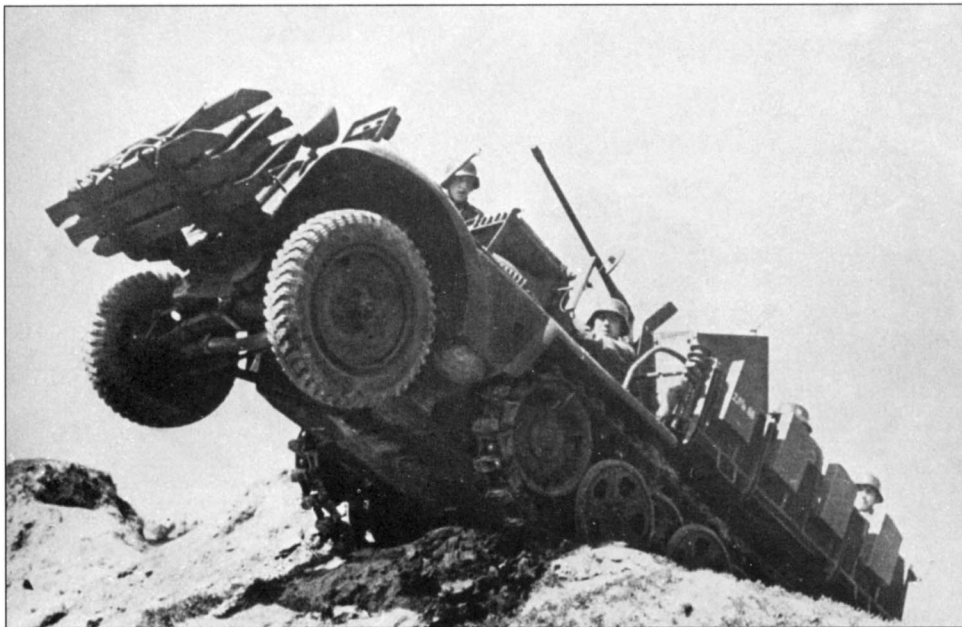
This impressive shot shows an unarmored Sd.Kfz. 10/4 combat vehicle negotiating a slope. The 1-ton halftrack was a most versatile vehicle. The version here, which is armed with the 2cm Flak 38 gun, quickly became famous as the *Sturmflak* - the anti-aircraft assault vehicle.

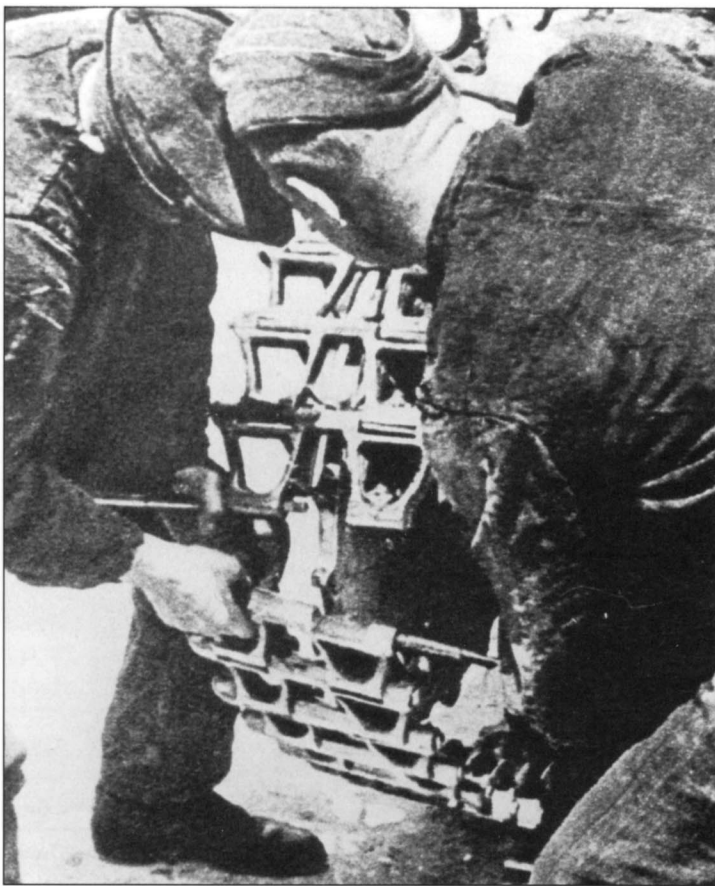
Maintenance was essential and had to be performed at any time and under any conditions. Here two tankers repair a damaged track, an easy job to accomplish with the light Pz.Kpfw. I. This view provides a good close-up look at how the track is assembled.

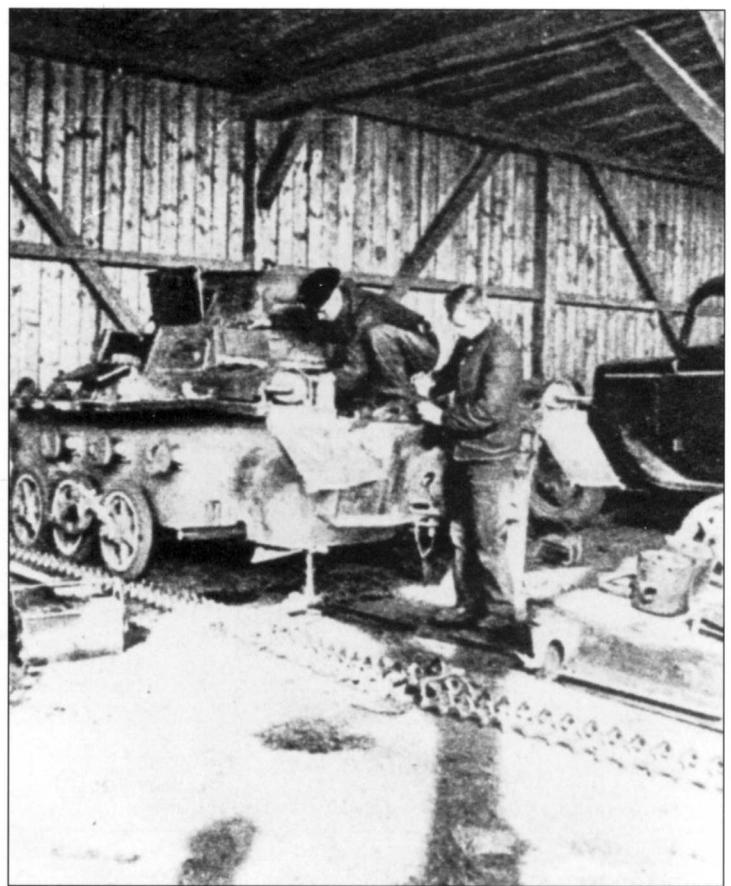
A barn serves as a shelter and an ersatz garage while two mechanics provide this Pz.Kpfw. I Ausf. A with a thorough maintenance check. The running gear of both the Pz.Kpfw. I and II proved to be prone to mechanical breakdowns.

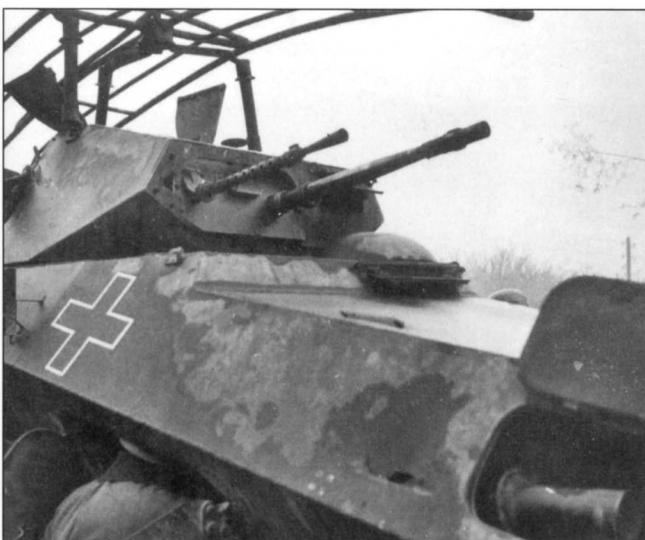
This Sd.Kfz. 232 *Sechsrad* (six-wheeler) was destroyed by a number of antitank rifle rounds. These old vehicles were phased out after the Polish campaign with only a few surviving in staff sections. Their cross-country performance and armor protection were never sufficient. Of interest is the German cross, whose inner portion has been neatly painted gray to discourage enemy gunners from using it to target the tank.

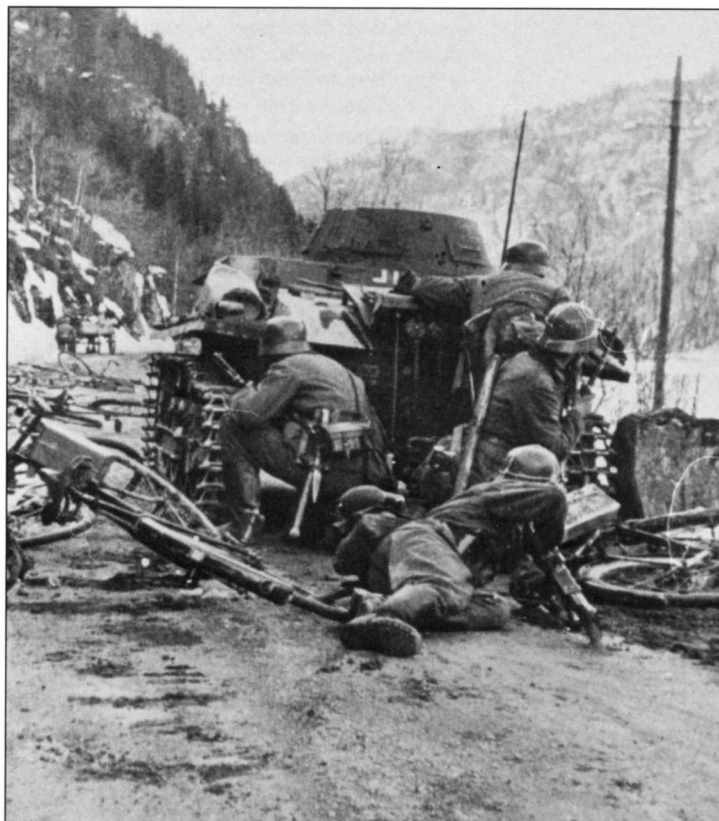
An infantry squad (mounted on bicycles) takes cover behind a Pz.Kpfw. I during action in Norway in 1940. Although understandable, this was a dangerous practice since any tank would attract enemy fire. Also, the tank could endanger prone soldiers if it should start to drive backwards. This particular vehicle is an Ausf. A of a late production batch, as is evident by the air intake covers of the cooling system.

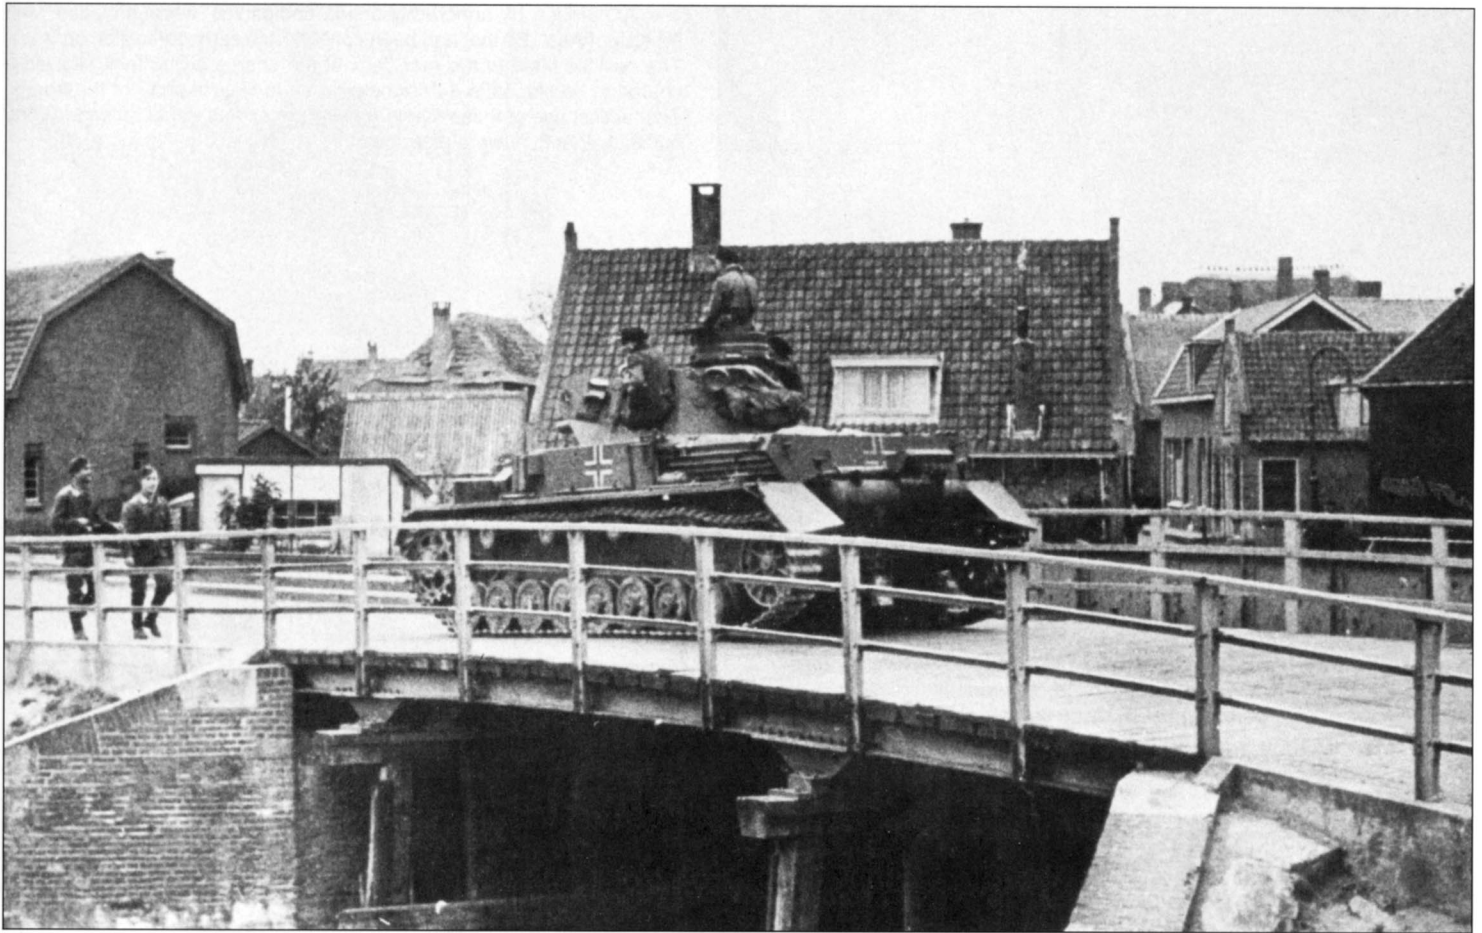
This Pz.Kpfw. IV Ausf. D crosses a bridge in the Low Countries in 1940. The tank wears the narrow white German crosses that were commonly seen during the Western campaign. It is also equipped with five smoke candle dischargers, which was typical for German tanks and StuGs in that year.

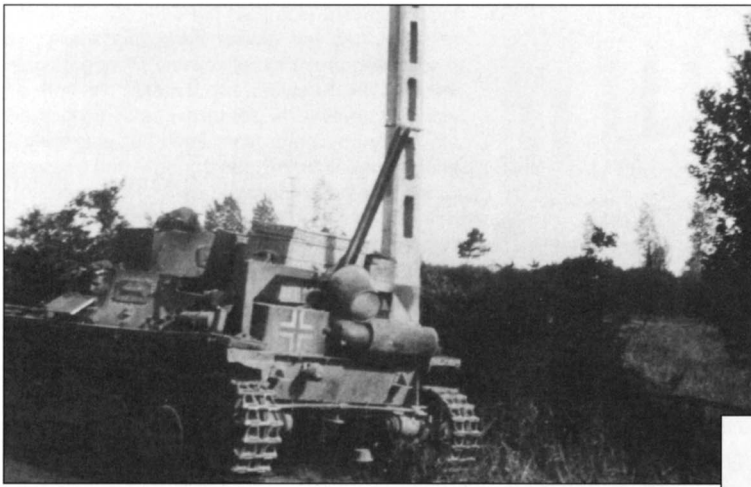
A number of armored pioneer companies were provided with Pz.Kpfw. I Ausf. Bs that had been converted to carry demolition charges. The devices fitted to the rear deck of the charge-laying tank allowed a charge to be placed in a designated area to clear a path for the troops. The tactical use of these *kleine Ladungsleger* was rather limited, so it is not likely that they were often used.

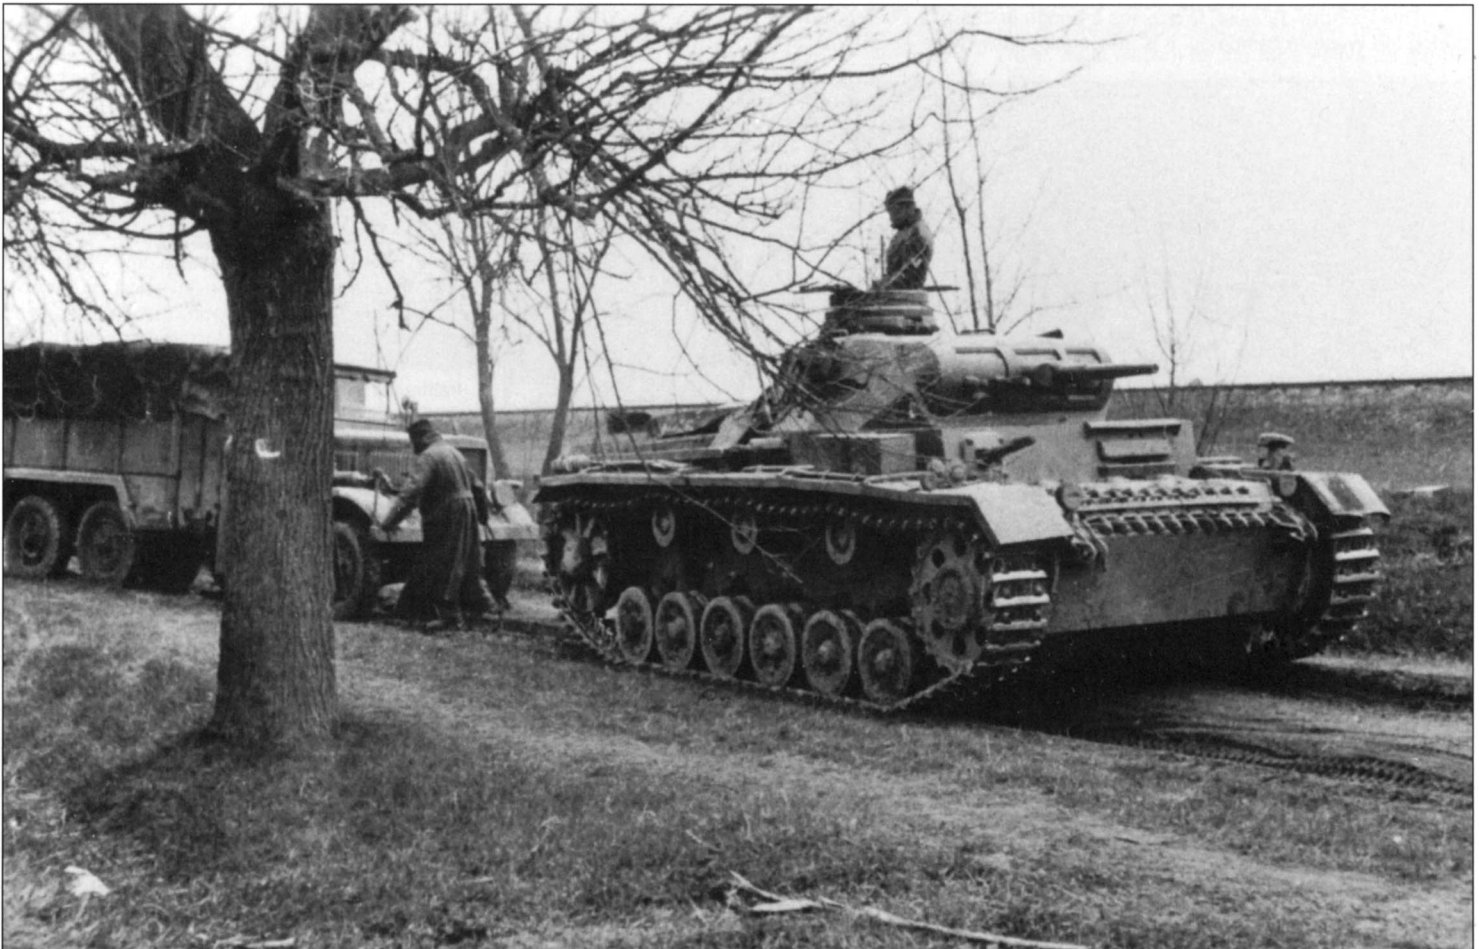
A Pz.Kpfw. III Ausf. E tows a disabled *Einheitsdiesel* truck. This medium tank was intended for tank vs. tank fighting. However, neither armament (3.7cm) nor armor protection (30mm maximum) proved to be sufficient for this task. It is interesting that the powerful 5cm KwK 40 gun was available in 1940 since the ordnance bureau's policy supposedly prevented the use of the gun before 1941.

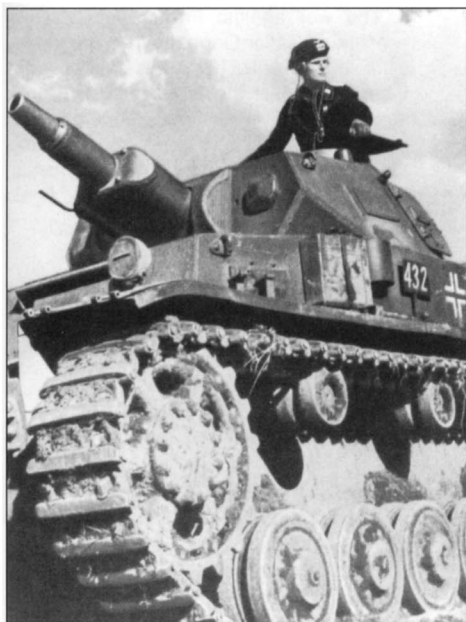
This well-known propaganda photo shows a Pz.Kpfw. IV Ausf. B or C of Pz.Rgt. 7, 10. Panzer-Division, as is indicated by the silhouette of the charging Bison stenciled on the lower left of the turret. The short-barreled 7.5cm gun is shown to advantage here. Also of interest is the antenna deflector attached to the gun.

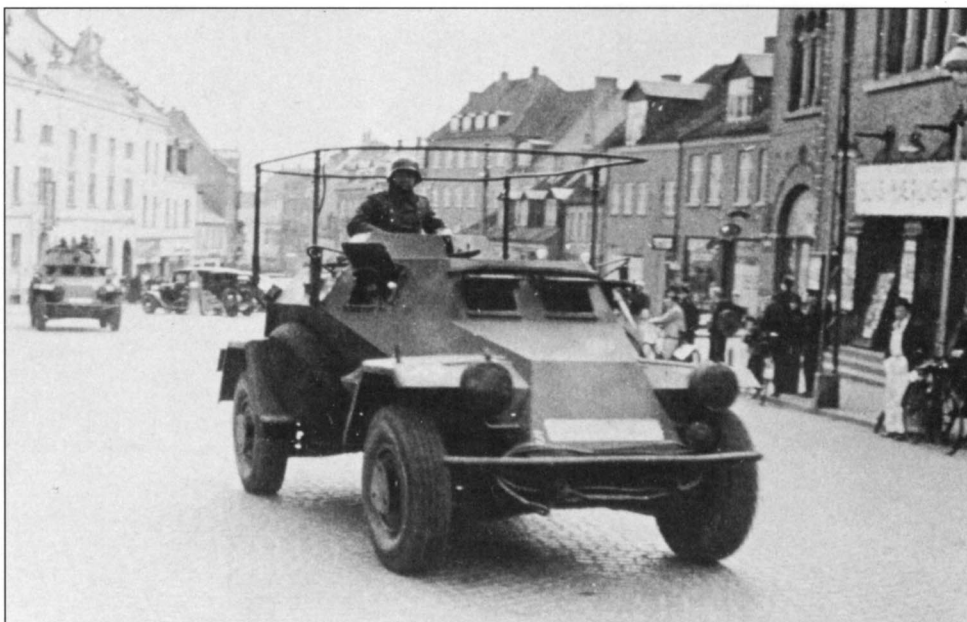
A Sd.Kfz. 223, followed by a Sd.Kfz. 222, passes through a French city. These armored cars were fitted with a large frame antenna, as most command and liaison vehicles were until 1942. Though effective, the conspicuous antenna attracted enemy attention, resulting in relatively high losses. Note the small number "5" next to the registration plate.

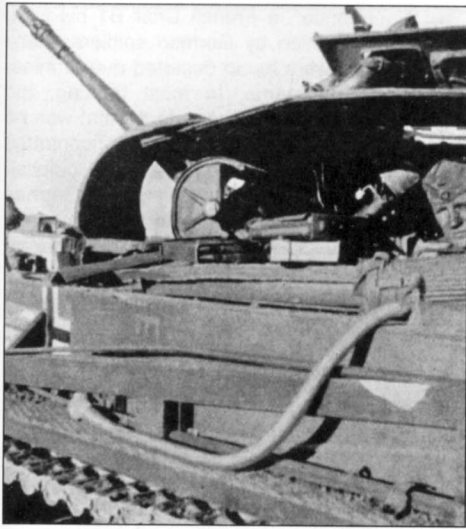
The armor of the light tanks was anything but sufficient. An artillery hit tore apart the entire side of the turret of this Pz.Kpfw. II. It belonged to 20.Panzer-Division, as the faint symbol of the Brandenburg Gate indicates.

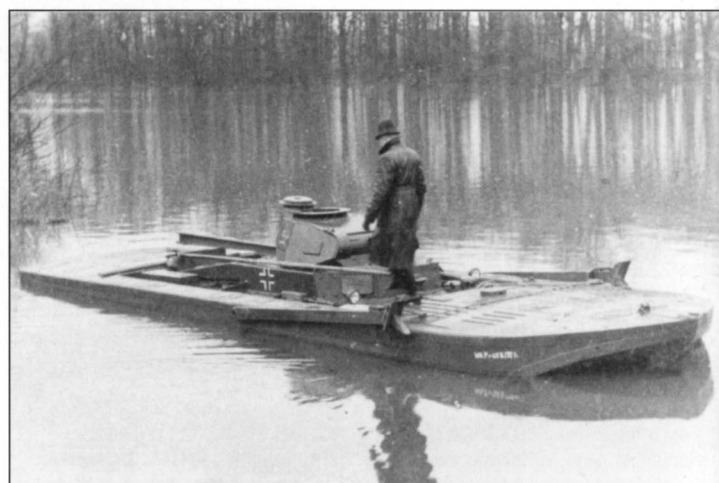
Shortly after the invasion of France, the Germans prepared for the planned invasion of Great Britain. This photo shows a prototype of the Schwimmpanzer II, a Pz.Kpfw. II Ausf. C that is carried through the water by a large pontoon. Equipment like this was later used along with deep-wading tanks during Operation "Barbarossa".

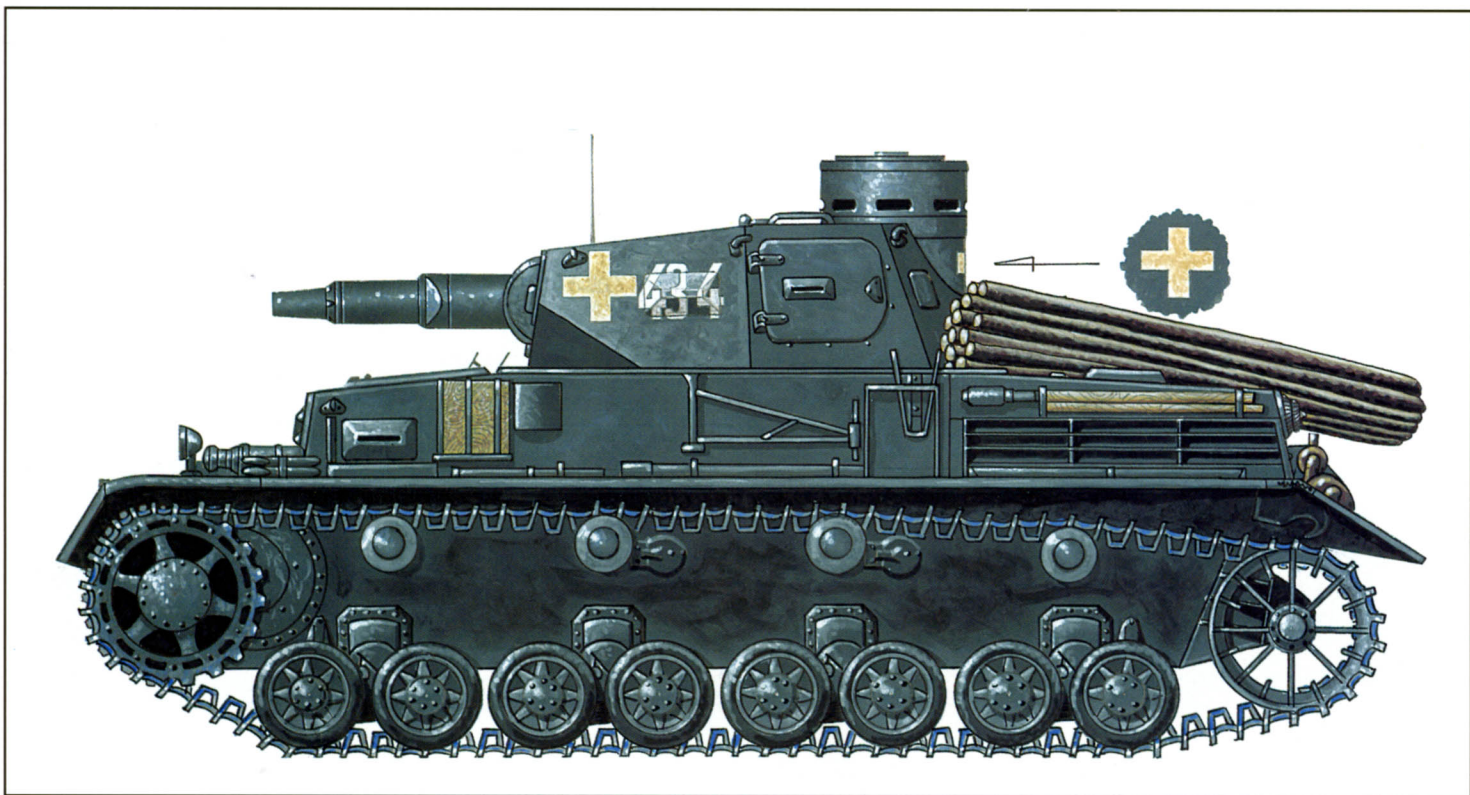
Pz.Kpfw. IV Ausf. A, 3.Panzer-Division, northern Poland, early September 1939

The Pz.Kpfw. IV Ausf. A was designed to monitor the combat of the main battle tanks (Pz.Kpfw. II and III). The fourth company of the tank regiments was provided with this vehicle. With its short-barreled 7.5cm gun, it could engage and destroy antitank positions and heavy enemy tanks. However, the armor protection (14.5mm with the Ausf. A) proved to be inadequate. At this time no German tank showed any camouflage scheme; all armored vehicles were painted in plain dark gray. This particular Ausf. A shows the full range of tactical markings introduced prior to the Polish campaign -- large white German crosses and vehicle numbers over-painted with mud or yellow paint. The tank carries fascines on the engine deck, which were often used to negotiate swampy terrain.
