PANZERWAFFE AT WAR

(1) NUREMBERG TO MOSCOW

Robert Michulec & Thomas Anderson

ARMOR AT WAR SERIES

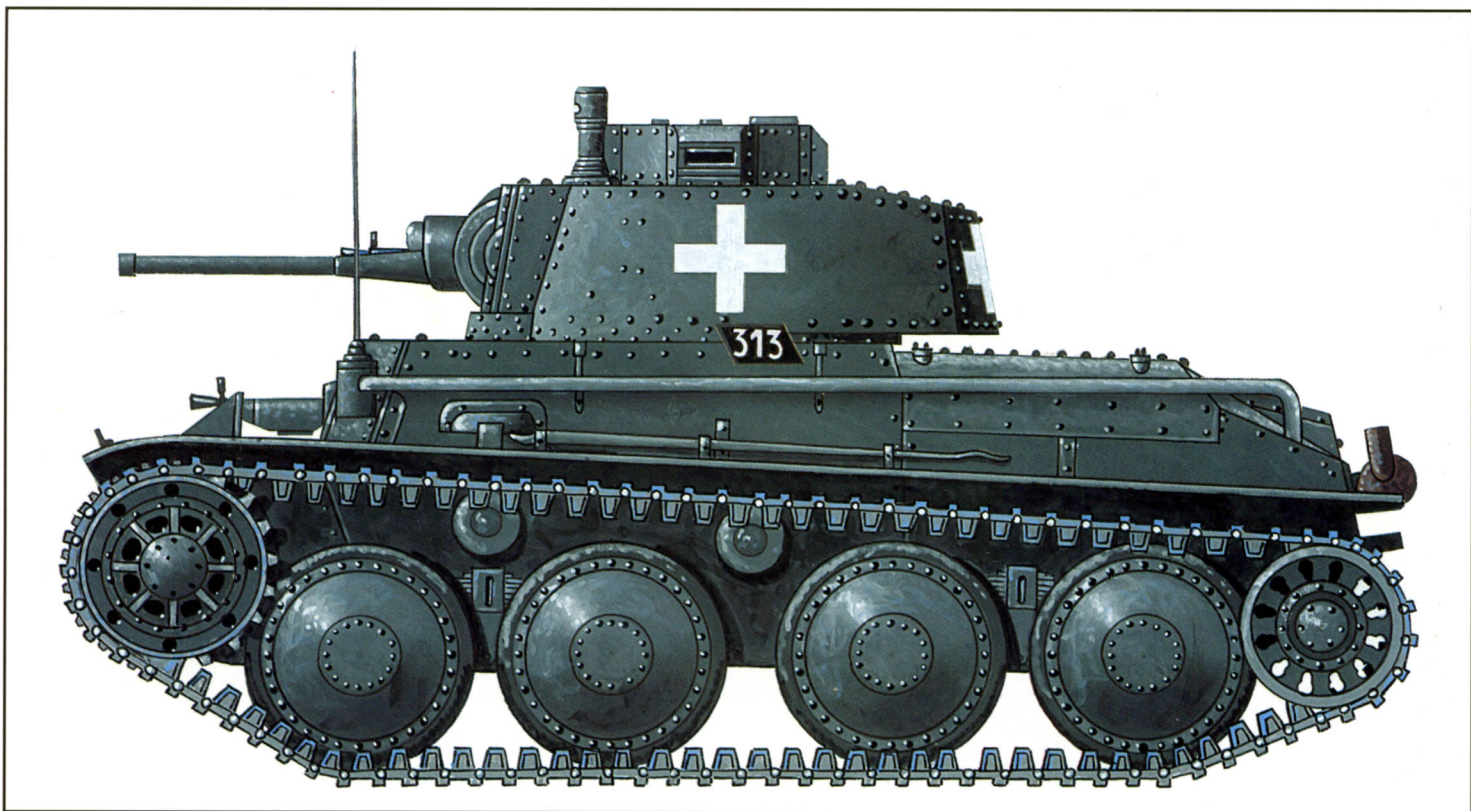
Pz.Kpfw. 38(t) Ausf. A, Pz.Abt. 67, 3.leichte-Division, southern Poland, September 1939

The fast and reliable Pz.Kpfw. 38(t) was used in the light divisions, the so-called schnelle Truppen, or rapid forces. This concept was not successful, however, and was soon rejected. This Pz.Kpfw. 38(t) Ausf. A of 3.leichte-Division, which is still equipped with a Czech combat antenna, has standard white German crosses painted on its turret. The vehicle numbers were painted on small rhomboid plates that were attached to both sides and the rear of the hull, another very common practice during the early campaigns. The prominent white crosses proved to be excellent aiming points for enemy gunners, thus many units covered them with mud or toned down the center with yellow paint.

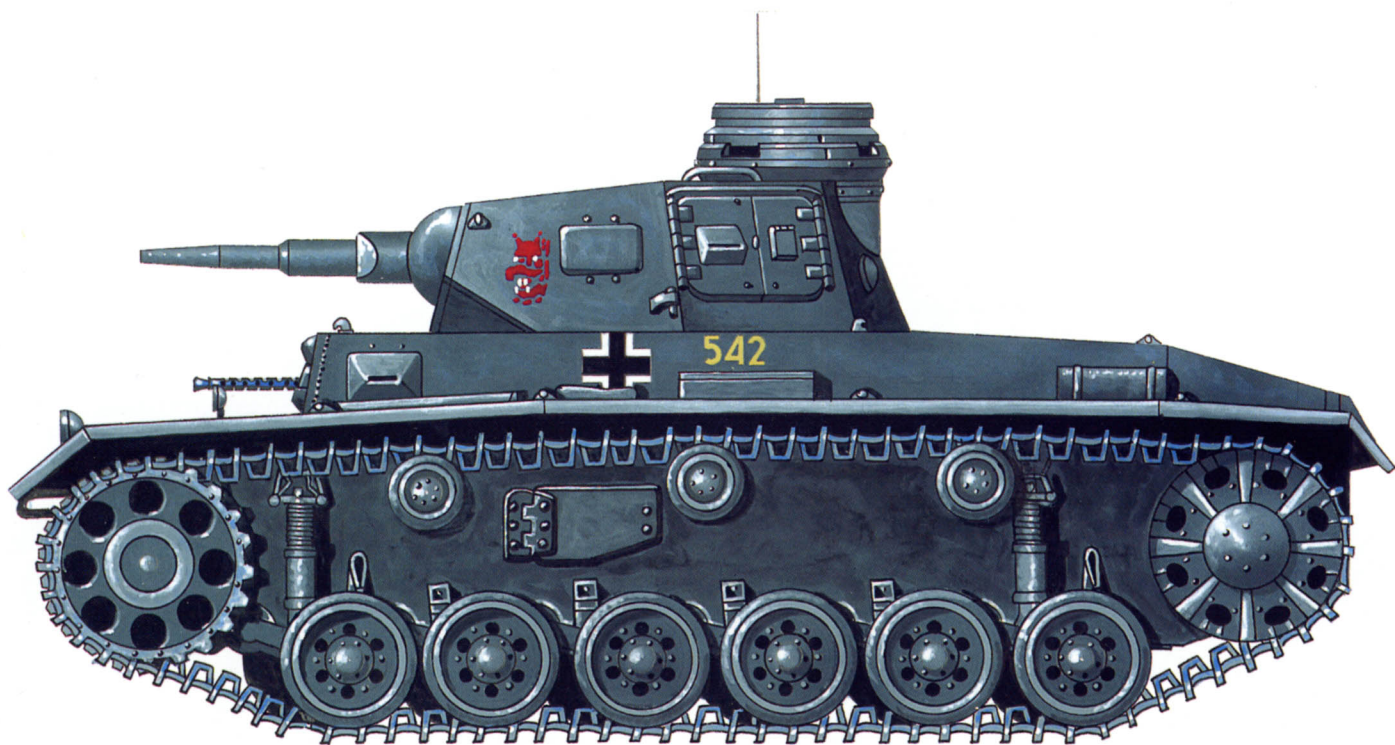
Pz.Kpfw. III Ausf. F, Pz.Rgt. 31, 5.Panzer-Division, France, June 1941

The Pz.Kpfw. III was the mainstay of Germany's tank formations from 1939 to 1942. Designed for tank vs. tank engagements, the first versions were equipped with the 3.7cm KwK, although development of the more powerful 5cm gun was soon finished. In 1940 the gun proved to be useless against the heavily armored French tanks. This Ausf. F wears the new-style German crosses outlined in white, the result of one of the lessons learned in the Polish campaign. The vehicle number is painted on the hull rather than on the turret. The number "542" denotes the position of the tank in the division: 5th company, 4th platoon, 2nd vehicle.

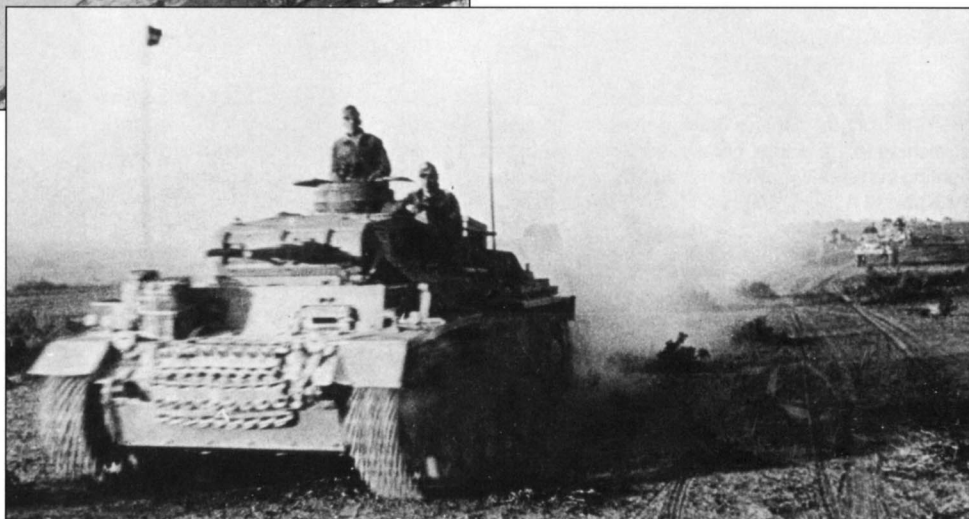
A Panzerbefehlswagen III Ausf. H leads a tank column through the desert. This command tank was fitted with a dummy gun resembling the 5cm KwK L/42. The 2m and the 1.4m rod antennae are both clearly visible; the larger frame antenna on the engine deck can just barely be seen.

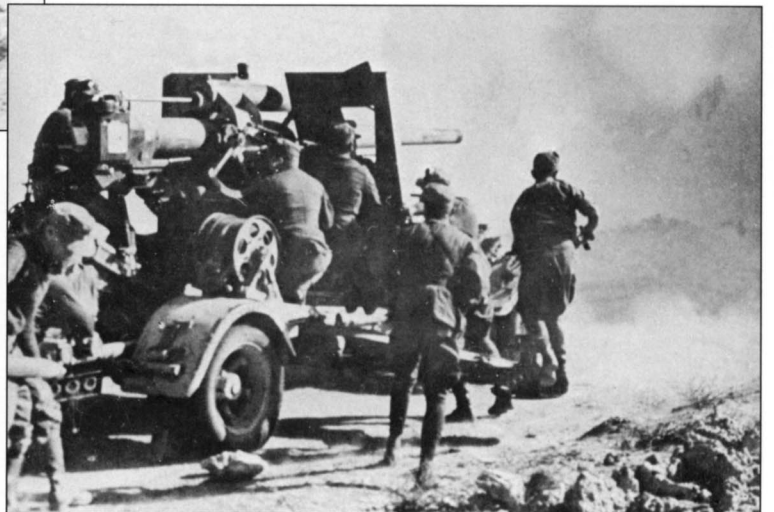
This interesting photo shows an 8.8cm Flak gun in full recoil. Although the practice was forbidden, the gun was sometimes fired from the trailer in an emergency situations. This put excess stress on the carriage and brakes. The gunners wear khaki tropical field caps, headgear that was popular with Afrika Korps vehicle crews.

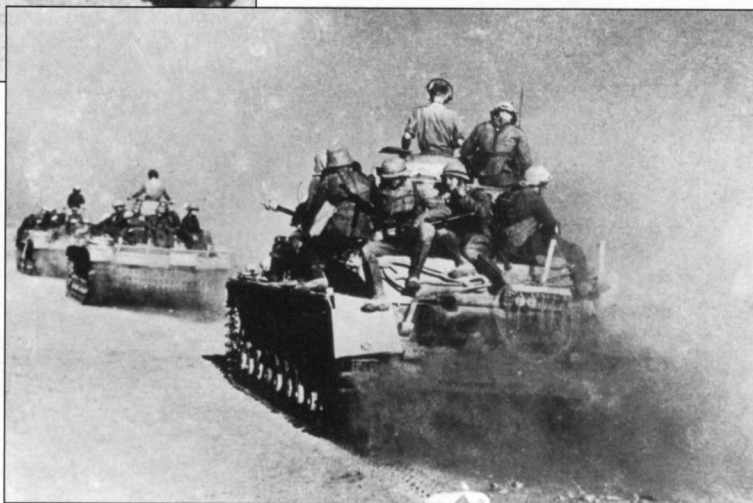
A Panzerbefehlswagen III Ausf. H command vehicle traverses the desert terrain along with several Italian infantrymen. A German radio set is visible behind the trailer. Note how extra jerry cans and other stowage has been secured at the rear of the hull of the tank.

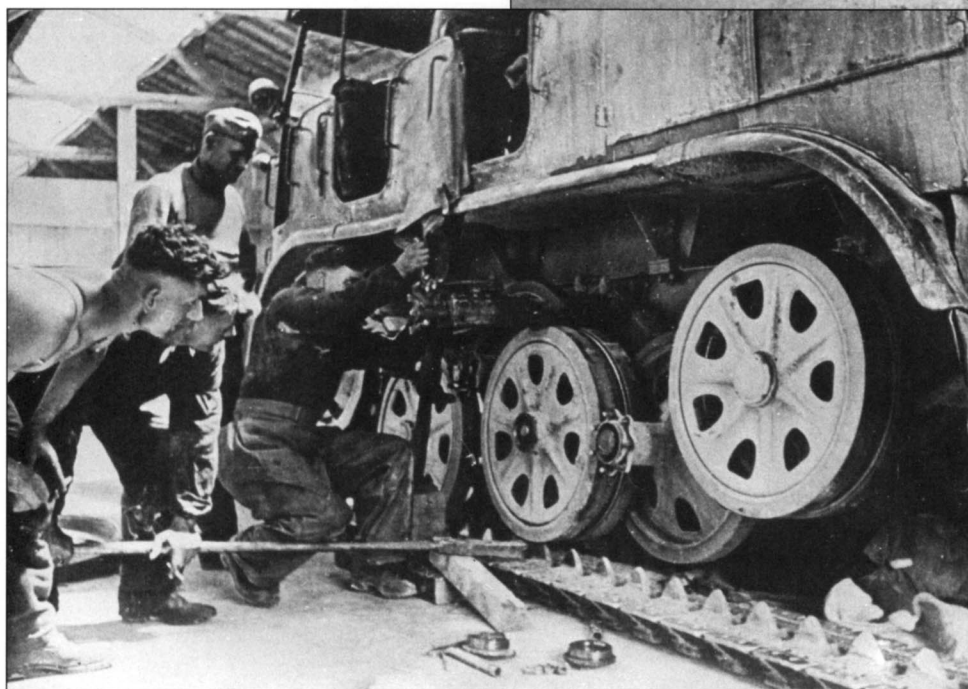
Mechanics perform some maintenance work on an early model 8-ton halftrack. Note that parts of the running gear have been removed. Though the German halftrack prime movers were most successful in their service, they were also complicated pieces of machinery subject to problems, as this photo shows. It is important to remember that none of the armored vehicles of the Panzerwaffe could have operated to its full potential without the assistance of the repair crews.

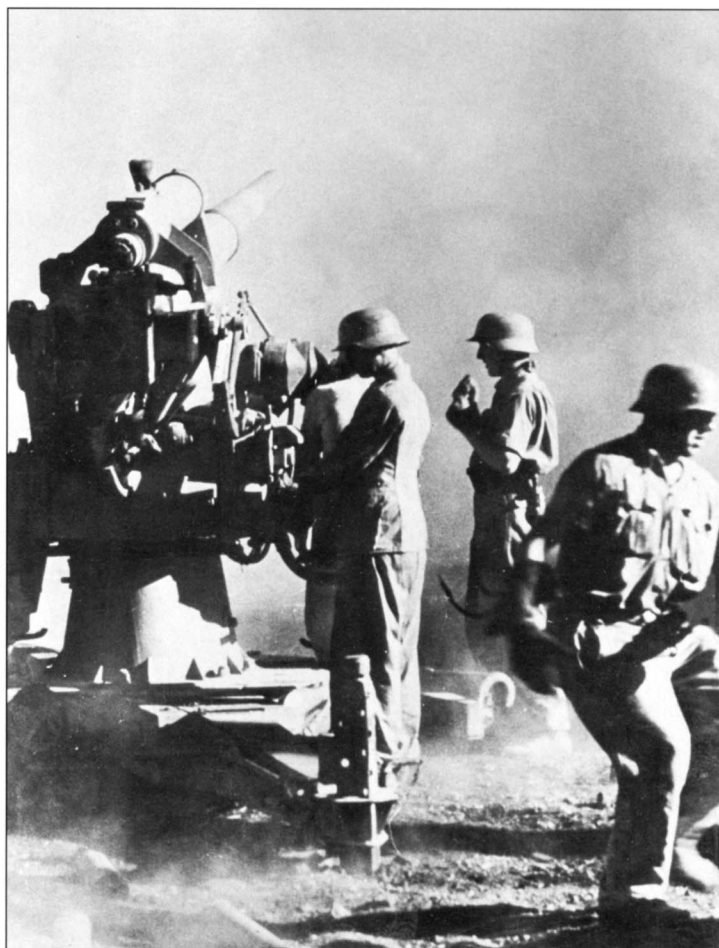
This 8.8cm Flak gun is being used in a more traditional artillery role as it provides support fire during an advance. One gunner can be seen standing at the gun looking at his *Folgezeiger* data transmitting system, while the commander supervises the action. It is noteworthy that the gun has no shield, leaving the crew without protection.

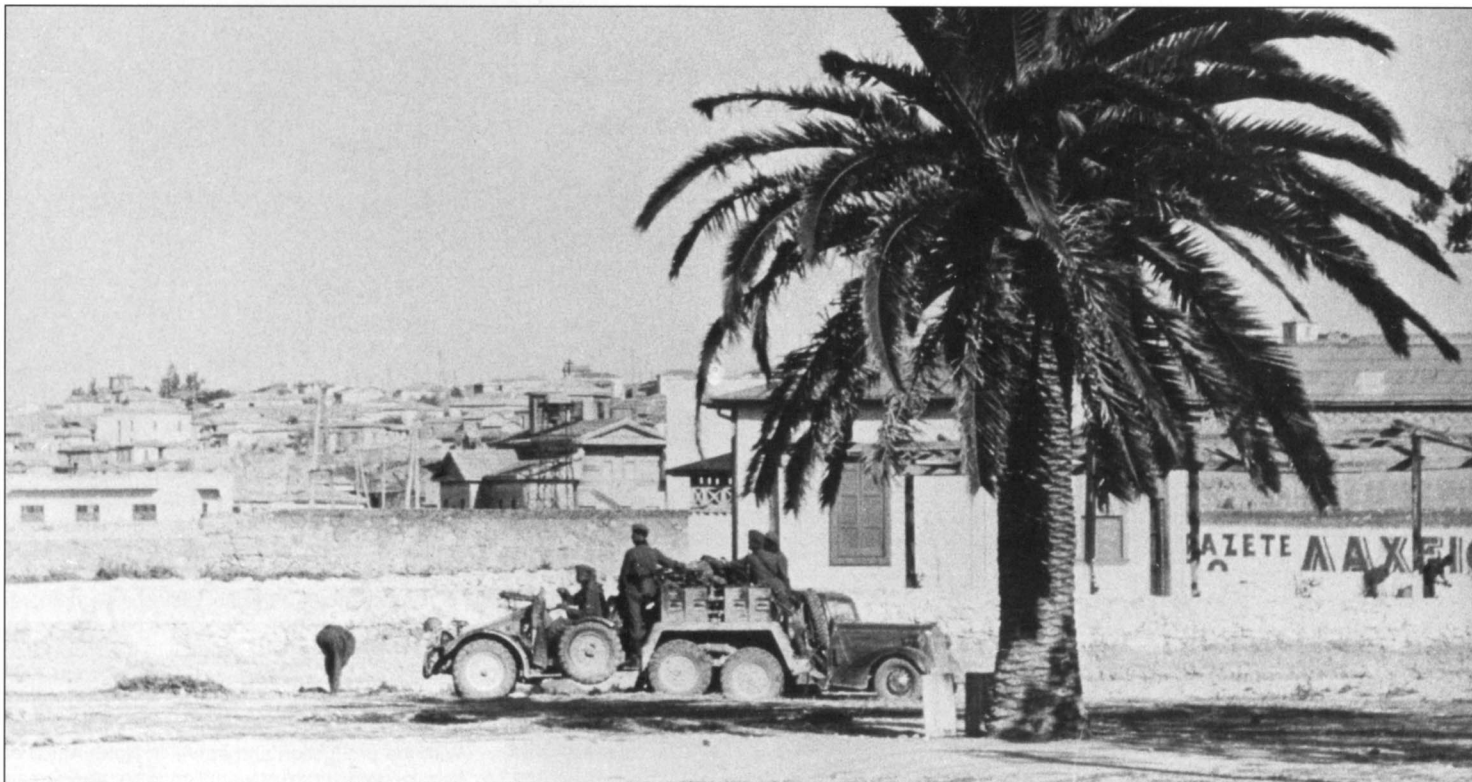
A Krupp-Protze gun tractor for a 3.7cm antitank gun passes by a palm tree somewhere near Tripoli. The gray vehicle is completely covered with dust, creating a most effective camouflage. Until later in the war, when the number of self-propelled guns on tracked chassis increased, artillery tractors like this one were essential for the success of the Panzerwaffe.

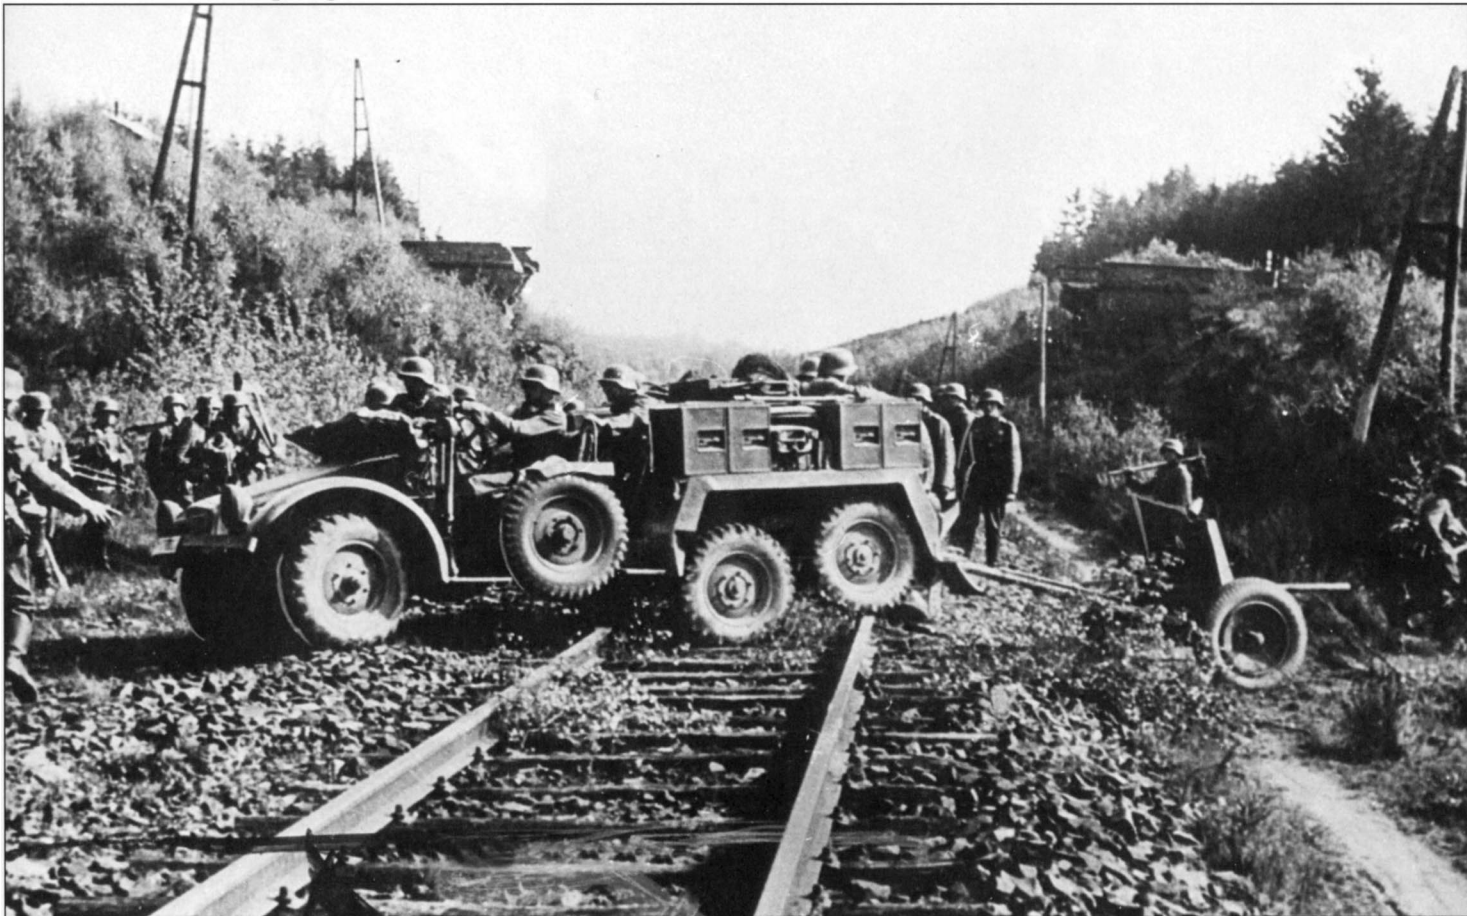
The North African desert created its own problems for the Afrika Korps, and the extremely rough terrain in the Balkans constantly reminded the Panzerwaffe troops there that they, too, were in for a difficult campaign. Here a Sd.Kfz. 69 Krupp-Protze maneuvers carefully across a railway line. These wheeled vehicles were designed for use with the 3.cm Pak 36 gun.

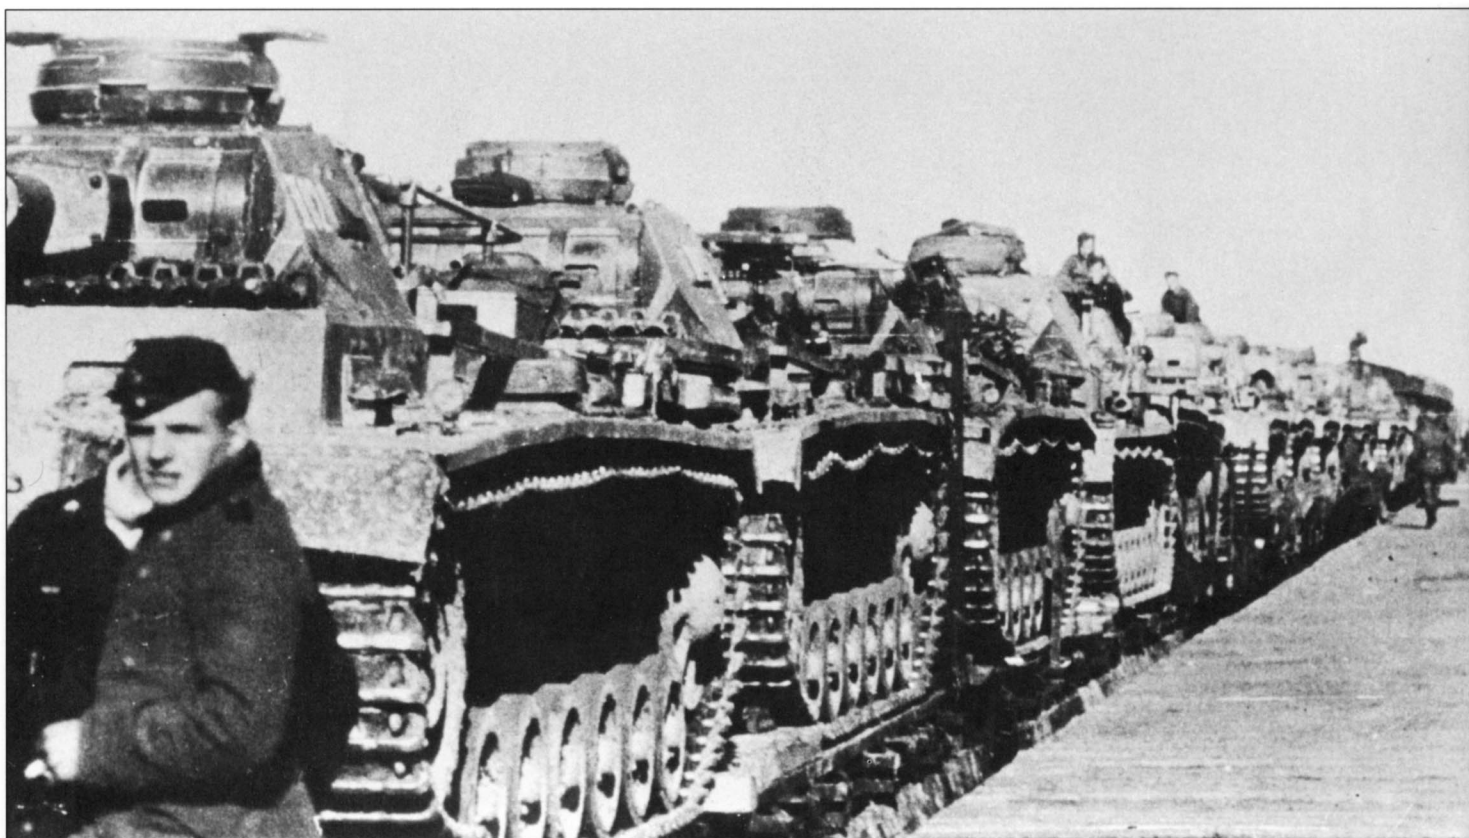
A tank unit, possibly part of 10. Panzer-Division belonging to Heeresgruppe Mitte, waits for railway shipment to the front. The first three vehicles are Panzerbefehlswagen III Ausf. H command vehicles, possibly belonging to the battalion staff section. These command tanks have been disguised with a fake 5cm KwK L/42 gun.

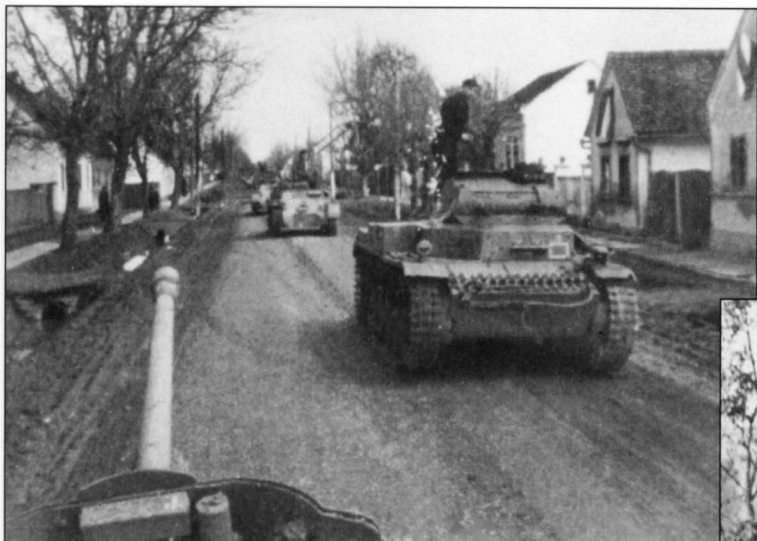
Here a platoon of light tanks passes by an antitank gun unit. The leading tank is a Pz.Kpfw. II Ausf. C; the following is a Pz.Kpfw. I Ausf. B. The 5cm Pak 38 was the most powerful German antitank gun of this period. Basically a very good gun, it became obsolete with appearance of the T-34 medium and the KV heavy tanks.

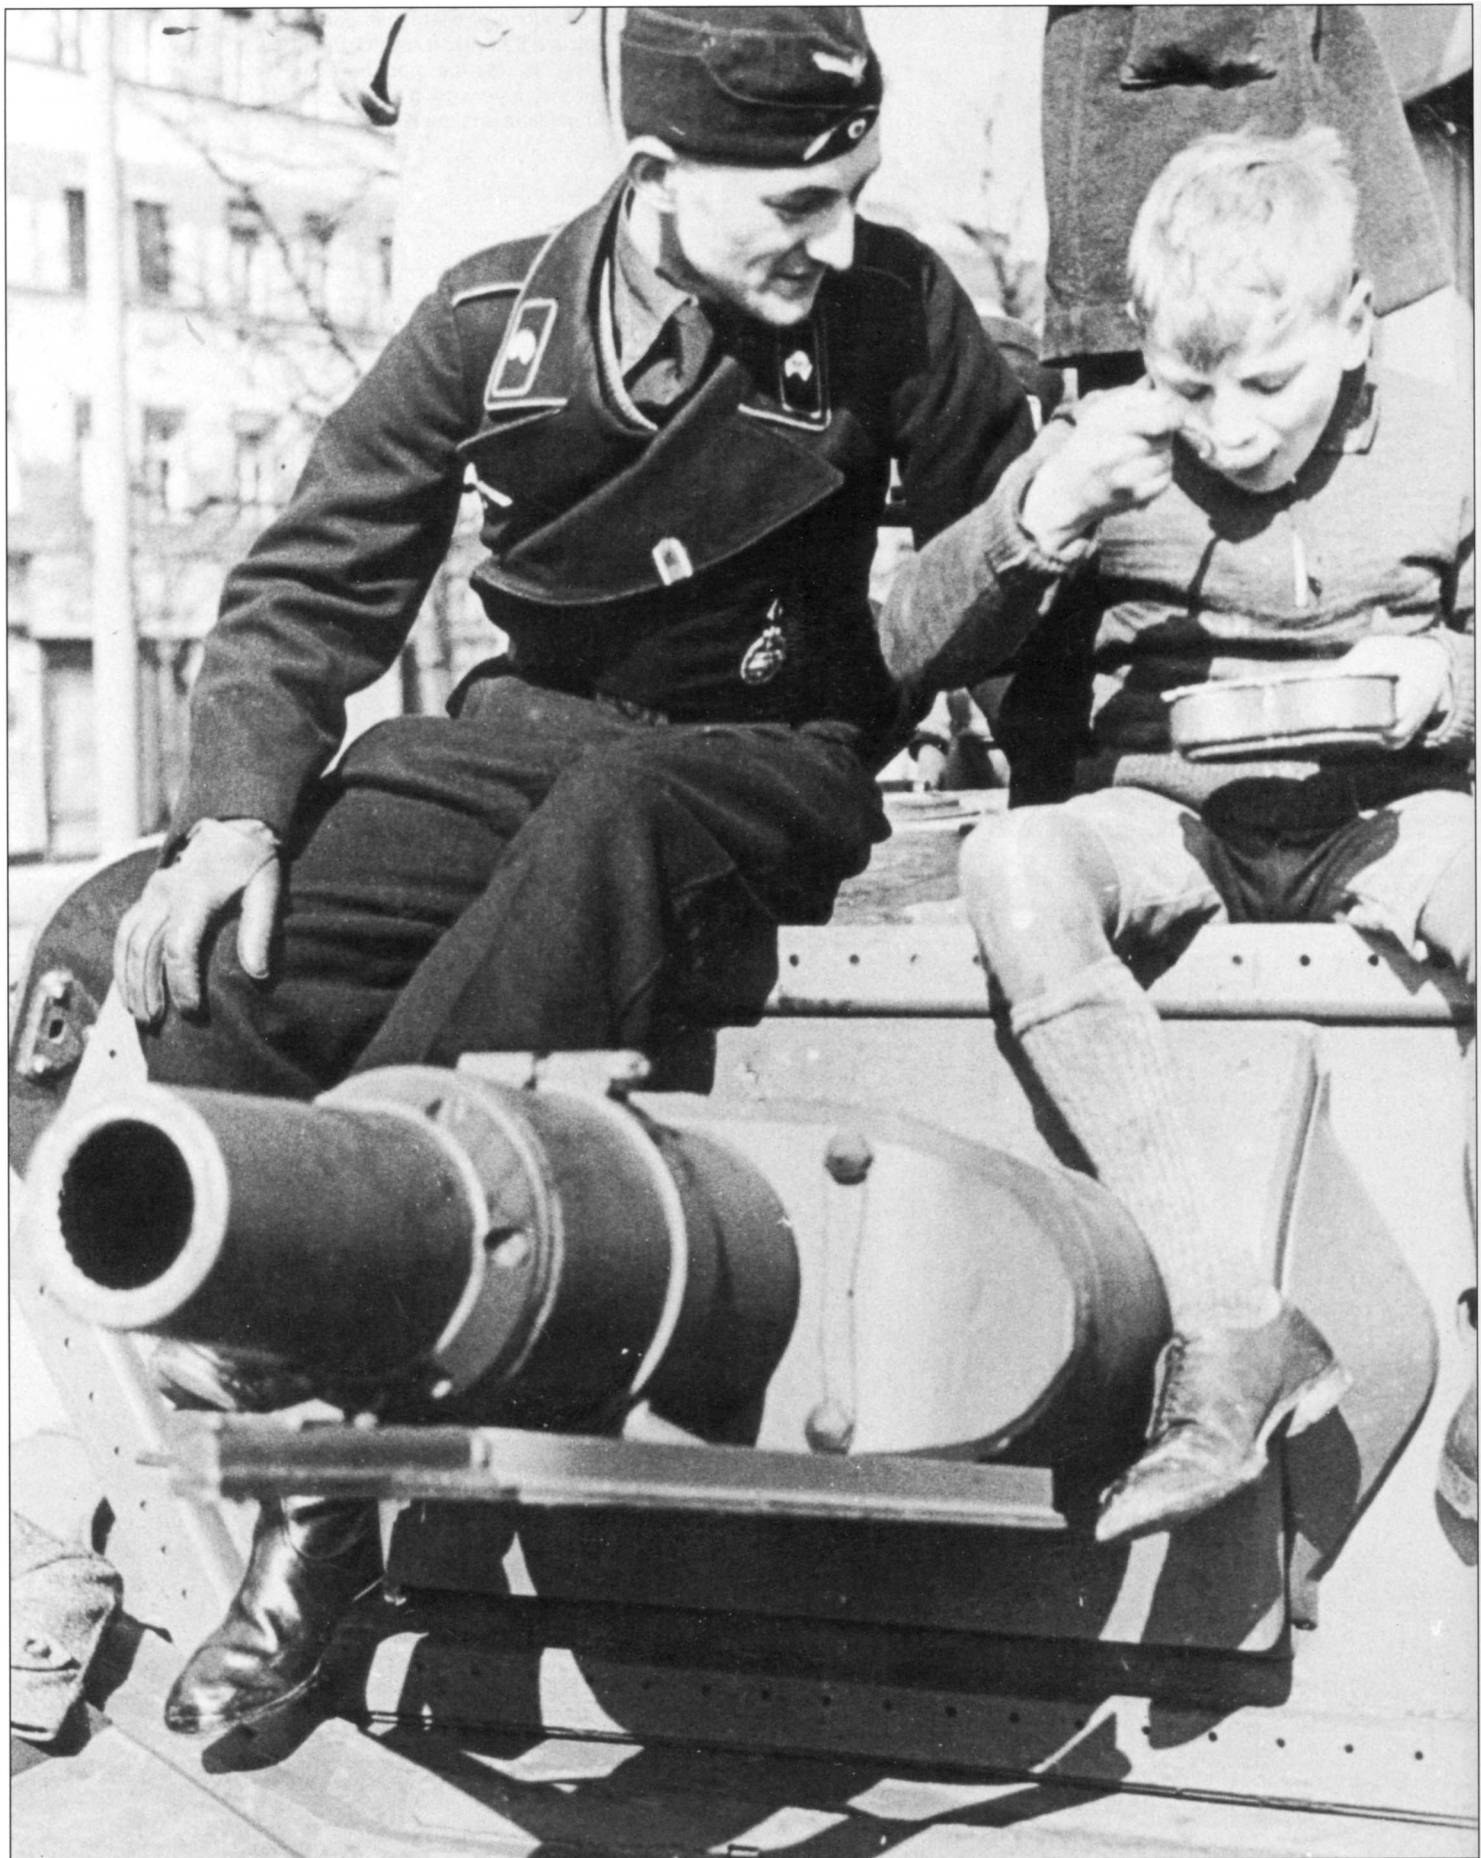
This interesting shot shows a tank trooper sharing rations with a young boy atop a *Tauchpanzer* IV wading tank, which is identifiable by the perforated frame mounted on the turret's front plate. The gun and deflector are clearly visible in this photo. With Operation "Sea Lion" abandoned, the bulk of the *Tauchpanzer*s went to 18. Panzer-Division, which crossed the River Bug underwater on 22nd June 1941. For uniform enthusiasts, this close-up shows an early pattern jacket with piped collar and the black *Feldmütze* sidecap, which was being issued by the time of Operation "Barbarossa".

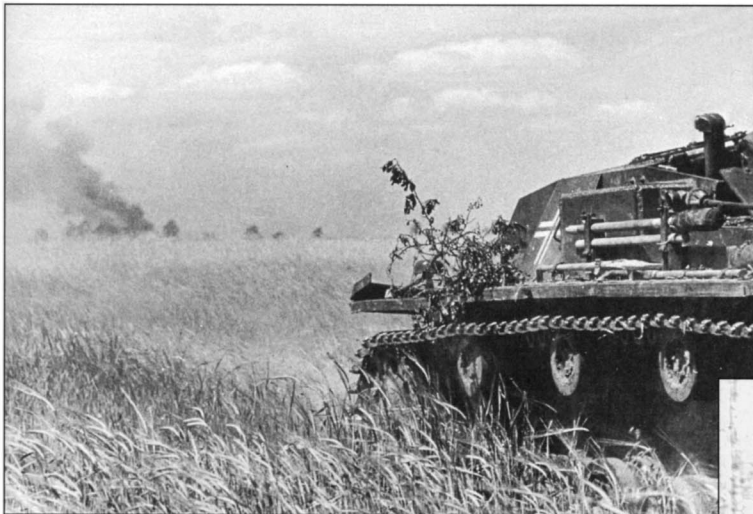
This impressive shot shows another StuG III involved in combat in a corn field. The commander surveys the battlefield using his periscope. His hatches remain open during battle. Note the two-piece gun cleaning kit stored in the rack on side of the hull.

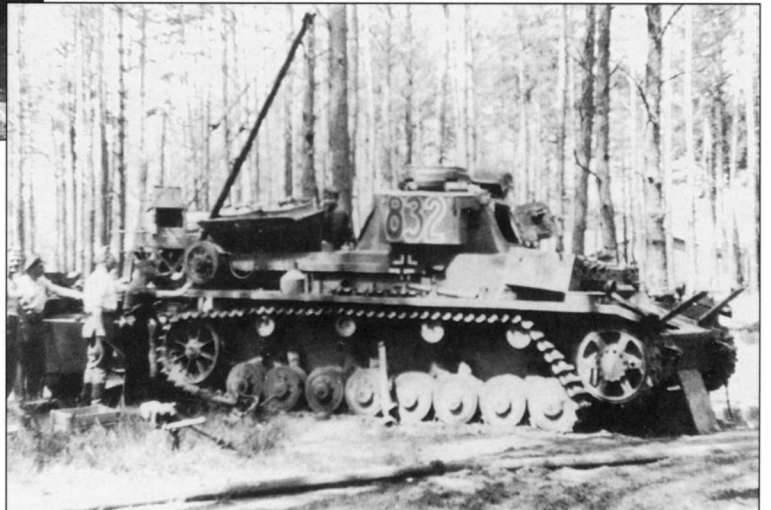
A damaged Pz.Kpfw. IV Ausf. E is being repaired in a forest workshop. Though its drive sprocket is broken, the vehicle was kept in running condition by repositioning the track around the frontal return roller and running wheel. A large crane, possibly mounted on a tank, is removing the engine.

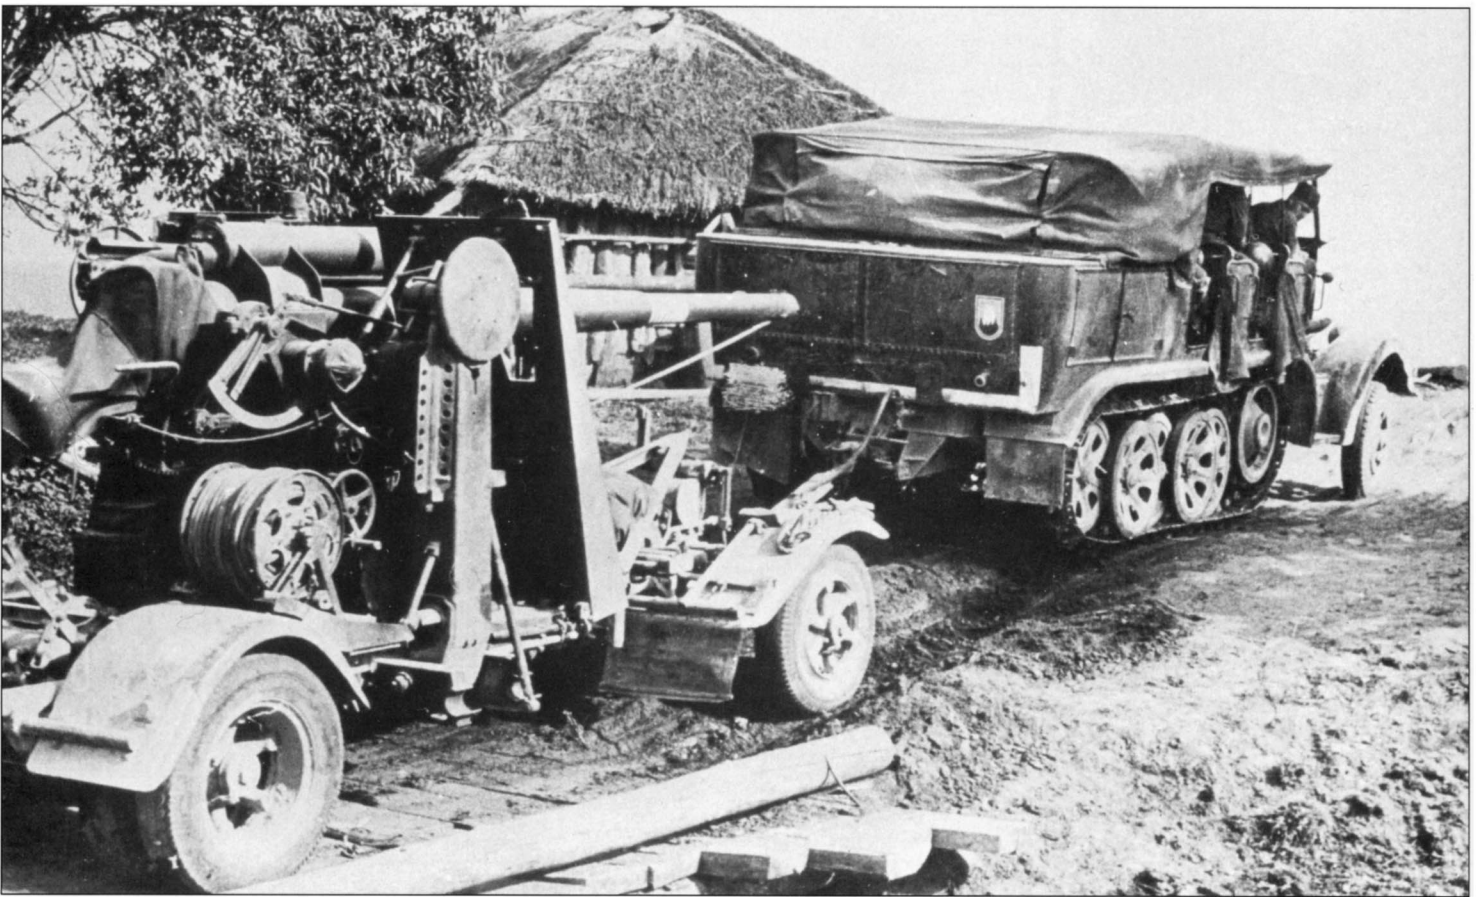
This early Sd.Kfz. 7 8-ton halftrack tows an 8.8cm Flak 18 AA gun to the next battle. Just as in the French campaign, the heavy AA batteries were often the last hope against heavy enemy tanks. Many touch-and-go combat situations were resolved thanks to this versatile and powerful gun.

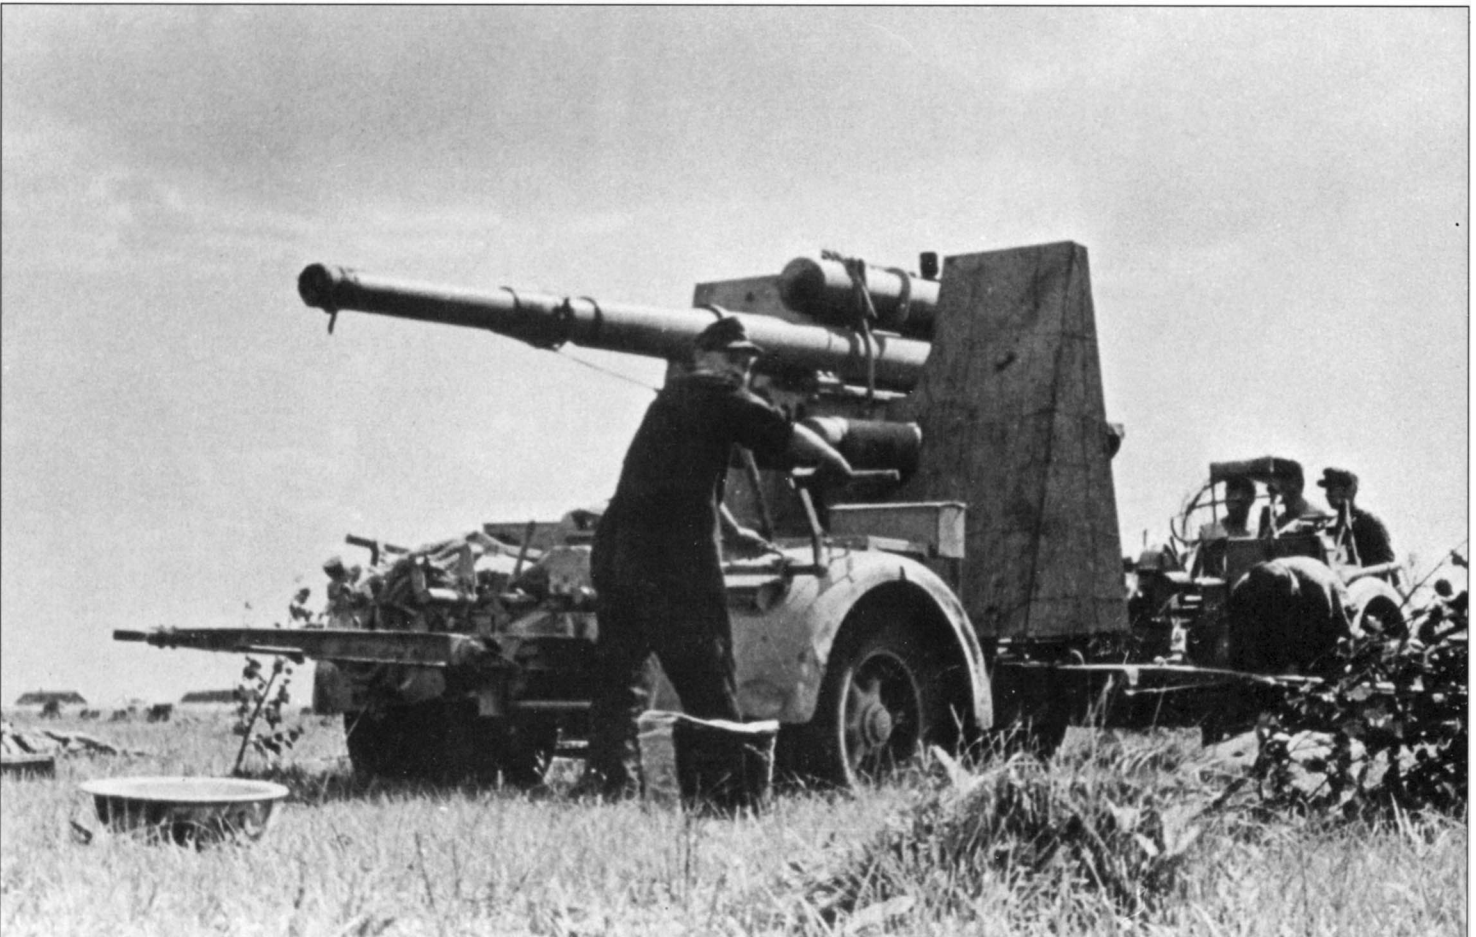
A crew member lowers down the rear support of an 8.8cm Flak 18. The AA guns used in ground combat were often not camouflaged since they could rely on their long-range antitank capability for protection. Further, sometimes the course of a battle did not allow this luxury.

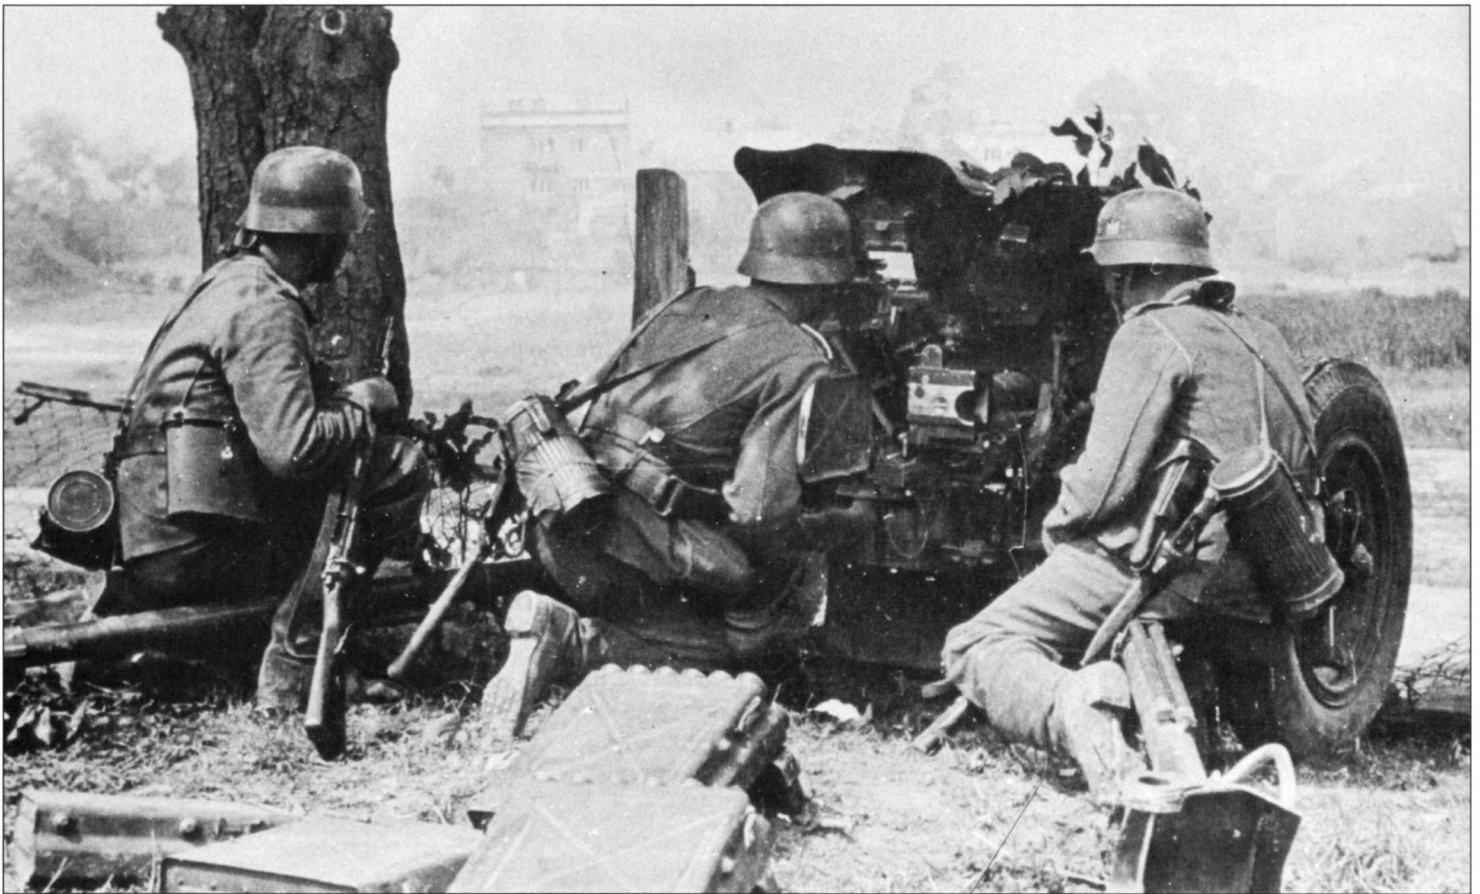
The 3.7cm Pak 35/36 was a good gun — by 1934 standards. However, by the time of the campaign in the West, it had already shown that its armor penetration was too weak. Hopelessly outclassed and ineffective in the East, the 3.7cm gun was nicknamed *Heeresanklopfergerät* — door knocker— by the German troops.

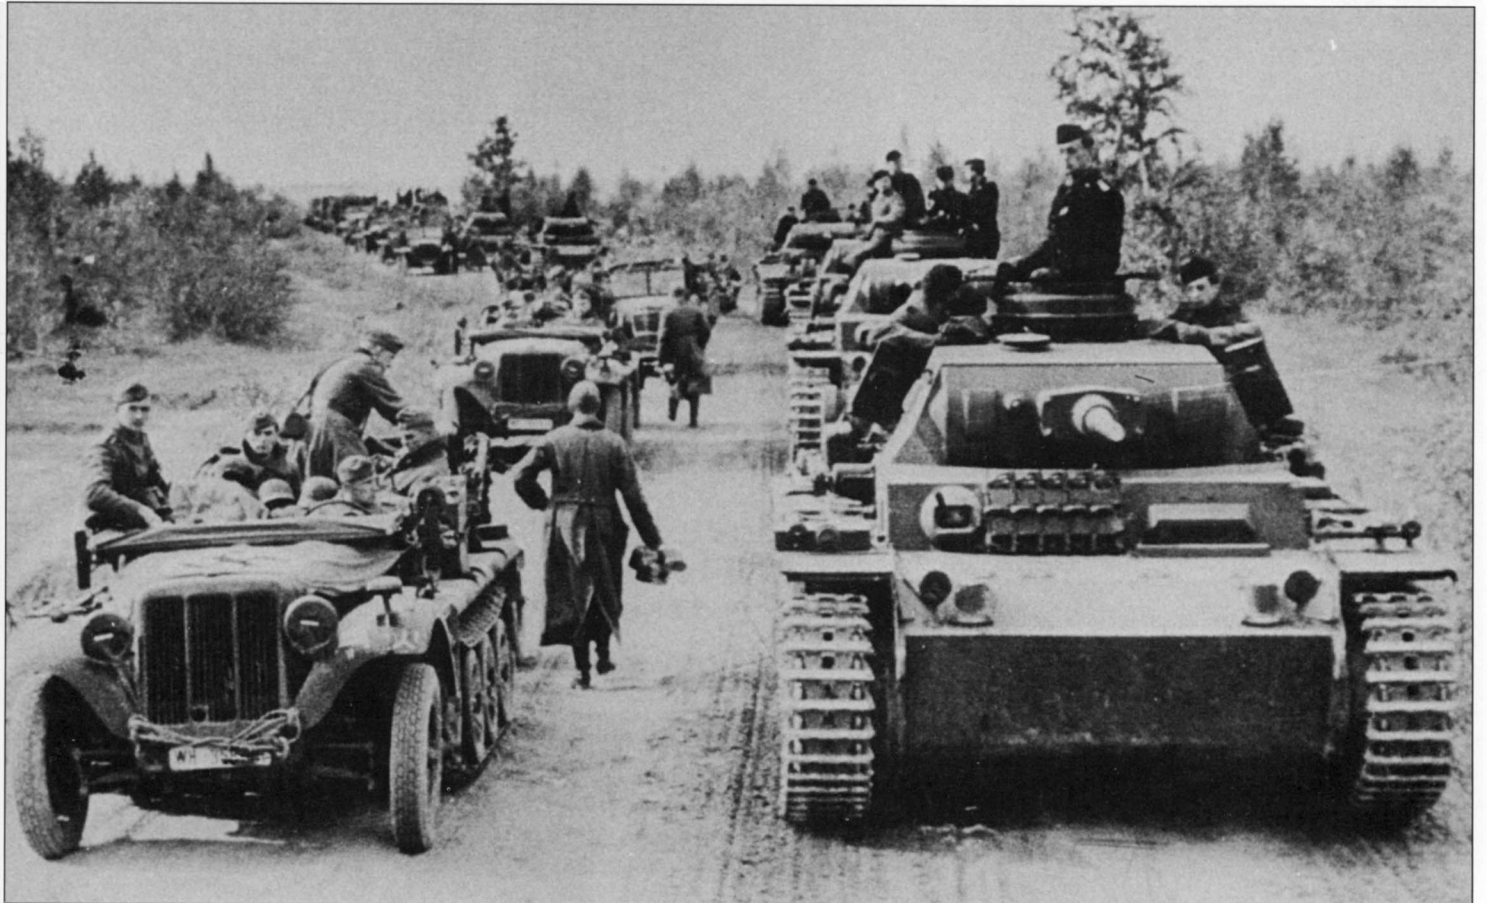
A mixed column of tanks and halftracks advances up a road. The Pz.Kpfw. III in the foreground is from an early Ausf. J production lot, as is evident by the ball-mounted MG 34 in the front of the hull. The Ausf. J featured many improvements, such as thicker armor on the superstructure, that were made based on combat experience.

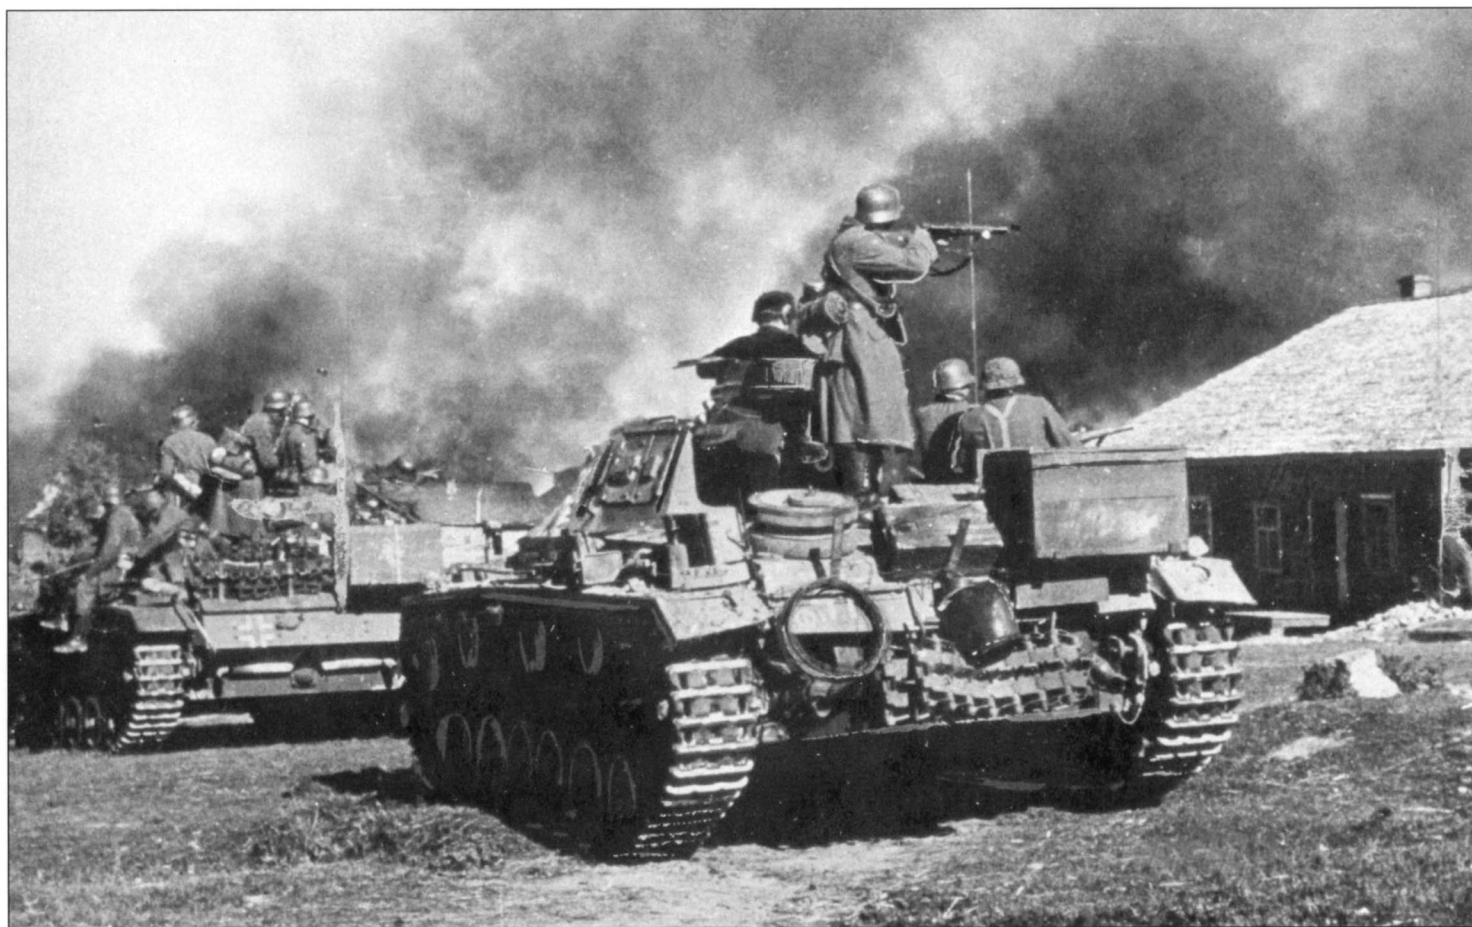
Photographed while entering a village, these Pz.Kpfw. IIIs of 11.Panzer-Division each carry a squad of infantrymen. Although it was dangerous for the troops to ride this way since tanks attract enemy fire, this tactic was essential for close combat defense of the tank. They were often threatened by antitank teams, particularly in areas where there were a lot of buildings.

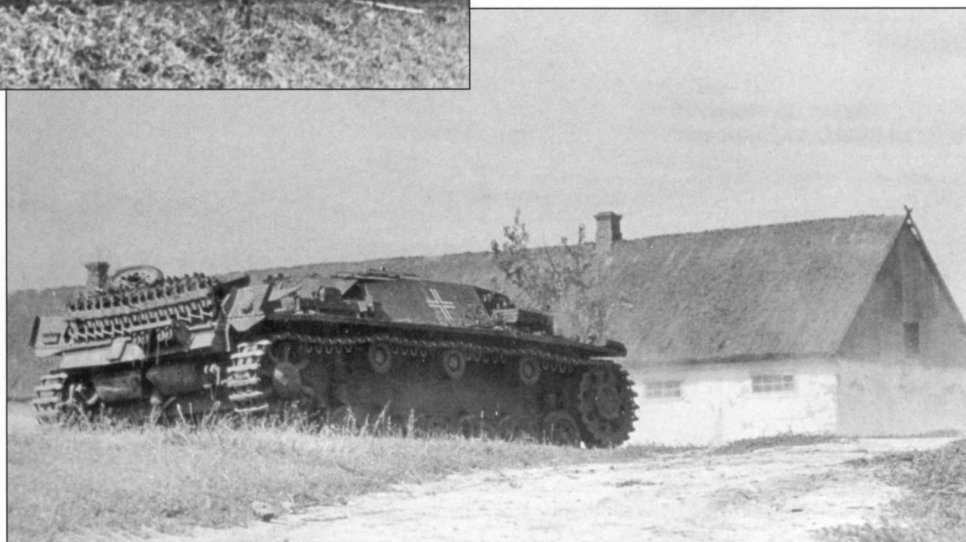
A StuG III Ausf. B slowly approaches a farmhouse. In general, the assault guns were well-suited for surprise attacks, aided by thick armor and a low silhouette. Concealed antitank teams, however, had to be fought by accompanying infantry. Thus, maximum cooperation was essential. Note the early-style smoke candle rack.

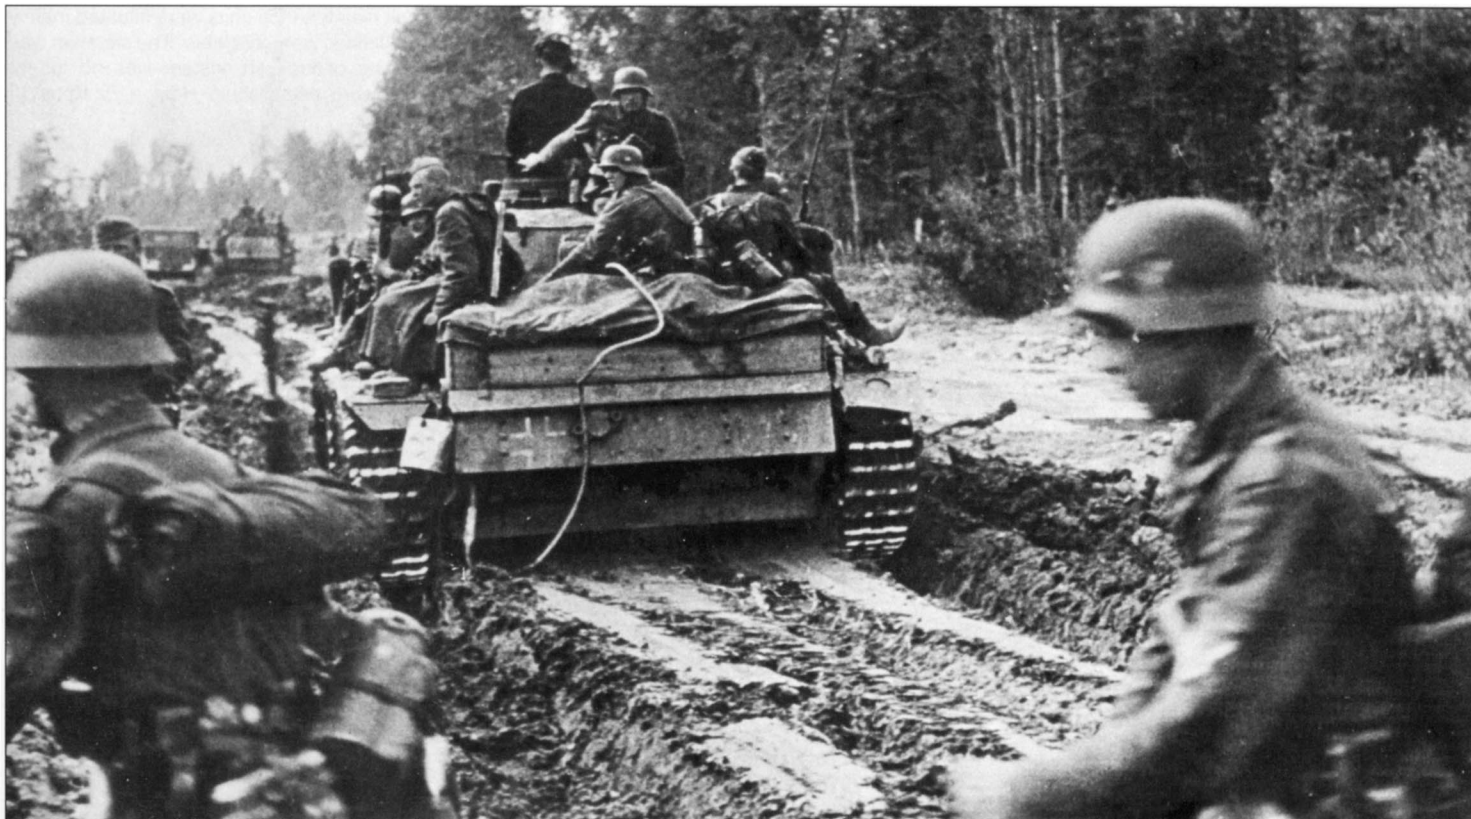
A tank convoy forces its way through deep mud somewhere in Russia. The Pz.Kpfw. III at center, probably an Ausf. J, has its towing cables fitted on the loops and ready for action. All too often the tanks had to stop to recover less maneuverable trucks.
