PANZERWAFFE AT WAR

(1) NUREMBERG TO MOSCOW

Robert Michulec & Thomas Anderson

ARMOR AT WAR SERIES

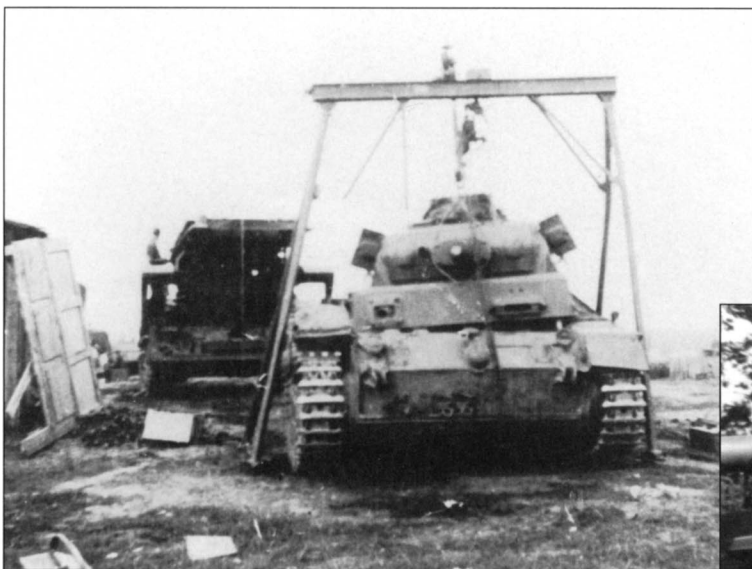
Up until 1941, German tank maintenance units were situated mainly in towns or cities, where large buildings were available. The situation was different in Russia, however. The centralized system was no longer practical, so mobile workshops were established. Here a Pz.Kpfw. III Ausf. G is about to undergo repairs.

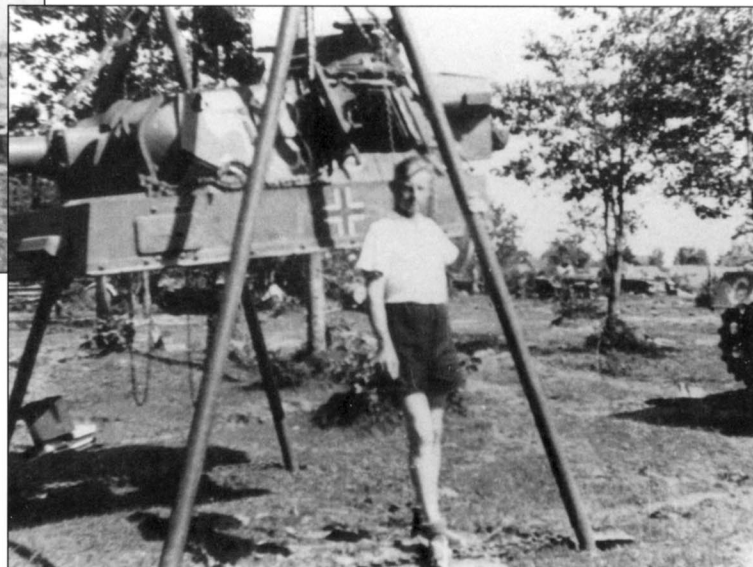
This photo, which was taken at a mobile field workshop, shows the complete hull and turret of a Pz.Kpfw. III Ausf. G that were removed using a portable jib. Now that entry to the hull was provided, almost any repair could be made without problems. It is interesting to compare the national insignia on this hull (with its black interior) with the solid white crosses painted on the tanks in the Polish campaign.

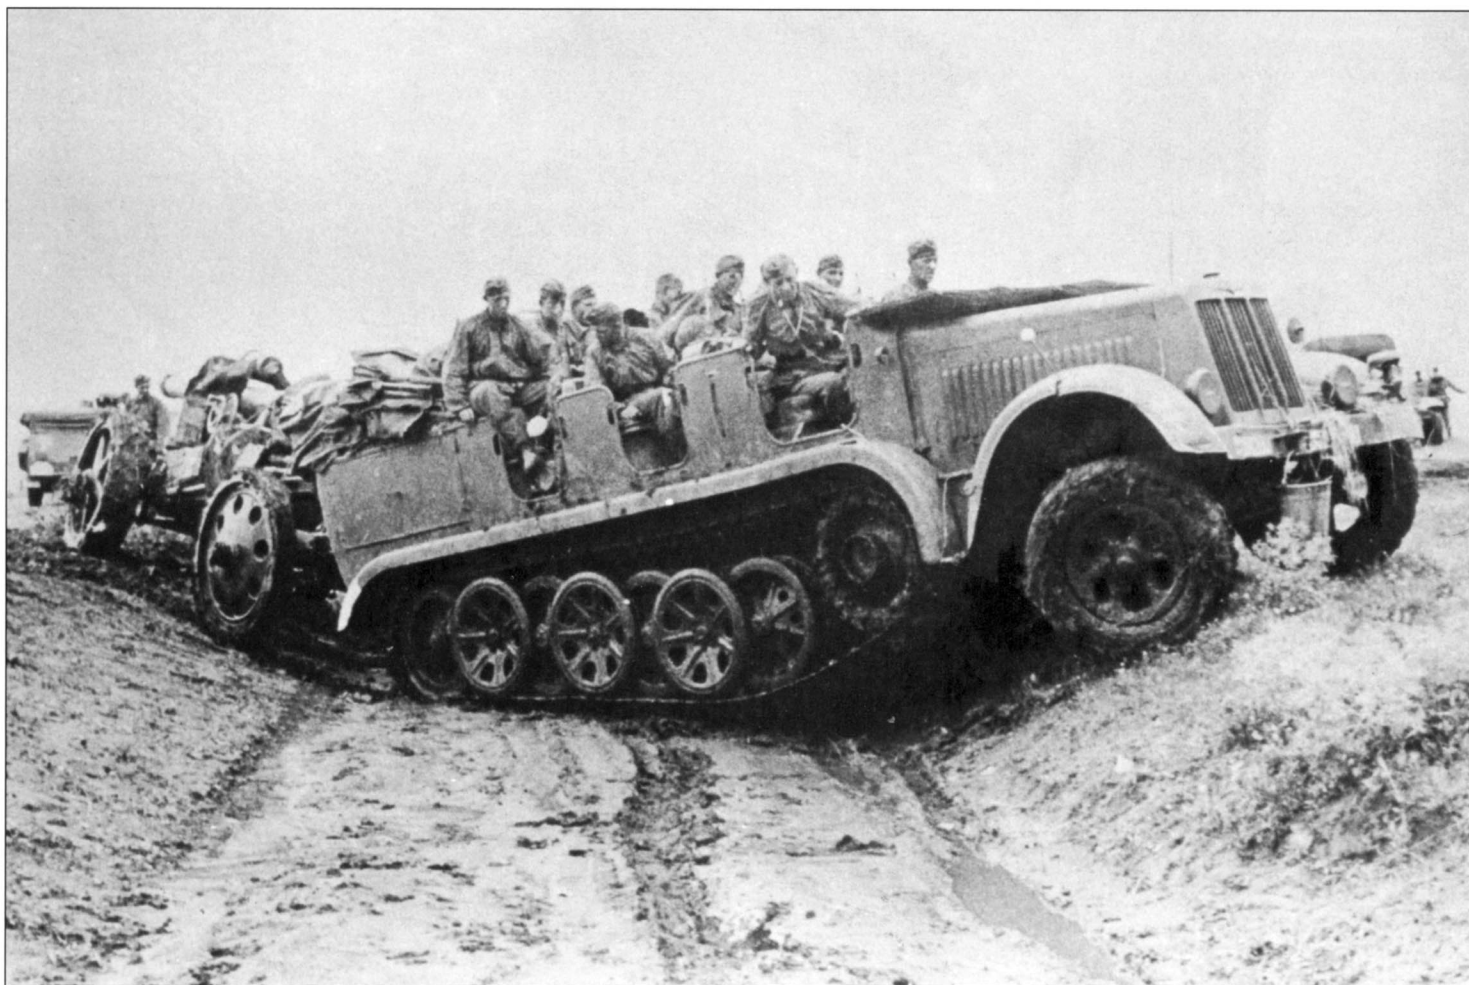
A medium artillery tractor, a Sd.Kfz. 7 8-ton halftrack, tows a 15cm sFH 18 gun across a ditch. The halftracks proved to be excellent prime movers — reliable off the roads and fast on the roads. However, the engineering involved in their production was too complicated and expensive for the war of attrition being carried out in the East.

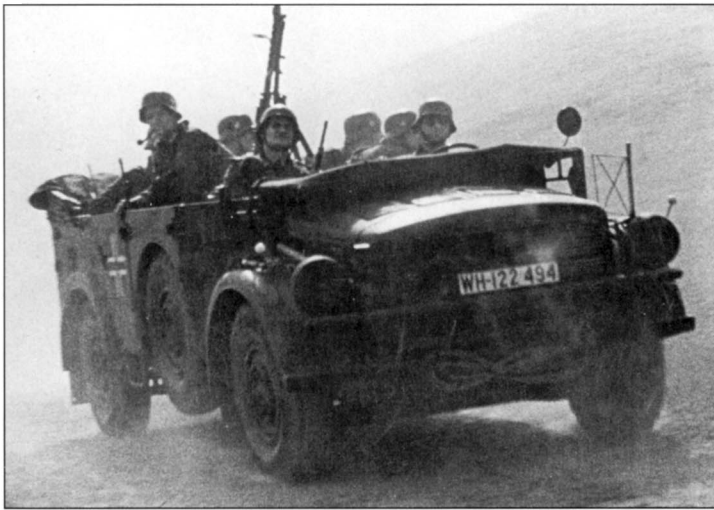
A Kfz. 69 "Horch" kicks up a cloud of dust as it travels at high speed over some barren Russian countryside. The heavy passenger car is manned by seven soldiers. Of interest is the anti-aircraft MG34 fitted in the center of the car and the prominent German cross on the vehicle's side. Note also the *Wehrmacht Heere*—Wehrmacht Army—license plate prefix.

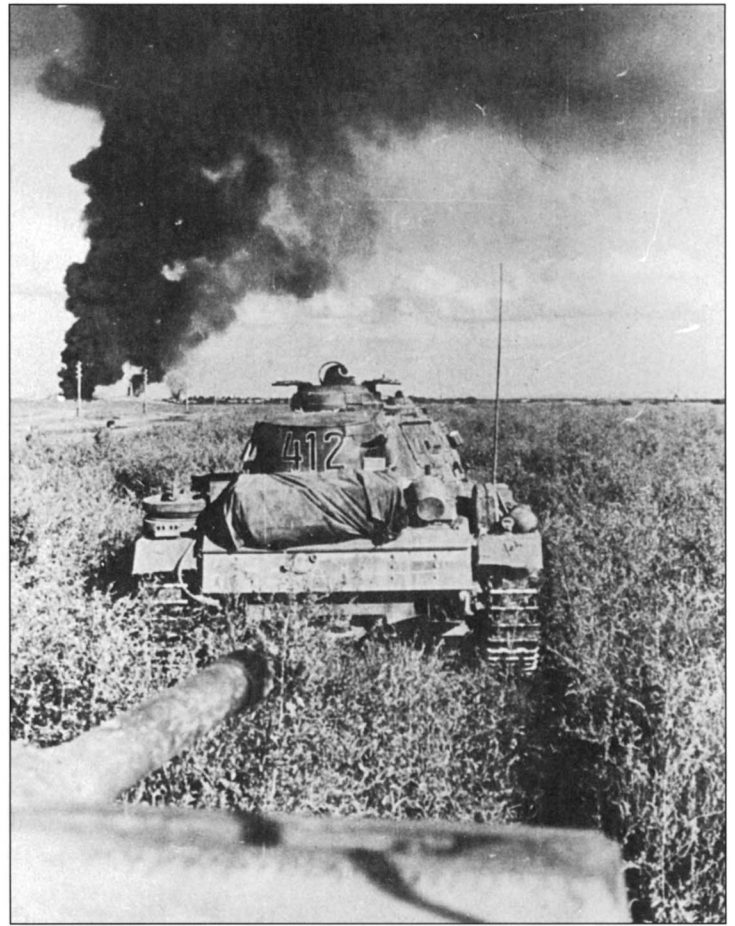
The Pz.Kpfw. III had to carry the burden of armored warfare in Russia in 1941/42. Basically, it was a well-balanced tank. But with appearance of the superior T-34 and KV, it quickly became obsolete. In this photo, an Ausf. J moves slowly up to the MLR while the commander carefully watches the horizon through his open hatch. The large turret number, "412", indicates that this is the second tank of the first platoon of the fourth company of whatever regiment it belongs to.

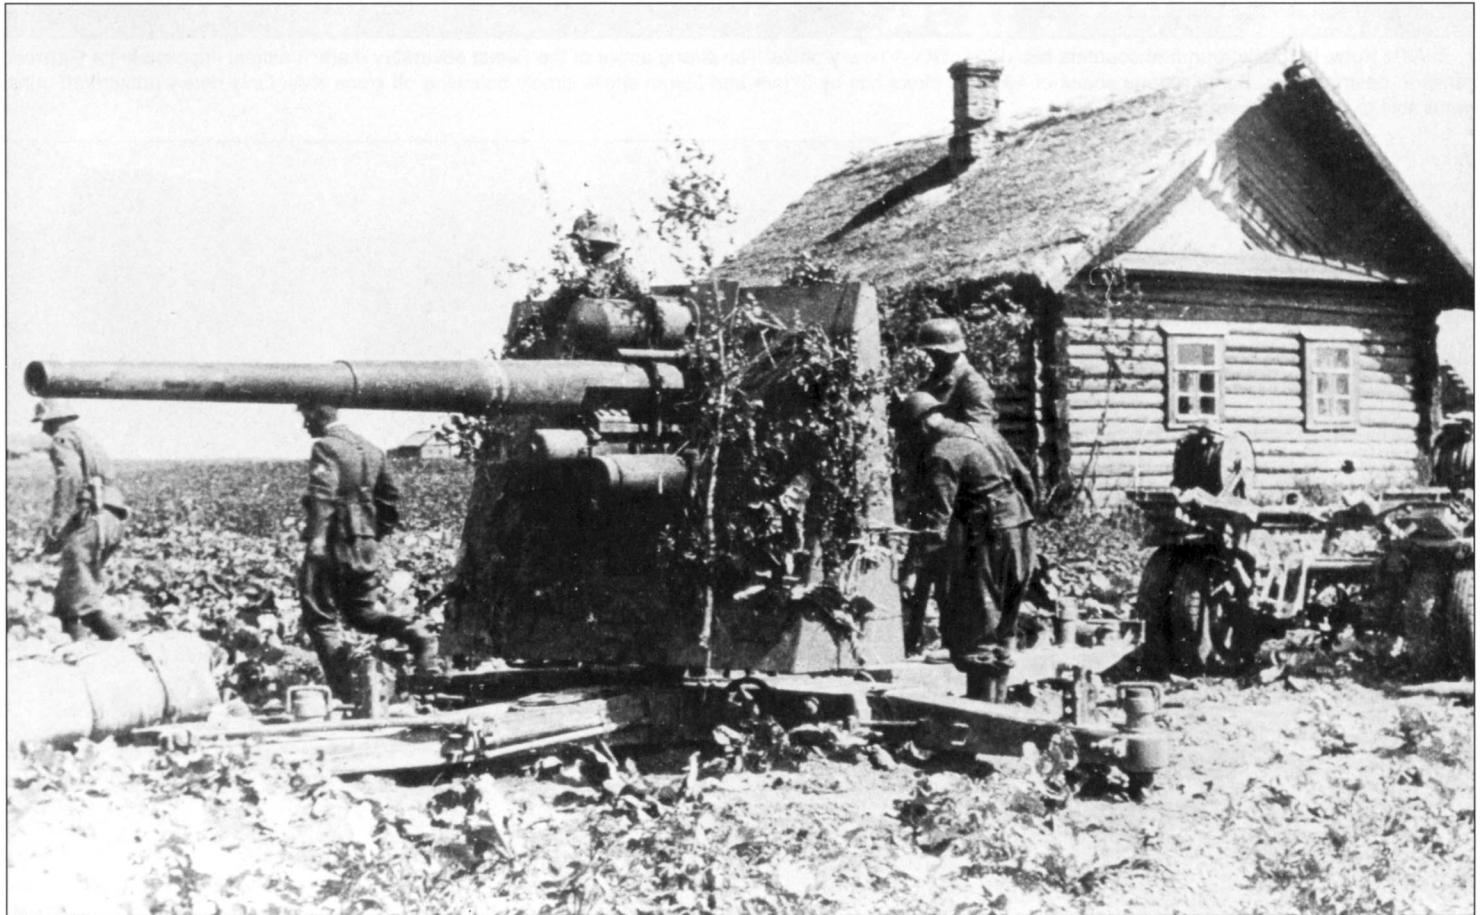
This photograph provides an excellent view of an 8.8cm Flak 18 gun in position and ready to go into action. The "88" was able to destroy any Soviet vehicle at ranges far beyond 2,000m (2,200 yards). Thus, it quickly became legendary among the German soldiers — and no doubt among the Russians, as well.

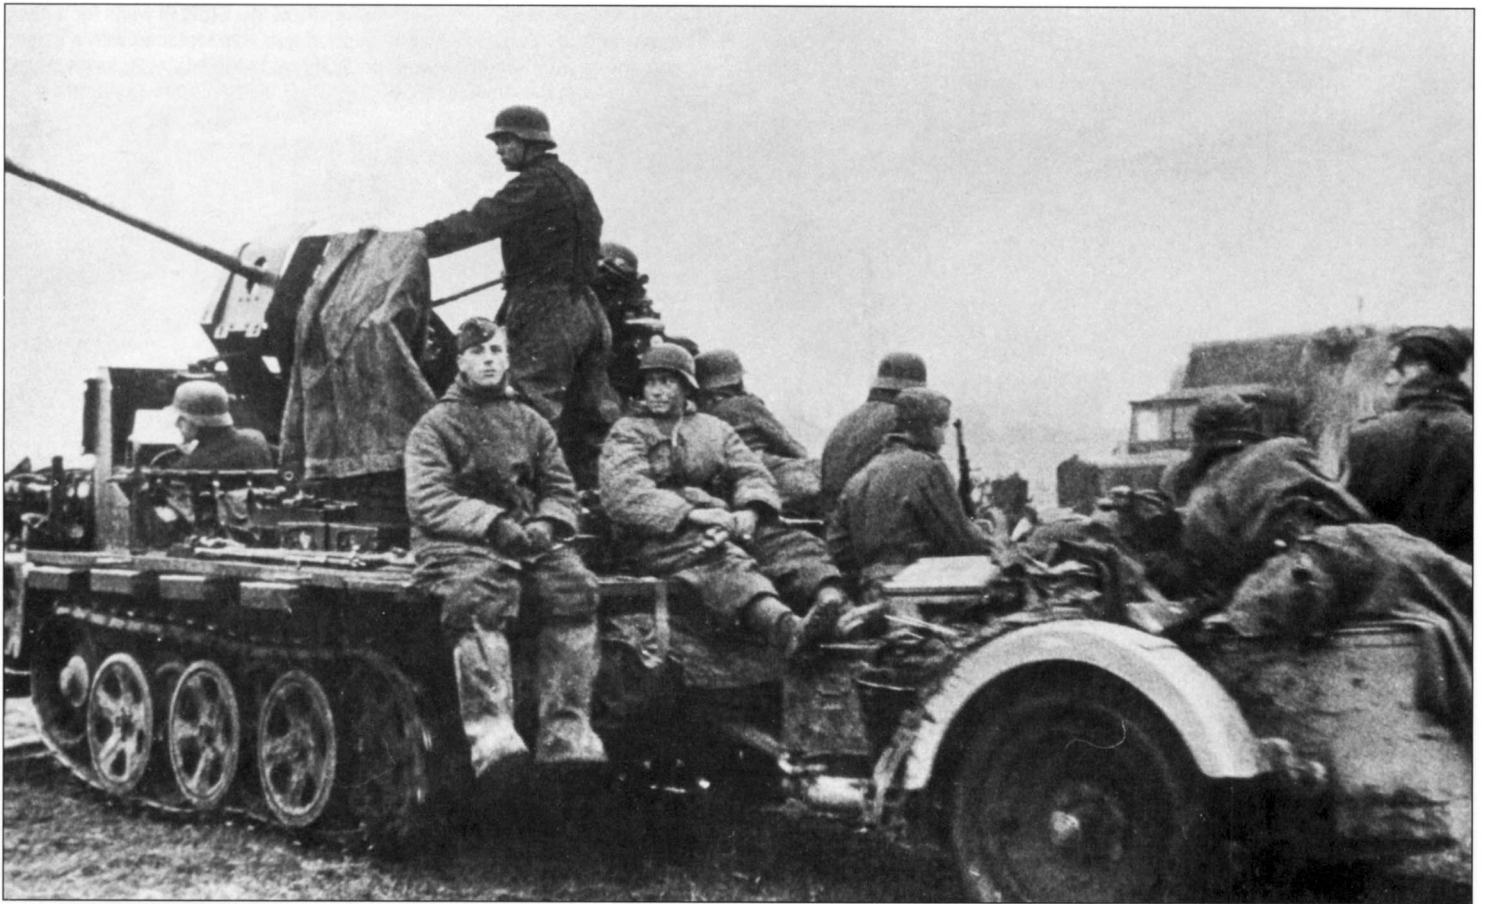
This Sd.Kfz. 10/4 shows a partly armored driver's cabin. These versatile vehicles were often used near the MLR for direct fire support for infantry units, a task they were not intended for. The inadequate armor protection resulted in heavy losses. Note the heavy winter clothing worn by the soldiers.

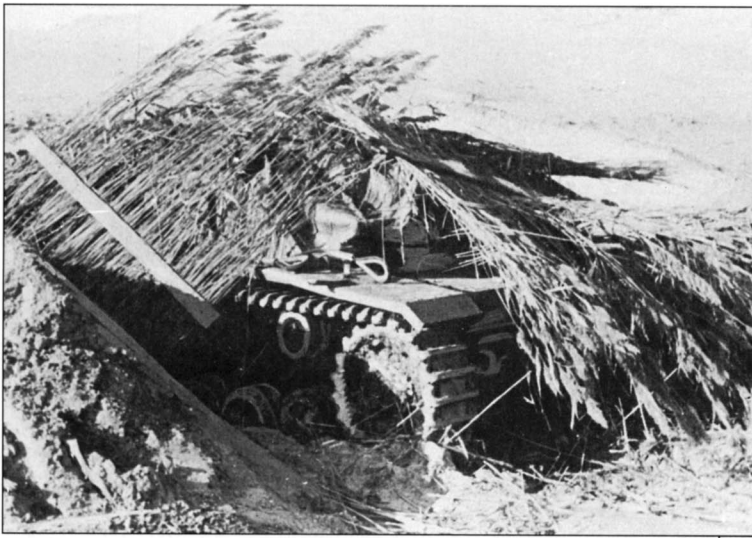
Perfectly concealed under some straw, this StuG III waits for action. After the StuG's smaller infantry support gun was replaced with a longer gun, the assault vehicle was a deadly threat to the heavy Russian tanks. Judging from the drive sprocket, this StuG III is an Ausf. B model.

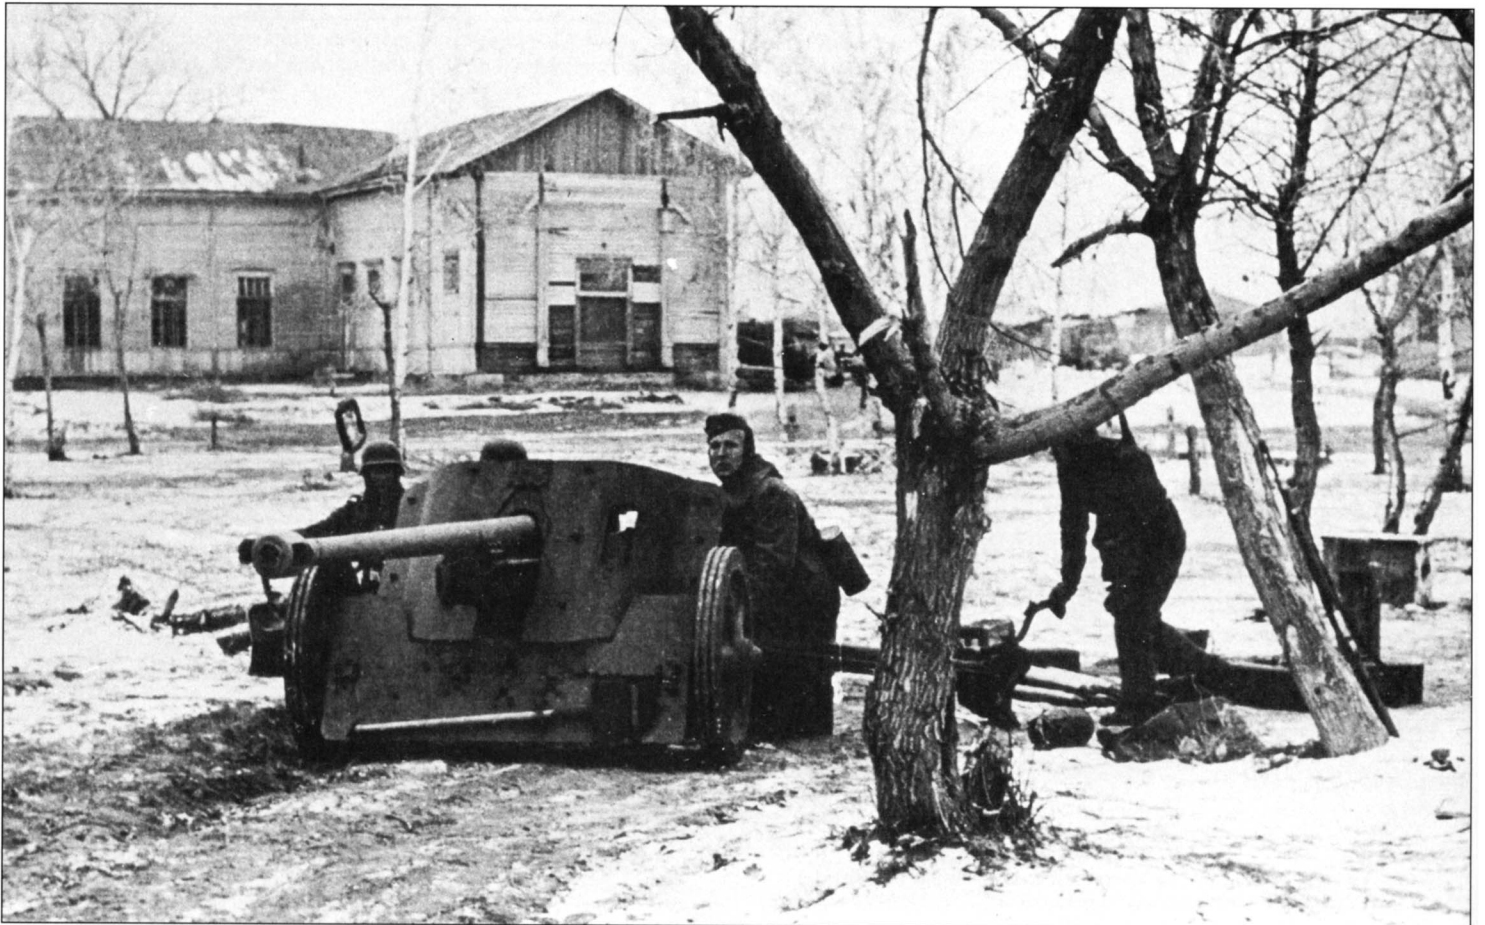
In 1941 the antitank units equipped with the rare 5cm Pak 38 were fortunate indeed. Although it boasted a sophisticated design, its caliber proved to be too small to deal with modern Soviet armor. However, at ranges below 500m (550 yards), the gun could be quite effective.

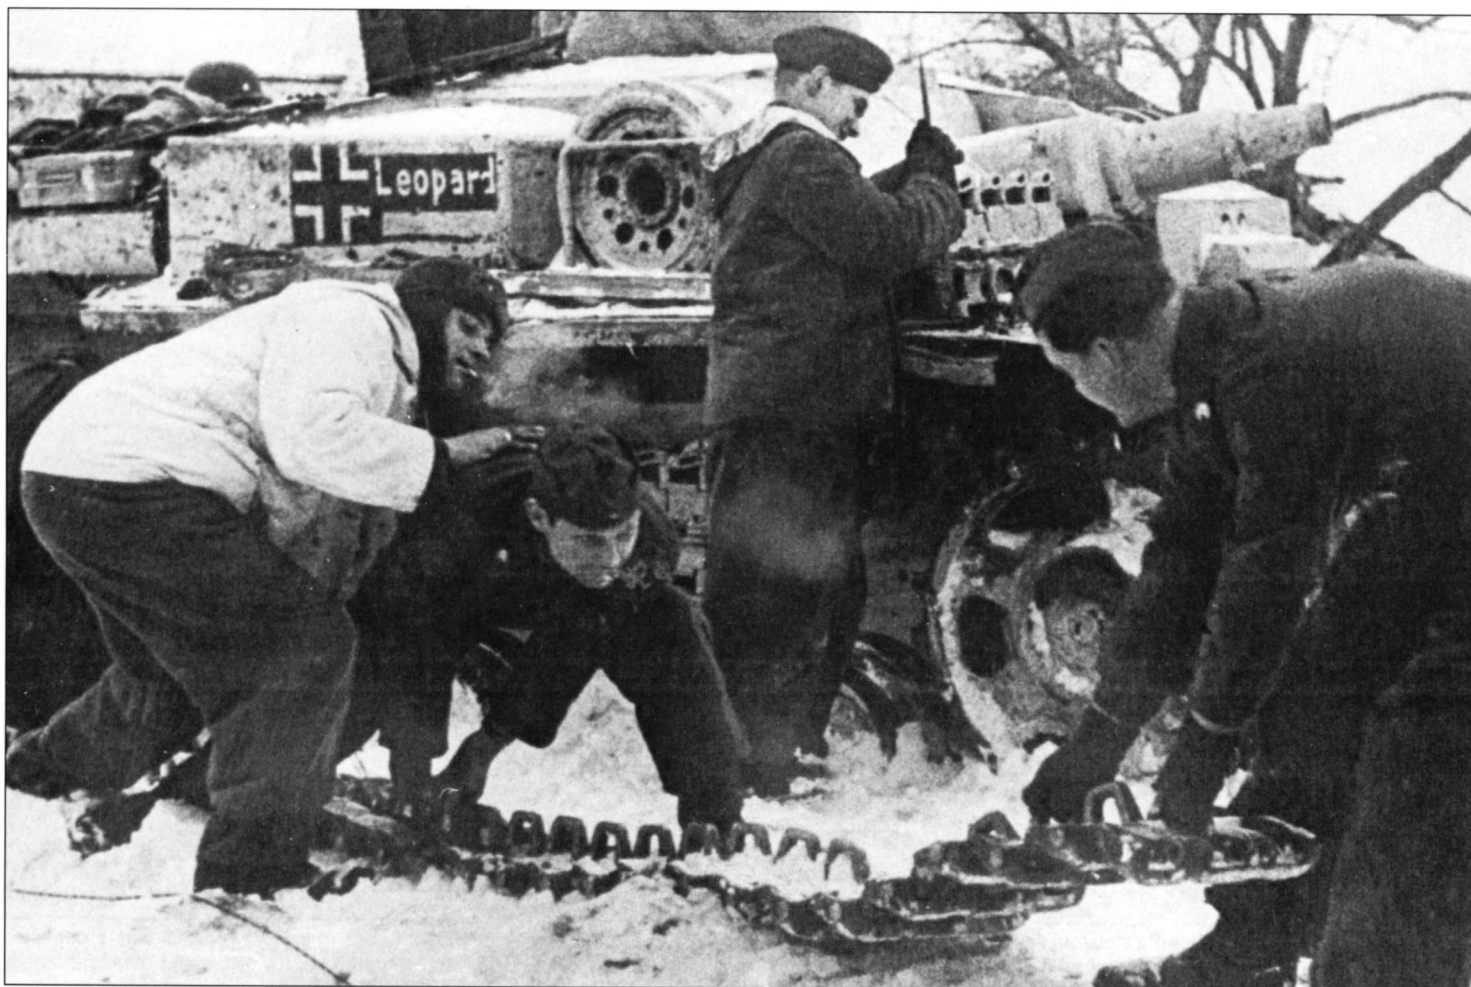
Here the crew of a whitewashed StuG III Ausf. E changes the track, possibly because of damage inflicted by a mine. Note that the vehicle was given the name "Leopard", a practice that was common among assault gun units. The vehicle is loaded with a lot of personal gear and spare parts.

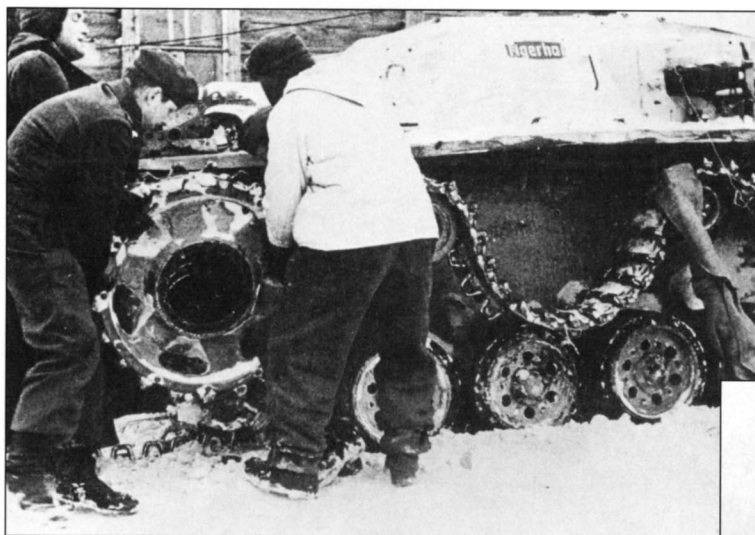
Another assault gun of the same unit undergoes the same track replacement procedure. This vehicle, an Ausf. C or D, was named "Tigerhai" (Tigershark). Note how the whitewash covers the original paint on every part of the vehicle, but leaves the name visible.

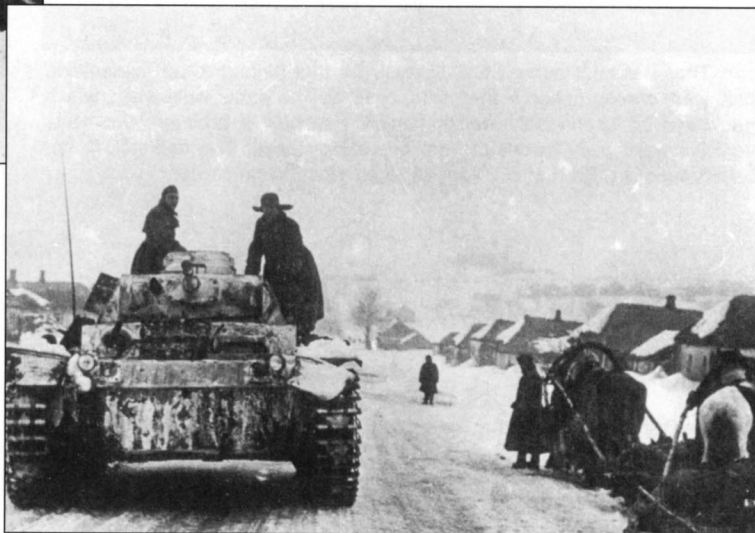
This whitewashed Pz.Kpfw. III Ausf. J encounters Russian peasants escaping from the front line. Although it was planned that the Ausf. J would be equipped with the 5cm L/60 gun, production delays prevented this from happening. So, the first production batches left the factories with the less powerful 5cm L/42 gun. This tank sports a rather scruffy winter camouflage.

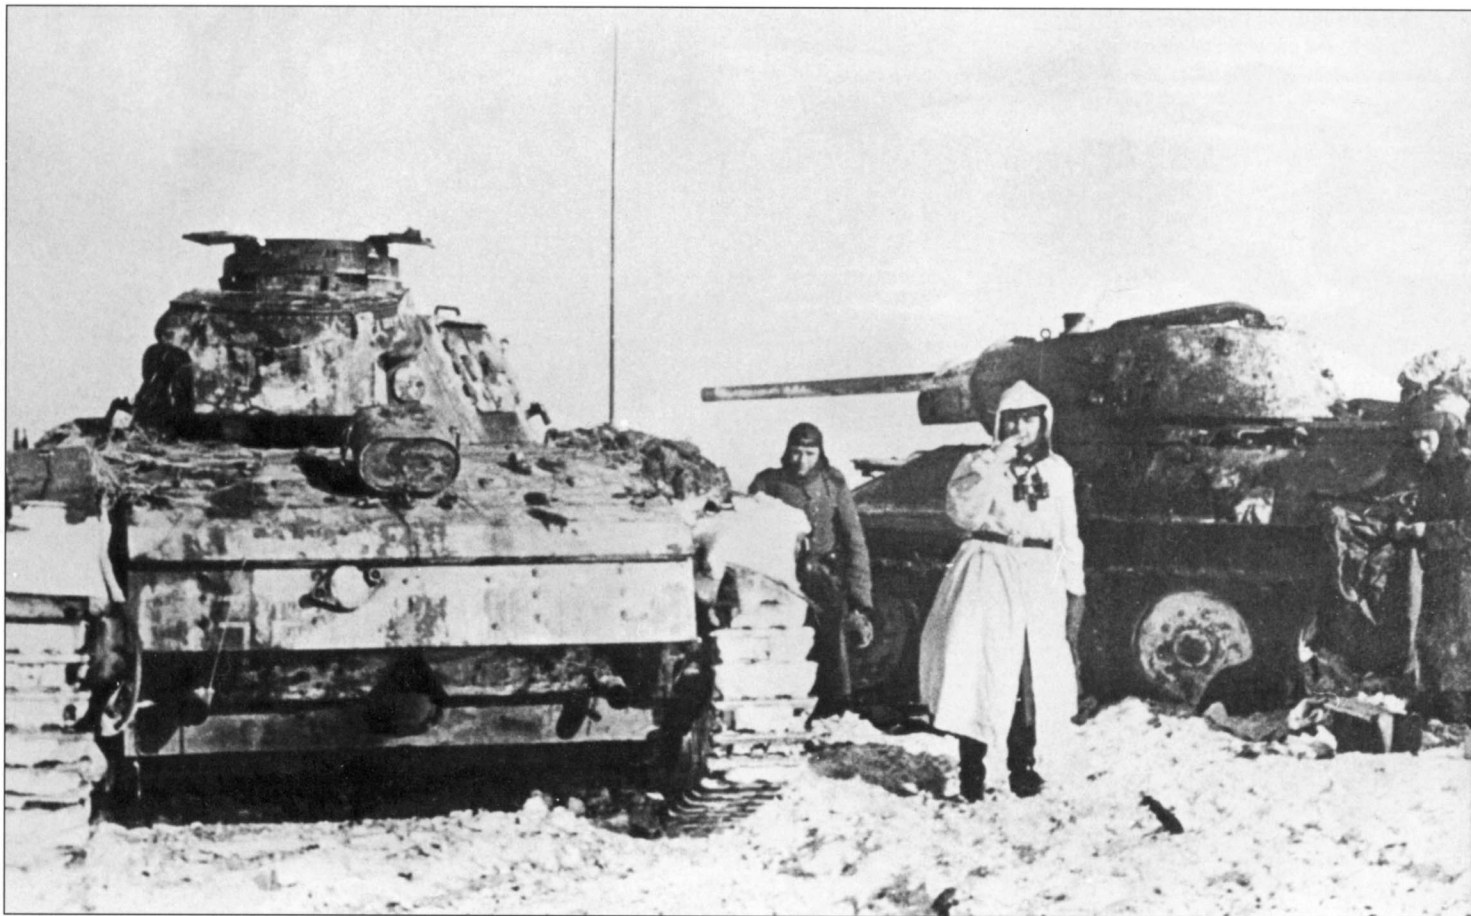
The victorious crew of this Pz.Kpfw. III Ausf. J takes a closer look at the T-34 Model 1941 they destroyed. Looting enemy vehicles was a common practice since the supply of clothes and food was never sufficient. The German tank commander shown here wears an improvised winter overcoat that is typical for the first winter.

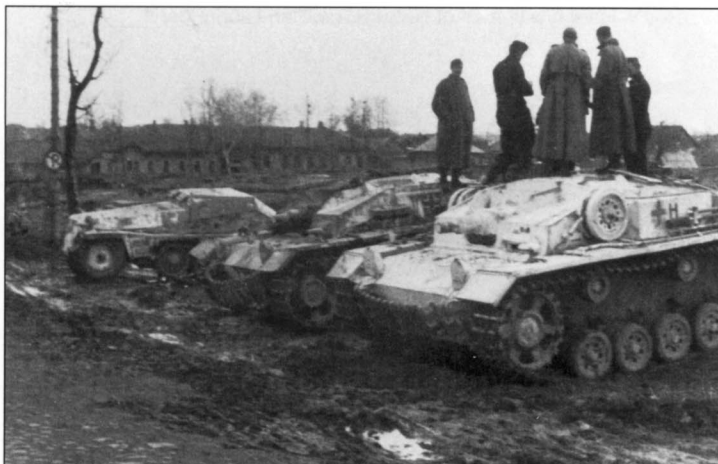
These assault guns, StuG III Ausf. Es that belong to an unidentified unit, were photographed in the spring of 1942. The winter whitewash, which had been so useful only weeks earlier, was now a problem; the white vehicles were easy to detect from a great distance. The halftrack in the background is a Sd.Kfz. 252 light armored ammunition carrier.
