# PANZERWAFFE AT WAR

## (2) MOSCOW TO BERLIN

Robert Michulec & Thomas Anderson

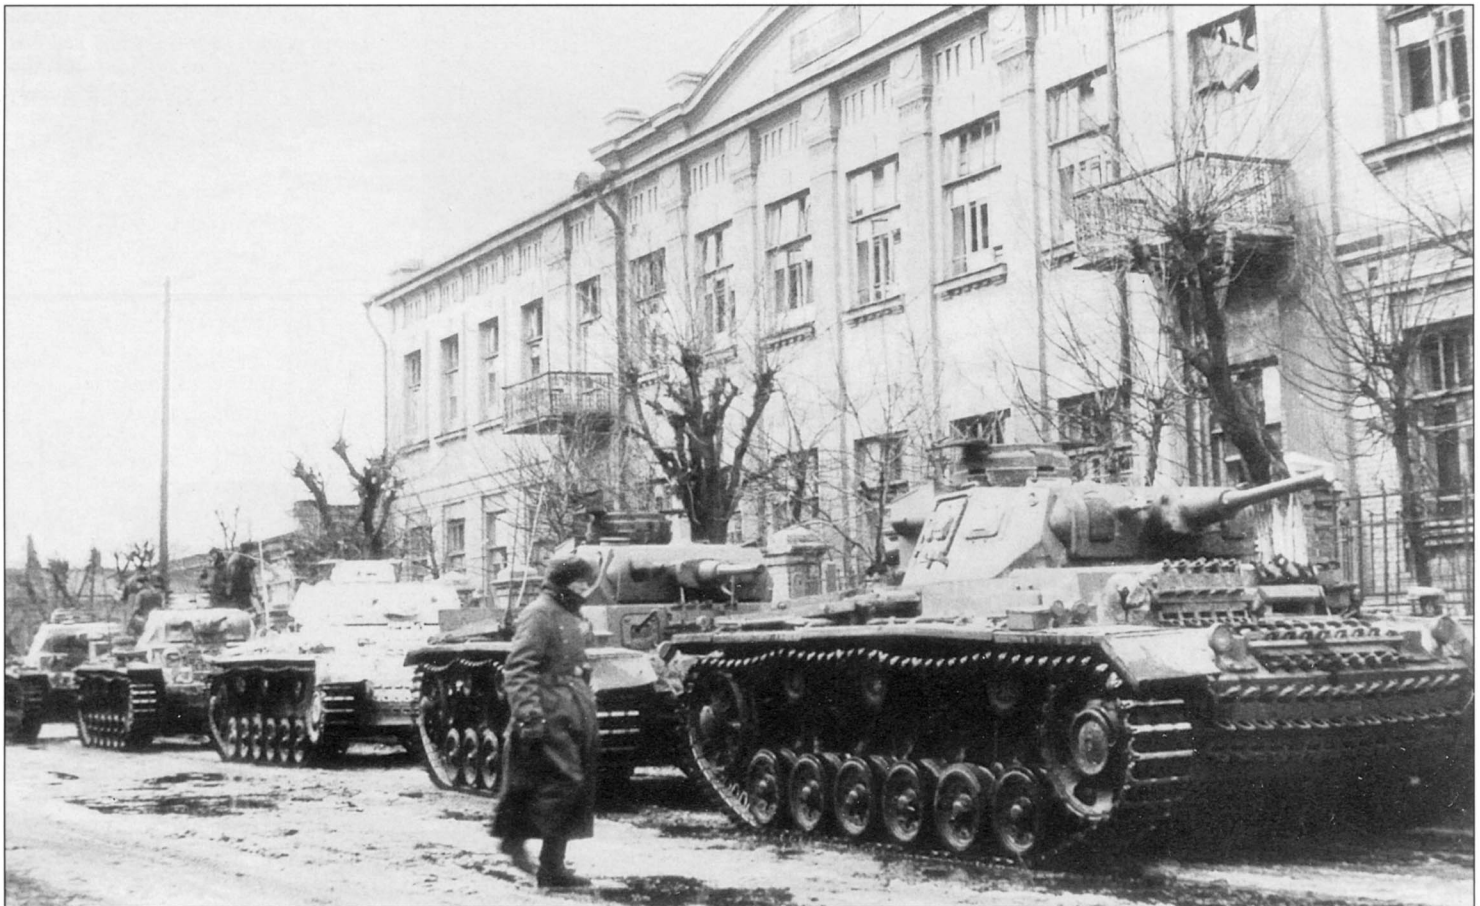
A number of Pz.Kpfw. IIIs of different production lots gather in a Soviet town. The third vehicle appears to be brand-new since the camouflage on all the others has worn off. Though upgunned with the L/42 gun prior to "Barbarossa", these tanks became obsolete on the battlefields of 1942.

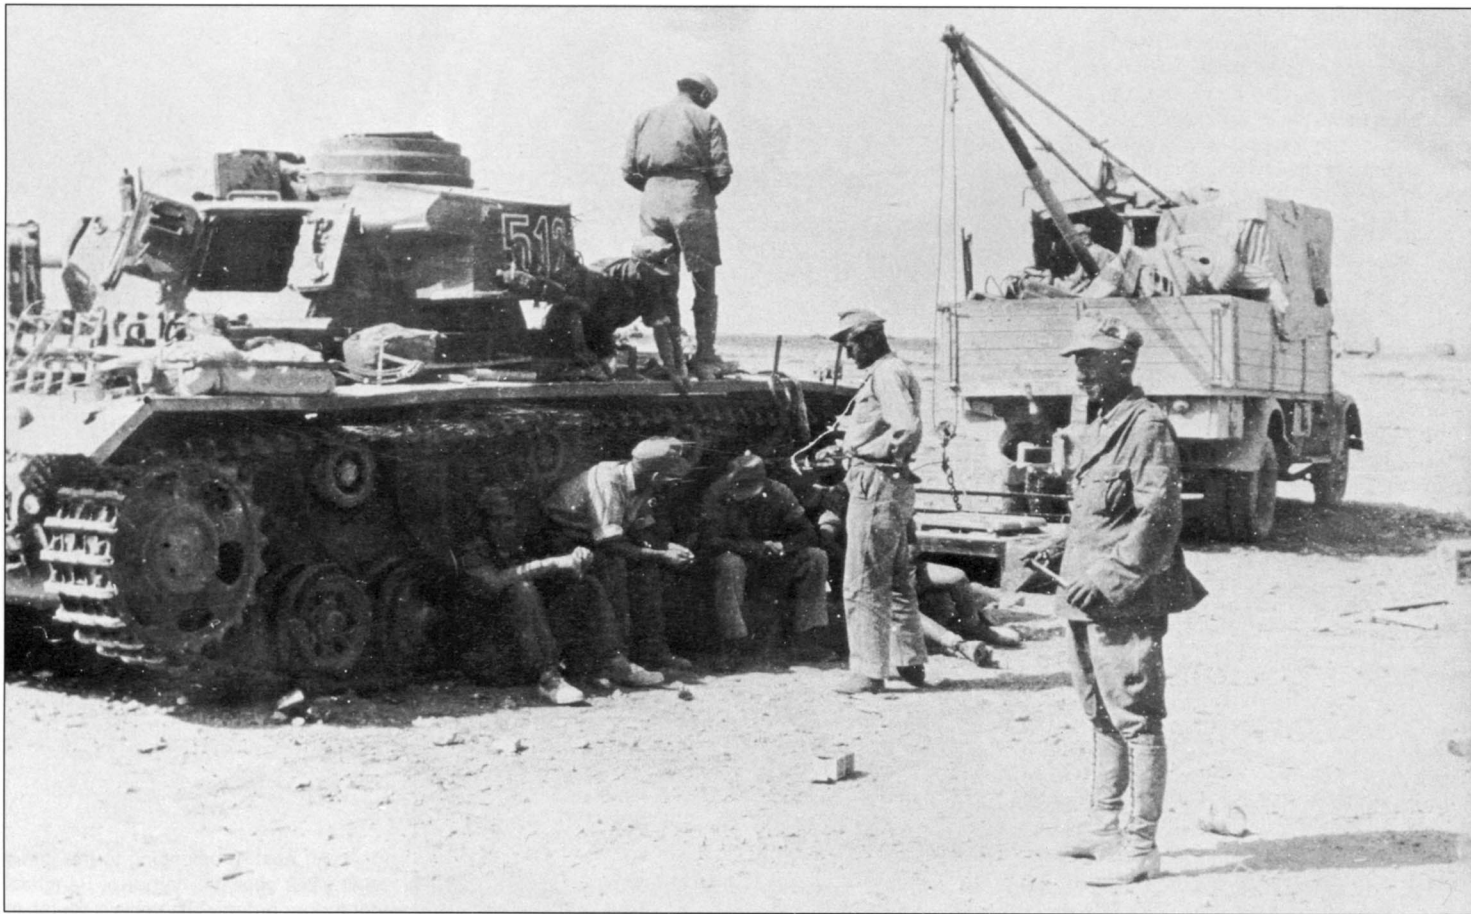
In this photo a 3-ton truck, which has been converted to a workshop, is employed to remove the engine cover of a damaged Pz.Kpfw. III Ausf. J. Apparently, the engine broke down, which was quite a frequent problem in the heat of North Africa. Note how the tank crew members escape the sun by sitting in the shade created by their vehicle.

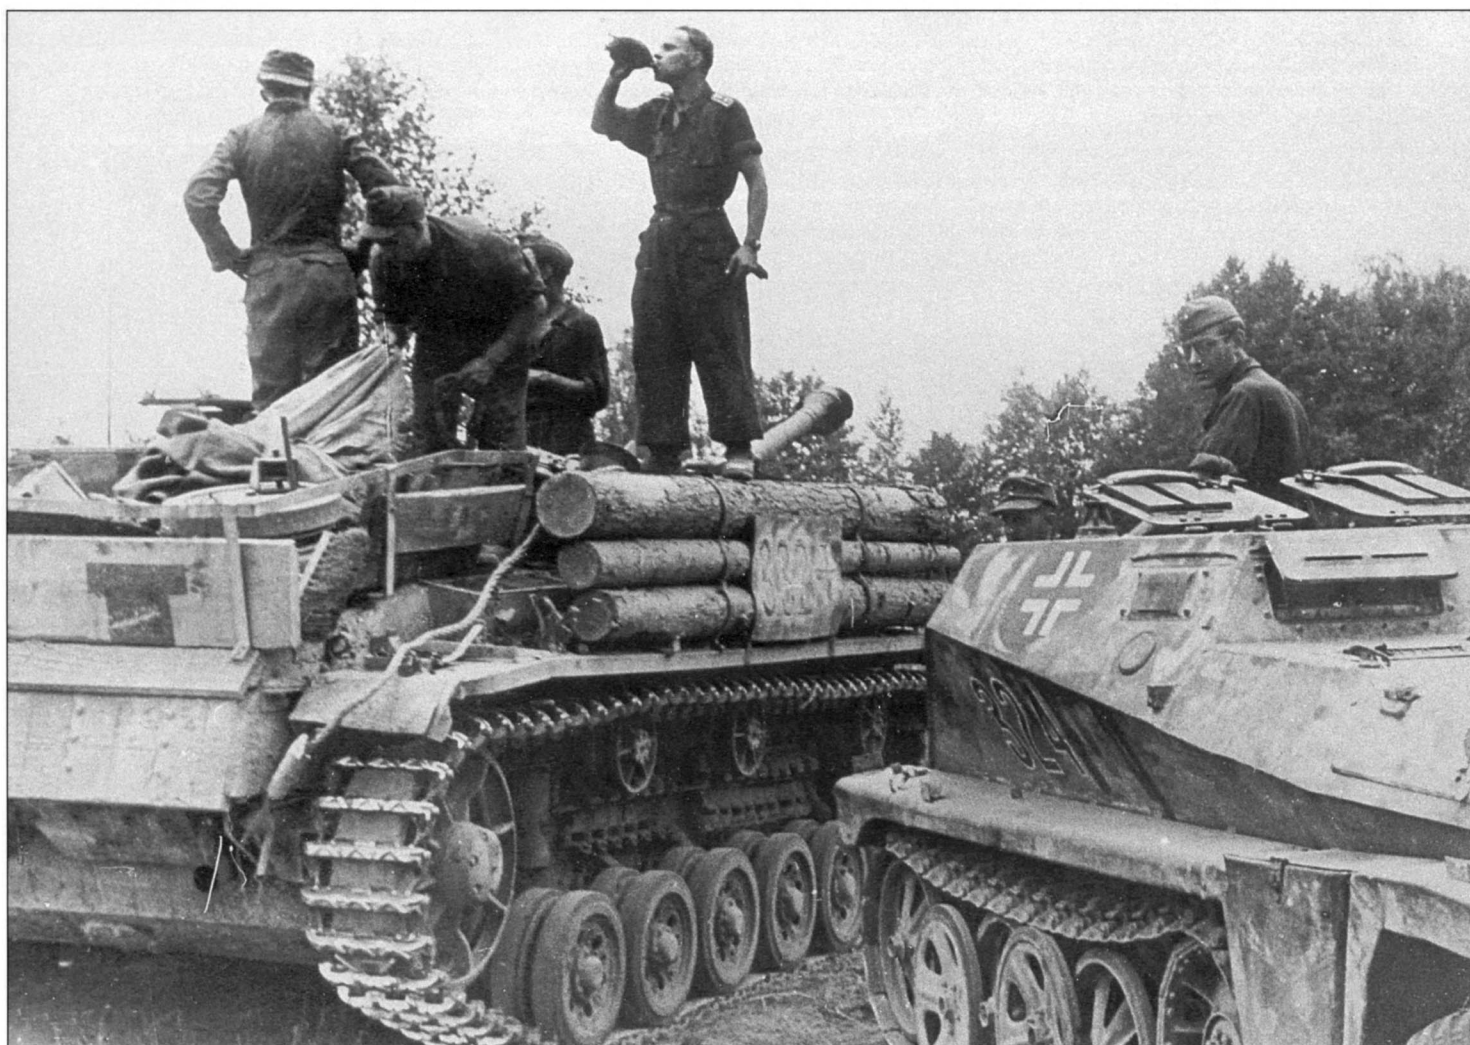
A surviving Sd.Kfz. 252 supplies a StuG III Ausf. G in mid-1943. The low silhouette of the half-track allowed it to be concealed easily during combat. The assault gun carries three long wooden beams on each side for additional 'armor' protection. The national marking and vehicle number are painted on a thin piece of sheet metal attached to the beams. The hull sides have been reinforced by sections of spare tracks.

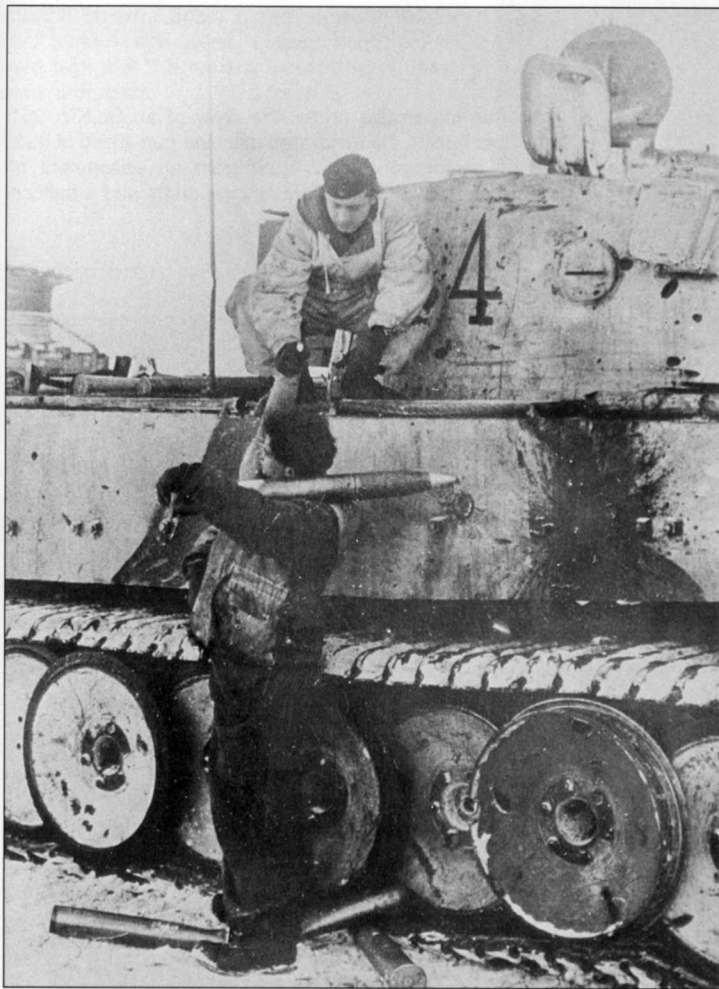
This photo quite dramatically illustrates the superiority of the Tiger tank. Though a number of hits are evident, not one has penetrated the heavy armor. The damaged roadwheel appears to be somewhat perforated by artillery splinters, however. The crew of this early Tiger is reloading ammunition. Note that the empty cartridges from the previous battle have been thrown to the ground.

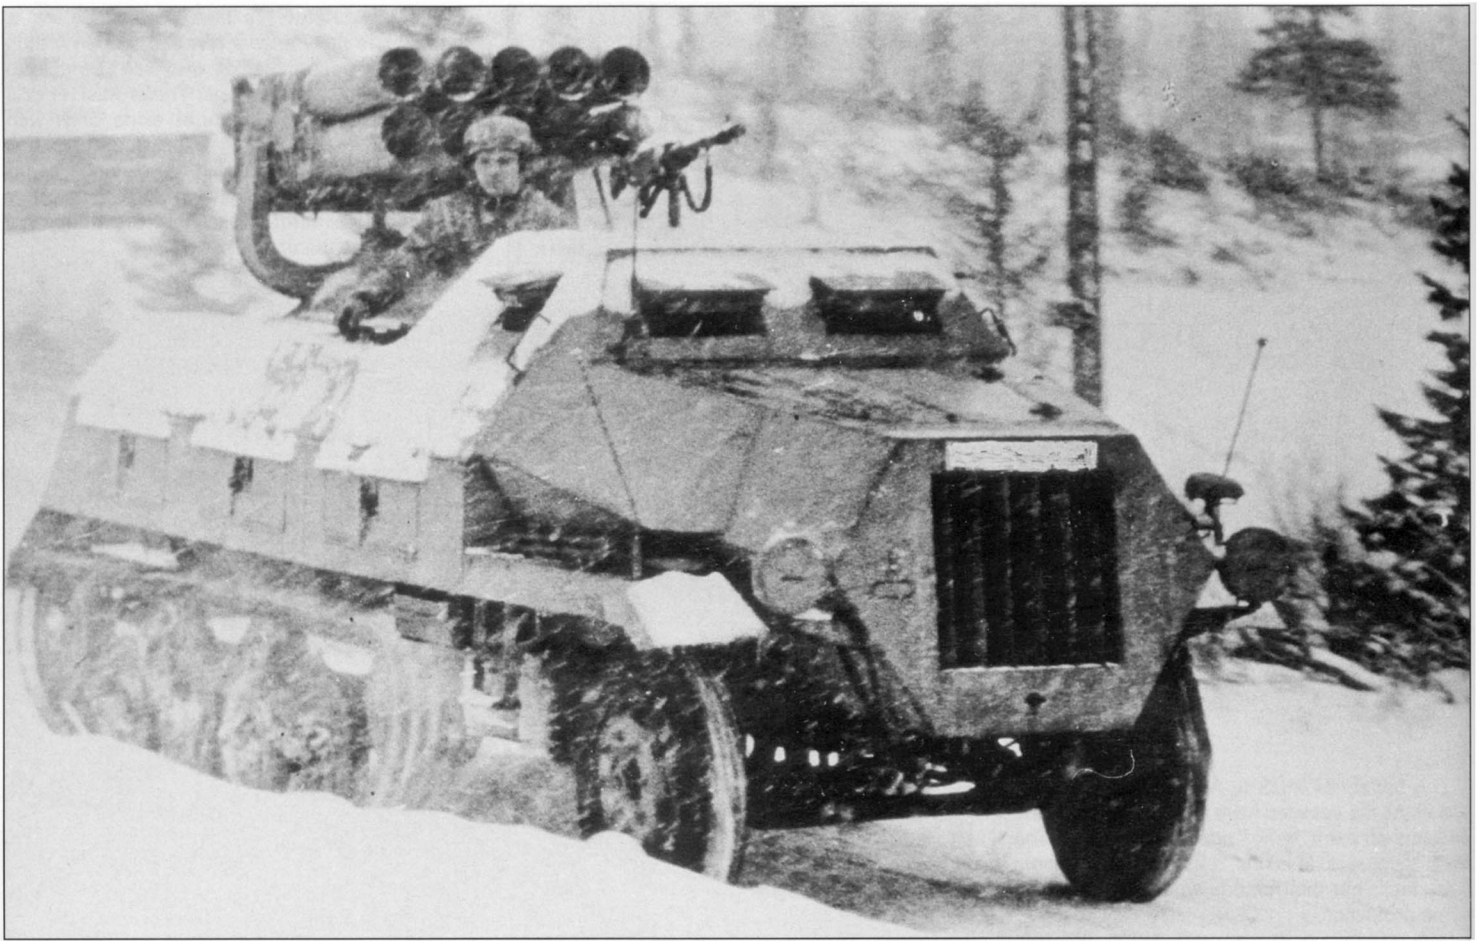
A valuable support weapon, this 15cm *Nebelwerfer* rocket launcher mounted on a 2-ton Maultier moves steadily through the snow. Fully armored, this vehicle was very successful. The vehicle commander stands in his open hatch. Note the MG34 mounted for close combat defense.

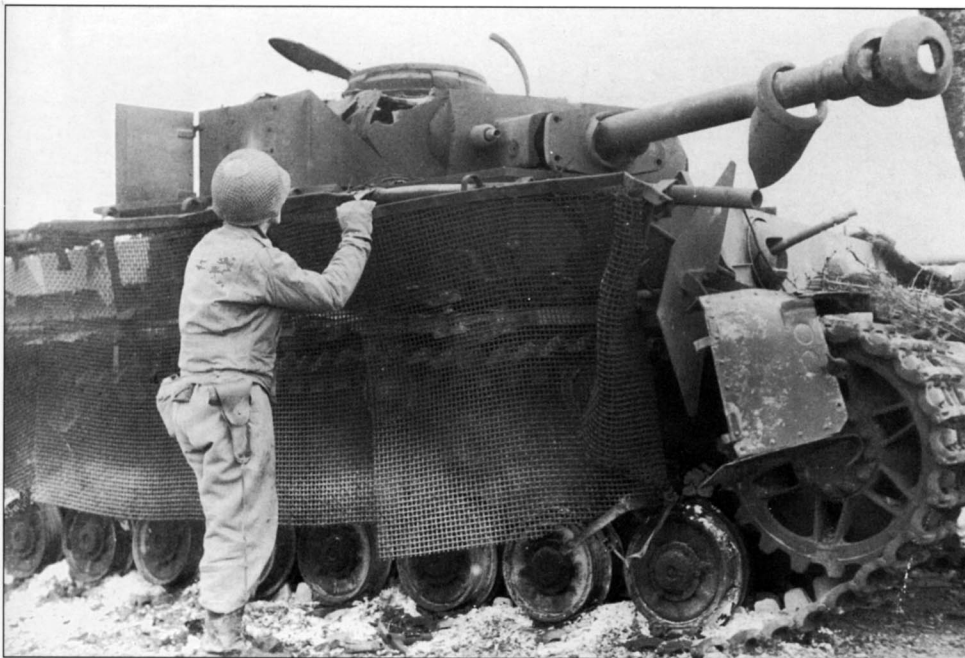
A fine view of a late-production Pz.Kpfw. Ausf. J. The tank was hit at the turret edge, but probably some other rounds penetrated its armor and caused a fire. All rubber coatings have burned down to ash. The G.I. is holding on to a wire mesh screen known as a *Thoma Schild* (Thoma shield), which was an antibazooka shield.
