STEEL BULWARK

THE LAST YEARS OF THE
GERMAN PANZERWAFFE
ON THE EASTERN FRONT 1943–45
A photographic history

Ian Baxter

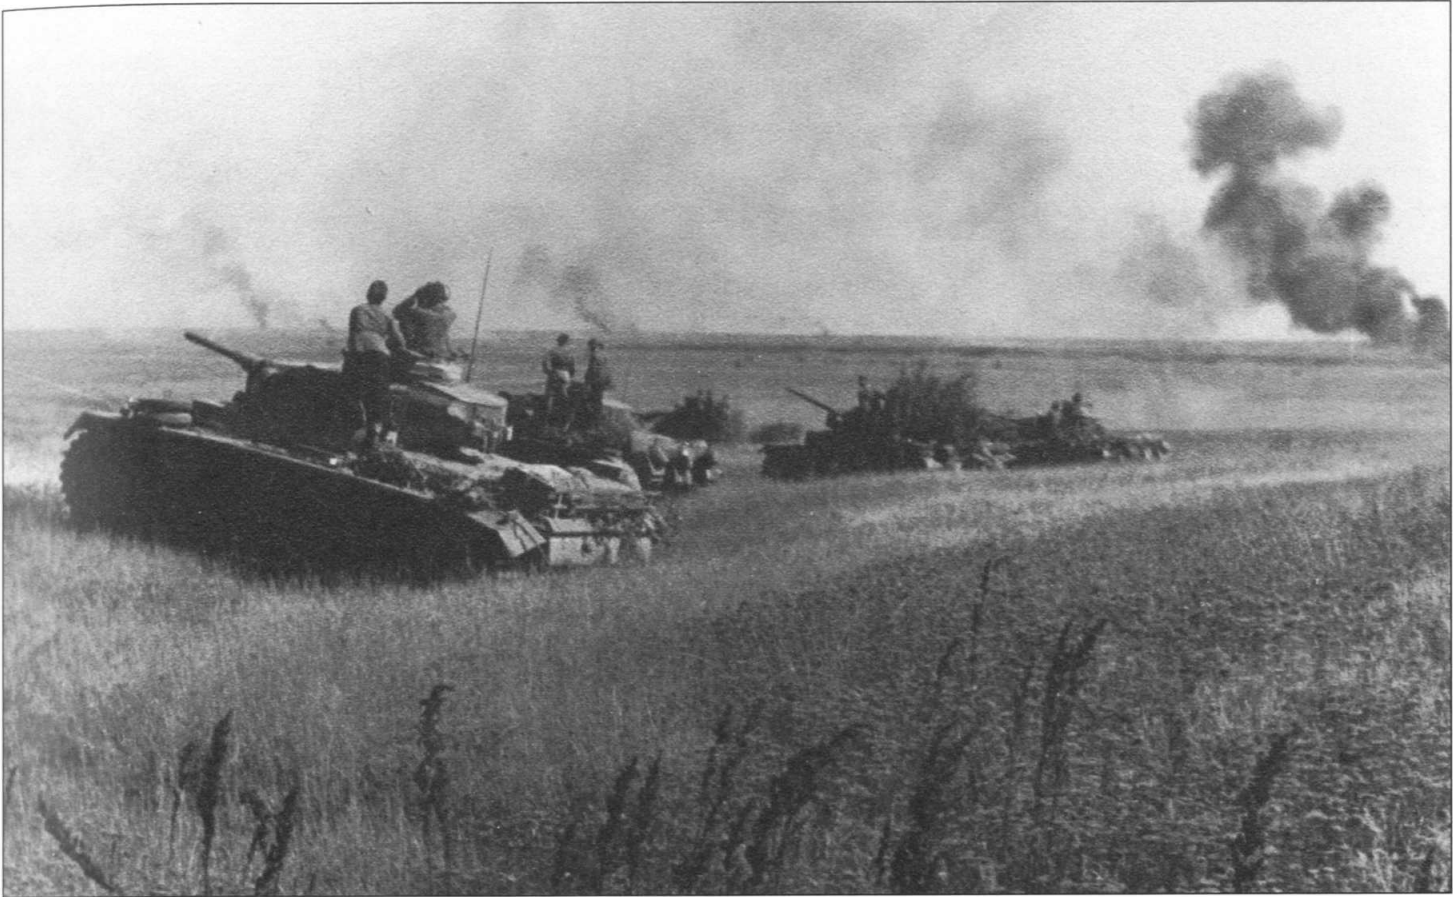
During the *Panzerwaffe*'s victorious drive through southern Russia a line of PzKpfw III's, with an Ausf J in the foreground, can be seen using a gradient in a field as concealment across the vast expanse of the Russian steppe.

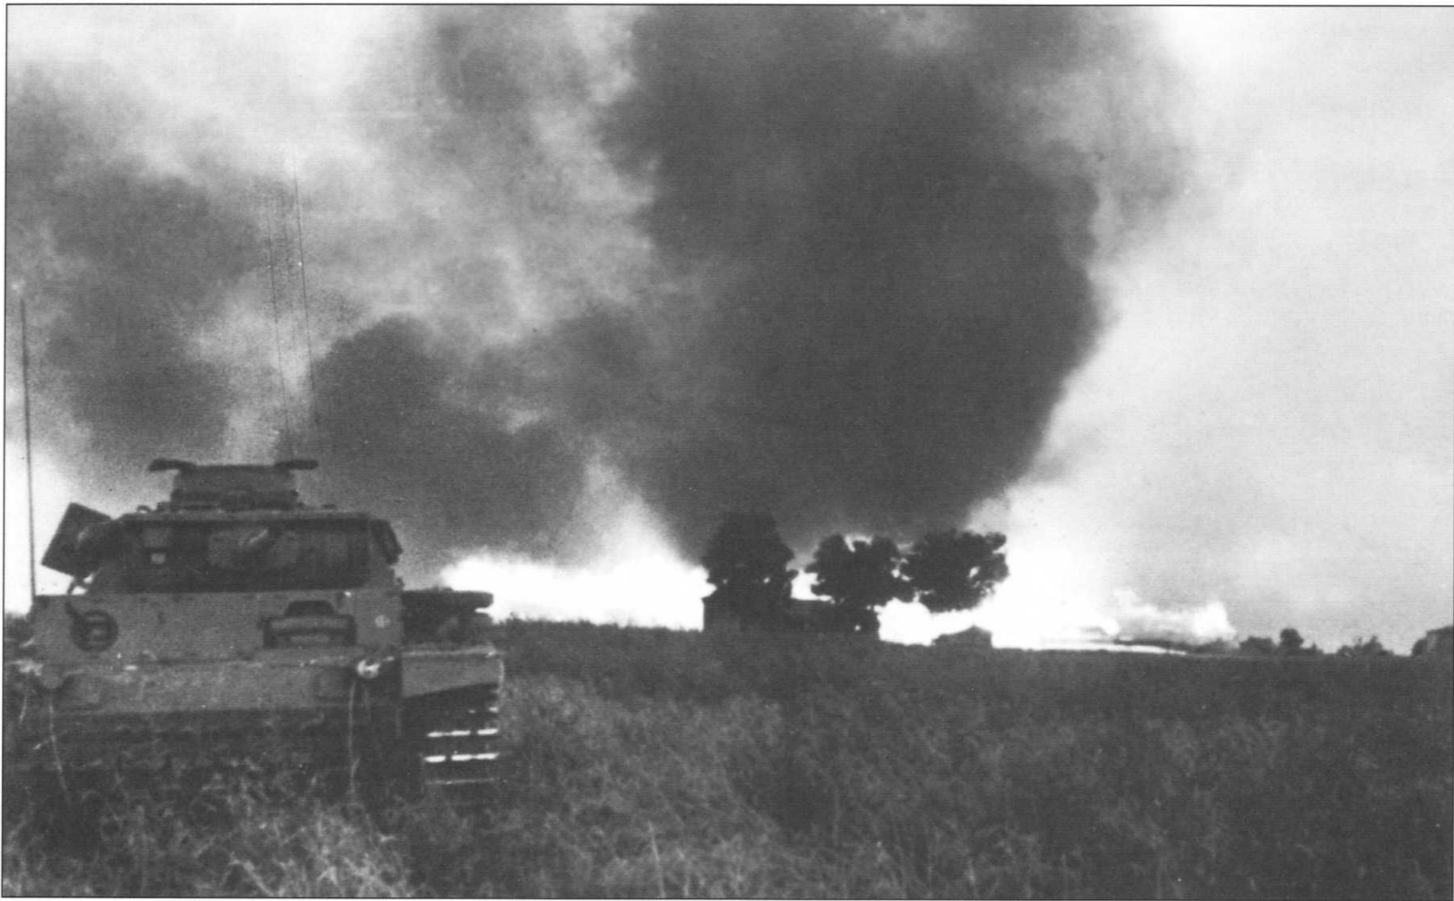
A PzKpfw III Ausf L advances through a field leaving a trail of devastation in its wake. This vehicle belongs to the 26th Panzer Division. During the opening stages of the invasion of the Soviet Union in June 1941, there were some 956 PzKpfw III's.

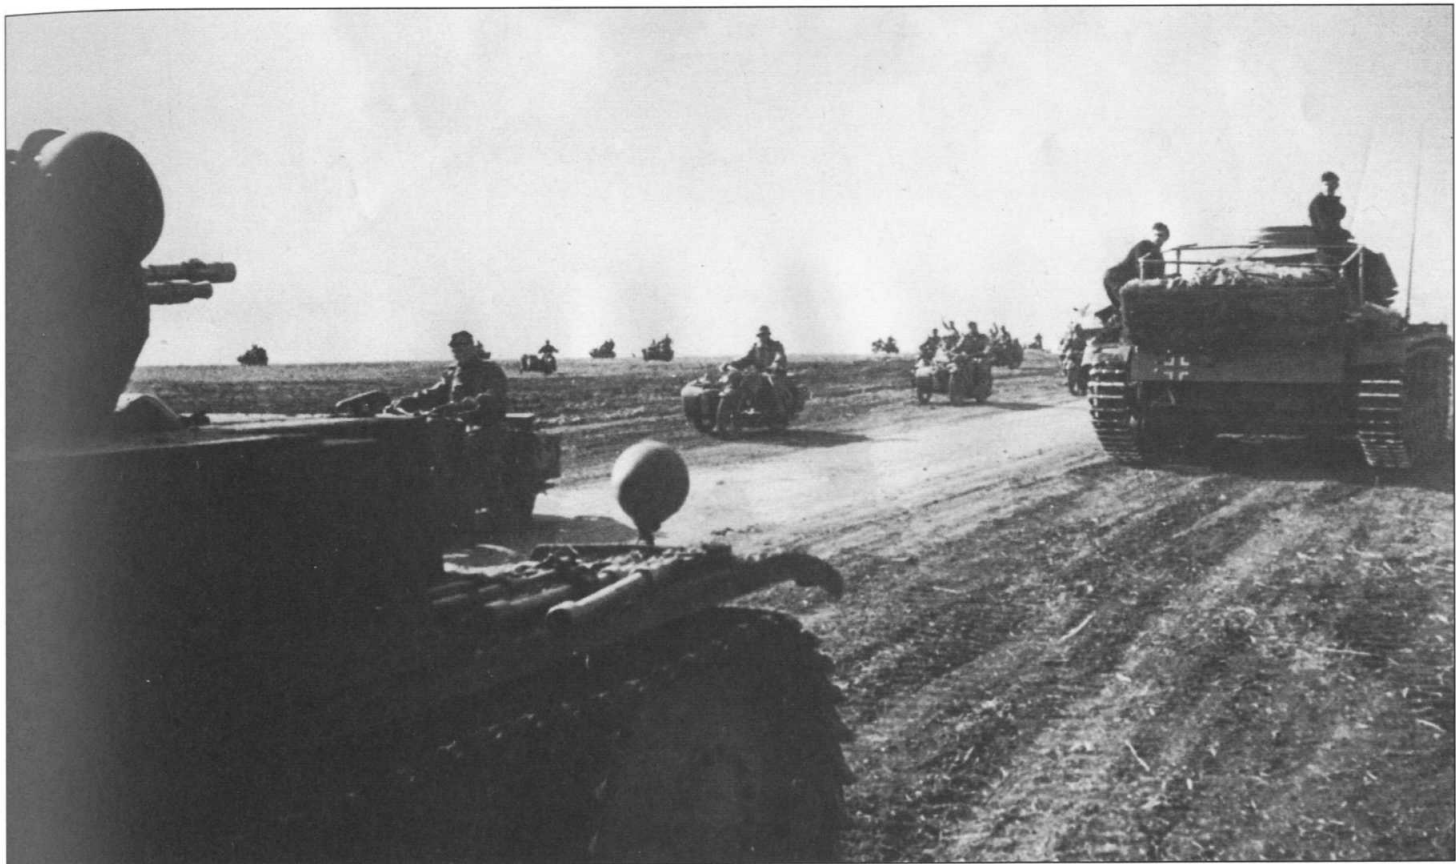
A PzKpfw II Ausf F and a PzKpfw III Ausf J have halted on a road in southern Russia. Two PzKpfw III crewmembers watch a number of motorcycle combinations crossing a field. Due to the high numbers of motorcyclists killed in battle, gradually during the war motorcyclists were relegated to communication and reconnaissance duties.

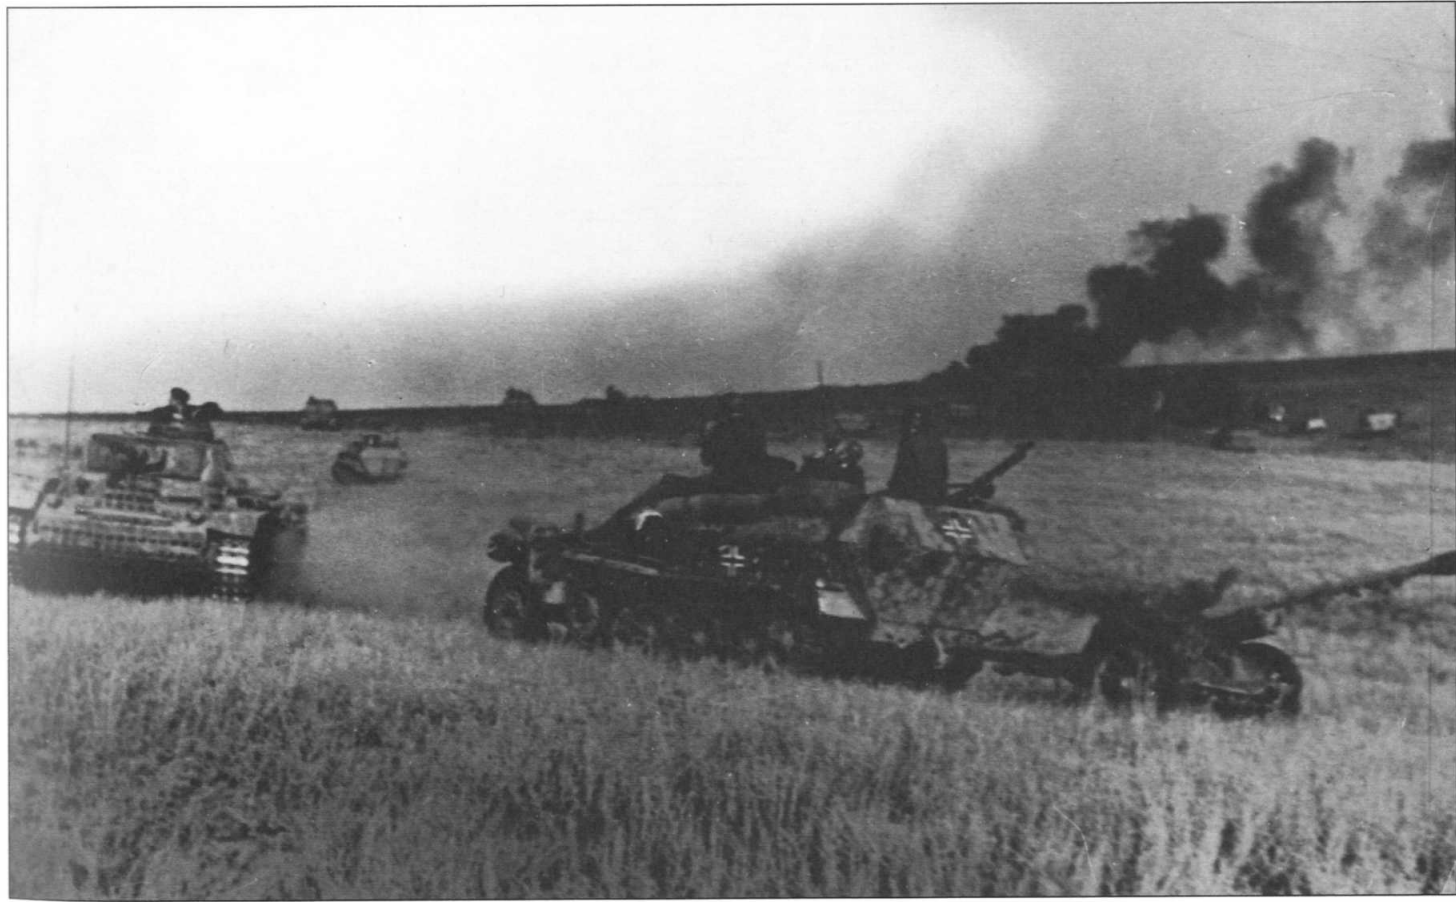
A halftrack towing what appears to be a PaK 40 across a field during operations in southern Russia in 1942. This anti-tank gun proved it worth in Russia and was more than capable of disabling heavy Soviet armour.

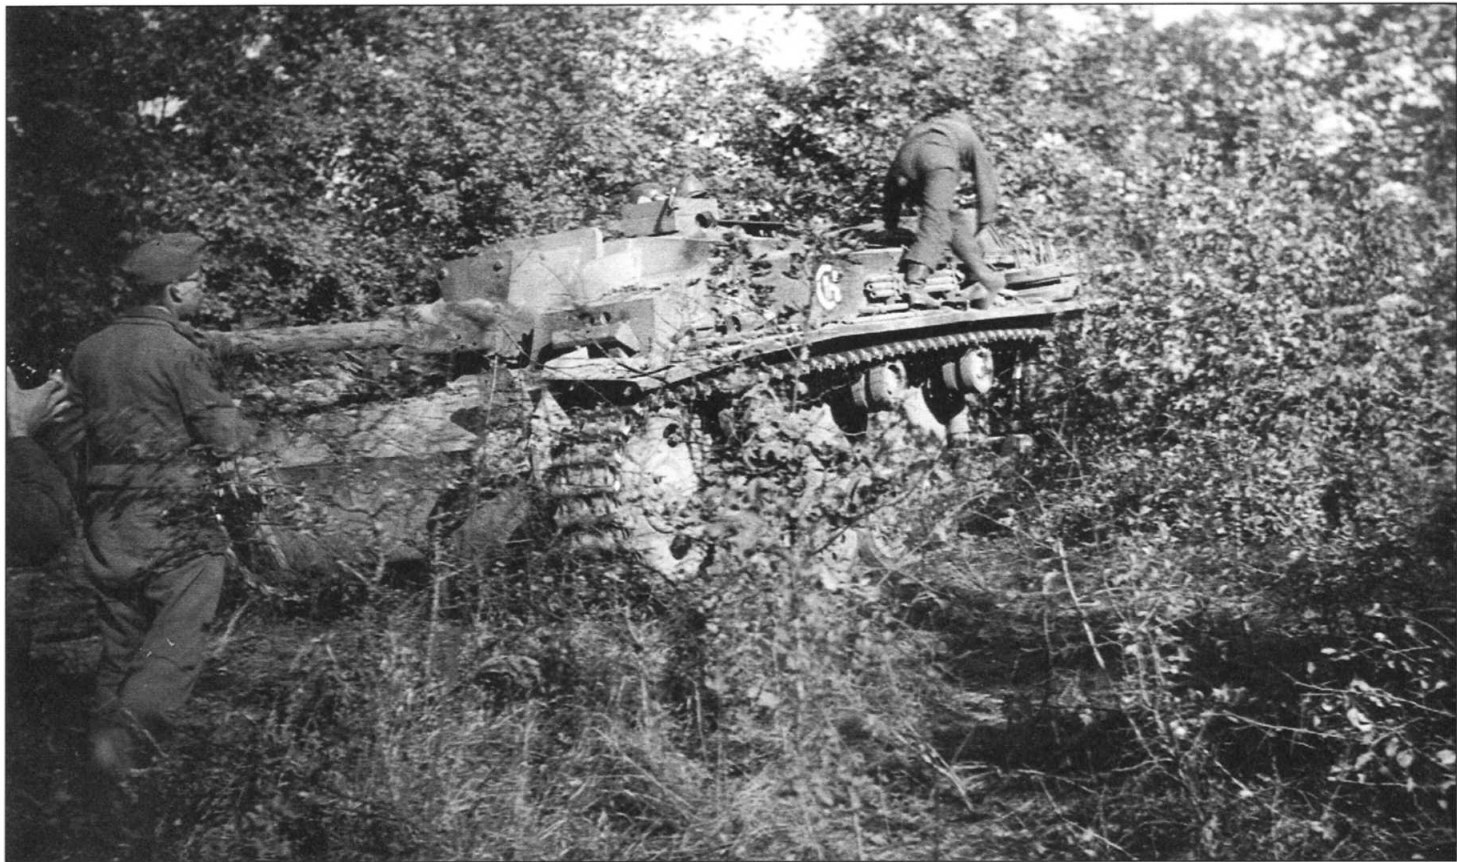
A StuG III has been concealed in some undergrowth during summer operations in 1943. Despite the longer 7.5cm barrel this assault gun was continually hard-pressed on the battlefield and constantly called upon for offensive and defensive fire support, where it was gradually compelled to operate increasingly in an anti-tank role.

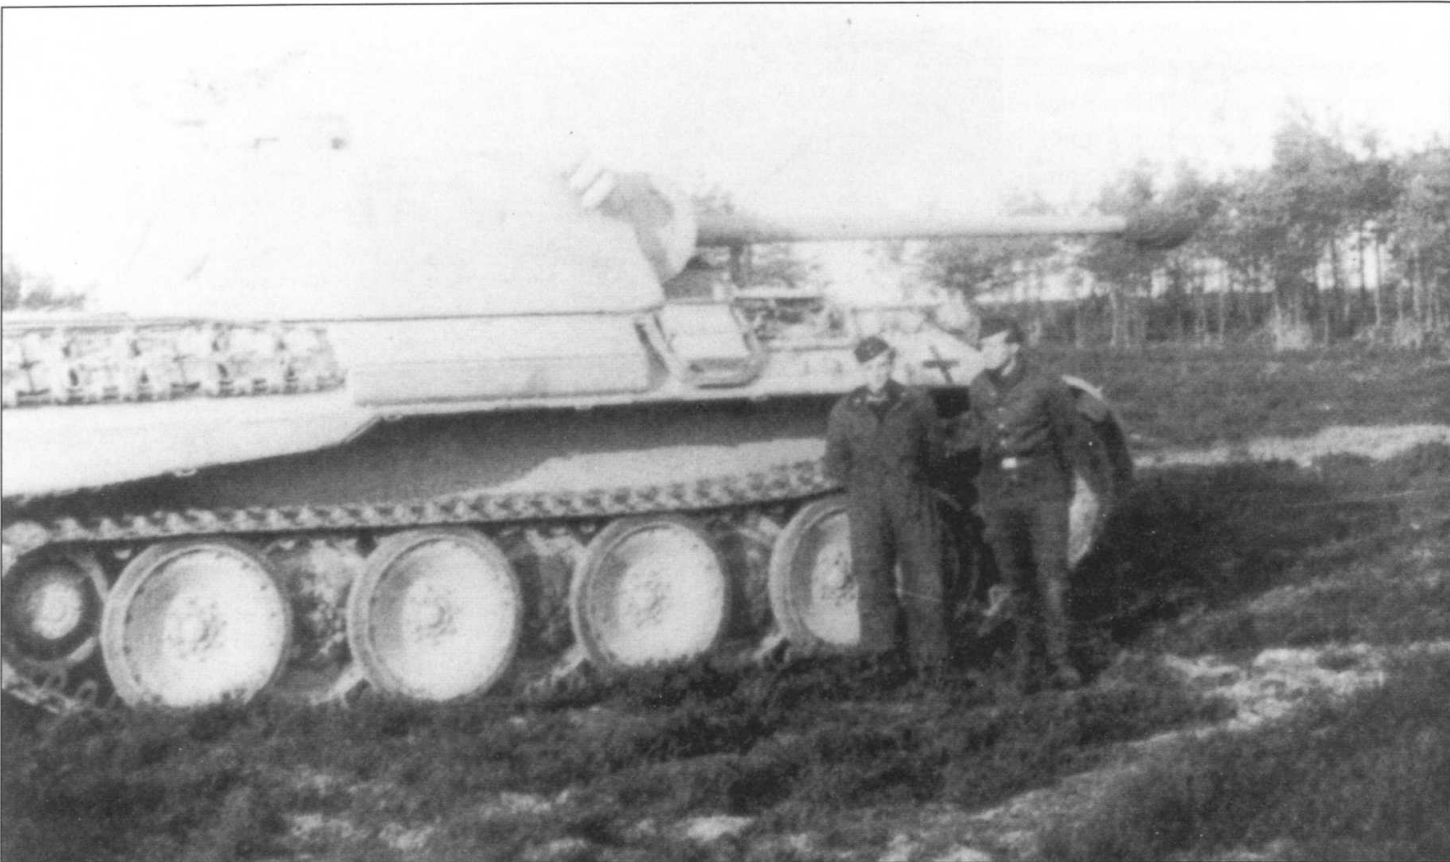
Two crewman stand beside their Panther during a training exercise. This variant mounts six smoke candle dischargers, three on each side of the turret. These were discontinued in production during June 1943. However, some Panthers still carried them for a number of months until they were finally removed.

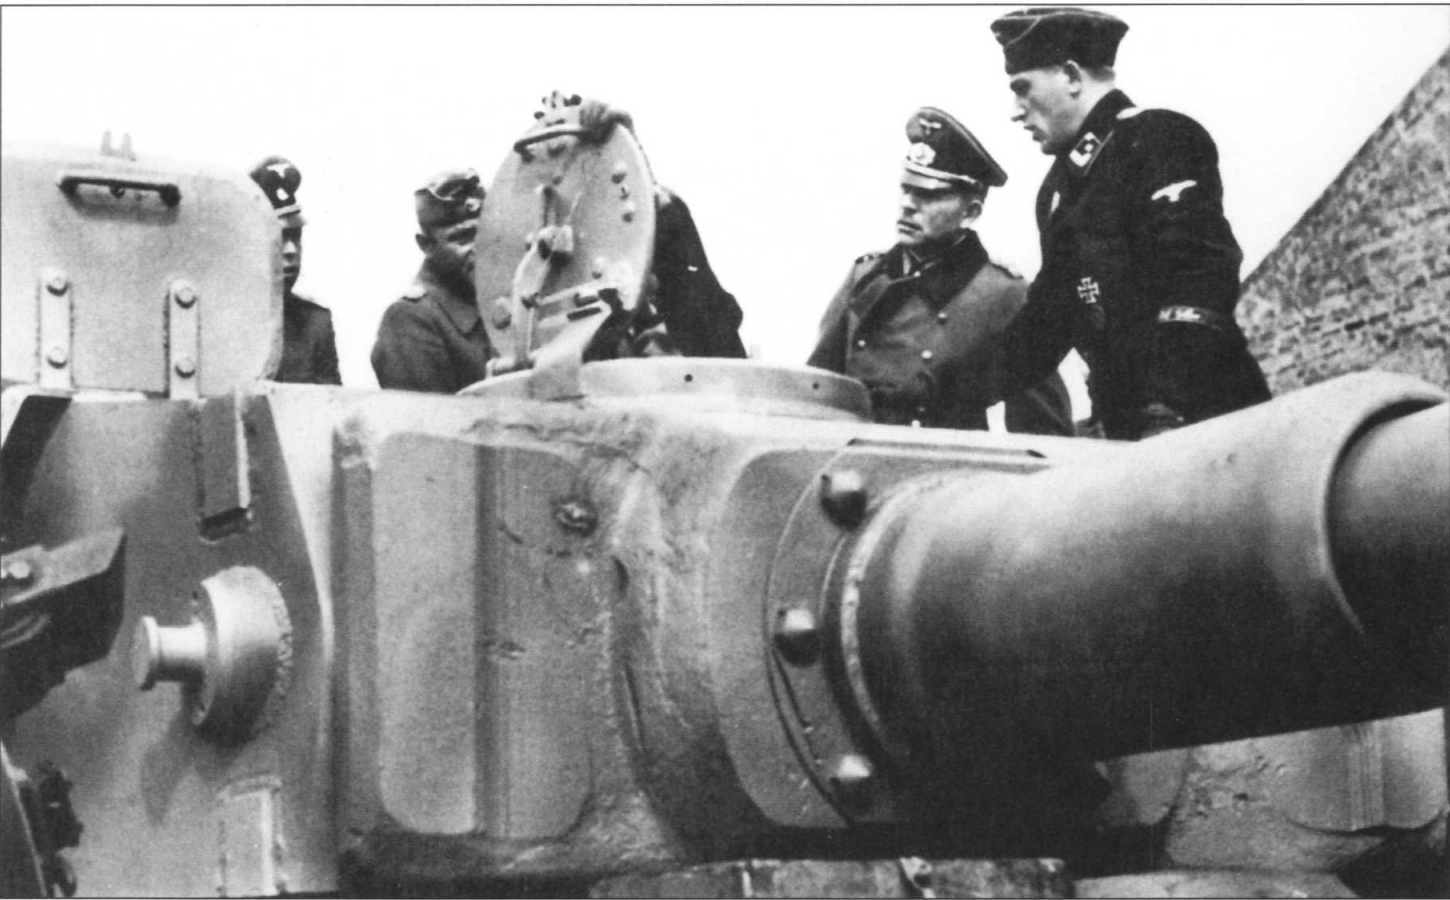
General Heinz Guderian and staff inspect a Tiger tank in 1943. One of the Panzer men opens the commander's cupola hatch and shows the General the internal view of the commander's compartment.

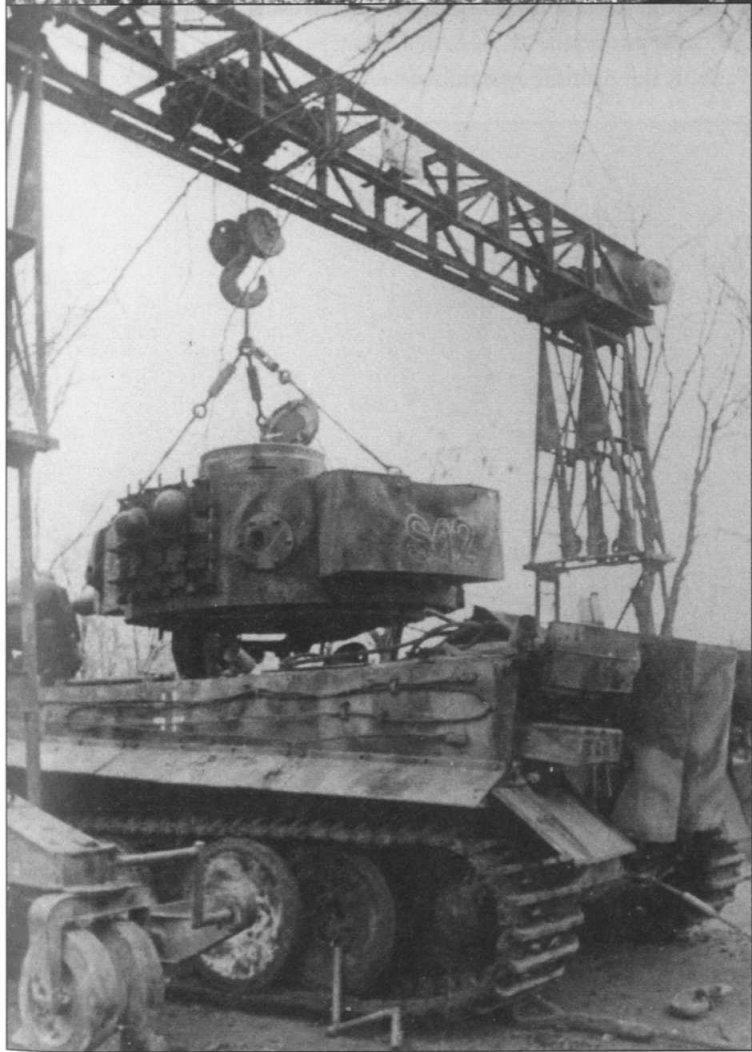
An interesting image showing one of the independent Tiger battalions undertaking mechanical work on a Tiger from SS schwere Panzer Abteilung 101 in 1943. The large portal crane is being used to remove the heavy turret for repairs.

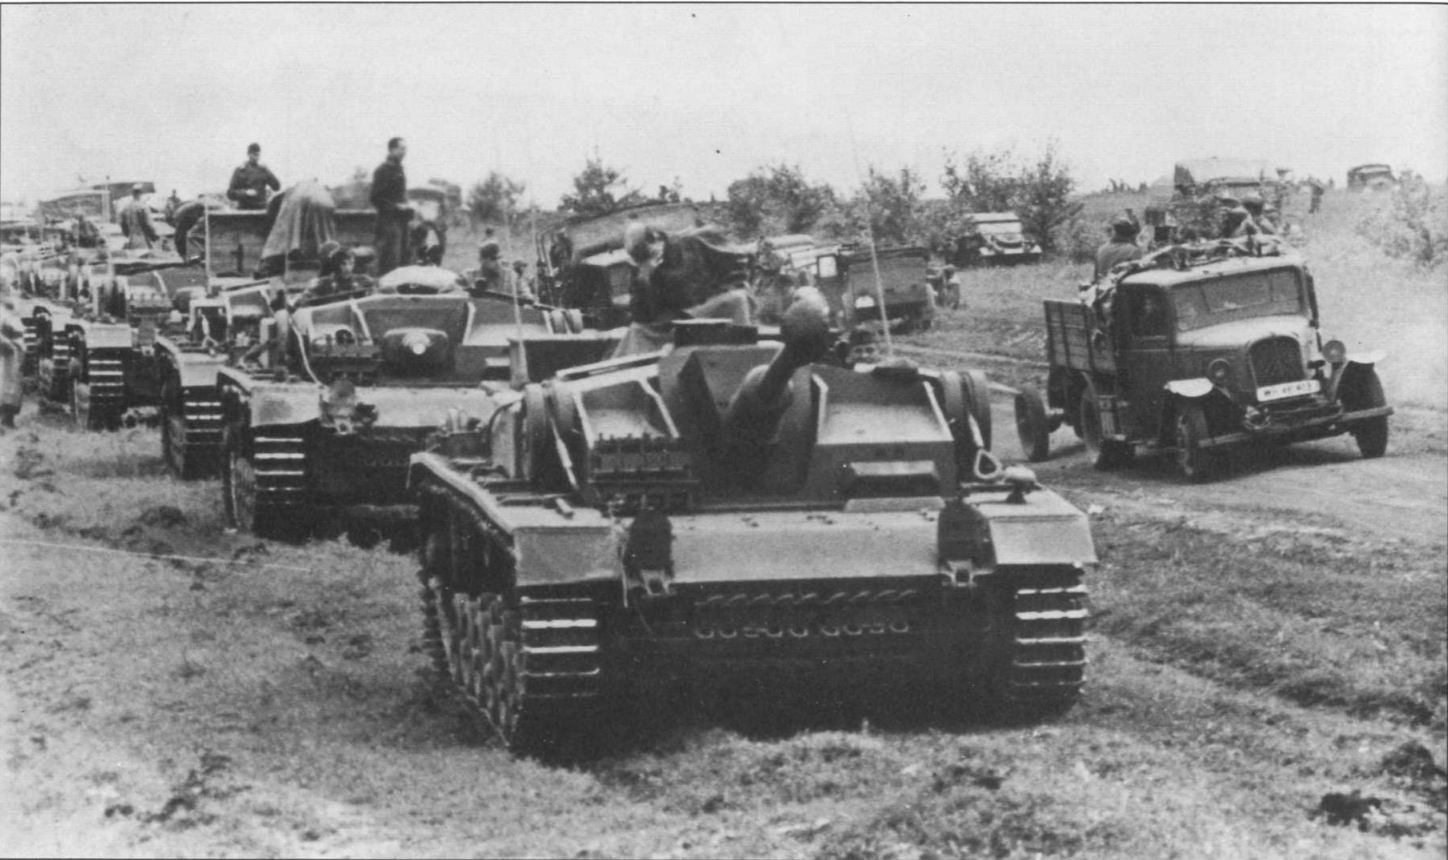
An impressive photograph showing a StuG III leading an armoured column. Because the StuG III was constantly in great demand in Russia Hitler ordered that the assault gun be up-gunned and up-armoured with a longer more potent 7.5cm gun. This more powerful assault gun went into production in mid-1942. The Ausf F variant mounted a 7.5cm StuK 40 L/43 gun. The following year the final StuG variant, the Ausf G, entered service with the *Panzerwaffe*.

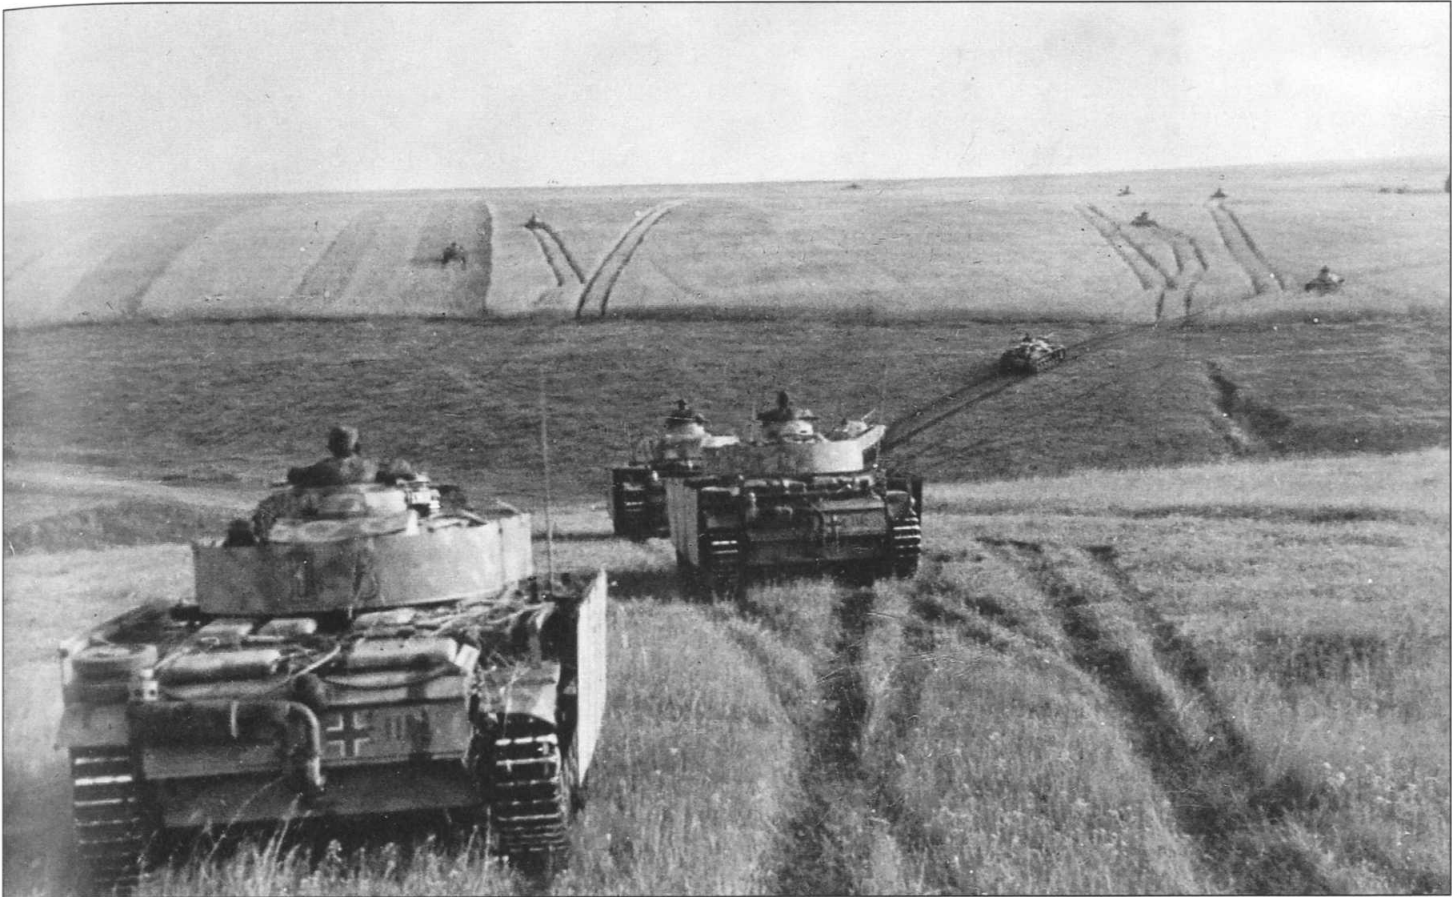
PzKpfw IVs advance through a field during the Battle of Kursk in July 1943. The *Panzerwaffe's* failure at Kursk resulted in huge losses of tanks and material. After the battle only five Wehrmacht Panzer divisions and one Waffen-SS Panzer division were sent as replacements to the Eastern Front in late 1943. Note the protective side-skirts or Schürzen on the vehicles.

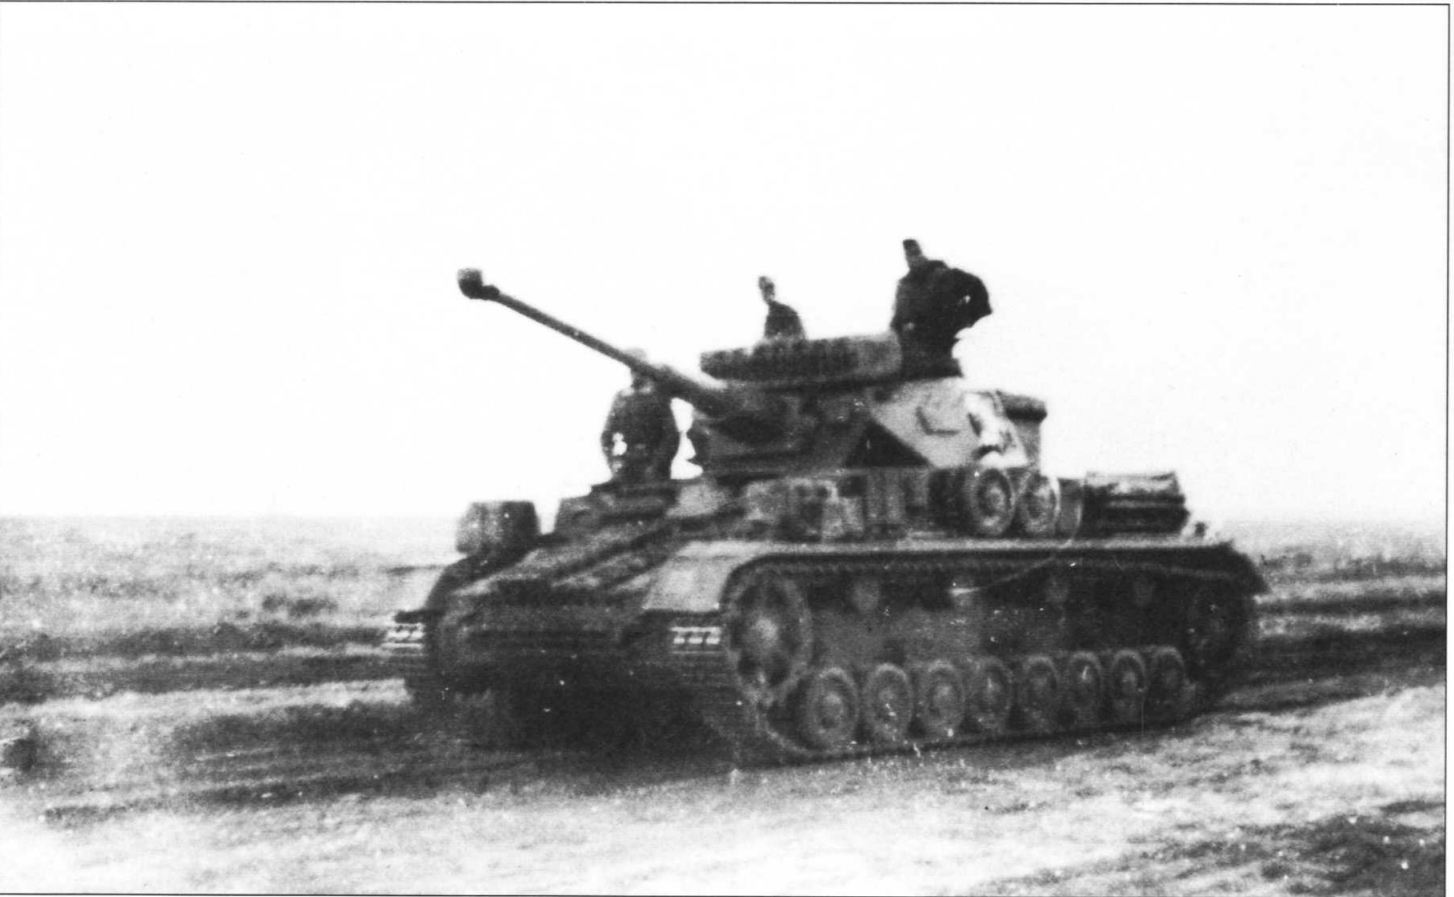
A PzKpfw IV moves hastily along a dusty road somewhere in southern Russia in the summer of 1943. Note the rack fitted with jerry cans on the turret roof, indicating the vehicle is in for a long road march.

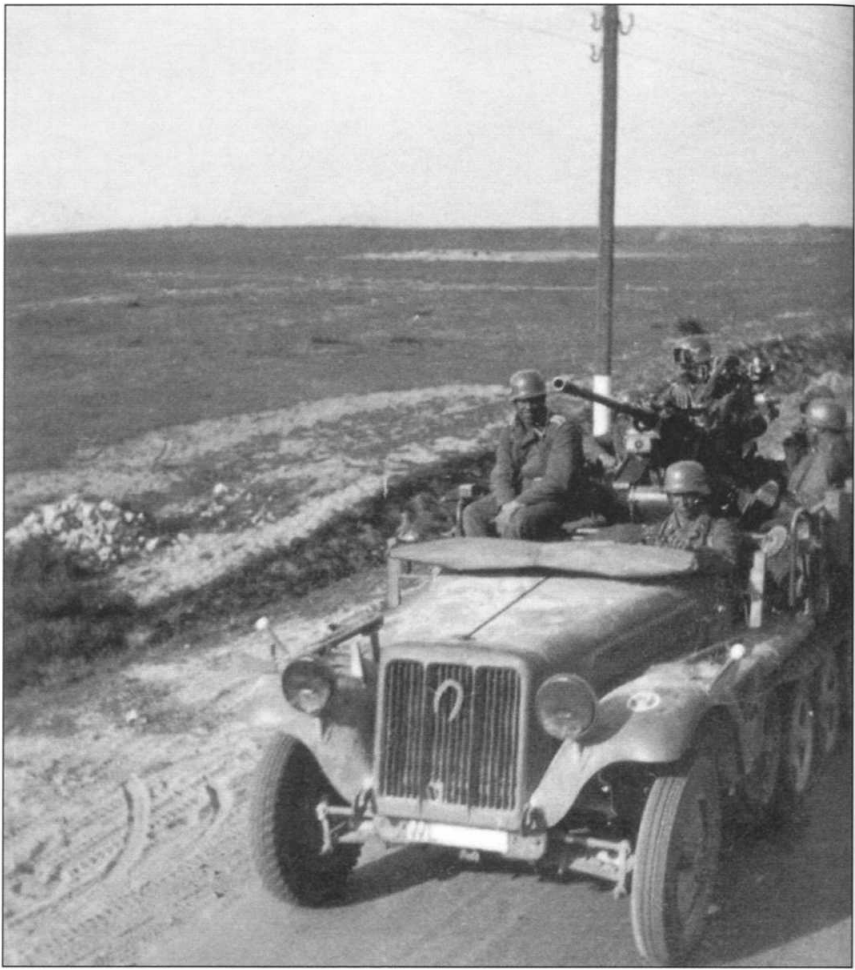
An SS soldier scours the terrain ahead in his stationary SdKfz 251/9 halftrack. This vehicle is armed with the short 7.5cm KwK 37 L/24, which was mounted on the PzKpfw IV before it was up-armoured with the 7.5cm L/43 and L/48. Note the kill rings on the barrel. [Michael Cremin]

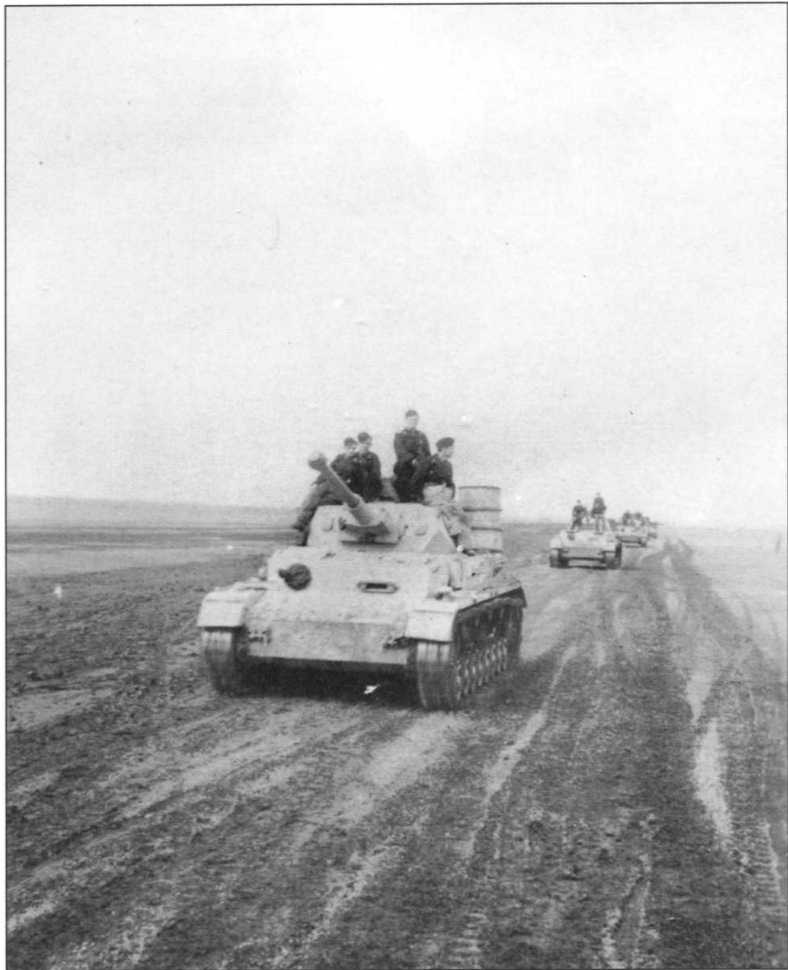
A column of PzKpfw IV's move along a typical road in southern Russia during operations in the early winter of 1943. Stowed on the rear of the engine deck of the leading vehicle are fuel drums. The vast distances in which these vehicles were compelled to travel meant that quite often tracked vehicles outstripped fuel supplies, prompting crews to carry reserves.

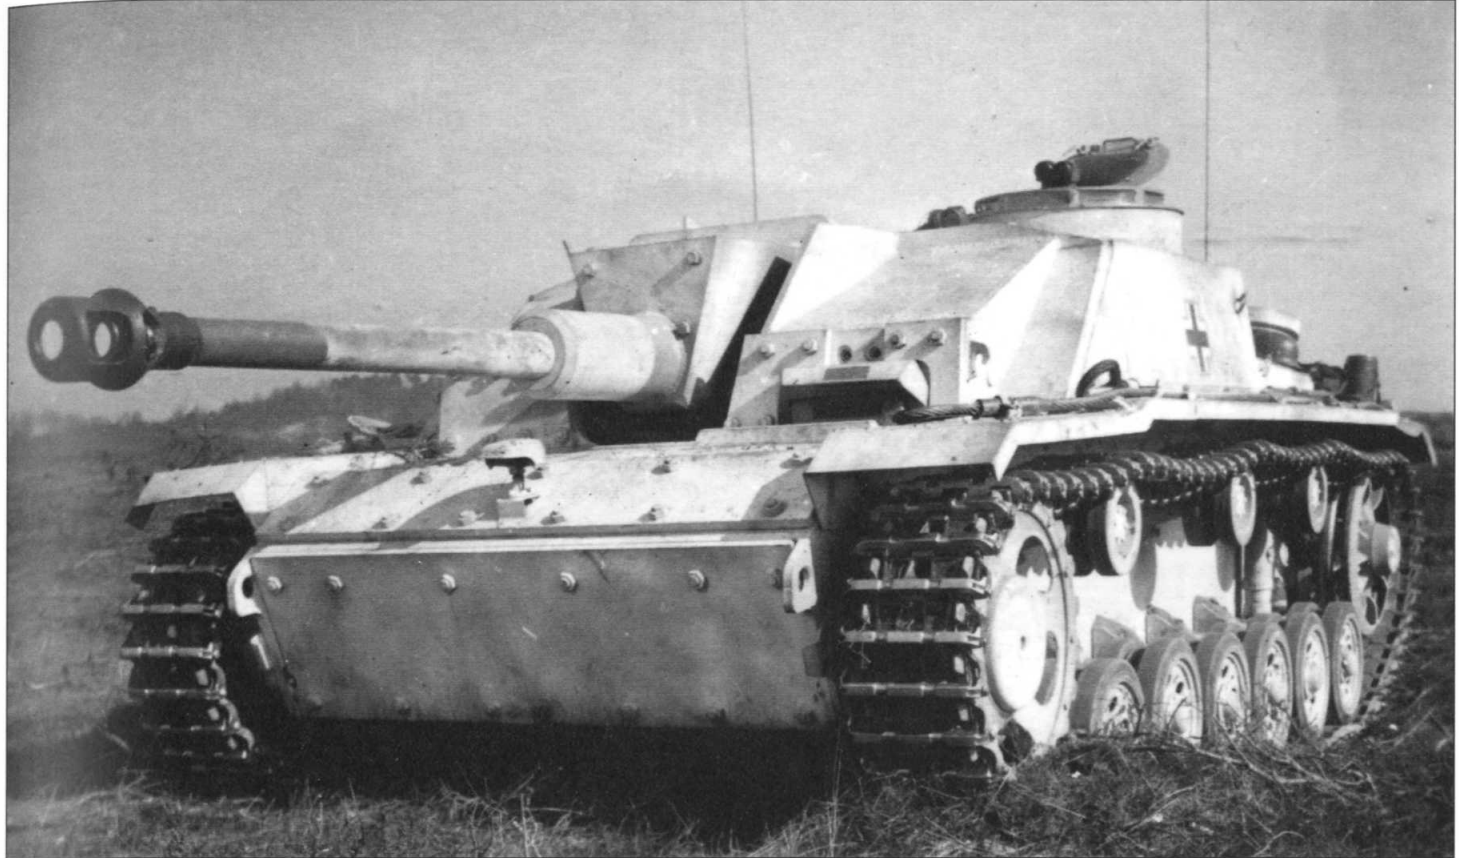
A StuG III Ausf G in a field with a full covering of winter whitewash paint. By 1943 the StuG III had become an extremely common assault gun in the *Panzerwaffe* on the Eastern Front. Its low profile and mechanical reliability saw its employment grow on the battlefield.

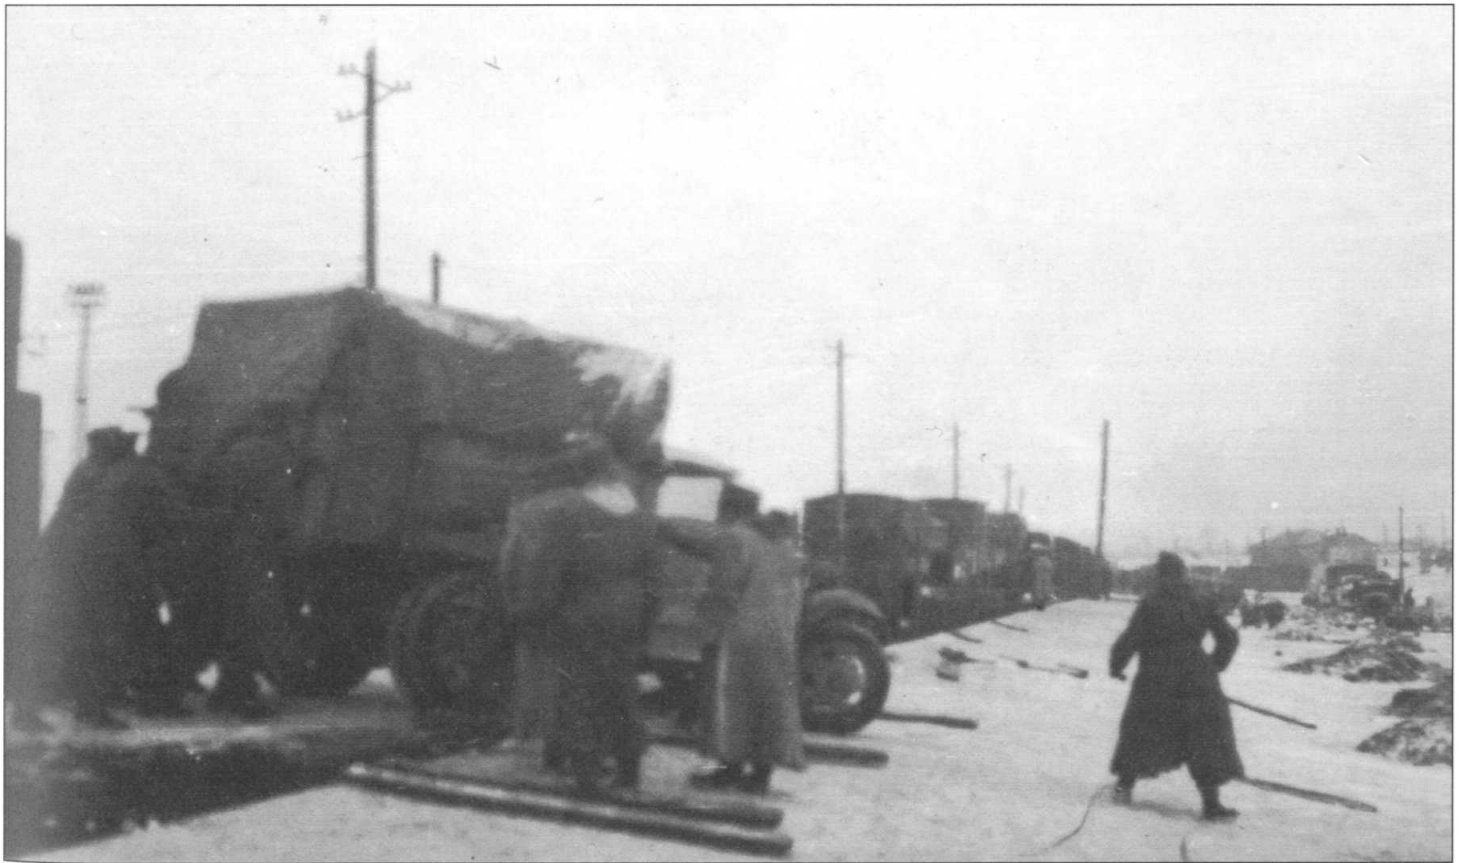
Vehicles are being loaded onto flatbed railway cars destined for the frontline. Moving vehicles by rail became a common requirement by the *Panzerwaffe* in late 1943. It enabled the Panzer divisions to move from one front to another quickly and effectively without wear and tear.

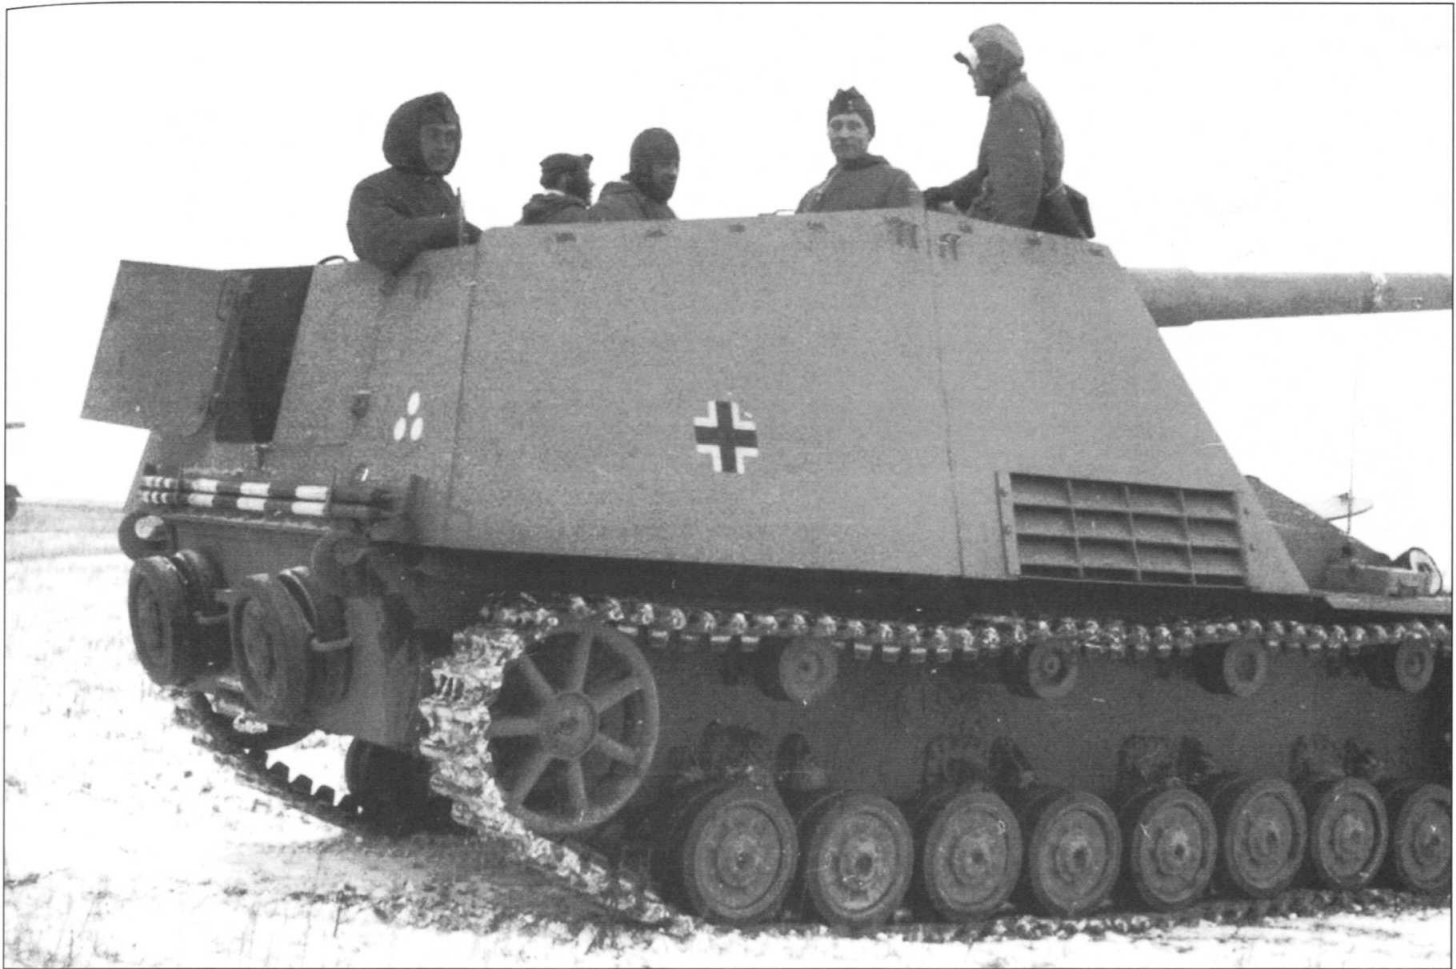
An SS crew wearing winter reversibles grey side out can be seen in the fighting compartment of a stationary Hummel. The Hummel mounted a standard 15cm heavy field howitzer in a lightly armoured fighting compartment built on the chassis of a PzKpfw III/IV. This heavy self-propelled gun carried eighteen 15cm rounds, but was a potent weapon against Soviet armour.

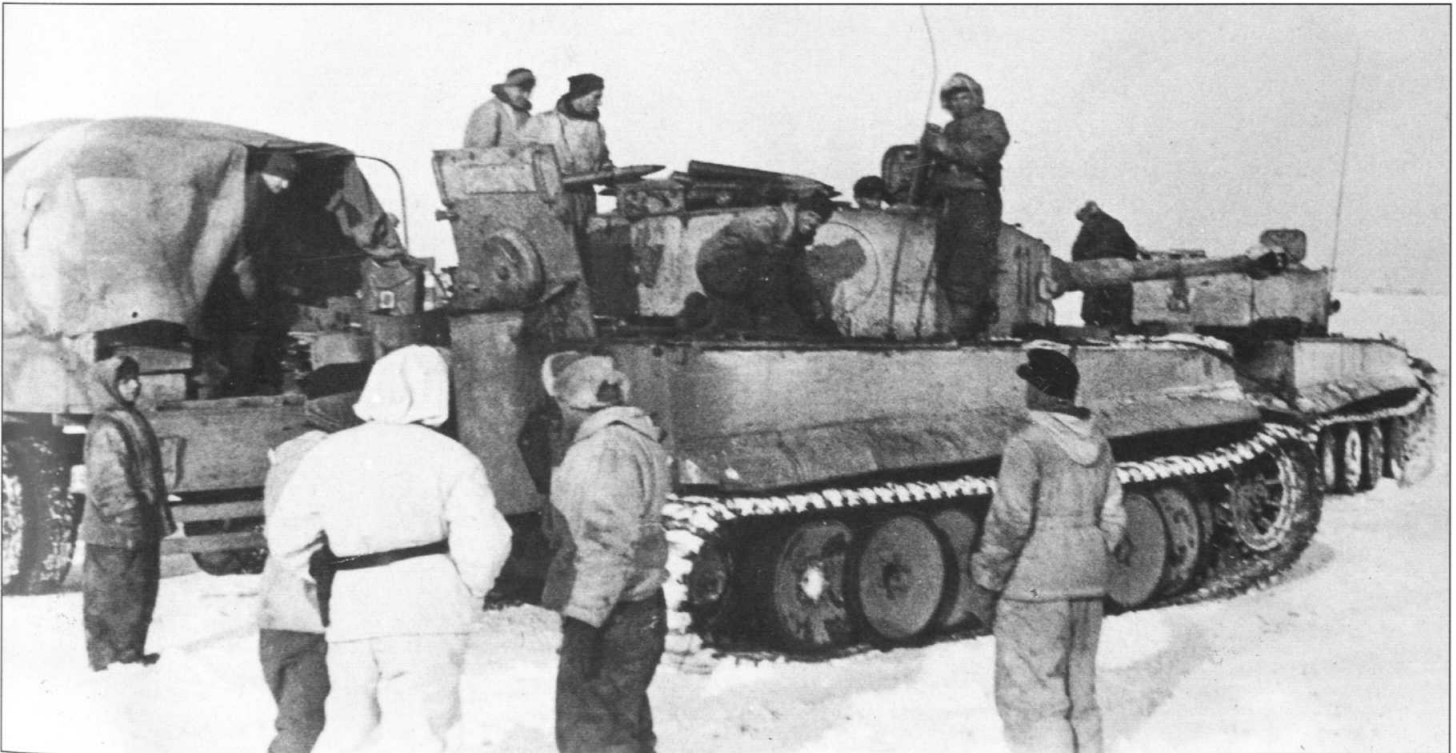
Tiger tanks are being replenished with ammunition. Shells are being carefully unloaded and passed through the hatch. In spite the German military reversal on the Eastern Front the *Panzerwaffe* would extensively use the Tiger in a number of prominent roles in both major offensive and defensive employments.
