STEEL BULWARK

THE LAST YEARS OF THE
GERMAN PANZERWAFFE
ON THE EASTERN FRONT 1943–45
A photographic history

Ian Baxter

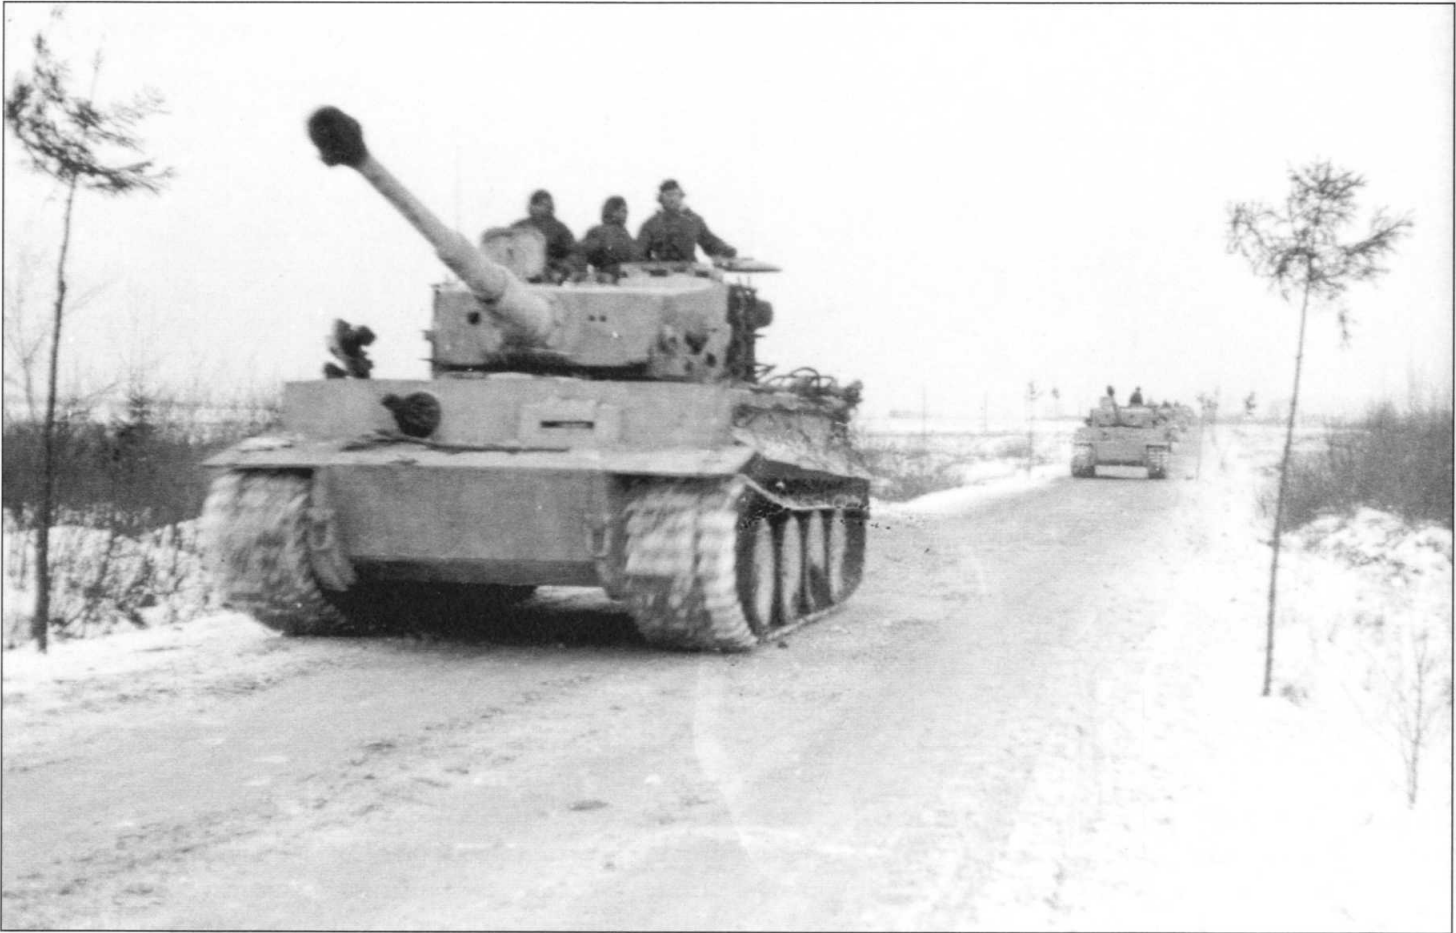
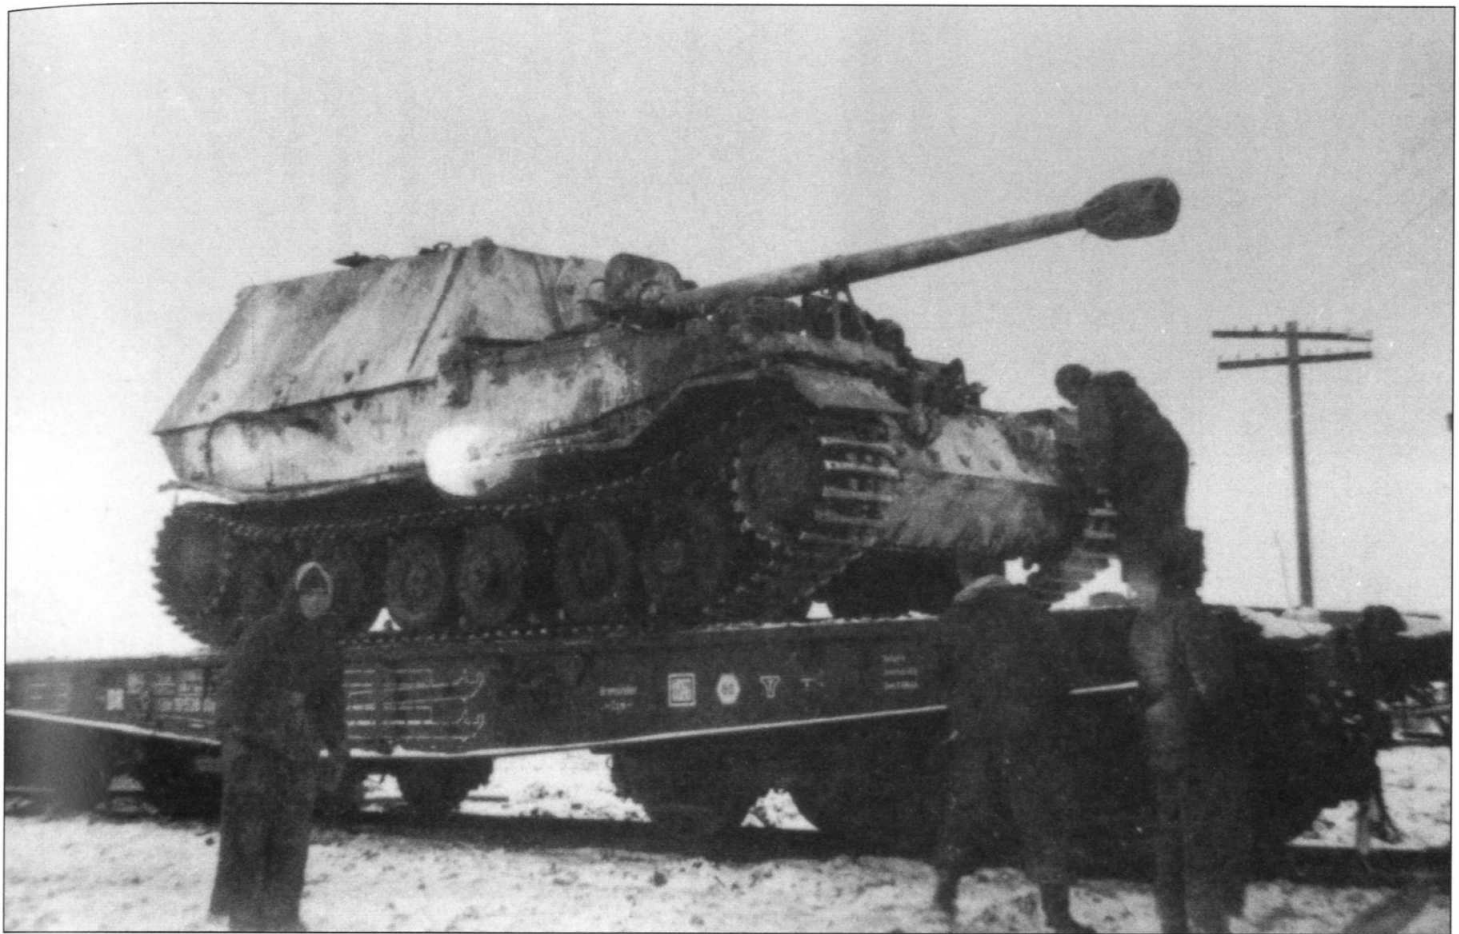
Two photographs showing Tiger tanks with an application of winter whitewash paint over a coating of Zimmerit anti-magnetic mine paste. By early 1944 the Tiger continued to play an important, mainly defensive, role.

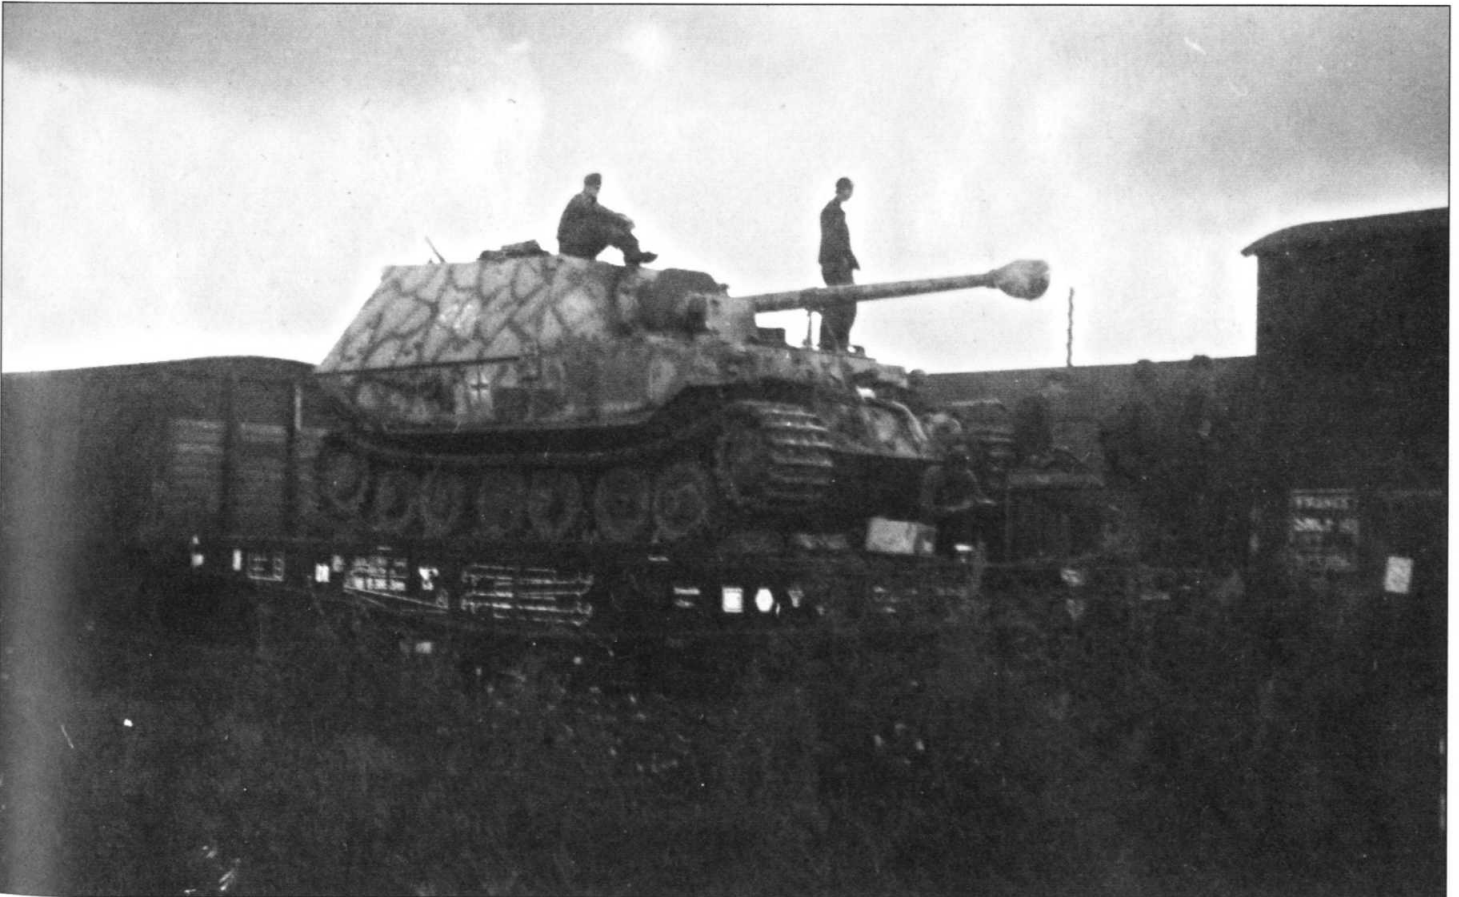
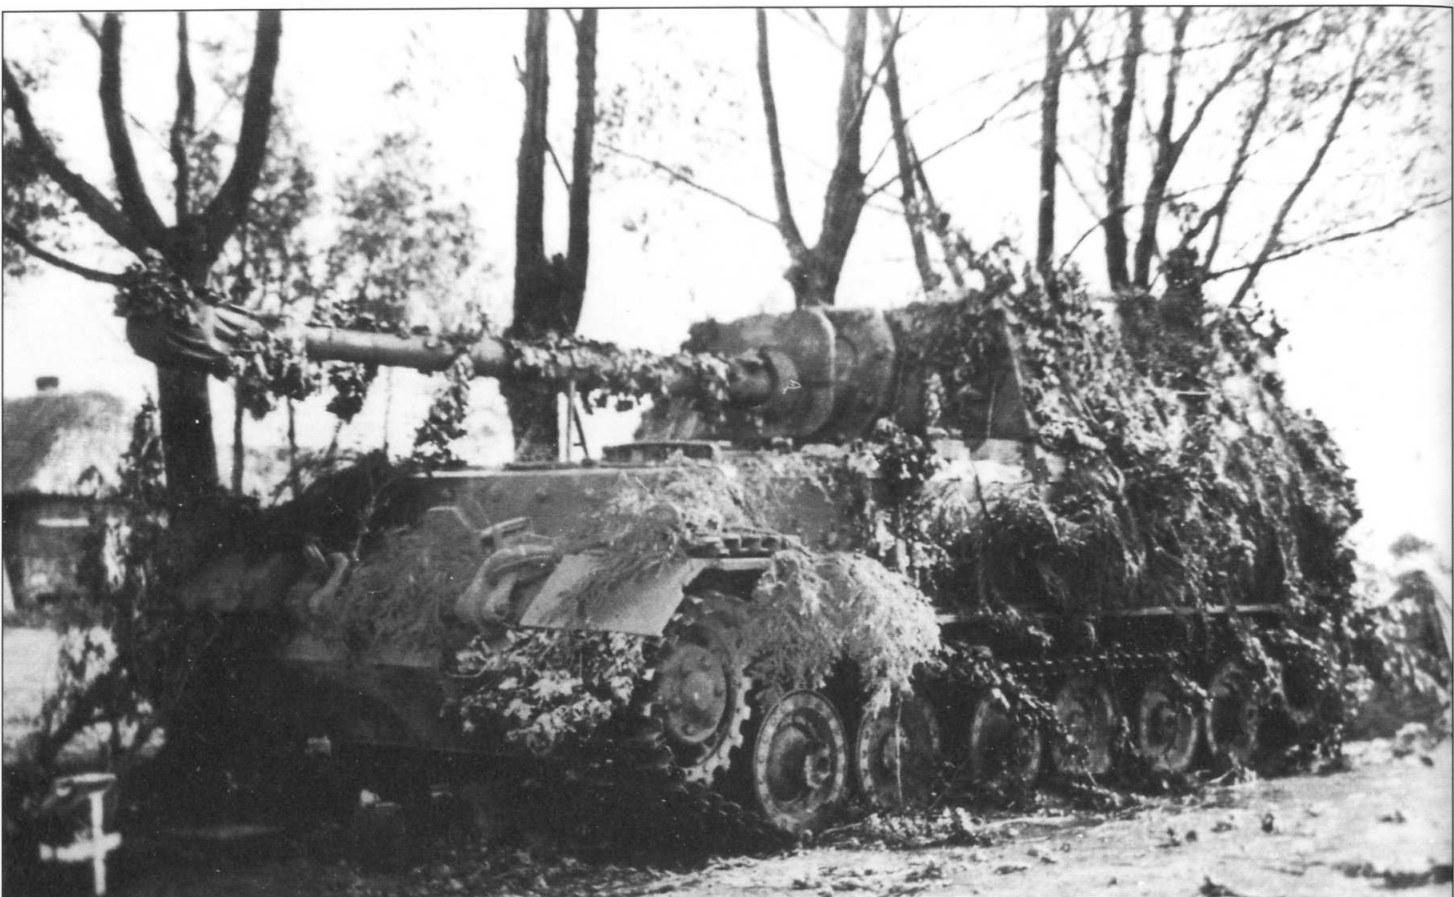
Two photographs showing Panzerjäger Tiger or Ferdinand Elefant tank destroyers that have been chocked and secured ready for their journey by rail. Due to their sheer size and weight, no more than six of these vehicles were permitted to be loaded on one train. These were interspersed with two flatcars to avoid overloading of the train, and also to prevent overloading of the bridges.

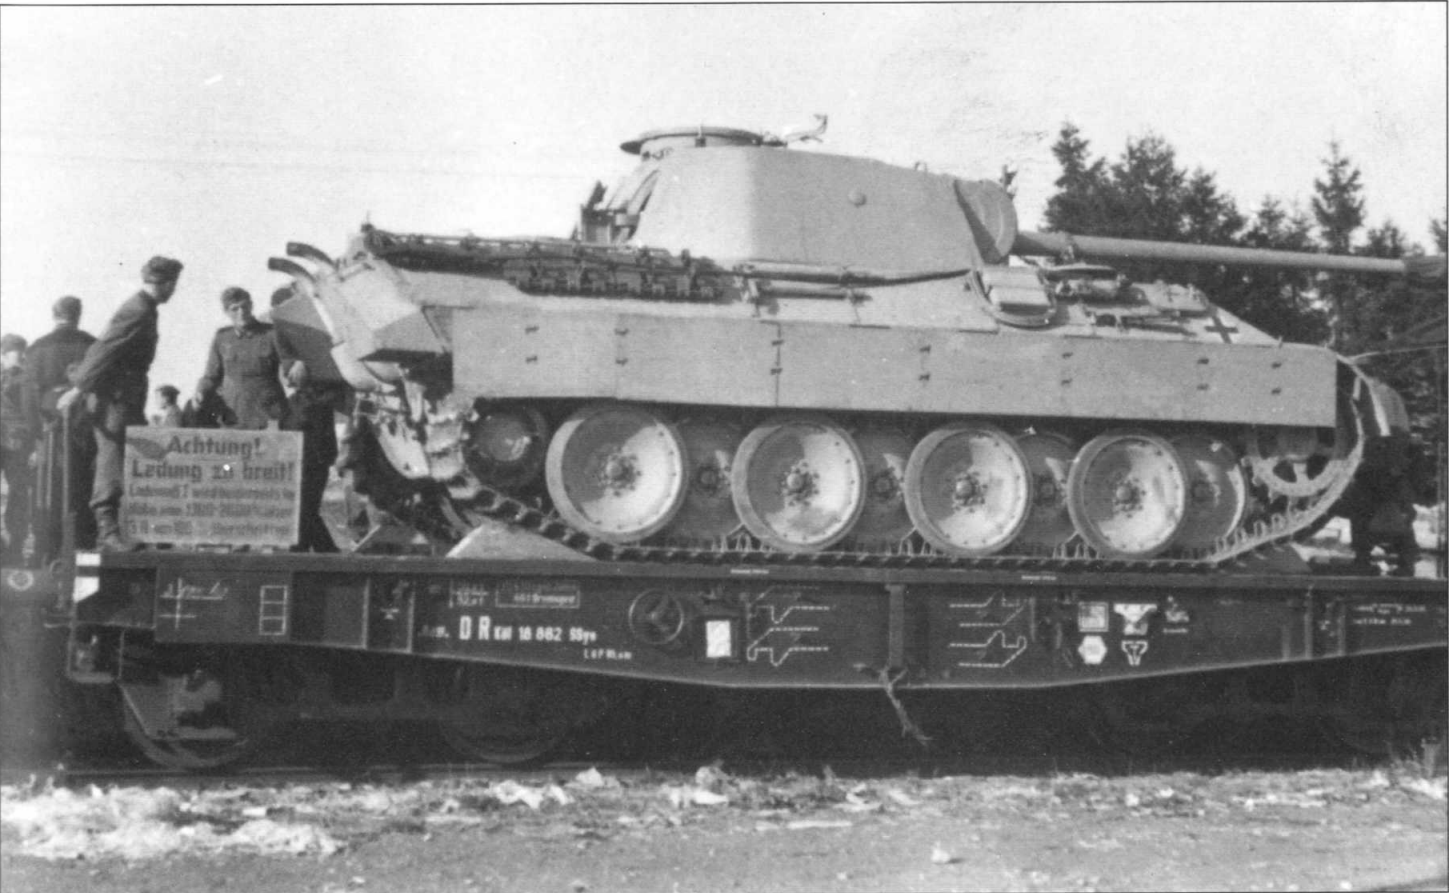
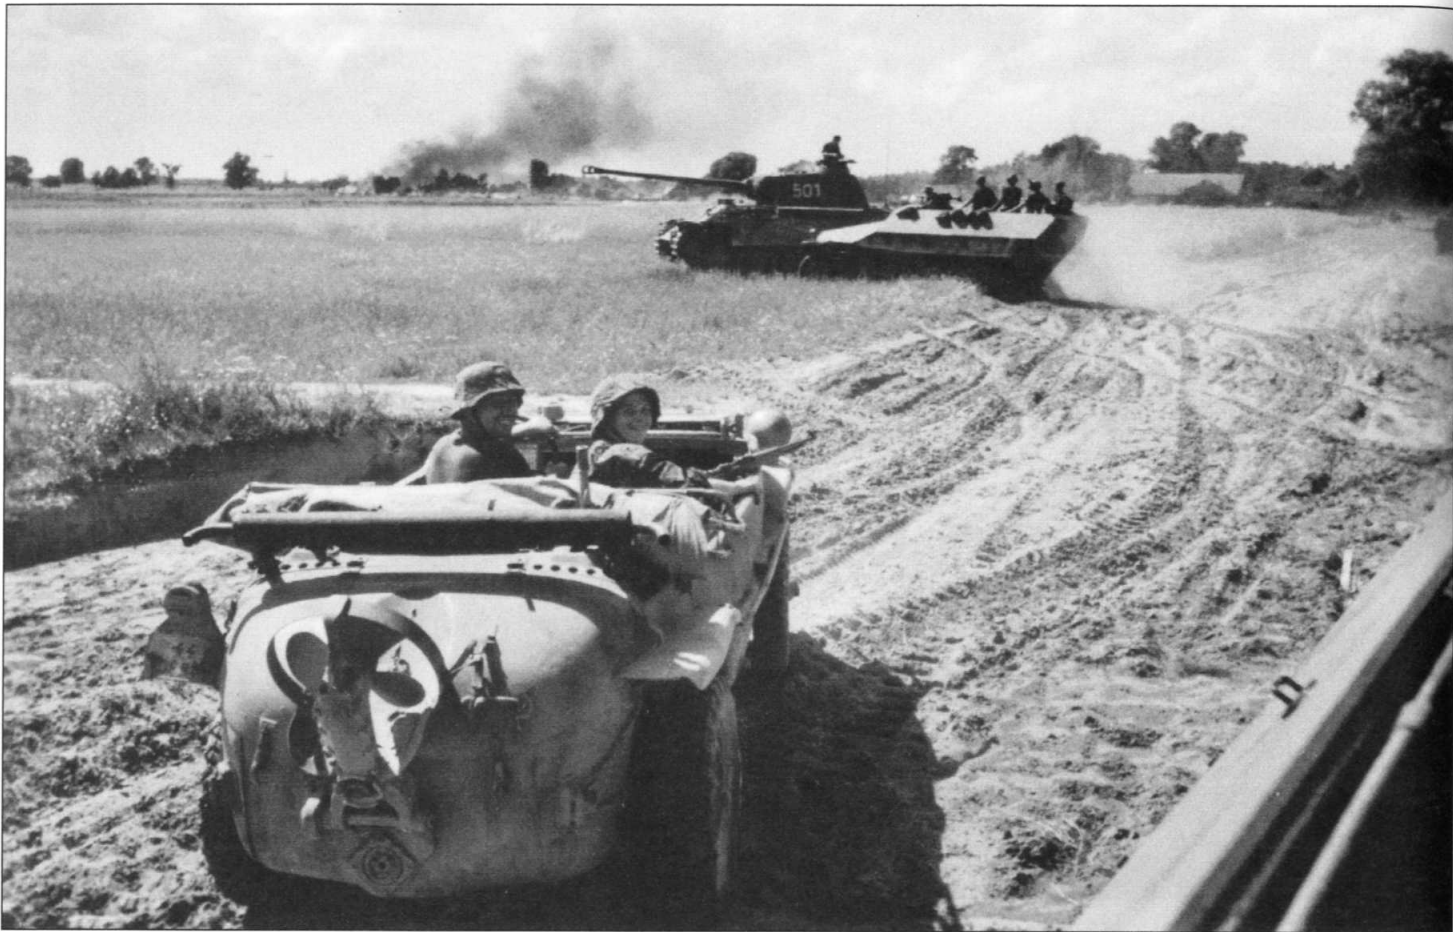
Two photographs showing Panthers being transported by rail to the front line. Transporting armour by rail was undertaken frequently in Russia by the *Panzerwaffe*. Not only did it save time on the huge distances that had to be covered, but it also allowed Panzer divisions to move from one part of the front to another quickly and effectively. In fact, a principal factor in the success of the Panzer divisions speed and mobility was attributed to rail transport.

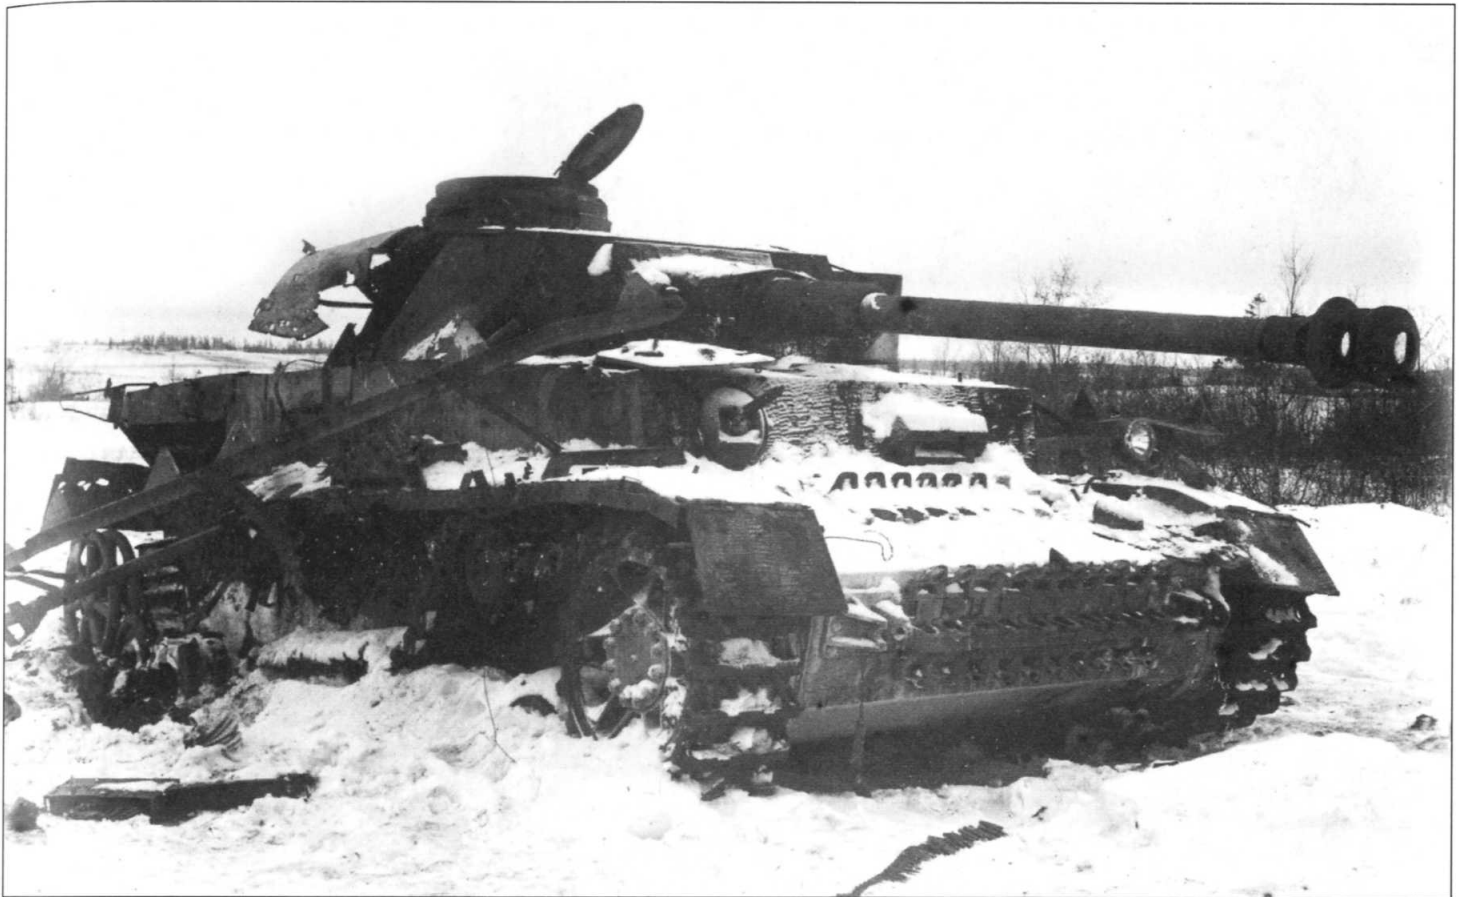
A knocked out PzKpfw IV in the snow. This tank has more than likely been hit by an anti-tank shell to the side of the vehicle and as a result the impact has blown part of the track off. Other damage is also visible along the side of the tank.

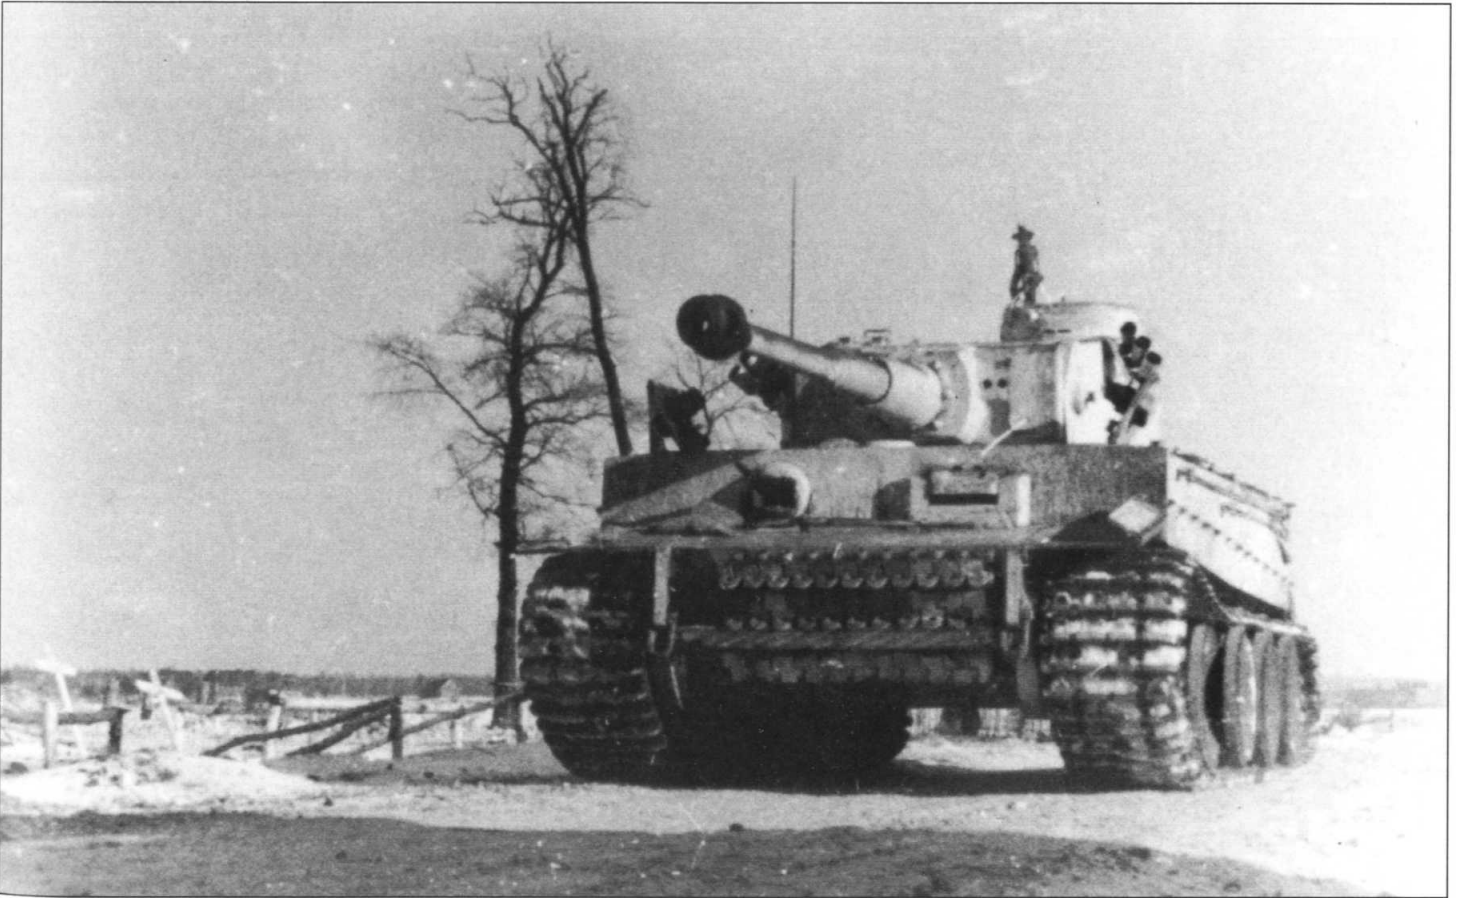
A Tiger I moves along a snow-covered road bound for the front line. This vehicle is well camouflaged with a good overall application of winter whitewash paint. Track links have been bolted to the front of the tank for additional armoured protection.

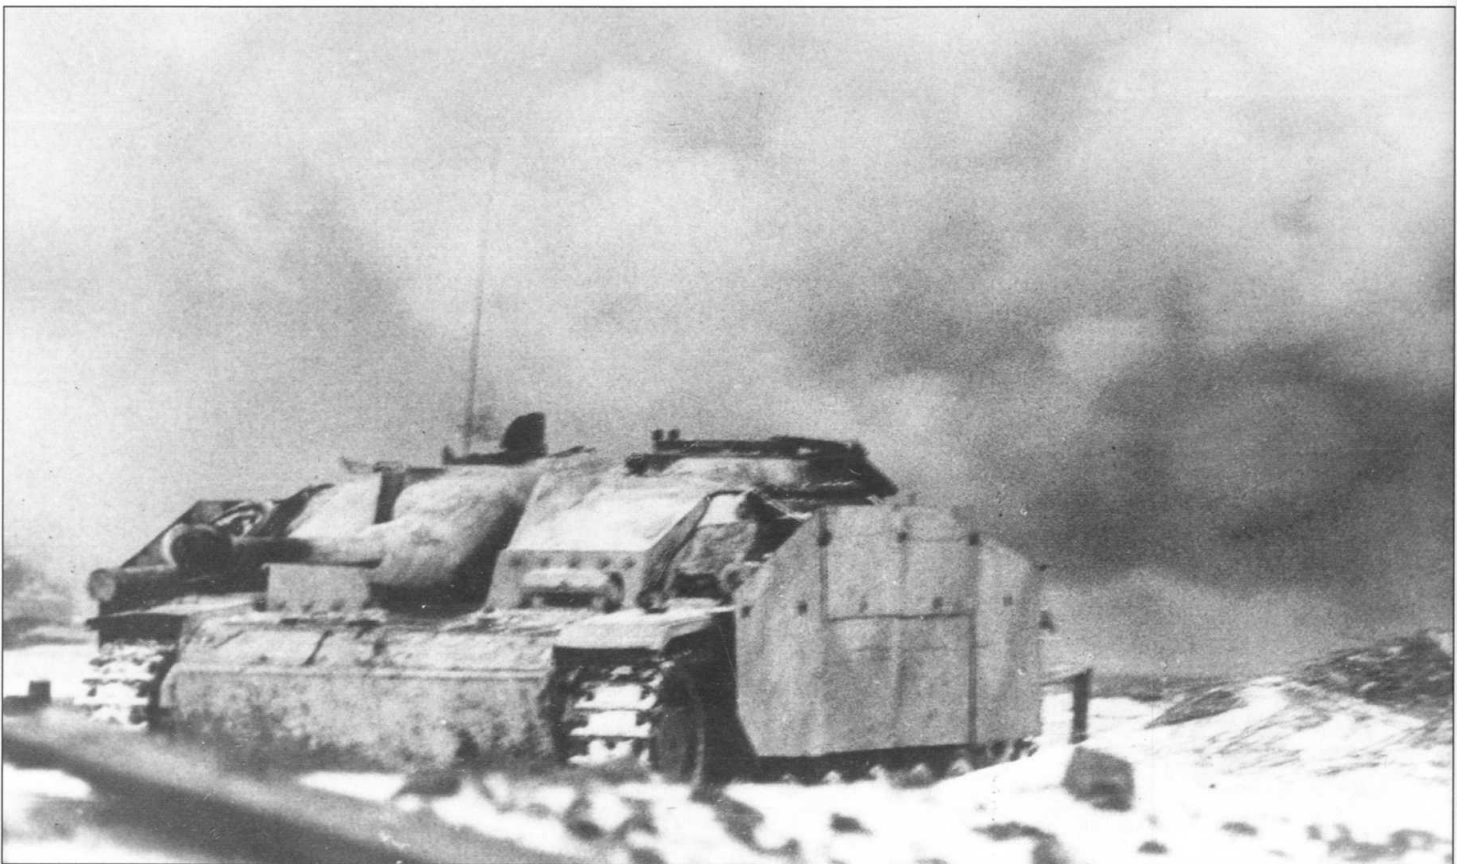
This photograph shows a StuG III Ausf G assault gun in the thick of battle. This vehicle is armed with a 7.5cm StuK 40 L/48 cannon, which both necessitated modification of the frontal superstructure and increased the overall weight to 21.3 tons.

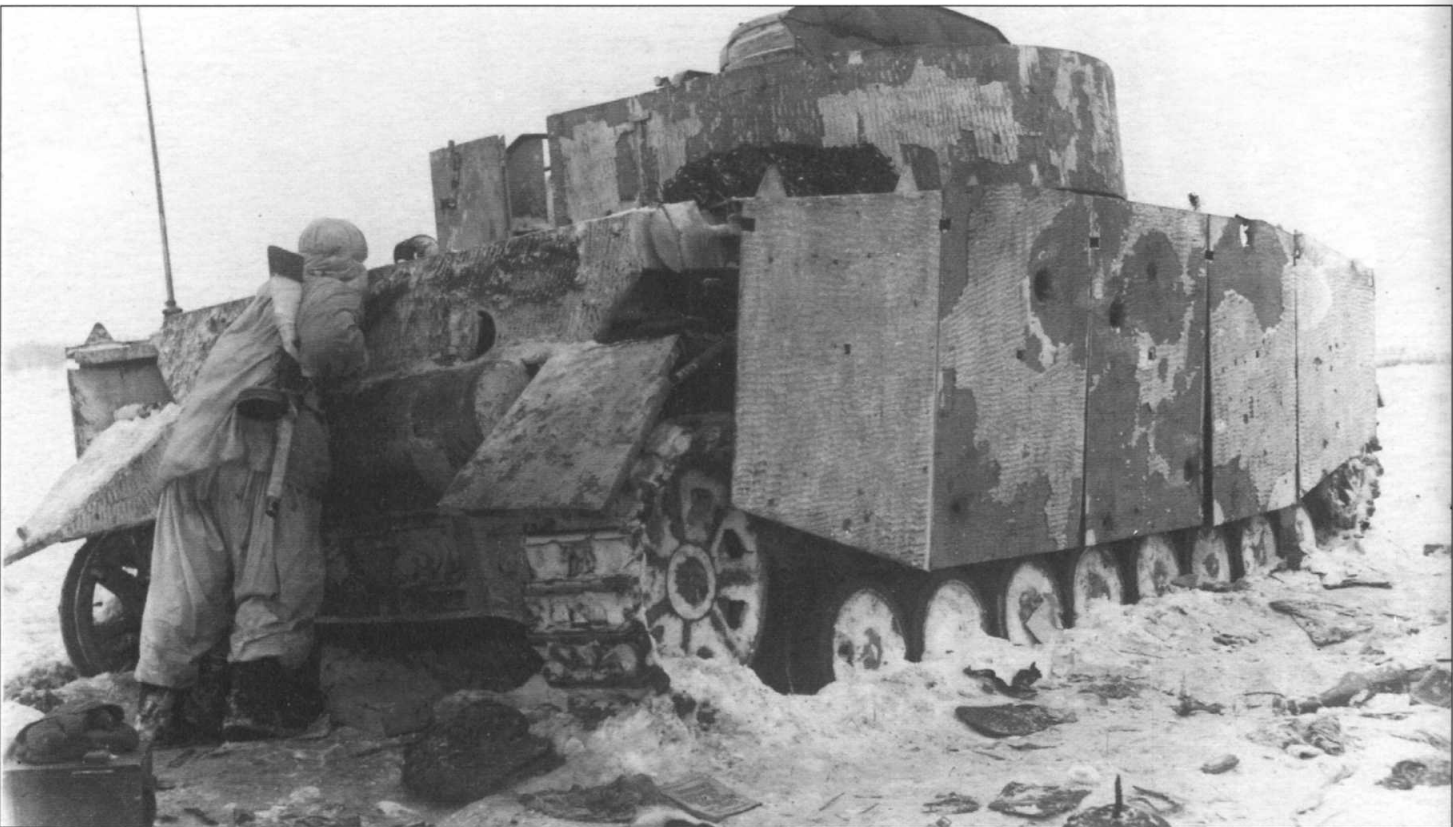
A grenadier takes cover behind a knocked out late variant PzKpfw IV during winter operations in 1944. It is evident from the number of shell holes in the tank's side skirts that it has been embroiled in a heavy contact with the enemy. The vehicle has probably had an internal fire as much of the Zimmerit and whitewash paint can be seen burnt off.

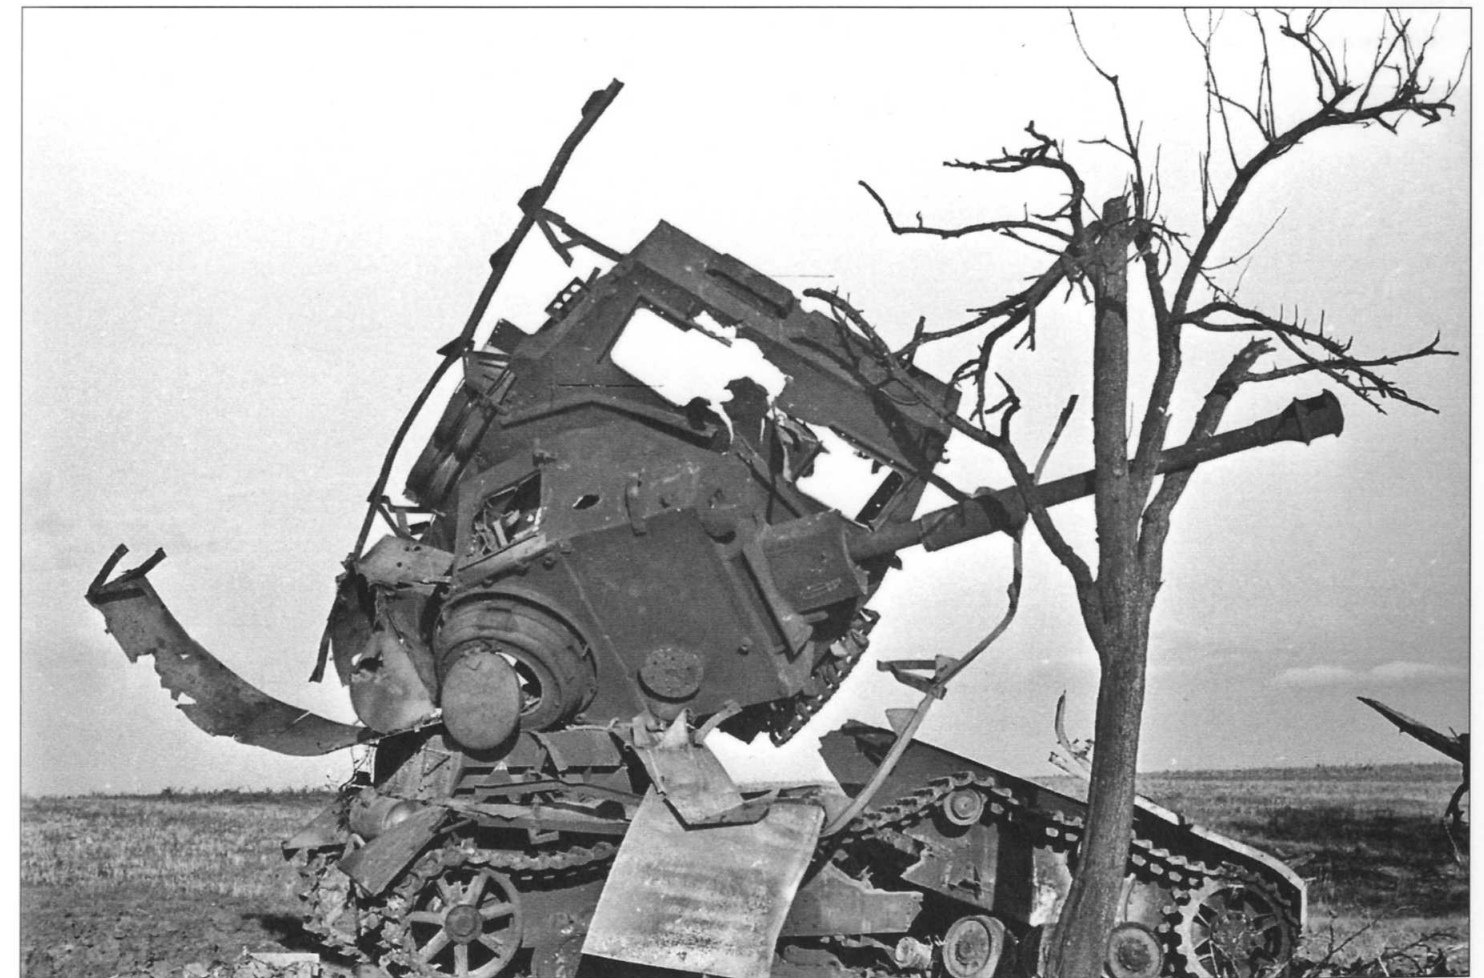
A completely destroyed PzKpfw IV stands twisted next to a charred tree. This Panzer has evidently suffered a violent explosion on board with its turret virtually blown off. Amazingly the vehicle's tracks are still intact.

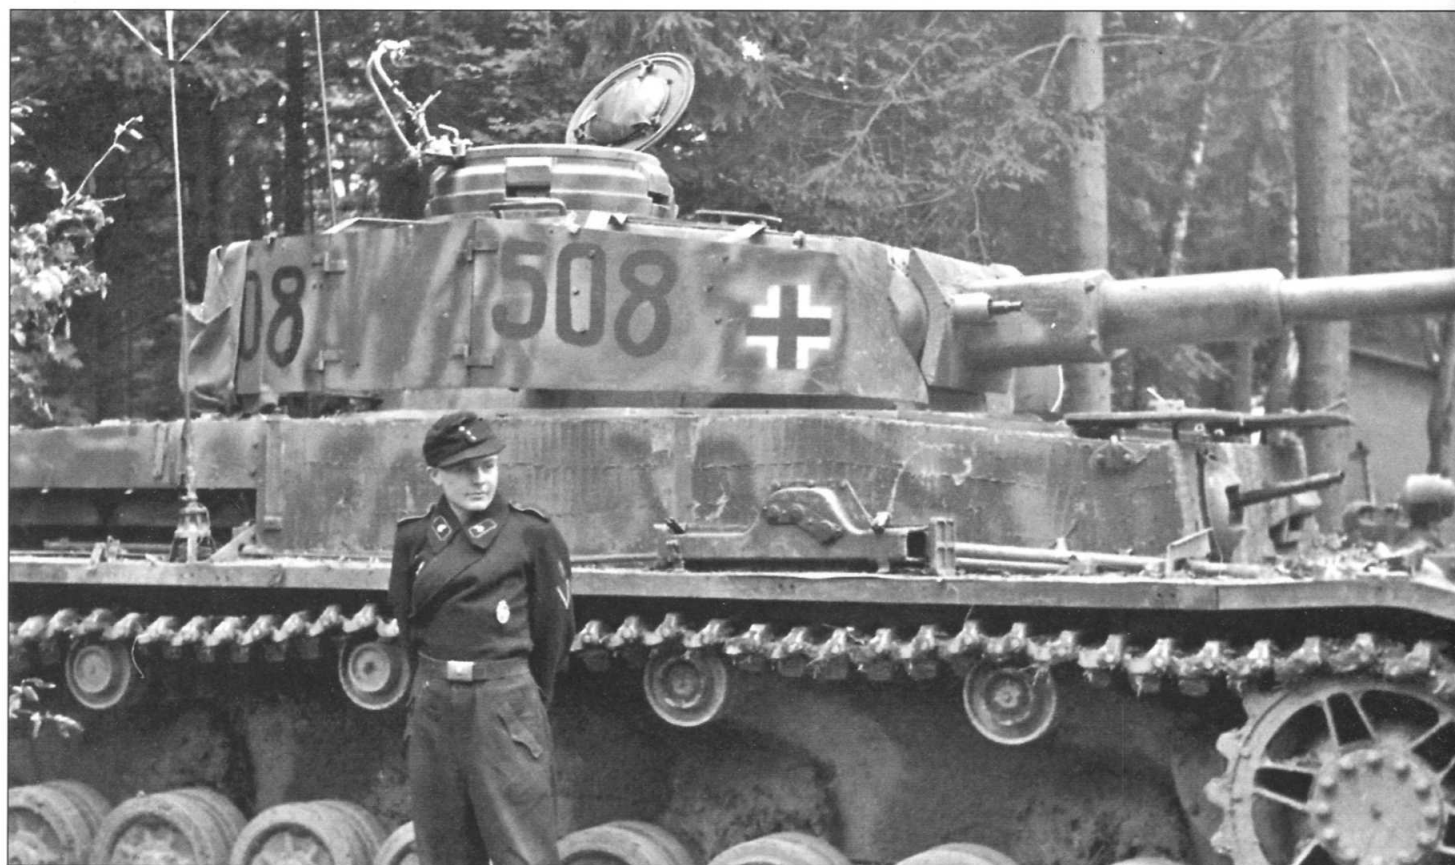
An interesting photograph showing a crewman posing for the camera in front of his PzKpfw IV Ausf G command tank in the summer of 1944. Note the coating of Zimmerit plaster coating on the vehicle, and the spaced armour plates around the turret, plus the star antenna.

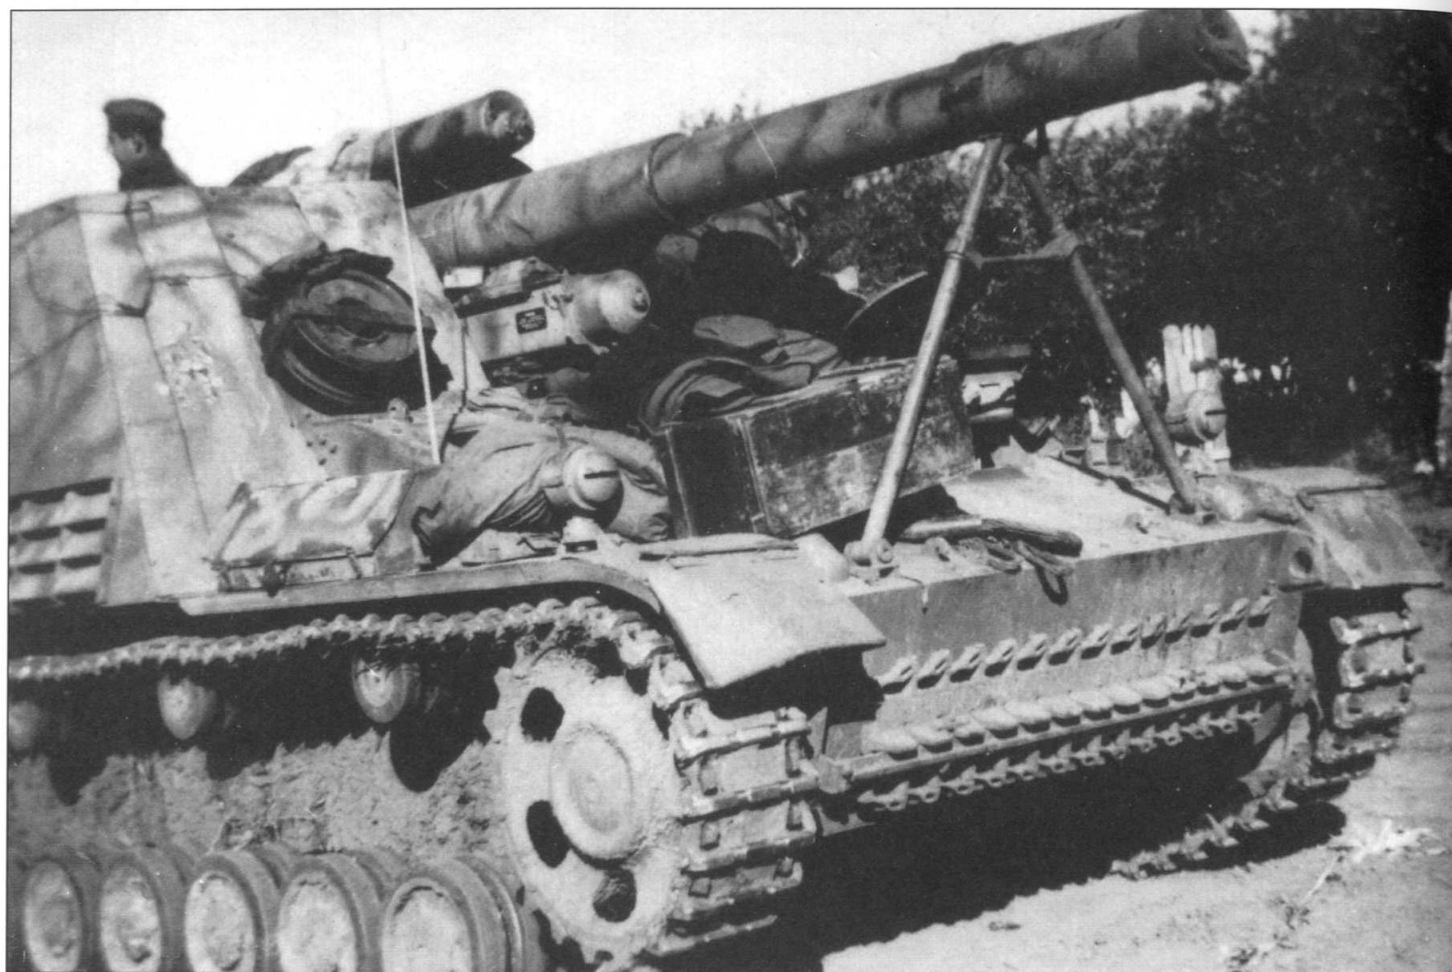
A Hummel on the move to join its battery during defensive operations in the east. This vehicle can clearly be seen carrying a number of various provisions under the 15cm gun on the frontal deck, including rolled up canvas sheeting used to help protect the crew against the weather.

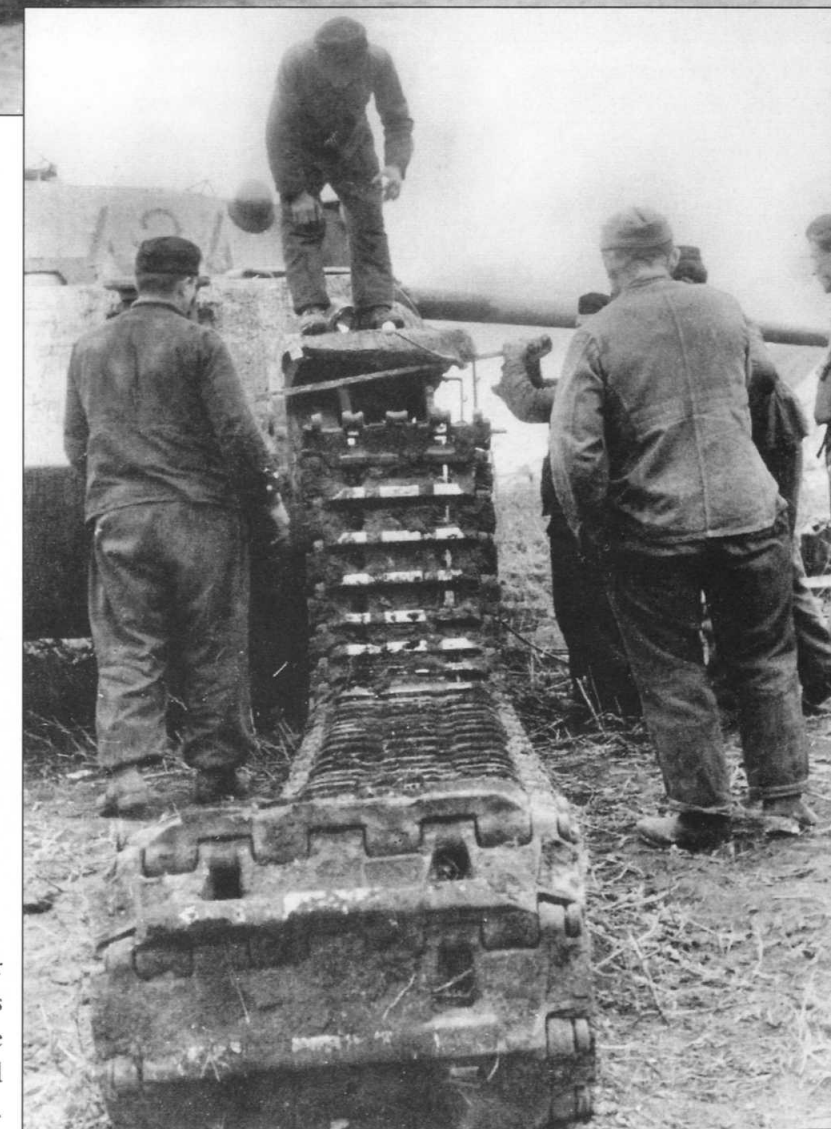
A Panther crew is preparing to change tracks for cross-country combat operations. The Panther tracks were fitted with chevroned cleats intended to increase traction and reduce slipping on icy conditions and on hard surfaces such as concrete and cobblestones.

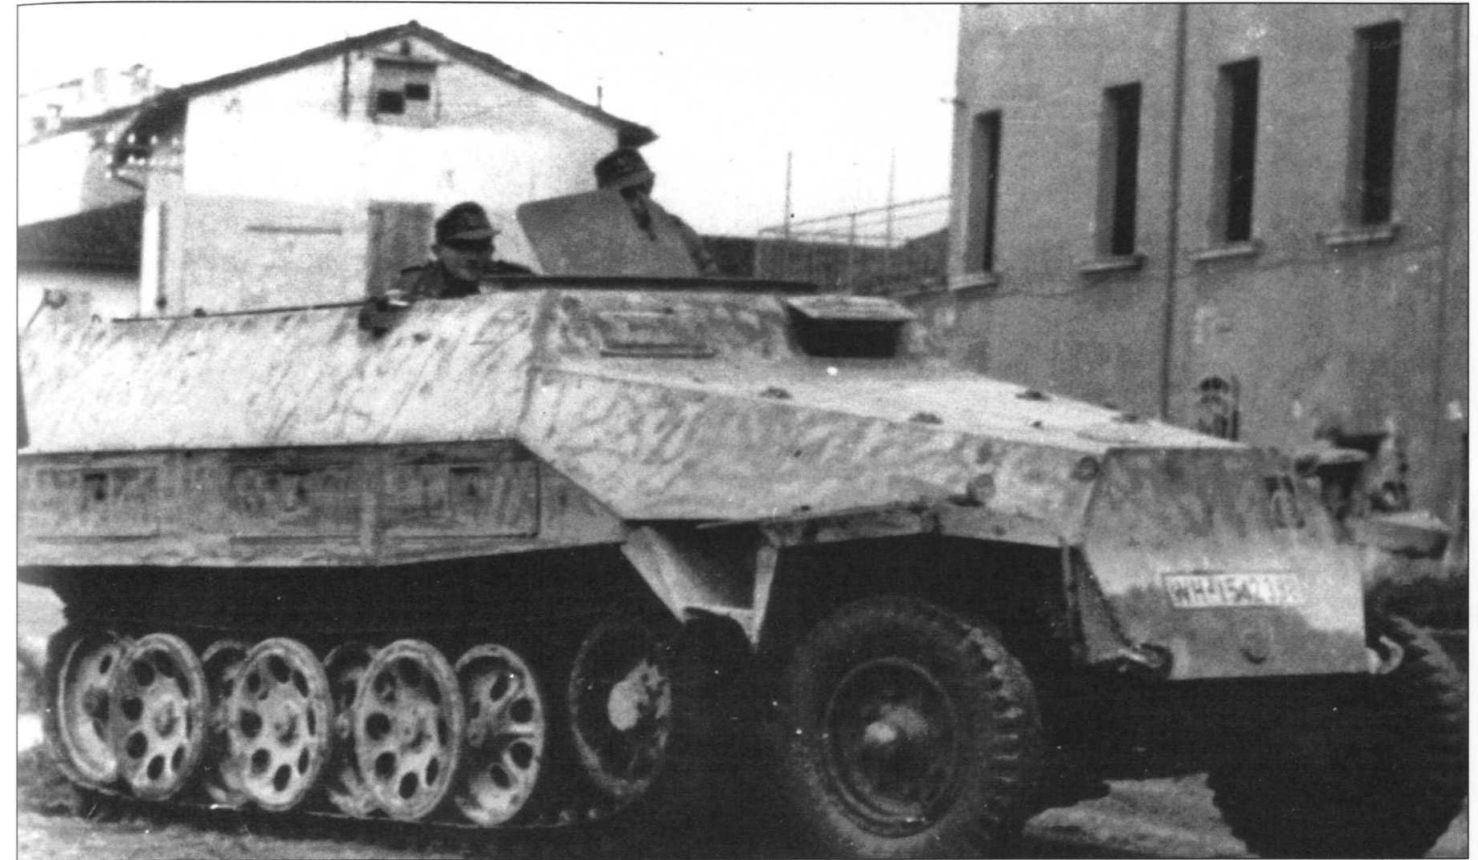
An SdKfz 251 makes its way through a village during intensive heavy fighting in western Poland in 1944/45. The SdKfz 251 had become not just a half-track intended to simply transport infantry to the edge of the battlefield, but also a fully-fledged fighting vehicle. [Michael Cremin]

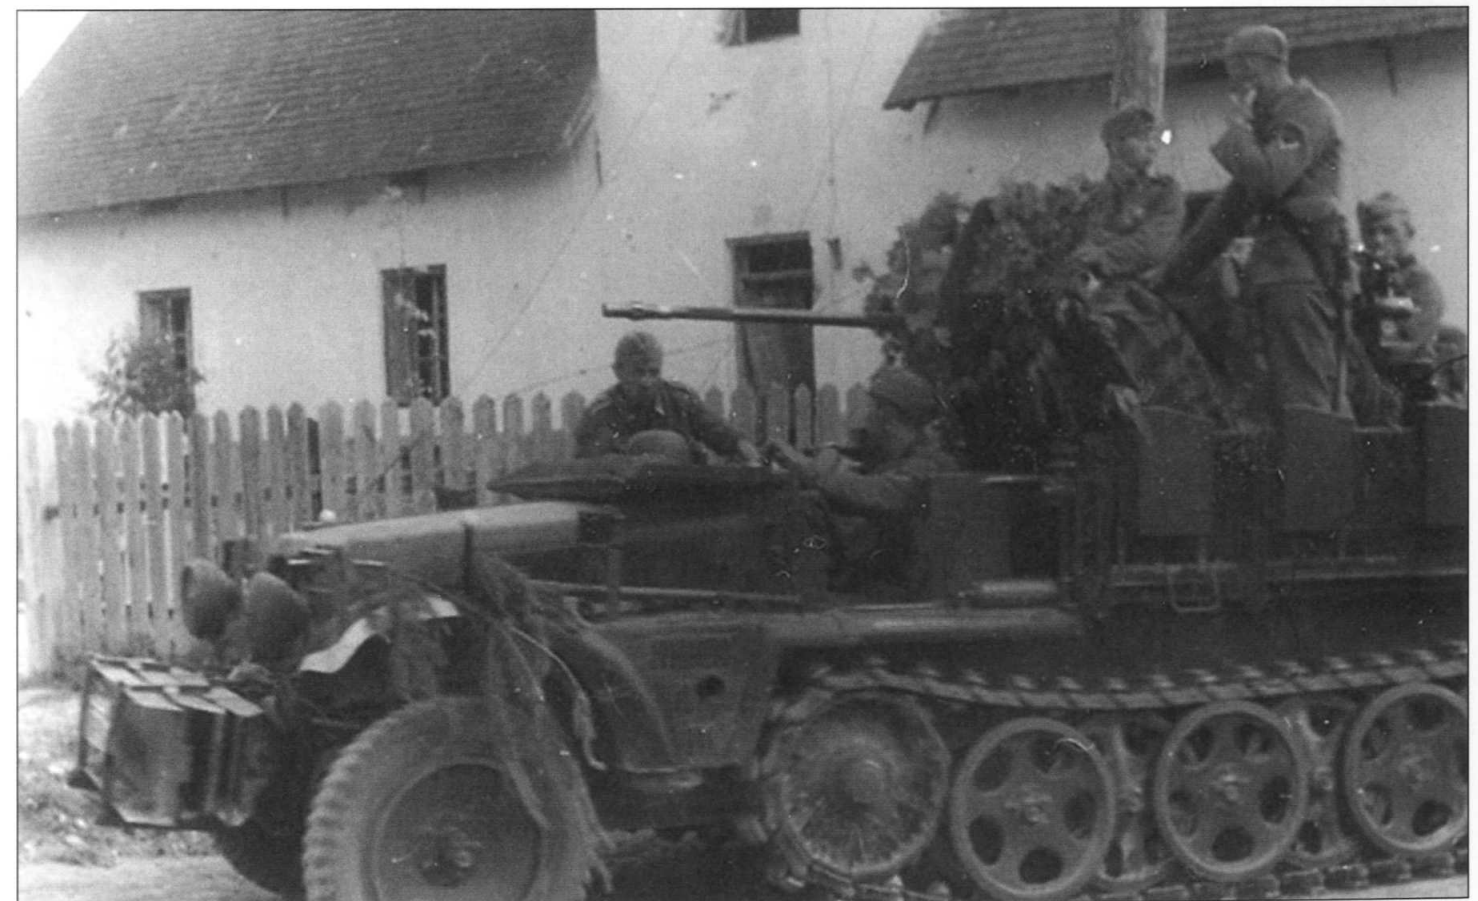
An SdKfz 10 advances through a destroyed village. This vehicle mounts a shielded 2cm Flak 30. Note the magazine containers on the drop sides. By 1944 both Wehrmacht and Waffen-SS mechanized formations were well-equipped with flak guns.

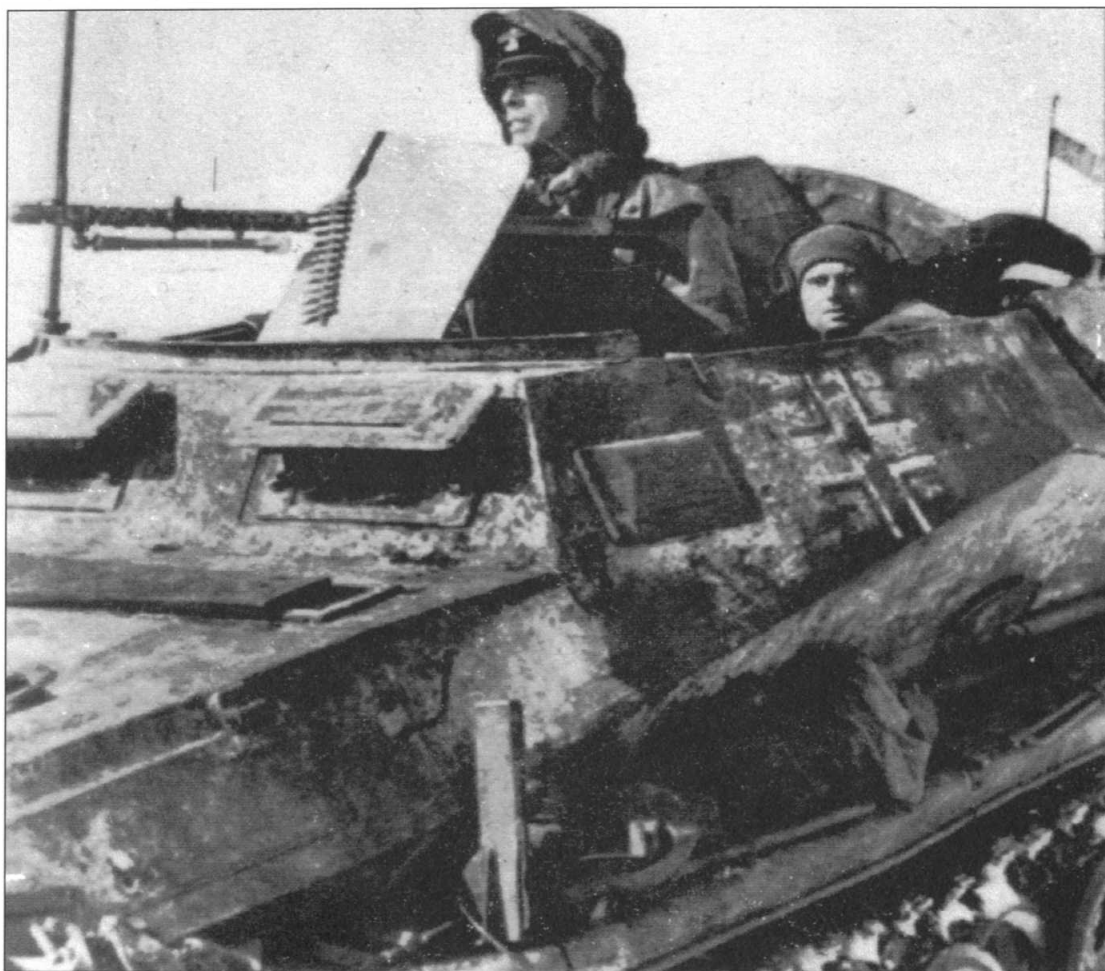
Two crewmembers can be seen inside an SdKfz 250 during operations in Poland in late 1944. This whitewashed vehicle is armed with an MG34 machine gun with splinter shield.
