STEEL BULWARK

THE LAST YEARS OF THE
GERMAN PANZERWAFFE
ON THE EASTERN FRONT 1943–45
A photographic history

Ian Baxter

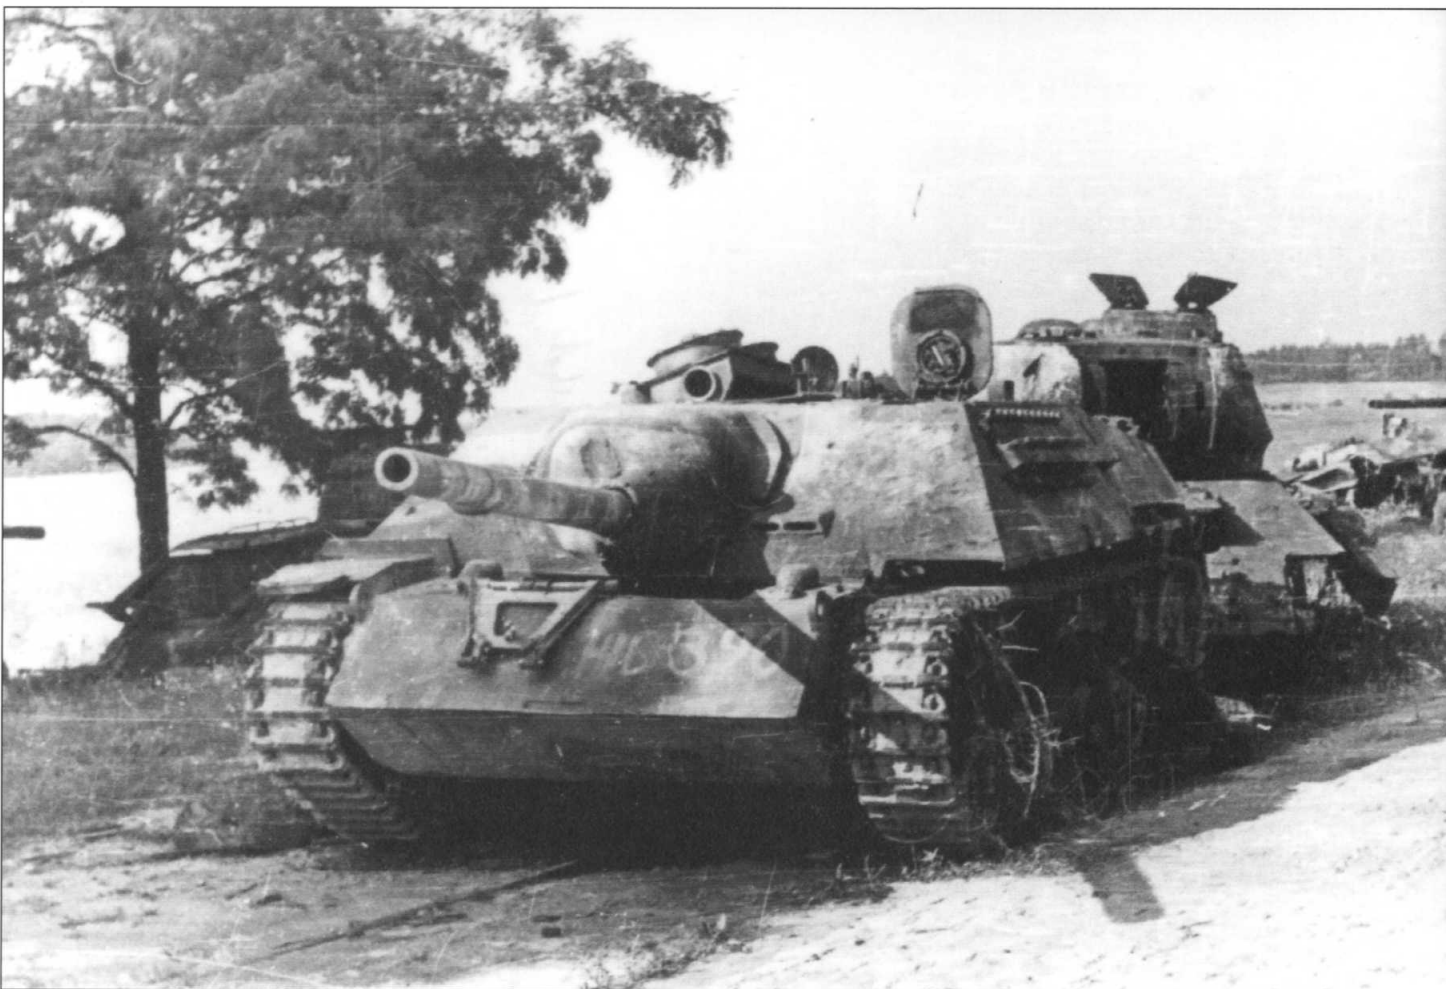
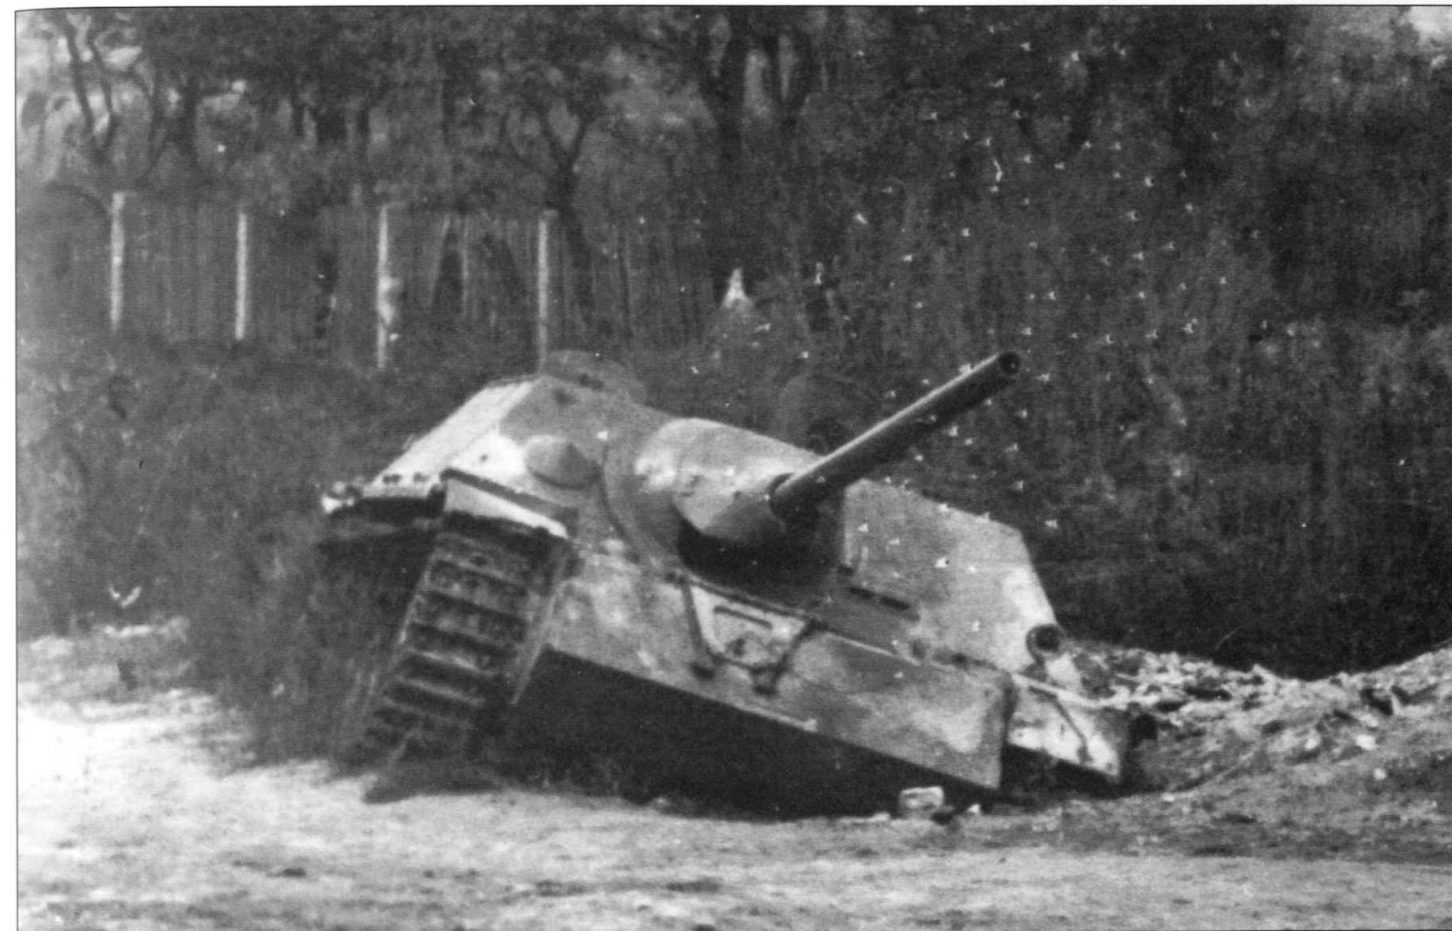
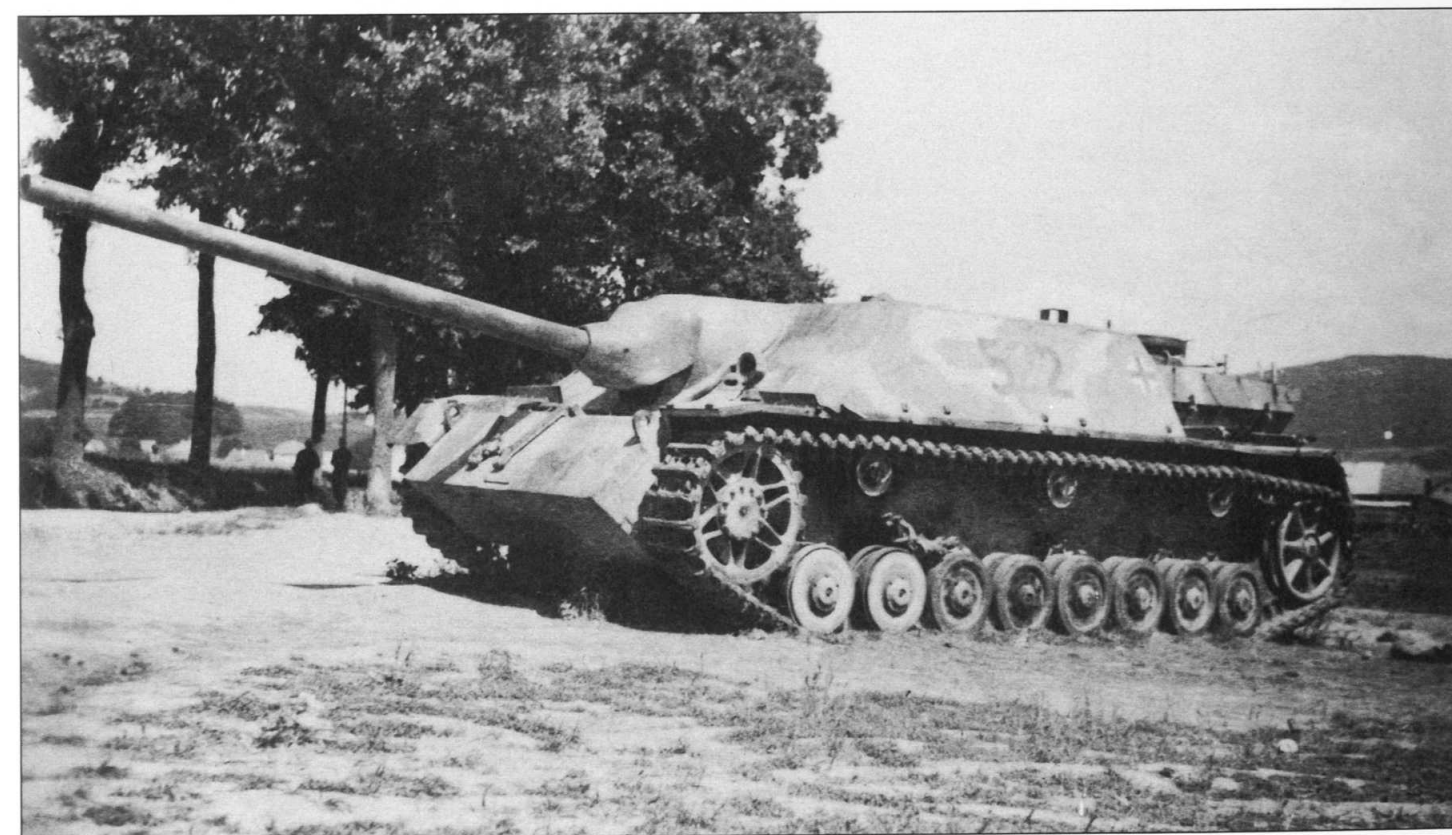
Three photographs showing abandoned Jagdpanzer IV's. With a drastic need for new armoured fighting vehicles, more second generation tank destroyers were built. One such vehicle that came off the production line in 1944 was the Jagdpanzer IV. This vehicle, built on the chassis of a PzKpfw IV, weighed 28.5 tons and was nicknamed 'Guderian's duck'. The vehicle was equal to any enemy tanks thanks to its potent 7.5cm gun. The Jagdpanzer saw extensive service in the east and with its reliability and well-sloped thick frontal armour it became a highly efficient fighting vehicle, if only for a short period of time.

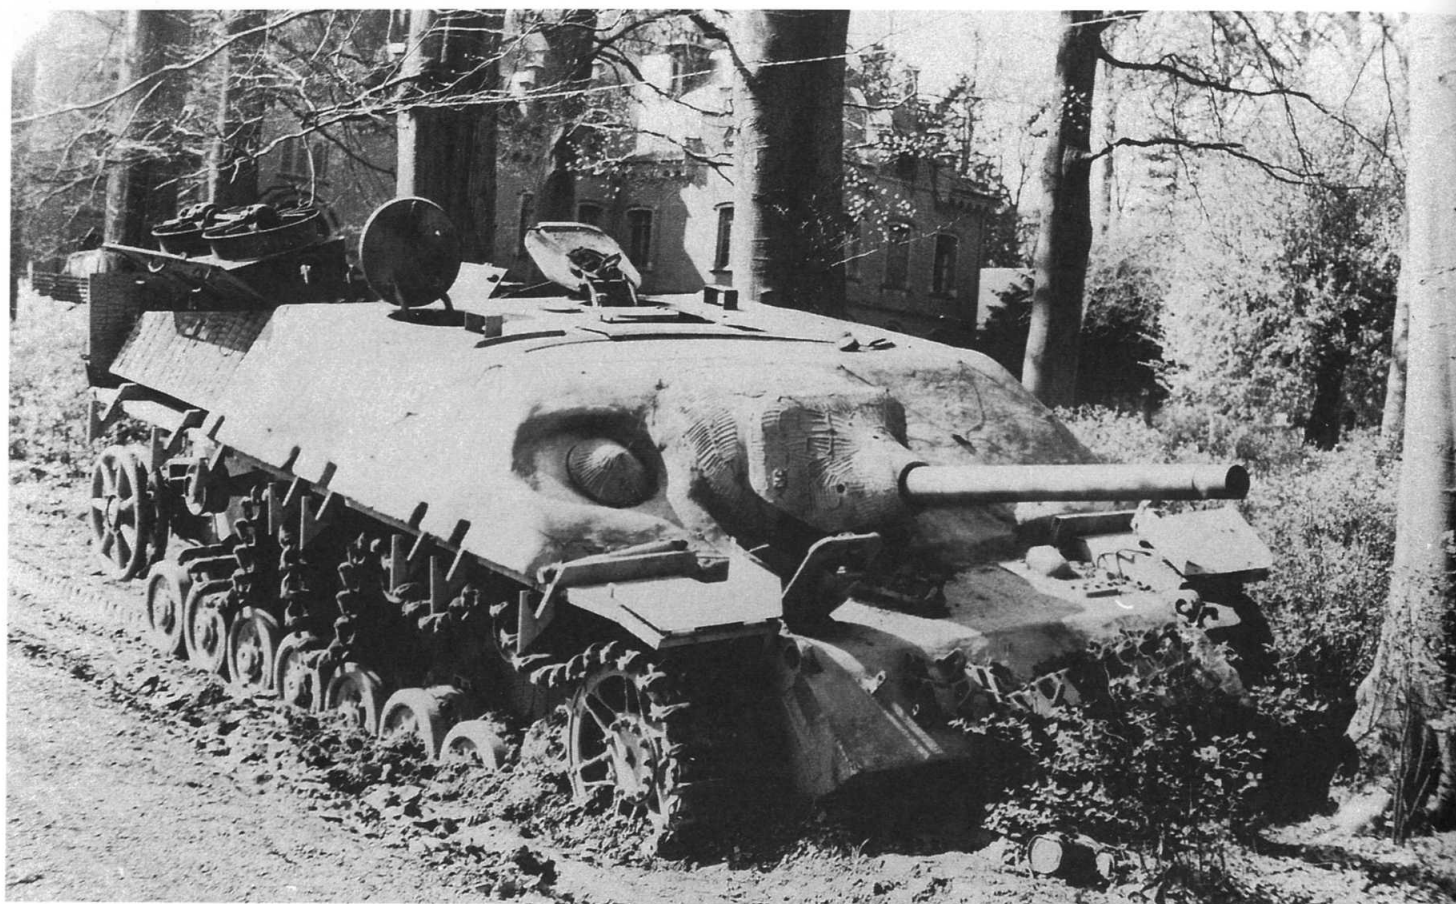
Another abandoned Jagdpanzer IV armed with the PaK 39 L/48. Note the engine doors at the rear of the vehicle are open showing the fans for the powerful Maybach HL120 TRM engine.

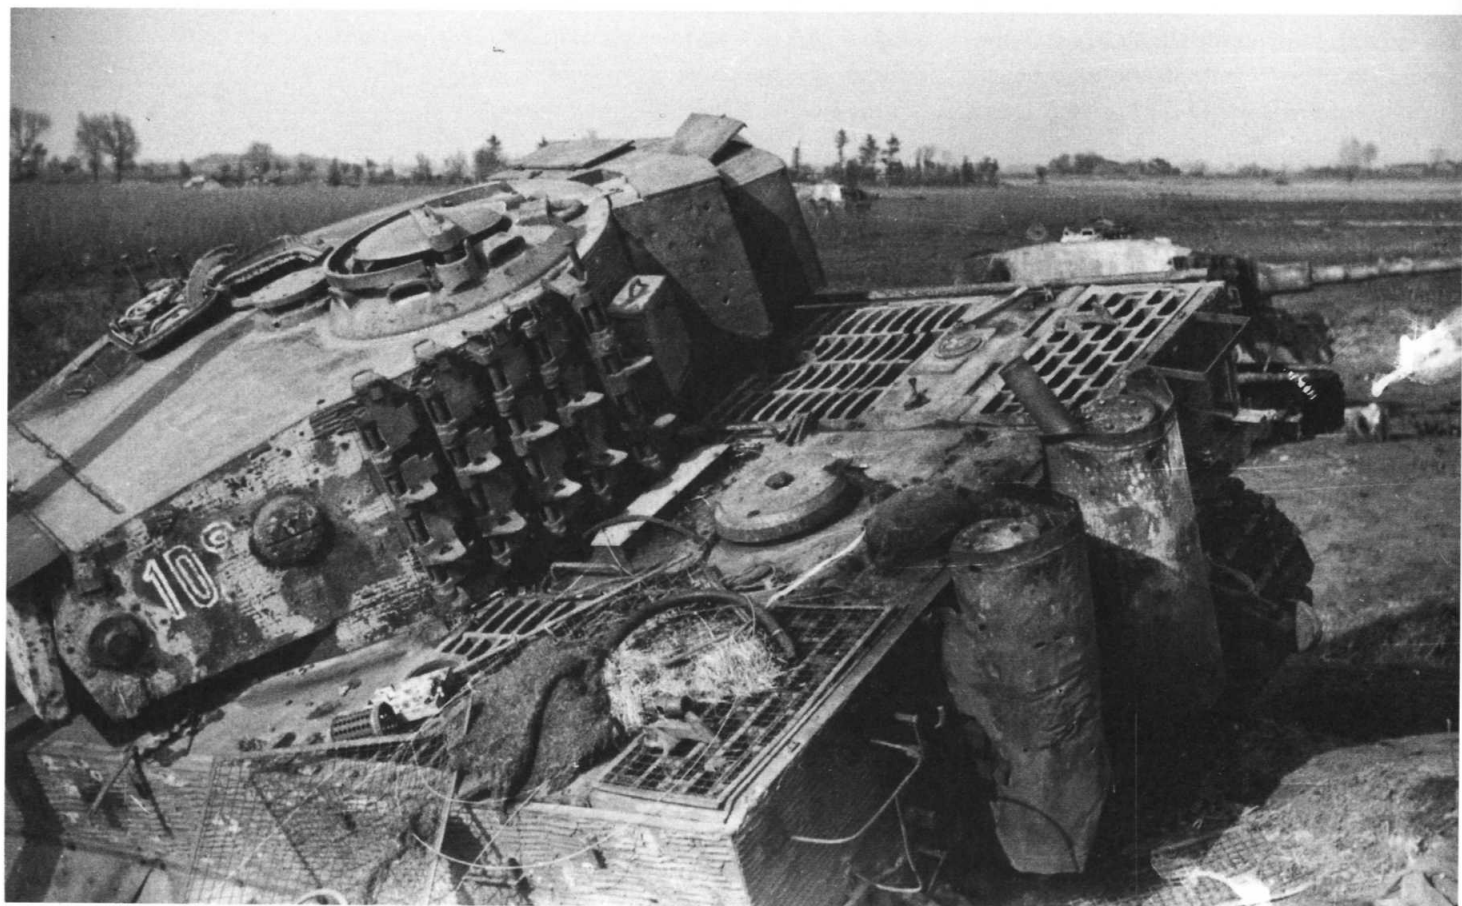
A knocked out Tiger I east of Berlin in April 1945. This Tiger may possibly be from the SS schwere Panzer Abteilung 503 which fought in this area against the advancing Red Army.

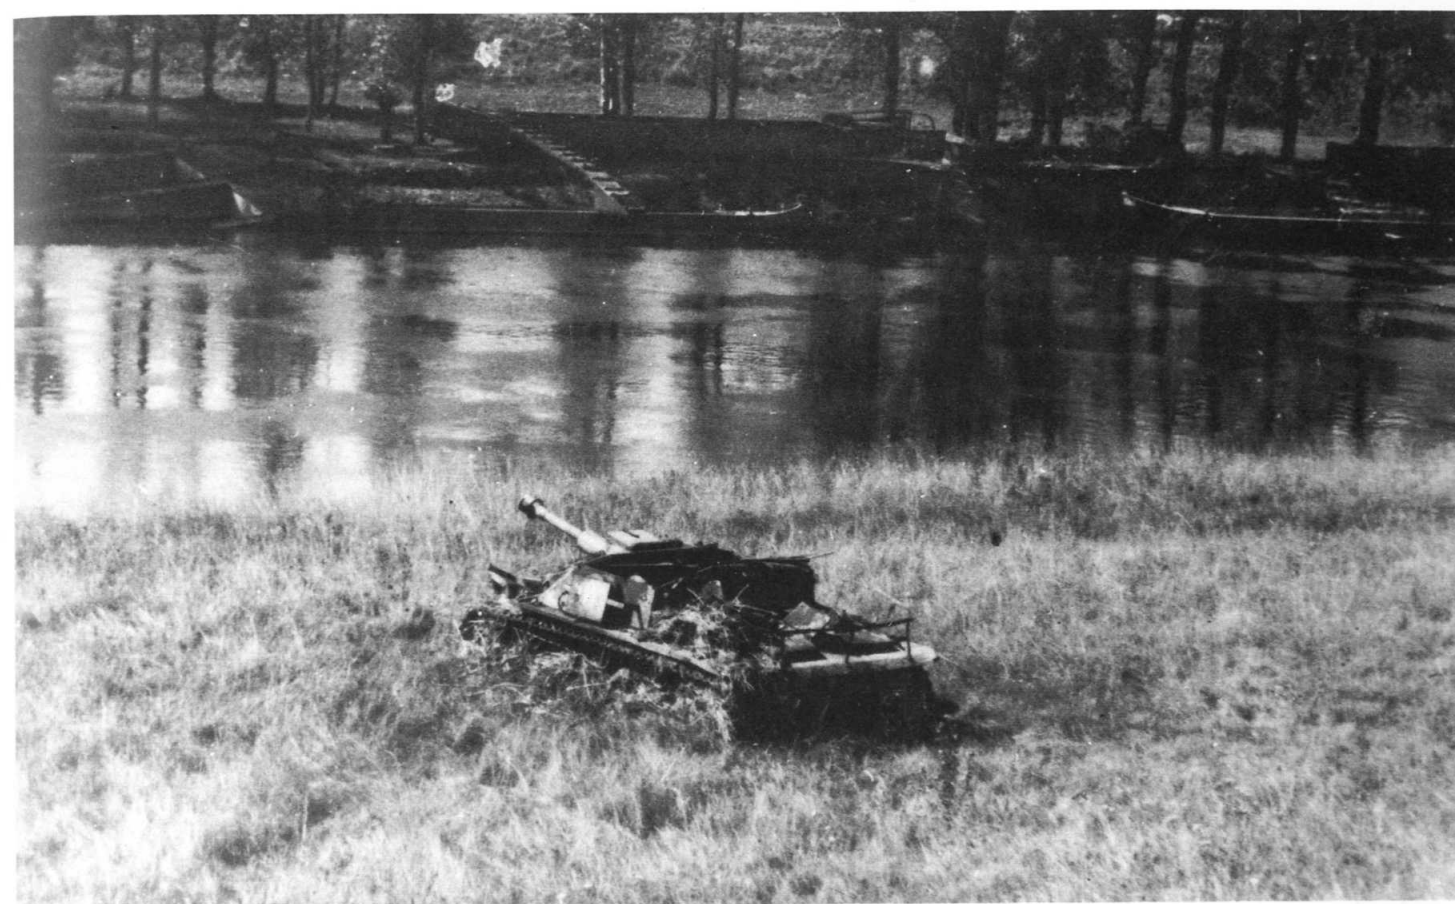
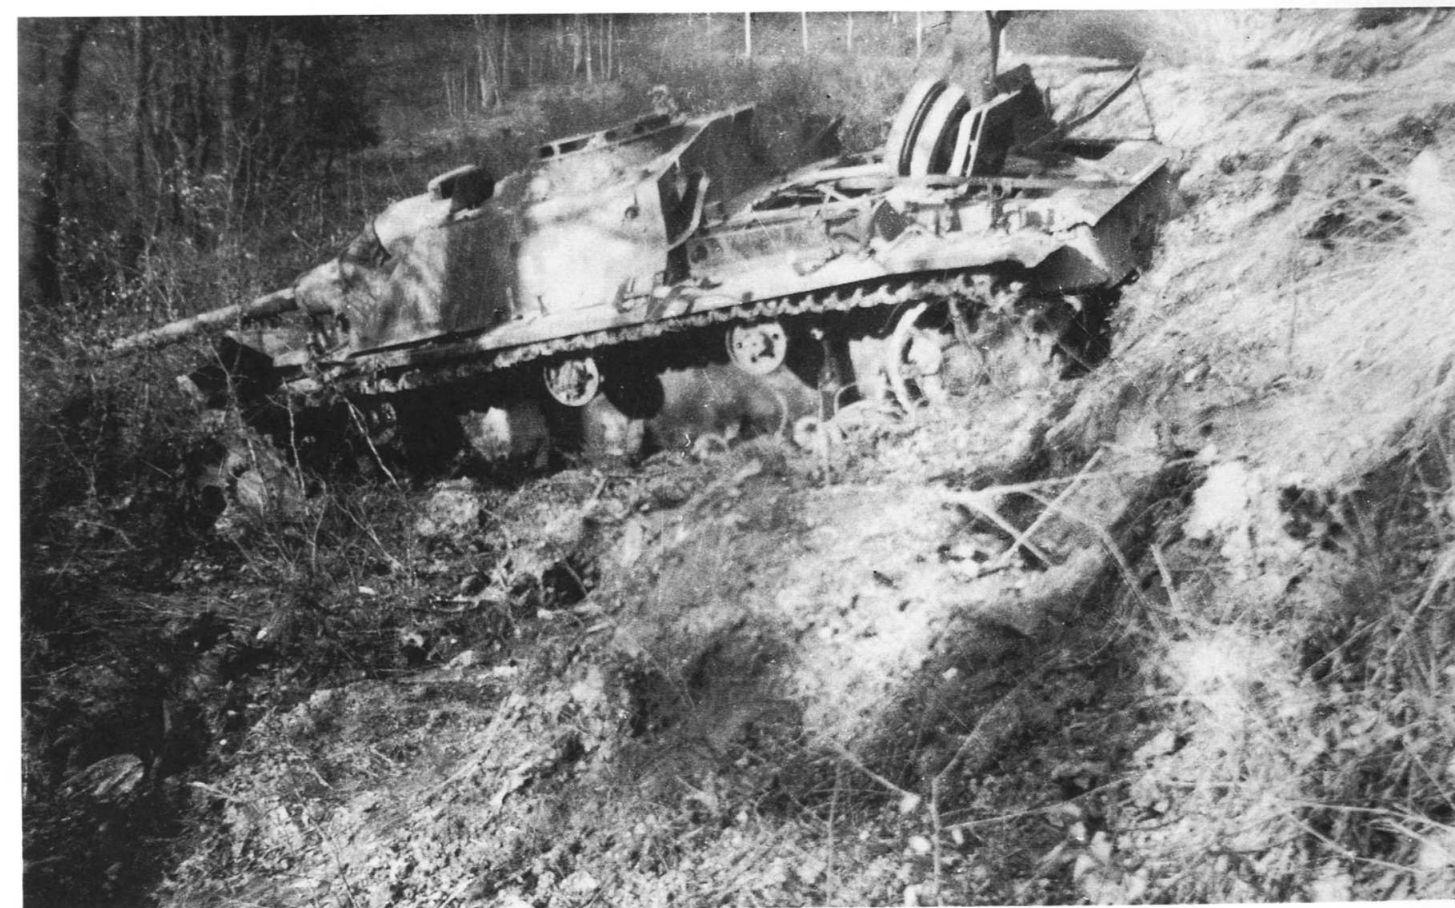
Two photographs showing abandoned StuG III's in the early spring of 1945. During the last two years of the war the StuG was gradually called upon for offensive and defensive fire support, where it was gradually embroiled in an anti-tank role trying to stem the might of the Red Army. During the last weeks of the war as fuel and spare parts became scarce many StuG's were either destroyed or simply abandoned by the crews.
