TOTAL DETAIL

Sd Kfz 252, 253 & early 250

Sd Kfz 252, 253 & 250 (Typ 1)

Volume 3 - Part 1

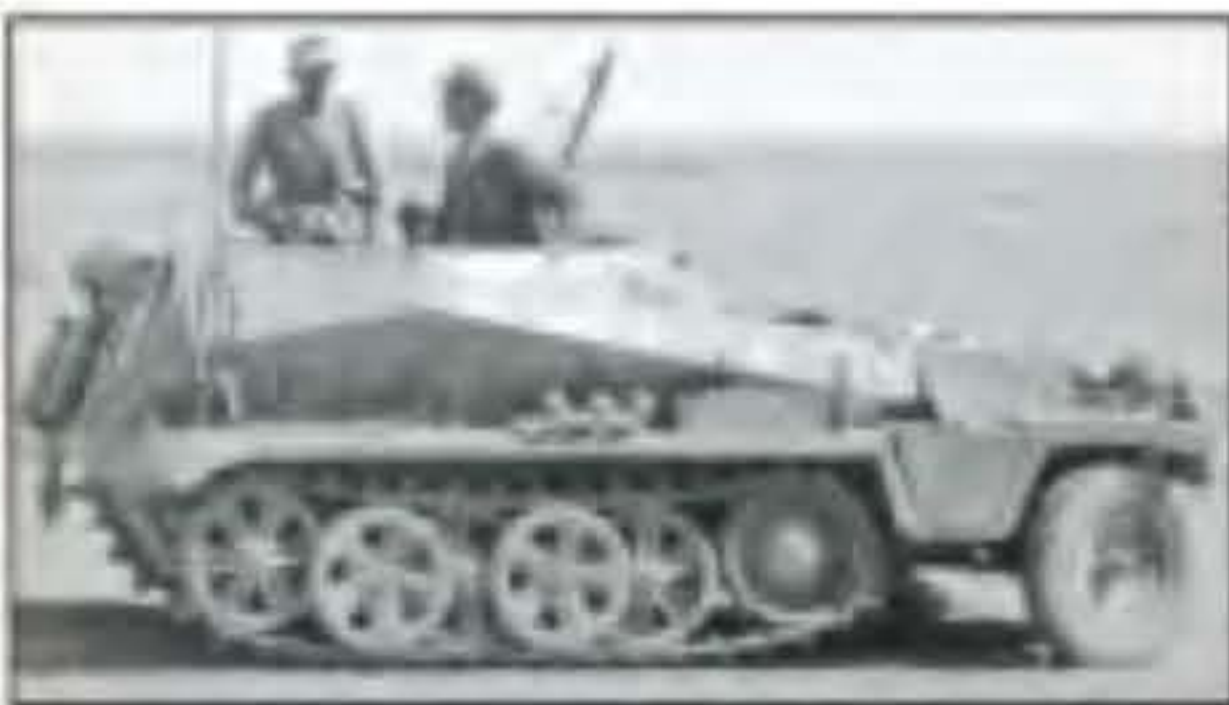
First production Sd Kfz 250s - see page 203

Built June / July 1941

Using converted 253 bodies with all the latest upgrades from the 252 and 253 series production

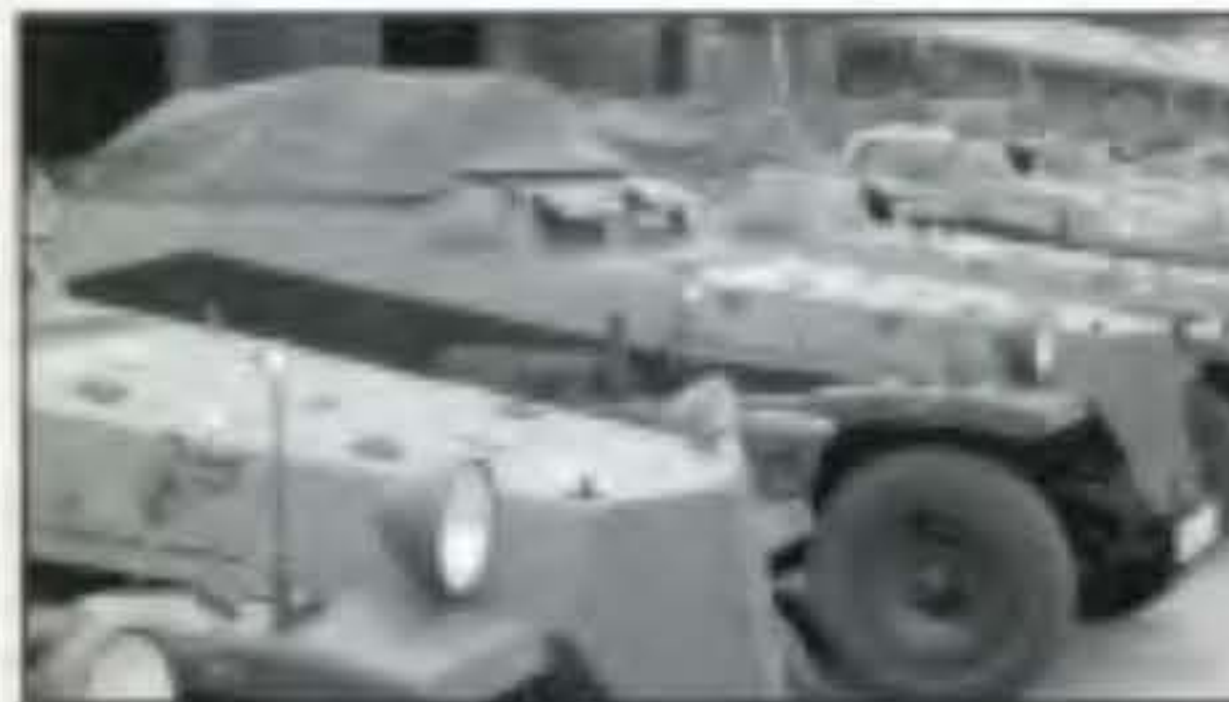
Last production 250s based on 253 body - see page 226

Built July / August 1941

Re-positioned tools

(Would have been late style 253s but I have not found photographs to show 253s with these detail changes)

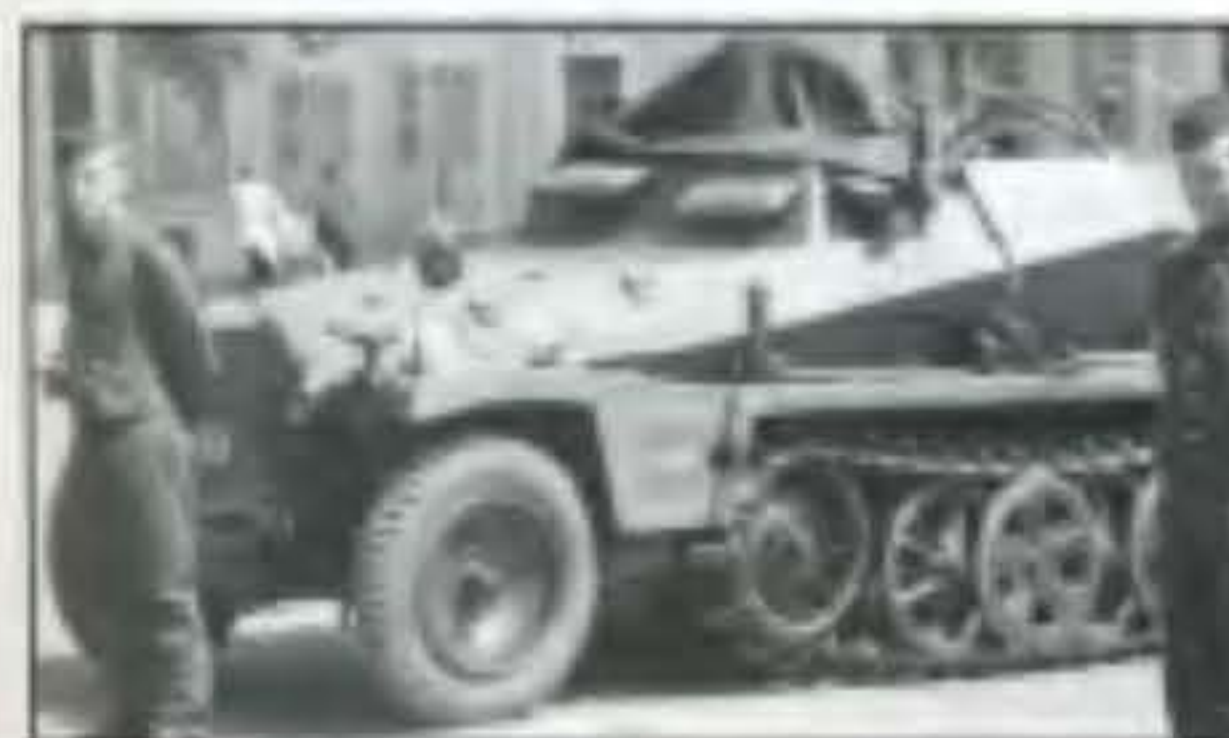
First production 250 Typ 2 - 250 Archive Book Part 2 - Page 9

Built August / September 1941

Mid production vehicles adopted the manual gearbox

Mud and track guards, as per Typ 2 but no beaded edge

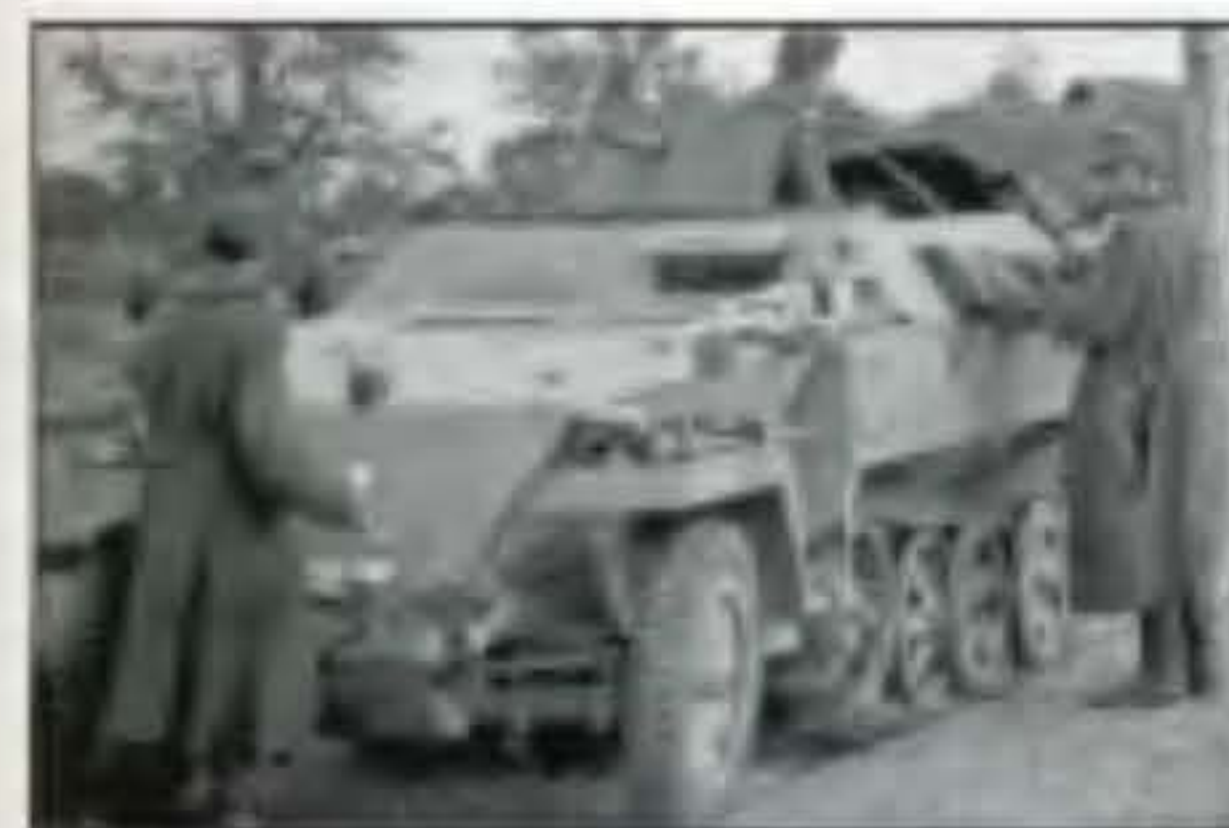
First production 250 Neu - 250 Archive Book part 2 - Page 144

Built from August 1943 in service September / October 1943

Manual gearbox fitted as standard

Possible run out of old rivetted chassis' used on early Neus.

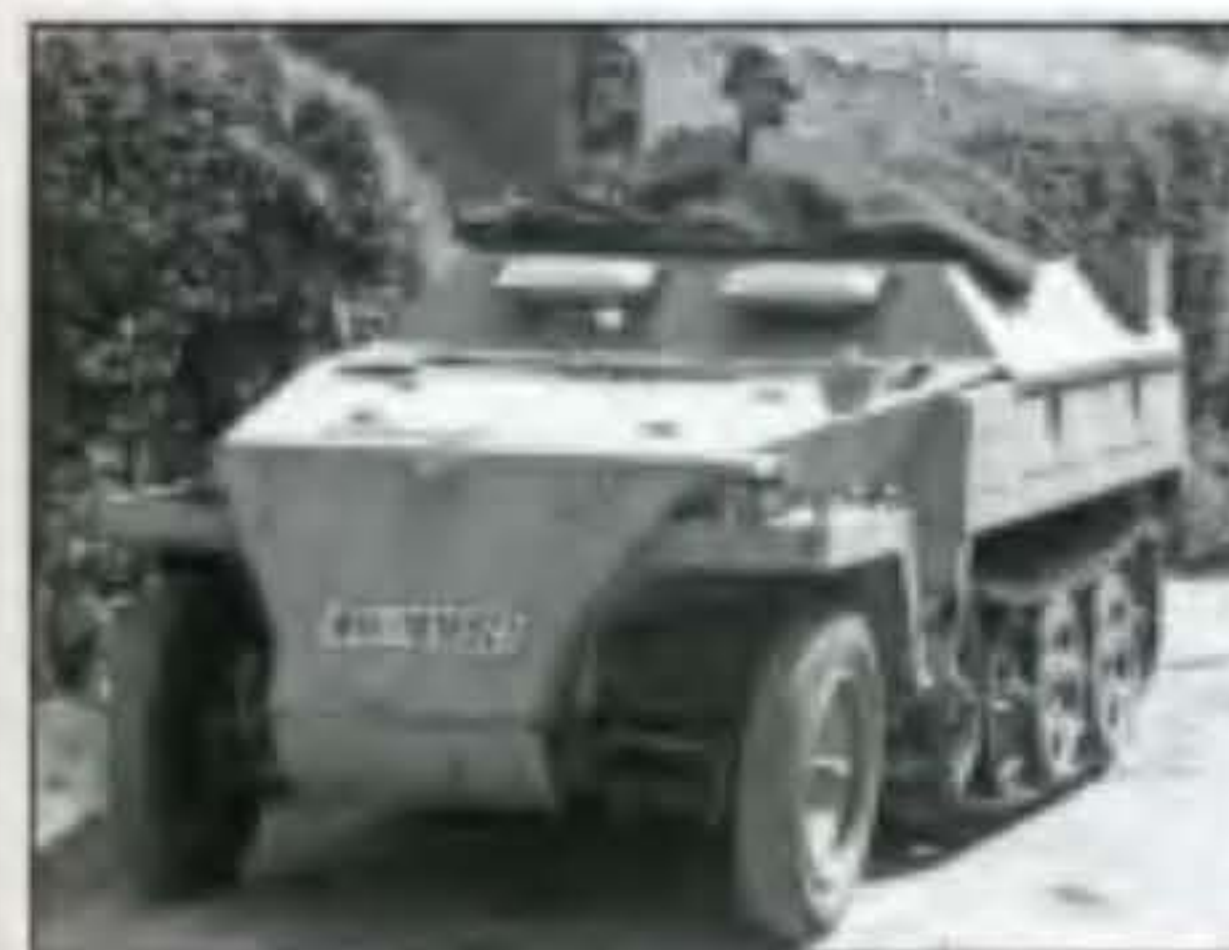
Mid production 250 Neu - 250 Archive Book part 2 - Page 170

Built from late 1943 / early 1944 (?)

Running lights deleted

Addition of tool brackets for 250/1 Neus

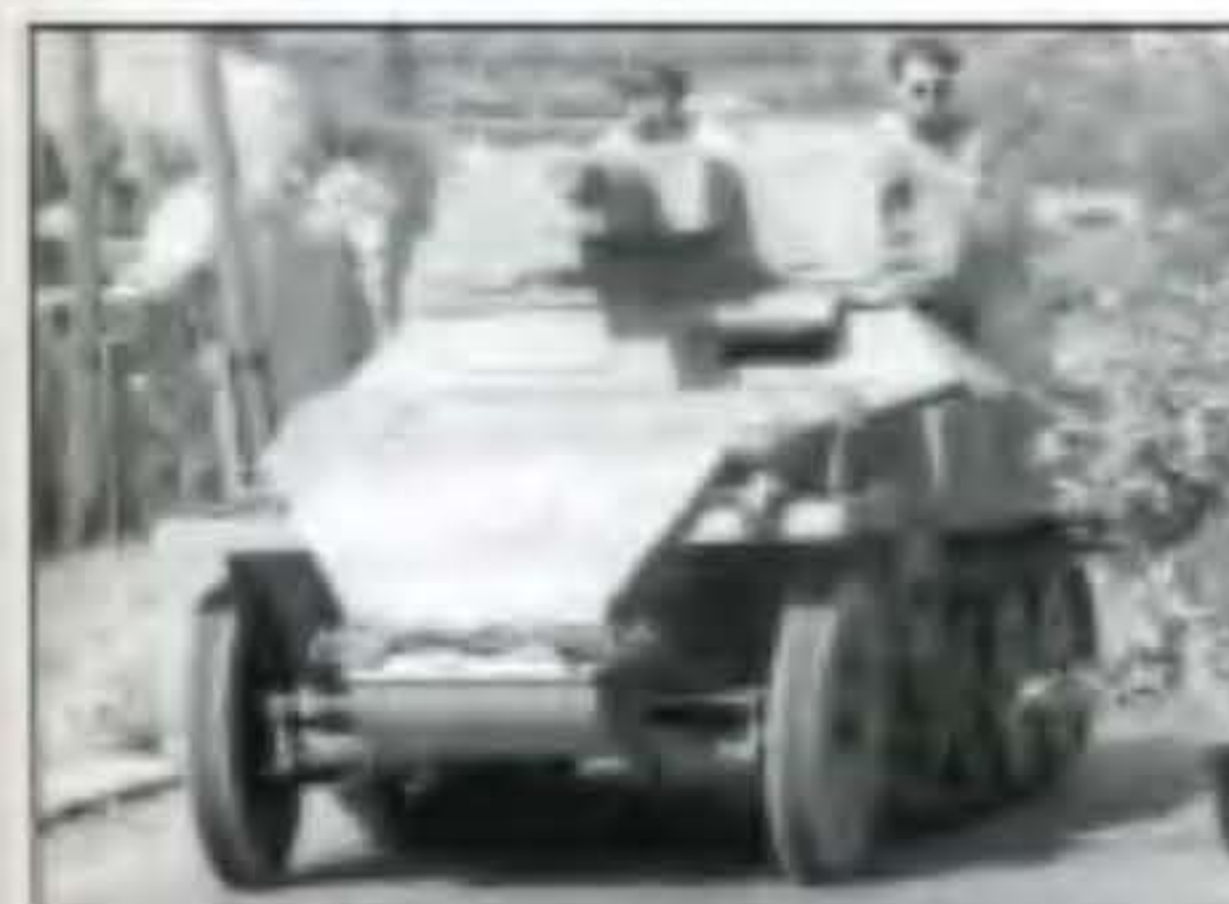
Mid production 250 Neu - 250 Archive Book part 2 - Page 180

Built from mid 1944 (?)

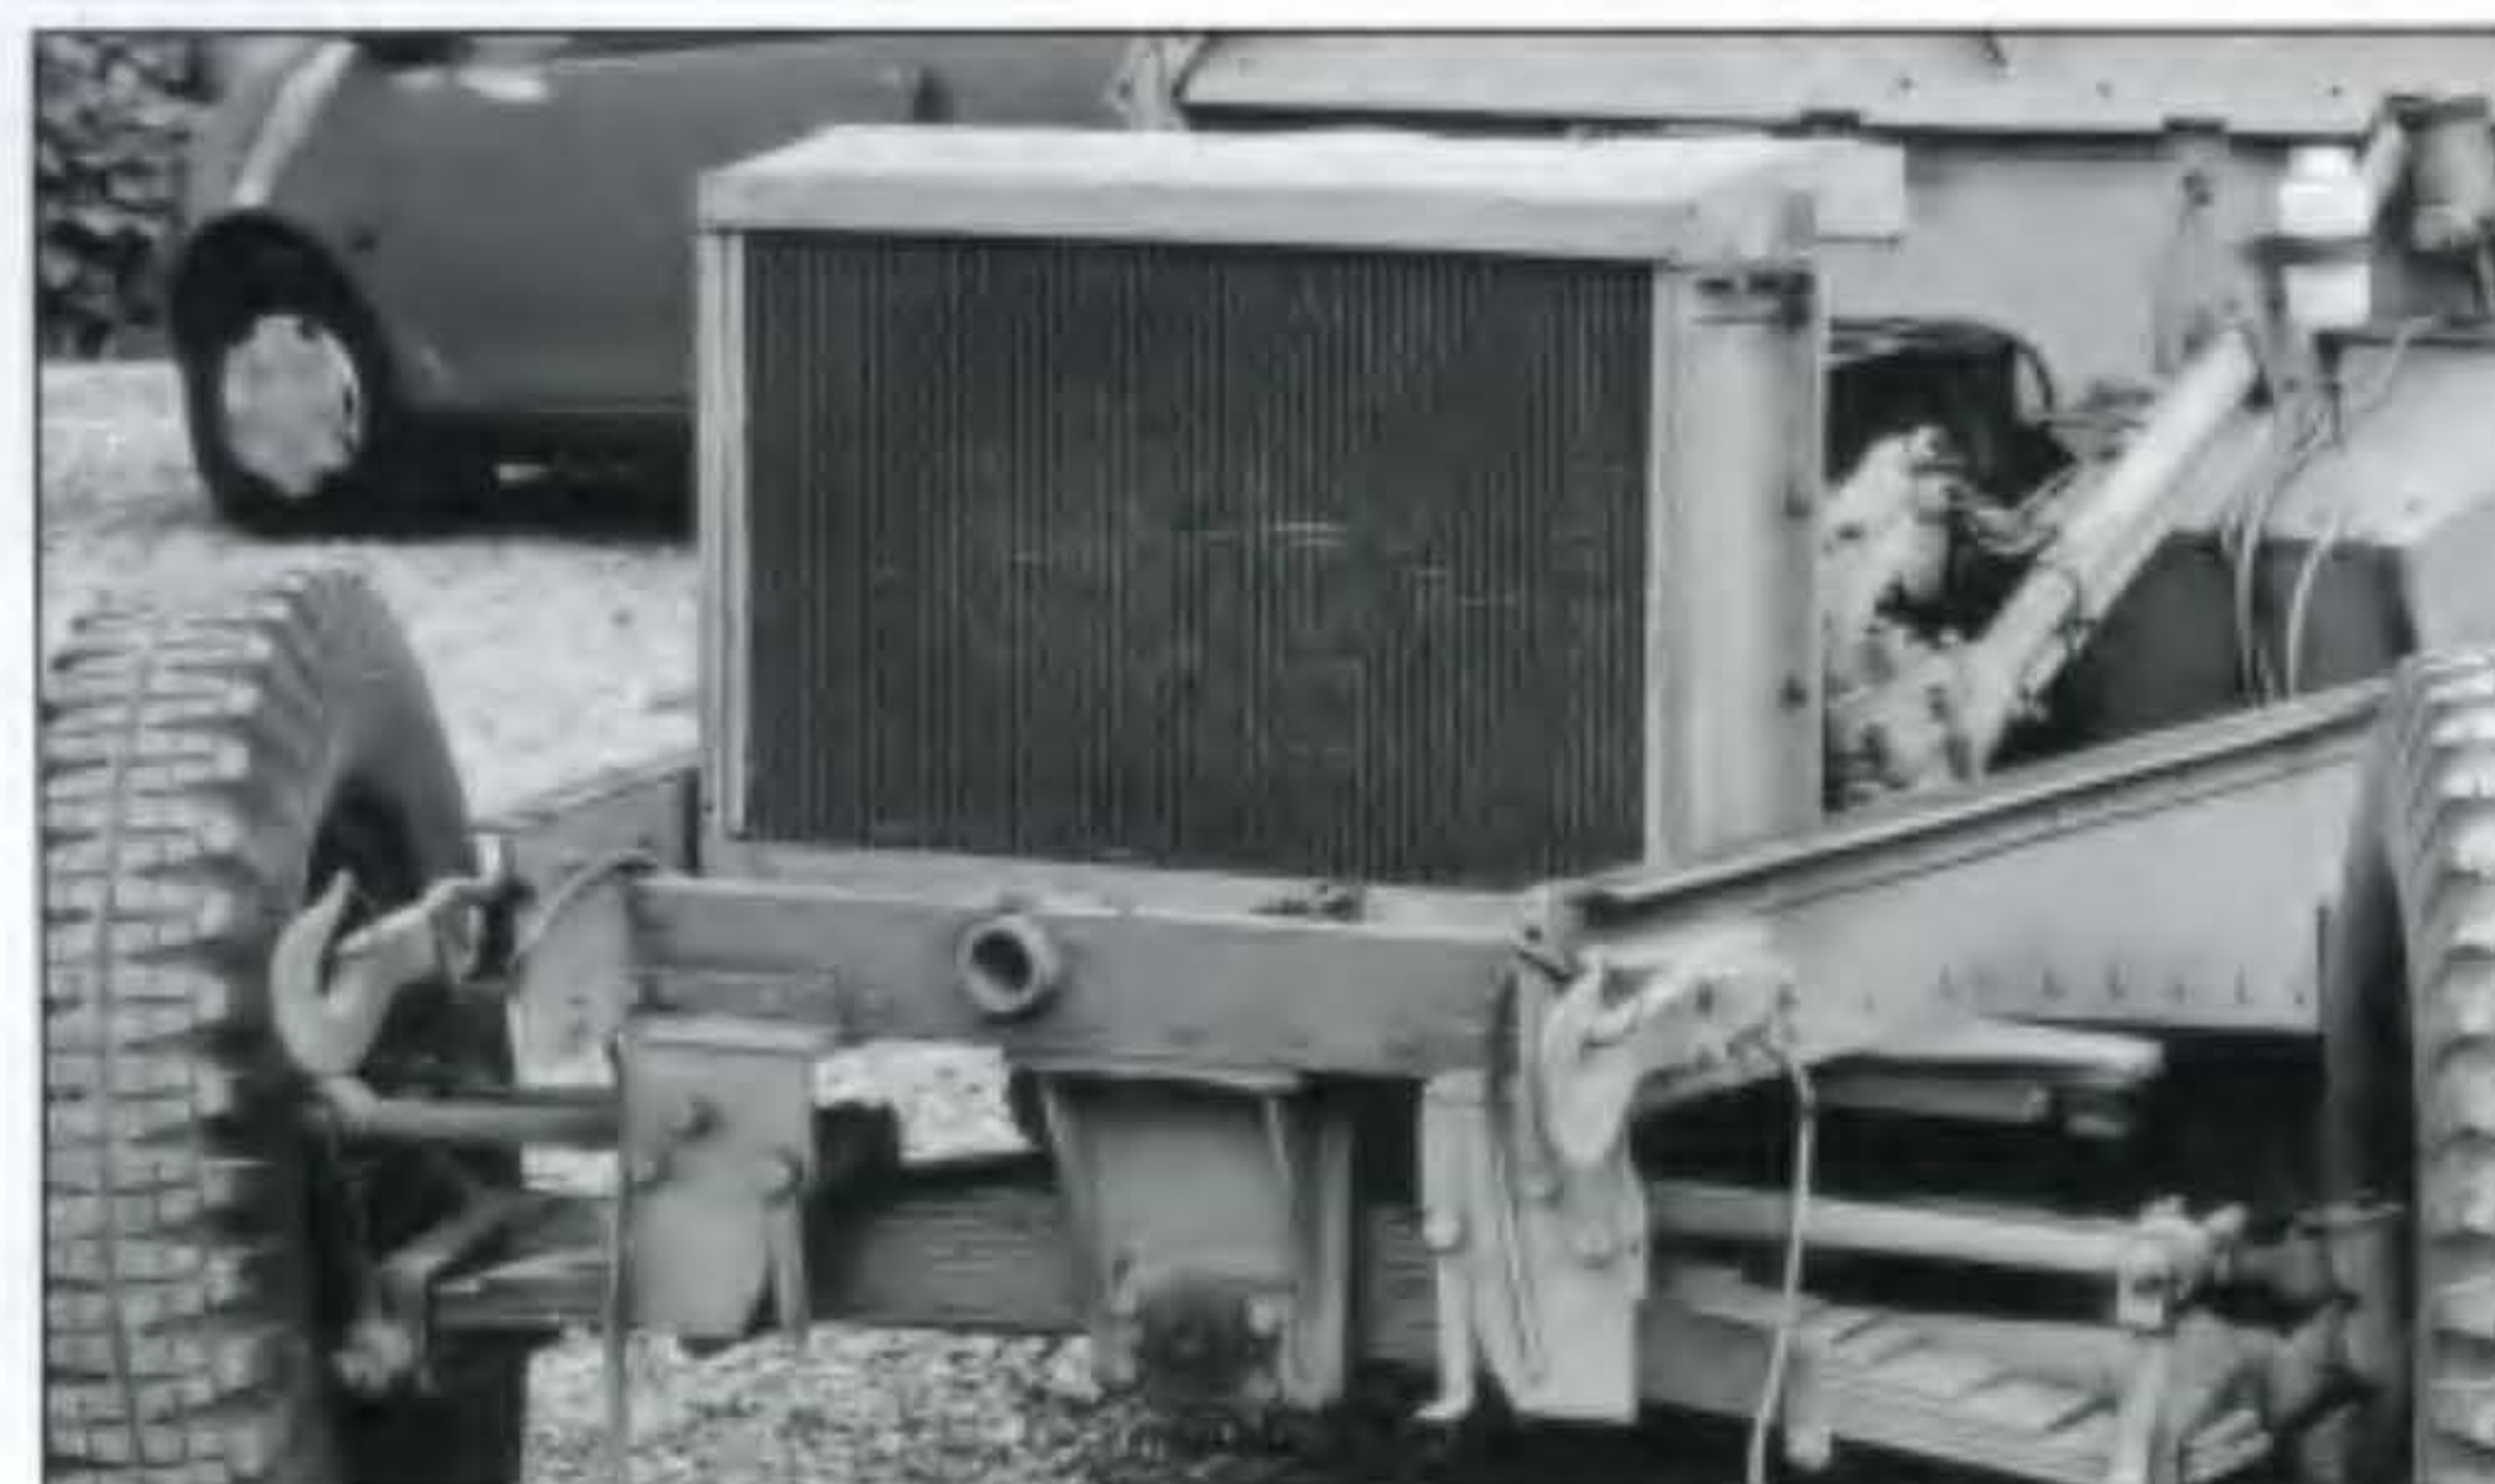
LEFT: Compare the details of the two pictures above to the classic 250 production chassis. See how the lower edge of the front side plates is on a continual line plus the greater overall depth. Note the flat shape of the bump stop arms, the difference in the shock absorber plates and the re-designed central clamp/fulcrum point for the front axle.

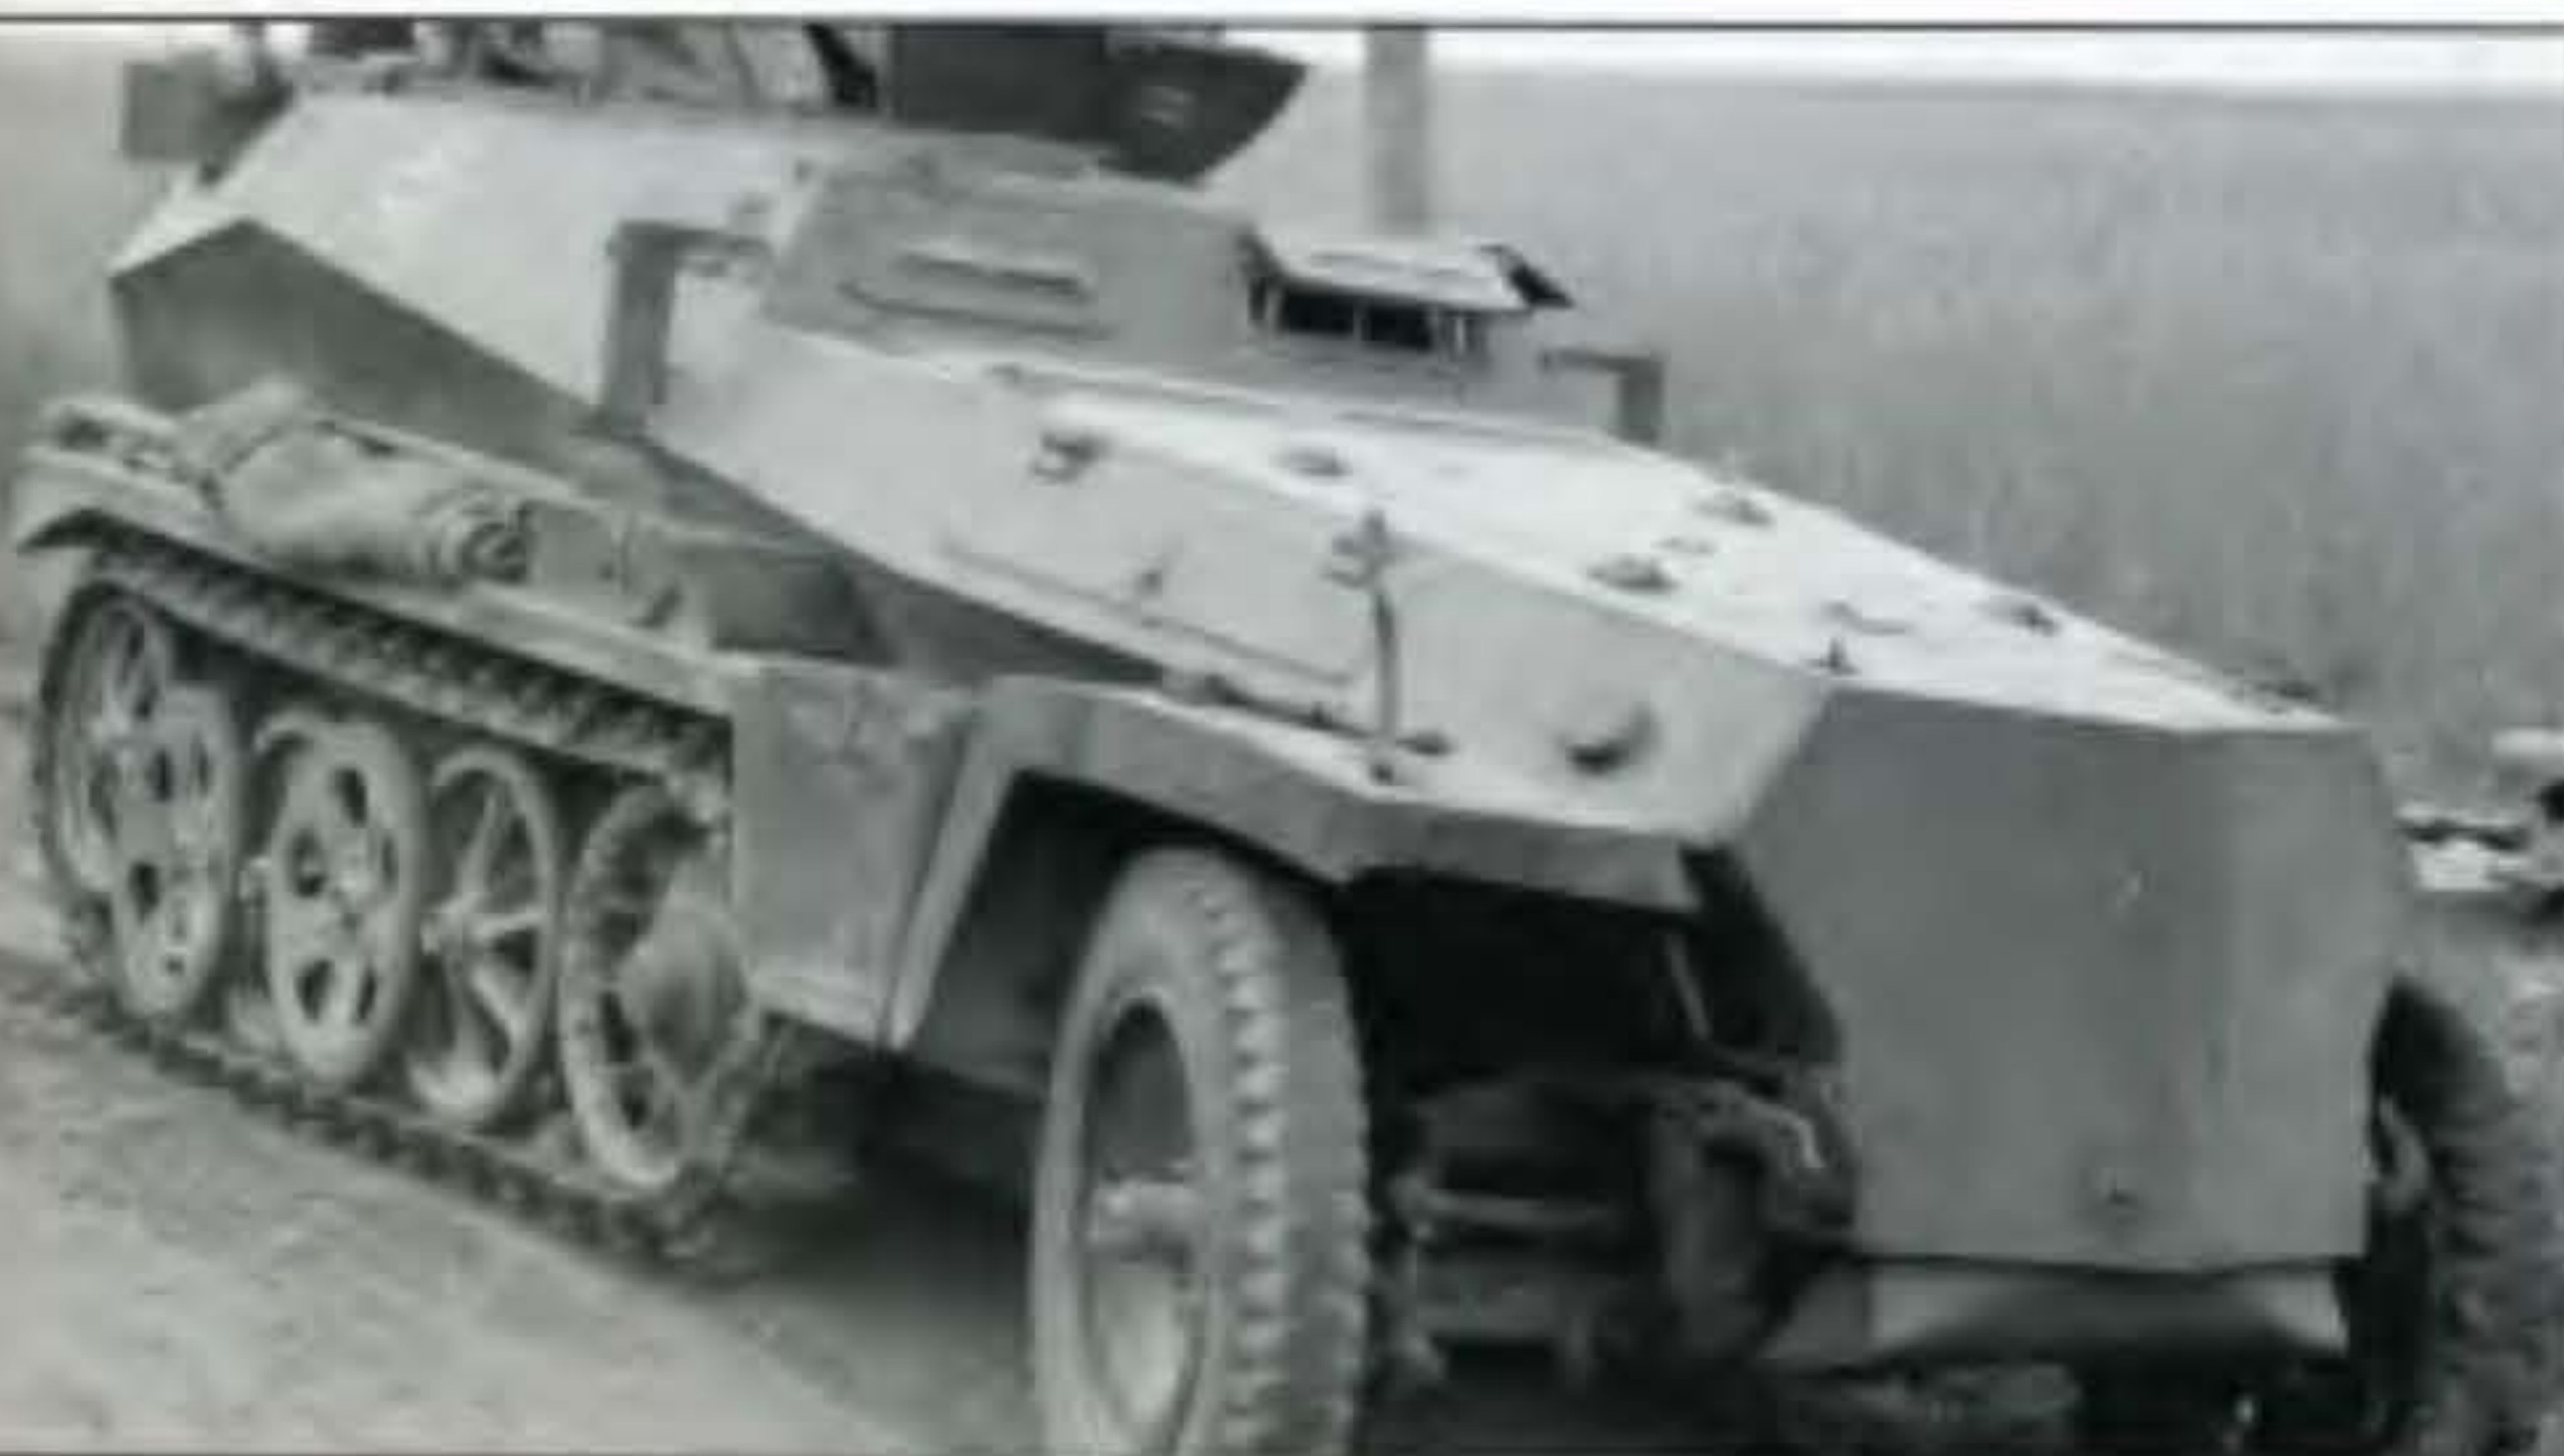
LEFT: This 253 has the chassis featured in the top two pictures opposite. With the angle of the upper edge of the bump stop and shallow chassis depth at the front carried over from the D6 / D7 chassis design. The fact that this vehicle (or one like it) is featured in the original manual, lends weight to the idea that this is one of the very first 253s built and one of the pre-production batch used for trials.

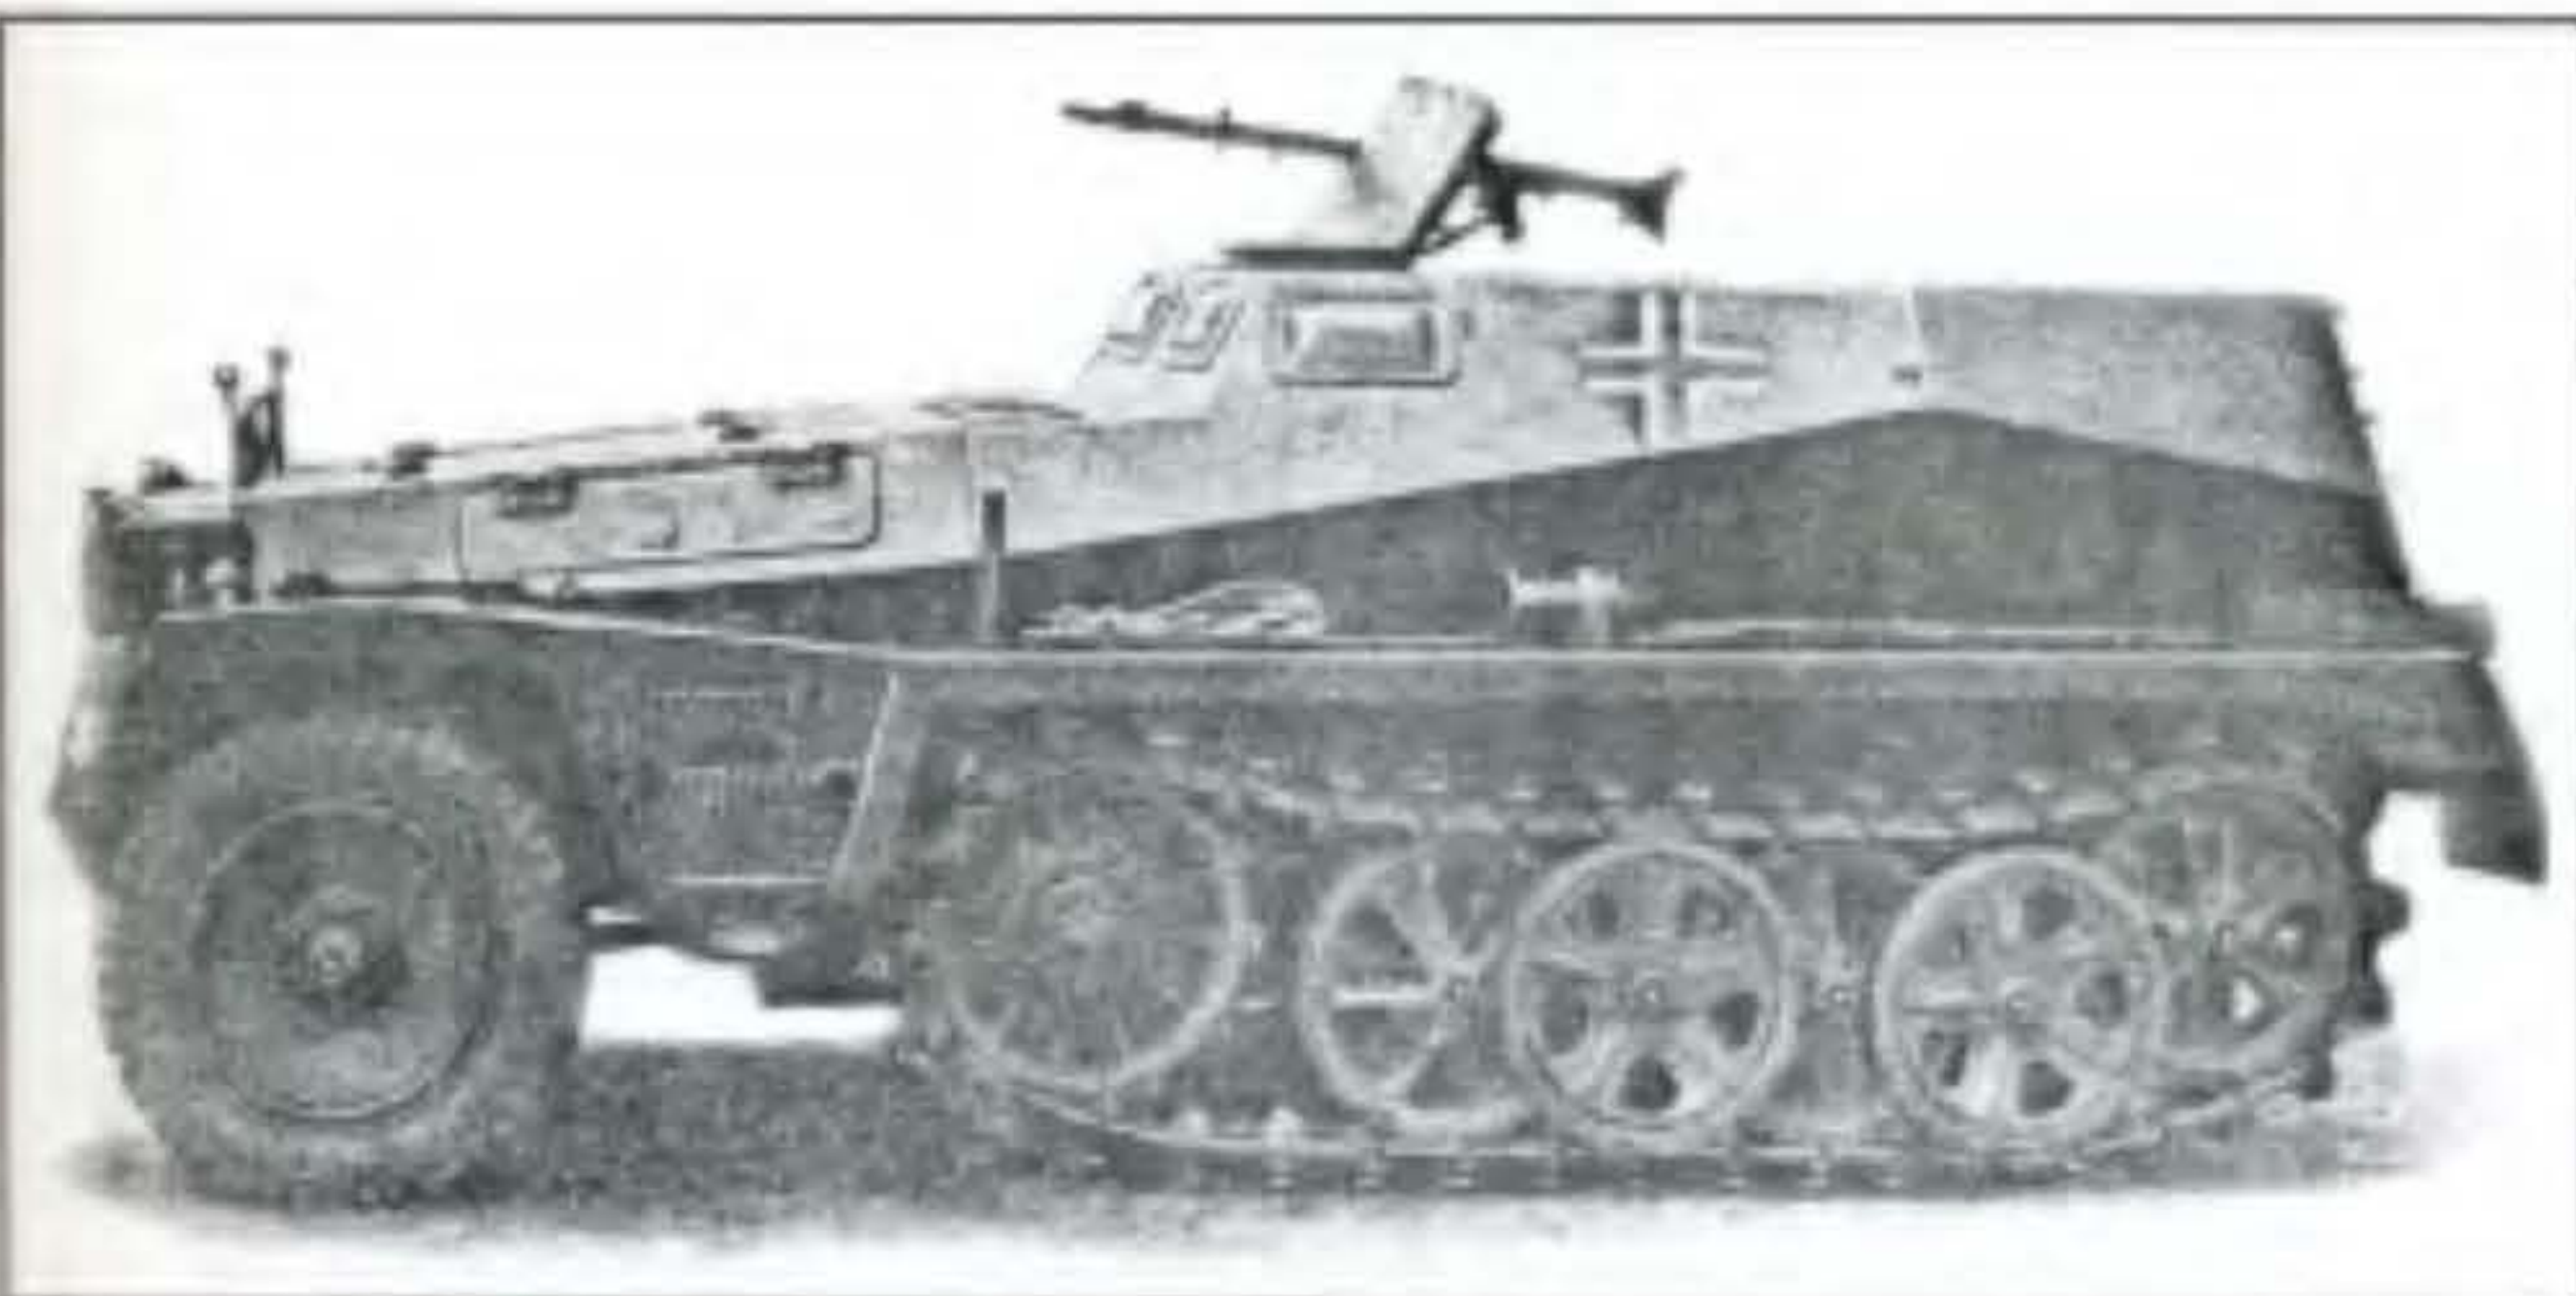
LEFT: This is the prototype of the 250/1 as built prior to August 1940 and listed with its new dimensions and weights for the 250 body. It was designed with a better angled front plate and a simplified rear plate and door arrangement. It has the last style of 253 mud and track guards, with the new 250 tool stowage arrangements, MG shield, tall width indicators, (but now set further forward), new headlamp mounts, and the single slot front visors. But look at the position of the front visors in the front plate. Someone thought that this would be a good idea. Perhaps he had never driven a 250 and did not understand that his head would be up against the cushion bolted to the roof all the times.

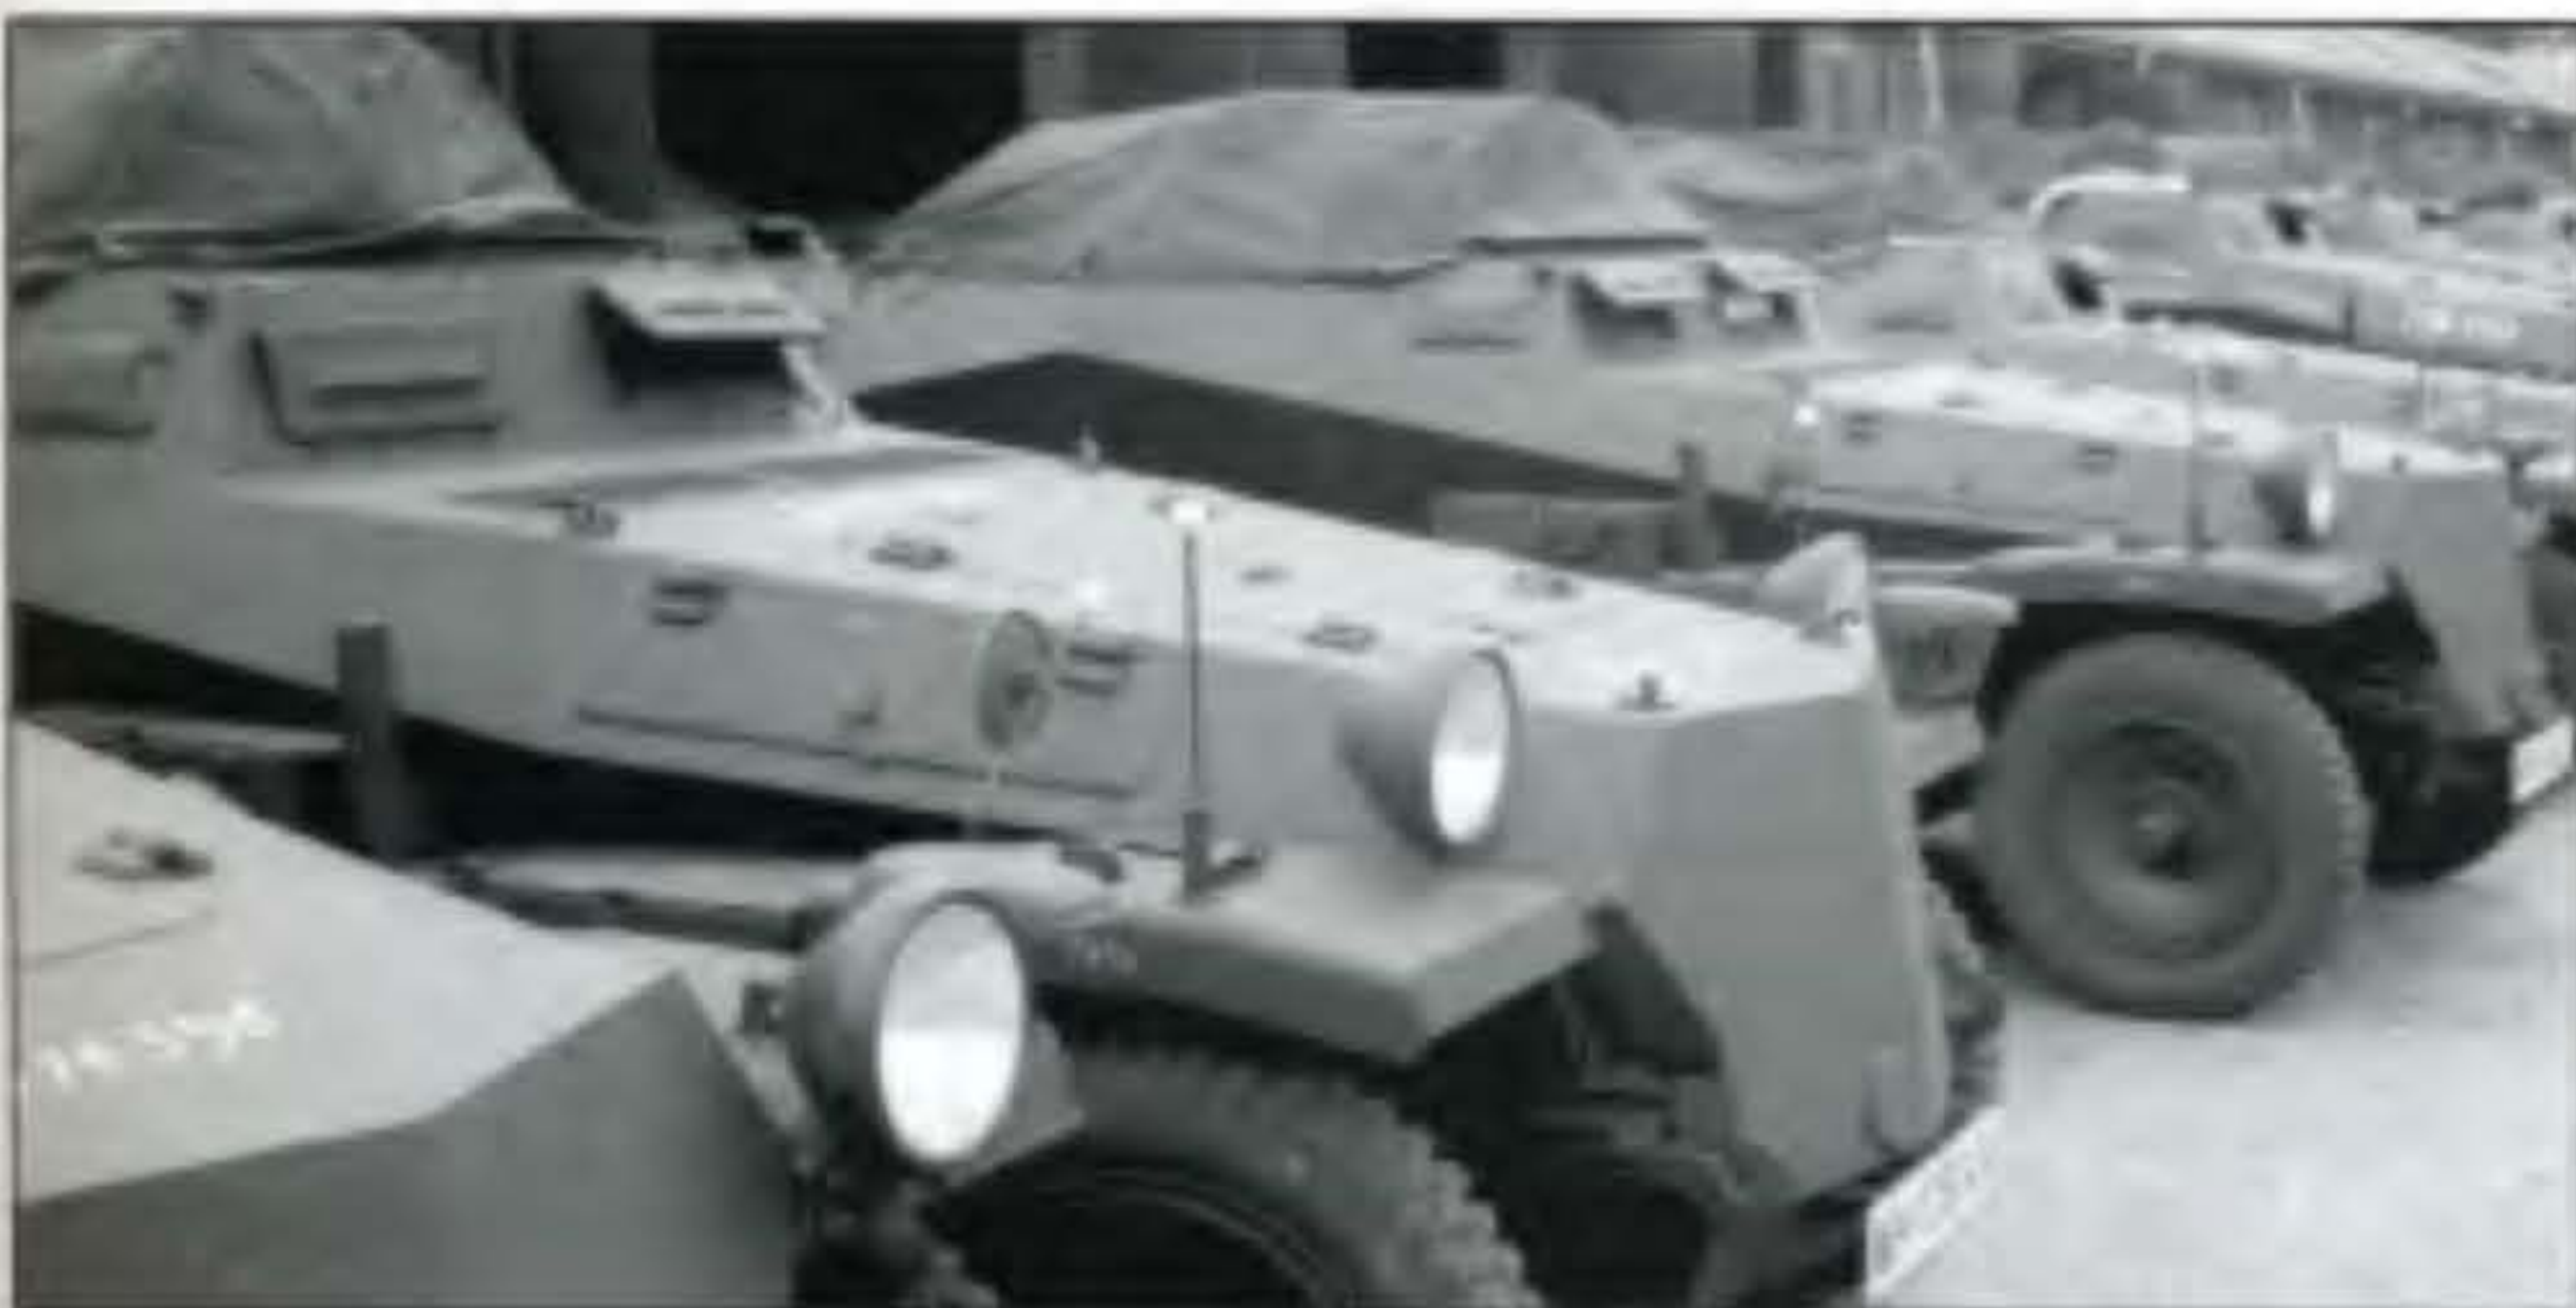
LEFT: The first Sd Kfz 250s built but based on existing Sd Kfz 253s and converted to 250 series specifications. These ex-253s have all the detail improvements for the late version 252s as seen on the prototype 250 above.
