TOTAL DETAIL

Sd Kfz 252, 253 & early 250

Sd Kfz 252, 253 & 250 (Typ 1)

Volume 3 - Part 1

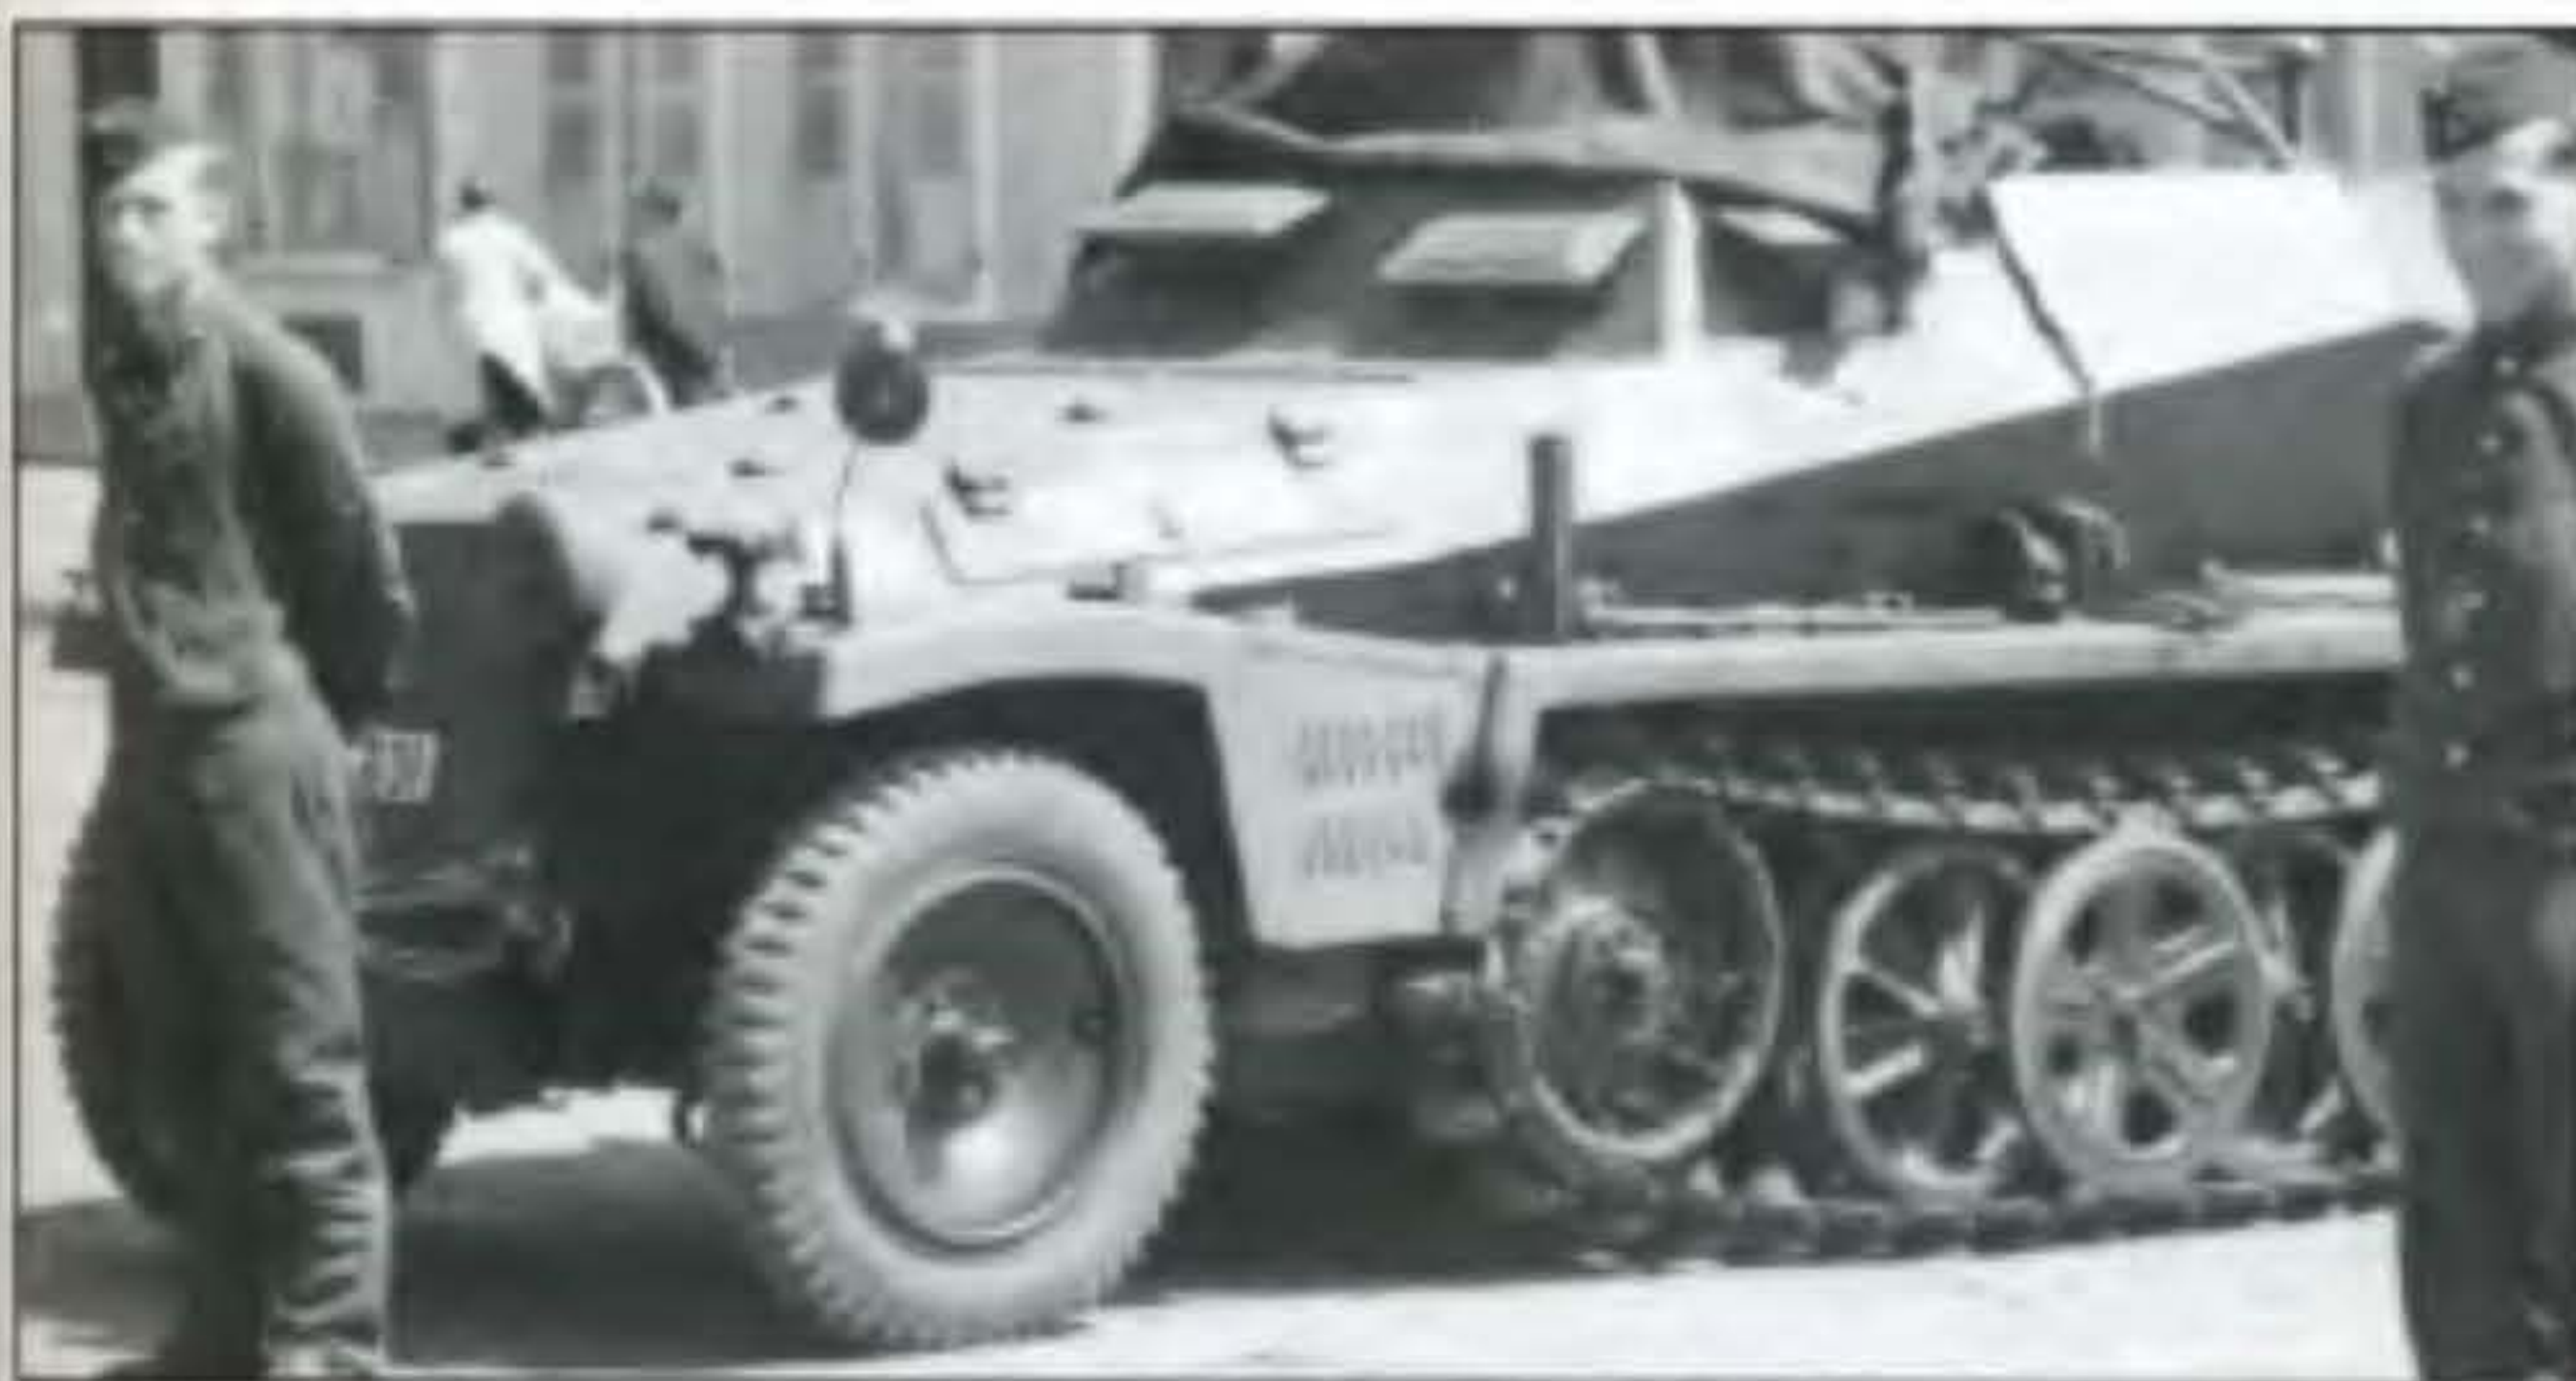
LEFT: This an early 250 Typ 2 with all of the upgrades listed above but now with the Typ 2 mud and track guards. The early models did not have the beaded edge as seen in the picture below.

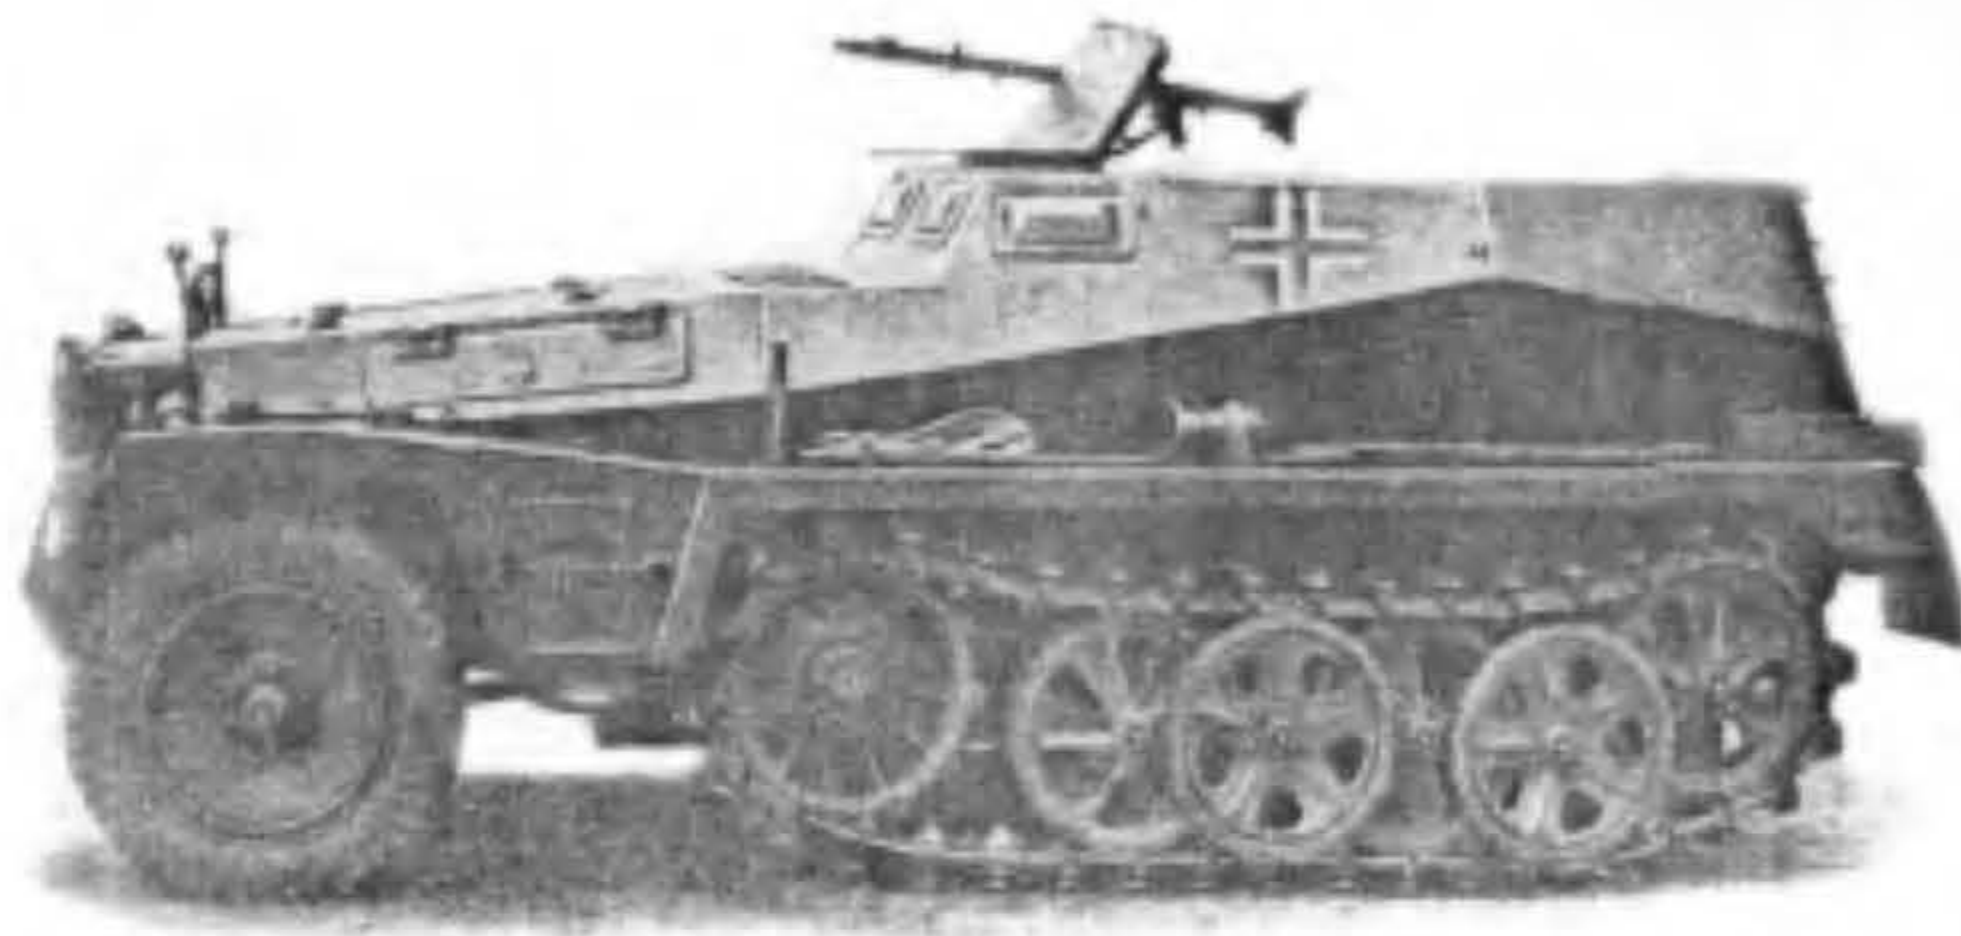
Bild 4

Light armoured Ammunition Transport vehicle (Sd Kfz 252)

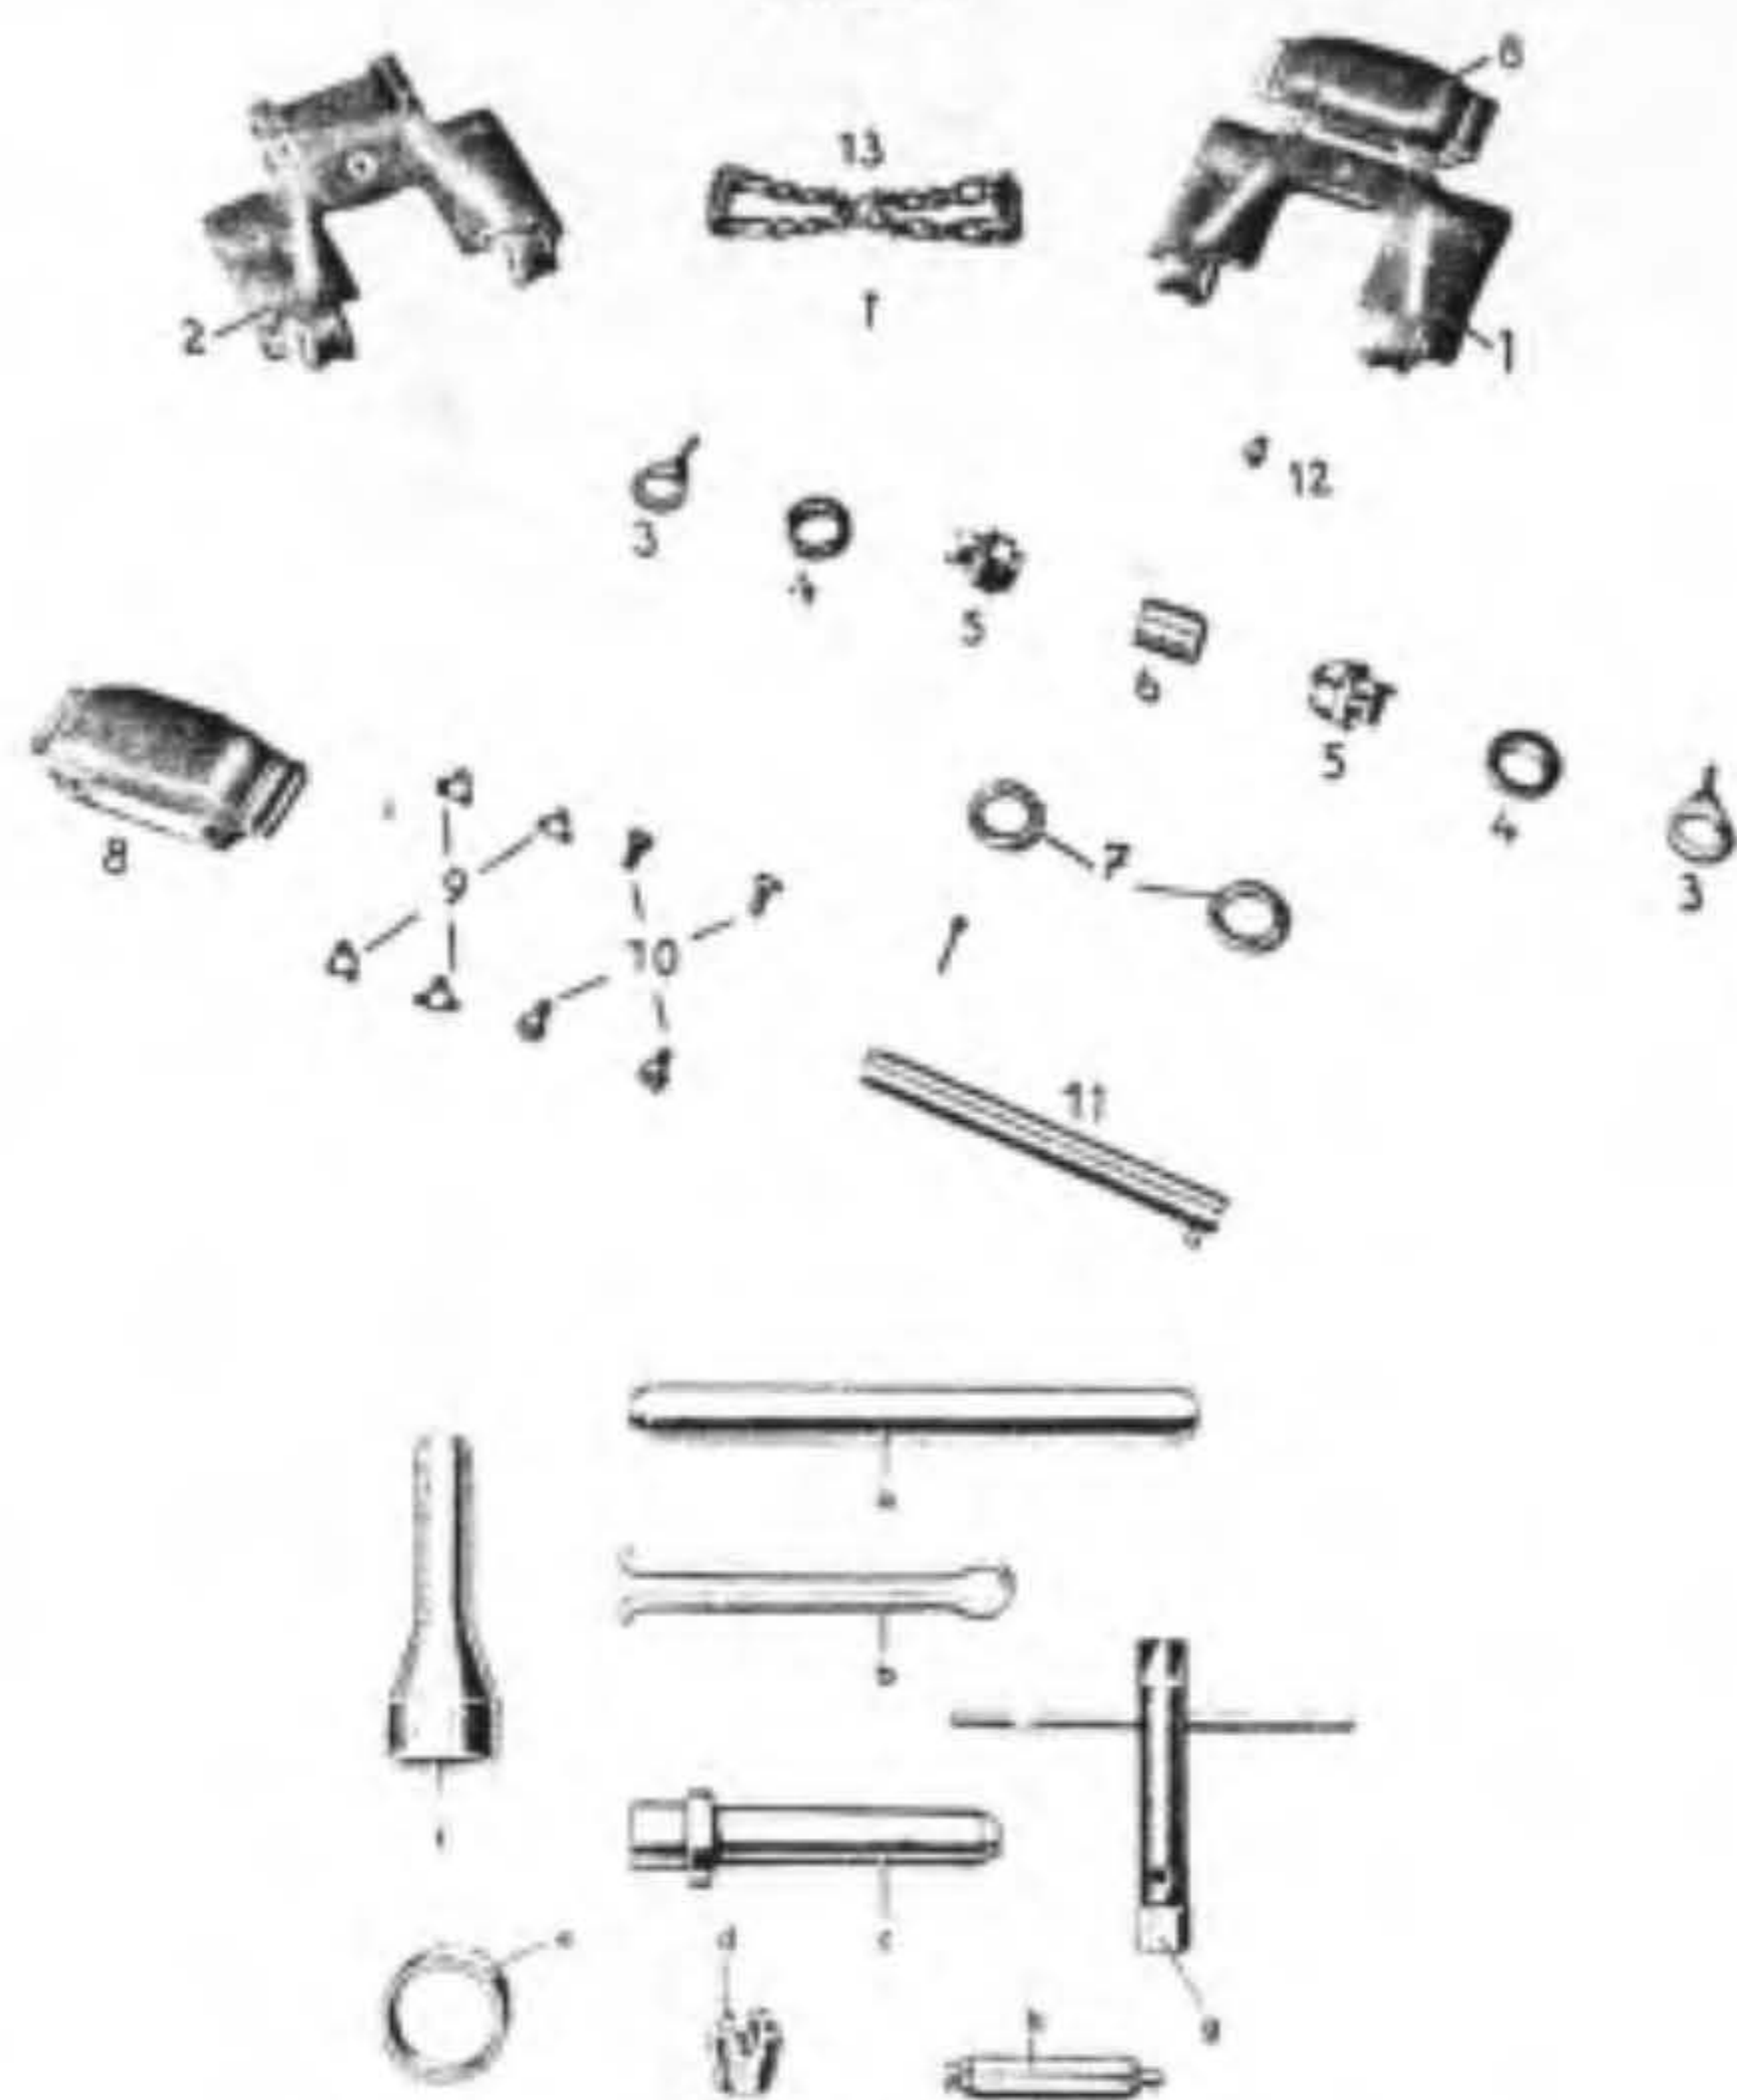
**Track Link**

8. Track Chains (Picture 17)

31. Track Links (Picture 17)

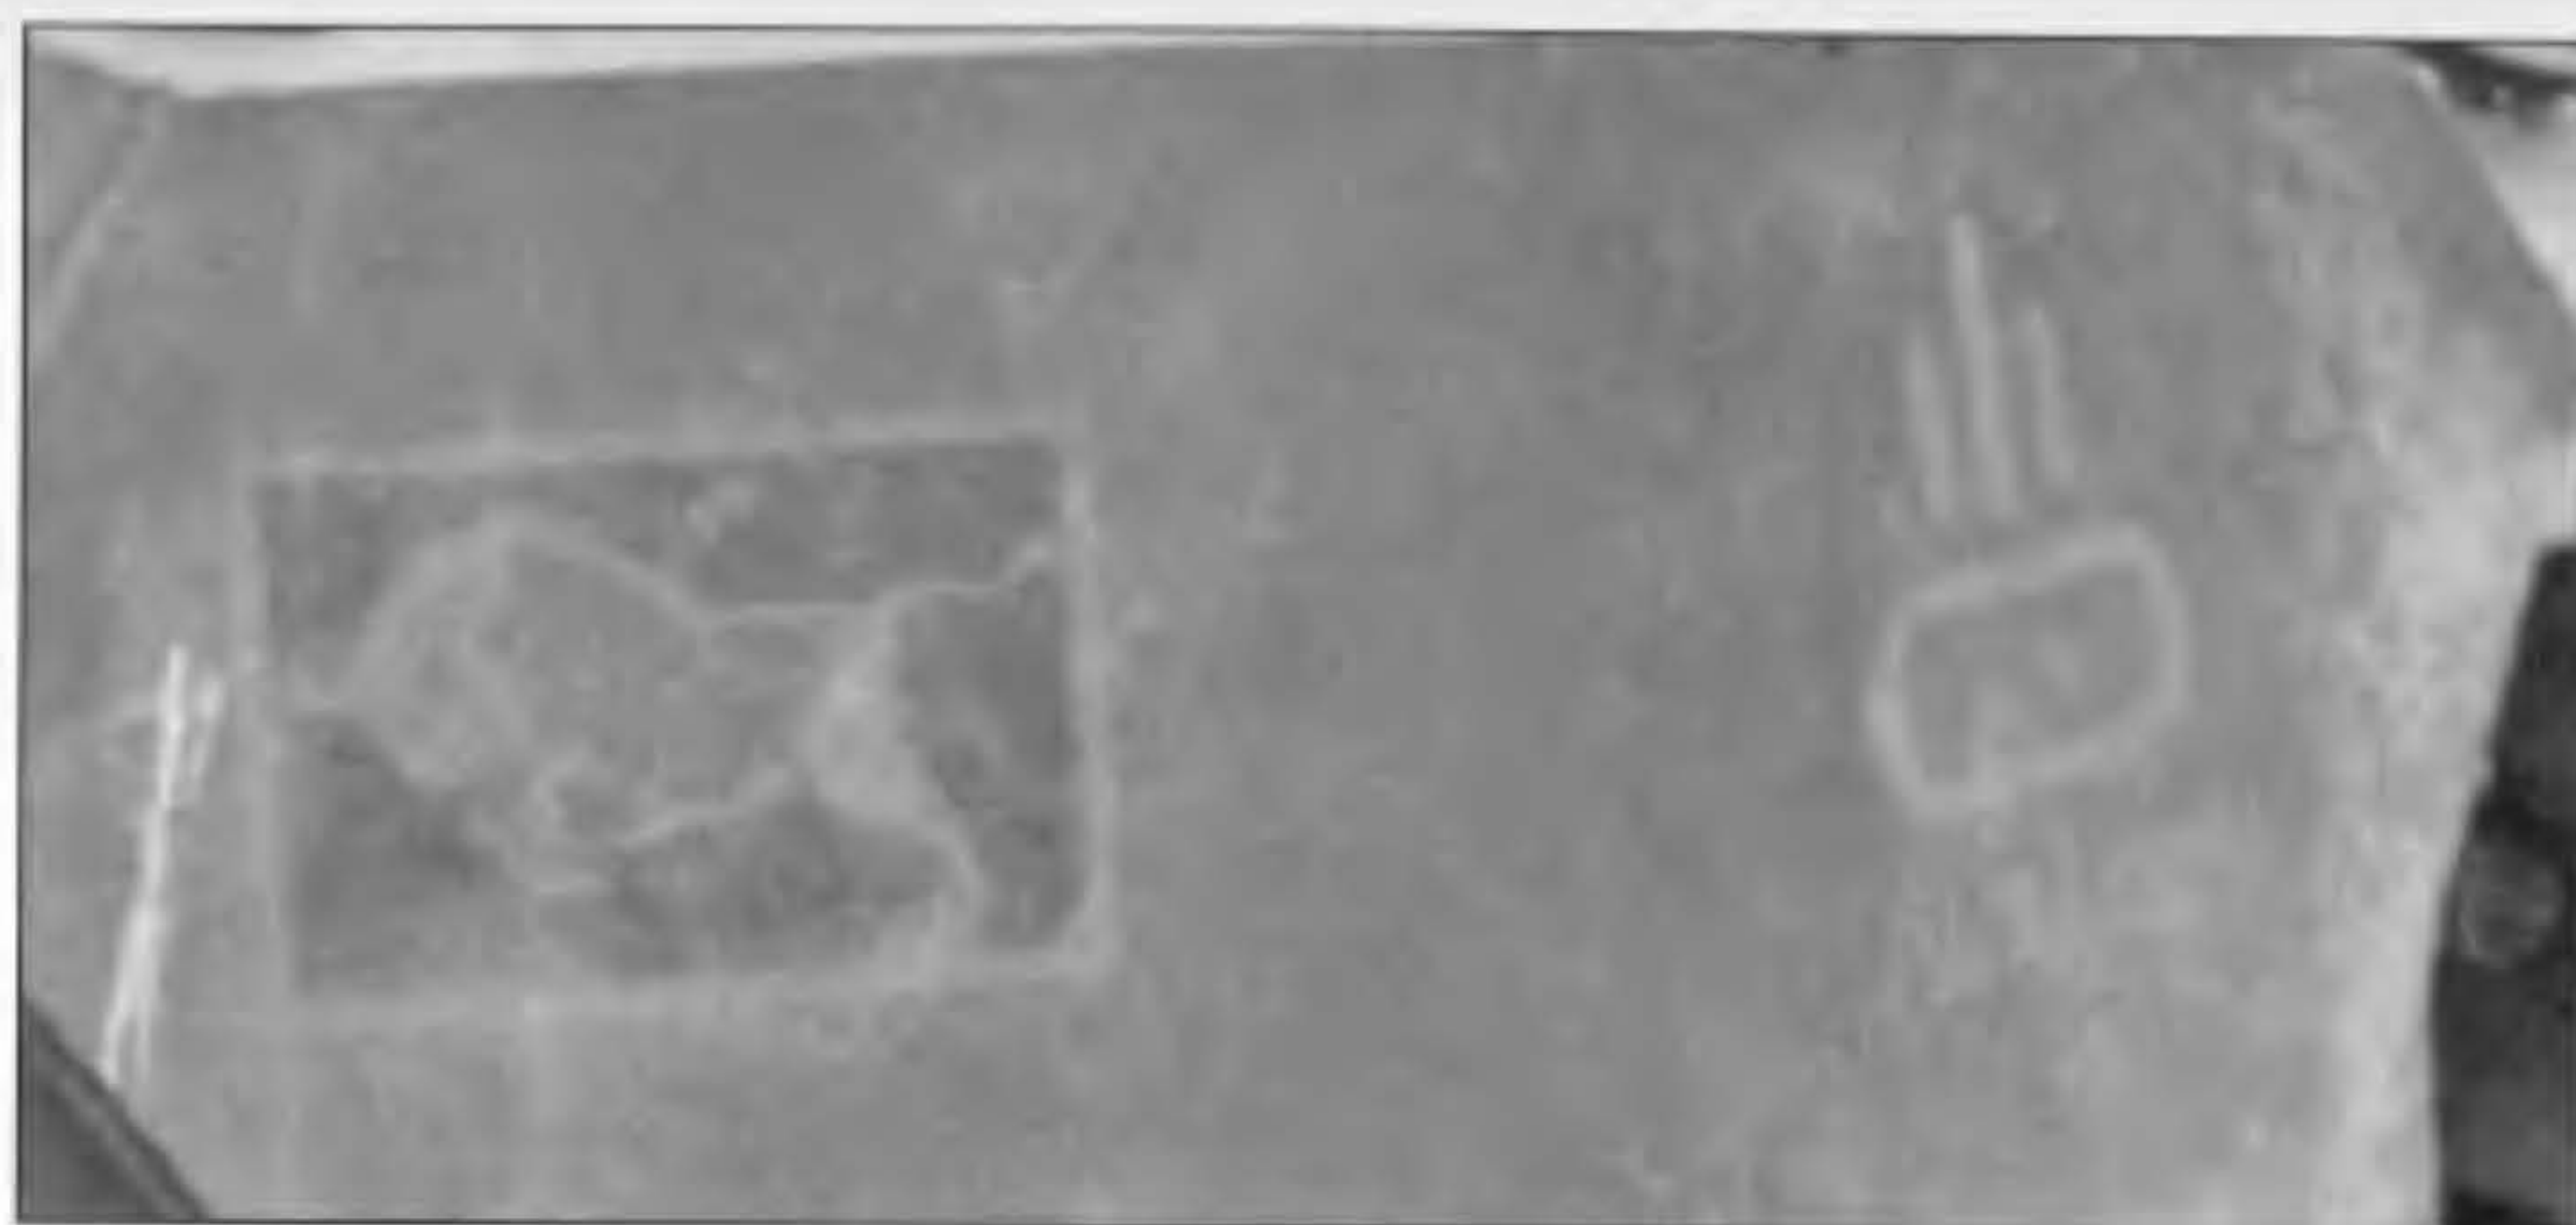
Units of the 191st Sturmabteilung (the 'Buffalo battalion') in a Bulgarian town en-route to the Greek border at the end of March 1941. This is an early 253 with the very square edged mud guards and low height width indicators; note the difference between the bump stop of this example compared to the 253 on page 81. The starter crank cap on the nose plate is also of a different design from both the prototypes and the later production models. For some reason the two hooks on the front have both been removed along with the front number plate. This is one of only a few 253s to be seen with an MG shield. The shield itself is fairly impressive, being curved in profile which certainly suits the vehicle, but quite how the MG is mounted is impossible to say. Even though this pre-dates the start of the 250 series production, the first batch of 250s were not equipped with a shield, yet here the crew or workshop company have come up with the obvious and practical solution.

The 'II' between the front visors probably denotes the Commander of the second battery of 6 guns. Because of the nature and terrain of the attack on the Metaxa's Line the vulnerability of any commander, be it of the battery or a platoon led the Army planners to re-appraise the use of such poorly protected vehicles. Is it a simple coincidence that the Balkan Campaign started on the 6th April using the K. St. N 445 configuration, dated 1st February 1941 and within 11 weeks it was amended to include an extra StuG for the battery commander and delete all four Sd Kfz 253s. It looks like a knee-jerk reaction to an unforeseen problem, leaving only one command vehicle instead of four to control and direct the battery of six StuGs. It is probably the lack of command support in the amended plan that led to many units retaining their 253s even after extra StuGs became available.

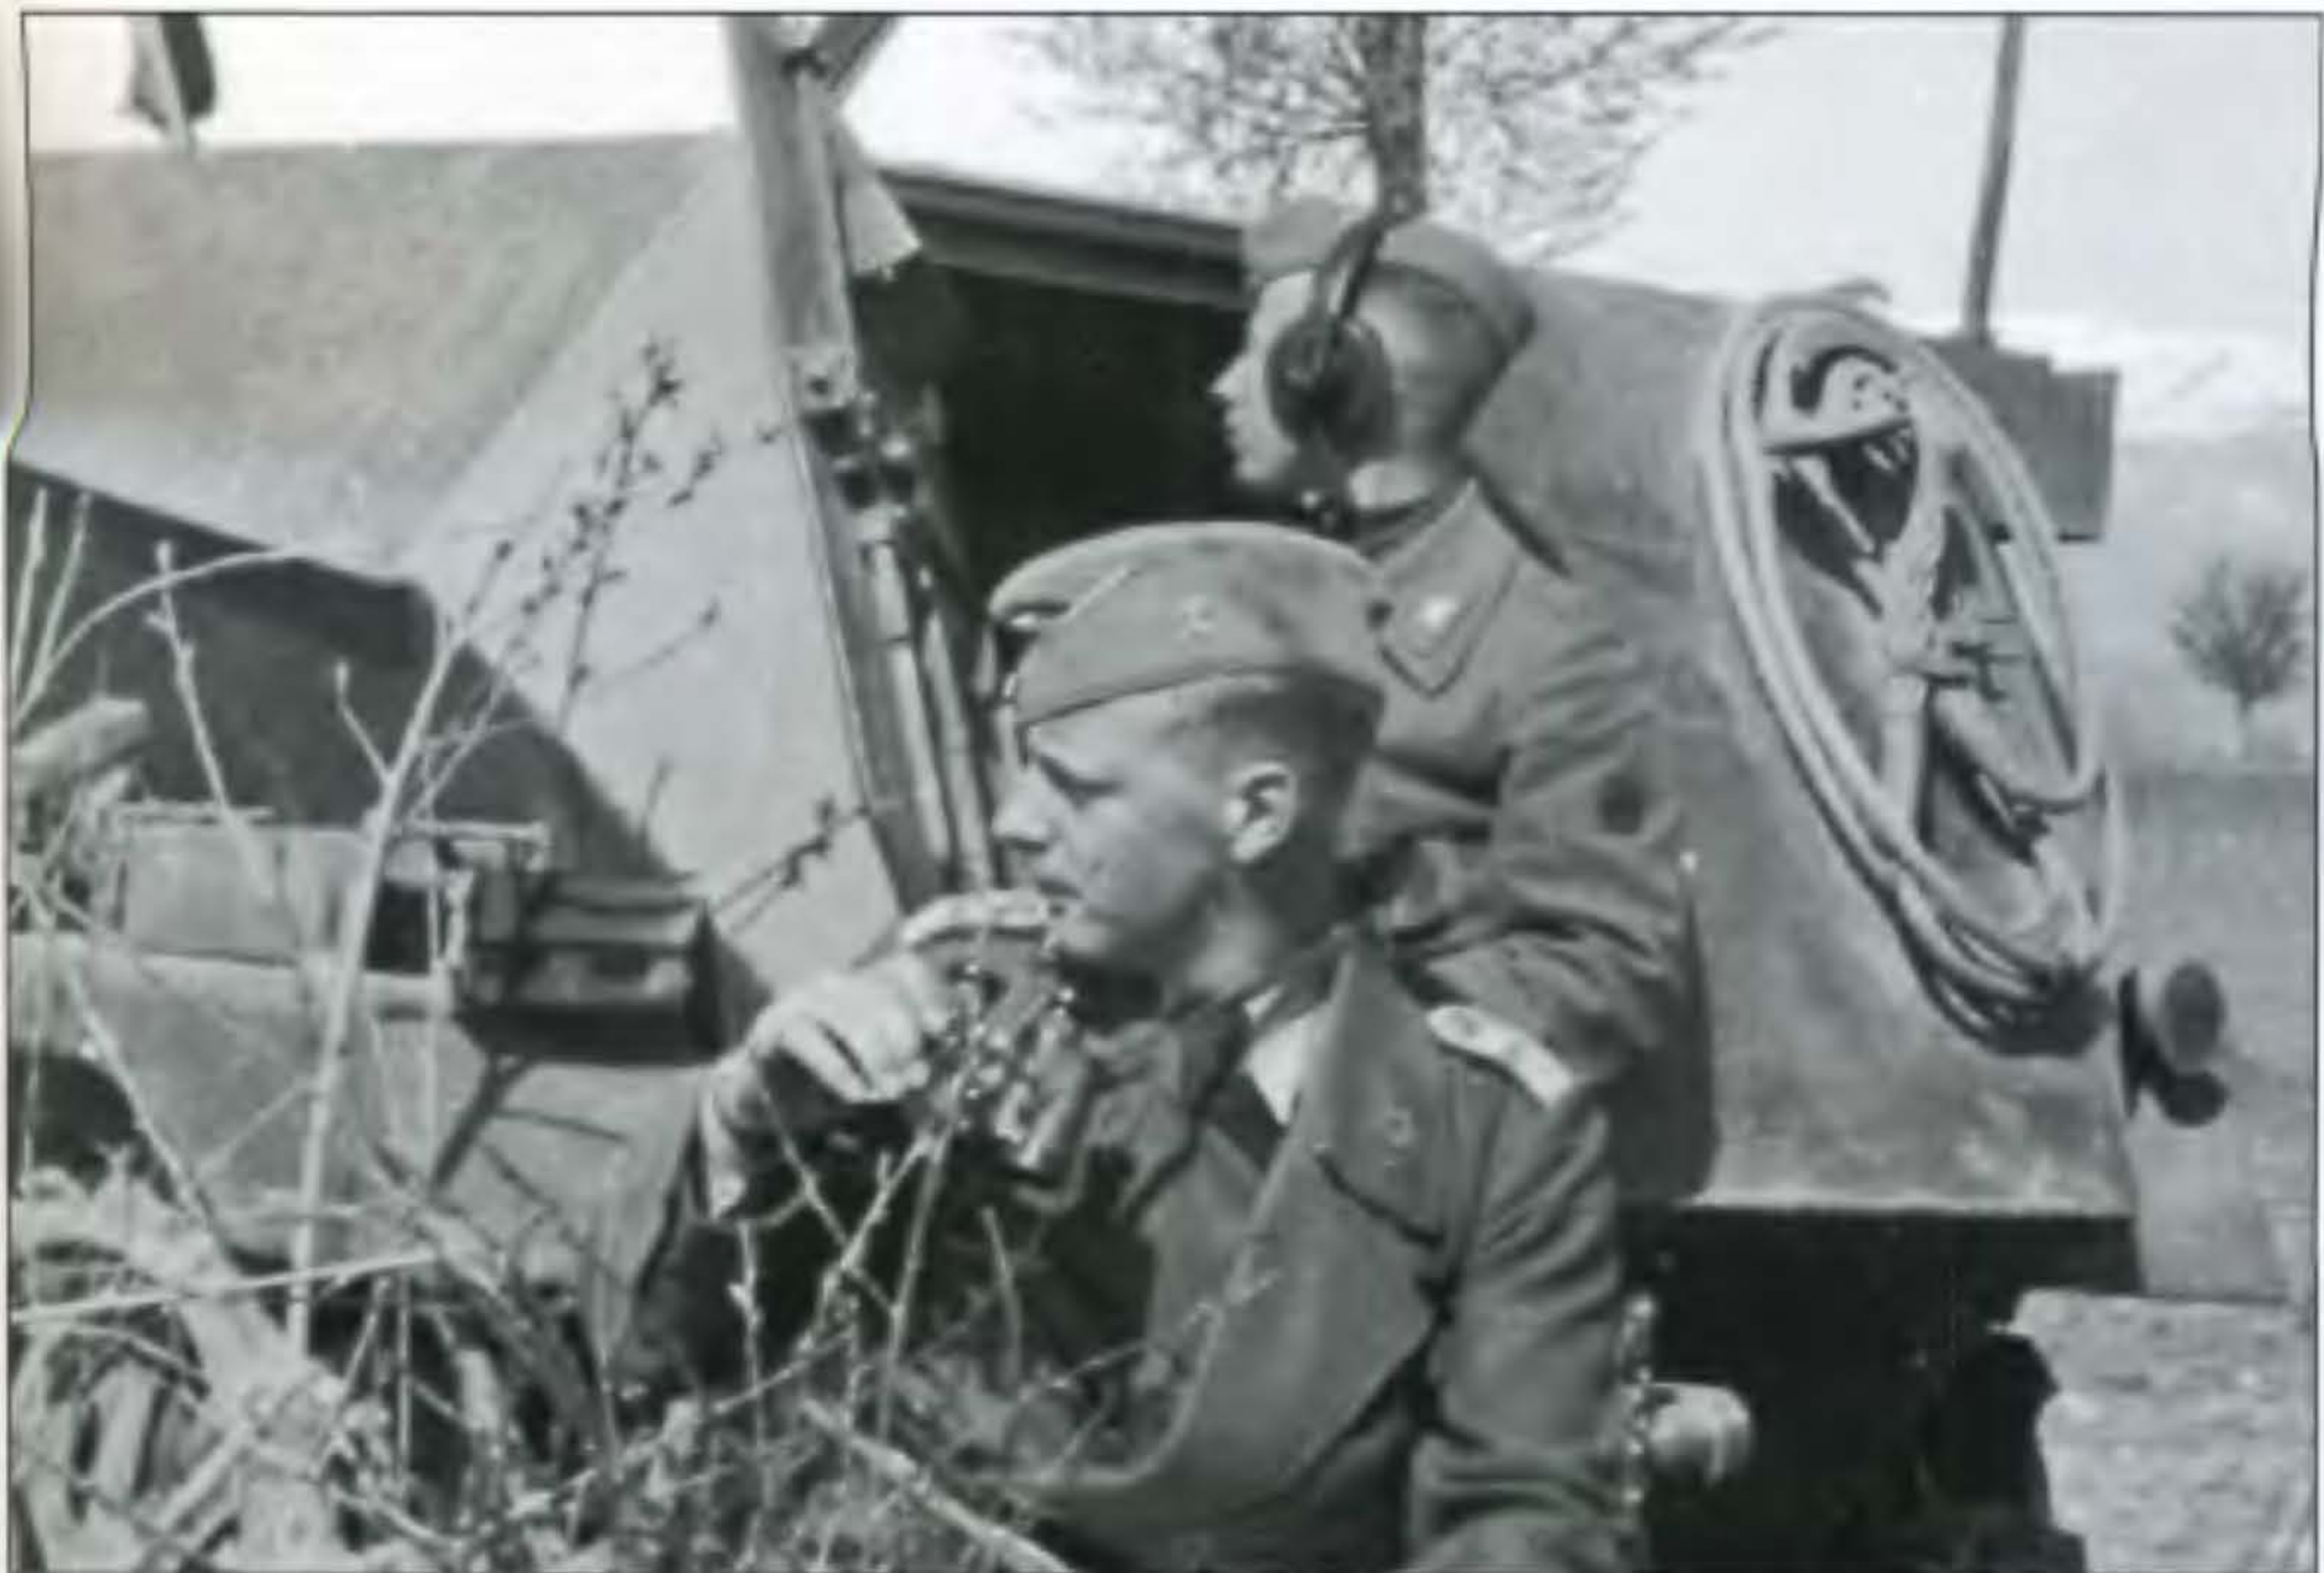
An almost perfect example of a fully stowed 253, missing only the medical box (Verbandkasten) on the rear door. These were often removed because it was all too easy to catch a leg or hip on the box edge on the way in or out. The box itself was held in place with a buckled canvas strap. On the later 250, the Verbandkasten was contained in a full cage that impeded ingress even further!

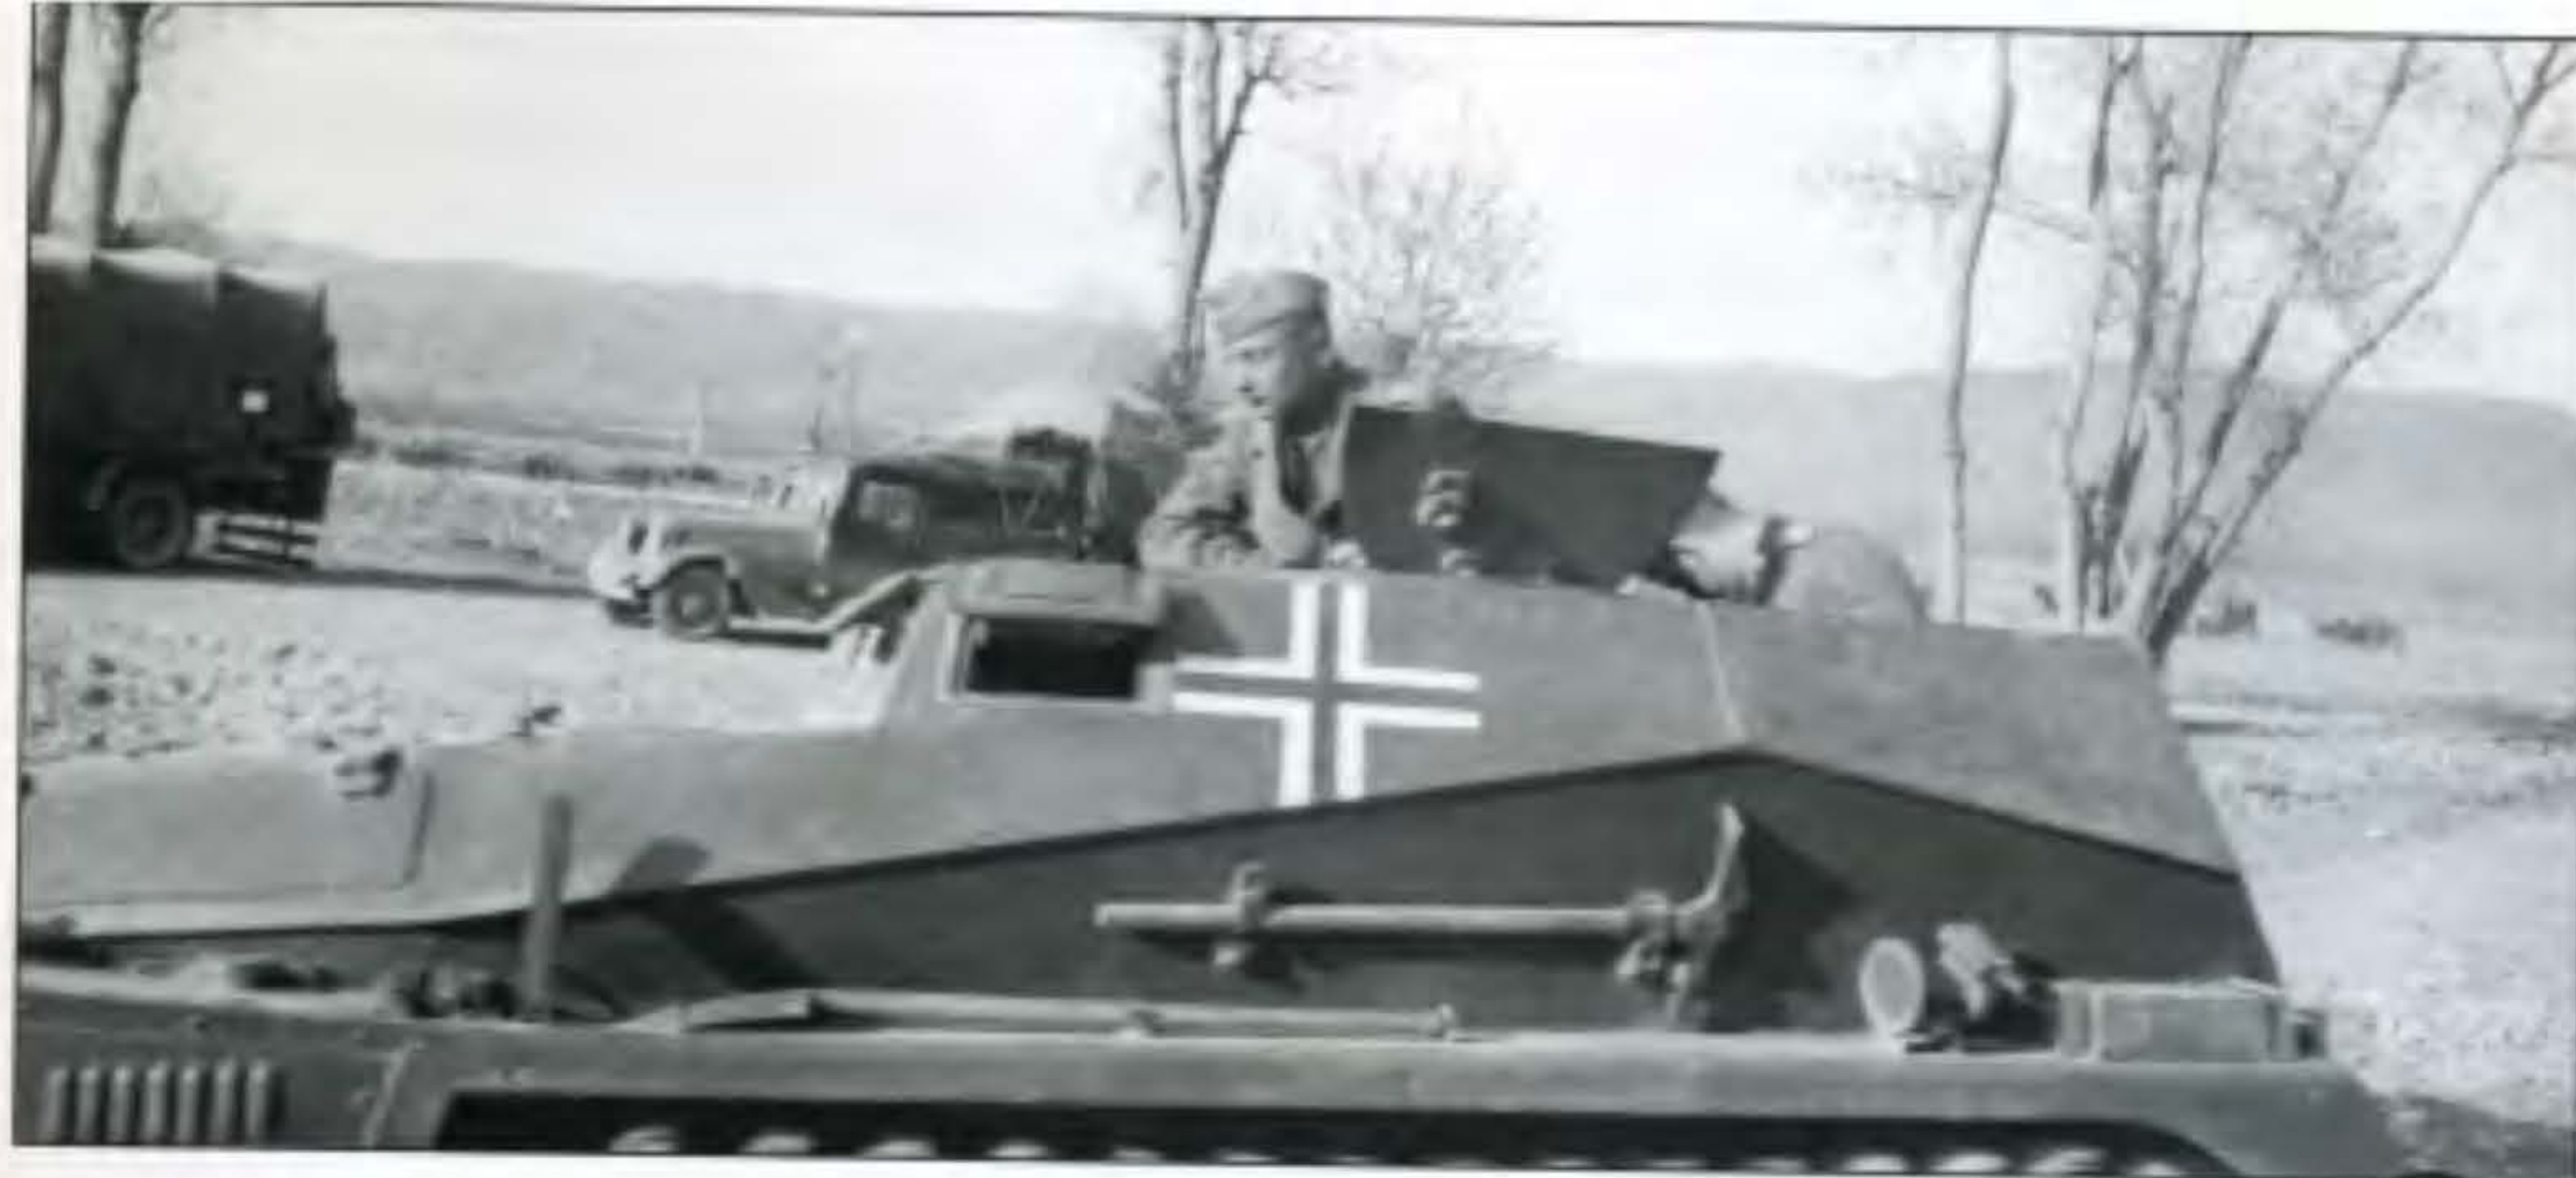
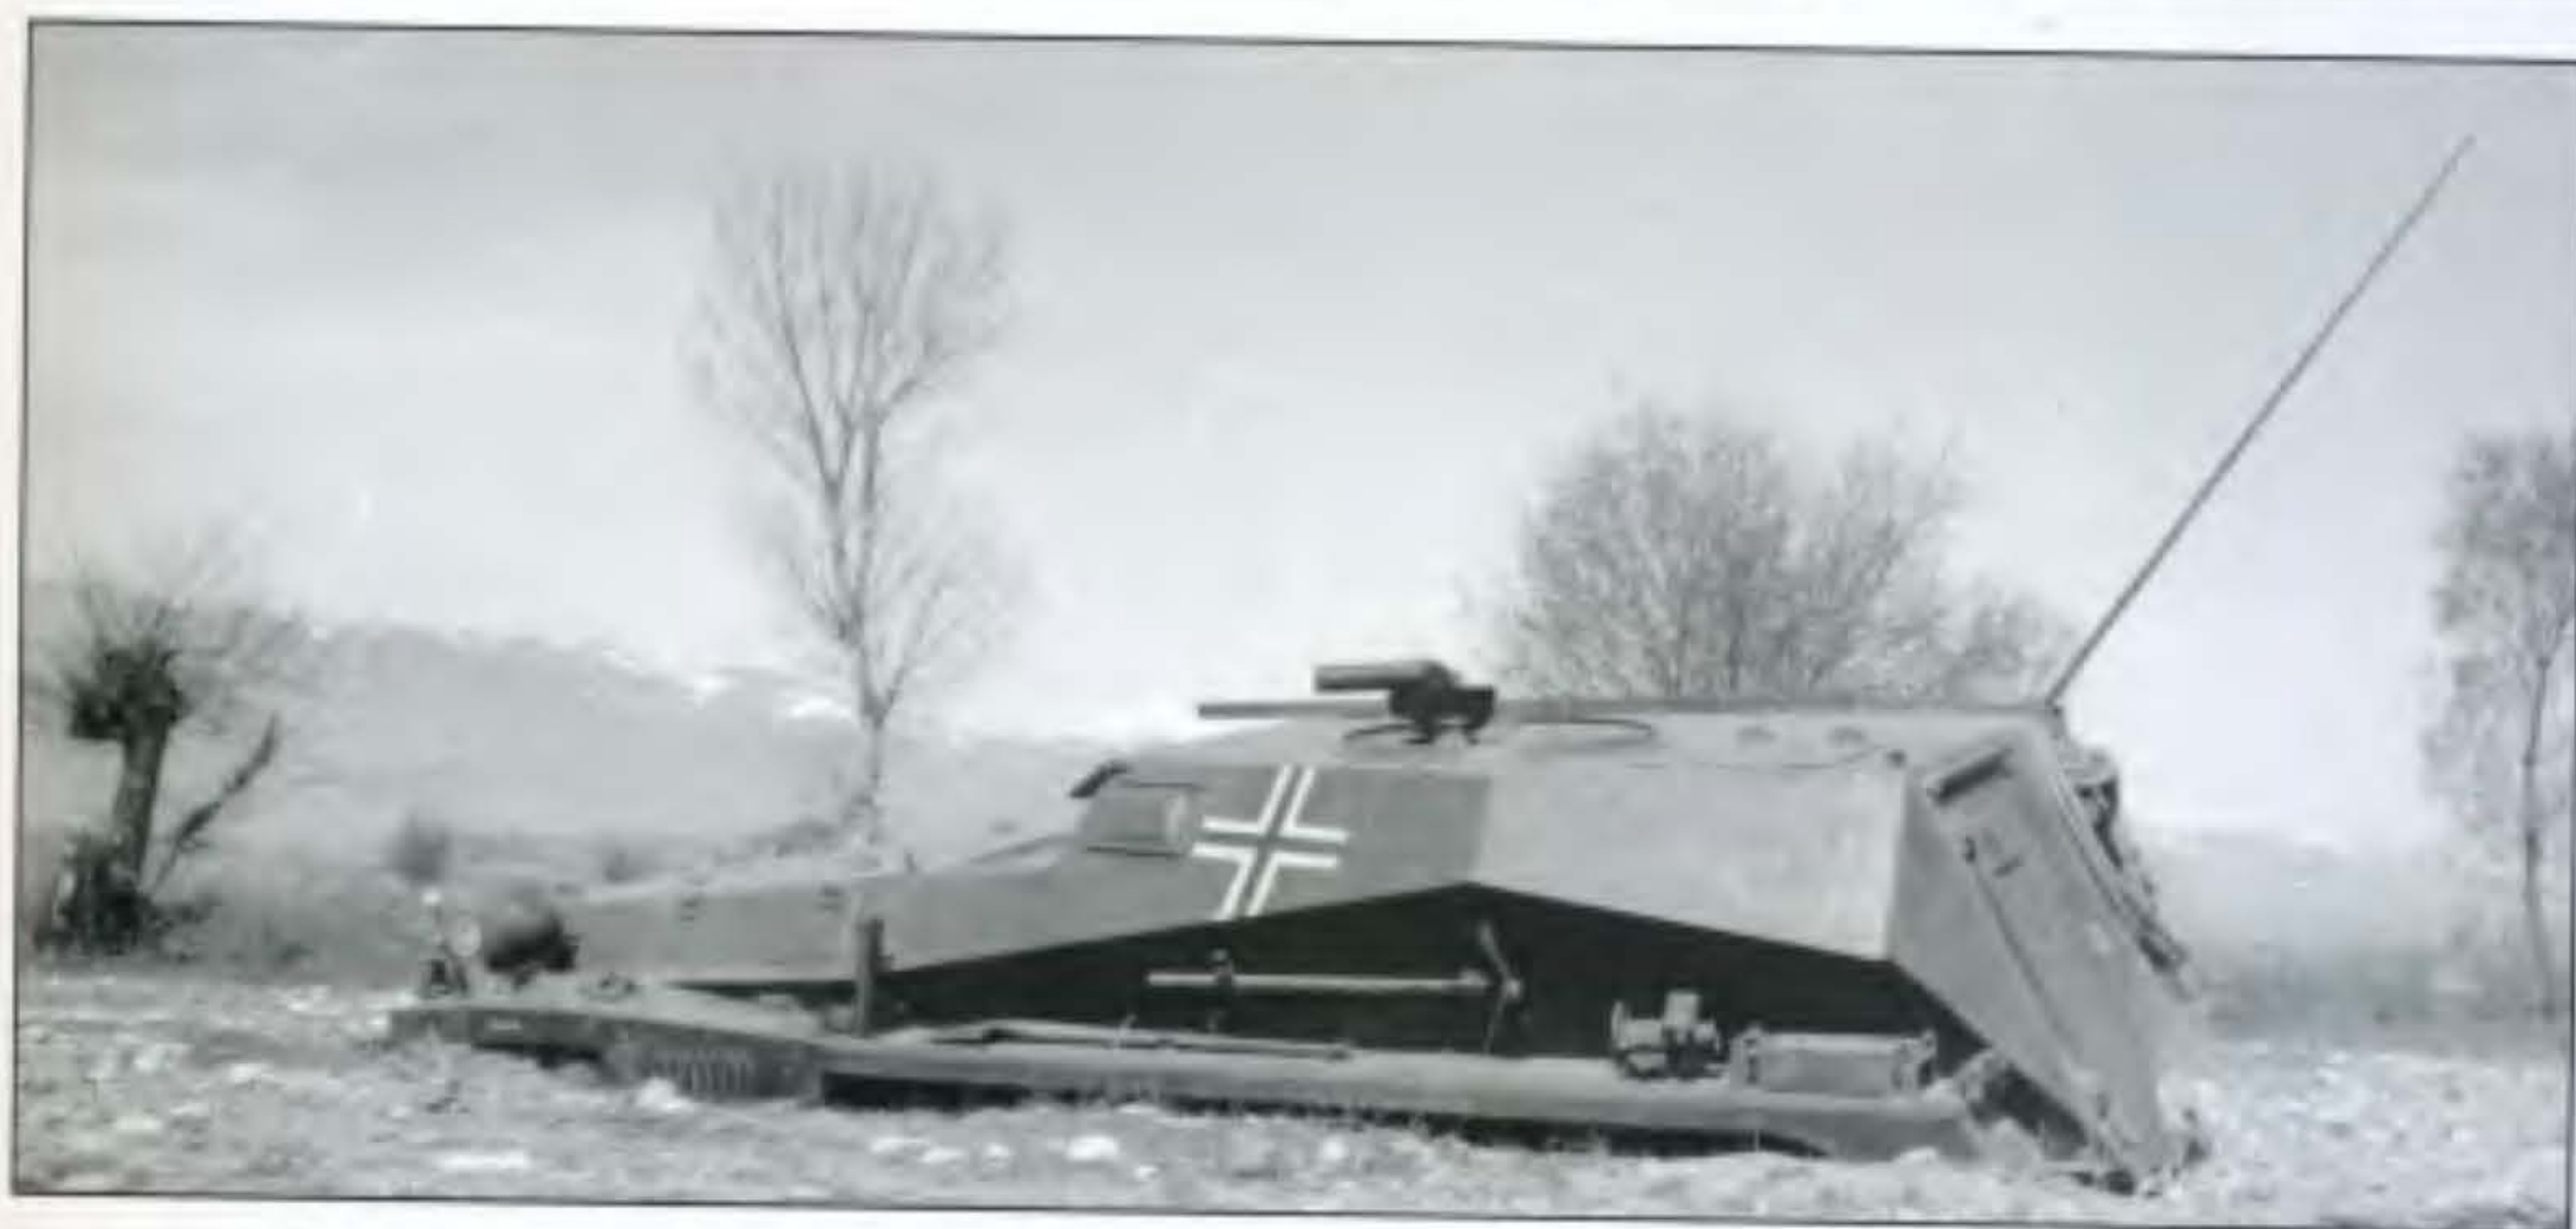
Clearly marked as the 1st Batterie of Sturmgeschuetz Abteilung 191 it is also the battery commander's vehicle as denoted by the 'Ch' for Chef or chief. However the soldier standing in the hatch is not the 'chef'.

This 253 has a two-piece engine deck and it just possible to see the join line in front of the engine bay doors. It is a hybrid vehicle with this early feature, but also has the late position for the semaphore indicators on the trackguards. Notice the leather covers for the headlamps. Compare these to the canvas version on page 153.

The two-piece engine deck was later dropped and never appeared on the 250 series. Apart from the wire-cutters missing on the front right wing, this 253 carries a full set of tools. In the centre photograph the crew have adopted a 'hull down' position and placed the dust /rain covers onto the binoculars. Note the angle of the aerial when deployed.
