TOTAL DETAIL

Sd Kfz 252, 253 & early 250

Sd Kfz 252, 253 & 250 (Typ 1)

Volume 3 - Part 1

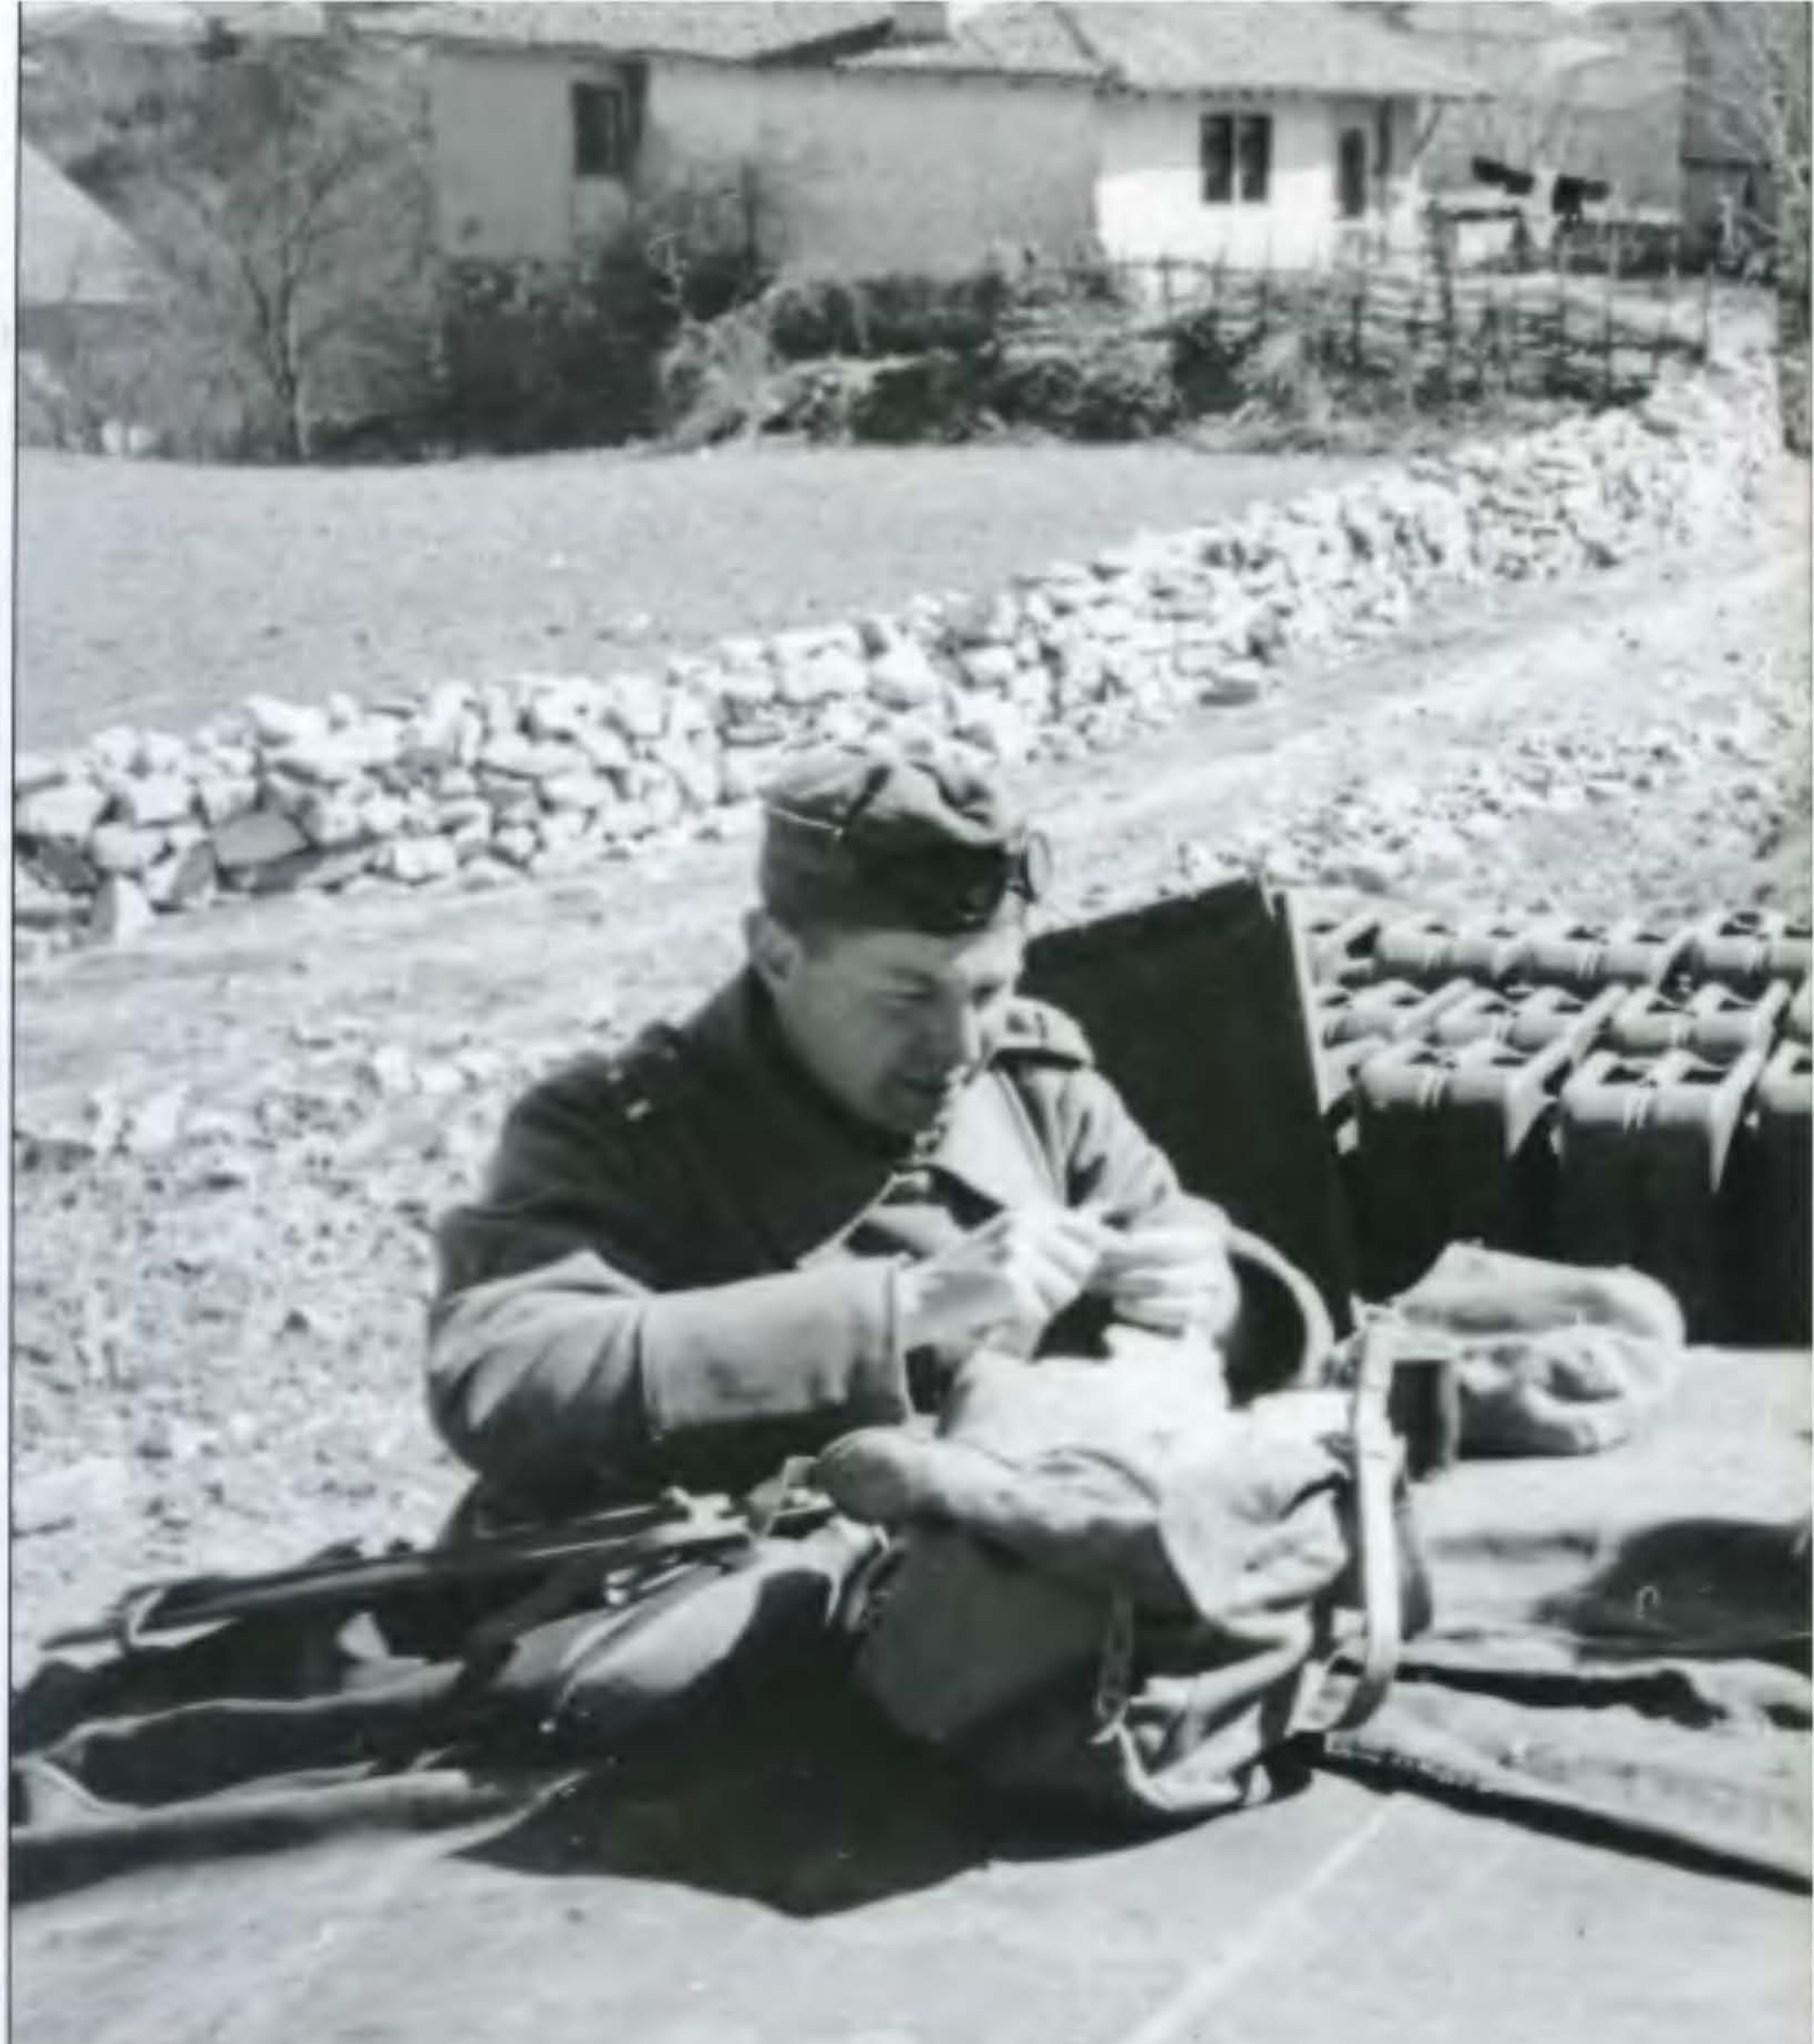
The lines of rivets hold the intermediate plates inside the trailer for the ammo. (For a photograph of the interior details, see page 113). Interestingly and because it still wears its original factory coat of paint, the manufacturers plates also remain in their original black and silver condition. He is wearing a M34 'Schiffchen' (little ship) side cap with the same heraldic lion badge and his dark blue Arbeitsanzug (work uniform). Given the differing tones perhaps the trousers are in blue and the jacket could be the earlier black version.

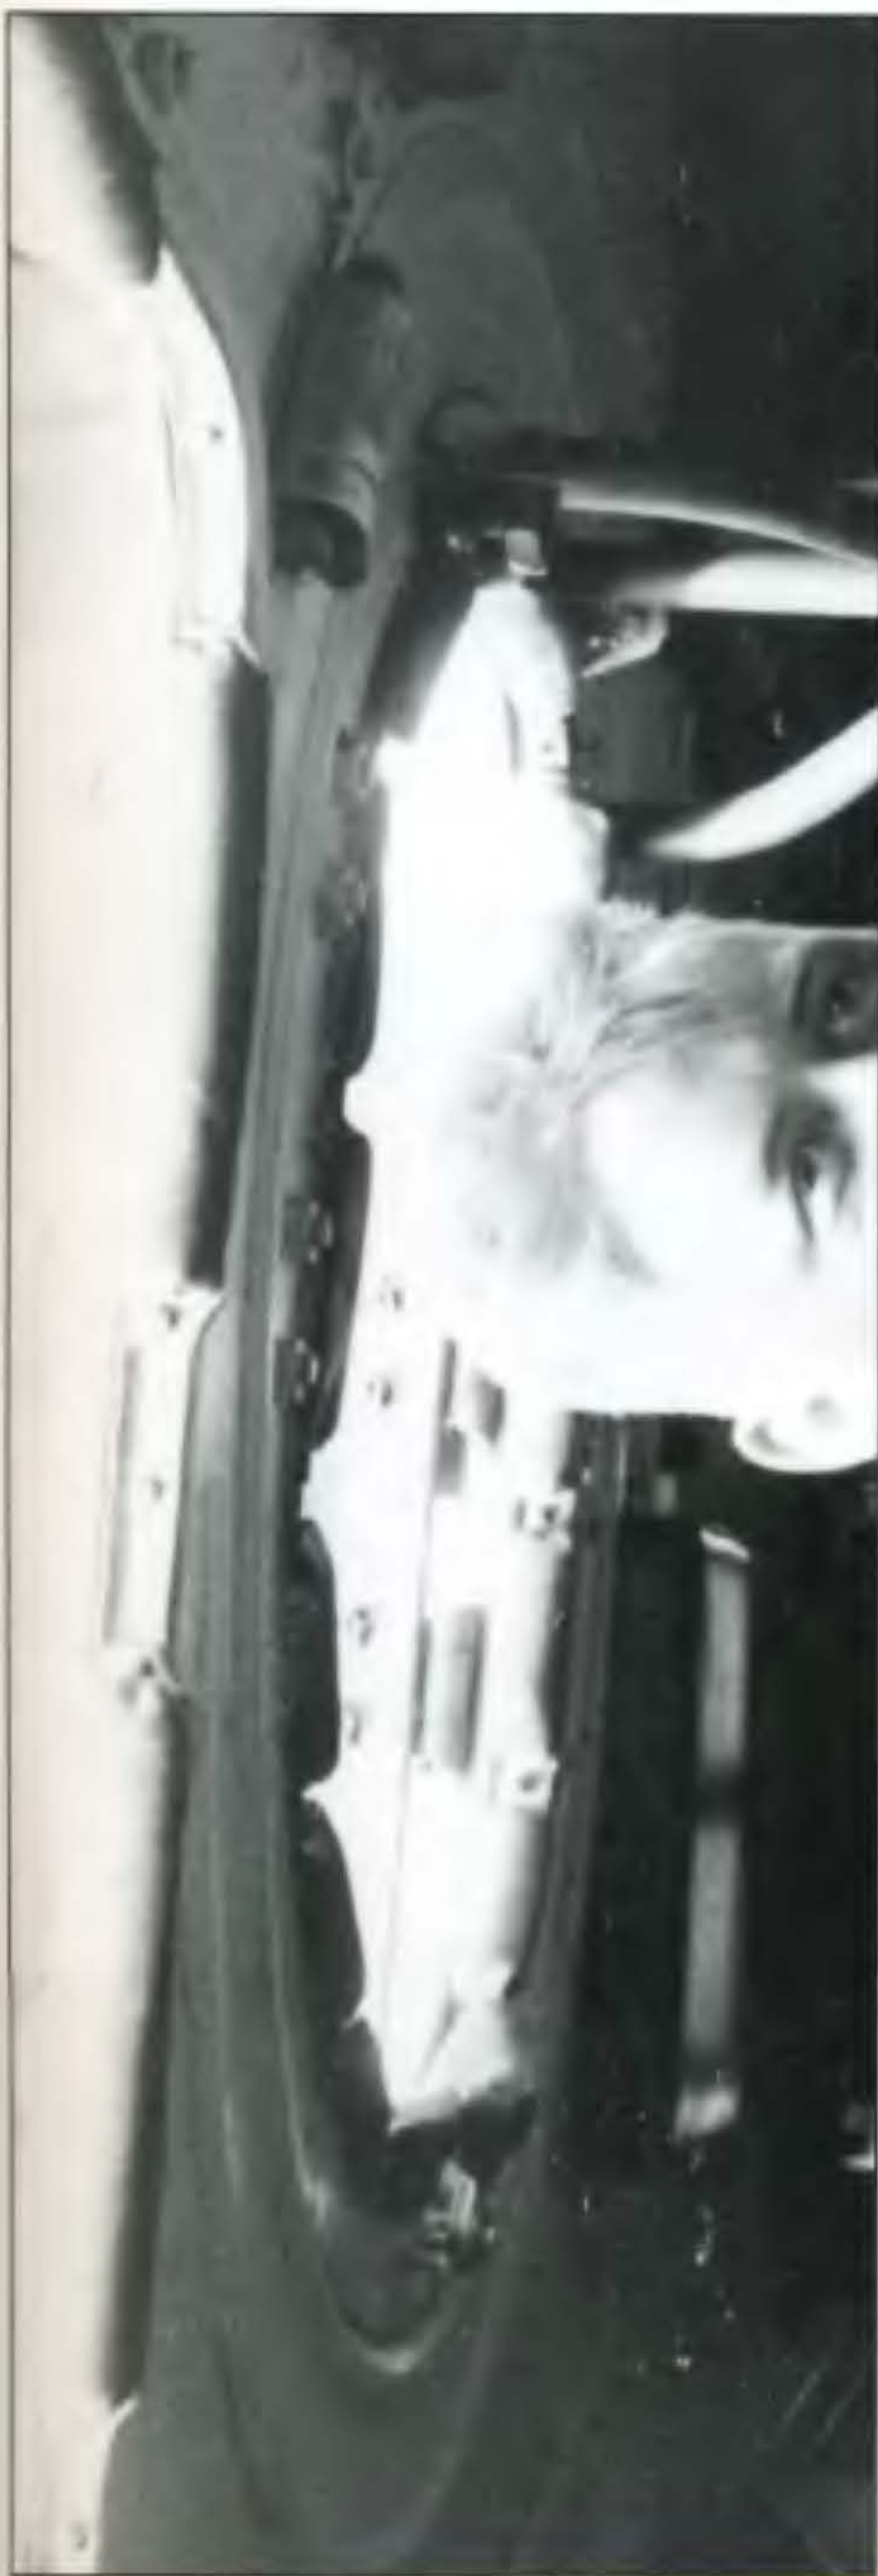
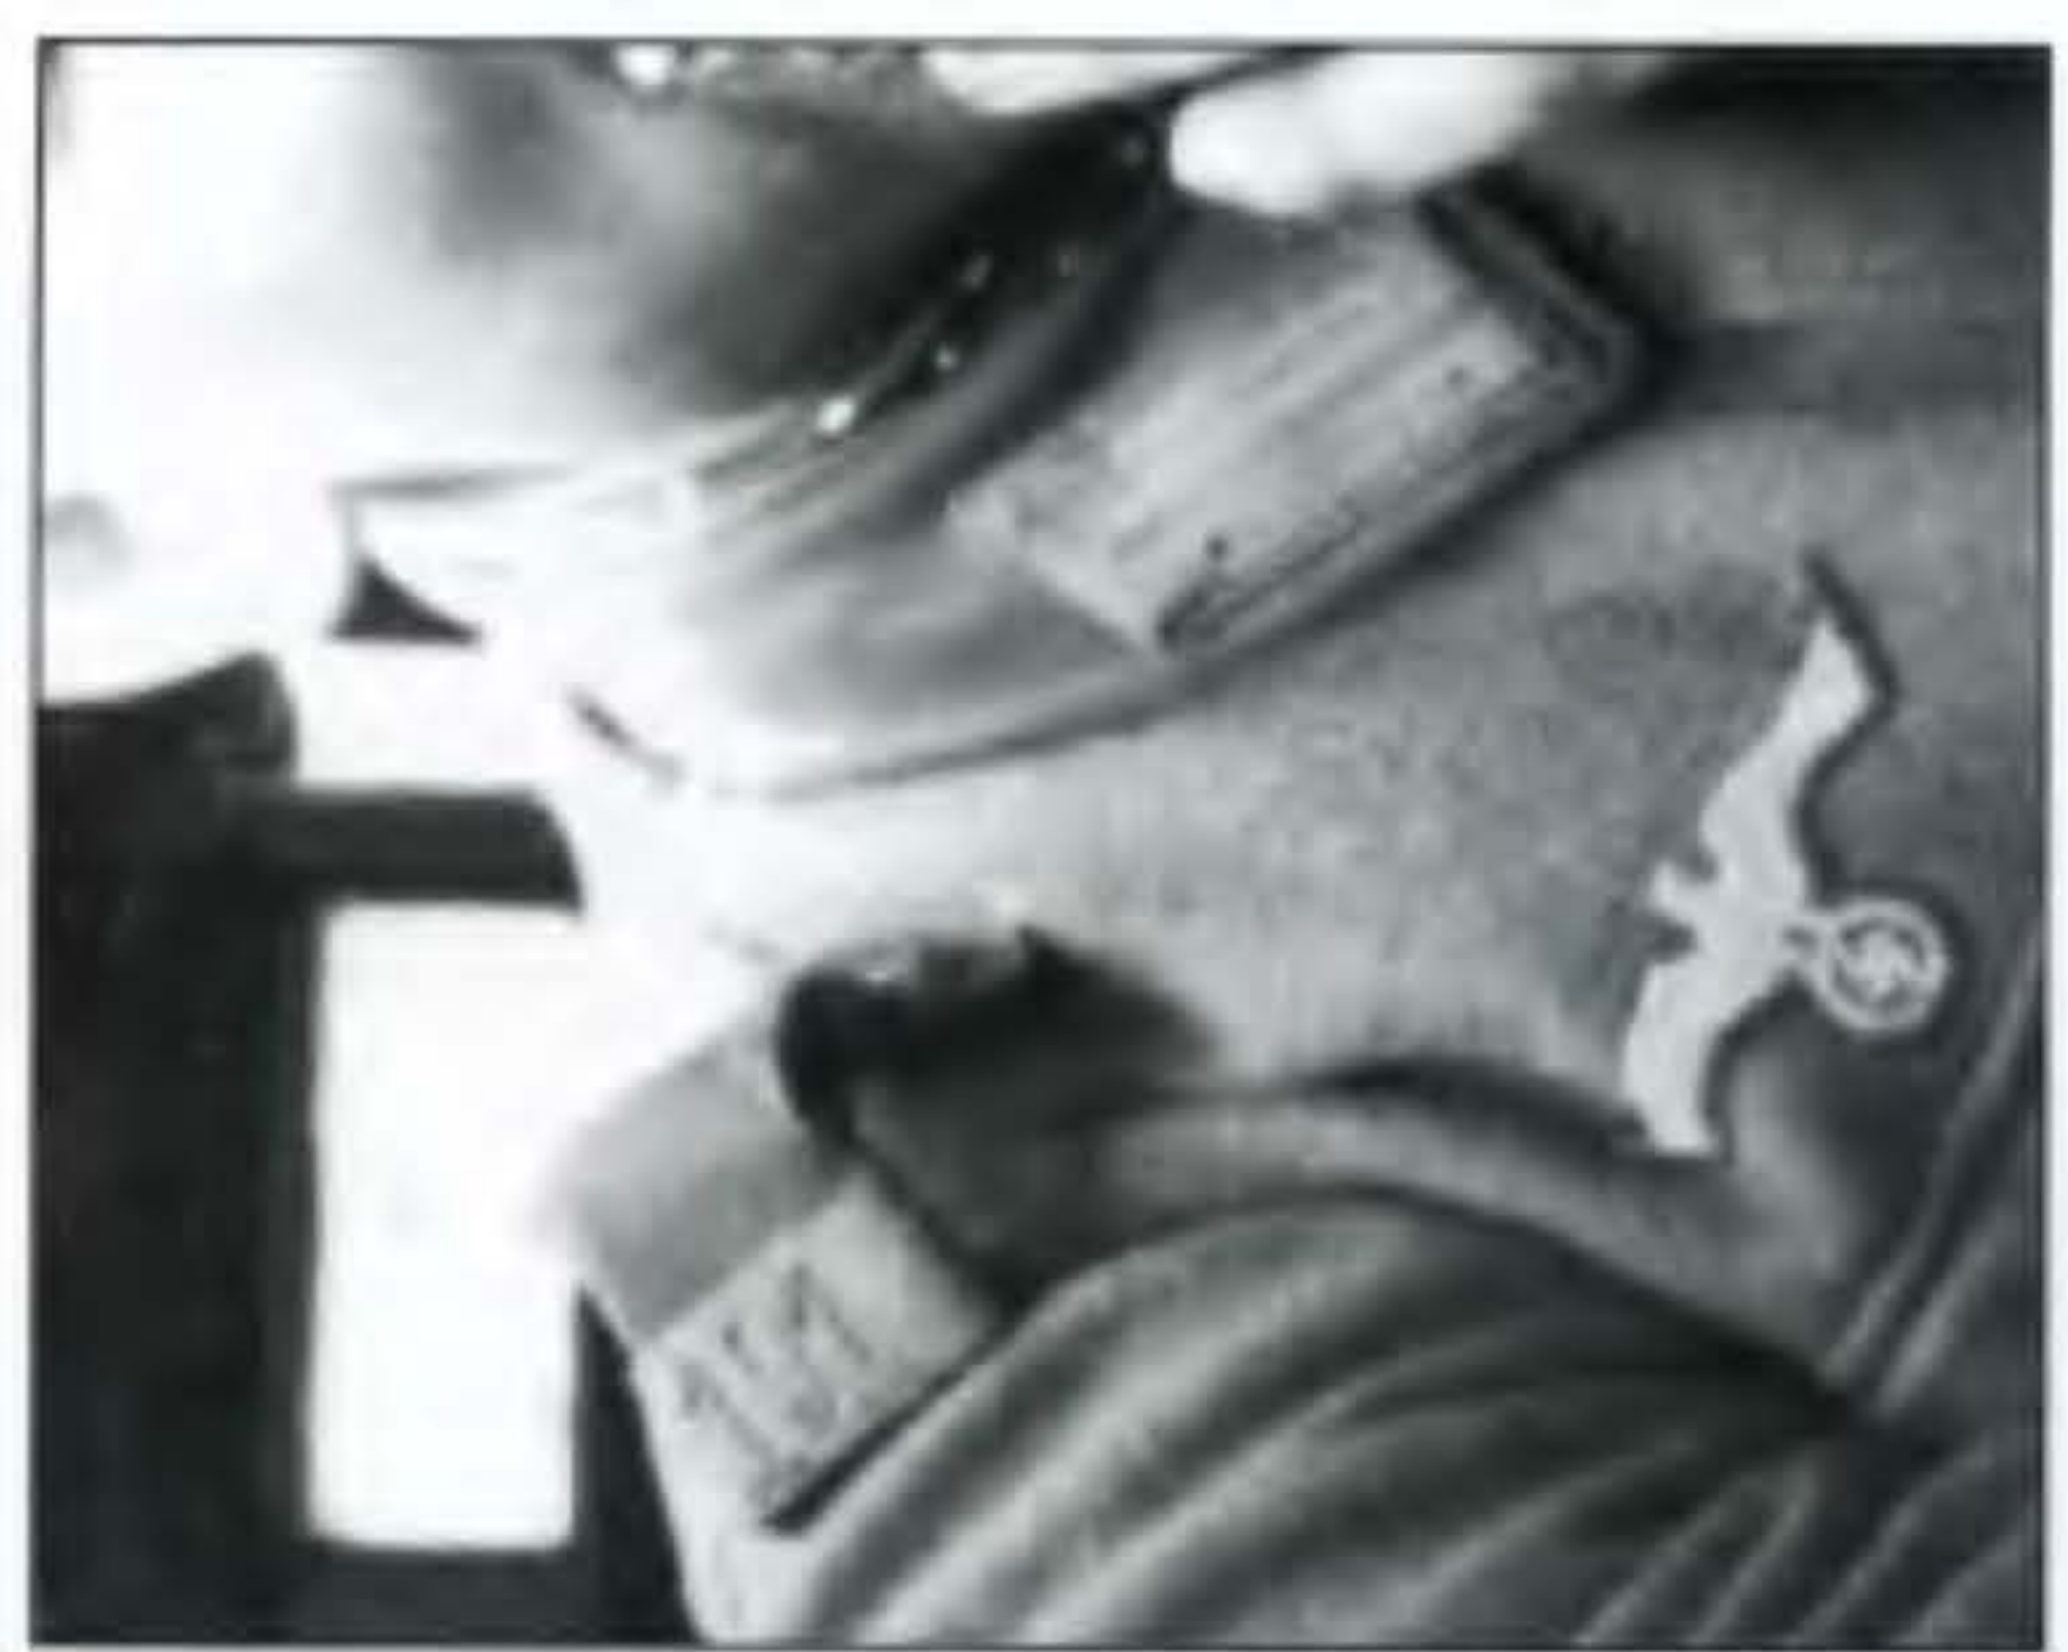
With early vehicles, the small interior details are usually of a high quality. Unlike later 250 Typ 2s that used simple rubber strips for the edges, this 253 has leather pads on both roof openings. To our lower left are three (and possibly one extra) coloured signal flags sitting in their three holders below the row of hand grenades. This 253 contains the Fu 1.5 and Fu 1.6 radio sets, both of which have the covers in place. (For an interior photograph of the artillery version see page 133). The lower clamp assembly for the binoculars includes the small tray to hold the battery box to power the sight illumination.

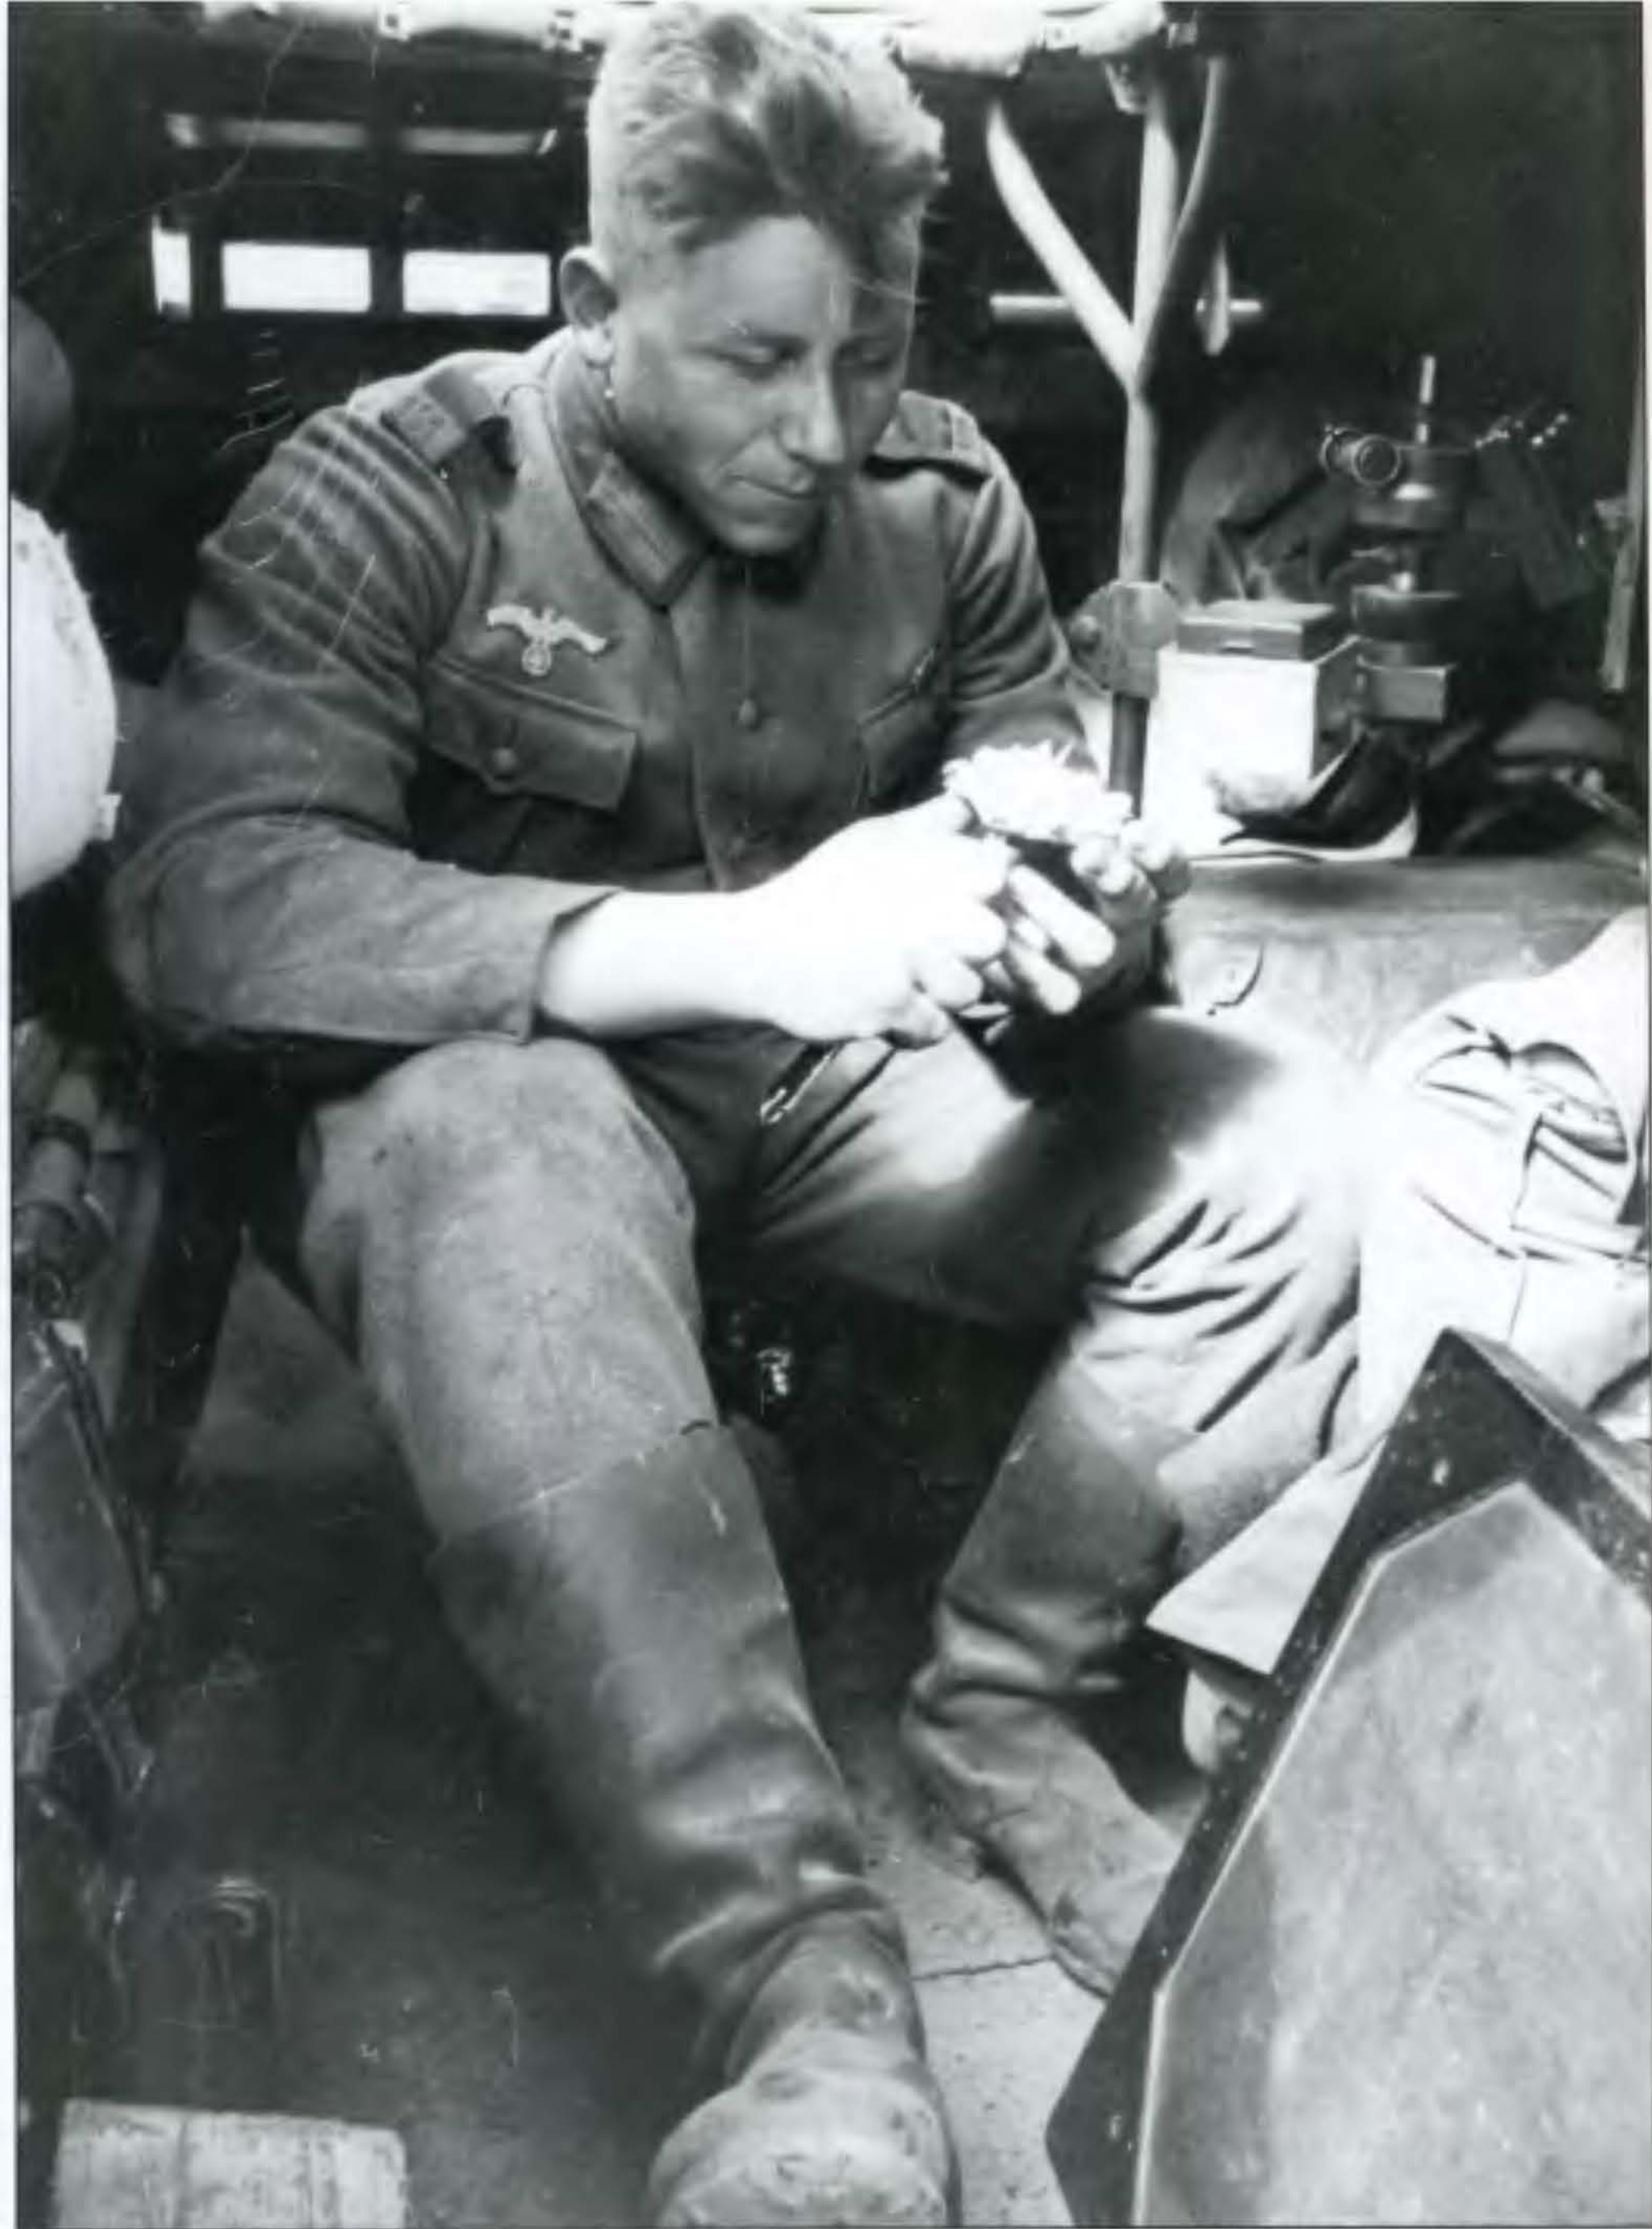
SCHERENFERNROHR 14 ZEISS (S.F. 14 Z.)

(Scissor telescope, binocular twin periscope)

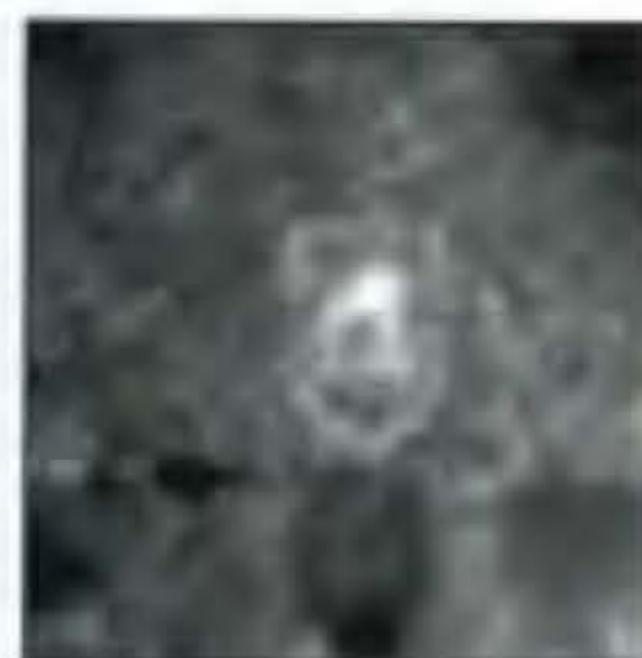
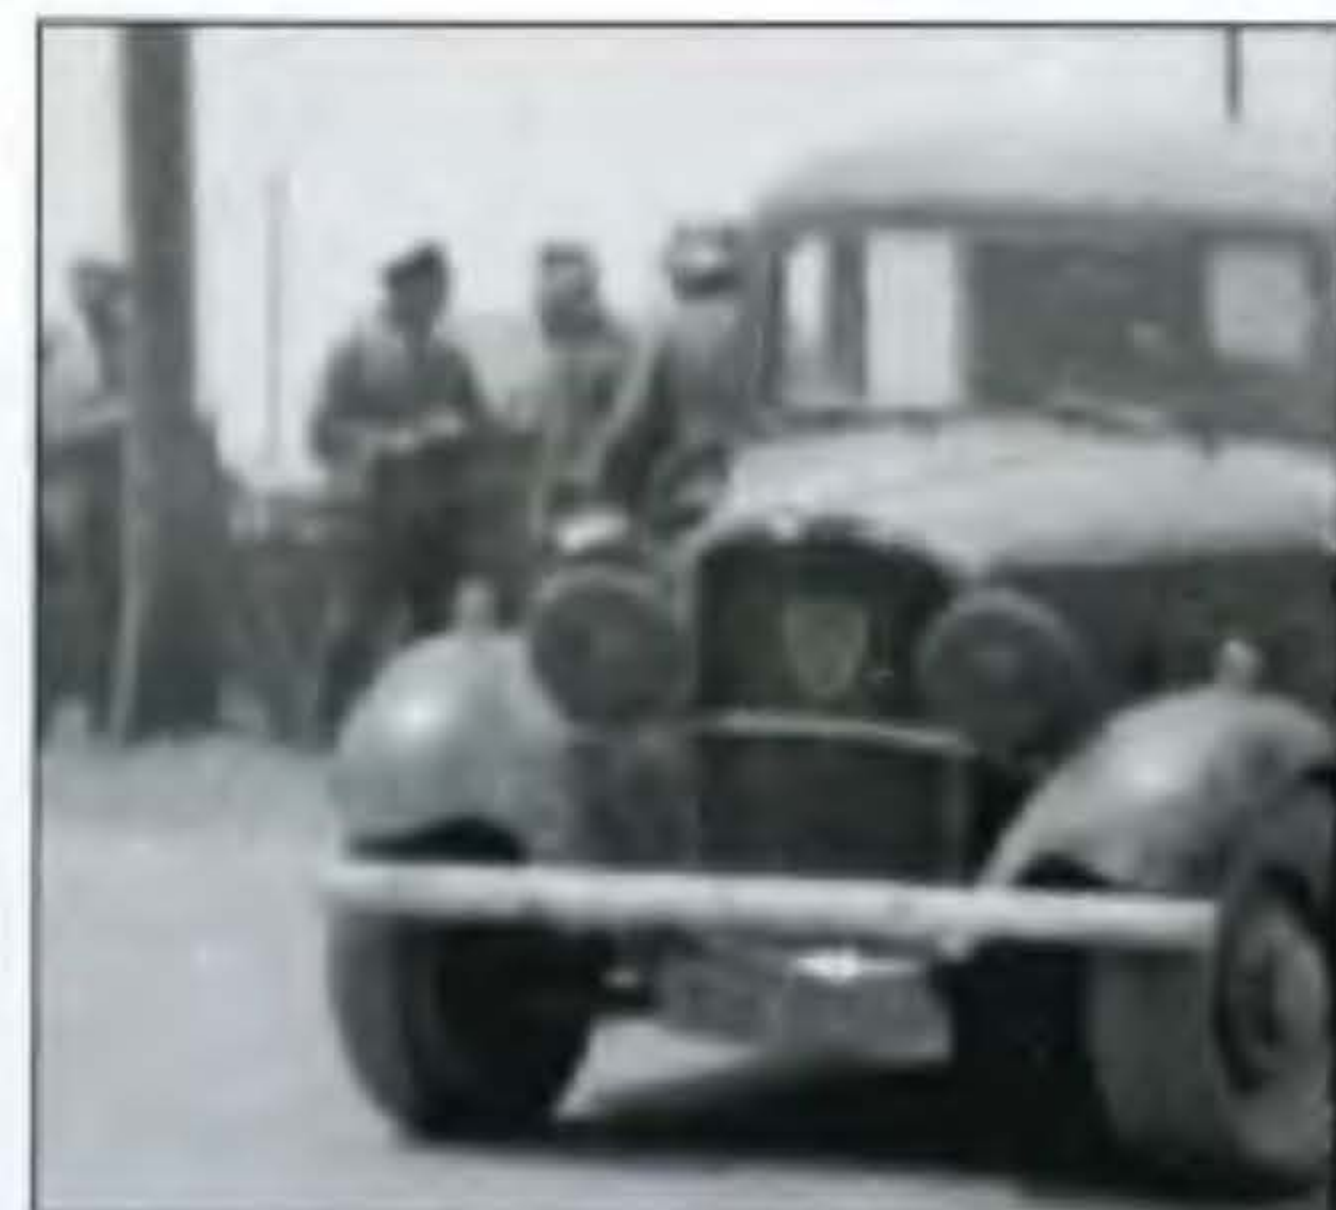
RIGHT: A close up detail picture of the tailboard of the Sd Kfz 9 showing the unit emblem of a white lion and edge on a red background. The unidentified saloon car also appears to wear the unit emblem on the right mud guard.

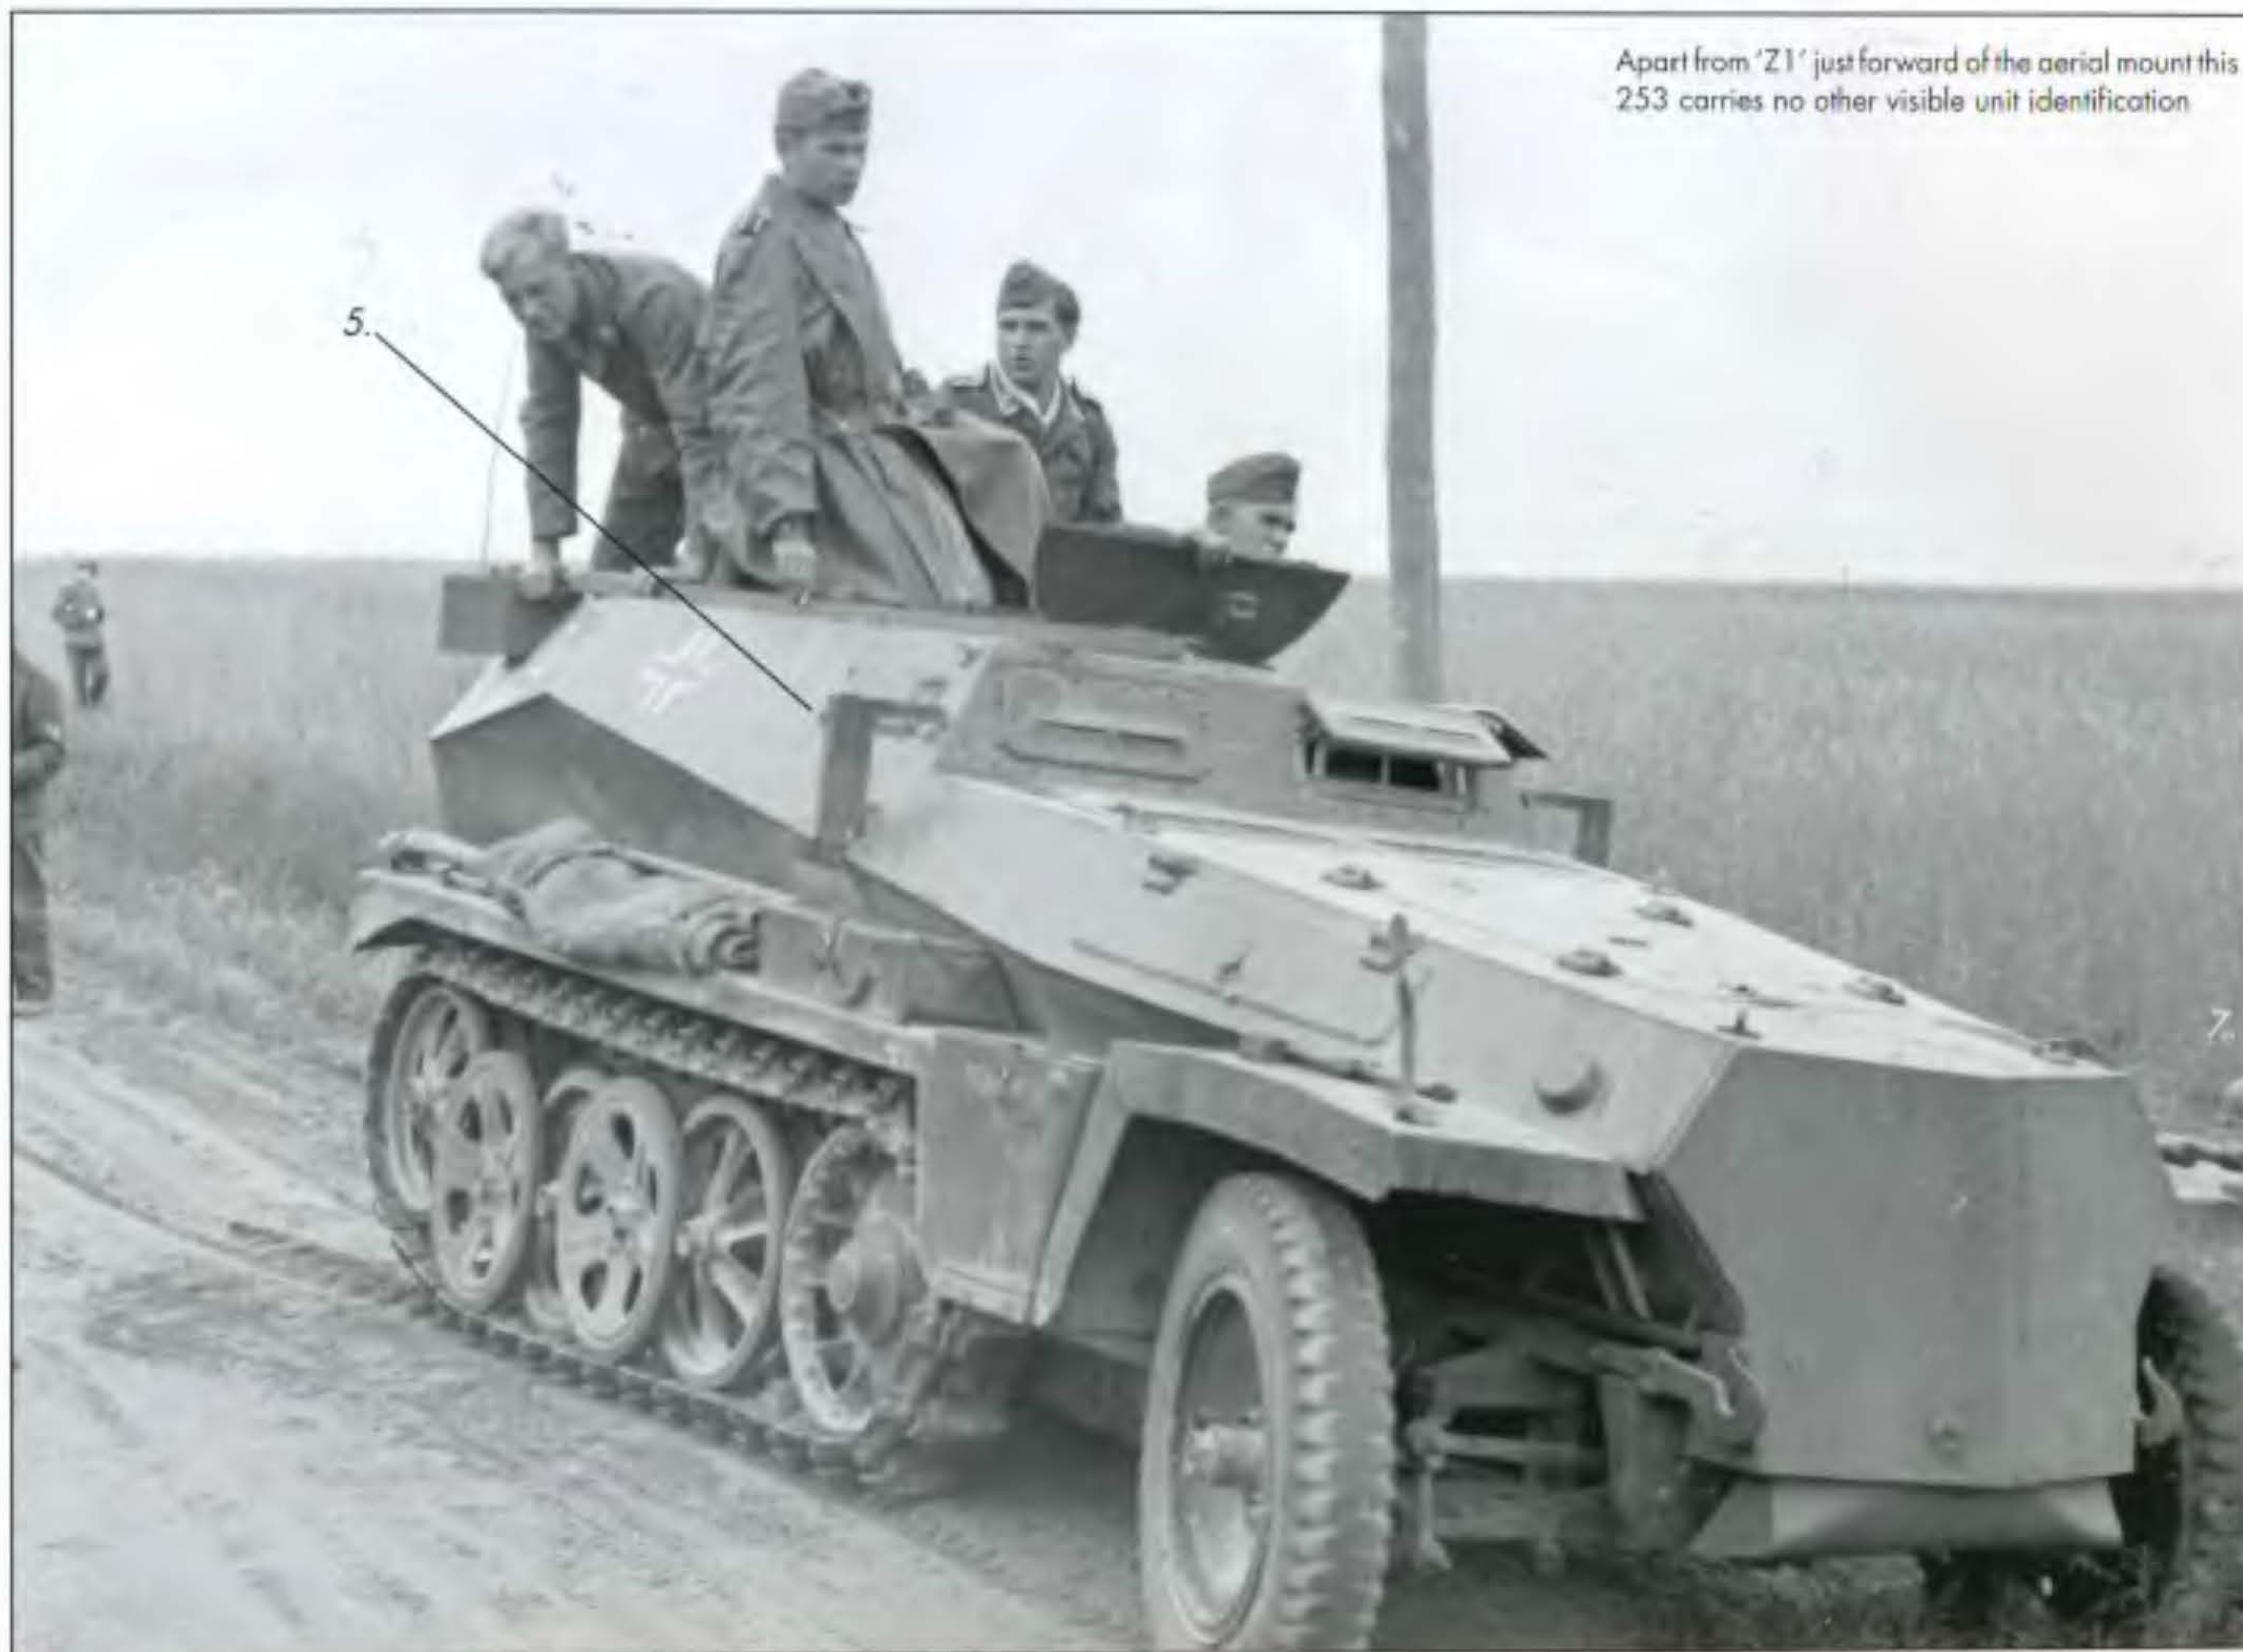
Apart from '21' just forward of the aerial mount this 253 carries no other visible unit identification
