TOTAL DETAIL

Sd Kfz 252, 253 & early 250

Sd Kfz 252, 253 & 250 (Typ 1)

Volume 3 - Part 1

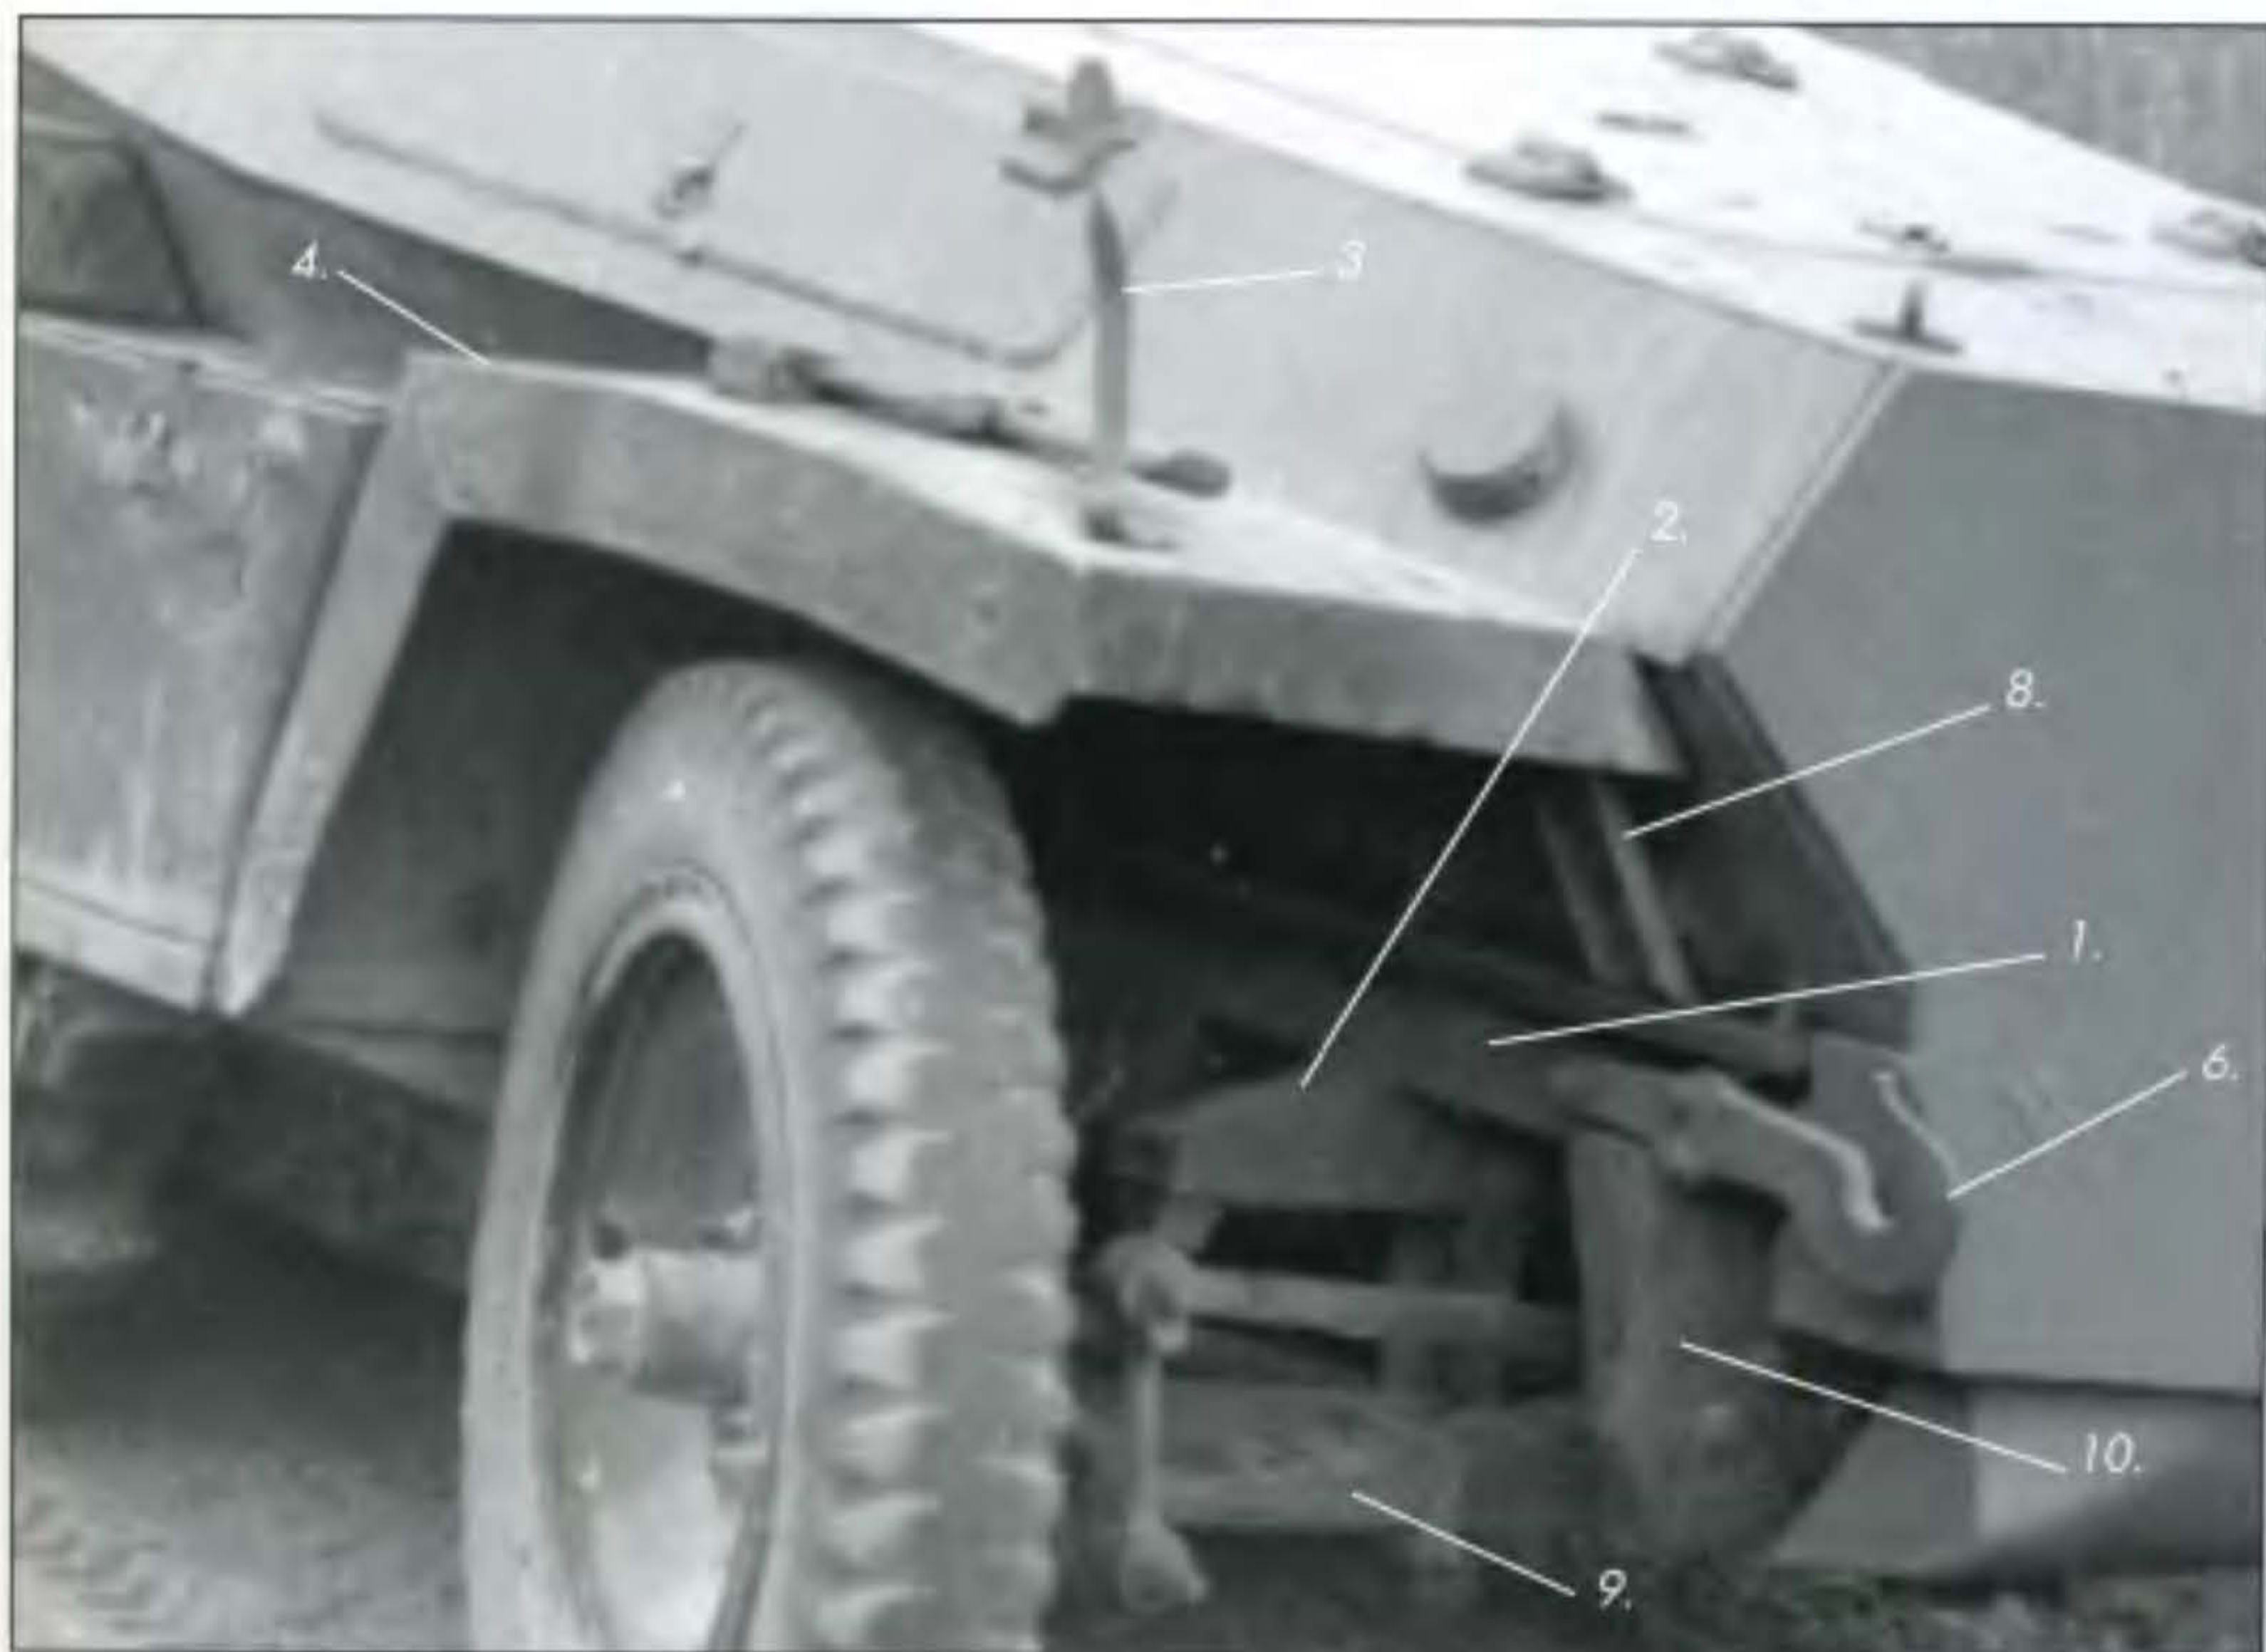
This 253 is one of the pre-production batch, or one of the first production vehicles, and as such has some unique features that identify its heritage, that match the detail pictures in the introduction to the D672/5 manual

1. The front of the chassis on this 253 is less deep and the top and bottom edges are parallel. The standard chassis was deeper at the front and the lower edge sloped gently down towards the rear. Note how steep the angle change is behind the bump stop arm.

TOP: The 253 looks like the same vehicle as shown on page 80 - 81. It is one of the pre-production examples with the early 'shallow' front chassis design. The original leaf-springs (from the Sd Kfz 10) on the A-frame front axle were found to be too weak for the weight of the armoured vehicle. Consequently with the A-frame fully articulated over rough terrain, the wheels would hit the mudguards. The front axle has already sagged and either there is a torsion bar problem causing the track wheels to sink or the rear idler requires attention to re-tension the tracks.

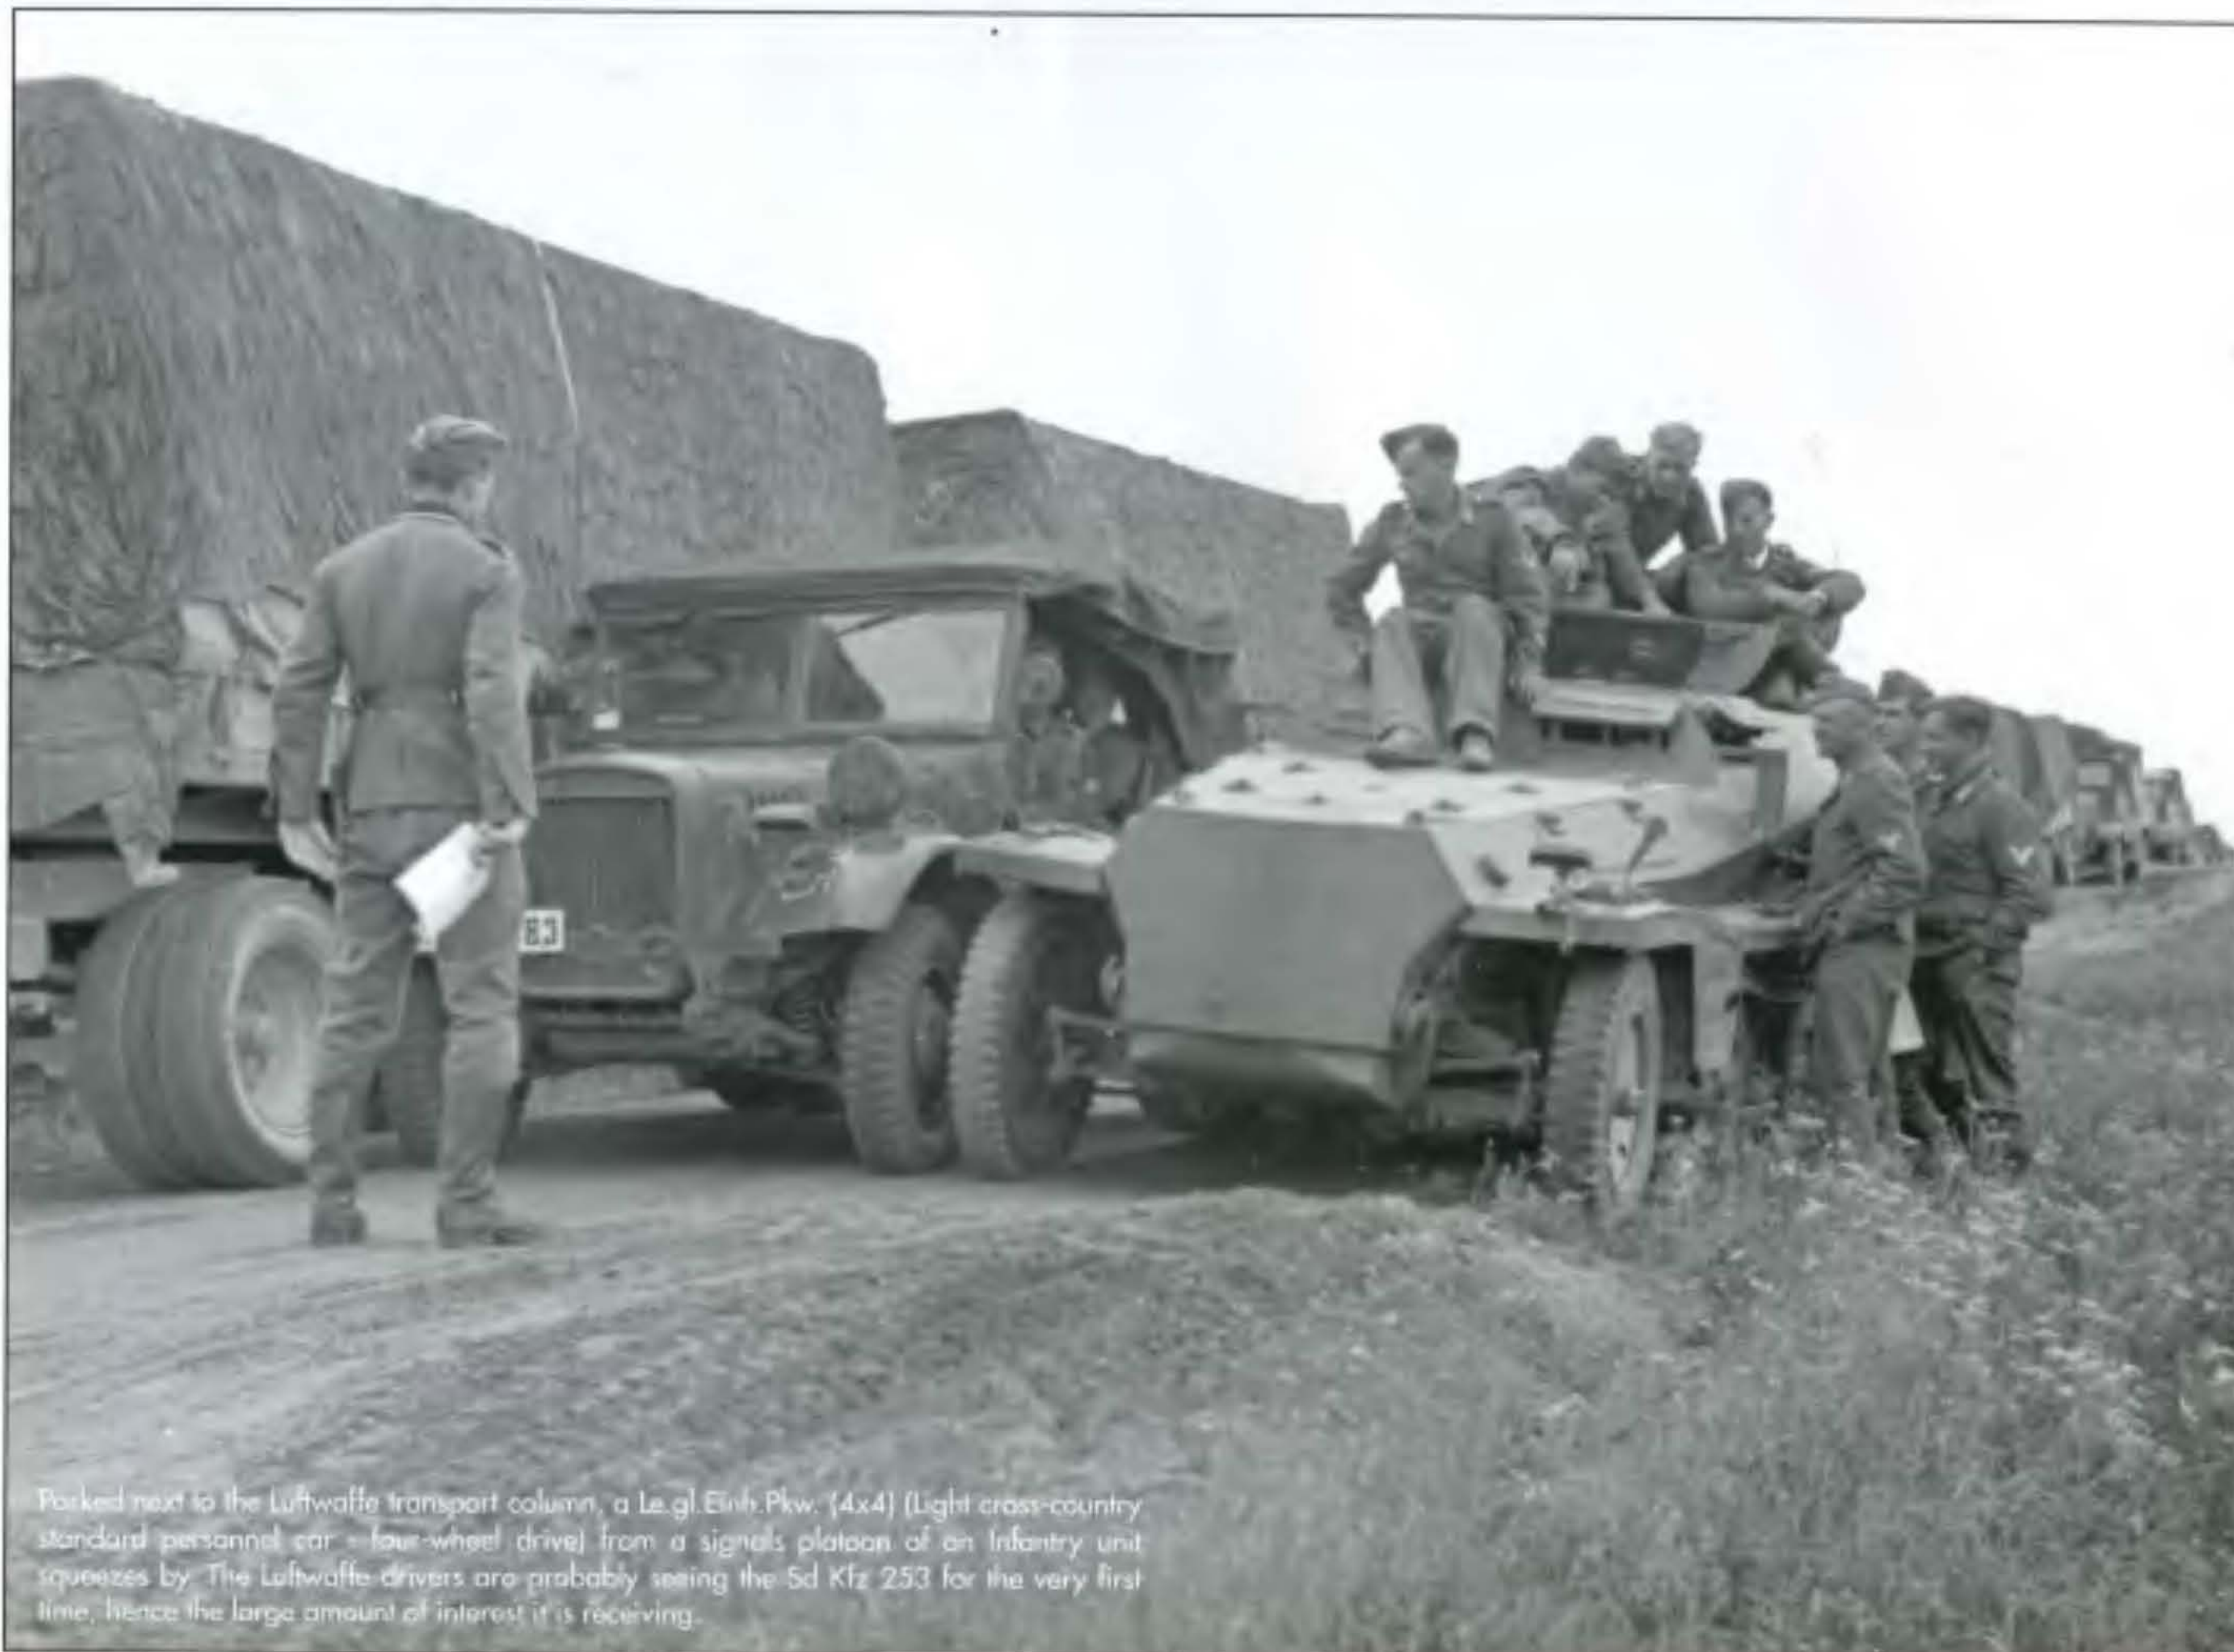
10. The shock absorber arm mounting plate is wider and extends beyond the chassis edge. For production vehicles this was flush with the outer edge.

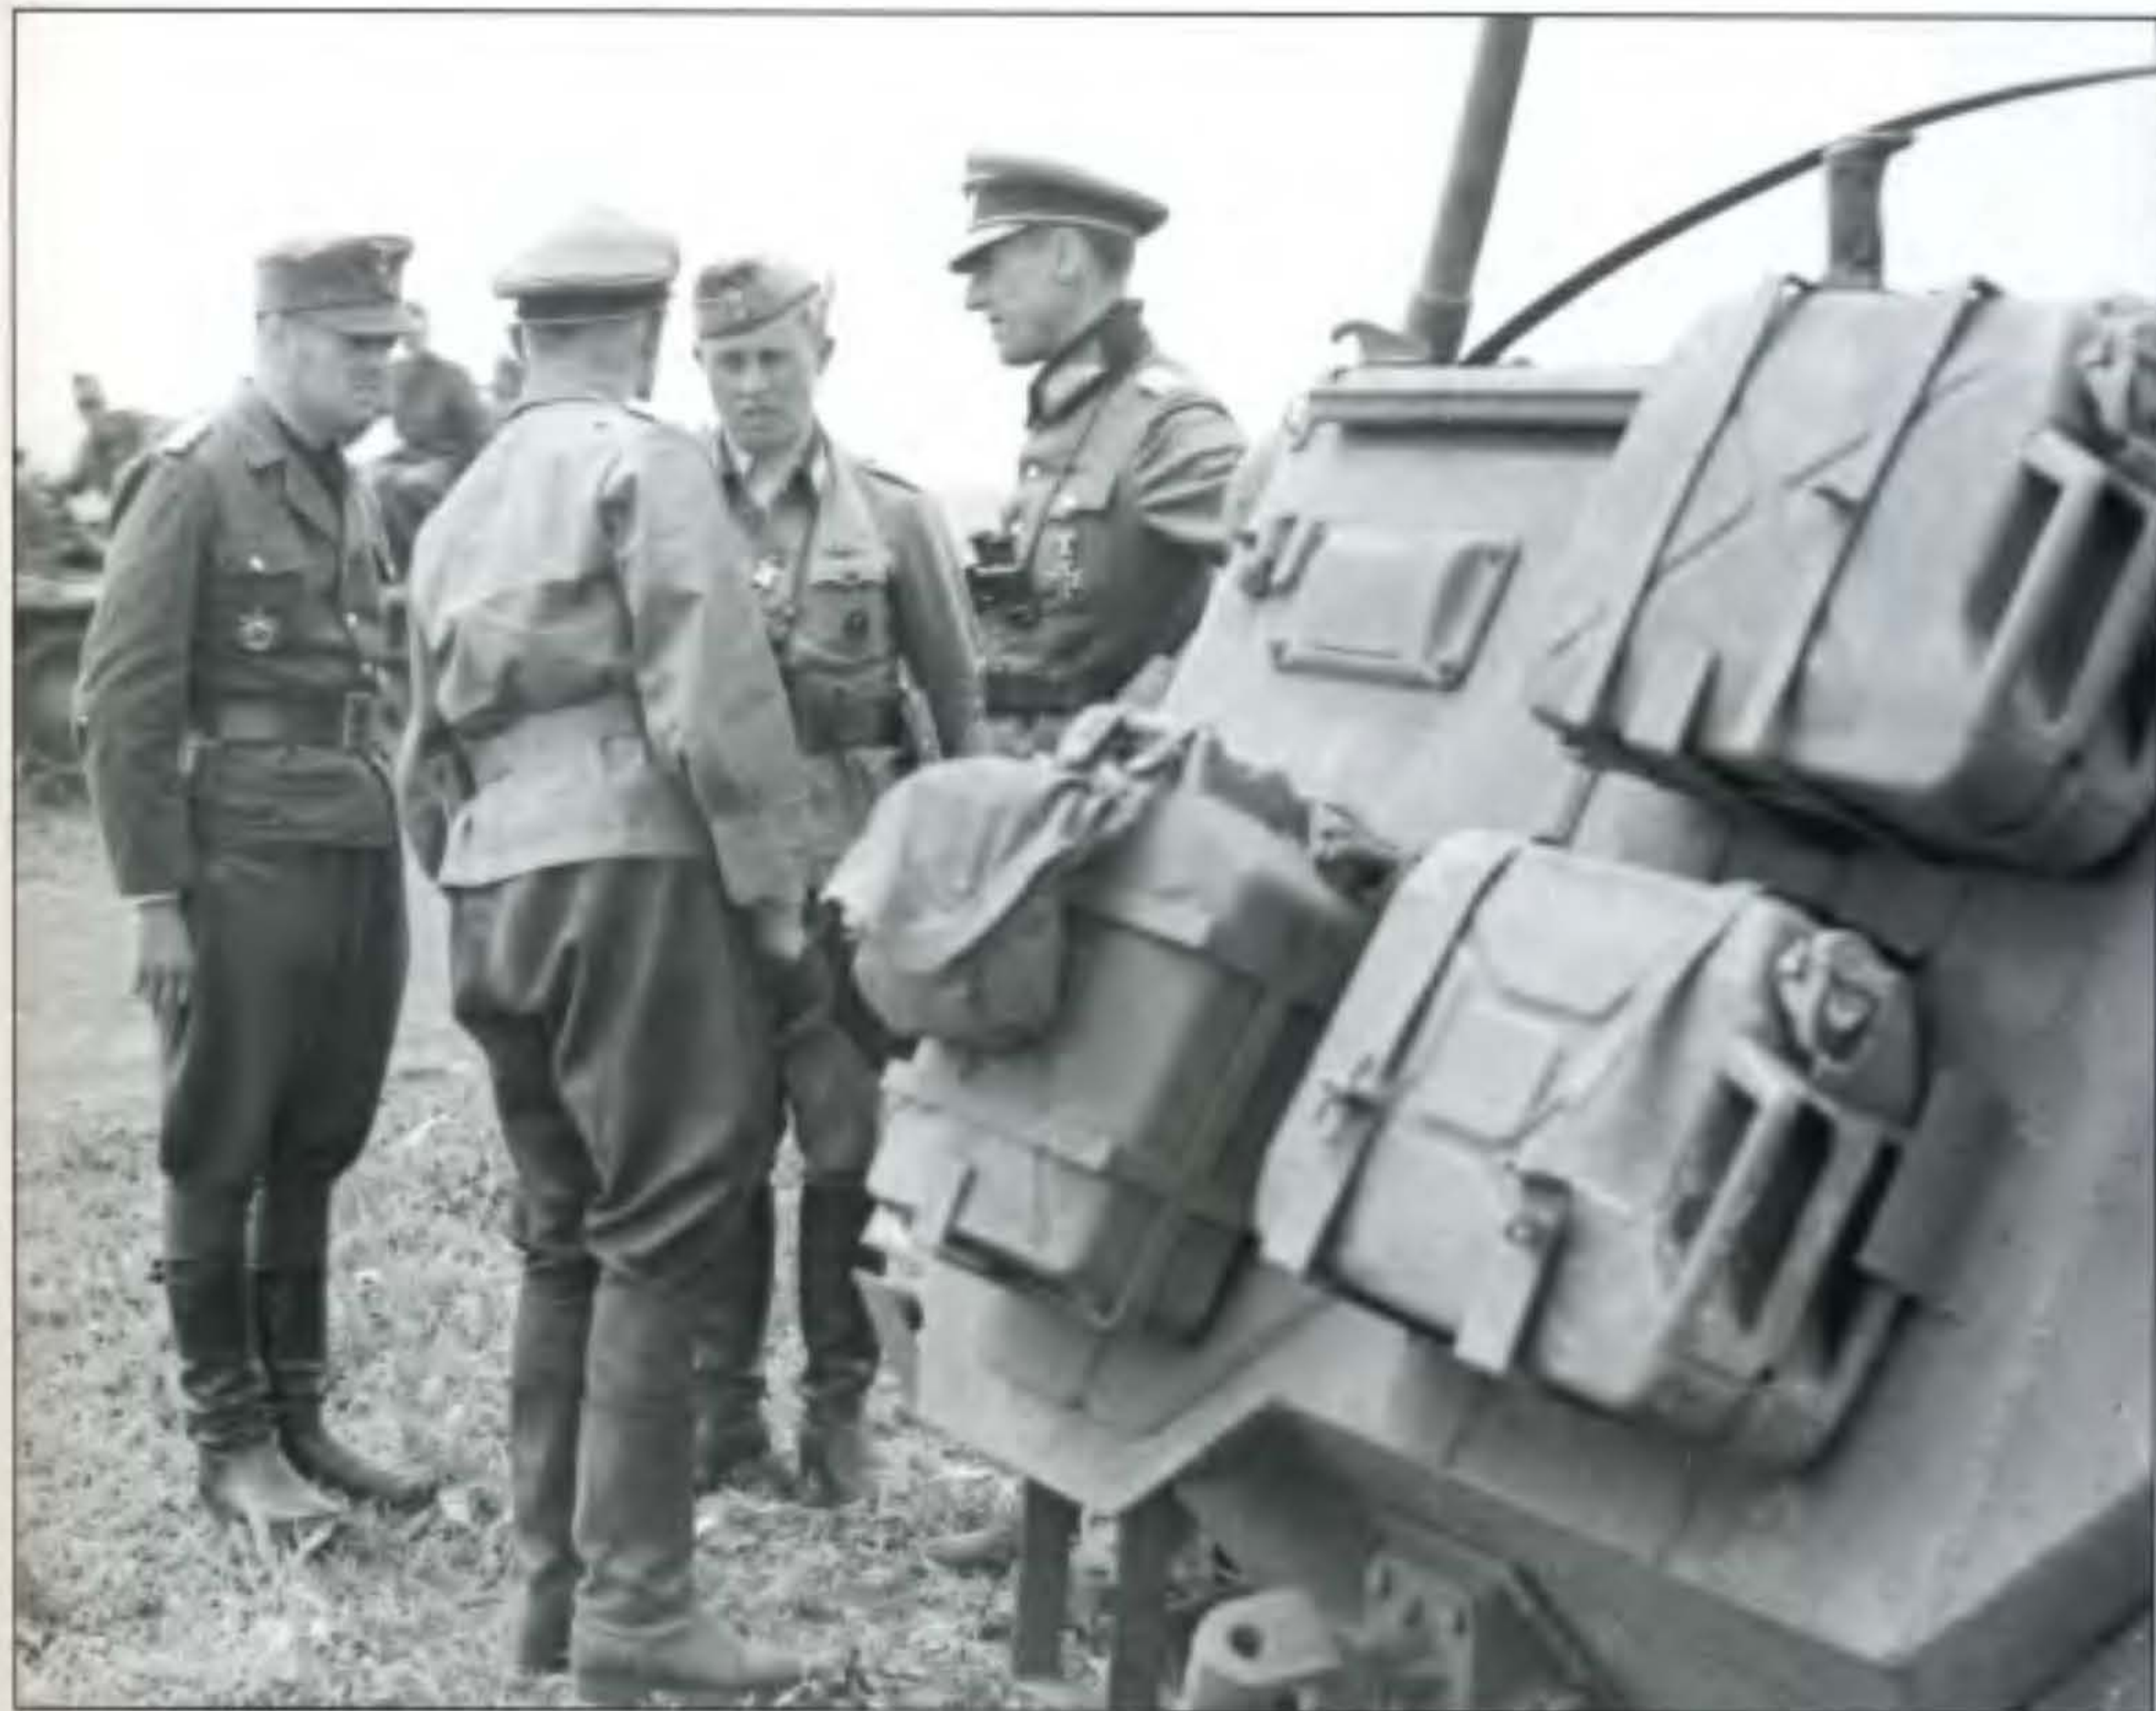
ABOVE: Instead of the often seen multi-can rack, the workshop company have built individual holders and gone to a fair amount of trouble as each holder is of a different design. The door-mounted rack is of a standard design where the can sits in the cage, but a full jerry can would have only hindered the use of the rear door. It would have required a hefty shove to open and close attention when closing to avoid trapping fingers in the door. The pair to the right were designed together, with the vertical metal strips bent and welded to form both the upper and lower racks. The retaining spar on the lower rack utilises a quick release bar welded to the strip that can be pulled over the lower arm to secure the can in place. It is not clear how the jerry can above is secured or removed. In this shot, the complicated set of panels of the 253-based 250s can be seen but deleted from the Typ 2 design from 1942 onwards. Note that the single spar rear reflector arm is hinged and stuck in the folded position.

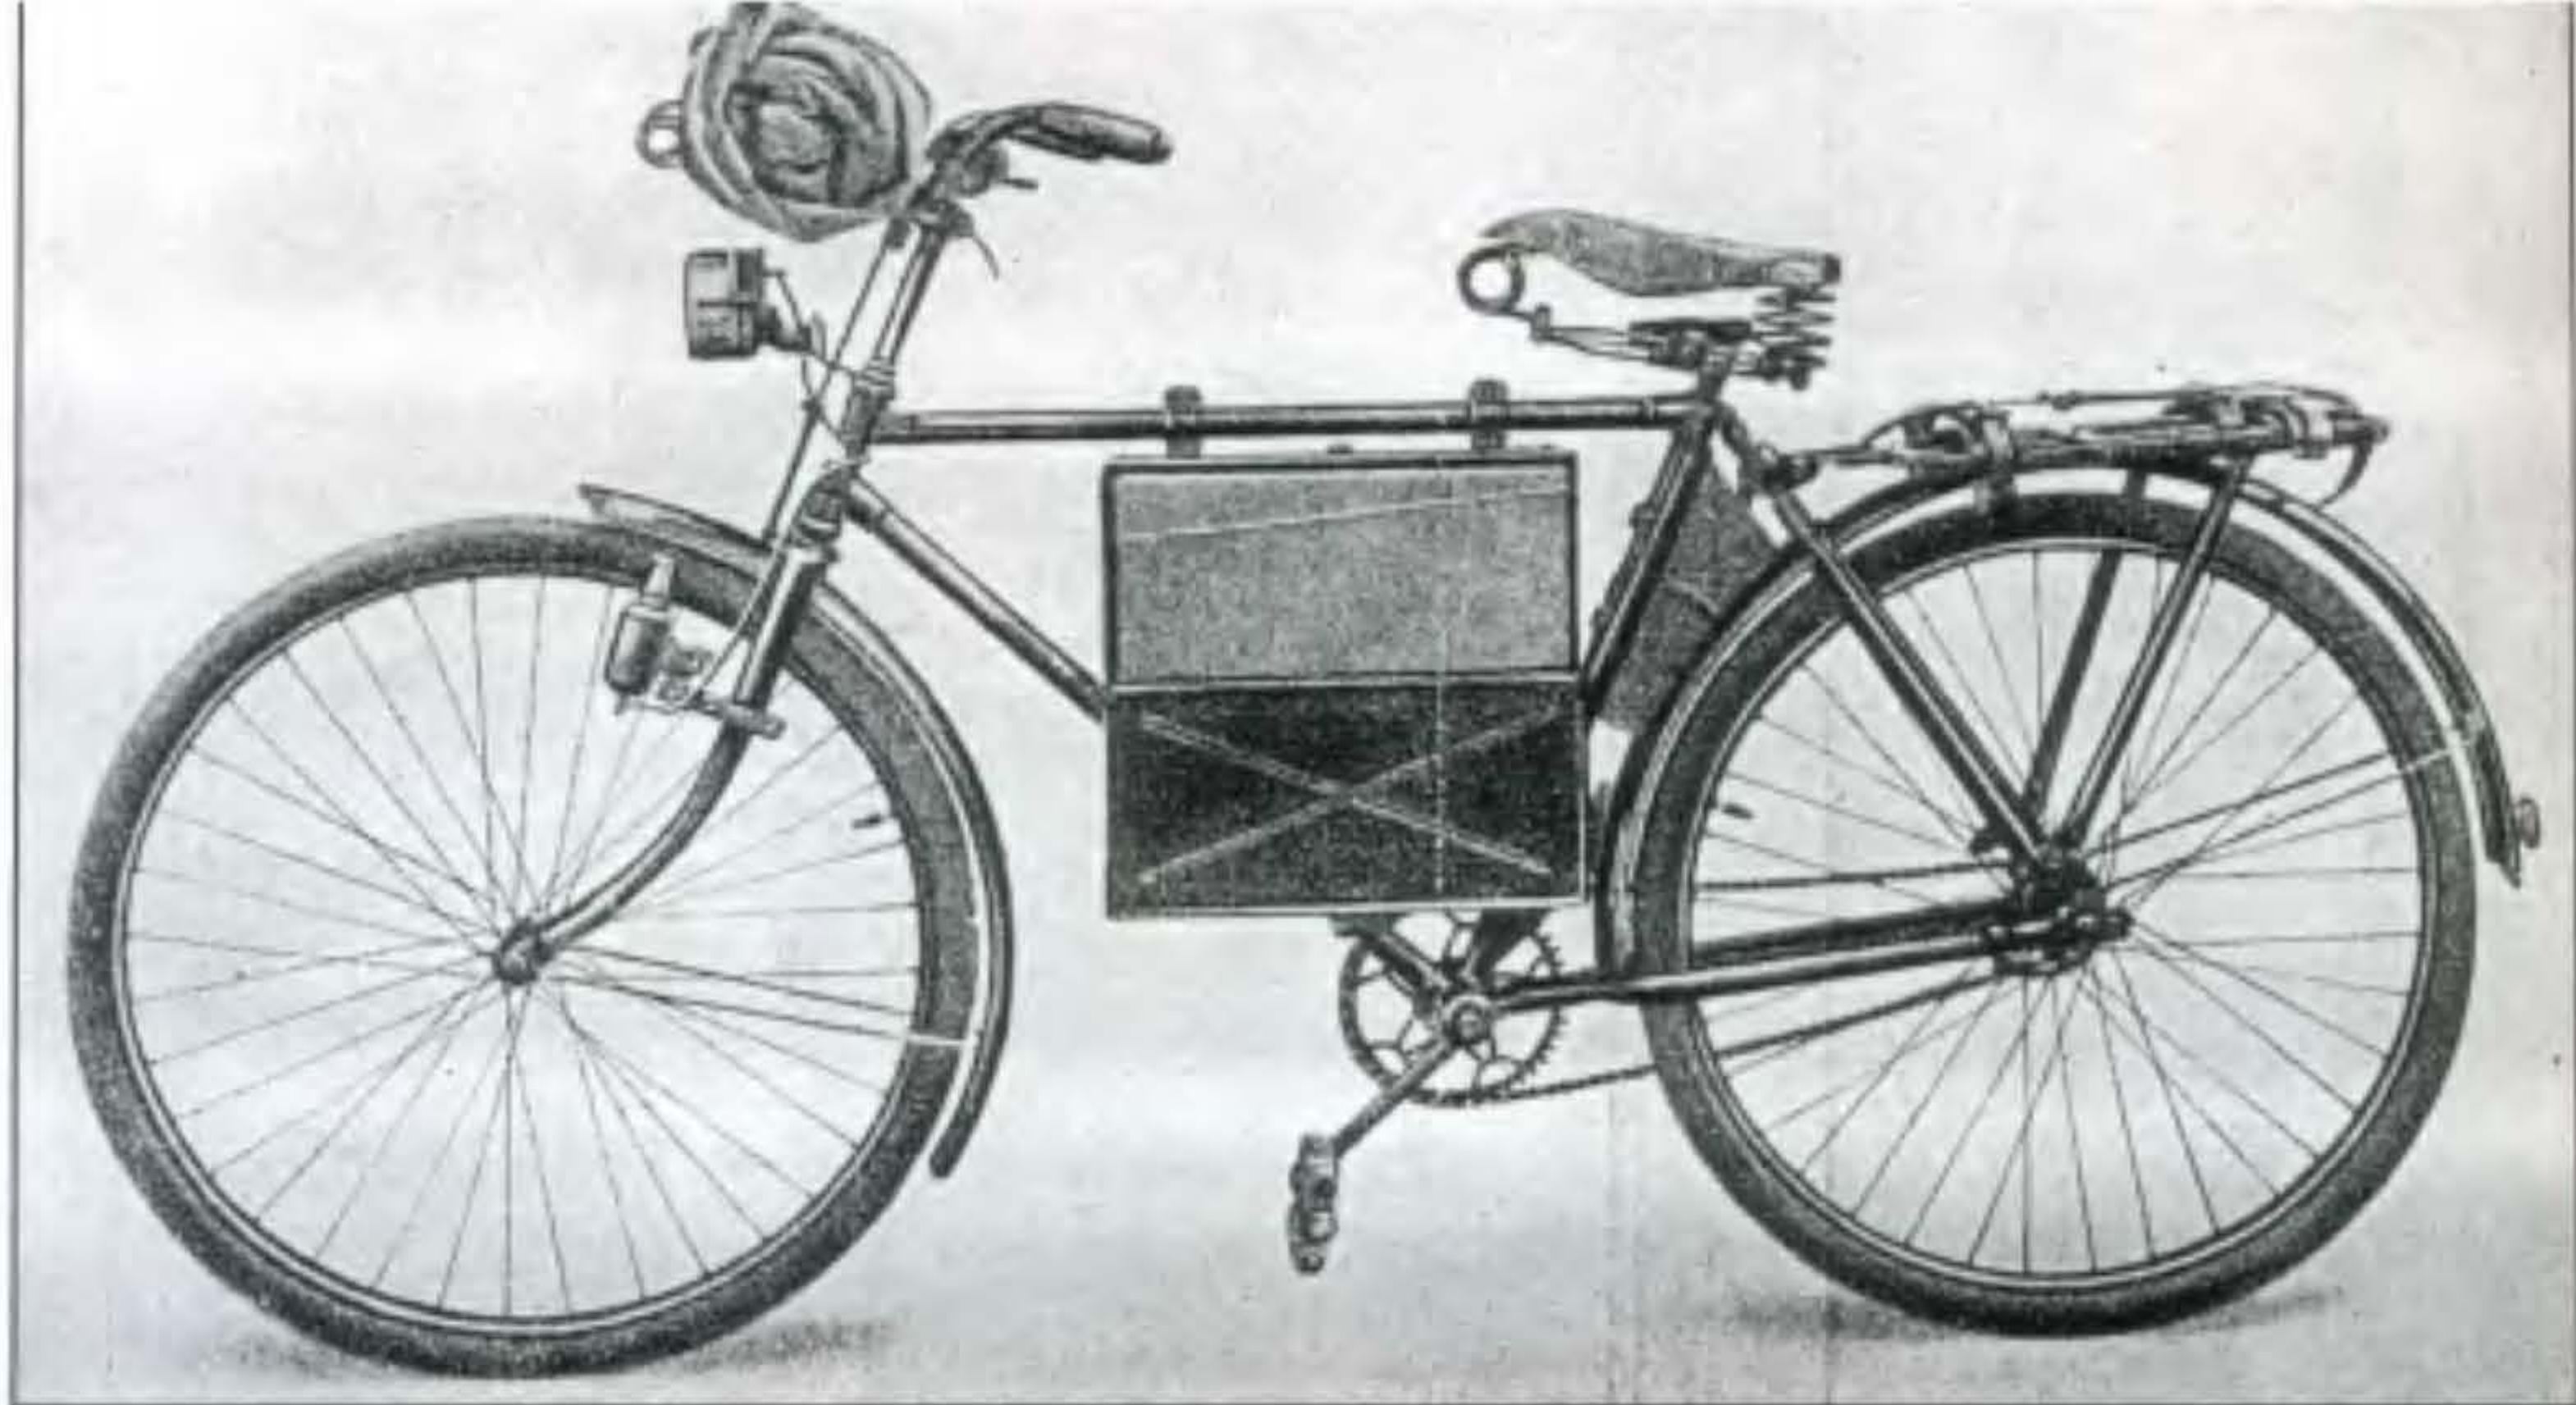
TOP: Truppenfahrrad mit Behälter für Patronenklaffen für MG

BOTTOM: Truppenfahrrad mit Lauffchusser 34

The closest bicycle has the mounting brackets for the *Dreibein 34* (anti-aircraft tripod for the *MG34*). The lower bracket is adjacent to the hand grenade and the top mount is just below and to the left of the cyclists right hand. The next pair consists of a standard bicycle to the right of the standing soldier and to his left and a ammunition carrying version. For all four variants of the bicycles used for an *MG34* unit, see the following pages.

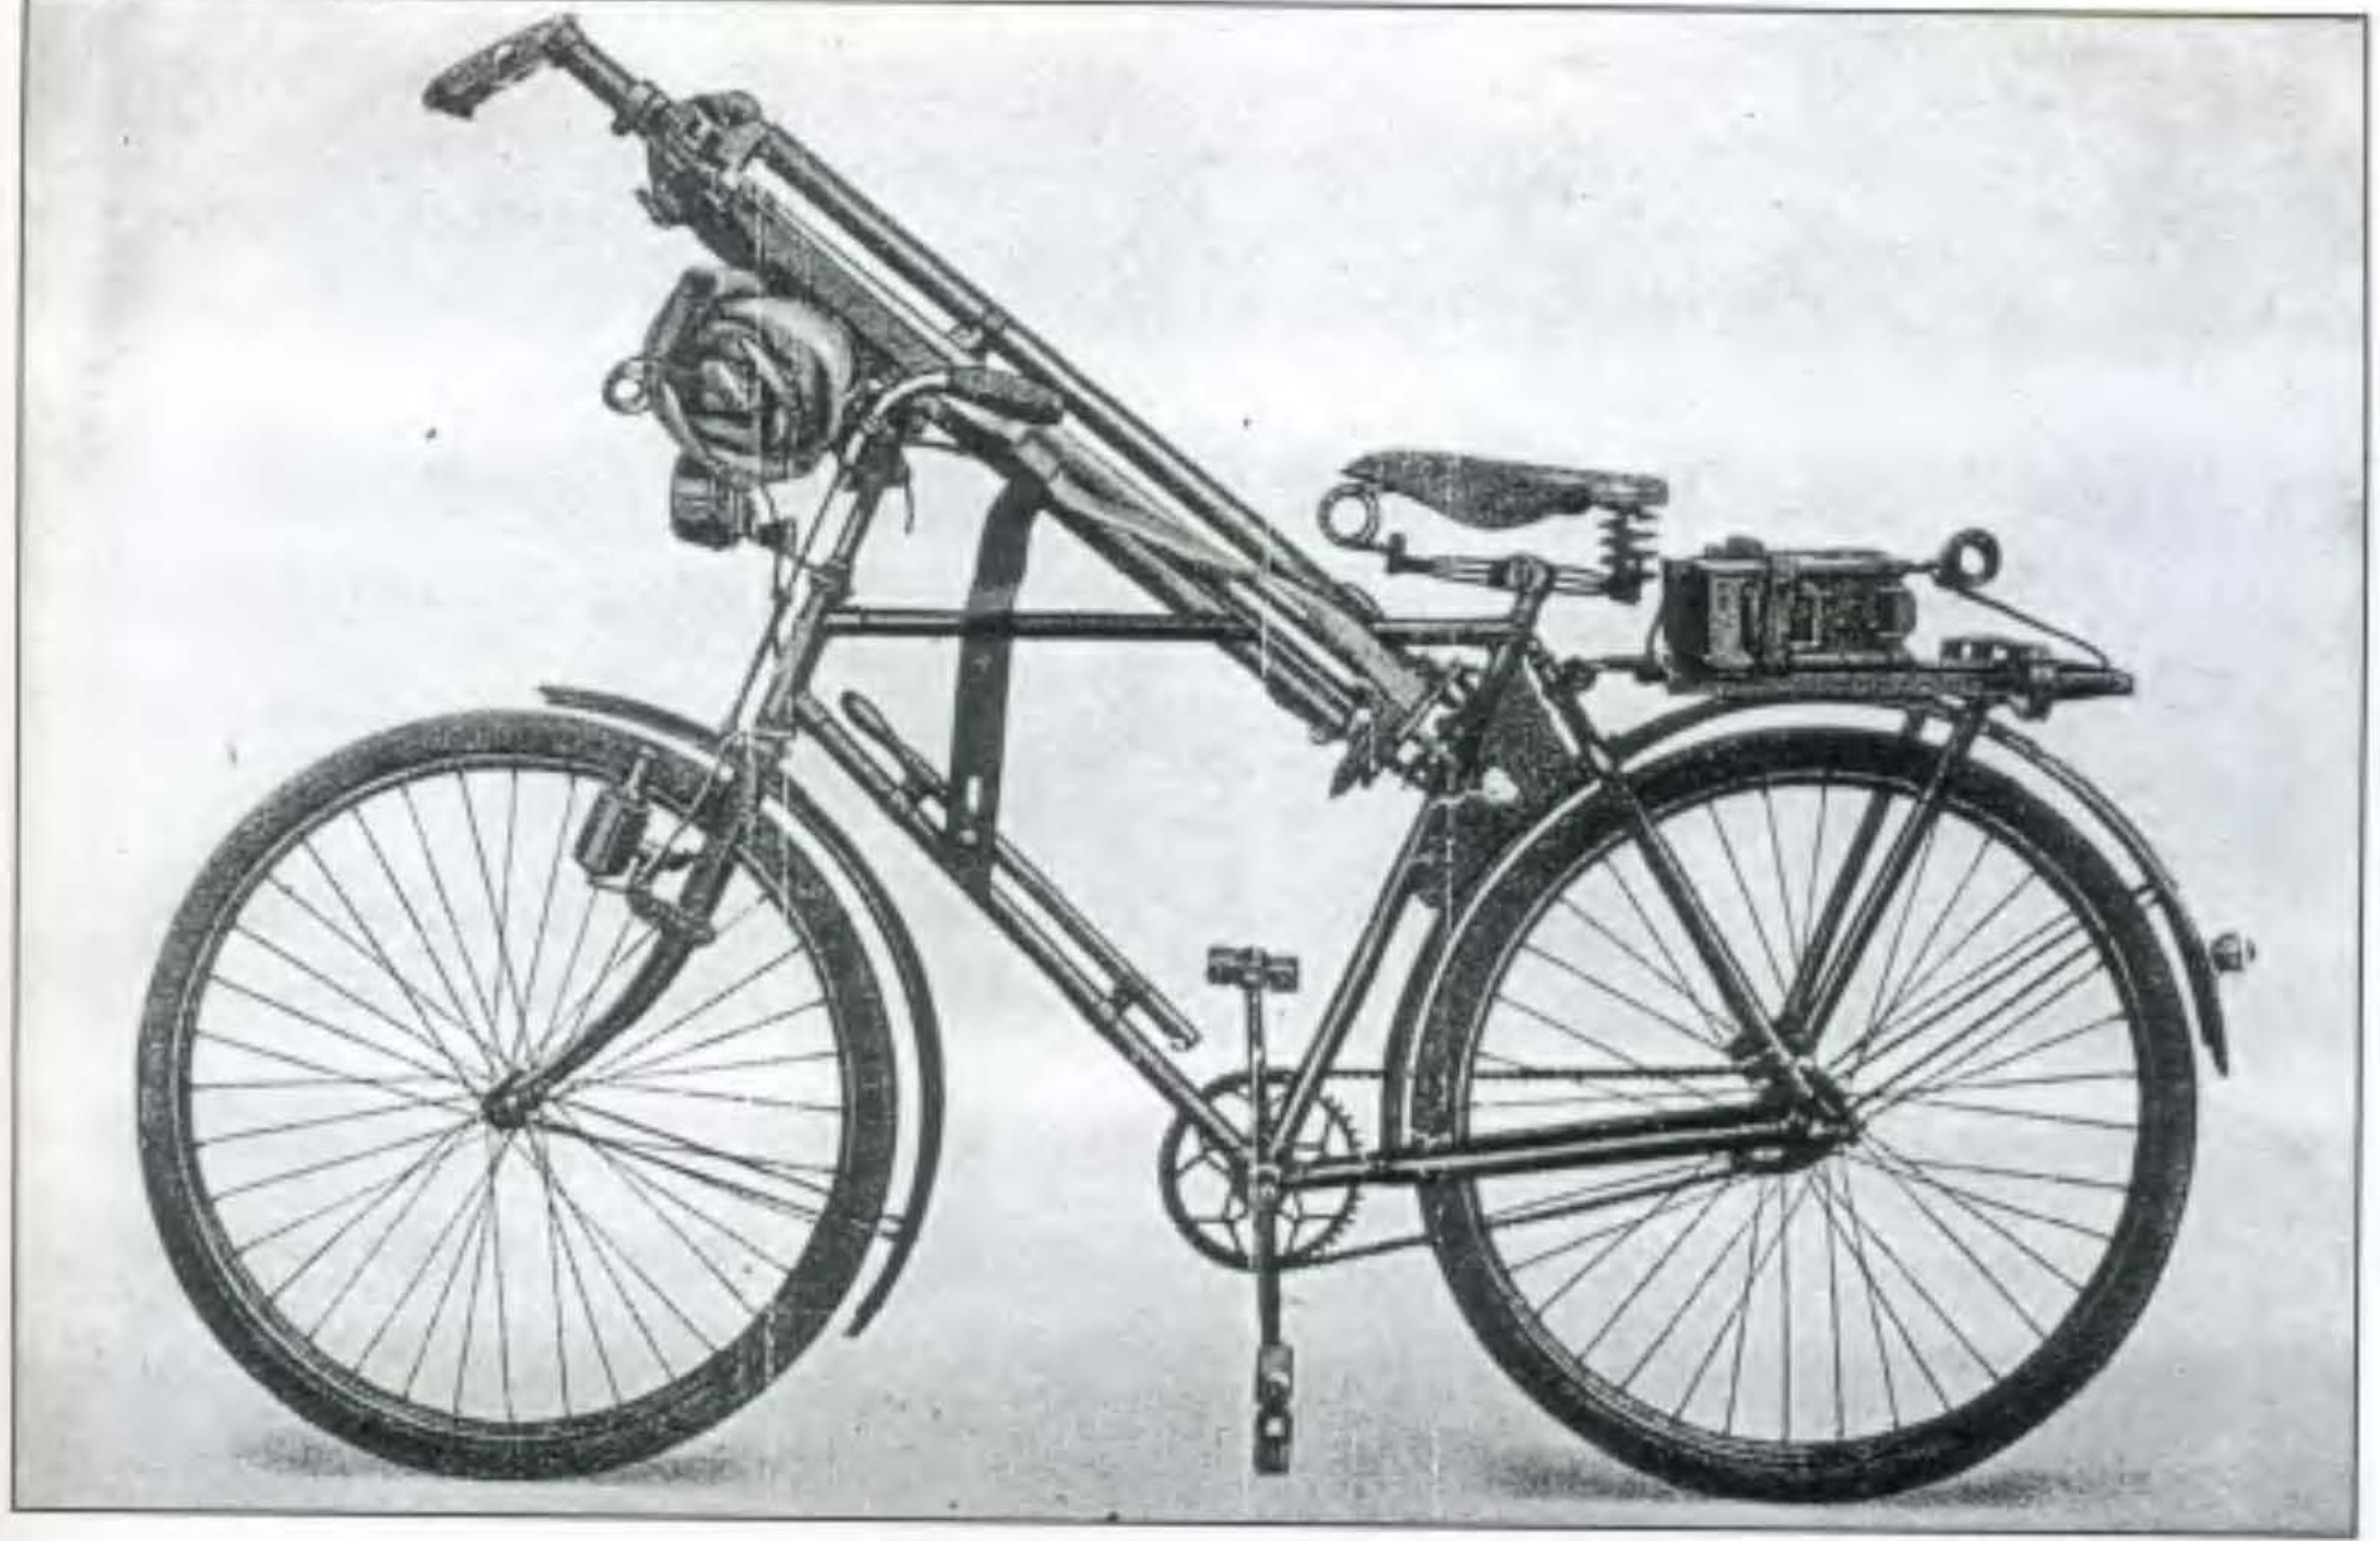
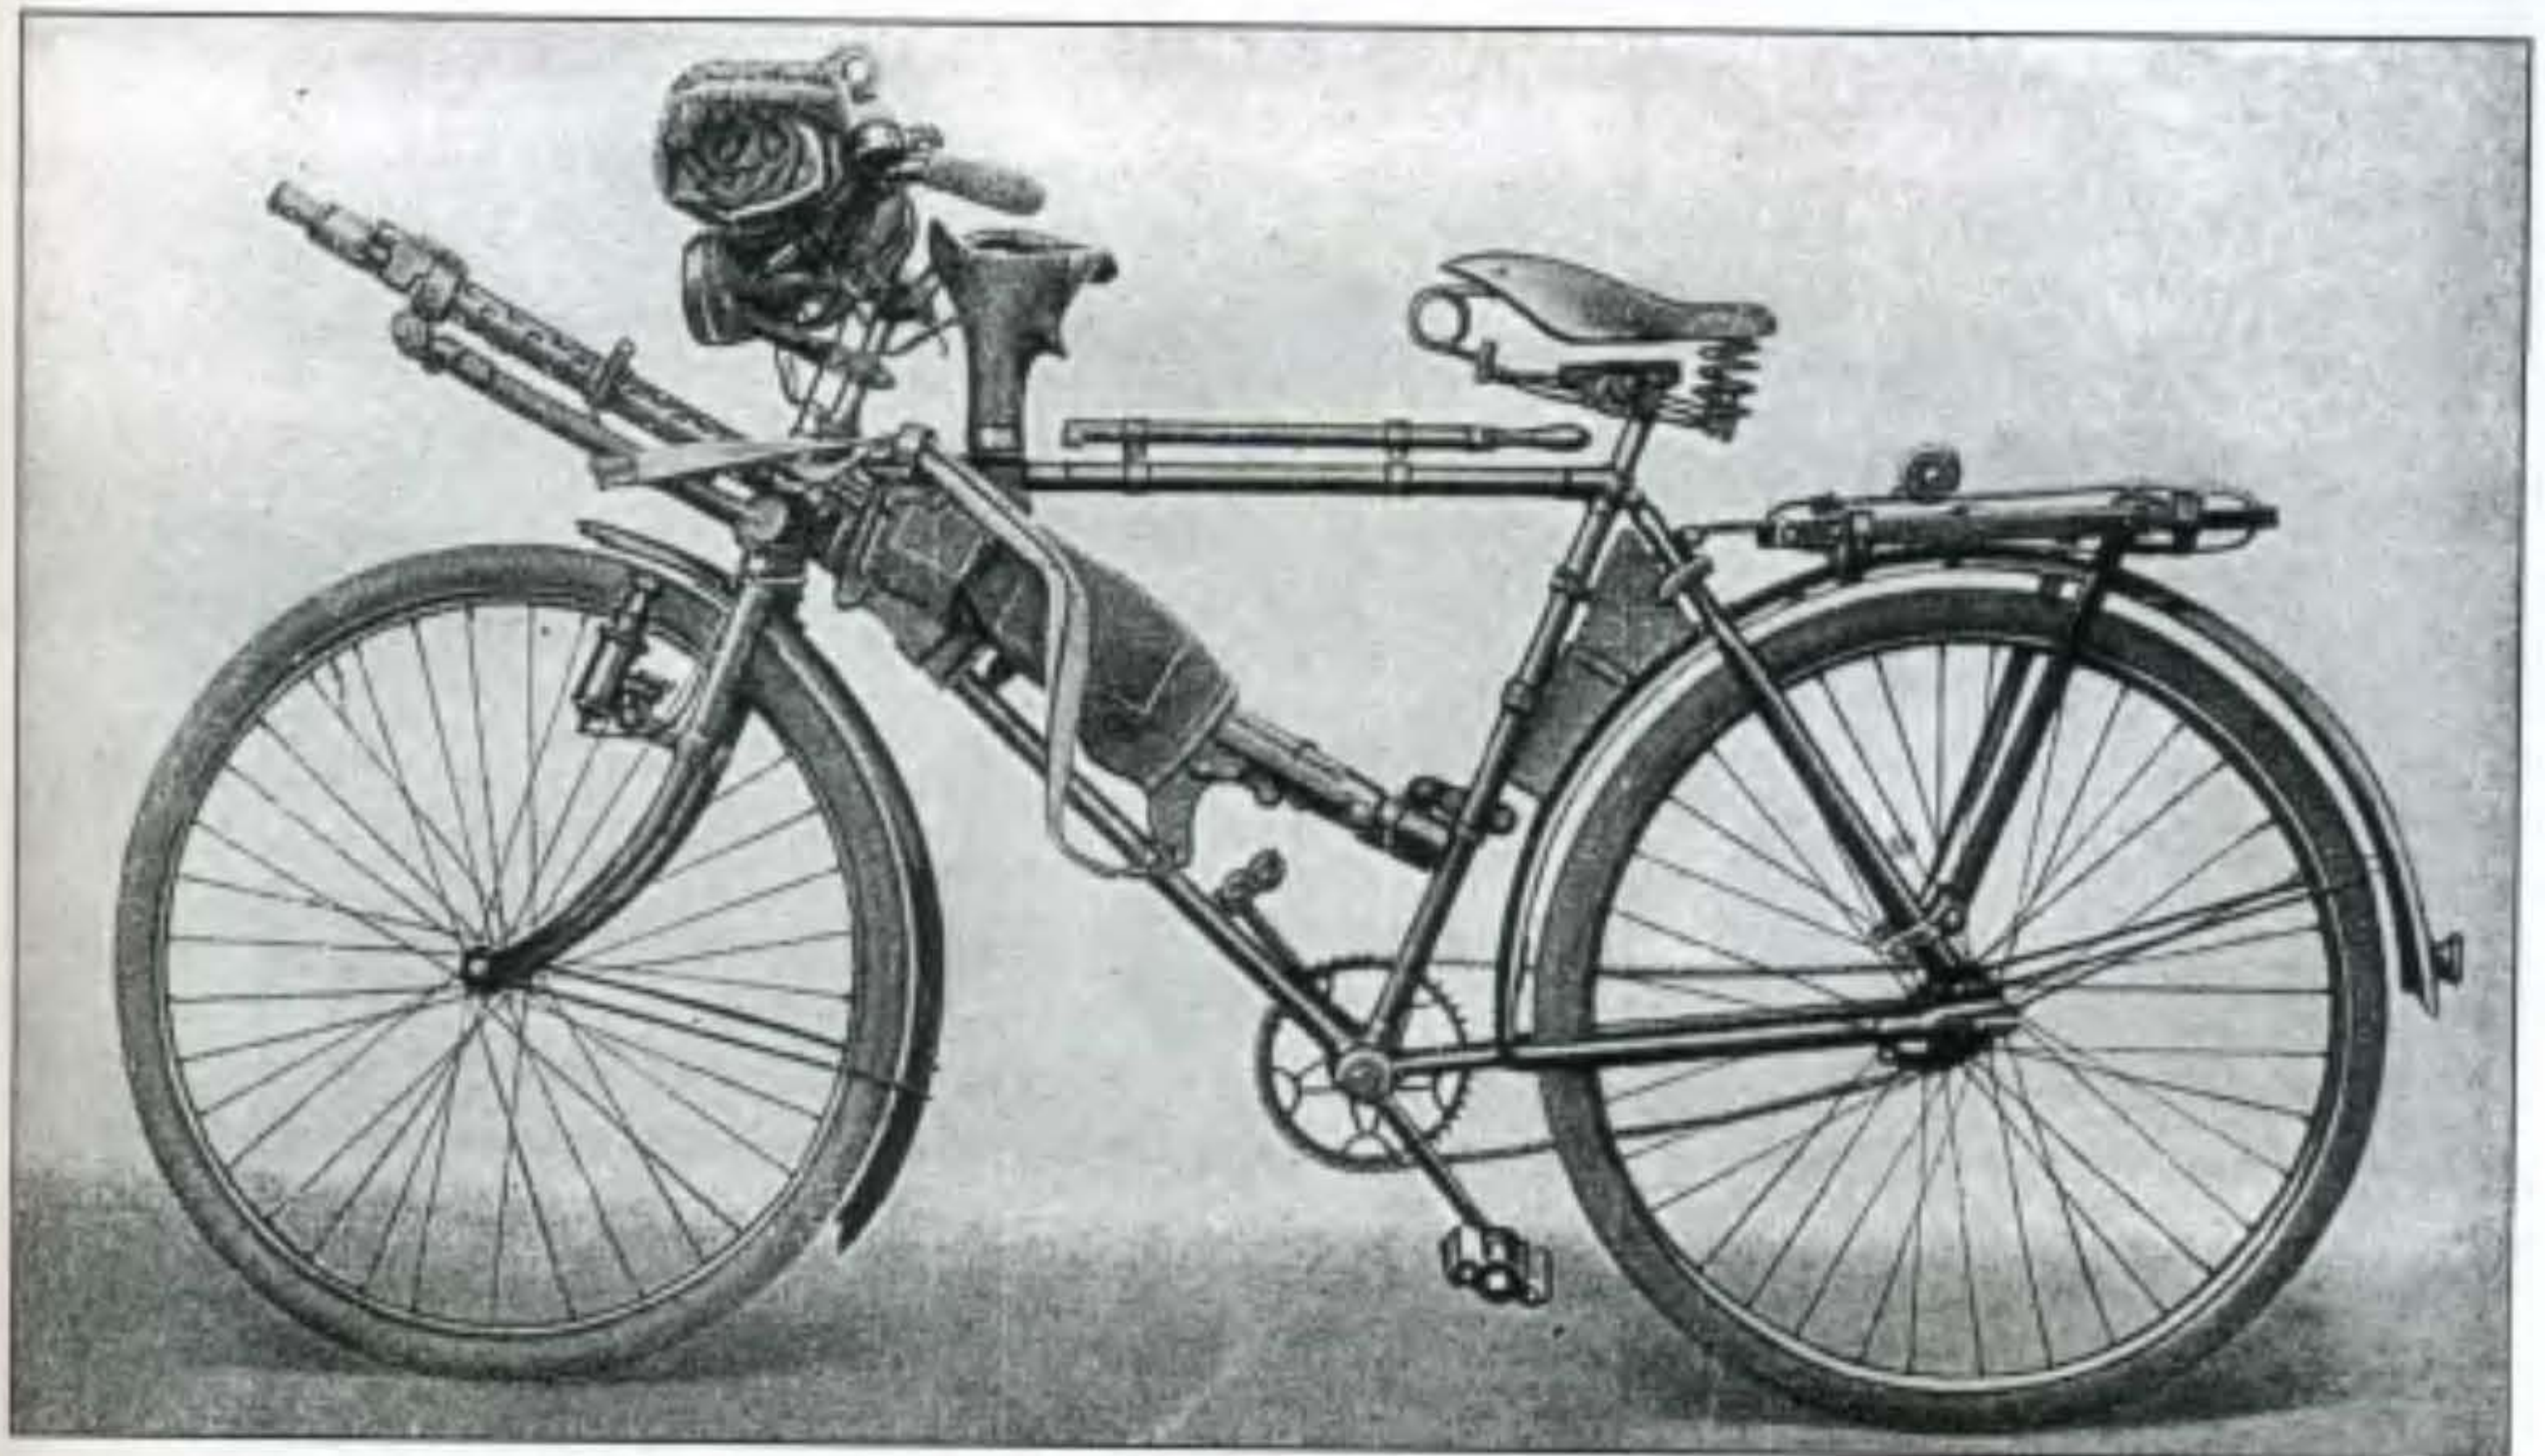
TOP: Truppenfahrrad mit Dreibein 34

BOTTOM: Truppenfahrrad mit MG34 als le. MG
