TOTAL DETAIL

Sd Kfz 252, 253 & early 250

Sd Kfz 252, 253 & 250 (Typ 1)

Volume 3 - Part 1

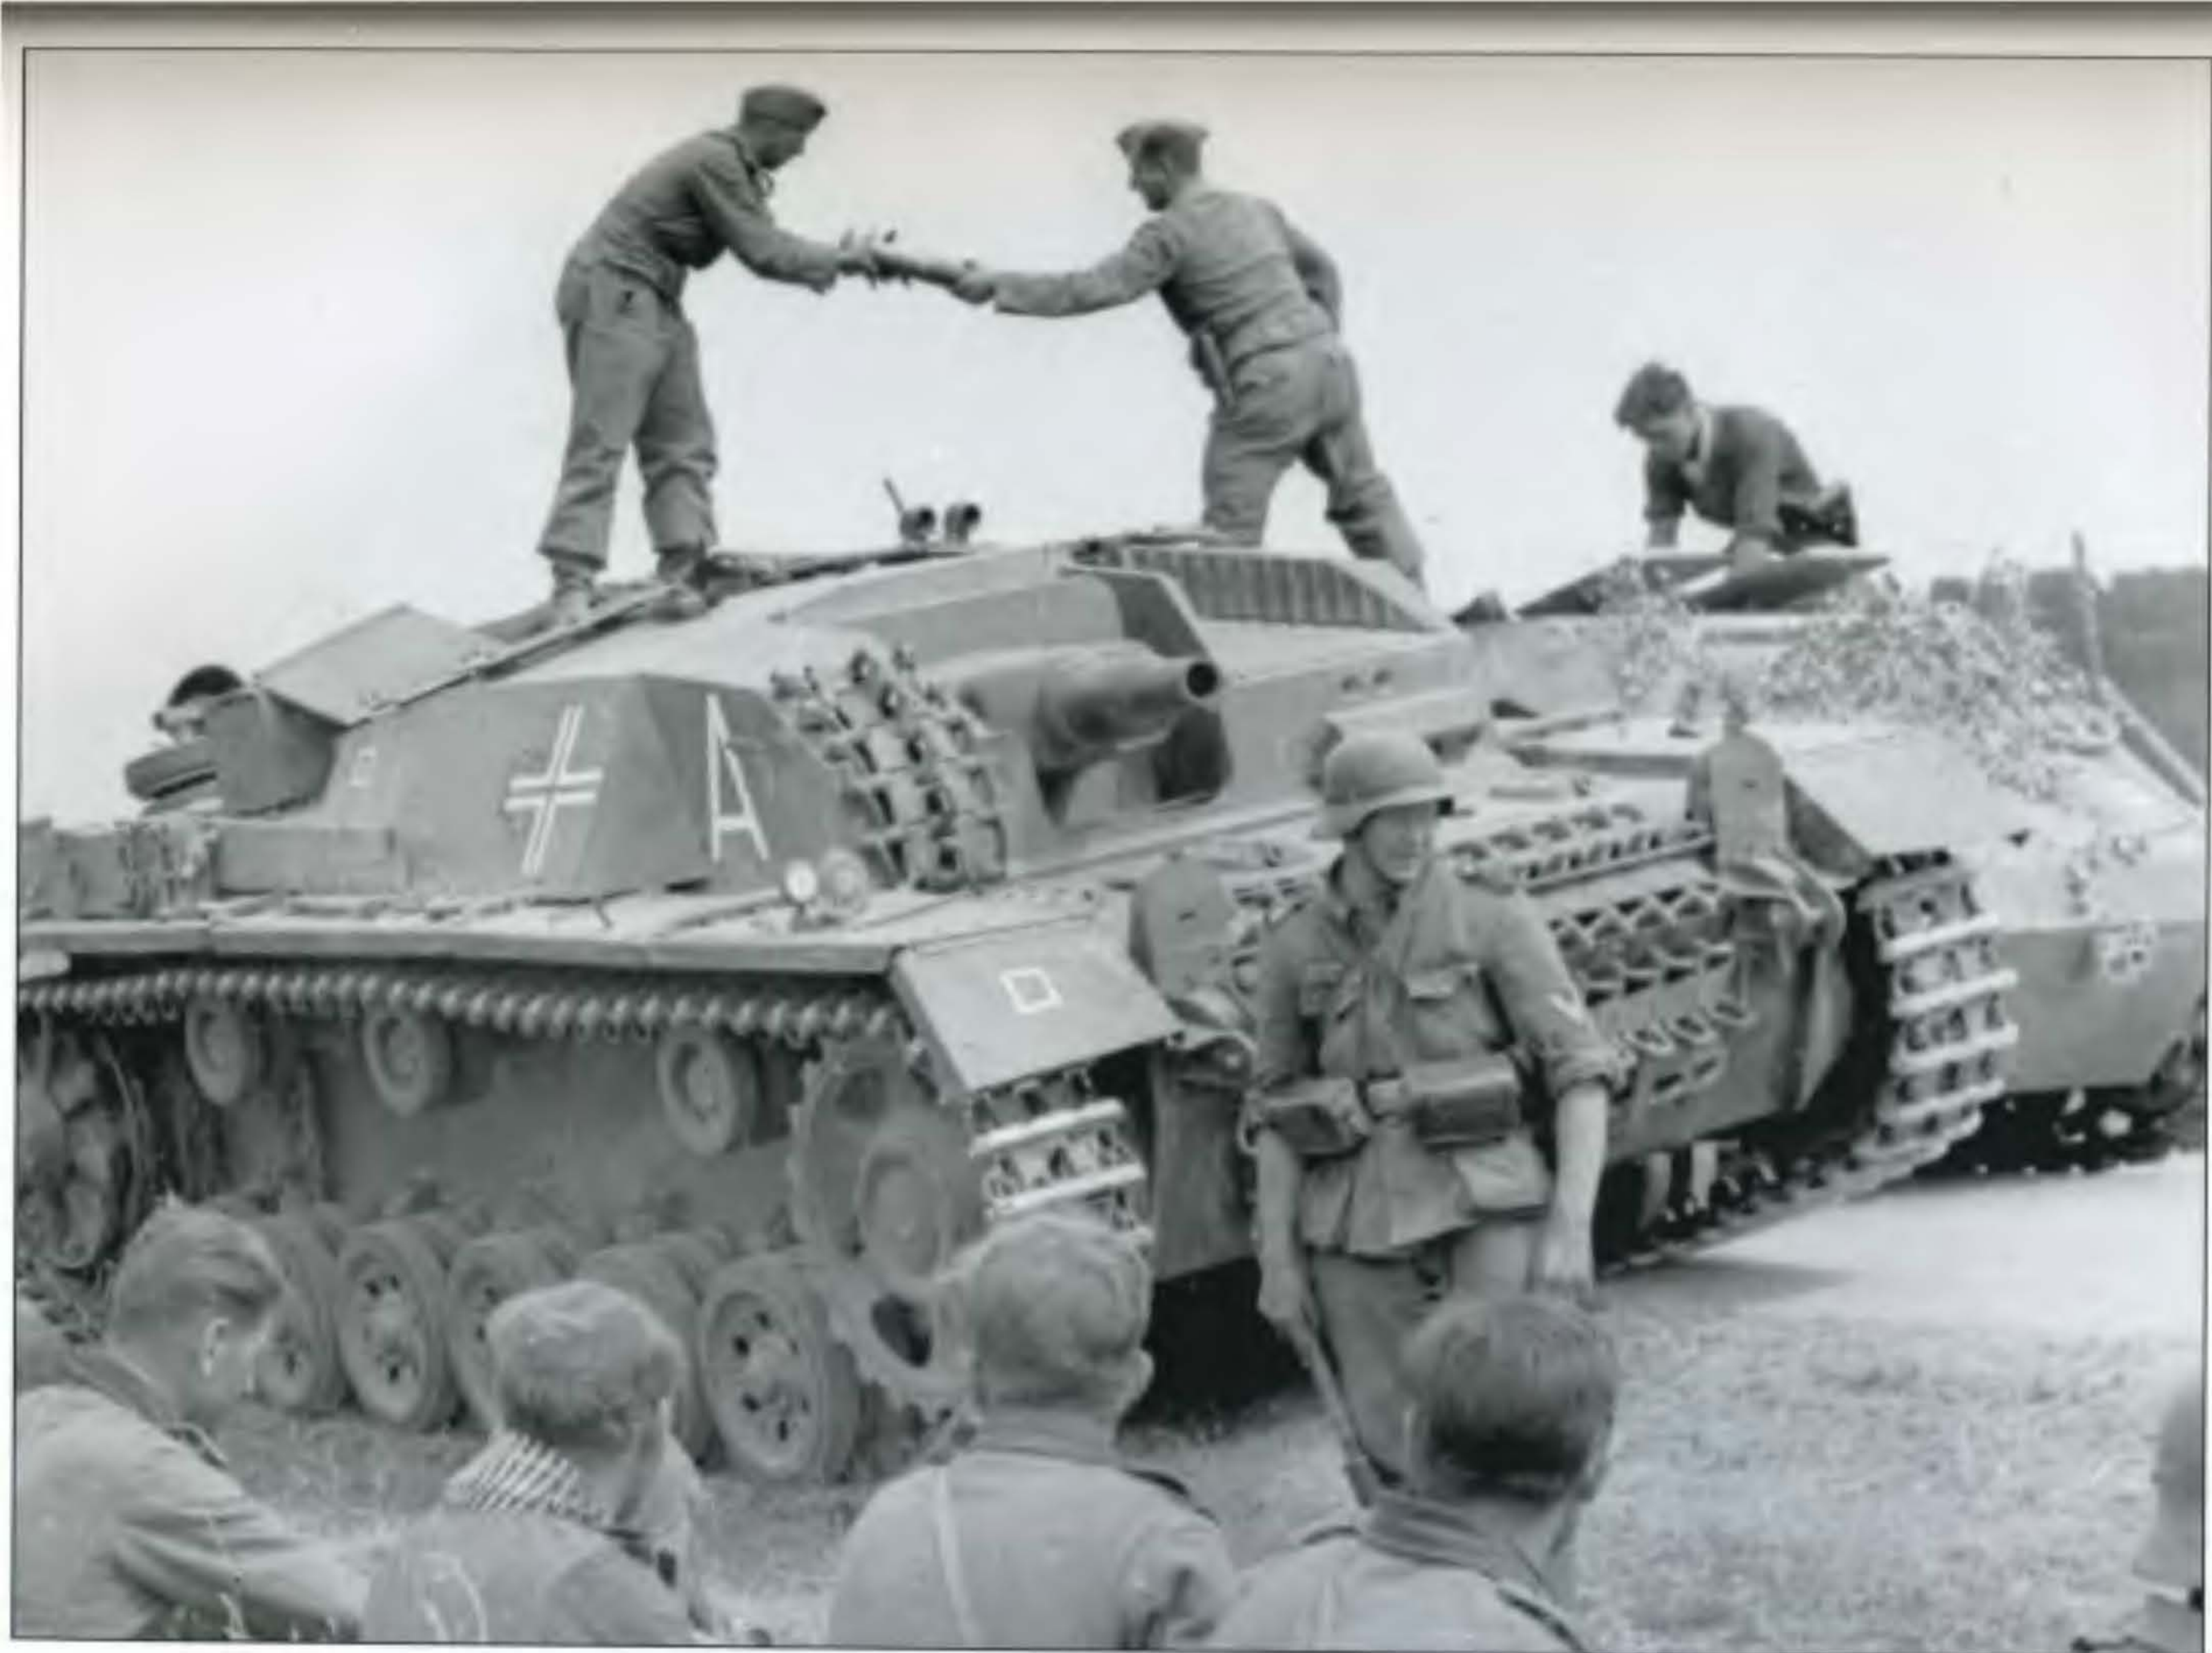
A pair of StuG III Ausf Bs (guns A and C) from Sturmgeschuetz Abteilung 185, both wearing the wider track (Typ 6100/120) and the re-designed front sprocket wheel to accomodate the increased 20mm width of the new 400 mm track links. Note the re-positioned first return roller which was moved closer to the drive sprocket to lessen the chance of throwing a track under heavy acceleration and braking which was a modification made to Ausf Bs during the production run.

Even though this photograph was taken early on in Barbarossa, the crew have already decided that extra track links are required to up-armour the StuG in response to the Russian T 34 and KV 1s encountered that were quite a shock to both StuG and Panzer crews alike. The 252 wears the same square Batterie symbol as the StuGs. Note the basic colour variation of the M36 Service tunics of the troops resting by the roadside and none of them are wearing 'Y' straps. The Obergefreiter holding the stick grenade is also wearing a pair of medical pouches.

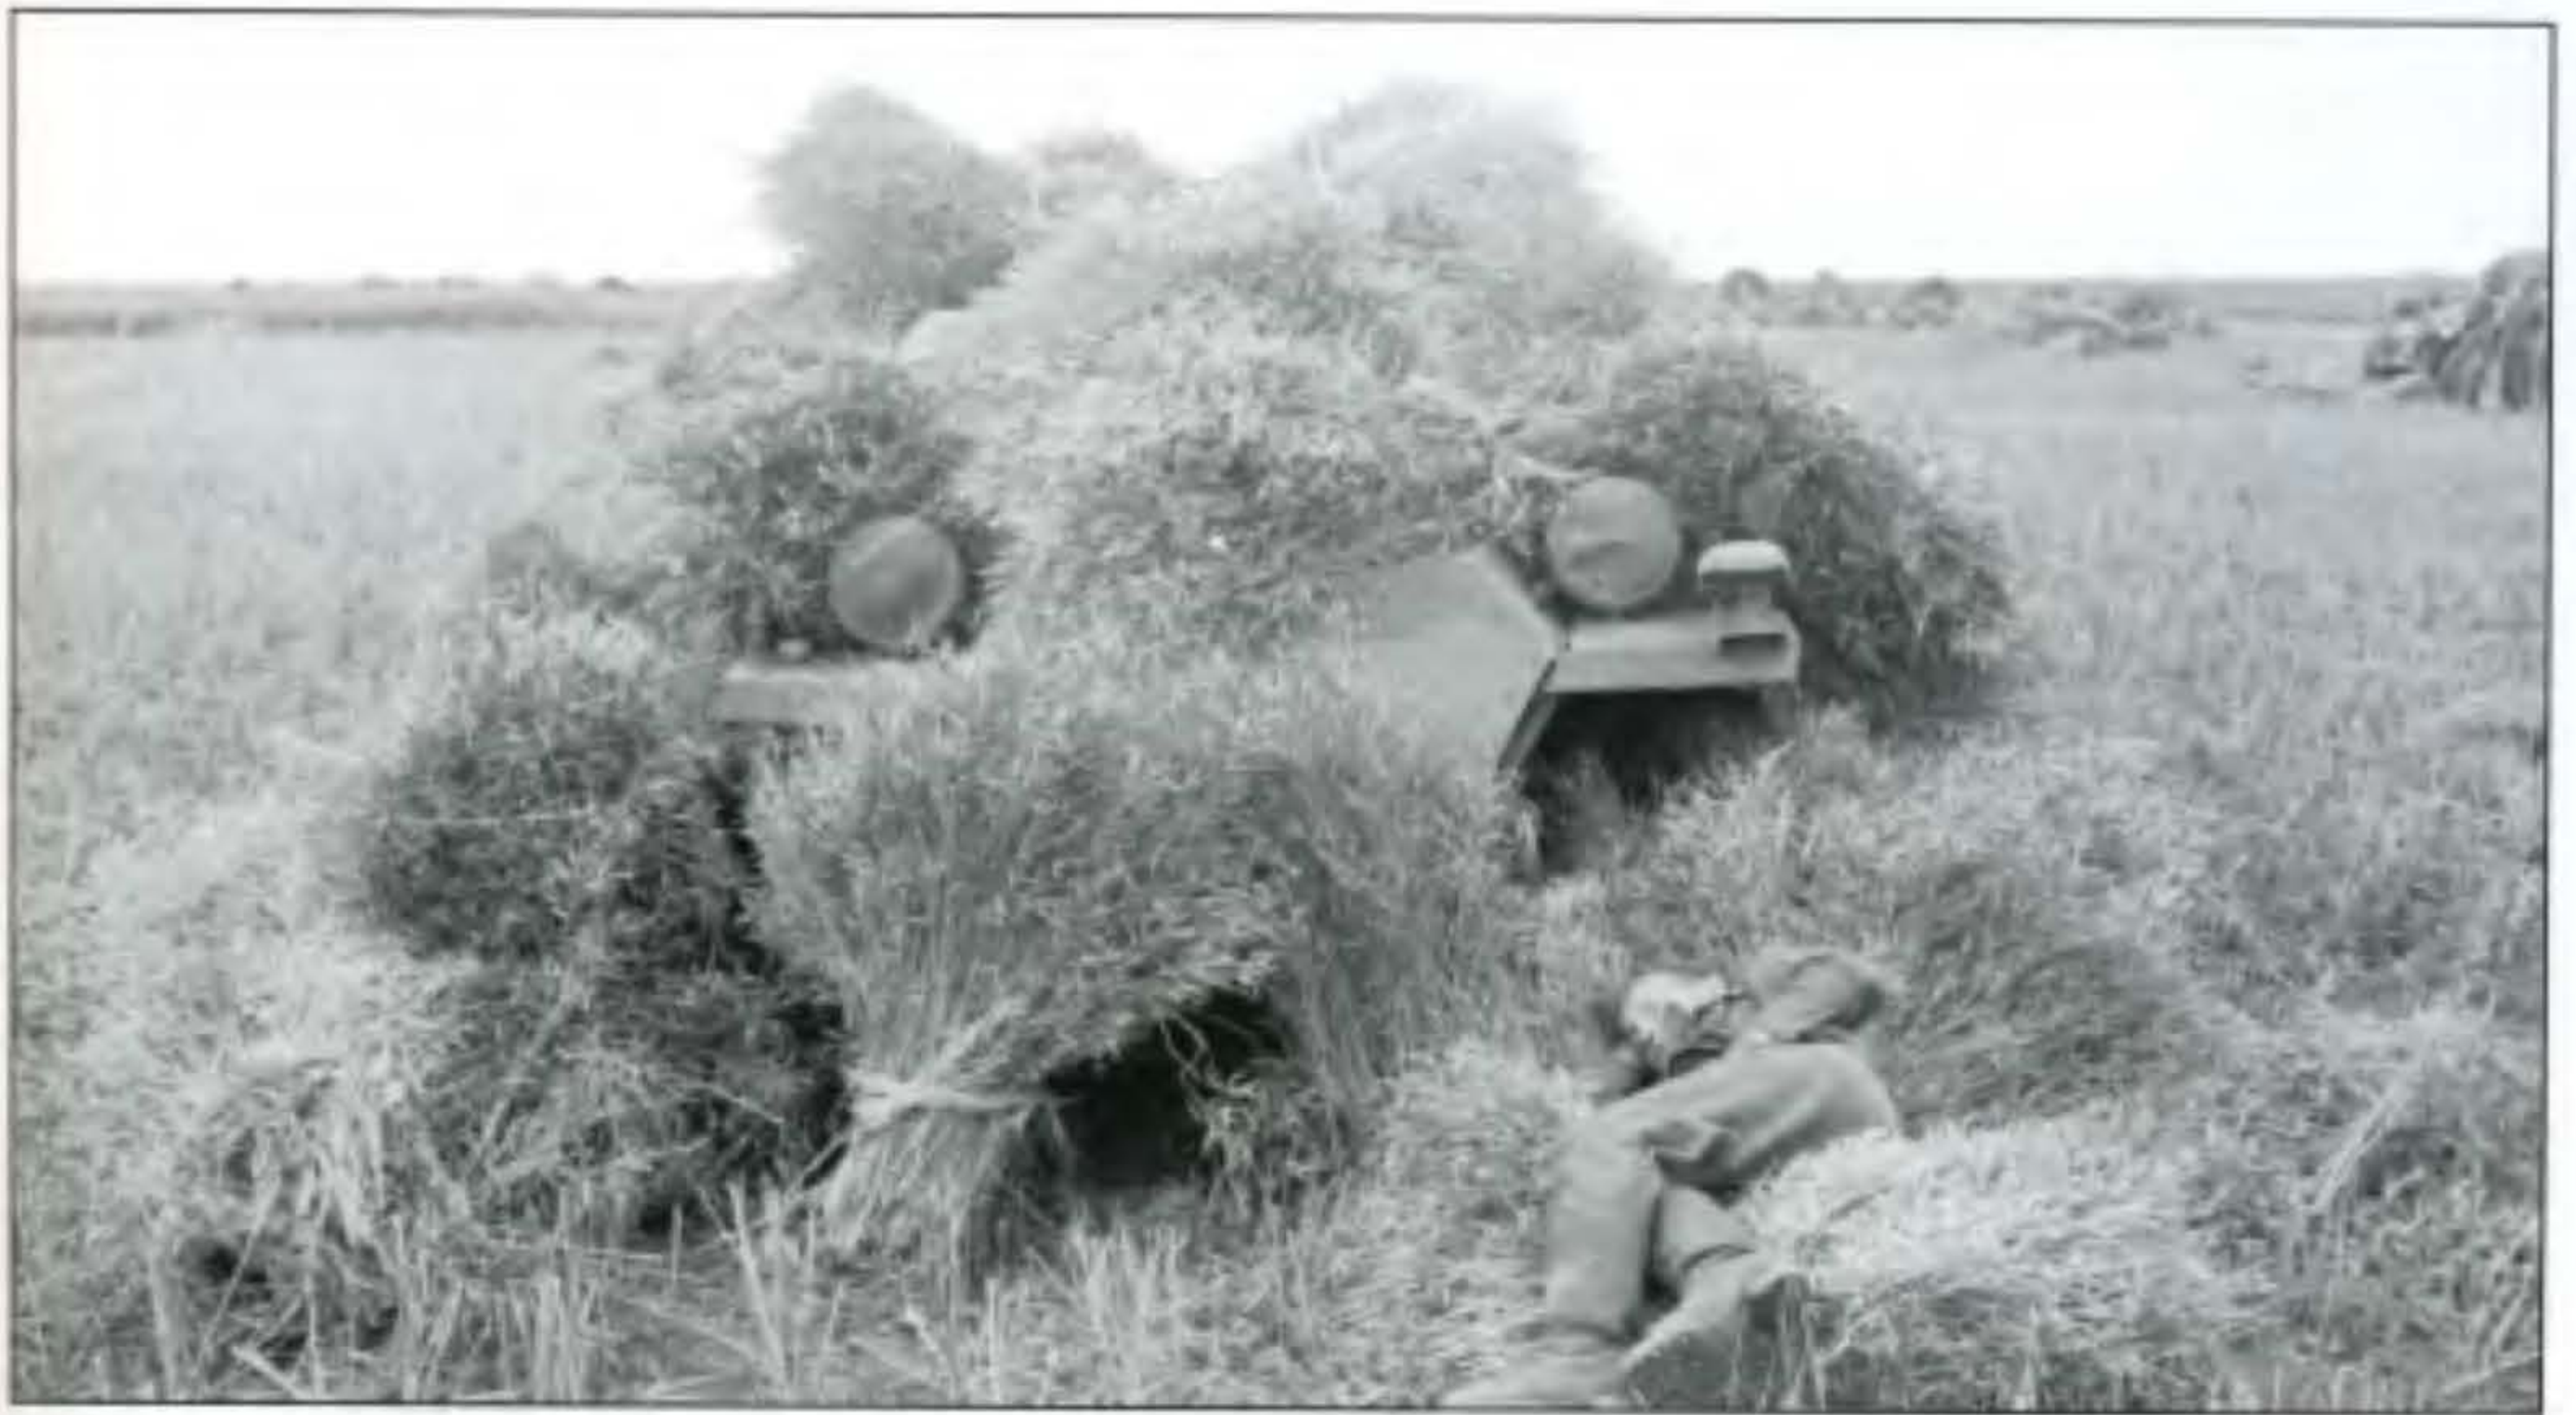
An almost mint example (except for the rear two stowage boxes) of an Sd Kfz 251/6 Ausf A complete with deployed aerial mast at the right rear corner. Note the extra front protection for the MG34 which is now on a raised mount, plus the use of a second shield at the rear. Just above and to the left of the Panzer Officer sitting alongside the 251 is what appears to be the divisional symbol for the 11th Pz. Division. The group of officers have settled down for what seems to be a relaxing few hours of lunch, whilst at least one Sd Kfz 250 crew member (above) grabs a few hours sleep amongst the sheaves of oats. The front of the Sd Kfz 251 shown opposite is just in shot to the right.

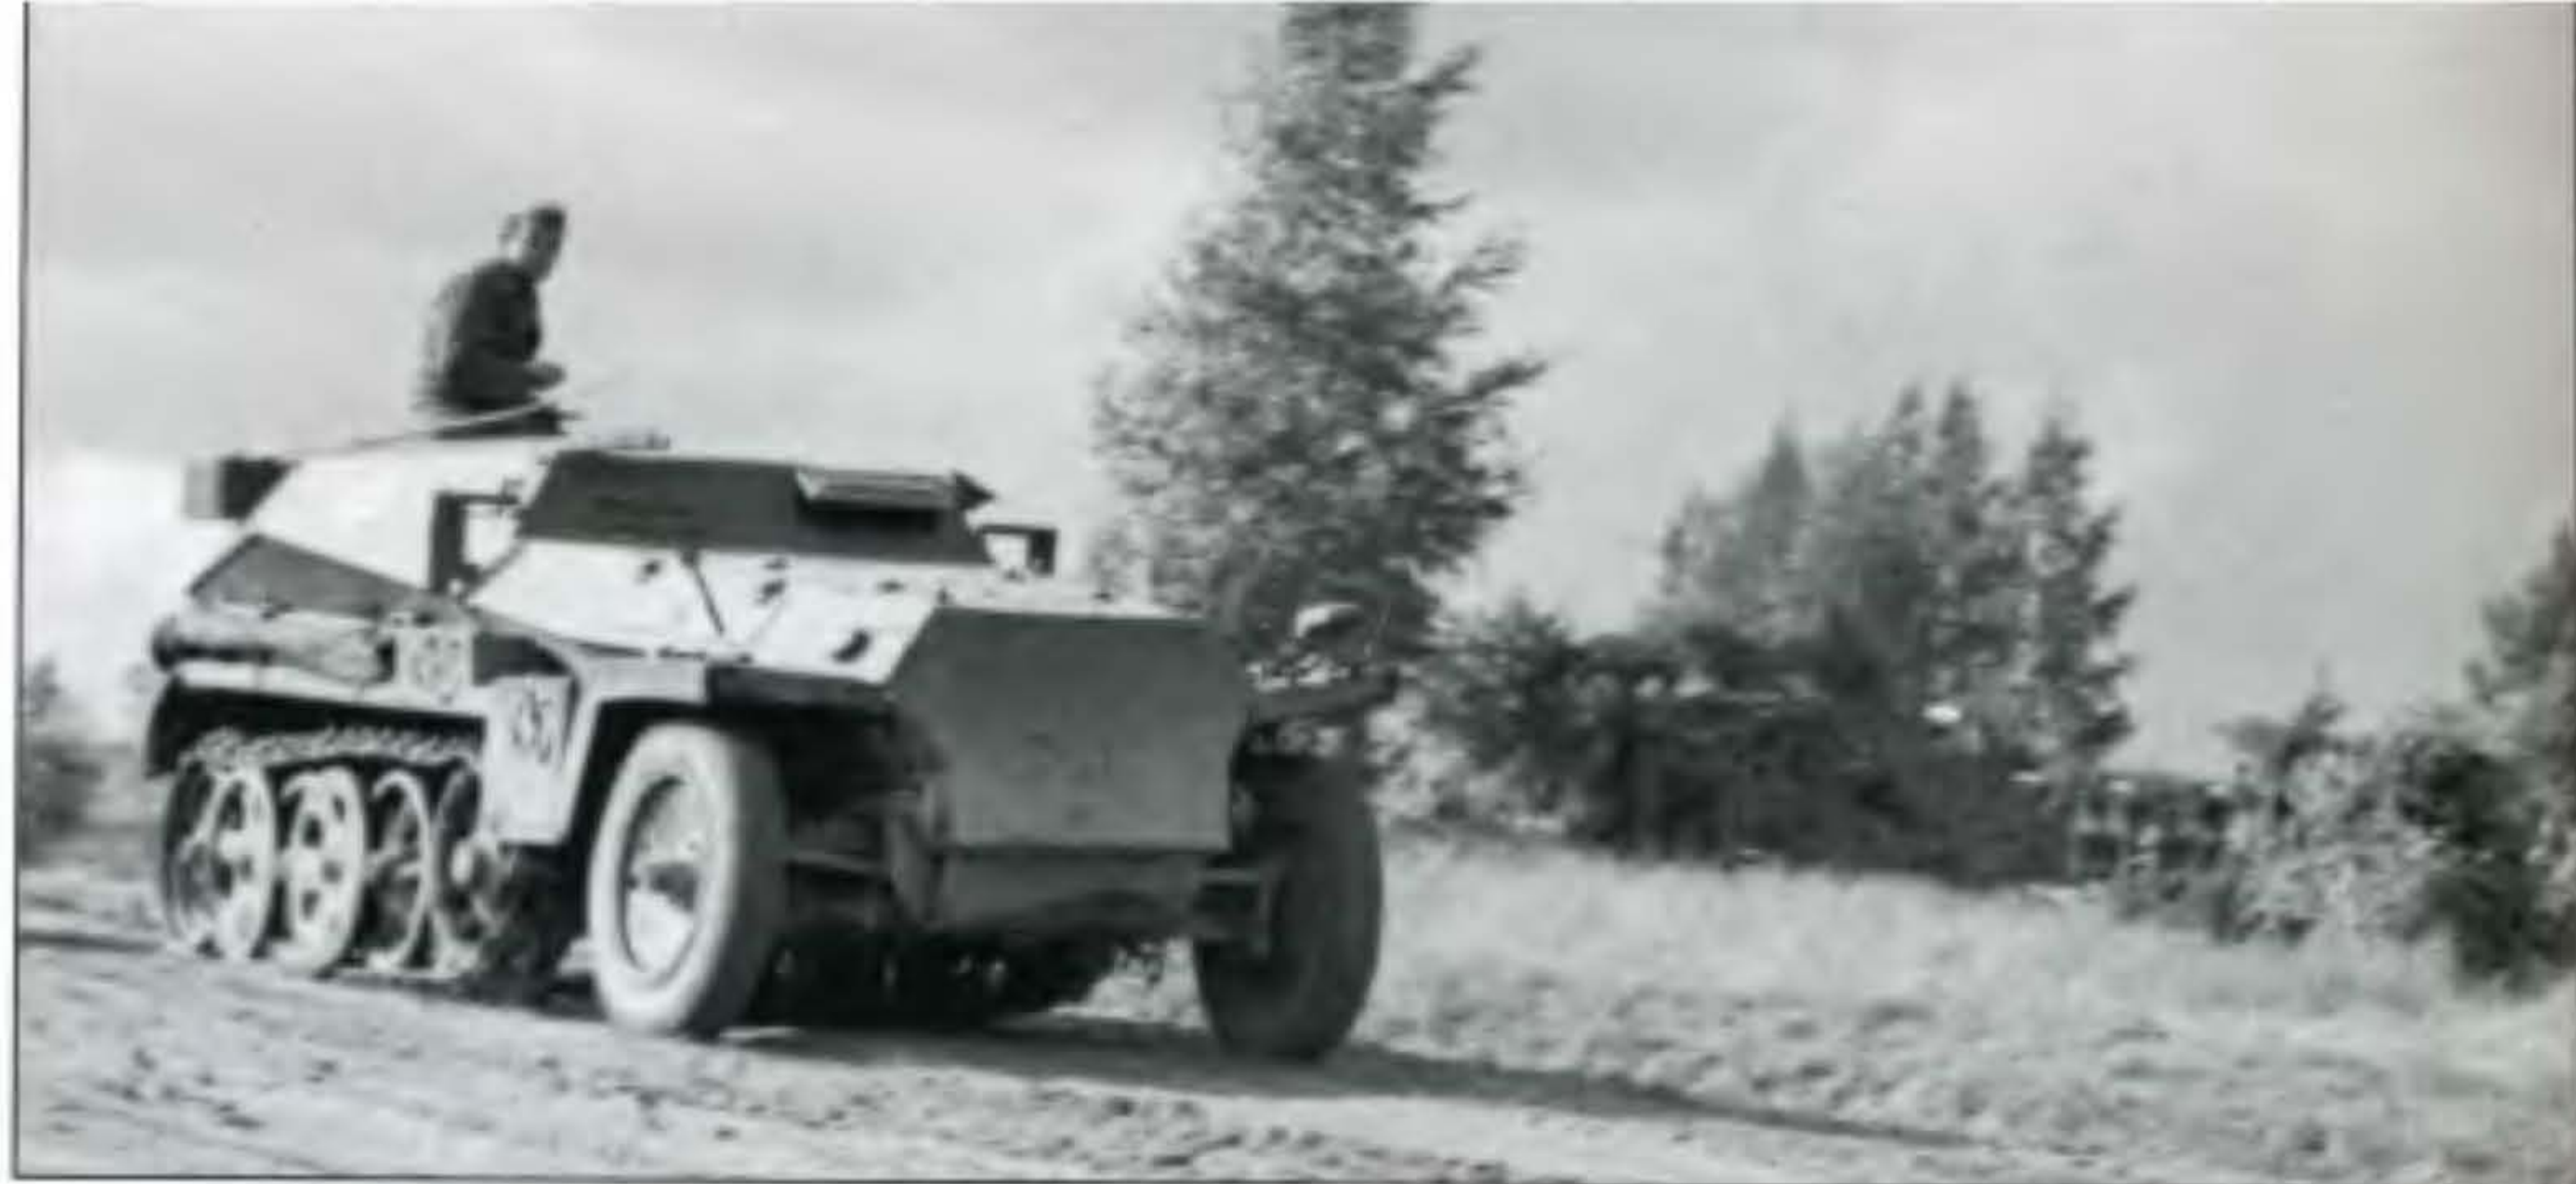
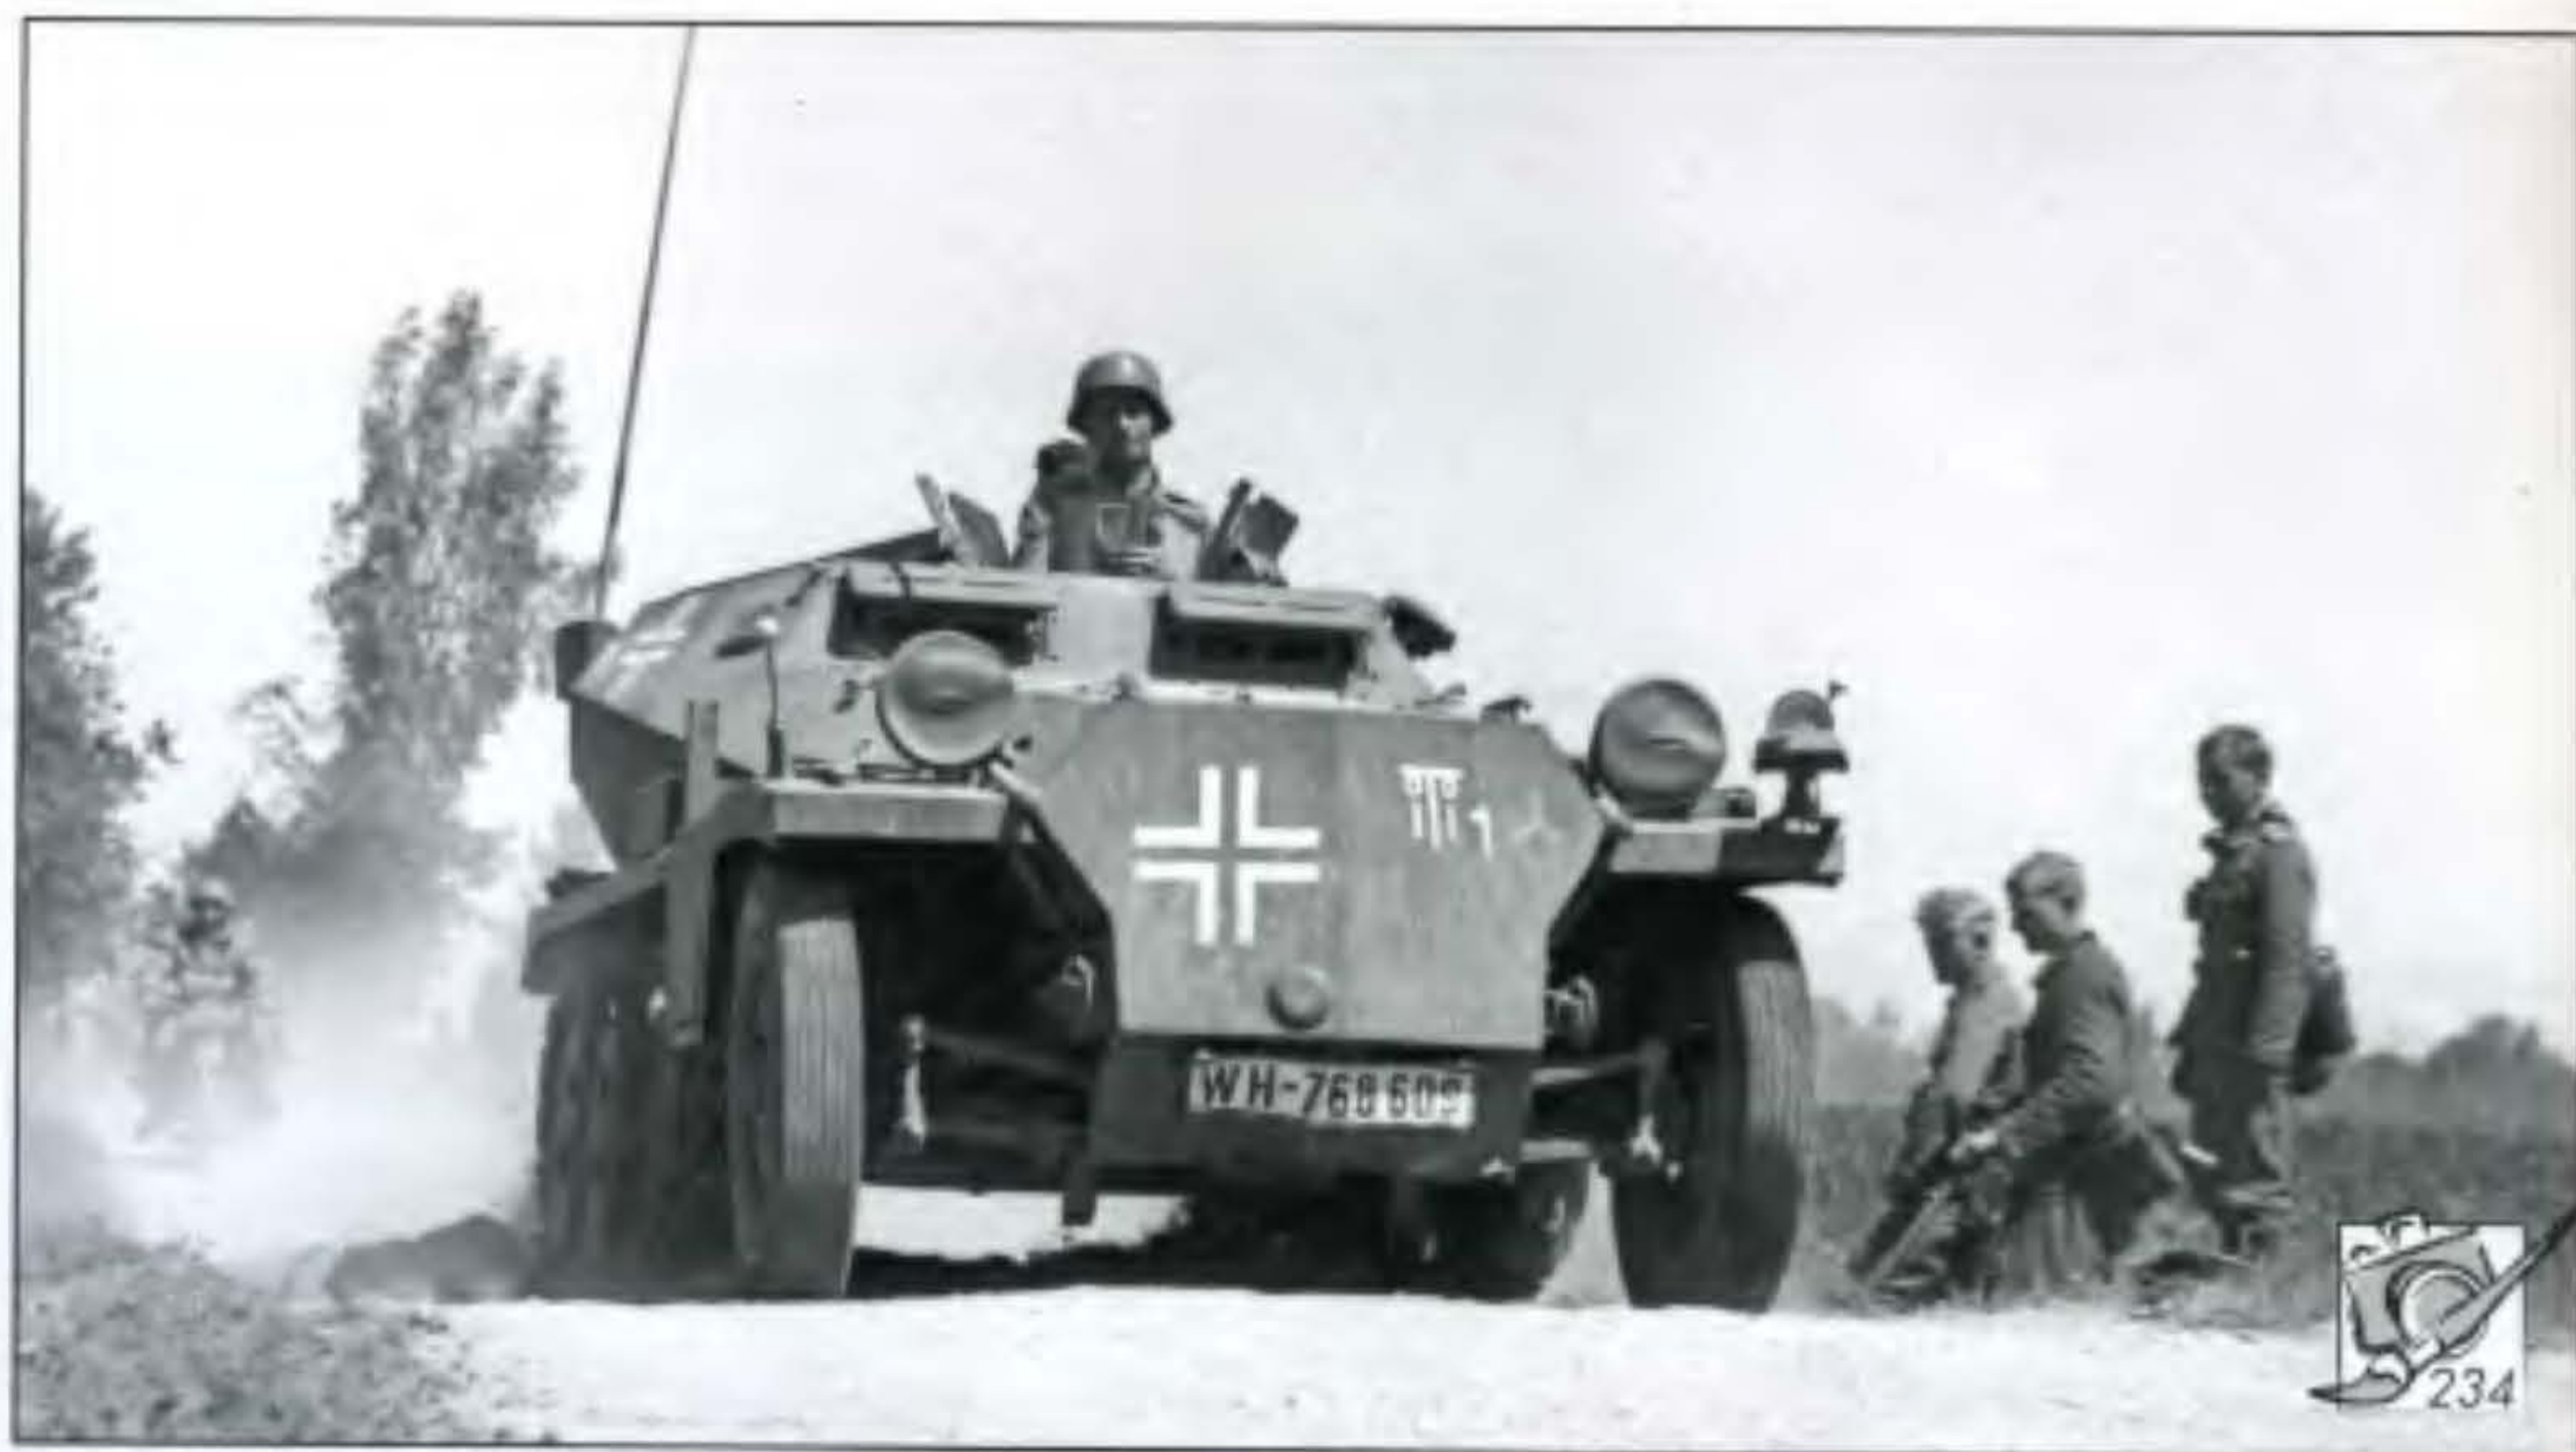
TOP: The 253 looks like the same vehicle as shown on page 80 - 81. It is one of the pre-production examples with the early 'shallow' front chassis design. The original leaf-springs (from the Sd Kfz 10) on the A-frame front axle were found to be too weak for the weight of the armoured vehicle. Consequently with the A-frame fully articulated over rough terrain, the wheels would hit the mudguards. The front axle has already sagged and either there is a torsion bar problem causing the track wheels to sink or the rear idler requires attention to re-tension the tracks.

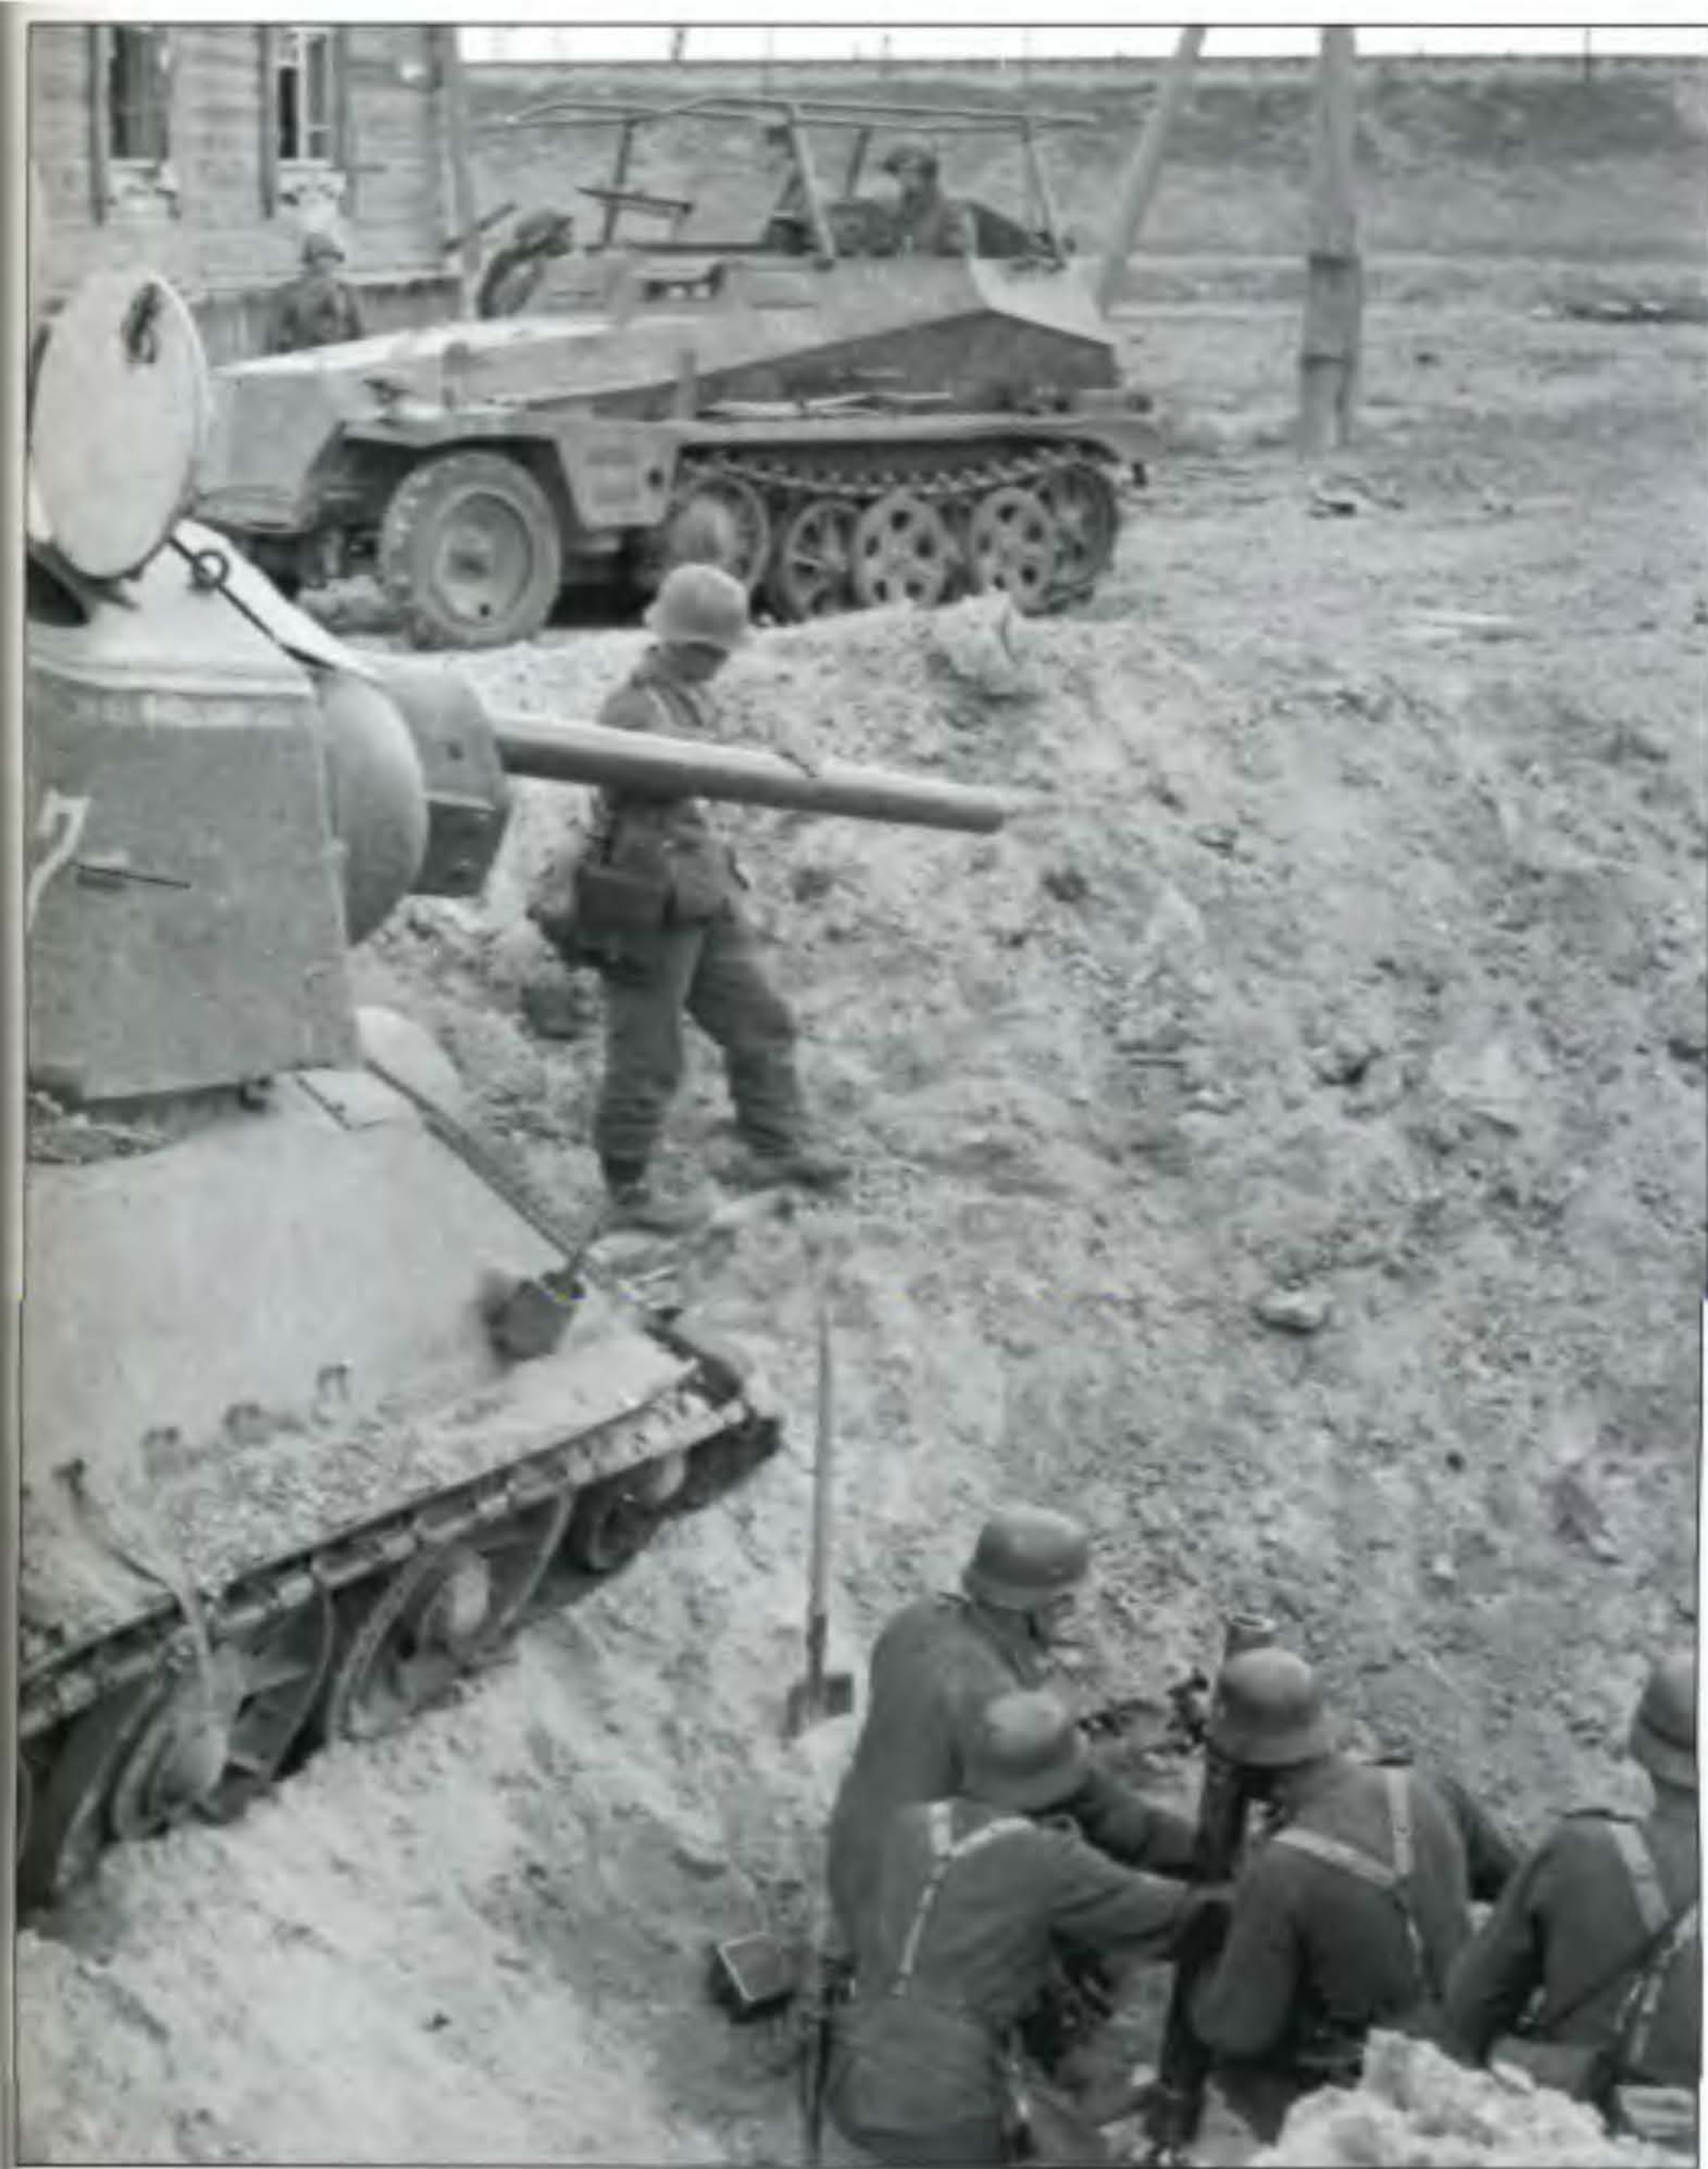
To the right of the Funkmeister is a third set of radios mounted on top of the existing frame. Given the space restrictions inside a 250, it would have been impractical to mount the extra set on the left side of the main carrying frame, so either the workshop has fabricated a new set of end supports, or this is an official variant that hasn't been listed. It is probably carrying the Fu 5, Fu 4 and Fu8 radio sets.

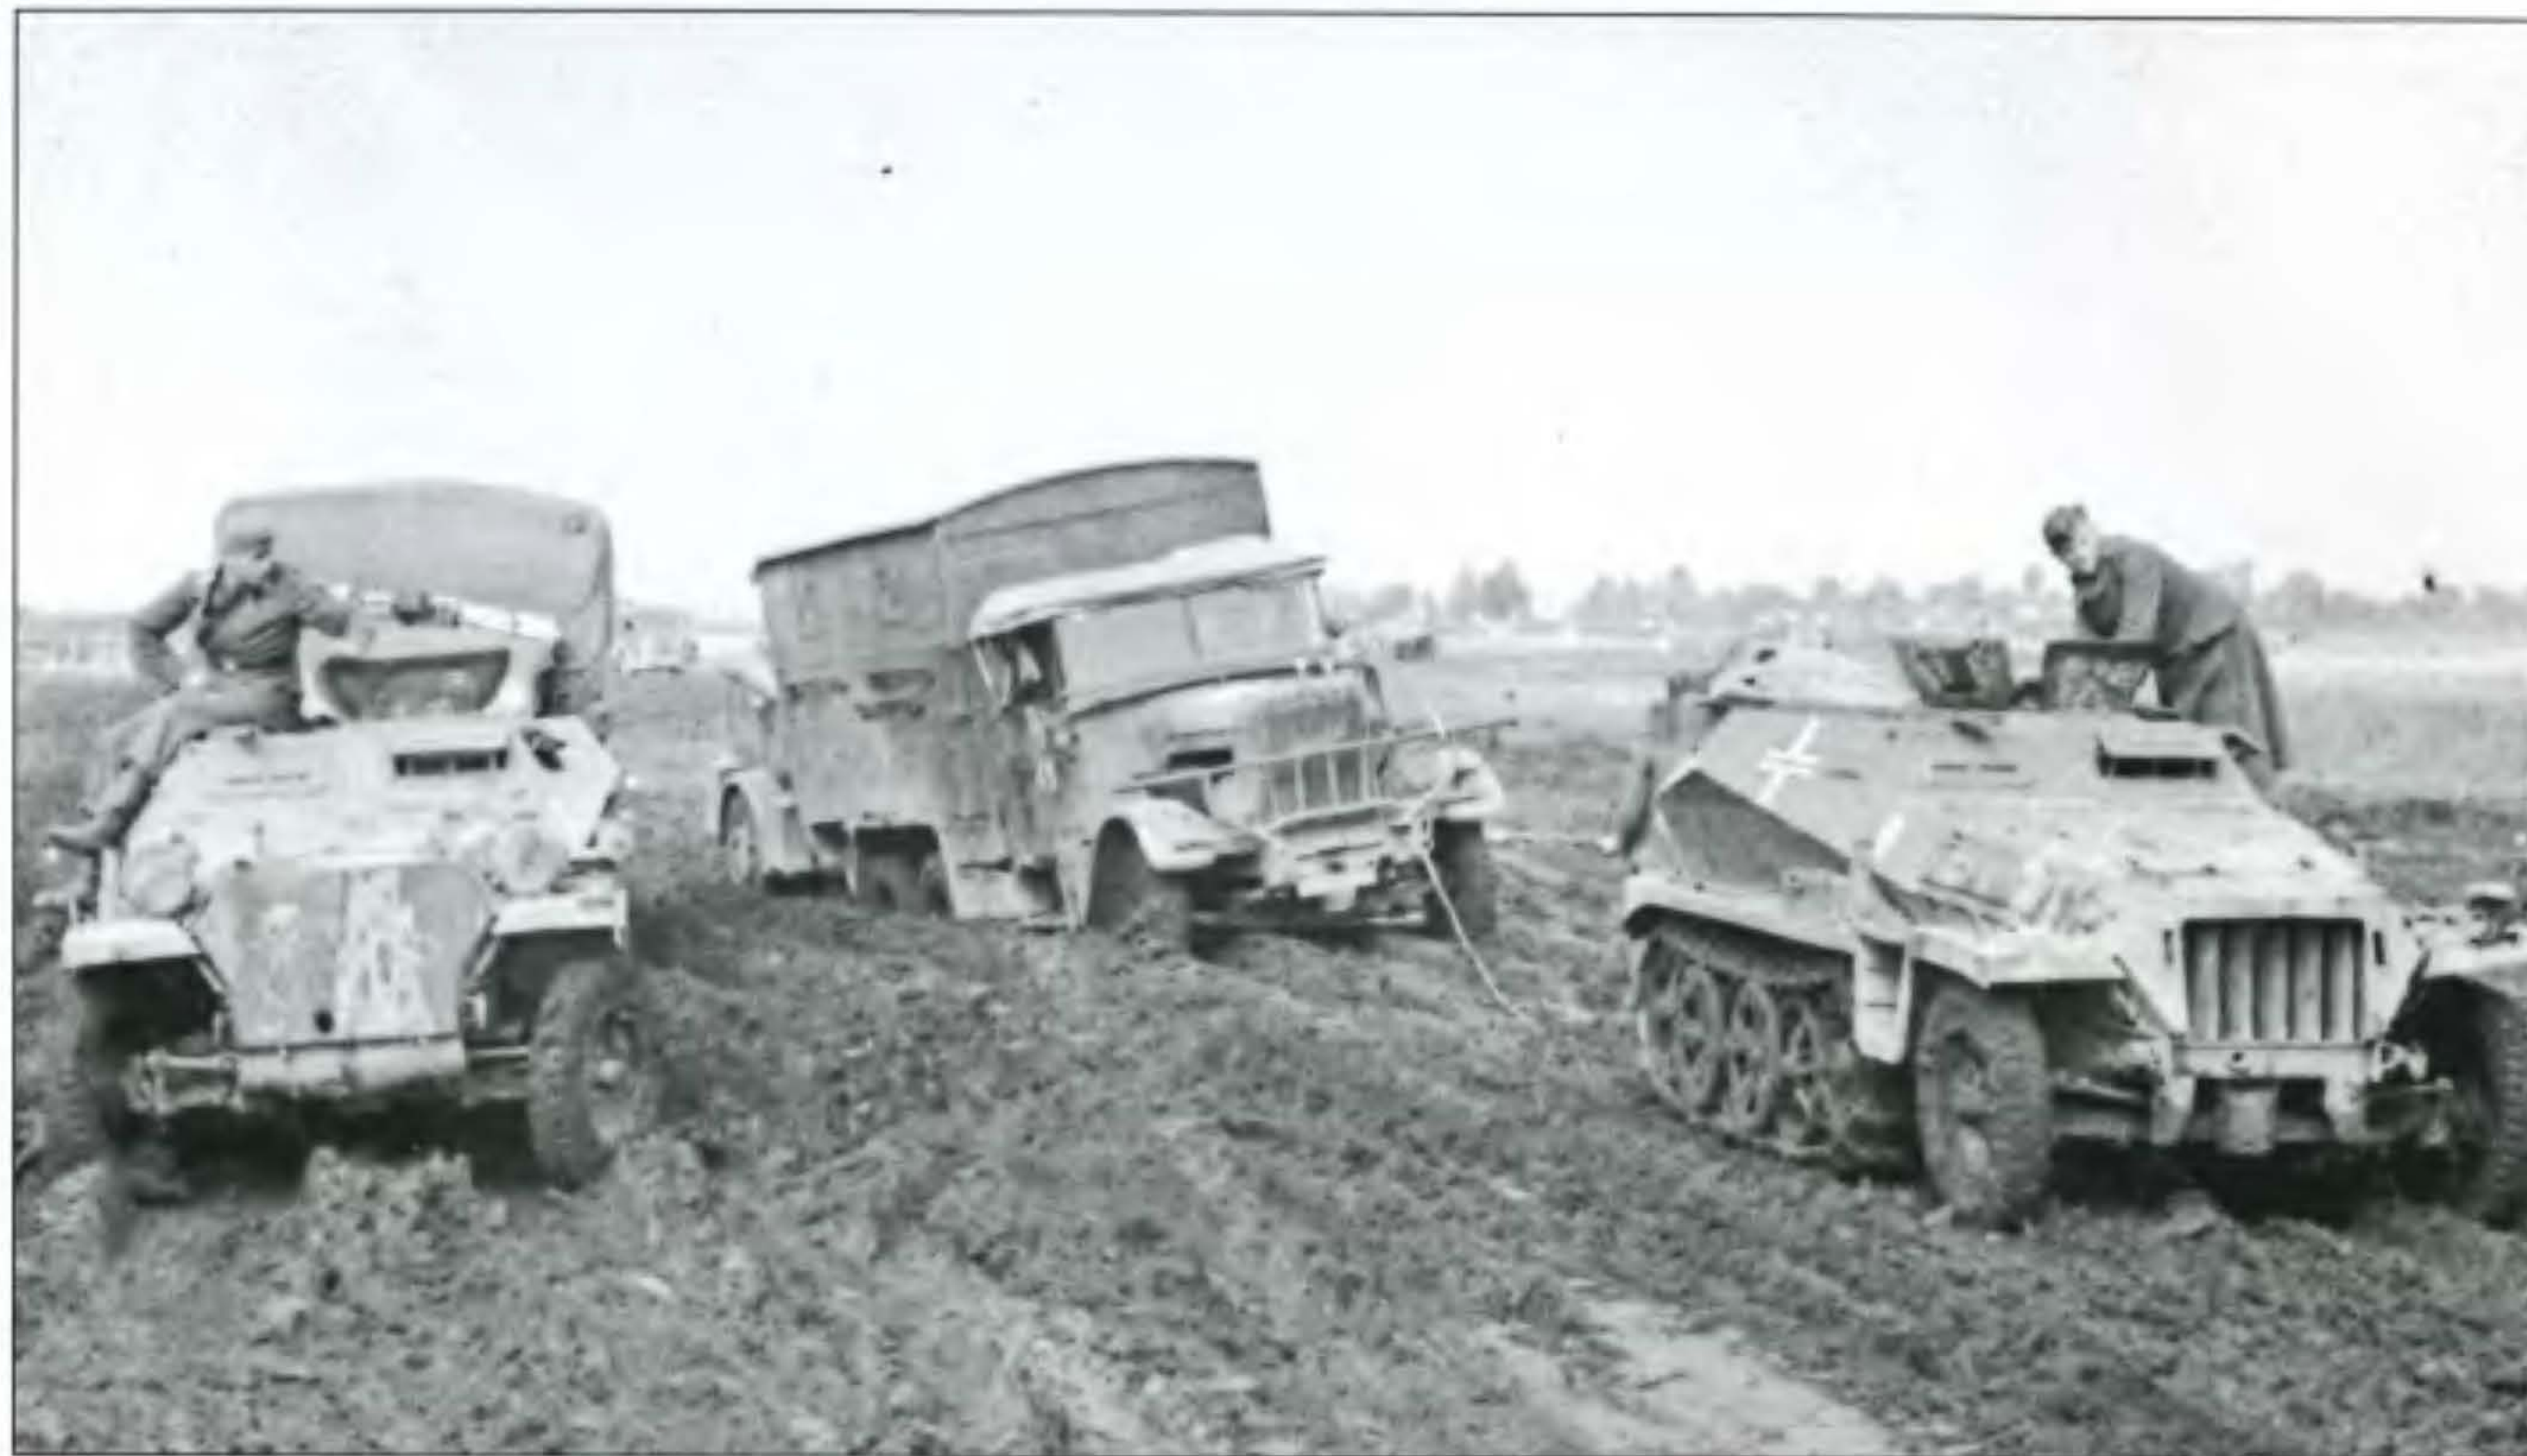
With the nose plate removed, it is possible to see the early radiator shutters used for cold starting / engine warming, very similar in design to the Sd Kfz 251, with vertical slats operated by a lever and arm from the driver's position inside the 253. (It was the same for the 252). On later versions this complicated design was dropped in favour of a simple, single horizontal flap assembly that hinged open and shut behind the base of the nose plate just ahead of the front chassis plate, along with the driver controlled left-hand engine door that was opened from the driver's position. It hasn't taken long for the condition of these vehicles to deteriorate by the end of 1941.
