TOTAL DETAIL

Sd Kfz 252, 253 & early 250

Sd Kfz 252, 253 & 250 (Typ 1)

Volume 3 - Part 1

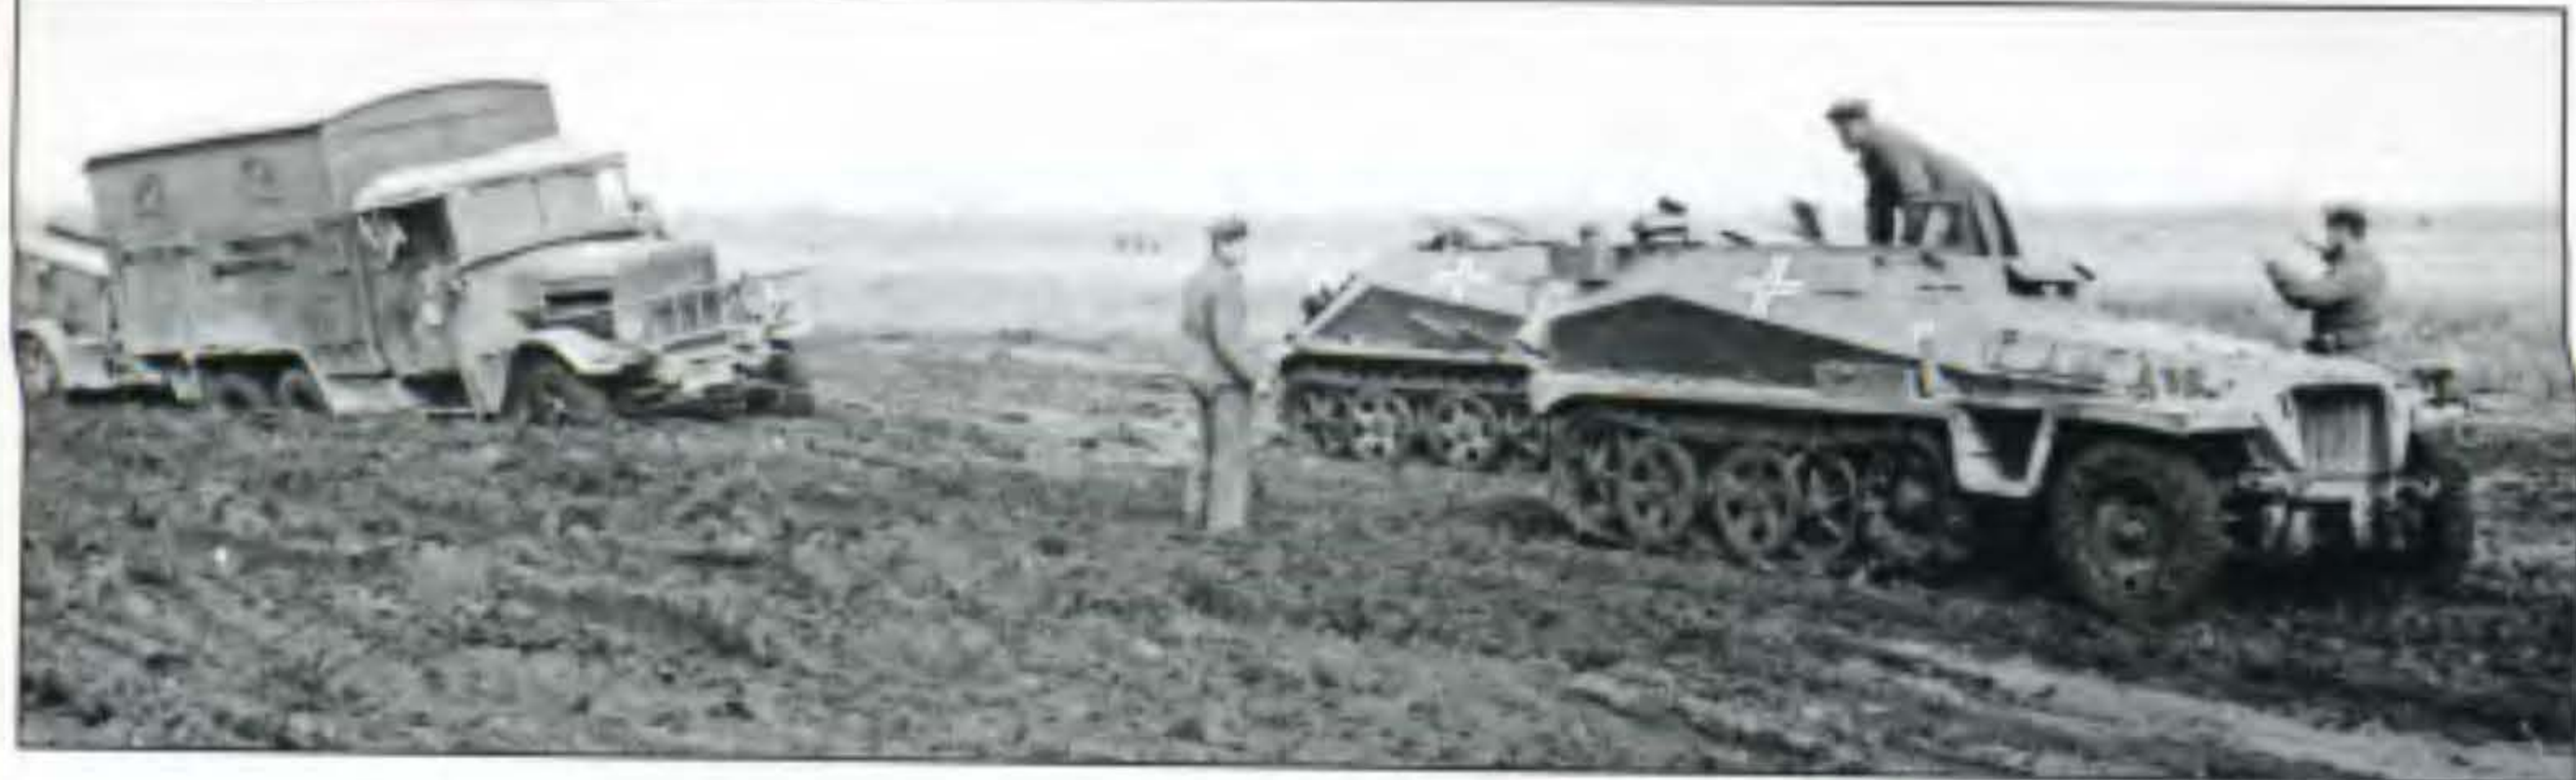
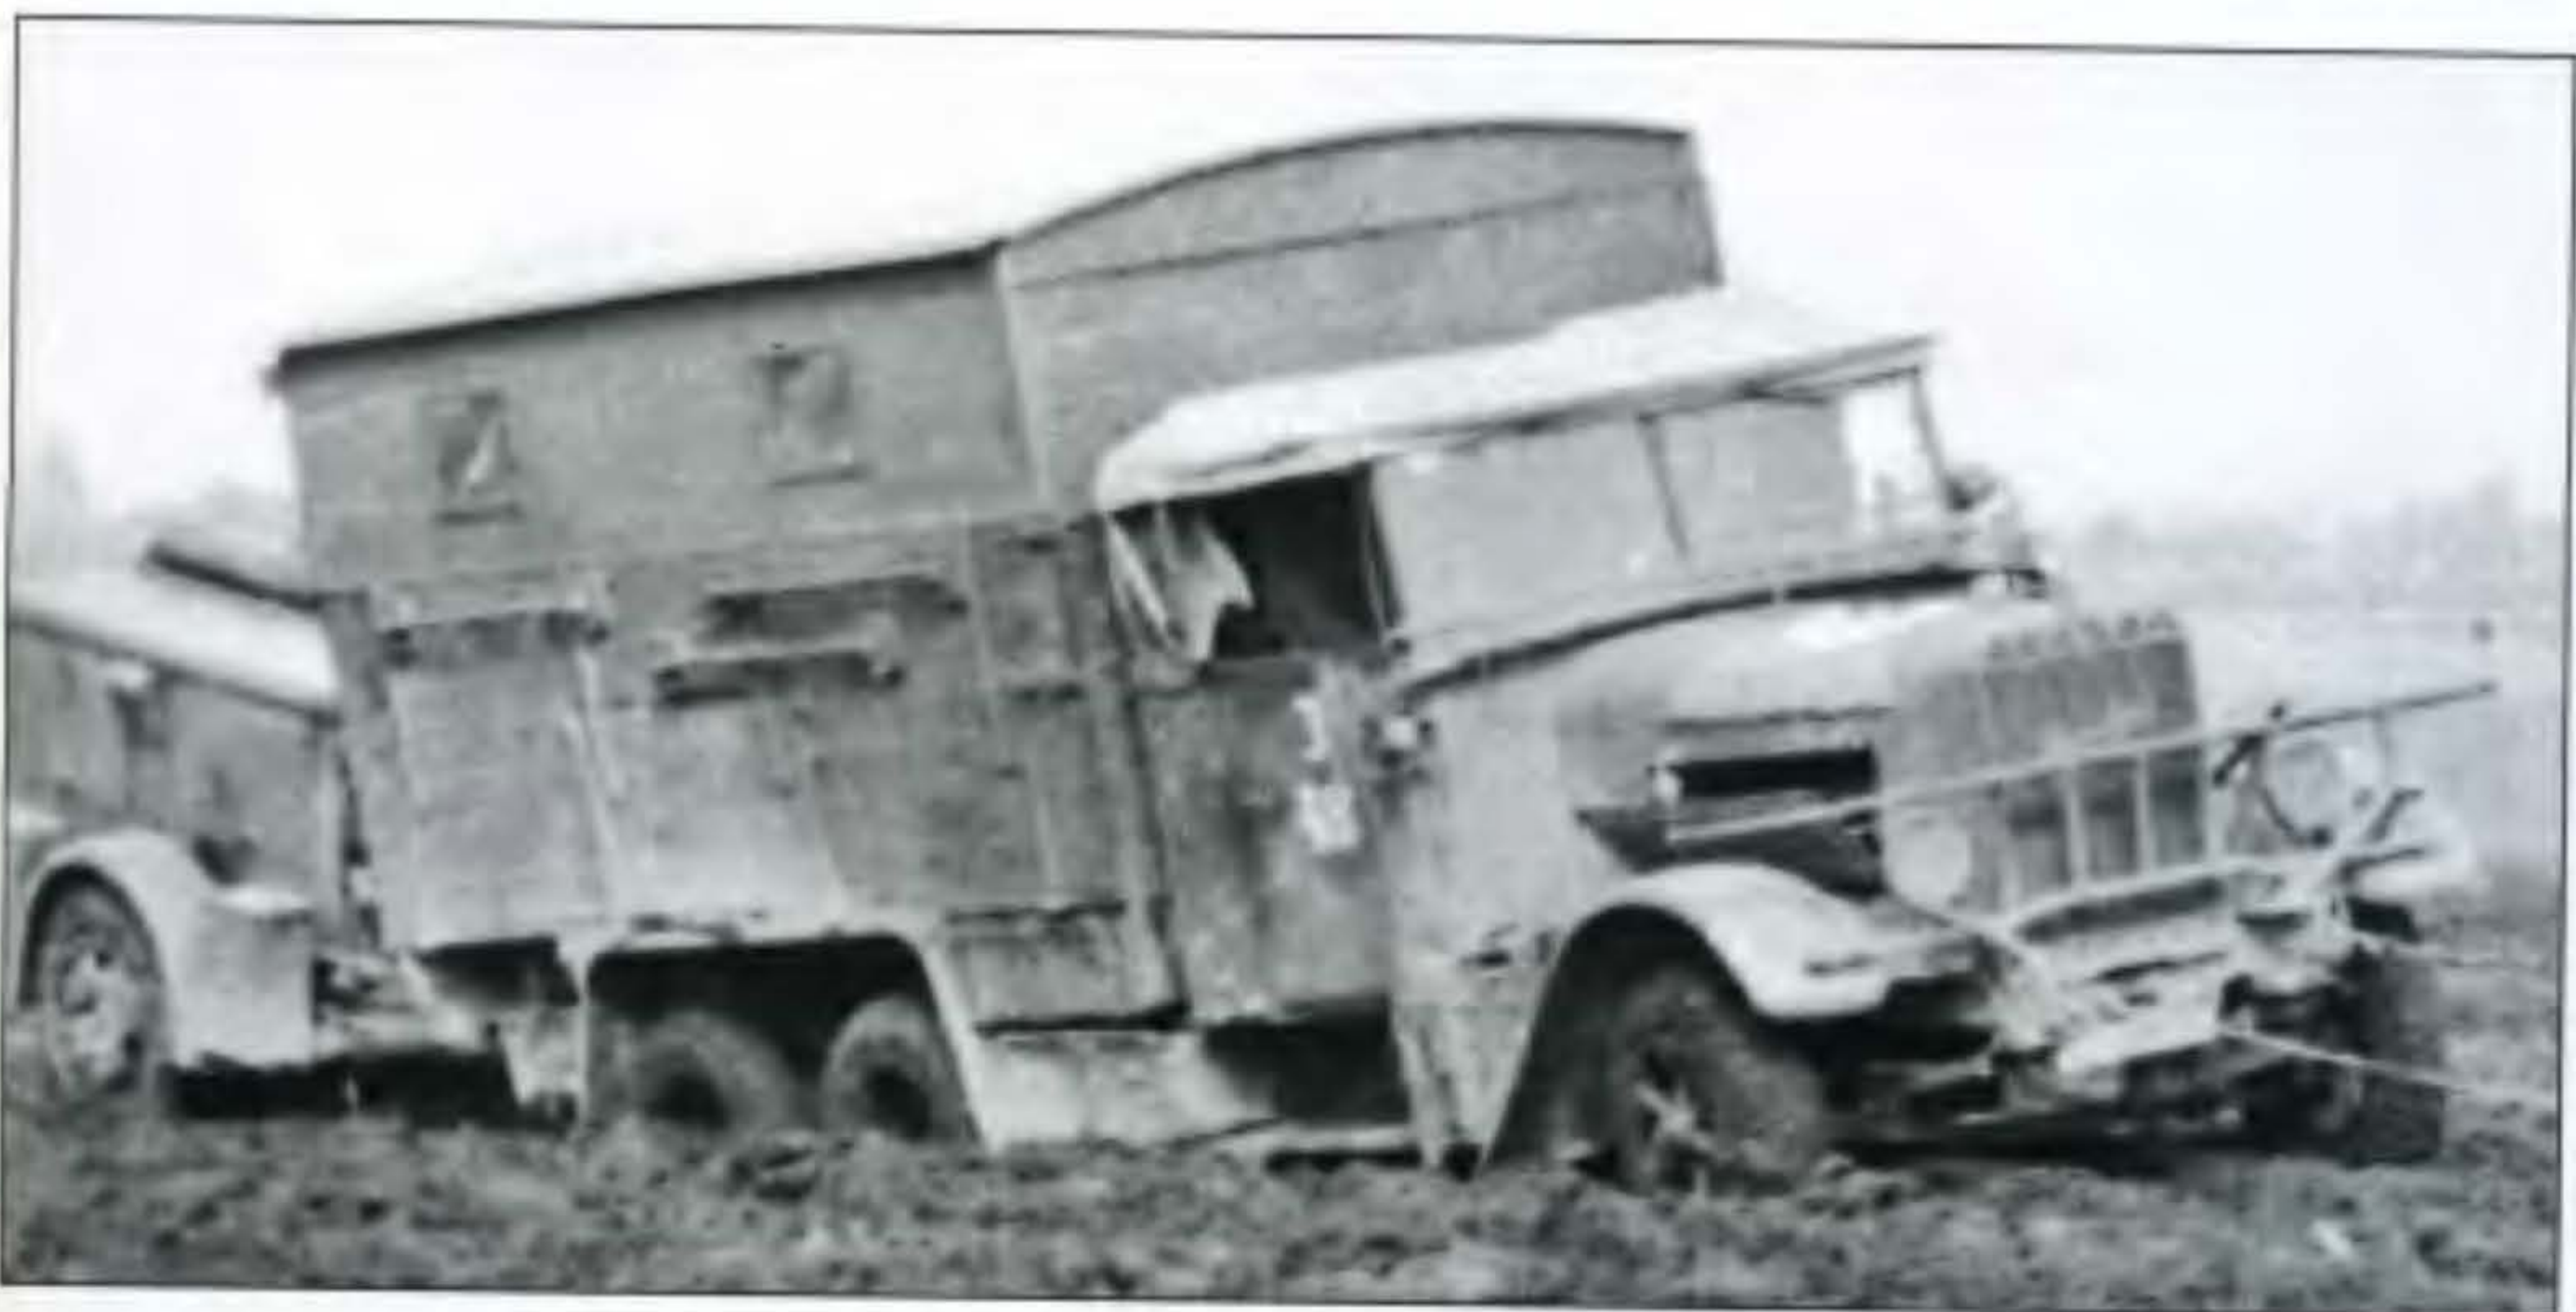
One of the problems of rain on unmade roads: just how to recover a 6-ton lorry and trailer up to its axles in mud? The ironic point is that, given the conditions of the roads, the workshop vehicle is probably required elsewhere to repair gearboxes and burnt out clutches of other vehicles in the same predicament. Possibly, having tried with just the 253, a 252 has returned to assist. If the mud is too deep, even the half-tracked vehicles would eventually bottom out with the chassis plate resting on the ground and the tracks turning and achieving nothing.

The lorry is a Henschel 33D1 Werkstattkraftwagen (Workshop truck) Kfz 79 m.gl.Lkw(O) (Mittlerer gelandegängiger Lastkraftwagen) (Medium cross-country load carrier) towing Sd. Anh.24 (Special trailer 24).

diesel engine, but de-tuned to produce 100PS. The 114-litre tank gave the Henschel 33 D1 a range of 250 Kms on the road and a cross-country range of 190 Kms. The diesel-powered versions could manage 380 and 250 Kms respectively. The trailer contained an A-Type heavy generator of 220/380 Volts, 12 Kilowatts, 25 Amperes. Used by the signal corps to power radio equipment, or in this case, machinery used by the workshop companies of Sturmartillerie Abteilung 190. The truck also shares the same 'Gothic' vehicle unit numbering system as the armoured vehicles.

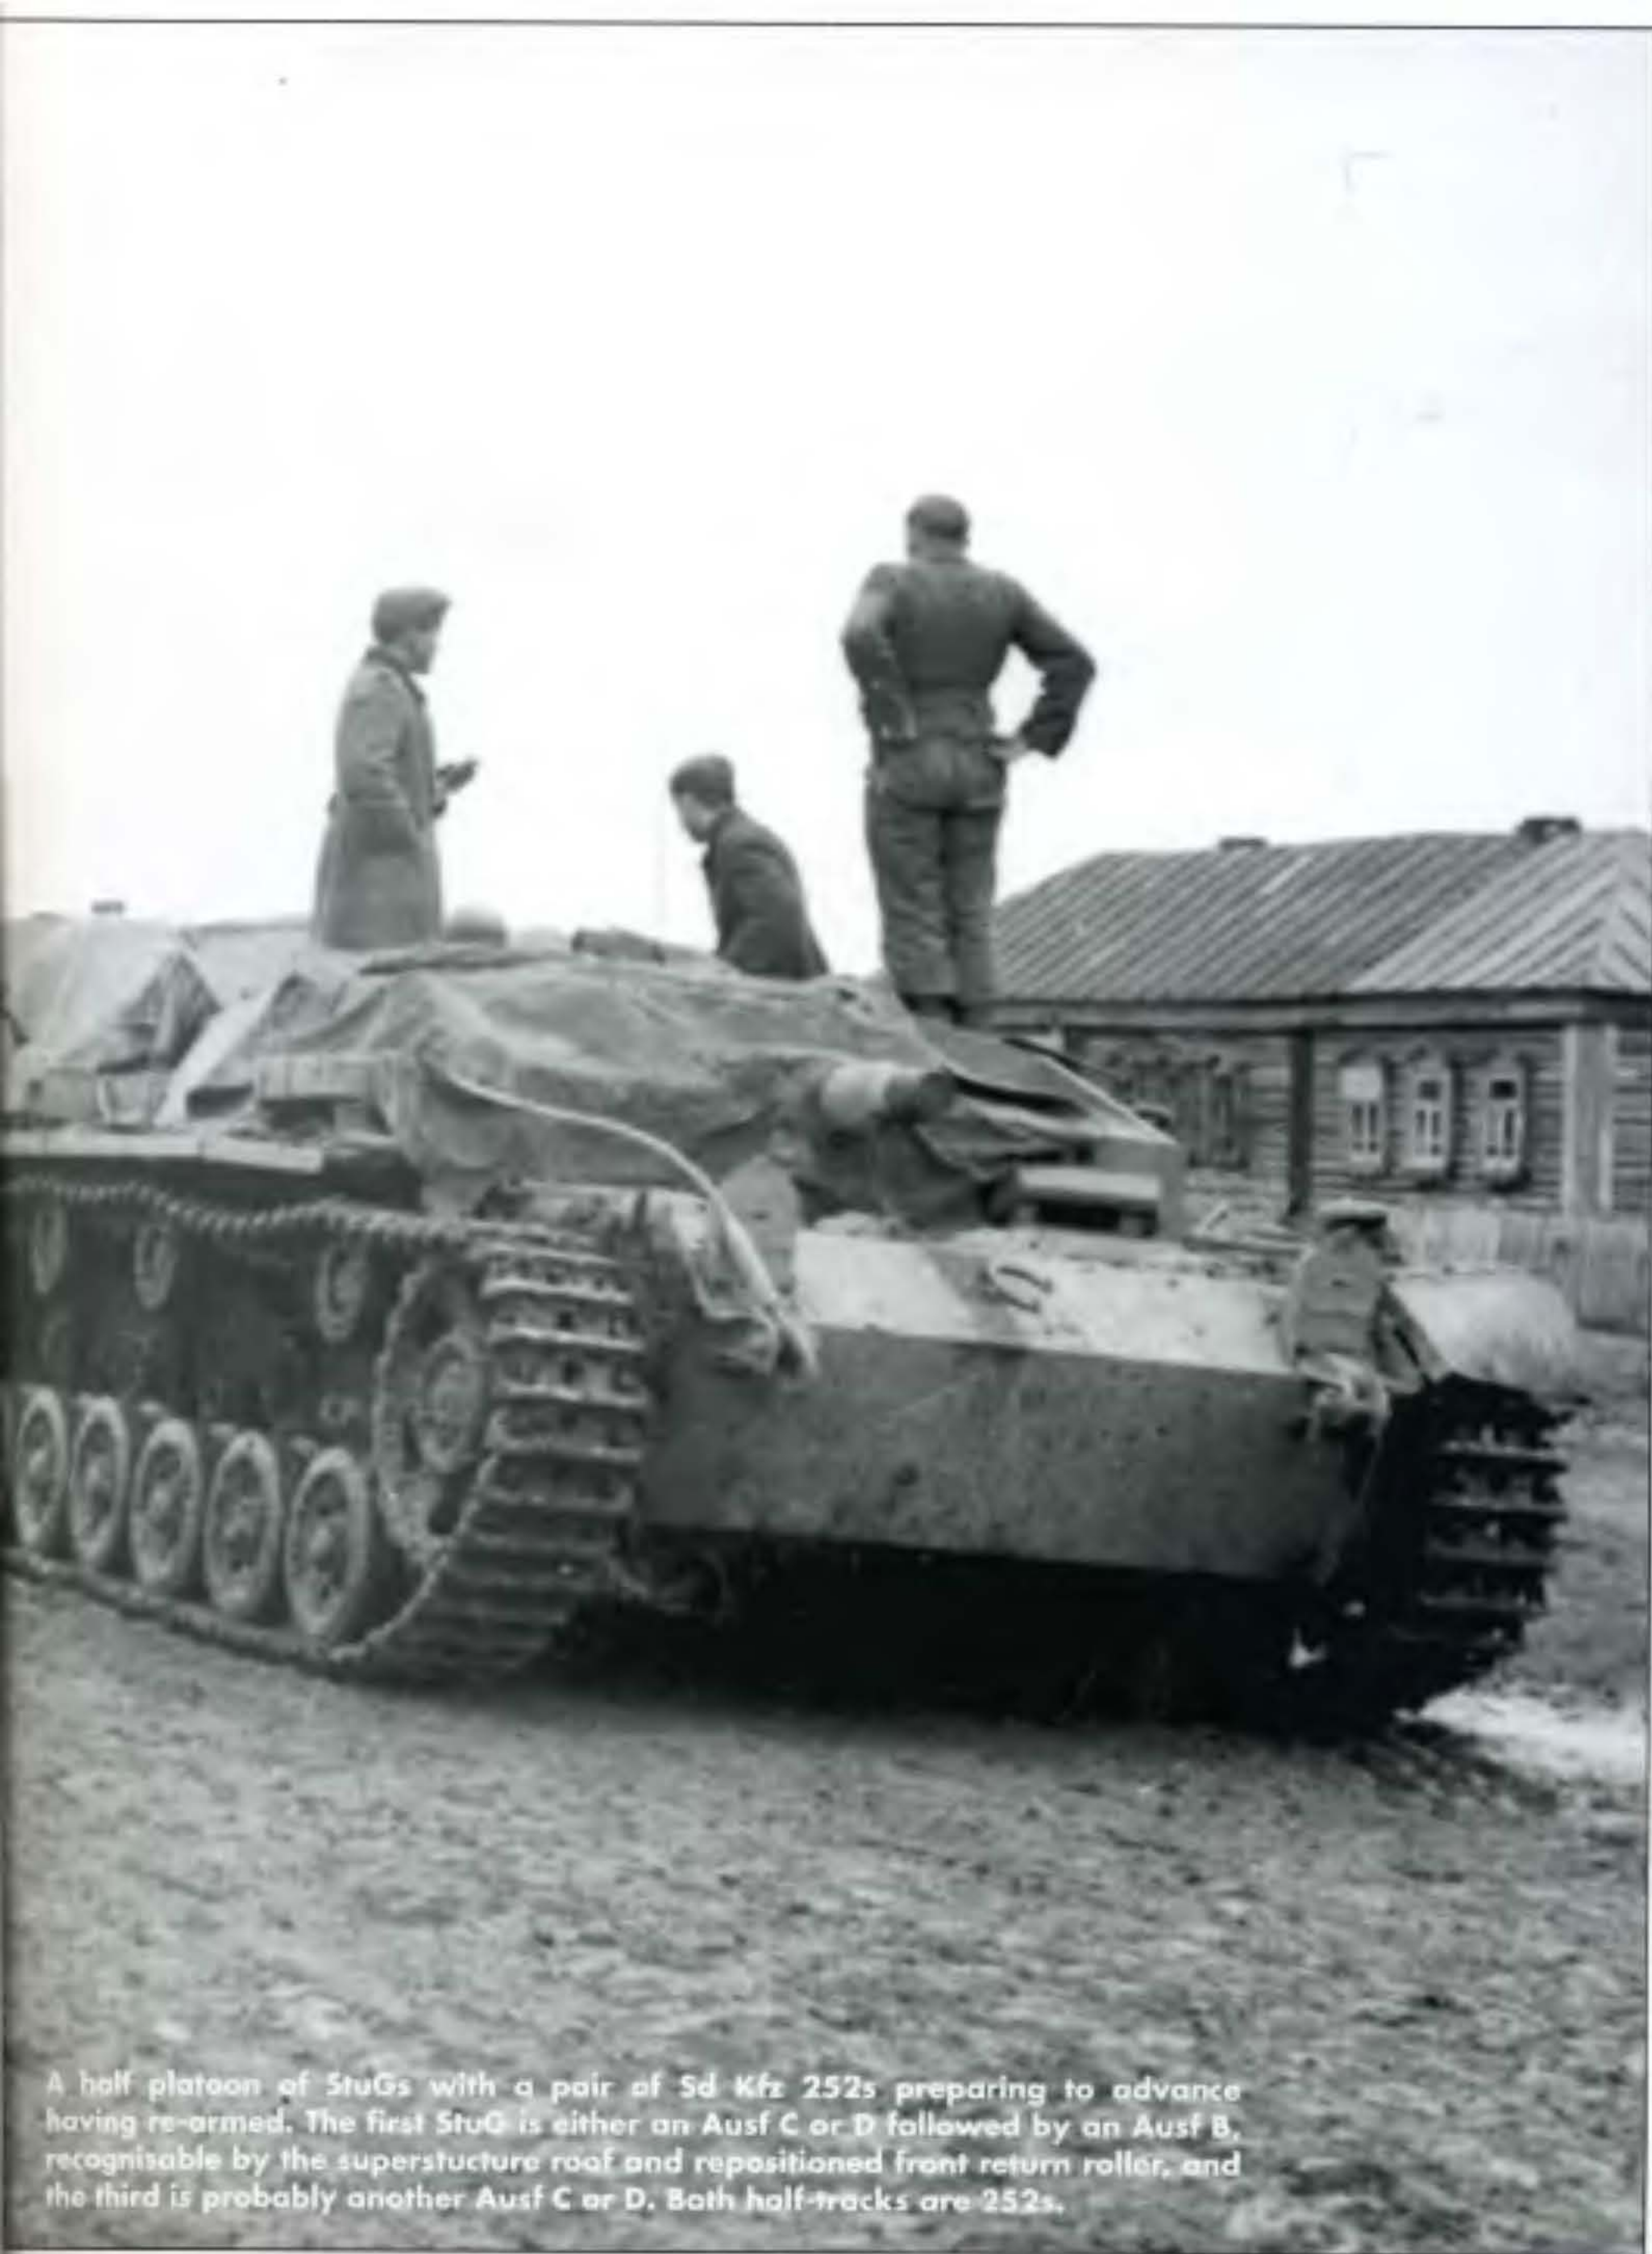
A half platoon of StuGs with a pair of Sd Kfz 252s preparing to advance having re-armed. The first StuG is either an Ausf C or D followed by an Ausf B, recognisable by the superstructure roof and repositioned front return roller, and the third is probably another Ausf C or D. Both half-tracks are 252s.

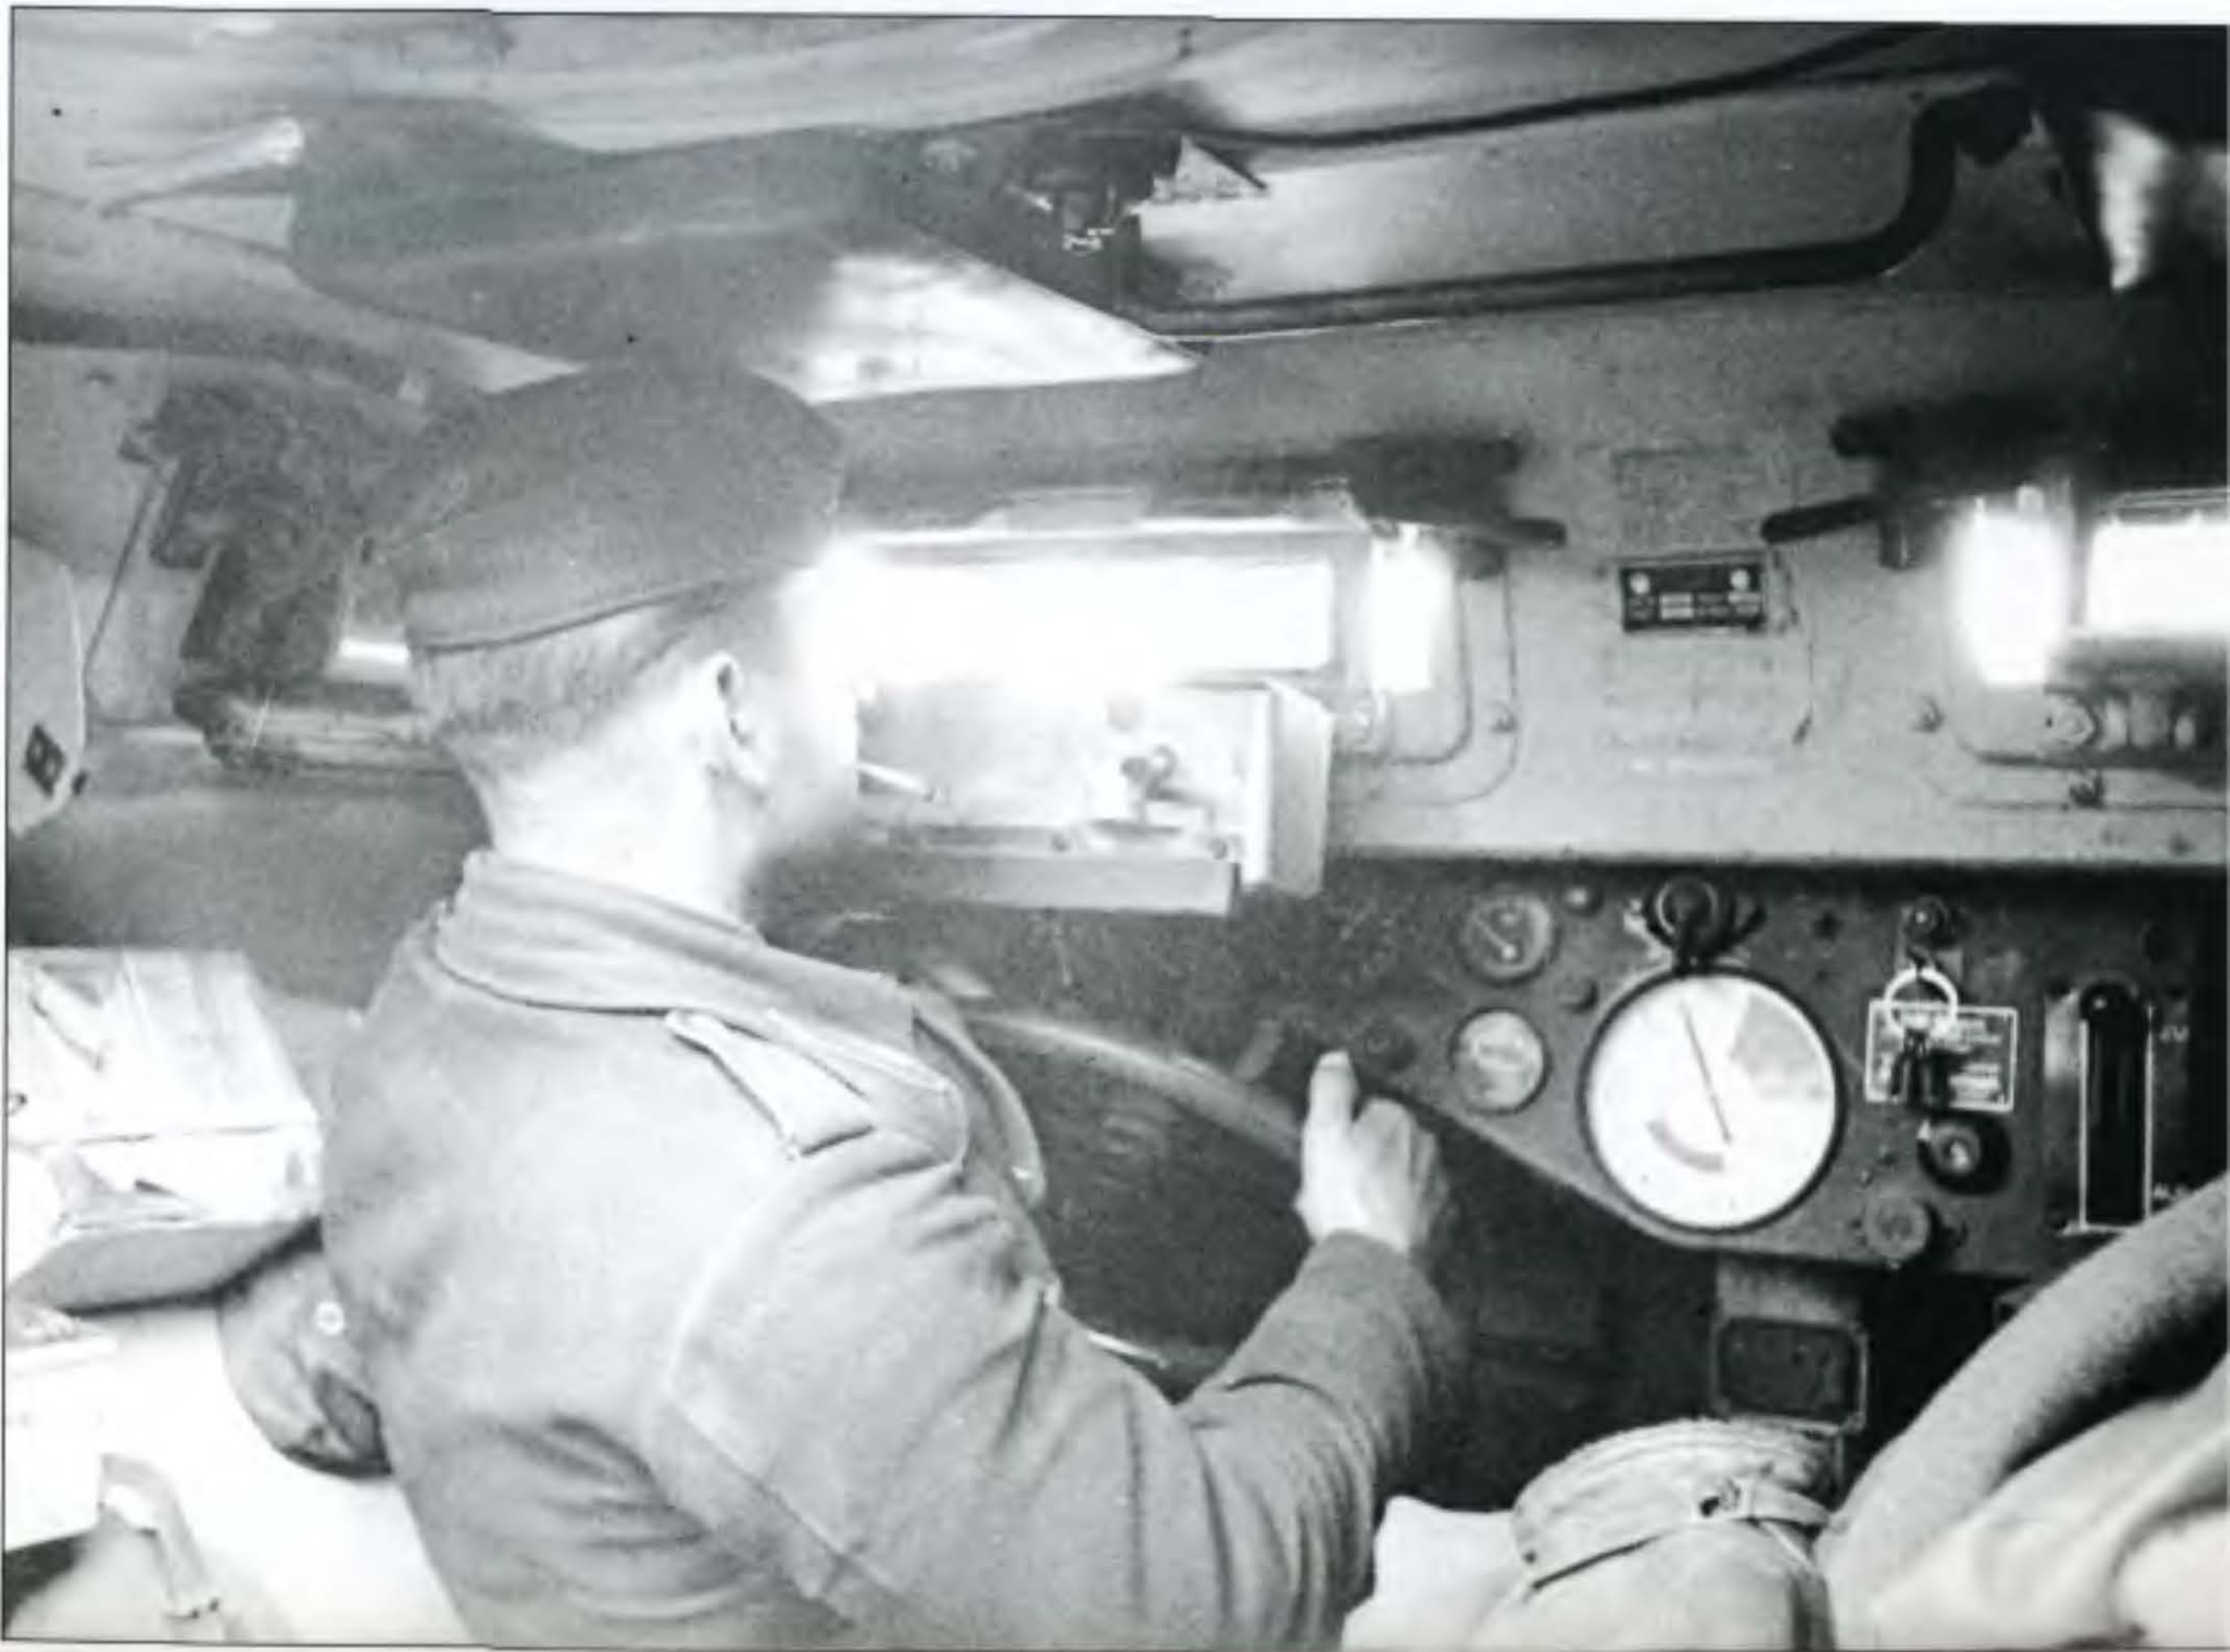
OPPOSITE PAGE: In the earlier vehicles, the front visors and the assembly to hold the glass blocks were separate. The recesses for the front visors were bolted to the armour plate from the inside. The pair of arms that supported the visor itself bolted onto and through the recess plate and the armour plate. To have a completely clear view out once the driver had raised the exterior visor, he would have had to open the block holder down like this. Once again, it is possible to see both the ingenuity and short-sightedness of some German designers.

The first version of the large front vision port accepted two standard sized glass vision blocks like the two wrapped in paper to protect them behind the driver, (there were two more stored in front of the driver on the upper armoured portion of what forms the firewall. It is because the front visors contained two glass blocks that the early armoured cover had two vision slits. Perhaps it was through combat reports filtering back to the High Command that explained how limited the forward vision was with the armoured cover closed. With the introduction of the Typ 2, the front visors were re-designed using a lengthened side visor assembly with a single large glass vision block and a continuous vision slit. It also allowed the glass block holder to move out and up with the armoured cover to provide an uninterrupted view out of the vehicle.

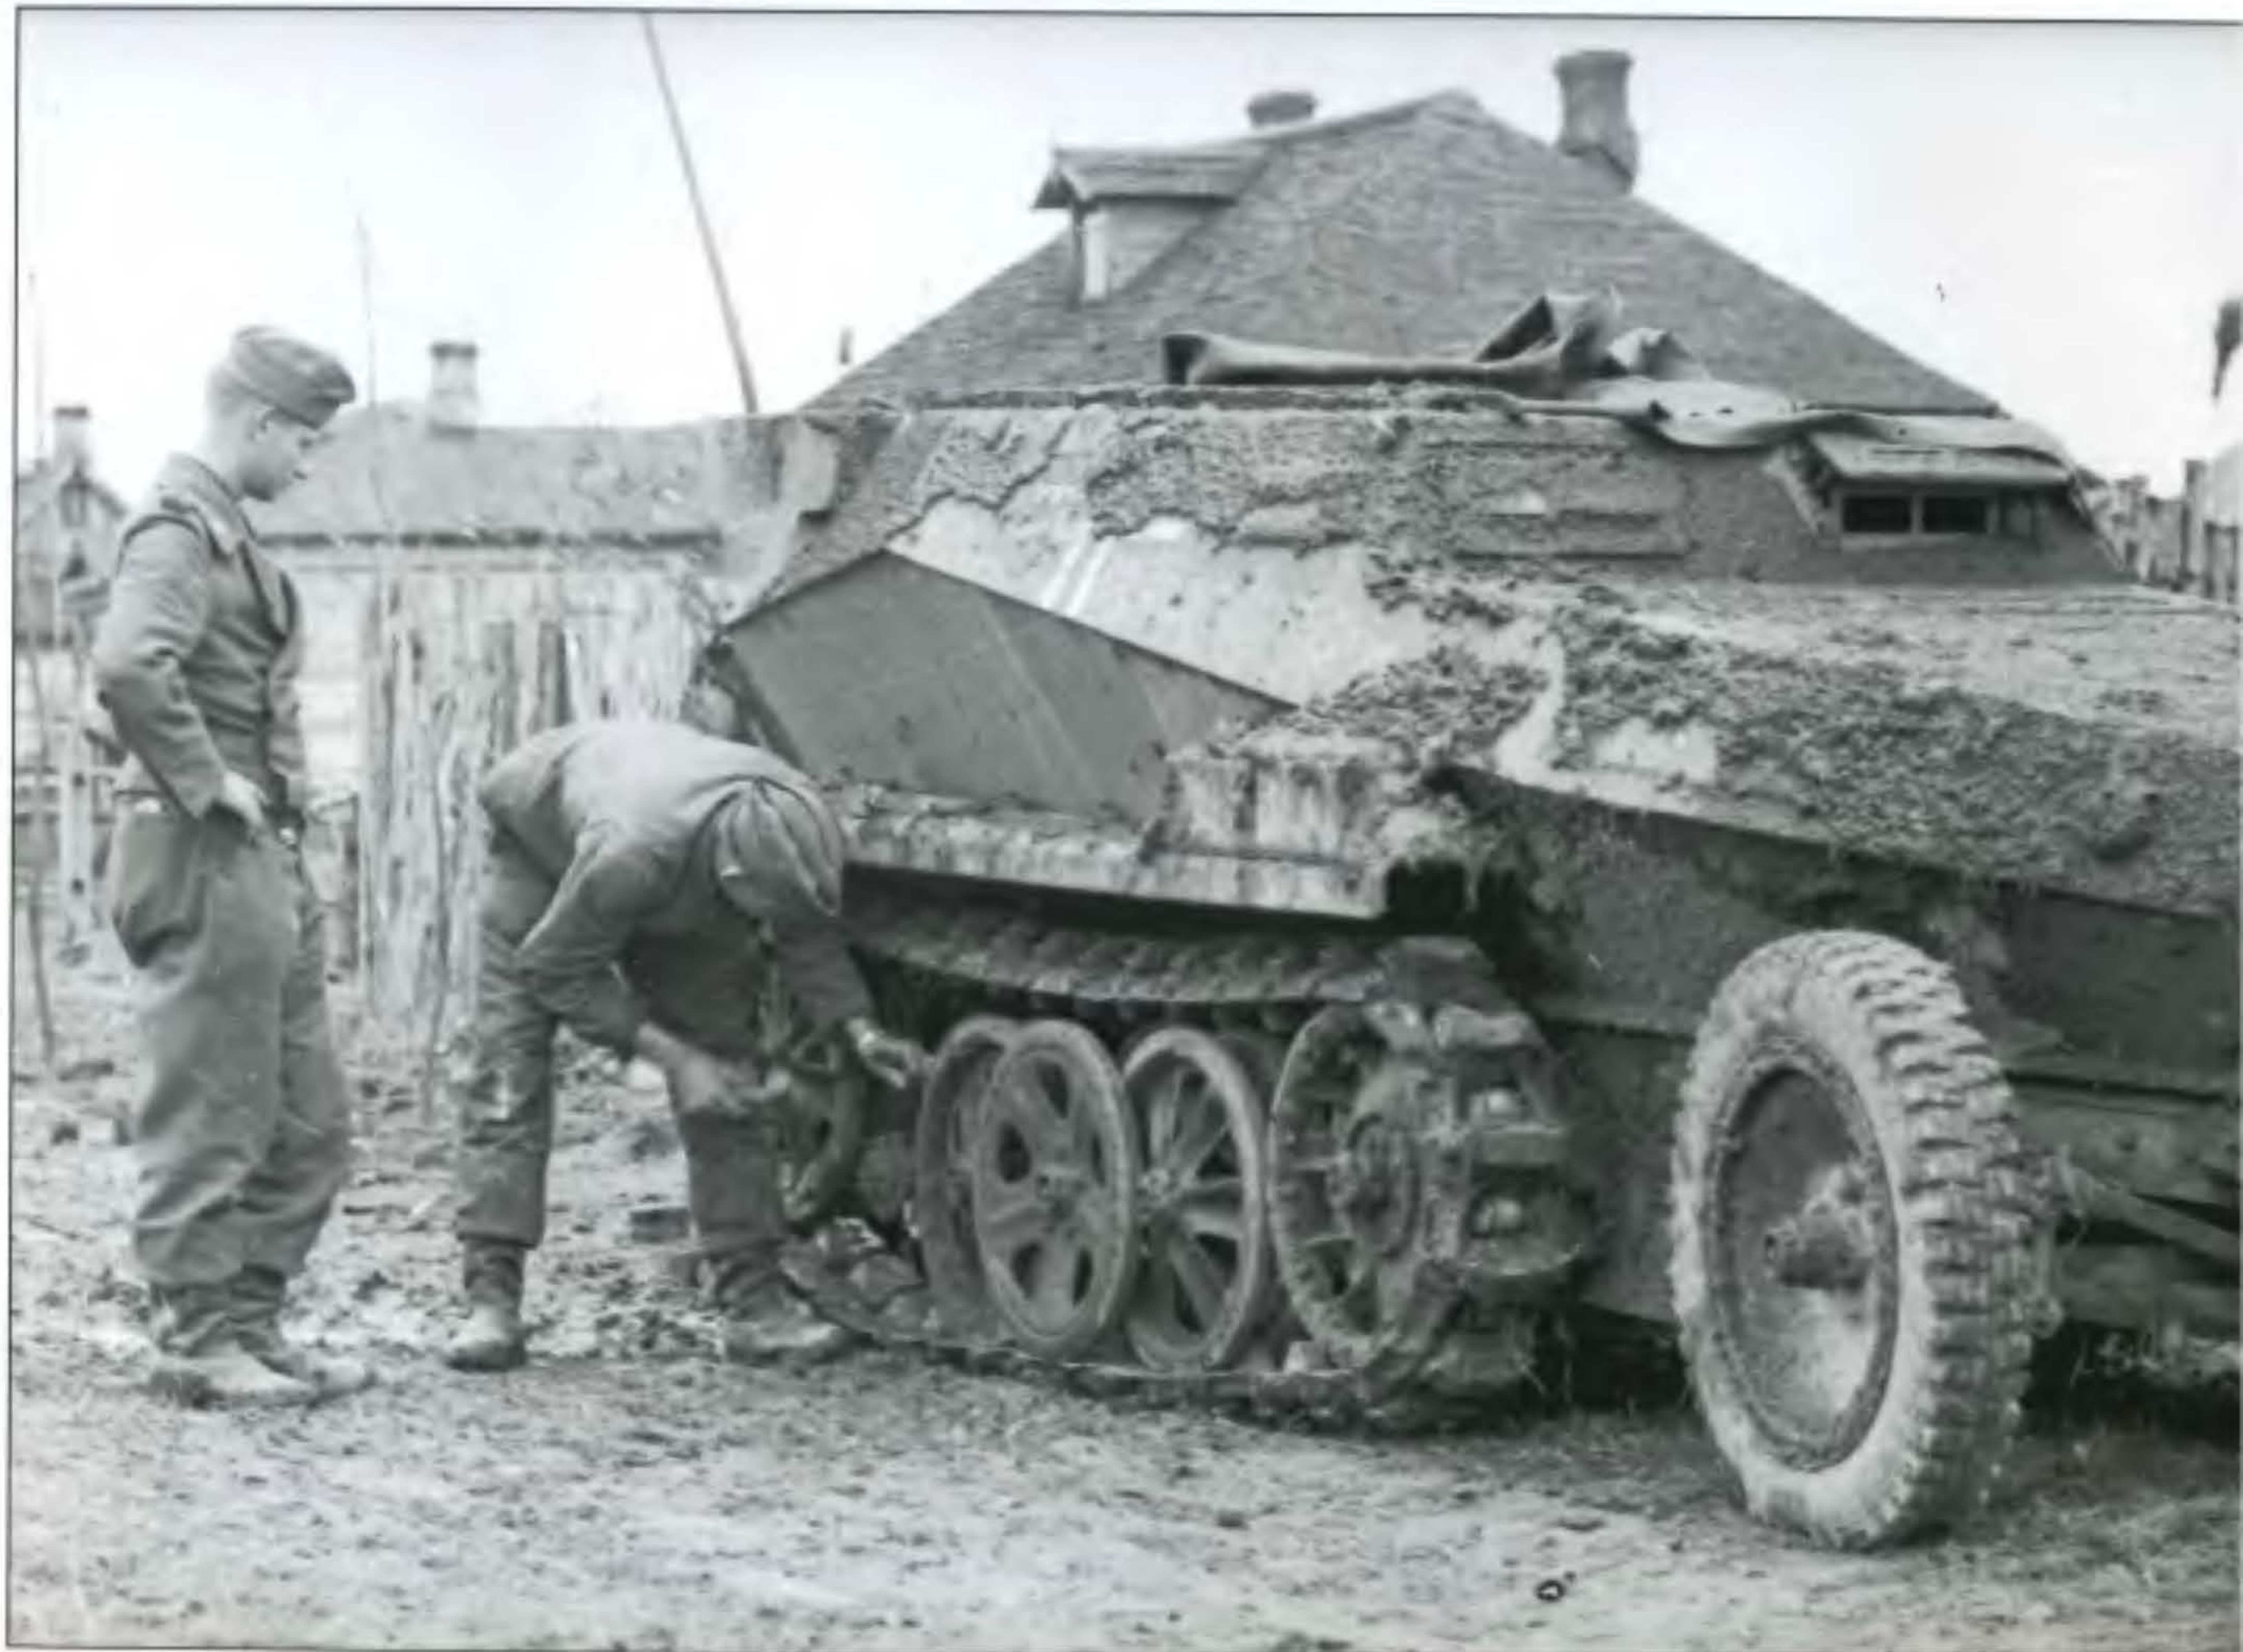
The black and silver name plate in between the front visors would proudly bear the manufacturers details, the chassis number and production date, complete with *Waffenamt* stamps. On later name plates, the manufacturers name was dropped in favour of the 3-letter code to keep the manufacturers name secret.

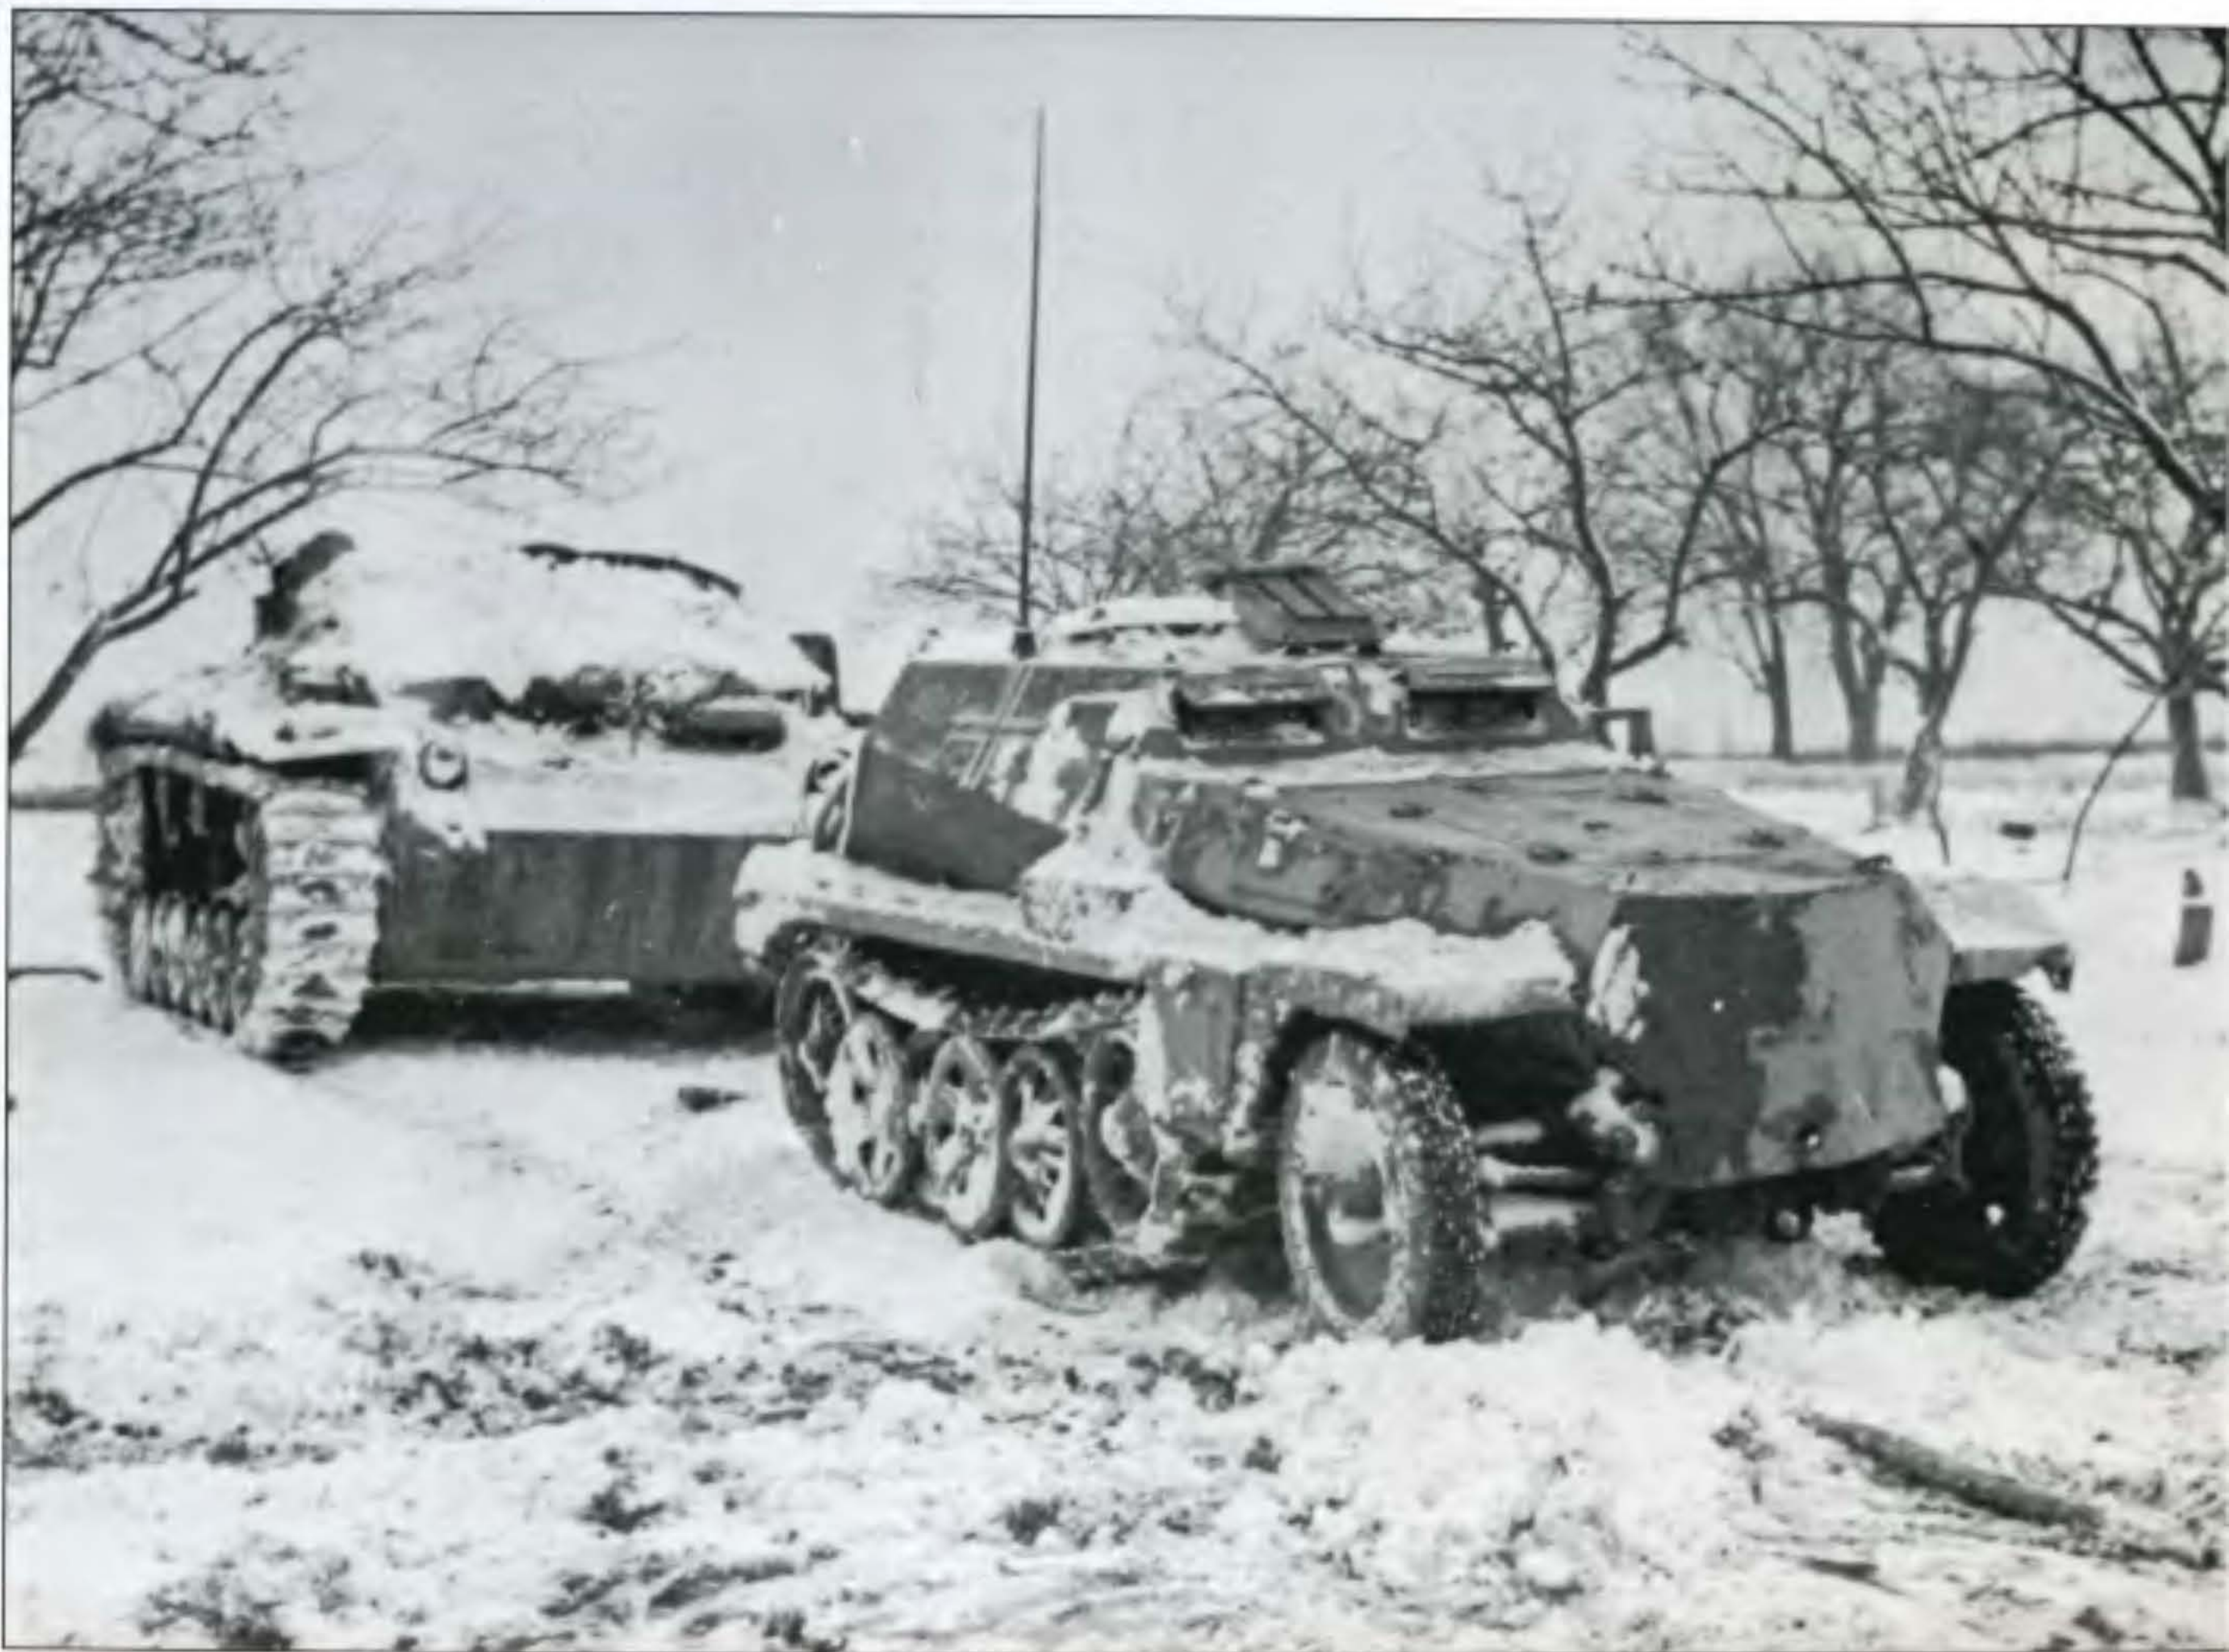
See the difference between sides where the left hand mudguard is broken and the right is still intact and the subsequent results of what the German soldiers ironically called 'Russian Asphalt' mud.
