TOTAL DETAIL

Sd Kfz 252, 253 & early 250

Sd Kfz 252, 253 & 250 (Typ 1)

Volume 3 - Part 1

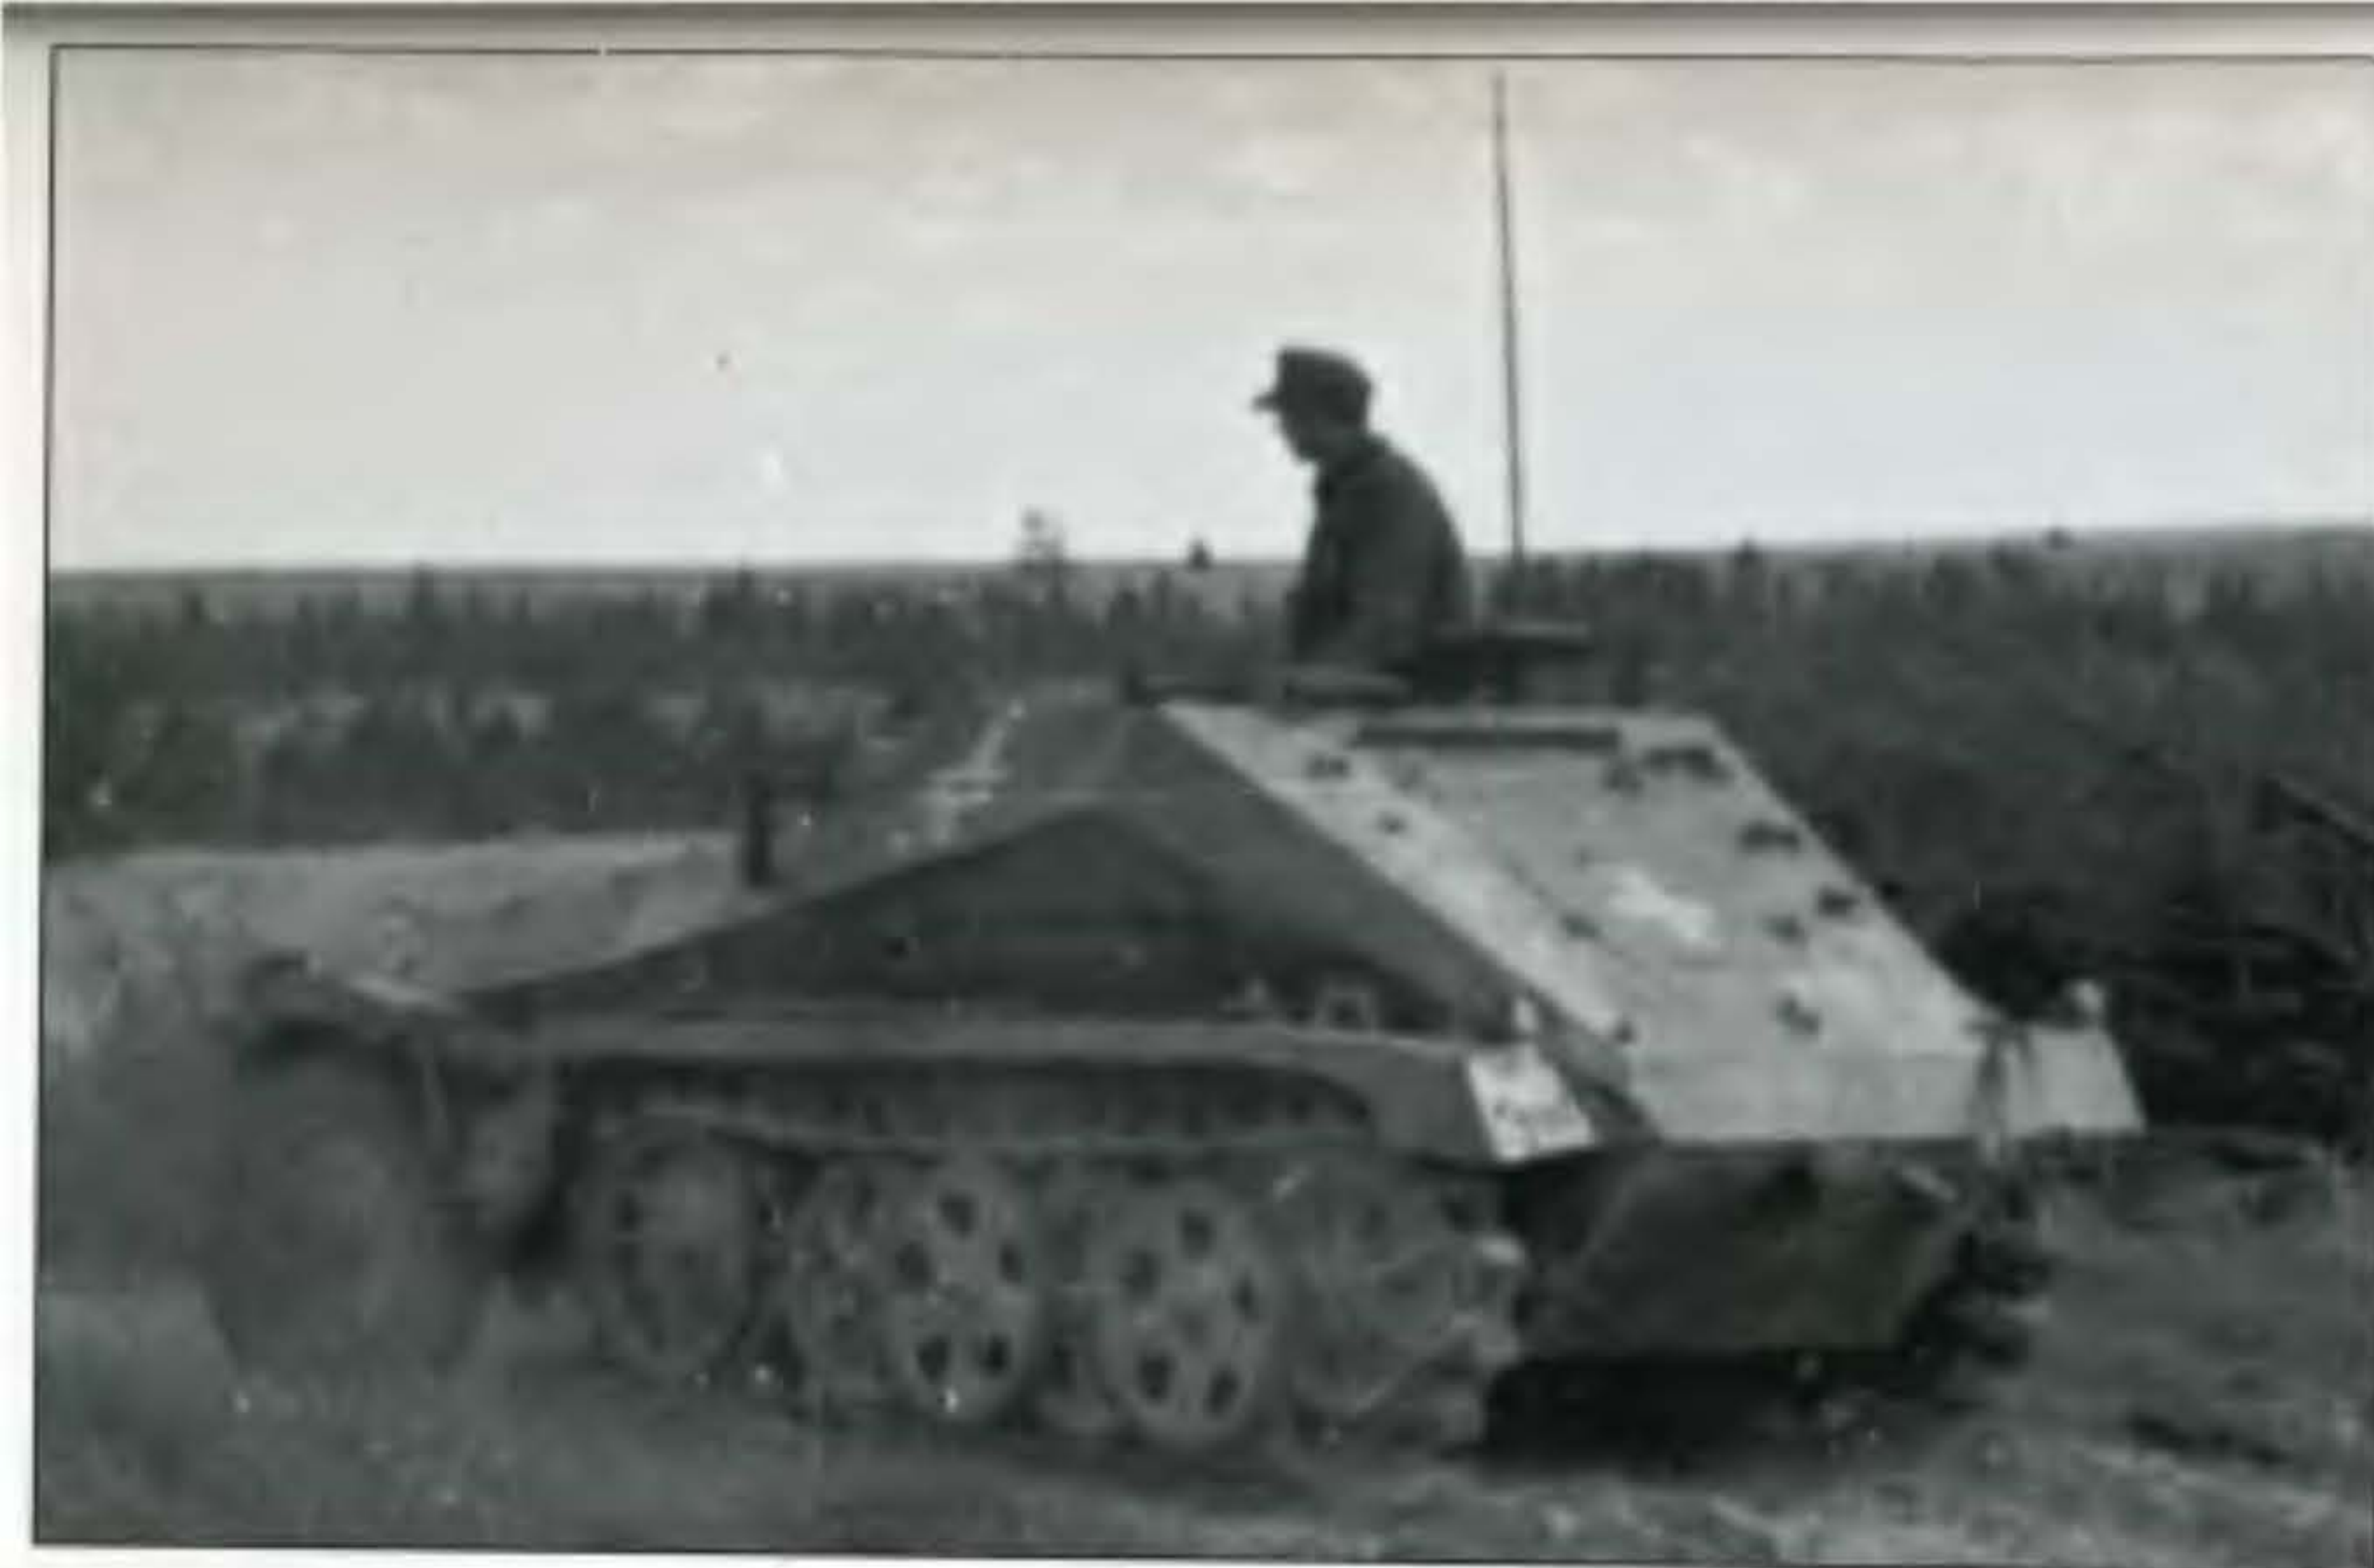
This rather tired looking Sd Kfz 252 has definitely seen better days. It is parked on the turning wash from a StuG III - note how widely the ground has been disturbed as the StuG has pivoted round. It has the almost obligatory bent front mud guards but interestingly, the rear pair of doors has the lock on the left side door, unlike the other 252s in this book. (See page 173). It also seems to be devoid of tools - apart from the spade, the three tool drawers are missing, it has lost its drive sprocket hub caps and has no unit markings, just plain white Balkenkreuz. The origin of the tow cable is uncertain, but it is thought that it is too long to be considered original equipment for the 252 and the vehicle only has one rear number plate.

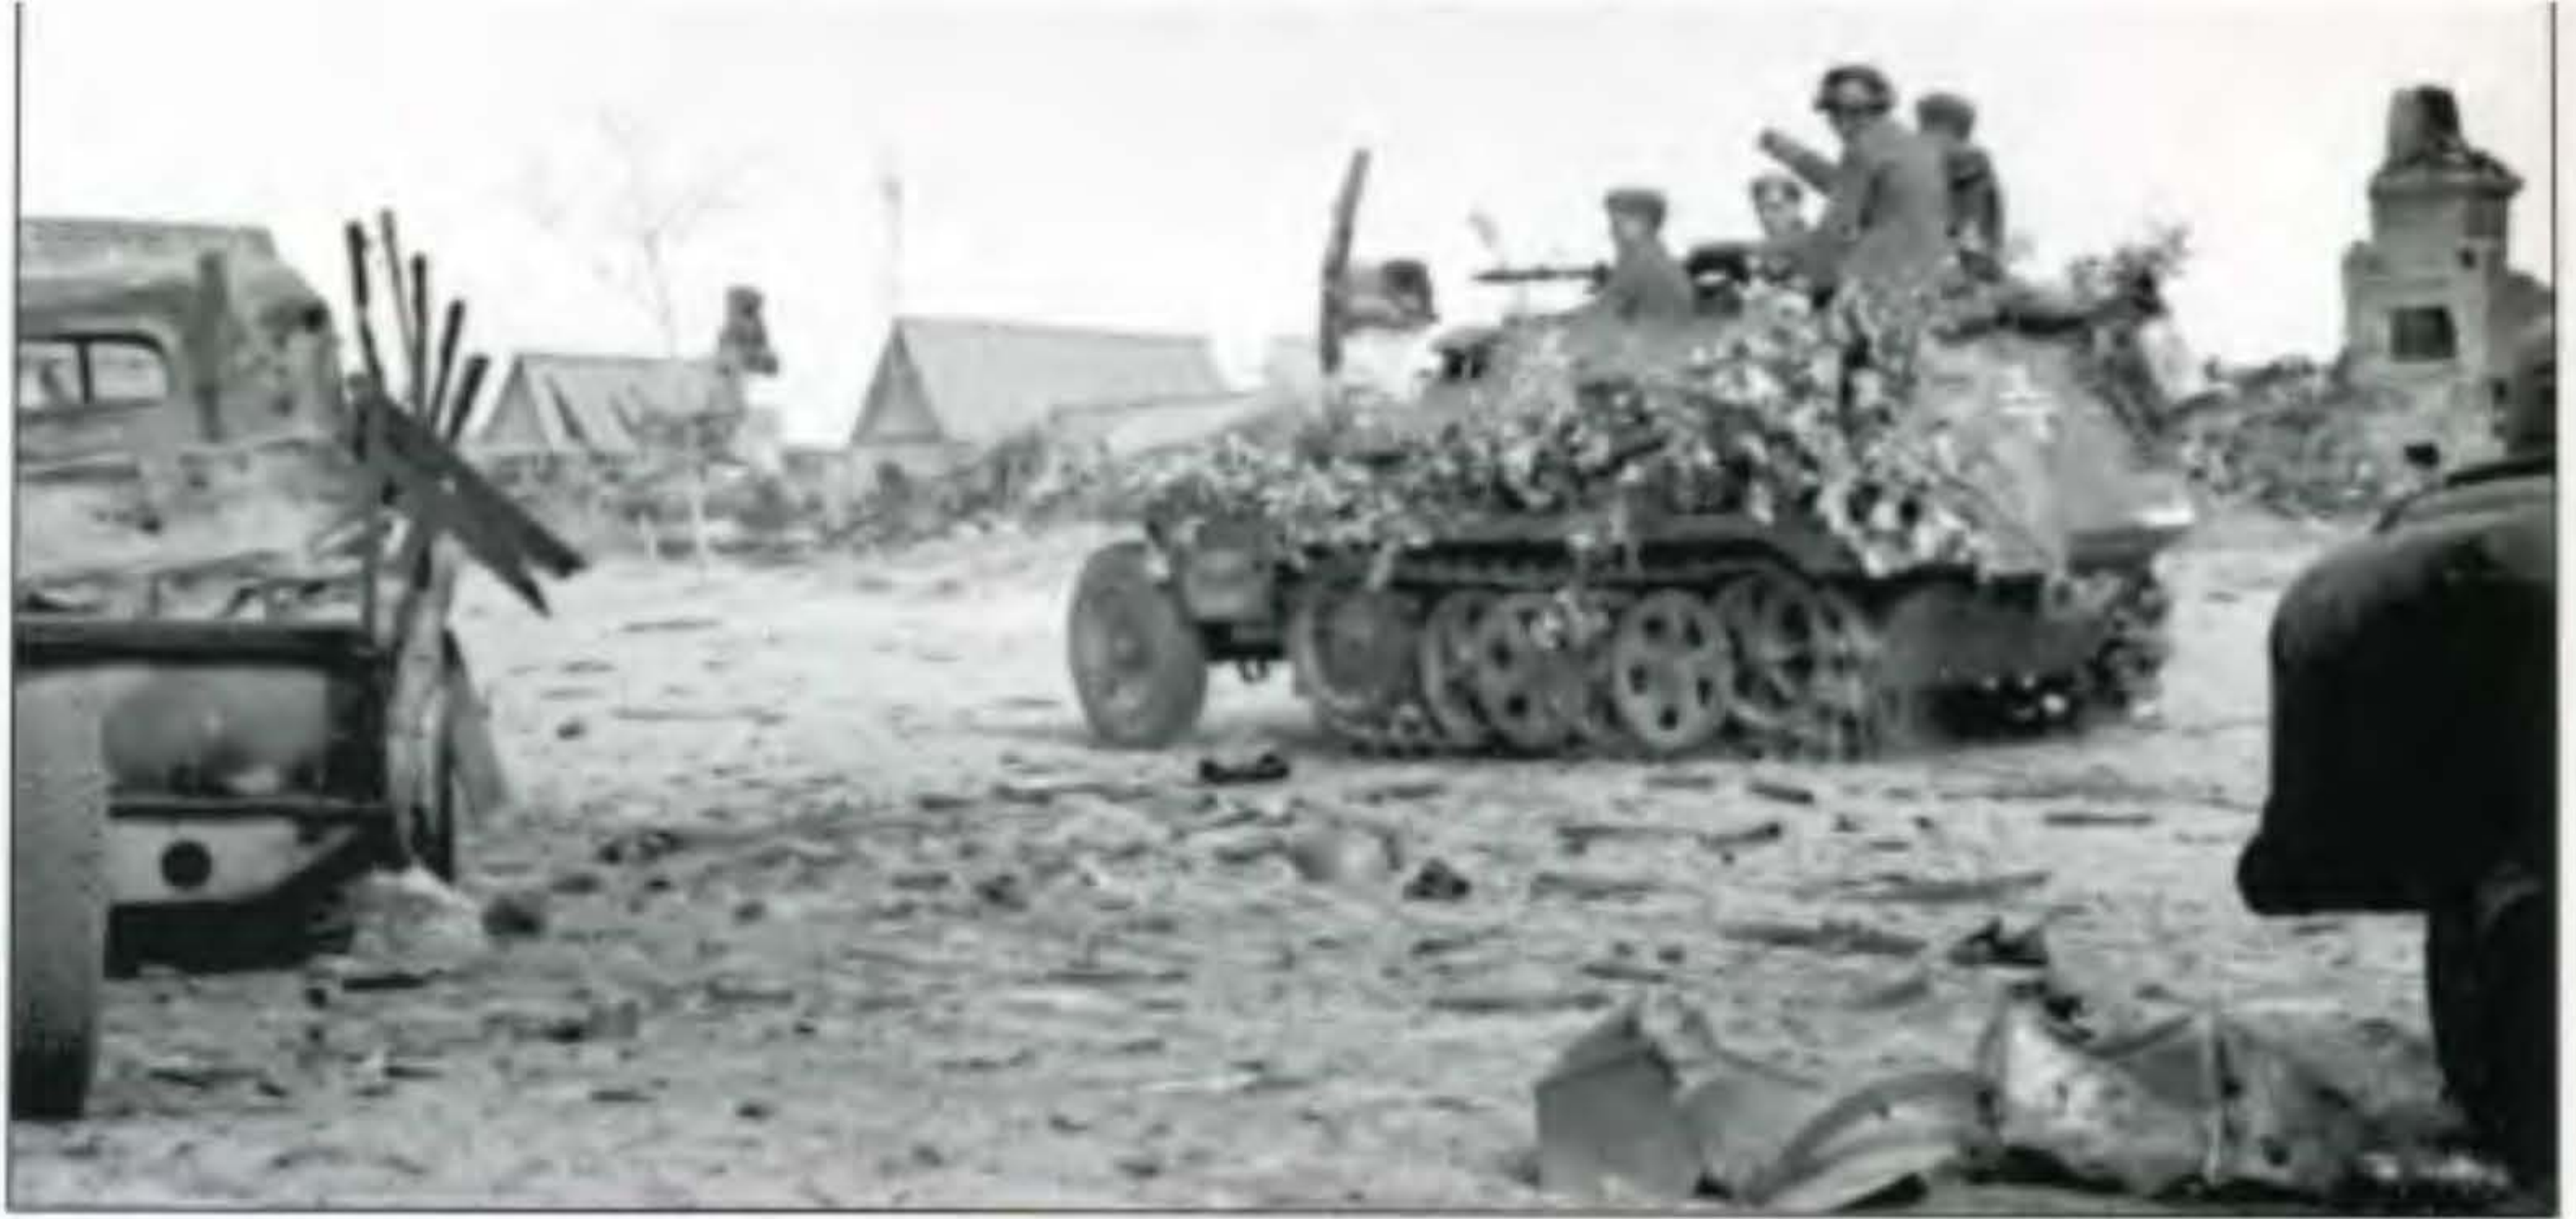
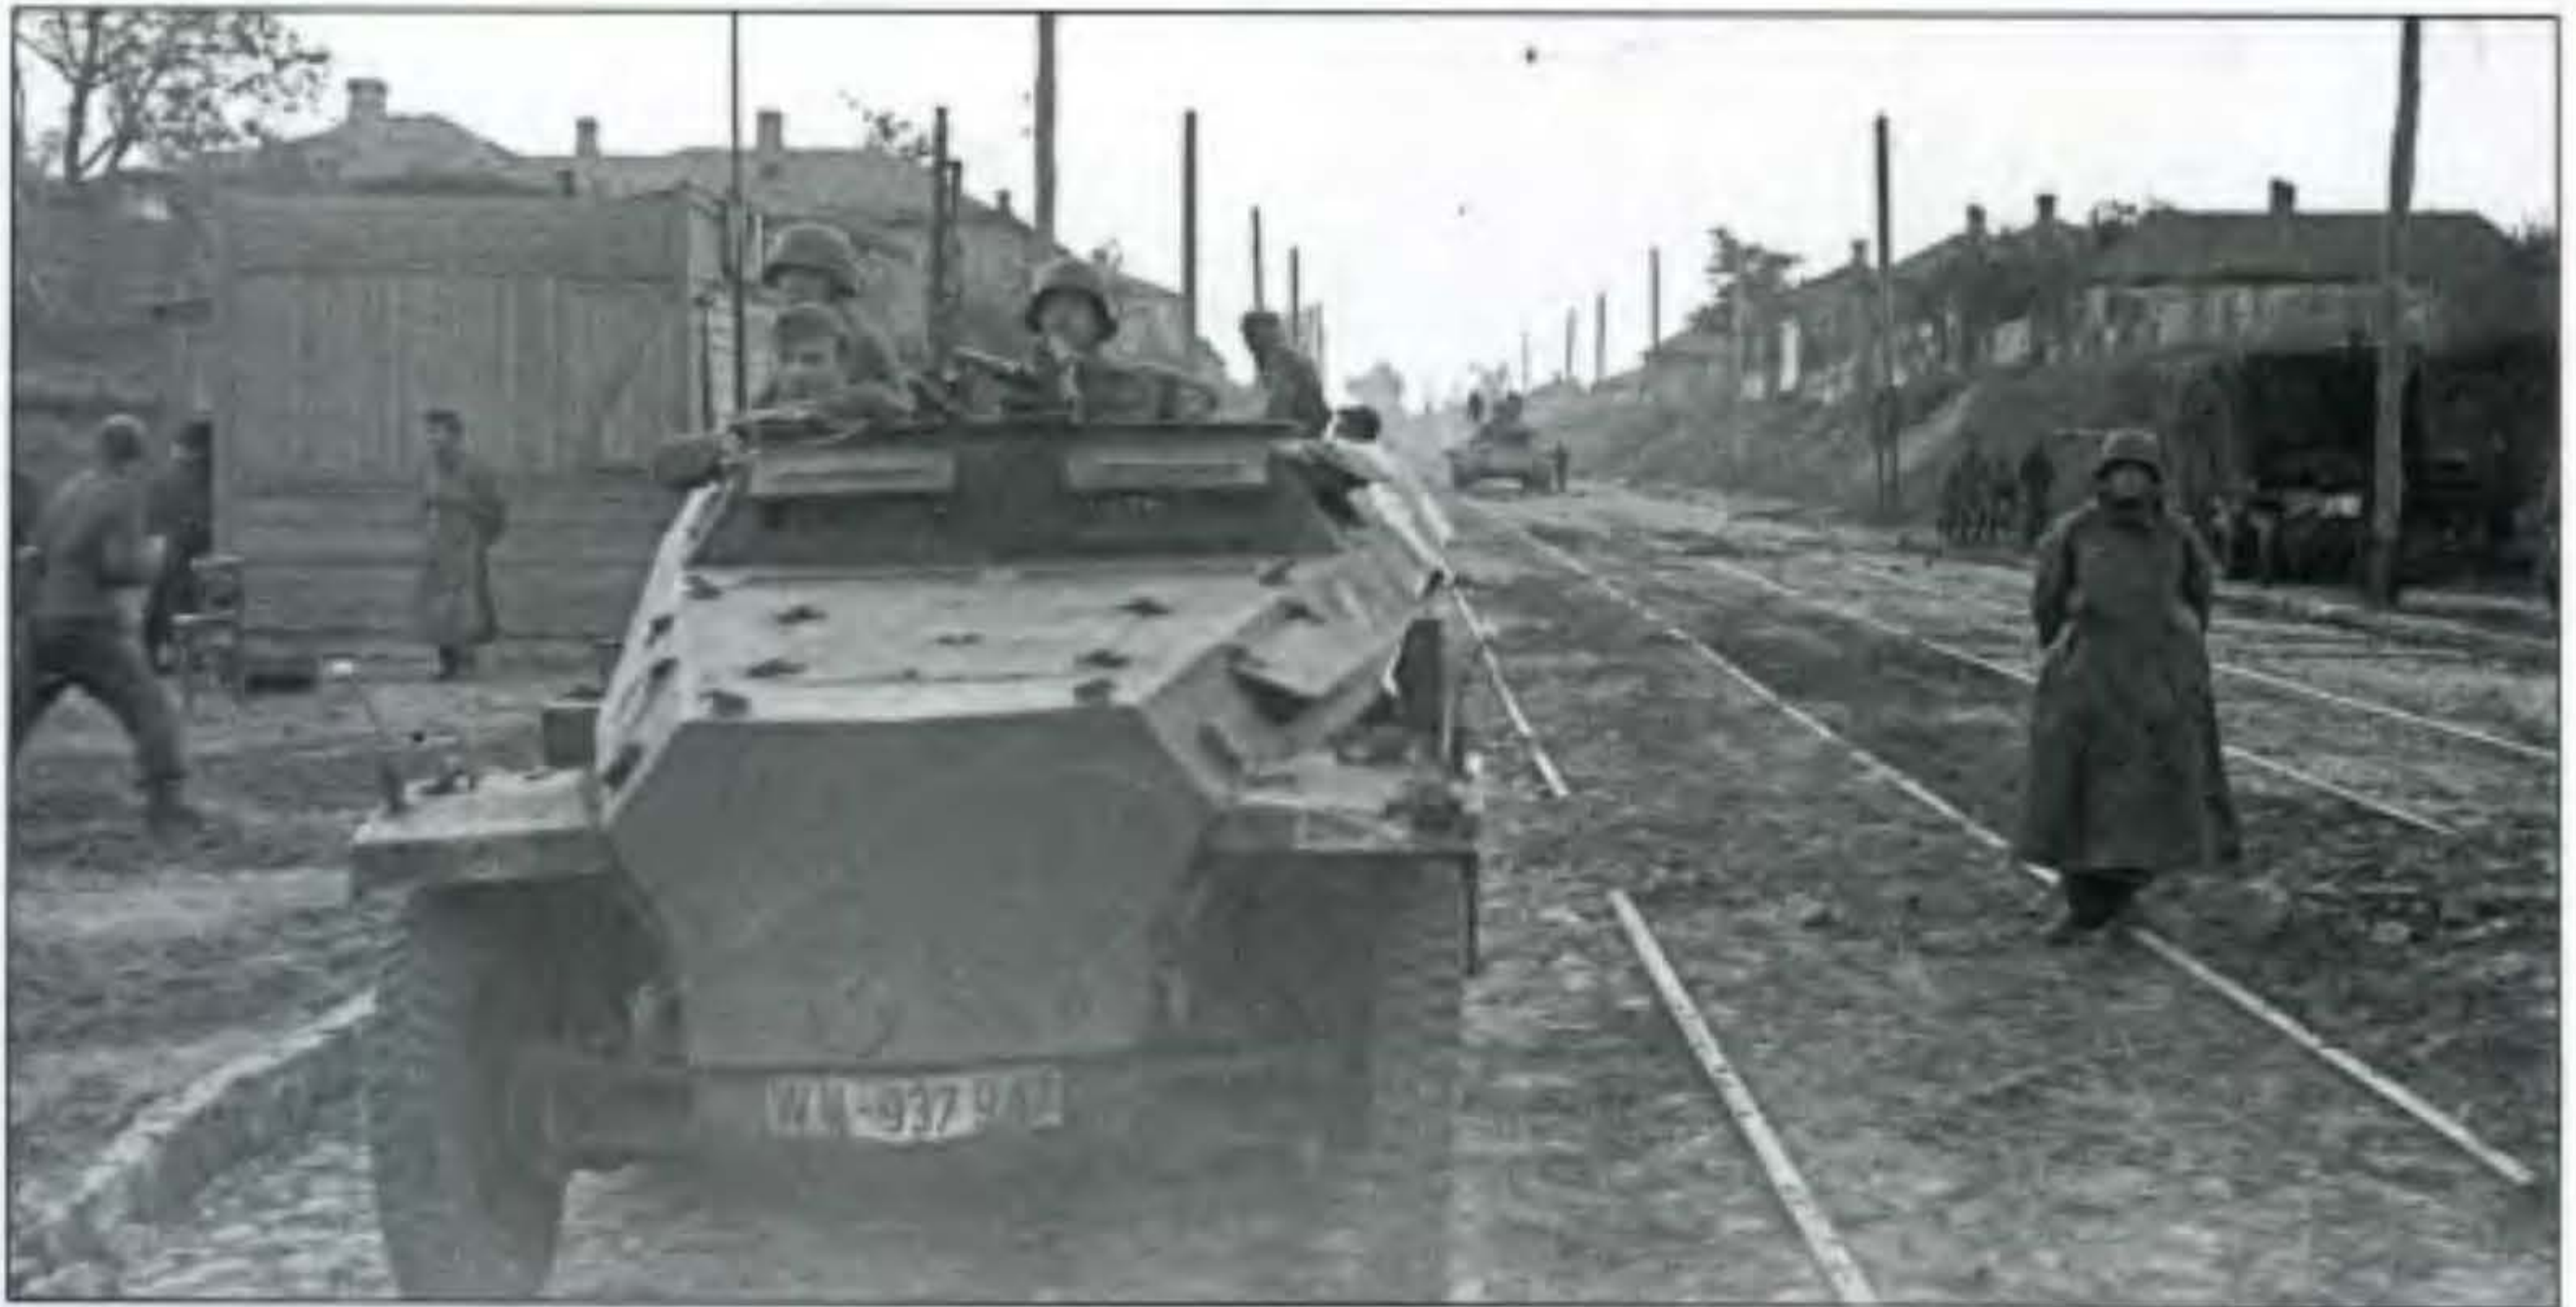
TOP: Sd Kfz 250/1 Typ 1 built from existing Sd Kfz 253 bodies but minus the roof, and used as part of the Aufklarungs Abteilungen (Reconnaissance Battalion). From photographic evidence, nearly all of the Typ 1 250s were incorporated the heavy mount for vehicles, similar in design to the top half of the MG34 lafette. It looks as though this crew have been parked up watching enemy troop movements judging by the heavy camouflage. Note the white width markers painted onto the armoured body.

ABOVE: Another standard Sd Kfz 250/1 Typ 1 equipped in the same manner, but it is unusual to see the rear MG34 hanging loose and not secured in its travel clamp. In the distance is an abandoned T34 and on the far right and partially hidden by the truck is parked a Pz Kpfw IV Ausf F2.

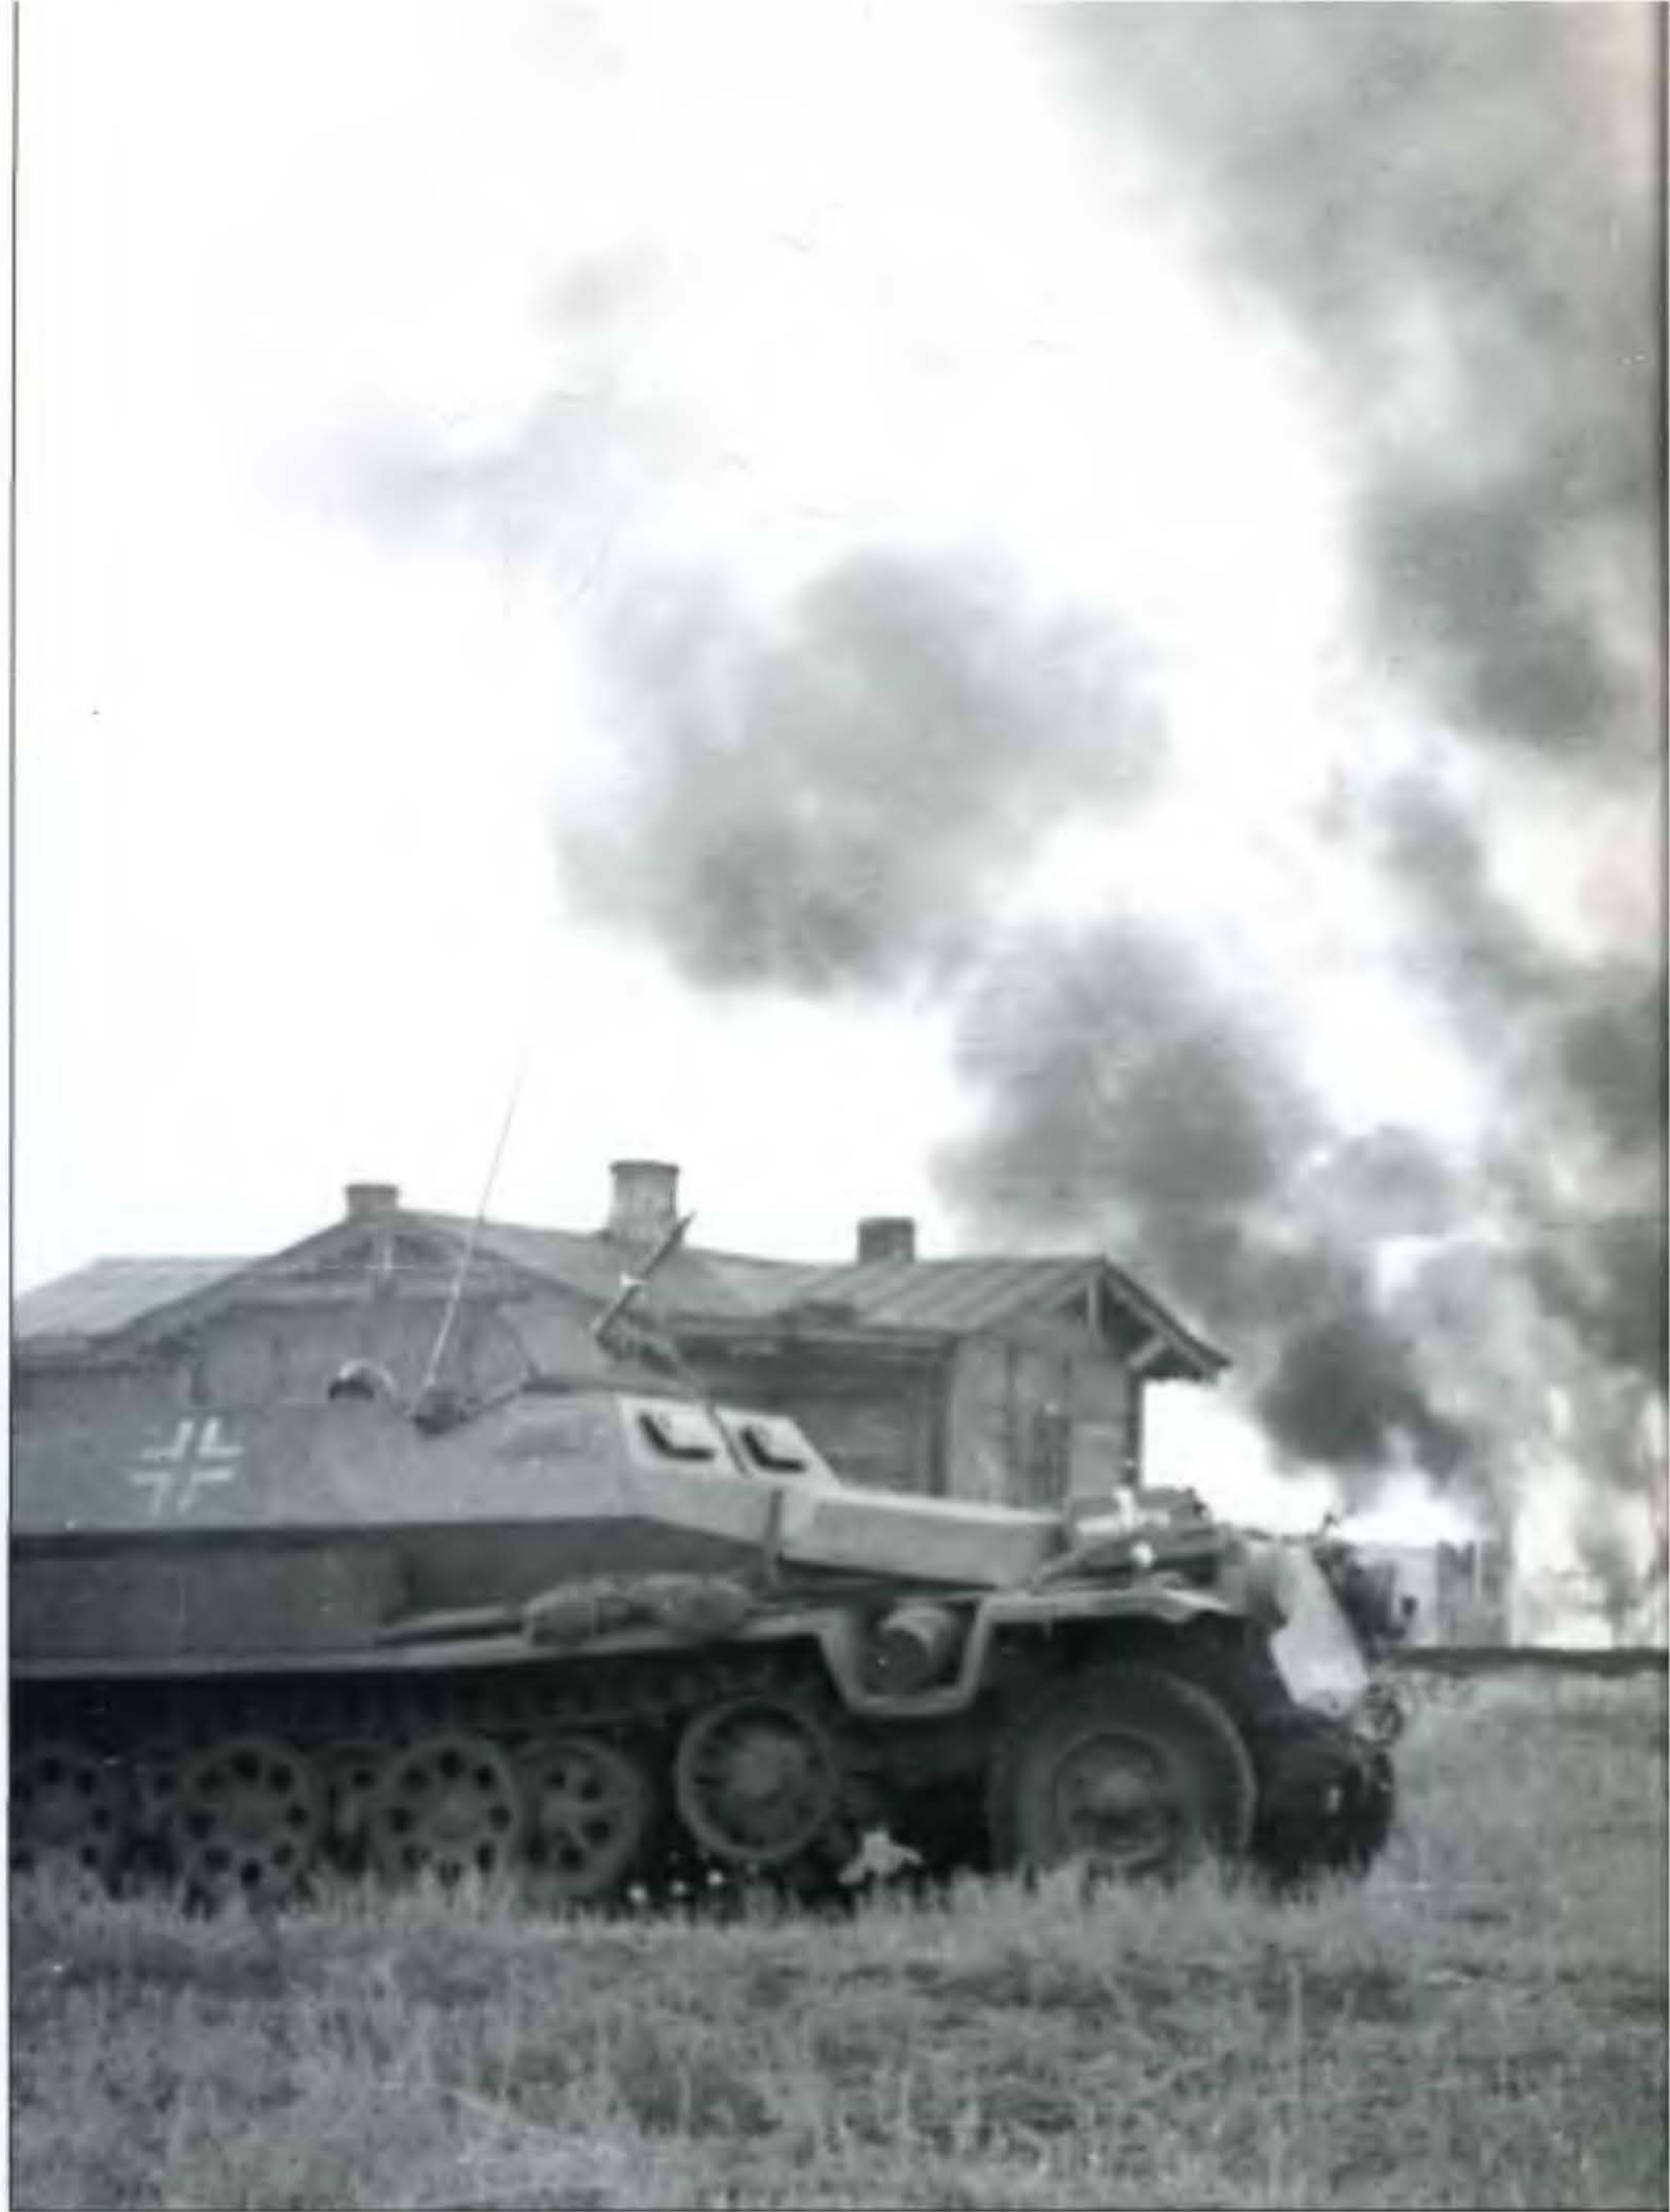
In 1942 the *Fu.Spr.f* radio was available to *Panzer Grenadier* units and this particular 250 Typ1 now has a pair of aerials. With the introduction of the *Fu.Spr.f* a new rack support was designed and the radio could now be fitted in front of the co-driver and the *SEUa 1* umformer was mounted on the firewall above the co-driver's feet. On the top edge of the front right panel of the armour, the new *Antennenzuleitung* with a 1.4 meter *Stabantenne* can be seen along with the original aerial mount on the rear of the 250 possibly for a *Torn E.b.* The 250 is notable for having an MG shield.

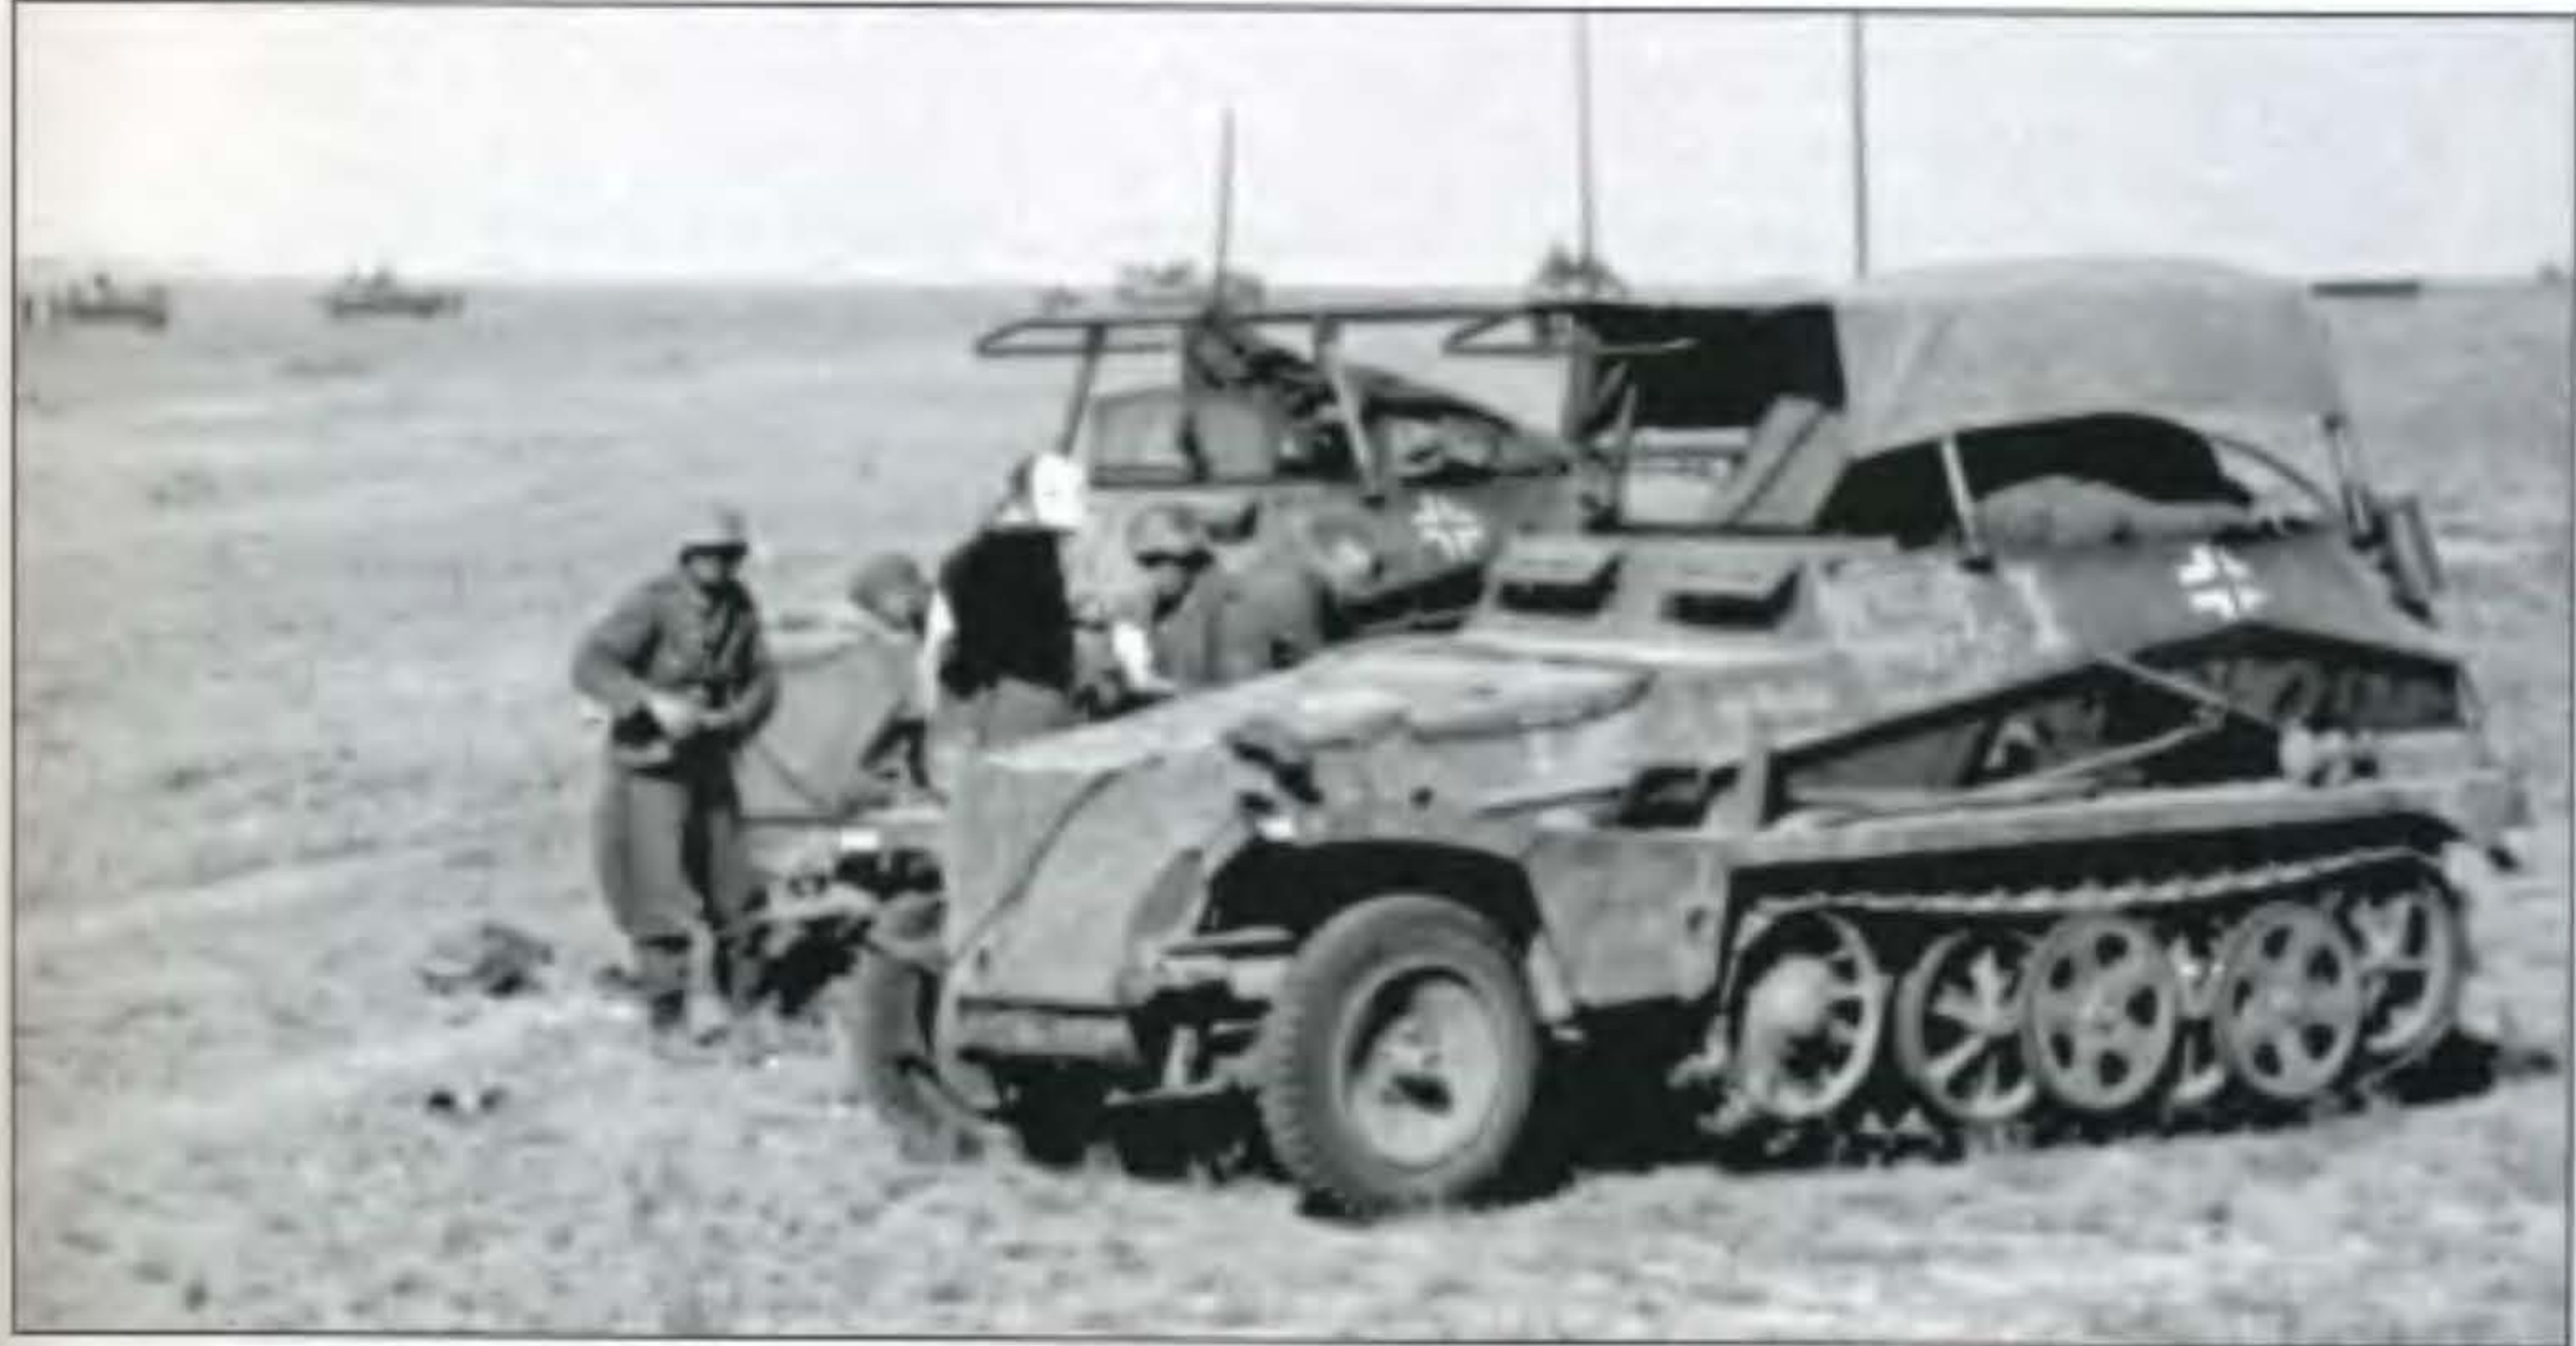
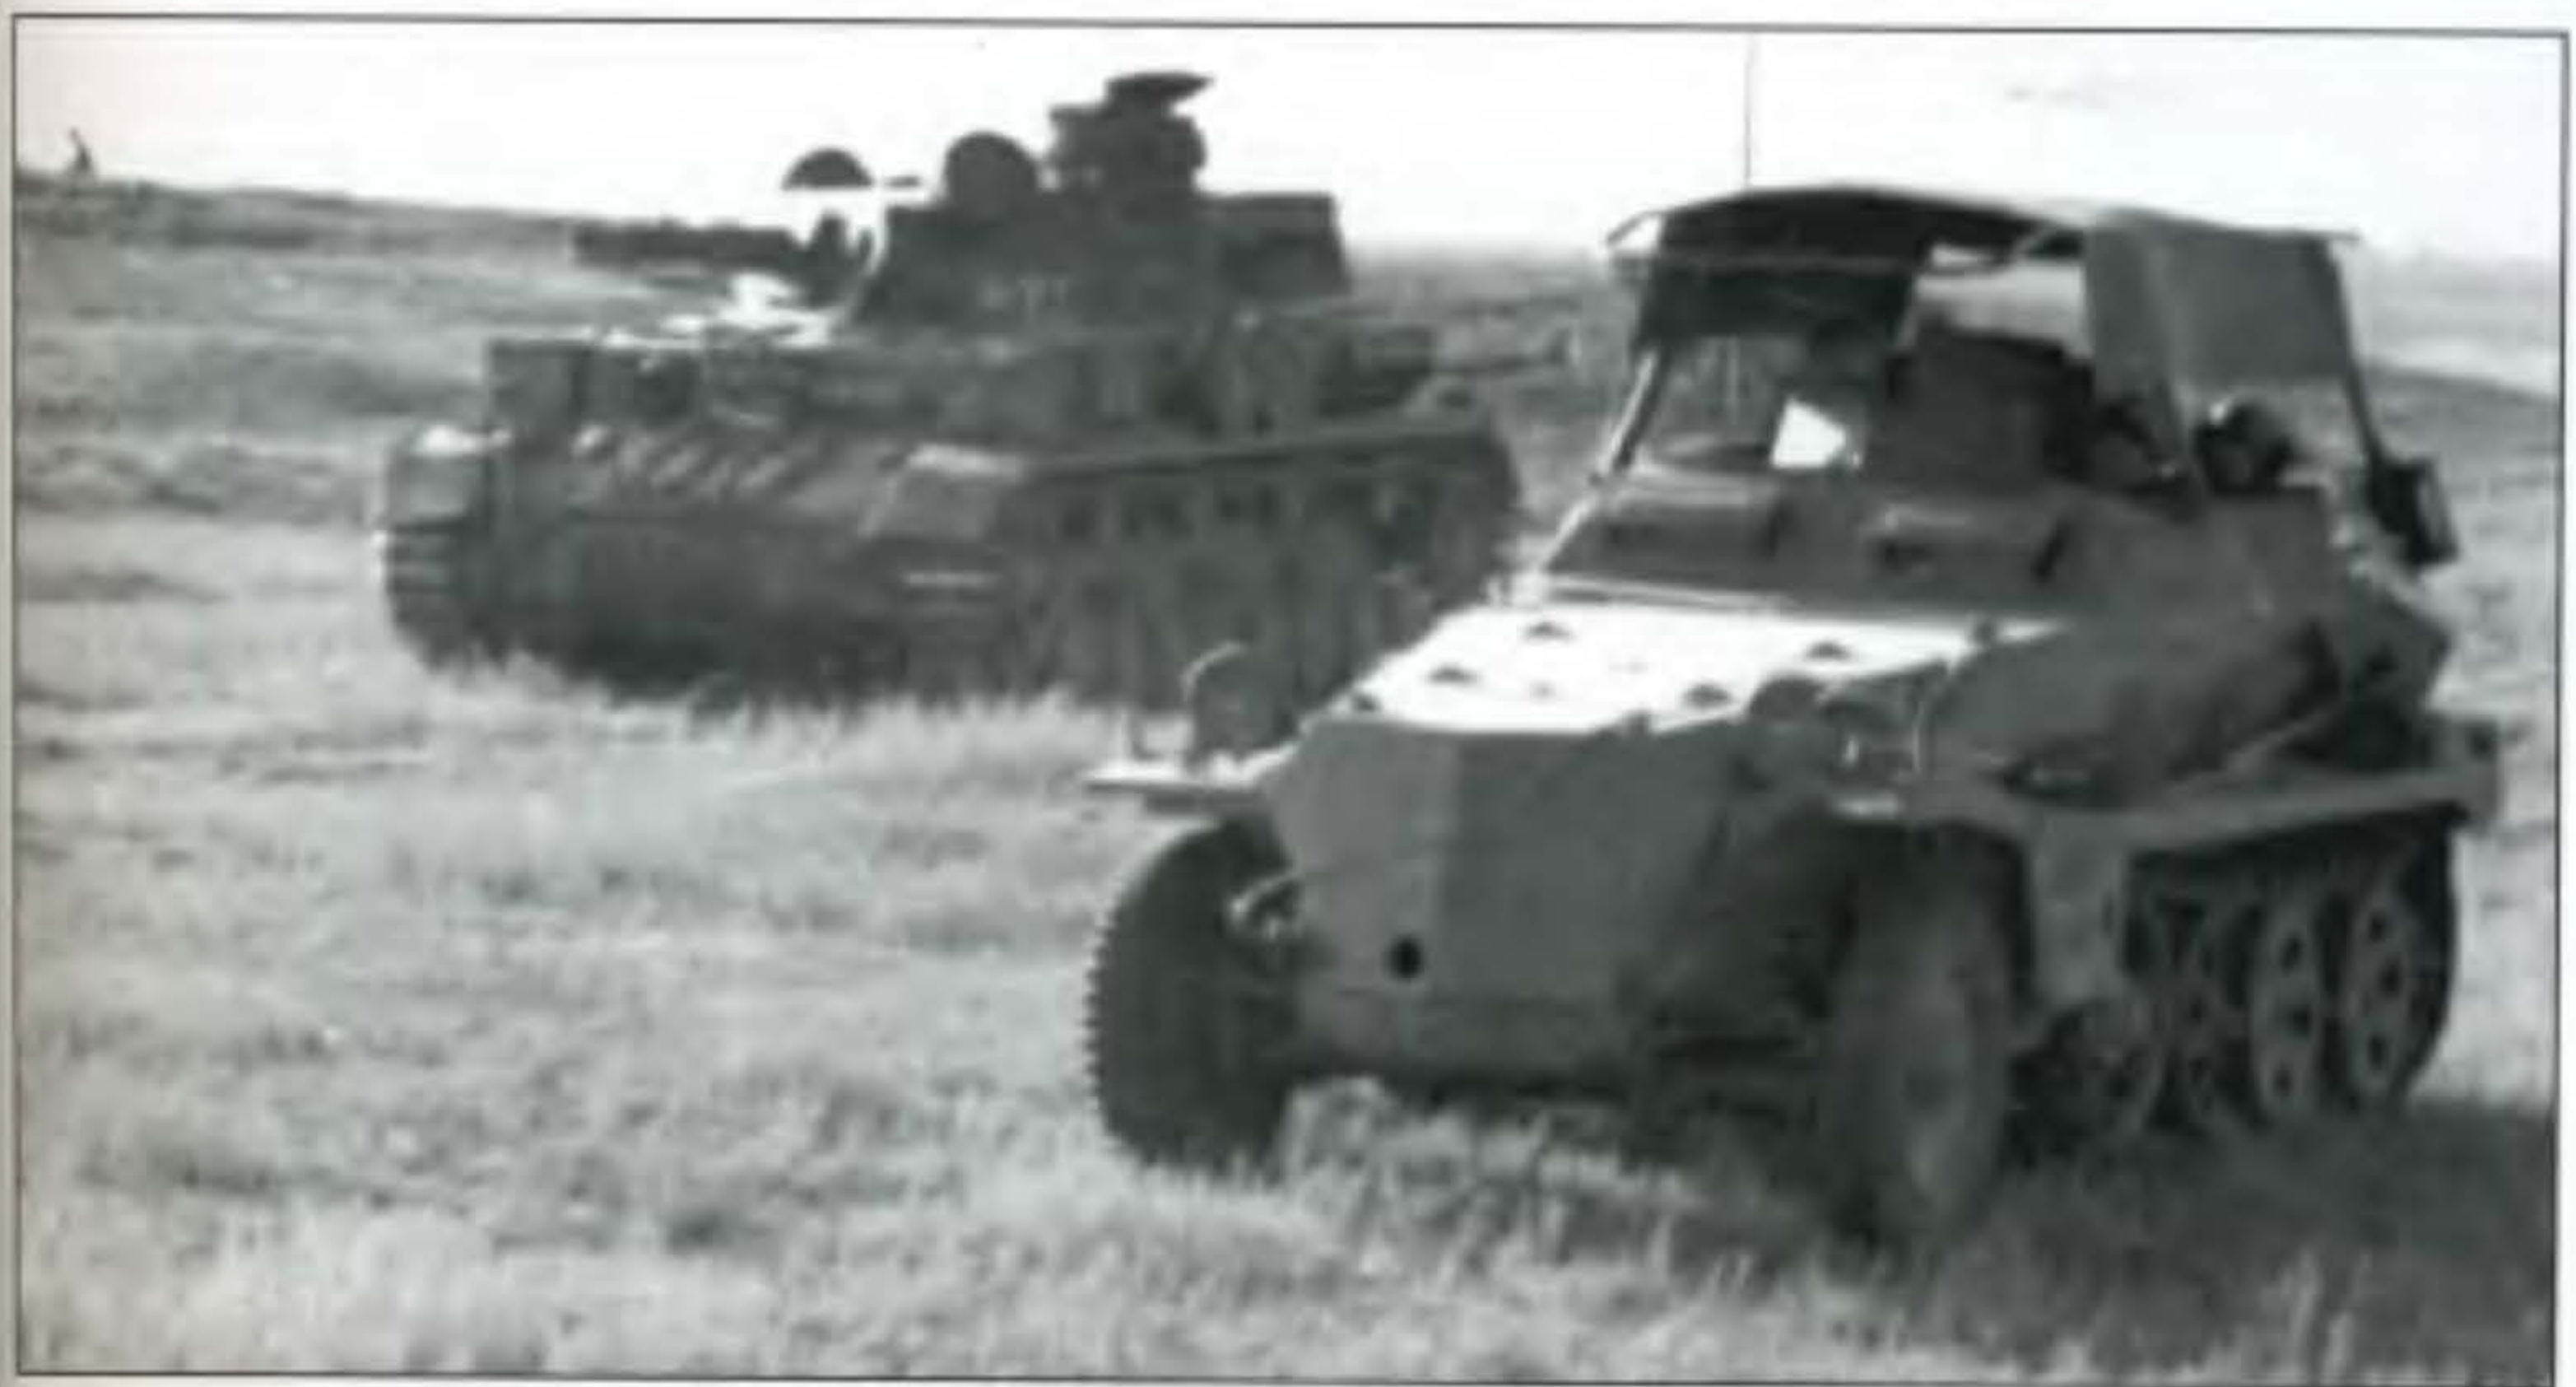
ABOVE: With two Typ 1 250/3s parked, it appears that someone is receiving medical attention from the crews. The closest vehicle carries a name painted on the side plate of the engine cover (below the left hand front visor) and a Roman numeral 'I' behind the side visor. Note the different position of the Balkenkreuz on each vehicle and the white tabs painted only on the front face of the mudguards of the closest vehicle. At the rear of the nearest 250 it is just possible to see the last of the tarpaulin hoops fixed in place below the canvas cover stretched across the frame aerial to protect their radios from the searing heat. This is the same 250/3 seen in the other photograph on this page plus the following page, but the interesting point is the stowage of the extra track wheels on the top of the turret of the Pz Kpfw IV Ausf F, numbered '422'.
