TOTAL DETAIL

Sd Kfz 252, 253 & early 250

Sd Kfz 252, 253 & 250 (Typ 1)

Volume 3 - Part 1

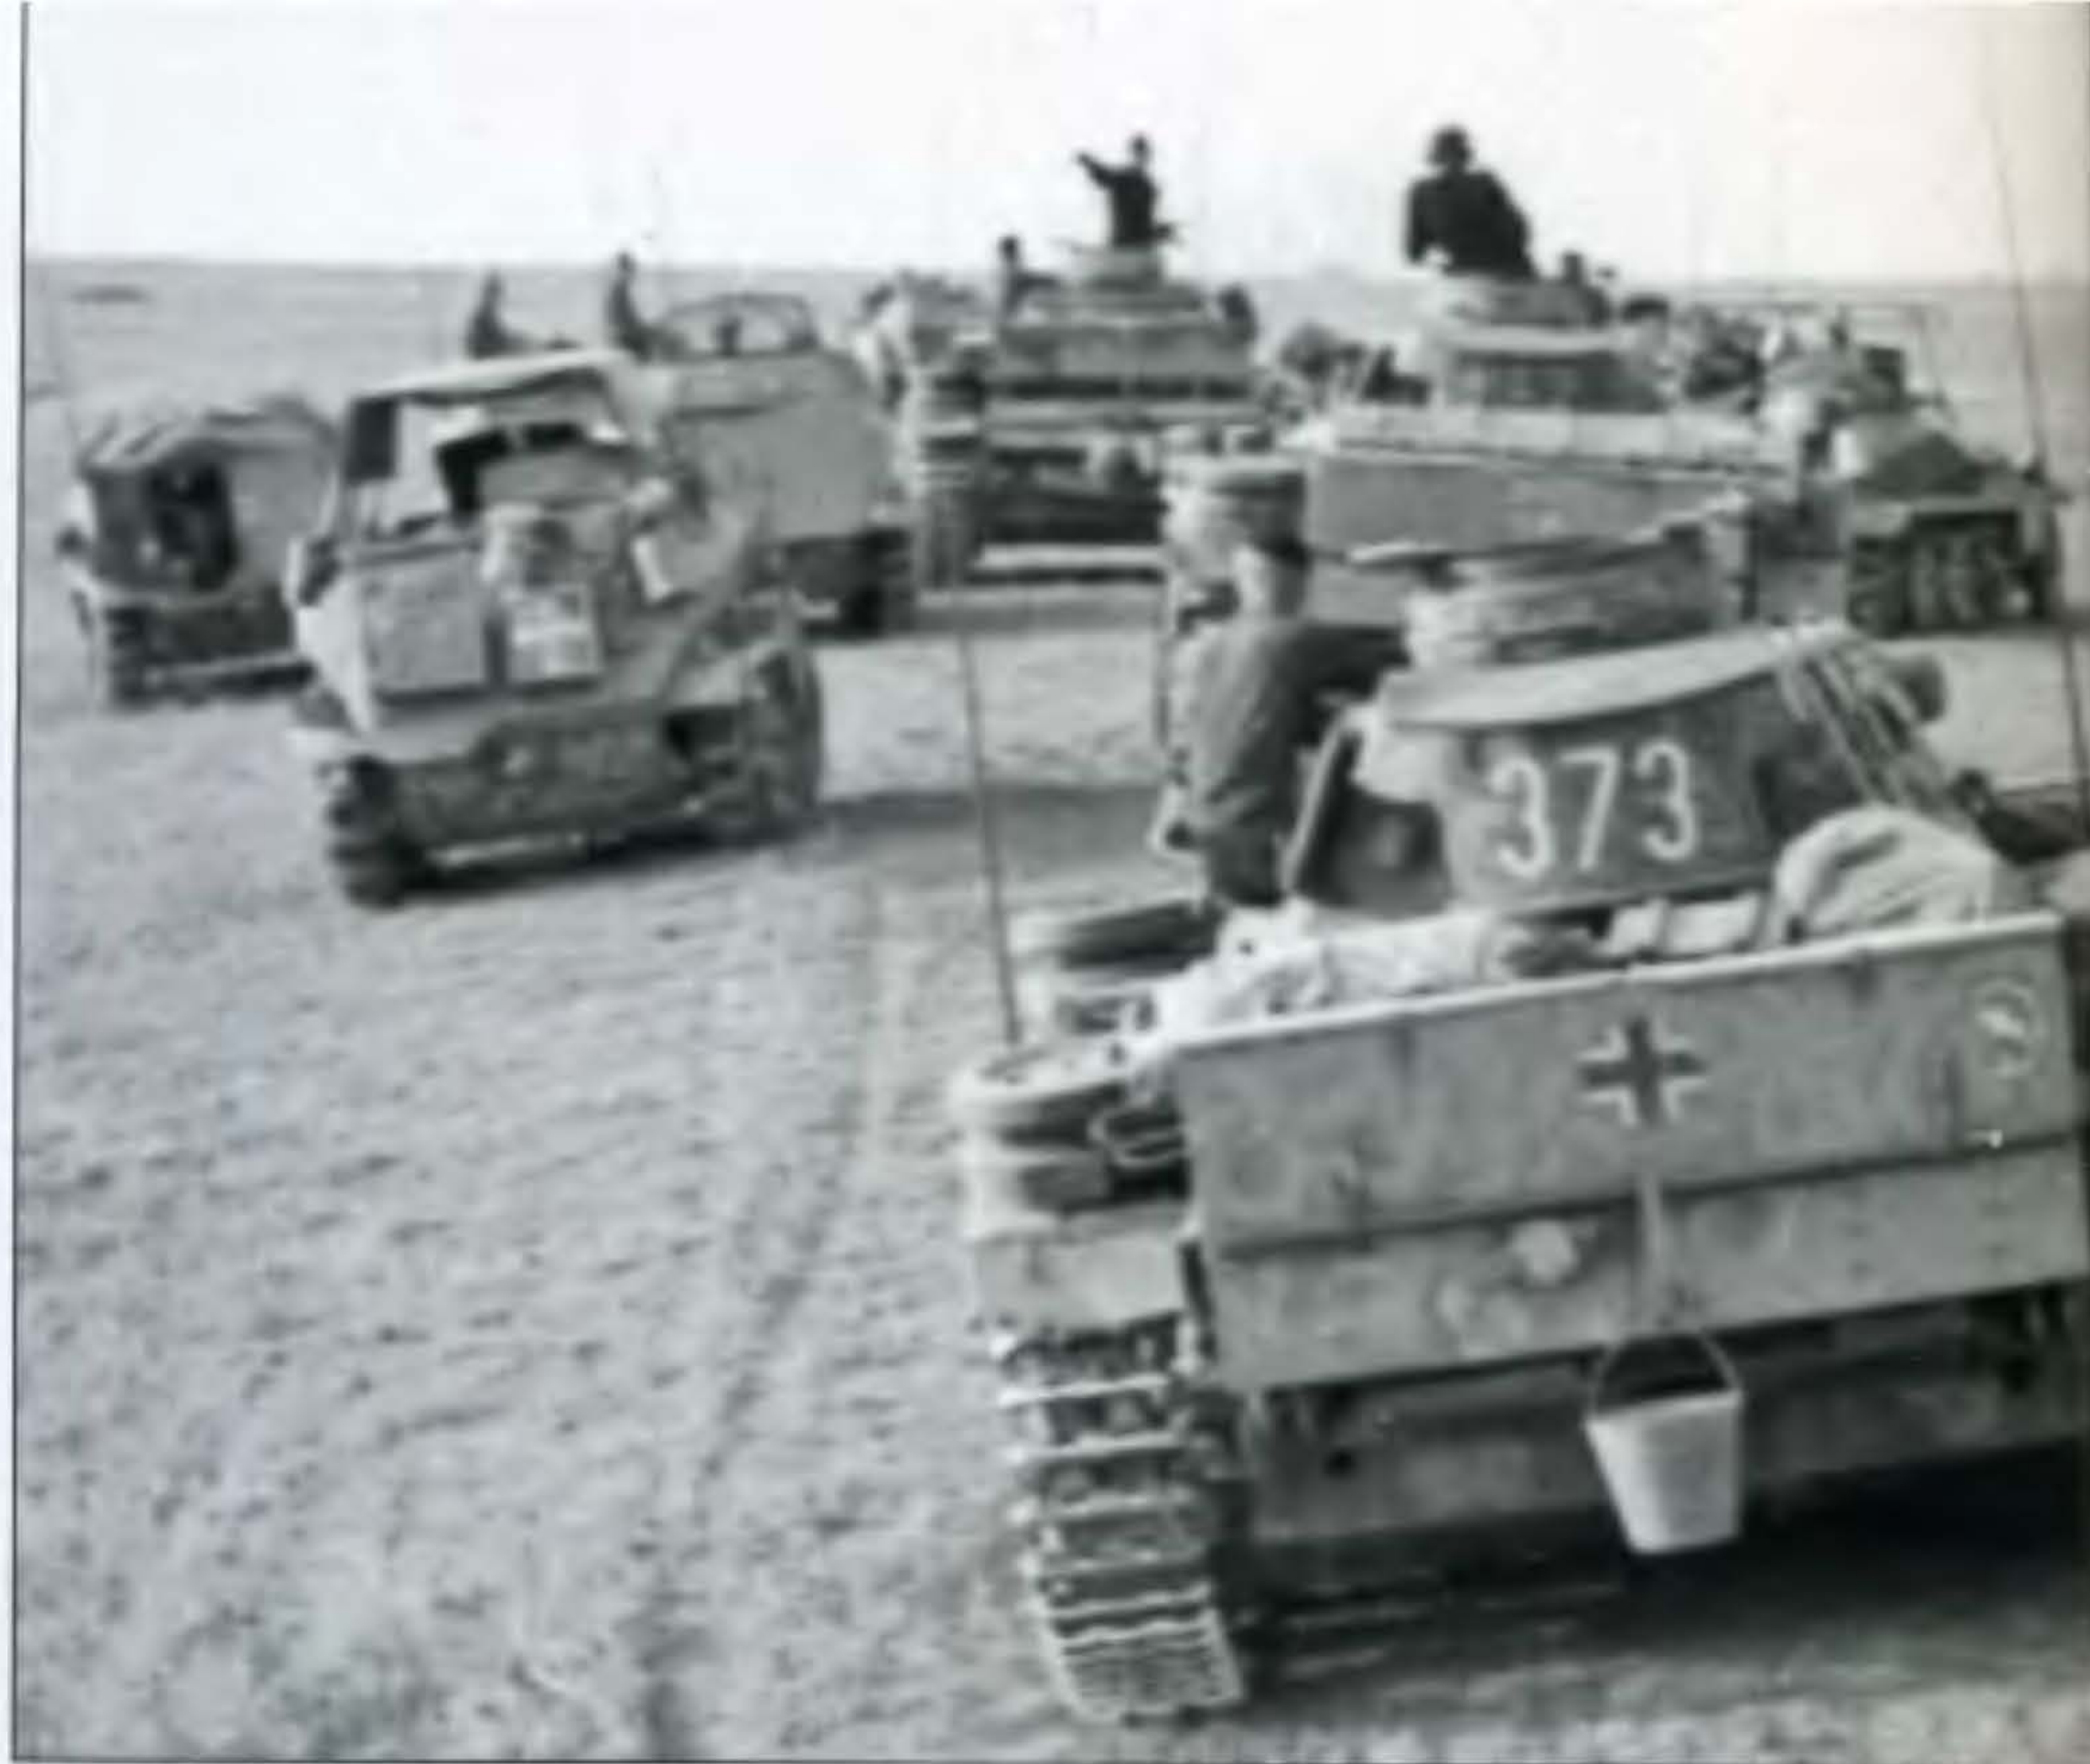
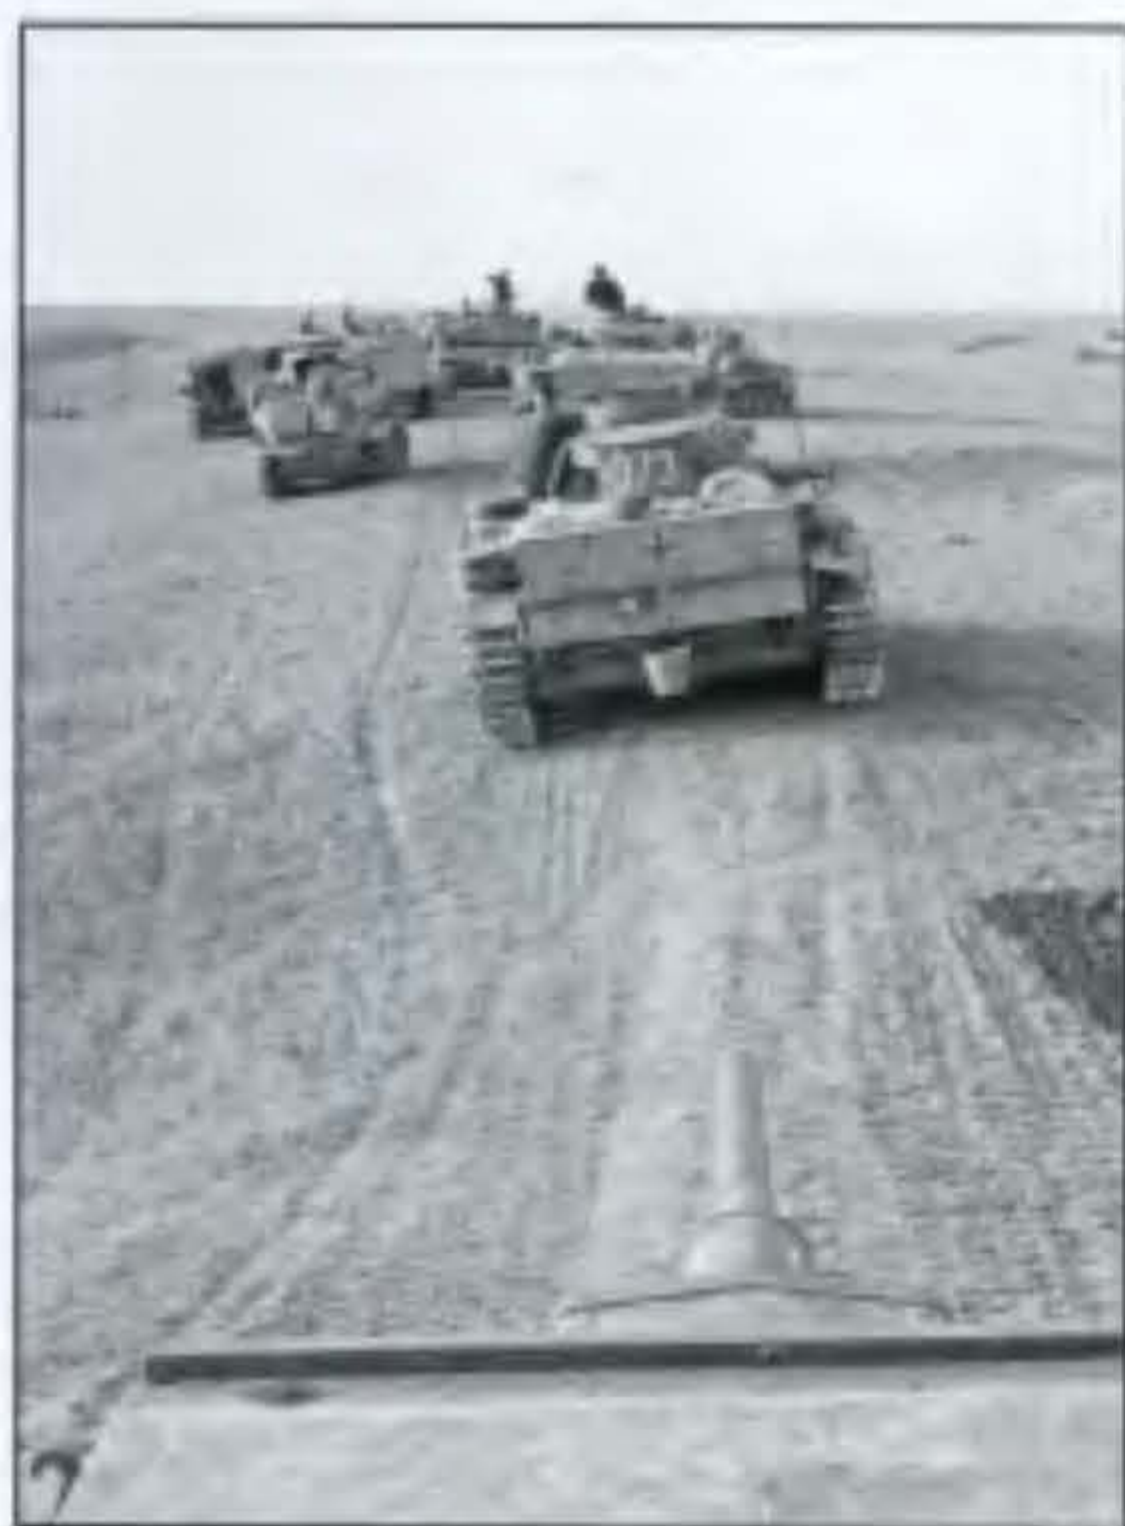
Even though it is an enlargement of the vehicles in the distance and therefore somewhat fuzzy, there is an interesting group of 250s parked up around the lead tank. The 250 on the far left is a 250/3 Typ 2 with the later Sternantenne D and parked to the right of it, is the same 250/1 or 3 featured in 250 Archive Part 2 page 55 with the hinged mesh cover that could belong to the commander of the headquarters unit of the Pz. Division. Behind this is the early Typ 1 250/3 with the bucket, jerry can and grenade case hung from the rear armour featured opposite bottom, and on the following 2 pages. On the far right is a 250/3 Typ 2 but with the earlier frame aerial.

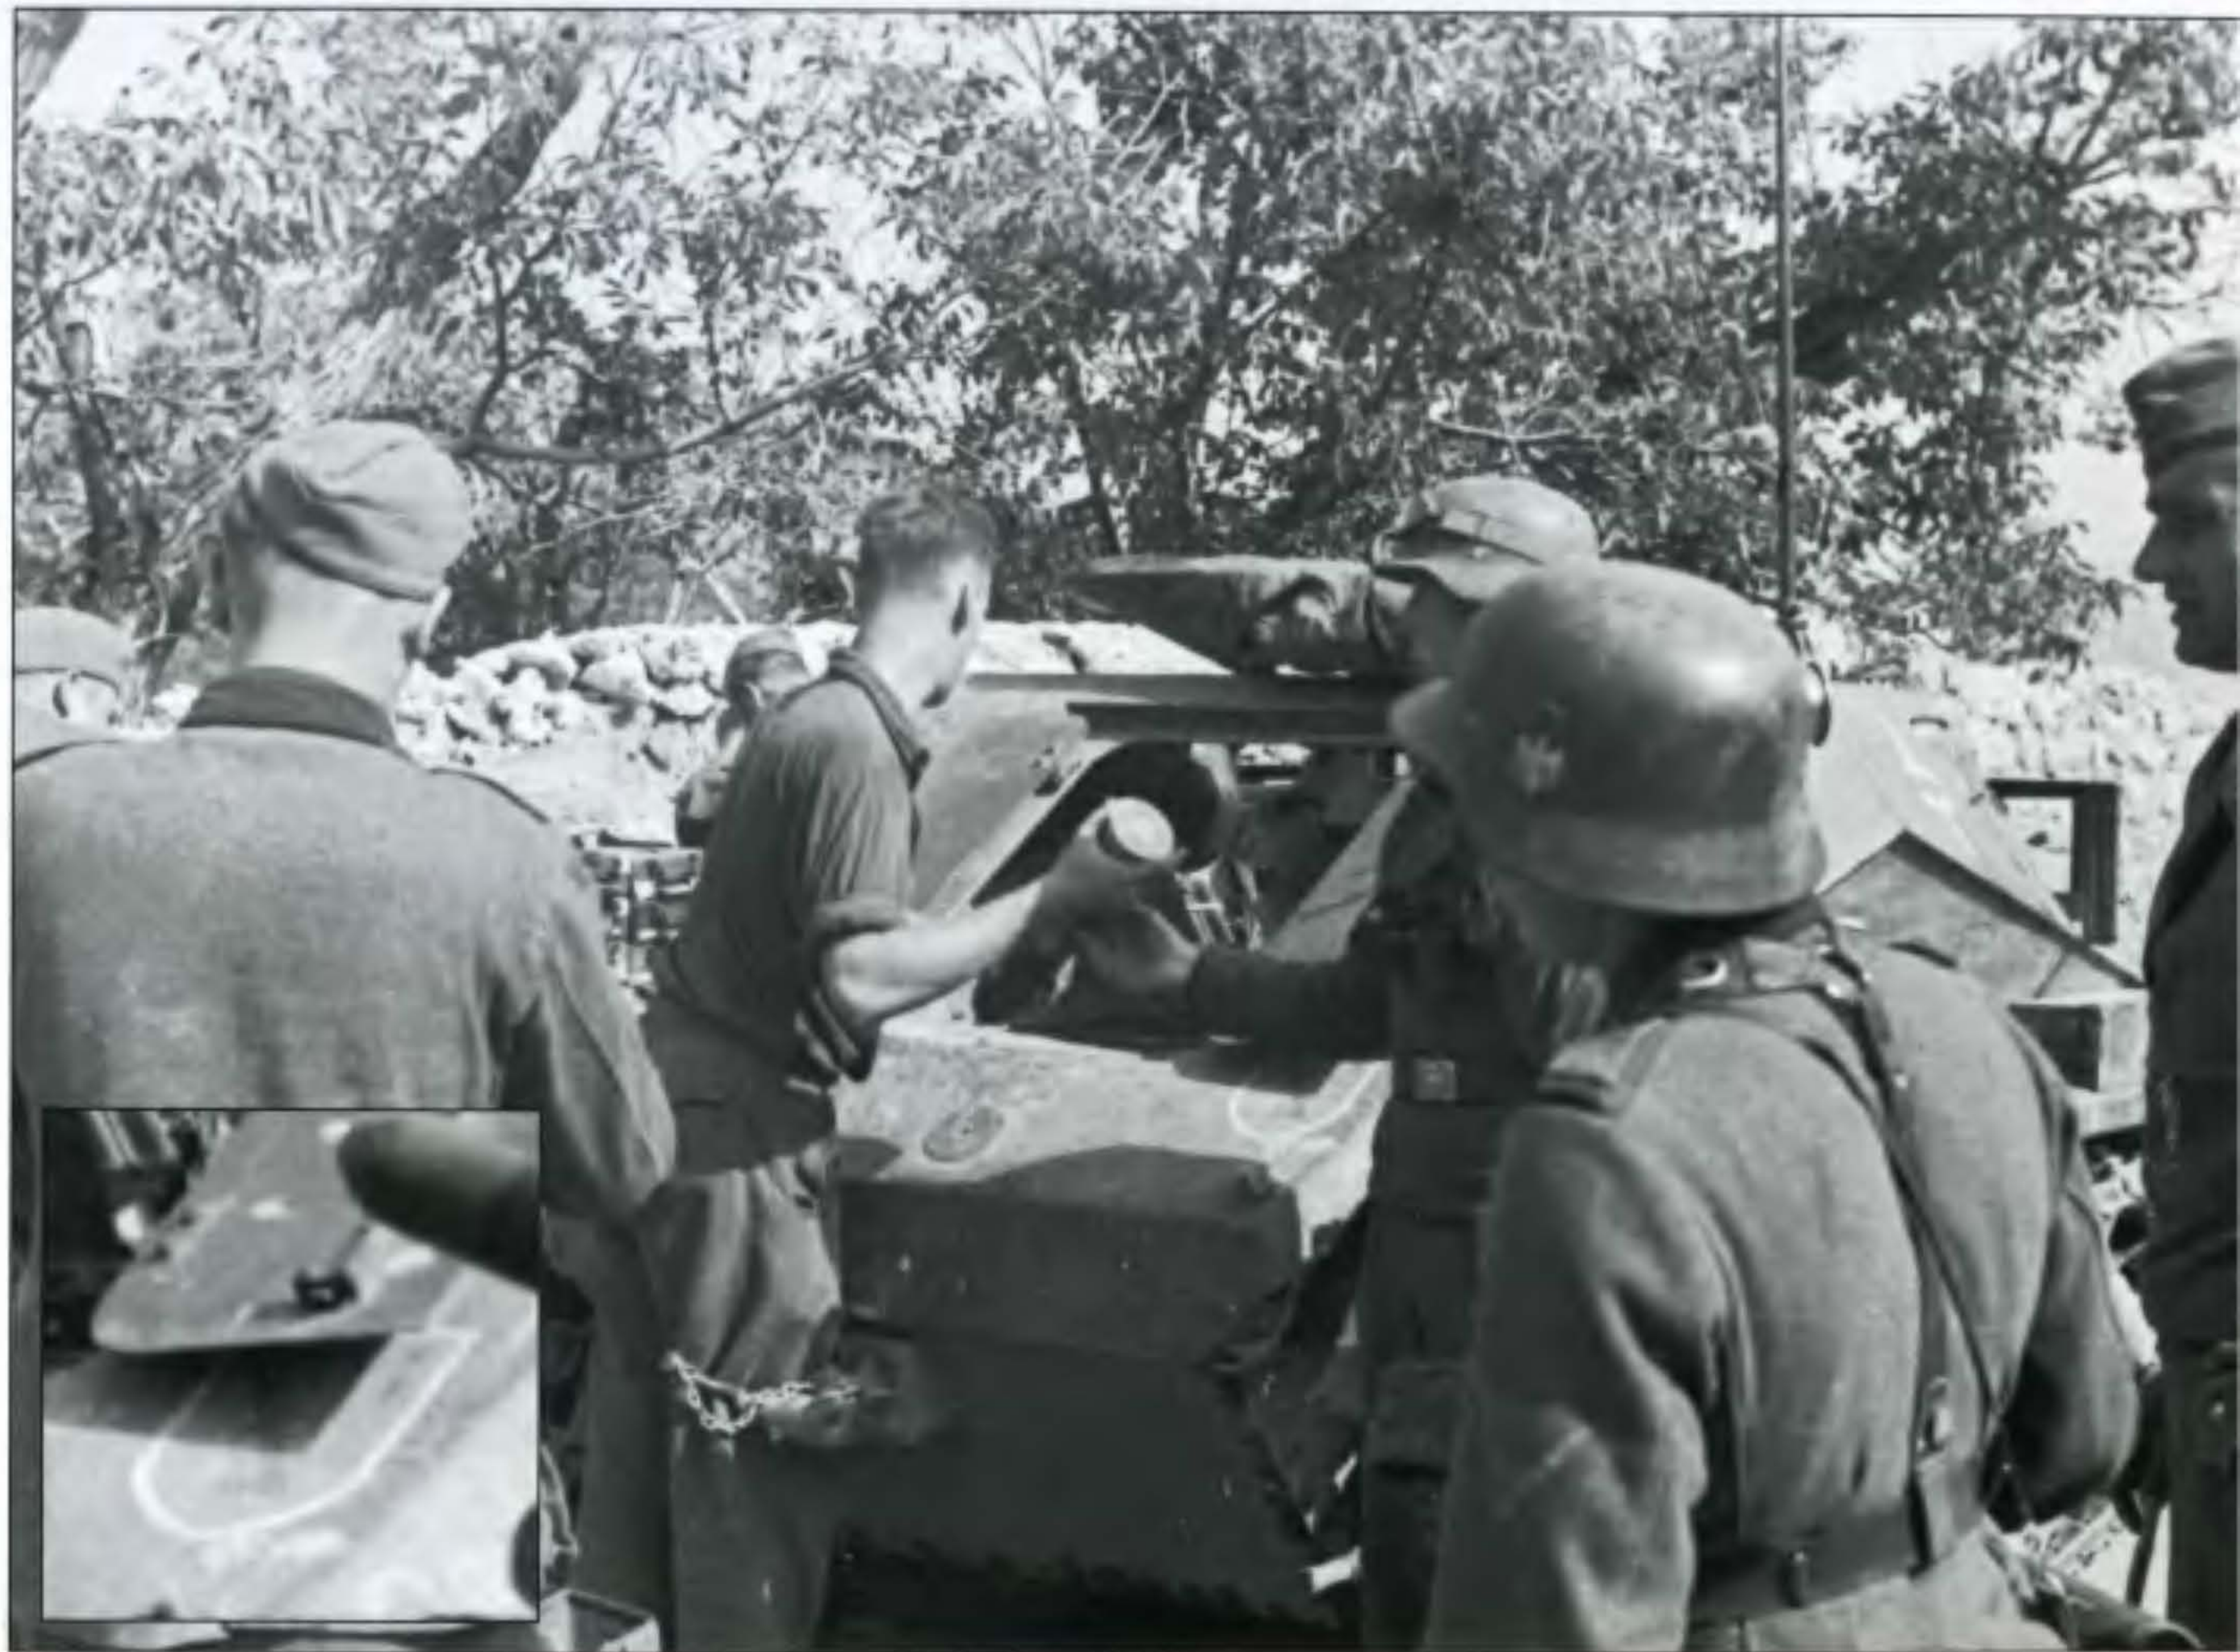
This fantastic photograph shows the texture of the mud paste applied to the basic grey base coat of this 250/3. The painter obviously did not feel the need to avoid all the original markings and has covered the name over (to the left of the stowage box) plus the three-digit number '130' below the side visors and the Balkenkreuz. It is probable that the mudguard is damaged and the small axe has now been pushed safely behind the wooden pole. Note that the padlock chain is contained in a canvas sleeve and the grill vents on the engine deck are in a poor condition. This 250 has the blanking plate over the aerial mount of what was originally intended to be a 253 and because it is a Typ 1, notice how far back the bullet proof glass block holder assembly is sited compared to the exterior armoured visor. The *Leutnant* is wearing a despatch riders coat and a M35 steel helmet.

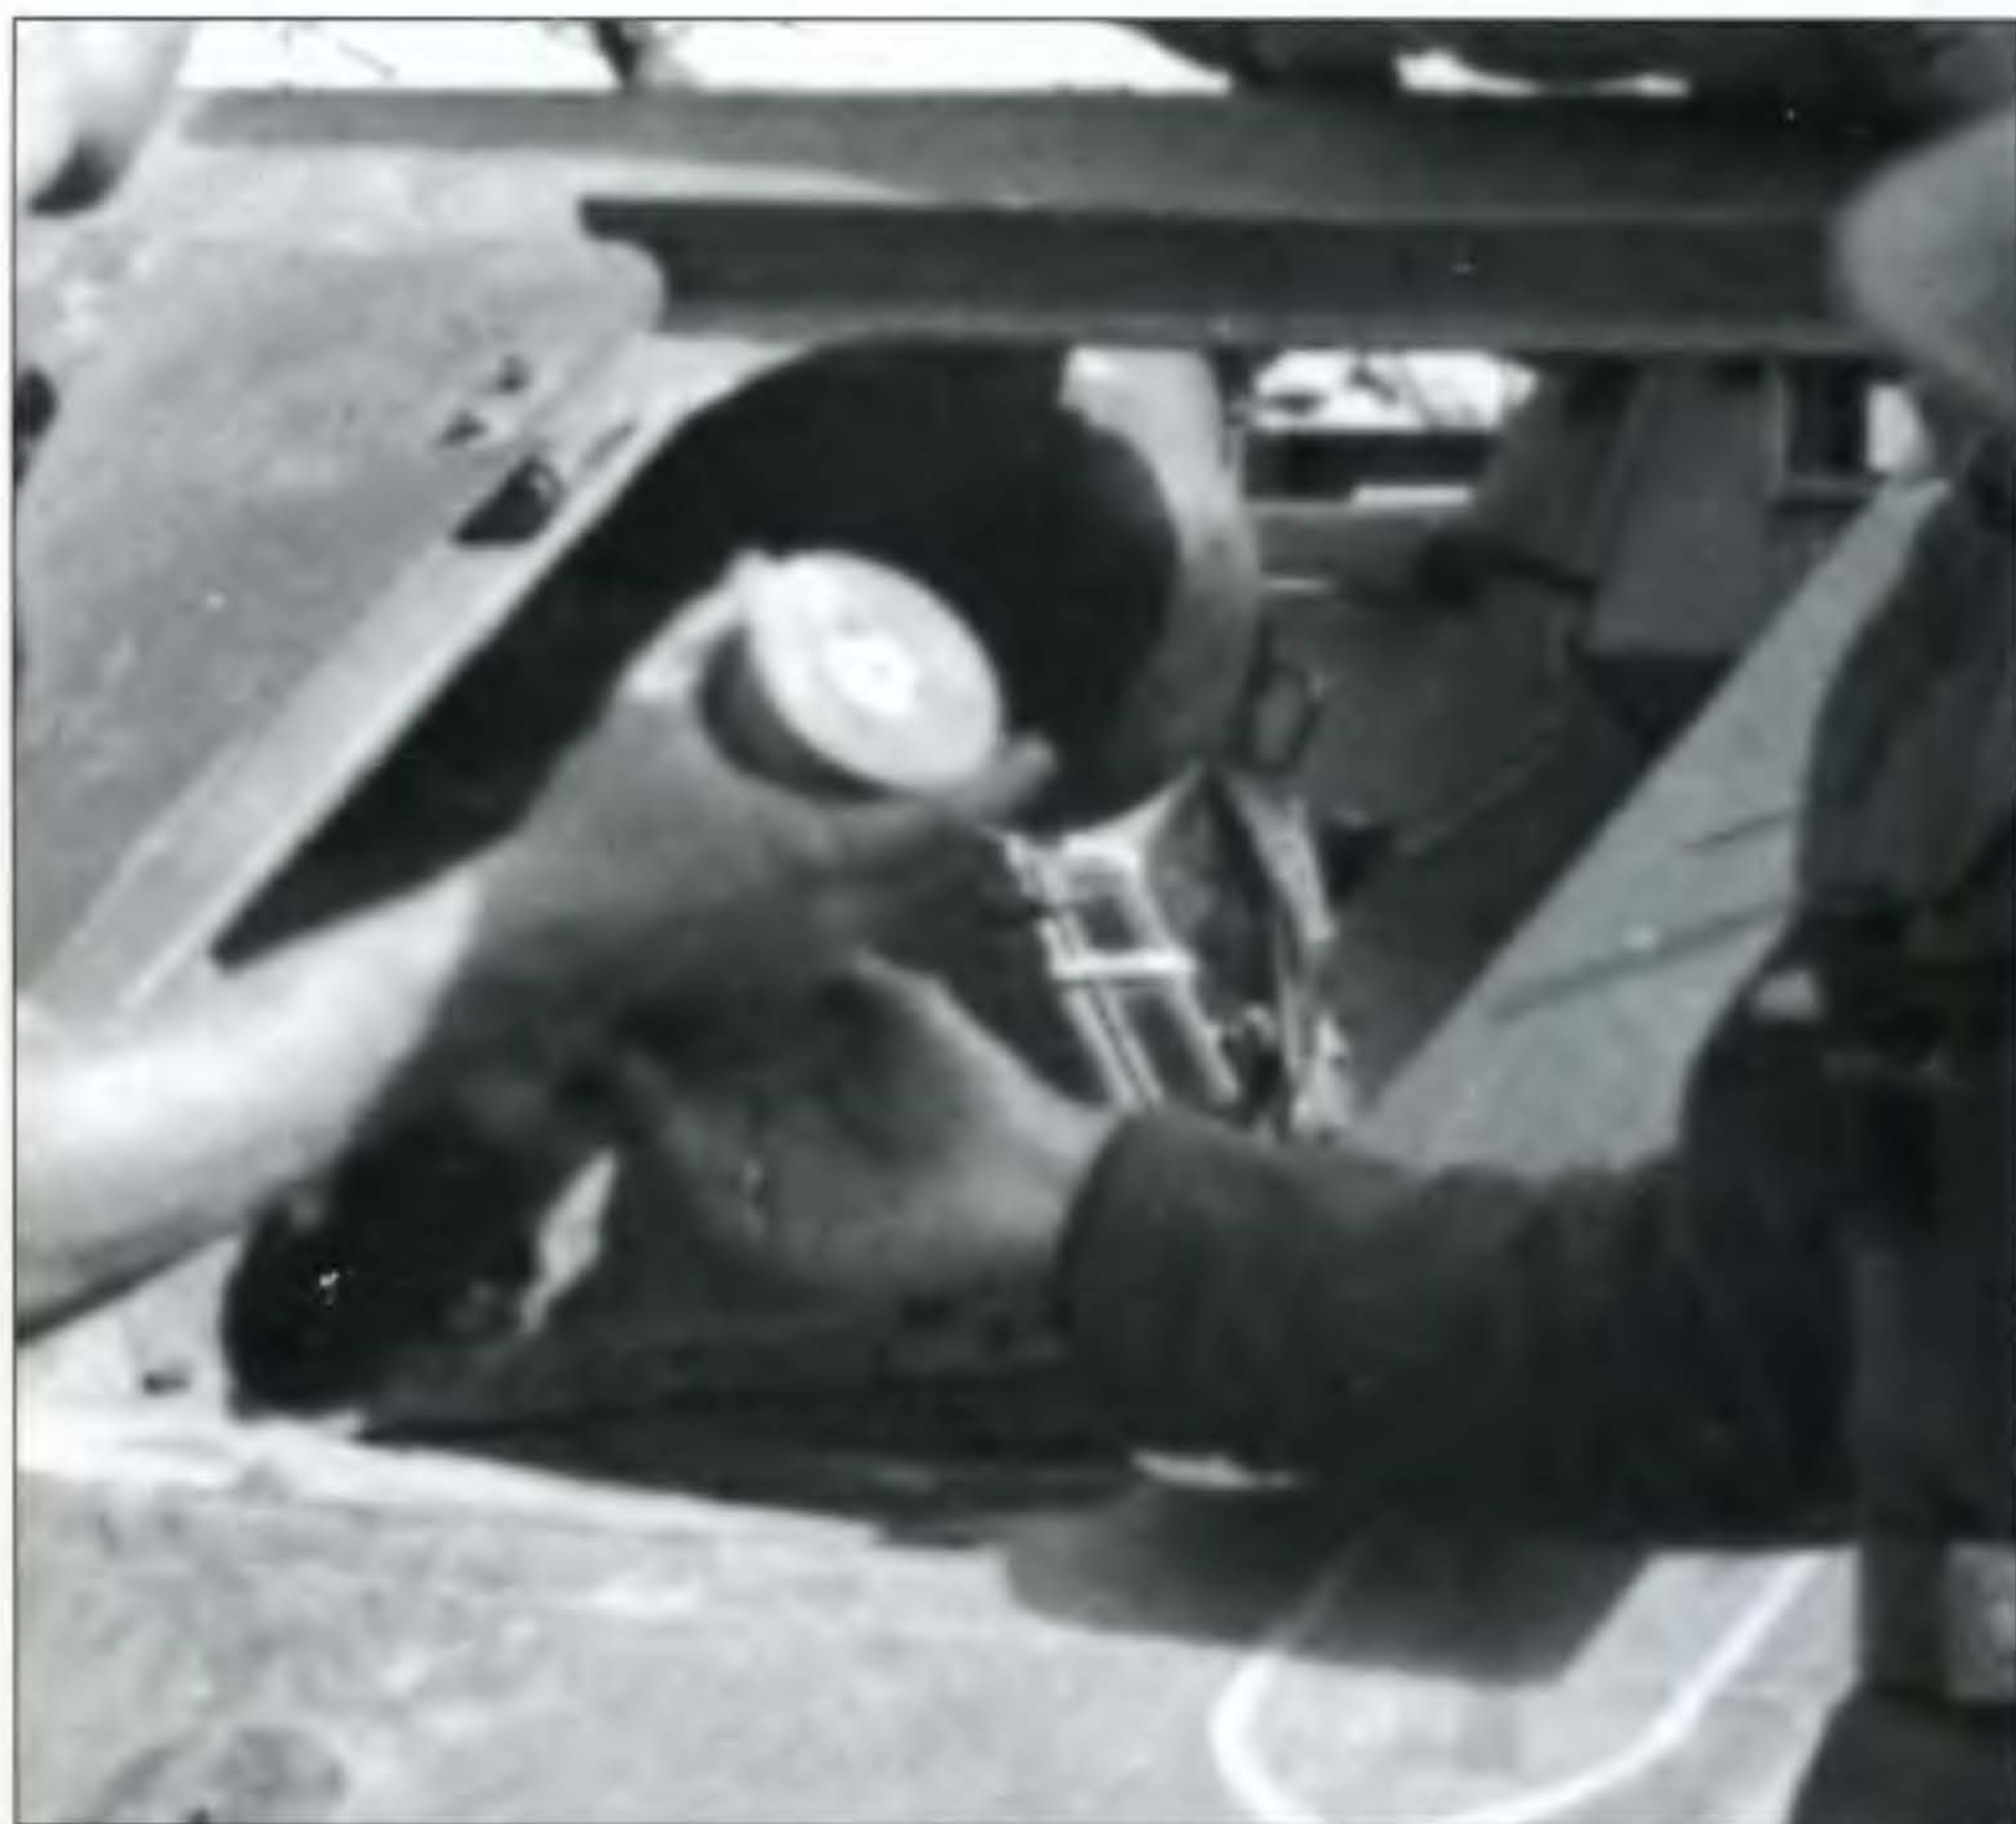
In this photograph and those on the following two pages, troops of *Sturmgeschütz Abteilung 249* assist the crew of the 252 to re-load with HE shells for 7.5cm *StuK L/24* for another trip forward to the *StuGs*. The metal ammunition cases are marked *Patr. 7.5cm KwK u Stu G 7.5cm*.

Note how the petrol and/or oil has seeped past the rivet heads on the rear of the chassis, the wiring from under the rear mudguard out to the stoplight and the triangular support for the rear reflector. Interestingly this 252 also has the door lock on the right-hand side. With the exception of the ammunition box, the rear doors and roof hatches (and like the 253s), the dash and firewall, the basic interior is painted white. Only small details such as the handle to lock the side visor are in *dunkel grau*. The glass vision blocks are painted in a pale-grey silver (like galvanized metal). They are made of three sheets of white glass contained in a two-piece silver soldered case that pushes into the visor assembly box and are locked in place behind the armoured visor plate.

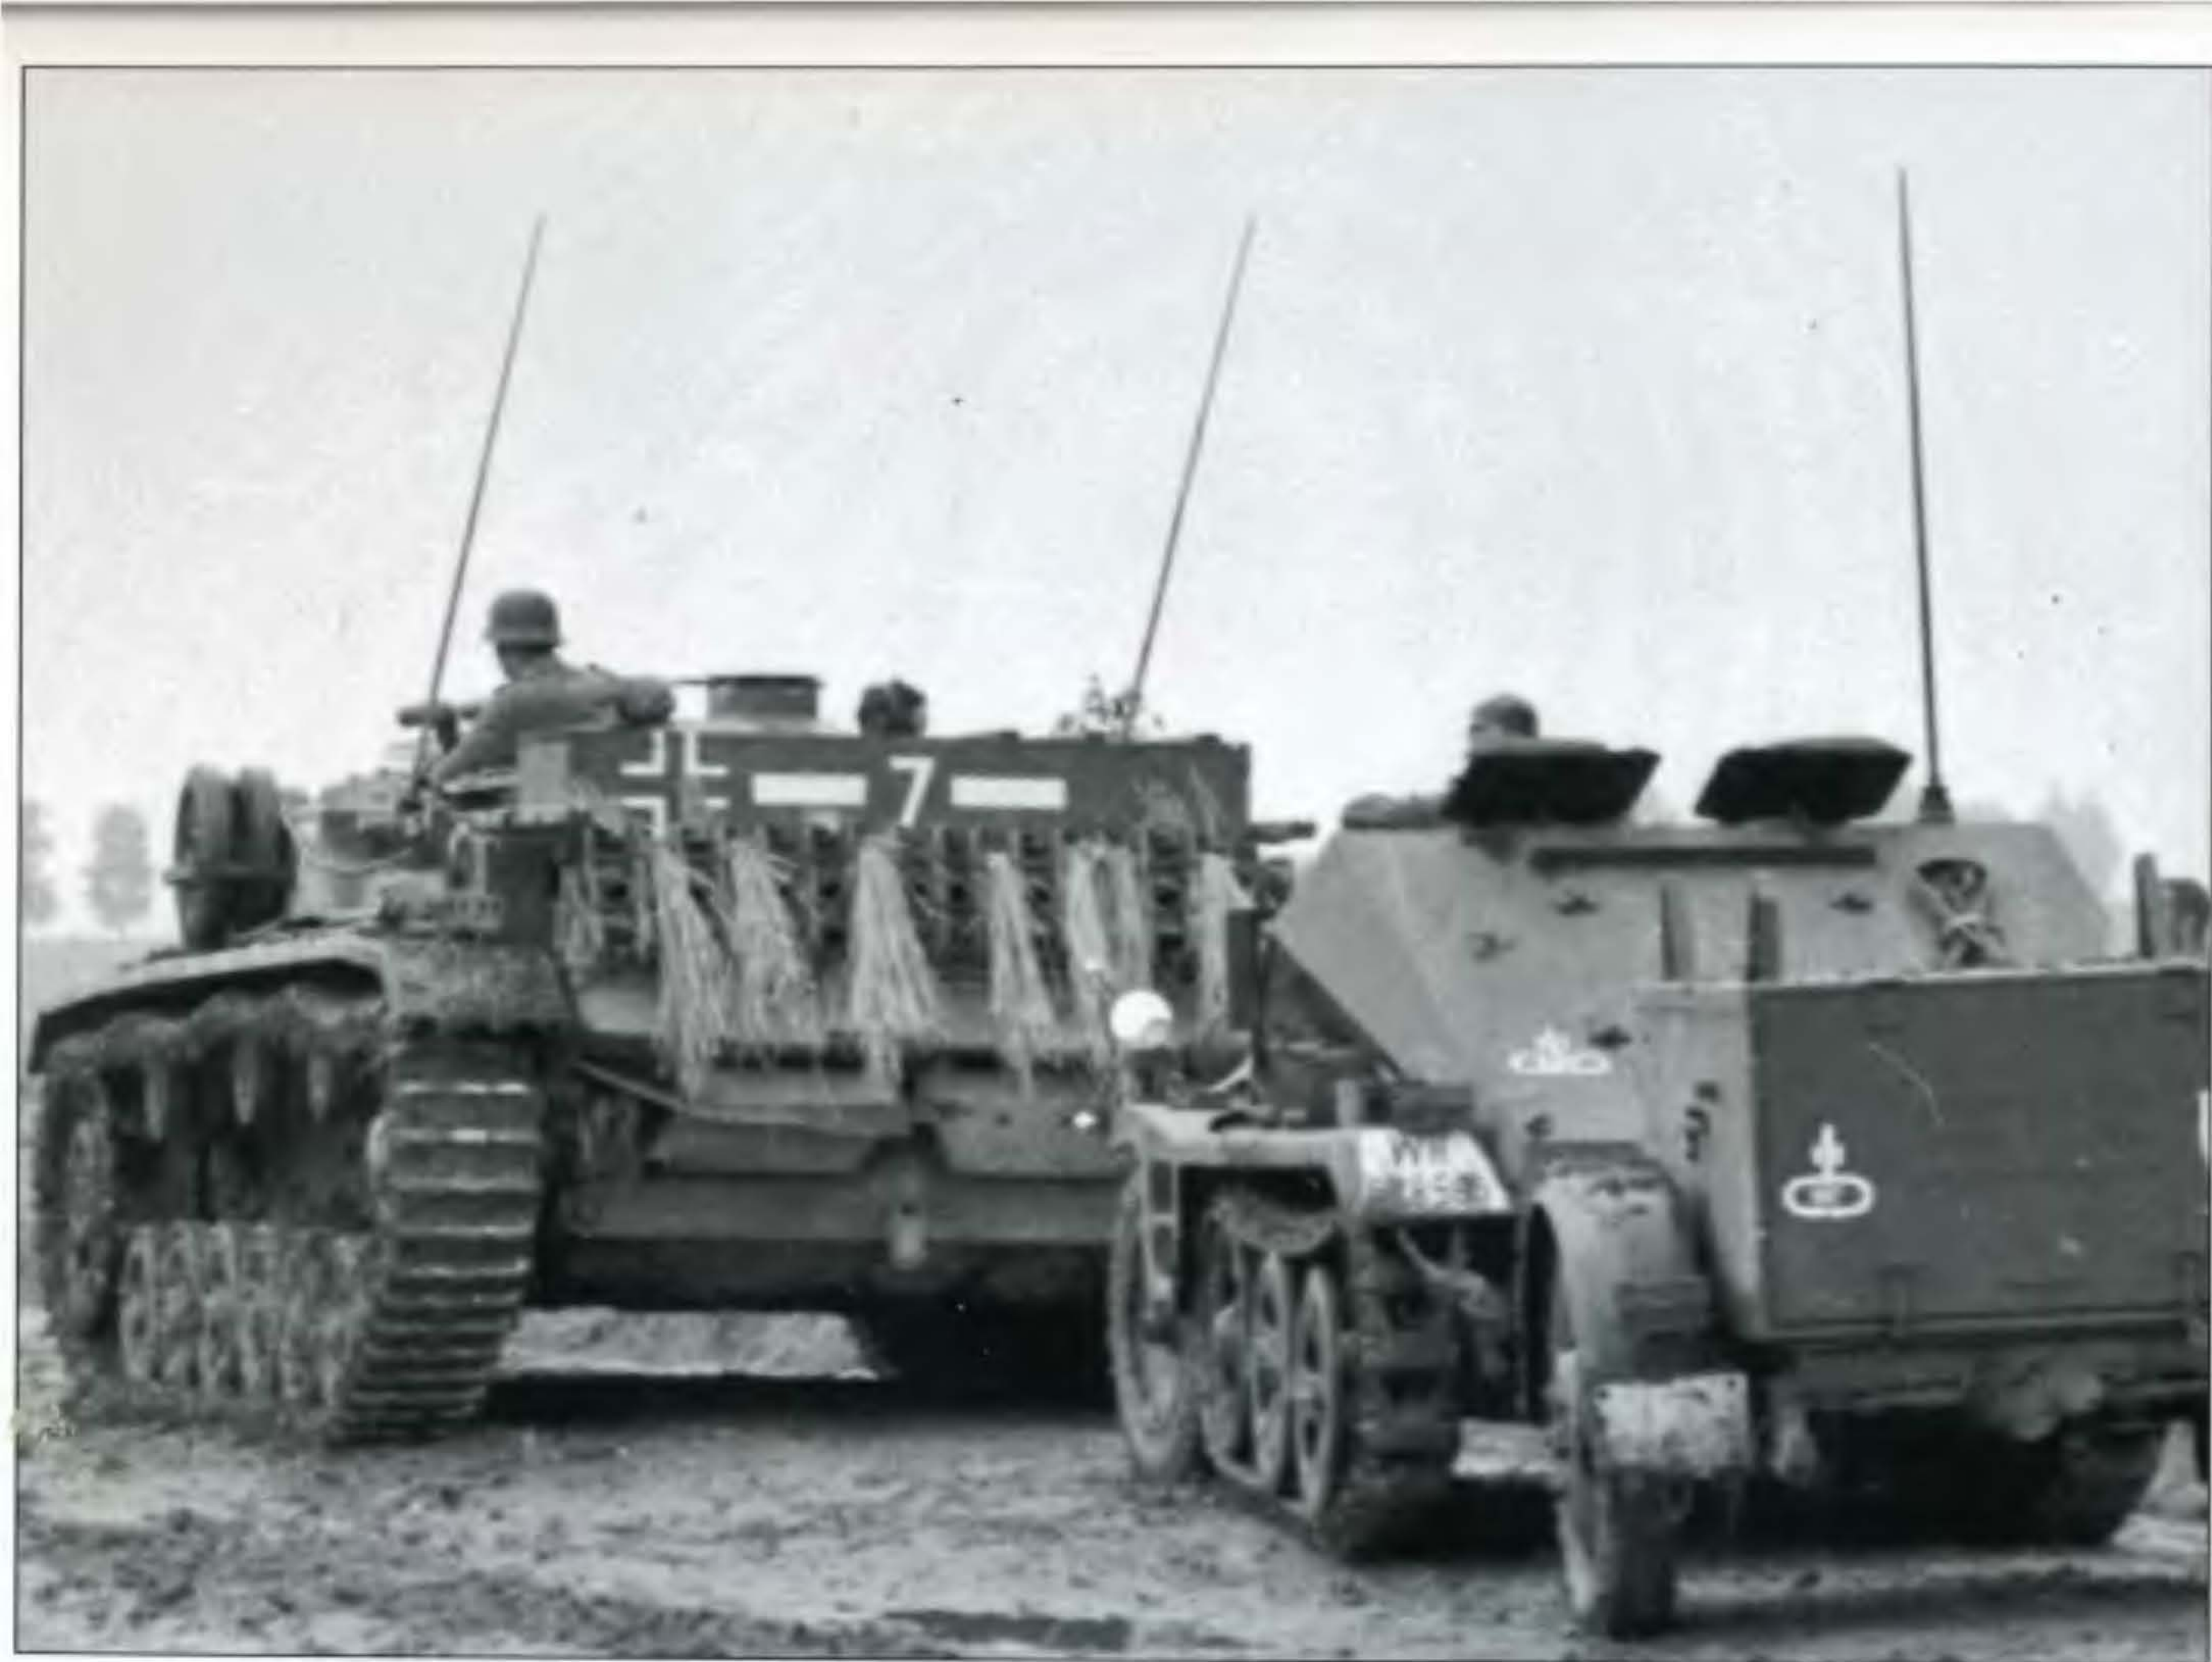
They received the new StuG III Ausf F with the 7.5 cm Sturmkanone 40 L/43 or L/48 main armament. The Ausf F was built from March to September 1942 and was basically an up-gunned Ausf E with the new L/43 armament with modifications to extend the traverse of the new gun mount, new ammunition bins and the addition of a fume extractor on the roof. This is one of the later models built after May 1942 without the armoured smoke candle rack on the rear. By the end of 1942 most L/24 armed StuGs had been superseded by this version. From the end of July 42 they served with Army Group Centre being shuttled around the front line between 39th Pz. Corps and the 28th Army Corps ending up around Rzhev at the end of the year. Judging by the condition of the vehicles in this photograph it cannot be more than a couple of months after their arrival on the Eastern front.

It isn't clear if the lead StuG crews have painted over the white bars on the rear box or that the two bars are painted possibly red, blue, yellow or green.

The two StuG Ausf Fs are followed by a fully equipped Sd Kfz 252 and trailer combination. Note the difference in height of the trailer box in comparison to the earlier box (see page 113) to accommodate the longer ammunition. The 252 continued to be listed as part of the formation given for *Sturmgeschütz Batterie (7 Gesch.)* (M. K. St. N.446. after the introduction of the Ausf E. The Sd Kfz 252 is one of the last production vehicles with the taller width indicators. Even though production of the 252 ended after the 253, it appears that no 252s were ever built with the semaphore indicator housings mounted down on the track guards. On the rear of the trailer with the tactical sign for a self-propelled artillery unit can be seen the numbers 667.
