TOTAL DETAIL

Sd Kfz 252, 253 & early 250

Sd Kfz 252, 253 & 250 (Typ 1)

Volume 3 - Part 1

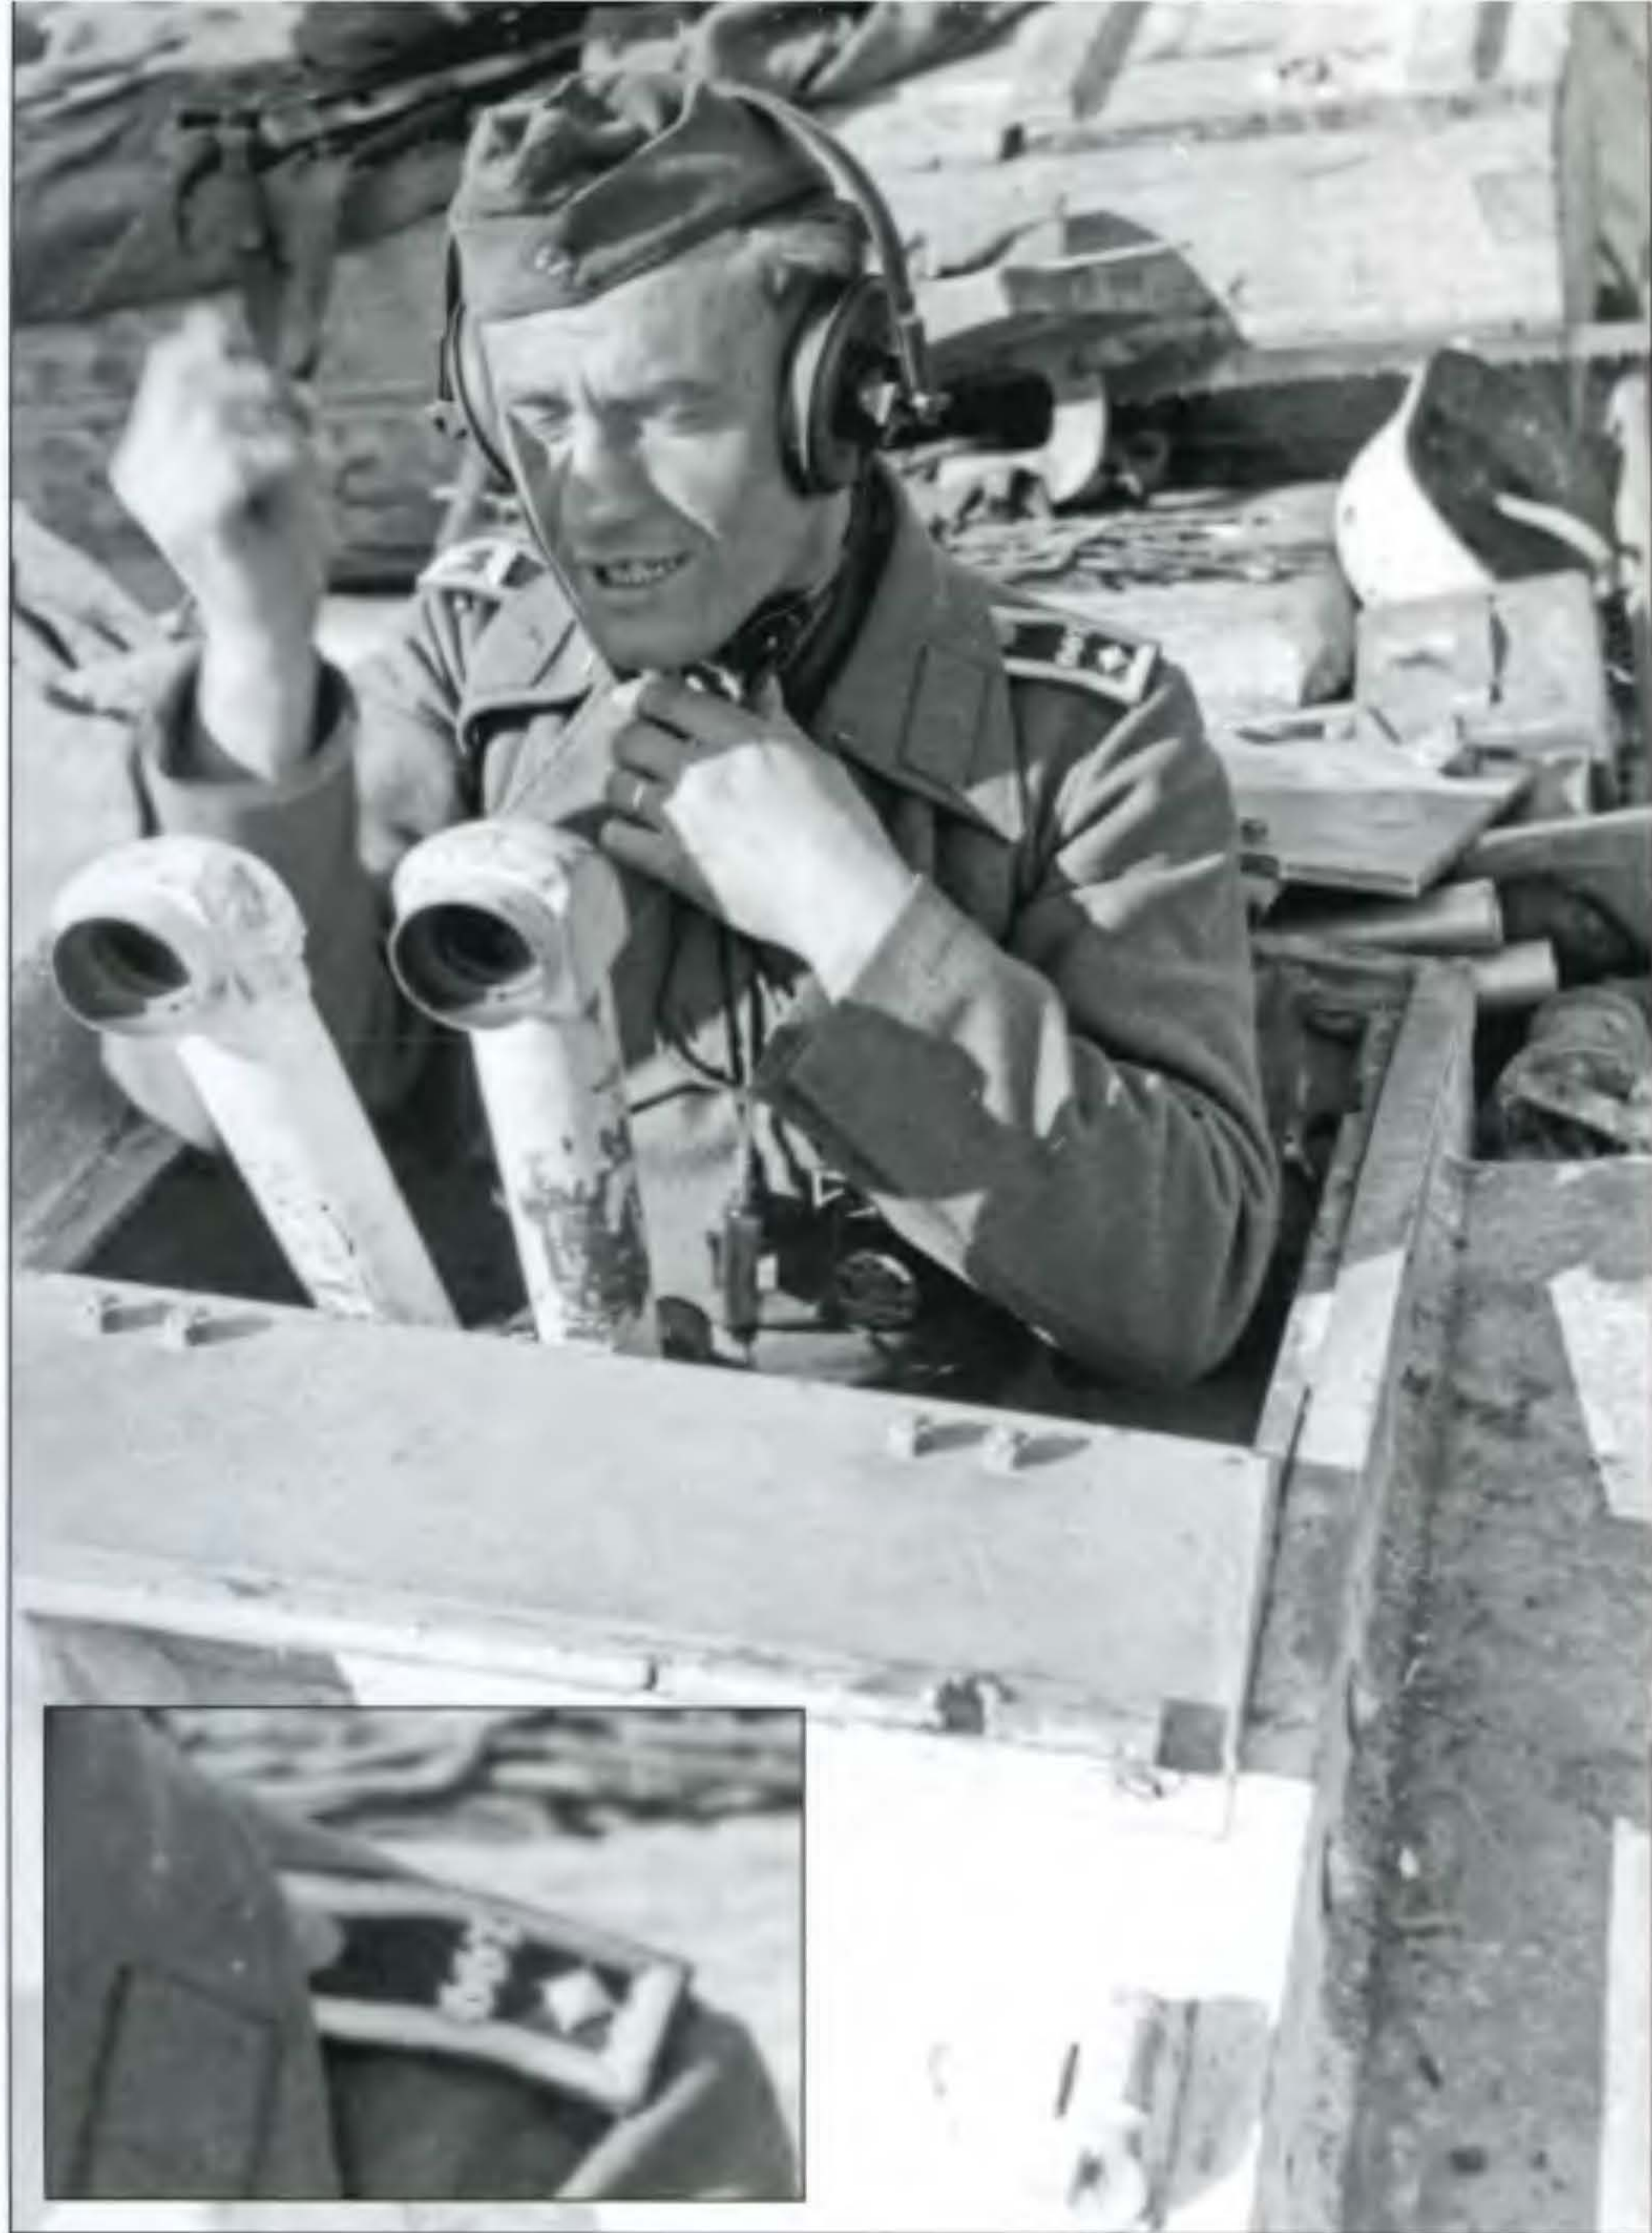
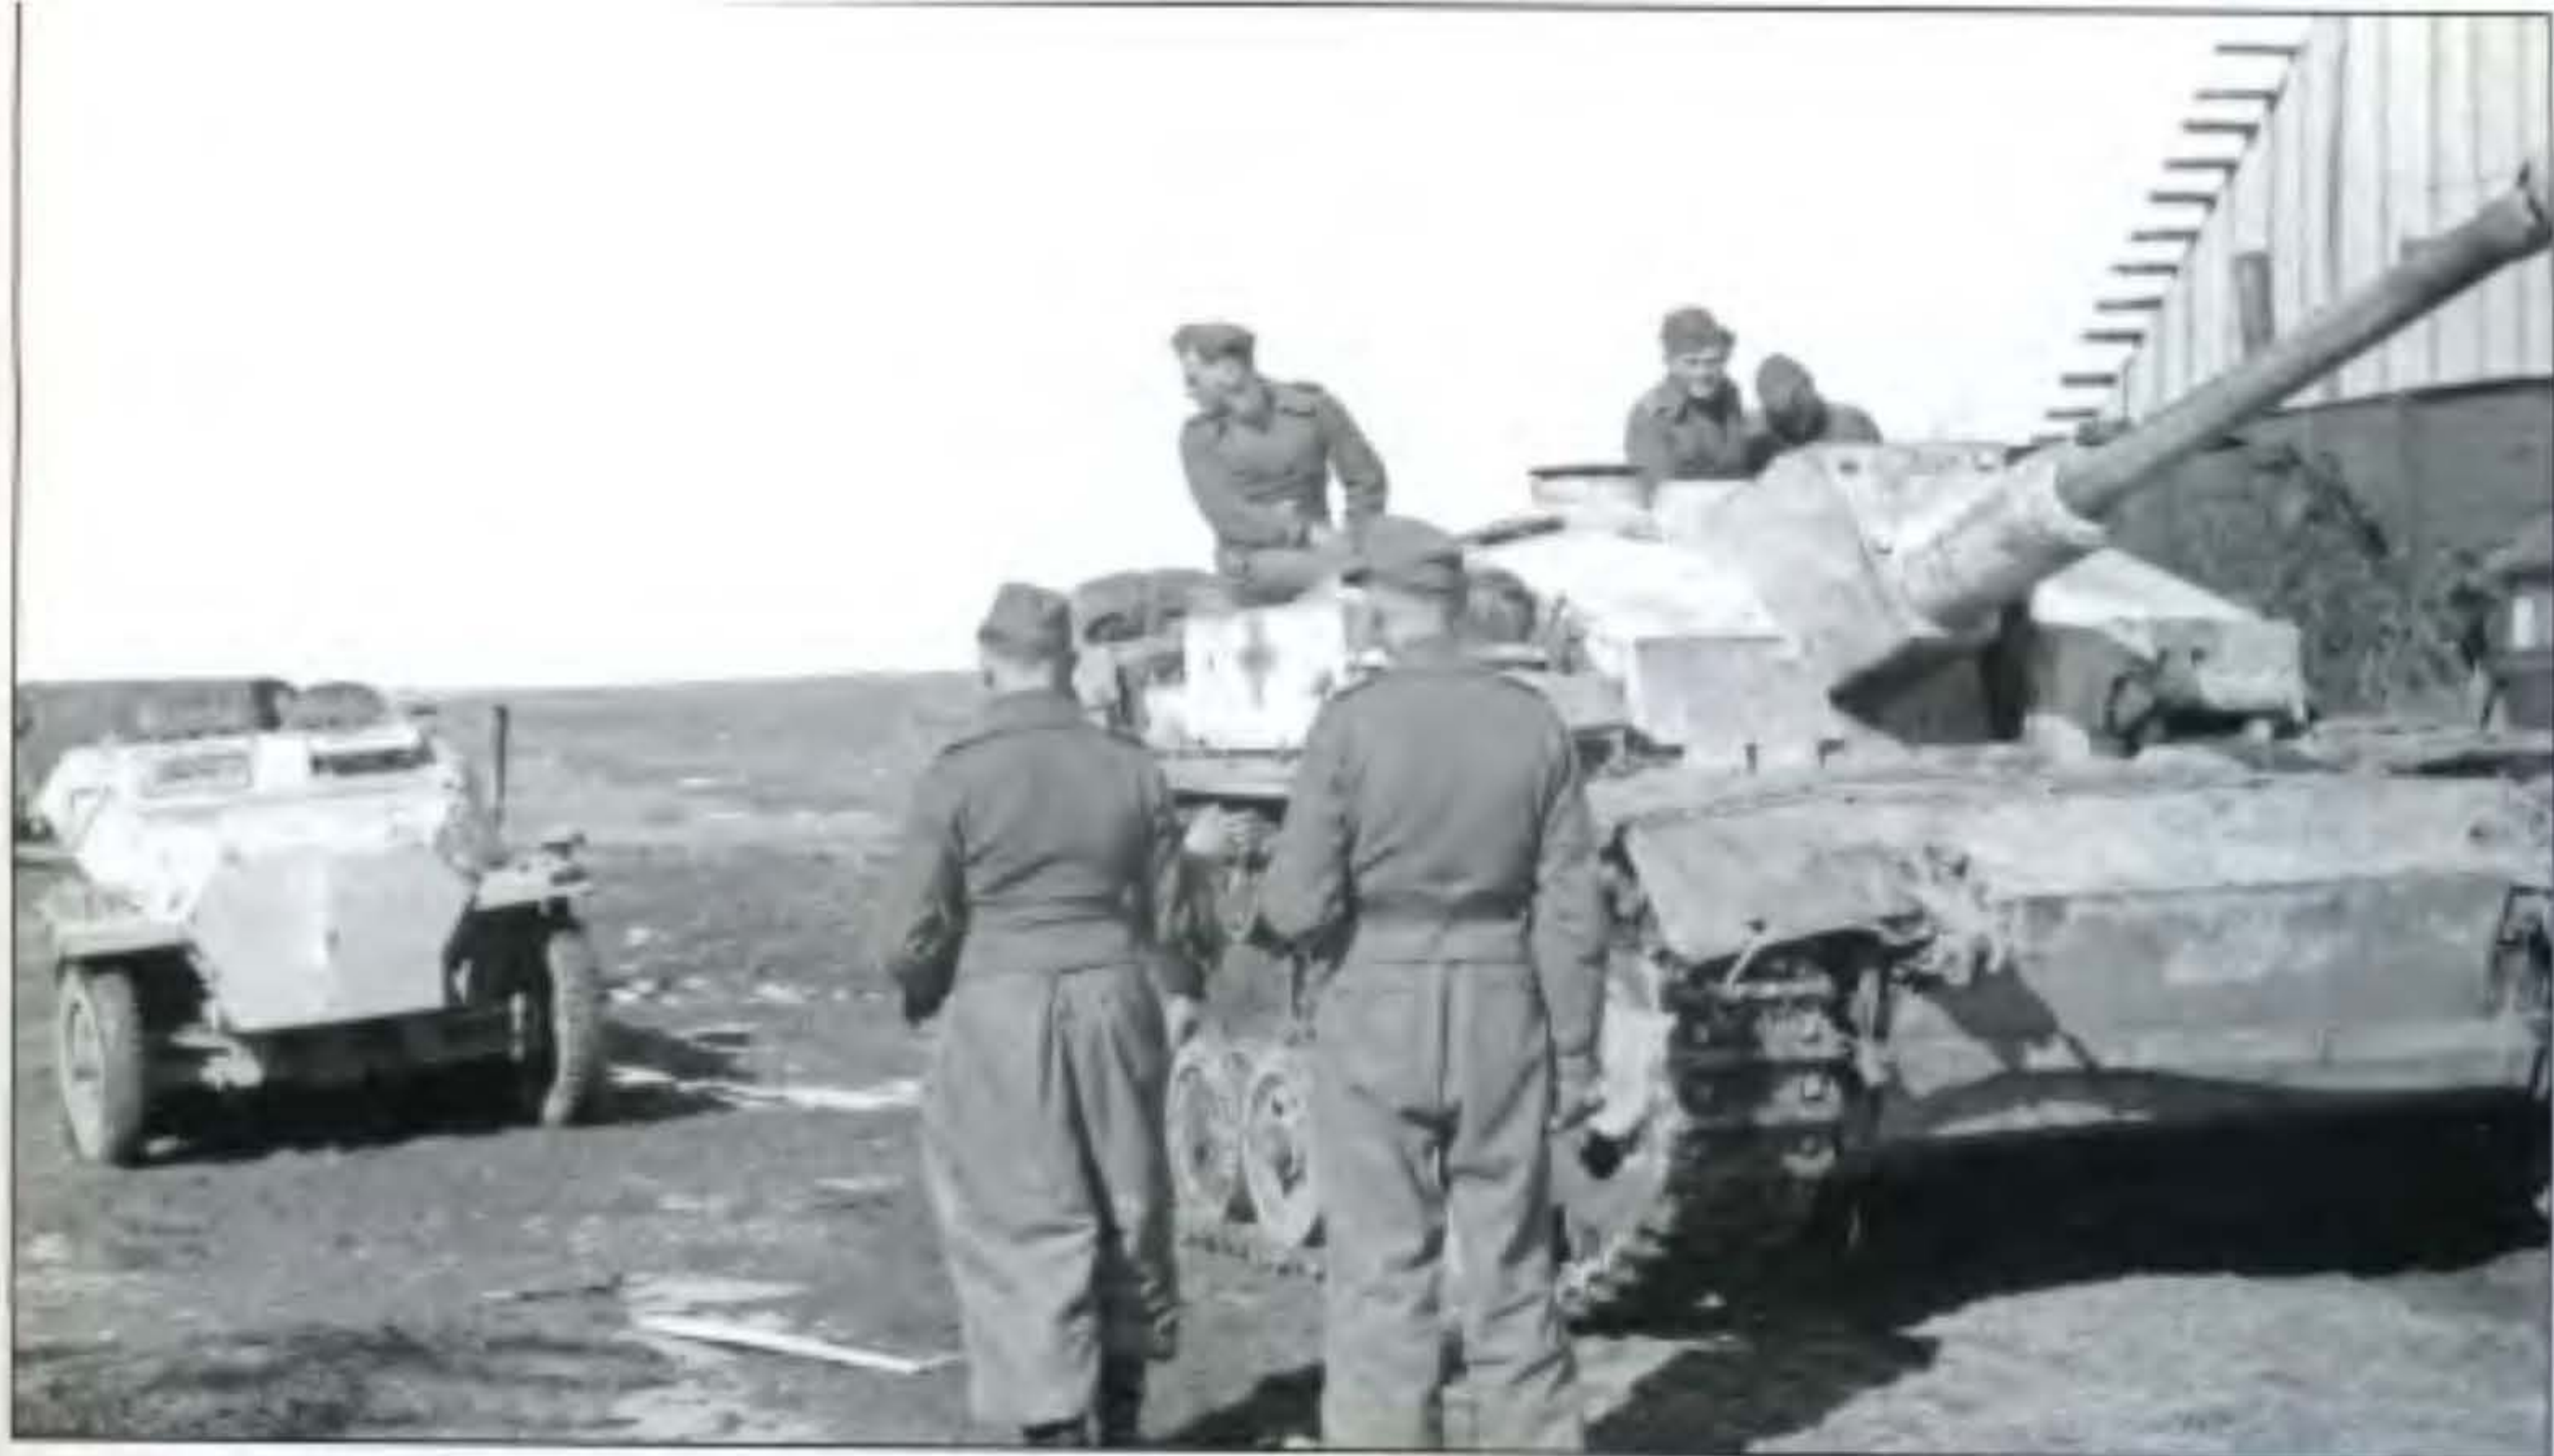
THIS PAGE TOP & RIGHT: *StuG III Ausf F mit Sturmkanone L/48* of the *Sturmabteilung 667* about to receive further ammunition. The 252 has lost its dust shield and semaphore indicators, but it does have one taller width indicator left. Note that the interior of the two doors remain in the original *dunkelgrau* (RAL 7021) colour. Look how battered the pair of vehicles have become compared to the previous page. I wonder just how quickly the snow has thawed to leave the vehicles still in their winter camouflage?

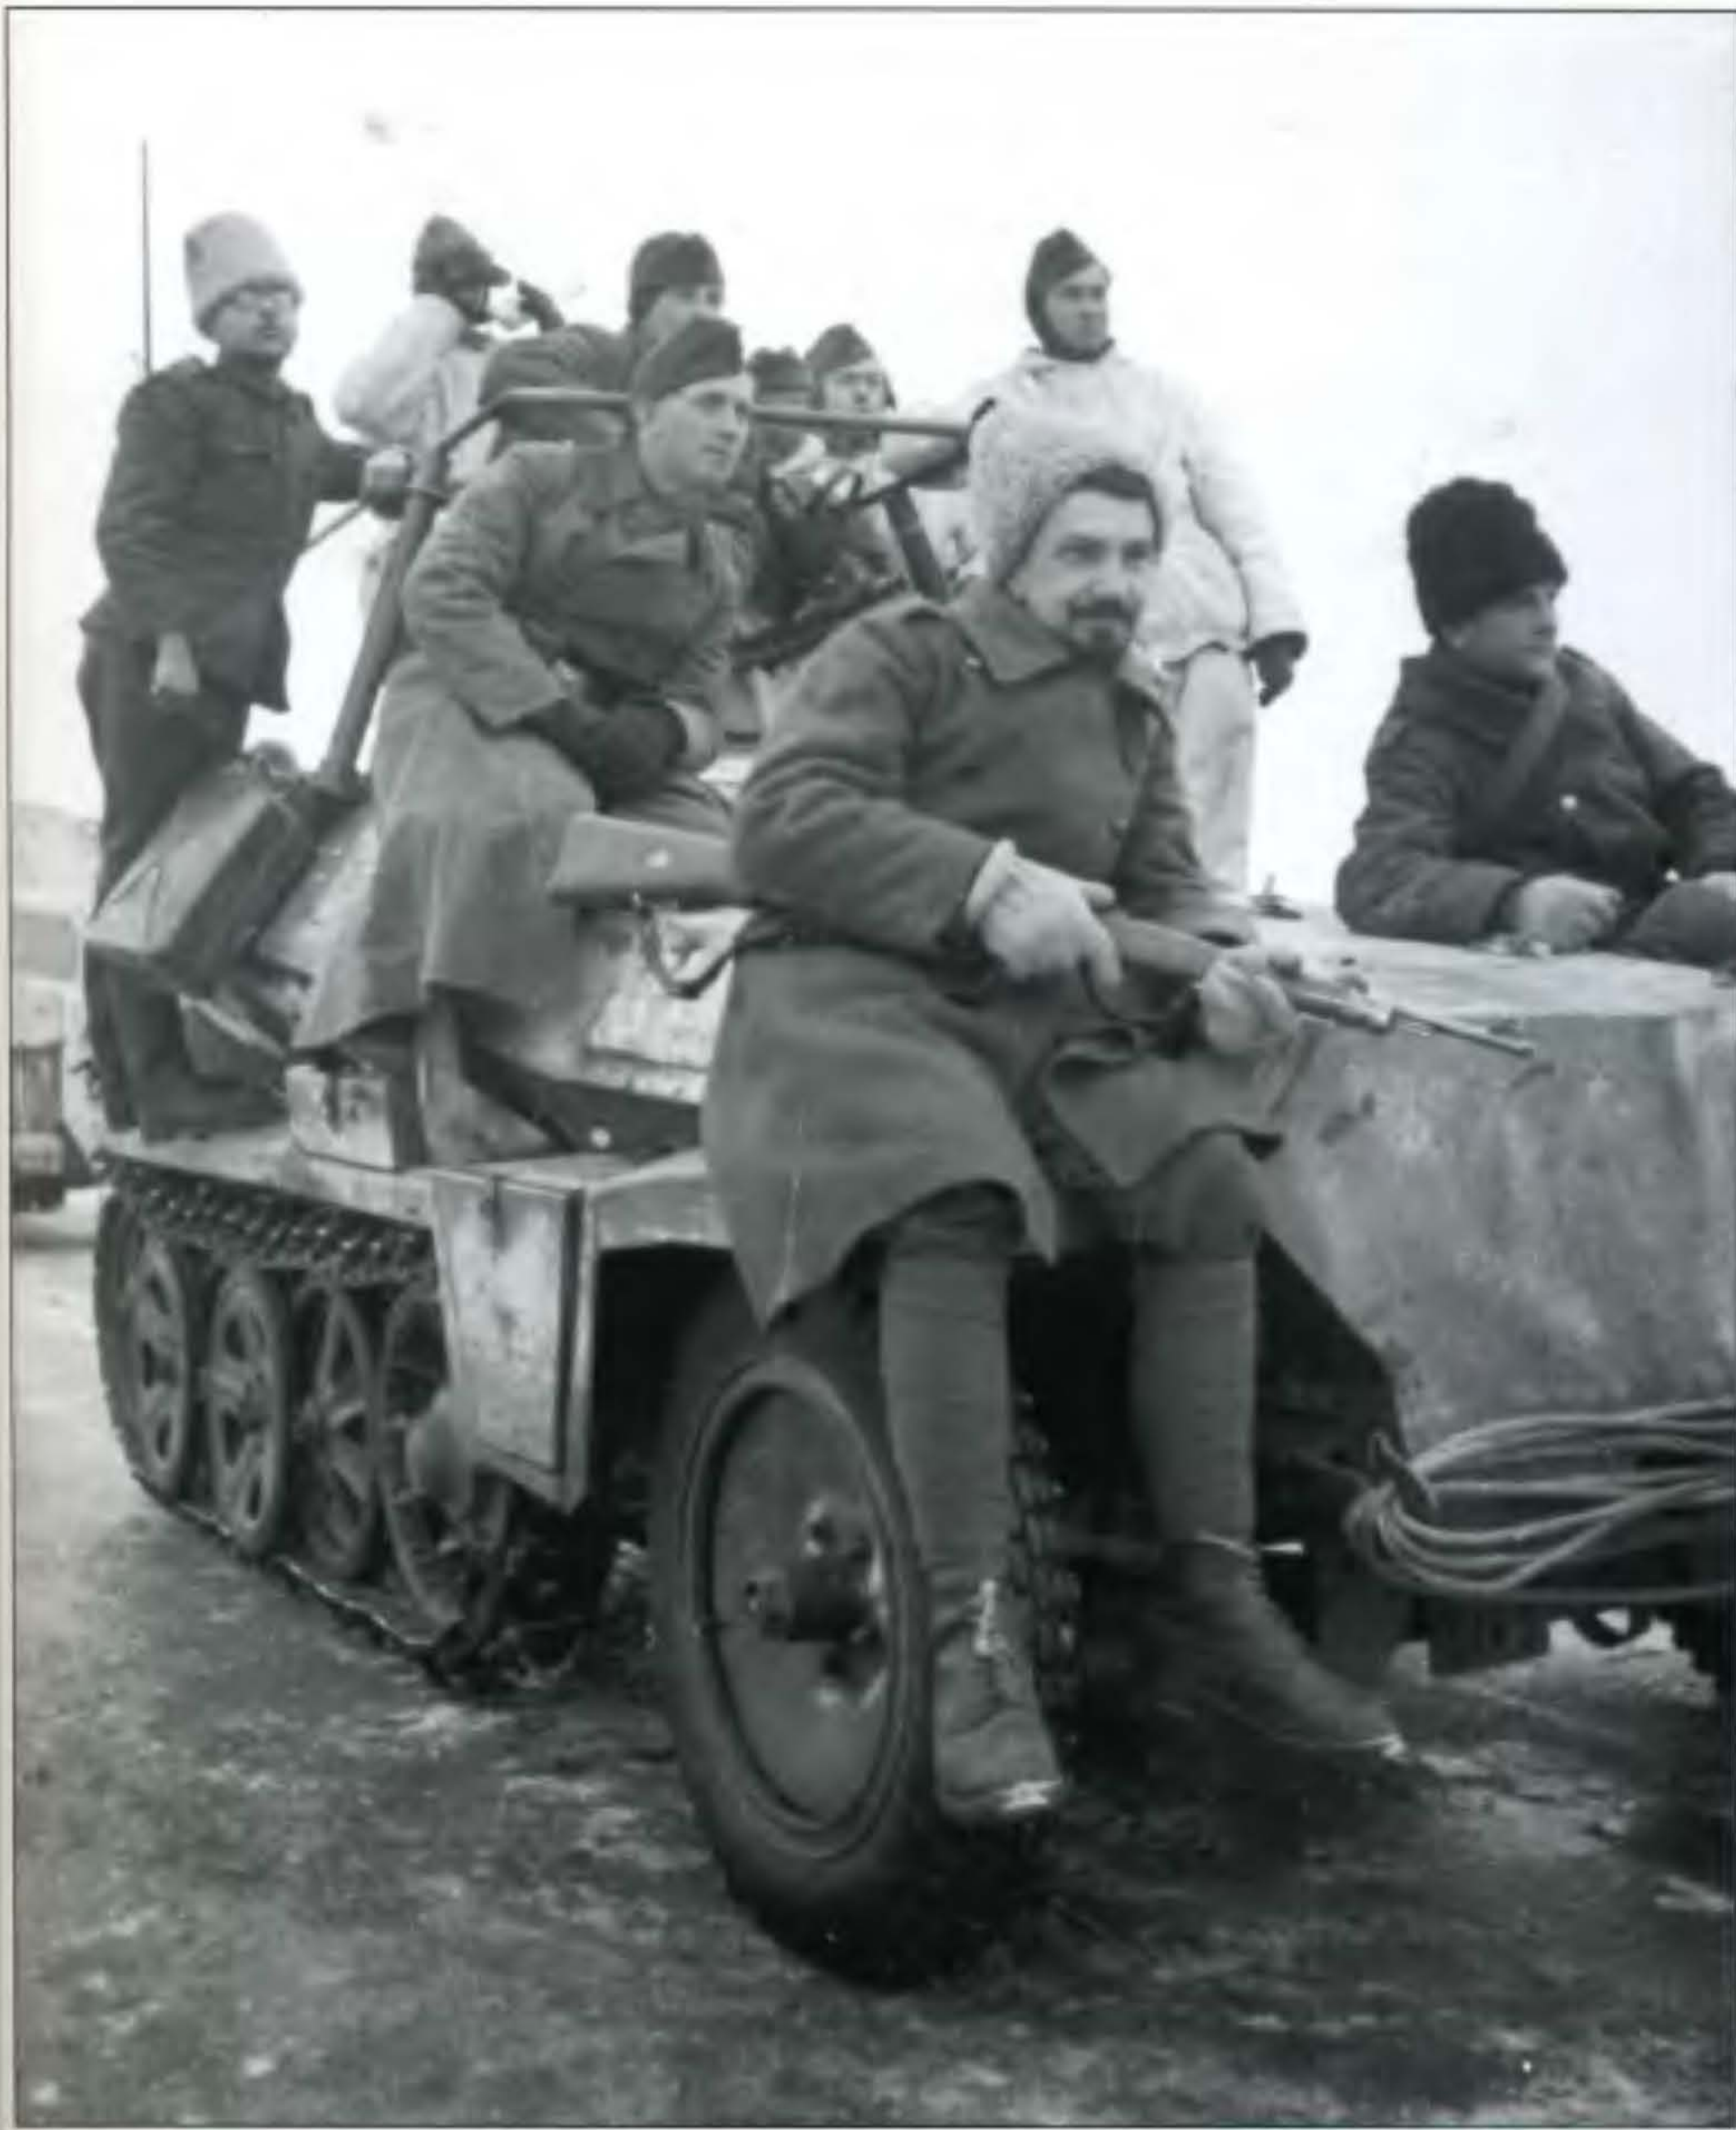
ABOVE: The left front wing is missing, as is the small axe, the wire cutters, front number plate and nose cap for the starter crank, but oddly, not the front dust shield. It has the second version intermediate height width indicators and the Fu. sprech. f. aerial is mounted on the right of the bodywork and not quite enough ice-cleats to place them in every third track plate. Generally lacking exterior stowage, this could be a rear echelon vehicle or headquarters vehicle and has either "A C F" or "A O F" on the nose above the front number plate.

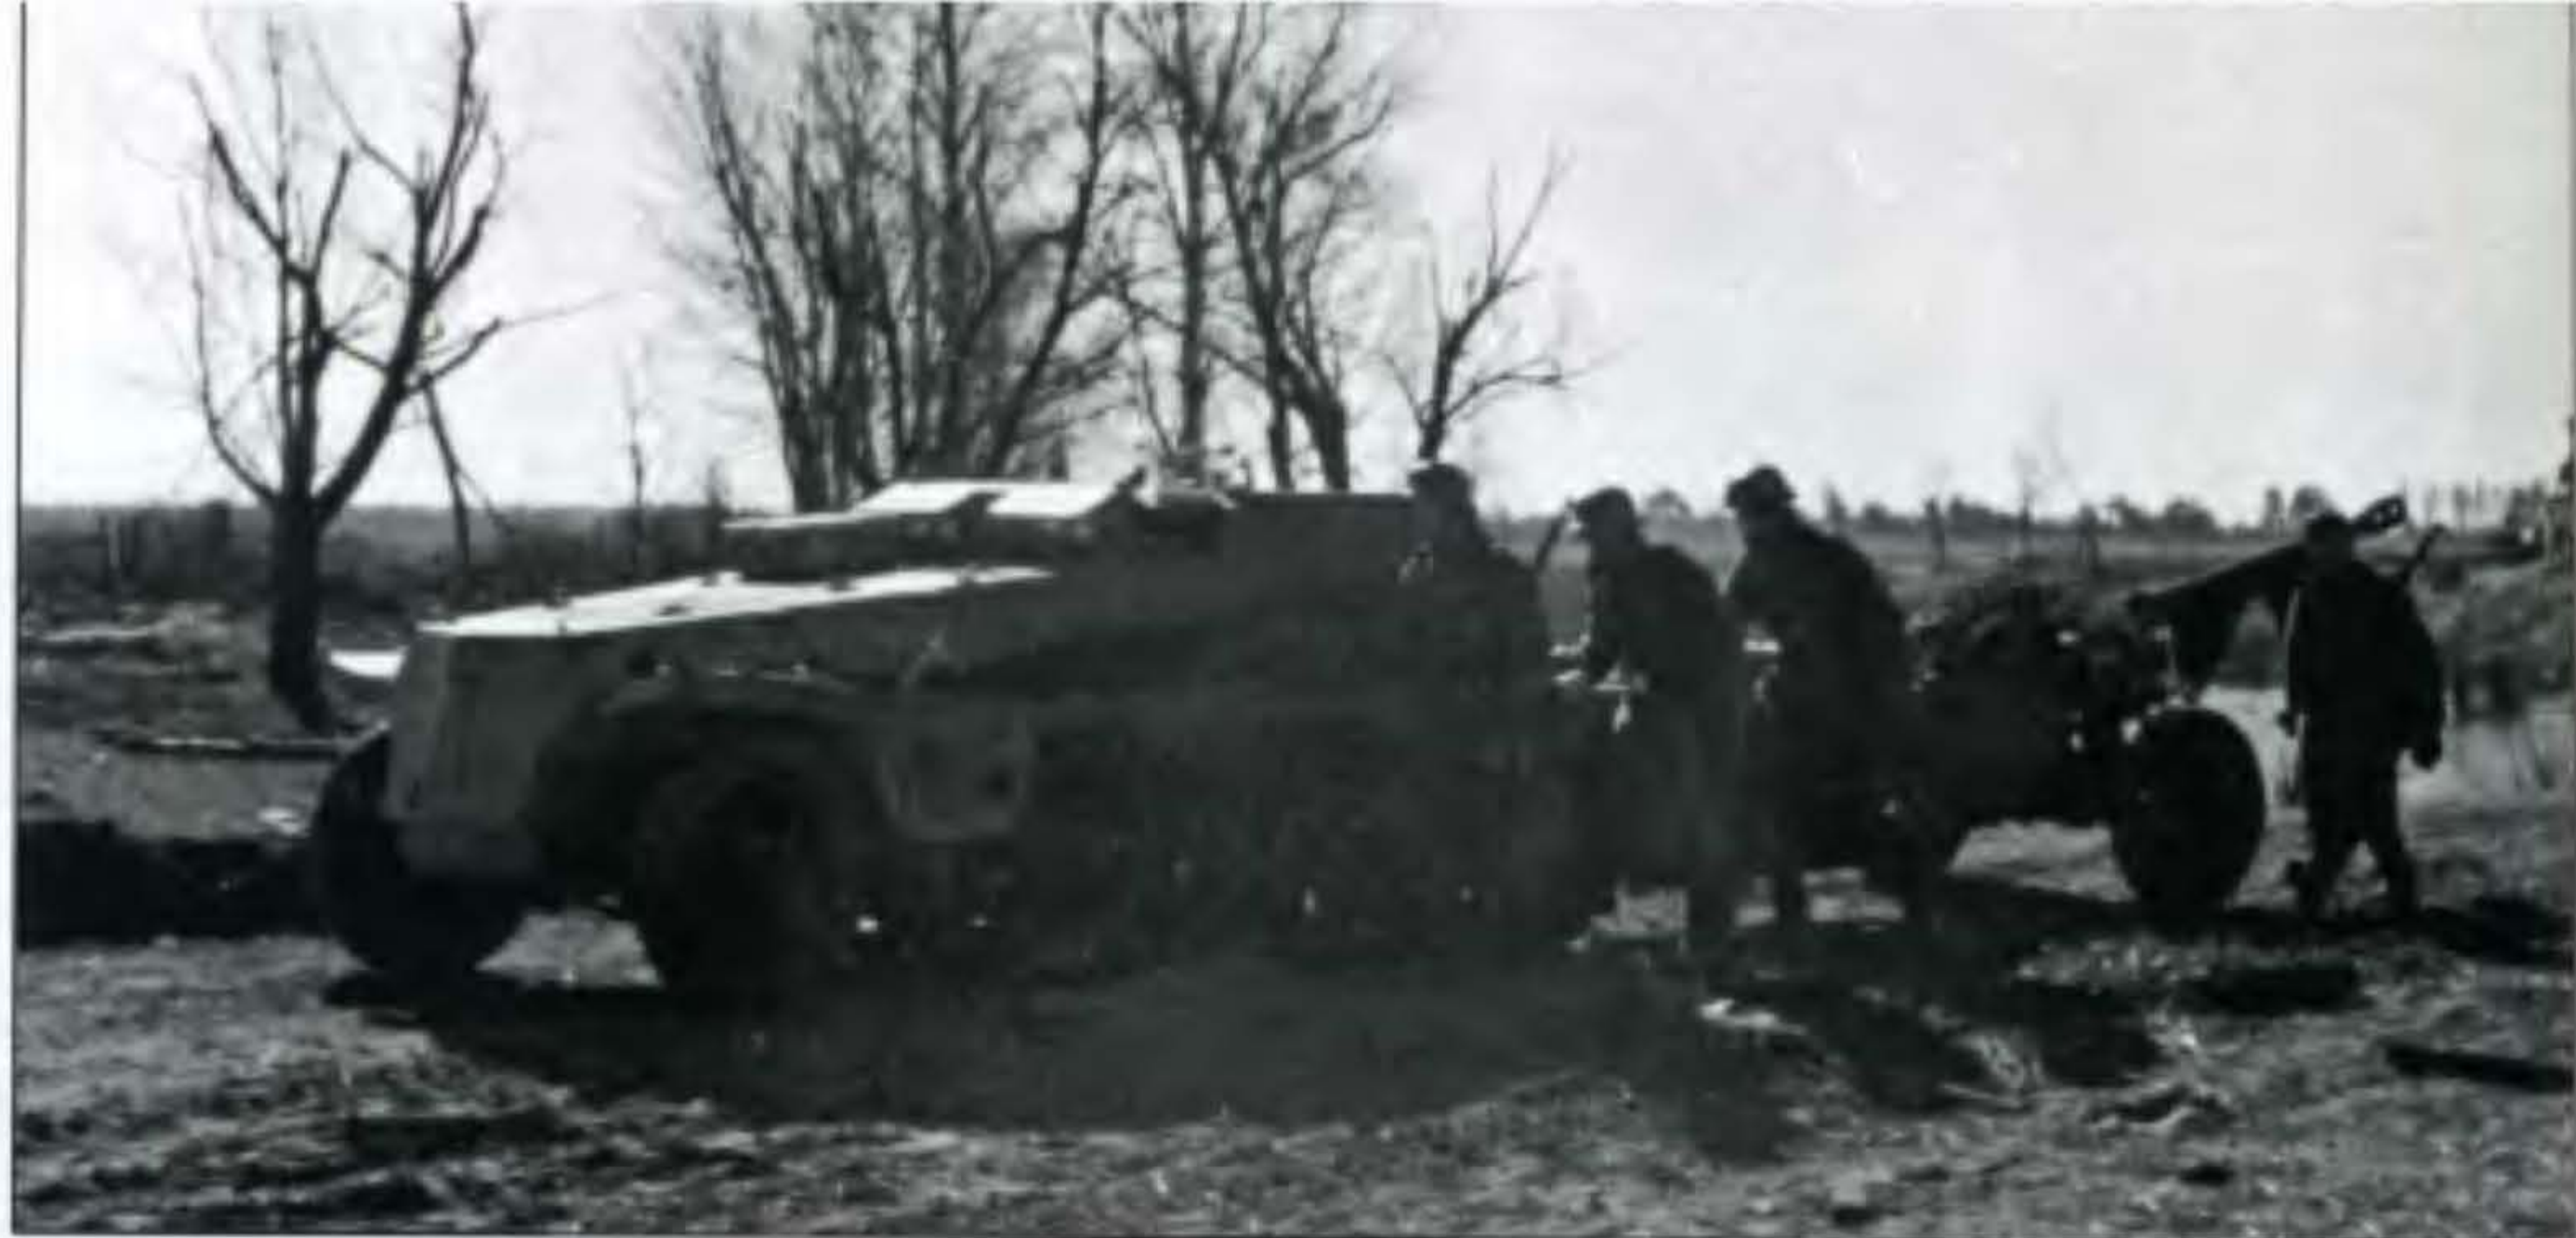
ABOVE: You can just see the roof mounted aerial base particular to the 252 series above the driver's front visor. It is unusual to see a 252 being used away from its intended role with the StuGs (unlike the 253s that did have a second life afterwards). Without any visible markings it is impossible to say for sure, but it does look like a dedicated panzerjaeger unit using an Sd Kfz 252 to tow a PaK 38 and use the internal stowage for anti-tank ammo. The only drawback is that the rest of the gun crew have to walk alongside the vehicle. Perhaps they did or do have an Sd Kfz 10 and it is currently out of commission, or this is an experiment to see how practical this arrangement could be or simply a case of needs must and this is the best they could find at the time. Typical of hard use both front mudguards have been pushed upwards by the tyres and the registration plate has been lost.

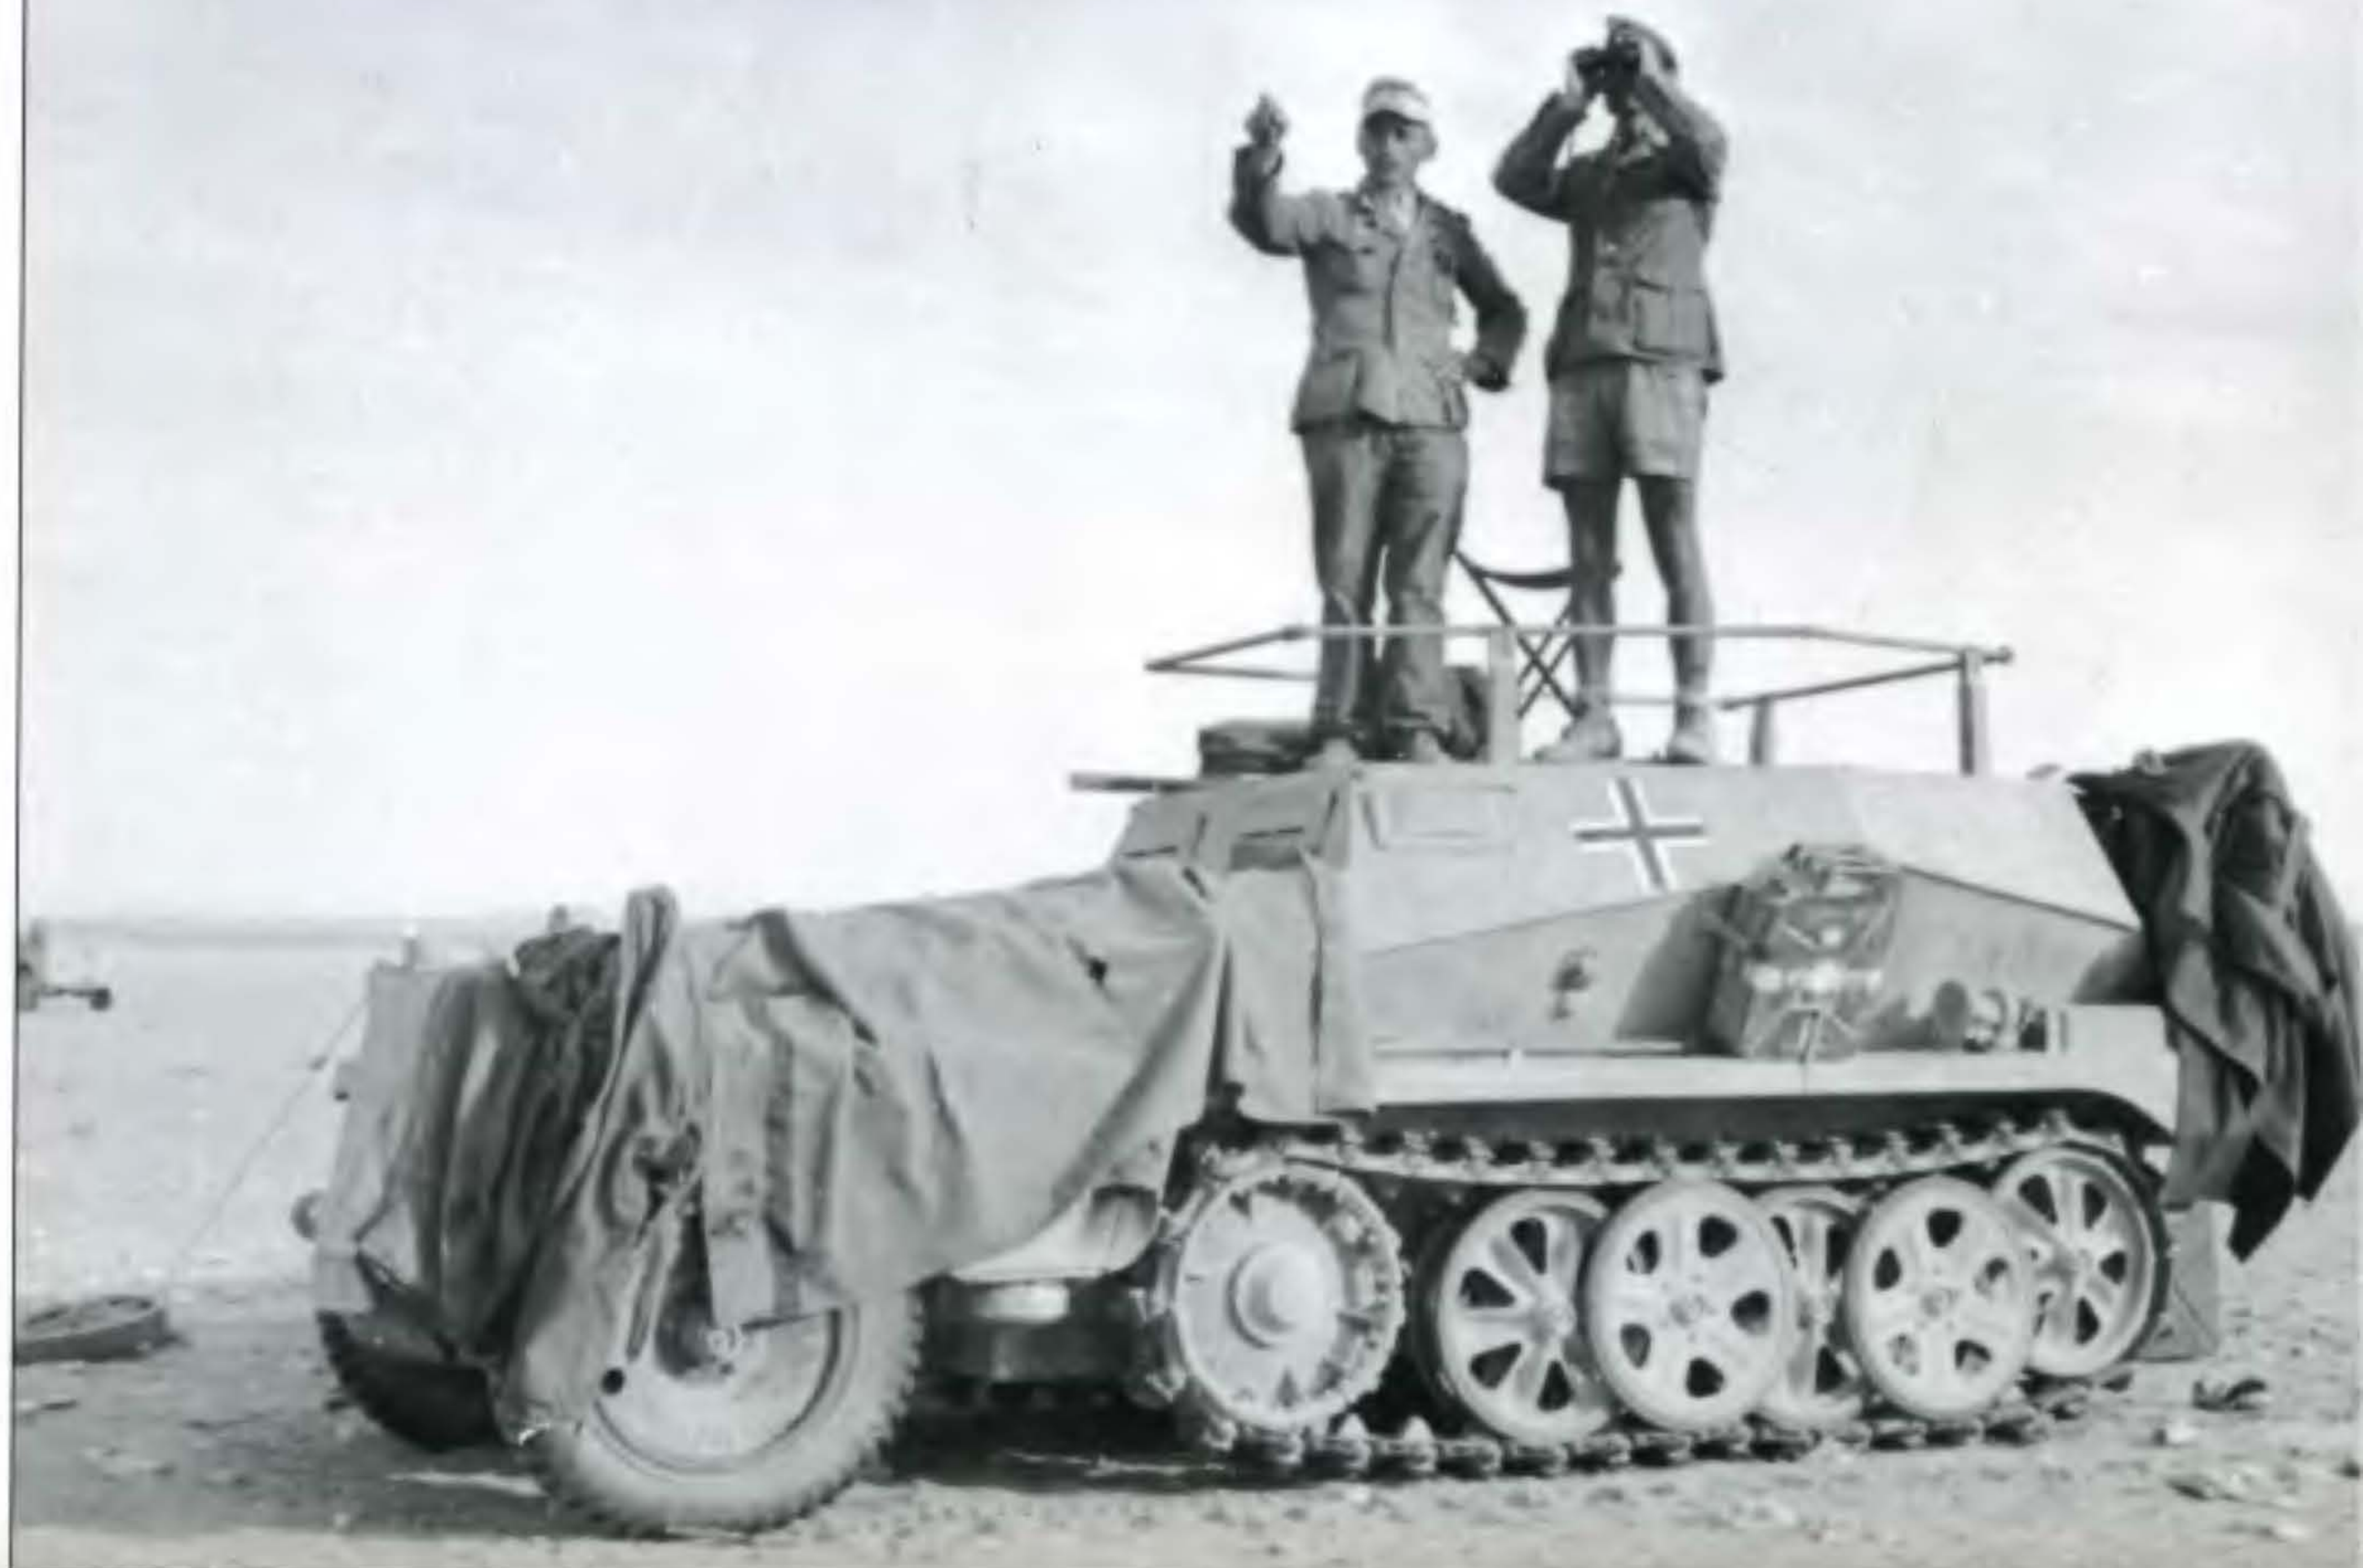
Given the various field modifications to radio vehicles, perhaps the German planners underestimated the expansive nature of desert warfare. In the case of this particular 250/1, perhaps the requested 250/3 has been lost en route across the Mediterranean Sea and consequently the workshop company has created this field fix out of whatever was available at the time? The mounting post for the front MG shield is still in place, so perhaps it is stowed within the vehicle. However if the shield was in place, firing the MG34 would take some care and attention to avoid destroying the frame aerial as it dips into the line of sight.

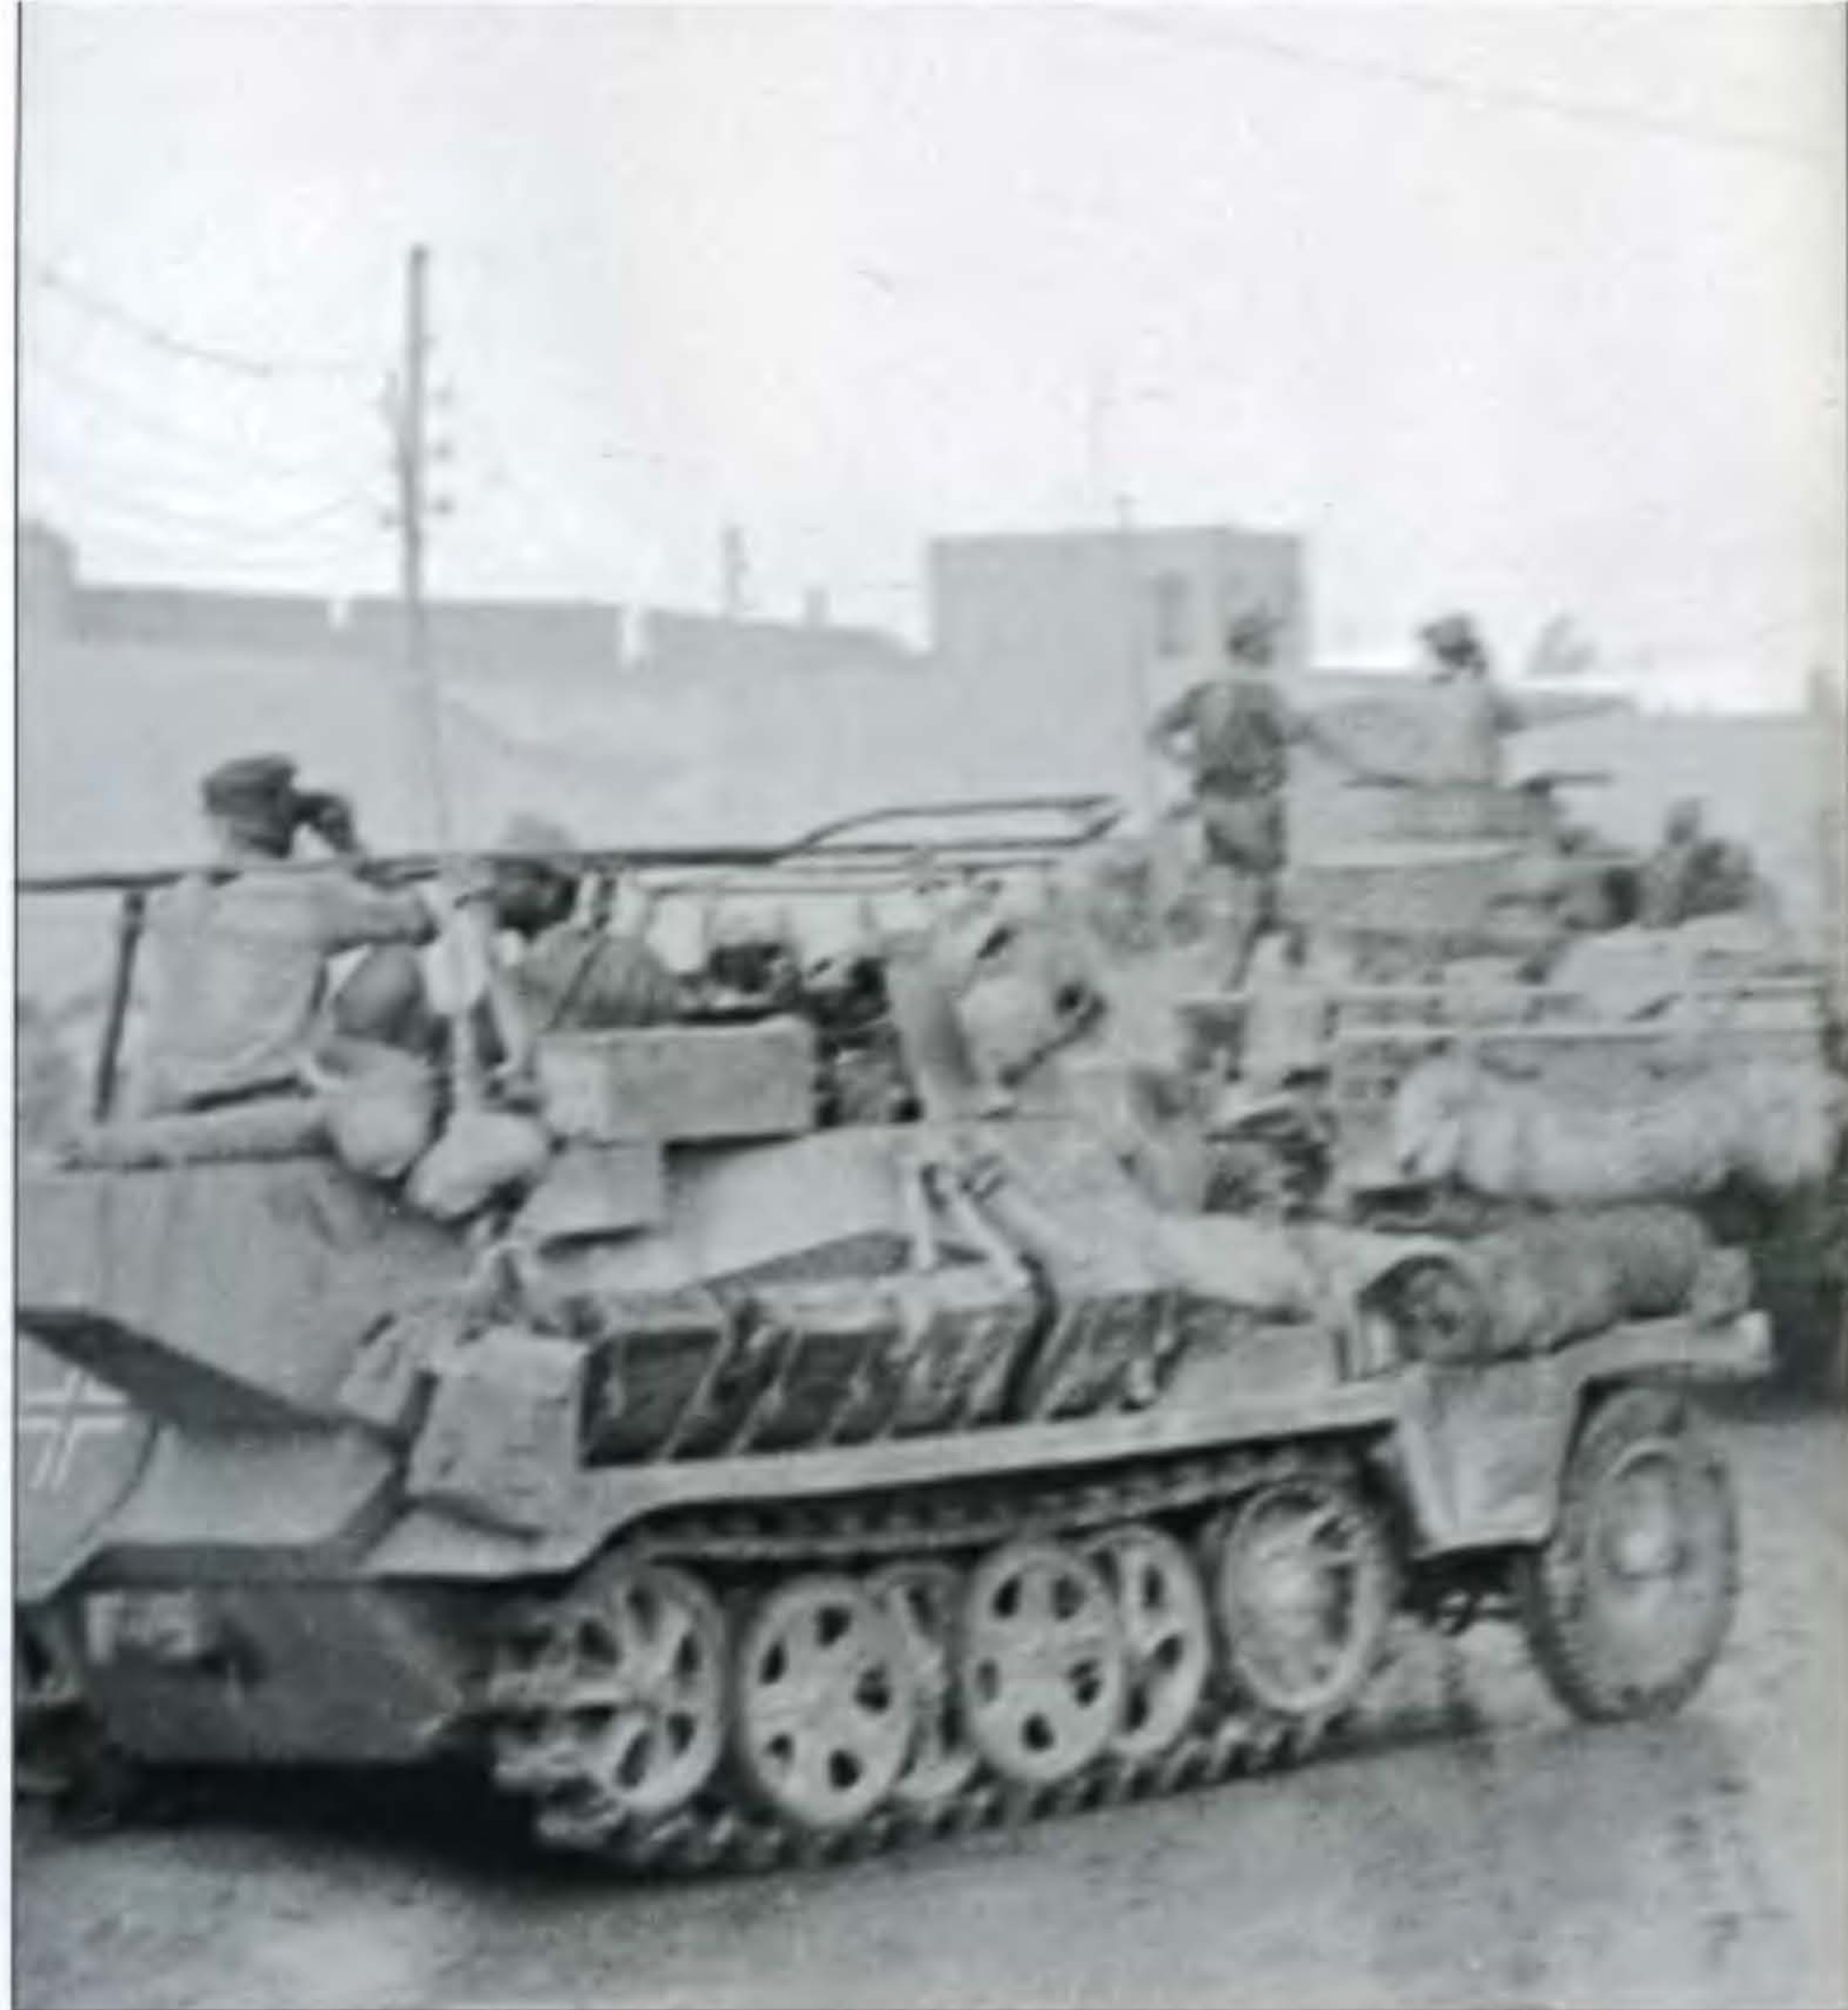
ABOVE: The frame aerial has been inverted and the front now angles upwards in comparison to the aerial on the opposite page. The stowage box is a bit of mystery. Close up photographs show it marked "not be stood upon", so it is not made of armour plate but sheet metal with a lockable door on the top surface. Quite why it is this shape and what exactly went in it is a bit of mystery. Perhaps it is the Sd Kfz 250/12 Light Survey version, (shown on page 239 of Sd Kfz 250 Archive Part 2) but with this extra stowage box for their specialist equipment.
