TOTAL DETAIL

Sd Kfz 252, 253 & early 250

Sd Kfz 252, 253 & 250 (Typ 1)

Volume 3 - Part 1

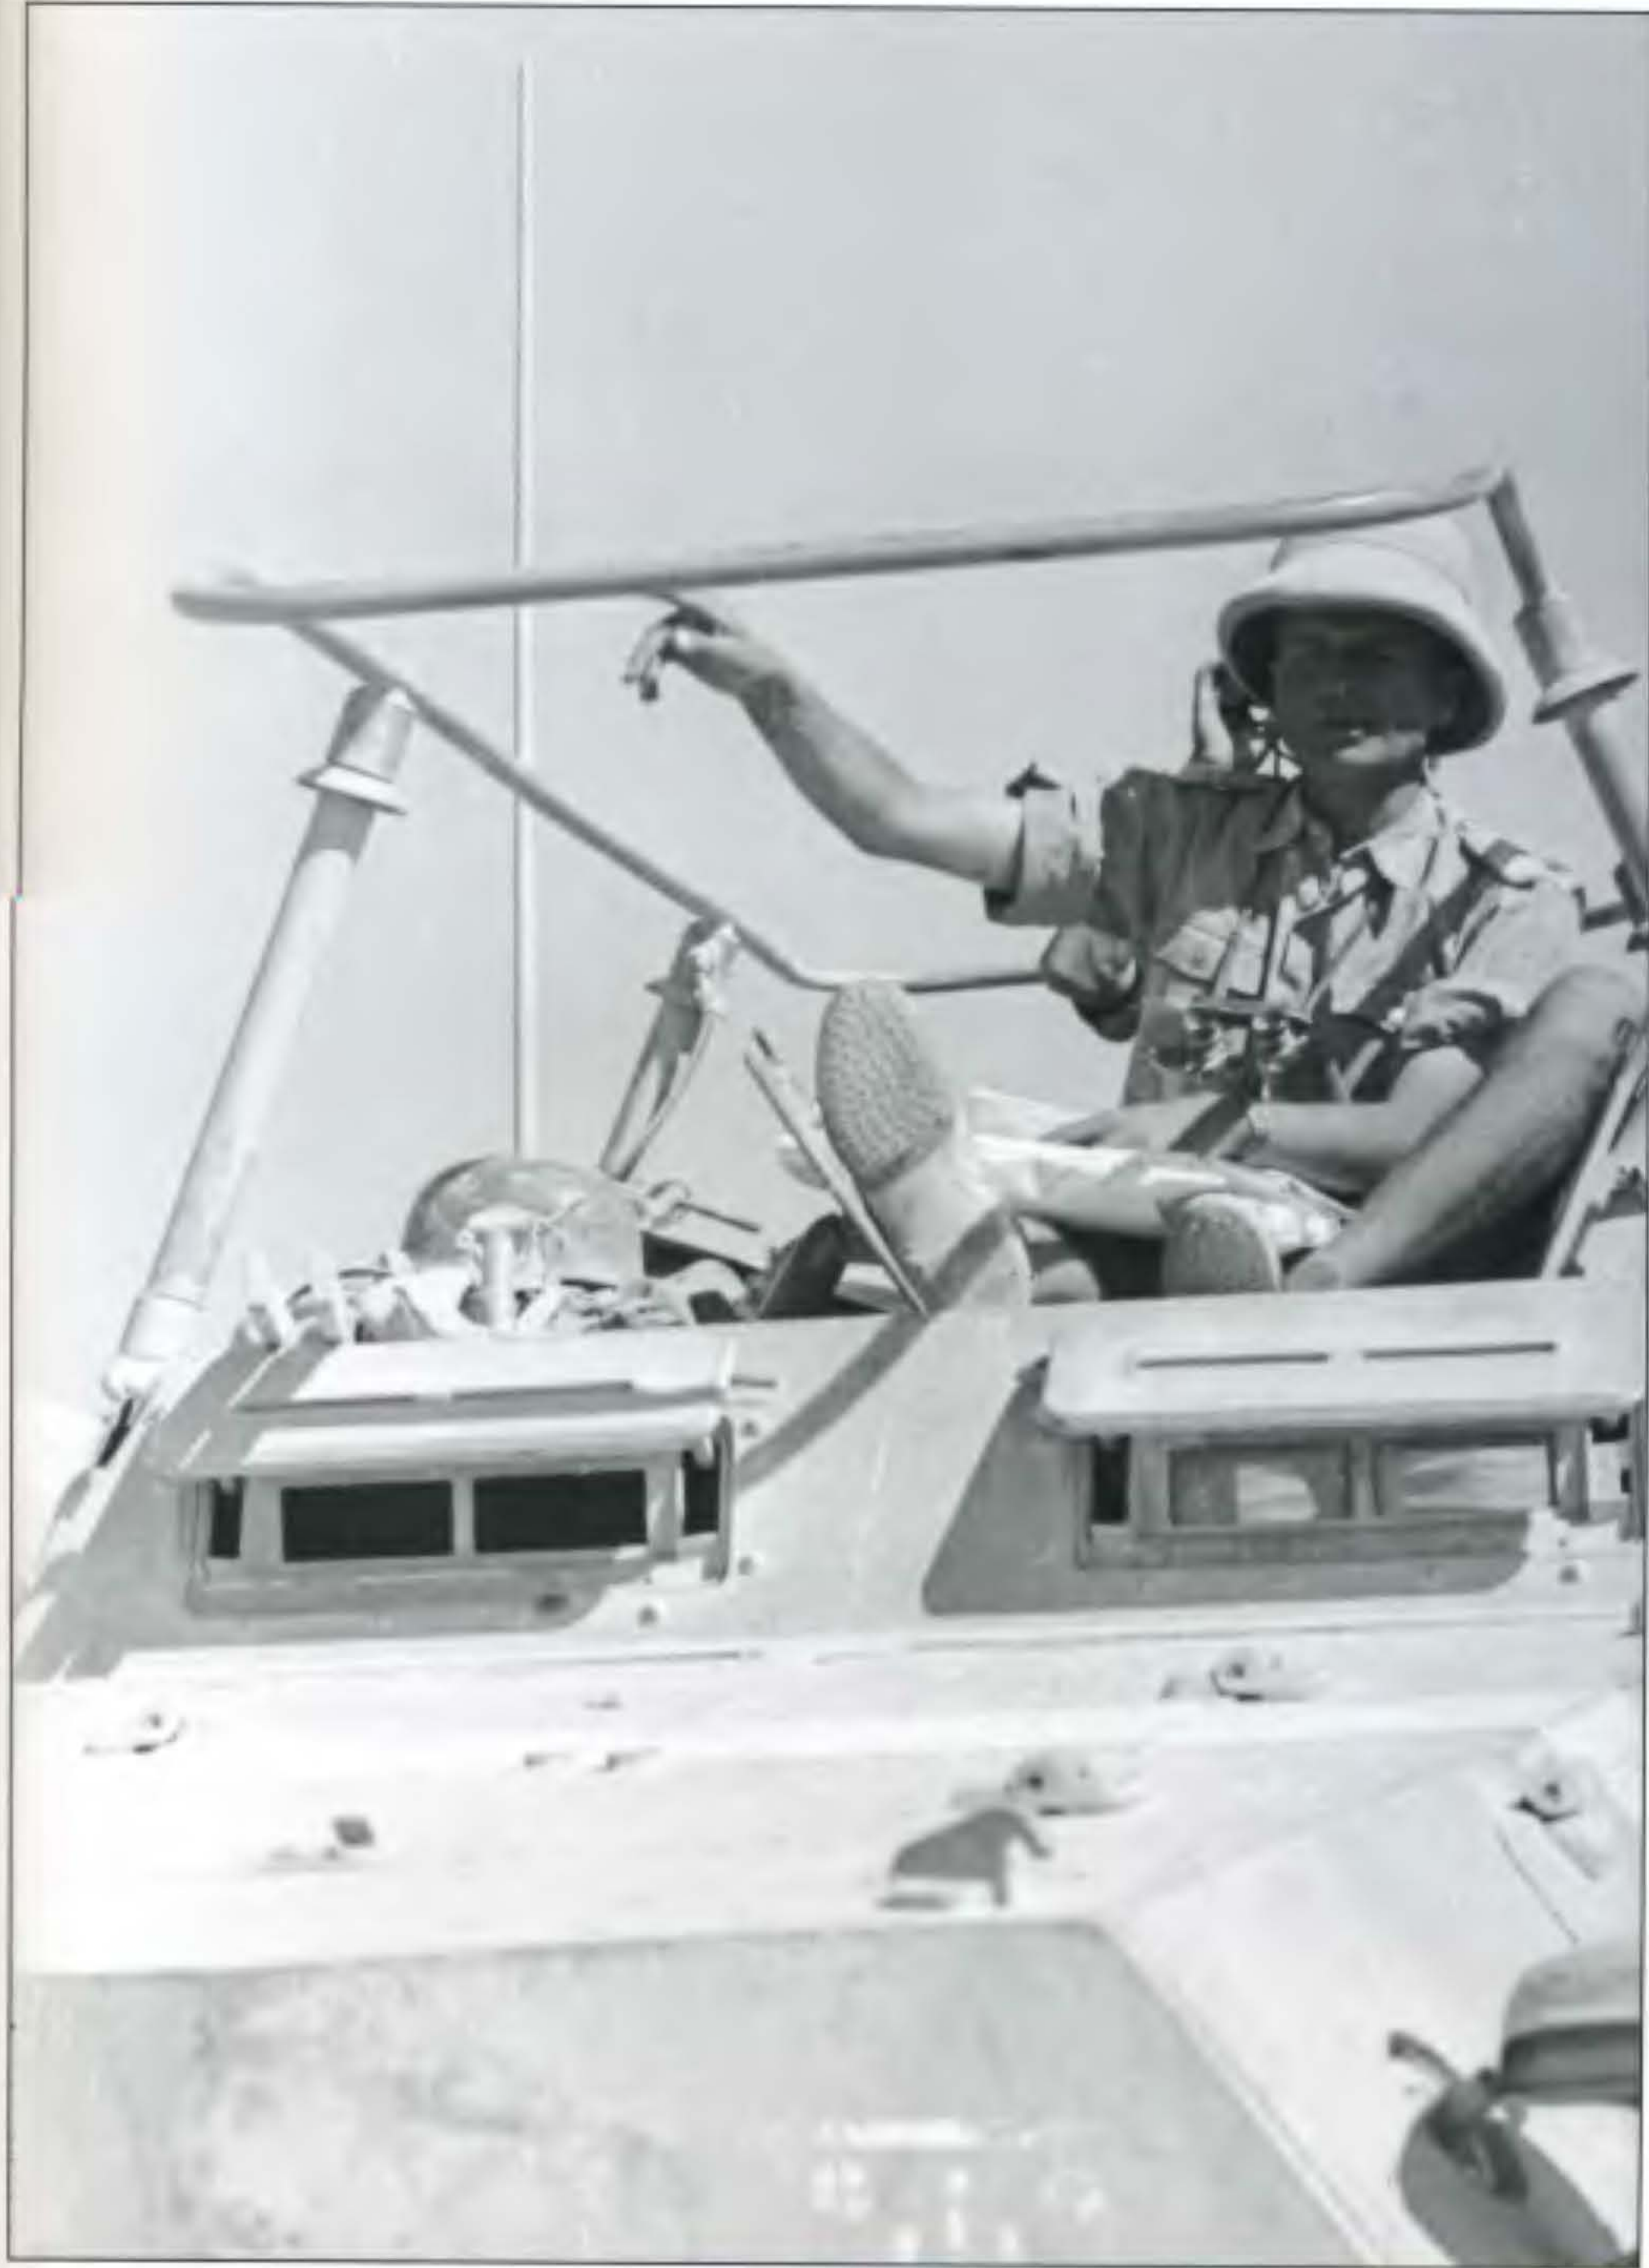
OPPOSITE PAGE: This is yet another variation on a theme. This 253 has acquired the complete frame aerial assembly from a 250/3 or 5 to increase the range and is consequently a far better resolved modification than those on the previous pages. It is clearly marked from an artillery unit but has a white air recognition stripe across the bonnet. There are clearly two layers of desert paint over the top of the original grey.

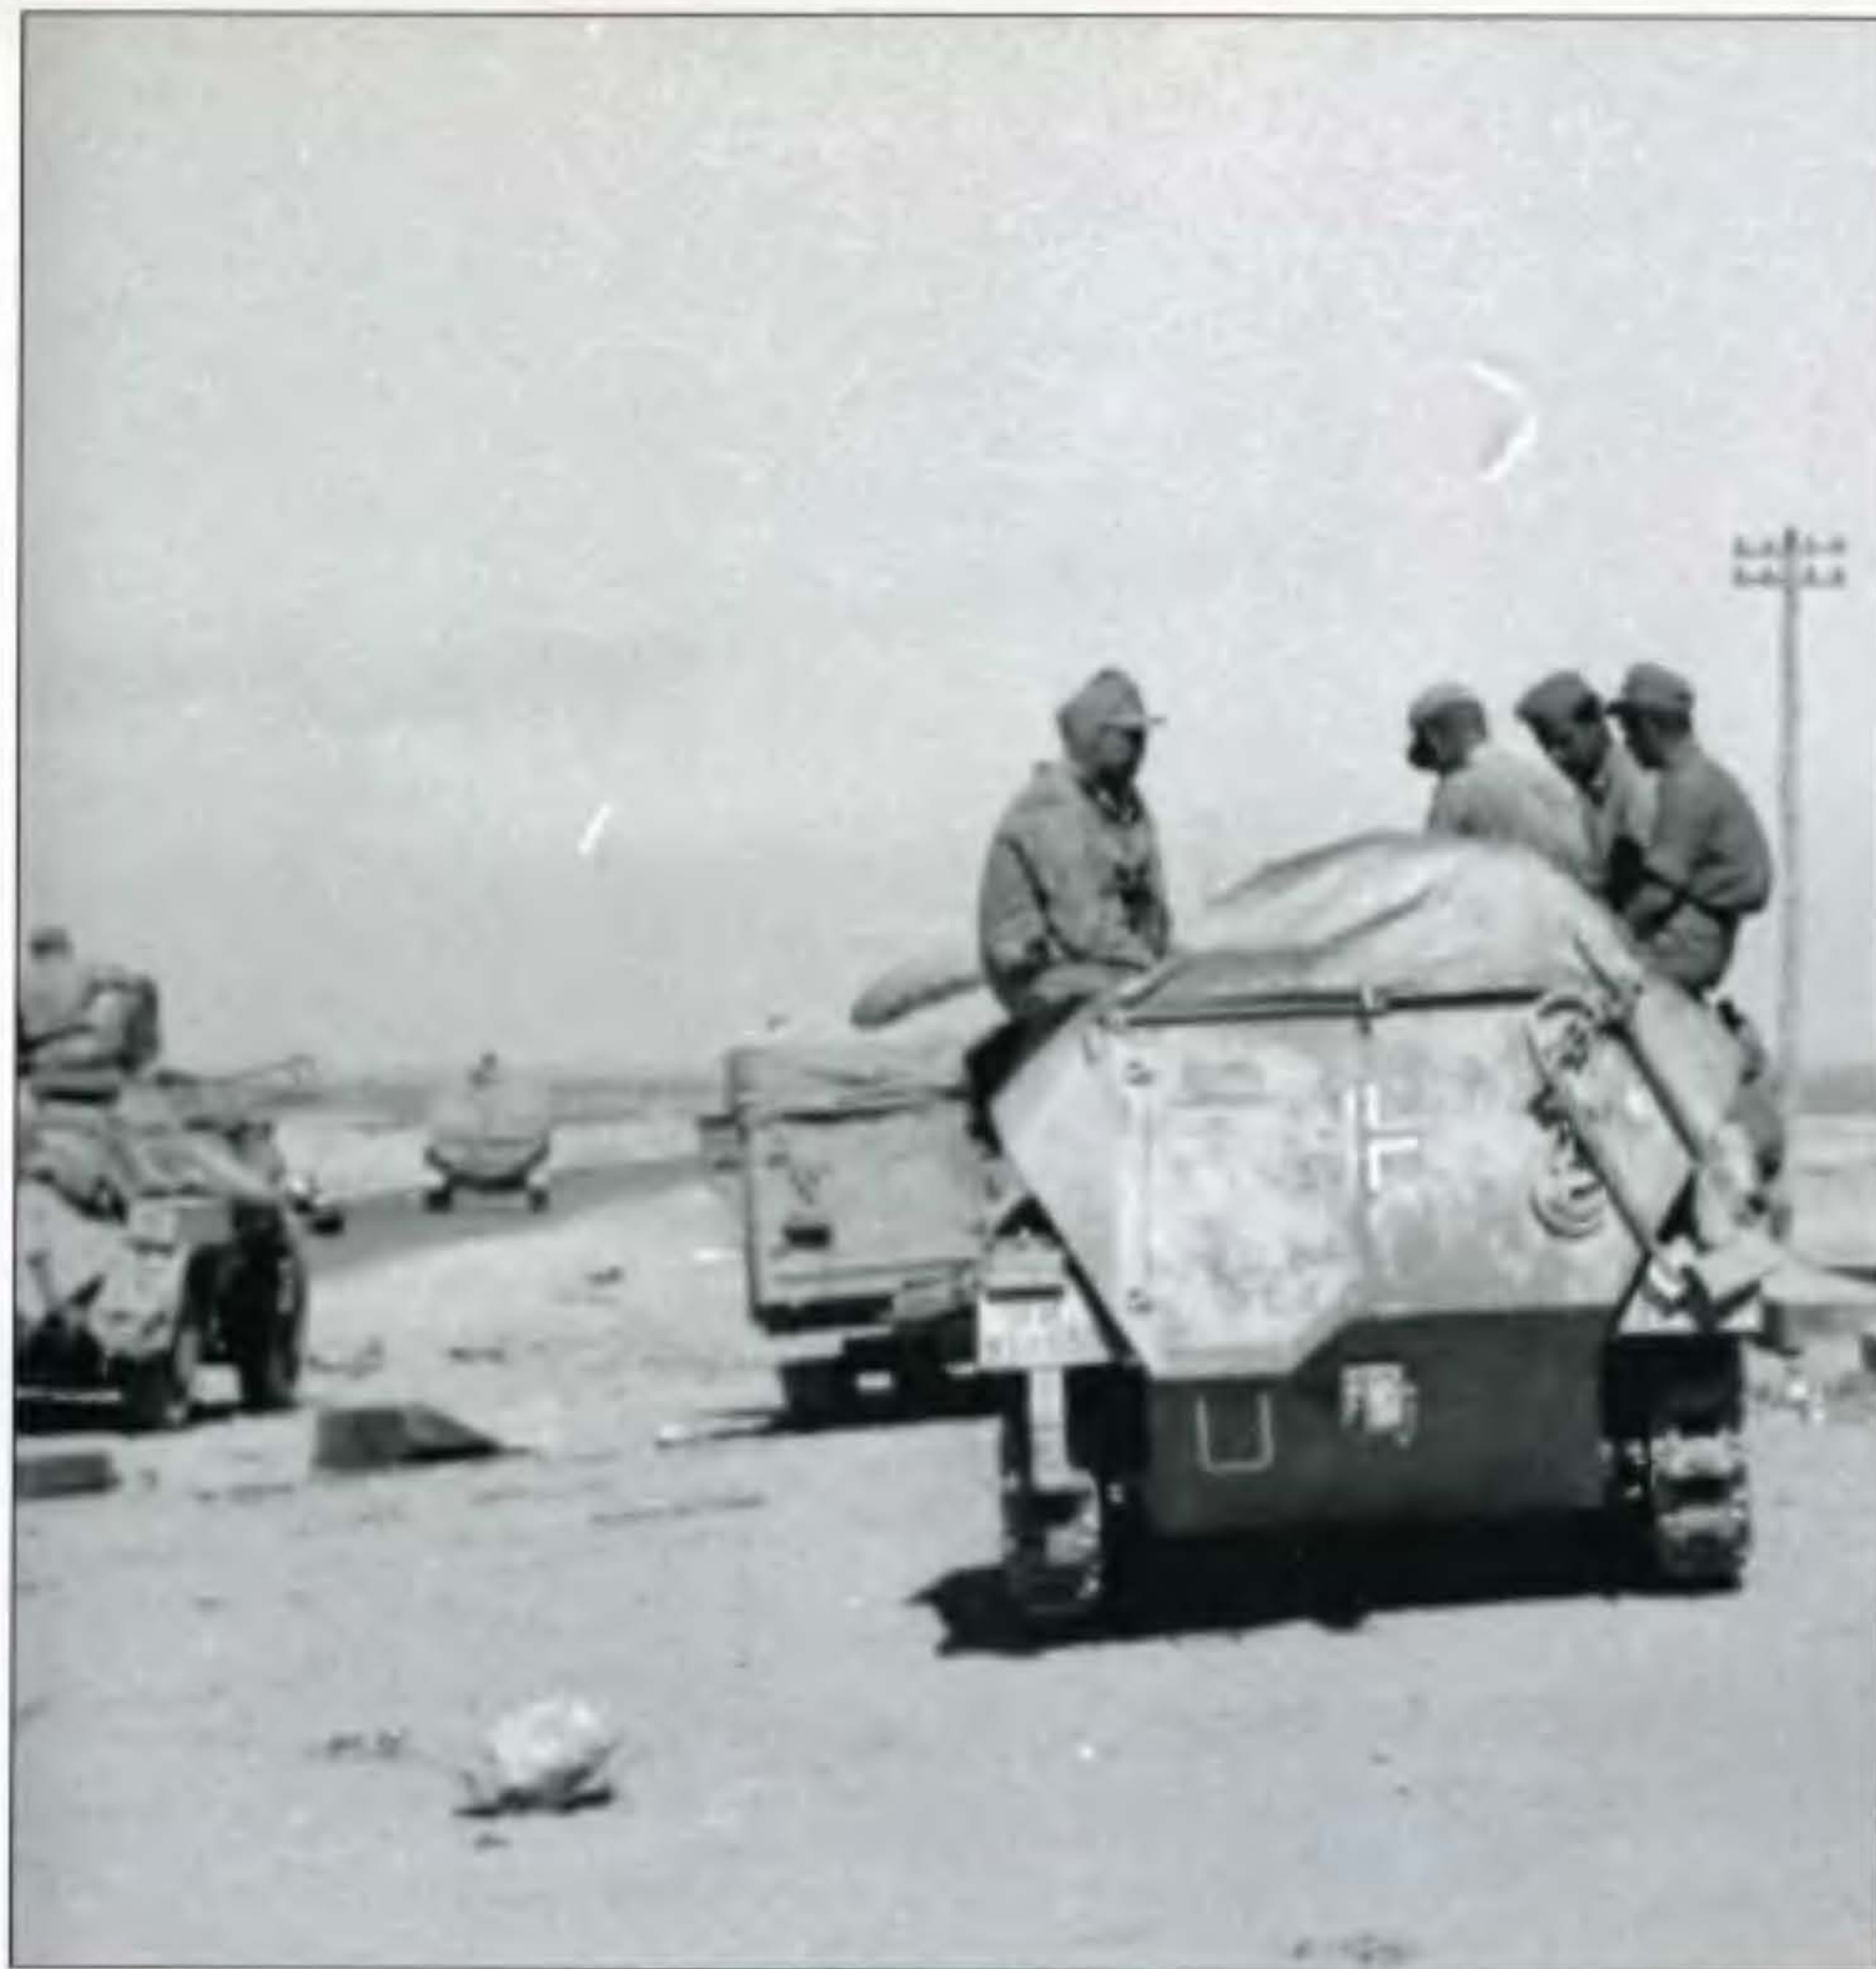
increased in comparison to the frame aerial. In this case only two of the three 1.25 metre metal poles are being used. If the aerial were to have been used at a 5-metre height it would provide a range of 25Kms for the 30 W.S.a. On top of the two pole sections sits the porcelain isolator and spigot that holds the antennae array itself. Notice how the cable for the frame aerial has been extended up to the mast and is deliberately held away from the metal poles by a mini spar to avoid any interference if the cable touched the poles.

Inside the rear door it is possible to see the Fu Spr.a or d radio set mounted under the right side of the main radio frame. This was only a feature of early 250/3s or 5s and only ever used in the Typ 1 versions of the 250 series. The loading plan manual produced in January 1943 shows only Typ 2 250/3s and 5s and the space where this is sited in this vehicle was used for a lockable cupboard and the radio has now moved in front of the co-driver, which was common to all Typ 2 interior layouts using the Fuspr.a, d or f.

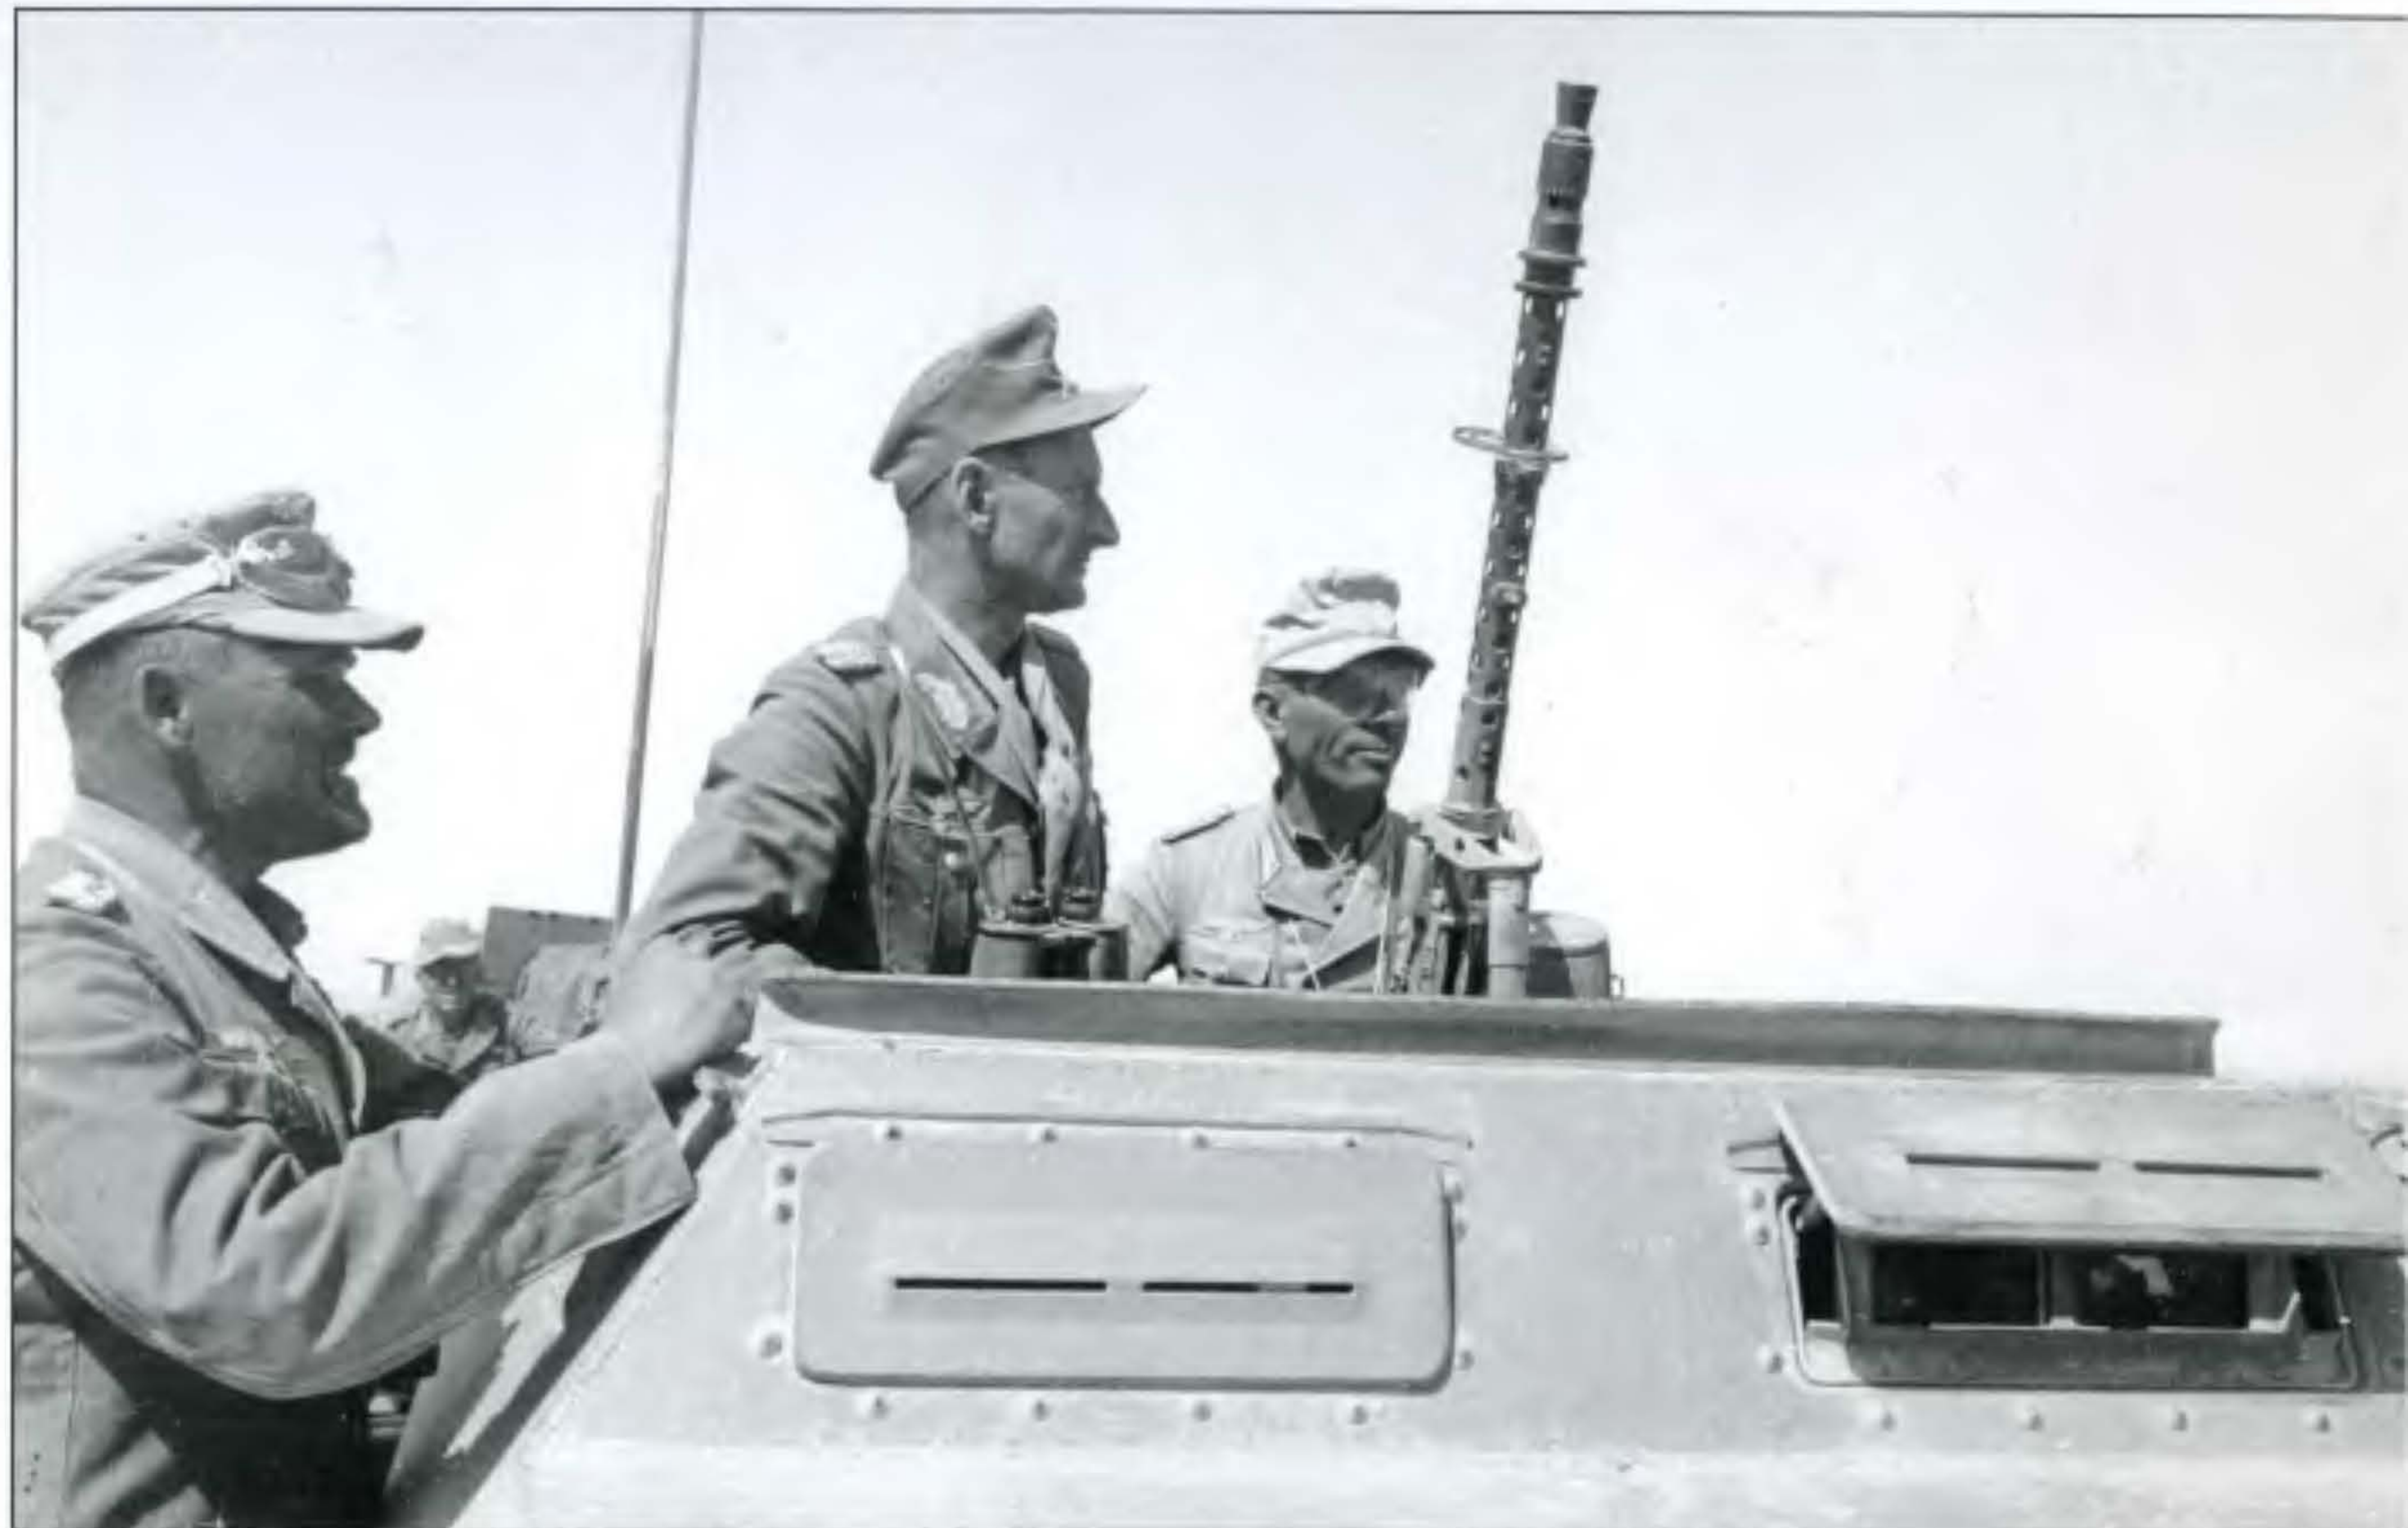
The Sd Kfz 222 was developed after the 223 and designed to equip the first schwadron of the *Aufklarungs Abteilung*. With fully independent suspension, four wheel drive, four wheel steering and 3.5 or 3.8 litre V8 Horch engine, it proved to be a highly mobile and effective vehicle armed with a 20mm KwK30 or 38 L/38 Kanone and co-axial MG34 with a range of 300 kms. A total of 989 were produced between 1936 - 43. This is the early version with the 3.5 litre engine and non-hydraulic brakes.

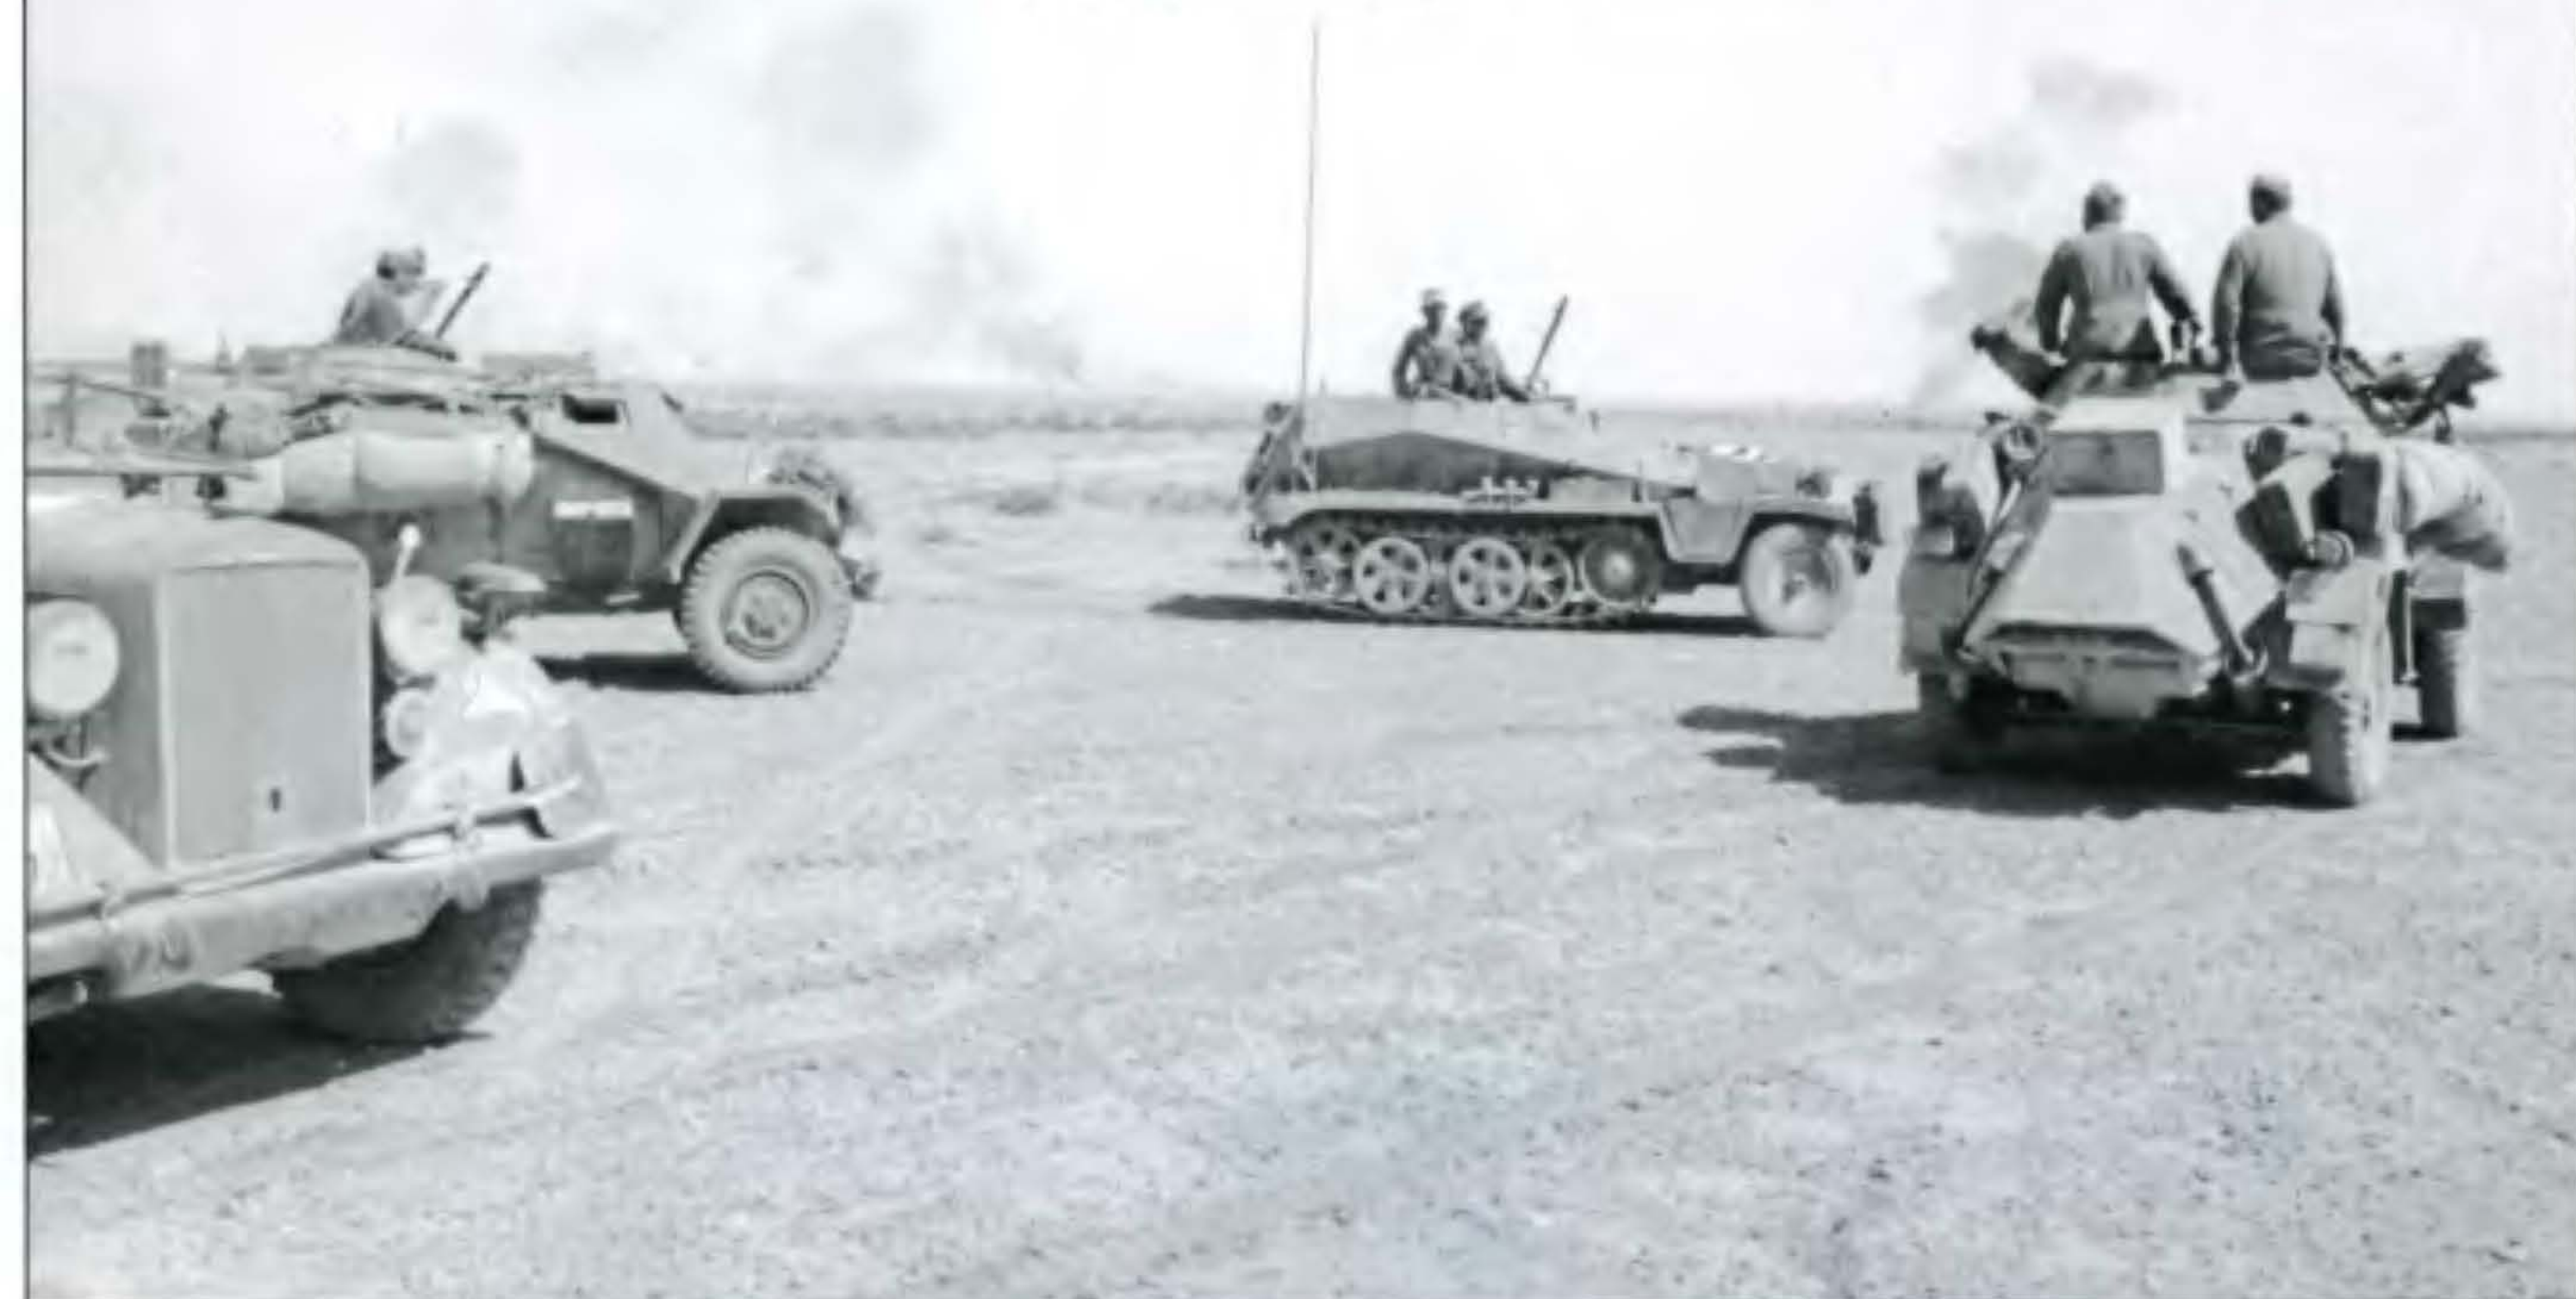
Sd Kfz 223 (*leichter Panzerspahwagen Fu*) was designed to provide long-range communications to armoured car squadrons of the Reconnaissance Battalions. In this case the 223 is an integral part of the Commanders communications network, because his 250 can only have a single set in the back. Without the 223, he would be unable to receive or send long distance information required to make critical decisions. Note that the 223 lacks the armoured hub plate protectors, but does have the ring protectors for the tyre valves. Despite the fact that the tyres are the bullet proof variety, it still has a small inflatable tube to assist in keeping the tyre from slipping on the wheel rim. In total 550 were produced between 1935 - 44. In this guise it carried the *Fu12* in conjunction with the frame aerial, to provide a range of 75 square kms, plus a *Fuspr.a* using the 1.4 or 2-metre aerial, which is mounted on the *antennenfuss 1* seen on the rear of the turret. The aerial can be seen stowed horizontally along the top of the superstructure behind the lead arm of the frame aerial.

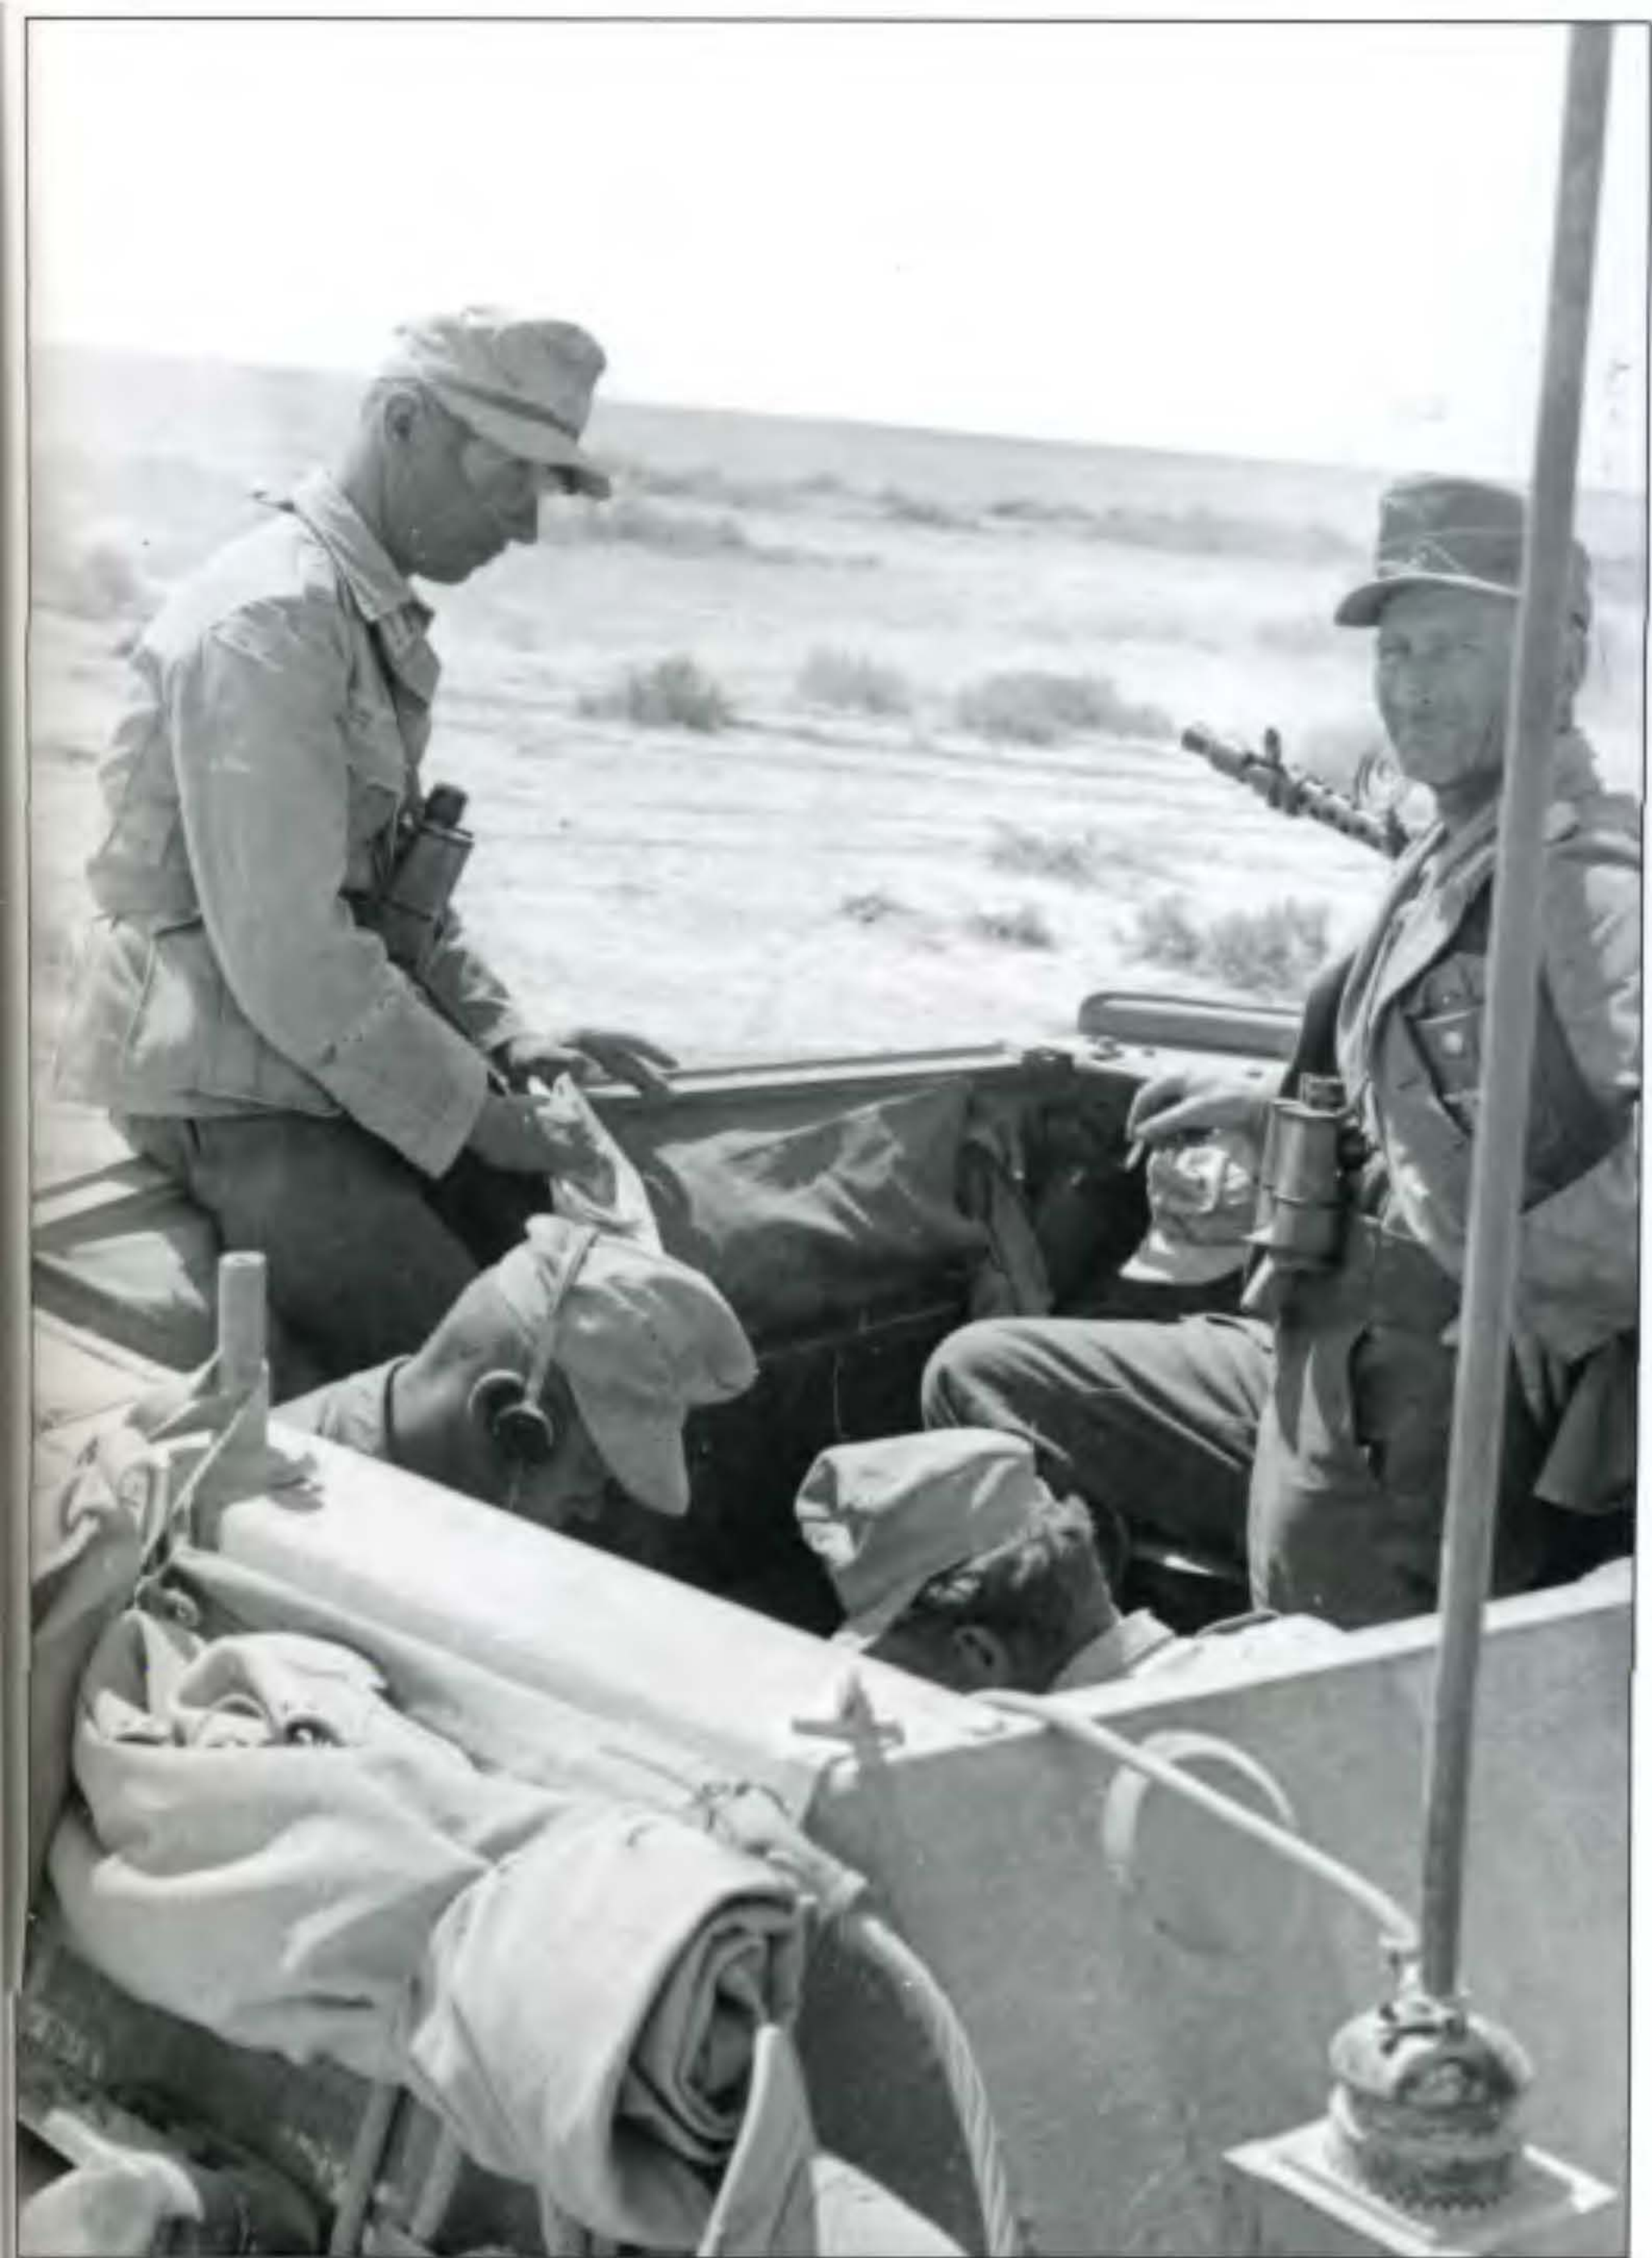
If it wasn't for the 'one-off' aerial base, this 250 would raise all sorts of questions about interior fittings for early 250s. They can only be using a single radio set given their proximity to each other, the only viable set would be the Torn E.b general receiver radio set that covered virtually every other frequency used by the different arms of service in the Wehrmacht. The first version of the Afrika Korps cuff title as worn here was instituted on 18th July 1941. Note the driver has turned his cap around 'hip-hop' style.

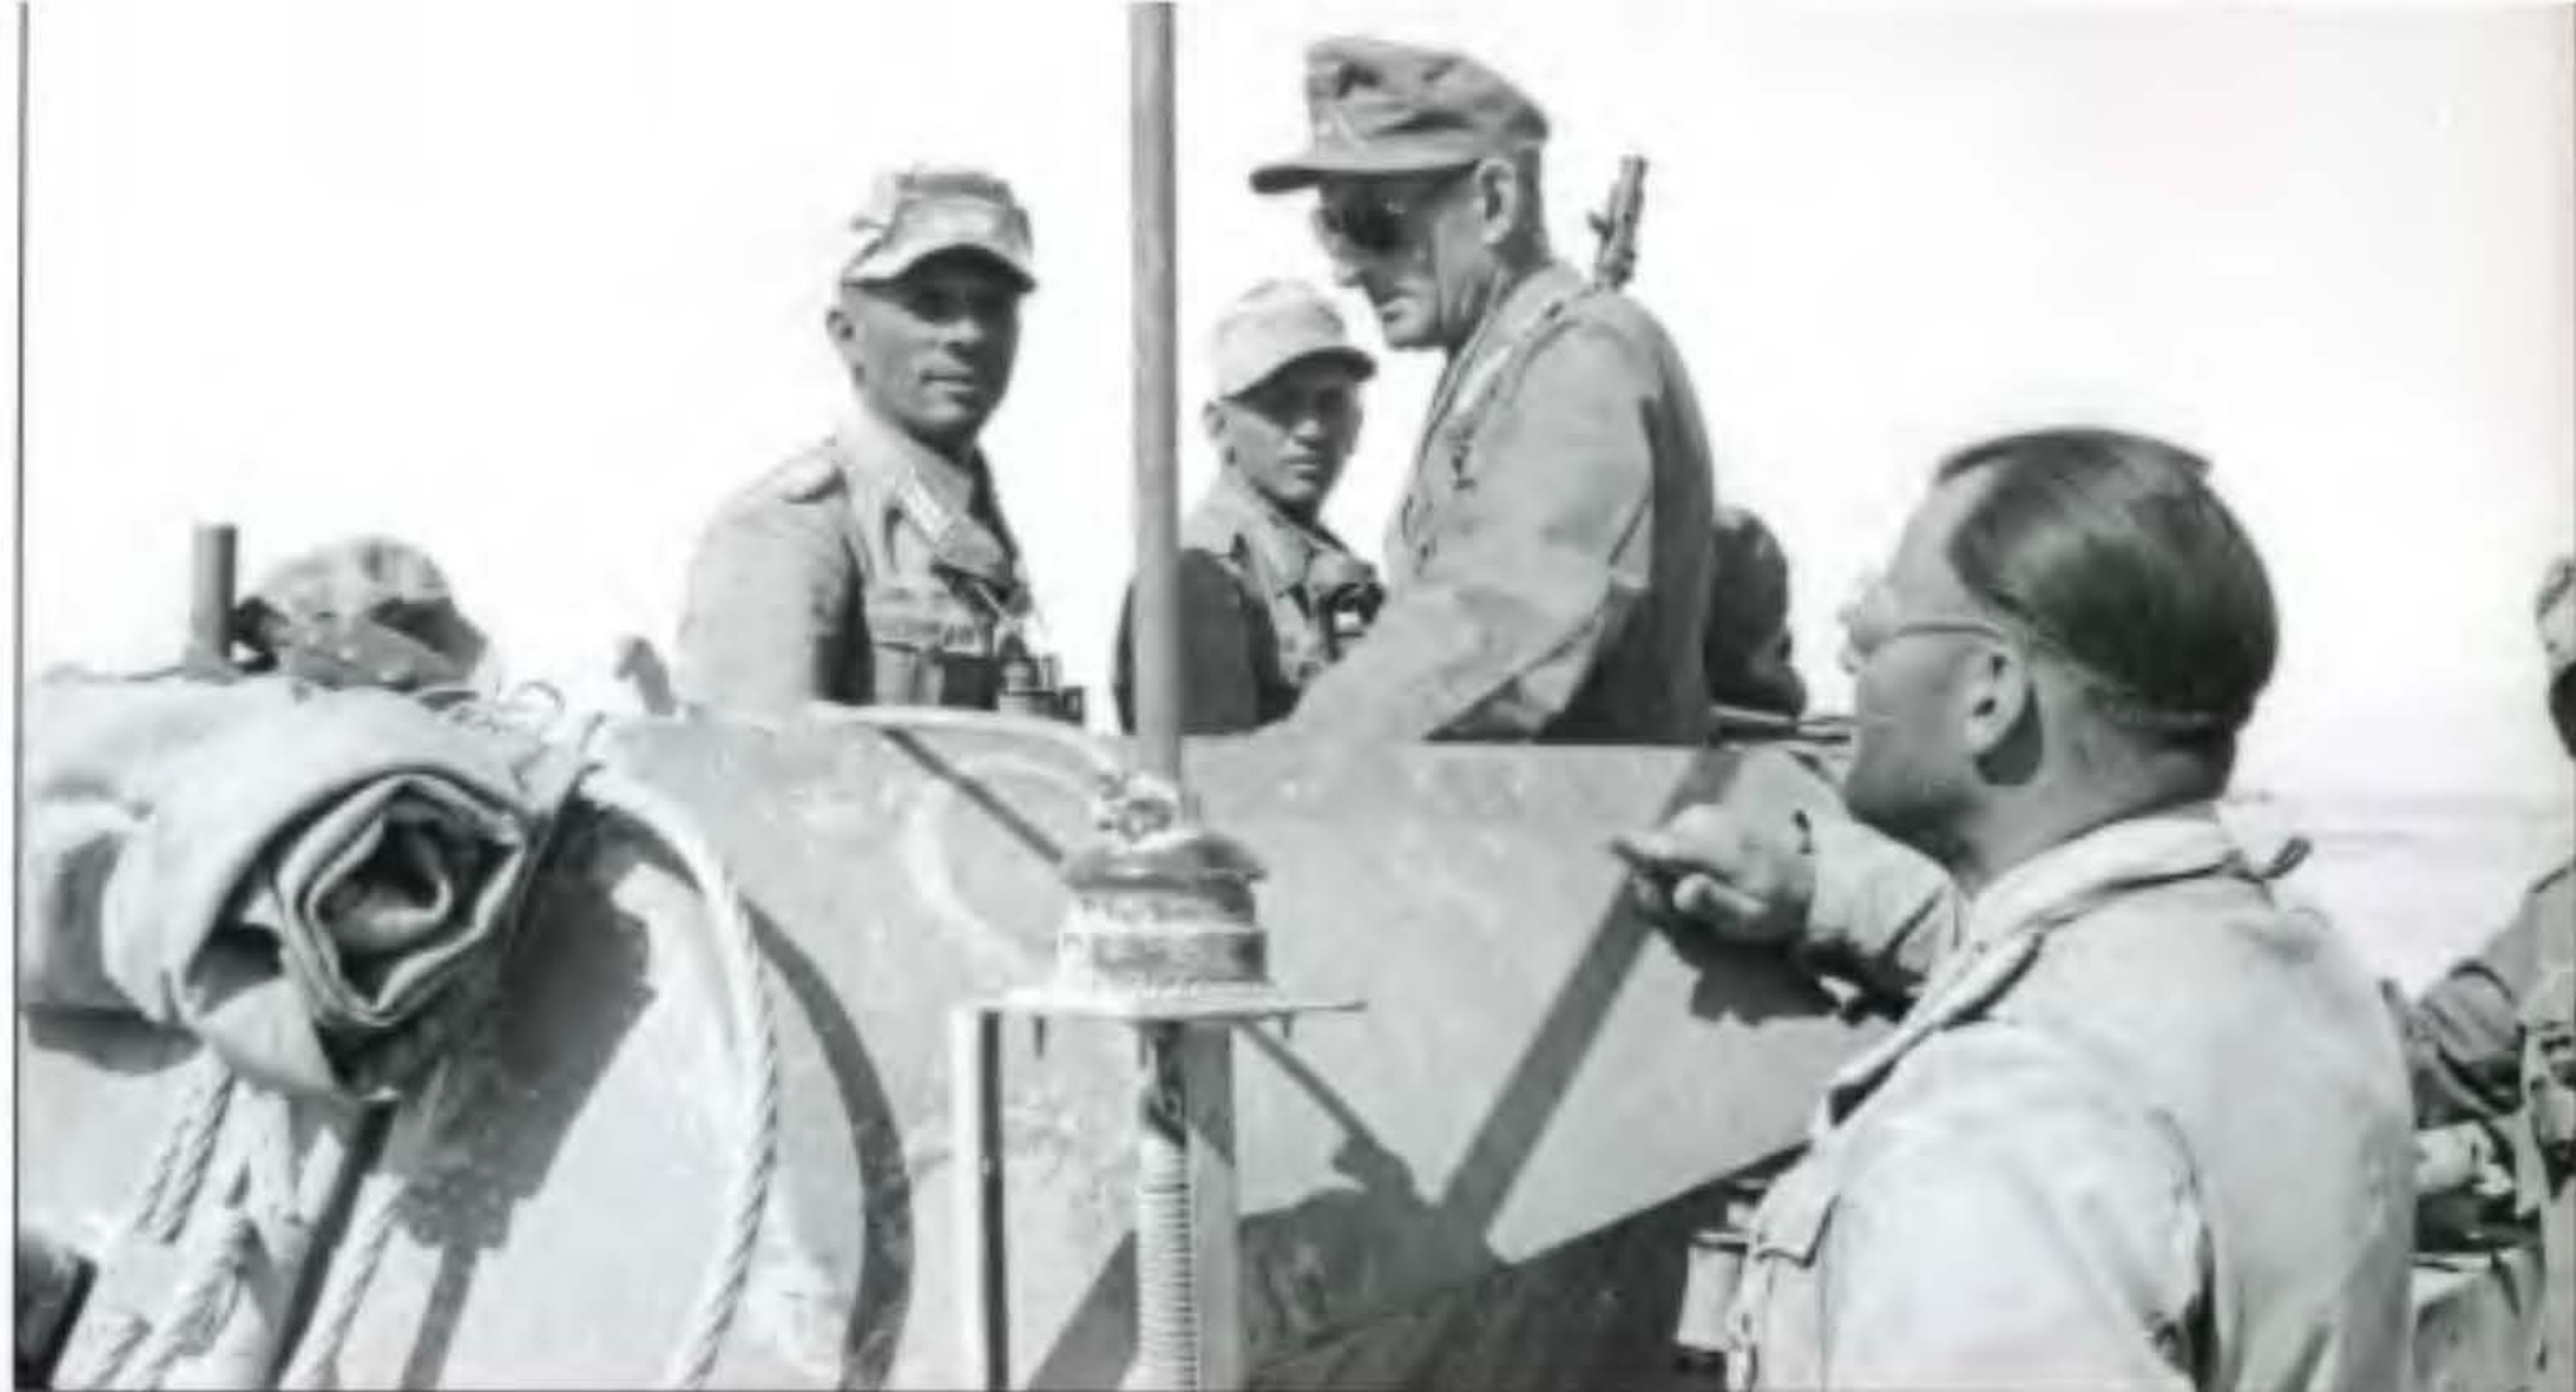
Even though the 250 is painted in Gelbbraun (RAL 8000) it would appear that it was applied in a fairly thin layer with the original Dunkelgrau (RAL 7021) showing through. Note how subtle the changes can be when comparing the dusty steel helmet in Dunkelgelb to the faded Gelbbraun. However the crew have at some point decided to add a layer of mud paste to lighten the tone. Over time it has either worn off or has been subsequently rubbed or washed off leaving patches in the recesses and streaks on the lower panels.
