TOTAL DETAIL

Sd Kfz 252, 253 & early 250

Sd Kfz 252, 253 & 250 (Typ 1)

Volume 3 - Part 1

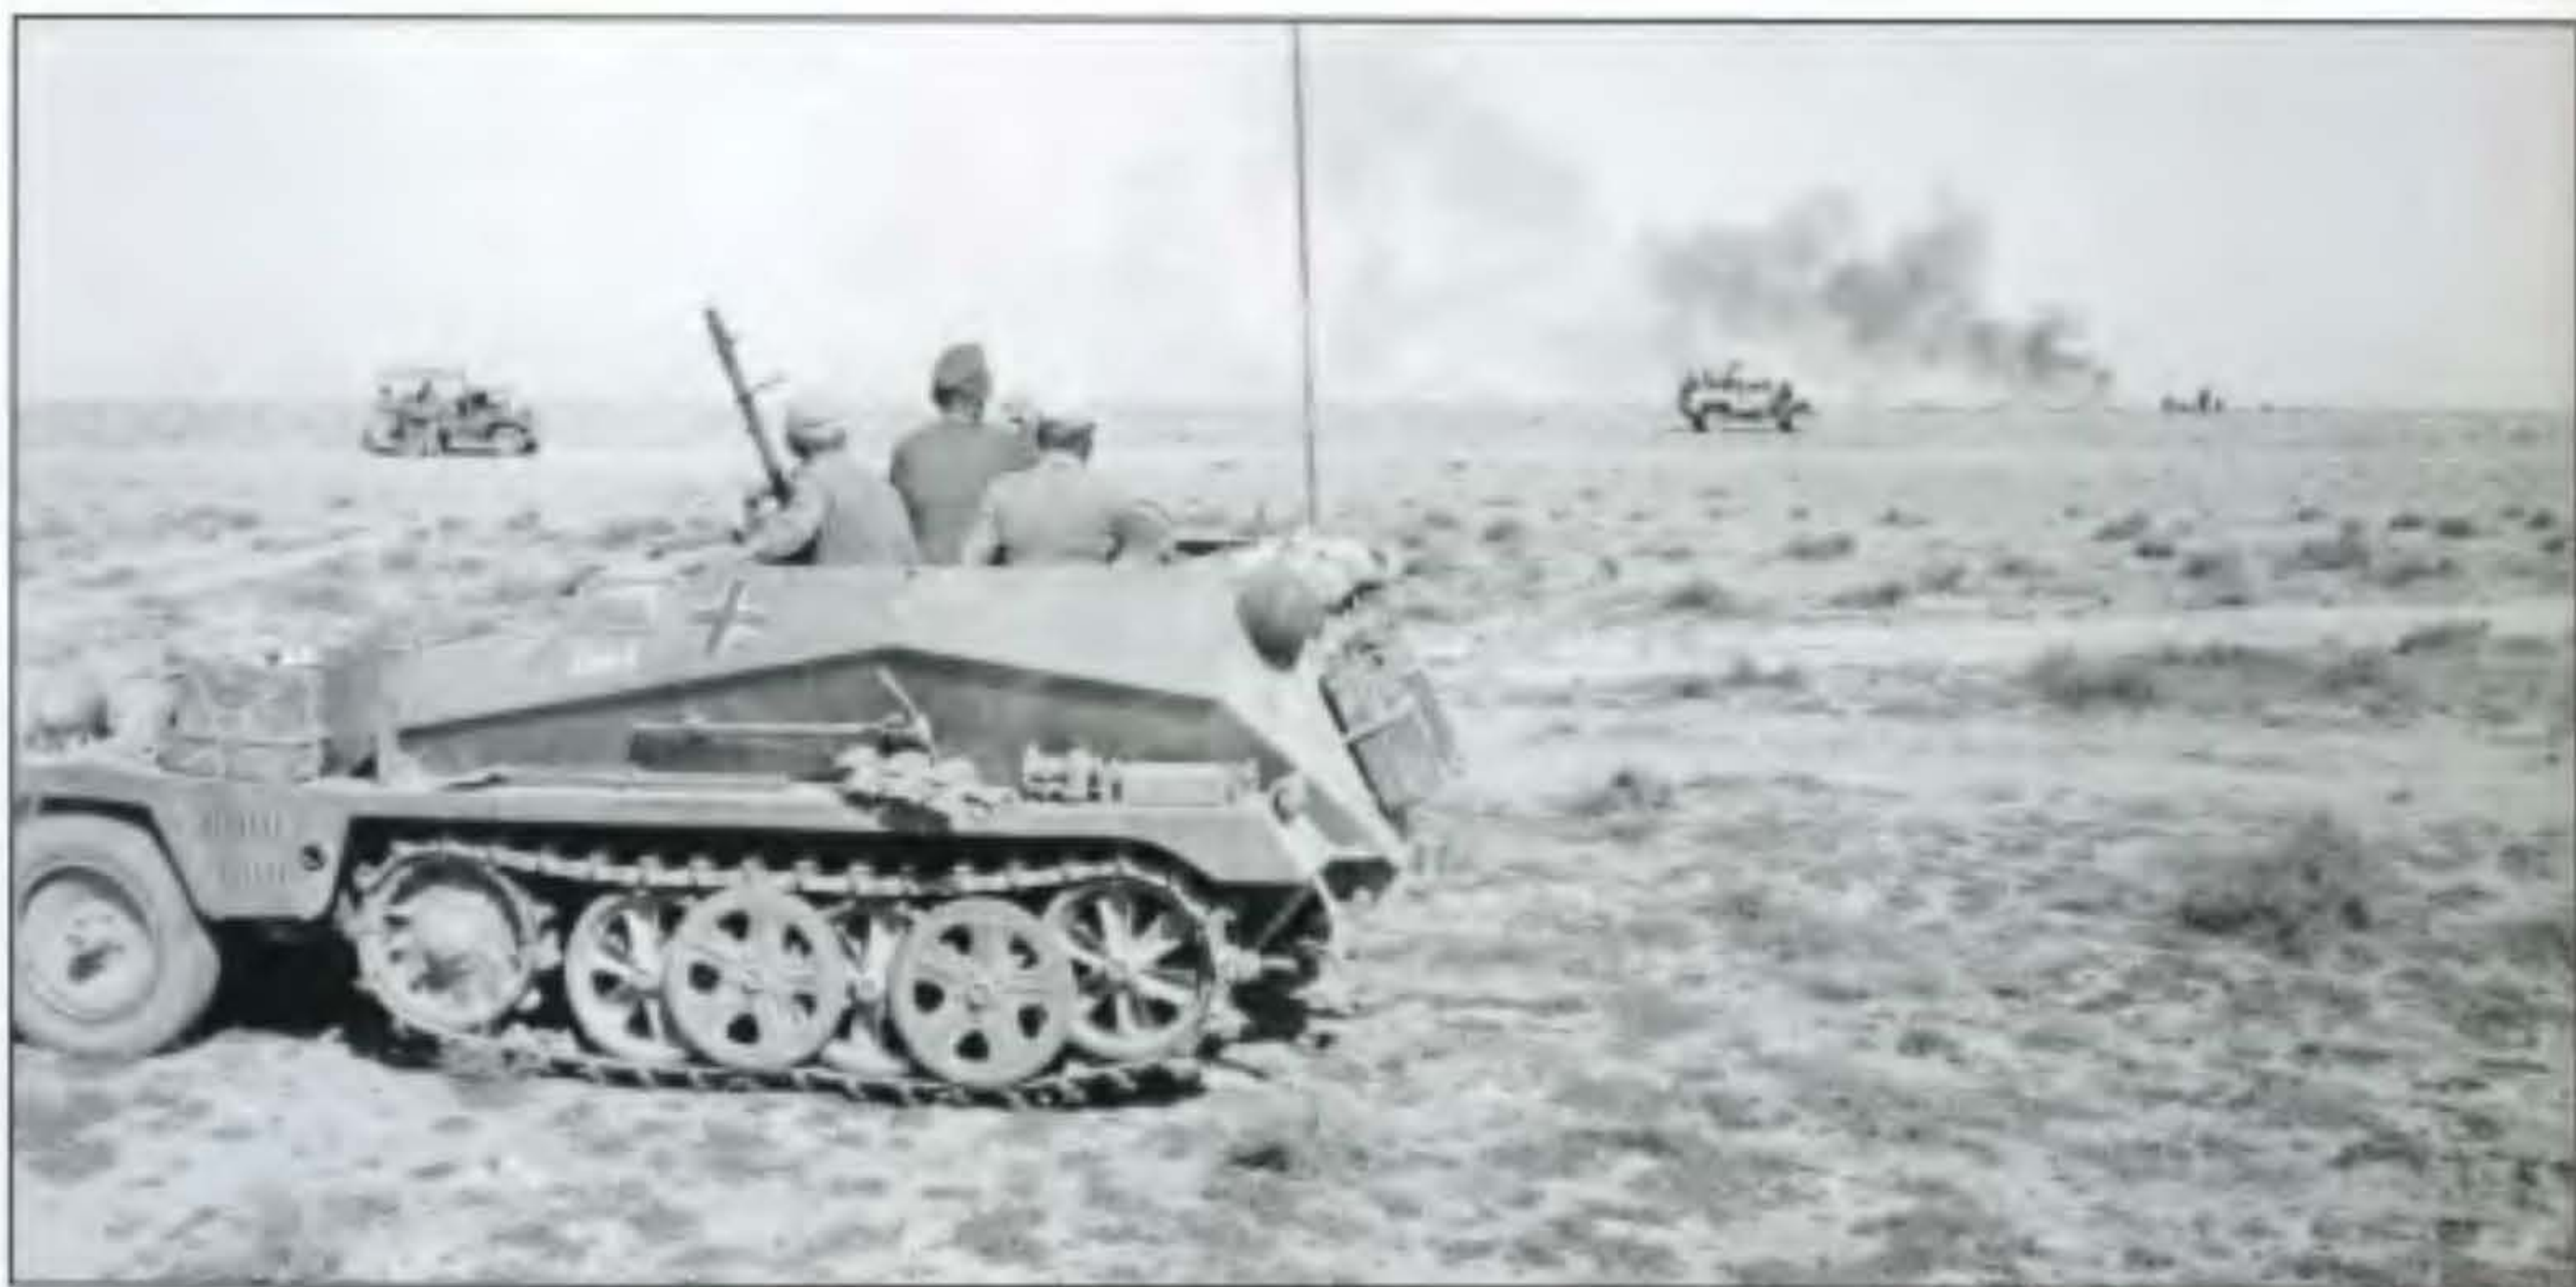
Even though the 250 is painted in Gelbbraun (RAL 8000) it would appear that it was applied in a fairly thin layer with the original Dunkelgrau (RAL 7021) showing through. Note how subtle the changes can be when comparing the dusty steel helmet in Dunkelgelb to the faded Gelbbraun. However the crew have at some point decided to add a layer of mud paste to lighten the tone. Over time it has either worn off or has been subsequently rubbed or washed off leaving patches in the recesses and streaks on the lower panels.

The circular plate that reveals this 250 Typ 1's heritage is clearly visible in the photograph, as is the placement of the aërials which copied the original format from the 253. The spring assembly is designed to hold the base in place on the frame without the need for bolts to interfere with the improvised mounting and the isolator.

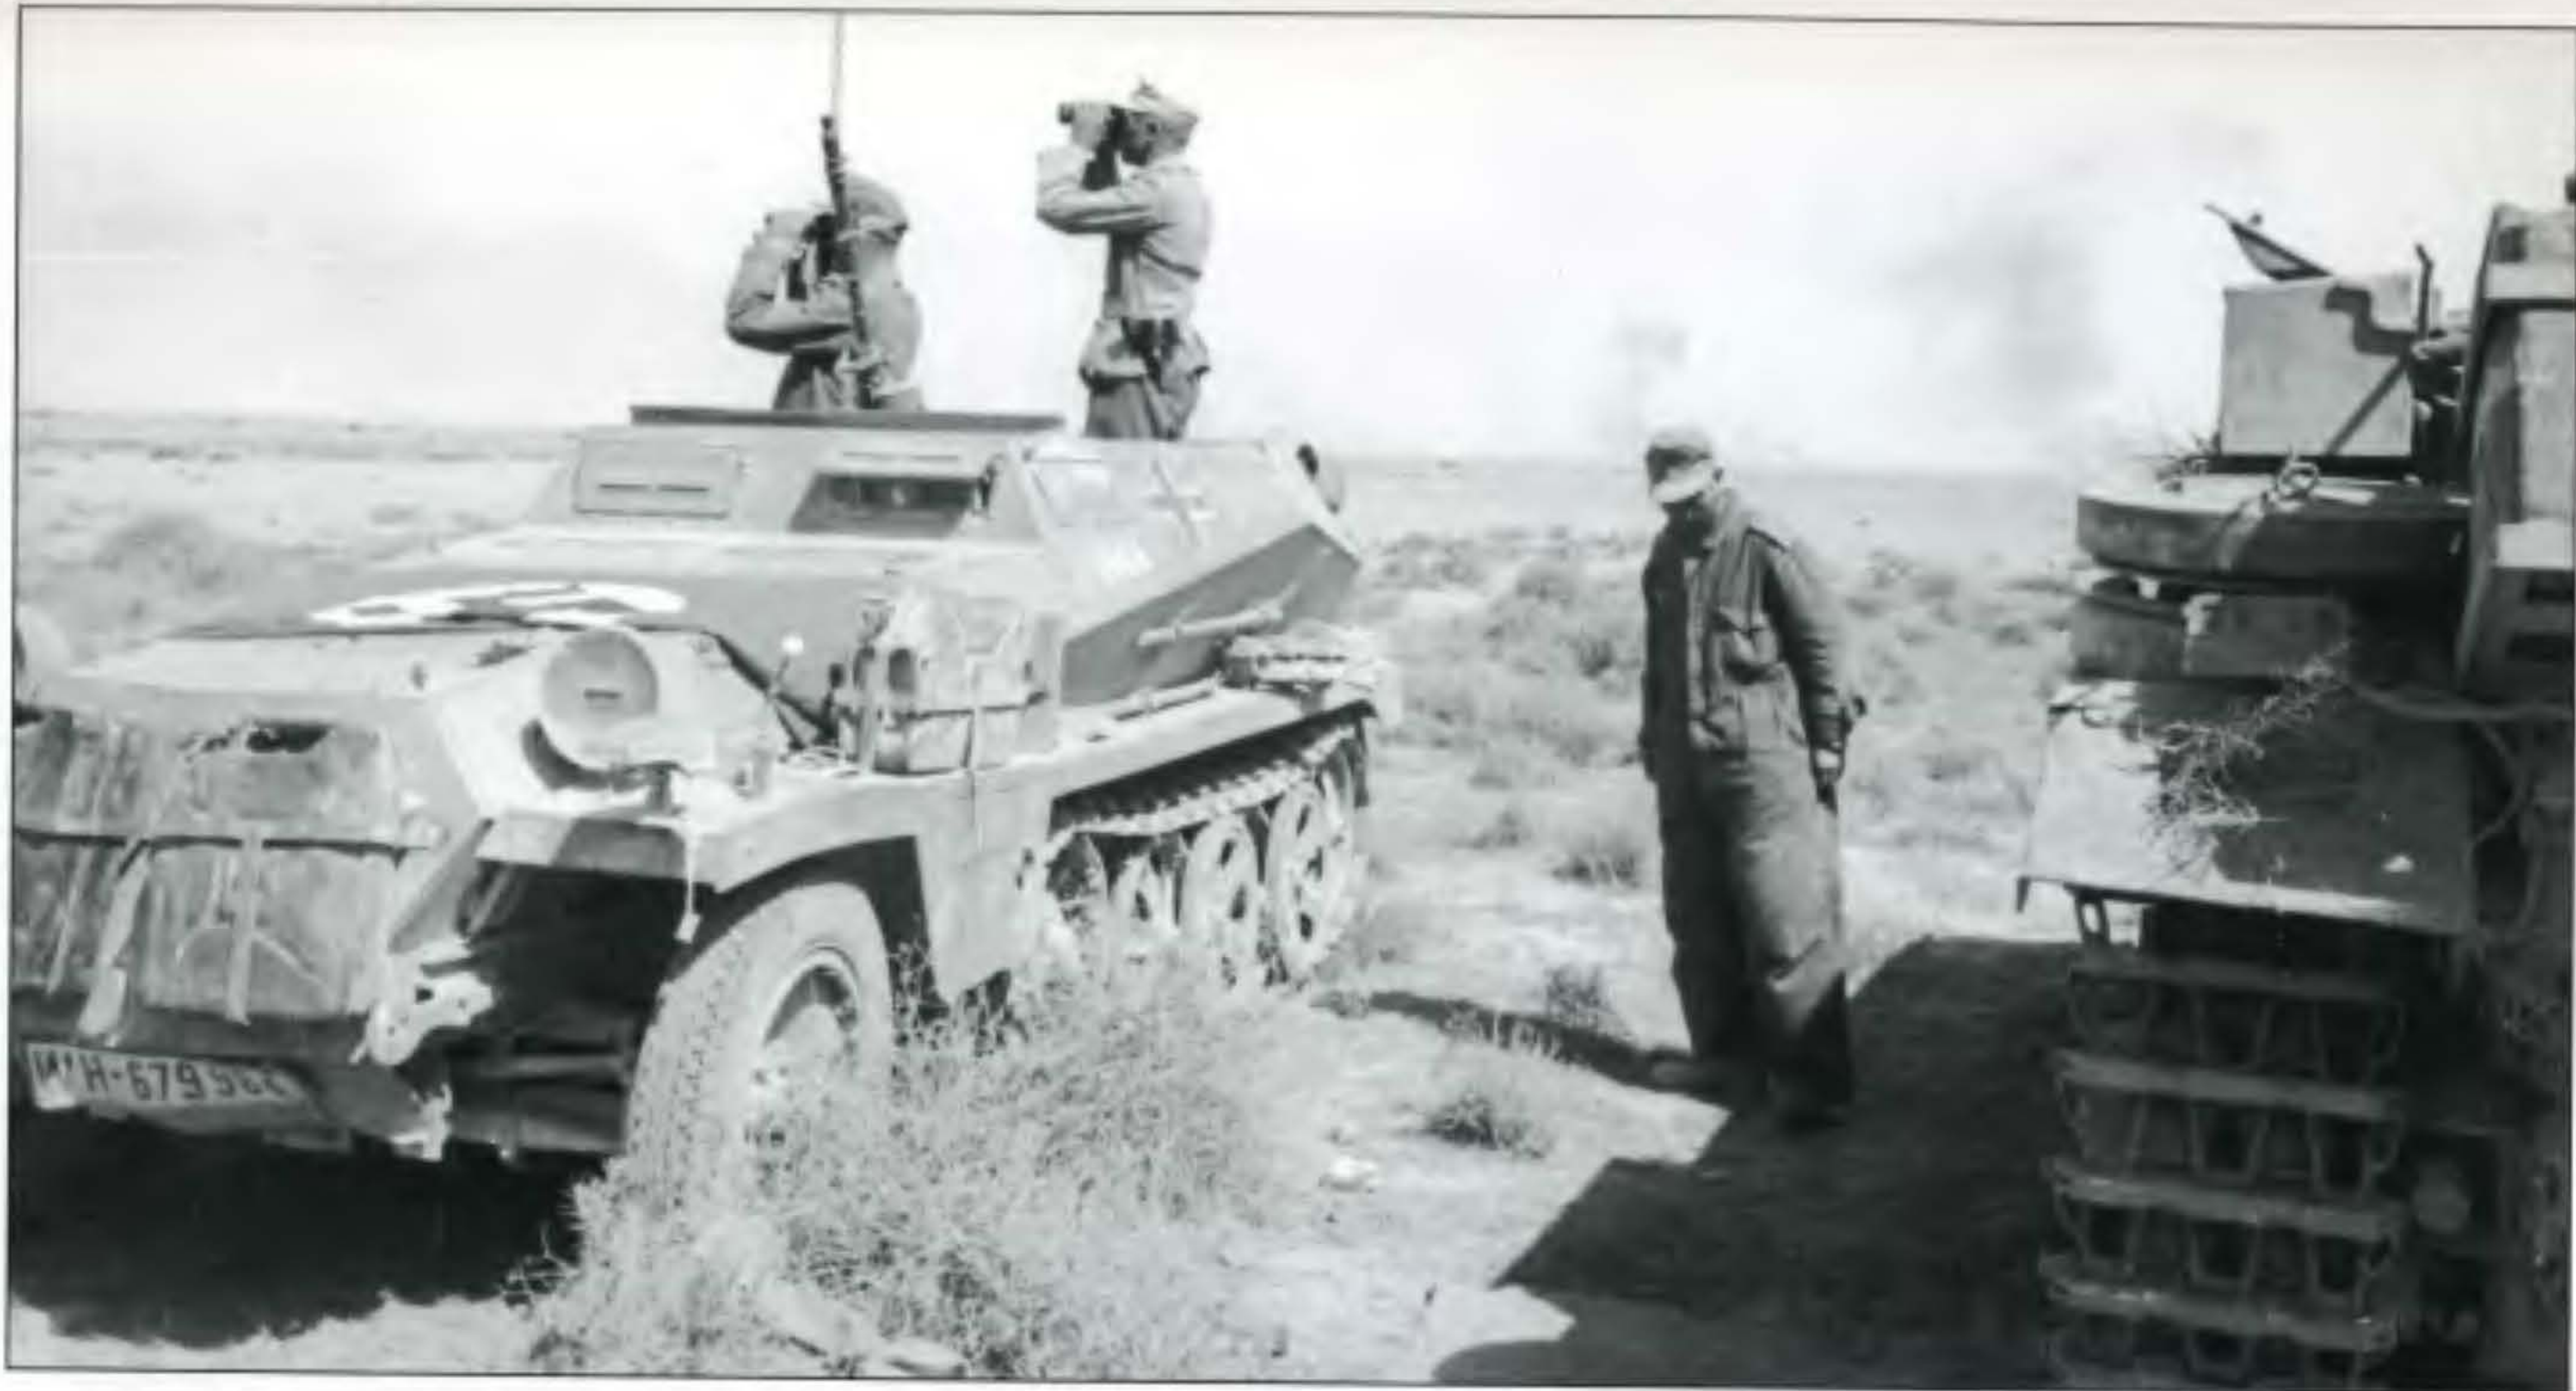
One of the Afrika Korps biggest problems was the re-supplying from Italy to Tripoli. It wasn't until April 1942 that Kesselring's 2nd Air fleet began bombing Malta, finally allowing sufficient supplies and new vehicles to find safe or somewhat safer passage from the RAF based on the Island. This StuG III Ausf D belongs to 5th Panzer-jäger Kompanie / Sonderverband 288 and was one of three from the original shipment of 6 StuG III Ausf Ds that arrived in April 1942. It has also been suggested that of the the three that did arrive, one fell into the sea upon unloading at the port, the second was captured leaving only one to see action as part S.vb 288. If this account is correct, perhaps this is the only StuG in North Africa until the arrival of 4 F/8s in November 1942. Note the purpose made rack for jerry cans on the rear.

The jerry cans on the nose of the 250 have covered up the tactical signs but it still has its number plate and the leather cap for the Notek light spigot. Note the low height width indicators for an early middle production vehicle and that the mud and track guards are still in good condition. Also note how the glass remains in the vertical position even with the visor open on the Typ 1, plus the different tread pattern on the front tyre.

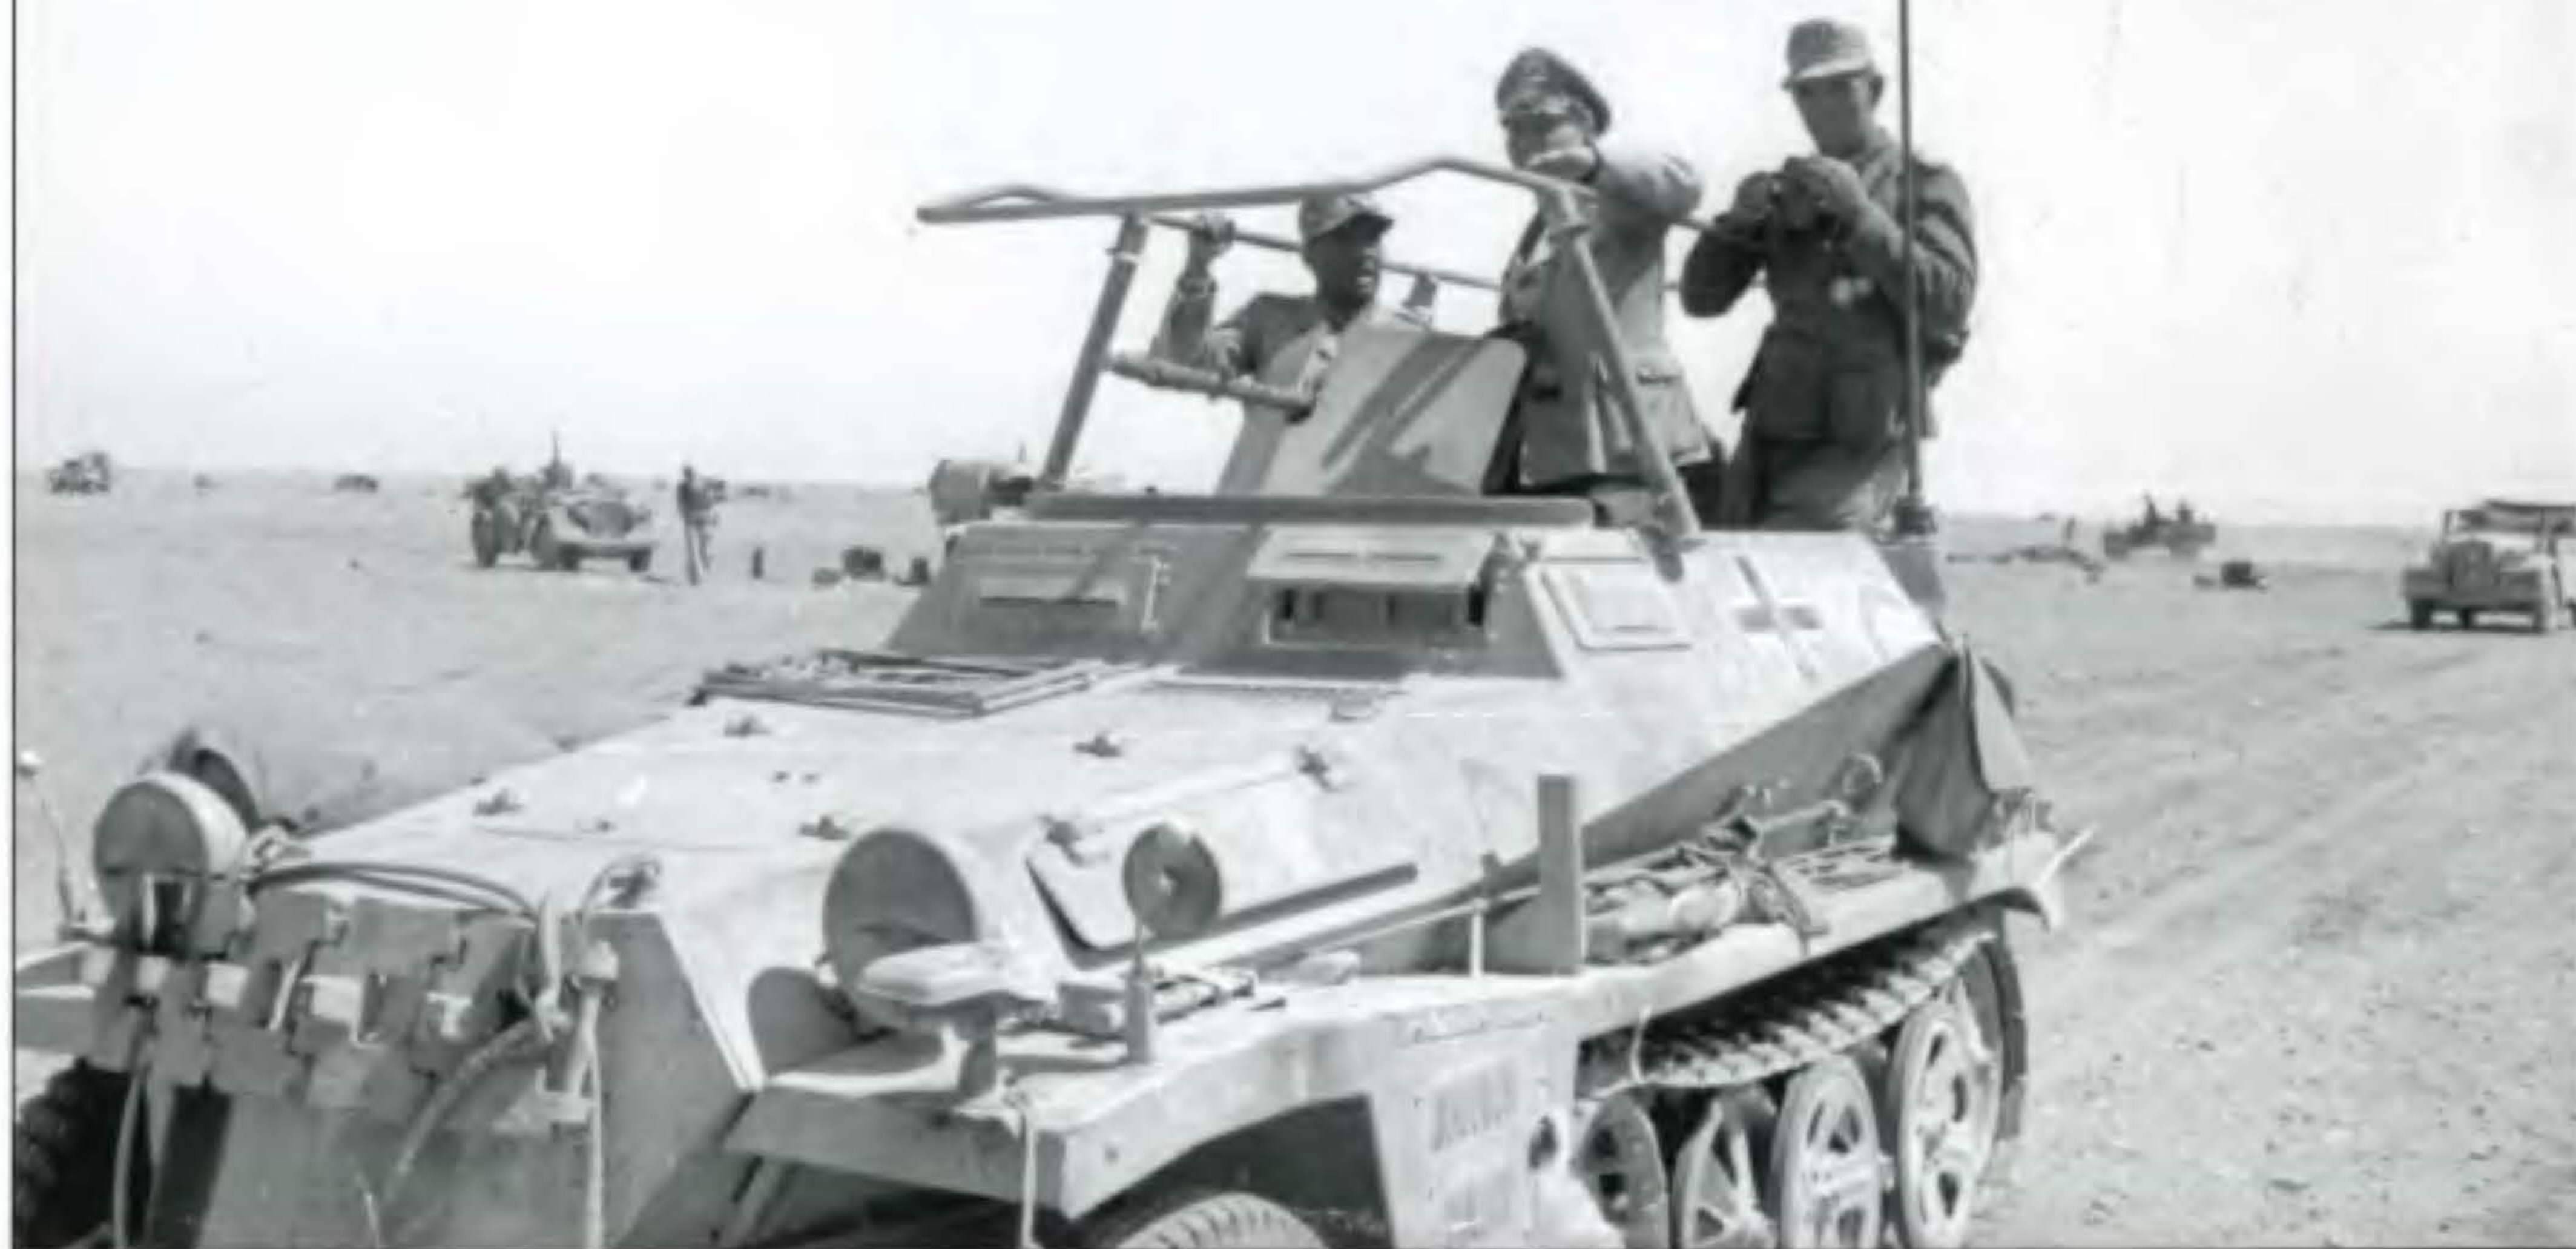
Perhaps the best-known 250 ever built. Rommel's 250/5 'Greif'. Often misquoted as a 250/5 this vehicle is most definitely a Sd Kfz 250/3. The soldier on the left is clearly standing on the seat box seen in 250/3s but missing from the 250/5s. It is a middle production vehicle with the track mounted semaphore indicators, but has the earlier medium height width indicators. Note the spare aerial in its own brackets with a supplementary support for the tip in front of the semaphore.

The leather cover for the Notek is still in place, the headlights have their original factory lens covers made of leather, the tracks hang from the front lifting hooks, as does the tow cable. In the background to the right is Rommel's personal Horch Kfz 21 staff car plus a Horch Kfz 15 to the left, (possibly Bayerlain's own), and both trucks appear to be British or Commonwealth vehicles.

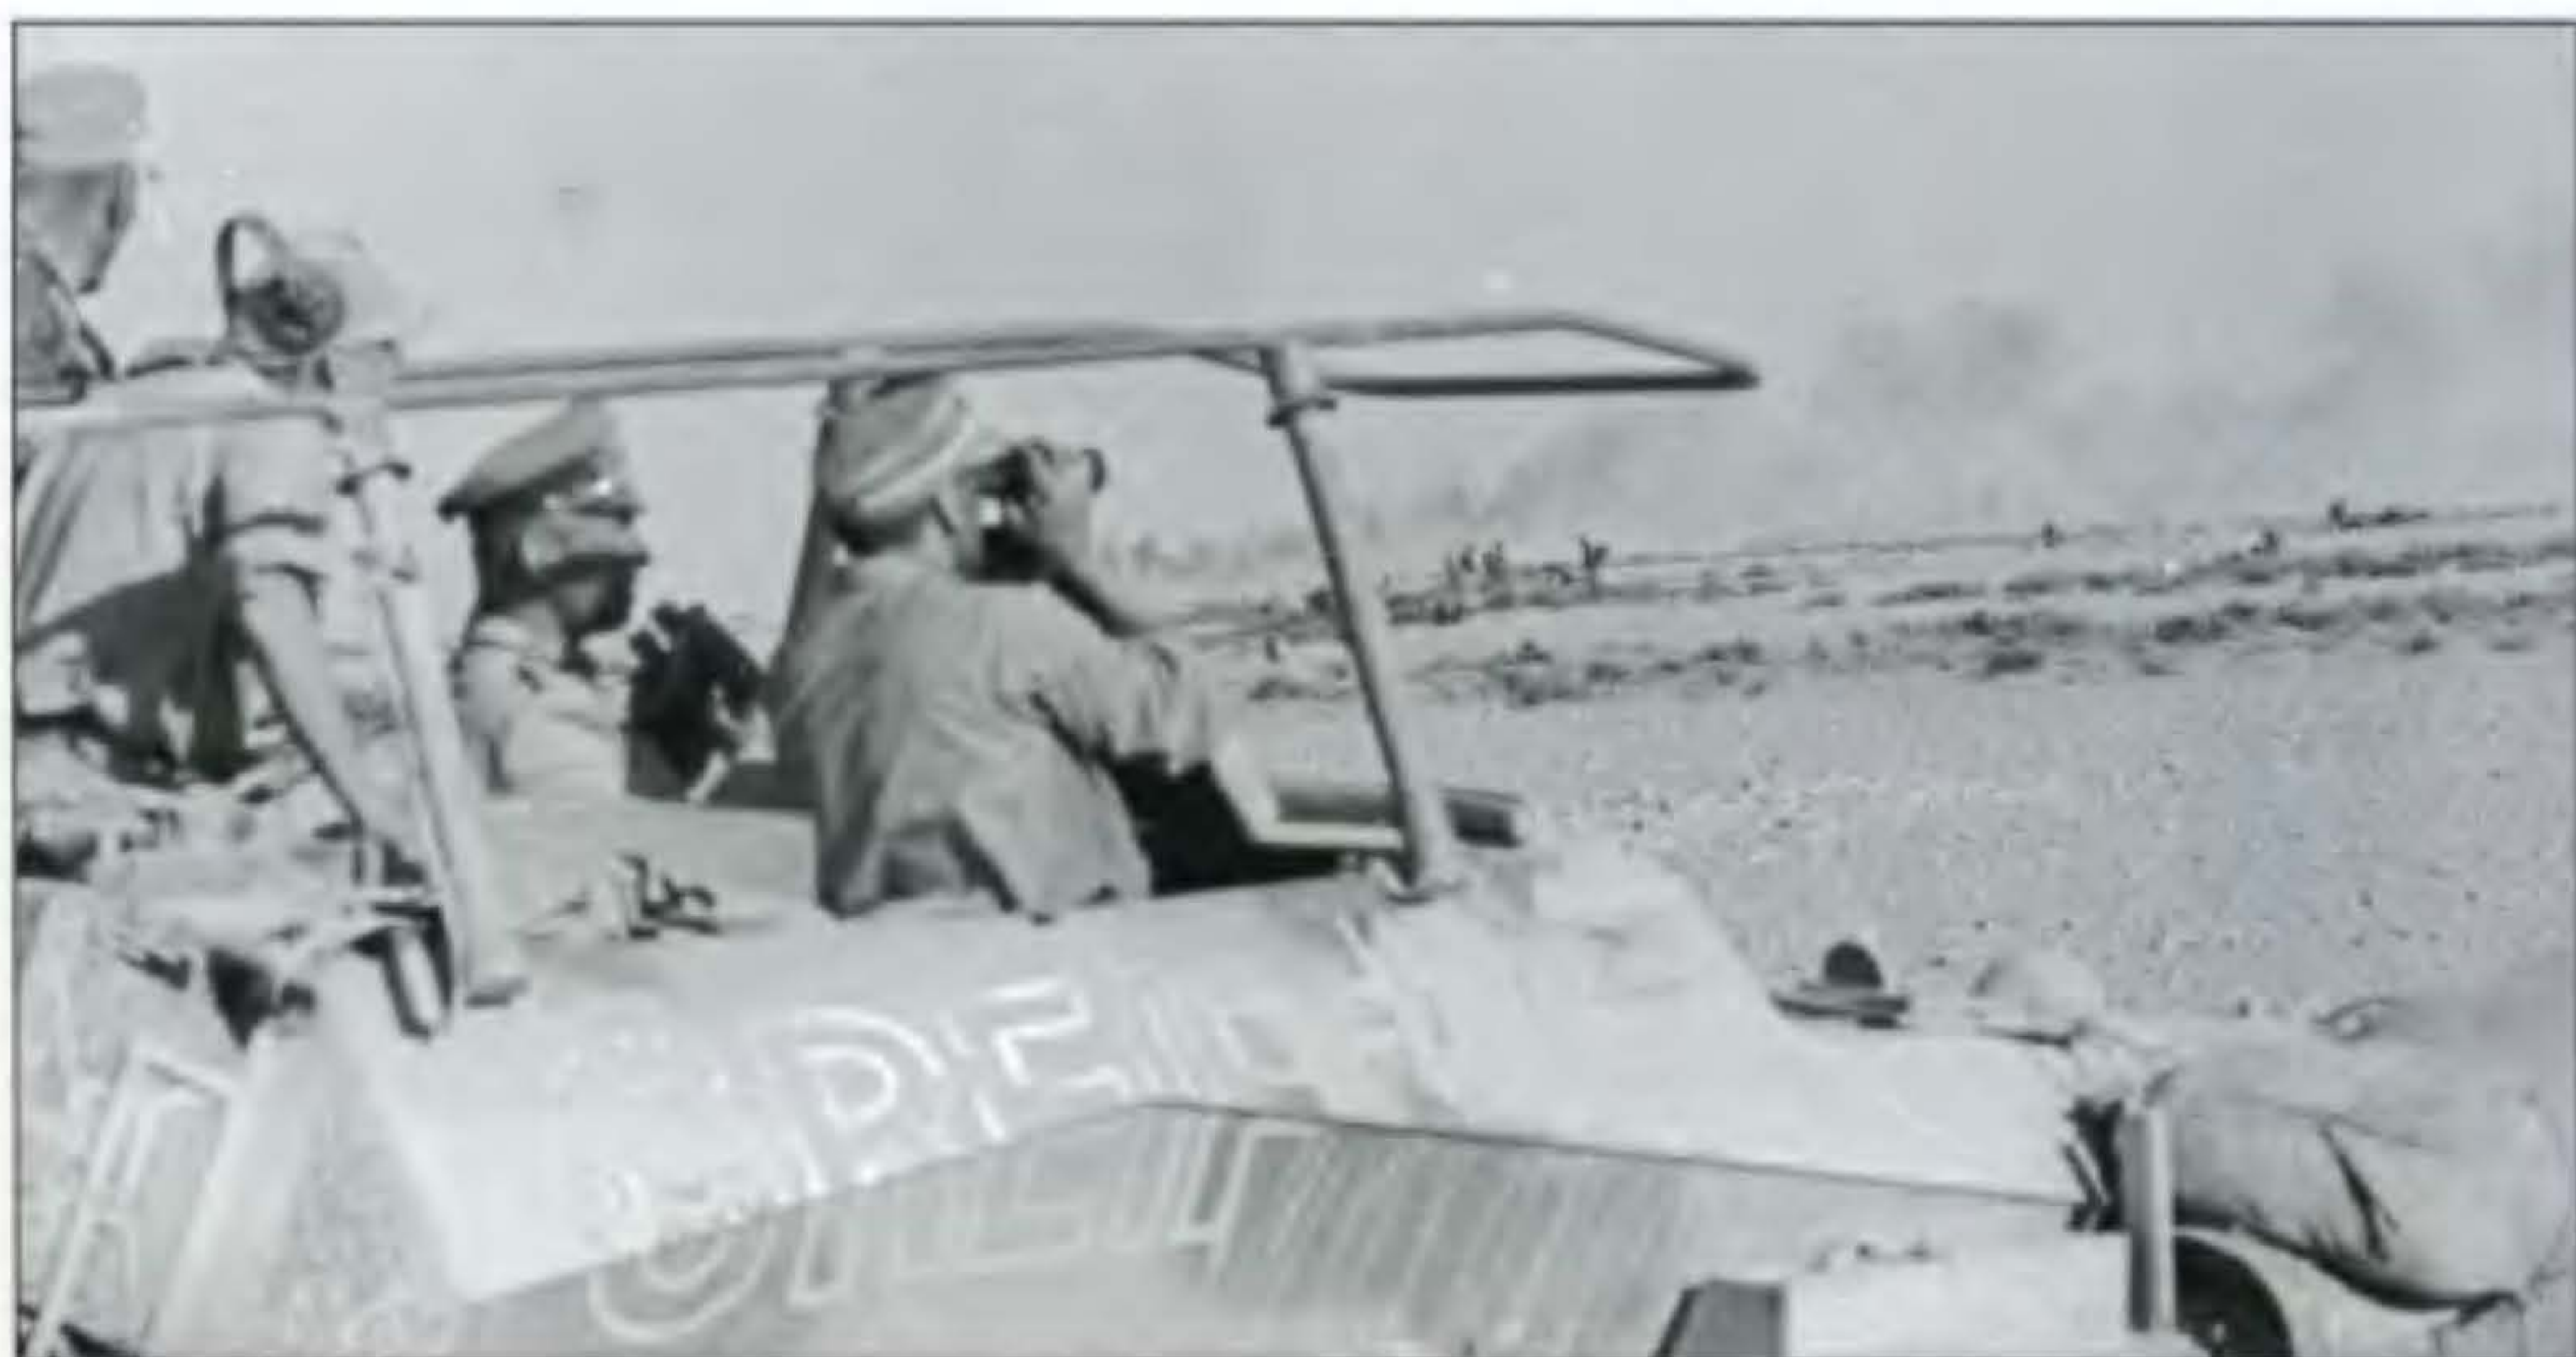
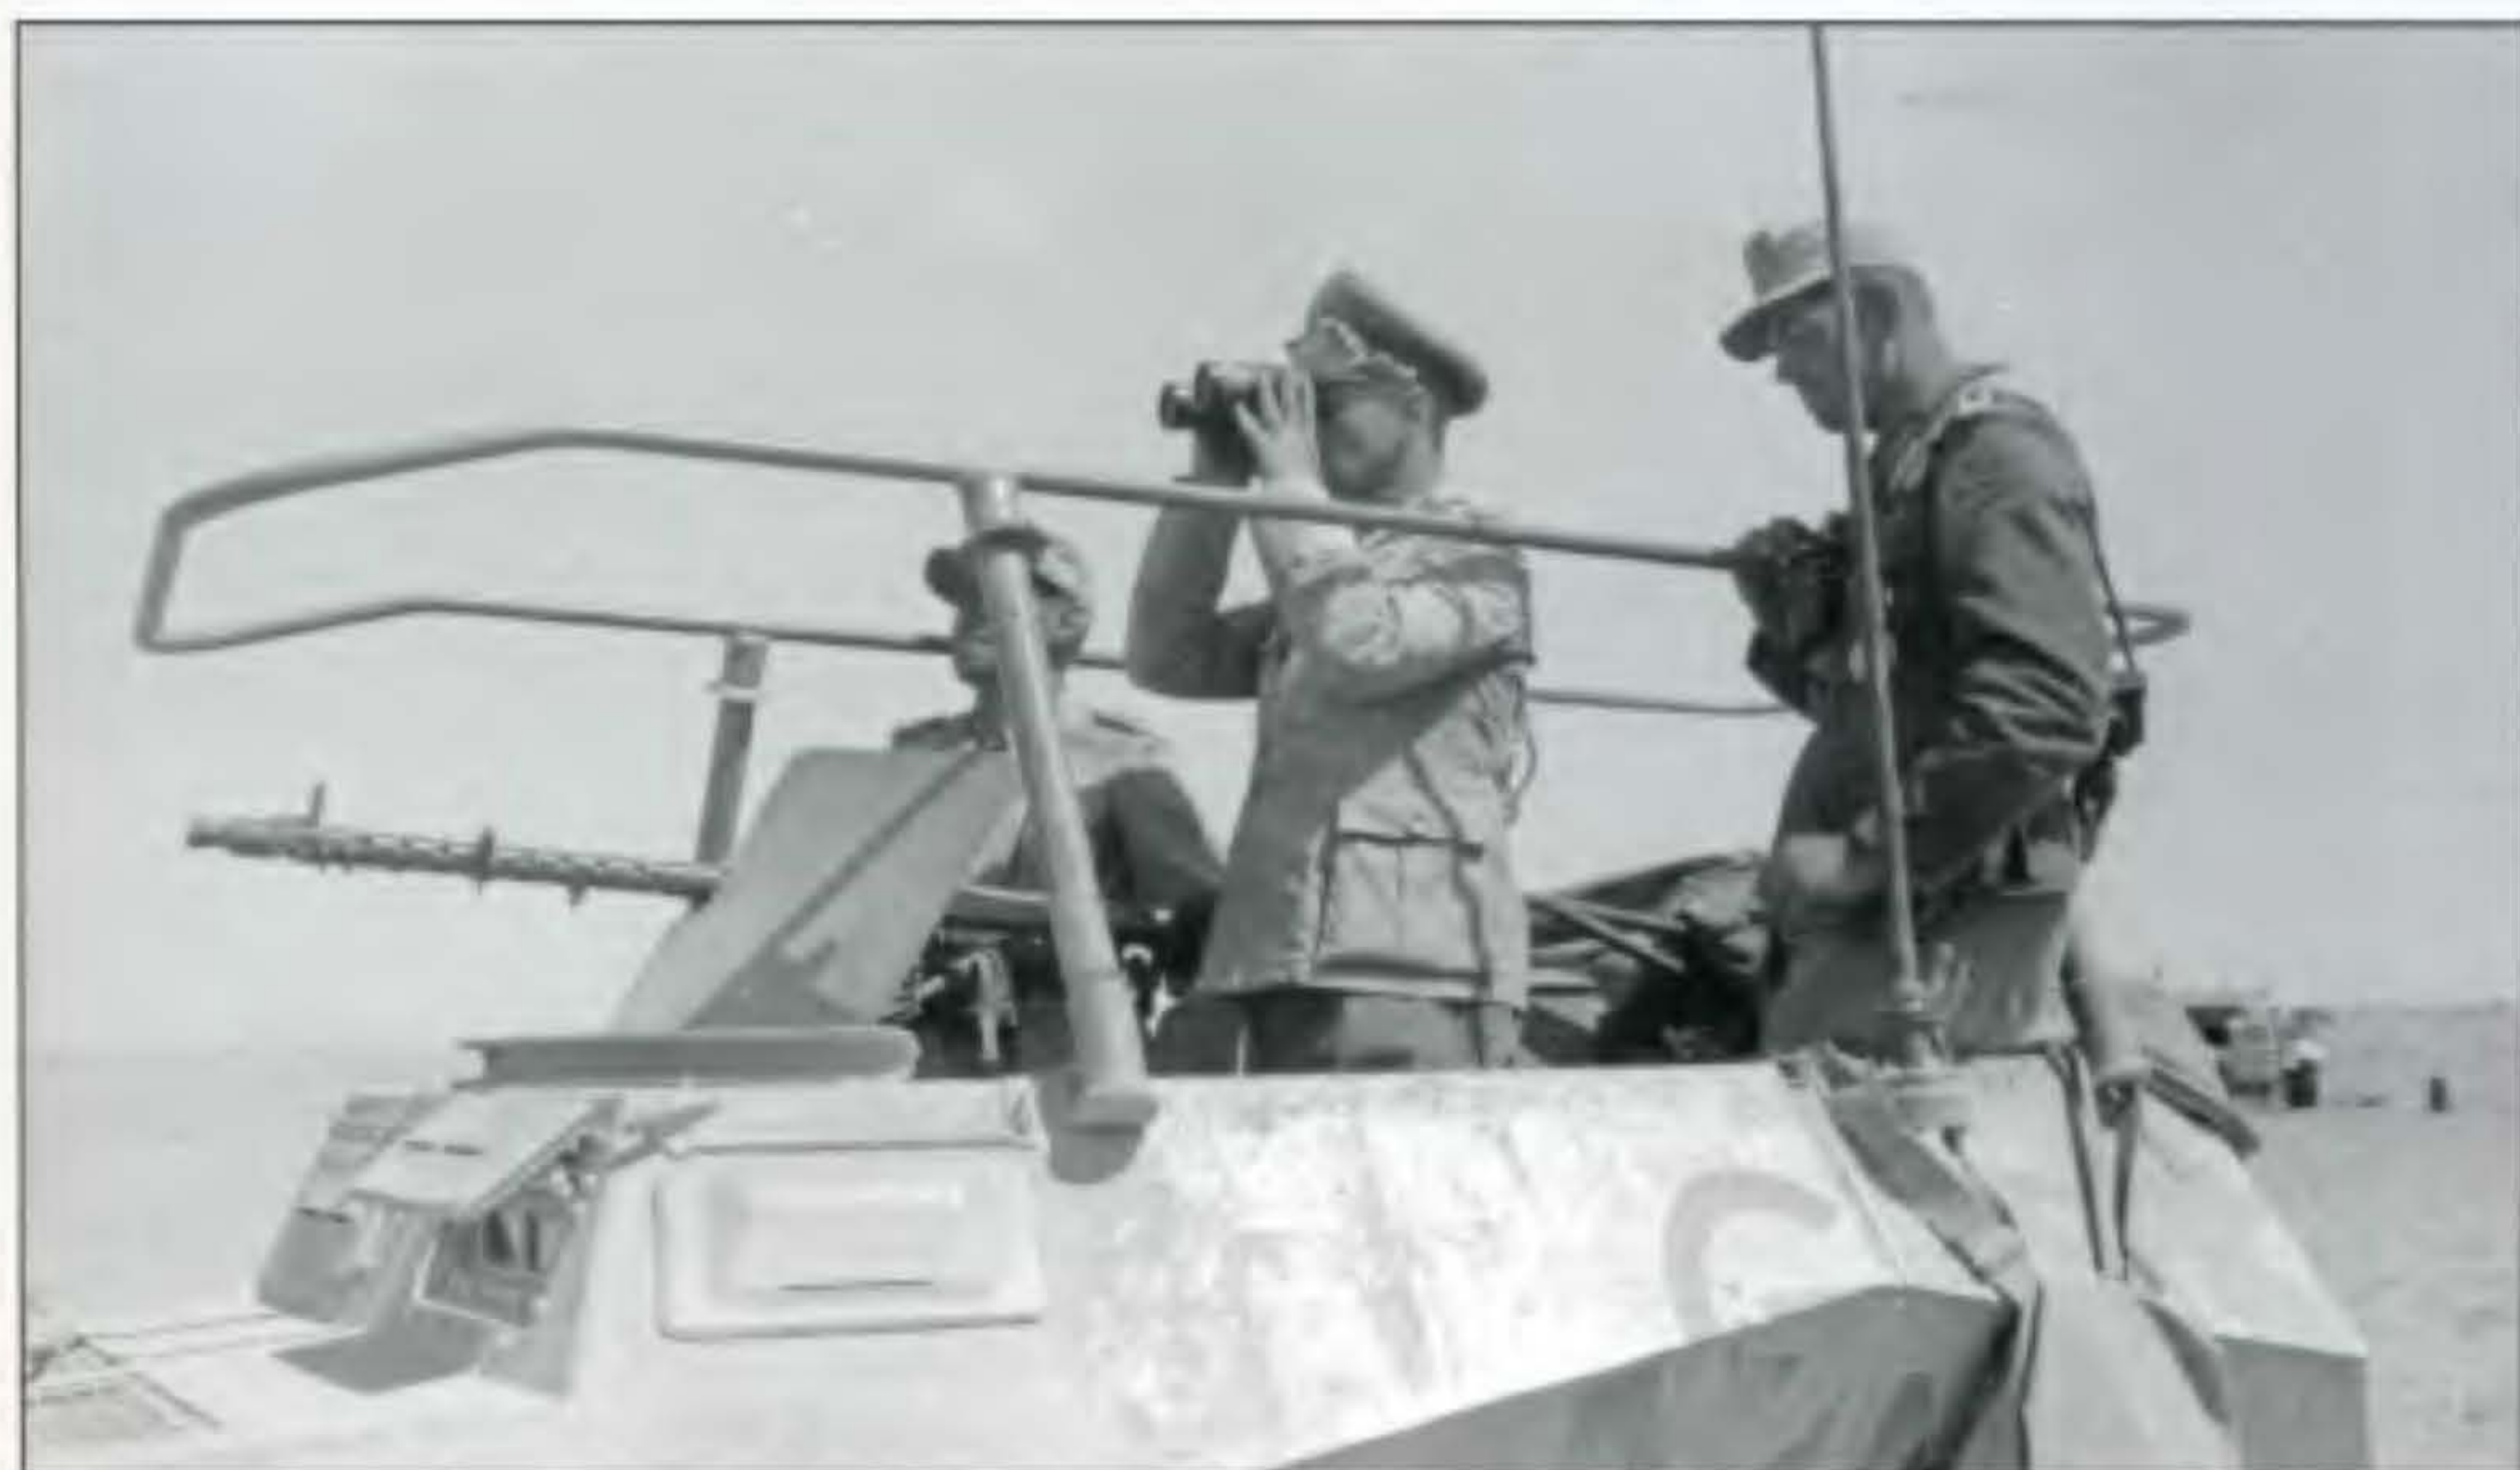
The 'GREIF' motif on the right was only an outline in white, whereas the left hand side was infilled with red. The post sited at the rear of the track guard in front of the rear light is for the sternantenne A to be fixed in place. This is one of the later Typ 1.250s with a complete top right side panel without the plated over mounting point left over from the 253.

instructions were a combination of Gelbbraun and Graugrün to cover the Dunkelgrau. This has been done, but once again the paint does appear to have been applied thinly and has easily worn away in high use areas such as the top edge of the fighting compartment. The vehicle has also received a secondary coat of mud paste that makes me wonder if the new directives to replace the Dunkelgrau were still too dark and the crews have decided to "knock back" the colour depth with the addition of the paler mud paste.

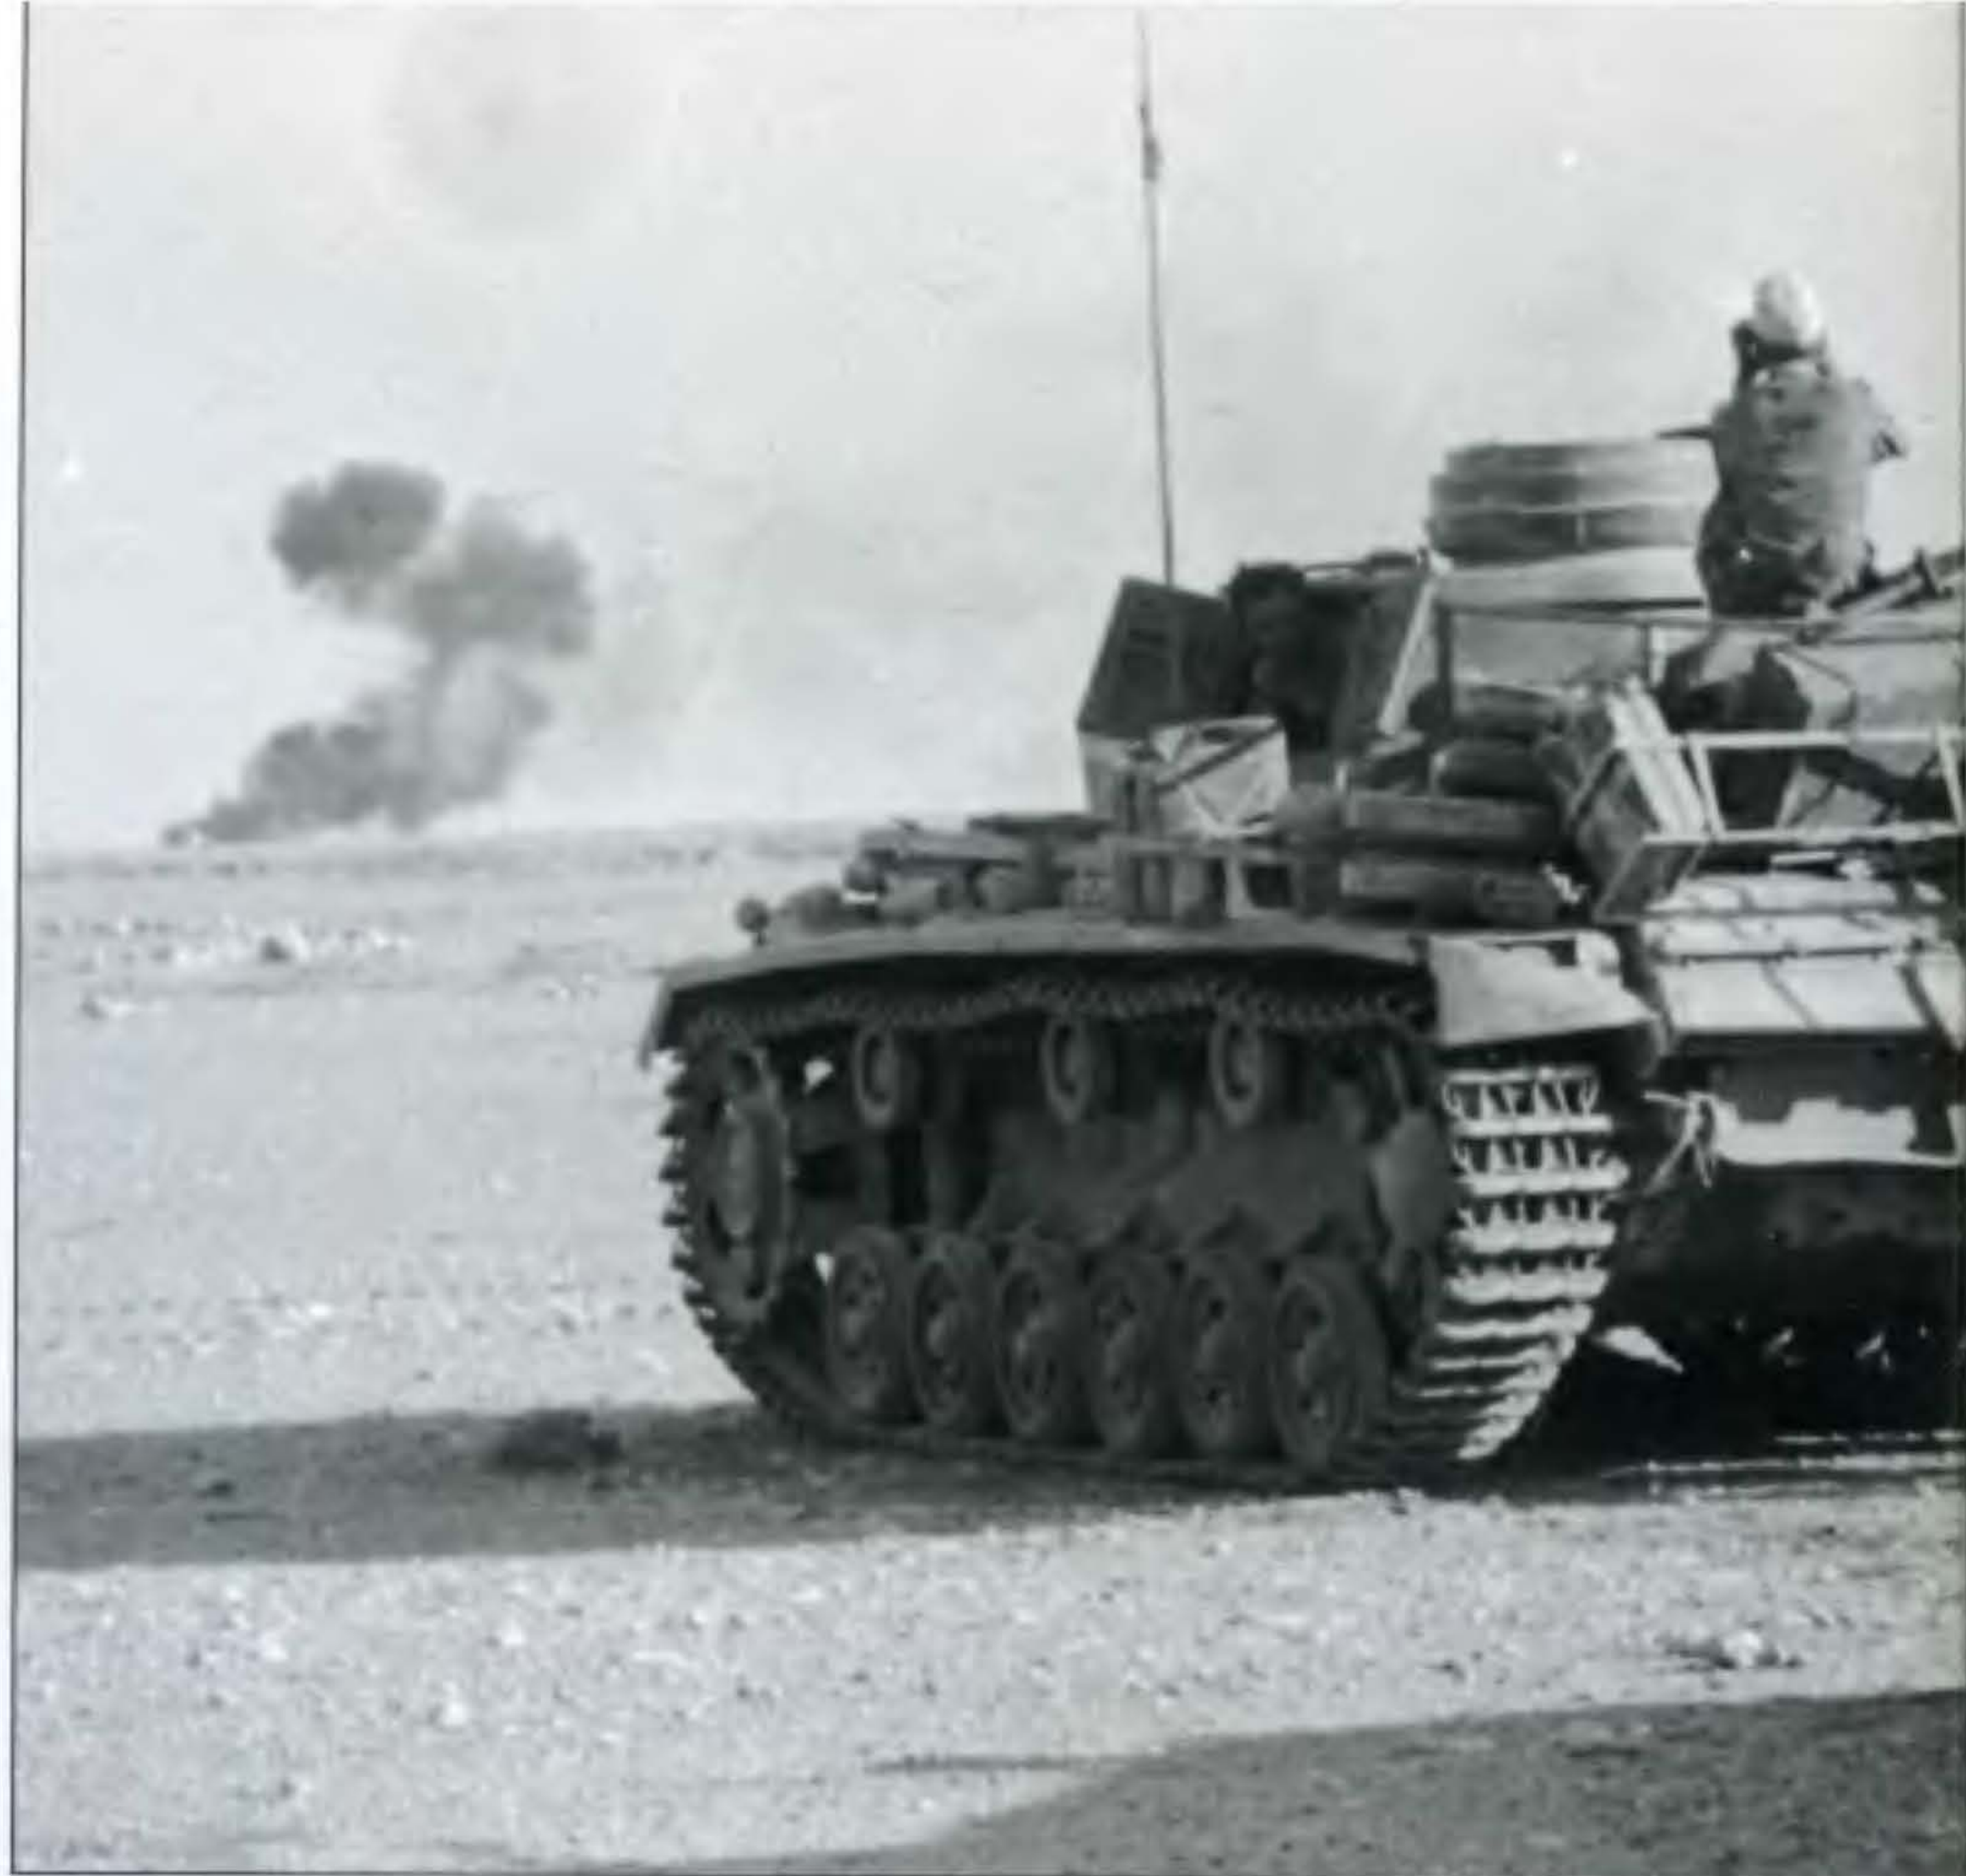
It is widely accepted that German radio design and technology and the use of radios to control and direct battles was the best in WW II. Here there are two levels of command in operation and as the attack goes in, all eyes are on the horizon. Rommel's 250/3 has parked behind a Panzerbefehlswagen Ausf. E. Officially it was designated as a 3 serie gr Pz Bef Wg. built from November 1940 to January 1942. This is an upgraded or overhauled Pz Kpfw III Ausf. E with the wider track, new drive sprocket, re-positioned front return roller, modified idler wheel and the later style armoured smoke candle rack at the rear.
