TOTAL DETAIL

Sd Kfz 252, 253 & early 250

Sd Kfz 252, 253 & 250 (Typ 1)

Volume 3 - Part 1

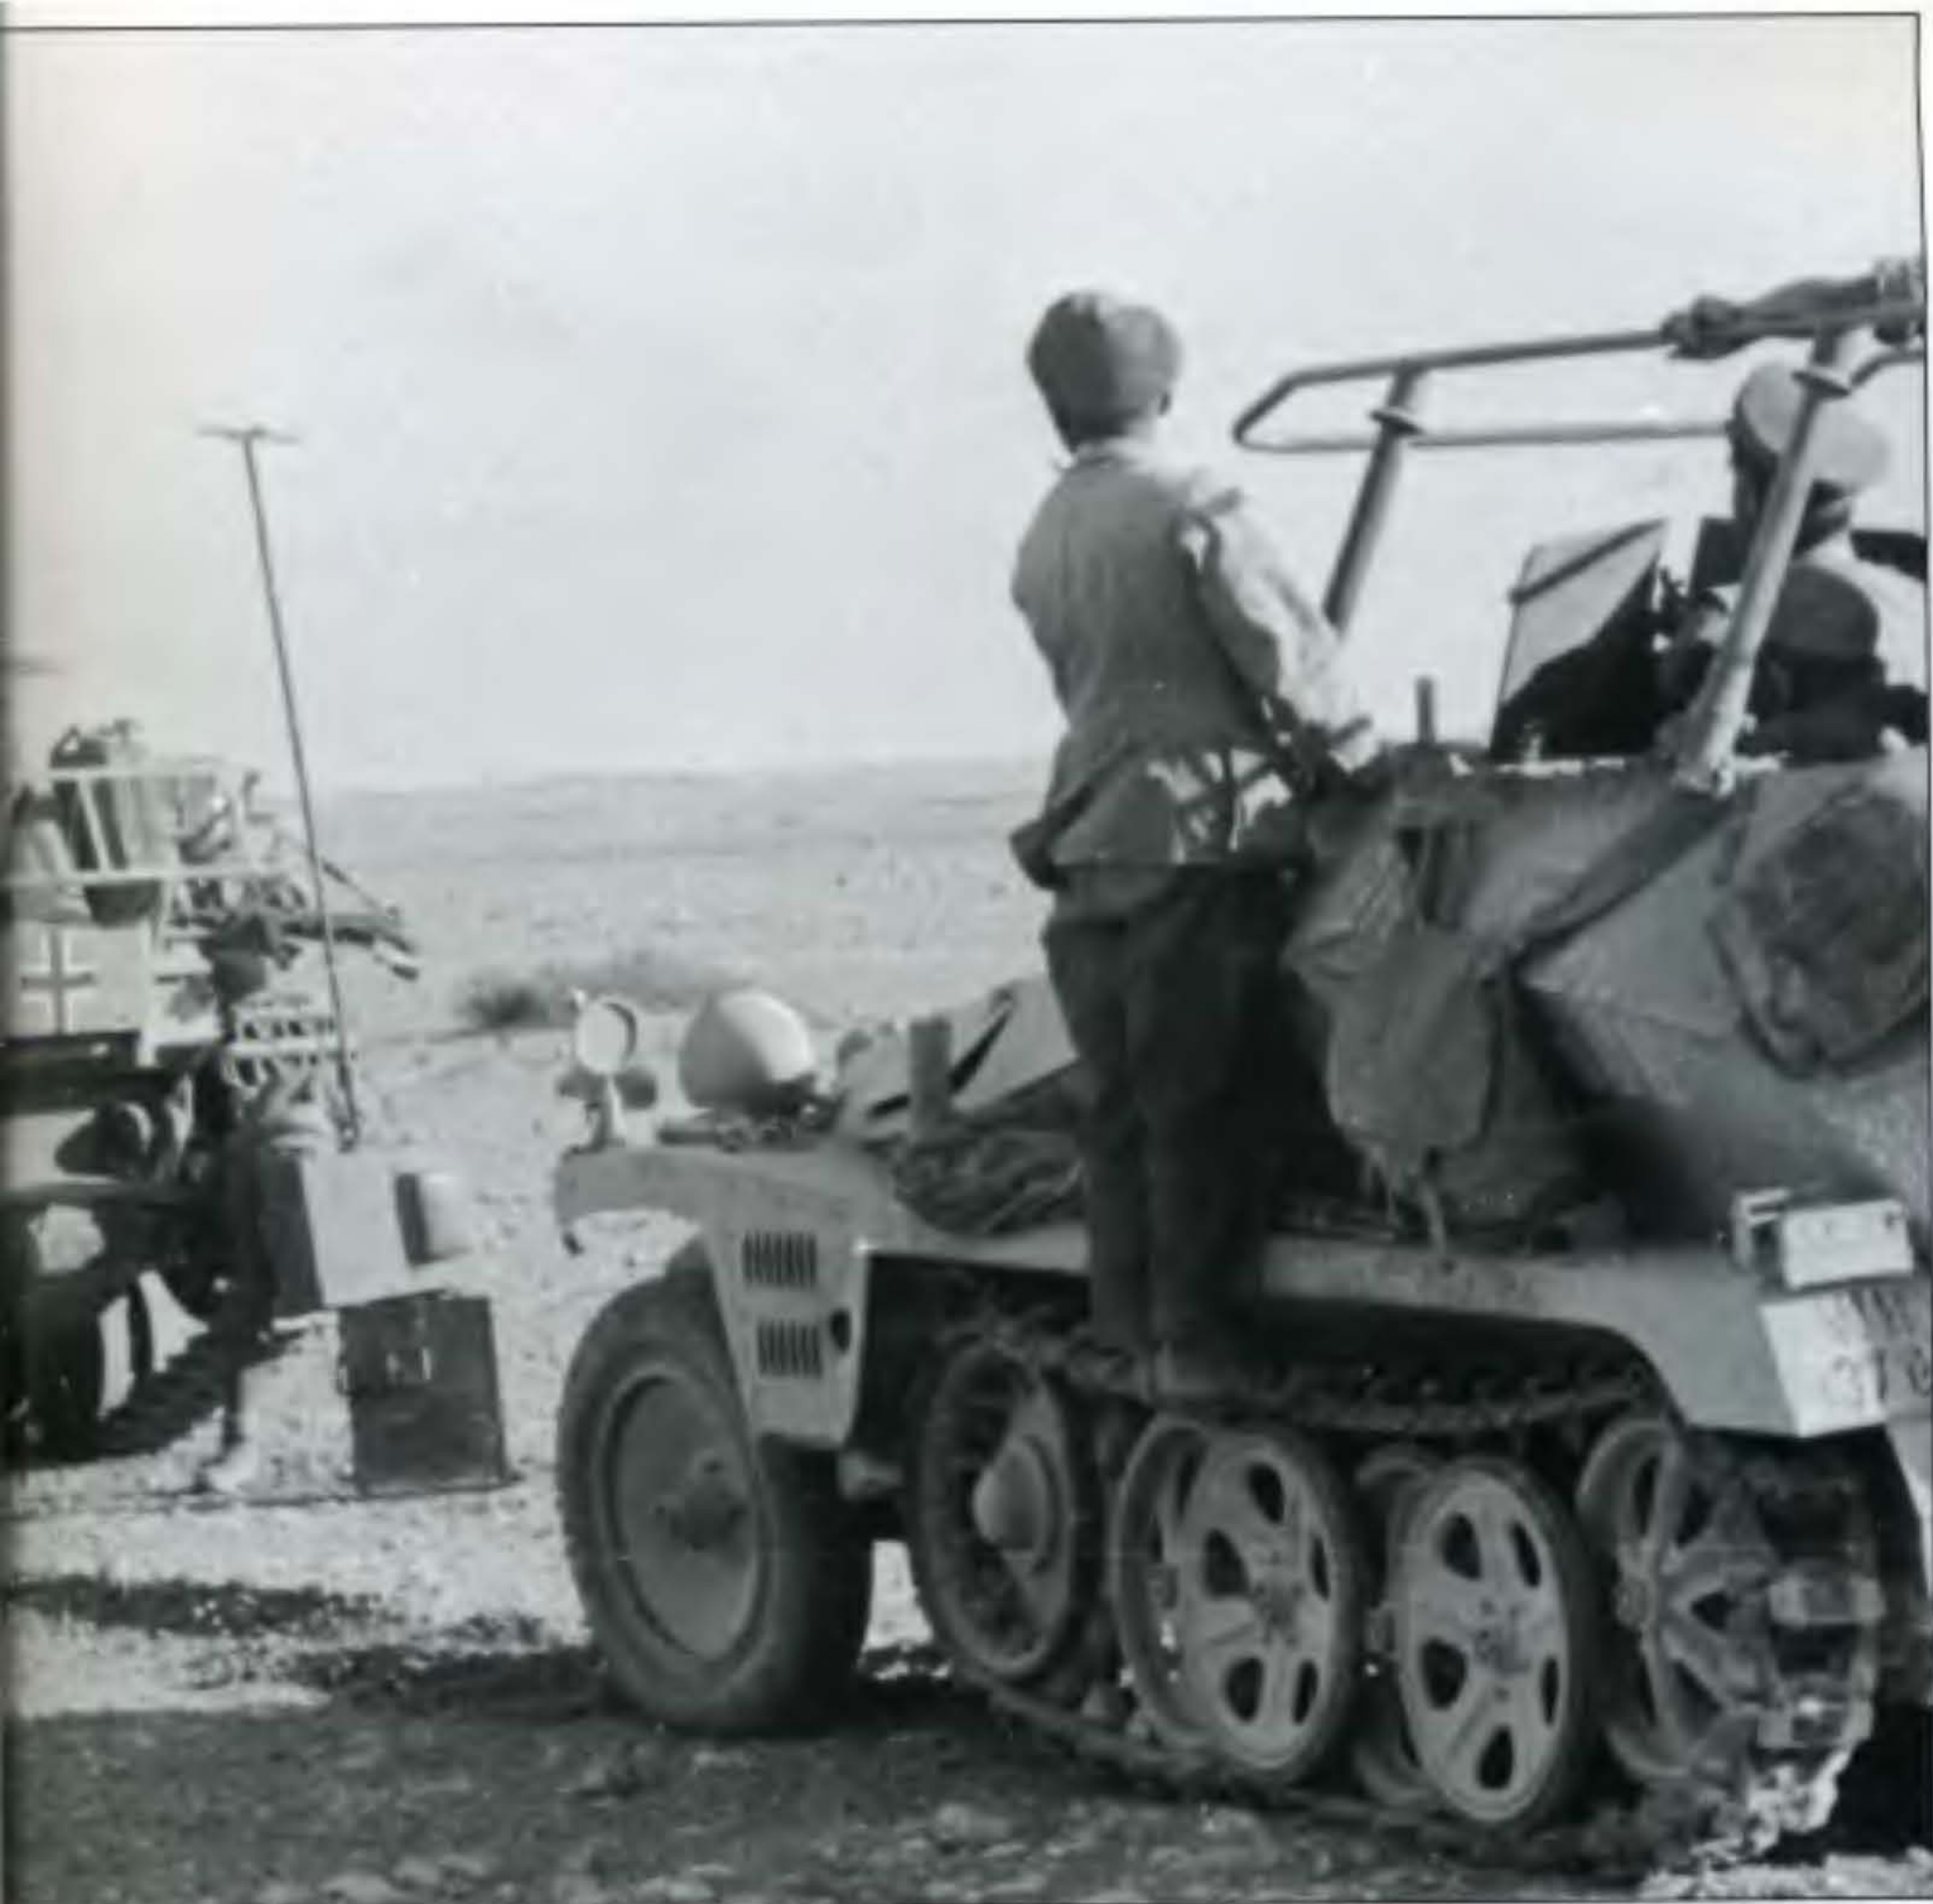
To the rear of the Pz Kpfw III another crewmember is operating a Torn.Fu.b1 (Tornister Funkgerat b1 - Portable radio set b1) precariously balanced on top of the power and accessories box, which formed the complete set. The Torn.Fu.b1 was a general set used by the infantry with a range of 12 miles when using the Morse key or 6 miles verbally.

The frame aerial posts are bound with what appears to be cloth. The posts look a little thin in comparison to the metal 'cup' base. Could it be that the wooden posts have shrunk with the heat? With the headlamp in position and the shorter version of the width indicator, the rear view mirror is next to useless. Note the extra bracket on the track guard to prevent the sternantenne D with its base carefully wrapped in canvas from falling off and the spare 2-metre aerial held in it's own clasp. (The tip can be seen above the exhaust cover)

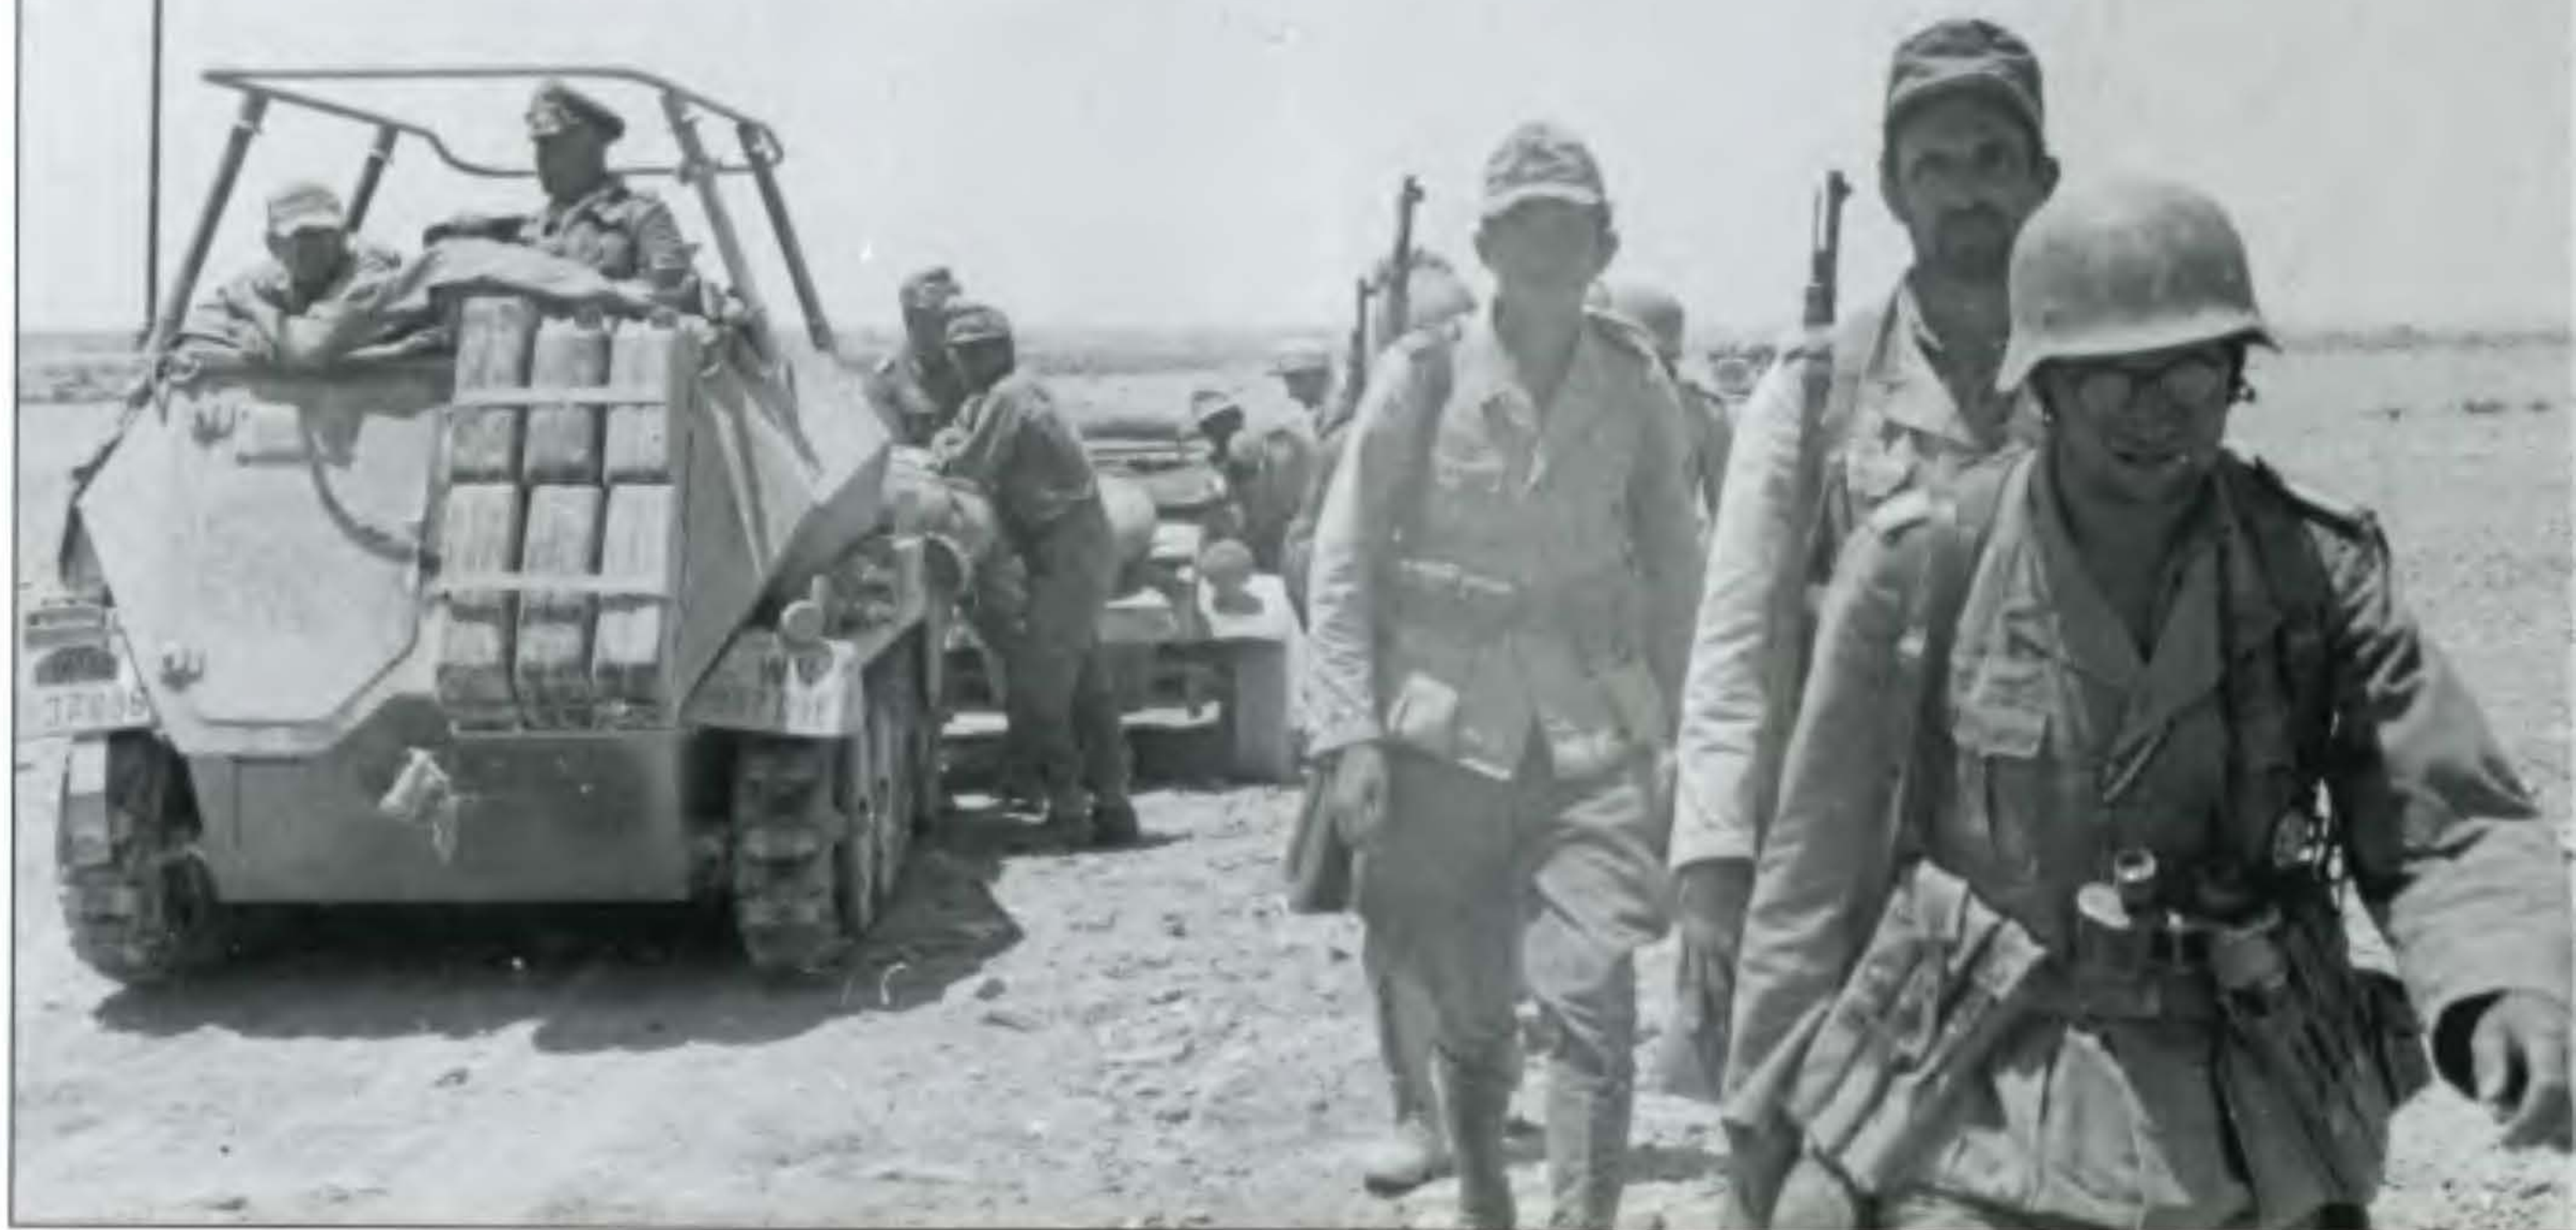
Notice how rough the signwriting of 'GREIF' actually is. Apart from the base grey and desert yellow plus the addition of the name, it is also covered in a mud / sand paste on the rear panels. The aerial cable cover hangs over the top edge of the armoured side and the cable is fastened to the pole. The cable is in two parts and is joined where the two piece U-clamp is bolted to the upright in order to allow the frame aerial to be removed easily. Bayerlein listens as Rommel converses with General Der Panzertuppe Walter Nehring. As with so many German Generals, Nehring was wounded in August 1942, to be temporarily replaced by Bayerlein.

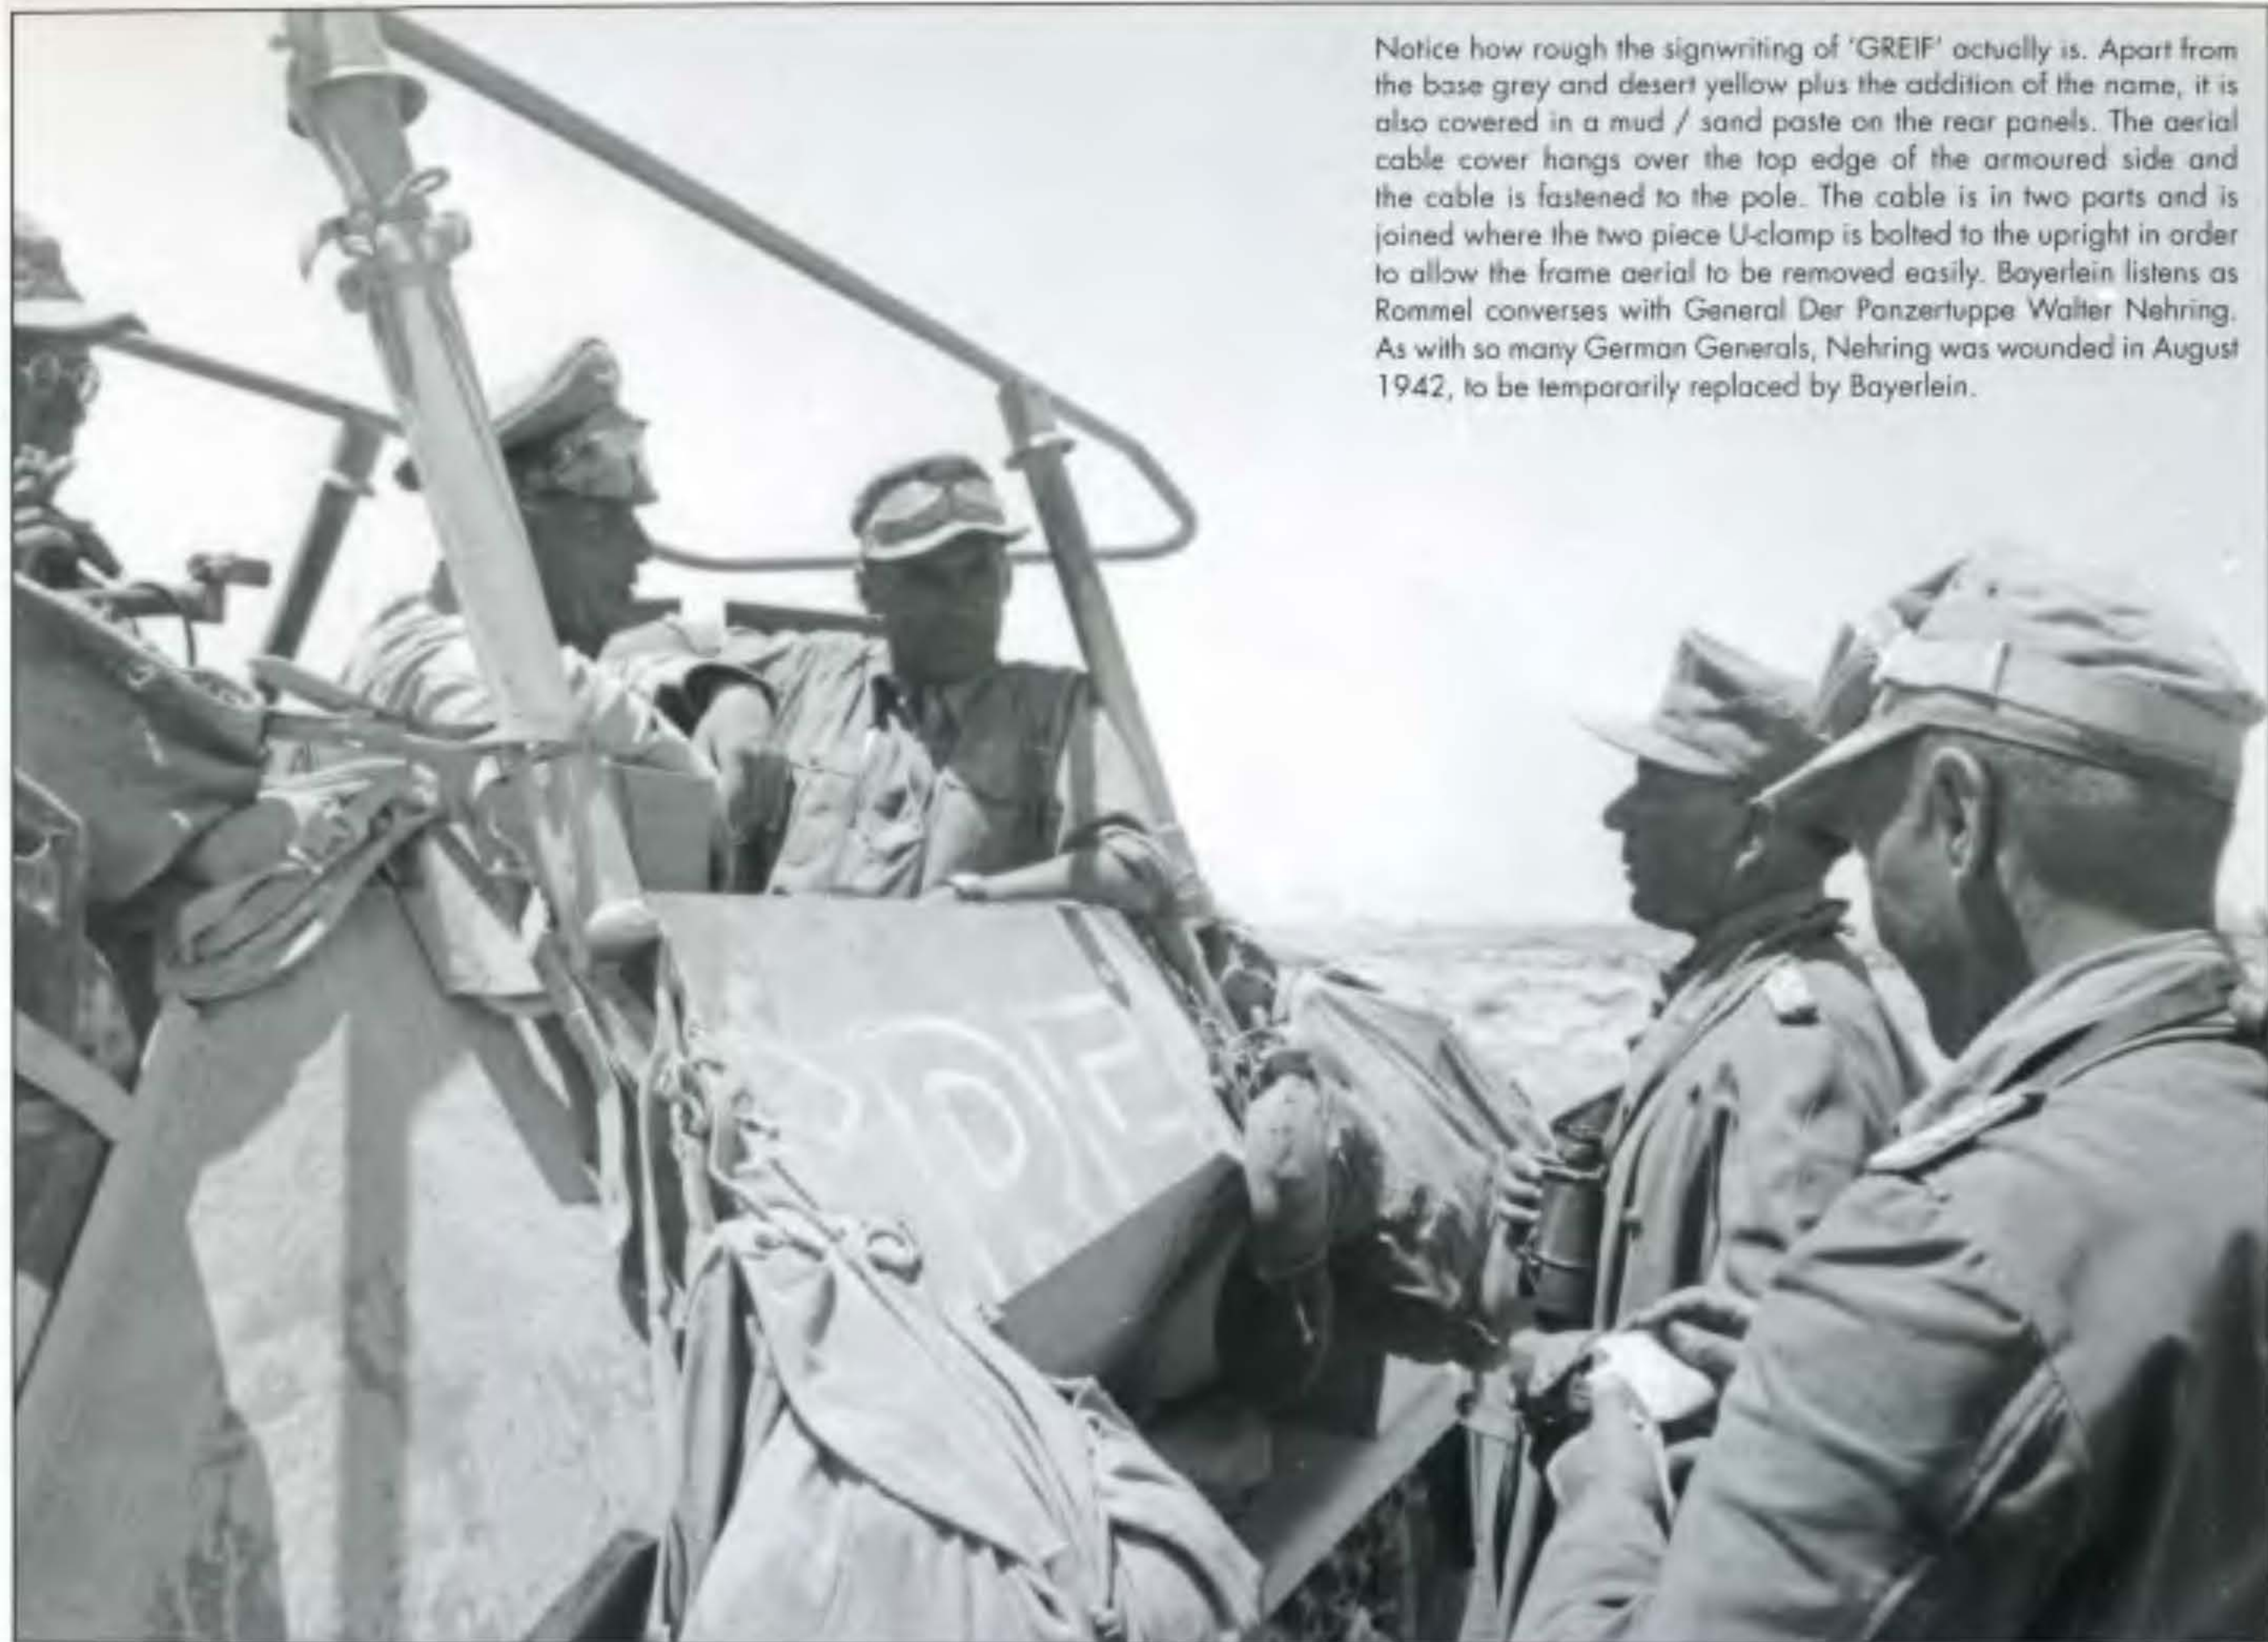
Apart from being a base feld grau 250, it received a second paint colour of sand but has also received various coats of mud paste. See how the paint layers are revealed on the front mudguard and how the paint has been worn away.
