The Decommissioning of a Tritium Contaminated Laboratory

THE DECOMMISSIONING OF A TRITIUM CONTAMINATED LABORATORY

A tritium laboratory facility at the Los Alamos National Laboratory, Los Alamos, New Mexico, was decommissioned in 1979. The project involved dismantling the laboratory equipment and disposing of the equipment and debris at an on-site waste disposal/storage area.

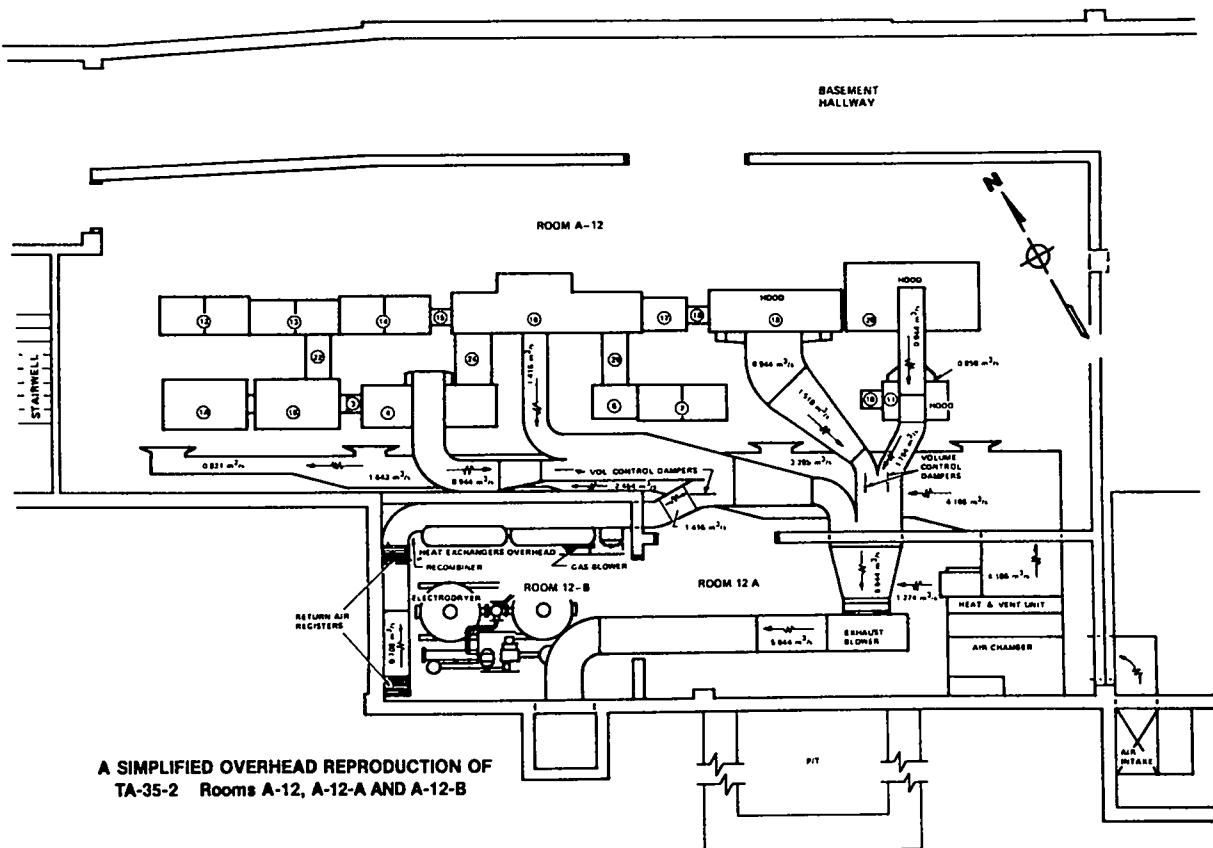
Fig. 1.
Rooms A-12, A-12-A, and A-12-B.

A tritium laboratory¹ was constructed at the Los Alamos National Laboratory in 1953 to handle kilocurie amounts of lithium tritide components. This laboratory was located in the basement of Building 2 in Technical Area (TA) 35. The laboratory occupied three basement rooms designated as A-12, A-12-A, and A-12-B (Fig. 1). It consisted of two glovebox lines totaling 25 meters in length (Figs. 2-3) and several equipment items such as heat exchangers, electrodryers, a refrigerator unit, a recombiner, and a gas blower (Fig. 4) that were interconnected with copper pipes (Fig. 5). The Laboratory had its own air supply and exhaust stack (Fig. 6).

The gloveboxes in Room A-12 were unbolted and separated into manageable sections. The sequence of removal can be best understood by referring to Fig. 1. Hoods number 11 and 20 were removed to provide space. Glovebox numbers 6 and 7 were removed as one unit. The sequence was then: transfer line number 25; box number 1A; box number 1B; transfer line number 22; hood number 4; box number 12; boxes numbers 13, 14, and 15; transfer line number 24; hood number 19; glovebox numbers 17 and 18. Glovebox number 16 (the hydraulic press box) was cut with a saber saw into three sections. The separation openings were sealed with sheet metal. Putty tape was used to seal between the sheet metal and glovebox edges. Roofing tar was then applied over the entire seal (Fig. 16), and around the windows (Fig. 17) and the metal sealed glove ports. Plywood was banded over the weaker portions of the gloveboxes (Fig. 18) such as windows and glove ports.

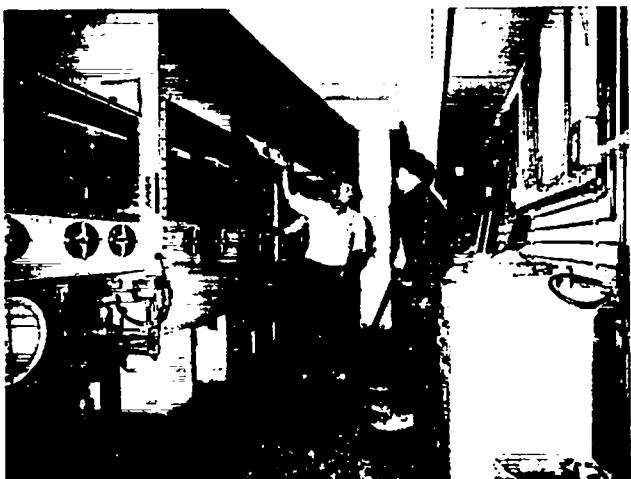
Fig. 2.
North glovebox line.

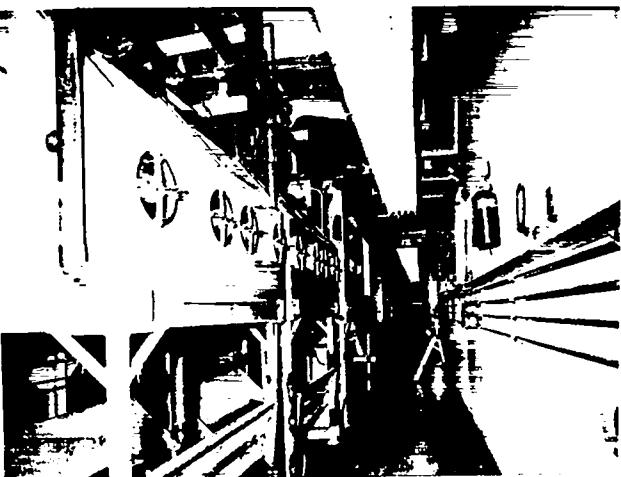
Fig. 3.
South glovebox line.

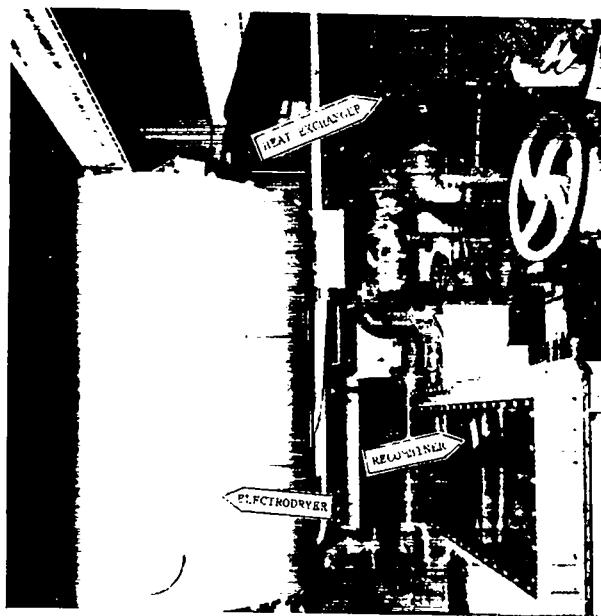
Fig. 4.
From left to right, electrodryer, heat
exchanger, and recombinder.

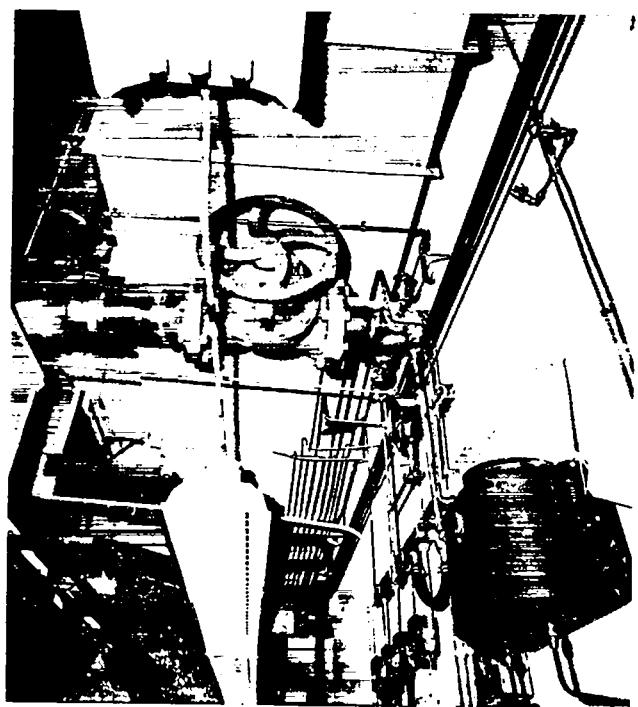
Fig. 5.
Typical copper piping.

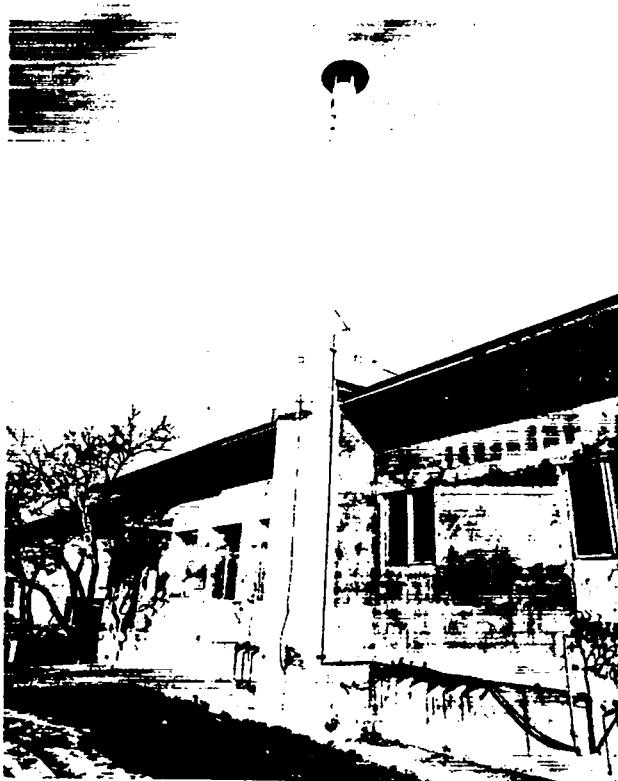
Fig. 6.
Exhaust stack.

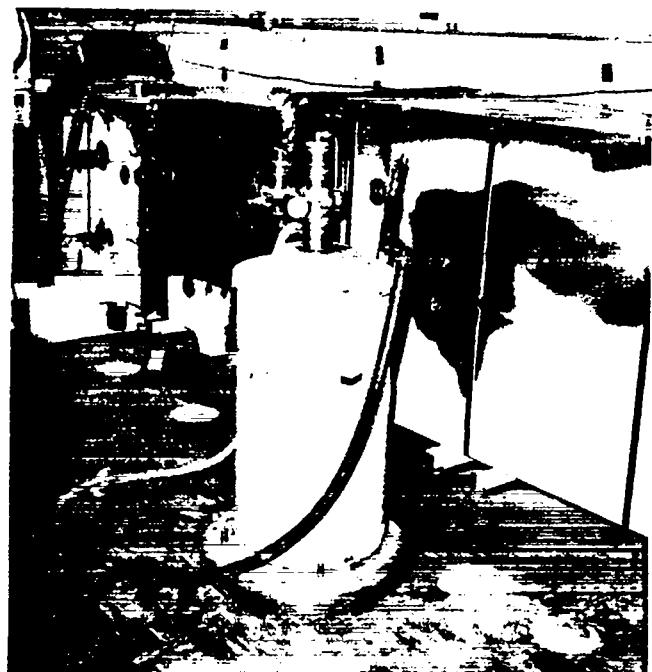
Fig. 7.
Asphalt gun.

An asphalt gun (Fig. 7) was used to apply a layer of tar undercoating to the interiors of all gloveboxes and hoods to fix in place residual dust and particulate material (Fig. 8). A 5-meter deep pit was excavated to provide access to the removable portion of the south wall of room A-12-A. Reinforced concrete walls were poured to prevent shoring problems in the pit, a plywood door was installed between the excavated pit and room A-12-A, and a removable roof was installed on top of the pit. All equipment was removed through this pit for transfer to waste disposal. A 1.9- by 3.9- by 3.3-m trench was excavated in the base of pit number 10 at TA-54, the Laboratory's Waste Disposal Site, to receive the tritium contaminated debris (Fig. 9).

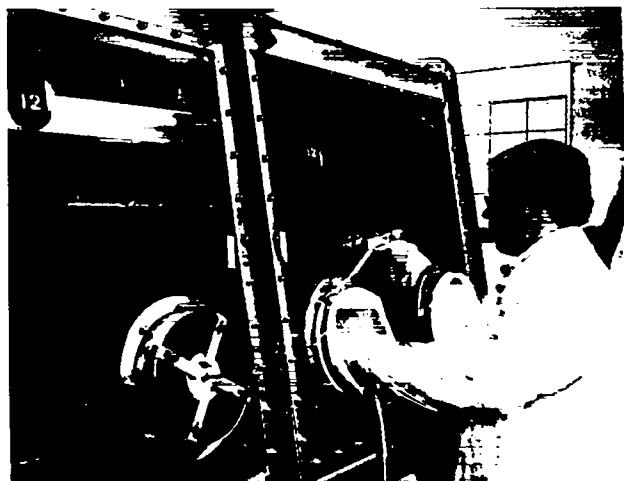
Fig. 8.
Application of tar undercoating.

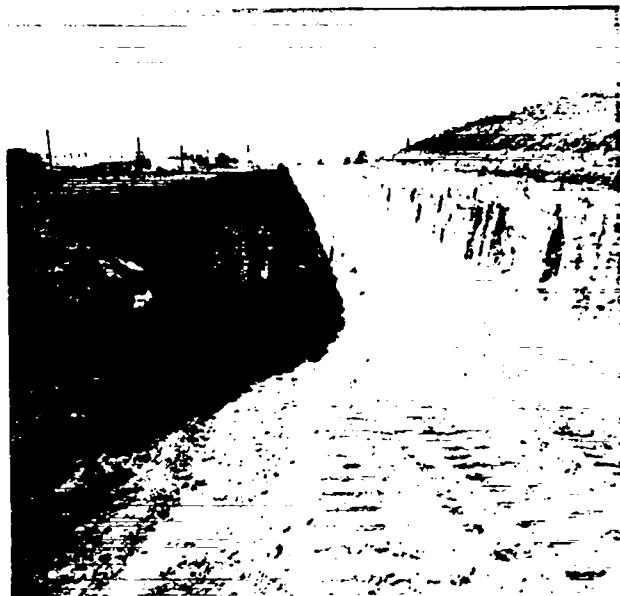
Fig. 9.
Tritium waste trench in waste pit
(left side).

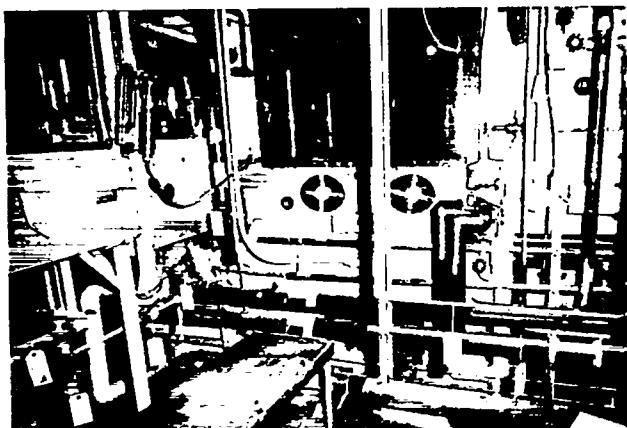
Fig. 10.
Copper piping prior to removal.

The removal of the more highly contaminated equipment items began with the copper pipes (Fig. 10), which were cut and capped with metal caps (Fig. 11). A portable exhauster was used during the pipe separations. Silicon rubber adhesive applied to the cap before insertion over the separated pipe ends provided an adequate seal to prevent spreading of contamination. After the adhesive had hardened (1-2 days), roofing tar was generously applied over the sealed pipe end (Fig. 12). The sections of pipe were placed into 1.3- by 1.3-

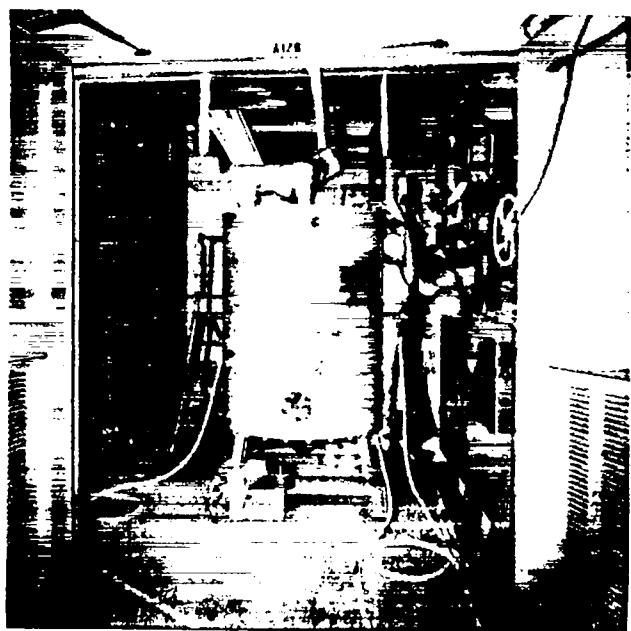
Fig. 13.
Disconnecting the electrodryers.

The electrodryers were stripped of accessories and connecting copper pipes (Figs. 13-14). They were removed and sealed in a 1.9- by 2.3- by 3.2-m FRP-coated plywood container (Fig. 15).

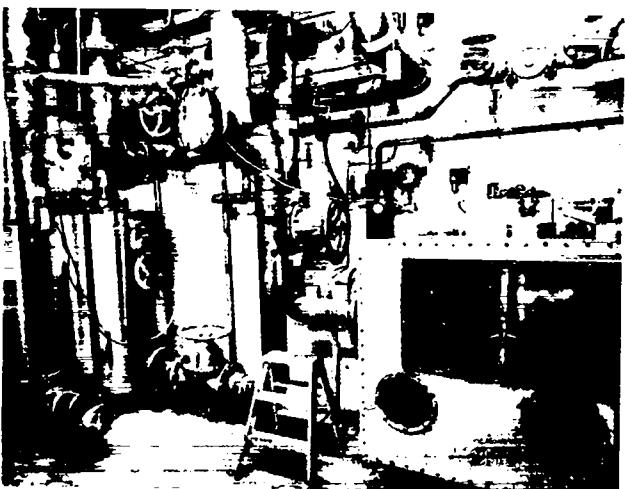
Fig. 14.
Room A-12-B after removal of
electrodryers.

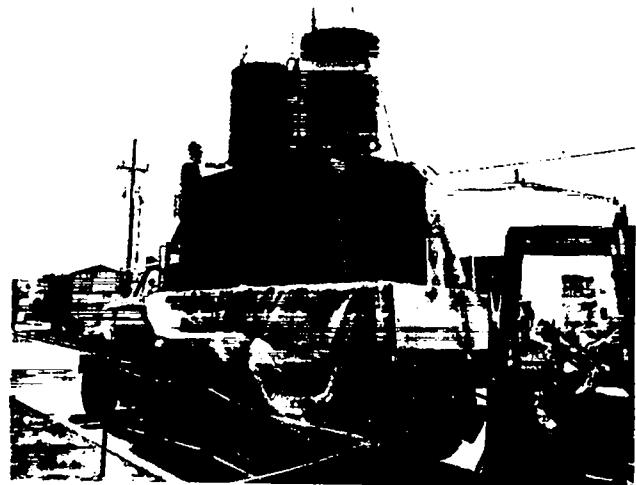
Fig. 15.
Placement of electrodryers in
fiberglass-coated plywood box.

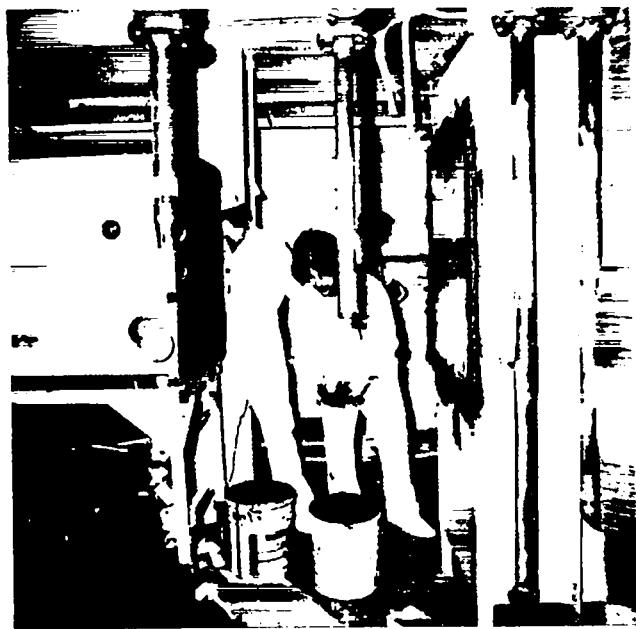
Fig. 16.
Application of roofing tar after a
glovebox separation.

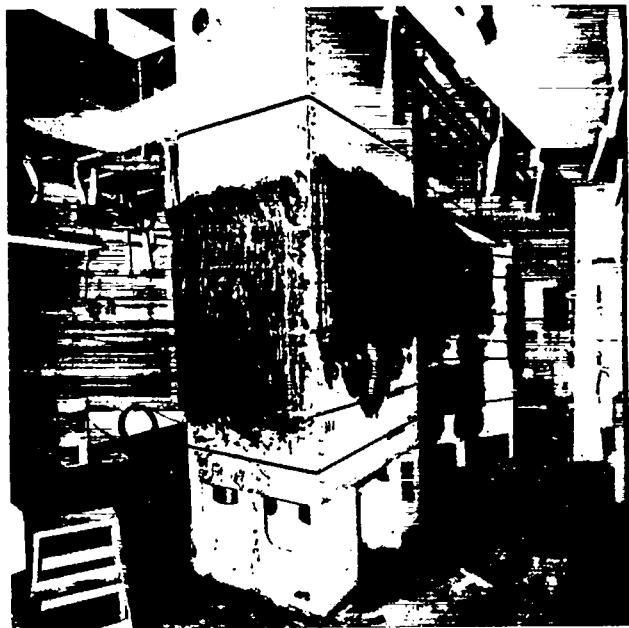
Fig. 17.
Roofing tar over windows and seals.

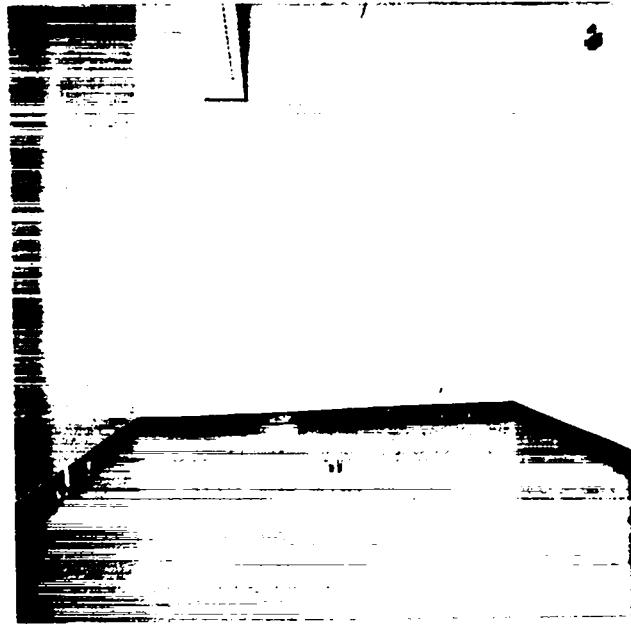
Fig. 19.
Rehabilitated room A-12-B.

The tile was removed from the floors in all three rooms. Surveys of the rooms found up to 500 dis/s/cm² swipeable contamination. The rooms were rehabilitated by patching holes in the walls, painting the walls, and reinstalling tile on the floors (Figs. 19-20).

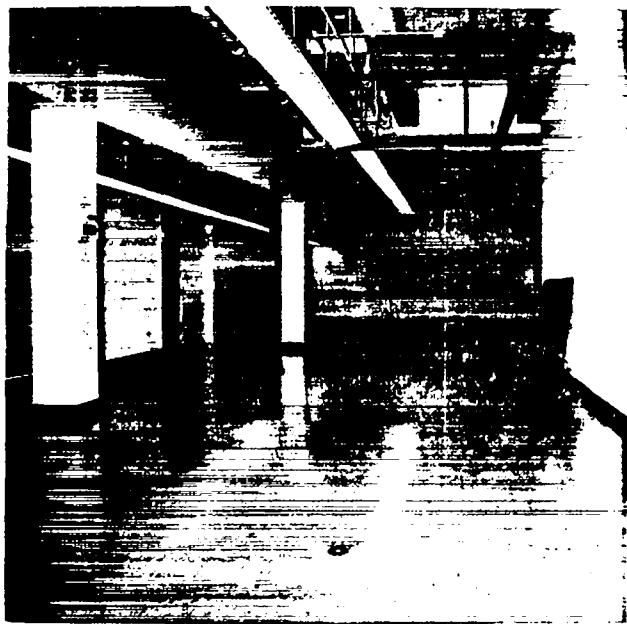
Fig. 20.
Rehabilitated room A-12.

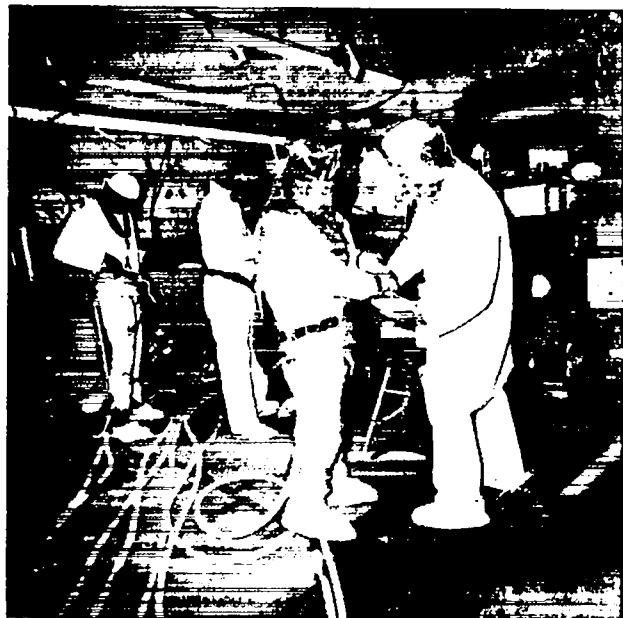
Fig. 21.
Supplied air suits.

Workers used protective (anticontamination) clothing for all work. This included coveralls, gloves, hoods, and booties. Other protective items used, dependent upon the potential of exposure, were the following: (1) a 0.006 gauge polyvinyl chloride supplied air suit consisting of a slip-over jacket with sealed-on hood and trousers with sealed-on boots (Fig. 21); (2) breathing air

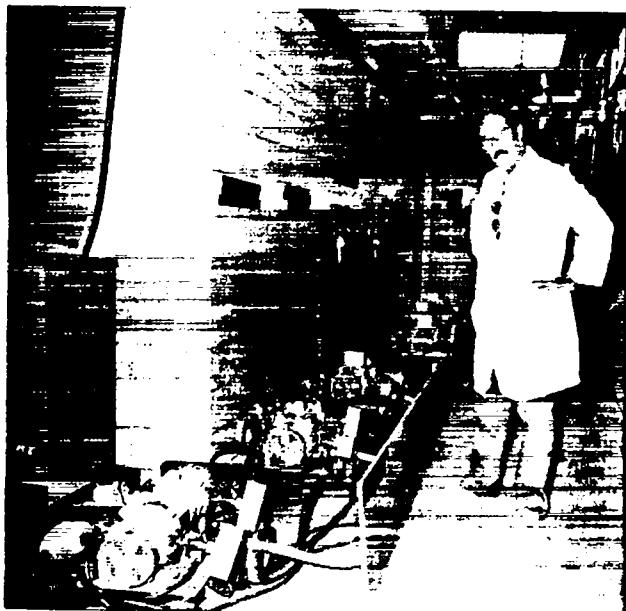
Fig. 22.
Breathing air compressors.

from compressors located outside the work area (Fig. 22); (3) self-contained breathing apparatus; and (4) arm length plastic gloves.

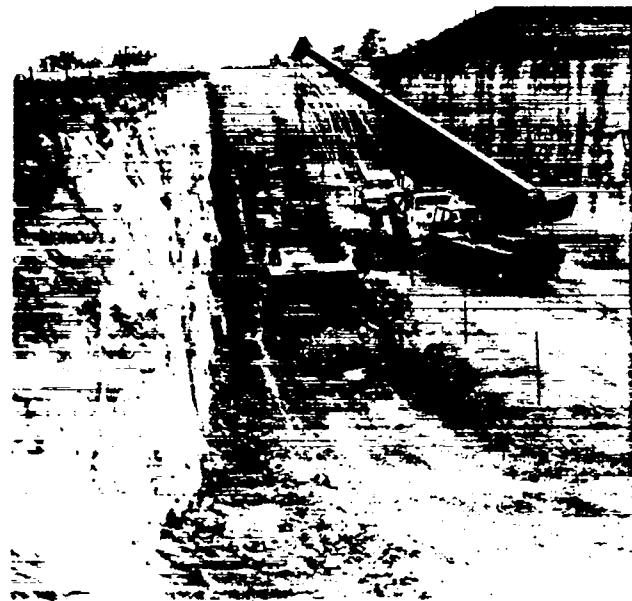
Fig. 23.
Disposal of tritium waste.

All wastes generated by this operation were buried at the Laboratory's TA-54 Radioactive Waste Disposal/Storage Site in a 1.9-m-deep by 3.9-m-wide by 33-m-long trench at the base of pit #10 (Fig. 23). The pit is located 8 km from the decommissioning site. The 183m^3 of contaminated debris containing an estimated 6×10^3 curies of tritium were placed into the trench, which was covered with noncontaminated soil. The pit was then used to receive other routine low-level solid radioactive wastes. Wastes were transported in plastic-lined dump trucks covered with tarpaulins.

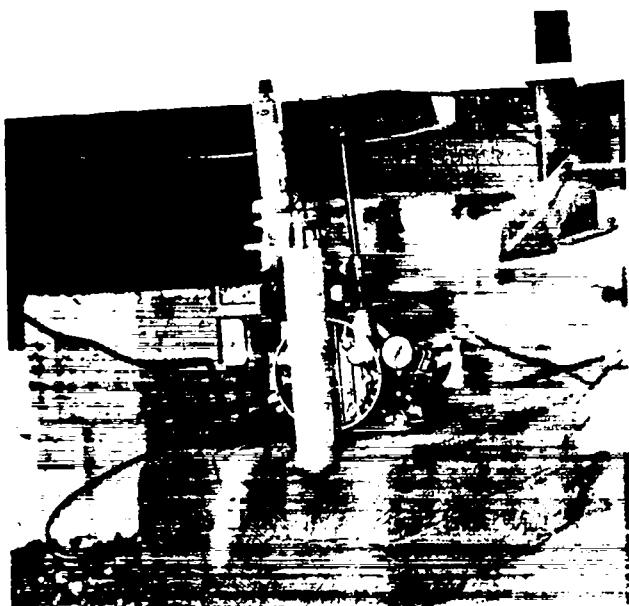
Fig. 24.
Environmental air sampler.

The Laboratory's Environmental Surveillance Group monitored the operation with its routine air sampling network² and two additional on-site sampling stations. One of the on-site stations (Fig. 24) was at the base of the excavated pit by the base of the stack and the other was 9 meters away. Table I

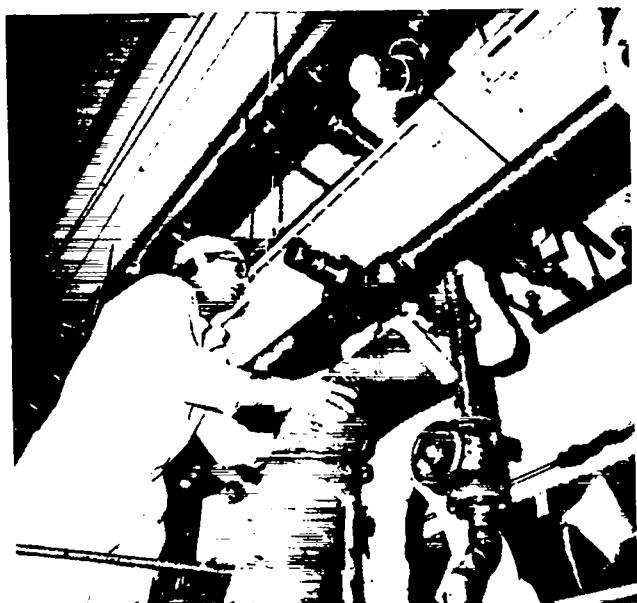
Fig. 25.
Portable ventilation duct in use
during pipe cutting.

Use of the portable ventilation system proved to be extremely valuable and cost effective (Fig. 25-26). It reduced costs and time by eliminating the need to use supplied air suits. The suits cost over \$30 each and posed problems such as limited maneuverability and increased tripping hazards. The donning and removal of the suits also reduced worker productivity.

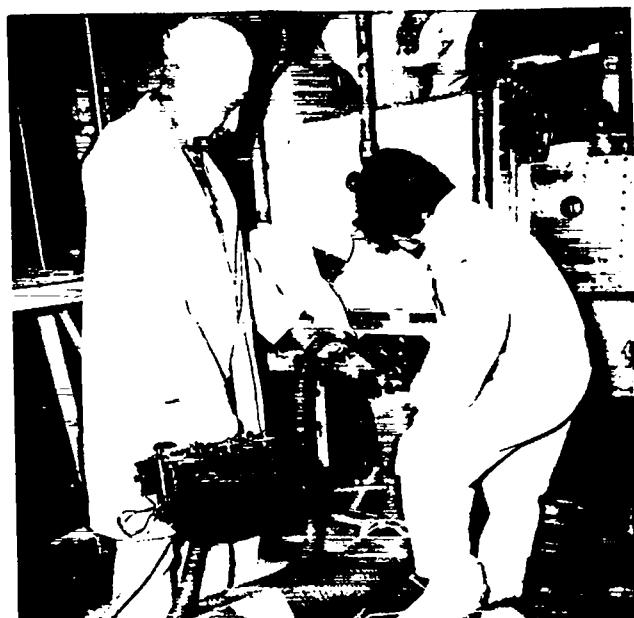
Fig. 26.
Portable ventilation duct in use while
inserting polyurethane foam.

Expanding polyurethane foam was introduced into some of the copper pipes before cutting them. The foam displaced tritium gases and created a filled dead area for pipe cutting. Air suits were not required for cuts on pipe sections filled with foam.
