Debris examination – update No. 2

Missing aircraft, Boeing 777, 9M-MRO, 8 March 2014

**Identification of two items of debris
recovered from beaches in South Africa
and Mauritius**

AE-2014-054

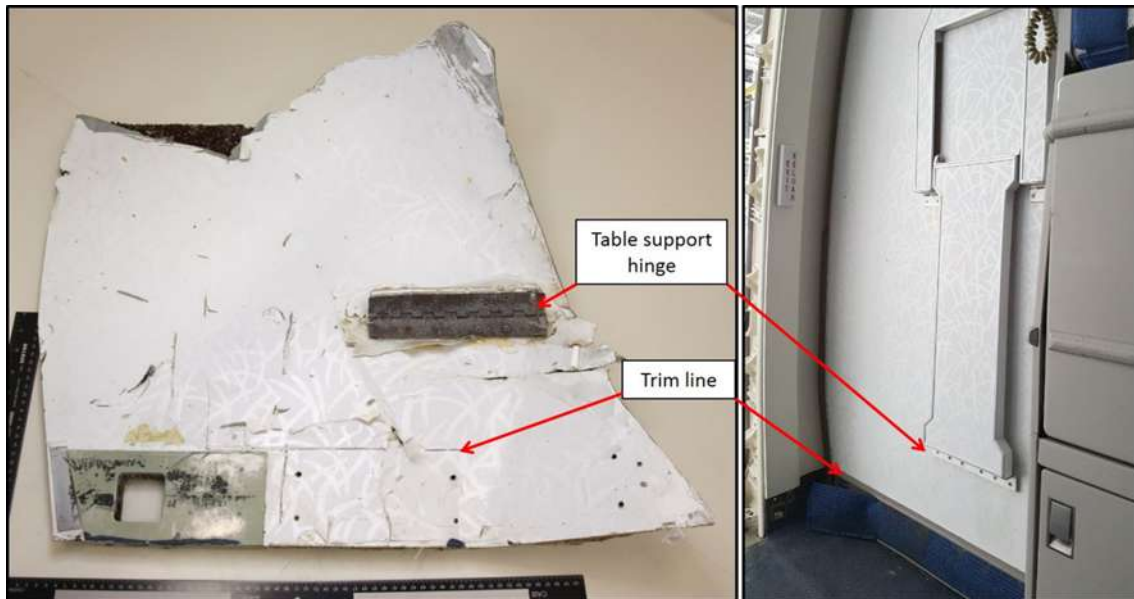
Figure 2: Comparison of recovered item with Malaysia Airlines Boeing 777 Door R1 panel assembly

Part number 4 was preliminarily identified by the decorative laminate as an interior panel from the main cabin. The location of a piano hinge on the part surface was consistent with a work-table support leg, utilised on the exterior of the Malaysia Airlines Door R1 (forward, right hand) closet

panel (Figure 2). The part materials, dimensions, construction and fasteners were all consistent with the drawing for the panel assembly and matched that installed on other Malaysia Airlines Boeing 777 aircraft at the Door R1 location.

There were no identifiers on the panel segment that were unique to 9M-MRO, however the pattern, colour and texture of the laminate was only specified by Malaysia Airlines for use on Boeing 747 and 777 aircraft. There is no record of the laminate being used by any other Boeing 777 customer.
