SAFETY INVESTIGATION FOR MH370

**Malaysia Airlines MH370 Boeing B777-200ER (9M-MRO)
08 March 2014**

Identification of Debris (Item 6 in the "Summary of Possible MH370 Debris Recovered") recovered south of Chidenguele, Mozambique on 24 April 2016

Ref: DB/01/17

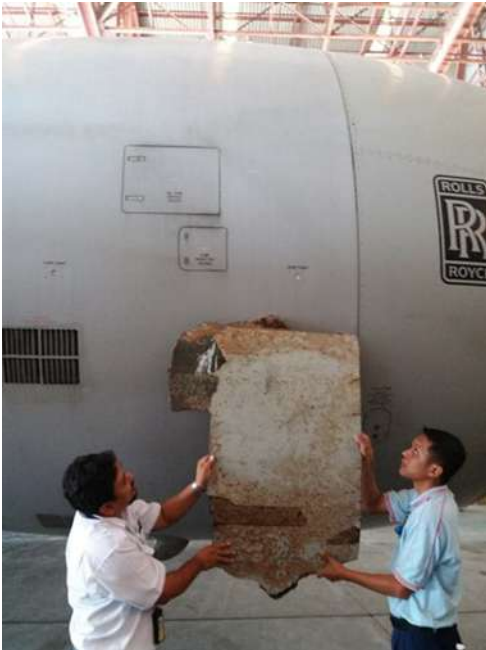
The part was brought near to the right fan cowl and was found to physically resemble it in terms of shape, size, colour and features.

Based on the above, the part is confirmed to be part of the ***Right Fan Cowl*** of a B777 aircraft.
