## **DEBRIS EXAMINATION REPORT**

### **SAFETY INVESTIGATION FOR MH370**

**Malaysia Airlines MH370 Boeing B777-200ER (9M-MRO)  
08 March 2014**

**Identification of Debris (Item 8 in the “Summary of Possible MH370 Debris Recovered”) recovered at Gris Gris Beach, Mauritius on 24 May 2016**

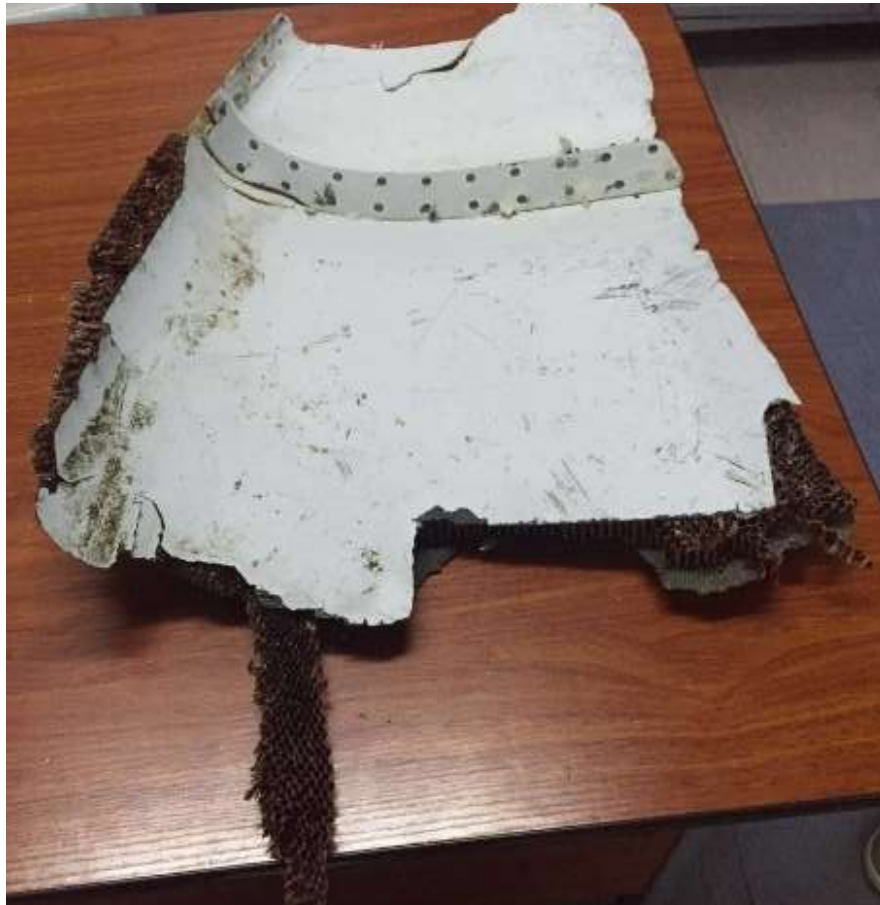
This item was recovered at Gris Gris Beach, Mauritius on 24 May 2016. It has been identified as Item No. 8 of the items found; refer to the “*Summary of Possible MH370 Debris Recovered*”.

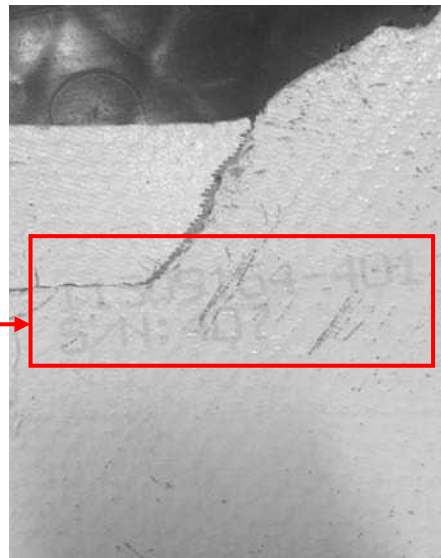
The part number was cross referenced to the Boeing component maintenance manual and drawings. This identified it as a component of the wing flap support fairing assembly and the fit closely matched that of the No. 1 flap support fairing. As the records of where these fairing tail cones are fitted are not normally kept by airlines, the serial number 407 could not be tracked to any particular aircraft.
