DEBRIS EXAMINATION REPORT

SAFETY INVESTIGATION FOR MH370

Malaysia Airlines MH370 Boeing B777-200ER (9M-MRO) 08 March 2014

Identification of Debris (Items 9 and 15 in the "Summary of Possible MH370 Debris Recovered") recovered at Macenta Peninsular, Mozambique on 22 May 2016 and Riake Beach, Nosy Boraha Island, Madagascar on 06 June 2016, respectively

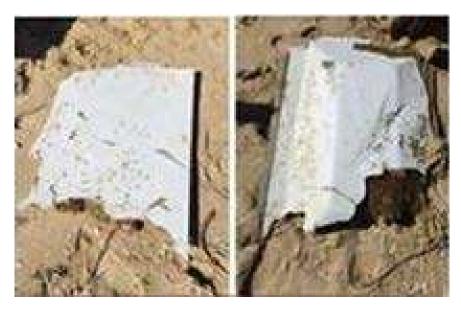
Item 9 was recovered at Macenta Peninsular, Mozambique on 22 May 2016 while Item 15 was recovered at Riake beach, Nosy Boraha Island, Madagascar on 06 June 2016. These parts were identified as Item No. 9 and 15 of the items found; refer to the "Summary of Possible MH370 Debris Recovered".

Item 9

Item 15

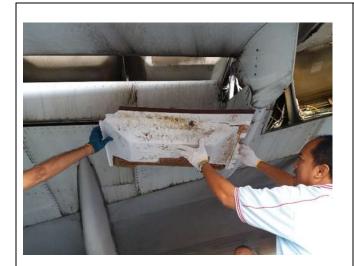
Similar matching process was carried out on Item 15; it was identified to be the outboard section of the "Upper Fixed Panel forward of the flaperon" on the **right** wing (refer to figure below). The pitch of the fasteners' holes on the right side (outboard) of the panel was measured to be 2 in. and that matched that on the debris.

Item 15 against Upper Fixed Panel forward of Right Flaperon

Item 15 had fractured at two places; the rear section was intact with the rub strip. The outboard section had the fasteners torn out with some of the fastener holes still recognizable. The inboard section was observed to have signs of 'net tension' failure as it had fractured along the fastener holes.
