## **DEBRIS EXAMINATION REPORT**

### **SAFETY INVESTIGATION FOR MH370**

**Malaysia Airlines MH370 Boeing B777-200ER (9M-MRO)  
08 March 2014**

**Identification of Debris (Item 26 in the “Summary of Possible MH370 Debris Recovered”) recovered from Nautilus Bay, South Africa on 23 December 2016**

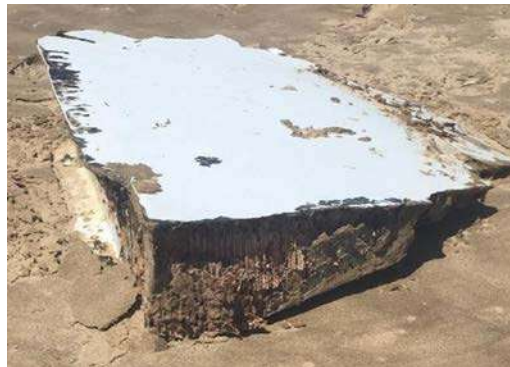
This item was recovered from Nautilus bay, South Africa on 23 December 2016. It is identified as Item No. 26 from the items recovered; refer to the “*Summary of Possible MH370 Debris Recovered*”.

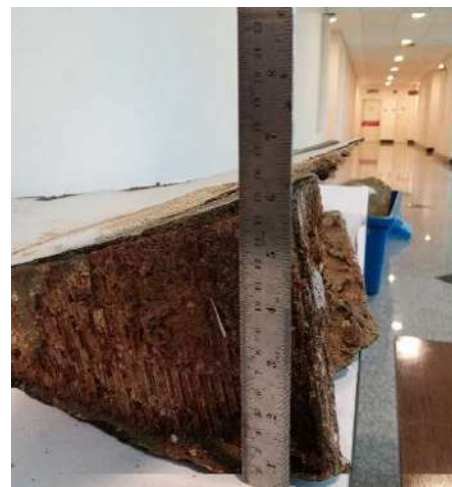
The spar like section height was 6.5 inches high

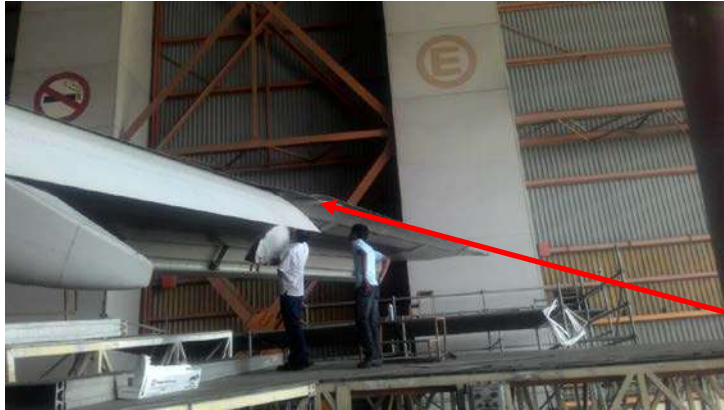
The part was taken to a B777-200ER, formerly operated by Malaysia Airlines (MAS), undergoing a maintenance check at Subang, Malaysia, for identification purposes.

The debris closely matched the inboard section of the Right Aileron.

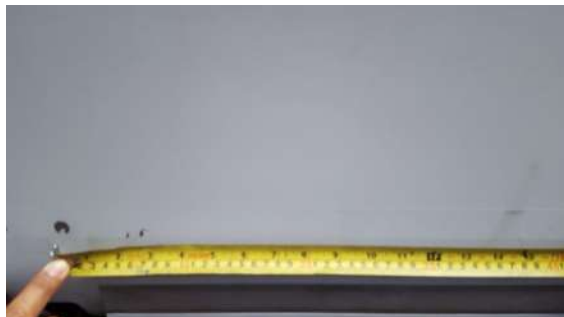
Spacing of fasteners on the aileron on aircraft

The numbers on the head of the fasteners on the debris were compared with those on the inboard section of the right aileron on the aircraft. These numbers matched. Additionally the spacing of the fasteners on the aileron also matched those on the debris. Refer to the photos above. The core and its dimensions also matched those on the inboard section of the right aileron. These confirmed that the debris is part of the inboard section of the right aileron of a B777 aircraft.

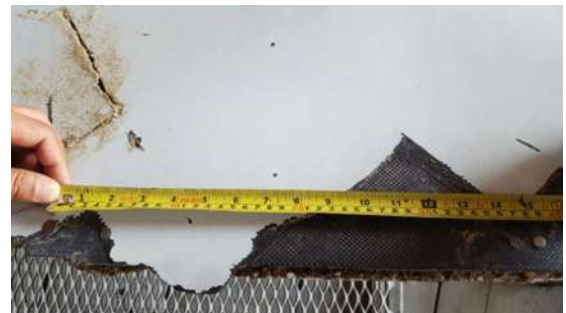
Spacing of fasteners on the debris
