## 2 LeCroy 7200 Restoration

Model: 7200 Mainframe with 7242B plug-in

Date of restoration: 3/12/2001 - 3/18/2001

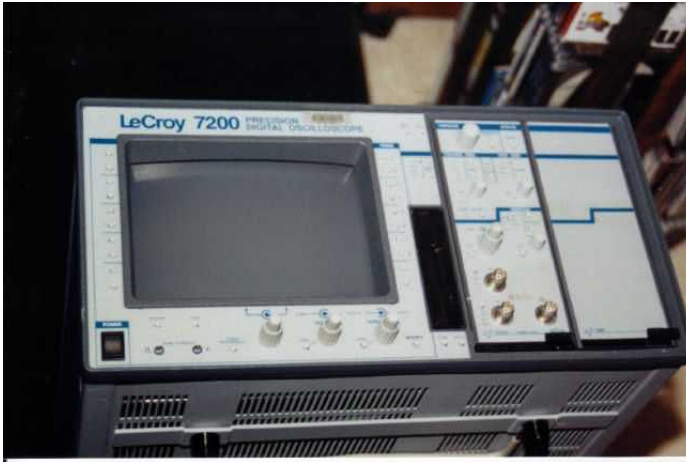
The scope was purchased for resale and to recover the 7242B plug-in for a different project. Initial investigation showed that the 7242B seemed to work at lower sampling rates but fails at higher frequencies. The mainframe appears in poor shape and does not have video. The author at this stage has refurbished two 7200 units similar to this one that were also from Keesler AFB.

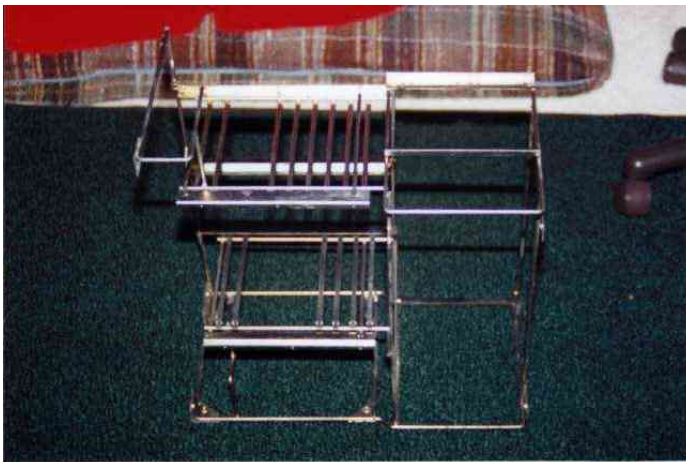
Below, the 7200 has been disassembled to the bare frame. This was done because the unit appears to have been dropped. The frame had been bent along with the case and some of the welds had broken. This picture was taken after brazing the brackets and straightening the frame.

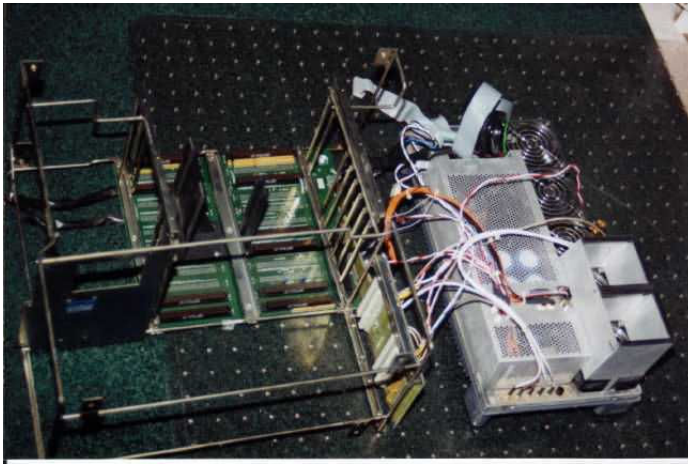
Below, the power supply has been tested and the back plane is ready to be installed. Notice that both the plug-ins and the VME have a back plane,

which are interconnected.

These scopes need a lot of airflow. If you think any of the fans are suspect, just get rid of them. The two fans located to the right side with the shrouds over them are the most critical. These supply the airflow to the plug-ins. The plug-ins have a thermal cutout switch in case of an over temperature condition. If you try and run the unit without the covers you may cause damage to the plug-in. During calibration this is difficult to avoid. It is best to have some portable fans around to get some airflow once you get to this stage.

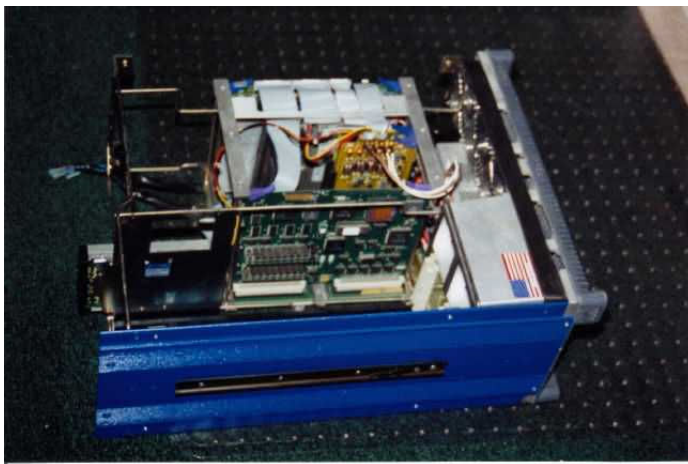
All of the CPU cards and DC to DC converter have now been tested and are installed. At this stage I use a known good frame to test each card, one at a time. The 7200 has two CPU cards both based on Motorola's 68020RC16E processor. This is a 68000 core running at 16MHz.

A re-certified hard disk has also been installed. These units used the old MFM drives used in some of the early AT clones. Only a few different disk drives are supported. All of these drives are in a 3.5" form factor, have 4 heads, 615 cylinders and 17 sectors per track. The 8425F which was a faster version of the 8425 will not work based on my testing. It is possible to use the KALOK OCTAGON KL320 disk drives. There are a couple of companies that are taking the old MFM drives and rebuilding them. You can get a drive like this for around \$200 with a trade-in. These companies will replace the heads if needed, the media and motors. The drives go through a burn-in and are then re-certified. You can also try to find an old used one. Good luck! I found a guy that had a few and I bought him out.

This unit now has a MiniScribe 8425 installed.

The case for the unit was again in poor condition. It was cleaned and repainted with the blue/gray scheme you see. LeCroy does not offer the original colors.

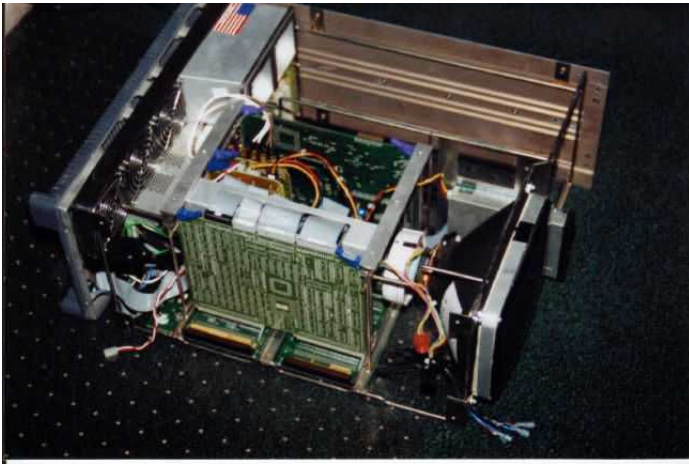
The video processor card is installed next. The CRT was in good shape with no burn marks. It was just cleaned up and re-installed.

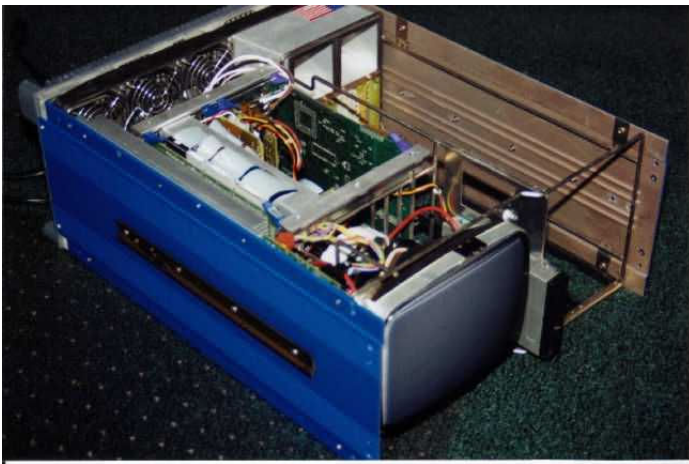
Both covers are now installed and the front keypad assembly is ready to be installed.

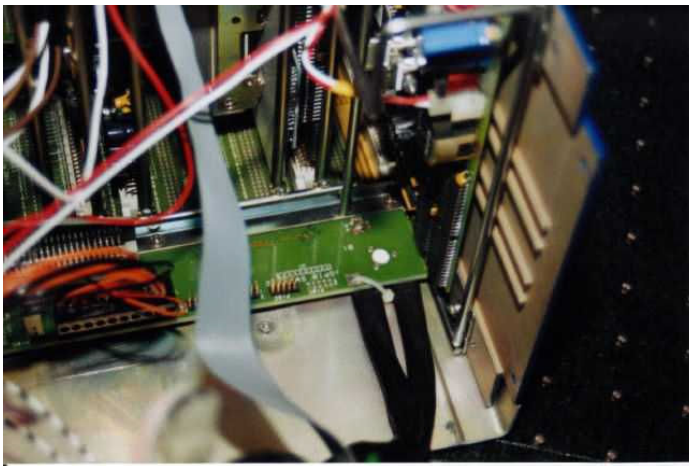
This is the rear view of the 7200s VME back plane. Notice the small white dot with three small dots surrounding it. This is where the battery was installed. Just above this there are three small diodes. I removed these diodes and replaced them with the charger circuit shown.

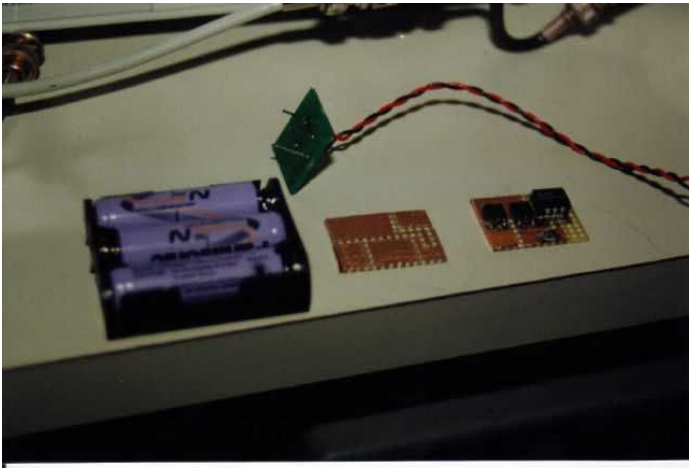
We are now ready to build the small charger.

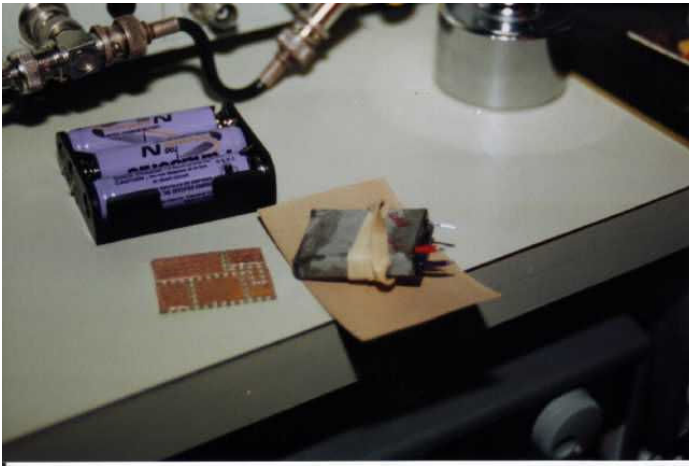
I have used 5-minute epoxy to enclose the charger circuit.

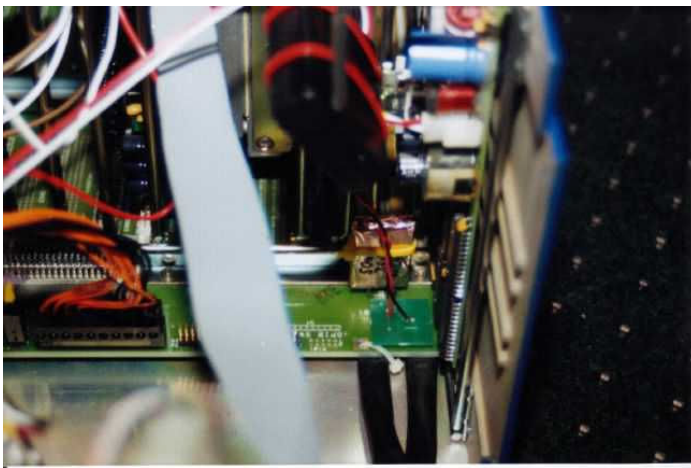
Copper foil is then wrapped around the unit and it is tied down to the back rail of the VME frame.

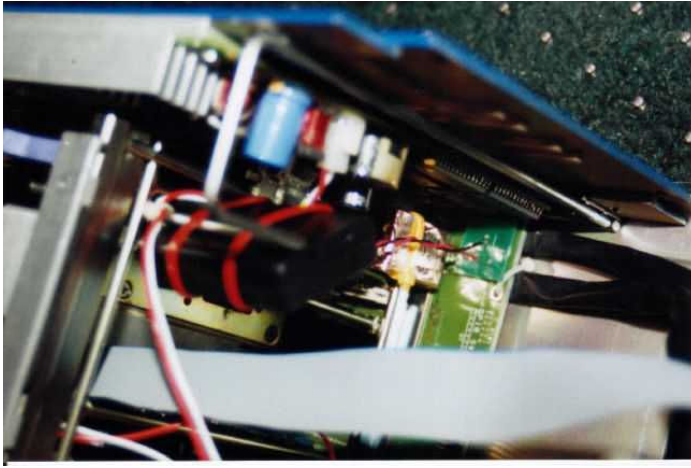
I ended up using sealed battery packs. This is held to the top of the frame. I reused the old battery quick connect. So far I have not seen any problems doing this with.

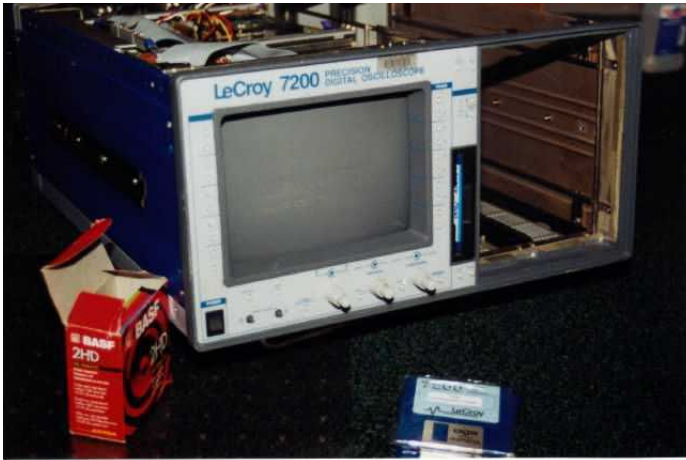
The lower cover has now been installed and the unit is powered up for the first time as a single unit. The LeCroy software is now used to perform the hard disk low-level format and initial software installation. The system is also run through some basic tests at this stage.

NOTE You can not use an old PC to low-format the MFM drives. It must be done using the LeCroy software. Also you can not use a PC to back up the hard drive. The 7200 used an AMD AM9580A-10LC/30 hard disk controller. This controller is different than the WD chips used in the old PCs.

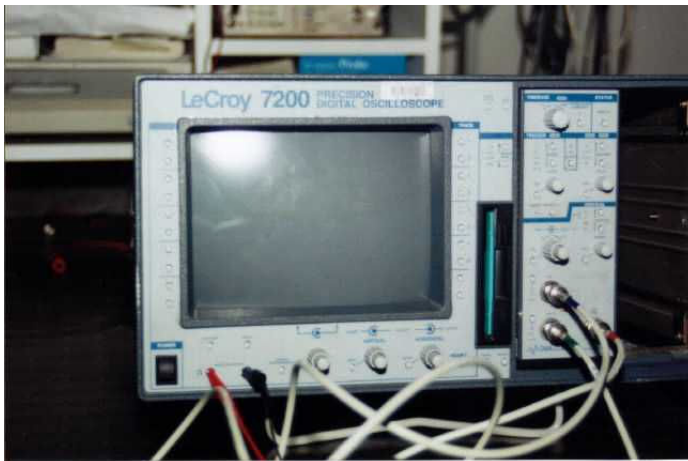
A plug-in is now installed for the final checkout.

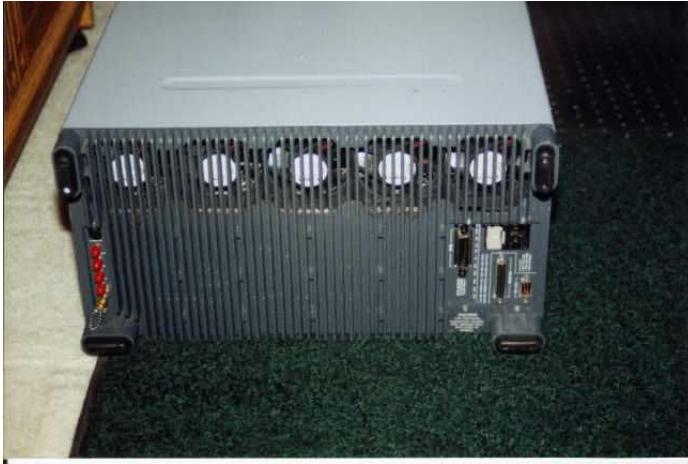
The top cover is now installed. This is all new paint on the bottom and top.

Notice the LeCroy logo cast into the heat-sink. The attention to the design detail goes beyond what one could imagine.

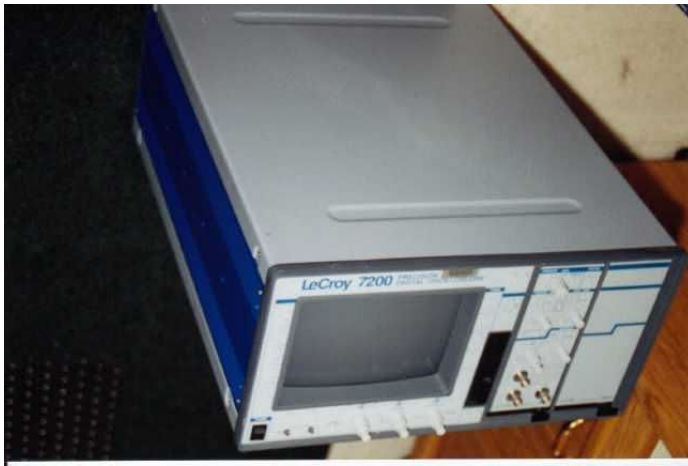
The unit is now shown ready for service.

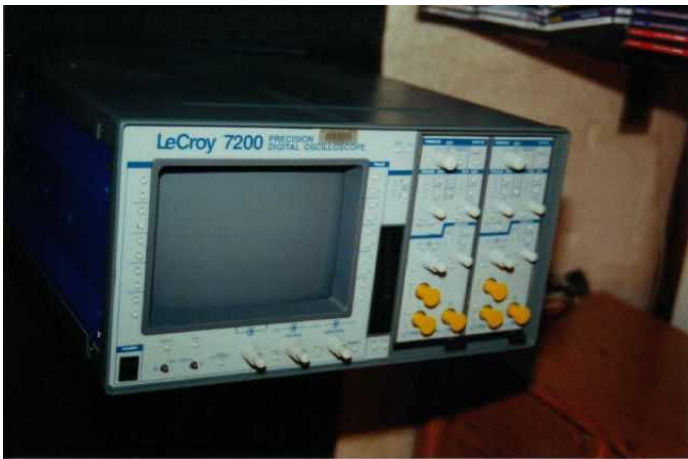
This next unit was also purchased on EBay for about \$500. It also came from the Keesler AFB. This unit was one of the first units I rebuilt. The people who had originally purchased the unit tried to repair it. The main problem was the video card, battery and disk drive were dead. They had mentioned that their tech. had left it running while they were working on it and that it no longer did anything. I think he had been running it without the covers and the thermal switch had tripped inside the plug-in. These units won't run without airflow! This one is painted with the dark blue and metal gray scheme. It looks much better than the picture. If you decide to paint one of these units do it while the unit is apart. The heatsink is a treat to get down to the bare metal. The front bezel is easiest to prep. by masking off the keypad area. Don't try and remove the plastic lettering.

I left the Asset plates on the units in fear of the damage it would cause by attempting to remove them. If you have an idea how to get these off without damage, let me know.

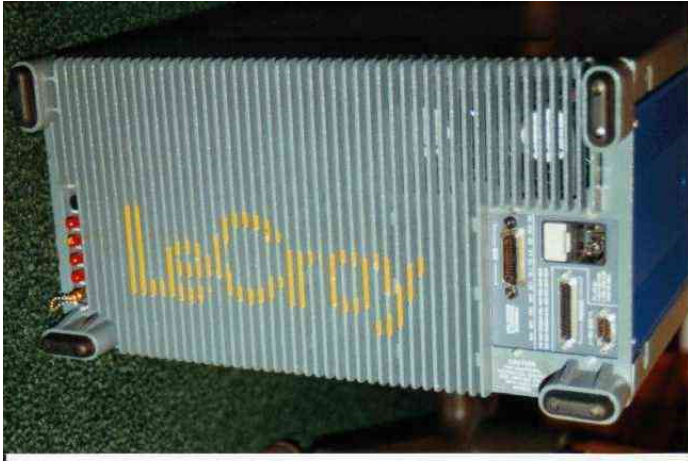
Same unit from the rear. The yellow caps came from Caplugs, PN# EP 8.
