3 LeCroy 7200A Restoration

3.1 System Checkout

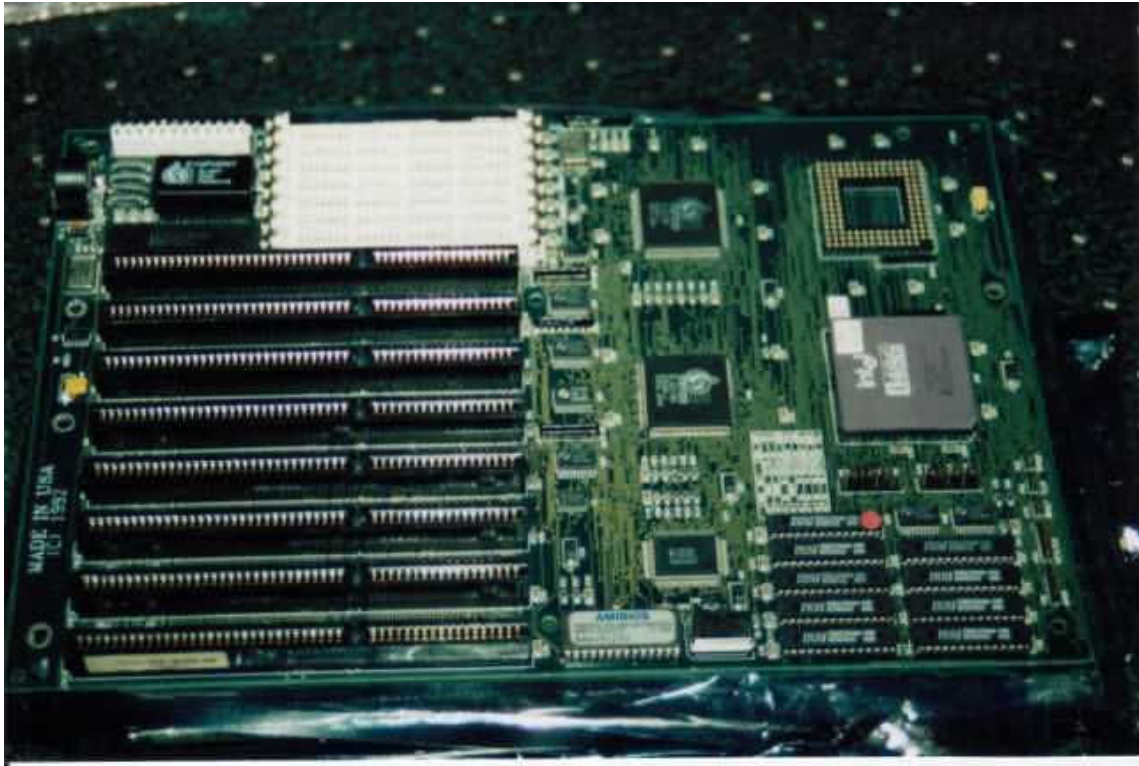
This is the motherboard that was supplied with the scope. Notice the new cap in the upper right corner of the board.

Also notice the AMIBIOS is used.

Once apart I noticed that a tantalum capacitor used on the 5 Volt supply had broken off the motherboard. The 7200A was shipped from LeCroy with an Intel 386 or 486 processor. My unit had a 486DX33. I repaired the board and re-tested the unit with a Diamond video card running some LINUX diagnostic software. I found that the board was still unstable. After changing the CPU, cache, main memory and testing the power supply I called LeCroy. I was told that they had tried to find boards a few years back and that they turned up nothing. The 7200A can not use just any PC motherboard. It support the Symphony chipset only and only certain versions of the silicon. After exhausting all of my resources I turned up two boards that ended up working.

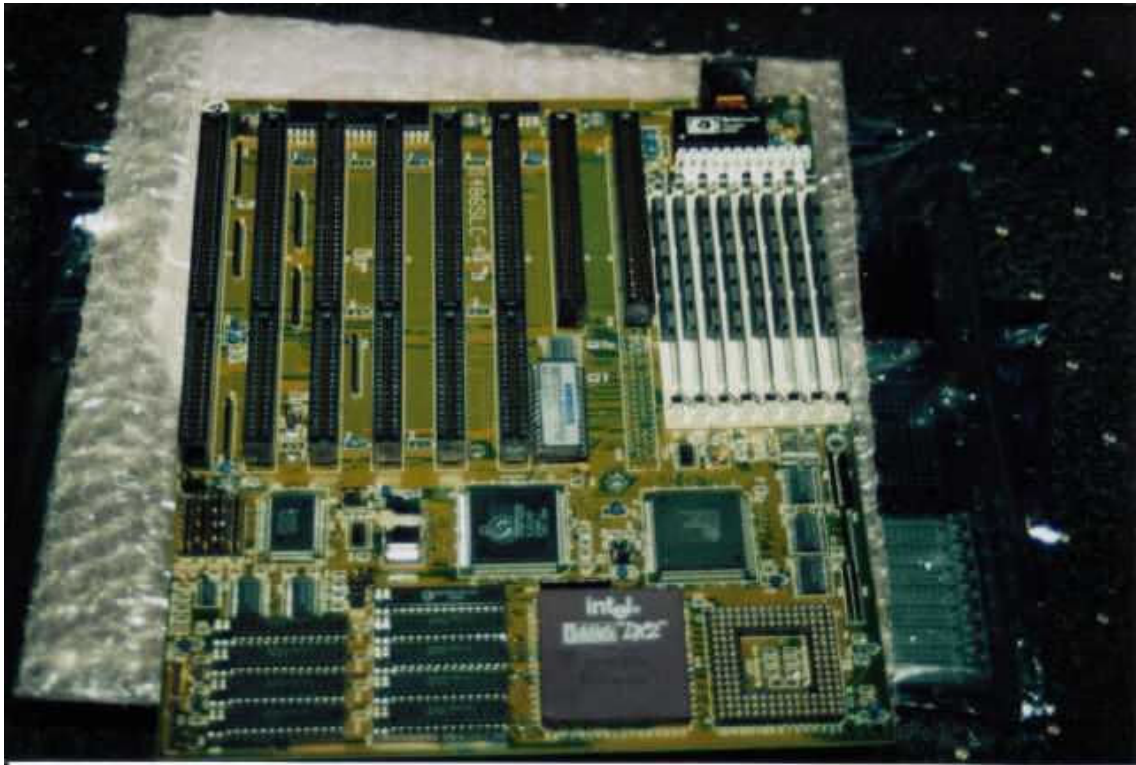
I found this board down in Texas. I picked it up for \$10.00 plus shipping on Ebay.

Notice that the board is much newer. This board has revision 6 silicon for the 82C461 and revision 1 for the 82C362. I did some basic testing with the board and it seemed to be fine. I have been unable to locate the documentation for the board and the jumpers are not marked on the silk screen. So I put this one in the spare box after finding the second board.

Note: I latter switched back to this card and noticed that my video flicker problem has gone away!! This card is a JOINDATA Systems, G486SLC-4. I ended up using 8M of RAM, 64K cache and an Intel 486DX2-66. With this configuration the unit seems very stable.

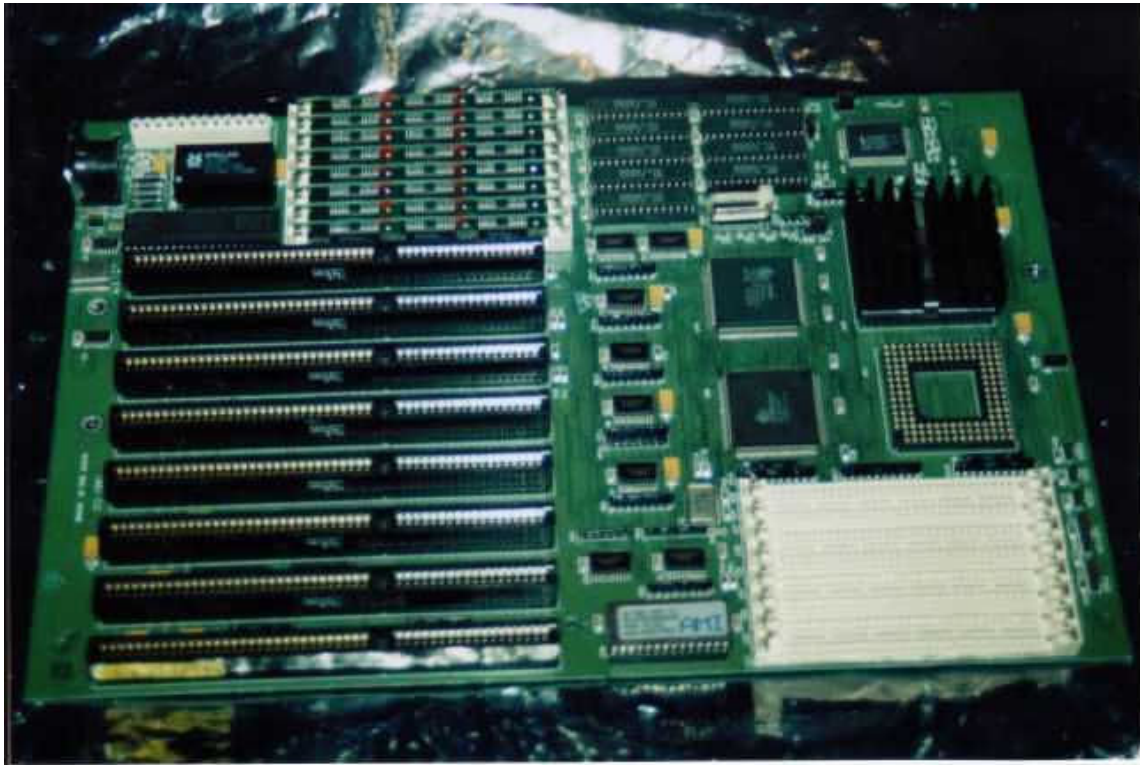
I later turned up this board. It was a gift from a good friend of mine. This card had the documentation and had the same version of silicon as the original board.

After running several hours of tests on the board I decided it was fit for service. I did some testing with the Intel DX-66 and the DX-100. I also tried a Cyrix M1 120MHz part for fun. This scope will outrun the 7200 by a long shot!!! This motherboard did not have the power supply on board and required an adapter socket for the M1. I ended up staying with the DX2-66 with a 33MHz bus.

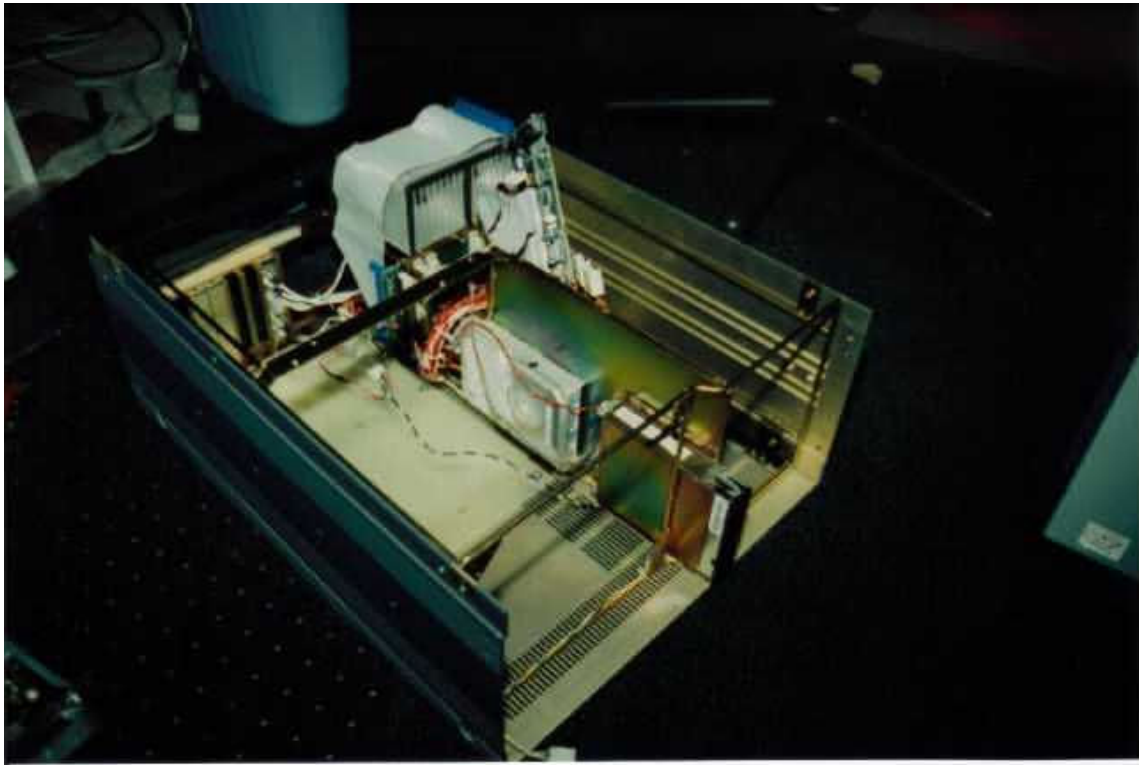
The following shows the empty frame. Not much to look at. The 7200A does use a standard IDE drive. My system came with a Quantum ProDrive LPS, 210AT model RR21A011. This is a 977 cylinder, 5 head, 17 sector/track, 41MB drive. This is double size of the drive used in the 7200. I ended up replacing this (did not want to risk the age and travel) with a Maxtor 1.2GB drive. It was the smallest I could turn up!! While I had no problems using the larger drive, it did take a very long time to format. I think about 2 hours or so!!

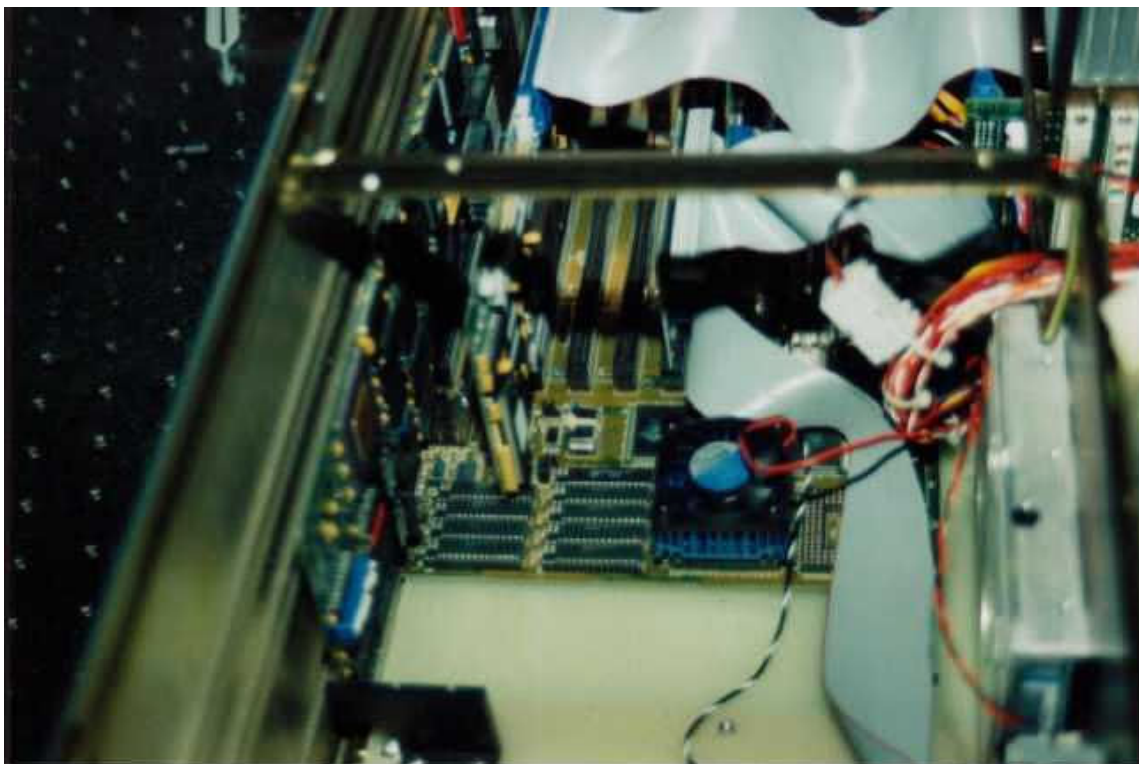
3.3 Texas M.B. with Cyrix 120MHz!!

Testing with the board from Texas running the Cyrix 120MHz and 32M of RAM. Considering the scopes originally had a 386, this board is a screamer. If I locate the books for this board it will go back in at some point to help with the math. I never saw any problems running the Cyrix processor, but I only had the board installed for a few days.

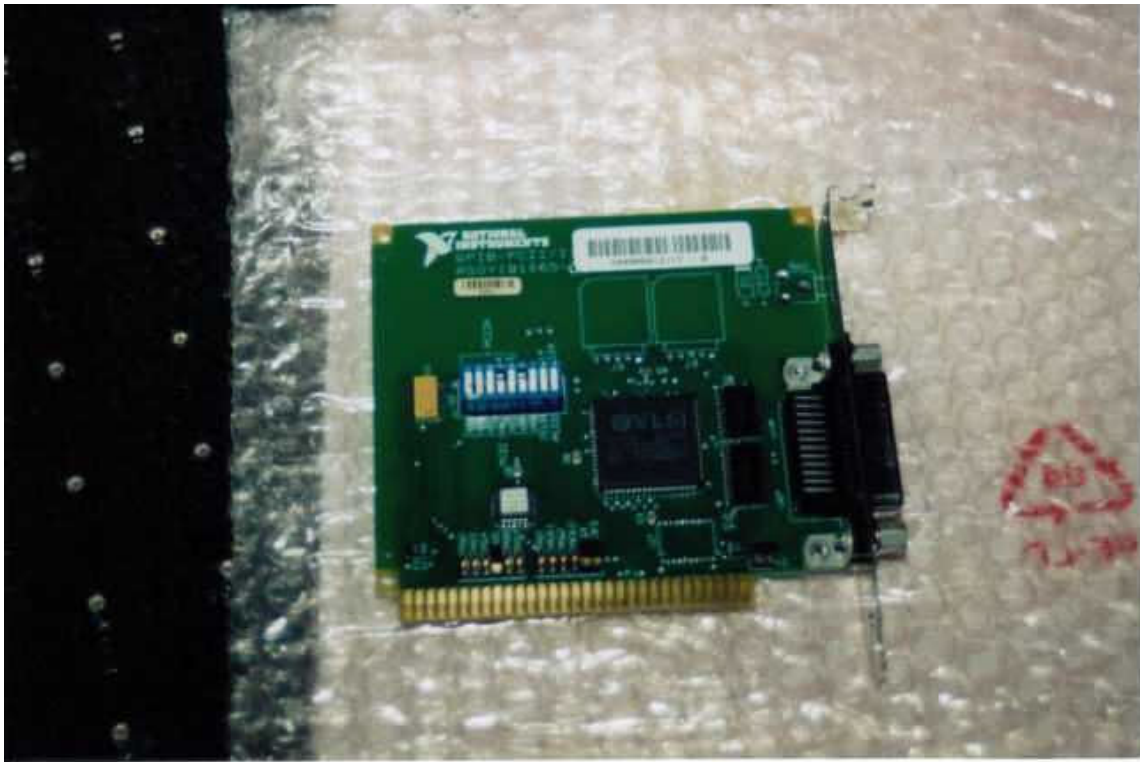
This is the GPIB card available from National Instruments.

Set as follows:

A3-OFF DRQ3
A4-OFF DACK3
A5-OFF
A6-ON
A7-OFF
A8-ON
A9-OFF
7210-OFF
PCII-OFF
IRQ5

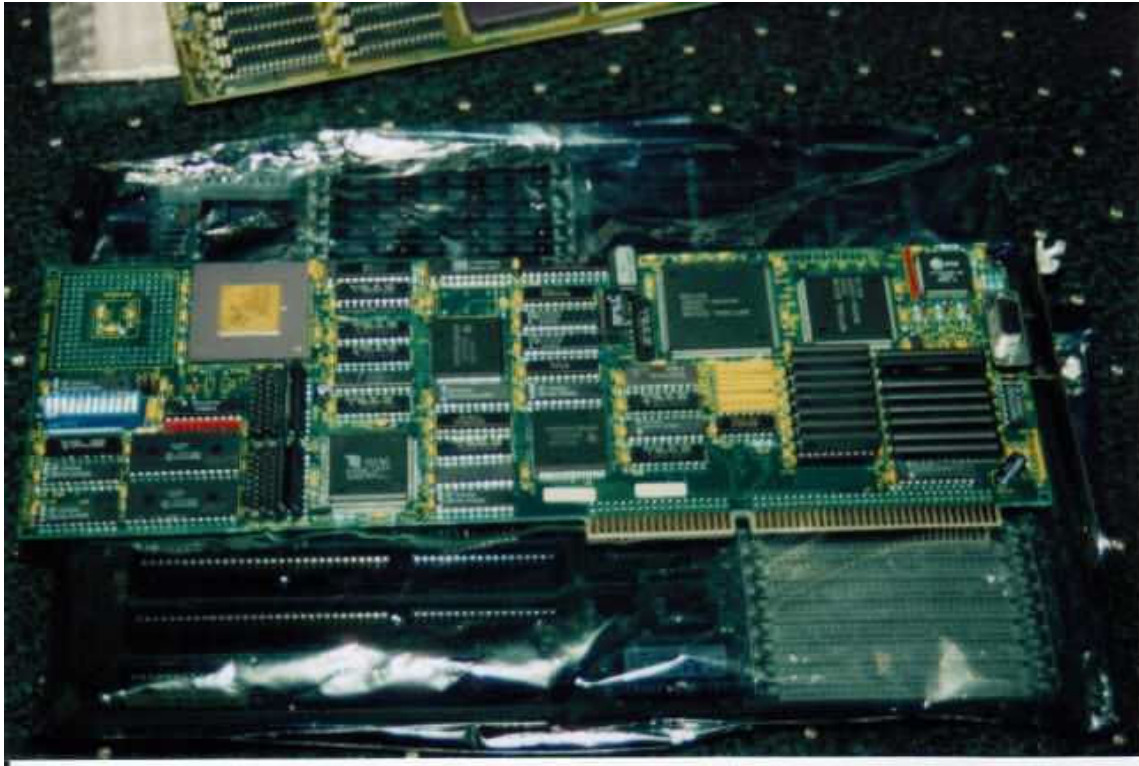
The video card is a way high end GSWPM01. The card uses a TSENG LABS and TMS34020GBL-32 for the video processing. ~~It's too bad but the software appears to not have been written to synchronize the video to the write pulse. So, at least with my scope, the video has a flicker every time the screen changes. This is my only complaint about the 7200A and I still stew over it!!~~ It turns out that this must be one of the problems with an incompatible motherboard. More testing revealed that running the unit with the Texas motherboard seems to clear up this problem. I am now using this card in place of the other card I had shown and am not having any problems.

The video card should be set as follows:

SW1-OFF
SW2-OFF
SW3-OFF
SW4-ON
SW5-ON
SW6-ON
SW7-ON
SW8-OFF
SW9-OFF
SW10-ON
SW11-ON
SW12-OFF

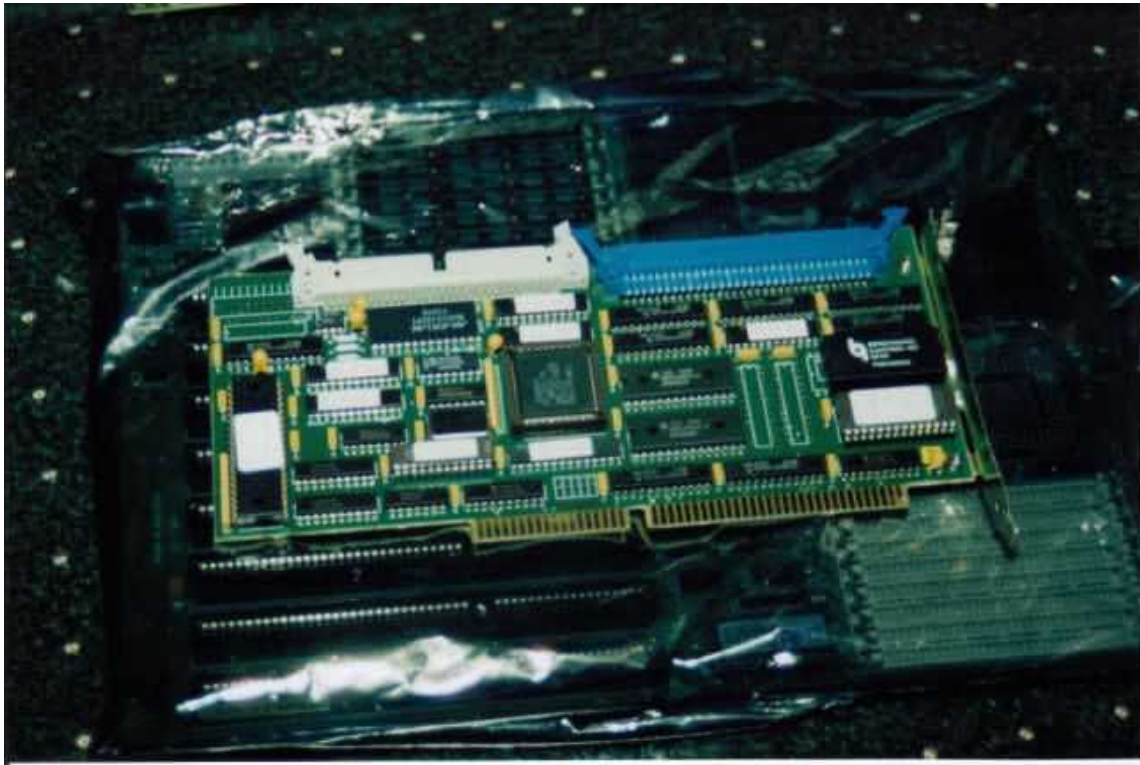
The interface to the plug-in is all custom.

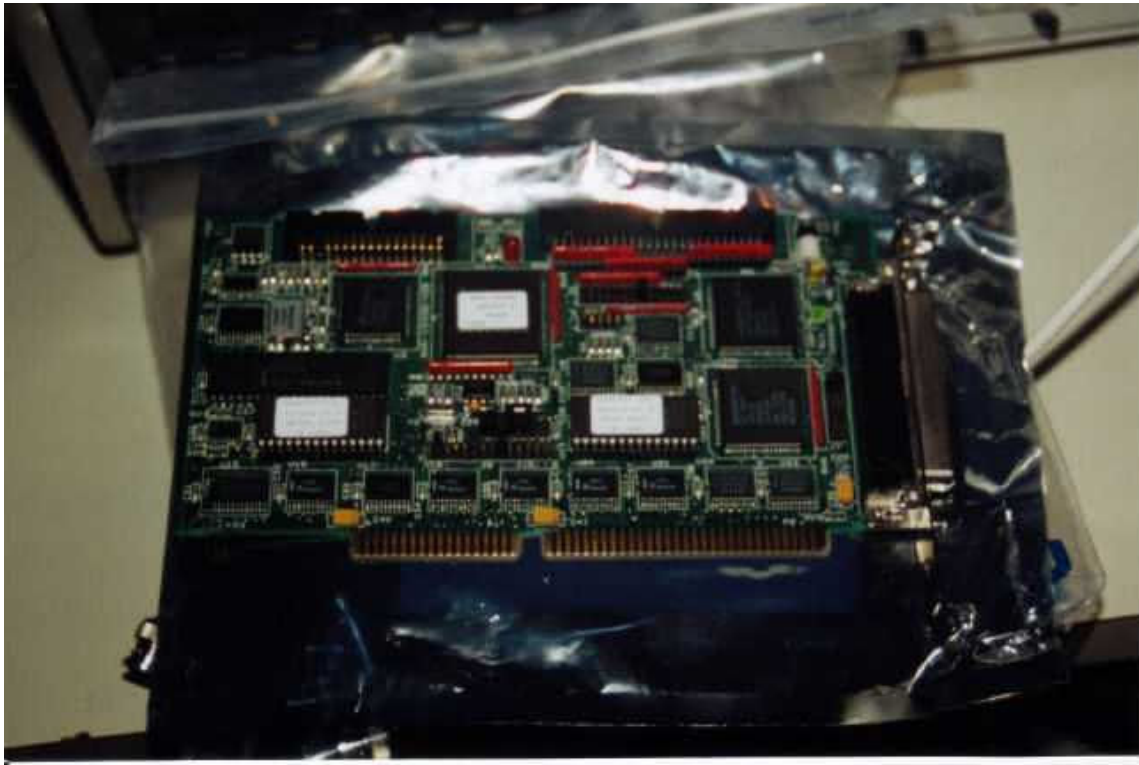
Note that you can use the cards that have floppy drive support. Just disable it.

One thing I noticed in the manual is that it wants the card in the scope to have an ID of 7. I tried to change this and the scope did ID the card with the new address. I have not done any testing yet to see if it is possible to use the card set like this.

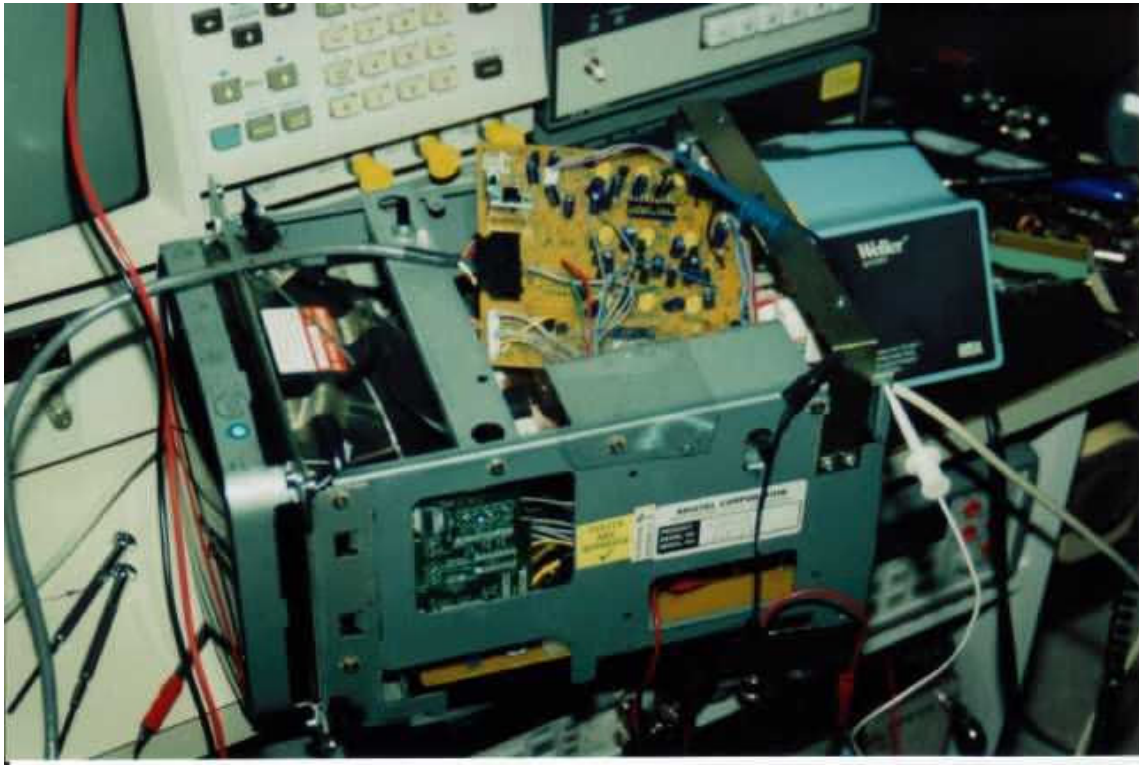
Next it was time to play with the CRT. The colors looked poor at best and the picture was dim. I hooked the CRT, which uses the standard VGA interface, to a PC. I found a blown gun driver and the video interface chip was bad causing the dim picture. I replaced these parts and realigned the whole unit. I contacted LeCroy and found that two CRTs were used. The early ones had a high failure rate and the others would need to have the intensity tweaked one a year. My unit is the newer and has a Sony Trinitron picture tube. Once aligned the picture was beautiful. I ended up having to do some minor adjustments once the unit was hooked back up to the LeCroy.

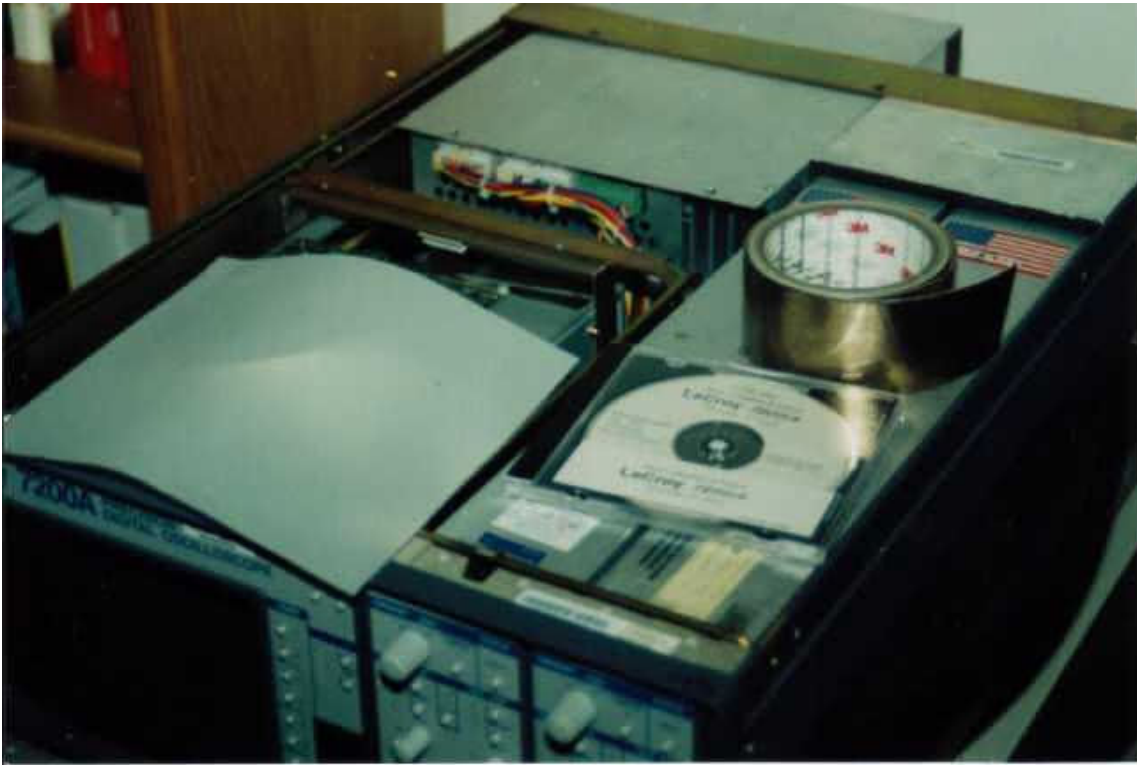
The CRT is now ready to be installed into the mainframe. I did some basic power up tests and found a very high frequency noise in the picture that was not there during my calibration. Taking out the spectrum analyzer I found the switching power supply, which is positioned directly behind the CRT was putting out enough EMI to interfere with the video. I also saw the 66MHz coming from the motherboard and a lot of low frequency noise when the plug-in would acquire data. To help reduce the noise I made a small shield for the CRT. This, a few beads and some copper tape and the noise was gone. The picture is now very clean except during video writes.

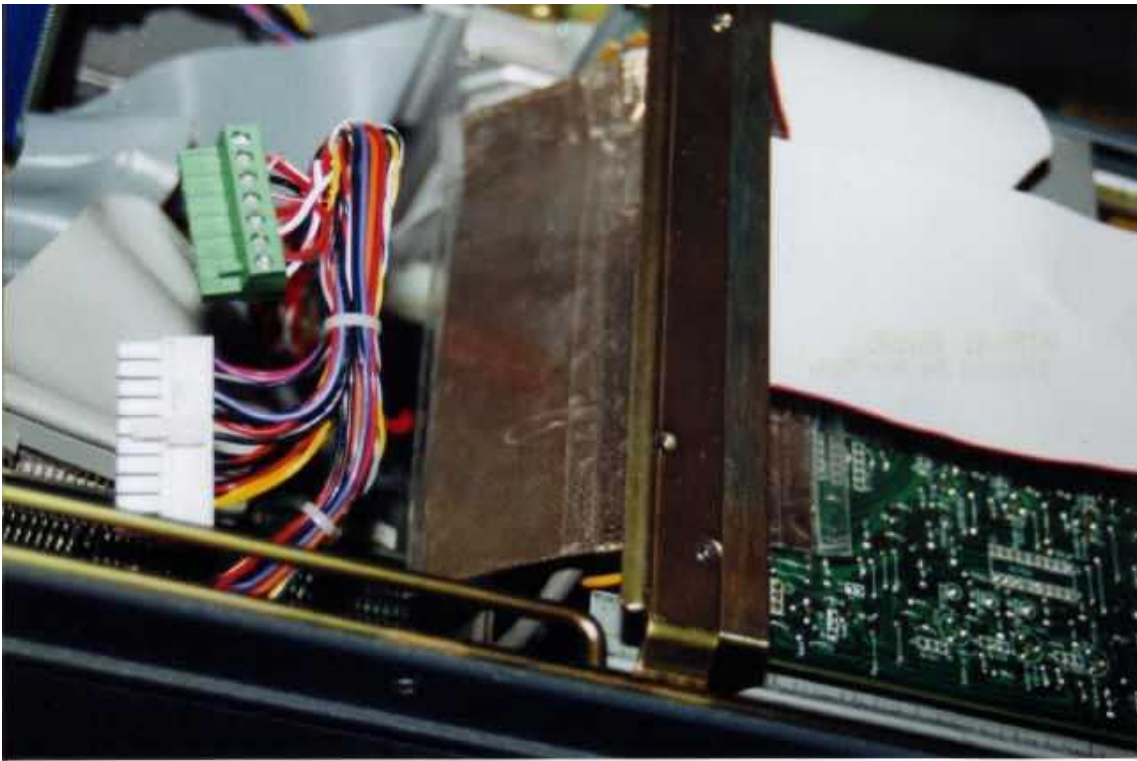
Mylar film and good old 3M tape. Notice where the power supply harness is going to be once the supply is pushed into place!

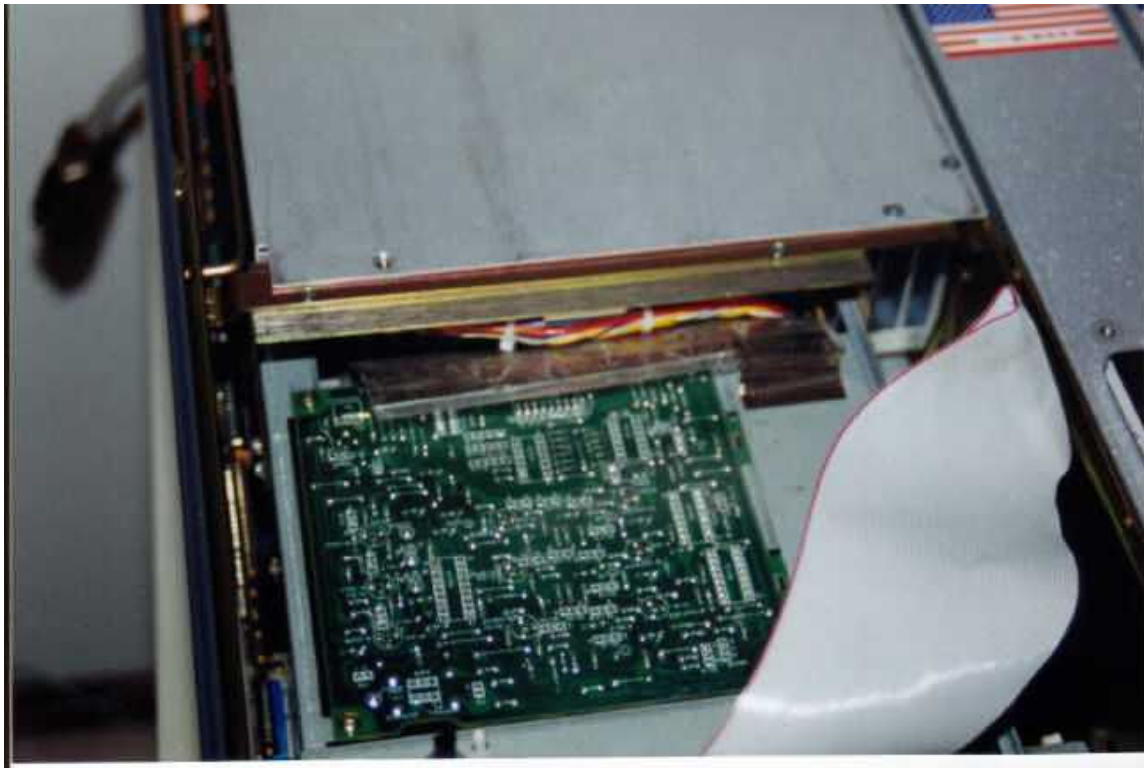
It may not look nice, but it works good.

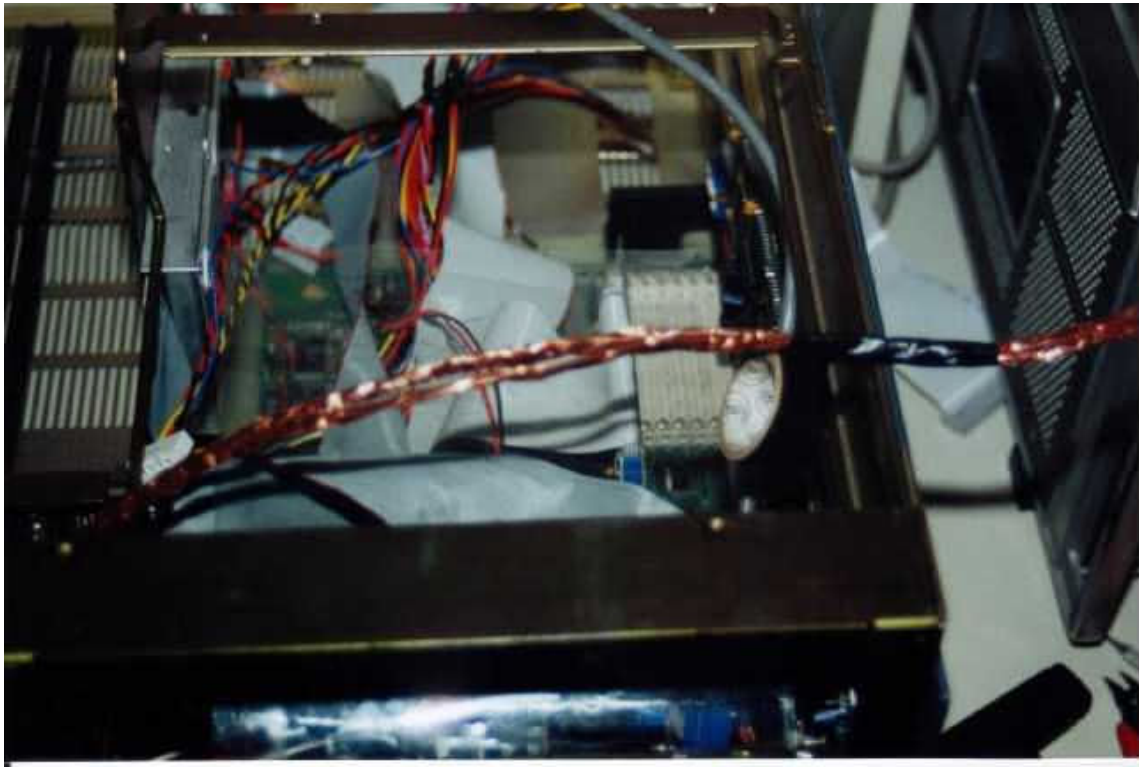
The two auxiliary power feeds for the plug-ins also created some large spike during acquisition.

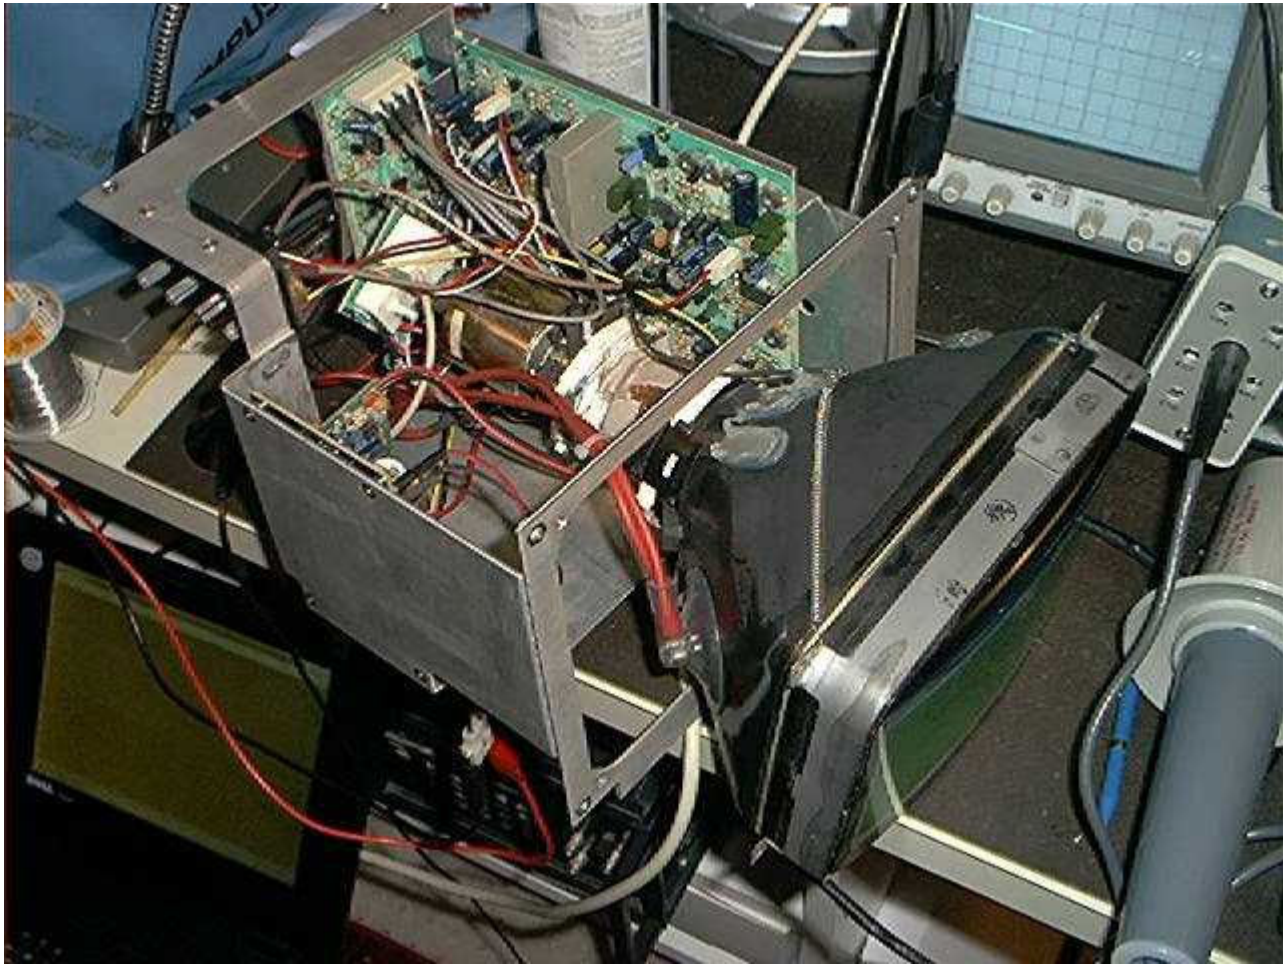
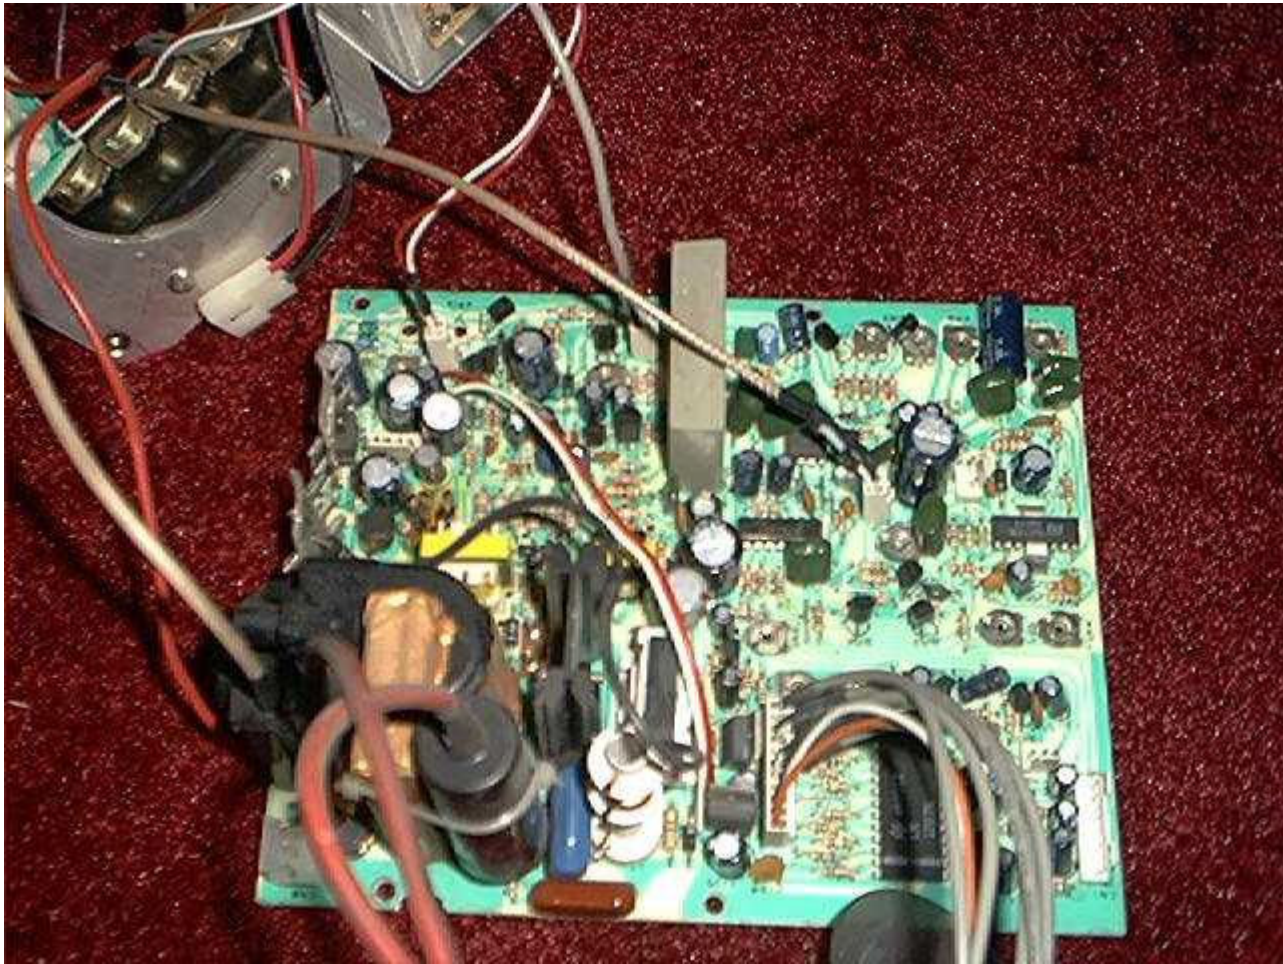
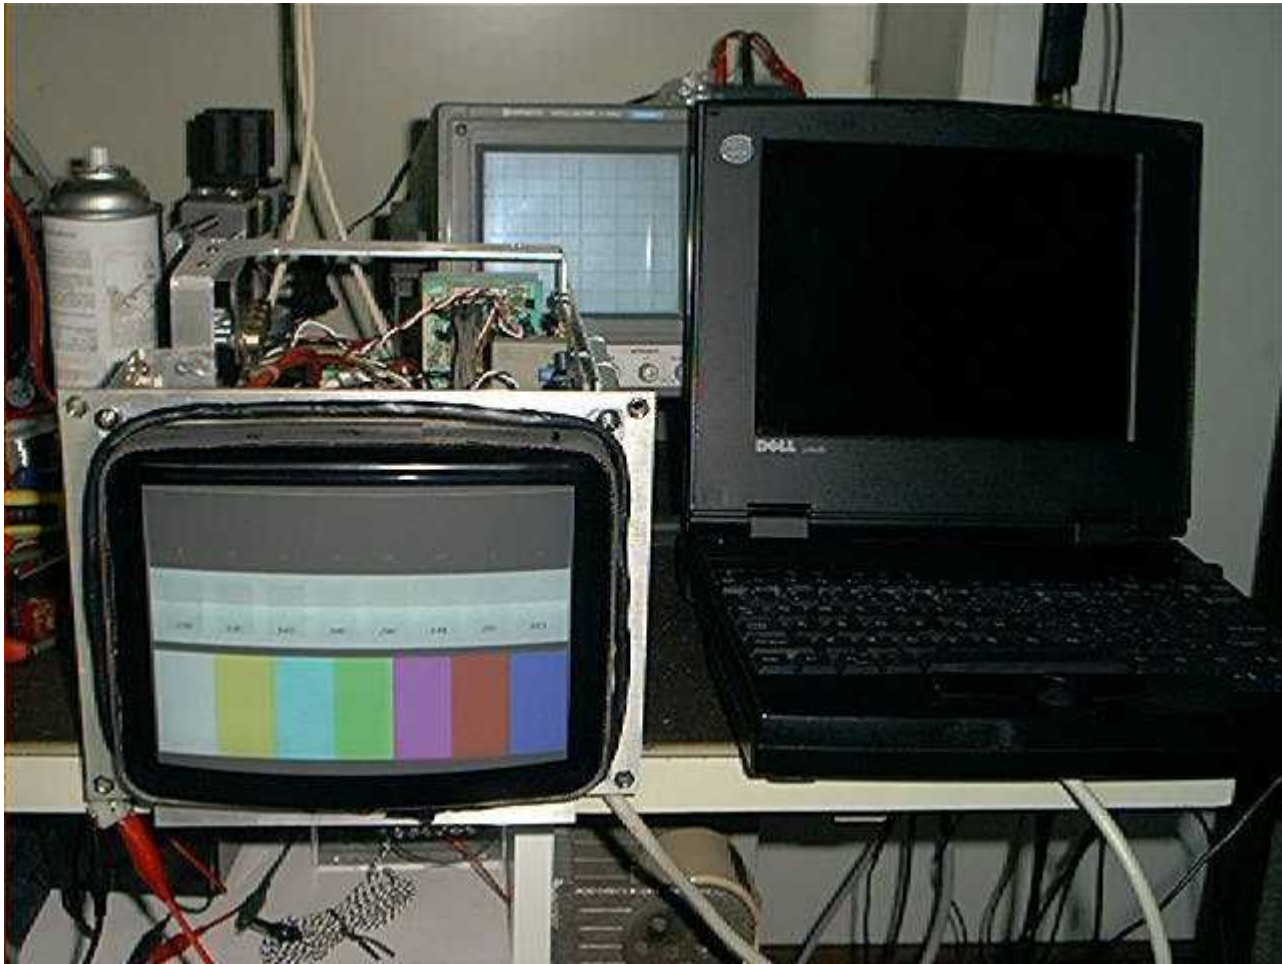
This is the other version of the monitor I have seen. I got this unit for a spare and it too needed repairs.

Once setup, this unit performed about as good as my original unit. It does run from 12V instead of 24 and requires 3.6 Amps to run.

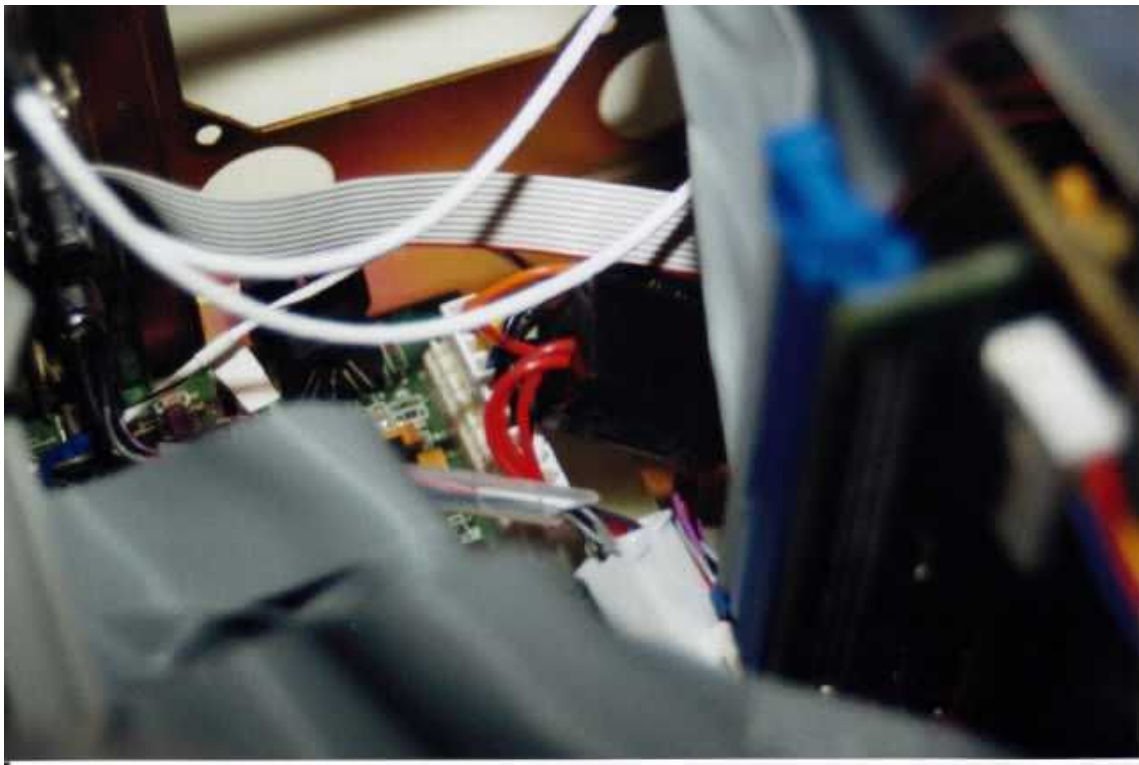
Notice the bead located at the PC's main supply feed. Every thing I did had a little effect. The over all performance is much better now.

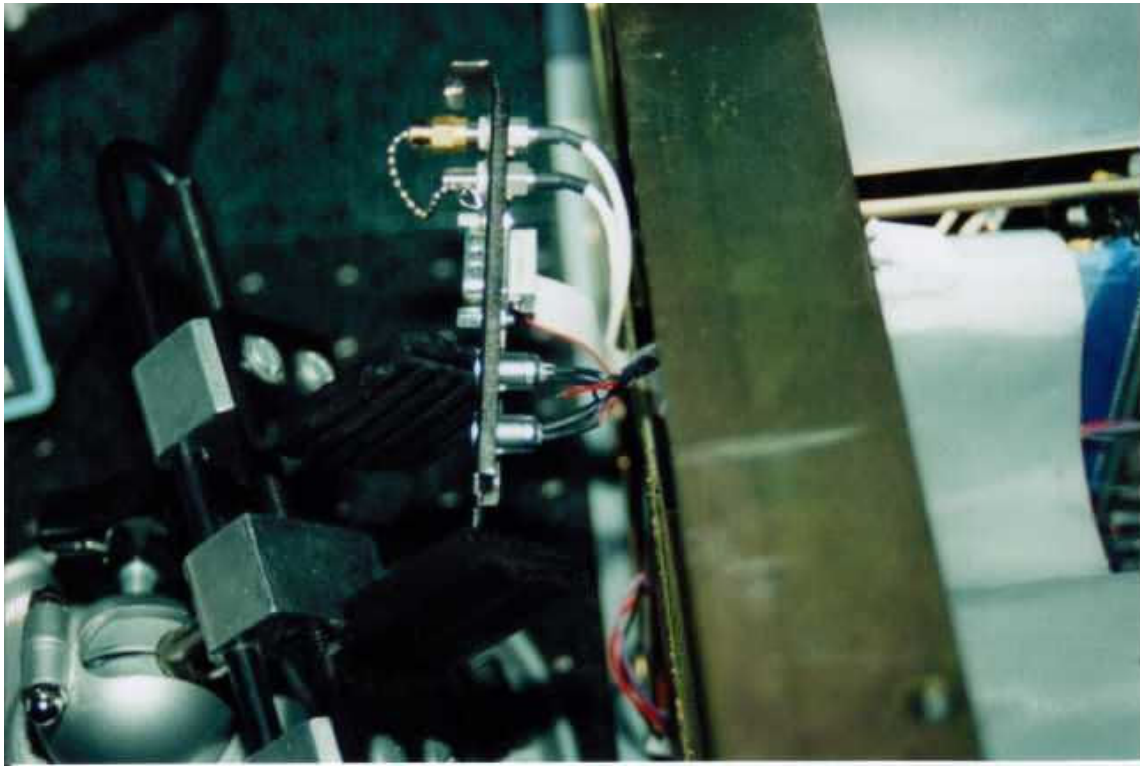
Next I checked the external peripheral interface connectors for broken wires. These wires are fragile and need to have some kind of strain relief.

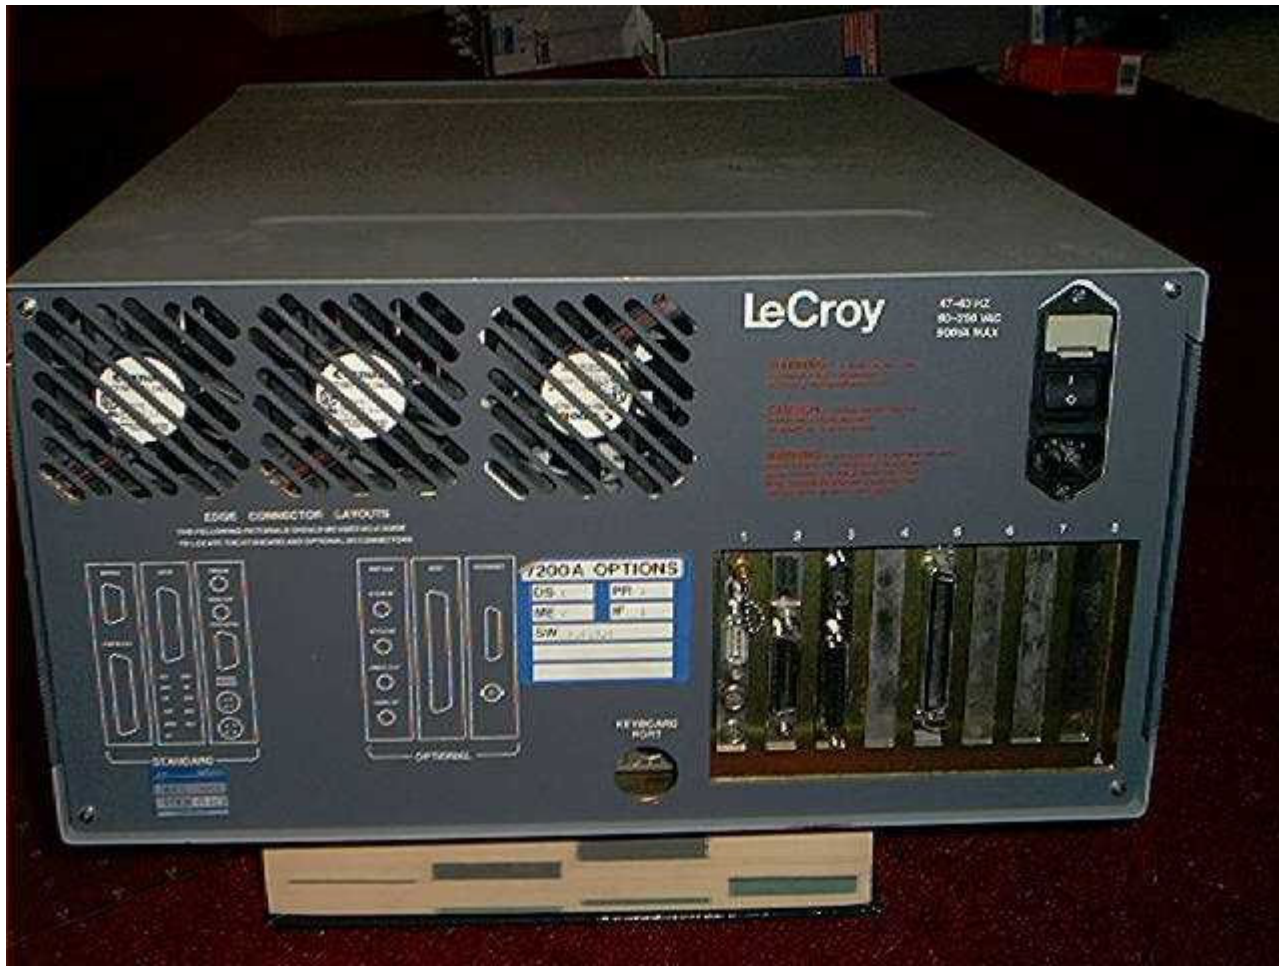
This is the cables to the unit. I have the RS-232 and GPIB interface hooked up here. Notice the older style SCSI connector is still not in use. I have yet to get the drivers written for LabView to support this feature.
