# Service Bulletin

**CSA-14**

**Model:** CDX-U404/U606 **No.** 292

**Subject:** Preventing Audio Dropouts **Date:** August 25, 1993

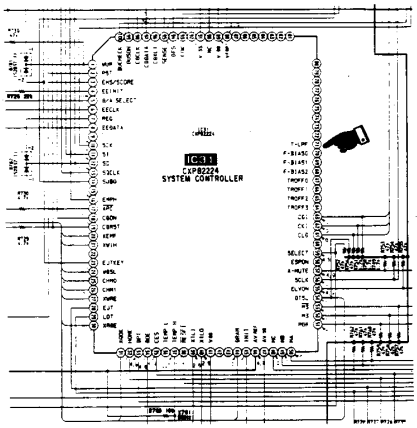
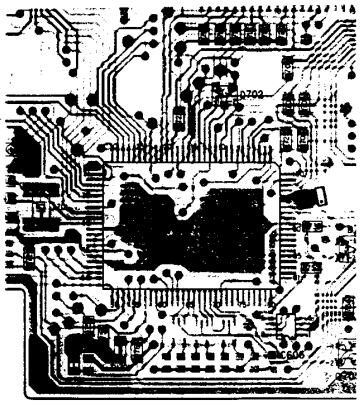
[SERVO BOARD]

(51) Audio dropouts occur without any relation to vibration of the vehicle or scratches on the disc.

**Solution:** Replace IC31 on the Servo board with the improved type shown below.
