| RIGOH | Technical Bulletin | | | No. RTB-014 | | |
| SUBJECT: FINISHER ENTRAN | ICE GUIDE | | | DATE:Jan. 31, '93 PAGE: 1 of 6 | | |

SUBJECT: FINISHER ENTRANCE GUIDE

| RIGOH | Technical Bulletin | | | No. RTB-027 | | |
|---|---|---|---|---|--|--|
| SUBJECT: SC733 | | | | DATE:Mar. 15 '94 PAGE: 1 of 3 | | |

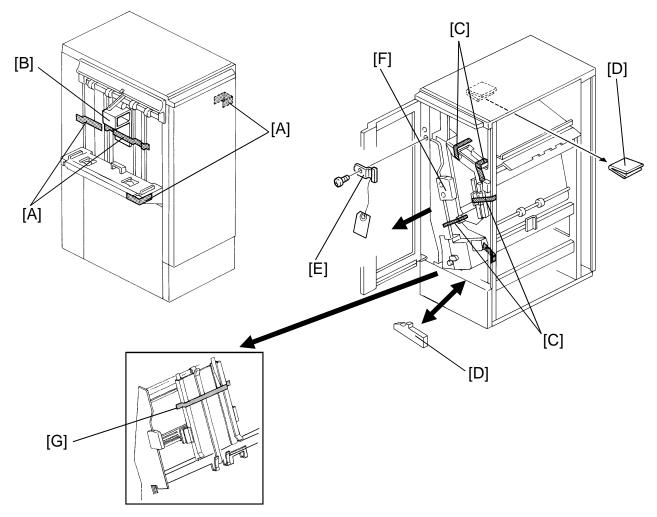
- 1. Remove the strips of tape [A] and the cushion [B].
- 2. Open the front door and remove the strips of tape [C] and cushions [D].
- 3. Remove a clamp [E] (1 screw).
- 4. Slide out the staple unit [F].
- 5. Remove a strip of tape [G].

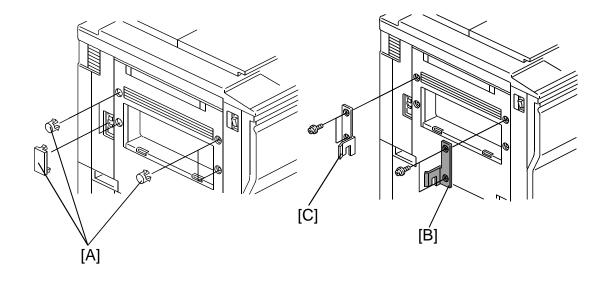
- 6. Remove five plastic caps [A] on the copier's left cover.
- 7. Install the front connecting bracket [B] (2 screws– M4 x 12) and the rear connecting bracket [C] (2 screws– M4 x 12) on the copier.
- 8. Stick the entrance guide mylar [D] on the copier exit area as shown.

NOTE: Align the edge [E] of the cover and the mylar.

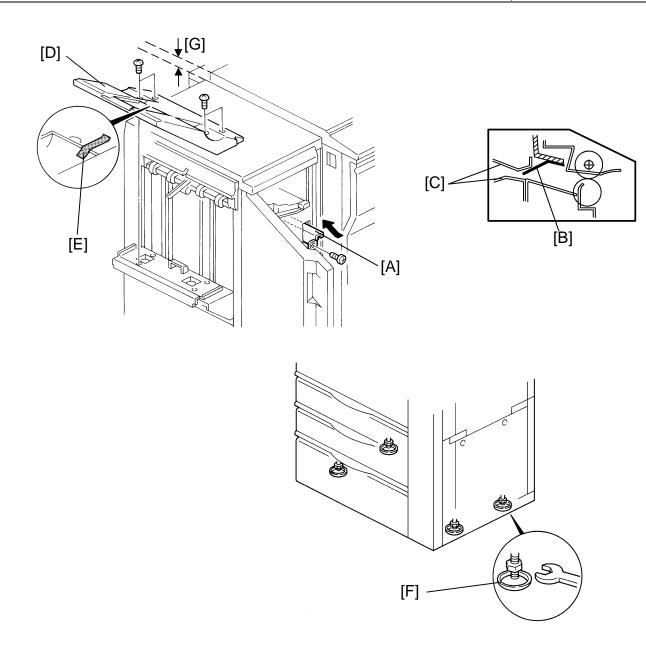
14. Align and press the finisher against the copier and fix them by raising the locking lever [A].

NOTE: At this time, confirm that the myler [B] locates between the guides [C].

- 15. Secure the locking lever [A] (1 screw).
- 16. Install the shift tray [D] with 4 screws M4 x 8. (Remove tape [E].)
- 17. Adjust the height of the copier by using the leveling feet [F] so that the difference in level [G] between the copier and the finisher will be 30 \pm 1 mm.

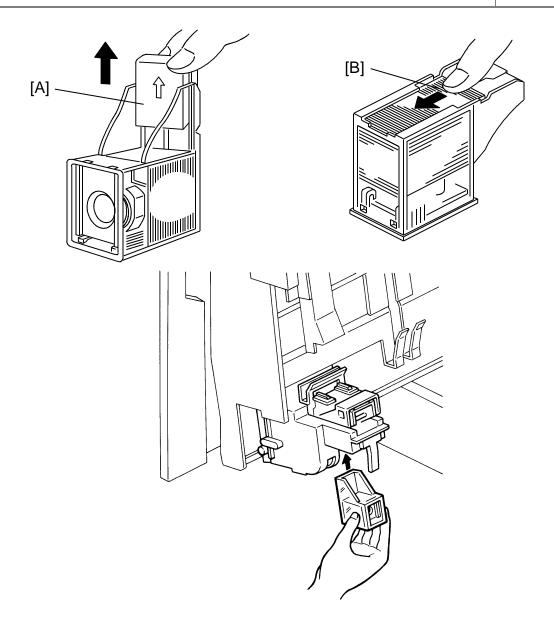
18. Remove the green plastic clip [A] from the staple cartridge, and install the cartridge in the stapler.

NOTE: When installing the staple cartridge. Make sure that all the staple sheets [B] are in the initial position.
