Model: PRIPORT PINKGOLD		Date: 20-May-02	No: R-C238-001
Subject: PINKGOLD firmware history		Prepared by: H. Onodera, Priport Service Planning Section	
Classification: <input type="checkbox"/> Troubleshooting <input checked="" type="checkbox"/> Part information <input type="checkbox"/> Action required <input type="checkbox"/> Mechanical <input type="checkbox"/> Electrical <input type="checkbox"/> Service manual revision <input type="checkbox"/> Paper path <input type="checkbox"/> Transmit/receive <input type="checkbox"/> Retrofit information <input type="checkbox"/> Other ()			
Model Name: Ricoh JP3000/JP3800, Gestetner 5430/5428C, RexRotary 1330, nashuatec CP430, Savin 3260DNP, Standard SD370

Model: PRIPORT PINKGOLD		Date: 20-May-02	No: R-C238-002
Subject: Image shift problem		Prepared by: H. Onodera, Priport Service Planning Section	
Classification:	<input checked="" type="checkbox"/> Troubleshooting <input type="checkbox"/> Part information <input type="checkbox"/> Action required <input type="checkbox"/> Mechanical <input type="checkbox"/> Electrical <input type="checkbox"/> Service manual revision <input type="checkbox"/> Paper path <input type="checkbox"/> Transmit/receive <i

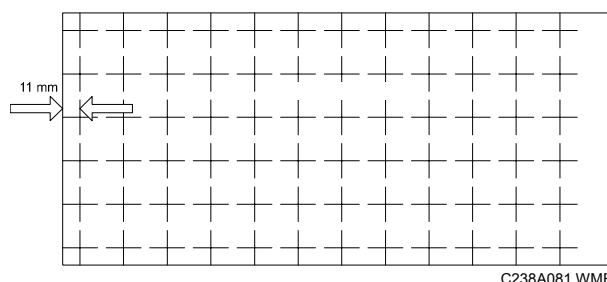
C238A081.WMF

1. Set SP2-24 (Slow starting mode) to a value of "2" (print from 15 rpm).
2. Set SP8-10 (Test patterns) to a value of "6", then press the Start key.
3. Make 6 copies at speed 5 (finishing with 120 rpm). Perform the adjustment below for all 6 copies:
 - Trial print: 15 rpm
 - 1st print: 30 rpm
 - 2nd print: 60 rpm
 - 3rd print: 75 rpm
 - 4th print: 90 rpm
 - 5th print: 105 rpm
 - 6th print: 120 rpm
4. The distance between the leading edge and first line should be 11 mm, as shown below.

5. If this distance is not 11 mm, access SP6-23. The zoom counter [A] displays the speed. If the I/O ROM is not C2385124-G or newer, the zoom counter [B] displays "SP6", and cannot be adjusted.

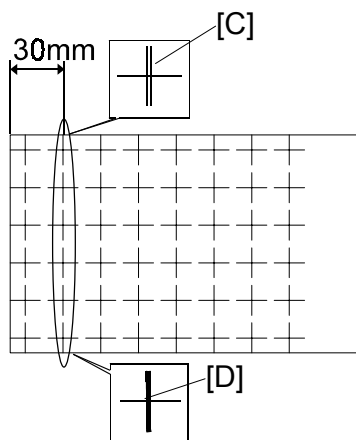
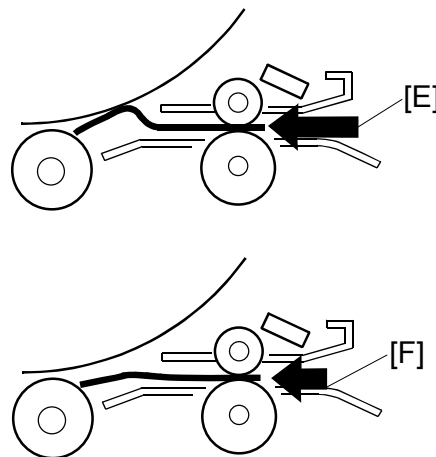
C238A082.WMF

Purpose: To adjust doubled [C] or blurred [D] images (e.g. bold lines, text) for each printing speed (15, 30, 60, 75, 90, 105, and 120 rpm), by changing SP settings.

4. Check the area from the leading edge to about 30 mm down for any doubled or blurred images.
5. If any are present, access SP6-27. The zoom counter displays the printing speed. If the I/O ROM is not version C2385124-G or newer, the zoom counter displays "SP6", and cannot be adjusted.
6. Input a value to adjust the blurred or doubled image (range: 0 to 100, step: 0.01).

Higher values ([E]): Blurred images improve, doubled images tend to be more noticeable.

Lower values ([F]): Doubled images improve, blurred images tend to be more noticeable.

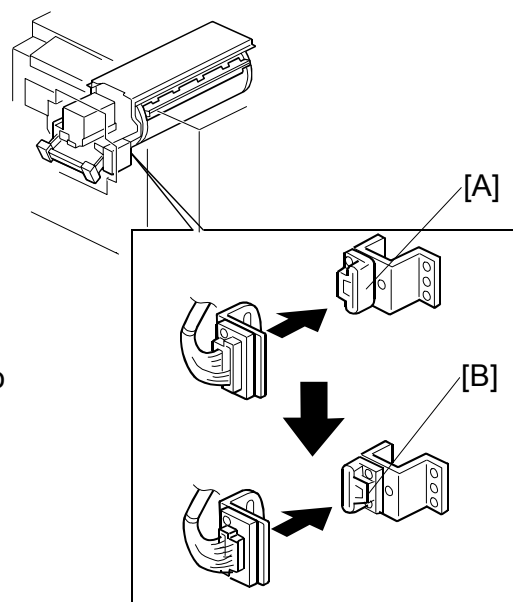
C238A085.WMF

Only B4 drums can be installed on the PG B4. The direction of the connector has been changed from [A] to [B] as shown, so that the A3/A4 drums used on the PINKGOLD cannot be installed on the PG B4.

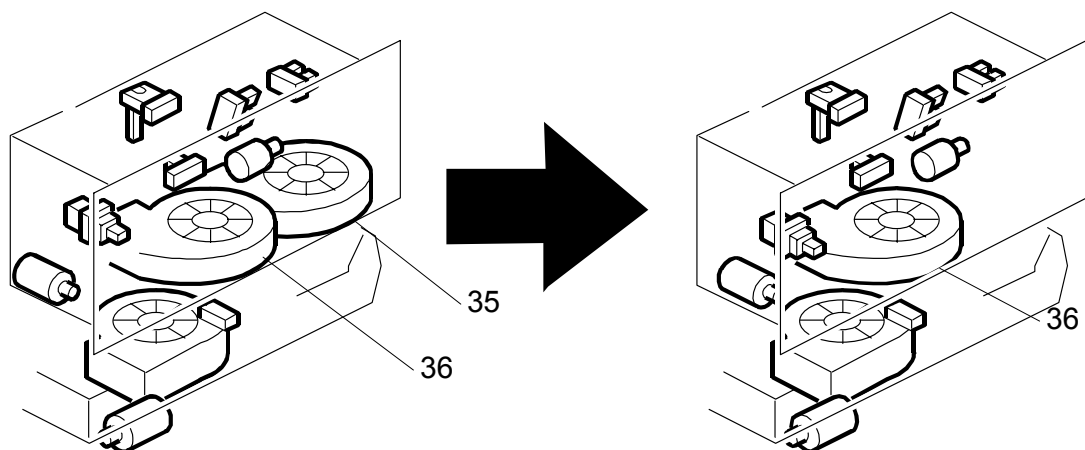
C247D001.WMF

The number of air knife fan motors has been decreased from 2 to 1, due to the decrease in size of the printable image area.

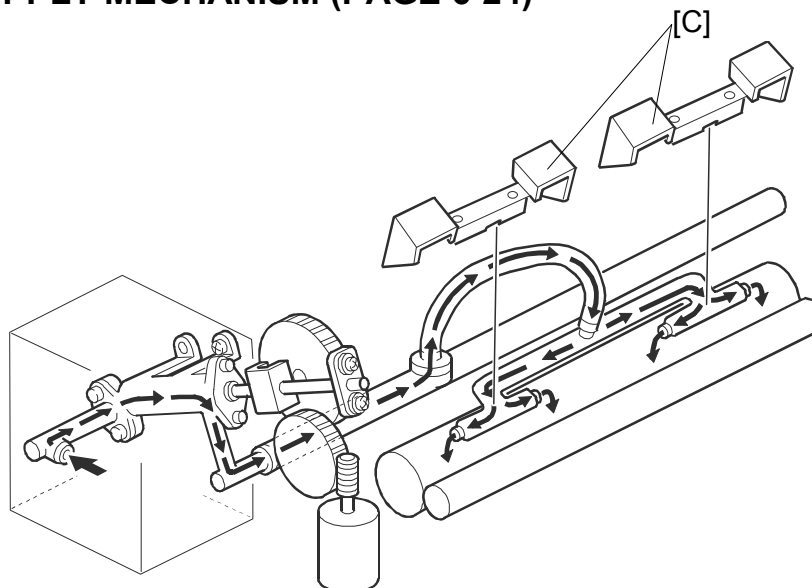
C247D005.WMF

Two ink pipe covers [C] have been added to ensure that ink from the ink distributor does not stick to the ink sensor.

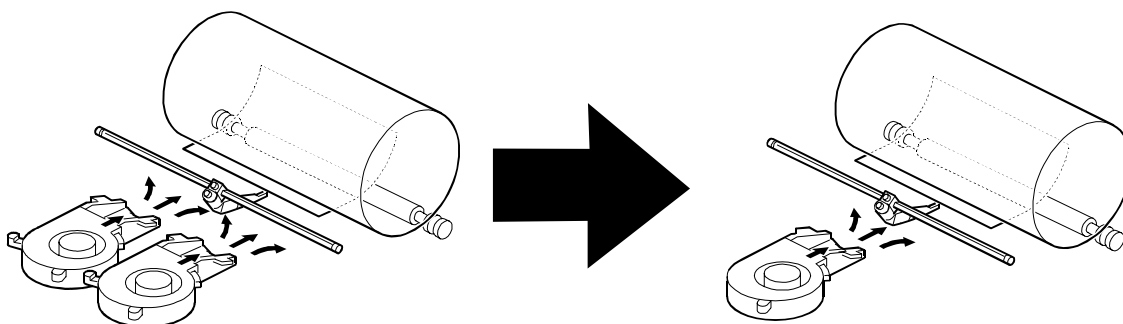
C247D002.WMF

The number of air knife fan motors has been decreased from 2 to 1, due to the decrease in size of the printable image area.

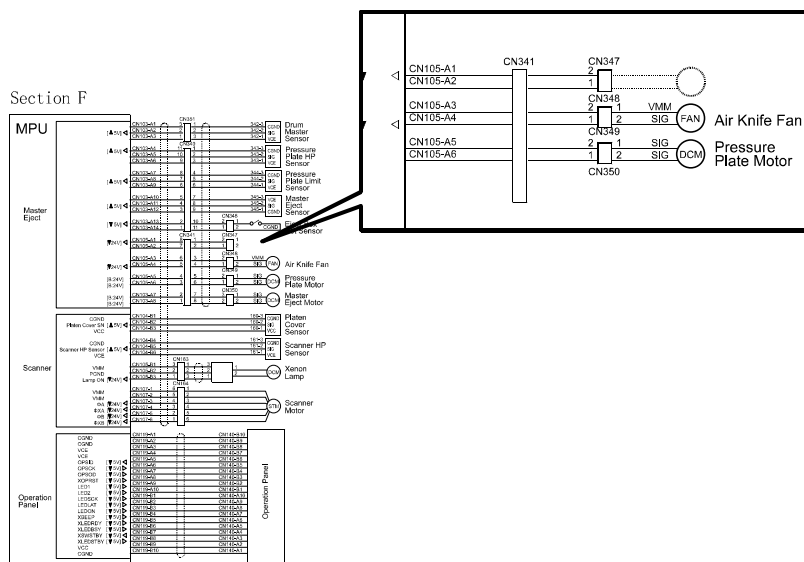
C247D003.WMF

The air knife fan motor previously connected to CN347 has been deleted (no. of motors reduced from 2 to 1).

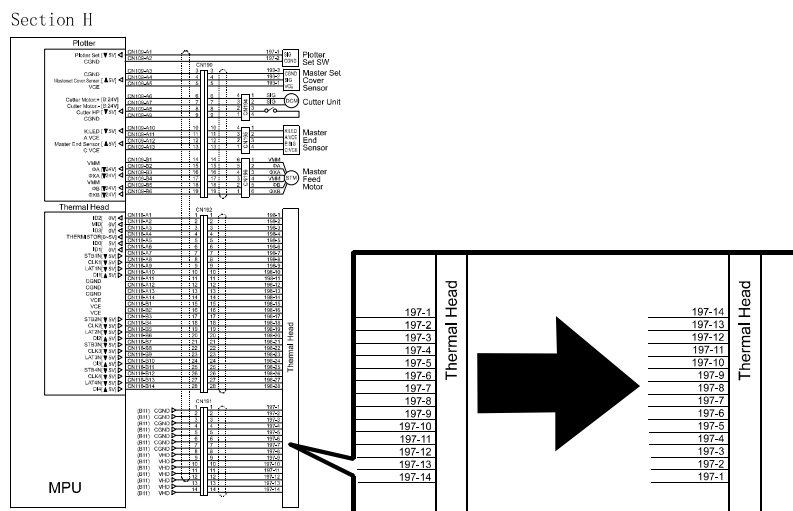
C247D004.WMF

The pin layout of the thermal head connector has been changed to conform to the new thermal head.

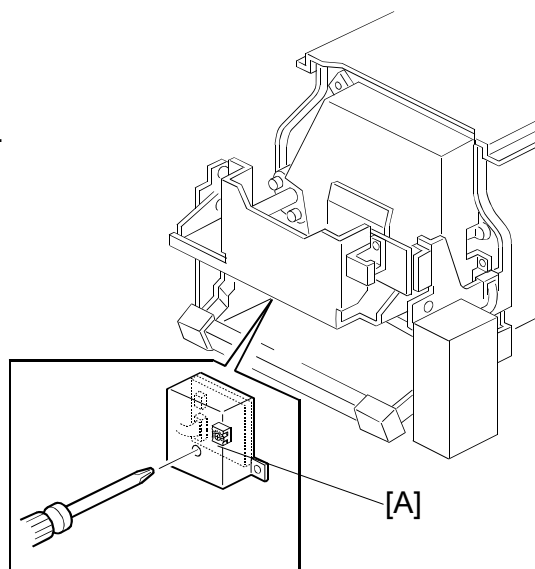
C238S013.WMF

Purpose: To ensure that the CPU detects a no ink condition.

Access SP6-40, and open the door cover, then turn the VR1 [A] on the ink detection board until the display becomes **"5.0 μ "** (5 μ s).

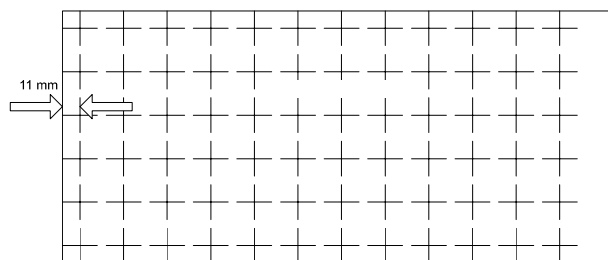
C238A081.WMF

1. Set SP2-24 (Slow starting mode) to a value of "2" (print from 15 rpm).
2. Set SP8-10 (Test patterns) to a value of "6", then press the Start key.
3. Make 6 copies at speed 5 (finishing with 120 rpm). Perform the adjustment below for all 6 copies:
 - Trial print: 15 rpm
 - 1st print: 30 rpm
 - 2nd print: 60 rpm
 - 3rd print: 75 rpm
 - 4th print: 90 rpm
 - 5th print: 105 rpm
 - 6th print: 120 rpm
4. The distance between the leading edge and first line should be 11 mm, as shown below.

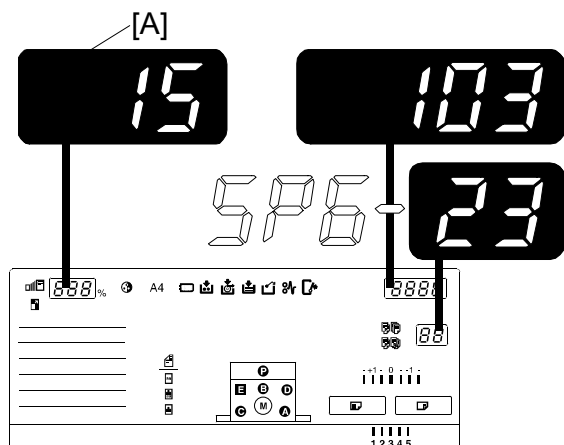
C238A077.WMF

5. If this distance is not 11 mm, access SP6-23. The zoom counter [A] displays the speed.

6. Input a value to adjust the distance (range 0 to 255):
The higher the value, the narrower the distance between leading edge and 1st line becomes (and vice-versa). Also, each step corresponds to about 0.58 mm. Input the value that will bring the distance to 11 mm.
7. Press the Enter key twice, which will change the zoom counter [A] to the next printing speed. Then repeat steps 4 thru 6 for each of the other five copy samples (i.e. 30, 60, 75, 90, 105, and 120 rpm samples).
8. Perform the adjustment again for any of the samples that are still outside the 11 mm standard.
9. Return SP2-24 (Slow starting mode) to the value it was at before the adjustment.

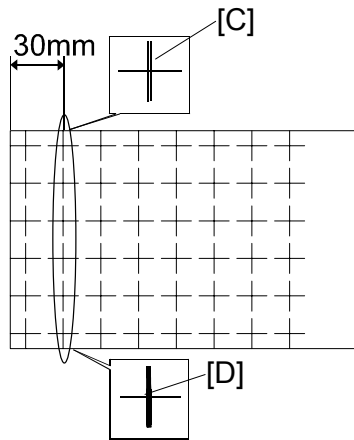
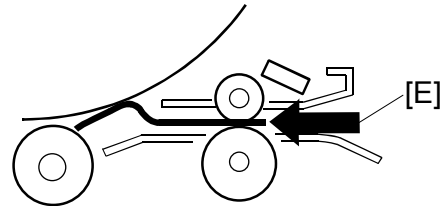
C238A082.WMF

Purpose: To adjust doubled [C] or blurred [D] images (e.g. bold lines, text) for each printing speed (15, 30, 60, 75, 90, 105, and 120 rpm), by changing SP settings.

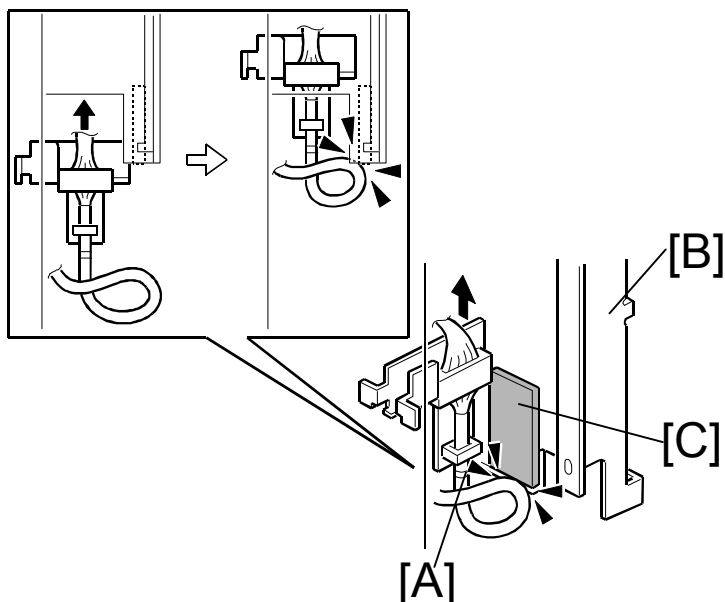
The paper tray harness (P/N: C2475237) [A] moves into a narrow space between two sides of the MPU (P/N: C2385601) [B]. This happens when the paper tray harness is curled as shown in the diagram and the paper table lifts up or down.
