# Structural Response and Failure of a Full-Scale Stitched Graphite–Epoxy Wing

Analytical and experimental results of the test for an all-composite full-scale wing box are presented. The wing box is representative of a section of a 220-passenger commercial transport aircraft wing box and was designed and constructed by The Boeing Company as part of the NASA Advanced Subsonics Technology program. The semispan wing was fabricated from a graphite–epoxy material system with cover panels and spars held together using Kevlar® stitches through the thickness. No mechanical fasteners were used to hold the stiffeners to the skin of the cover panels. Tests were conducted with and without low-speed impact damage, discrete source damage, and repairs. Upbending, downbending, and brake roll loading conditions were applied. The structure with nonvisible impact damage carried 97% of design ultimate load before failure through a lower cover panel access hole. Finite element and experimental results agree for the global response of the structure.

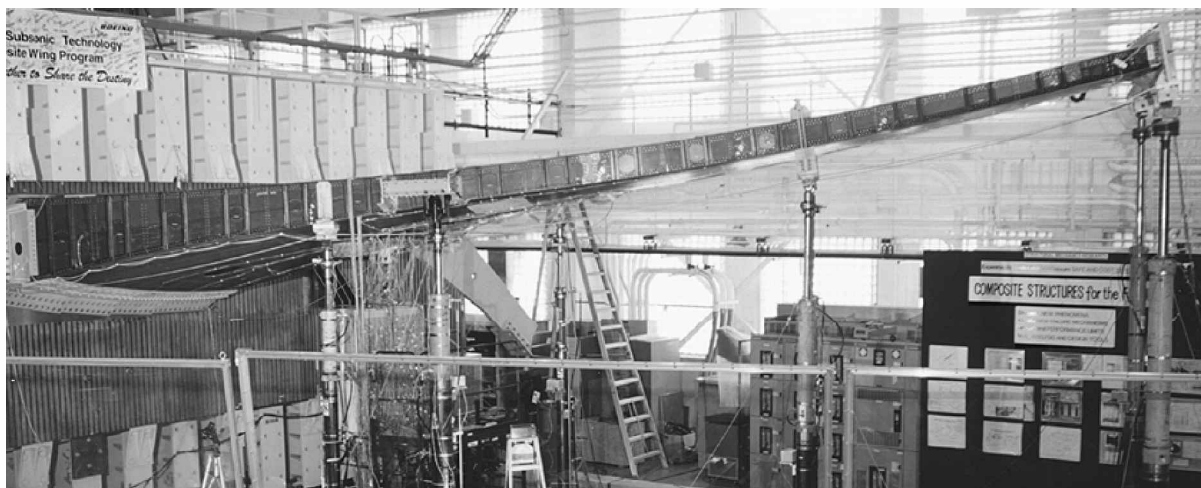
The test article supported 97% of its design ultimate load (DUL) before failure in test 8. DUL is 150% of DLL. A photograph of the test article loaded at 95% DUL is shown in Fig. 6.

Fig. 6 Deformed test article loaded to 95% of DUL.

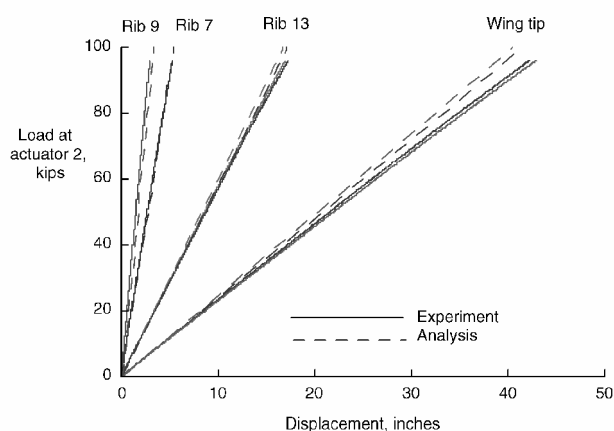
Analytical and experimental displacements at the six most outboard actuator locations are shown in Fig. 7. Solid lines represent the measured displacements and dashed lines represent predicted displacements. Measured displacements are the elongation of the actuator rather than a measurement perpendicular to the floor. Because the initial position of all actuators active in the 2.5-*g* condition is vertical, the difference between the displacement perpendicular to

Fig. 7 Displacements at six outboard load introduction points (1 kip = 1000 lb).

the floor and the stroke of the actuator is dependent on the rotation of the actuator during loading. The largest displacement (and largest rotation) is for actuator 2 at the wing tip. The measured deflection is 40 in., and the initial position of the intersection of the actuator assembly and the test article is 168 in. above the floor. The angle between the initial vertical position of the actuator and the final tilted position can be calculated to be less than 2 deg, resulting in a negligible difference between vertical displacement and stroke.<sup>7</sup> Analytical results for the global displacements are within 8% of the experimental results for the final test.

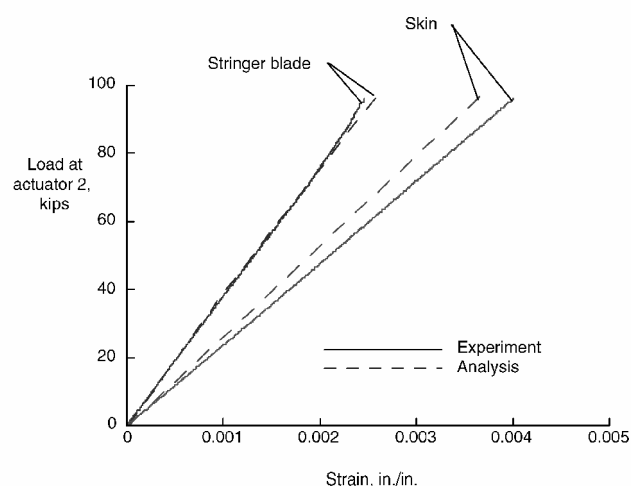
Fig. 9 Strain in stringer blade and skin at stringer 4 in the lower cover panel between ribs 12 and 13.

Strains in the lower cover panel at stringer 4 between ribs 12 and 13 and at stringer 7 between ribs 7 and 8 are shown in Figs. 9 and 10, respectively. Excellent correlation between experiment and analysis is seen in the skin between ribs 7 and 8 and in the stringer between ribs 12 and 13 until immediately before failure. The repair, which was not modeled in the analysis, is located between ribs 8 and 9 and may have some influence on these blade strains. Strains remain linear until immediately before failure. Strains in the lower cover runout of stringer 2 where it terminates at rib 10 are shown in Fig. 11. Analytical strains at this runout agree well with experimental data.

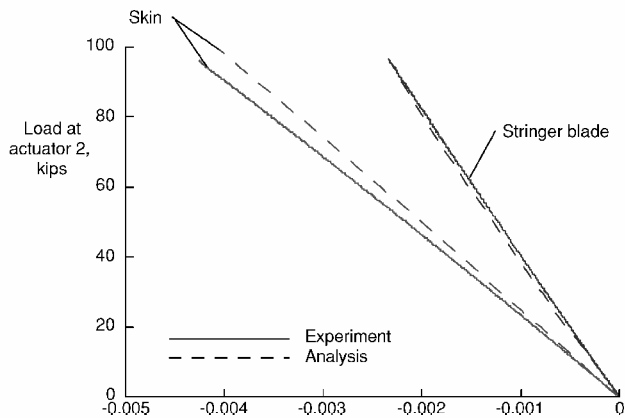
**Fig. 12** Strain in stringer blade and skin at stringer 6 in the upper cover panel between ribs 12 and 13.

Strains in the upper cover panel at stringer 6 between ribs 12 and 13, at stringer 6 between ribs 9 and 10, at stringer 2 between ribs 8 and 9, and at stringer 8 between ribs 8 and 9 are shown in Figs. 12, 13, 14, and 15, respectively. For most of these cases, the agreement between analytical and experimental results is good. Excellent correlation between experiment and analysis is seen in the skin inboard from rib 12 and in the stringer outboard from rib 12 until immediately before failure. The repair, which was not modeled, is located between ribs 10 and 11 and may have some influence on experi-

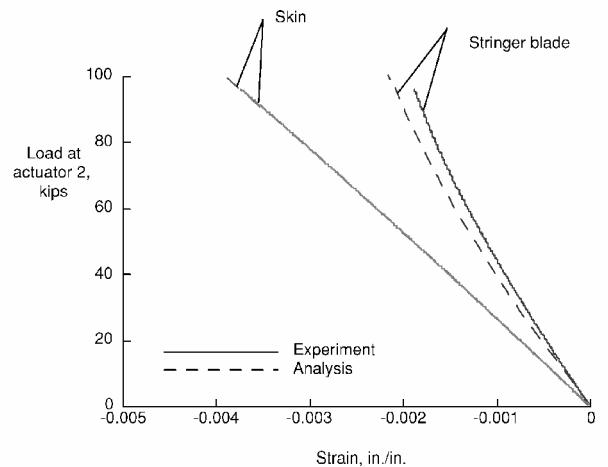
**Fig. 14** Strain in stringer blade and skin at stringer 2 in the upper cover panel between ribs 8 and 9.

mental strain data. Strains do not remain linear in the upper cover panel. The maximum strains in any upper cover runout location are in the runout region at the rear spar at rib 9. Strains at this stringer runout 10.5 in. inboard from rib 9 are shown in Fig. 14. The blade is tapered in height as well as thickness at this location.
