# Fatigue Testing of a Stiffened Lap Joint Curved Fuselage Structure

Abubaker Ahmed\* and John G. Bakuckas Jr.<sup>†</sup>

*Federal Aviation Administration William J. Hughes Technical Center,  
Atlantic City International Airport, New Jersey 08405*

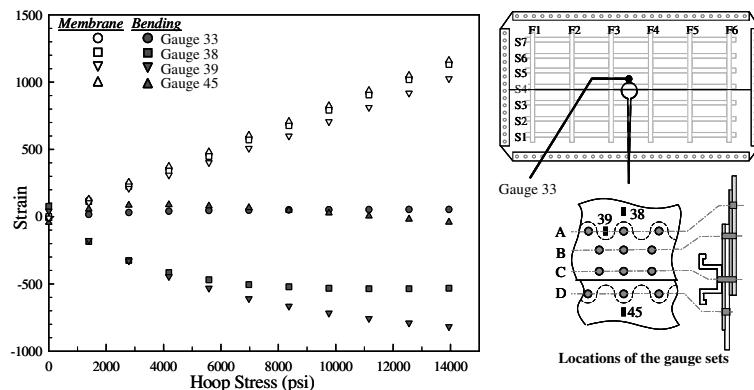
Fig. 4 Membrane and bending strain measured at four locations on the skin.

and outer surfaces) and bending strain (half of the difference between the inner and outer surface measurements), at the four locations, are shown in Fig. 4. The membrane strain was nearly the same at all four locations. The bending strain differed significantly depending on the location. The highest bending strain was recorded by gauge set 39 along rivet row A. As a result of the local bending, the inner surface of the skin along rivet row A of the lap joint experienced high tensile stresses, making this rivet row a likely area for damage initiation.

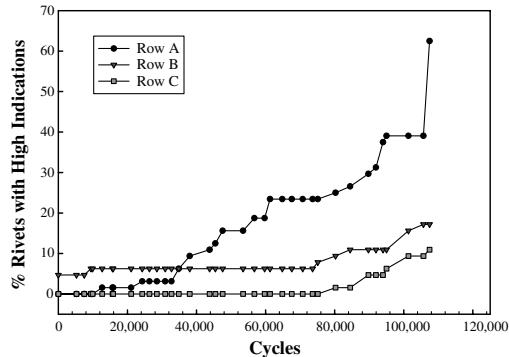
Fig. 5 Percentage of rivet holes in lap joint with crack indications using eddy current.

During the fatigue test, crack formation in the lap joint was monitored and recorded using the rotating-probe eddy-current system and the RCCM system. Eddy-current indications of subsurface damage in rivet row A were recorded as early as 12,600 cycles (Fig. 5). As shown in the figure, the number of rivets in row A with high-level signals increased with fatigue cycles. A few high-level signals were also detected in rows B and C. Rivet row D was not accessible for reliable inspection with the rotating-probe system during the test because of the joint's geometry.

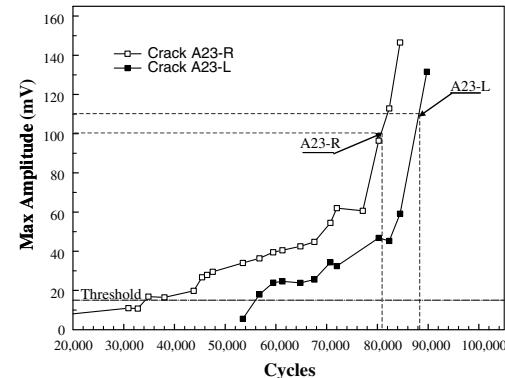
Fig. 7 Change in maximum amplitudes of eddy-current signals recorded at rivet holes A22 and A23.

All four cracks emanating from rivet holes A22 and A23 were detected by high eddy-current signals before they were visually detected. The plot in Fig. 7 summarizes the results of eddy-current inspections of rivet hole A23. High-level signals were first detected on the right-hand side of A23 after 35,000 cycles, well before crack A23-R was visually detected at 80,550 cycles. At 55,000 cycles, eddy-current inspections indicated the presence of damage on the left-hand side of A23, where crack A23-L was visually detected at 88,390 cycles. The increase in the amplitude of the inspection signals is an indication of subsurface crack growth. Eddy-current inspection results were correlated with the subsurface crack growth history reconstructed by fractographic examinations (as discussed next).

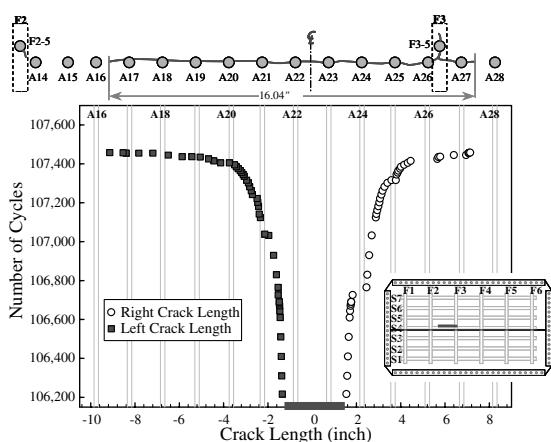
Figure 9 shows the length of the lead crack (measured visually via the RCCM system) as a function of the number of fatigue cycles. Crack length measurements were recorded relative to a reference line

Fig. 9 Growth of the right and left crack tips of the lead crack during the fatigue test.

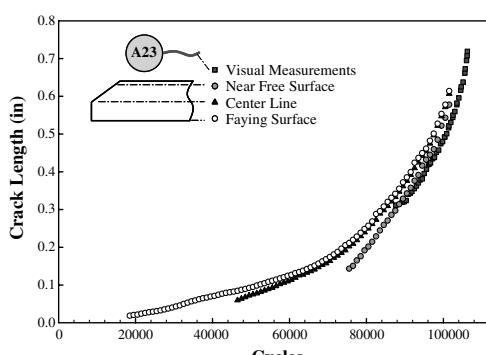
Fractographic and visual crack length measurements for crack A23-R are plotted as a function of load cycles in Fig. 14. As seen, the fractographic measurements near the free surface (along line a in Fig. 13) correlated very well with the visual crack measurements, validating the fractography data reduction process. The fractographic results also indicated that crack A23-R existed as early as approximately 19,000 cycles. The subsurface crack length measured along the faying surface at that number of cycles was 0.015 in., which is within the range of 0.004–0.02 in. of the smallest crack length

Fig. 14 Crack lengths from fractographic examinations and visual measurements.

Using the rotating eddy-current probe system, crack A23-R was first detected at 35,000 cycles (Fig. 7). From the marker band reconstruction of the crack history, the crack length, measured near the faying surface, was approximately 0.05 in. after 35,000 cycles (Fig. 14). As mentioned earlier, the rotating-probe system has a probability of detection of 90% for a 0.032 in. hidden crack. A complete correlation of the results of the rotating-probe inspections with the fractographic examination results is underway.

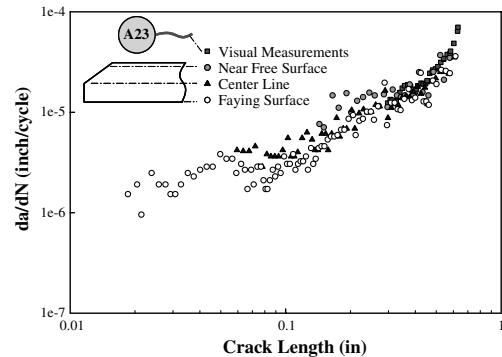
Fig. 15 Crack growth rates from fractographic examinations and visual measurements.
