Surveyor Spacecraft Vernier Propulsion System Survival in Lunar Environment

GILBERT F. PASLEY*

Hughes Aircraft Company, El Segundo, Calif.

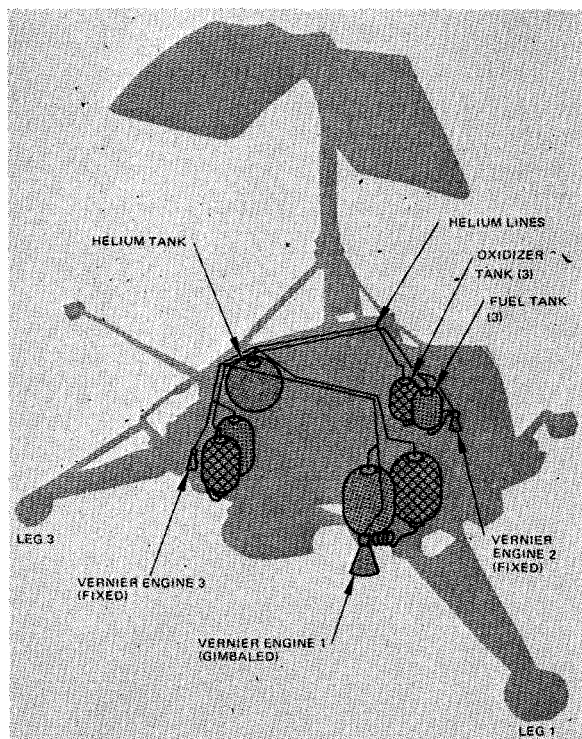
Fig. 2 Vernier propulsion system installation.

ment of the tanks on the spaceframe is illustrated in Fig. 2. Propellant freezing or overheating during earth/lunar transit was prevented by a combination of active and passive thermal controls, utilizing surface coatings, multilayered blankets, and electrical and solar heating. The propellant tanks were thermally isolated from the spaceframe.
