AIAA 81-0716R

# Results of the Mission Profile Life Test— First Test Segment: Thruster J1

E.L. James\*

R.T. Bechtel†

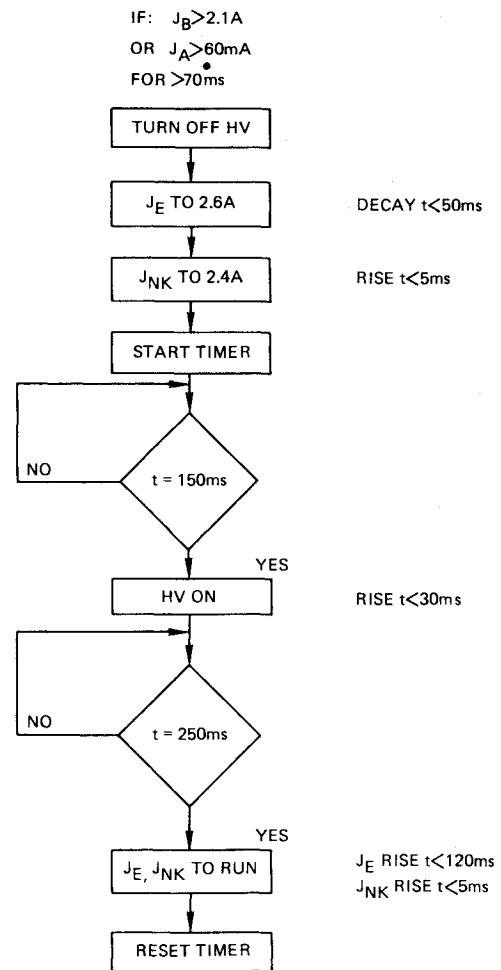
**Fig. 1** High voltage recycle algorithm.

Because the apparent failure of the neutralizer to survive a high voltage recycle sequence was the only thruster control problem encountered, a test program using thruster 804 was conducted to determine if an operating set point change could be made to improve the recycle sequence. The sequence used throughout the J1 test is shown in Fig. 1. At first it was believed that the neutralizer keeper discharge would extinguish when the high voltage turned off. The neutralizer outage actually occurred when the current was switched from 2.4 back to 1.8 A.

Since the high voltage recycle sequence occurs in 300 ms, the changes in neutralizer operation occur at constant flow rate. Figure 2 shows the  $V_{NK}$  vs  $T_{NV}$  characteristic for selected conditions. At 1.8-A keeper current the maximum  $V_{NK}$  for successful recycle every time is very close to the minimum  $V_{NK}$  that maintains control stability. This requires operation of neutralizer at or very near the maximum  $V_{NK}$ . Small perturbations can thus cause outages during recycle. By increasing the neutralizer keeper current from 1.8 to 2.1 A during beam-on operation; the maximum  $V_{NK}$  for successful recycle can be increased from 12.5 to 15.5 V. The neutralizer can then be operated sufficiently far from the limit to preclude outages.
