Contamination and Damage to Filmed Microchannel Plates on the International Space Station

J. D. Carpenter,* T. J. Stevenson,[†] and G. W. Fraser[‡]
University of Leicester, Leicester, England LE1 7RH, United Kingdom

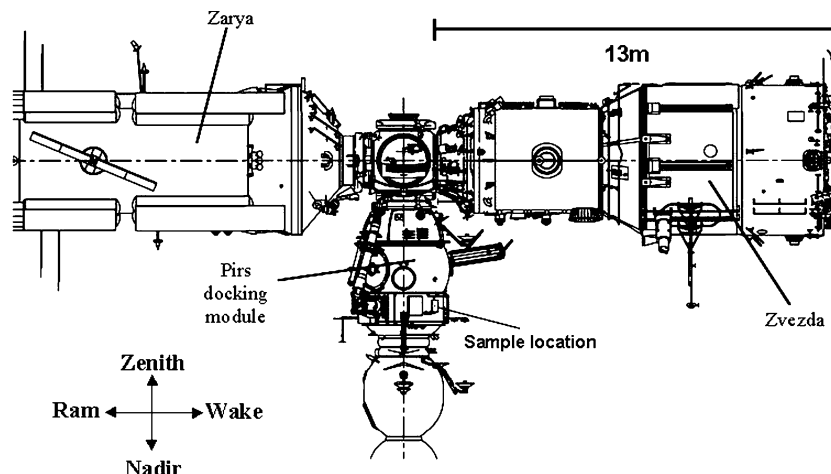
Fig. 2 Mounting location of samples on outer surface of docking compartment 1 Pirs (image courtesy of Kayser-Threde and RKK Energia).

The location of the MCP samples on the ISS docking module (Pirs) is shown in Fig. 2. Exposure began at 2204 on 25 January 2002 and ended 756 days later at 0022 on 27 February 2004.
