## Effect of Li/MgO methane coupling catalyst on Alonized steel reactors

M. Dean Phillips and Alan D. Eastman

*Research and Development, Phillips Petroleum Company, Bartlesville, OK 74004, U.S.A.*

Alonized 316 stainless steel reactors were used in life tests of a Li/MgO methane coupling catalyst. Severe corrosion of the portion of the reactor in contact with the catalyst bed was observed. Loss of physical integrity and chemical passivity resulted from layer formations of differing elemental compositions from the bulk metal. Chromium was leached from the stainless steel alloy and deposited on the catalyst. There were no adverse changes in those portions of the reactor not in direct contact with the catalyst. These results demonstrate that Alonized 316 stainless steel is unsuitable for use in methane coupling service with this lithium-containing catalyst.

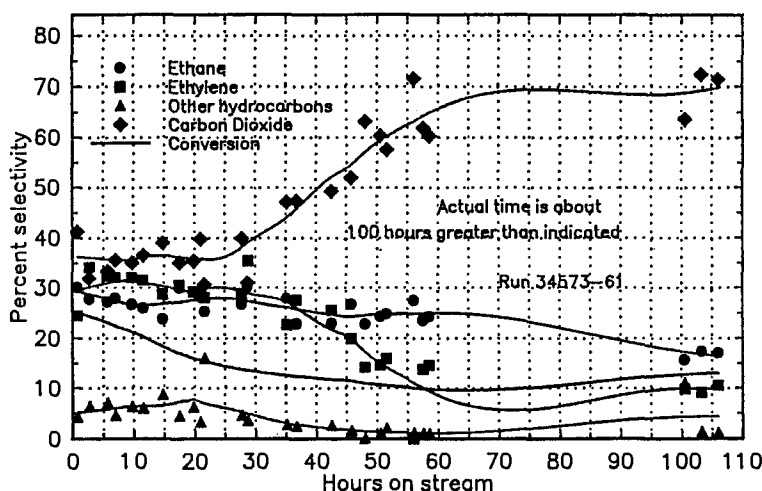
Fig. 5. Alonized reactor life test.

about 100 hours greater than shown; the extra time is not believed to have affected catalyst or reactor performance. By about 200 hours into the run, selectivity to carbon dioxide had risen to 70%, while conversion had leveled out at about 11–12%.

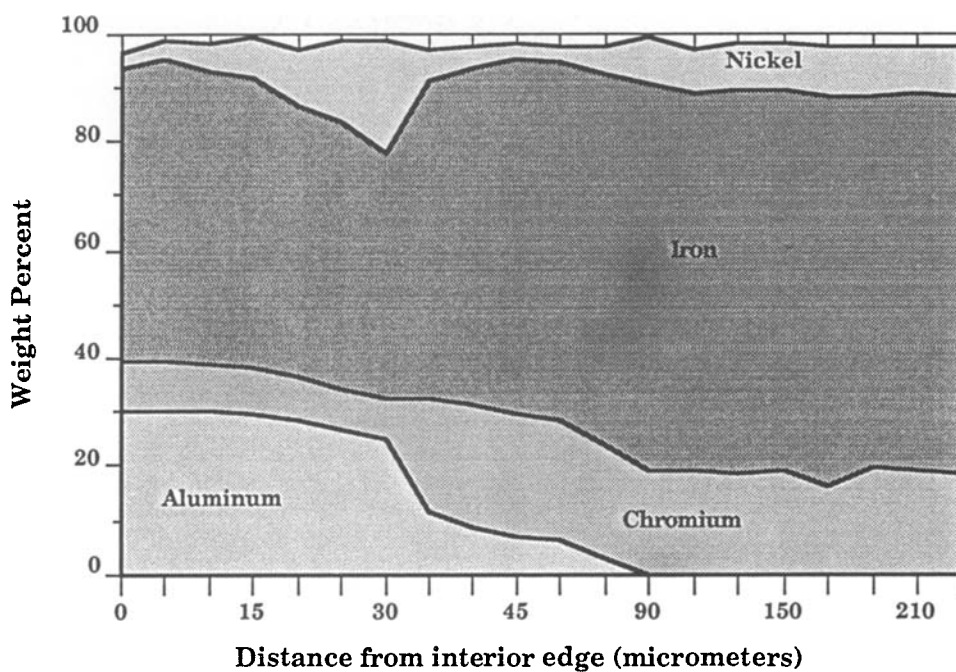
Fig. 8. Cross-sectional traverse of PRC tube wall above the catalyst bed.

Fig. 7 is a backscatter electron image (BEI) of a cross-section of the tube wall in the region of the reactor above the catalyst bed. The brightness of an area in a backscatter image is proportional to the average atomic number of that area. Three distinct levels of brightness are visible in the photograph. The microprobe results graphed in fig. 8 reveal the differences in elemental distributions that cause the variation in the backscatter image. The darkest layer is the region approximately 30–40 micrometers thick where the aluminum concentration is highest and fairly constant. The medium-bright area just below this region is where the aluminum concentration starts decreasing to zero. This shifts the average atomic number of this region to a higher value and results in a brighter backscatter image. The brightest region of the image corresponds to the bulk stainless steel (non-Alonized) metal. Distribution profiles of the elements present are consistent with what is seen with a new reactor. An elemental X-ray dot map from this area is shown as fig. 9.

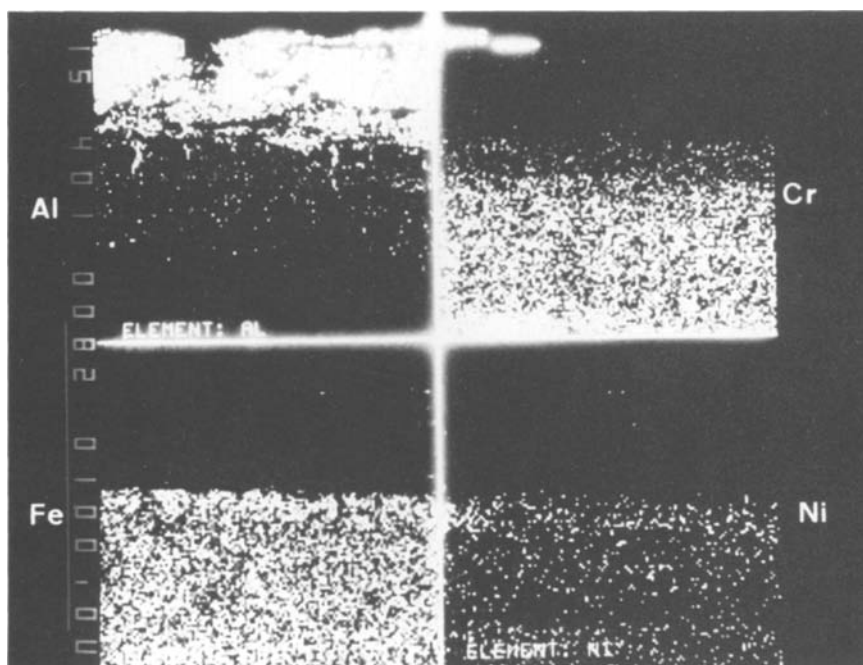
Fig. 15. Elemental dot maps of cross-section of PRC tube wall in the region of the catalyst bed (400 $\times$ ).

When looking with the naked eye at the interior surface of the used reactor (fig. 6), the portion of the reactor in contact with the catalyst bed appears to be raised above the level of the undamaged reactor surface. The microprobe analysis of the cross-section confirms and amplifies that observation. Fig. 13, the photomicrograph, and fig. 15, the dot map of a region in the center of the catalyst bed, clearly show the layering of the reactor surface, together with some segregation of iron and aluminum. Those changes are also evident in the analysis given in fig. 14.
