Influence of Joining on the Fatigue and Fracture Behavior of High Density Polyethylene Pipe

H. Chen, R.J. Scavuzzo, and T.S. Srivatsan

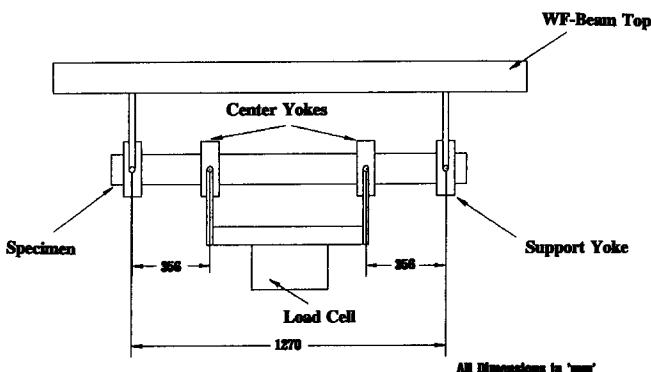
Fig. 5 Test fixture for deforming the high-density polyethylene pipes in bending fatigue

Table 2 summarizes the results. Cyclic bending fatigue testing was controlled by specifying the peak amplitude of the hydraulic actuator. The actuator amplitudes used to cycle the pipe specimens varied from +76 mm (3.0 in.) to +122 mm (4.8 in.) (Fig. 5).

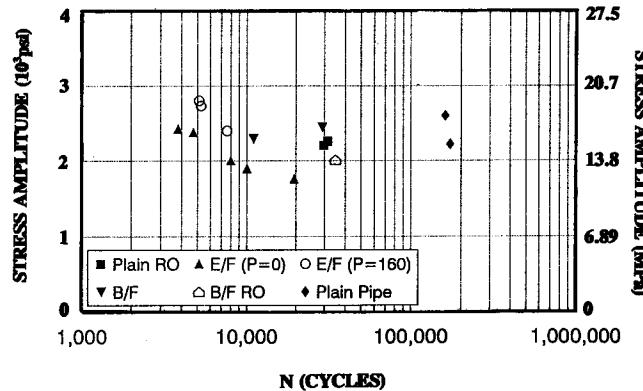
Fig. 10 Variation of stress amplitude with fatigue cycles for the high-density polyethylene pipes

Figure 10 shows the results obtained from the bending fatigue tests and the variation of stress amplitude with fatigue life. Table 2 summarizes fatigue loads and the resulting bending stresses. Considering the stiffening effect of the E/F coupler, the intrinsic forces associated with fatigue testing of the E/F specimens exceeded those of the B/F specimens and the plain PE pipe counterpart. Therefore, stress amplitude-fatigue life is the most meaningful interpretation. Results shown in Fig. 10 suggest that the worst B/F joint specimen is superior to the best E/F joined specimen. In general, for a given level of stress, an approximate factor of two to three orders of magnitude difference in

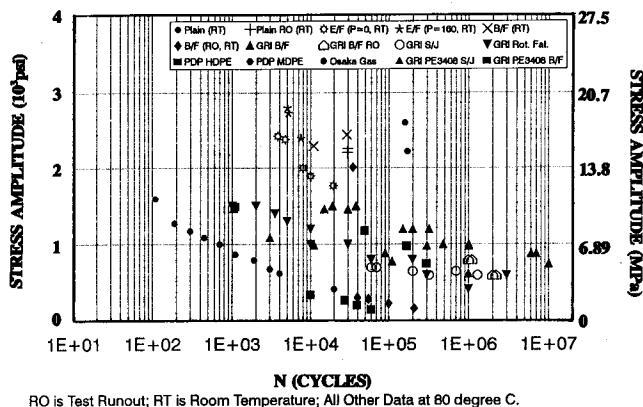
Fig. 11 A comparative representation of fatigue test data on polyethylene pipes showing the variation of stress amplitude with cycles

Figure 11 shows that the results obtained in this study agree well with other research (Ref 16-19). It is apparent that at identical stress amplitudes, the unwelded plain and joined HDPE pipes used in this study show improved bending fatigue life over those obtained in earlier studies. The reason for this notable difference is rationalized on the basis that the earlier investigations were conducted at a test temperature of 80 °C. This temperature is above the α -transition temperature (70 °C) for HDPE, where the crystallized region is softer. Based on the results obtained in this experimental study, it is clear that temperatures higher than ambient temperature degrade bending fatigue durability, quantified in terms of fatigue life (N_f) of the HDPE pipe by a factor of 100 to 1000, while concurrently reducing the stress level by a factor of three to seven (Ref 20). Converting the results obtained in this study from room temperature (28 °C) to 80 °C (Fig. 12), the current test data agree well with data proposed by others. This fact clearly establishes the four-point bending test initiated and implemented in this experimental study as a potentially viable, cost effective, and time saving fatigue test technique for quantifying the fatigue response of HDPE pipes.

RO is Test Runout; RT is Room Temperature; All Other Data at 80 degree C.
