Investigations on the Suitability of Coated Steel Piping System for High Pressure Seawater Reverse Osmosis Application

Mohammad Mobin

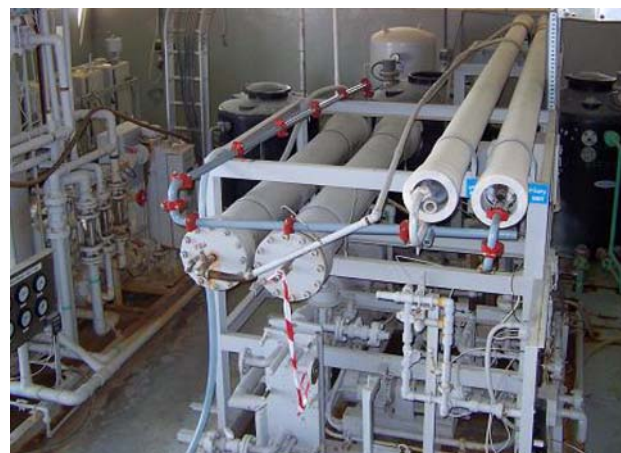
The Hollow fine fiber SWRO pilot plant was modified by introducing the thermoplastic piping products (diameter 25.4 and 31.75 mm) in feed and rejects streams (Fig. 1) and was operated continuously for 10 months. During the test, seawater feed and brine from SWRO membrane was passed through the piping at high pressure of about 70 bars. The typical composition of seawater feed is shown in Table 1. The water samples collected periodically from seawater feed, RO reject and RO product were analyzed to investigate any leaching from thermoplastic material. After completion of the test run, the coated pipes were taken out and physically examined.

Fig. 1 Photograph showing the SWRO pilot plant test unit modified with thermoplastic piping

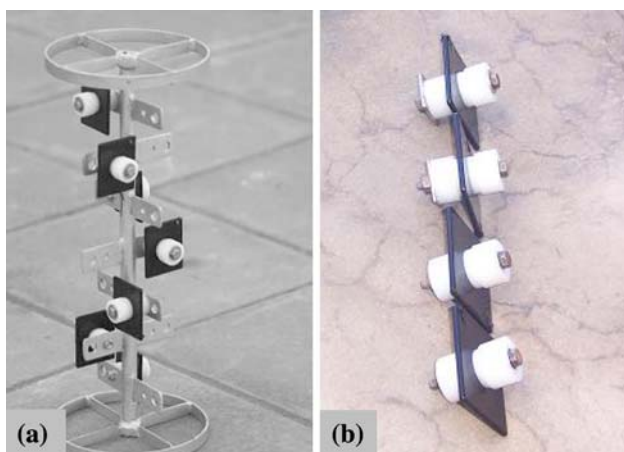
Fig. 2 Photograph of the assembly to be used for testing the coating under crevices in (a) pilot plant and (b) in laboratory

(Fig. 2a) and introduced in SWRO feed stream for a period of 6 months. After the required exposure, the coupon holder was taken out and the coupons were subjected to thorough examination. The following parameters were observed: (i) change in physical appearance, (ii) change in weight, (iii) adhesion loss, and (iv) blistering effect.

3.3.2 Laboratory Test. Coated steel coupons attached with the crevice formers (Fig. 2b) were immersed in a tank containing seawater. After 6 months, the coupons were taken out and subjected to thorough physical examination.
