# Microscopic Observations on the Origin of Defects During Machining of Direct Aged (DA) Inconel 718 Superalloy

G.K. Dosbaeva, S.C. Veldhuis, A. Elfizy, G. Fox-Rabinovich, and T. Wagg

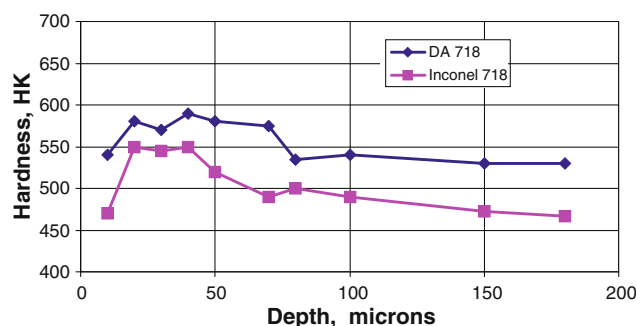
**Fig. 2** Microhardness depth profile of the DA and Inconel 718 workpiece surface after the finishing operation

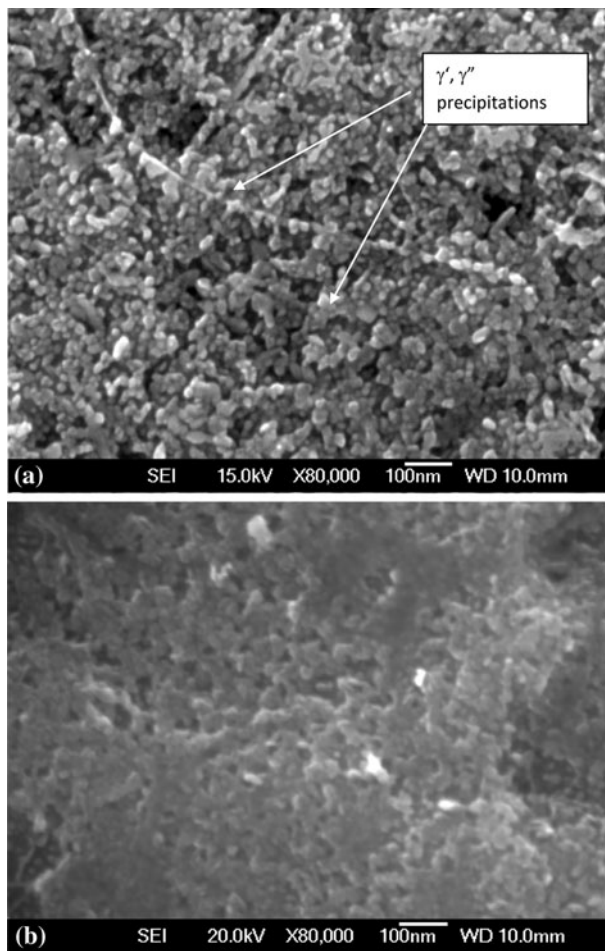
First, the microstructure of workpiece material (DA 718 alloy) was compared to regular Inconel 718 alloys before machining using high-resolution SEM microscopy (Fig. 3a and b). There is a big difference in microstructure: the precipitates form at the grain boundaries and then in grain interior creating strengthening as well as harsh machining environment for the

**Fig. 3** Microstructure of studied workpiece materials: (a) DA 718 and (b) Inconel 718 alloys (HR SEM, magnification 80,000×)

DA 718 (Fig. 3a). As a result, the average microhardness values of both alloys are different: HK 467 (HRC 46) for the Inconel 718 and HK 533 (HRC 51) for the DA 718.
