General Electric LM2500 Gas Turbine

LM2500 SAC Borescope Inspection UNIT TM42

ENGINE SERIAL NUMBER:
481-757

LM2500 SAC BORESCOPE REPORT	
Location:	Dar ES Salaam, Tanzania
Purchase order:	TBC, W/O UK80000157
Date of visit:	13-18 May 2008
Purpose:	Borescope inspection in accordance with GEK 97310, Vol. 1, Table 5-4 to Table 5-11
Purpose:	Lube and Scavenge Pump Inlet Screens Inspection and Cleaning in accordance with GEK 97310, Vol. 1, Table 5-3.18
Written by:	Mark Devine
Engine hours:	1281.28
Starts:	N/K
Fuel type:	Dual
Overview:	Engine is acceptable for further operation.

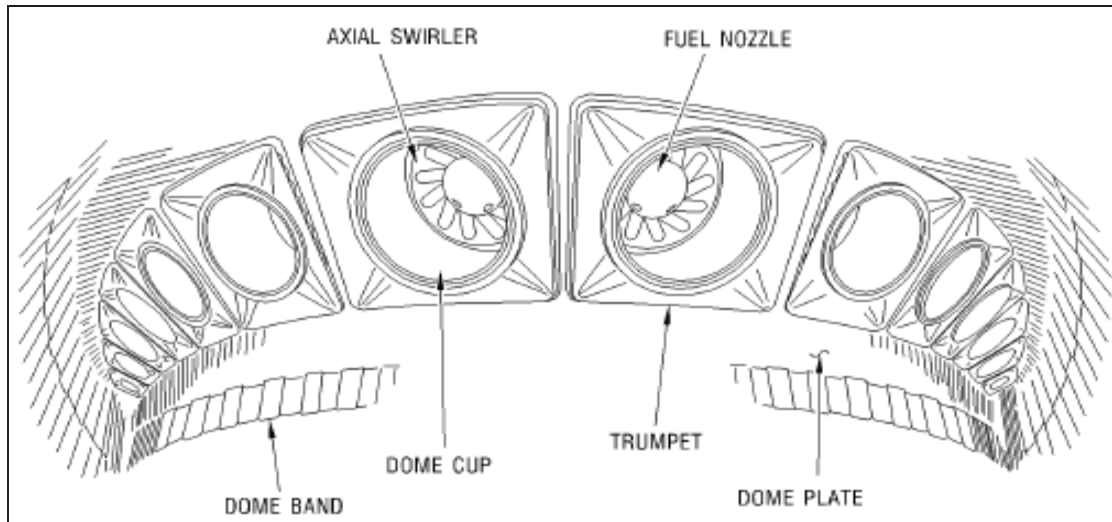
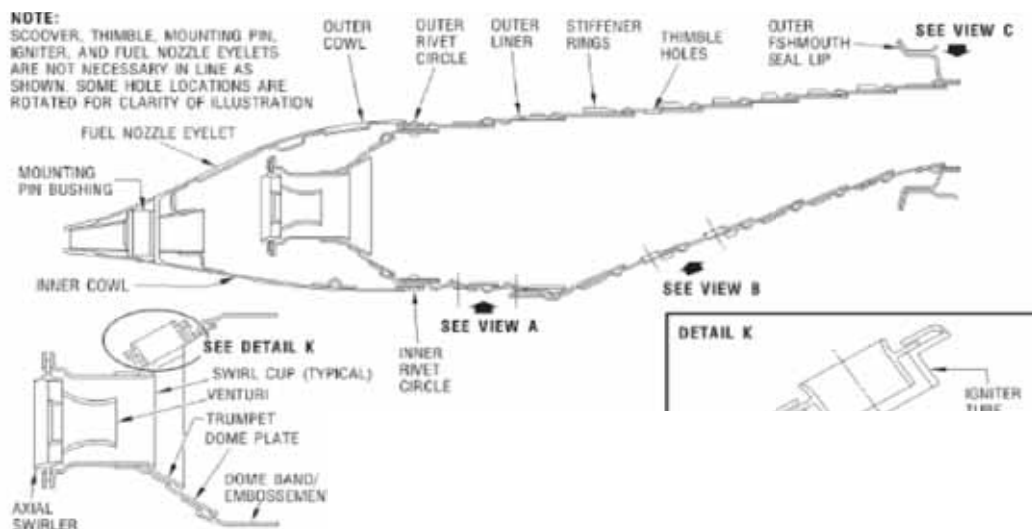
GEK 937310 Inspection References:

Component	Condition
All Combustor Surfaces	<ul style="list-style-type: none"> General condition good.
Dome Band/Dome Plate	<ul style="list-style-type: none"> Very minor thermal barrier coating loss/degradation-acceptable
Riveted Joints	<ul style="list-style-type: none"> No defects found
Trumpet and swirler cups	<ul style="list-style-type: none"> Very minor thermal barrier coating loss/degradation-acceptable.
Dome Assembly	<ul style="list-style-type: none"> No defects found
Igniter Ferrule	<ul style="list-style-type: none"> No defects found
Combustor Cowl	<ul style="list-style-type: none"> No defects found
Inner and Outer Liner	<ul style="list-style-type: none"> No defects found
Fuel nozzle	<ul style="list-style-type: none"> 3 fuel nozzles were removed from engine for inspection. #10 pos S/N PHCHN973, #11 pos S/N PHCHN846, #21 pos S/N PHCHN846. Condition satisfactory
