General Electric LM2500 Gas Turbine

LM2500 SAC Borescope Inspection UNIT TM 43

CUST – DOWANS

ENGINE SERIAL NUMBER:
481-774

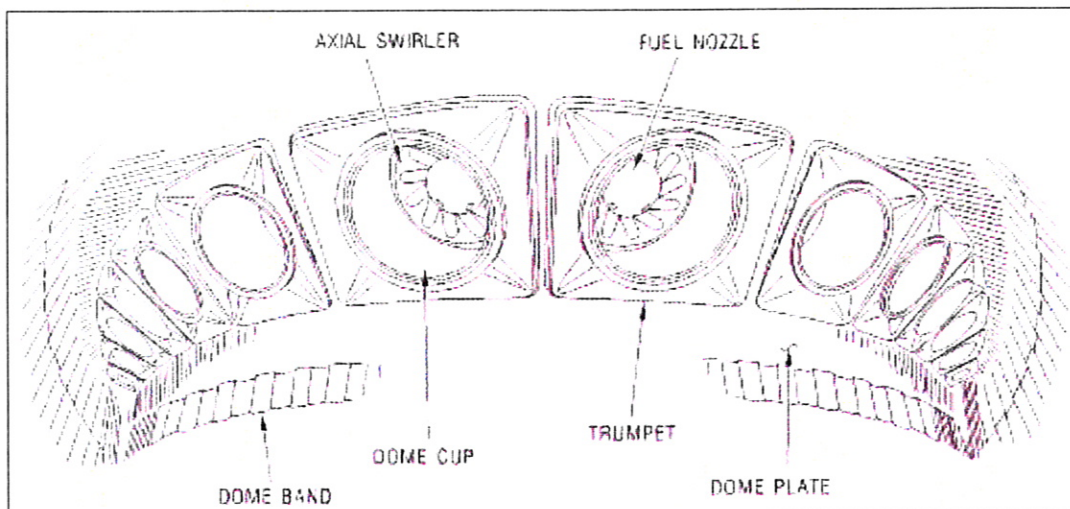
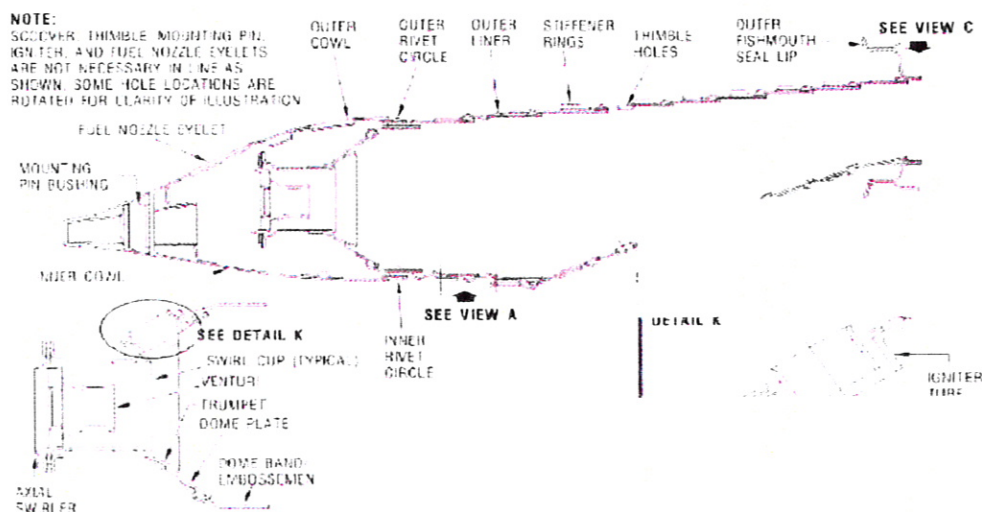
Component	Condition
All Combustor Surfaces	<ul style="list-style-type: none"> General condition good.
Dome Band/Dome Plate	<ul style="list-style-type: none"> Minor thermal barrier coating loss/degradation-acceptable
Riveted Joints	<ul style="list-style-type: none"> No defects found
Trumpet and swirler cups	<ul style="list-style-type: none"> Thermal barrier coating loss/degradation-acceptable.
Dome Assembly	<ul style="list-style-type: none"> No defects found
Igniter Ferrule	<ul style="list-style-type: none"> No defects found
Combustor Cowl	<ul style="list-style-type: none"> No defects found
Inner and Outer Liner	<ul style="list-style-type: none"> No defects found
Fuel nozzle	<ul style="list-style-type: none"> No defects found

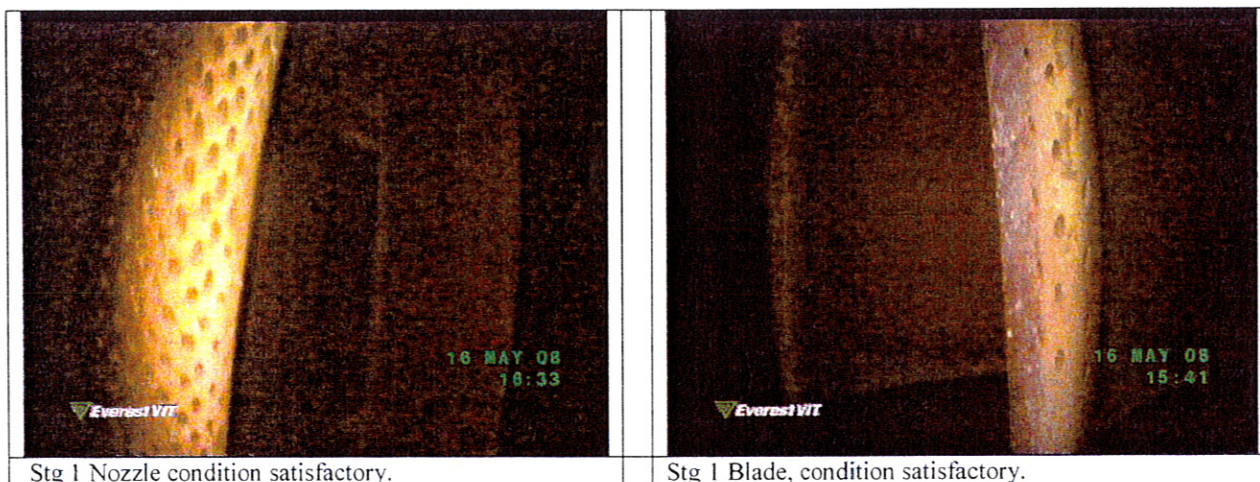
Reference Photographs – HPT assembly

Component	Condition		
HPT Stage 1 Nozzle Assembly	Defect	Location	Findings/GEK limits
	Nozzle airfoil		
	N/A	N/A	No defects found in areas inspected
	Inner and Outer Platform		
	N/A	N/A	No defects found in areas inspected
HPT Rotor Blade-Stage 1	General remarks	Condition satisfactory for continued use.	
	Defect	Location	Findings/GEK limits
	HPT Rotor Blades-Leading Edge Area A		
	N/A	N/A	No defects found
	HPT Rotor Blades-Leading Edge Area B		
	N/A	N/A	No defects found
	HPT Rotor Blade Tips
