BOEING
 767
 FAULT ISOLATION/MAINT MANUAL

Scandinavian Airlines System

CHAPTER 24

EFFECTIVE PAGES

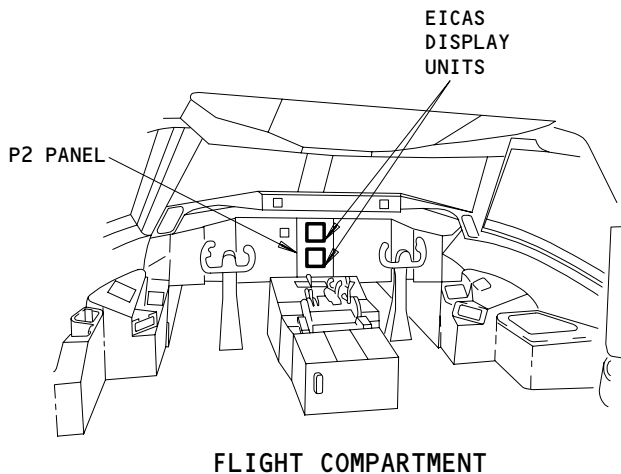
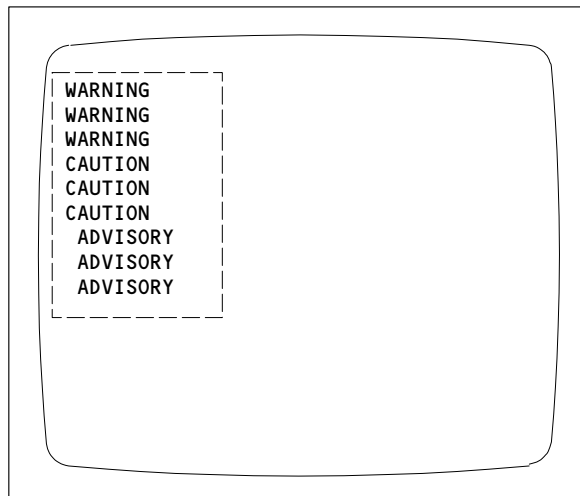
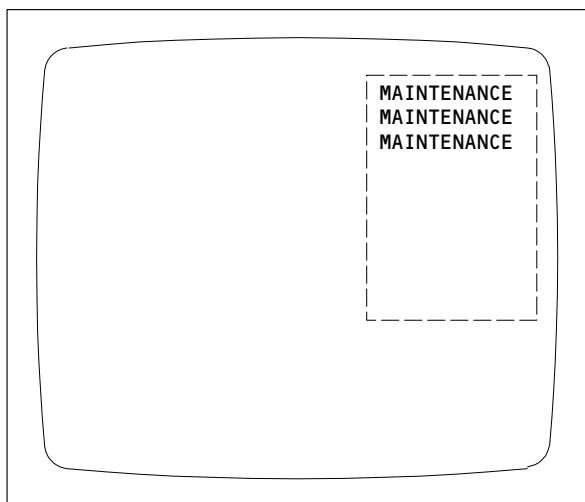
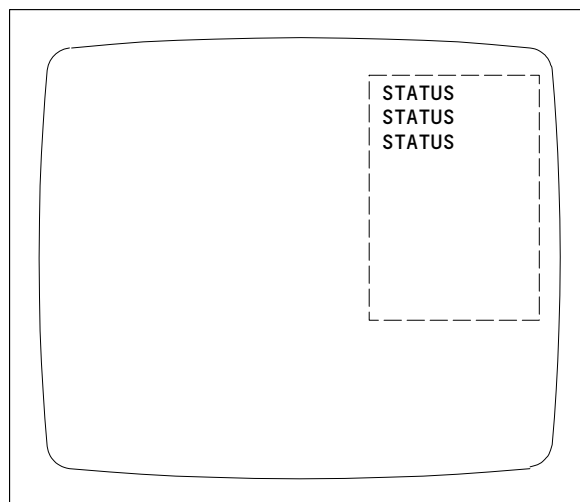
EICAS Message Locations
Figure 1

ENGINE PRIMARY PAGE OR COMPACTED PAGE
(TOP DISPLAY UNIT)

ECS/MSG PAGE
(BOTTOM DISPLAY UNIT)

STATUS PAGE
(BOTTOM DISPLAY UNIT)

LEVEL	COLOR
A-WARNING	RED
B-CAUTION	YELLOW
C-ADVISORY	YELLOW
S-STATUS	WHITE
M-MAINTENANCE	WHITE

- A. This procedure shows the EICAS message locations and gives a list of procedures to find the solution for each message.
 - (1) EICAS Message Locations (Fig. 1)

- (a) Figure 1 shows the location of the EICAS display units and the area where the messages show on the display units.
 - (b) Each message level has a different location. The location and color of each message level is also shown.

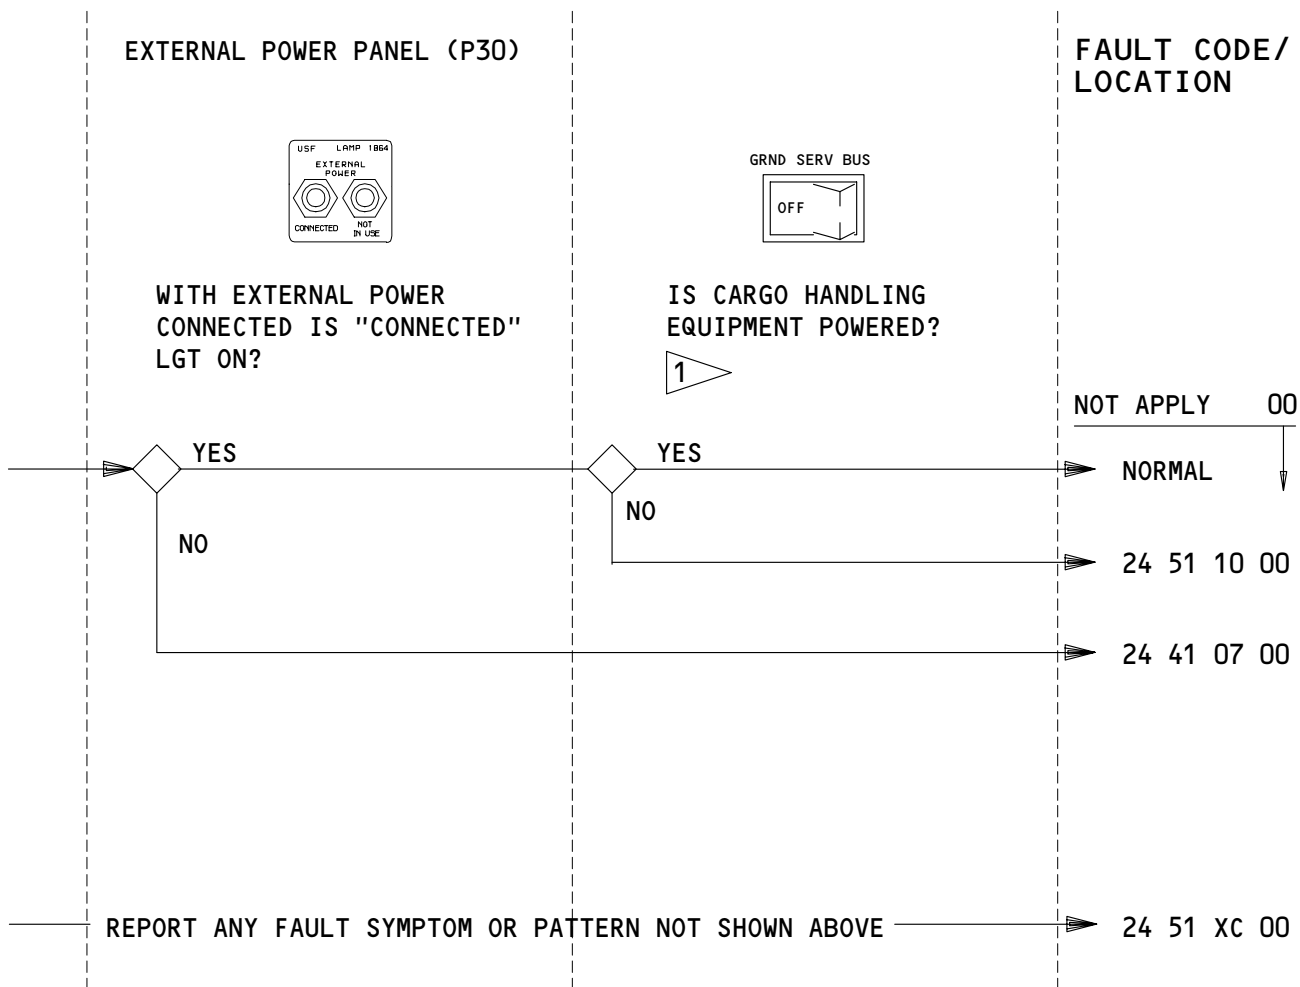
1 MOMENTARY OUT-OF-TOLERANCE CONDITIONS MAY CAUSE GROUND HANDLING BUS TO TRIP. RESET GROUND HANDLING BUS BY CYCLING GND SVCE SWITCH ON FORWARD ATTENDANT'S PANEL P21.

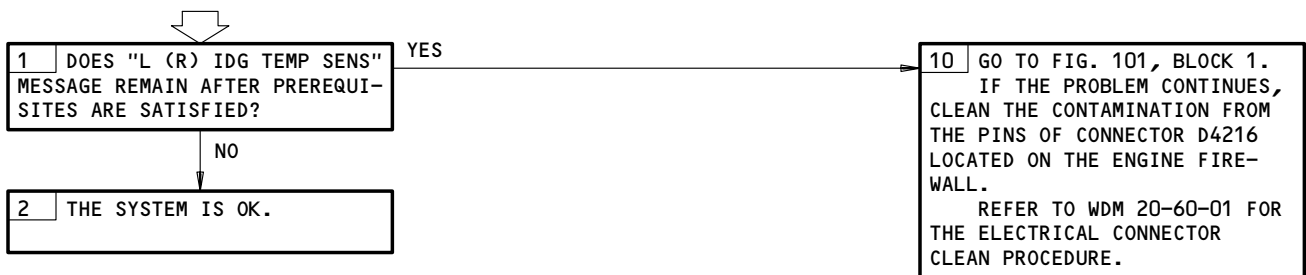
EICAS Message L (R) IDG TEMP SENS Displayed
 Figure 104

EICAS MSG "L (R)
 IDG TEMP SENS"
 DISPLAYED

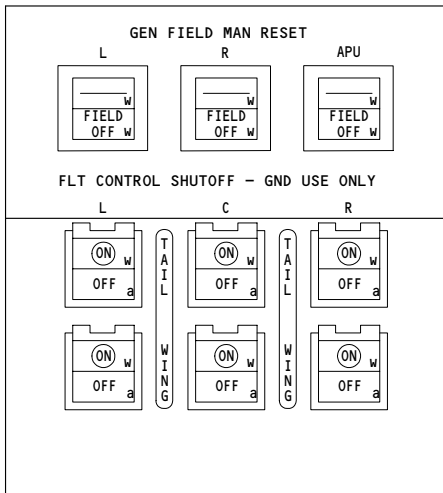
Control - Component Location
Figure 102

GENERATOR FIELD AND HYDRAULIC CONTROL PANEL, M1087

ELECTRICAL SYSTEM CONTROL PANEL, M10063

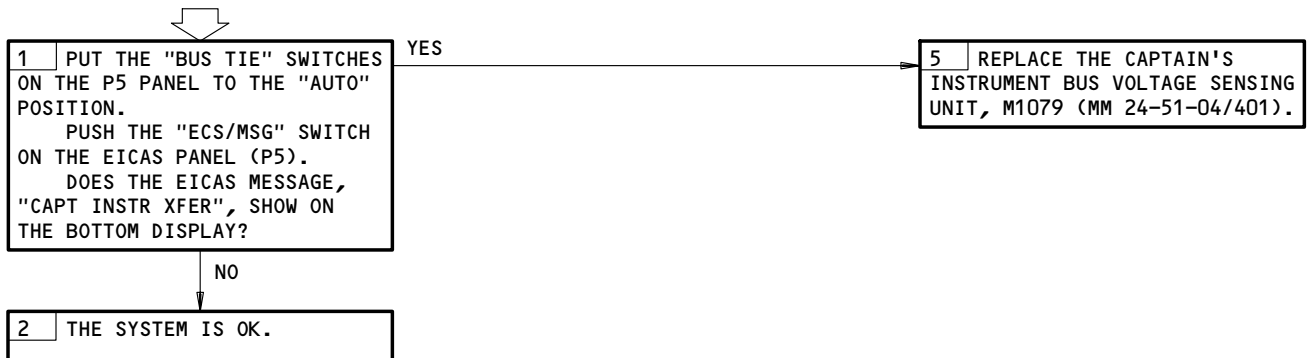
EICAS Msg "CAPT INSTR XFER" Displayed
Figure 103

MAKE SURE THESE CIRCUIT BREAKERS ARE CLOSED:
6A15,6A21,6C15,6G11,6G24,6J14,6J15,6J16,11S34,
11S35,11S36

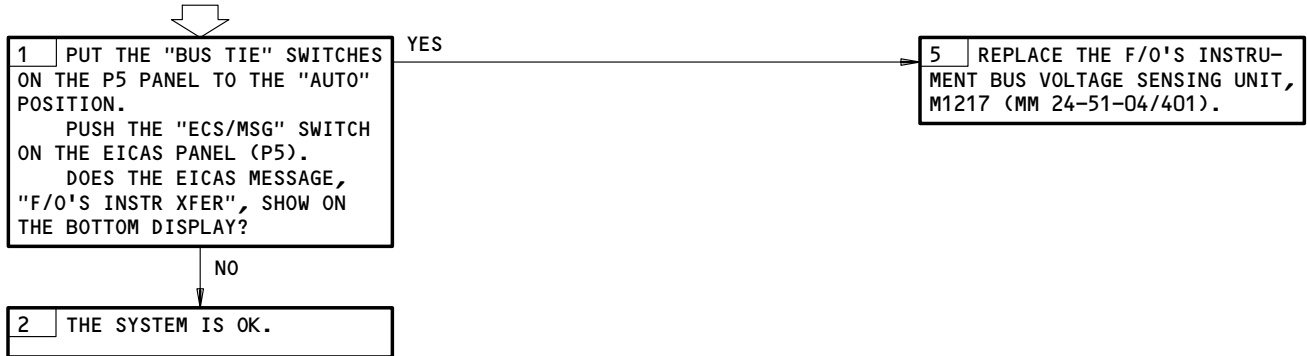
EICAS Msg "F/O INSTR XFER" Displayed
Figure 104

MAKE SURE THESE CIRCUIT BREAKERS ARE CLOSED:
6A15,6A21,6C12,6C18,6L20,6L21,6L22,11S7,11S8,11S9

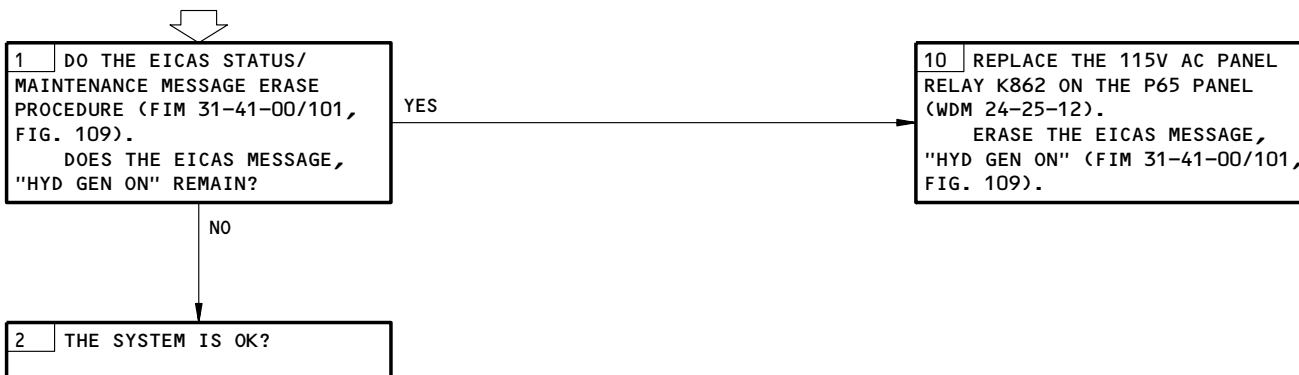
EICAS Msg HYD GEN ON Displayed
 Figure 104

**EICAS MESSAGE
 "HYD GEN ON"
 DISPLAYED**

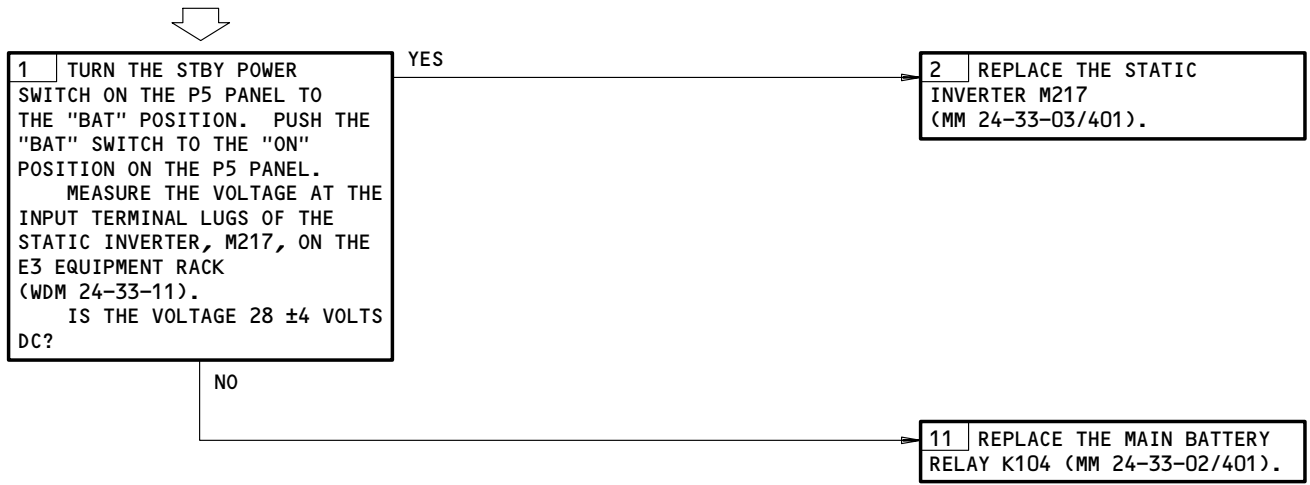
Stby Pwr Sw in BAT, STBY INVERTER Msg on EICAS
 Figure 105

STBY PWR SWITCH IN
 BAT POS, EICAS MSG
 "STBY INVERTER" DIS-
 PLAYED

PREREQUISITES
 CB'S: 6D2,6J11,6J12

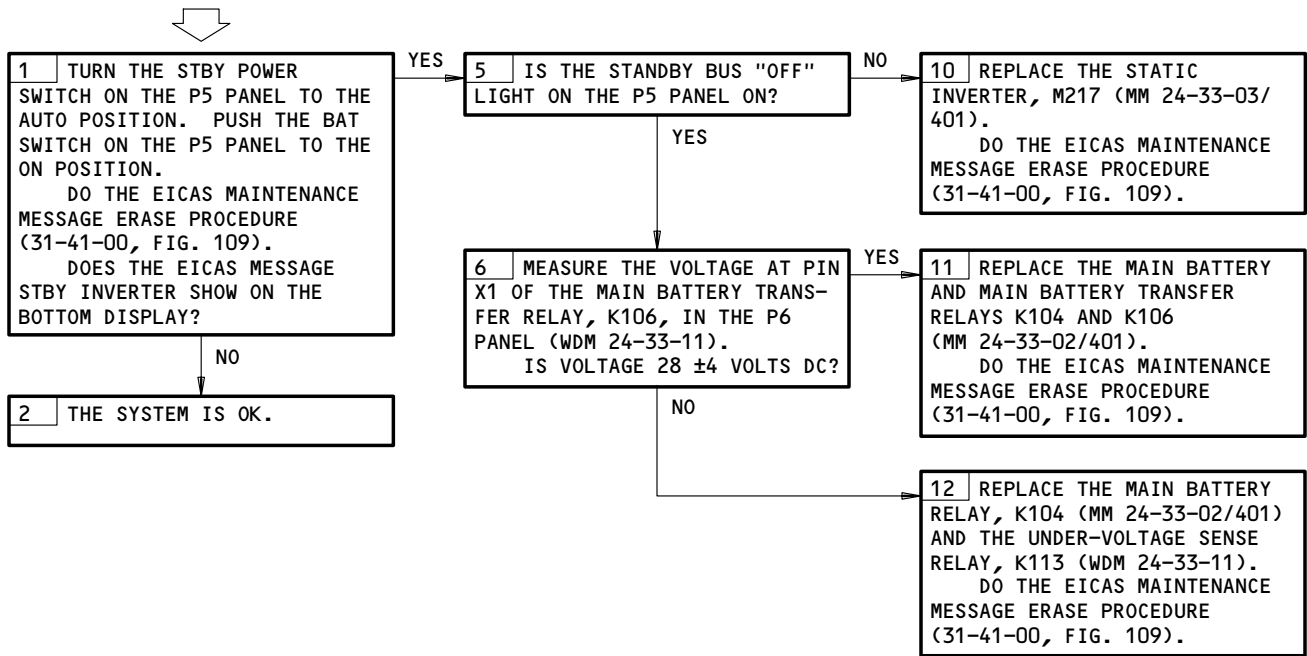
EICAS Msg STBY INVERTER Displayed
Figure 106

**EICAS MSG "STBY
INVERTER" DISPLAYED**

PREREQUISITES
ELECTRICAL POWER (MM 24-22-00/201)
EICAS (MM 31-41-00/201)
CB'S: 6A6,6C11,6C12,6C18,6C24,6D2,6D10,6D11,6D12,
6G10,6G11,6L16

STANDBY BUS OFF	C	FIM 24-33-00/101, Fig. 107, Block 1
STBY INVERTER	S,M	FIM 24-33-00/101, Fig. 106, Block 1
T-R UNIT	S,M	FIM 24-32-00/101, Fig. 103, Block 1

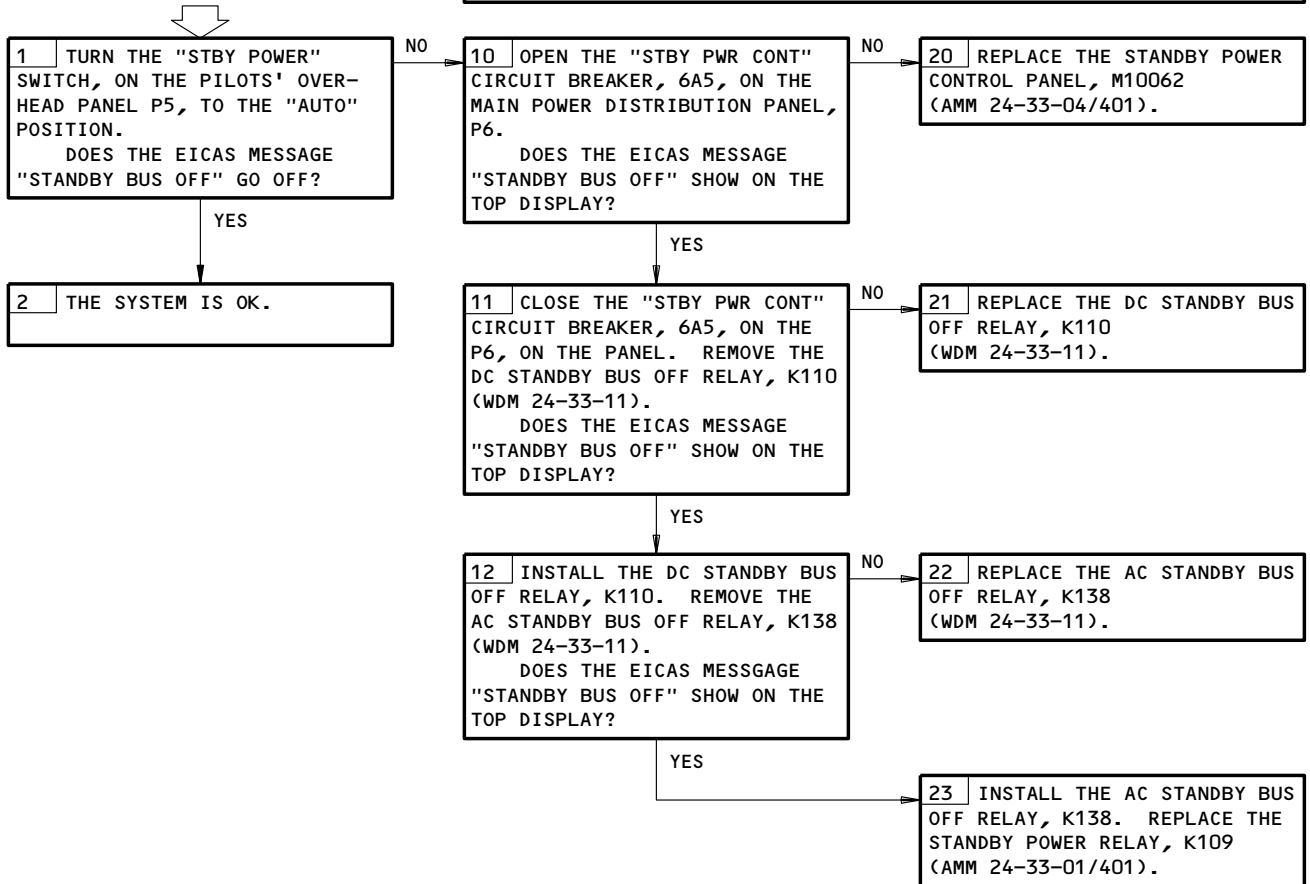
Eicas Message "STANDBY BUS OFF" Shows
Figure 107

MAKE SURE THESE CIRCUIT BREAKERS ARE CLOSED:
6A1,6A2,6A5,6C11,6D2,6D12,6G6,6J9,6J10,6J11,6J17,
11D1,11D2,33E2

MAKE SURE THE AIRPLANE IS IN THIS CONFIGURATION:
ELECTRICAL POWER IS ON (AMM 24-22-00/201)

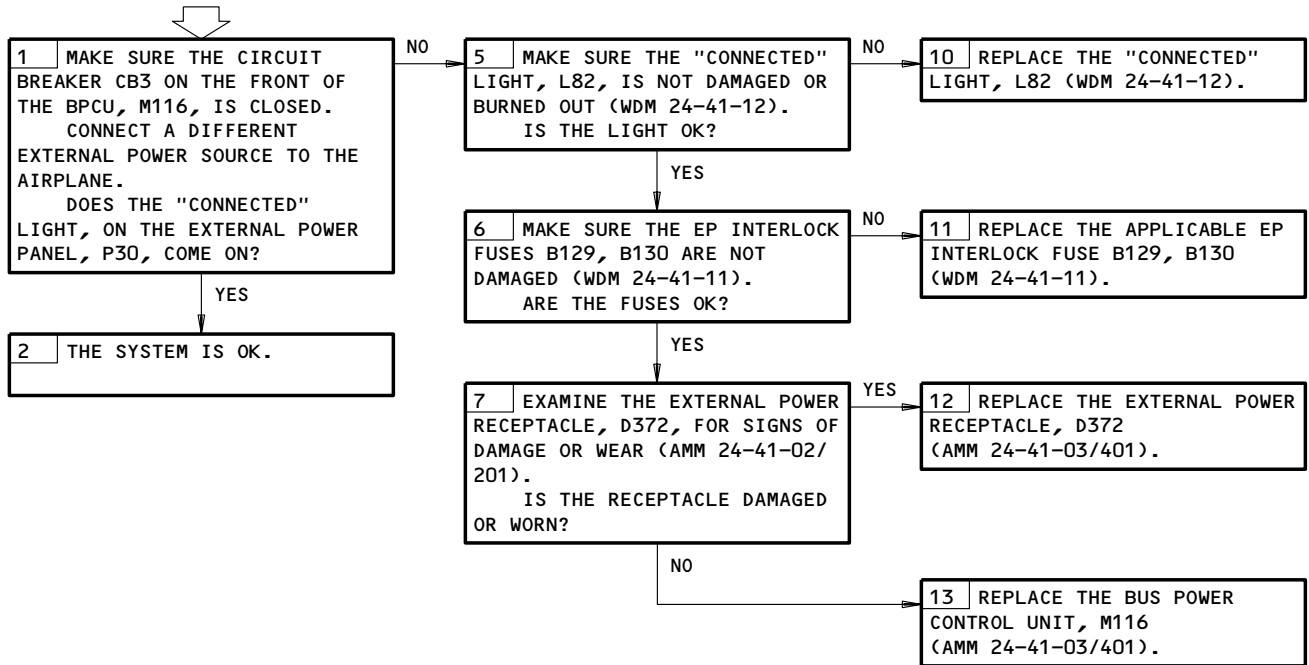
External Power AVAIL or CONNECTED Lgt Extin with
External Power Connected to Receptacle
Figure 104

MAKE SURE THIS CIRCUIT BREAKER IS CLOSED:
34M6

MAKE SURE THE AIRPLANE IS IN THIS CONFIGURATION:
POWER TO THE GROUND HANDLING BUS (AMM 24-22-00/201)
