BOEING CARD NO. 72-401-01-1

SKILL WORK AREA RELATED TASK INTERVAL MPD TASK CARD PHASE REVISION REV 00500 HRS 016 DEC 22/08 ENGIN | ENGINE 1 10101 APPLICABILITY
ANF ENGINE STRUCTURAL ILLUSTRATION REFERENCE AIRPLANE CHECK/INSP **ENGINE 1 FAN ROTOR BLADES**

VISUALLY CHECK THE ENGINE 1 FAN ROTOR BLADES.

1. <u>1st-Stage Fan Blade Airfoil Inspection of Surface Damage and Cracks</u> (Fig. 601)

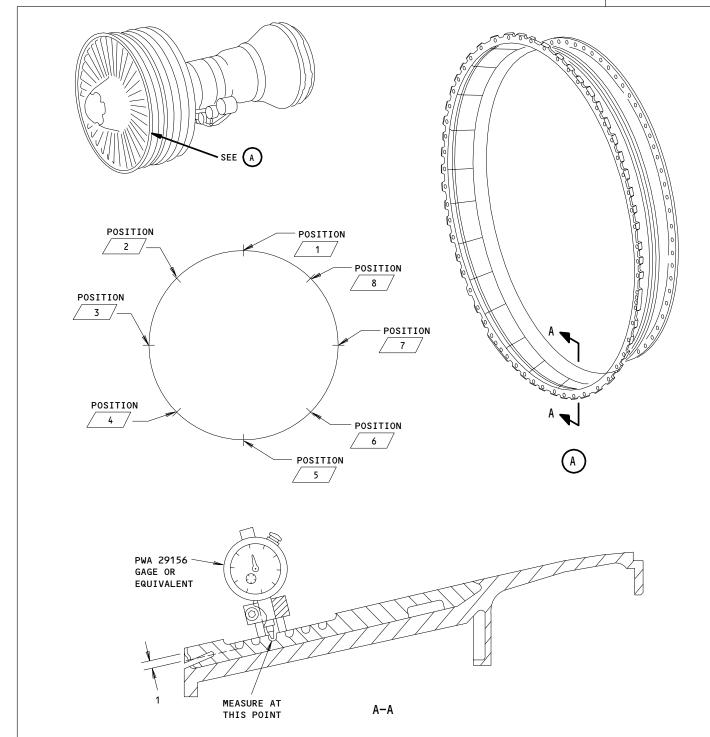
1. 0.140 INCH (3.556 MM) MINIMAL DEPTH, AVERAGE OVER SPECIFIED POSITIONS L-A3777

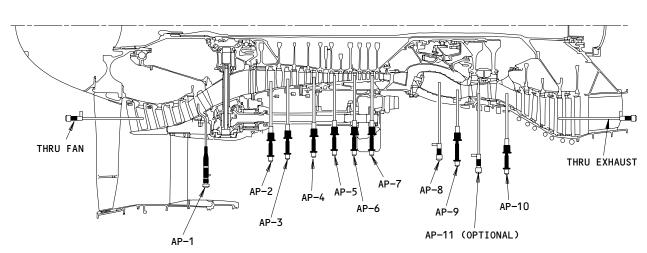
ACCESS PORT GASPATH LOCATION

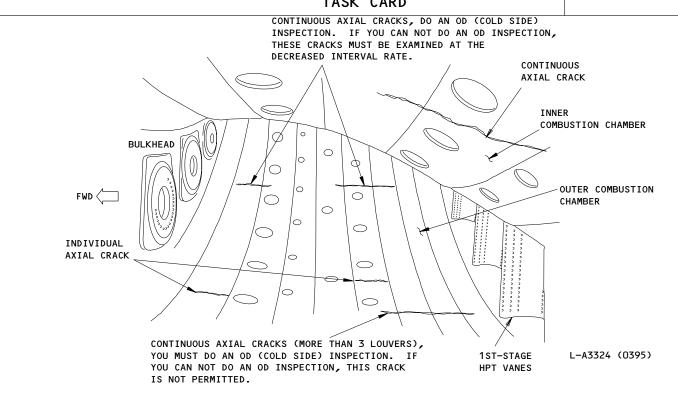
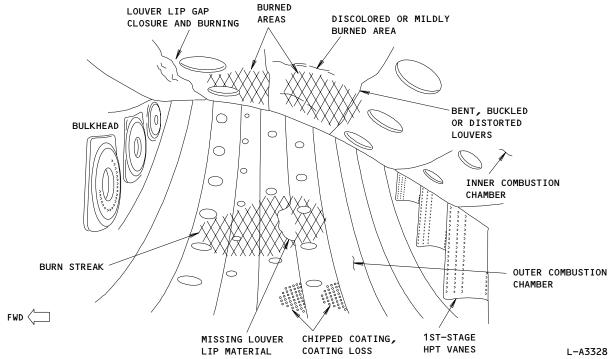
Inner and Outer Combustion Chamber Distress Figure 613 (Sheet 1)

VIEW IN THE CIRCUMFERENTIAL DIRECTION

(4) Compare the damage as identified in Figs. 612, 613, and 614 with the continue-in-service limits shown in Table 602A and Table 602B.

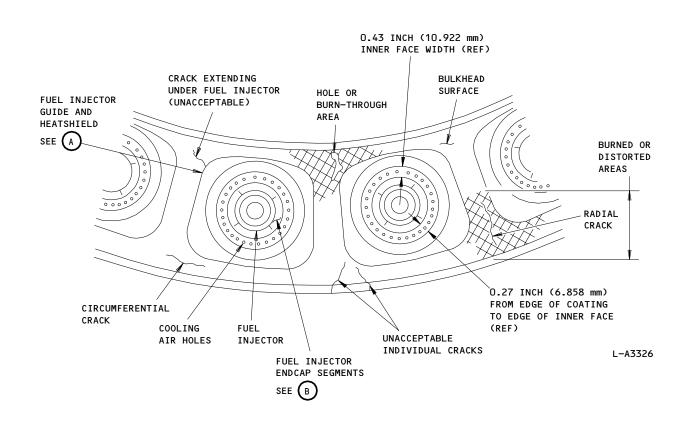
Combustion Chamber Bulkhead and Fuel Injector Guide Heatshield Distress Figure 614 (Sheet 1)

COMBUSTION CHAMBER BULKHEAD

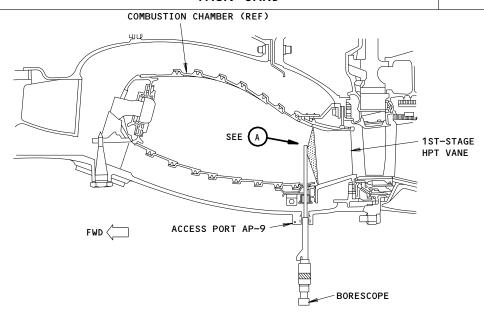
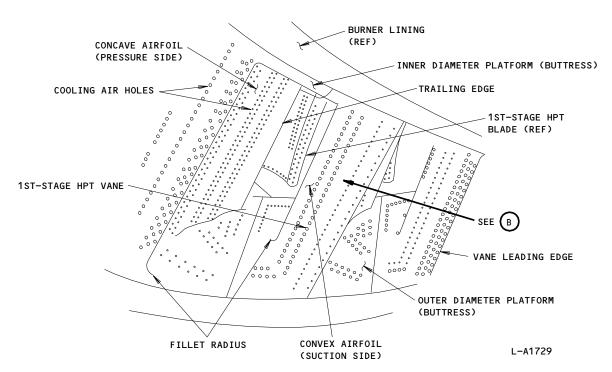
VIEW OF 1ST-STAGE HPT VANES THROUGH BORESCOPE

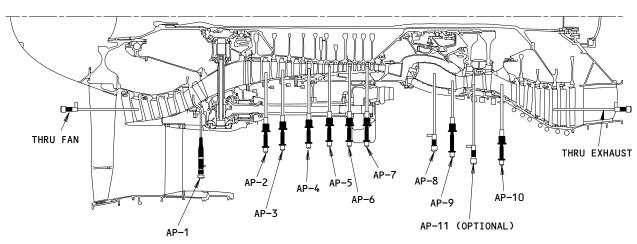
ACCESS PORT GASPATH LOCATION

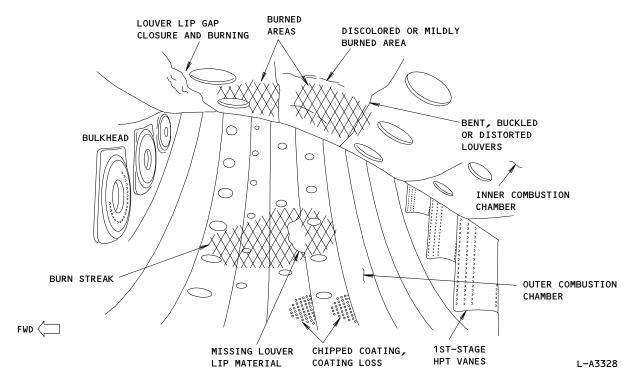
Inner and Outer Combustion Chamber Distress Figure 613 (Sheet 1)

CONTINUOUS AXIAL CRACKS, DO AN OD (COLD SIDE) INSPECTION. IF YOU CAN NOT DO AN OD INSPECTION, THESE CRACKS MUST BE EXAMINED AT THE DECREASED INTERVAL RATE. CONTINUOUS AXIAL CRACK INNER COMBUSTION CHAMBER BULKHEAD 0 OUTER COMBUSTION FWD (0 CHAMBER \bigcirc INDIVIDUAL AXIAL CRACK CONTINUOUS AXIAL CRACKS (MORE THAN 3 LOUVERS), YOU MUST DO AN OD (COLD SIDE) INSPECTION. IF 1ST-STAGE L-A3324 (0395) YOU CAN NOT DO AN OD INSPECTION, THIS CRACK HPT VANES

VIEW IN THE CIRCUMFERENTIAL DIRECTION

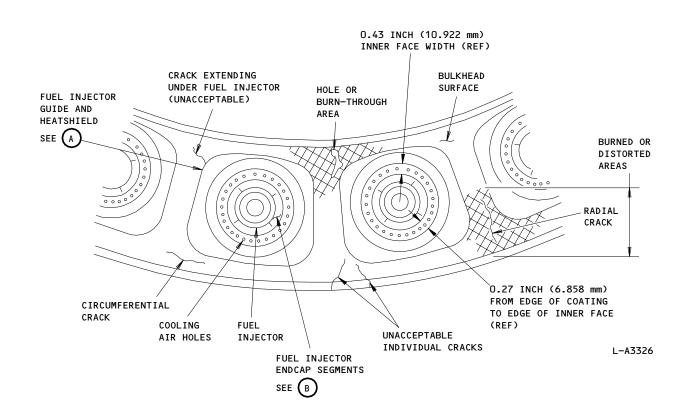
Combustion Chamber Bulkhead and Fuel Injector Guide Heatshield Distress Figure 614 (Sheet 1)

COMBUSTION CHAMBER BULKHEAD

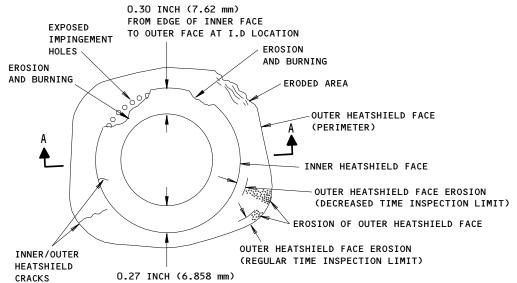
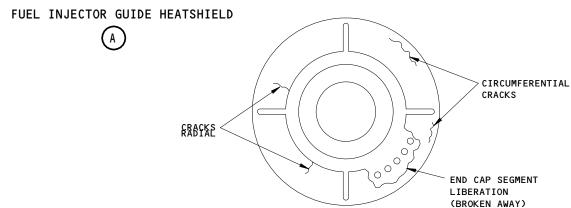
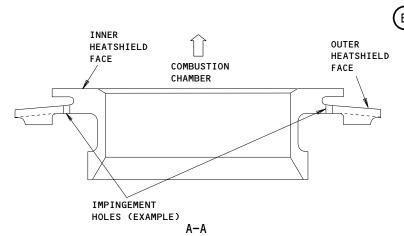
Combustion Chamber Bulkhead and Fuel Injector Guide Heatshield Distress Figure 614 (Sheet 2)

FROM EDGE OF INNER FACE
TO OUTER FACE AT O.D LOCATION

FUEL INJECTOR ENDCAP SEGMENTS

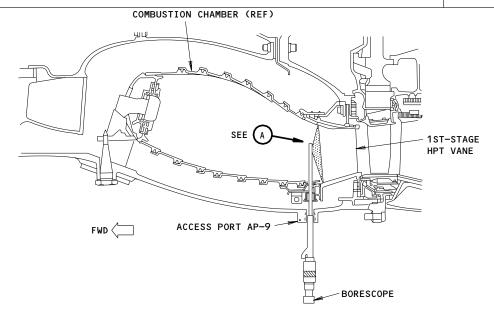
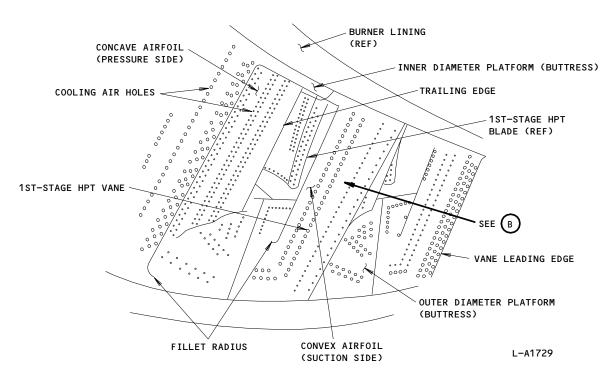
VIEW OF 1ST-STAGE HPT VANES THROUGH BORESCOPE

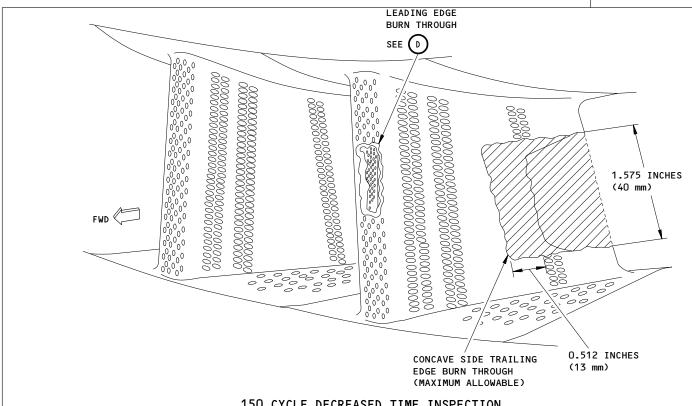
150 CYCLE DECREASED TIME INSPECTION (CONCAVE AIRFOIL SURFACE)

LEADING EDGE BURN THROUGH
