GP160F/160DF/160

SERVICE HANDBOOK

FY8-23B3-000

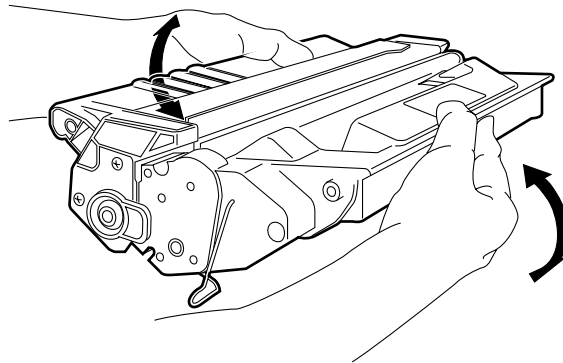
Figure 1-1

- a) When setting the cartridge in the copier, or when blank areas occur in the copy image because toner runs out during copying, hold the cartridge level, as shown in figure 1-1, and shake it several times at about 90° in both directions. After the toner inside the cartridge has been leveled evenly, set the cartridge in the copier. If the cartridge is shaken in a manner other than that described above, there is the danger that toner may leak from the developing assembly and cleaning assembly.

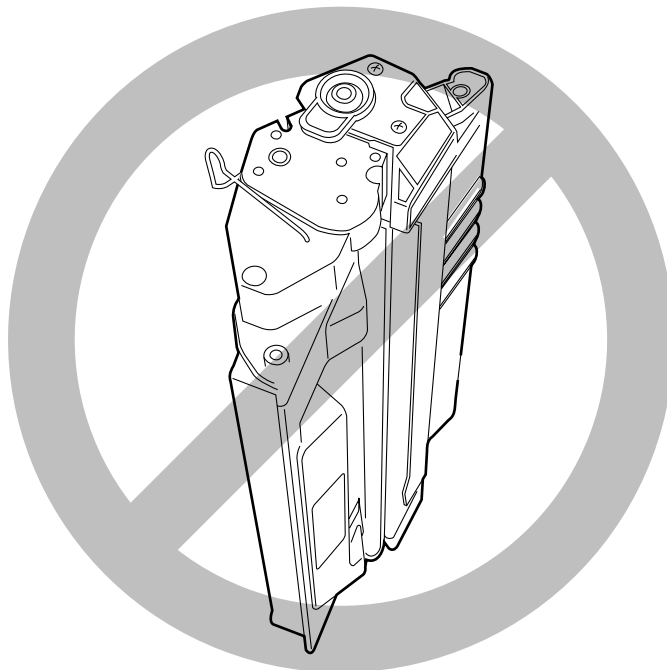
Figure 1-2

- b) As shown in Figure 1-2, do not hold the cartridge vertically or upside down. Also, do not wave it about.

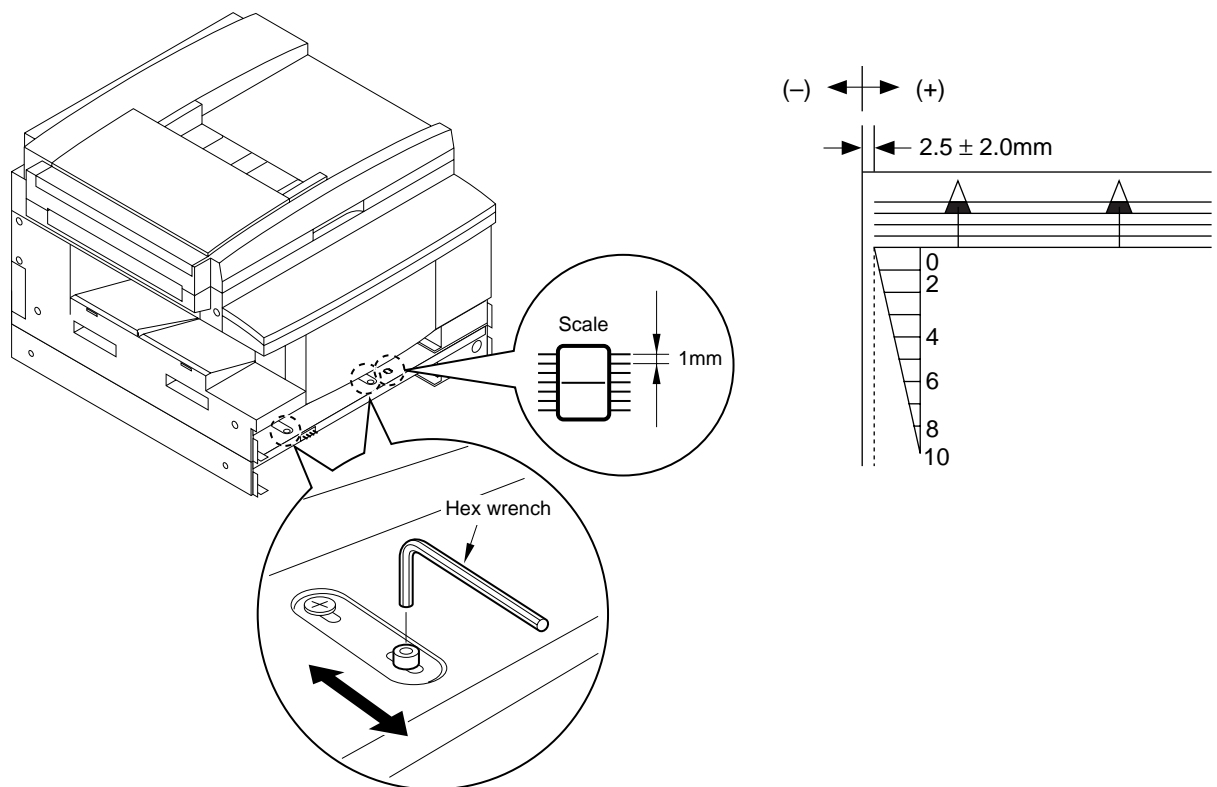
Figure 2-1

- 1) Remove the cassette from the cassette level that needs adjustment.
- 2) Loosen the hex screw and move the adjusting plate back and forth. Adjust by lining up with the 1mm interval scale marks.

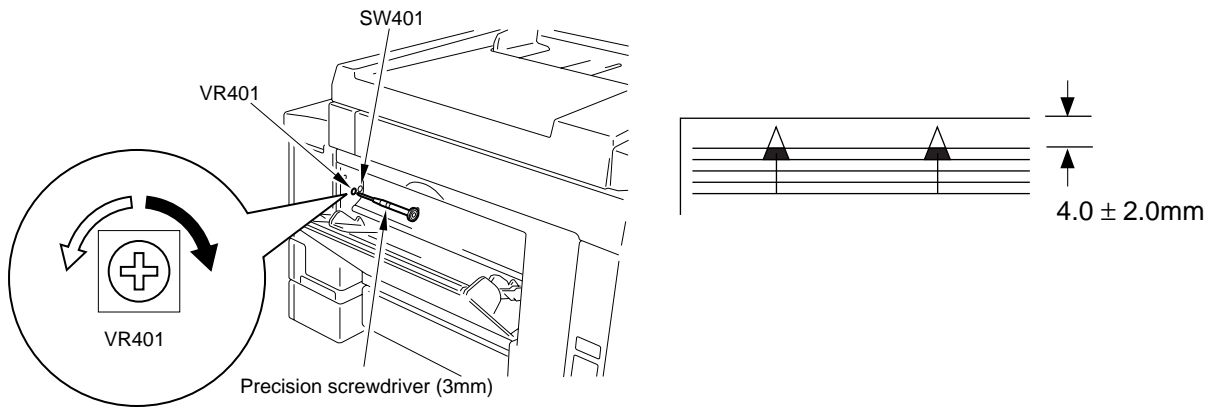
Figure 2-2

Adjustment when the leading edge of the printed image is out of alignment.

- Use a precision screwdriver to press down on SW401 and output a test print.
- Turn VR401 and adjust the leading edge margin of the test print to $4.0 \pm 2.0\text{mm}$.

VR401 : VR for image leading edge margin adjustment
 SW401 : Push switch for test print output

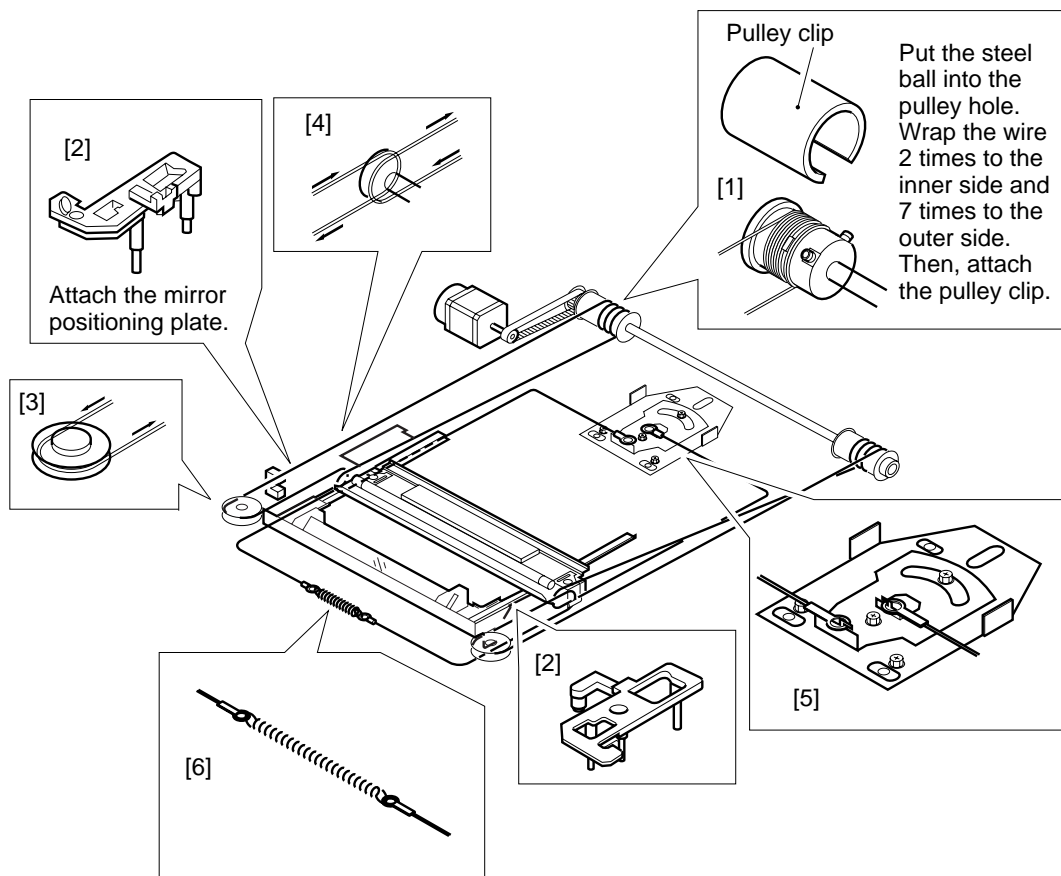
Figure 2-3

Attach the wire, following steps 1 to 9. Then perform the mirror positioning adjustment described on the next page.

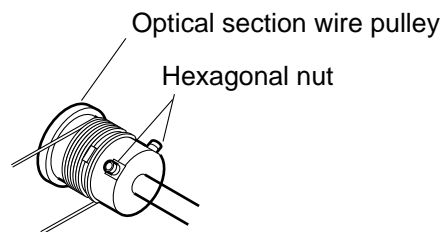
Figure 2-4

a) Adjusting position of No. 2 mirror mount

If the optical section wire pulley's hexagonal fixing nut has been loosened, follow the procedures described below to adjust the position of the No. 2 mirror mount, and then tighten the hexagonal nut.

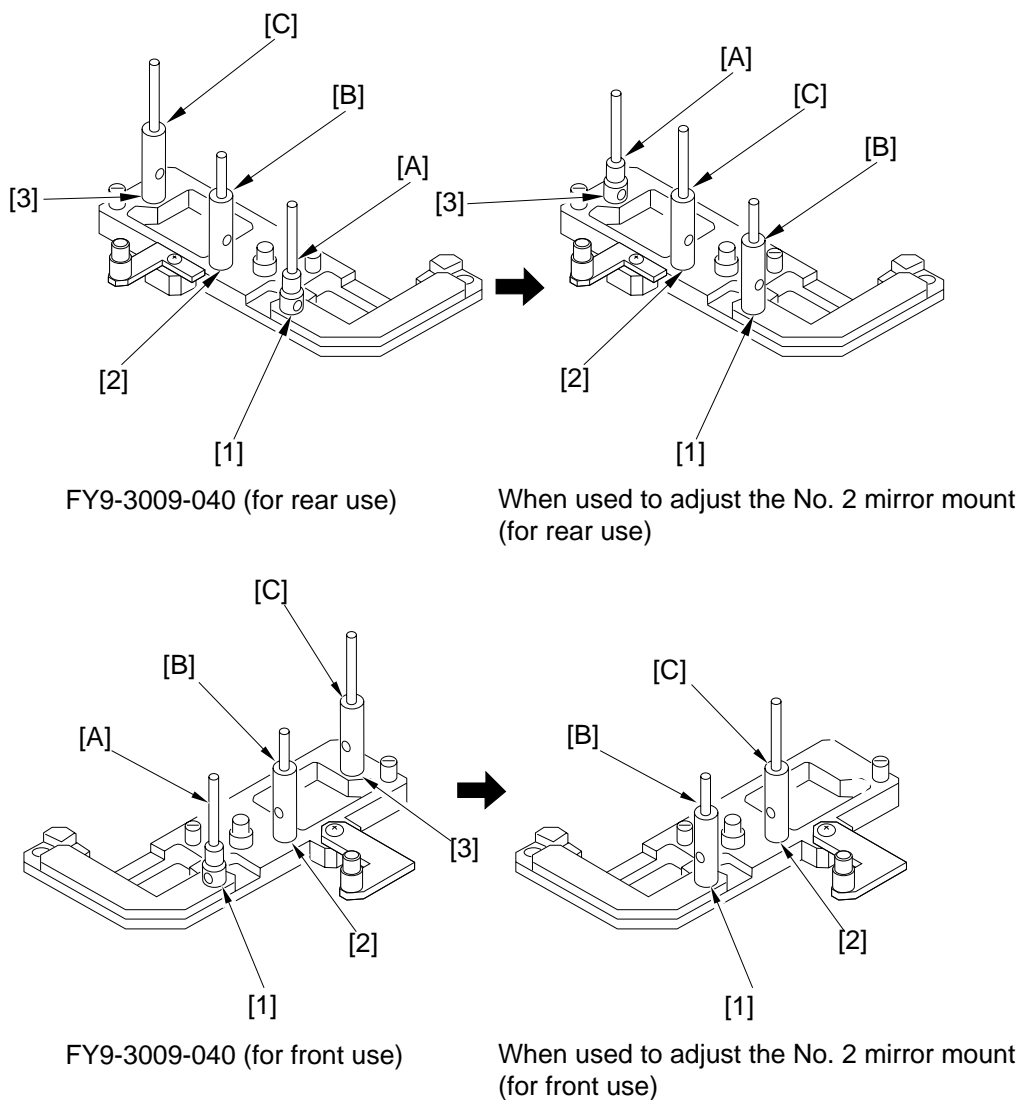
Figure 2-5

The mirror positioning tool used in the positioning of the No. 2 mirror mount is illustrated below.

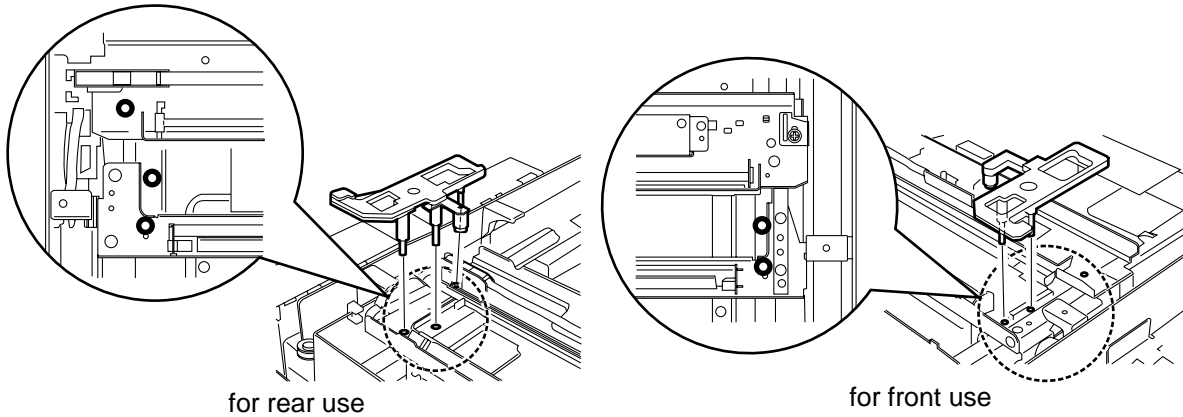
Figure 2-6

With the mirror positioning tool fitted in the holes shown below, tighten the optical unit wire pulley's hexagonal fixing nut.

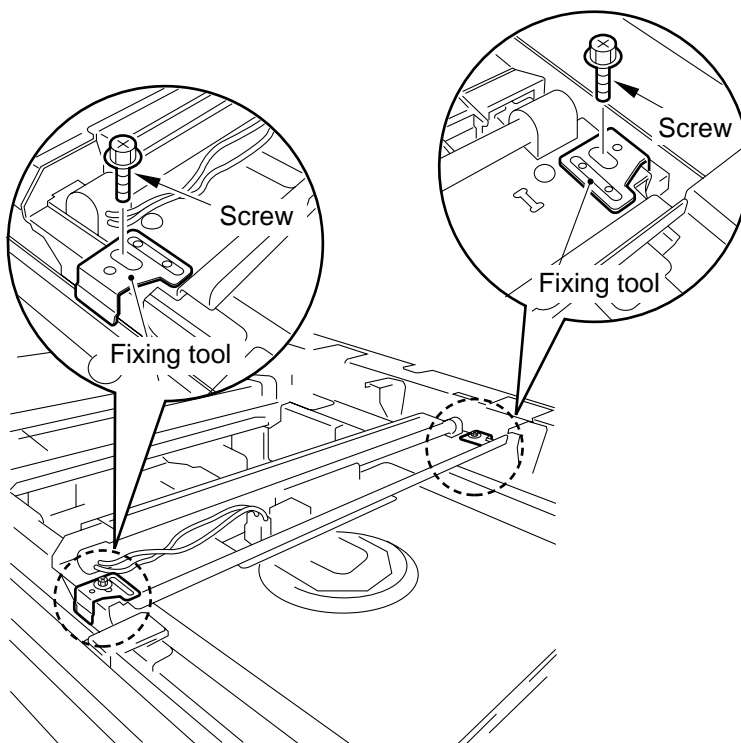
Figure 2-7

b) Adjustment of distance between No. 1 and No. 2 mirror mounts

With the optical system wire fixing tool for No. 1 mirror mount loosened, follow the procedures described below to adjust the distance between No. 1 and No. 2 mirror mounts, and then tighten the fixing tool.

This adjustment should be performed after the operation to adjust the position of No. 2 mirror mount, as described above.

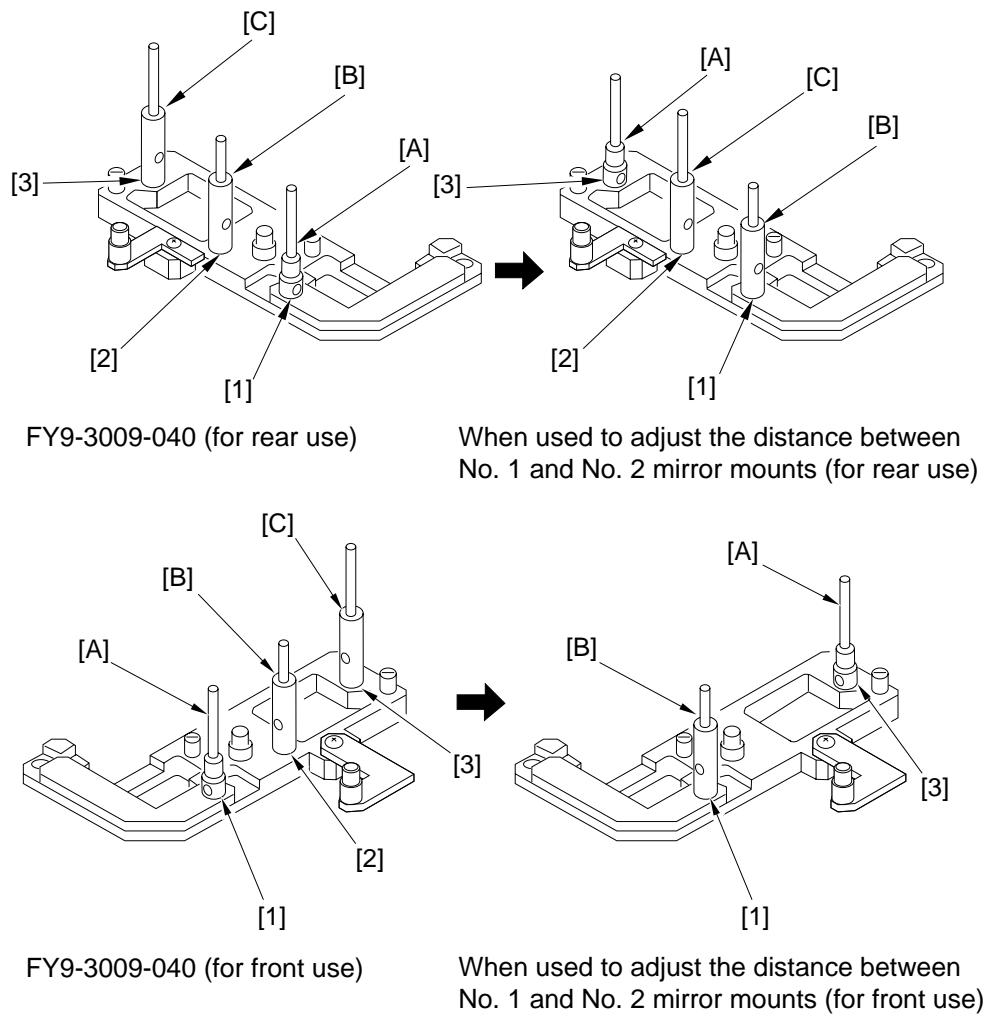
Figure 2-8

The mirror positioning tool used in the adjustment of the distance between No. 1 and No. 2 mirror mounts is illustrated below.

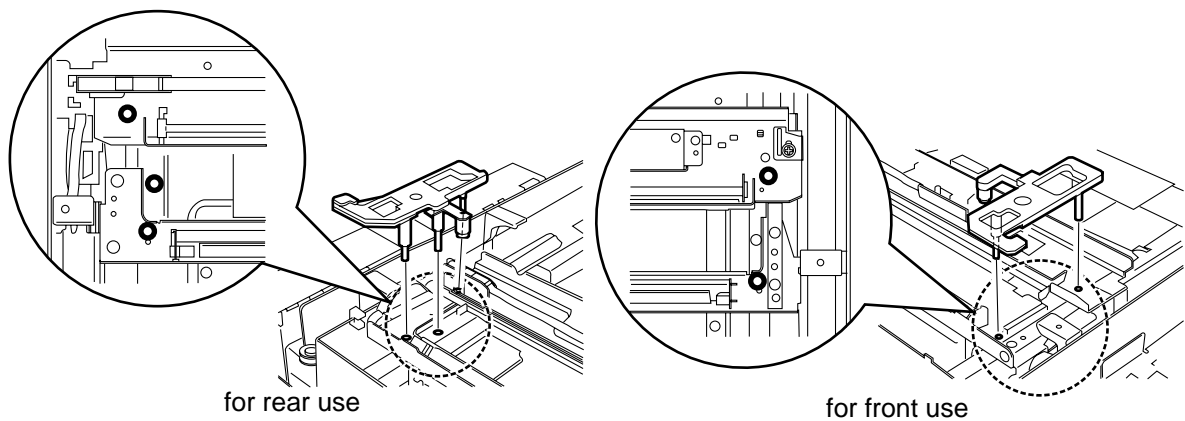
Figure 2-9

With the mirror positioning tool fitted in the holes shown below, attach the optical unit wire hexagonal fixing tool.

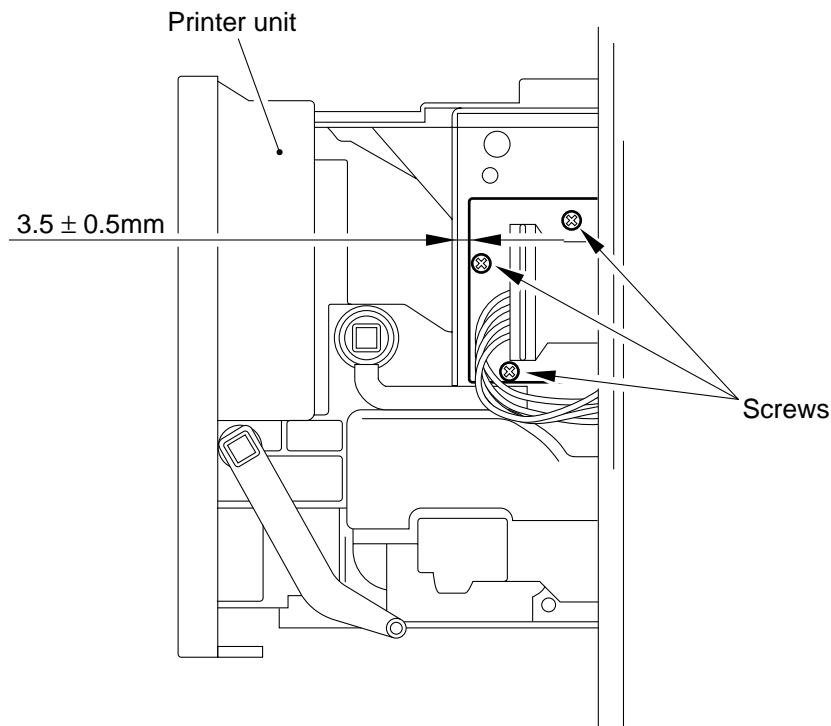
Figure 2-10

When the printer unit receptacle connector is removed or attached, adjust the mount position, following the procedure described below.

- 1) Loosen the 3 receptacle connector screws.
- 2) Adjust so that the interval between the printer unit frame and the receptacle connector is $3.5 \pm 0.5\text{mm}$.

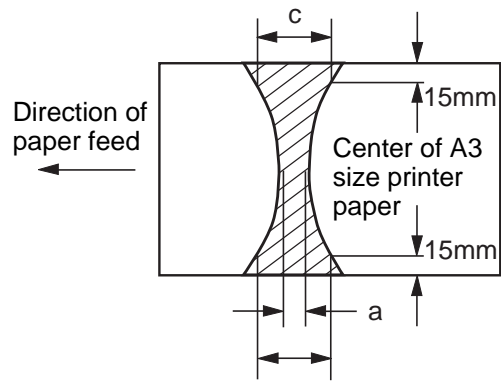
**Figure 2-11**

- 1) Make one solid black copy on size A3 paper.
- 2) Place the black side of the paper face down and set the solid black copy in the multi-feeder.
- 3) When the leading edge of the paper comes out into the copy tray, quickly switch off the power source and leave it as is for about 10 seconds.
- 4) Remove the paper as you would to clear a paper jam from the printer unit.
- 5) Measure the width of the part of the removed paper that is wet and shiny with toner. Check that the width is within the range displayed in Table 2-1.

Dimensions
a	5.5 ± 1.0 (mm)
c - a	1.0 (mm) or less
b - a	1.0 (mm) or less
b - c	1.0 (mm) or less

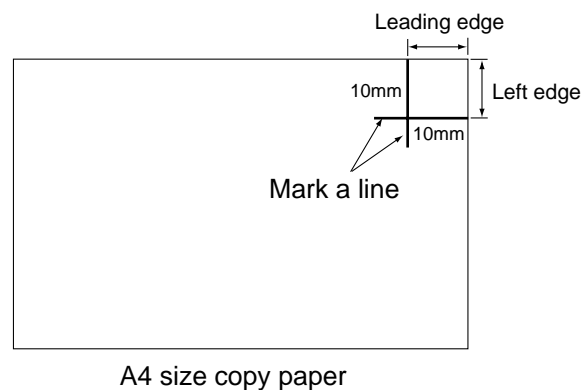
Figure 2-12

- 1) Make a test chart with marks every 1cm from the leading and left edges of the page, as shown in the figure below.

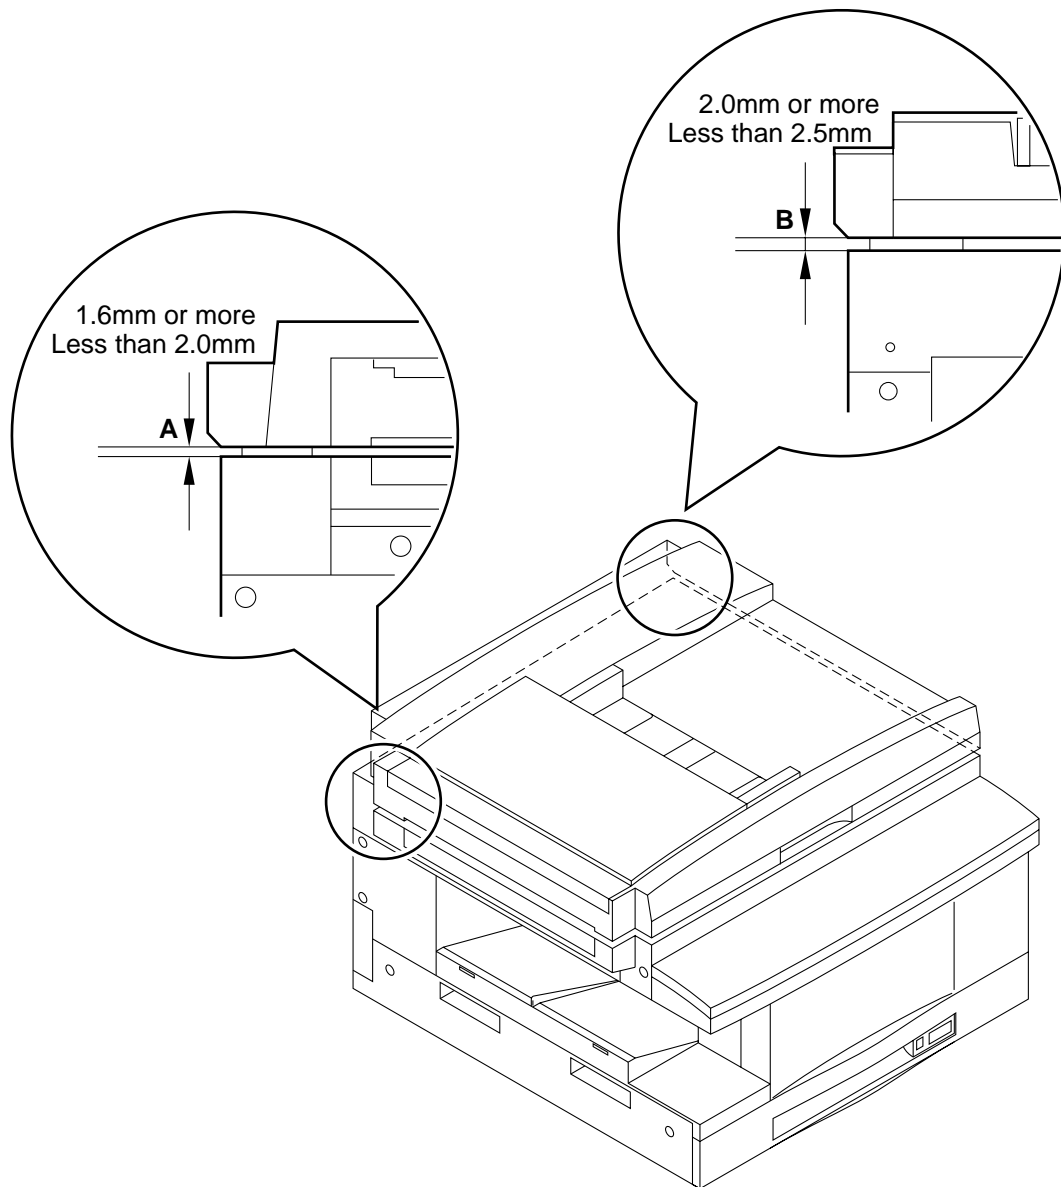
Figure 2-18

Measure the clearance at the locations indicated in the diagram to check that they meet the standard value. If the clearance length is outside the standard value, adjust the height.

Clearance A standard: 1.6 mm or more to less than 2.0 mm.
Clearance B standard: 2.0 mm or more to less than 2.5 mm.

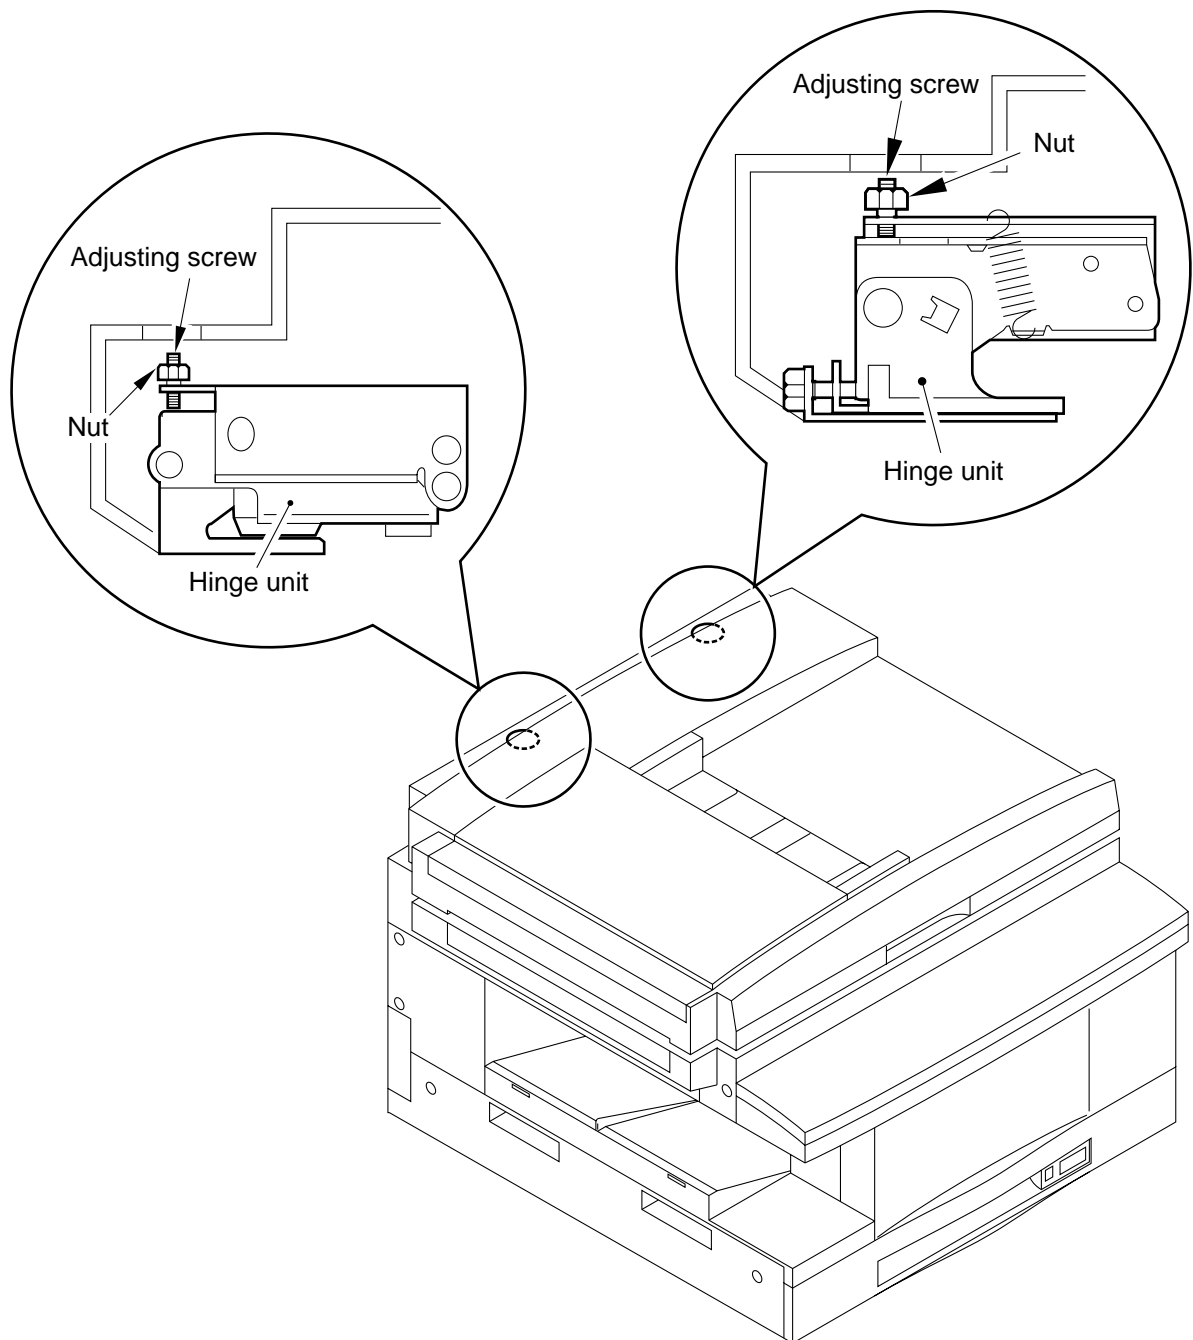
Figure 2-19

If the clearance is outside the standard, loosen the nut on the ADF hinge unit and adjust with the adjusting screw.

When clearance A is outside the standard value, turn the adjusting screw on the left hinge unit.

When clearance B is outside the standard value, turn the adjusting screw on the right hinge unit.

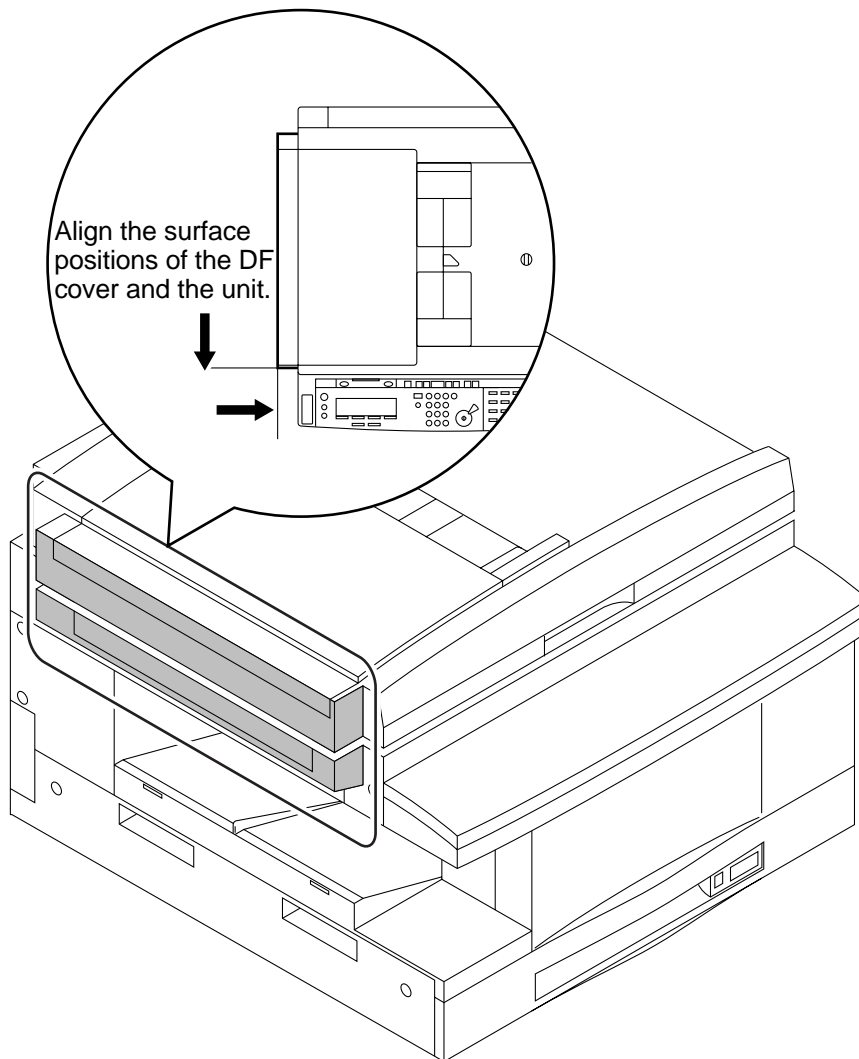
Figure 2-20

Compare the surface position of the DF cover and DF delivery cover to make sure that the surface positions are correctly aligned.

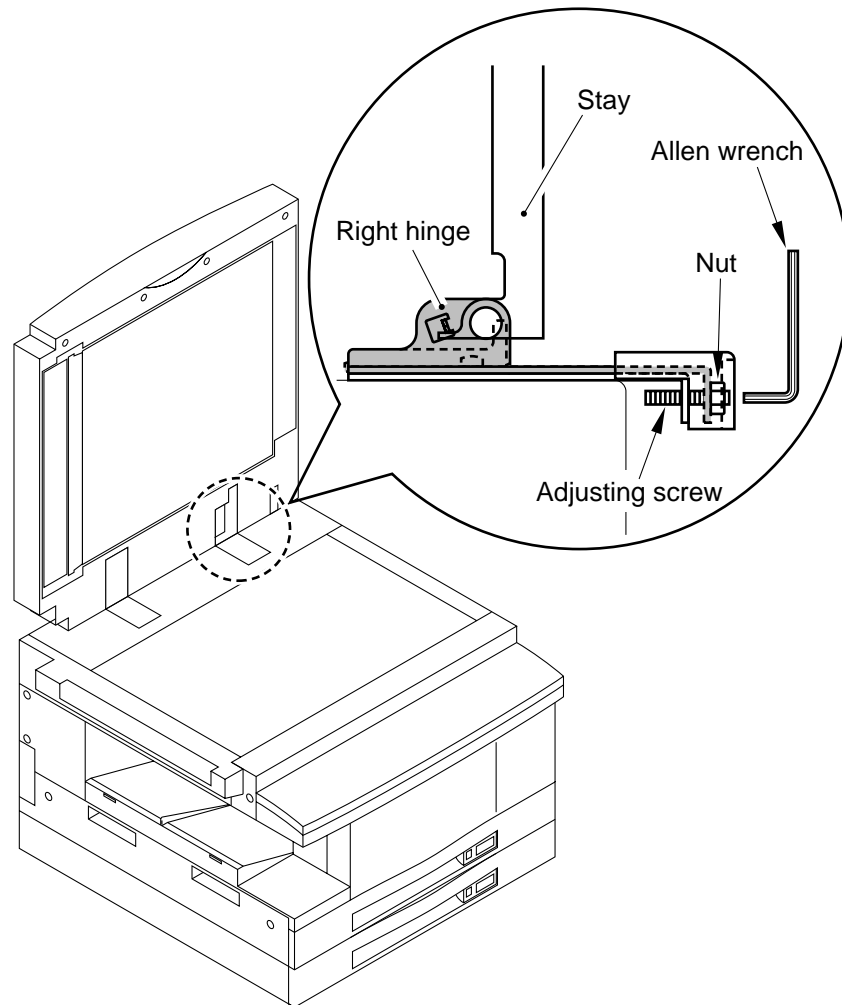
Figure 2-21

- 1) Loosen the right ADF hinge nut.
- 2) Use an Allen wrench to turn the adjusting screw and adjust ADF position.
- 3) After adjusting skew feed, tighten the nut to secure the adjusting screw.

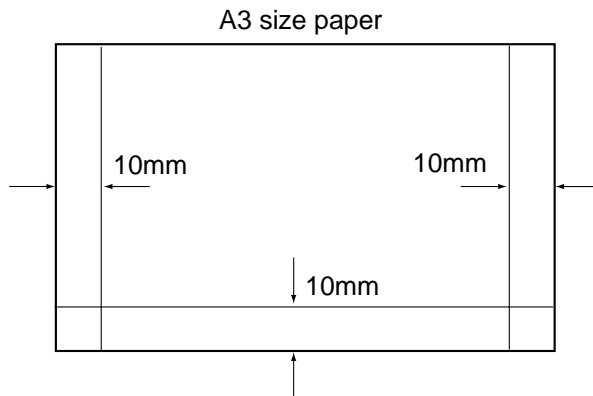
Figure 2-22

- 1) Use A3 (297 × 420 mm) size plain paper (64 to 80 g/m²) and draw a straight line 10 mm from the paper edge on three sides of the paper to create a simple chart.

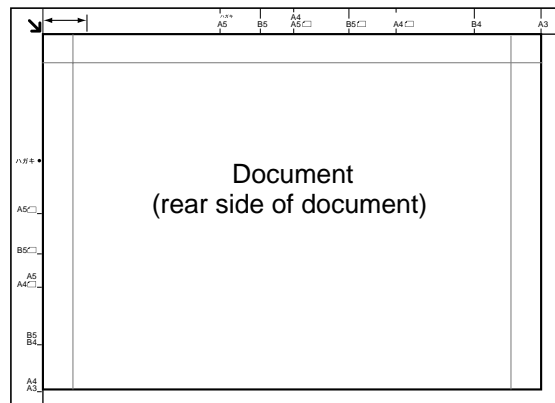
Figure 2-23

- 2) Place the chart on the copyboard glass and make a direct copy to A3 (297 × 420 mm) size paper. The delivered copy is sample A.

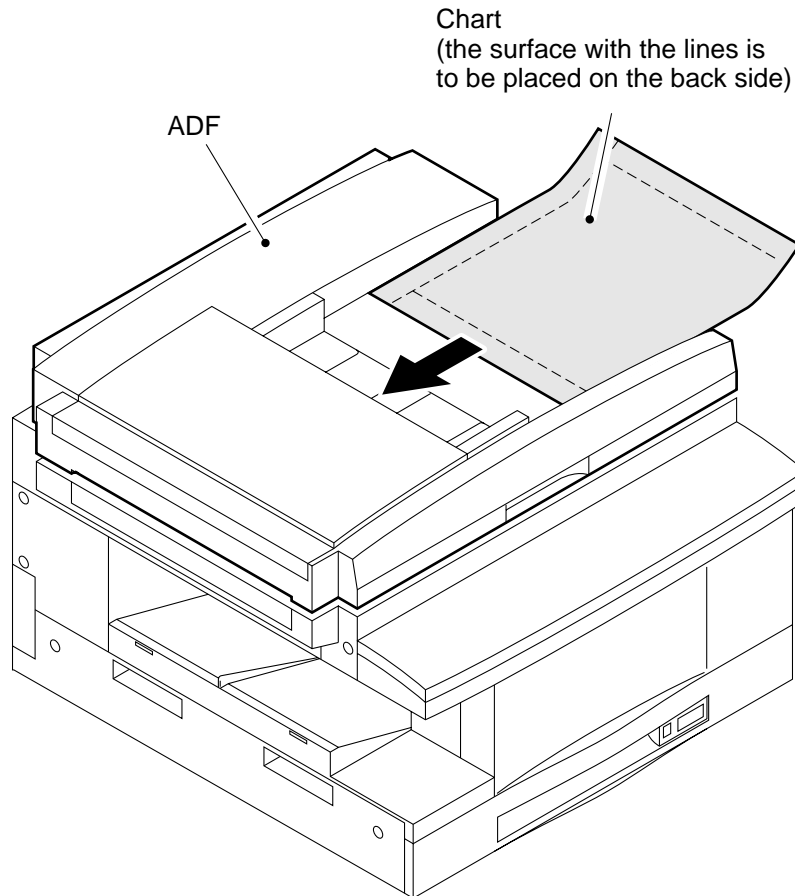
Figure 2-24

- 3) Place the chart in the ADF and make a direct copy to A3 (297 × 420 mm) size paper. The delivered copy is sample B. Make sure that the chart is correctly oriented.

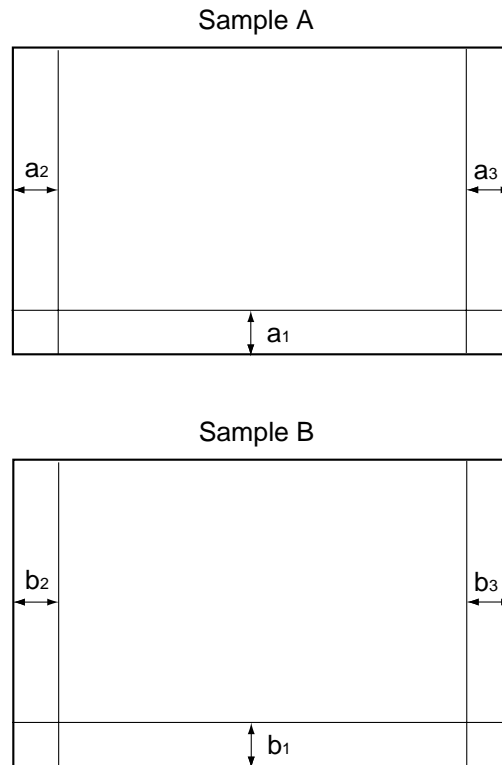
Figure 2-25

- 4) Measure the distance from the ruled line on sample A and sample B to the edge of the paper. The distances to be measured are a_1 , a_2 , a_3 , b_1 , b_2 and b_3 .

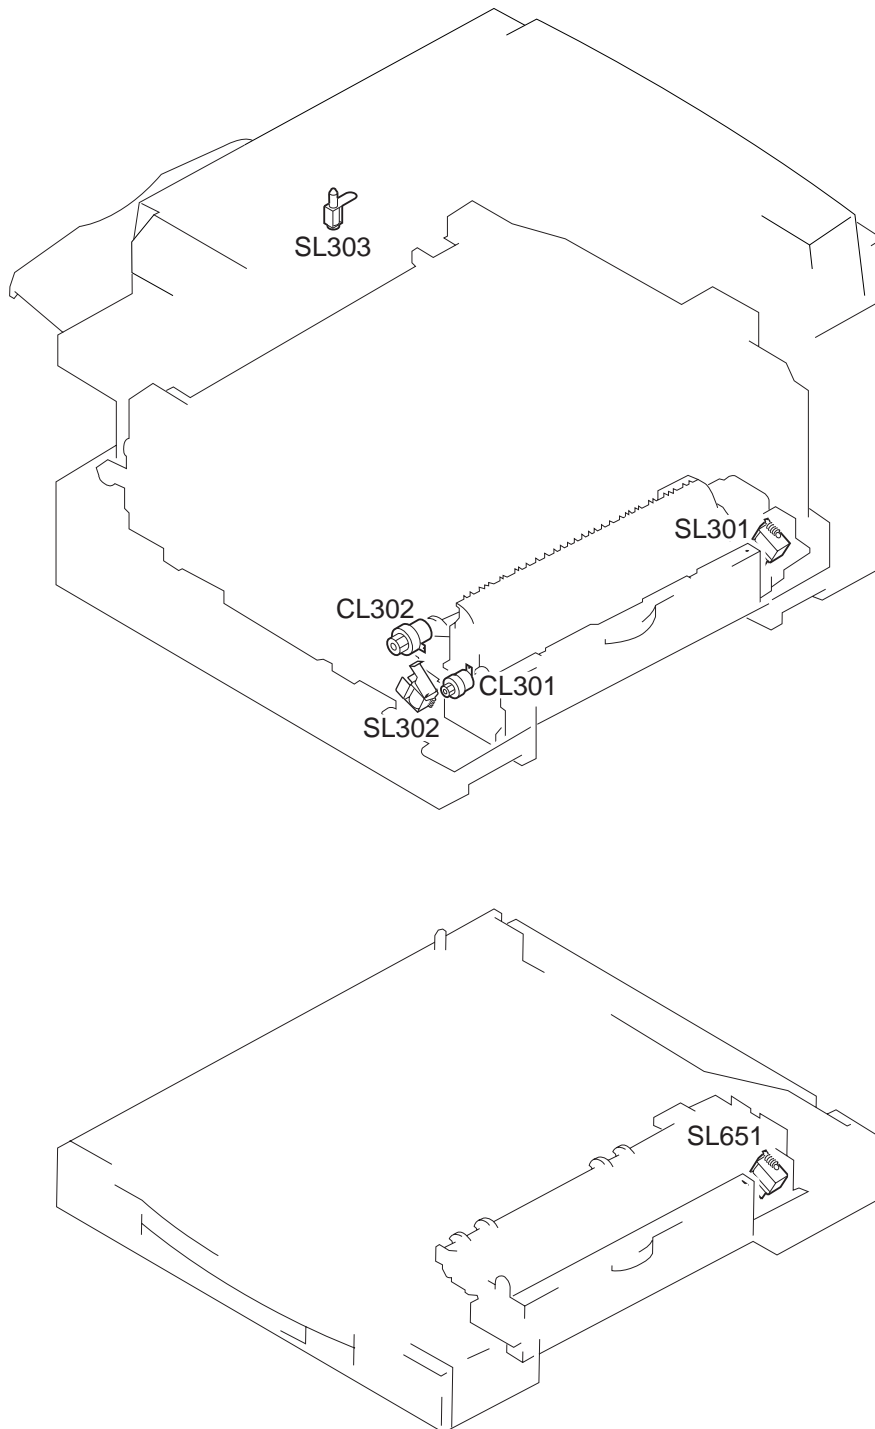
Figure 3-1

Clutch, solenoid types

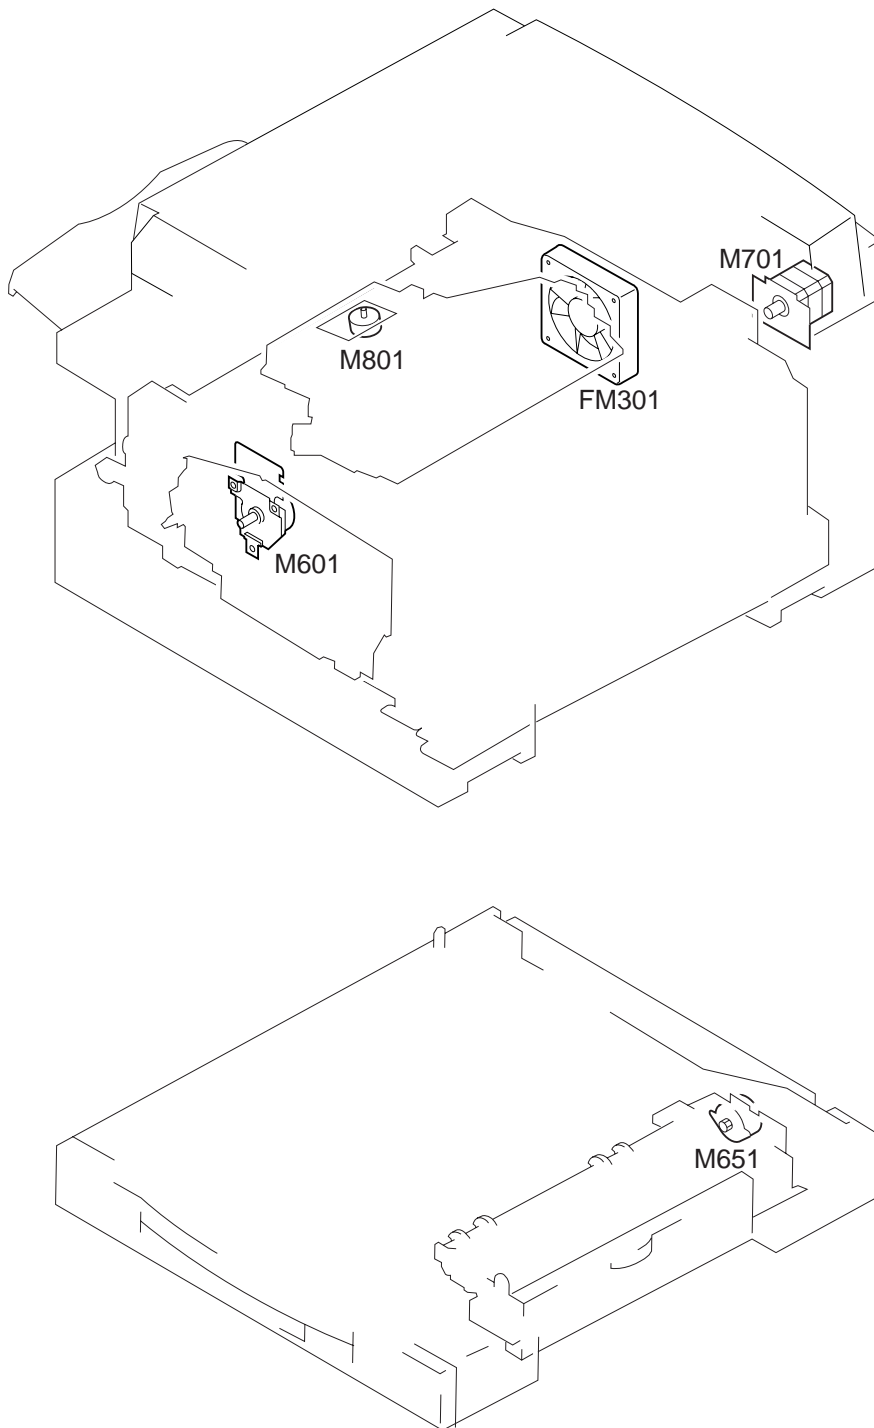
Figure 3-2

Motors, fans

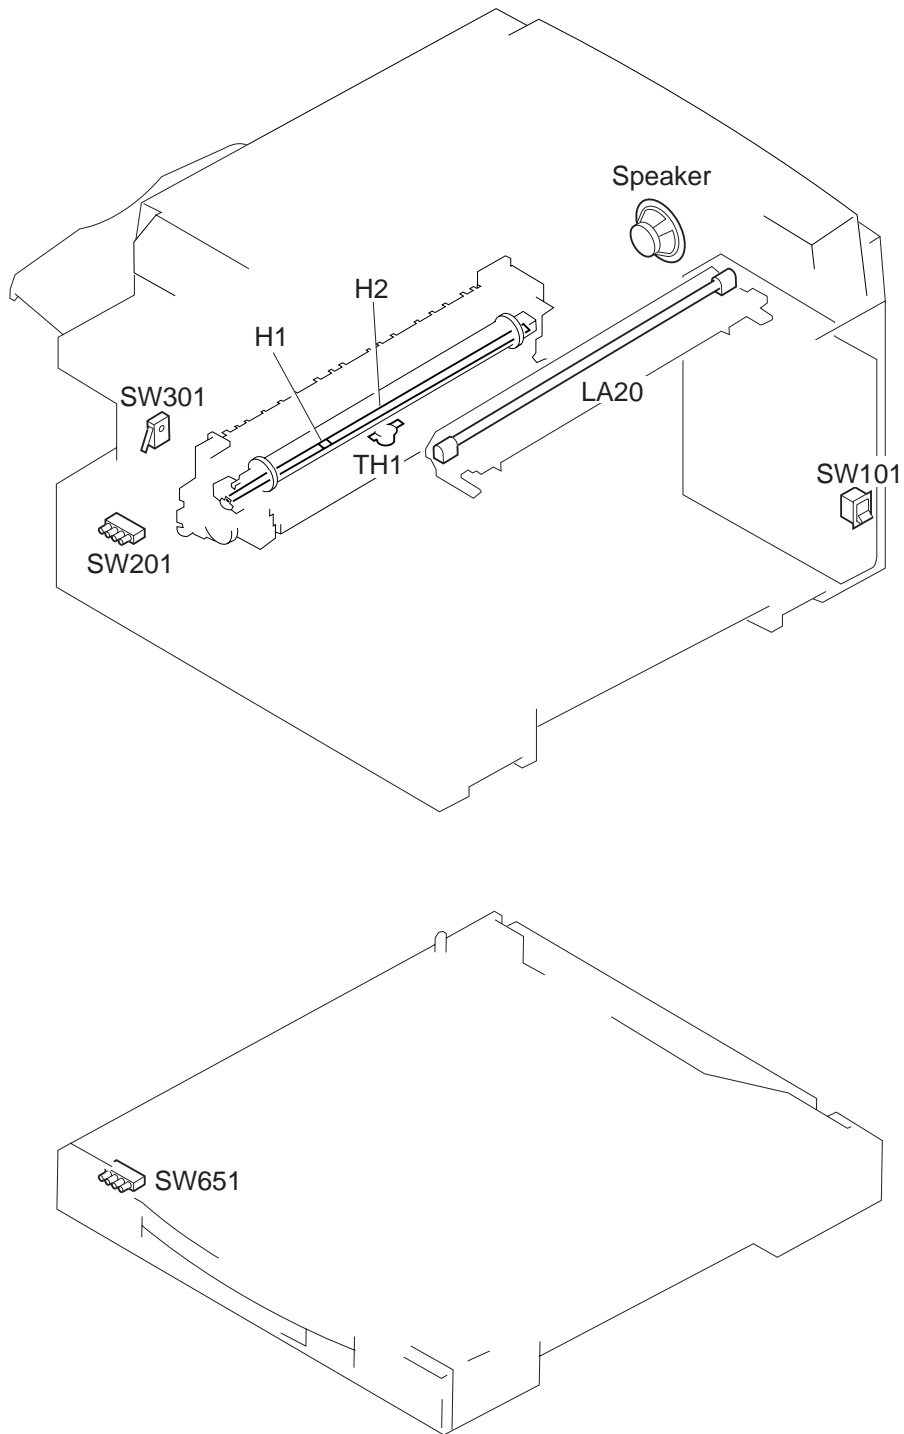
Figure 3-4

Switches, lamps, miscellaneous

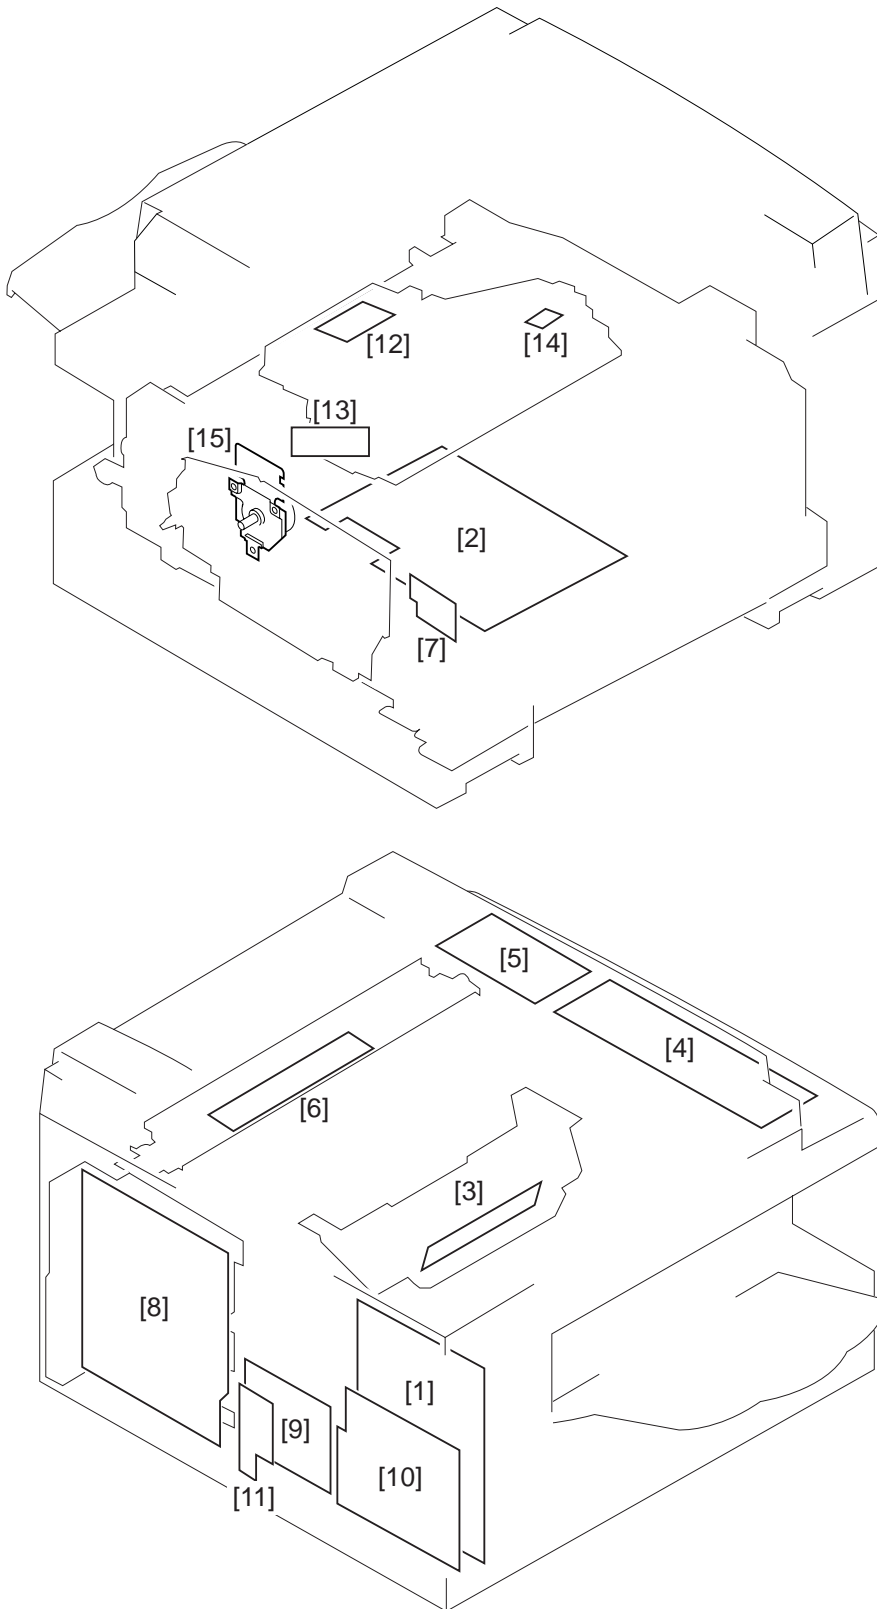
Figure 3-5

PCBs

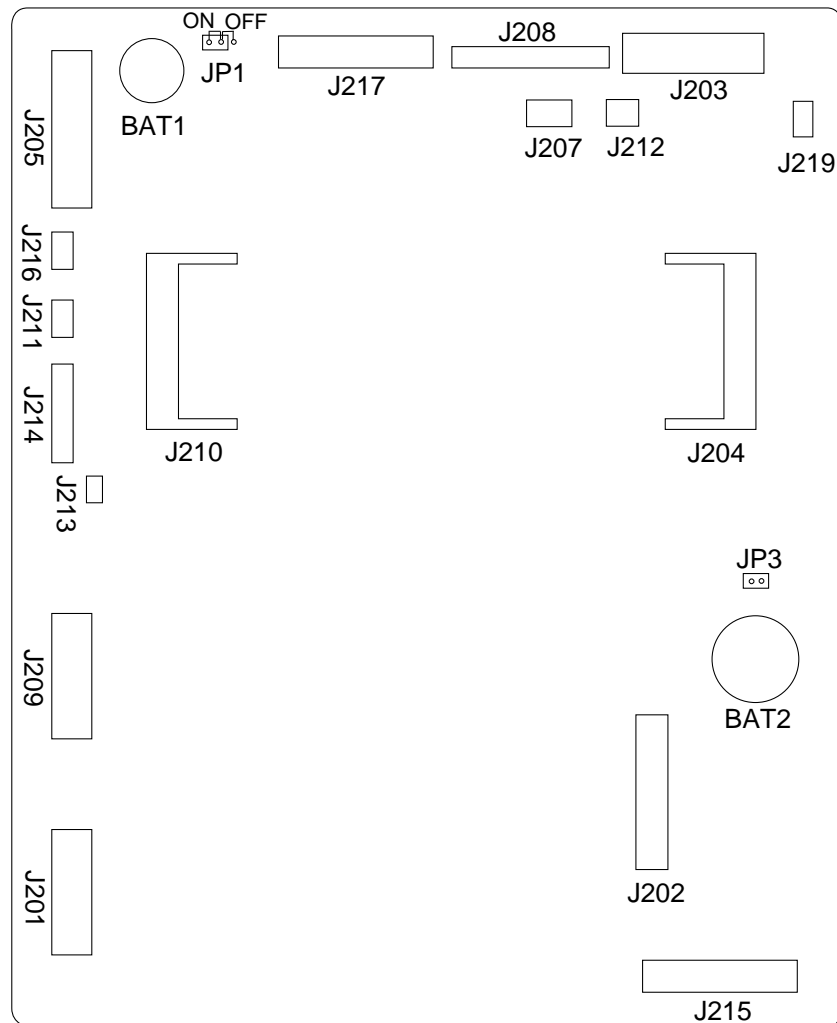
Figure 3-6

1. Image processor PCB

- **JP1** : Image memory backup battery (BAT1) electrification jumper plug
- **JP3** : Data control (user data, service mode data) memory backup battery (BAT2) electrification jumper plug
- **BAT1** : Fax transmission image memory backup battery
- **BAT2** : Control data (service mode data, user mode data) memory backup battery

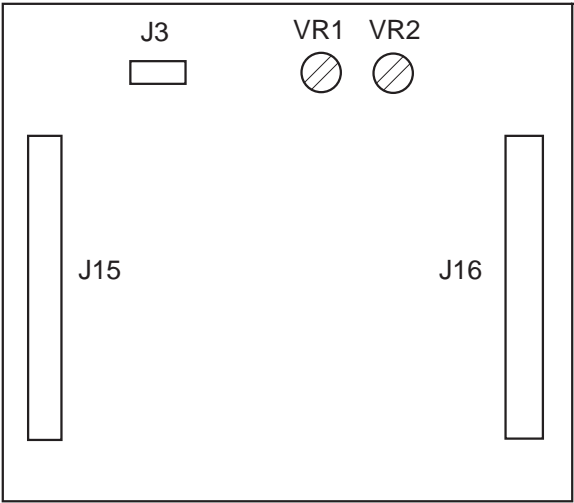
Figure 3-11

4. Modem board

No.	Role
J3	Connector for future expansion
J15	NCU interface connector
J16	Image processor PCB interface connector

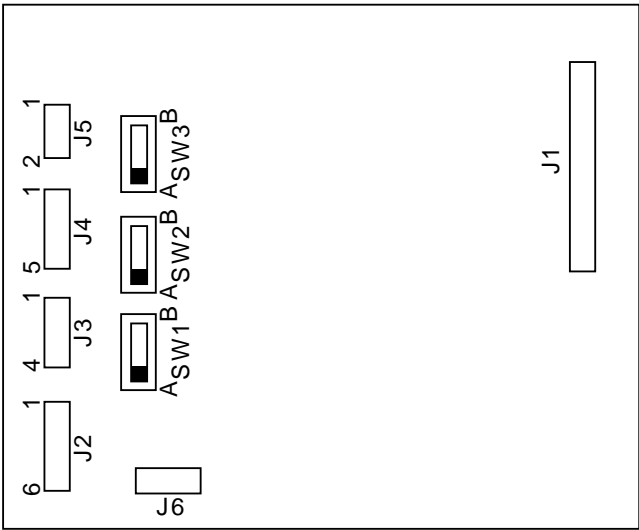
Figure 3-12

5. NCU board

Note: The NCU in the French model donot have SW1 through SW3.

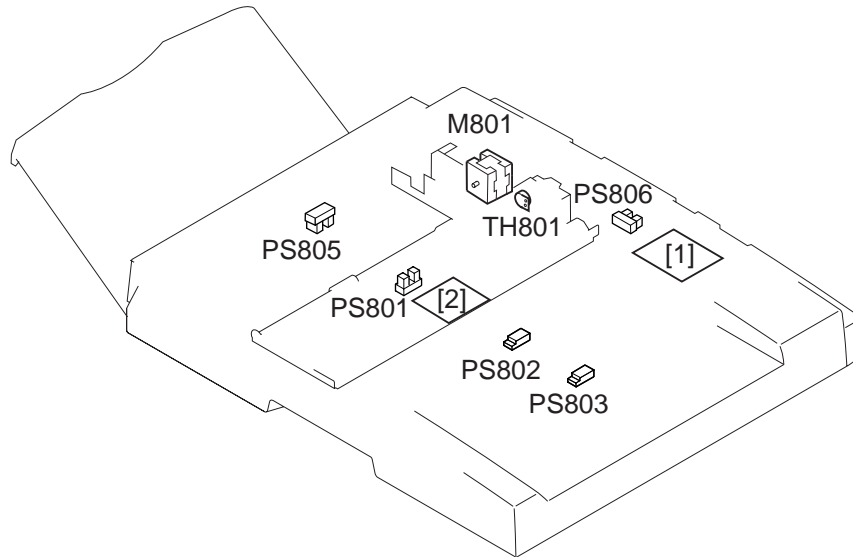
Figure 3-13

6. ADF

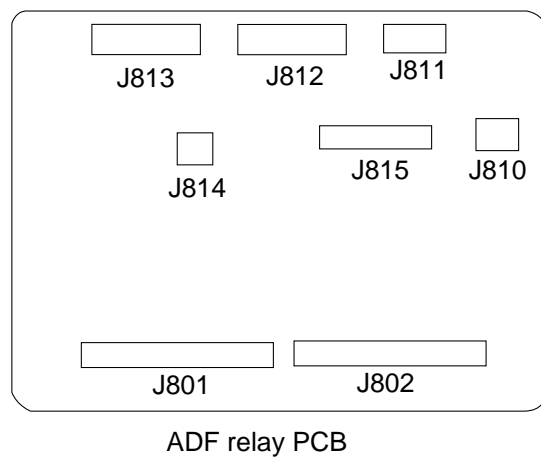
Figure 3-14

Symbol	Name	Role
[1]	ADF relay PCB	Communication signal interface between ADF and main unit
[2]	Document width sensor PCB	Document width detection
